13 November 2019

Fatal Accident Investigation Team

**INSPECTION REPORT OF BICYCLE (WHITE & BLUE) - TRAFFIC POLICE
POUND REPORT NO. 4340/19**

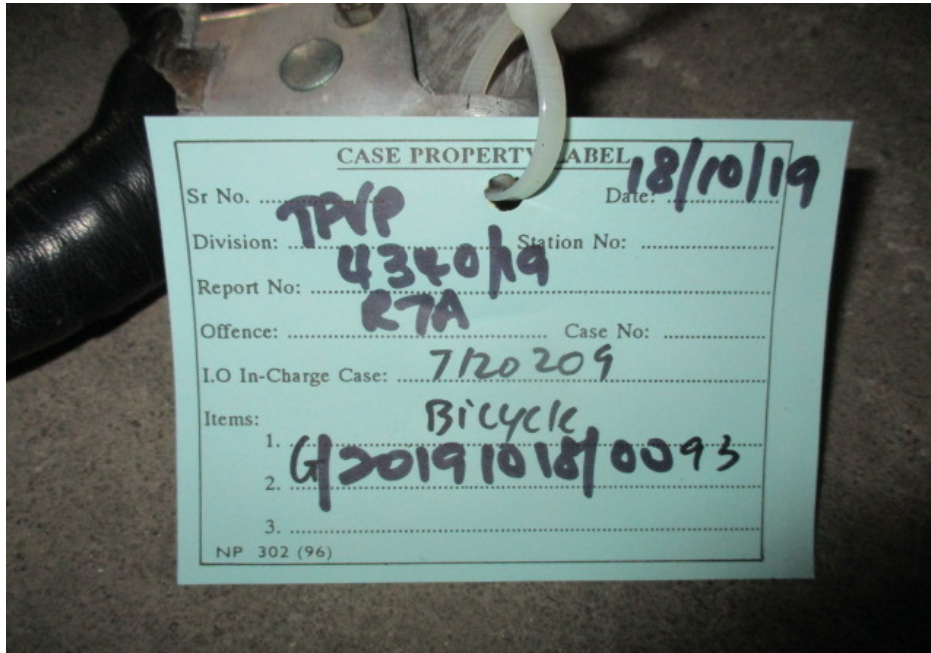
Photo 1 shows the identification of the Bicycle with reference to Traffic Police Pound Report No. 4340/17.

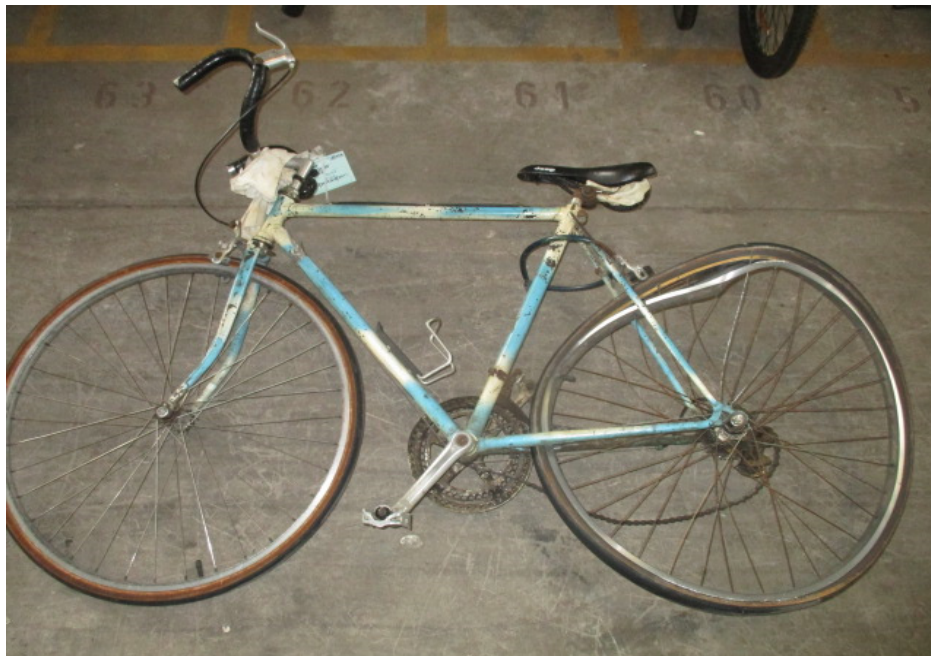
Photo 2 shows the left portion of the Bicycle at time of our inspection. The bicycle had sustained damages to its right and rear portion. The body parts that were found to have been damaged include its handlebar, frame, rear braking components & gear train, amongst others as a result of the accident.

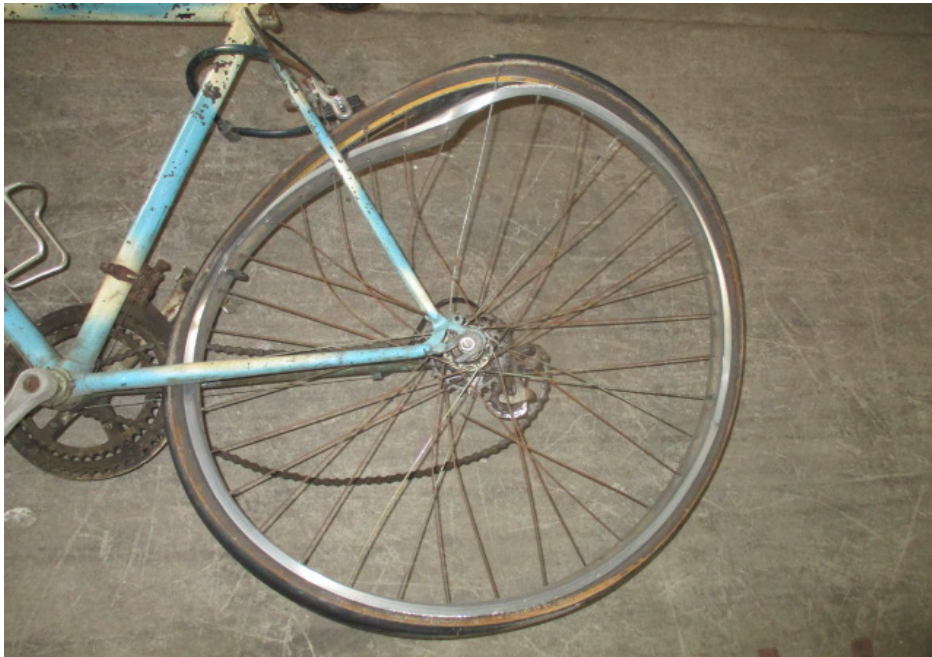
Photo 3 shows the left rear portion of the Bicycle at time of our inspection. The bicycle had sustained damages to its right and rear portion.

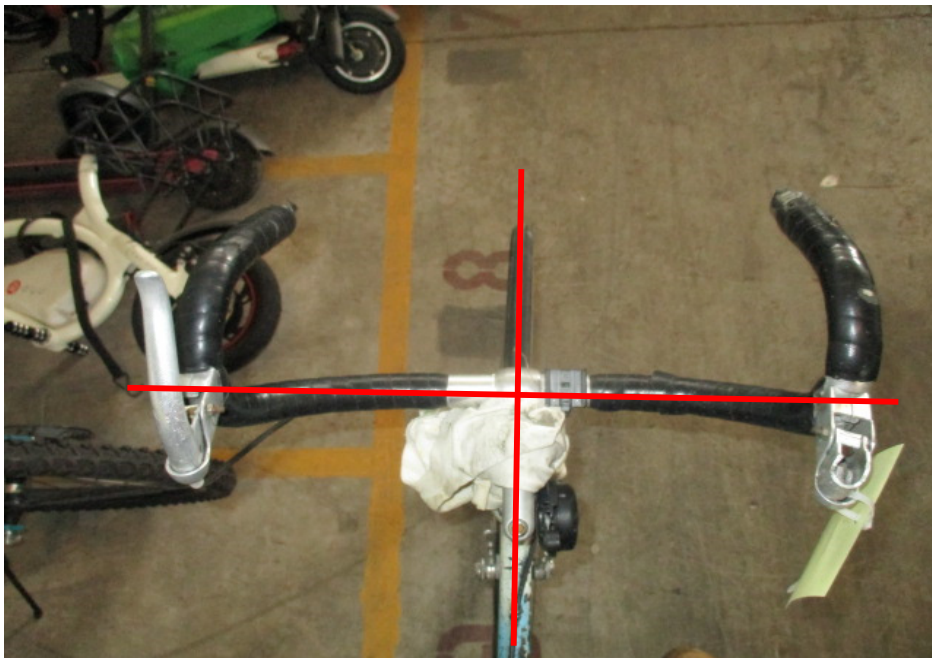
Photo 4 shows the frontal portion of the Bicycle (top view) at the time of our inspection. No misalignment of the handle bar & front tyre was observed.

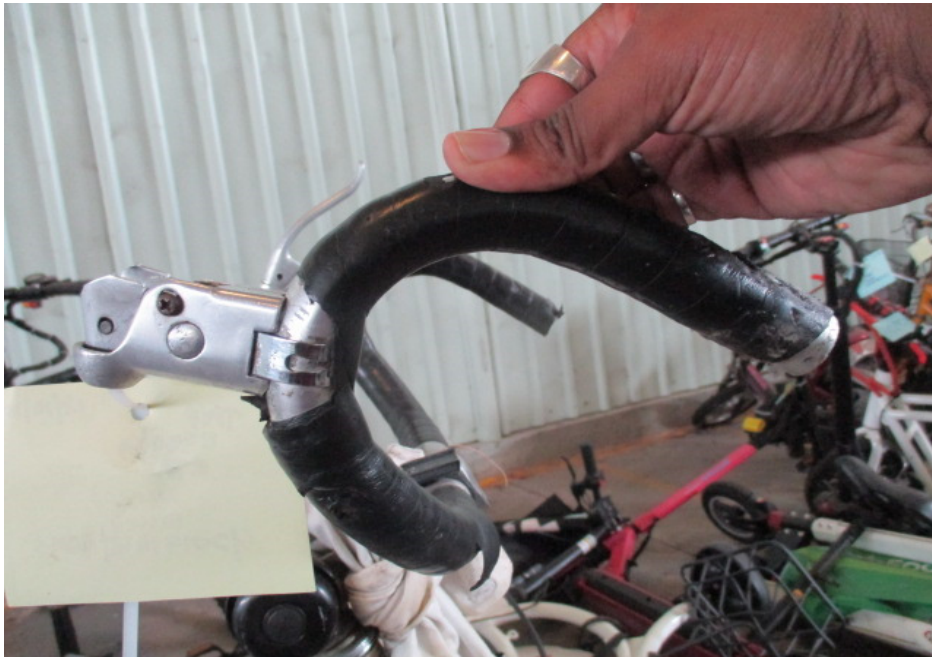
Photo 5 shows the damaged right handlebar grip of the Bicycle at the time of our inspection.

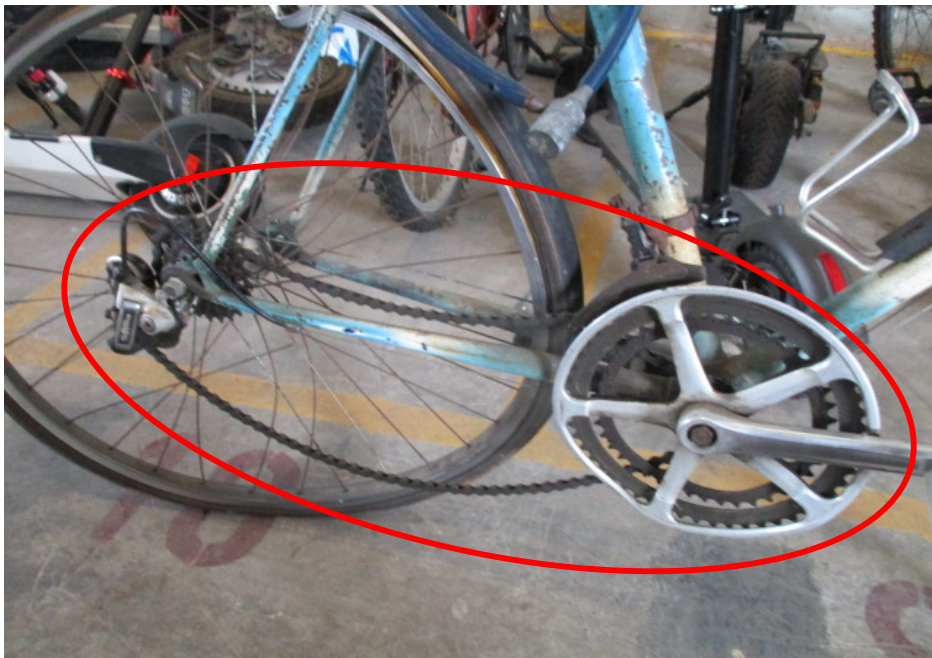
Photo 6 shows a close-up view of the drive train of the Bicycle at the time of our inspection. It was observed to have sustained damages at the circled area of the Bicycle due to the accident.

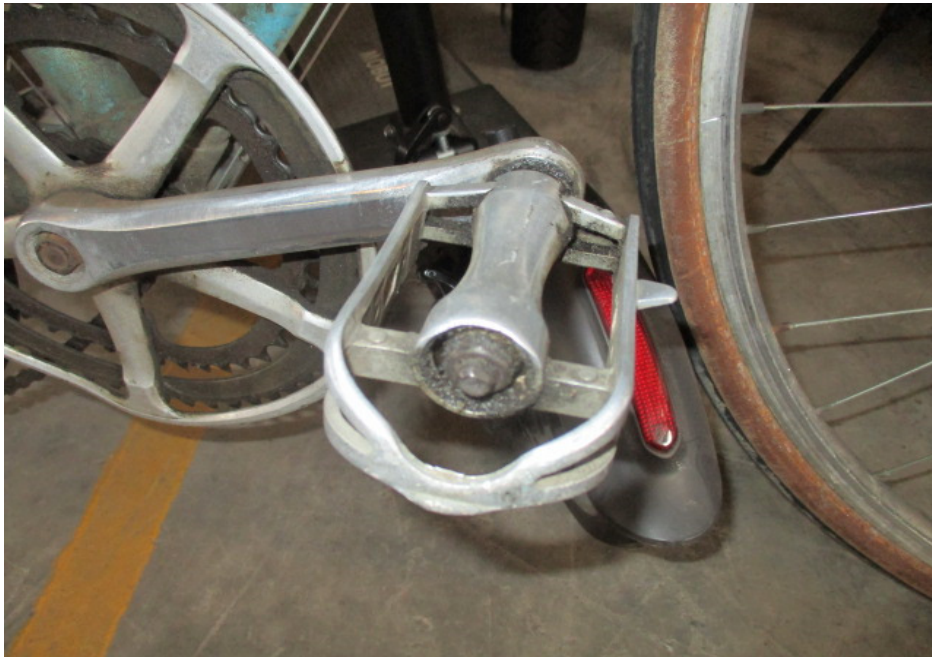
Photo 7 shows the damaged right pedal of the Bicycle at the time of our inspection.

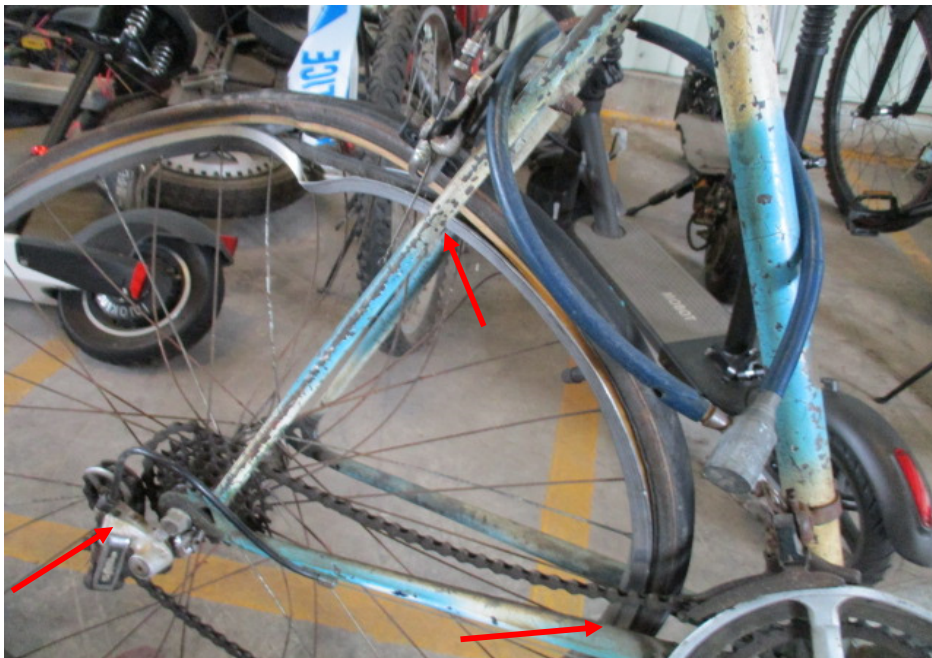
Photo 8 shows a close-up view of the rear sub frame and gear train (arrowed) of the Bicycle at the time of our inspection. These components were observed to be pushed against the rear tyre of the Bicycle as a result of the accident.

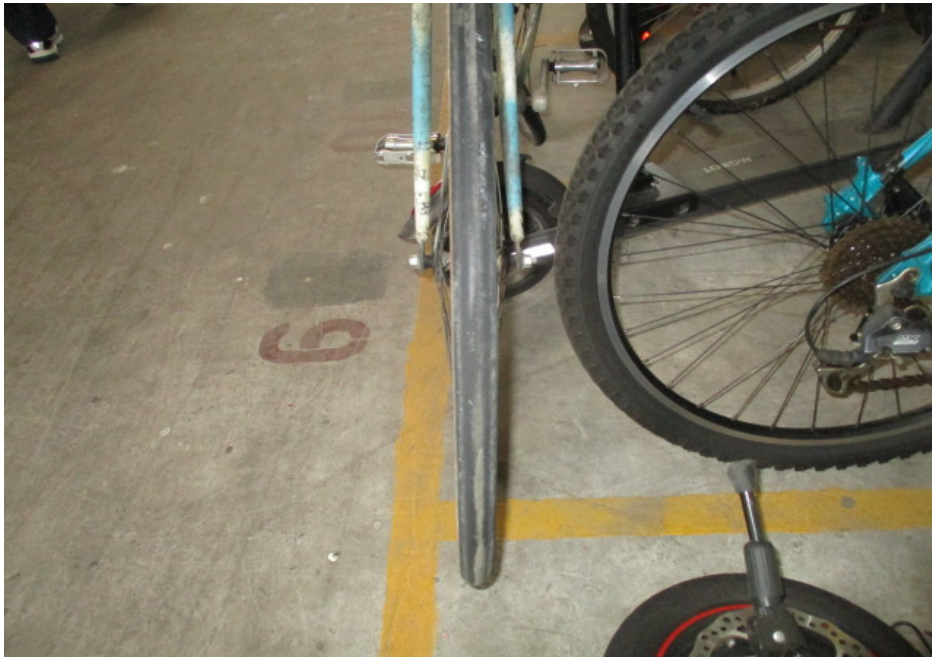
Photo 9 shows the front tyre of the Bicycle. The pattern of the tread was clearly visible. There was no tear, burst mark(s) and/or punctured hole(s) on the sidewalls as well as across the tread of the front tyre.

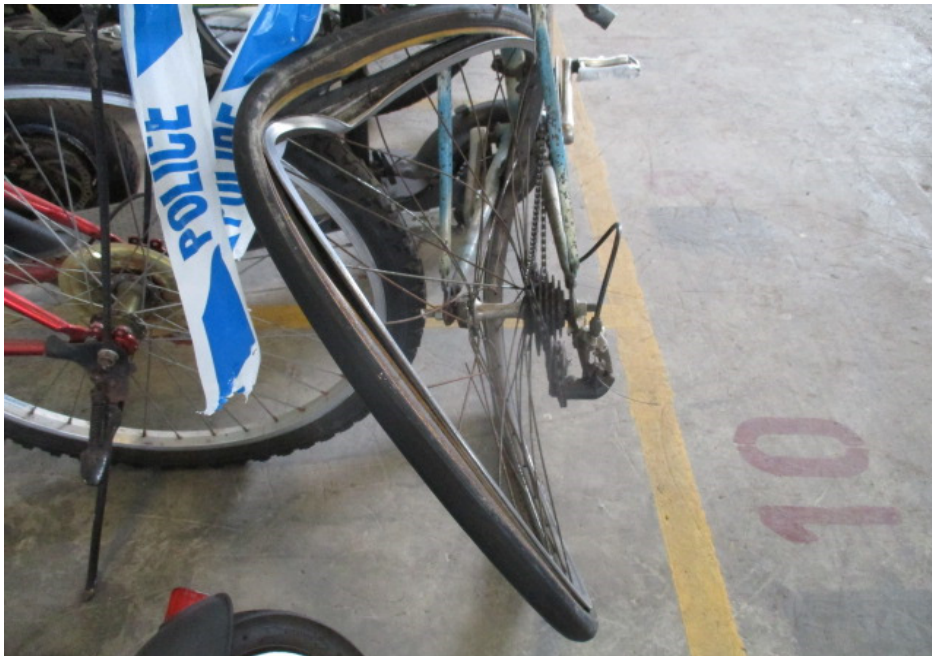
Photo 10 shows the rear tyre of the Motorcycle. The pattern of the tread was clearly visible. There was no tear, burst mark(s) and/or punctured hole(s) on the sidewalls as well as across the tread of the front tyre. However the rear tyre was observed to be deflated due to the bent rear wheel rim.

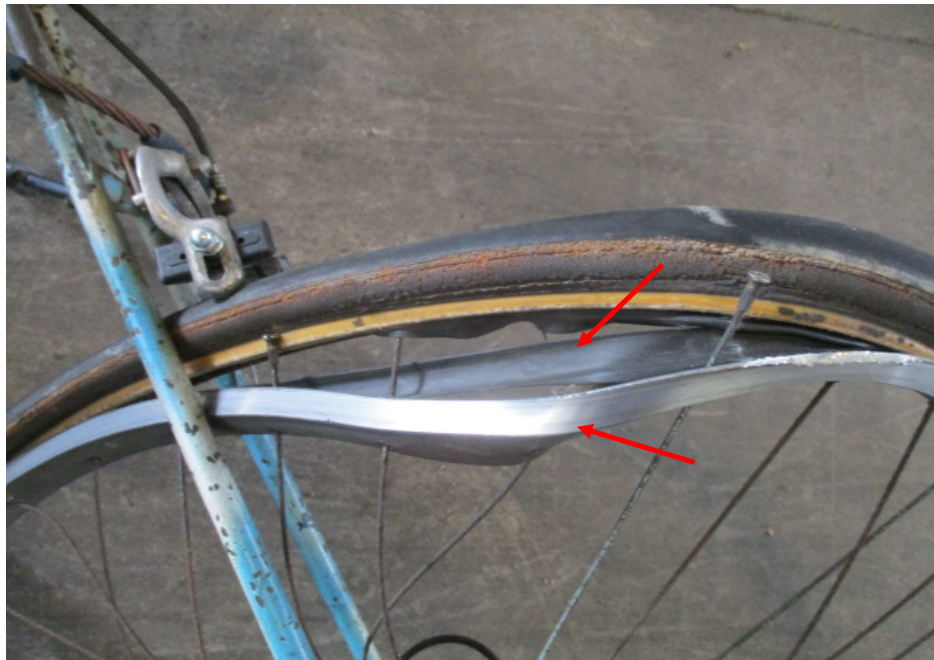
6. Both tyres were wrapped around alloy spoke wheel rims. At the time of our inspection, we did not observe any visible damage on the front wheel rim of the Bicycle. However we did observe that the rear wheel rim was bent and the spokes on the rear wheel rim were broken as a result of the accident. See photos 9 - 12 below.

Photo 11 shows the bent rear wheel rim of the Bicycle at the time of our inspection (arrowed).

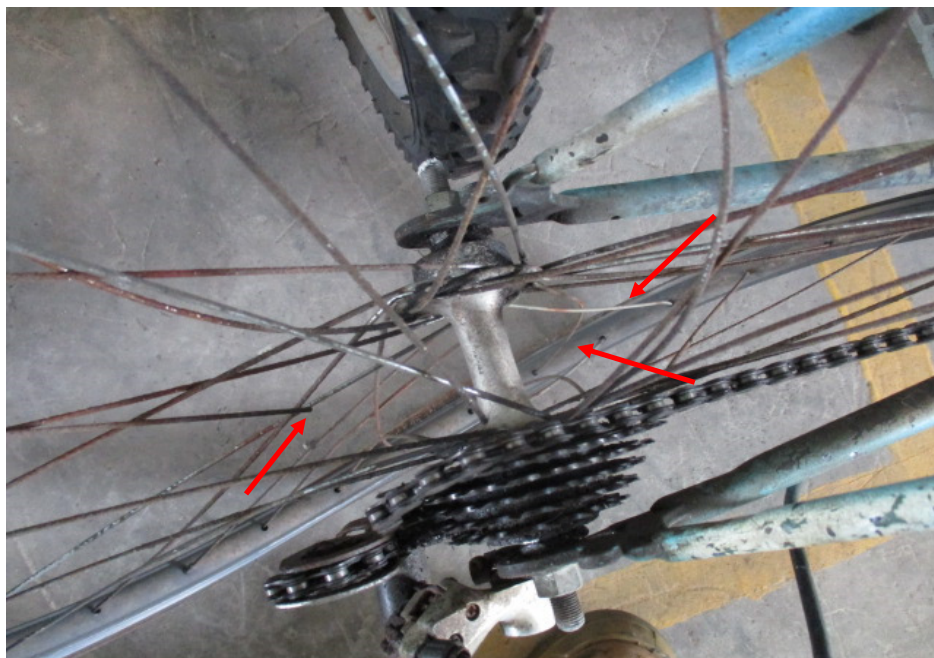
Photo 12 shows the broken spokes on the rear wheel rim of the Bicycle at the time of our inspection (arrowed).

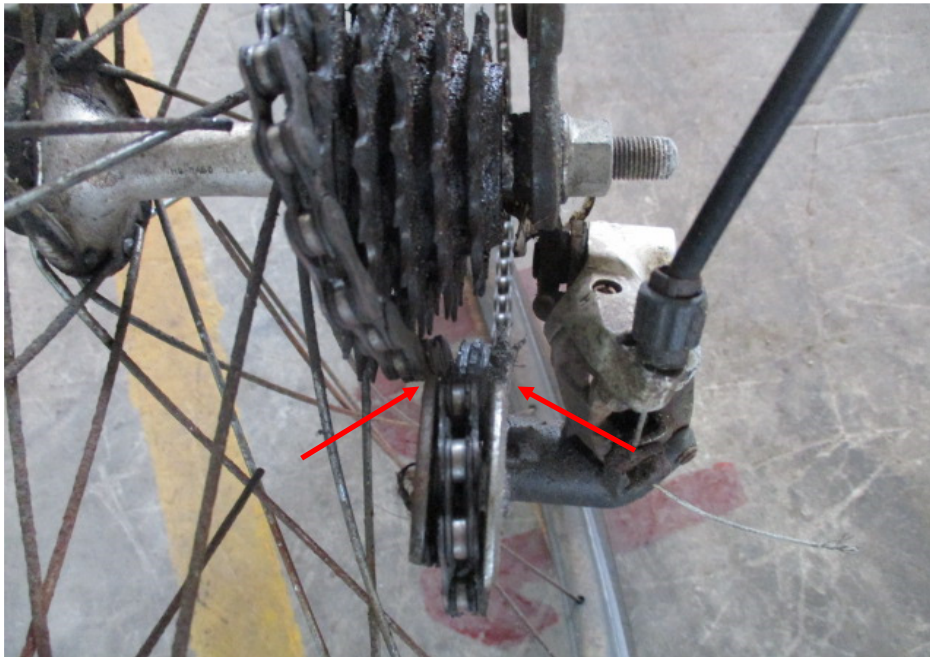
7. The gear train of the Bicycle was found to be severely damaged as a result of the accident. No free play tension test can be conducted due to the extensive damages. See photo 13 below.

Photo 13 shows a close up view of the gear train of the Bicycle, which was observed to have sustained severe damages as a result of the accident (arrowed).

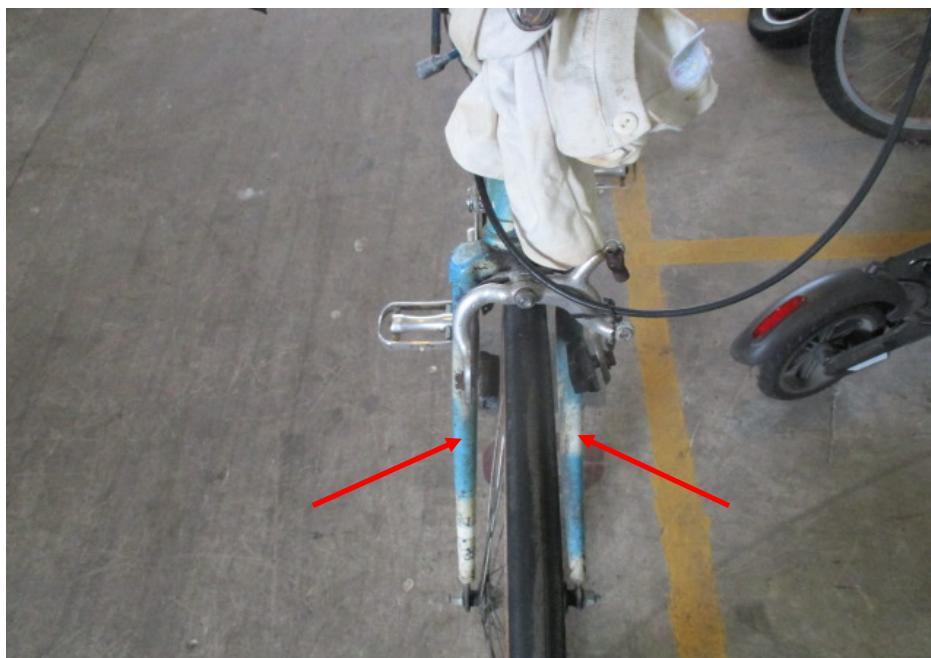
Photo 14 shows the front fork (arrowed) of the Bicycle. The front fork and fork bracket of the Bicycle were both found to be intact and undamaged. Turning the Bicycle's handle bar towards the left and right did not produce any abnormal free play. The steering system of the Bicycle was in serviceable condition at the time of our inspection.

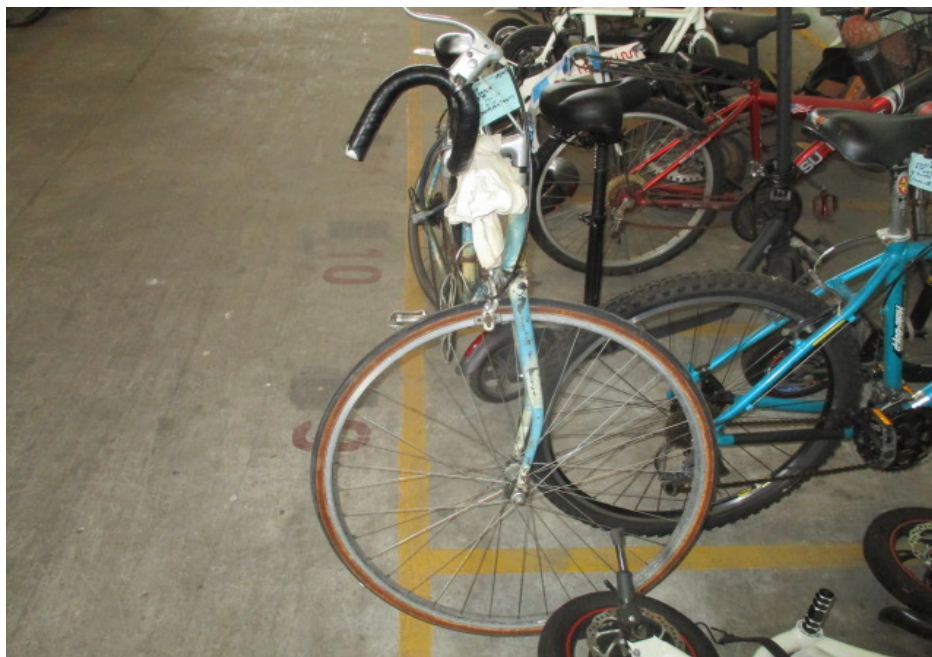
Photo 15 shows the front wheel of the Bicycle turned towards its full right. Turning the Bicycle's handle bar towards the right did not produce any abnormal free play and/or resistance. This would indicate that the steering system of the Bicycle was in serviceable condition at the time of our inspection.

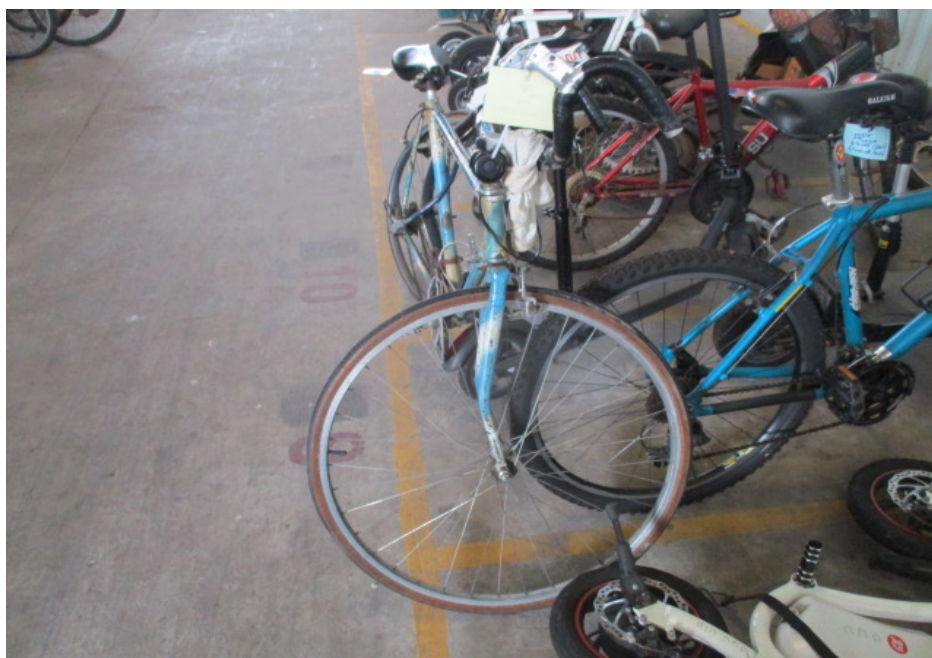
Photo 16 shows the front wheel of the Bicycle turned towards its full left. Turning the Bicycle's handle bar towards the left did not produce any abnormal free play and/or resistance. This would indicate that the steering system of the Bicycle was in serviceable condition at the time of our inspection.

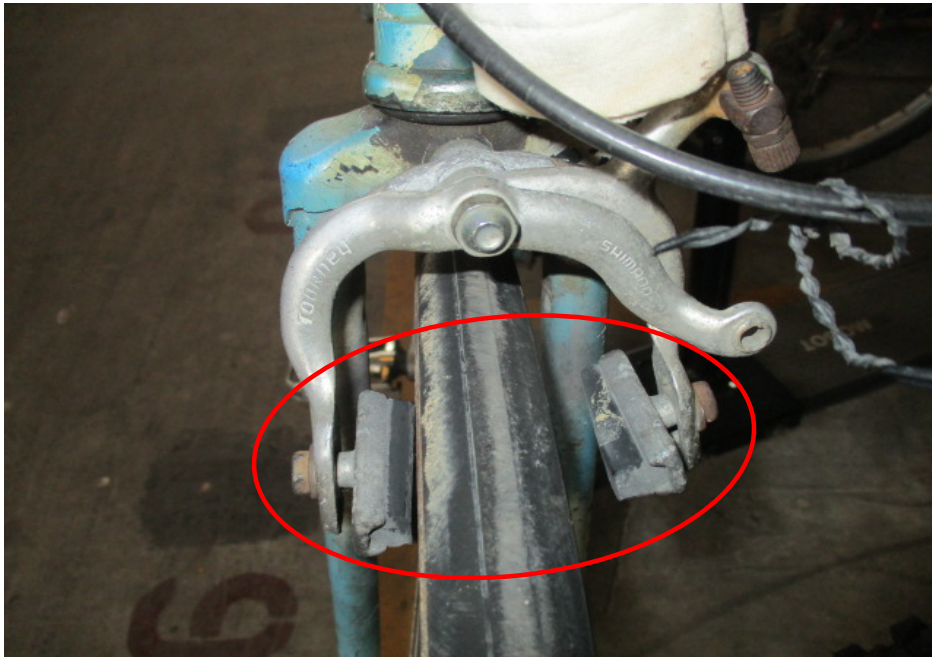
Photo 17 shows the front brake clamp assembly of the Bicycle which was intact however it was observed to be slightly misaligned (circled).

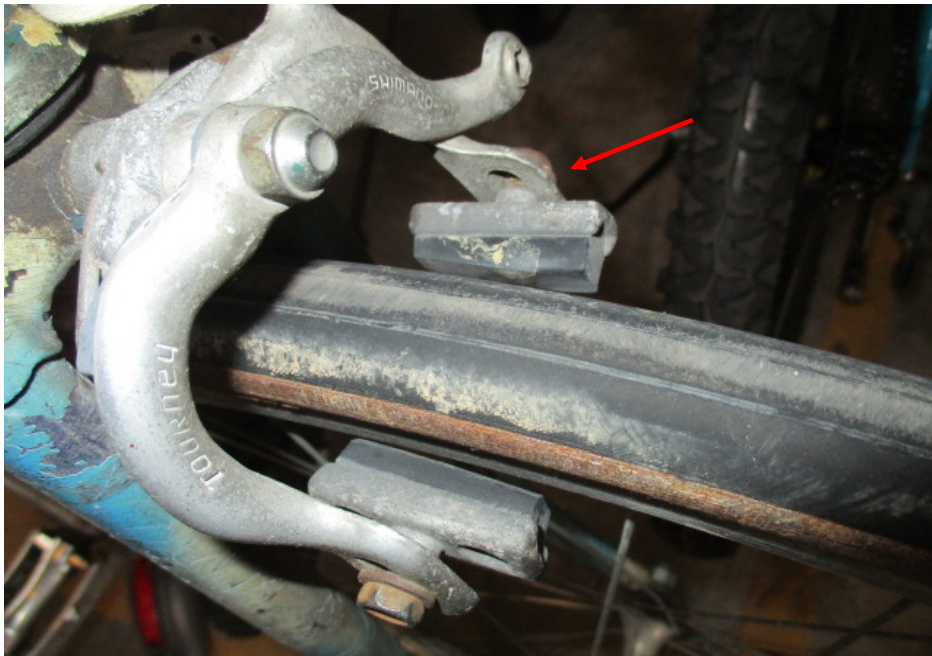
Photo 18 shows a close up view of the front brake clamp assembly of the Bicycle which was intact however it was observed to be slightly misaligned (arrowed).

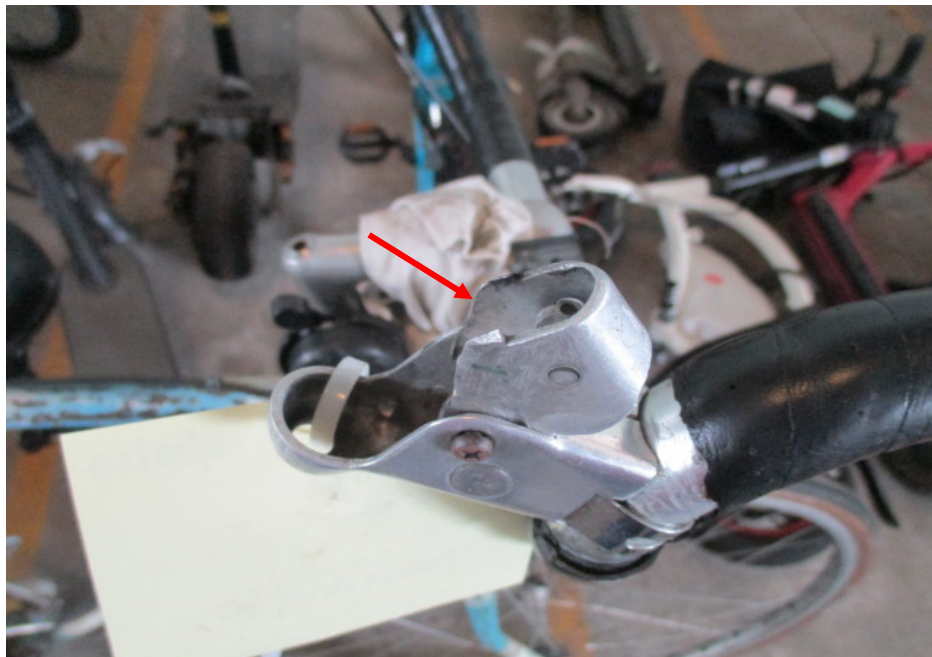
Photo 19 shows the broken front brake lever as a result of the accident (arrowed). Hence a static brake test could not be conducted on the Bicycle's front braking system.

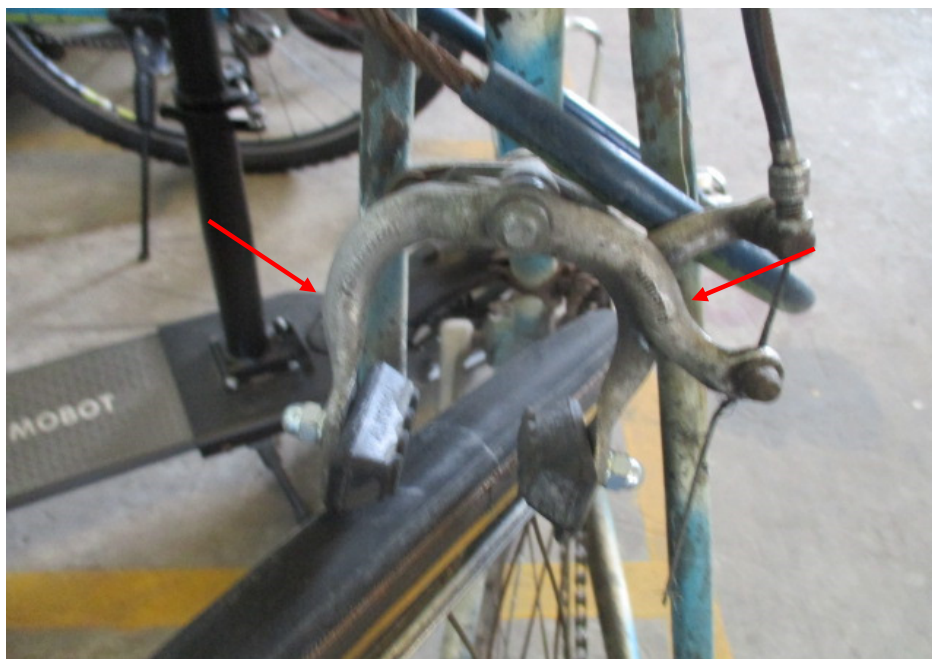
Photo 20 shows the rear brake clamp assembly which was observed to be dislodged as a result of the accident (arrowed).

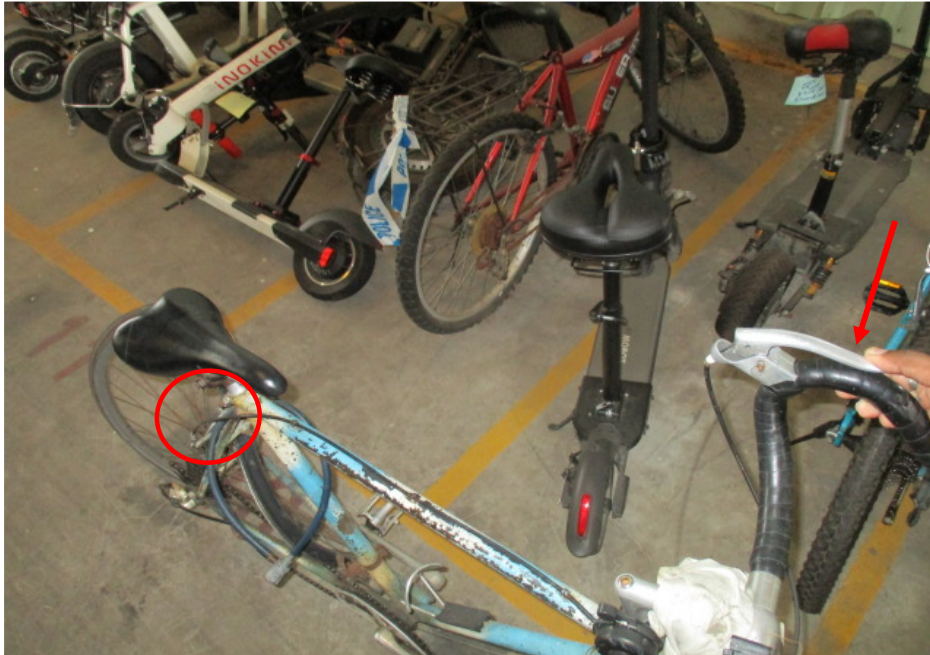
Photo 21 shows a static brake test conducted on the Bicycle's rear brake. It shows that the rear brake clamps responded to the gripping action (circled) after depressing the left hand brake lever (arrowed). However the rear brake clamp assembly was observed to be dislodged as a result of the accident, causing the rear rubber brake blocks to be misaligned from the rear wheel rim.

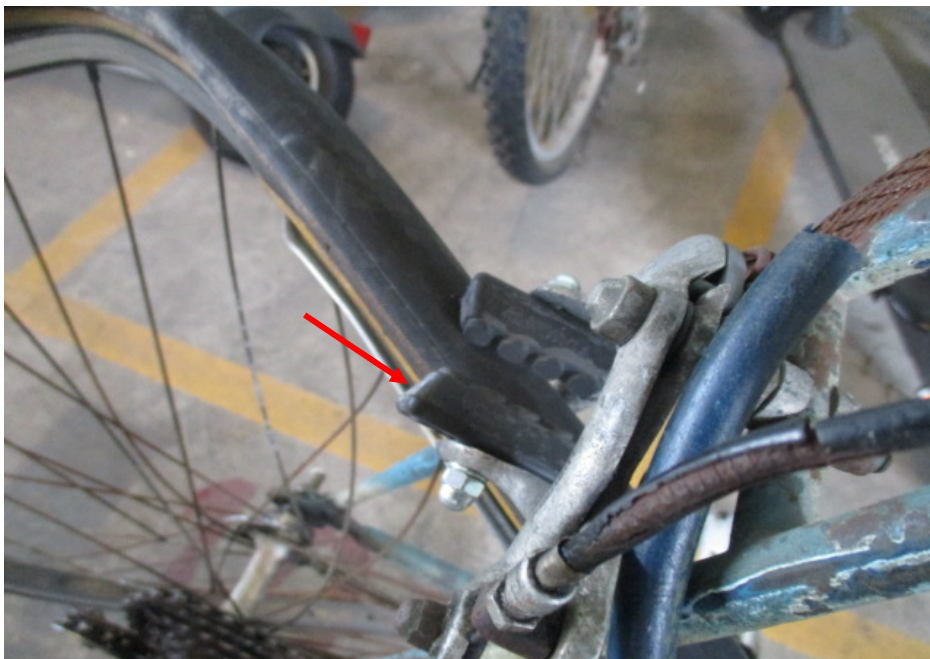
Photo 22 shows a close up view of the rear brake rubber brake blocks which responded to the gripping action after depressing the left hand brake lever. However they were observed to be misaligned from the rear wheel rim (arrowed) due to the dislodgement of the rear brake clamp assembly and broken rear wheel rim as a result of the accident.
