Your Ref: TP/IP/60999/2019
Our Ref : CI/TPD19020216/N

13 November 2019

Fatal Accident Investigation Team

INSPECTION REPORT OF MOTORCYCLE JSG 3986

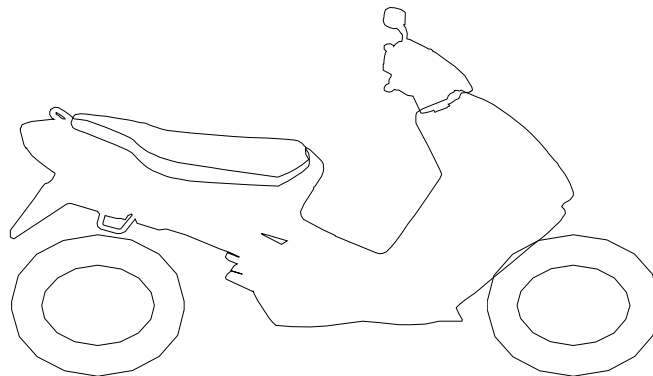
Diamond 80/90 - 17
(bald at centre portion)

Maxxis 70/90 - 17 (3mm)

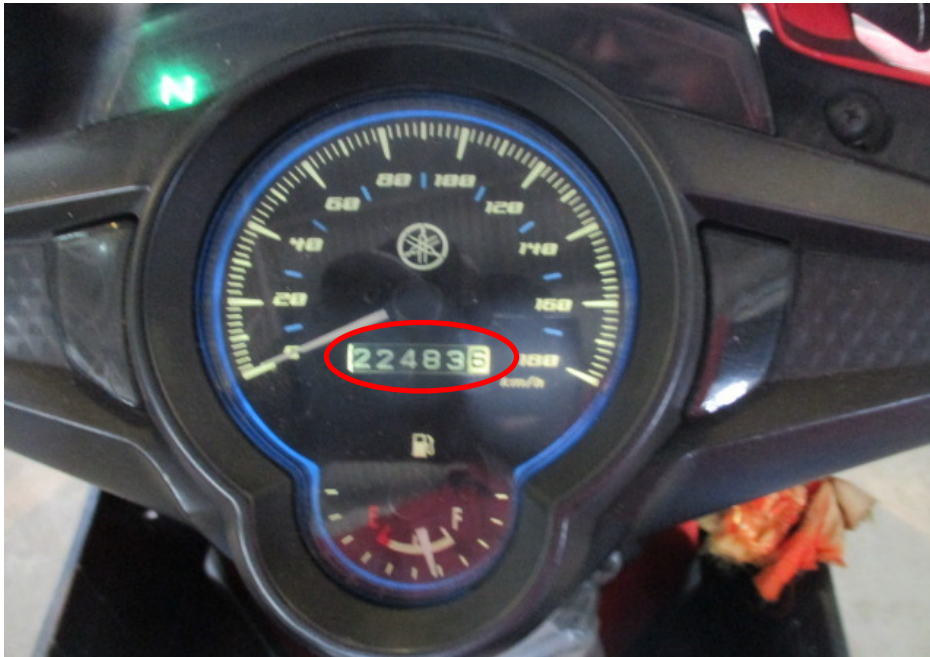
Photo 1 shows the speedometer gauge of the Motorcycle where the mileage recorded at the time of our inspection was 22, 483km (circled).

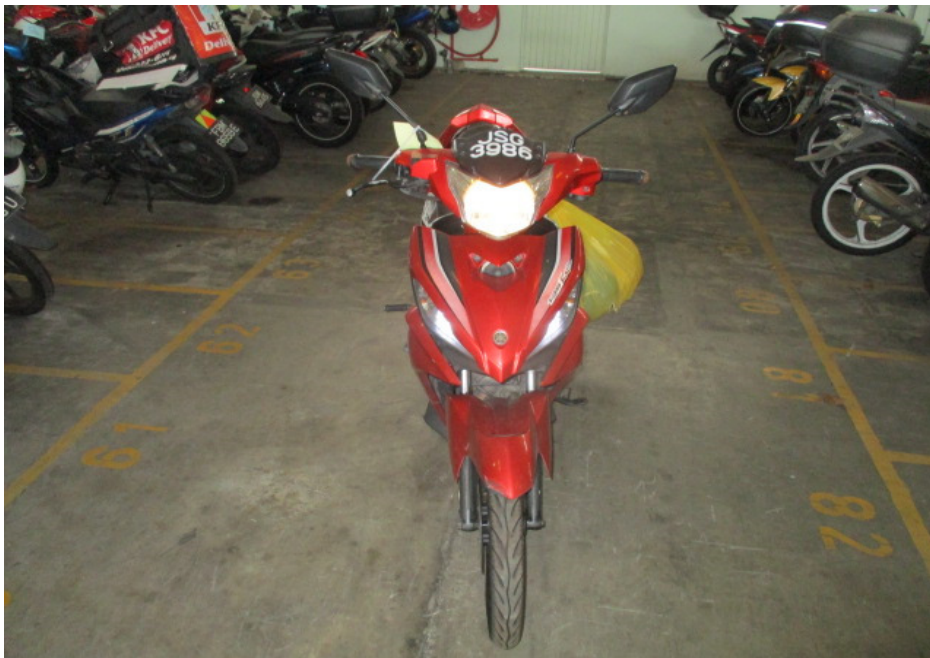
Photo 2 shows a general view of the frontal portion of the Motorcycle at the time of our inspection. The Motorcycle was observed to have sustained damages at its frontal portion and right body.

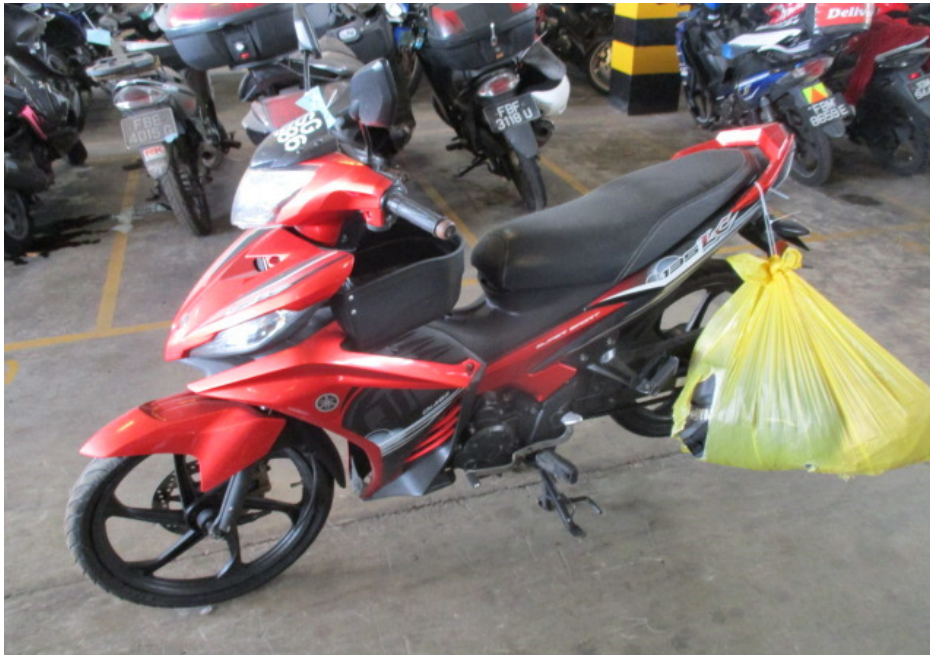
Photo 3 shows a general view of the left body of the Motorcycle at the time of our inspection. The Motorcycle was observed to have sustained damages at its frontal portion and right body.

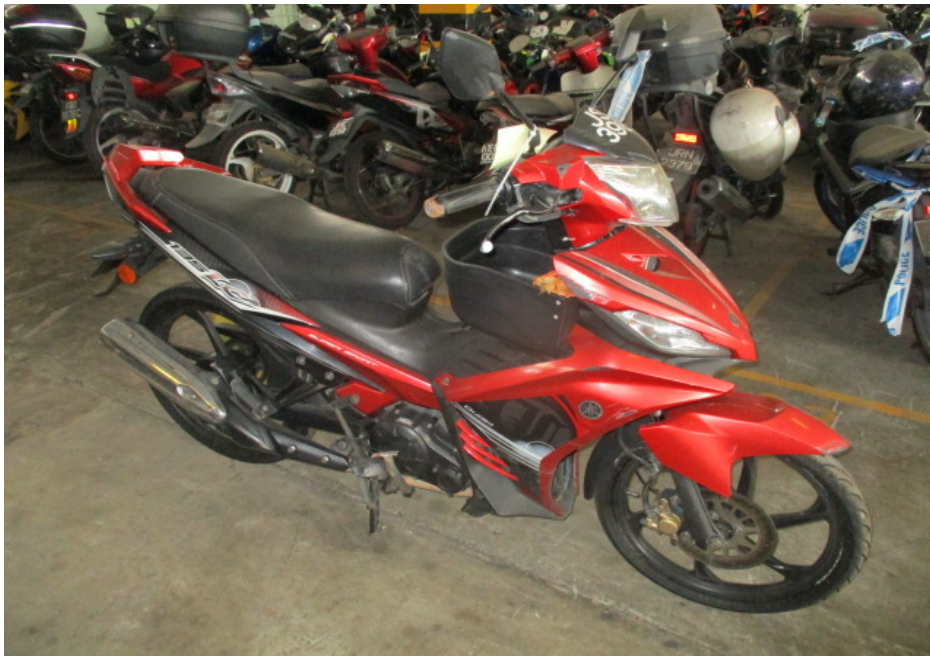
4. The mileage of the Motorcycle at the time of our inspection was 22, 483km.
5. The Motorcycle was observed to have sustained damages at its frontal portion and right body. The body parts that were found to have been damaged include its head cowling, right side cowling, right handlebar end, right side mirror, front brake lever, rear brake pedal, right front footrest, right rear side cover and exhaust muffler, amongst others.

Photo 4 shows a general view of the right body of the Motorcycle at the time of our inspection. The Motorcycle was observed to have sustained damages at its frontal portion and right body. Amongst the body parts that were found to have been damaged include its head cowl, right side cowl, right handlebar end, right side mirror, front brake lever, rear brake pedal, right front footrest, right rear side cover and exhaust muffler, amongst others.

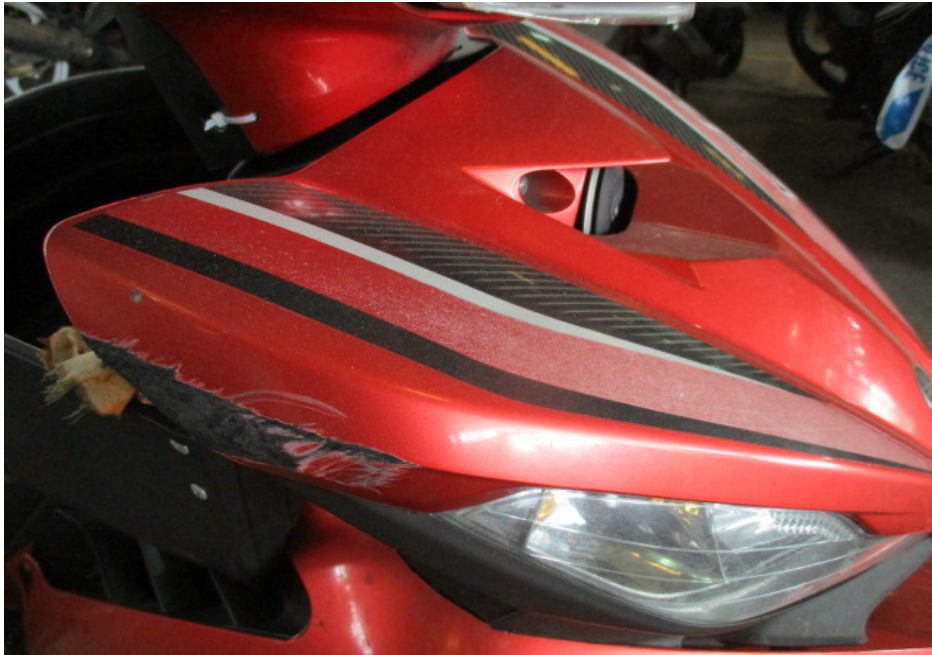
Photo 5 shows a closer view of the front cowling of the Motorcycle that had sustained damages of grazing nature as a result of the accident.

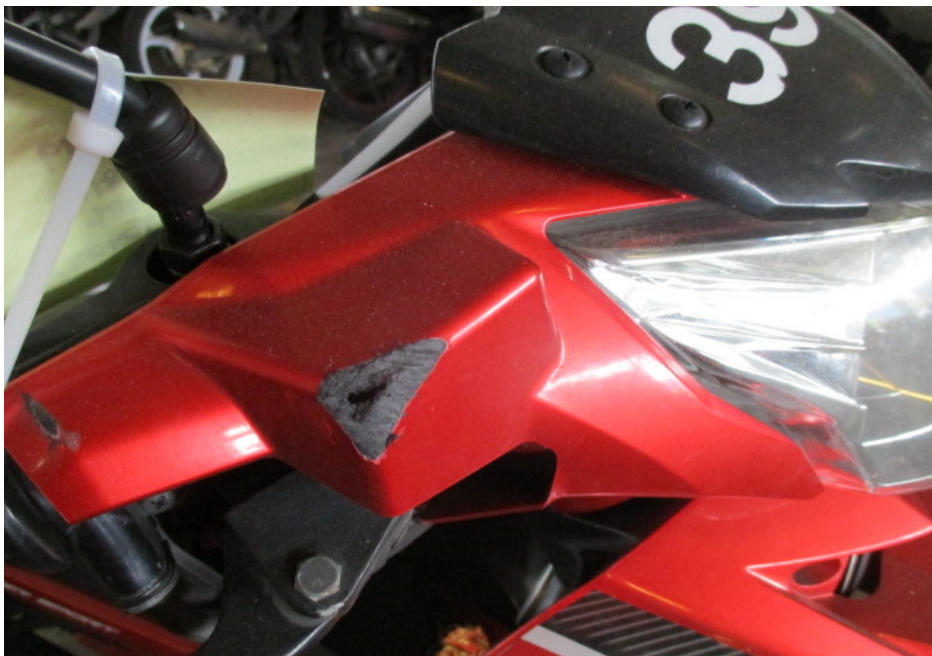
Photo 6 shows a close up view of the head cowling which was amongst the body parts of the Motorcycle that had sustained damage as a result of the accident.

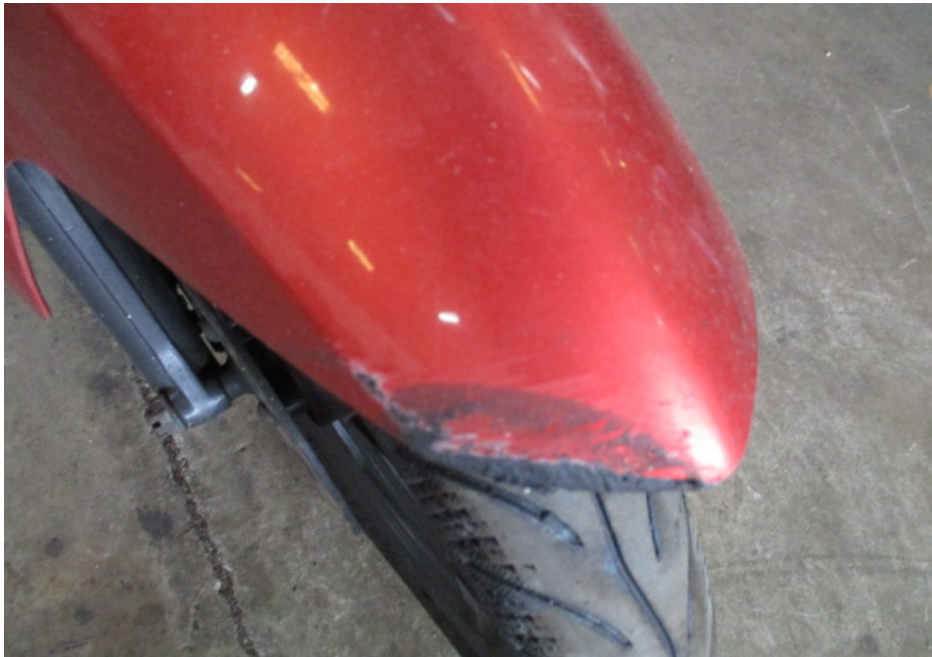
Photo 7 shows a closer view of the front mudguard which was amongst the body parts at the front body of the Motorcycle that had sustained damage as a result of the accident.

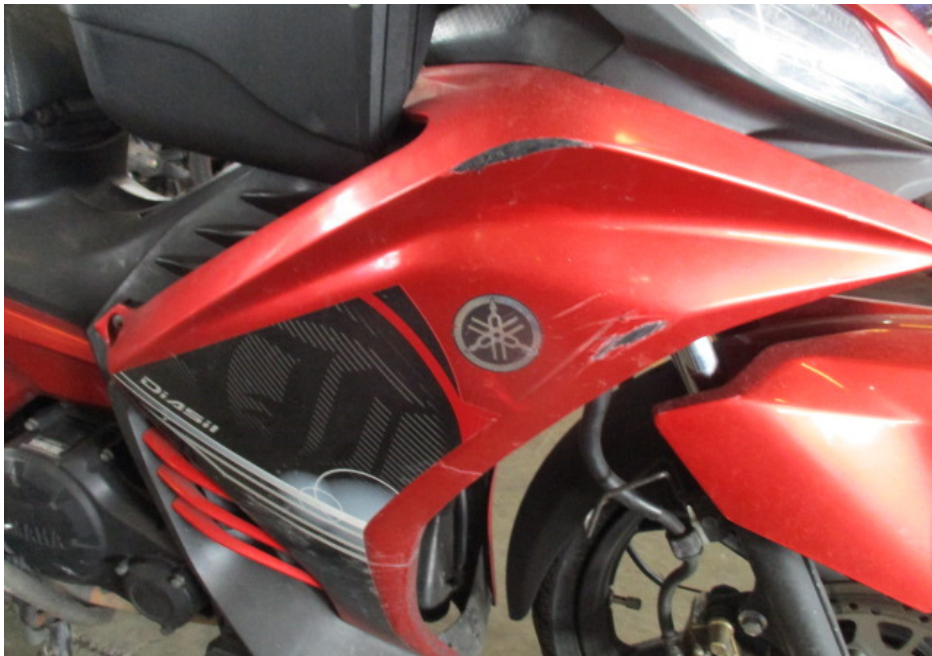
Photo 8 shows a closer view of the right cowl of the Motorcycle that had sustained damages of grazing nature as a result of the accident.

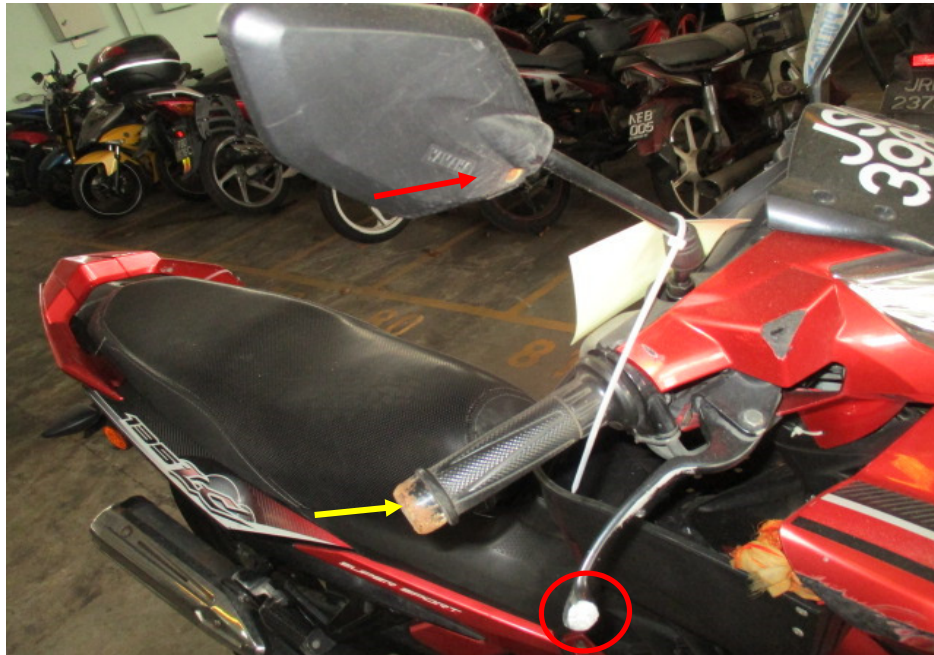
Photo 9 shows a closer view of the right handlebar end (yellow arrow), right side mirror (red arrow) and front brake lever (circled) which were amongst the body parts of the Motorcycle that had sustained damage as a result of the accident.

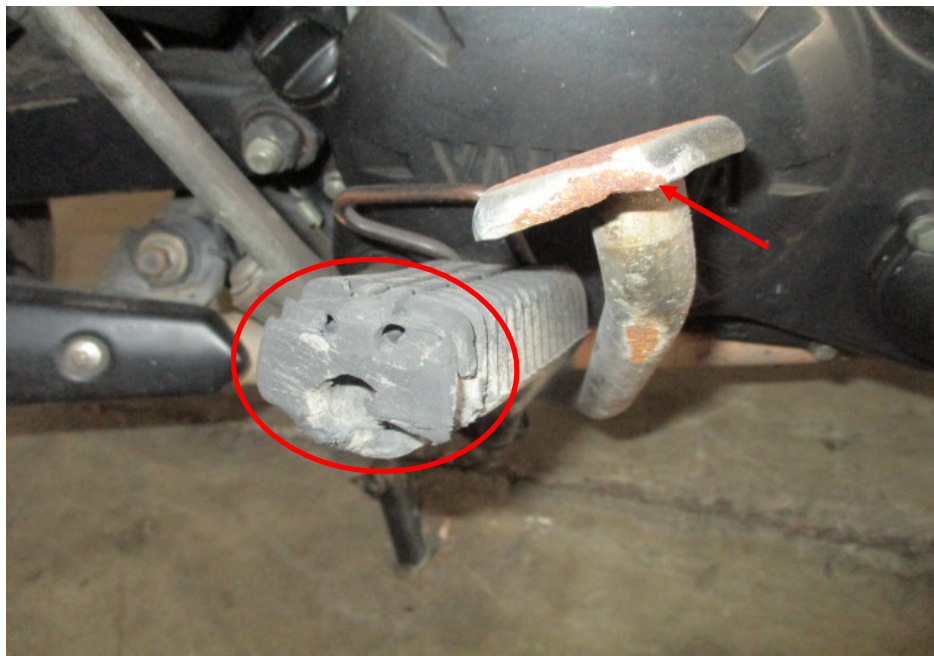
Photo 10 shows a closer view of the bent rear brake pedal (arrowed) and deformed right front footrest (circled) which were amongst the body parts of the Motorcycle that had sustained damage as a result of the accident.

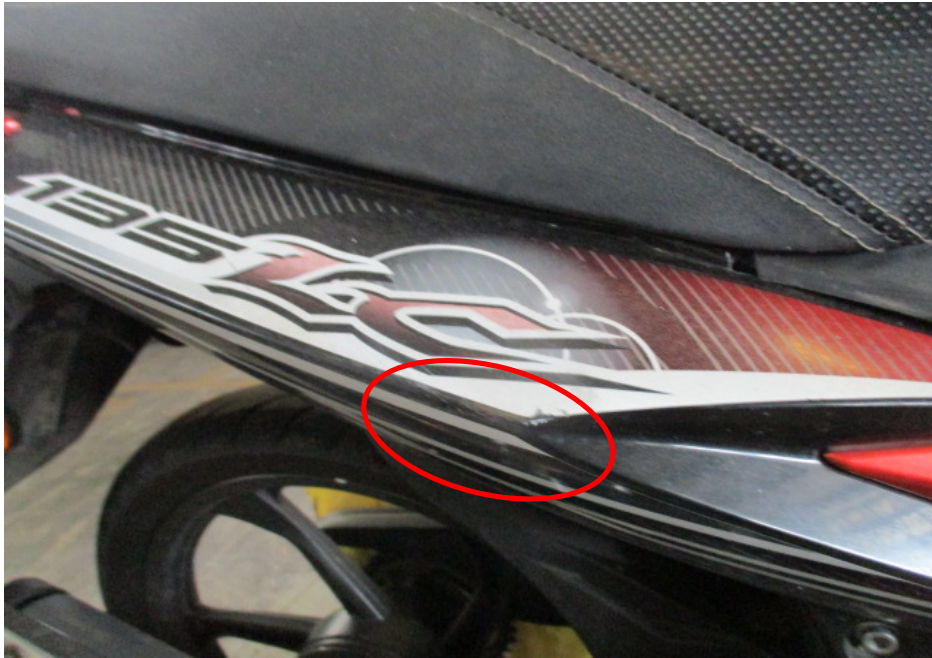
Photo 11 shows a closer view of the right rear side cover which was amongst the body parts of the Motorcycle that had sustained damages of grazing nature as a result of the accident (circled).

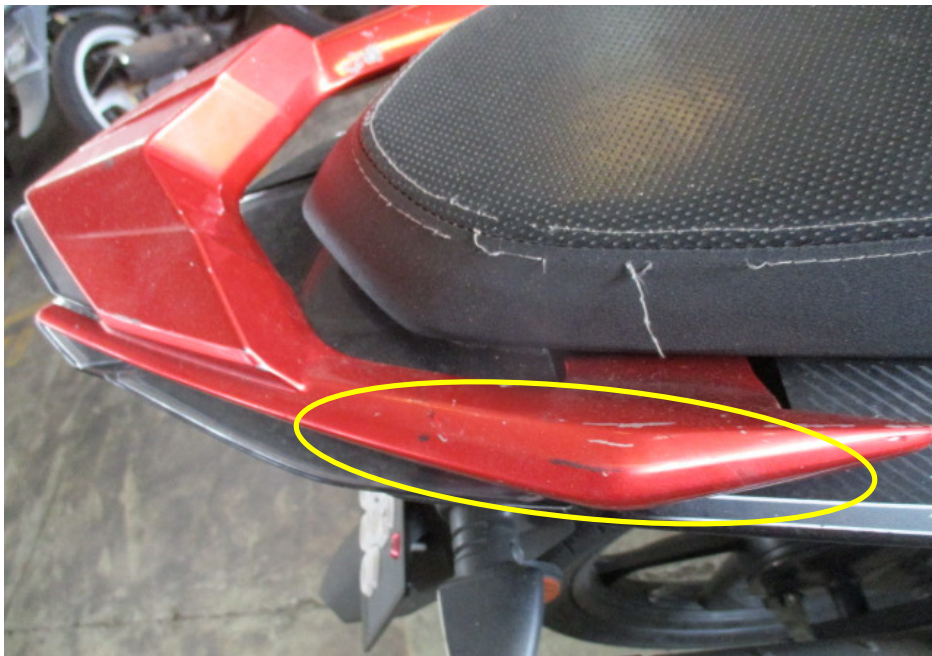
Photo 12 shows a closer view of the right pillion grab rail which was amongst the body parts of the Motorcycle that had sustained damages of grazing nature as a result of the accident (circled).

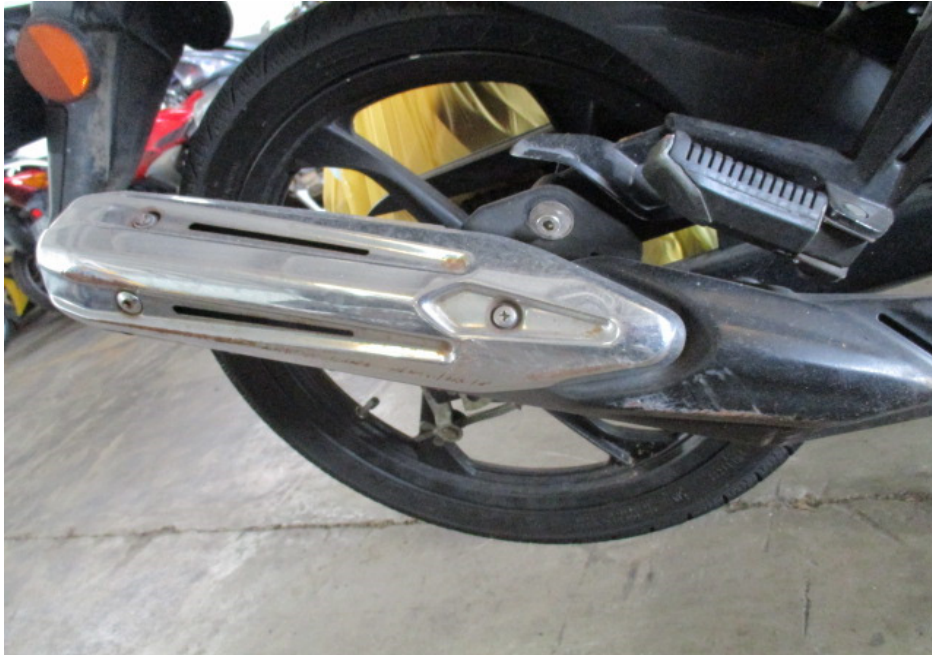
Photo 13 shows a closer view of the exhaust muffler and exhaust muffler heat shield of the Motorcycle that had sustained damages of grazing nature as a result of the accident.

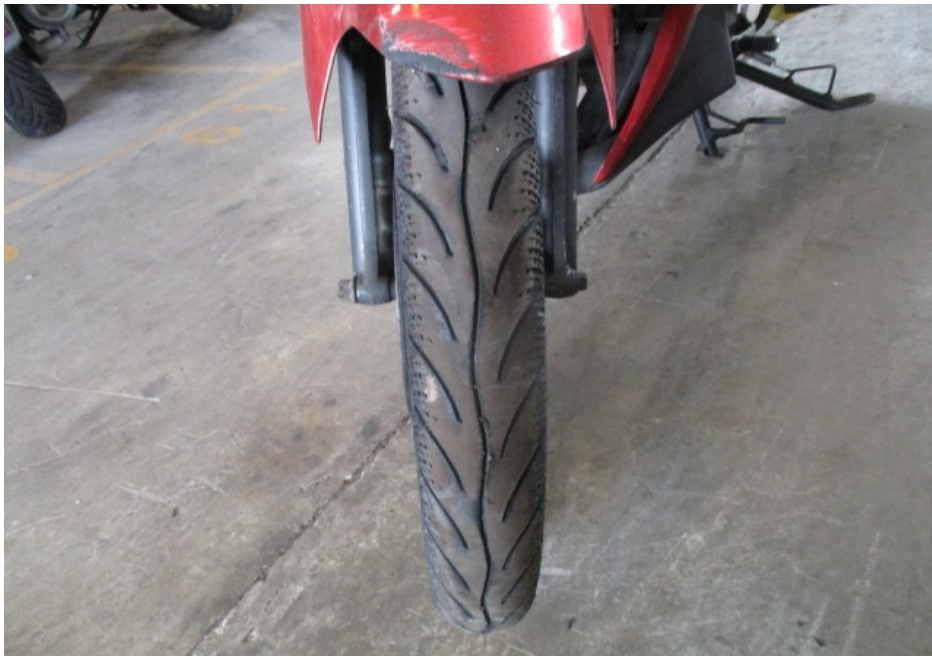
6. The condition of the front tyre of the Motorcycle was observed to be in serviceable condition. We did not observe any tear, burst mark(s) and/or punctured hole(s) on the sidewalls as well as across the tread of the front tyre. The front tyre was observed to be sufficiently inflated for vehicular operation.
7. The condition of the rear tyre of the Motorcycle was observed to be bald at the centre portion. However we did not observe any tear, burst mark(s) and/or punctured hole(s) on the sidewalls as well as across the tread of the rear tyre. The rear tyre was observed to be sufficiently inflated for vehicular operation.
8. The tyre brand, tyre size and remaining tread depth of the 2 tyres were recorded as follows:-

Photo 14 shows the condition of the Motorcycle's front tyre. The front tyre was observed to be in serviceable condition with remaining tread depth of approximately 3mm. There was no tear, burst mark(s) and/or punctured hole(s) on the sidewalls as well as across the tread of the front tyre.

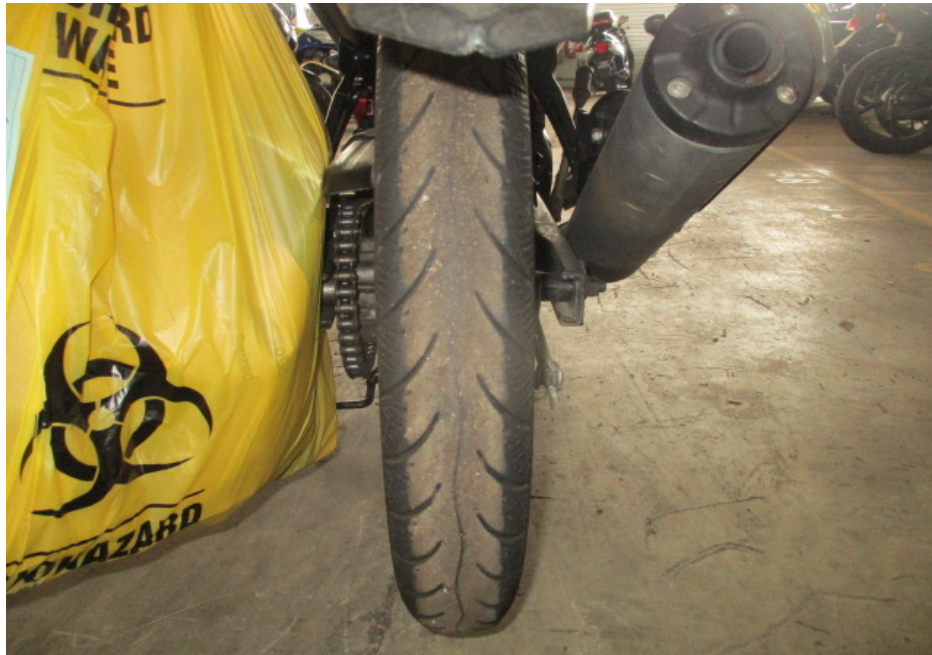
Photo 15 shows the condition of the Motorcycle's rear tyre. The rear tyre was observed to be bald at the centre portion. The tyre was also observed to be sufficiently inflated for vehicular operation. We did not observe any tear, burst mark(s) and/or punctured hole(s) on the sidewalls as well as across the tread of the rear tyre.

19. The rear tyre of the Motorcycle was found to be bald at the centre portion. However there was no tear, cut or burst mark(s) on the outer and the inner sidewalls as well as across the tread of the rear tyre. The rear tyre was sufficiently inflated for vehicular operation.

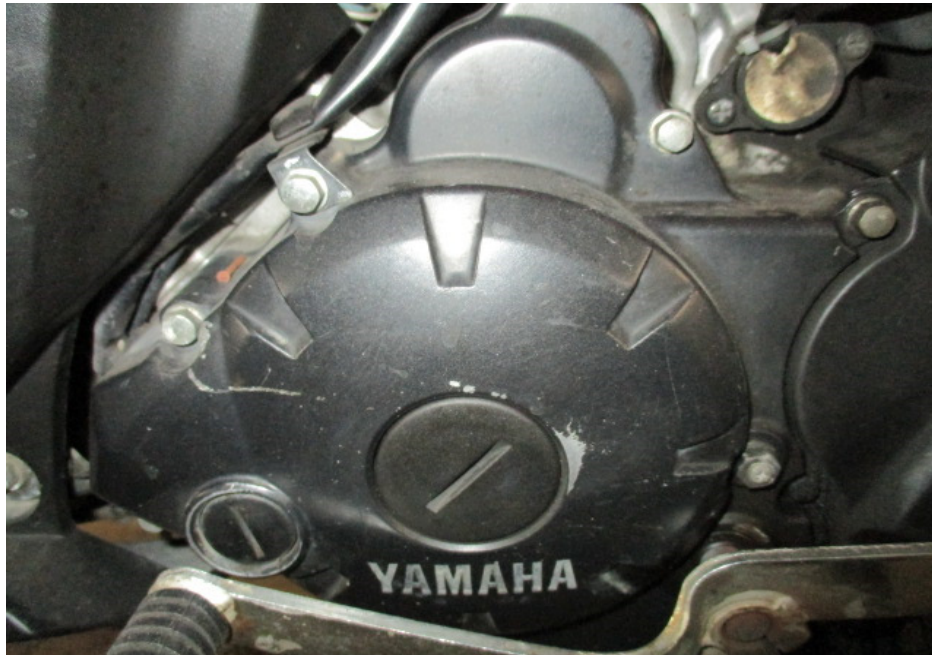
Photo 16 shows the left side of the engine of the Motorcycle at the time of our inspection. The various engine related parts and components were found to be intact with no visible damage. There was also no sign(s) or indication(s) of fluid leak observed around the left engine area of the Motorcycle.

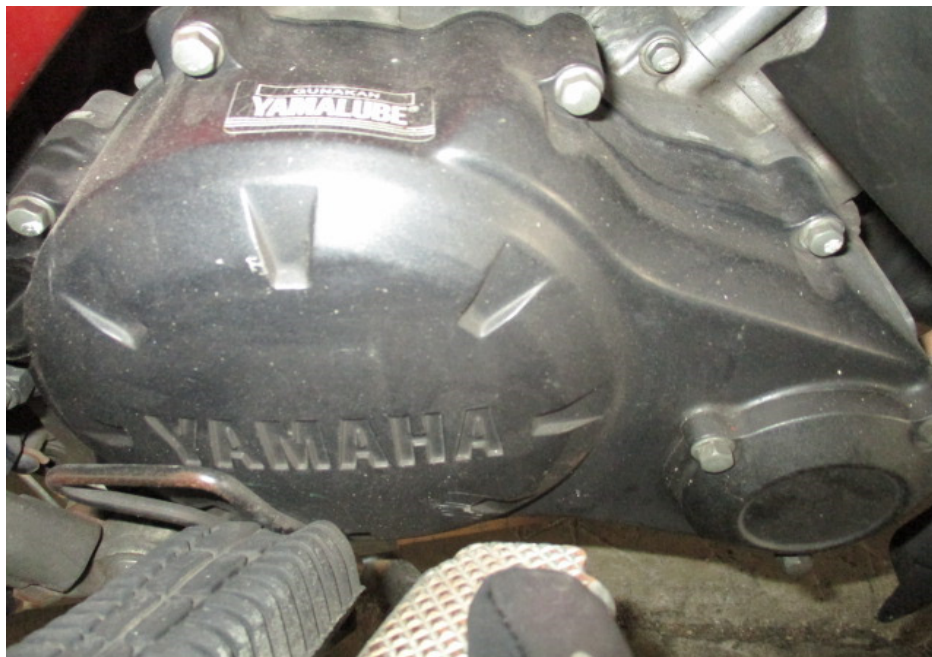
Photo 17 shows the right side of the engine of the Motorcycle at the time of our inspection. The various engine related parts and components were found to be intact with no visible damage. There was also no sign(s) or indication(s) of fluid leak observed around the right engine area of the Motorcycle.

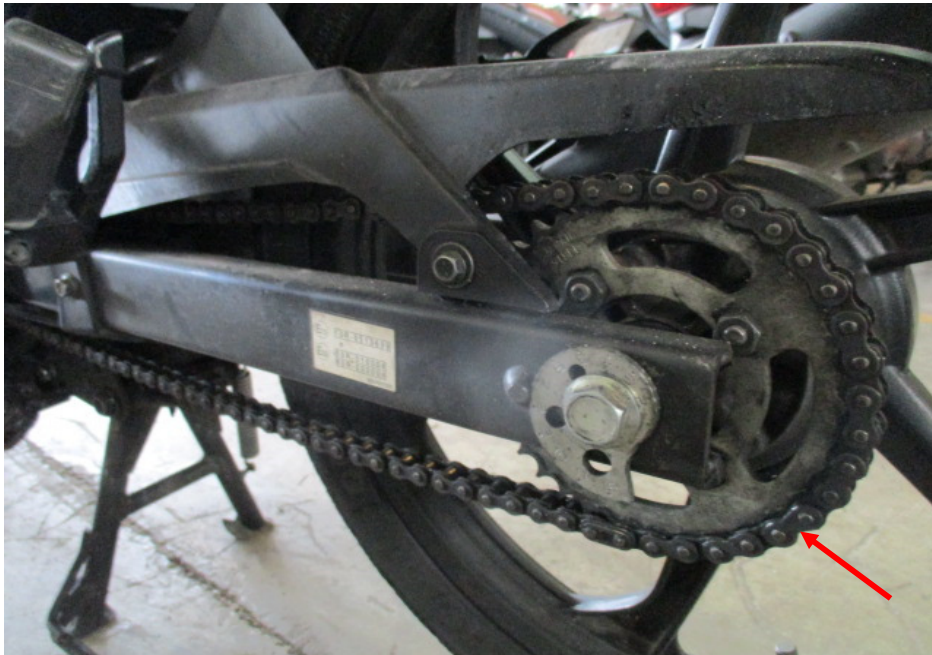
Photo 18 shows the general view of the gear train (arrowed) of the Motorcycle, which was observed to be intact with no misalignment. It was also adequately lubricated for operating purposes.

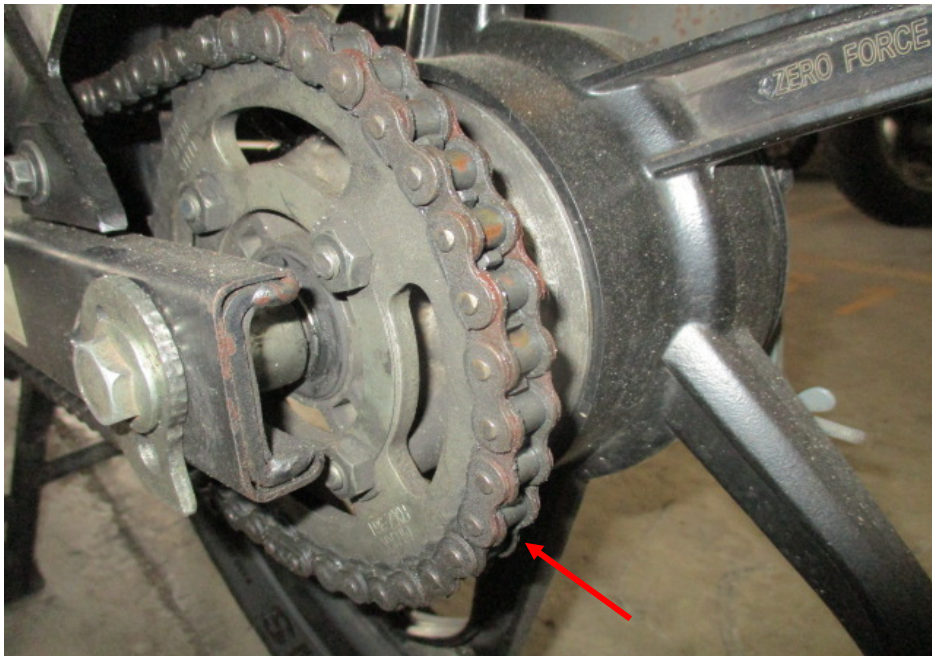
Photo 19 shows a closer view of the gear train (arrowed) of the Motorcycle, which was observed to be intact with no misalignment. It was also adequately lubricated for operating purposes.

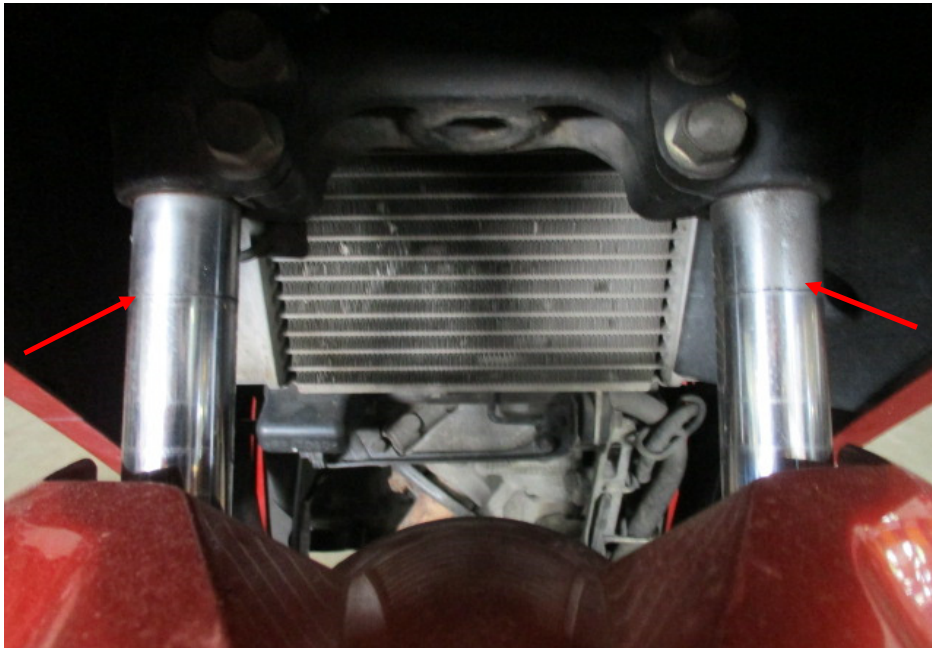
12. Our checks on the various steering components of the Motorcycle revealed that its steering system was in serviceable condition. Its front fork was found to be intact and undamaged. Turning the handle bar towards the left and right also did not produce any abnormal free play and/or resistance.

Photo 20 shows the front fork (arrowed) of the Motorcycle. The front fork and fork bracket of the Motorcycle were both found to be intact and undamaged. Turning the Motorcycle's handle bar towards the left and right did not produce any abnormal free play and/or resistance. The steering system of the Motorcycle was in serviceable condition at the time of our inspection.

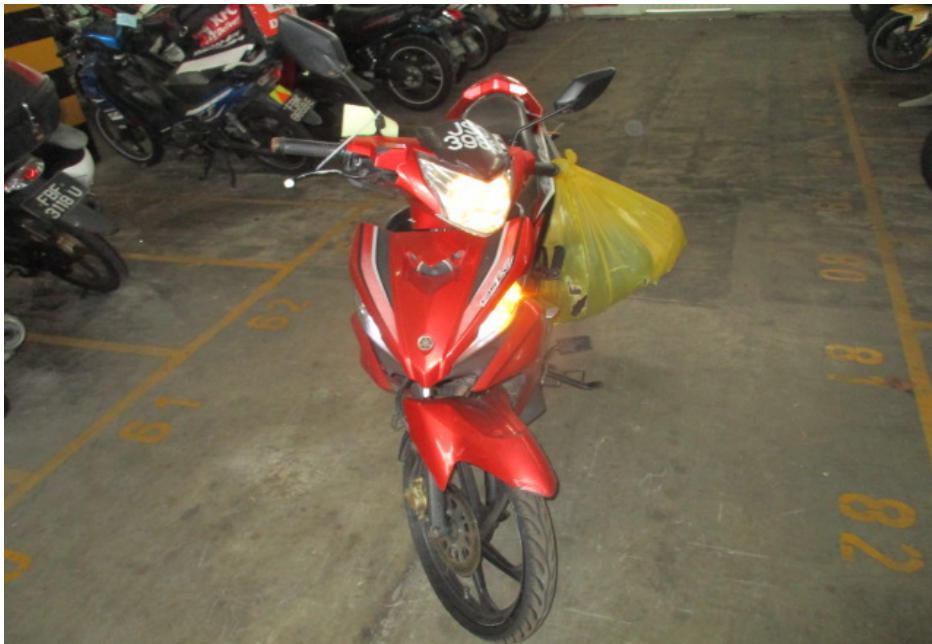
Photo 21 shows the front wheel of the Motorcycle turned towards its full left. Turning the Motorcycle's handle bar towards the left and right did not produce any abnormal free play and/or resistance. This would indicate that the steering system of the Motorcycle was in serviceable condition at the time of our inspection.

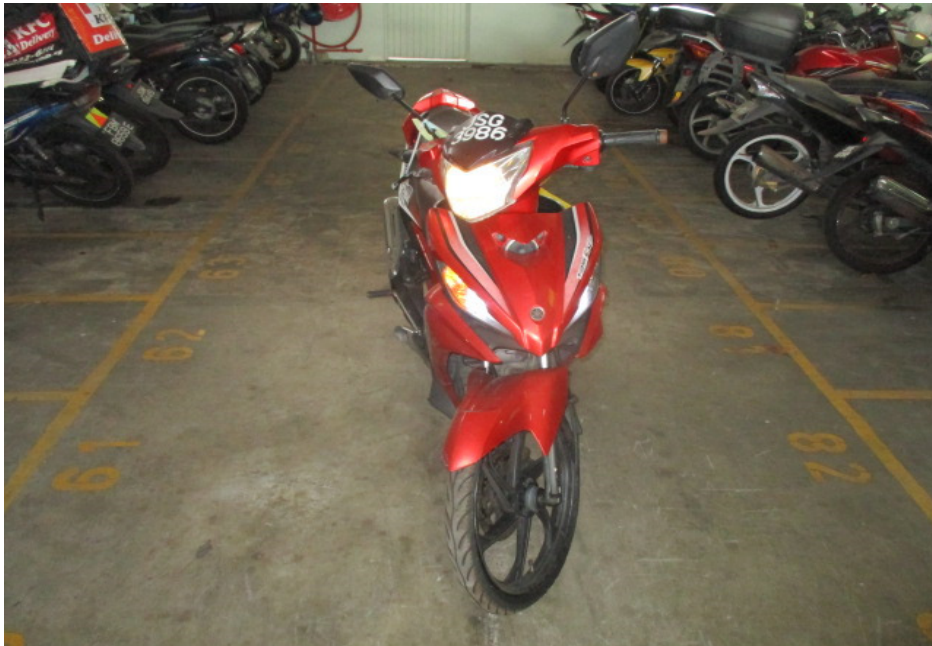
Photo 22 shows the front wheel of the Motorcycle turned towards its full right. Turning the Motorcycle's handle bar towards the left and right did not produce any abnormal free play and/or resistance. This would indicate that the steering system of the Motorcycle was in serviceable condition at the time of our inspection.

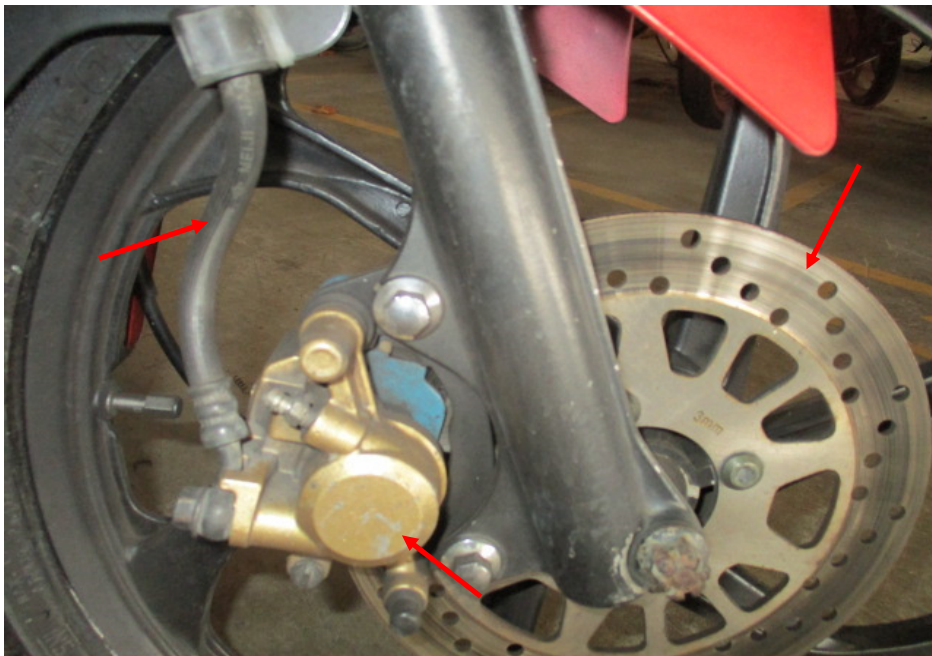
14. Our visual examination of the various components in the Motorcycle's front braking system like the brake disc, brake caliper and brake hose revealed all to be intact and without damage. There was also no leakage of brake fluid observed along the brake hose. This was from the respective brake fluid reservoir to the front brake caliper of the Motorcycle. The brake fluid for the front brake was also found to be of sufficiently level and without any contamination.

Photo 23 shows a close up view of the front brake caliper, front brake disc and front brake hose (arrowed) of the Motorcycle, which are all part of the components in the hydraulic front brake system of the Motorcycle. Our visual checks of these various components had revealed all to be intact with no visible damage. No leakage of brake fluid was also observed.

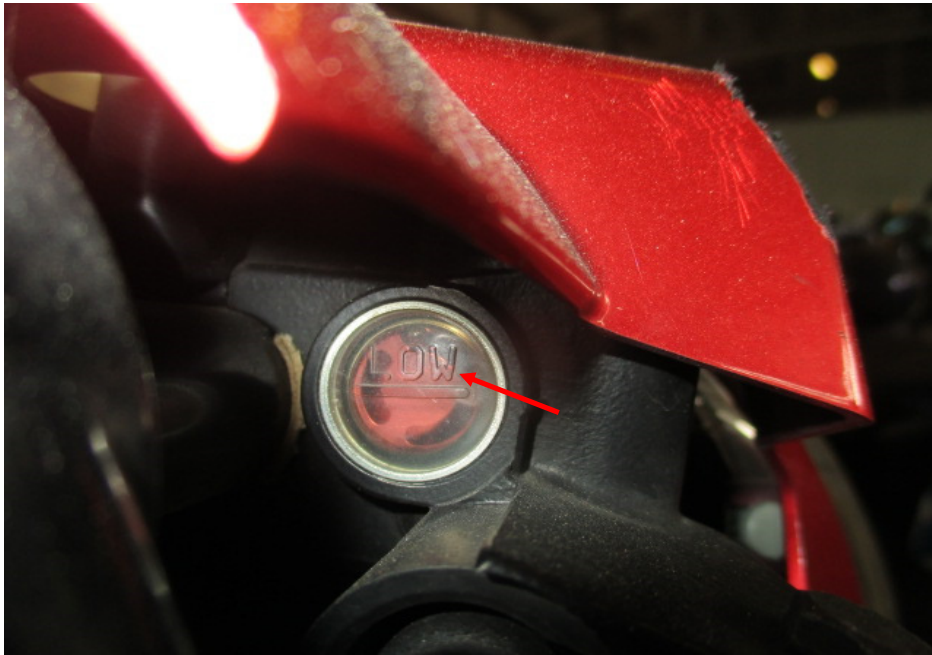
Photo 24 shows the brake fluid reservoir for the front brake of the Motorcycle. The brake fluid was observed to be of sufficient level and without contamination for operational purposes (arrowed).

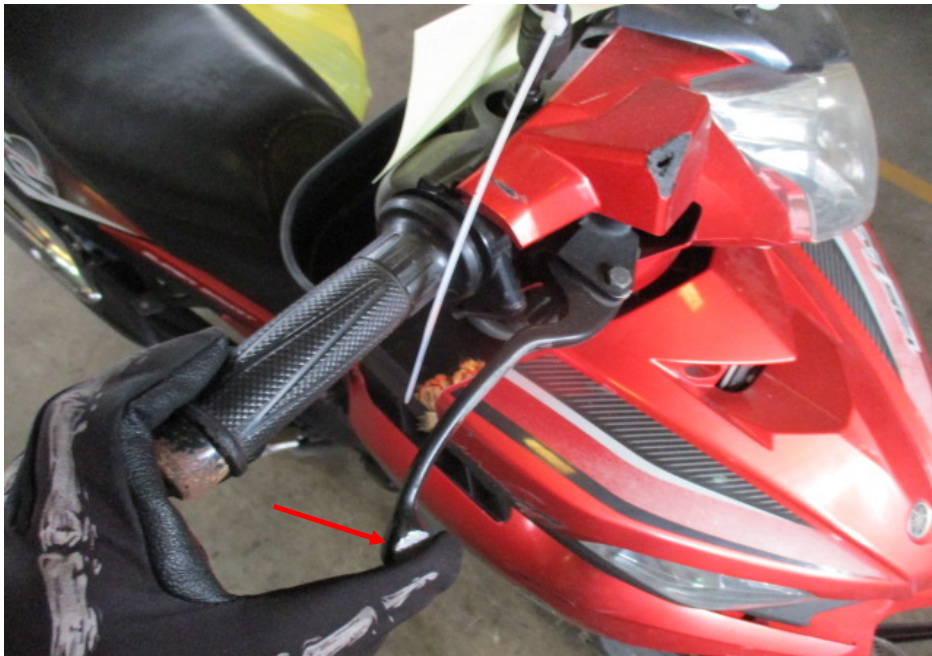
15. Static brake tests conducted on the Motorcycle had appear to indicate that the front braking system of the Motorcycle was in serviceable condition. There was some resistance felt (spongy like feel) upon pressing the brake lever. This would indicate that there was no leakage of pressure/vacuum in the front brake system.

Photo 23 shows the front brake lever being depressed. There was some resistance felt (spongy like feel) upon pressing the front brake lever (arrowed). This would indicate that there is no leakage of pressure/vacuum in the brake system.

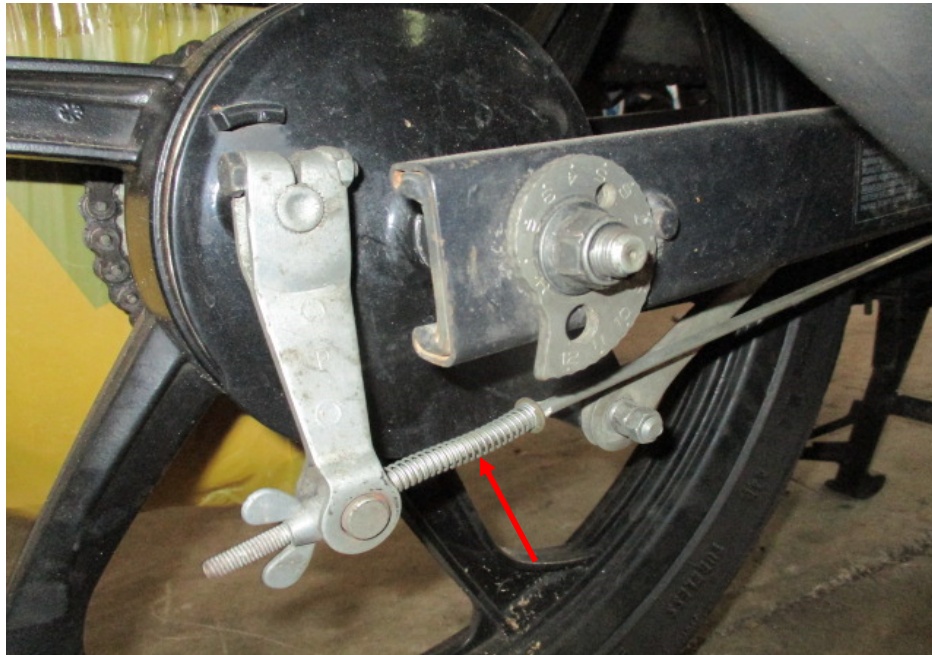
13. The brake system of the Motorcycle was of a semi-hydraulic type, where hydraulic (brake fluid) pressure controls the brake for the front wheel while the brake for the rear wheel is controlled by mechanical means (cables and springs). Our visual examination of the various components in the rear braking system, like the brake drum and brake foot pedal, revealed all to be intact and without damage. There was also no visible tear or cut observed on the connecting hoses and cables.

Photo 24 shows the rear wheel of the Motorcycle. The type of brake system for the rear wheel was of a mechanical type, controlled by the brake foot pedal of the Motorcycle. Our checks of the cable (arrowed), spring and drum which are all part of the components in the rear brake system of the Motorcycle reveal all to be intact and without damage.
