Your Ref: C10004587/LA
Our Ref : CS/AGI19020265/P

28th November 2019

**TECHNICAL INVESTIGATION REPORT OF FIRE INCIDENT INVOLVING THE
INSURED VEHICLE SGP 5912T ON 13th November 2019**

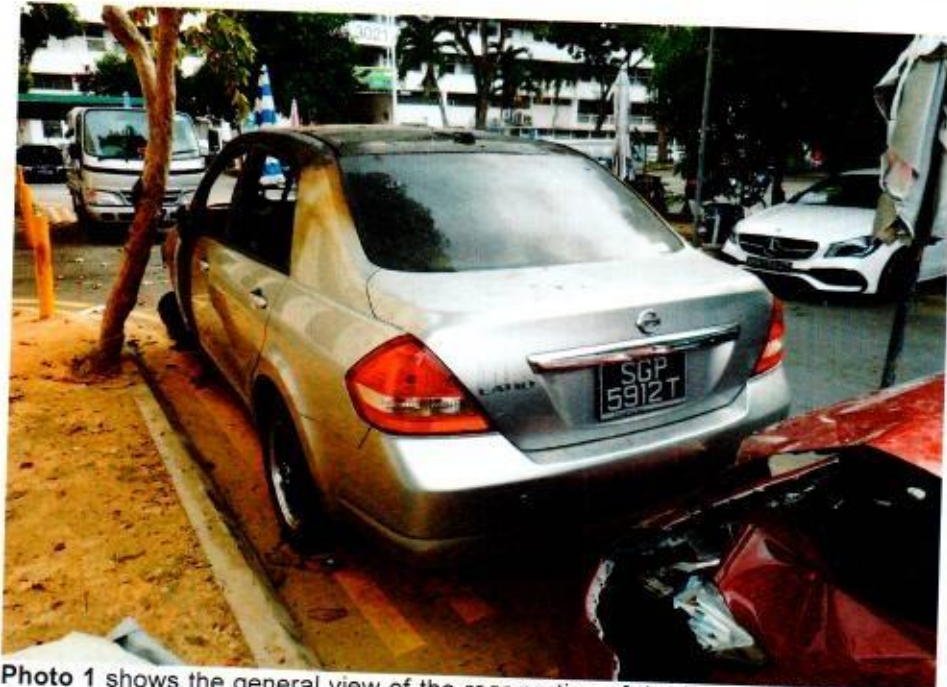
Photo 1 shows the general view of the rear portion of the Insured Vehicle which was observed to be affected heat and smoke damage at the time of our inspection as a result of the fire.

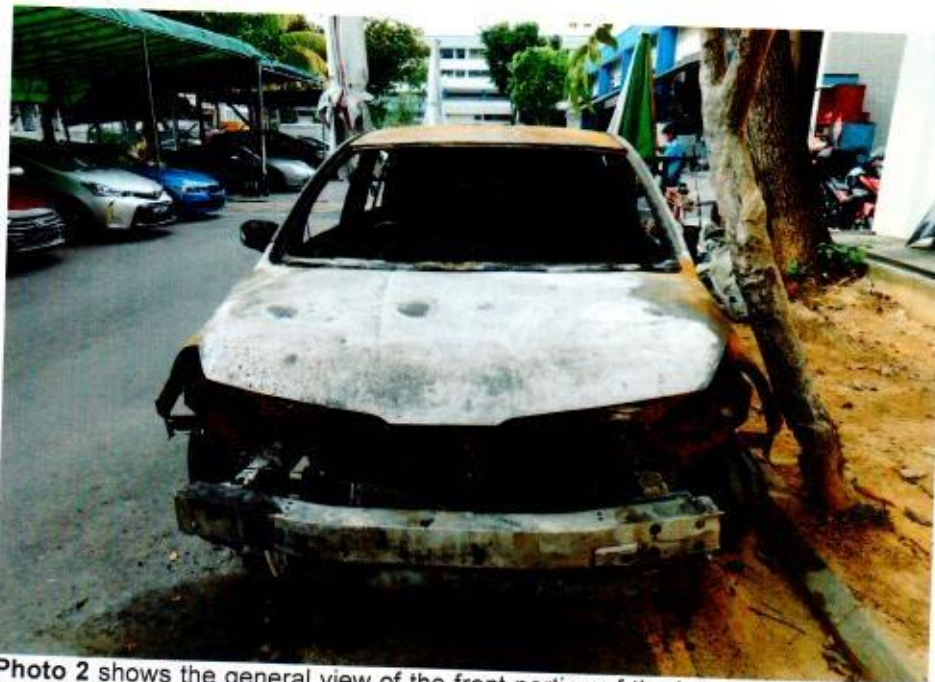
Photo 2 shows the general view of the front portion of the Insured Vehicle at the time of our inspection. The Insured Vehicle was observed to have sustained extensive fire damage all around. Its engine compartment and interior compartment were completely burnt. Rust had accumulated all over the front and centre portion of the Insured Vehicle as a result of exposure to environmental condition for a period of time.

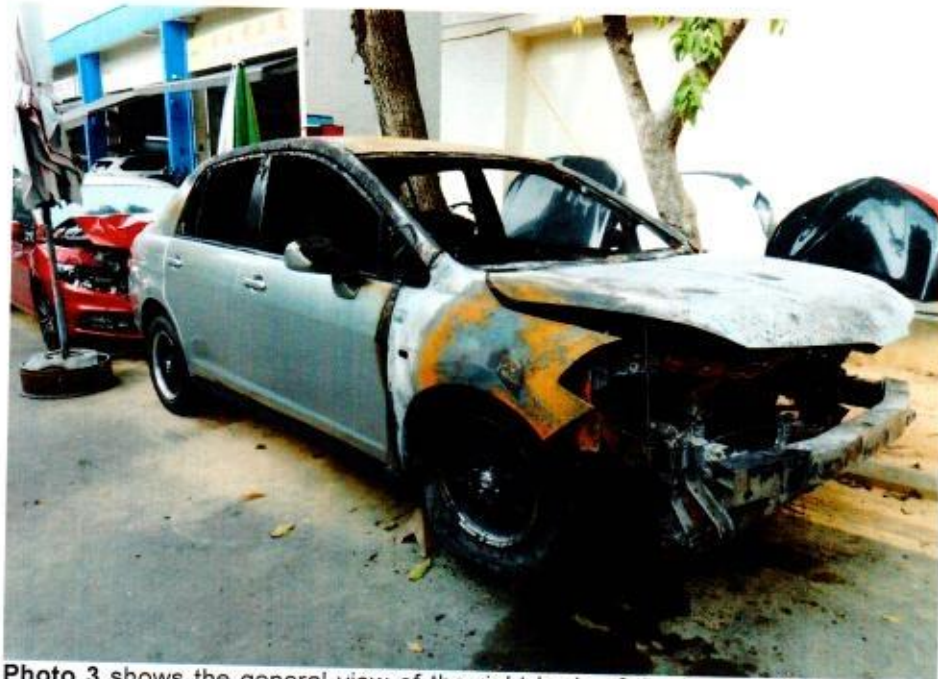
Photo 3 shows the general view of the right body of the Insured Vehicle at the time of our inspection. The Insured Vehicle was observed to have sustained extensive fire damage all around. Rust had accumulated all over the front and interior compartment of the Insured Vehicle as a result of exposure to environmental condition for a period of time.

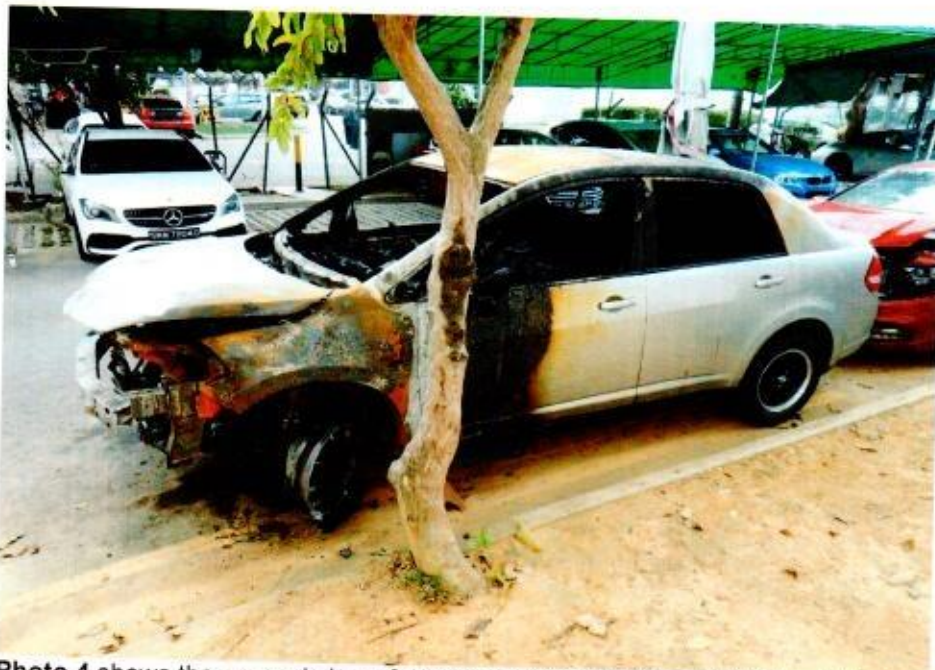
Photo 4 shows the general view of the left body of the Insured Vehicle at the time of our inspection. The Insured Vehicle was observed to have sustained extensive fire damage all around. Rust had accumulated all over the front and centre portion of the Insured Vehicle as a result of exposure to environmental condition for a period of time.

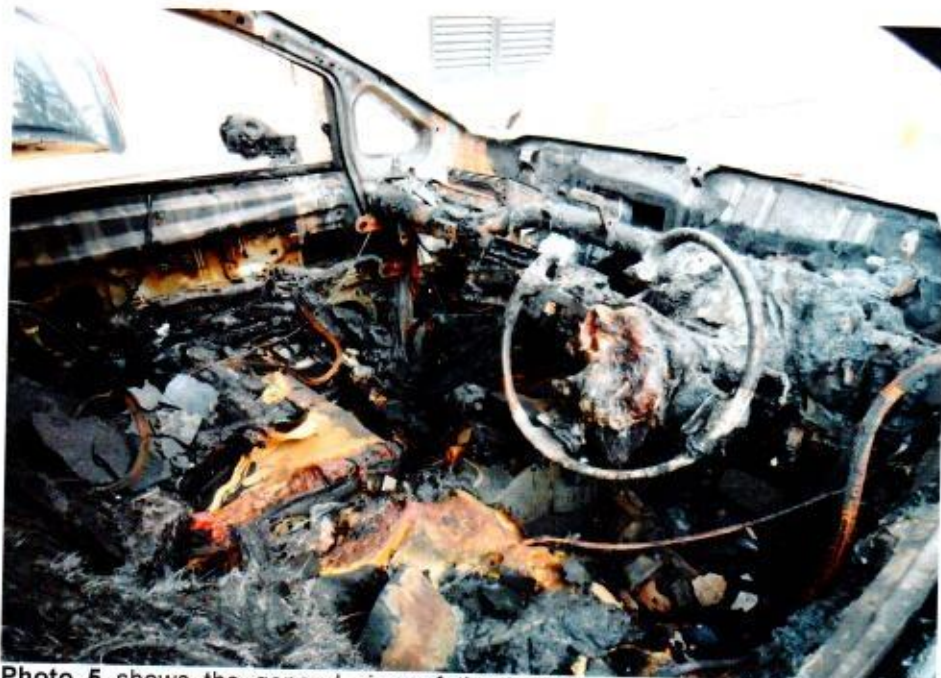
Photo 5 shows the general view of the interior compartment of the Insured Vehicle at the time of our inspection. Its interior compartment was completely burnt as a result of the fire.

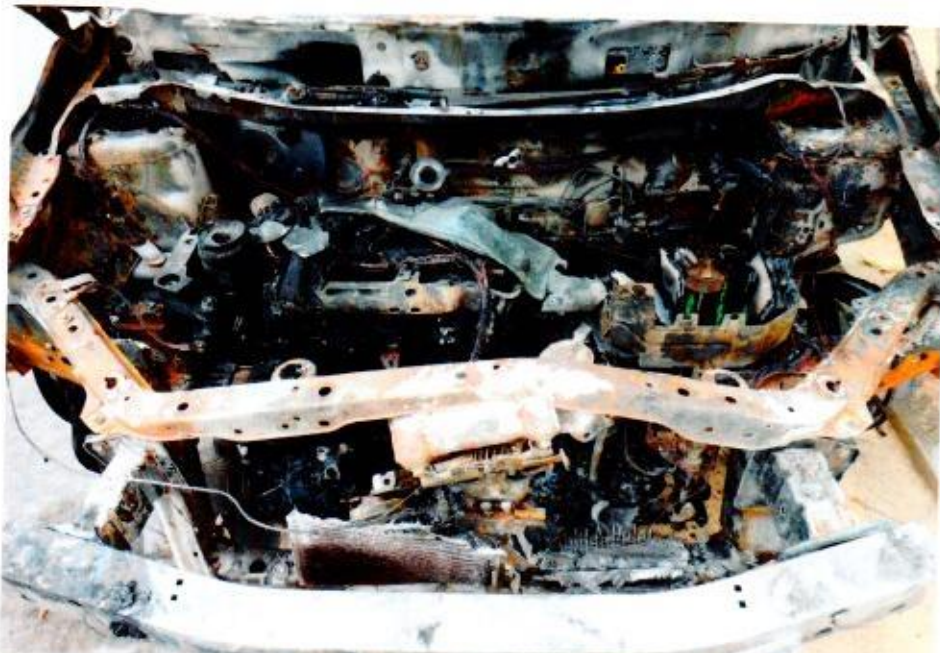
Photo 6 shows the engine compartment of the Insured Vehicle at the time of our inspection. The entire engine compartment of the Insured Vehicle was observed to be severely burnt. Most of the parts inside the engine compartment were found to be burnt and/or melted as a result of the fire.

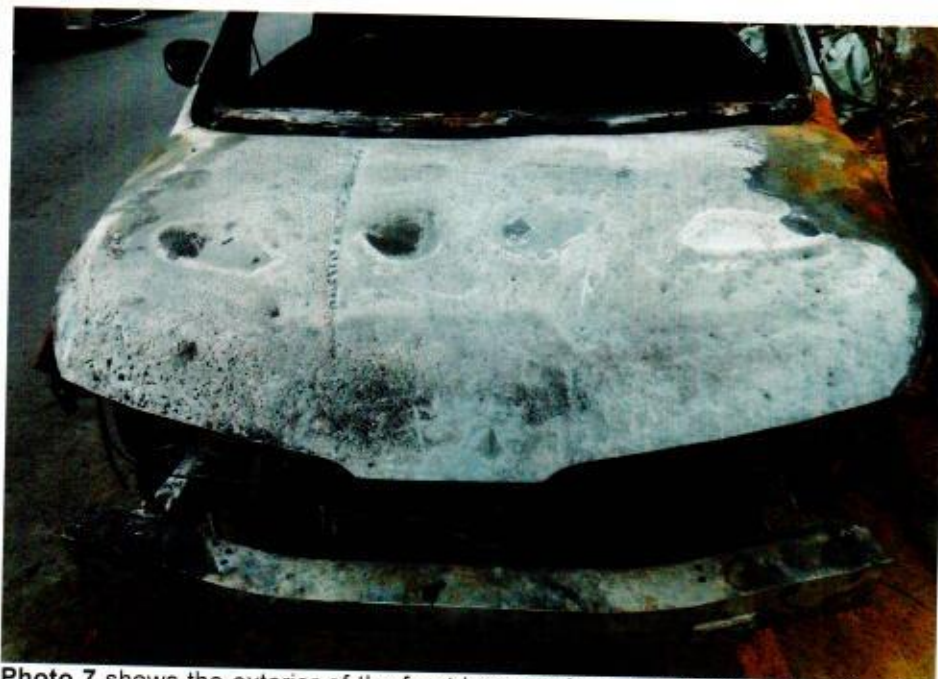
8. These whitish burn marks are a result of exposure to prolong heat intensity. Rust would normally start to develop around these areas soon after a fire as the prolonged exposure to high heat intensity usually causes the bare steel/metal material of the body parts to be exposed to natural environmental condition. The rust that had developed on the front bonnet and centre portion, in the immediate vicinity of where these whitish burn marks were found, would also support our findings of where the fire had affected the Insured Vehicle. See photo 7- 10 below.

Photo 7 shows the exterior of the front bonnet of the Insured Vehicle at the time of our inspection. The high heat intensity burn marks (whitish burn marks) and rust that had development found on the exterior surface of the bonnet indicates that the fire had originated from the front portion of the Insured Vehicle.

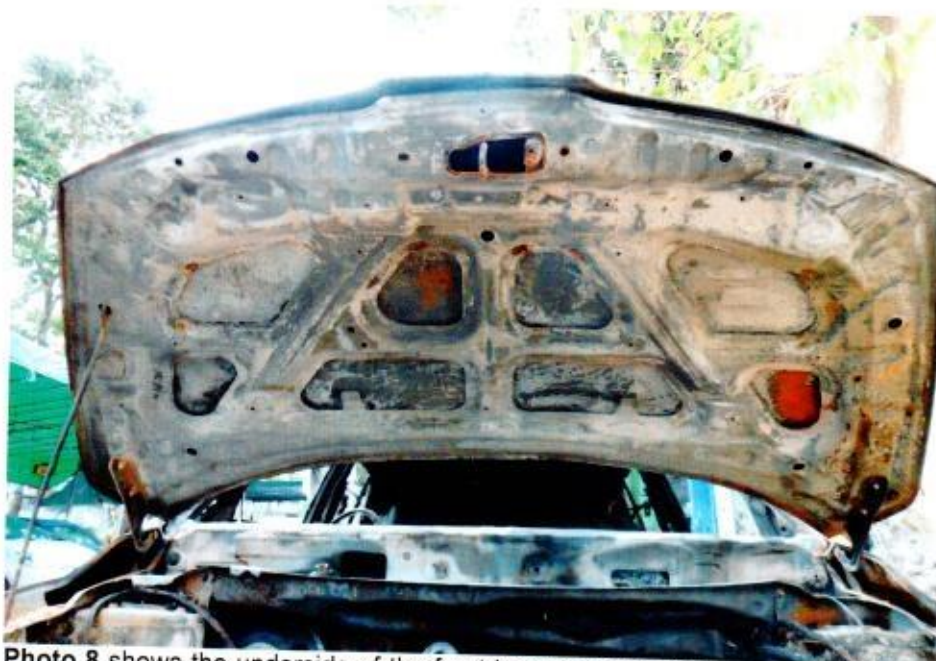
Photo 8 shows the underside of the front bonnet cover of the Insured Vehicle at the time of our inspection. The High heat intensity burn marks (whitish burn marks) and rust that had development found on the exterior surface of the bonnet indicates that the fire had originated from the front portion of the Insured Vehicle.

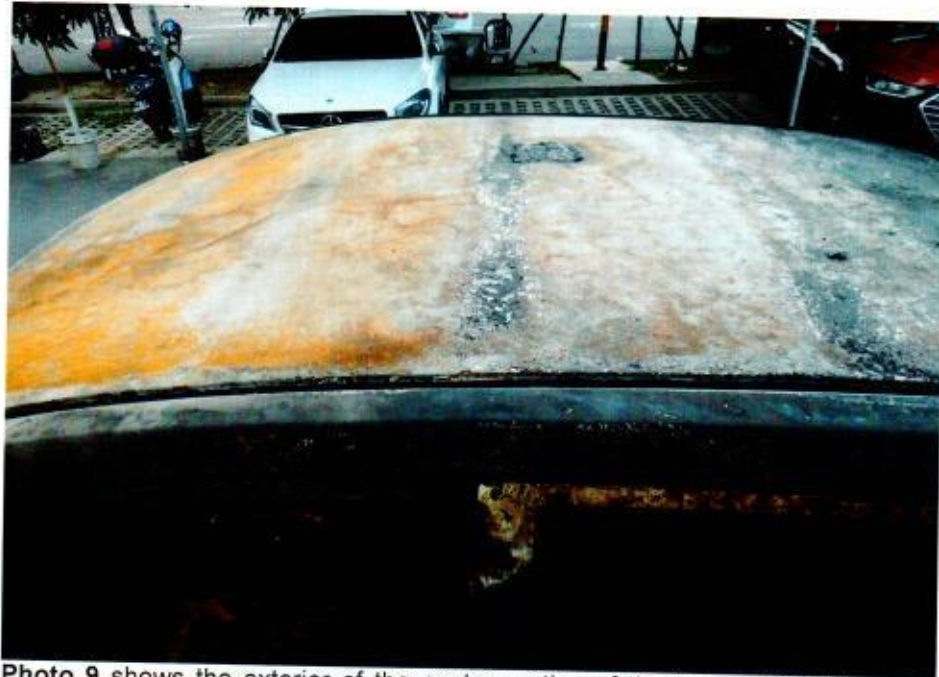
Photo 9 shows the exterior of the centre portion of the Insured Vehicle at the time of our inspection. The high heat intensity burn marks (whitish burn marks) and rust that had development found on the exterior surface indicates that the fire had originated from the frontal portion of the Insured Vehicle.

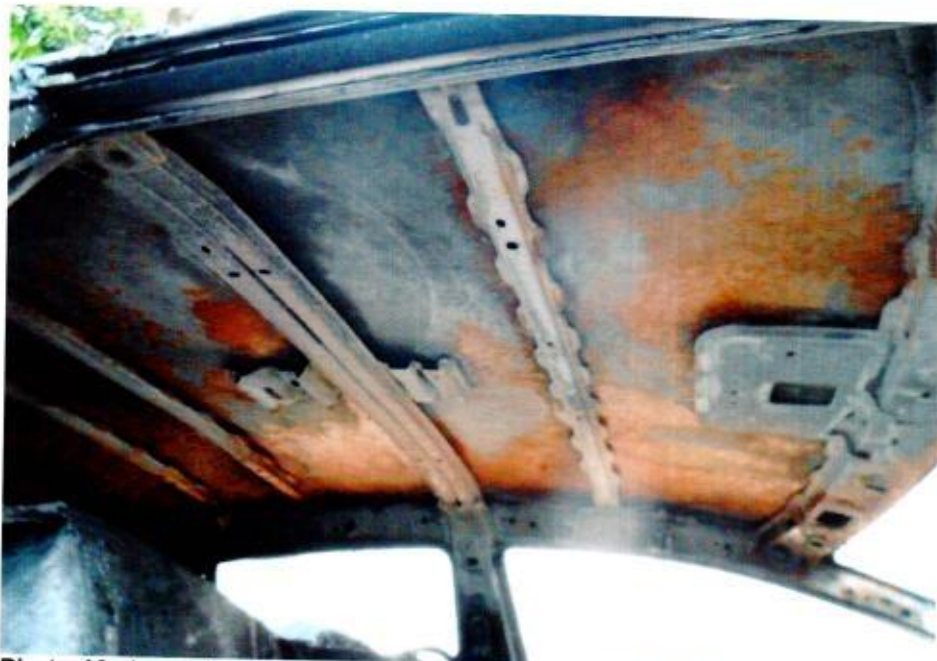
Photo 10 shows the underside of the front bonnet cover of the Insured Vehicle at the time of our inspection. The High heat intensity burn marks (whitish burn marks) and rust that had development found on the exterior surface of the bonnet indicates that the fire had originated from the front portion of the Insured Vehicle.

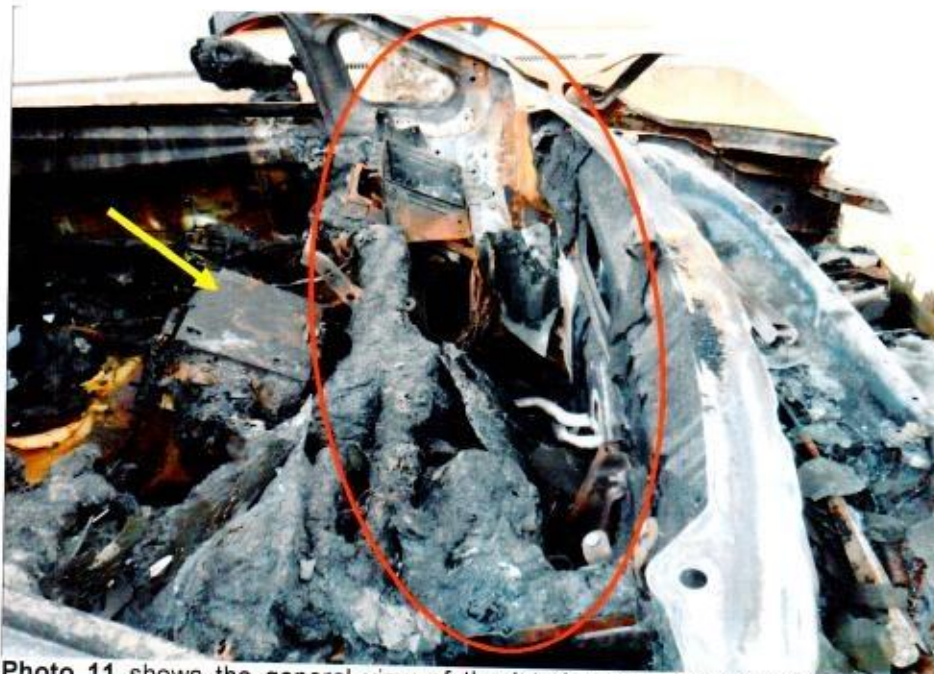
Photo 11 shows the general view of the interior compartment of the Insured Vehicle at the time of our inspection. The fire damage to the Insured Vehicle has affected its engine and interior compartment. Its interior dashboard (circled), radio head unit (yellow arrow), various original wiring harnesses was amongst the parts in the compartment that were found to have been affected as a result of the fire.

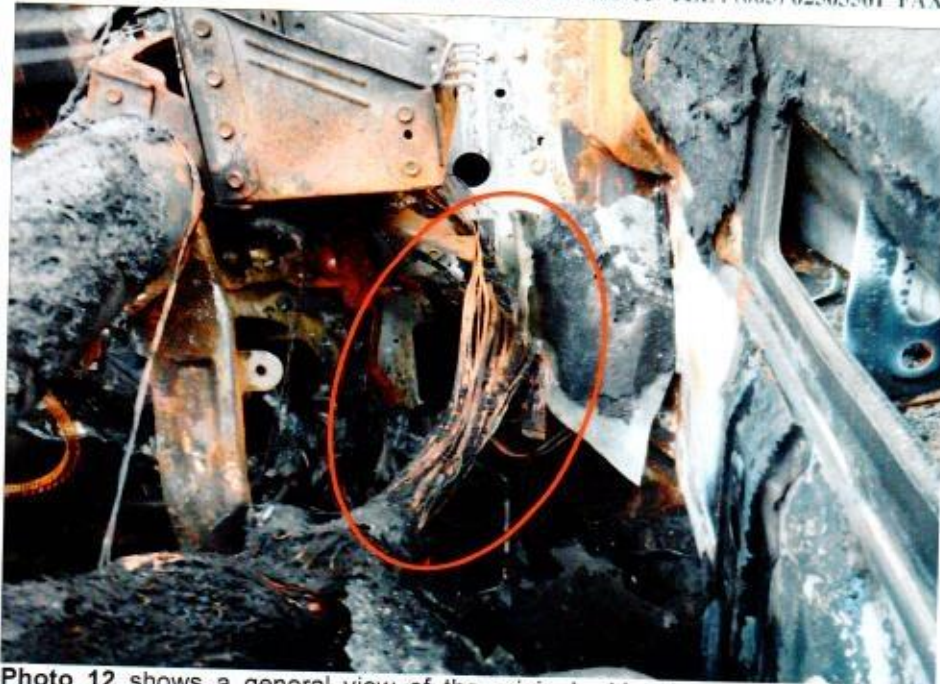
9. Upon closer examination of the front portion of the Insured Vehicle which was where the fire had started, we had found traces of greenish residue on the main wirings harnesses leading from the battery to the electrical components of the Insured Vehicle. The wirings were original wirings fitted from the manufacturer. The presence of greenish residue indicates internal heating of copper wires, a sign of an electrical short circuit occurring. The greenish residue is normally left behind from the oxidation as a result of chemical reaction involving the copper wires. This physical evidence would then appear to suggest that the cause of fire to the Insured Vehicle could have possibly been due to electrical in nature. See photos 11 - 13 below.

Photo 12 shows a general view of the original wiring harness in the engine compartment. The original wiring harness (circled) was observed with greenish residue on the surface. The presence of greenish residue indicates internal heating of copper wires, a sign of an electrical short circuit occurring. The greenish residue is normally left behind from oxidation as a result of chemical reaction involving the copper wires.

22. The possibility of the fire being due to electrical in nature would then seem more likely given that engine overheating and external factors would both seem unlikely. The fire being due to electrical nature is also supported by the condition of the original wiring harnesses wirings that were found leading from the battery assembly to the electrical components on the Insured Vehicle, which was earlier discussed in paragraph 9 above.

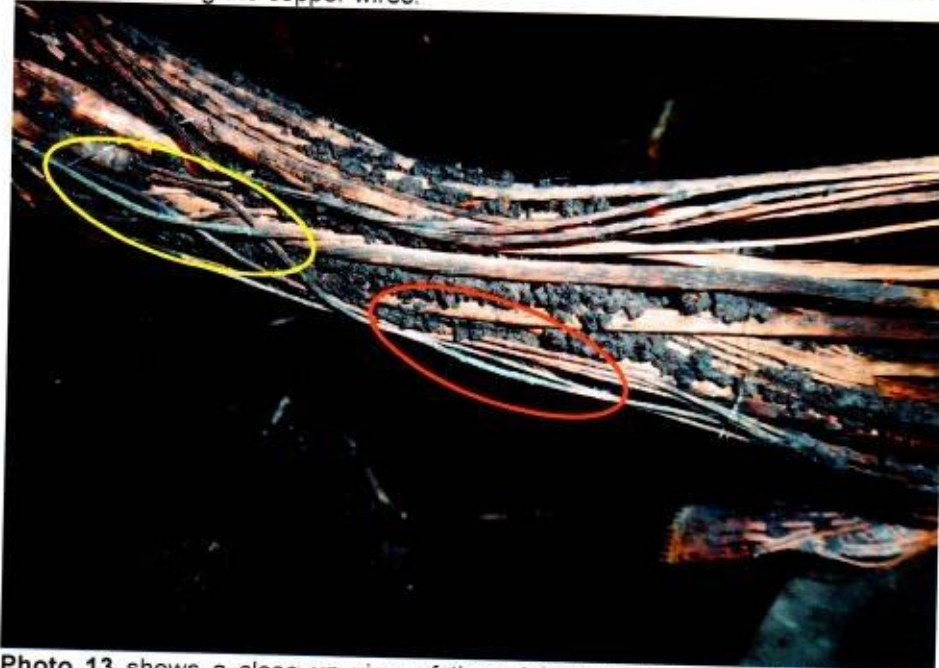
Photo 13 shows a close up view of the original wiring harness in the engine compartment. The original wiring harness (yellow and red circled) was observed with greenish residue on the surface. The presence of greenish residue indicates internal heating of copper wires, a sign of an electrical short circuit occurring. The greenish residue is normally left behind from oxidation as a result of chemical reaction involving the copper wires.

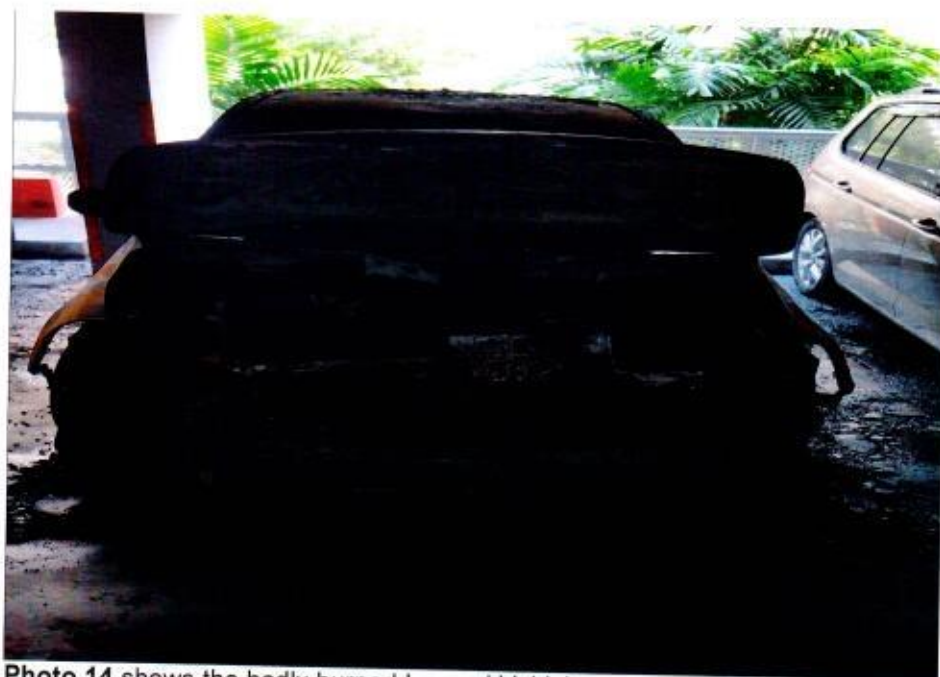
Photo 14 shows the badly burned Insured Vehicle at the MSCP after the fire was put out by the SCDF. In general, the information that could be gathered from this photograph had corresponded to the events that were related to us by Mr Chow, location when the fire broke out.

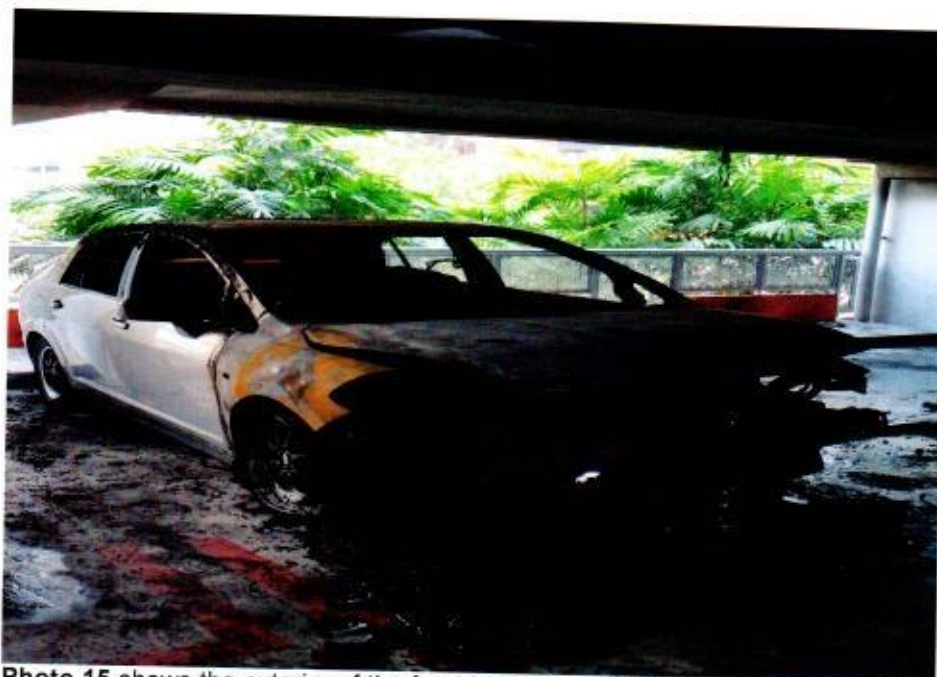
Photo 15 shows the exterior of the front bonnet of the Insured Vehicle at the time of our inspection. The high heat intensity burn marks (whitish burn marks) and rust that had development found on the exterior surface of the bonnet indicates that the fire had originated from the front portion of the Insured Vehicle. In general, the information that could be gathered from this photograph had corresponded to the events that were related to us by Mr Chow, location when the fire broke out.

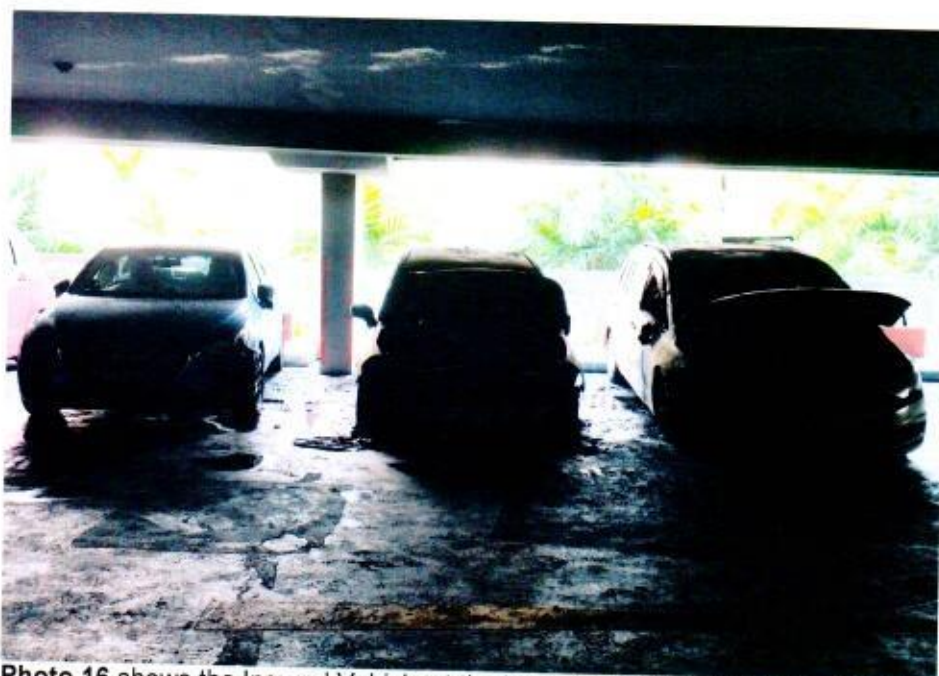
Photo 16 shows the Insured Vehicle at the incident location and the two Vehicles beside the Insured Vehicle had also sustain fire damage for the burning of the Insured Vehicle.
