Your Ref: C10004587/LA  
Our Ref : CS/AGI19020265/P

28<sup>th</sup> November 2019

**TECHNICAL INVESTIGATION REPORT OF FIRE INCIDENT INVOLVING THE INSURED VEHICLE SGP 5912T ON 13<sup>th</sup> November 2019**

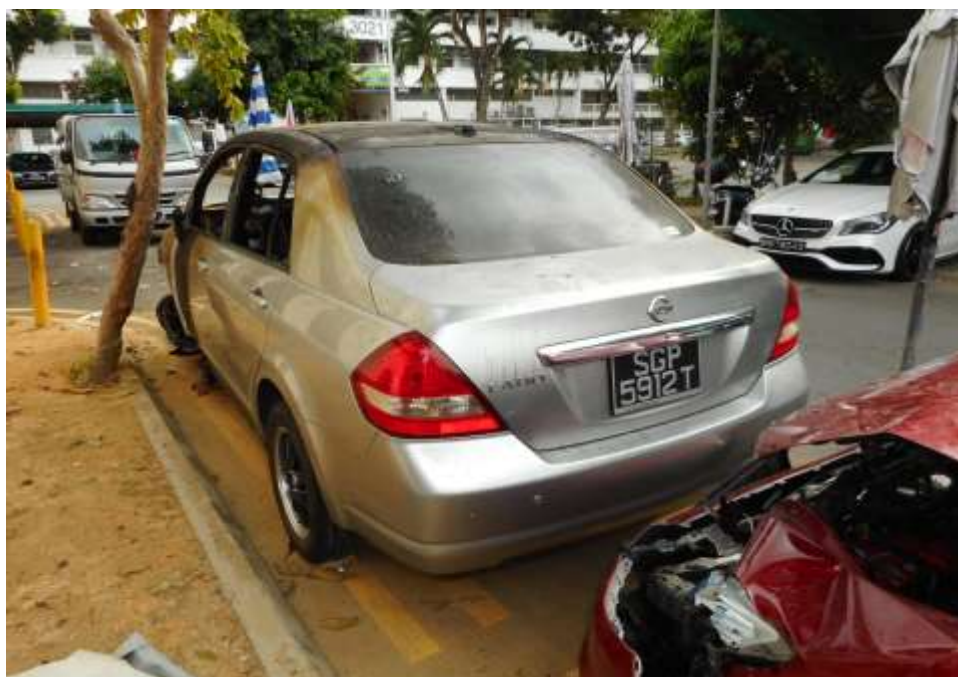
**Photo 1** shows the general view of the rear portion of the Insured Vehicle which was observed to be affected heat and smoke damage at the time of our inspection as a result of the fire.

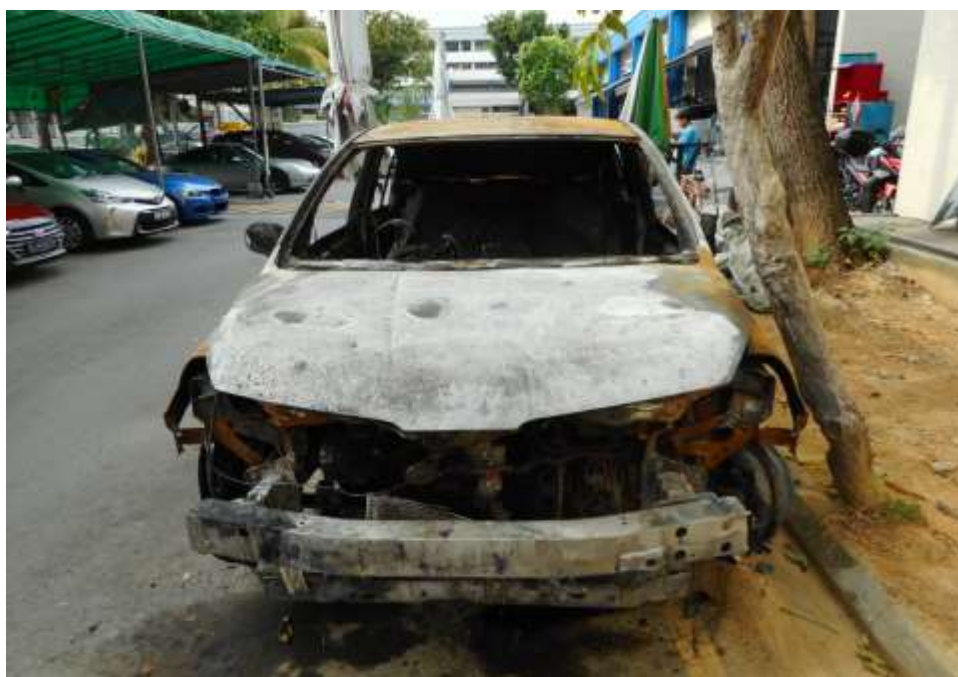
**Photo 2** shows the general view of the front portion of the Insured Vehicle at the time of our inspection. The Insured Vehicle was observed to have sustained extensive fire damage all around. Its engine compartment and interior compartment were completely burnt. Rust had accumulated all over the front and centre portion of the Insured Vehicle as a result of exposure to environmental condition for a period of time.

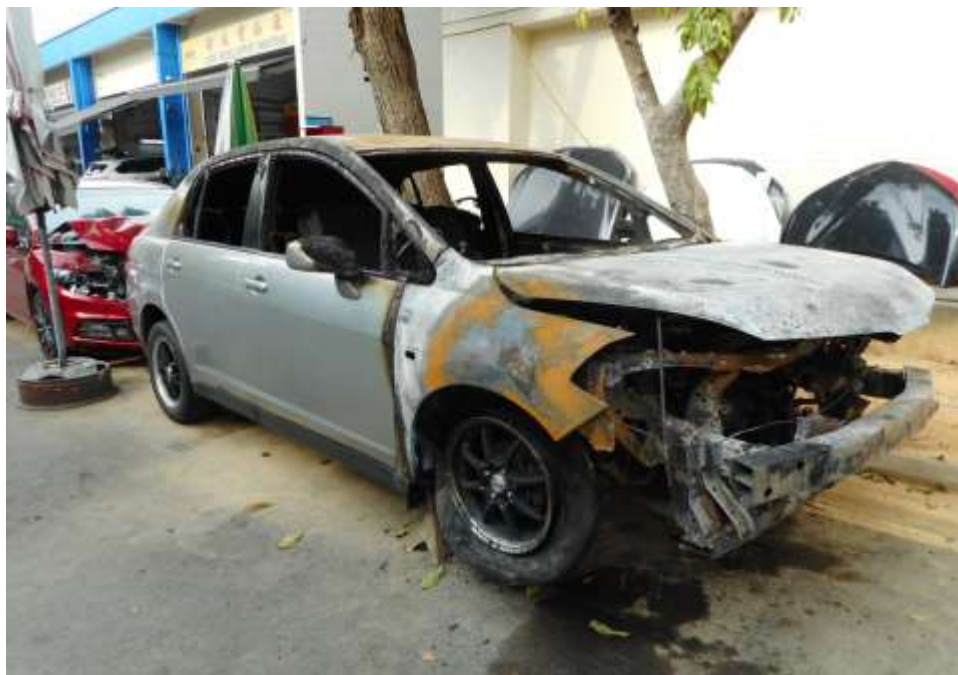
**Photo 3** shows the general view of the right body of the Insured Vehicle at the time of our inspection. The Insured Vehicle was observed to have sustained extensive fire damage all around. Rust had accumulated all over the front and interior compartment of the Insured Vehicle as a result of exposure to environmental condition for a period of time.

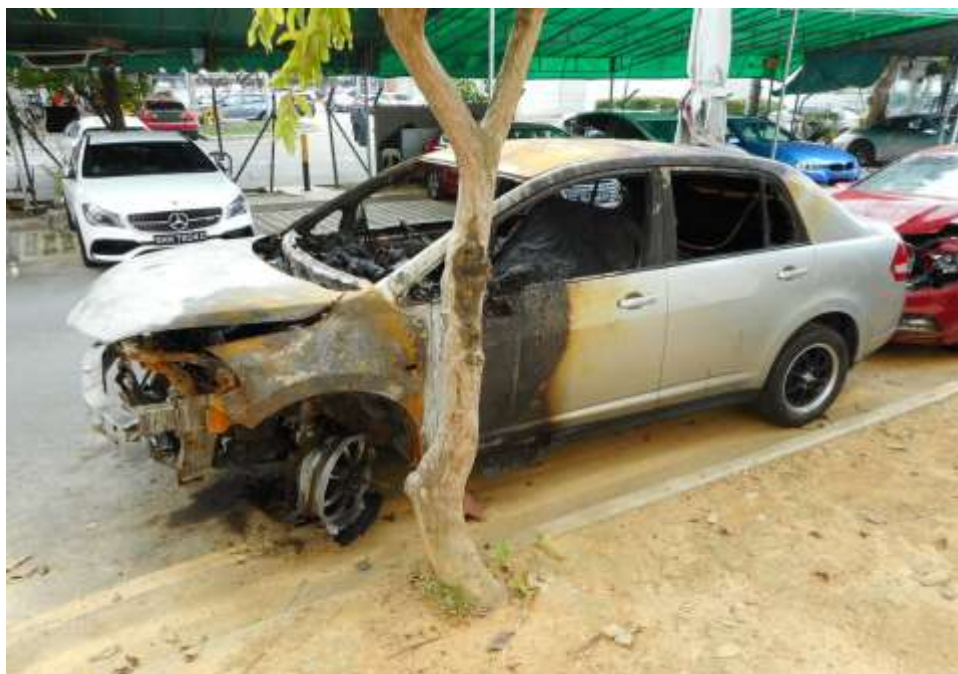
**Photo 4** shows the general view of the left body of the Insured Vehicle at the time of our inspection. The Insured Vehicle was observed to have sustained extensive fire damage all around. Rust had accumulated all over the front and centre portion of the Insured Vehicle as a result of exposure to environmental condition for a period of time.

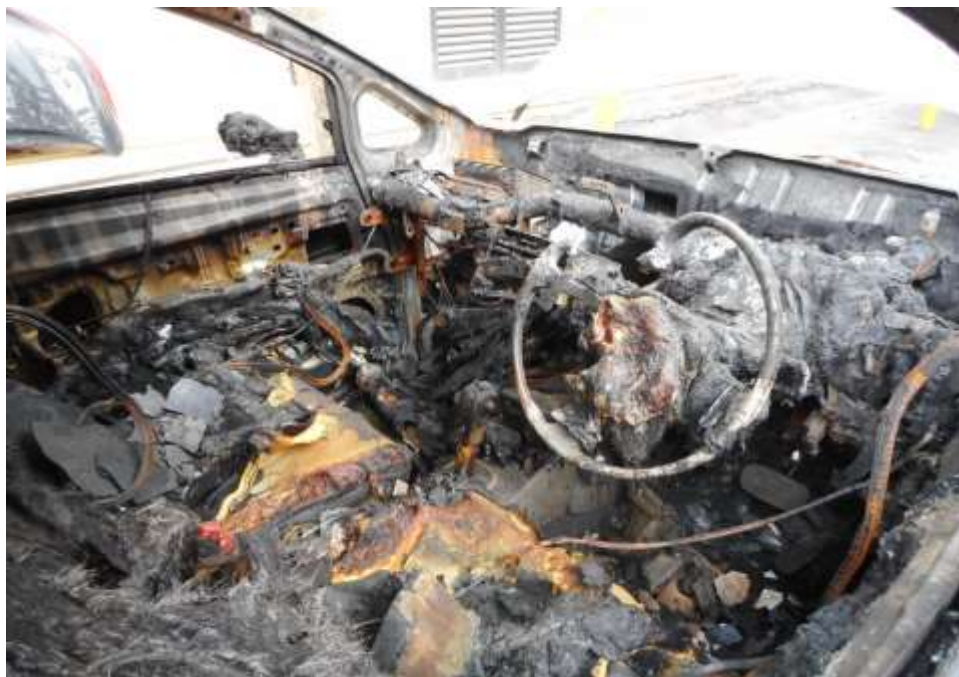
**Photo 5** shows the general view of the interior compartment of the Insured Vehicle at the time of our inspection. Its interior compartment was completely burnt as a result of the fire.

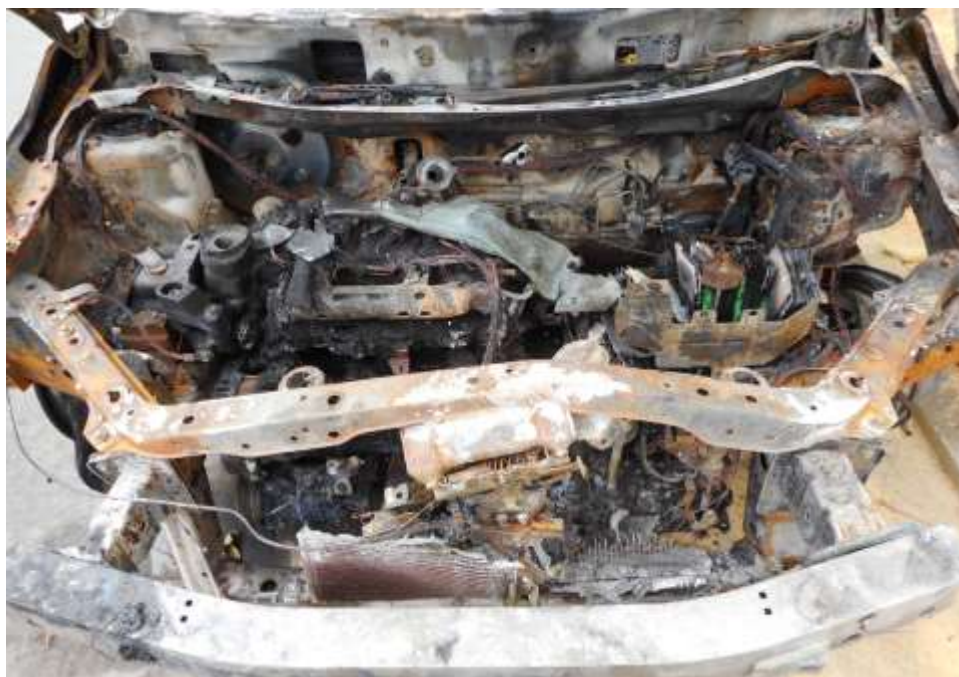
**Photo 6** shows the engine compartment of the Insured Vehicle at the time of our inspection. The entire engine compartment of the Insured Vehicle was observed to be severely burnt. Most of the parts inside the engine compartment were found to be burnt and/or melted as a result of the fire.

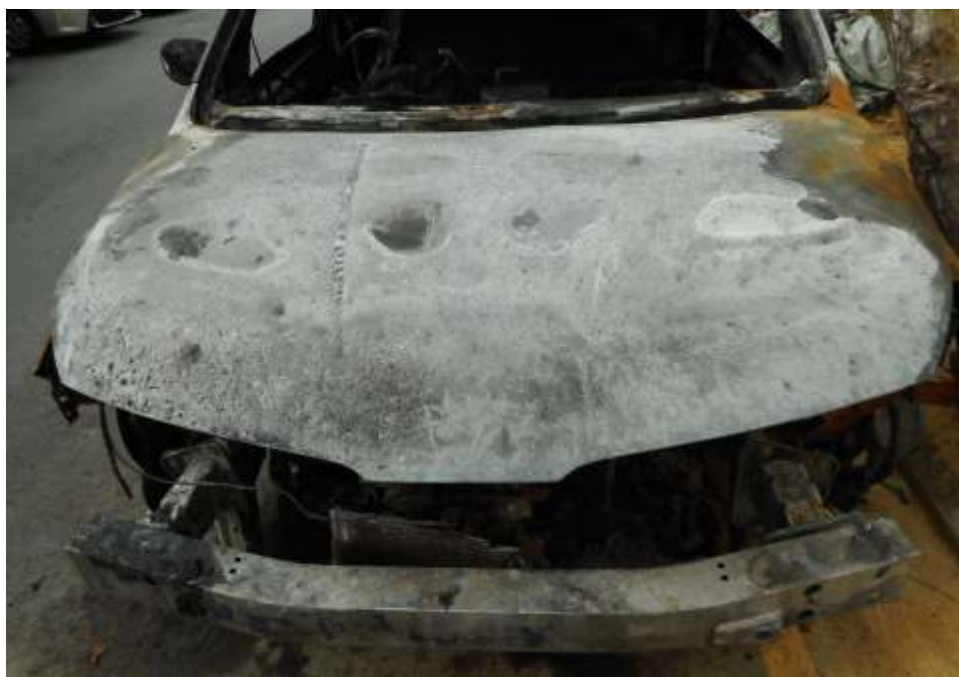
7. Based on the circumstances for this particular case, the fire appears to have originated from the front of the Insured Vehicle, somewhere around the front and spread to the centre portion. This can be determined basing on the area where the extent of fire damage was most severe, the circumstances of the fires' origin at the material time of incident and also the high heat intensity burn marks (whitish burn marks) that were found on the exterior surface of its front bonnet and centre portion.

8. These whitish burn marks are a result of exposure to prolong heat intensity. Rust would normally start to develop around these areas soon after a fire as the prolonged exposure to high heat intensity usually causes the bare steel/metal material of the body parts to be exposed to natural environmental condition. The rust that had developed on the front bonnet and centre portion, in the immediate vicinity of where these whitish burn marks were found, would also support our findings of where the fire had affected the Insured Vehicle. See photo 7- 10 below.

**Photo 7** shows the exterior of the front bonnet of the Insured Vehicle at the time of our inspection. The high heat intensity burn marks (whitish burn marks) and rust that had development found on the exterior surface of the bonnet indicates that the fire had originated from the front portion of the Insured Vehicle.

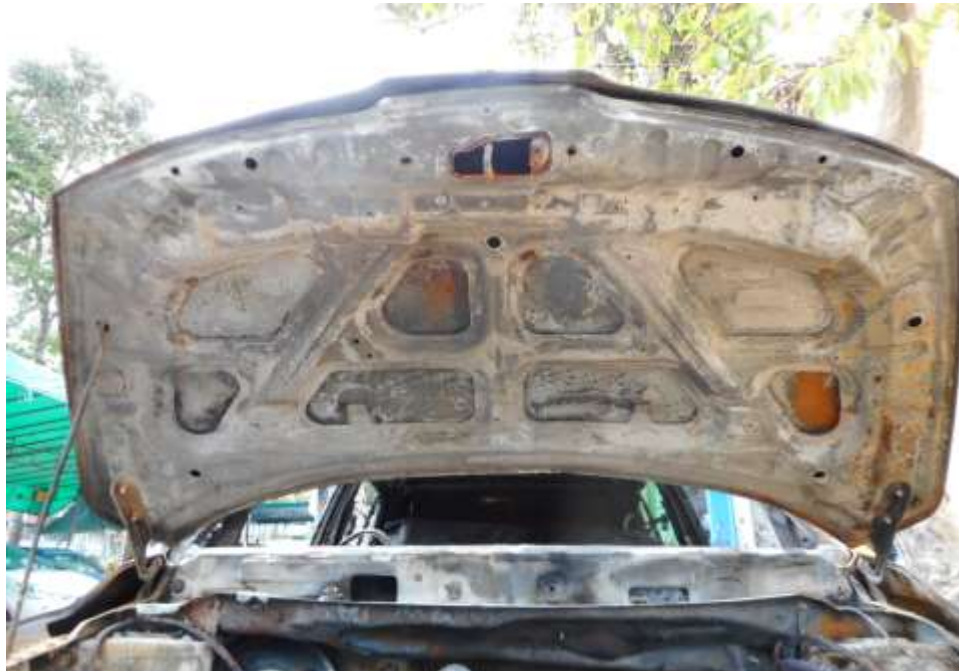
**Photo 8** shows the underside of the front bonnet cover of the Insured Vehicle at the time of our inspection. The High heat intensity burn marks (whitish burn marks) and rust that had development found on the exterior surface of the bonnet indicates that the fire had originated from the front portion of the Insured Vehicle.

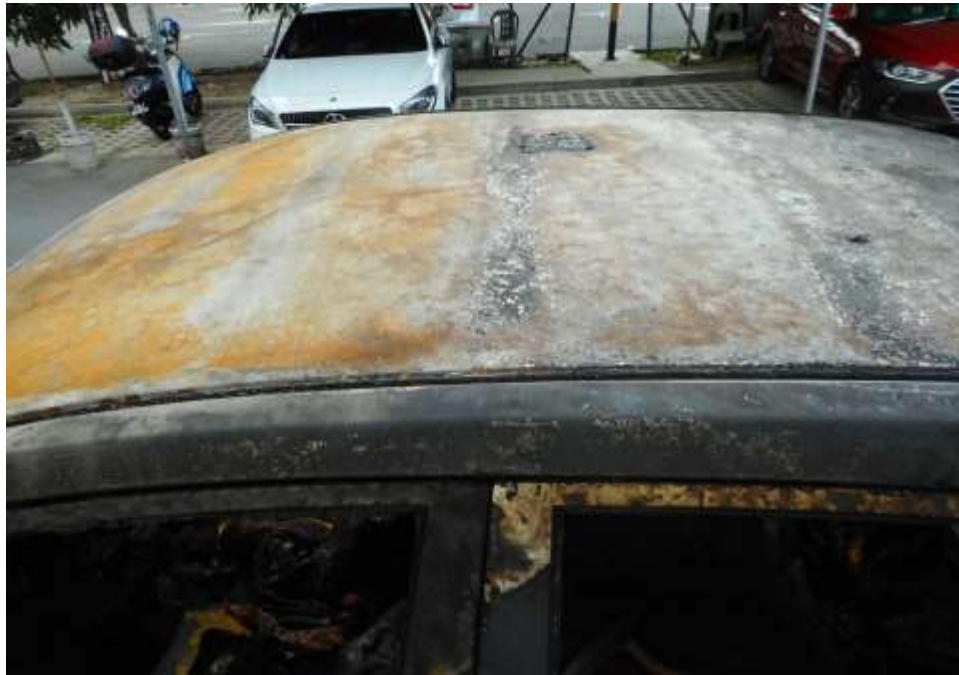
**Photo 9** shows the exterior of the centre portion of the Insured Vehicle at the time of our inspection. The high heat intensity burn marks (whitish burn marks) and rust that had development found on the exterior surface indicates that the fire had originated from the frontal portion of the Insured Vehicle.

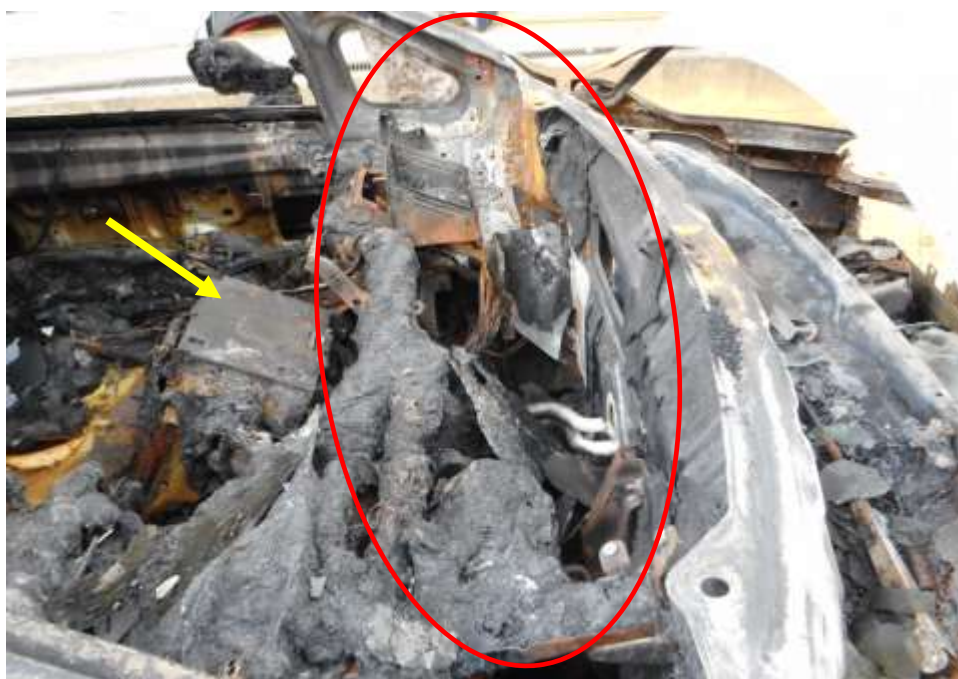
**Photo 11** shows the general view of the interior compartment of the Insured Vehicle at the time of our inspection. The fire damage to the Insured Vehicle has affected its engine and interior compartment. Its interior dashboard (circled), radio head unit (yellow arrow), various original wiring harnesses was amongst the parts in the compartment that were found to have been affected as a result of the fire.

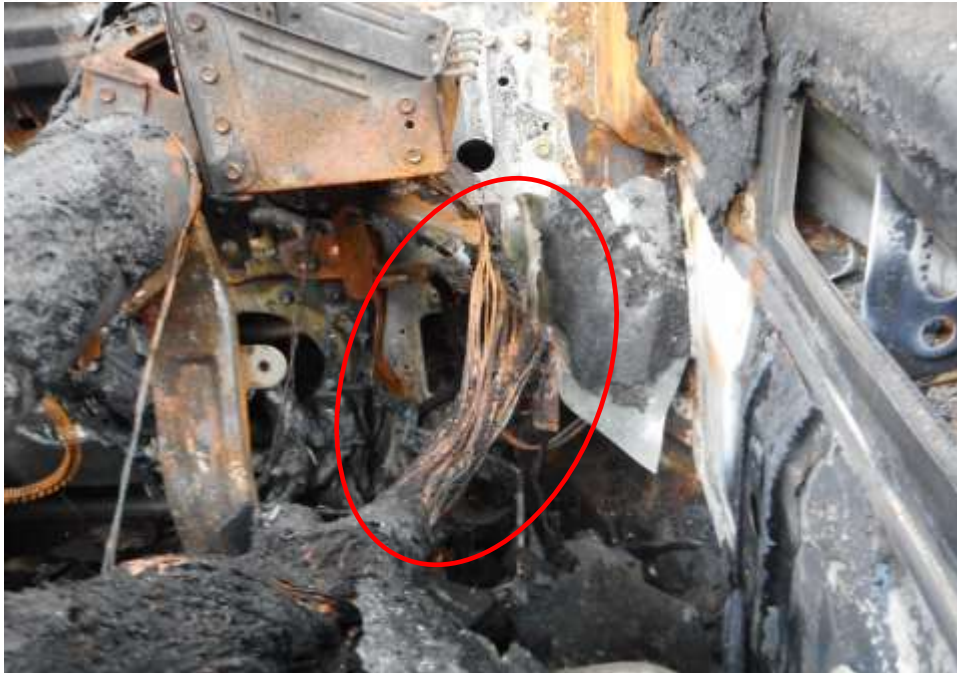
9. Upon closer examination of the front portion of the Insured Vehicle which was where the fire had started, we had found traces of greenish residue on the main wirings harnesses leading from the battery to the electrical components of the Insured Vehicle. The wirings were original wirings fitted from the manufacturer. The presence of greenish residue indicates internal heating of copper wires, a sign of an electrical short circuit occurring. The greenish residue is normally left behind from the oxidation as a result of chemical reaction involving the copper wires. This physical evidence would then appear to suggest that the cause of fire to the Insured Vehicle could have possibly been due to electrical in nature. See photos 11 - 13 below.

**Photo 12** shows a general view of the original wiring harness in the engine compartment. The original wiring harness (circled) was observed with greenish residue on the surface. The presence of greenish residue indicates internal heating of copper wires, a sign of an electrical short circuit occurring. The greenish residue is normally left behind from oxidation as a result of chemical reaction involving the copper wires.

24. Having investigated and technically analysed the damages of burnt nature to the Insured Vehicle, we are of the view that the cause of fire to the Insured Vehicle was of electrical nature. For this particular case, the fire had originated along the original wiring harnesses leading to the battery to the electrical components of the Insured Vehicle.

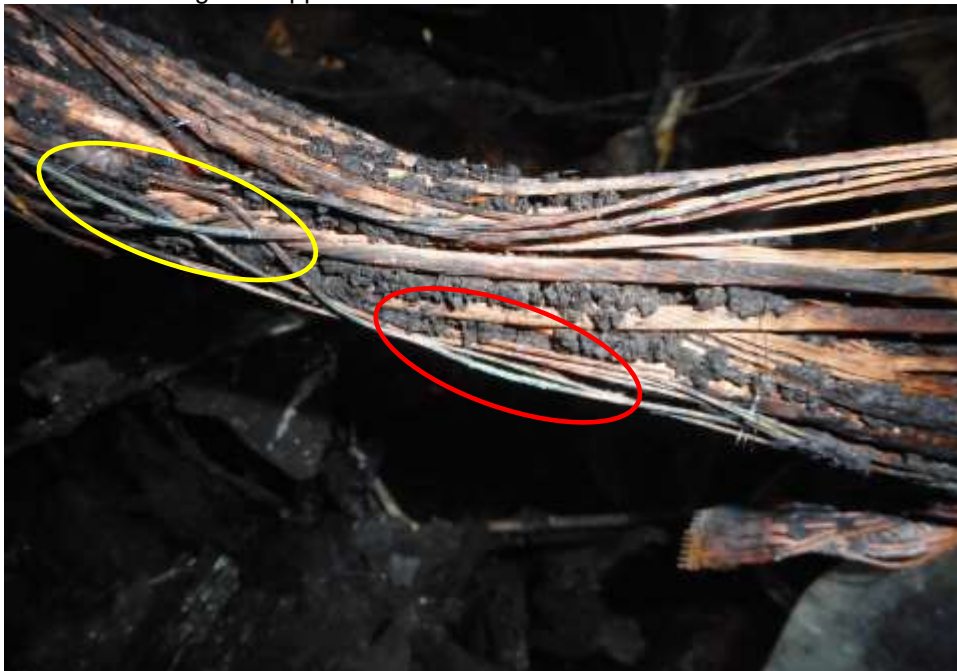
**Photo 13** shows a close up view of the original wiring harness in the engine compartment. The original wiring harness (yellow and red circled) was observed with greenish residue on the surface. The presence of greenish residue indicates internal heating of copper wires, a sign of an electrical short circuit occurring. The greenish residue is normally left behind from oxidation as a result of chemical reaction involving the copper wires.

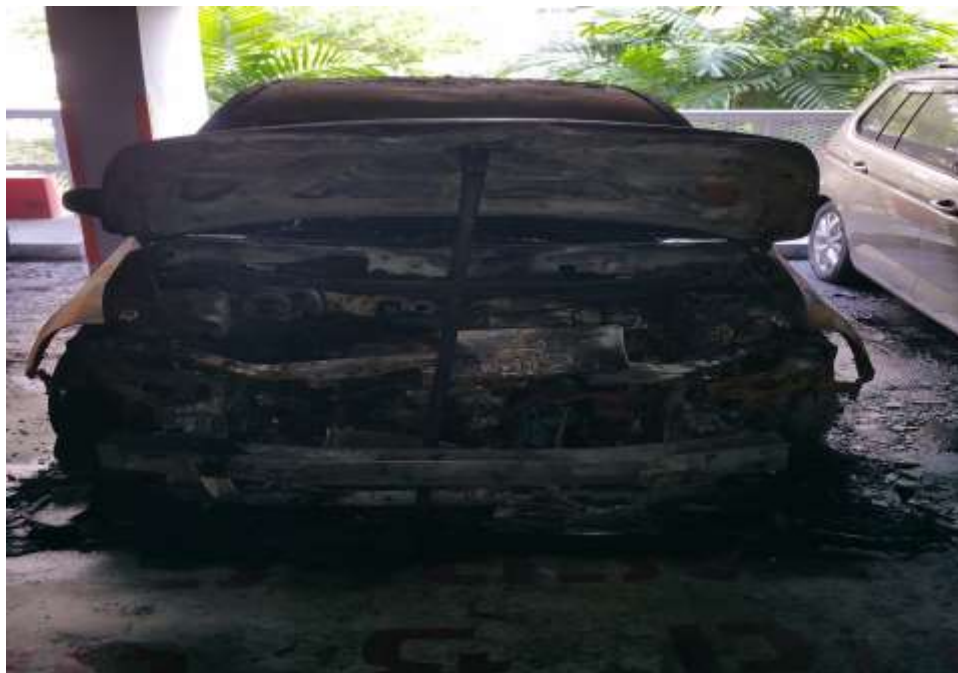
**Photo 14** shows the badly burned Insured Vehicle at the MSCP after the fire was put out by the SCDF. In general, the information that could be gathered from this photograph had corresponded to the events that were related to us by Mr Chow, location when the fire broke out.

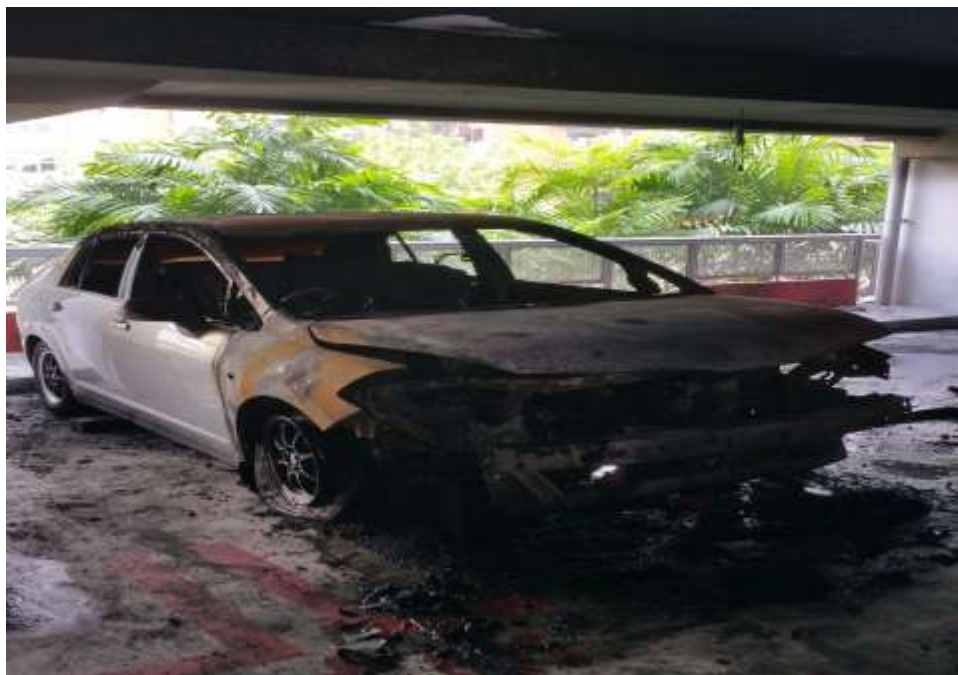
**Photo 15** shows the exterior of the front bonnet of the Insured Vehicle at the time of our inspection. The high heat intensity burn marks (whitish burn marks) and rust that had development found on the exterior surface of the bonnet indicates that the fire had originated from the front portion of the Insured Vehicle. In general, the information that could be gathered from this photograph had corresponded to the events that were related to us by Mr Chow, location when the fire broke out.

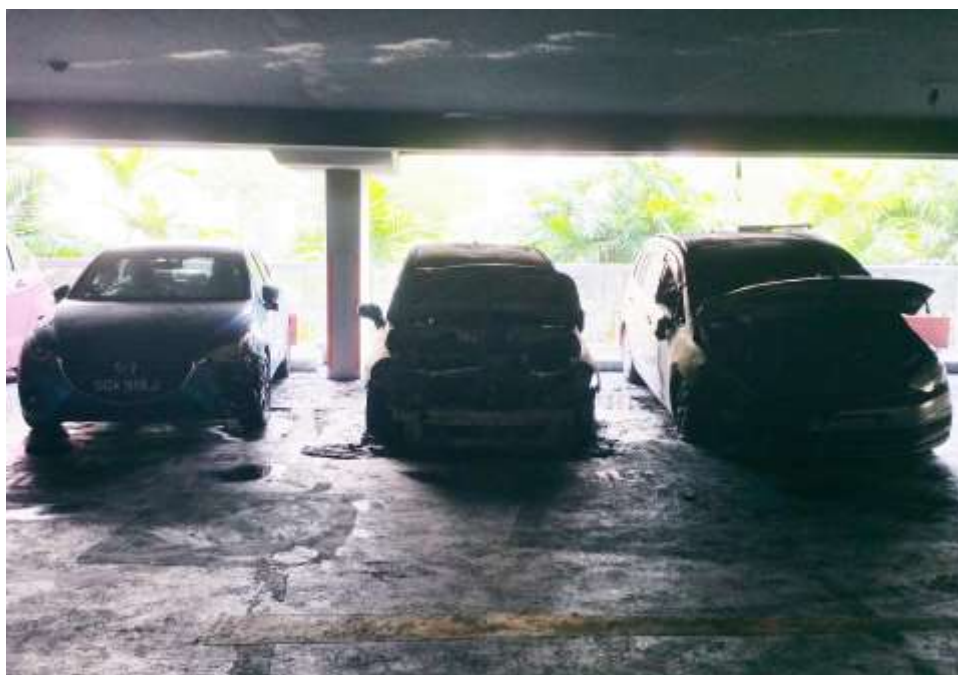
**Photo 16** shows the Insured Vehicle at the incident location and the two Vehicles beside the Insured Vehicle had also sustain fire damage for the burning of the Insured Vehicle.
