Your Ref: Mercedes Benz GLE 43  
(chassis number WDC1660642B152614)  
Our Ref : CI/TP19020352/D

15 November 2019

**INSPECTION REPORT OF AN UNREGISTERD MERCEDES BENZ GLE 43  
MOTOR CAR WITH CHASSIS NUMBER WDC1660642B152614**

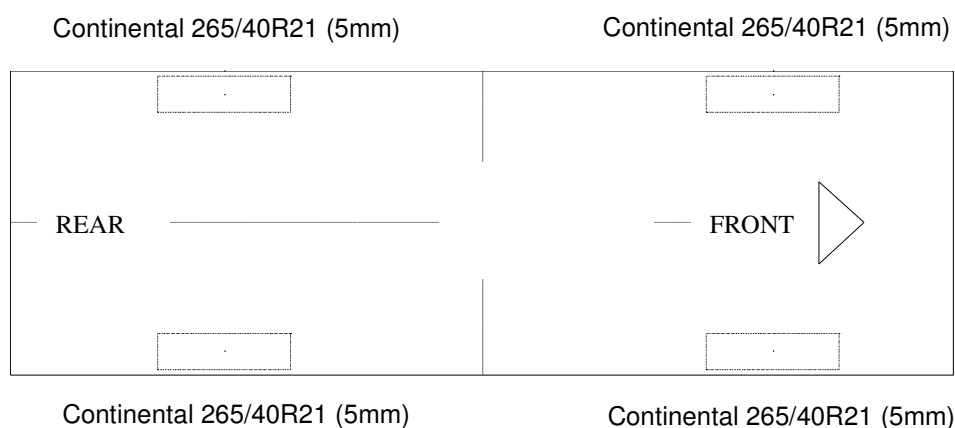
6. It was fitted with 21inch sport wheel rims that were wrapped with tyres that were observed to be of serviceable condition. The tyres were also sufficiently inflated for vehicular operation. The tyre brand, tyre size and approximate remaining tread depth of the 4 tyres of the Motor Car were recorded as follows: -

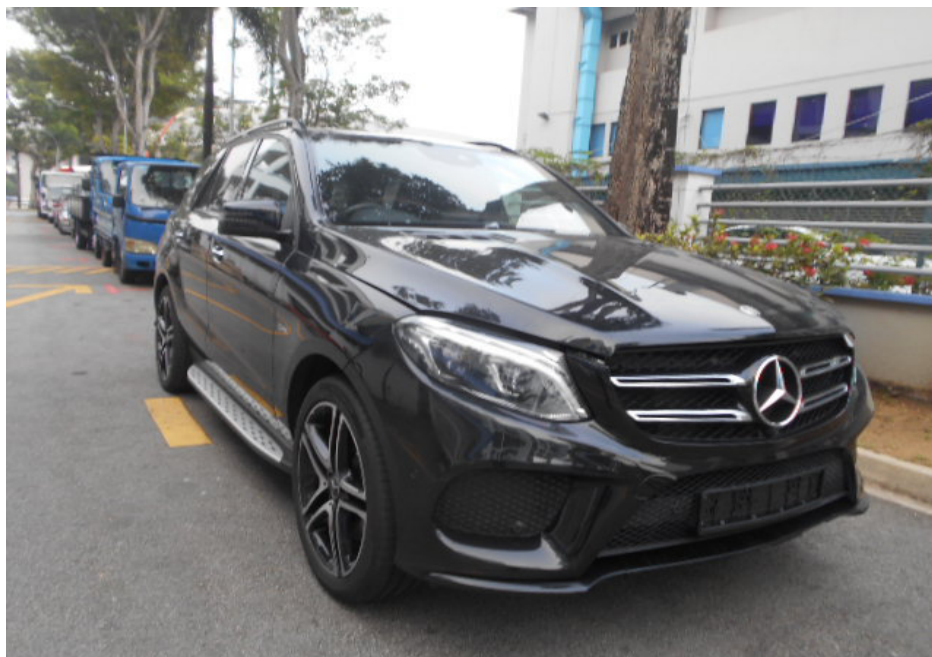
**Photo 1** shows a general view of the front right body of the Motor Car at the time of my inspection. The Motor Car was observed to be in relatively good general condition with no loose exterior fittings observed.

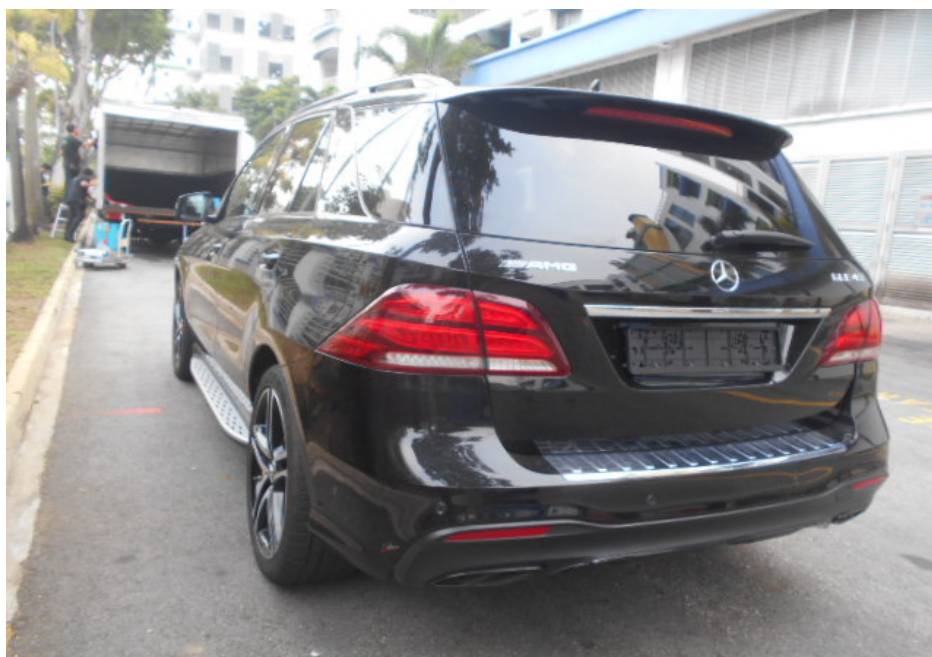
**Photo 2** shows a general view of the rear left body of the Motor Car at the time of my inspection. The Motor Car was observed to be in relatively good general condition with no loose exterior fittings observed.

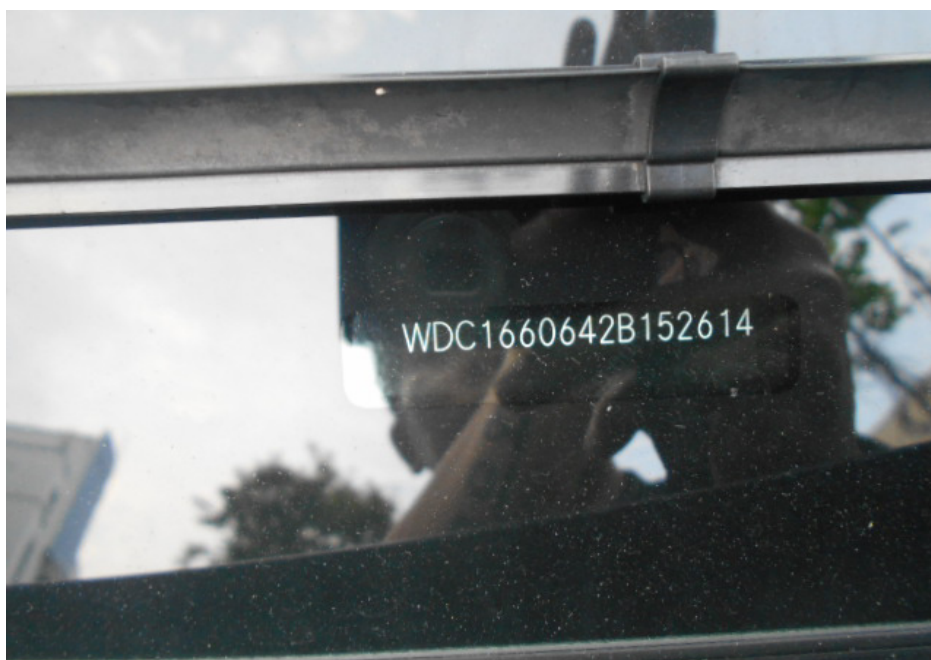
**Photo 3** shows the chassis number of the Motor Car. The chassis number recorded was WDC1660642B152614.

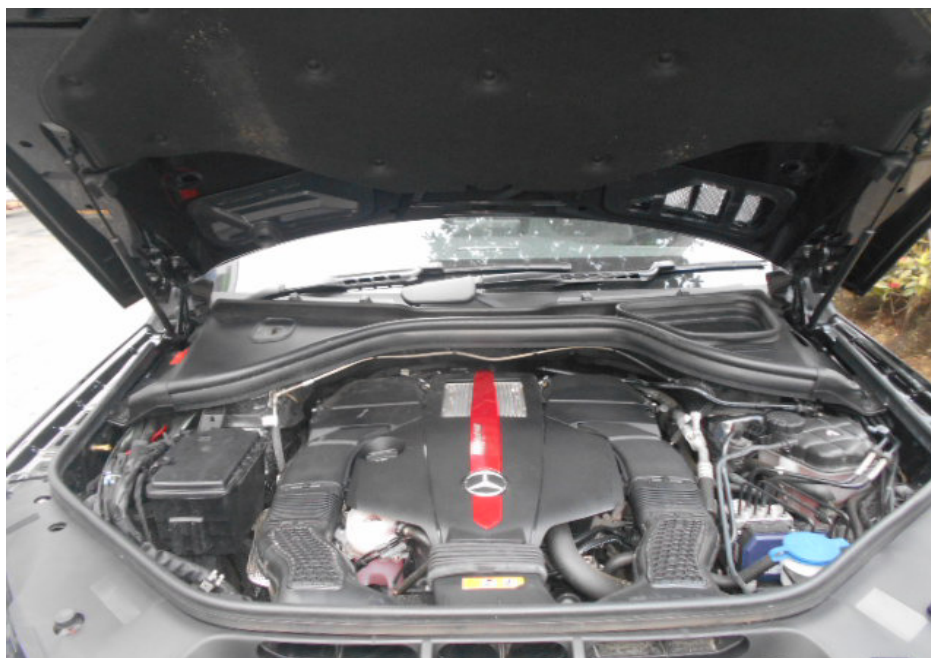
12. My examination of the engine compartment of the Motor Car revealed that the various parts and components inside the engine compartment were all intact and properly fitted. The engine oil, brake fluid and engine coolant were all found to be of sufficient level for operating purposes. Visually, there was also no contamination found to these fluids.
13. My checks on the underside of the Motor Car revealed no sign(s) or indication(s) of fluid leakage and/or fluid stain(s). The engine block and automatic transmission assembly were both secured properly. They were not mounted onto the chassis/structure body or any integral body part of the Motor Car. All undercarriage components of the Motor Car were also observed to be intact and secured in an appropriate manner.

**Photo 4** shows a general view of the engine compartment of the Motor Car at the time of my inspection. The various parts and components inside the engine compartment were all observed to be intact and properly fitted. There was also no sign(s) or indication(s) of fluid leak and/or fluid stain found inside the engine compartment.

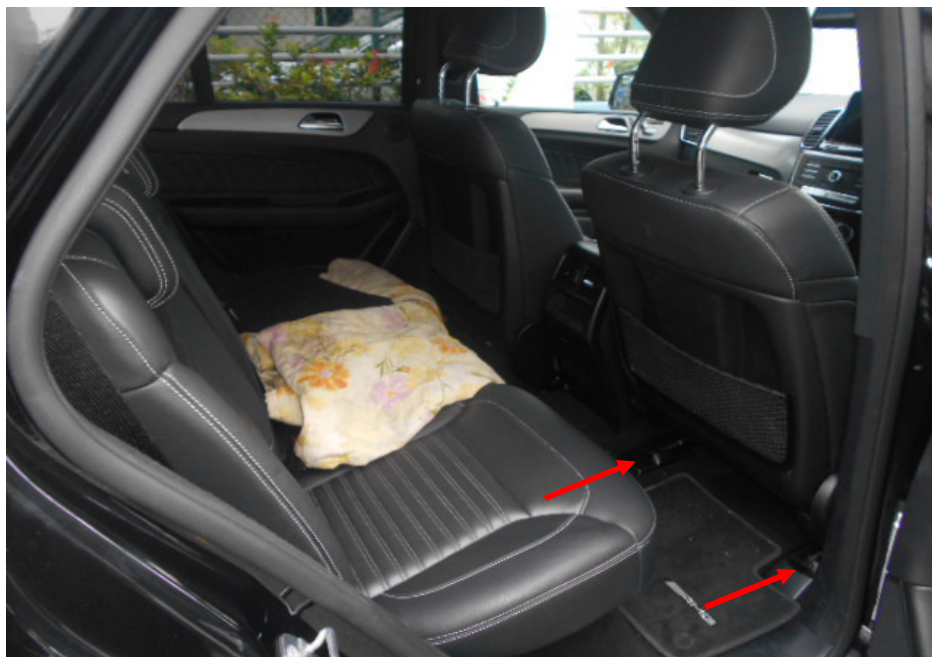
10. The seats of the Motor Car were found to be secured to the floor board of the Motor Car via seat rails bolted onto the floor board. Retractable seat belt reels and pre-tensioners were fitted on all seats of the Motor Car. The seat belt reels were able to be fastened securely into the respective pre-tensioners that were fixed to the side of all the seats.

**Photo 5** shows the seats of the Motor Car, which were secured via seat rails (arrowed) to the floor board. All the seats of the Motor Car were fitted with a retractable seat belt reel and pre-tensioner. The seat belts were also able to be fastened into the respective pre-tensions that were fitted on the side of each individual seat.

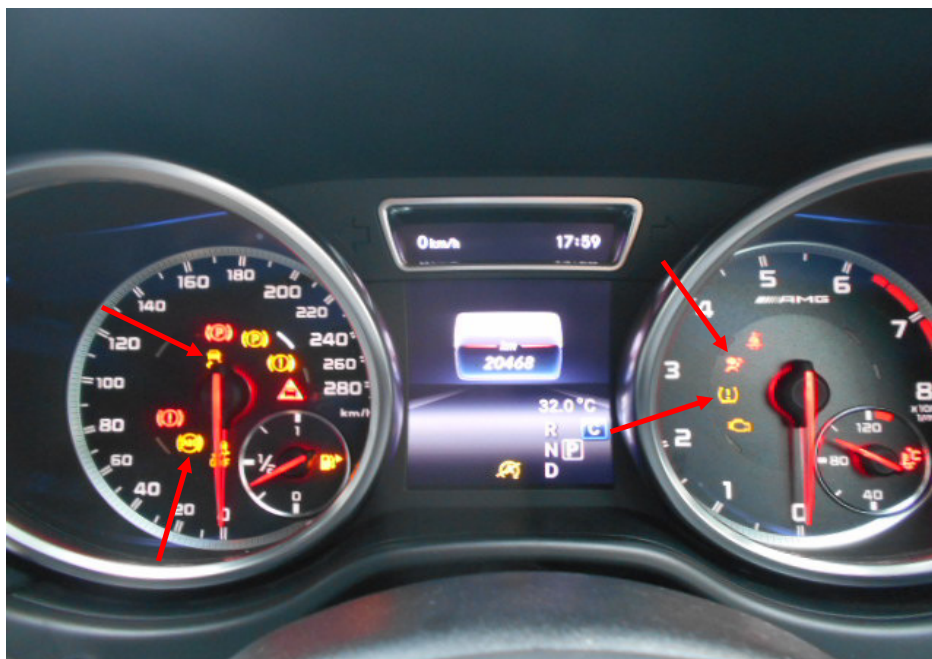
**Photo 6** shows the warning lights for the various electronic safety features appearing on the instrument panel of the Motor Car during its self-test when the engine is cranked, in particular the ABS, SRS, TPM and TCS lights (arrowed).

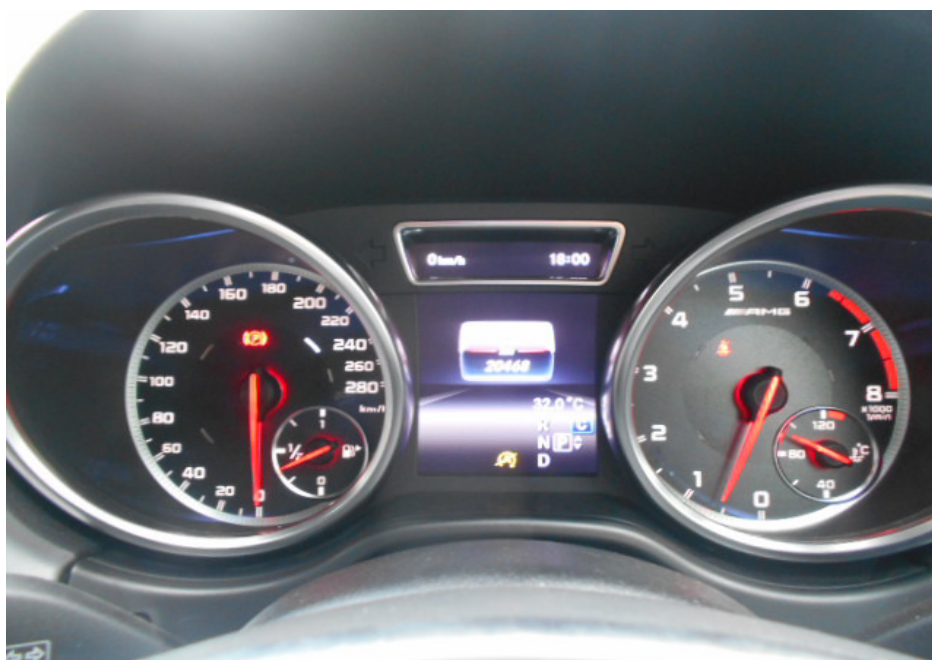
11. The Motor Car's automatic self-test of the functionality of its various electronic safety features like the Anti-Lock Brake System (ABS), Supplemental Restraint System (SRS), Tyre Pressure Monitor (TPM) and Traction Control System (TCS) during cranking of the engine had indicated that these electronic systems were in working condition. This was determined from the respective warning lights disappearing from the instrument panel after the self-test.

**Photo 7** shows the respective warning lights no longer illuminated after the engine was started, indicating that there was no fault detected to the ABS, SRS, TPM and TCS systems of the Motor Car during the self-test. These electronic systems were hence in working condition at the time of my inspection.

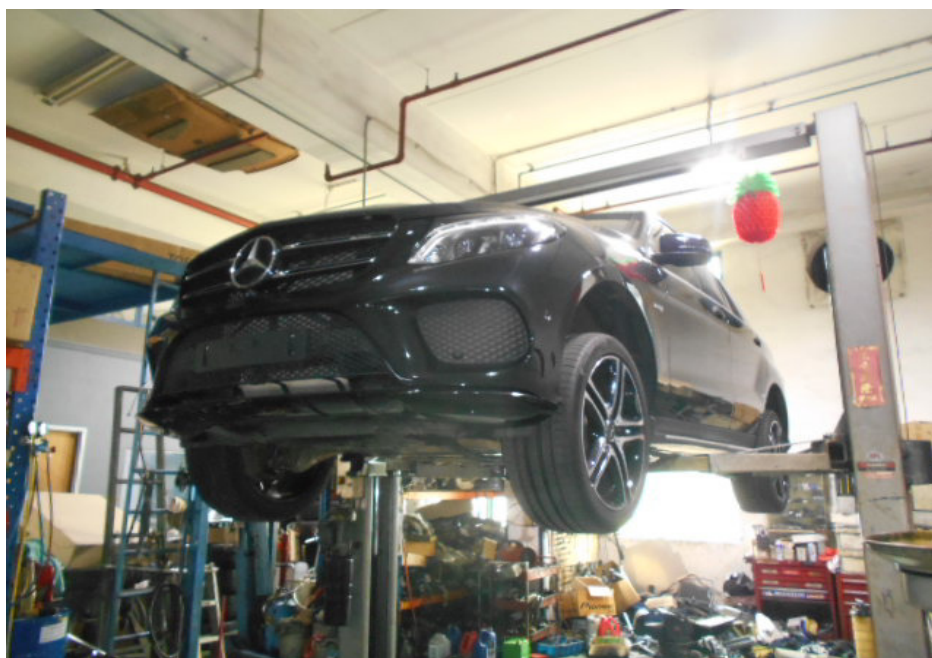
**Photo 8** shows the Motor Car hoisted up for checks on its undercarriage. There was no sign(s) or indication(s) of fluid leakage and/or fluid stain(s) on the underside of the Motor Car. The undercarriage components of the Motor Car were also all observed to be intact and secured in an appropriate manner.

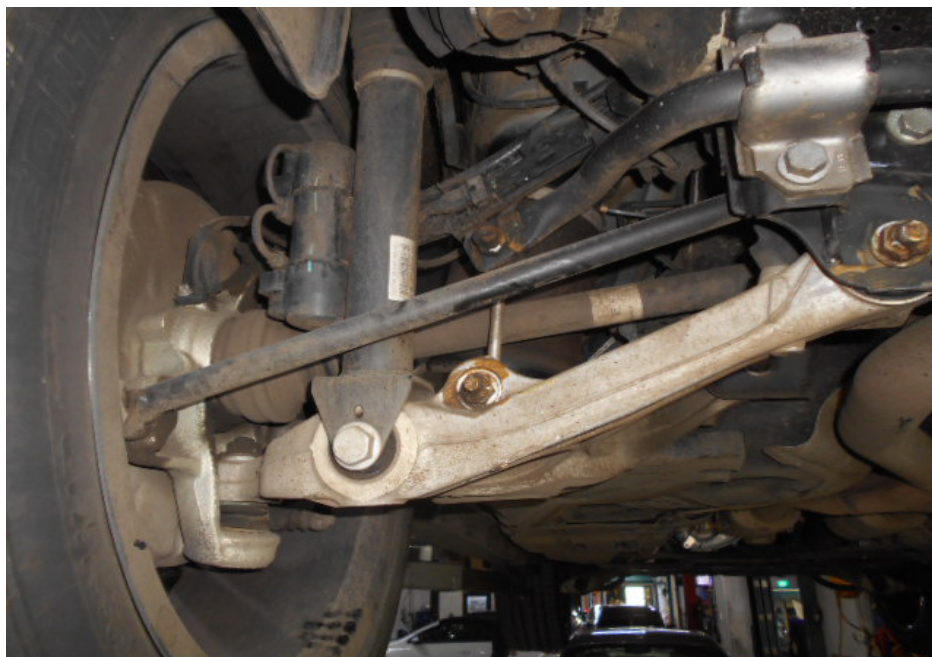
**Photo 9** shows a general view of the control arms and linkages at the rear left wheel of the Motor Car. I did not observe any fluid leak and/or fluid stain on the underside of the Motor Car. All of the Motor Car's undercarriage components were observed to be intact and secured in an appropriate manner.

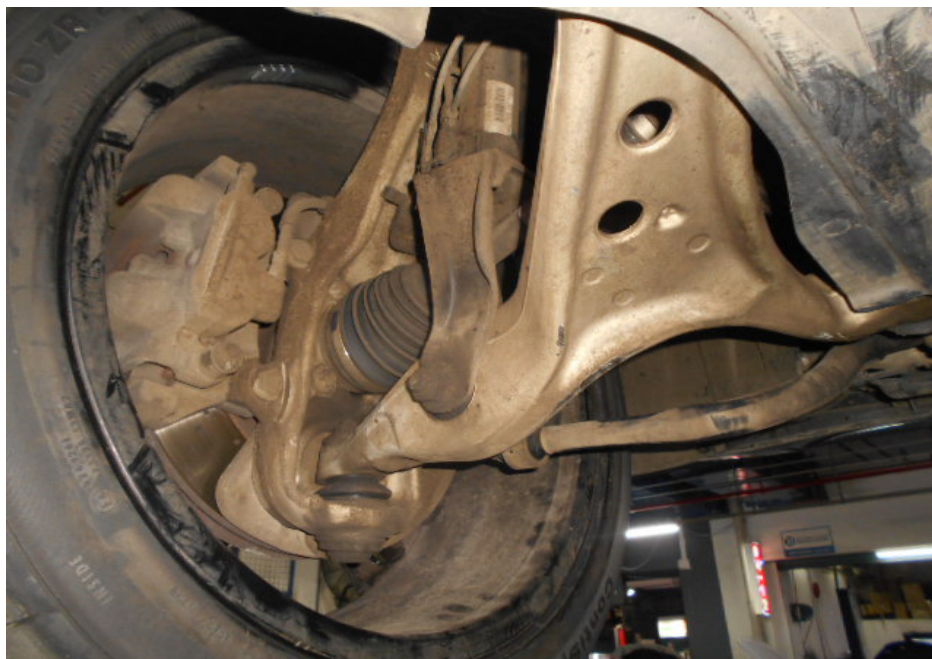
**Photo 10** shows the various undercarriage components at the front left wheel of the Motor Car. The mechanical components, control arms and linkages were all found to be intact and secured in an appropriate manner.

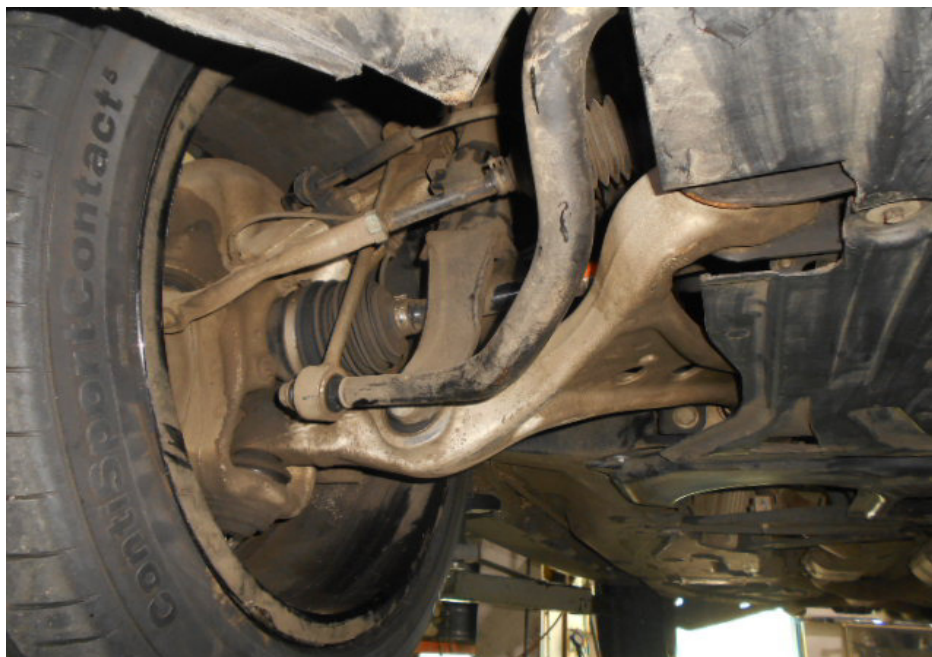
**Photo 11** shows the various undercarriage components at the front right wheel of the Motor Car. The mechanical components, control arms and linkages were all found to be intact and secured in an appropriate manner.

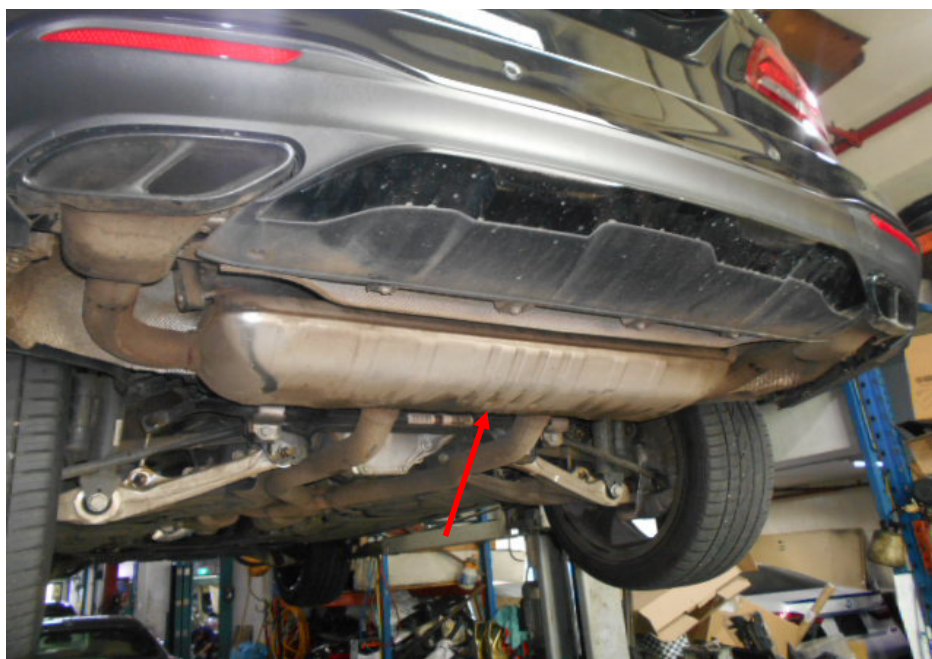
**Photo 12** shows the Motor Car's rear exhaust muffler (arrowed). My examination of the Motor Car's exhaust system revealed no sign(s) or indication(s) of any cut or weld marks along its exhaust pipes and on its rear muffler.

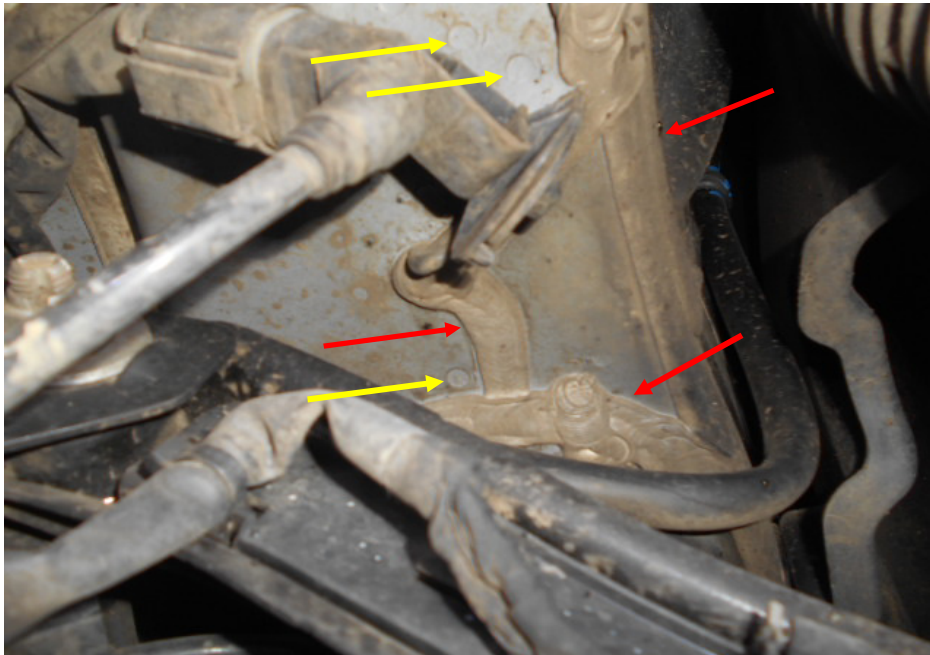
9. Visually, I did not find any weld marks, other than the original spot weld marks, on the chassis/structure body of the Motor Car. The original factory sealant at the joints along the chassis/structure body was also untouched, again indicating that no replacement of the chassis/structure body was carried out; and that the chassis/structure body was originally fitted.

**Photo 13** shows the chassis/structure body at the underside rear right of the Motor Car. Visually, I did not find any weld marks other than original spot weld marks (yellow arrow) on the chassis/structure body of the Motor Car. The original factory sealant (red arrow) at the joints along the chassis/structure body was also untouched, indicating no work was done on the chassis/structure body of the Motor Car and that the chassis/structure body was originally fitted.

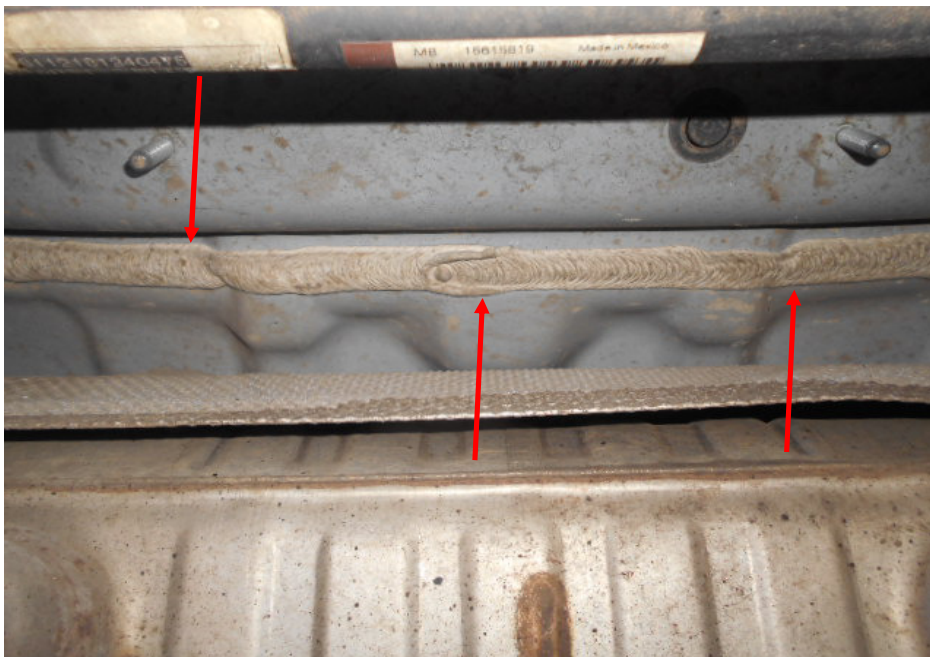
**Photo 14** shows the floor board at the underside rear of the Motor Car. The original factory sealant at the joints along the non-detachable body panels were untouched, indicating no work was done on the non-detachable body panels of the Motor Car; and that these body panels were originally fitted.

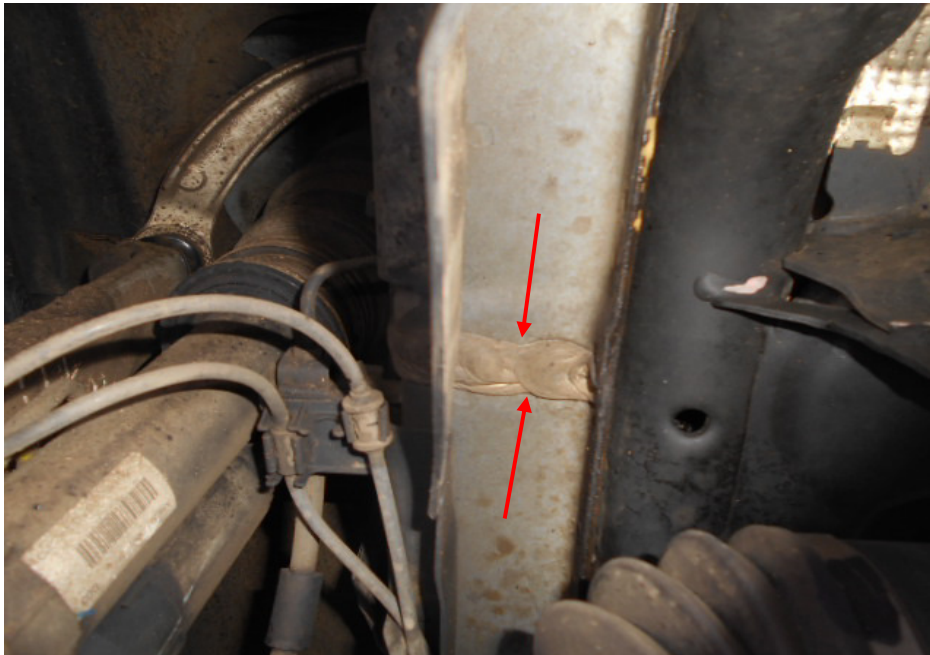
**Photo 15** shows the chassis/structure body at the underside front left of the Motor Car. Visually, I did not find any weld marks other than original spot weld marks on the chassis/structure body of the Motor Car. The original factory sealant (arrowed) at the joints along the chassis/structure body was also untouched, indicating no work was done on the chassis/structure body of the Motor Car and that the chassis/structure body was originally fitted.

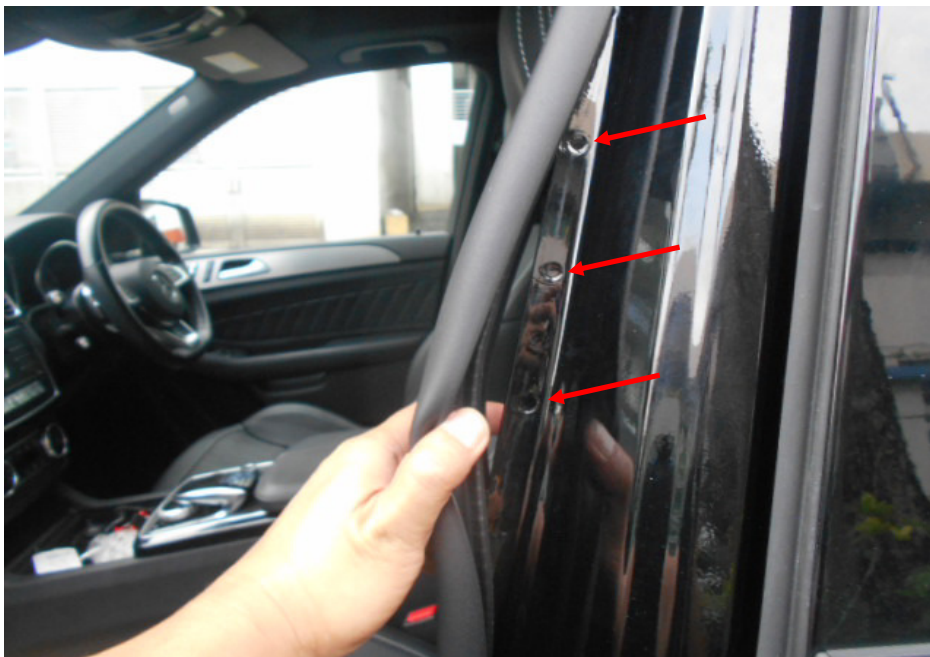
**Photo 16** shows the left "B" pillar of the Motor Car. I did not find any weld marks other than original spot weld marks (arrowed) on the non-detachable body panels of the Motor Car, indicating that there was no re-welding works carried out; and that the non-detachable body panels of the Motor Car were originally fitted.

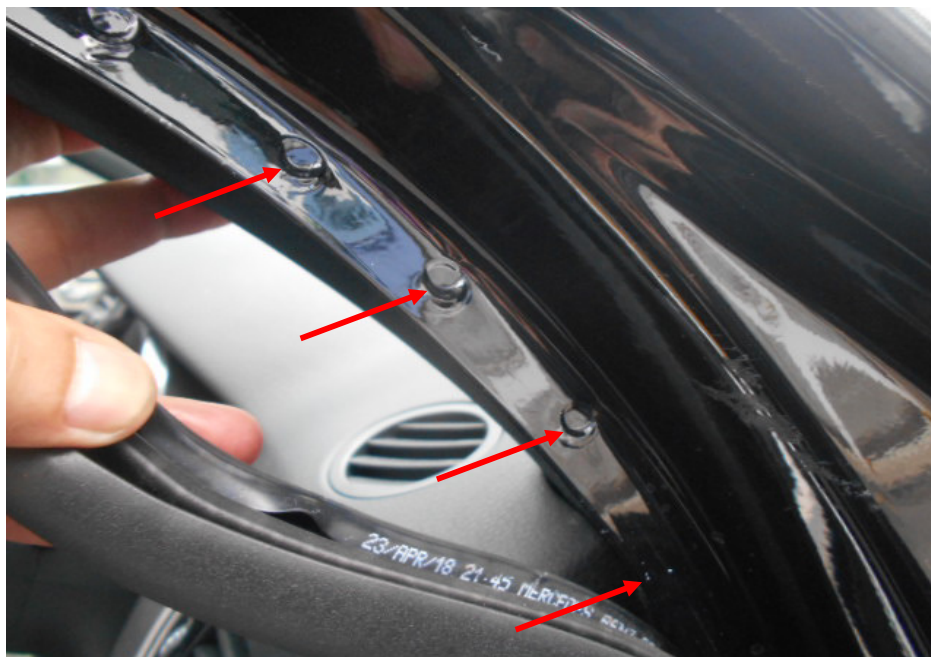
**Photo 17** shows the right “A” pillar of the Motor Car. I did not find any weld marks other than original spot weld marks (arrowed) on the non-detachable body panels of the Motor Car, indicating that there was no re-welding works carried out; and that the non-detachable body panels of the Motor Car were originally fitted.
