Your Ref: BMW 540i
(chassis number WBAJB32080WW06265)
Our Ref : CI/TP19020353/D

15 November 2019

INSPECTION REPORT OF AN UNREGISTERD BMW 540i MOTOR CAR WITH CHASSIS NUMBER WBAJB32080WW06265

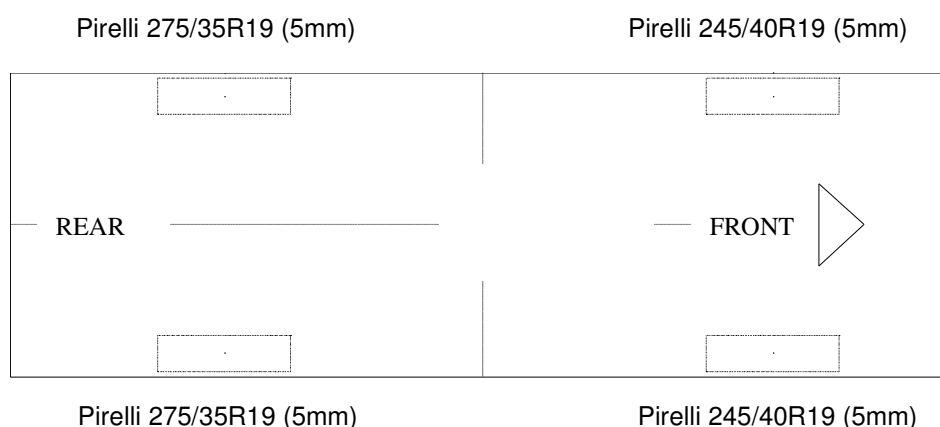
6. It was fitted with 19inch sport wheel rims that were wrapped with tyres that were observed to be of serviceable condition. The tyres were also sufficiently inflated for vehicular operation. The tyre brand, tyre size and approximate remaining tread depth of the 4 tyres of the Motor Car were recorded as follows: -

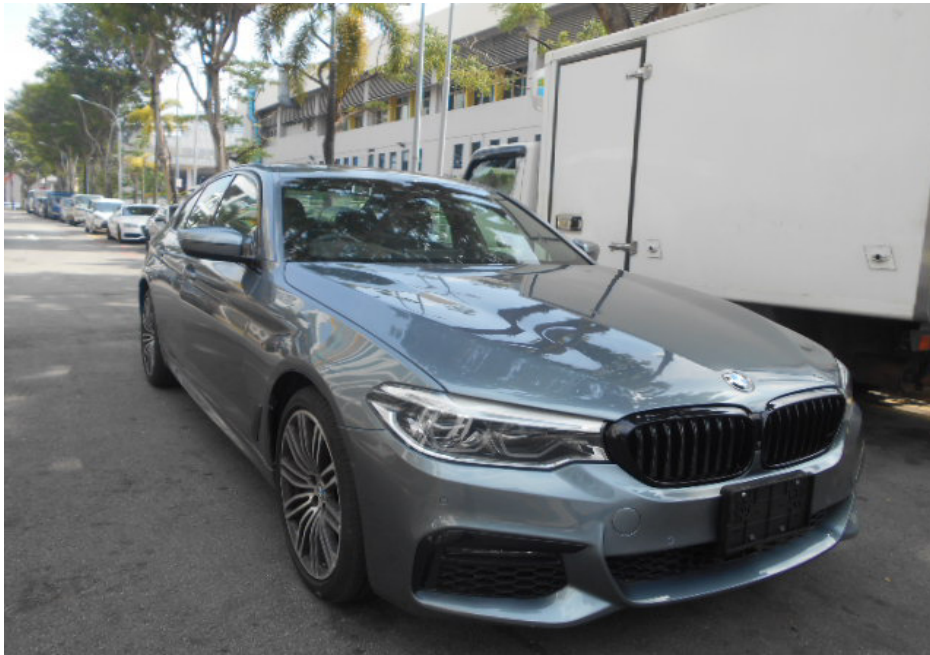
Photo 1 shows a general view of the front right body of the Motor Car at the time of my inspection. The Motor Car was observed to be in relatively good general condition with no loose exterior fittings observed.

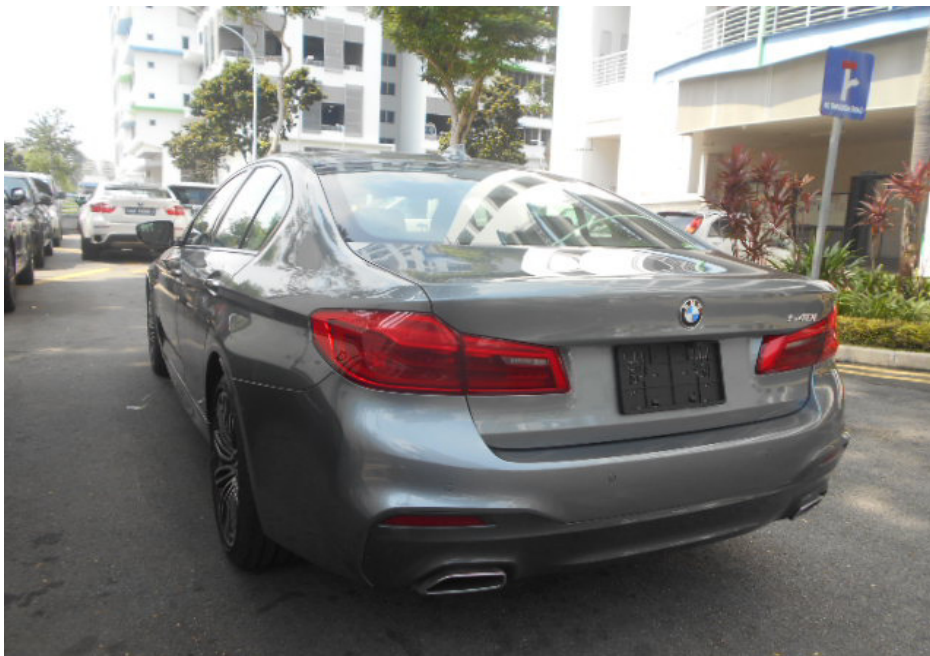
Photo 2 shows a general view of the rear left body of the Motor Car at the time of my inspection. The Motor Car was observed to be in relatively good general condition with no loose exterior fittings observed.

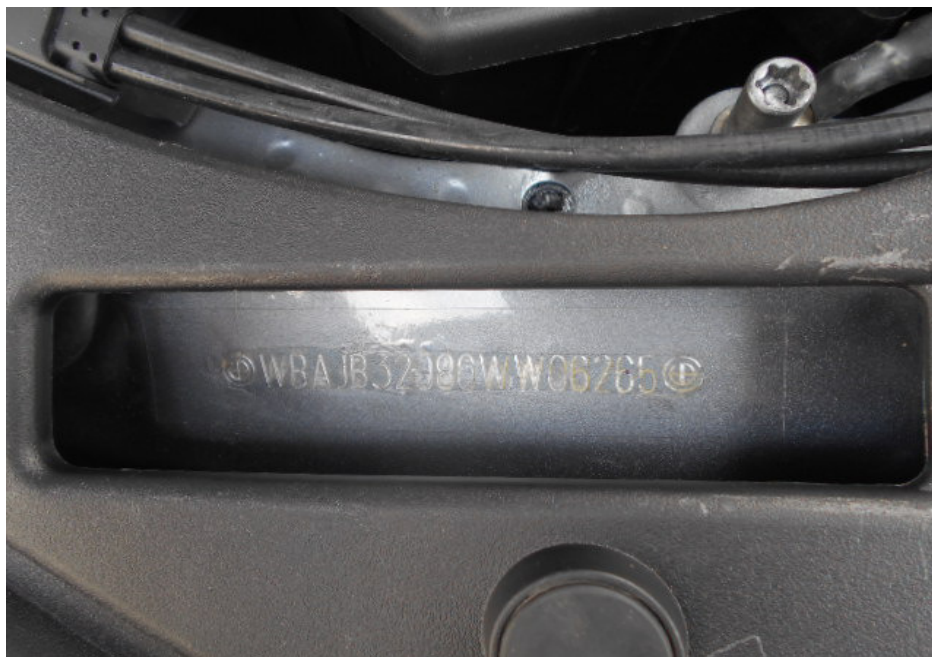
Photo 3 shows the chassis number of the Motor Car. The chassis number recorded was WBAJB32080WW06265.

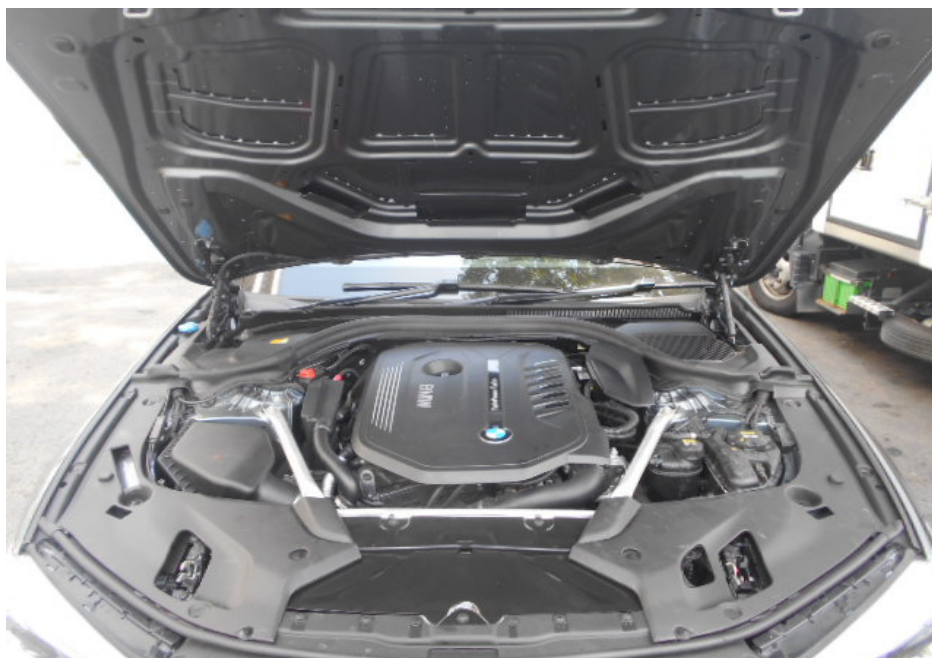
12. My examination of the engine compartment of the Motor Car revealed that the various parts and components inside the engine compartment were all intact and properly fitted. The various operating fluids like the brake fluid and engine coolant were all found to be of sufficient level for operating purposes. Visually, there was also no contamination found to these fluids.
13. My checks on the underside of the Motor Car revealed no sign(s) or indication(s) of fluid leakage and/or fluid stain(s). The engine block and automatic transmission assembly were both secured properly. They were not mounted onto the chassis/structural body or any integral body part of the Motor Car. All undercarriage components of the Motor Car were also observed to be intact and secured in an appropriate manner.

Photo 4 shows a general view of the engine compartment of the Motor Car at the time of my inspection. The various parts and components inside the engine compartment were all observed to be intact and properly fitted. There was also no sign(s) or indication(s) of fluid leak and/or fluid stain found within the engine compartment.

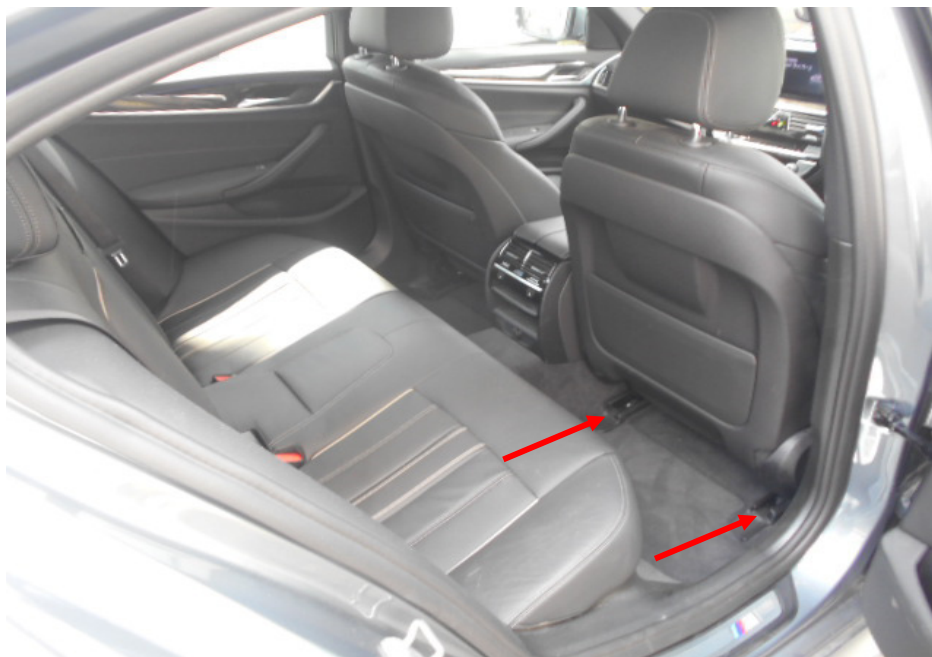
10. The seats of the Motor Car were found to be secured to the floor board of the Motor Car via seat rails bolted onto the floor board. Retractable seat belt reels and pre-tensioners were fitted on all seats of the Motor Car. The seat belt reels were able to be fastened securely to the respective pre-tensioner that is fixed to the side of all the seats.

Photo 5 shows the seats of the Motor Car, which were secured via seat rails (arrowed) to the floor board. All the seats of the Motor Car were fitted with a retractable seat belt reel and pre-tensioner. The seat belts were also able to be fastened to the pretension that were fitted on the side of each individual seat.

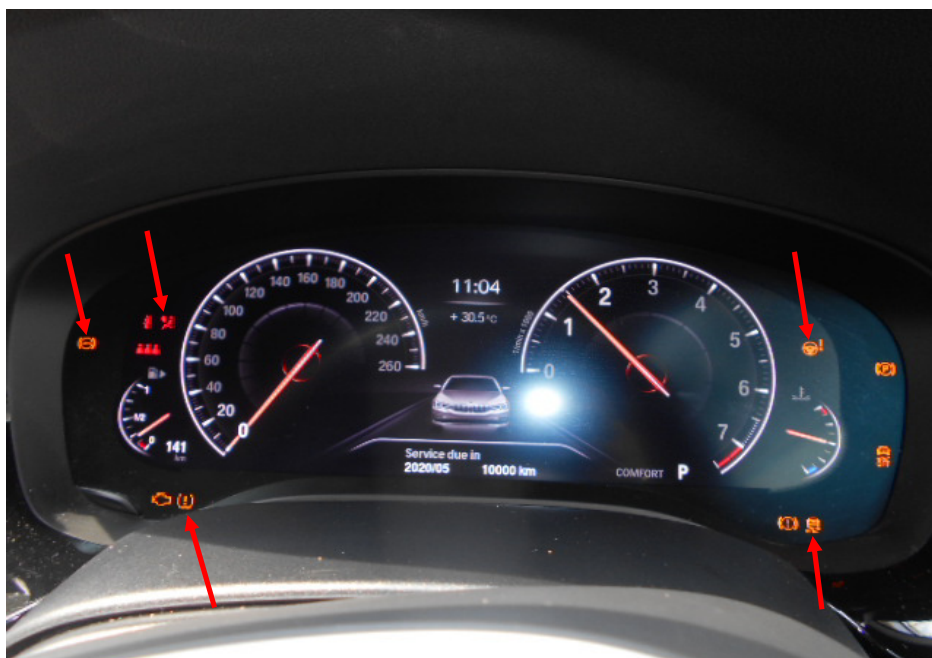
Photo 6 shows the warning lights for the various electronic safety features appearing on the instrument panel of the Motor Car during its self-test when the engine is cranked, in particular the ABS, SRS, IAS, TPM and DSC lights (arrowed).

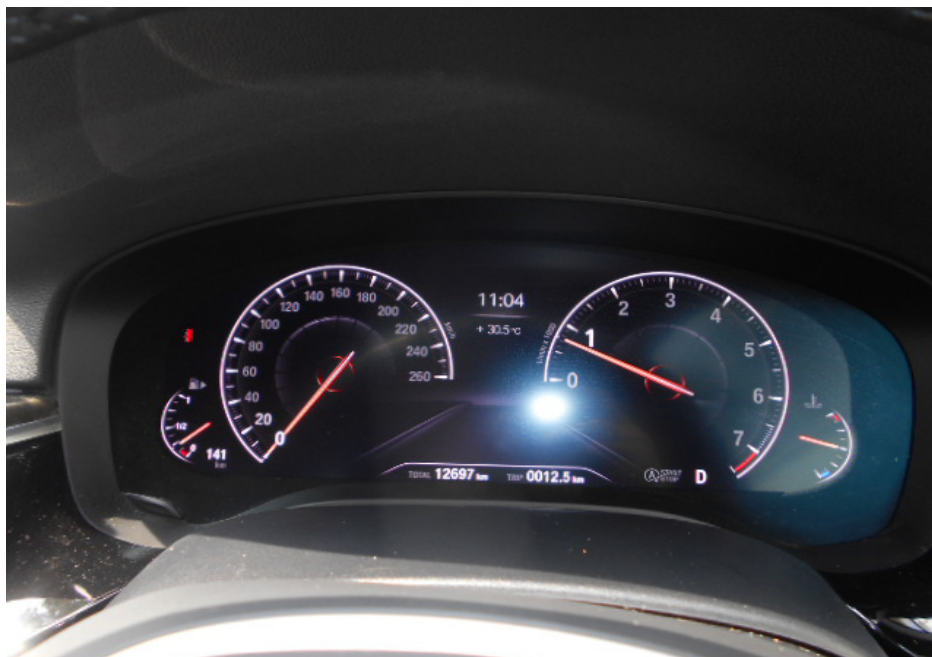
11. The Motor Car's automatic self-test of the functionality of its various electronic safety features like the Anti-Lock Brake System (ABS), Supplemental Restraint System (SRS), Integral Active Steering (IAS), Tyre Pressure Monitor (TPM) and Dynamic Stability Control (DSC) during cranking of the engine had indicated that these electronic systems were in working condition. This was determined from the respective warning lights disappearing from the instrument panel after the self-test.

Photo 7 shows the respective warning lights no longer illuminated, indicating that there is no fault detected to the ABS, SRS, IAS, TPM and DSC systems of the Motor Car during the self-test. These electronic systems were hence in working condition at the time of my inspection.

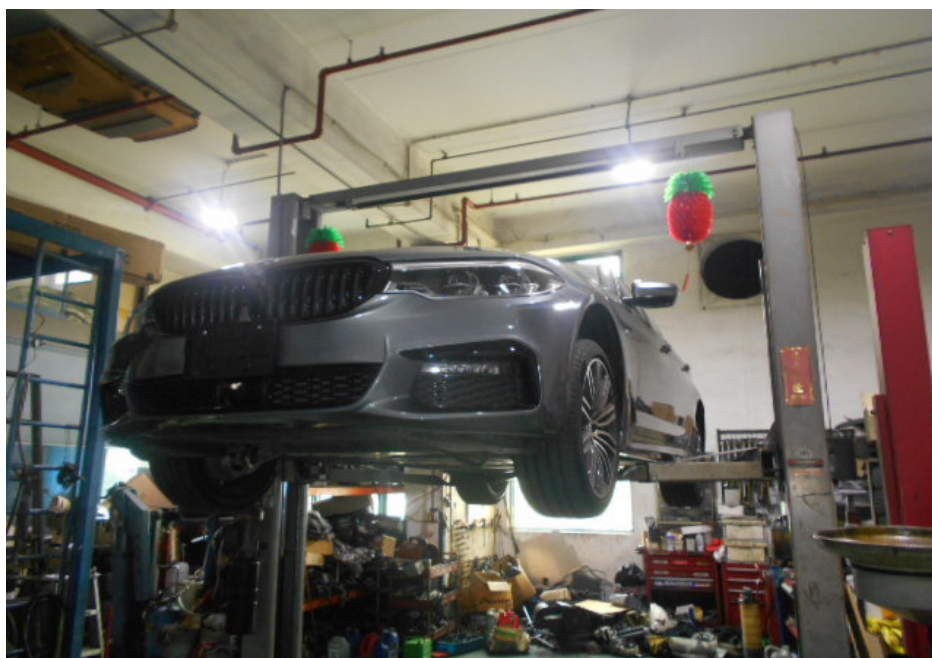
Photo 8 shows the Motor Car hoisted up for checks on its undercarriage. There was no sign(s) or indication(s) of fluid leakage and/or fluid stain(s). The undercarriage components of the Motor Car were also all observed to be intact and secured in an appropriate manner.

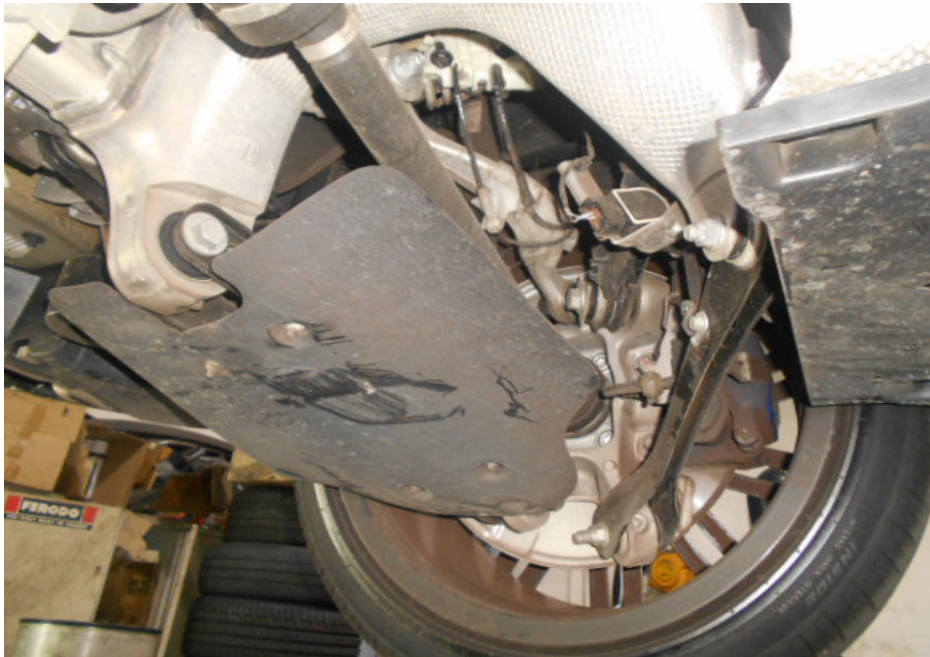
Photo 9 shows a general view of the control arms and linkages at the rear left wheel of the Motor Car. I did not observe any fluid leak and/or fluid stain on the underside of the Motor Car. All of the Motor Car's undercarriage components were observed to be intact and secured in an appropriate manner.

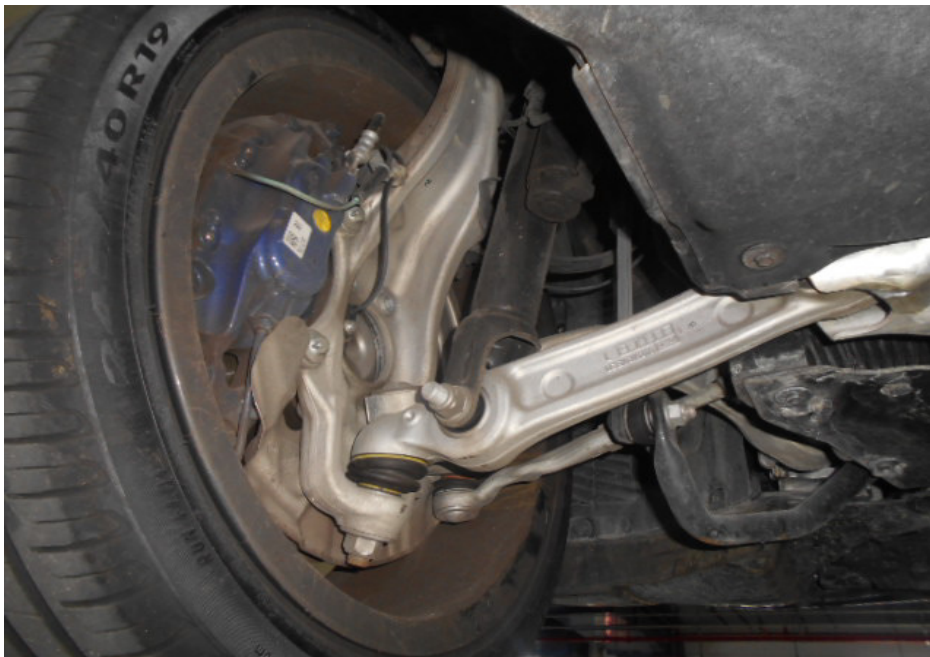
Photo 10 shows the various undercarriage components at the front left wheel of the Motor Car. The mechanical components, control arms and linkages were all found to be intact and secured in an appropriate manner.

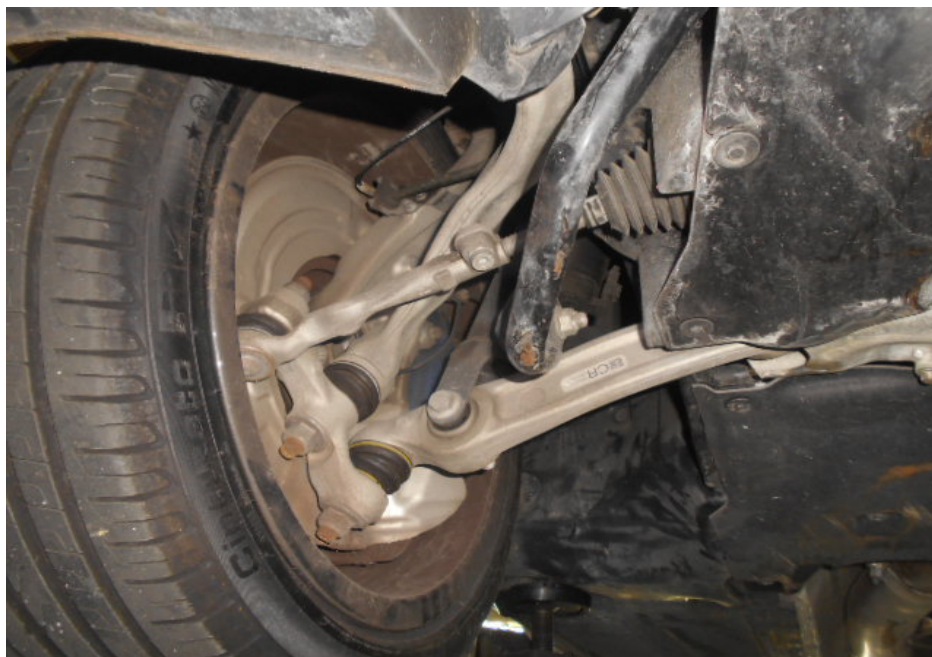
Photo 11 shows the various undercarriage components at the front right wheel of the Motor Car. The mechanical components, control arms and linkages were all found to be intact and secured in an appropriate manner.

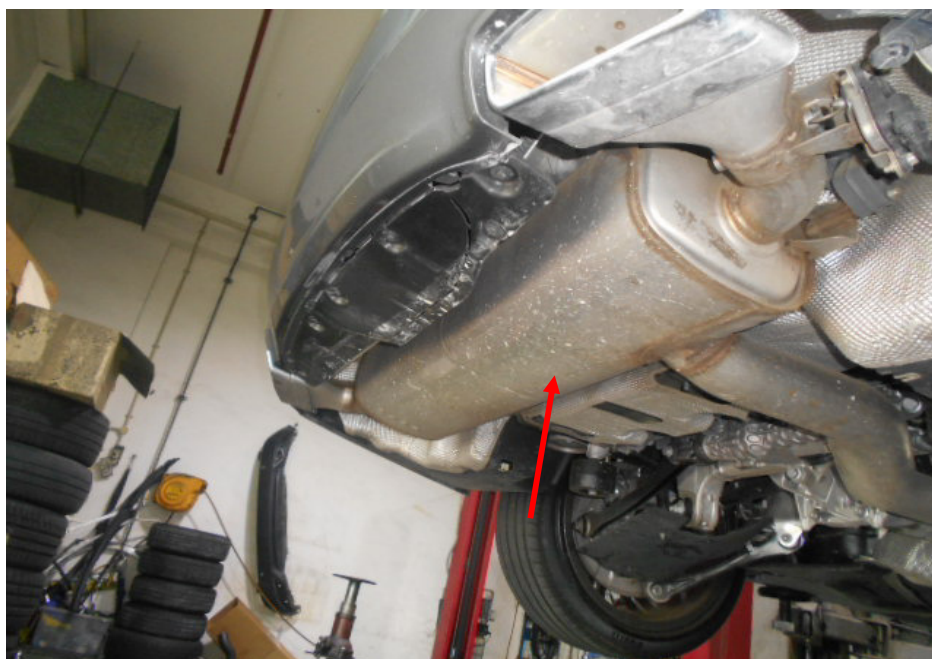
Photo 12 shows the Motor Car's rear exhaust muffler (arrowed). My examination of the Motor Car's exhaust system revealed no sign(s) or indication(s) of any cut or weld marks along its exhaust pipes and on its rear muffler.

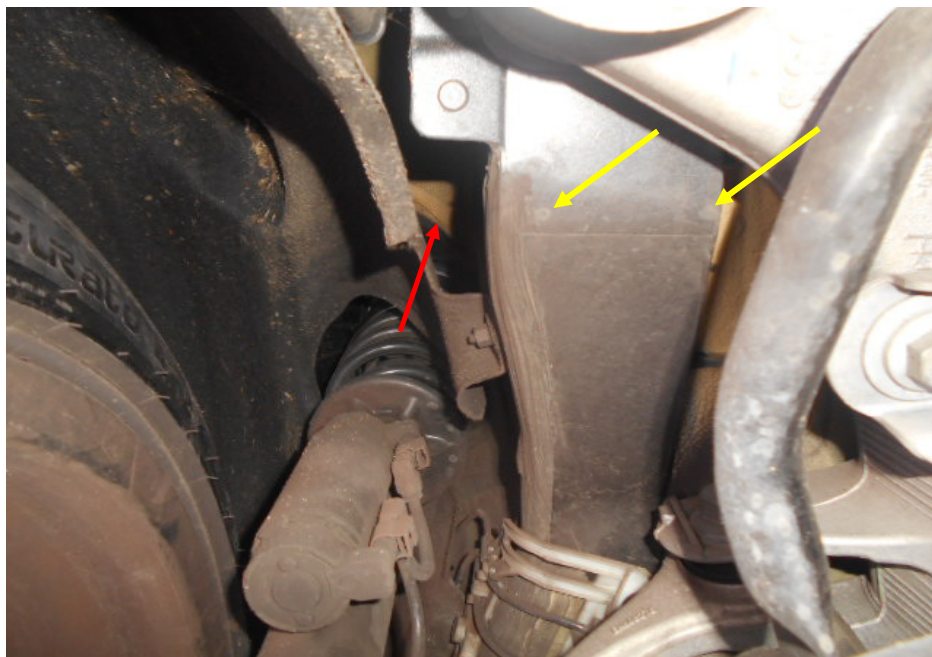
9. Visually, I did not find any weld marks, other than the original spot weld marks, on the chassis/structural body of the Motor Car. The original factory sealant at the joints along the chassis/structural body was also untouched, again indicating that no replacement of the chassis/structural body was carried out; and that the chassis/structural body was originally fitted.

Photo 13 shows the chassis/structural body at the underside front left of the Motor Car. Visually, I did not find any weld marks other than original spot weld marks (yellow arrow) on the chassis/structural body of the Motor Car. The original factory sealant (red arrow) at the joints along the chassis/structural body was also untouched, indicating no work was done on the chassis/structural body of the Motor Car and that the chassis/structural body was originally fitted.

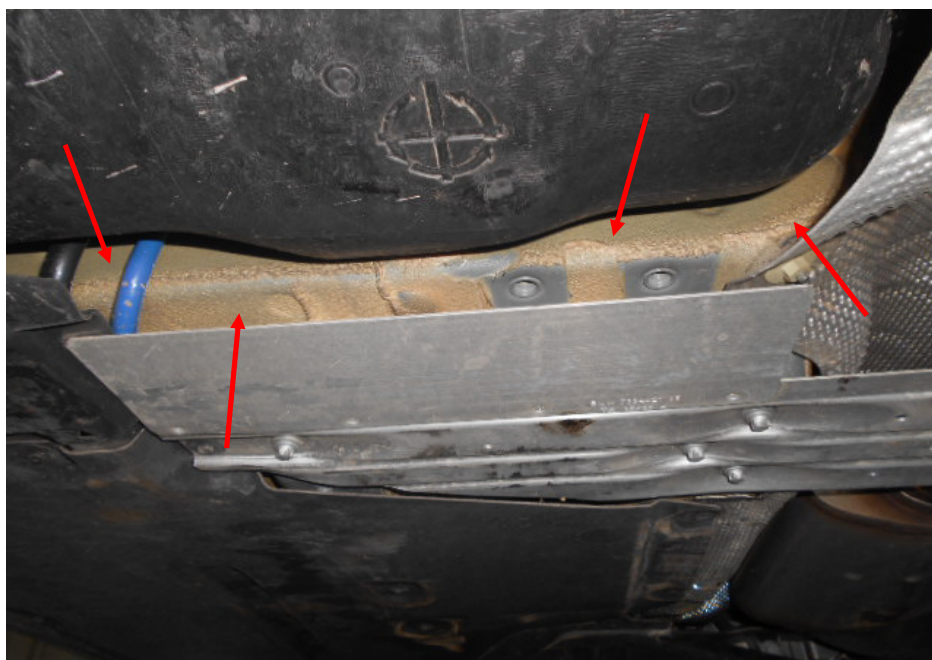
Photo 14 shows the floor board at the underside centre of the Motor Car. The original factory sealant (arrowed) at the joints of the non-detachable body panels was all untouched indicating no replacement of the non-detachable body panels was carried out;

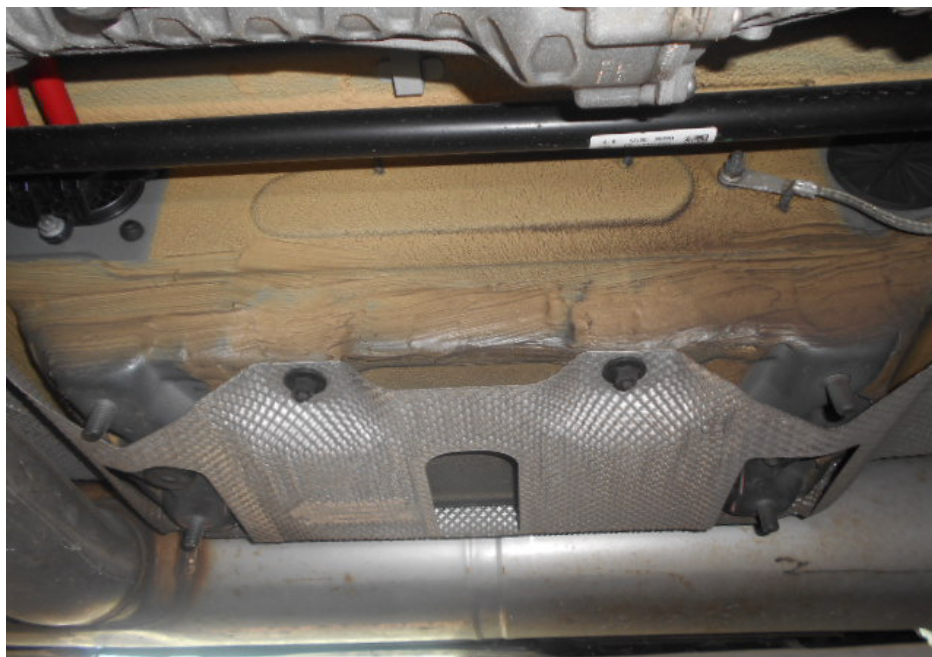
Photo 15 shows the floor board at the underside rear of the Motor Car. The original factory sealant at the joints along the non-detachable body panels were untouched, indicating no work was done on the non-detachable body panels of the Motor Car; and that the non-detachable body panels were originally fitted.

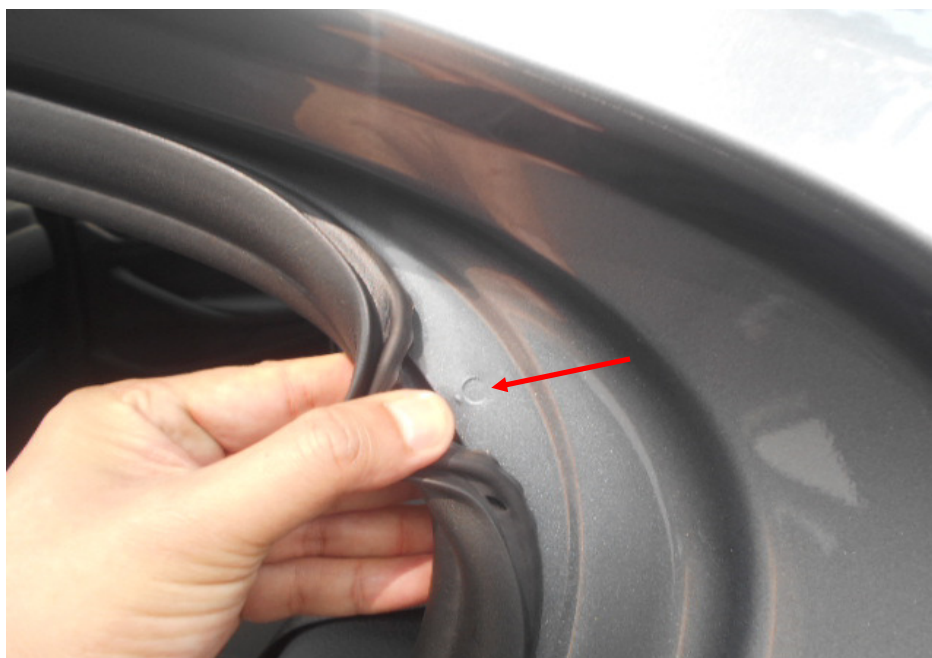
Photo 16 shows the rear left "C" pillar of the Motor Car. I did not find any weld marks other than original spot weld marks (arrowed) on the non-detachable body panels of the Motor Car, indicating that there was no re-welding works carried out; and that the non-detachable body panels of the Motor Car were originally fitted.

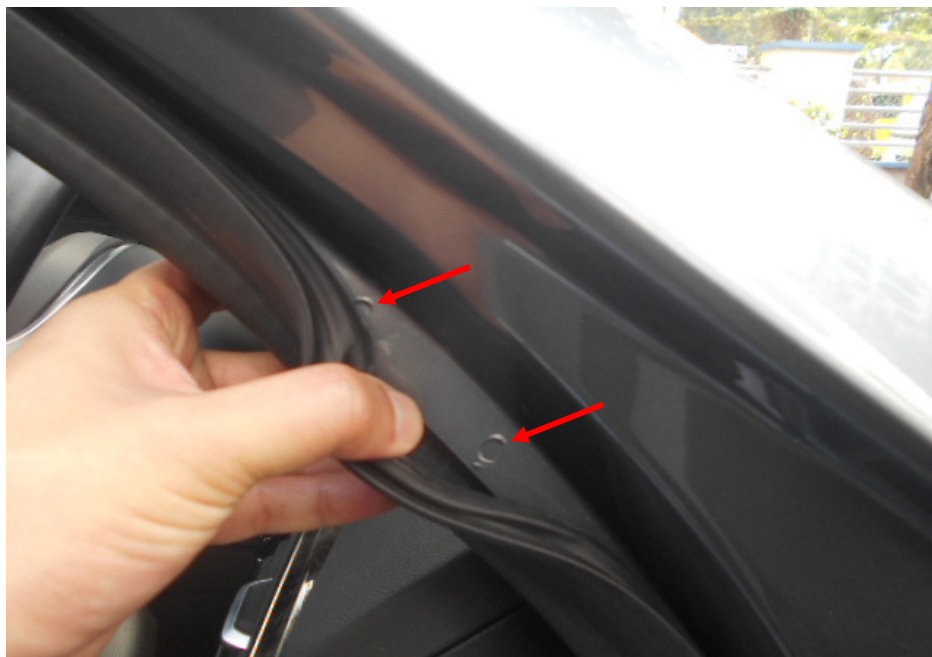
Photo 17 shows the front right “A” pillar of the Motor Car. I did not find any weld marks other than original spot weld marks (arrowed) on the non-detachable body panels of the Motor Car, indicating that there was no re-welding works carried out; and that the non-detachable body panels of the Motor Car were originally fitted.
