Your Ref: Maserati Ghibli
(chassis number ZAMSS57C001189661)
Our Ref : CI/TP19020354/D

15 November 2019

INSPECTION REPORT OF AN UNREGISTERD MASERATI GHIBLI MOTOR CAR WITH CHASSIS NUMBER ZAMSS57C001189661

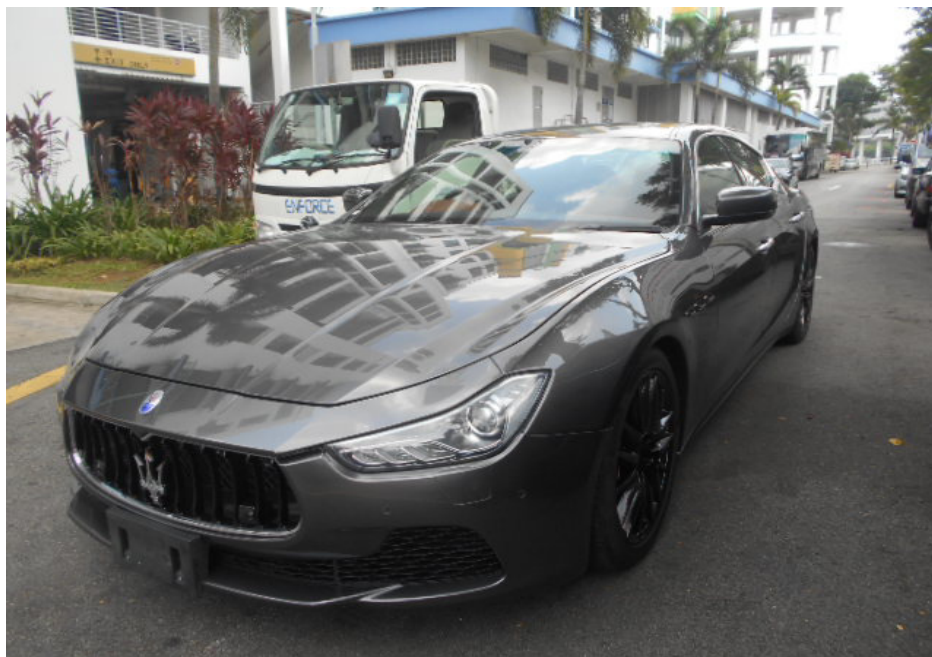
Photo 1 shows a general view of the front left body of the Motor Car at the time of my inspection. The Motor Car was observed to be in relatively good general condition with no loose exterior fittings observed.

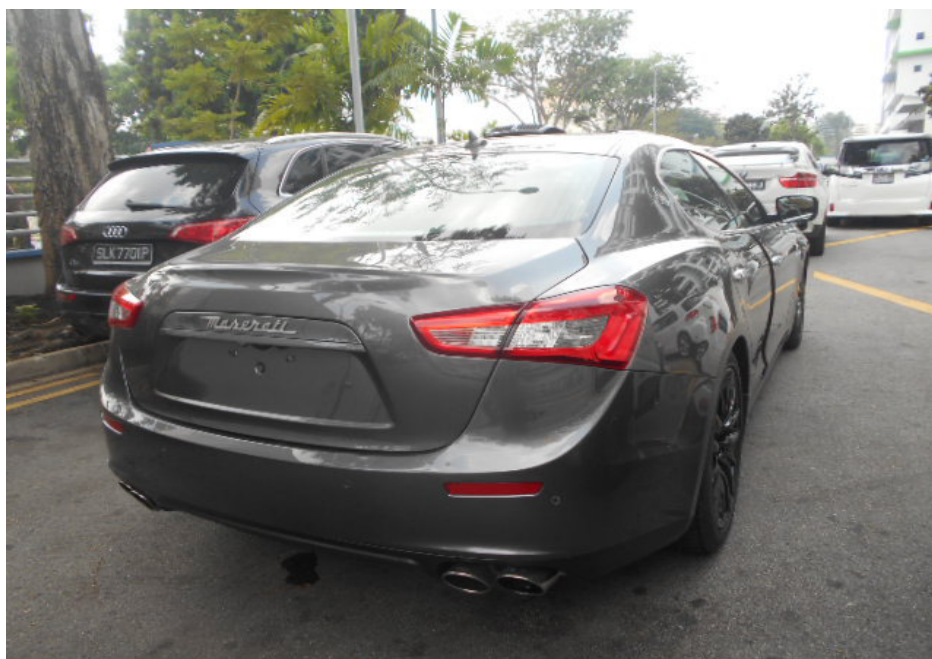
Photo 2 shows a general view of the rear right body of the Motor Car at the time of my inspection. The Motor Car was observed to be in relatively good general condition with no loose exterior fittings observed.

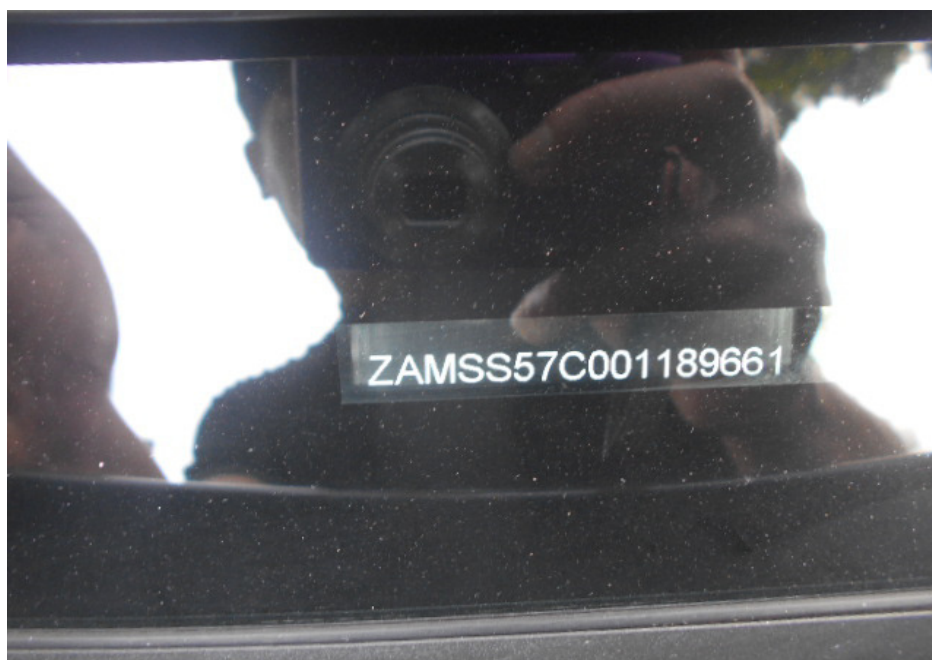
Photo 3 shows the chassis number of the Motor Car. The chassis number recorded was ZAMSS57C001189661.

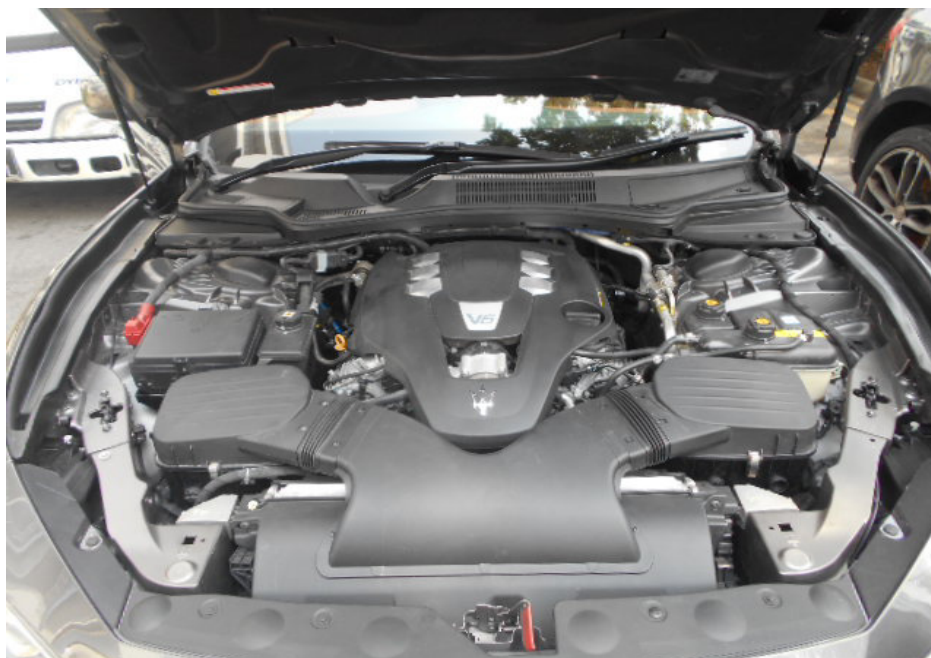
12. My examination of the engine compartment of the Motor Car revealed that the various parts and components inside the engine compartment were all intact and properly fitted. The engine oil, brake fluid, power steering fluid and engine coolant were all found to be of sufficient level for operating purposes. Visually, there was also no contamination found to these fluids.
13. My checks on the underside of the Motor Car revealed no sign(s) or indication(s) of fluid leakage and/or fluid stain(s). The engine block and automatic transmission assembly were both secured properly. They were not mounted onto the chassis/structure body or any integral body part of the Motor Car. All undercarriage components of the Motor Car were also observed to be intact and secured in an appropriate manner.

Photo 4 shows a general view of the engine compartment of the Motor Car at the time of my inspection. The various parts and components inside the engine compartment were all observed to be intact and properly fitted. There was also no sign(s) or indication(s) of fluid leak and/or fluid stain found inside the engine compartment.

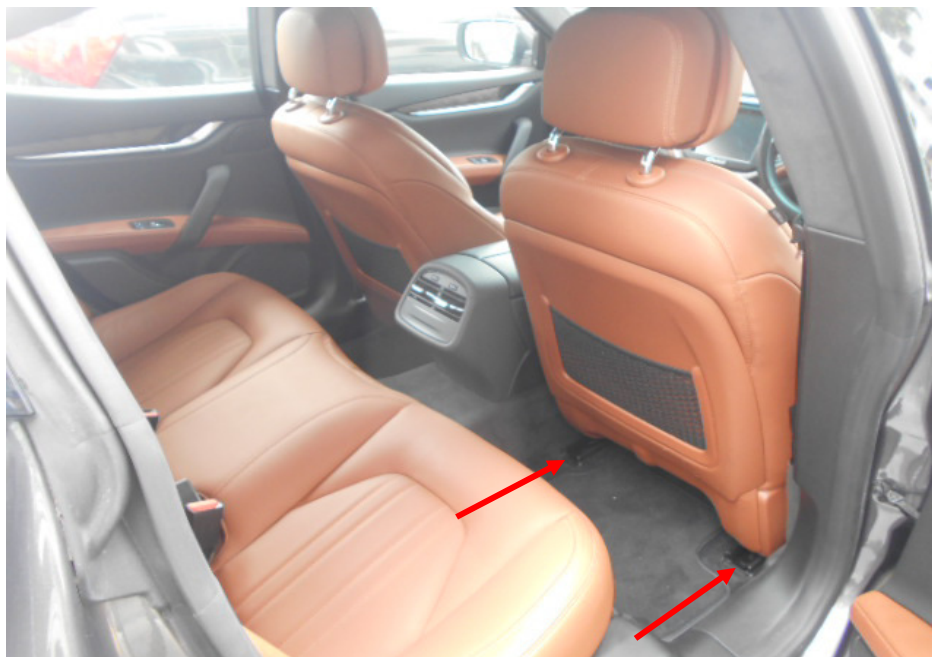
10. The seats of the Motor Car were found to be secured to the floor board of the Motor Car via seat rails bolted onto the floor board. Retractable seat belt reels and pre-tensioners were fitted on all seats of the Motor Car. The seat belt reels were able to be fastened securely into the respective pre-tensioners that were fixed to the side of all the seats.

Photo 5 shows the seats of the Motor Car, which were secured via seat rails (arrowed) to the floor board. All the seats of the Motor Car were fitted with a retractable seat belt reel and pre-tensioner. The seat belts were also able to be fastened into the respective pre-tensions that were fitted on the side of each individual seat.

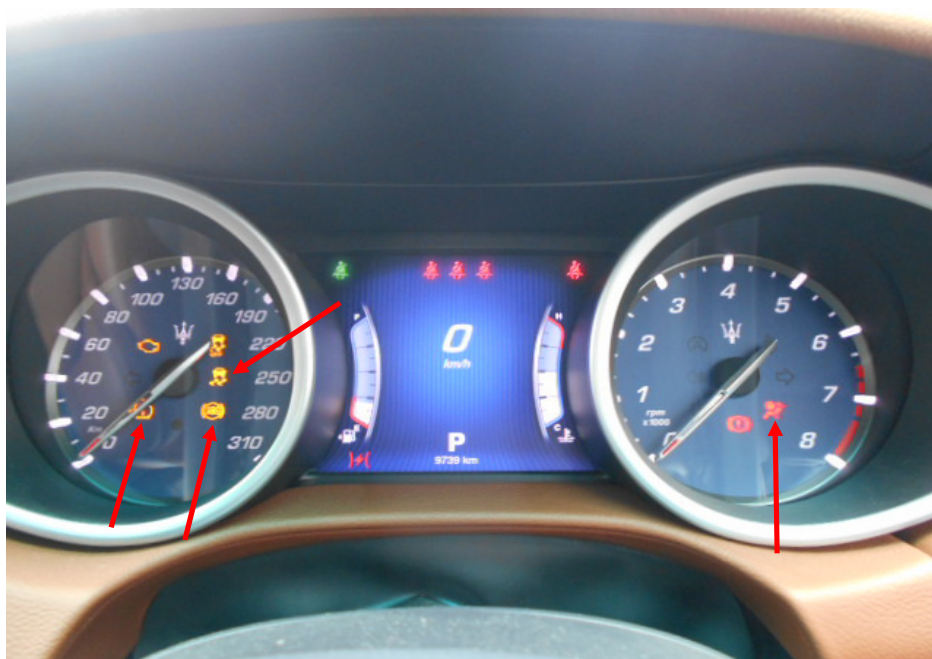
Photo 6 shows the warning lights for the various electronic safety features appearing on the instrument panel of the Motor Car during its self-test when the engine is cranked, in particular the ABS, SRS, TPM and TCS lights (arrowed).

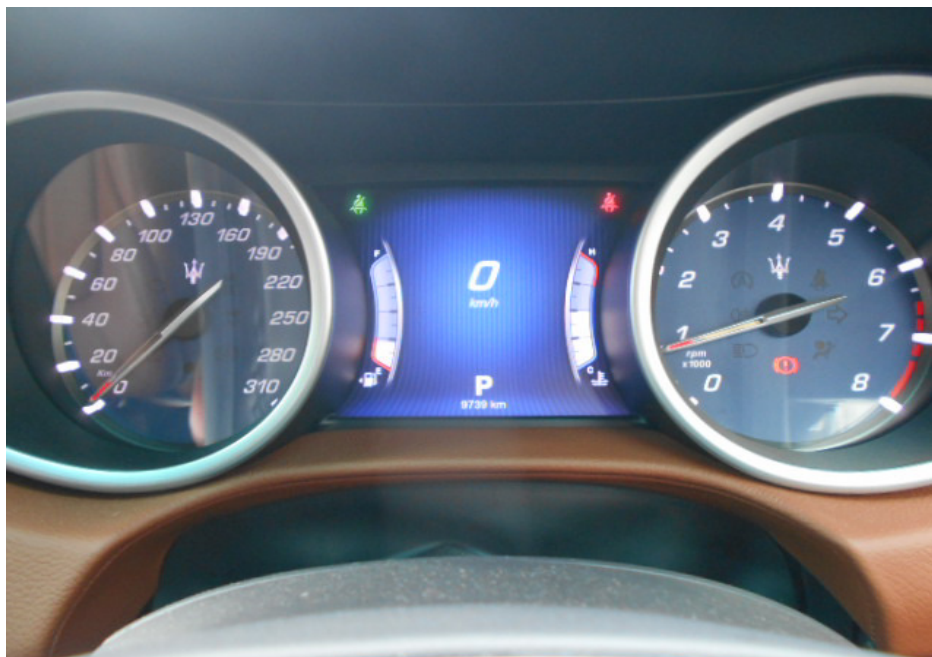
11. The Motor Car's automatic self-test of the functionality of its various electronic safety features like the Anti-Lock Brake System (ABS), Supplemental Restraint System (SRS), Tyre Pressure Monitor (TPM) and Traction Control System (TCS) during cranking of the engine had indicated that these electronic systems were in working condition. This was determined from the respective warning lights disappearing from the instrument panel after the self-test.

Photo 7 shows the respective warning lights no longer illuminated after the engine was started, indicating that there was no fault detected to the ABS, SRS, TPM and TCS systems of the Motor Car during the self-test. These electronic systems were hence in working condition at the time of my inspection.

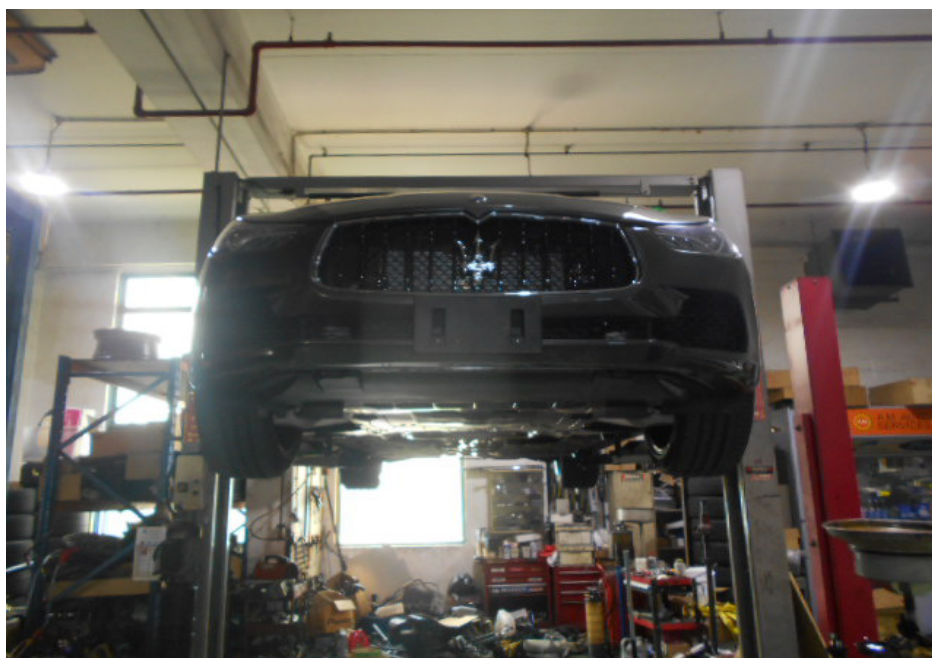
Photo 8 shows the Motor Car hoisted up for checks on its undercarriage. There was no sign(s) or indication(s) of fluid leakage and/or fluid stain(s) on the underside of the Motor Car. The undercarriage components of the Motor Car were also all observed to be intact and secured in an appropriate manner.

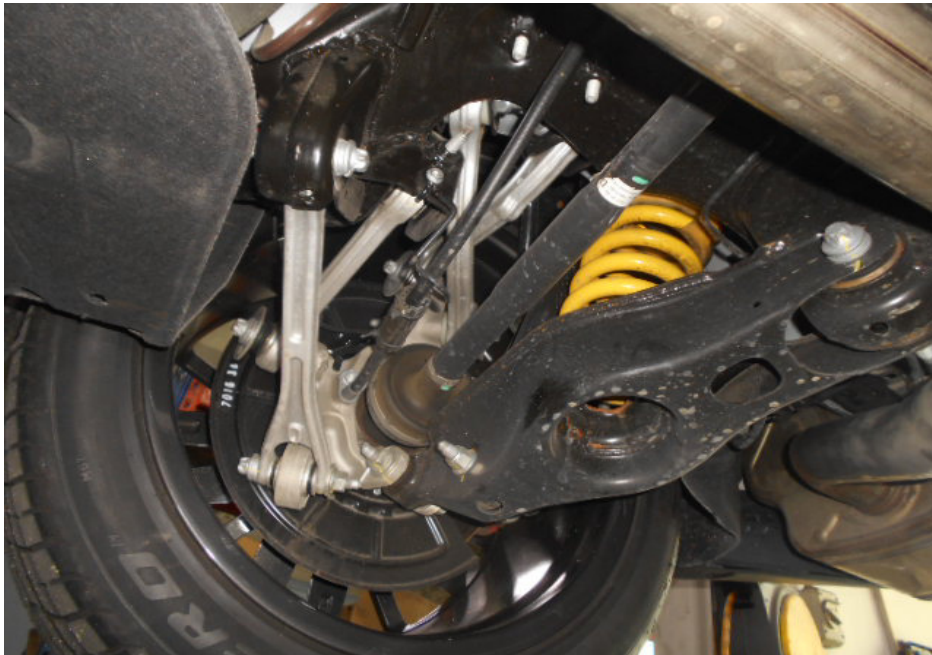
Photo 9 shows a general view of the control arms and linkages at the rear right wheel of the Motor Car. I did not observe any fluid leak and/or fluid stain on the underside of the Motor Car. All of the Motor Car's undercarriage components were observed to be intact and secured in an appropriate manner.

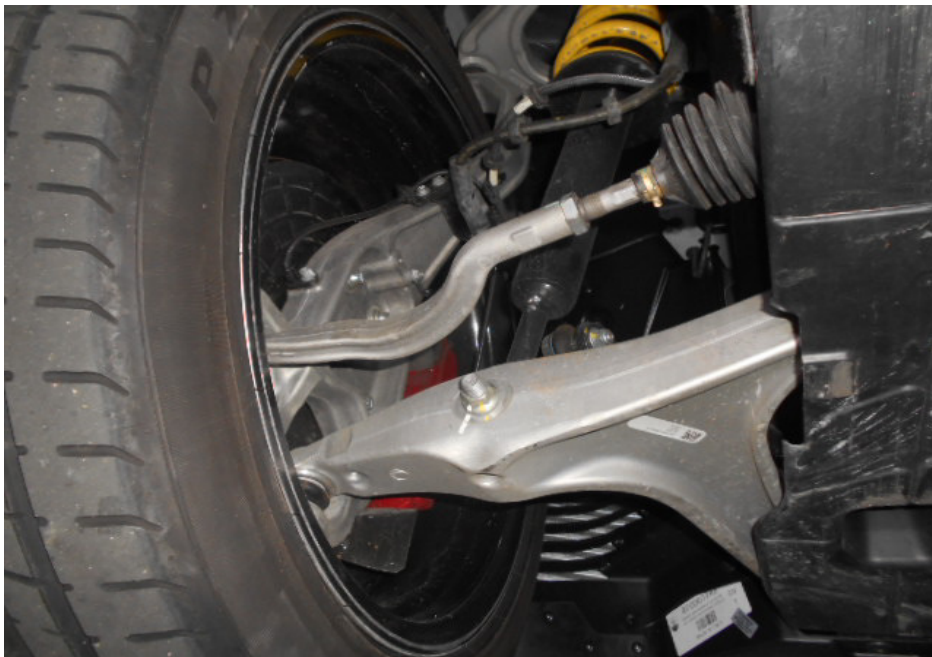
Photo 10 shows the various undercarriage components at the front left wheel of the Motor Car. The mechanical components, control arms and linkages were all found to be intact and secured in an appropriate manner.

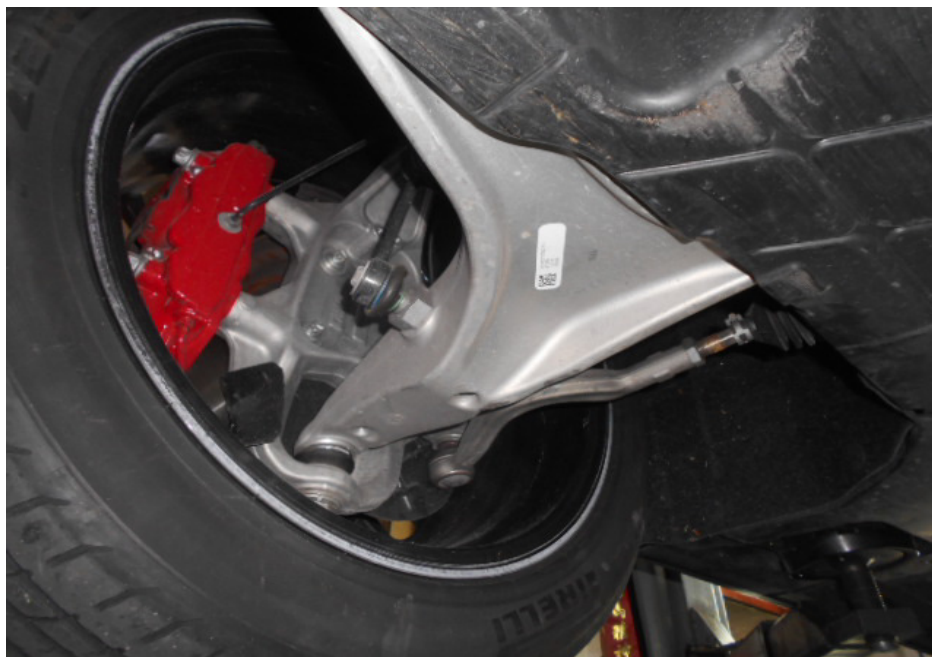
Photo 11 shows the various undercarriage components at the front right wheel of the Motor Car. The mechanical components, control arms and linkages were all found to be intact and secured in an appropriate manner.

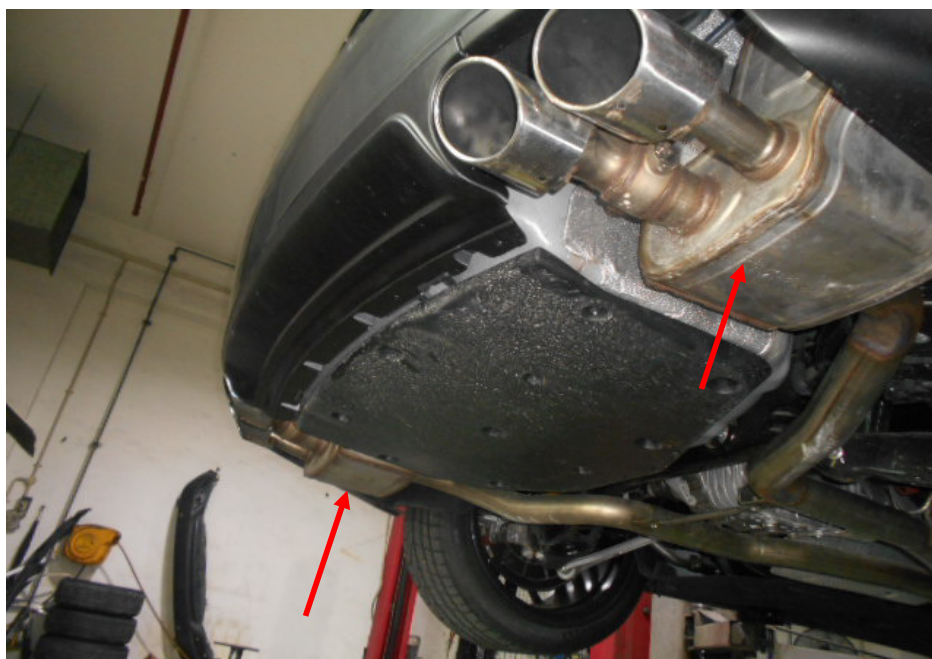
Photo 12 shows the Motor Car's rear exhaust mufflers (arrowed). My examination of the Motor Car's exhaust system revealed no sign(s) or indication(s) of any cut or weld marks along its exhaust pipes and on its rear mufflers.

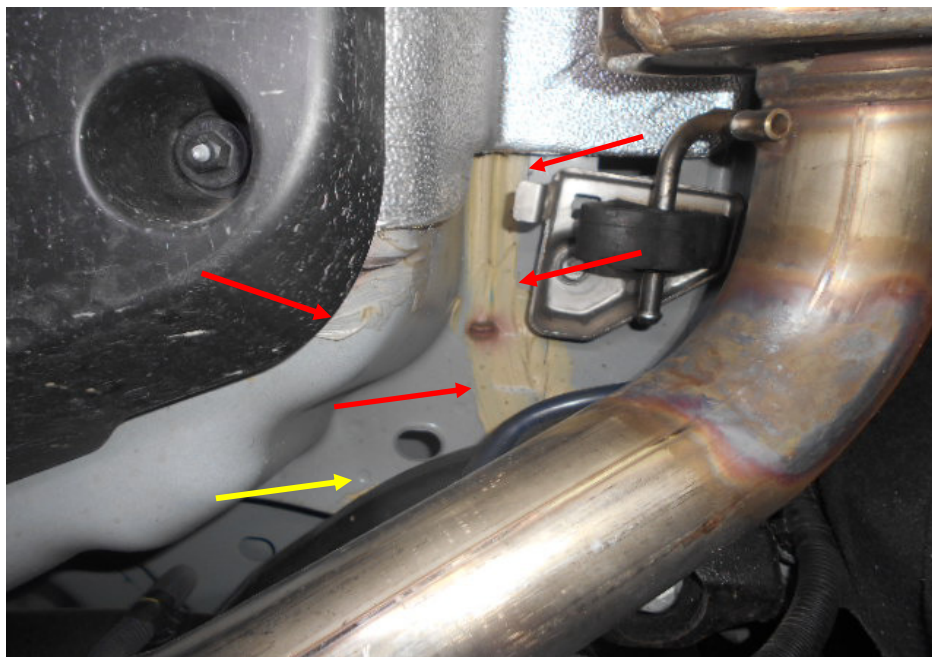
9. Visually, I did not find any weld marks, other than the original spot weld marks, on the chassis/structure body of the Motor Car. The original factory sealant at the joints along the chassis/structure body was also untouched, again indicating that no replacement of the chassis/structure body was carried out; and that the chassis/structure body was originally fitted.

Photo 13 shows the chassis/structure body at the underside rear right of the Motor Car. Visually, I did not find any weld marks other than original spot weld marks (yellow arrow) on the chassis/structure body of the Motor Car. The original factory sealant (red arrow) at the joints along the chassis/structure body was also untouched, indicating no work was done on the chassis/structure body of the Motor Car and that the chassis/structure body was originally fitted.

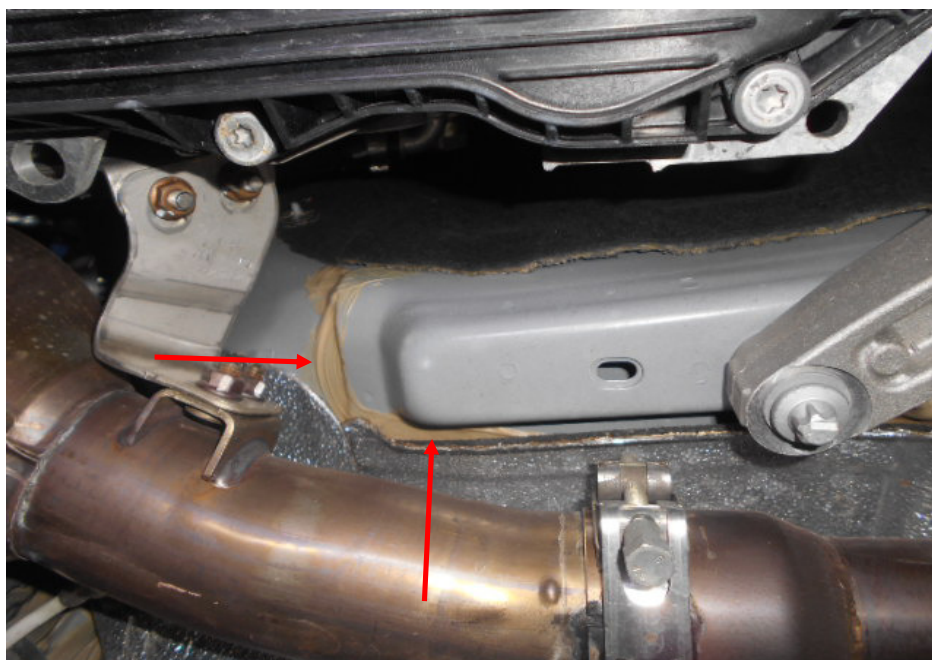
Photo 14 shows the floor board at the underside centre of the Motor Car. The original factory sealant at the joints along the non-detachable body panels were untouched, indicating no work was done on the non-detachable body panels of the Motor Car; and that these body panels were originally fitted.

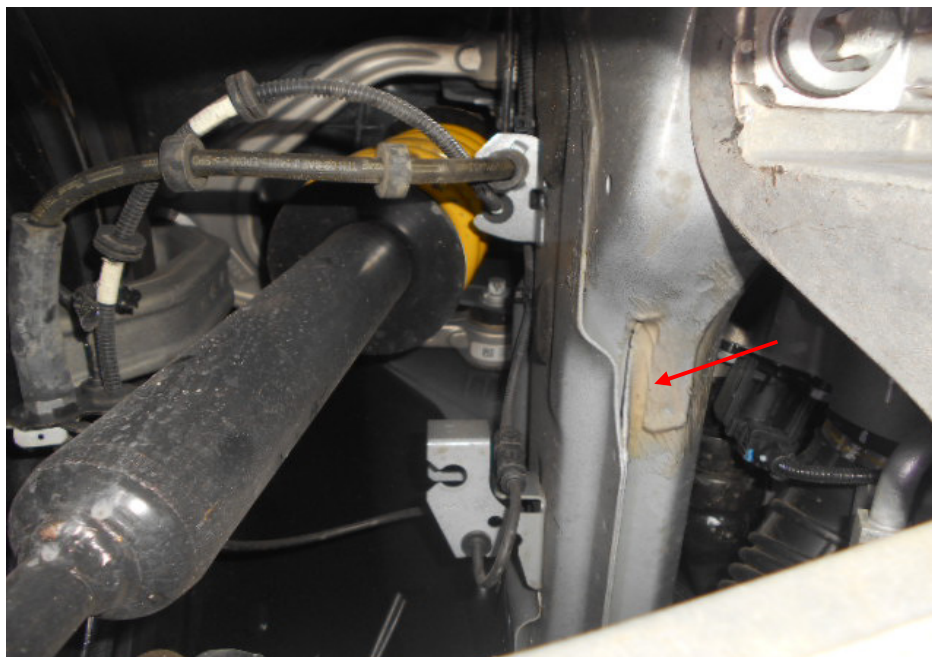
Photo 15 shows the chassis/structure body at the underside front left of the Motor Car. Visually, I did not find any weld marks other than original spot weld marks on the chassis/structure body of the Motor Car. The original factory sealant (arrowed) at the joints along the chassis/structure body was also untouched, indicating no work was done on the chassis/structure body of the Motor Car and that the chassis/structure body was originally fitted.

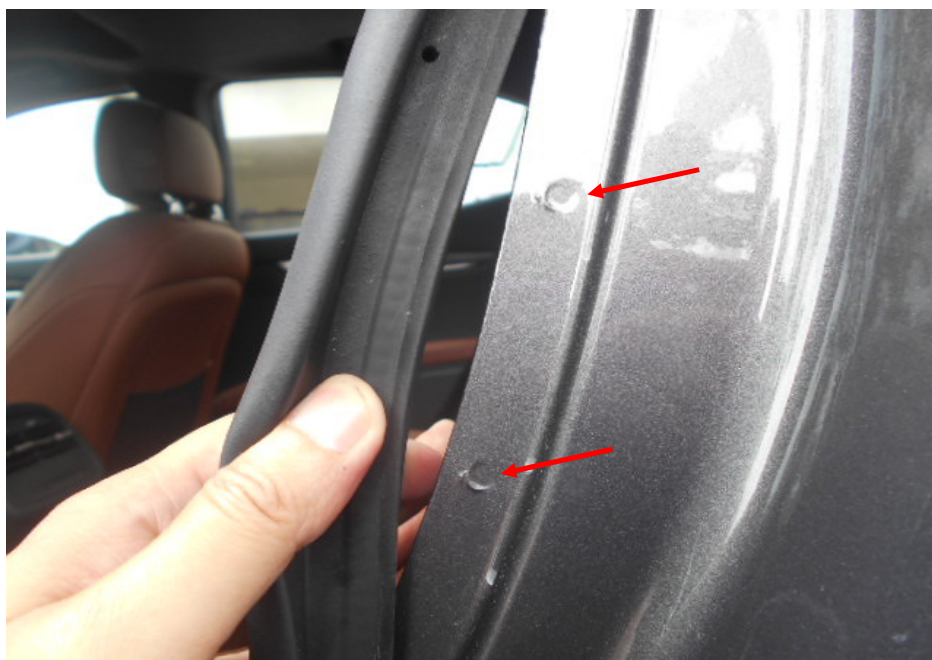
Photo 16 shows the left "C" pillar of the Motor Car. I did not find any weld marks other than original spot weld marks (arrowed) on the non-detachable body panels of the Motor Car, indicating that there was no re-welding works carried out; and that the non-detachable body panels of the Motor Car were originally fitted.

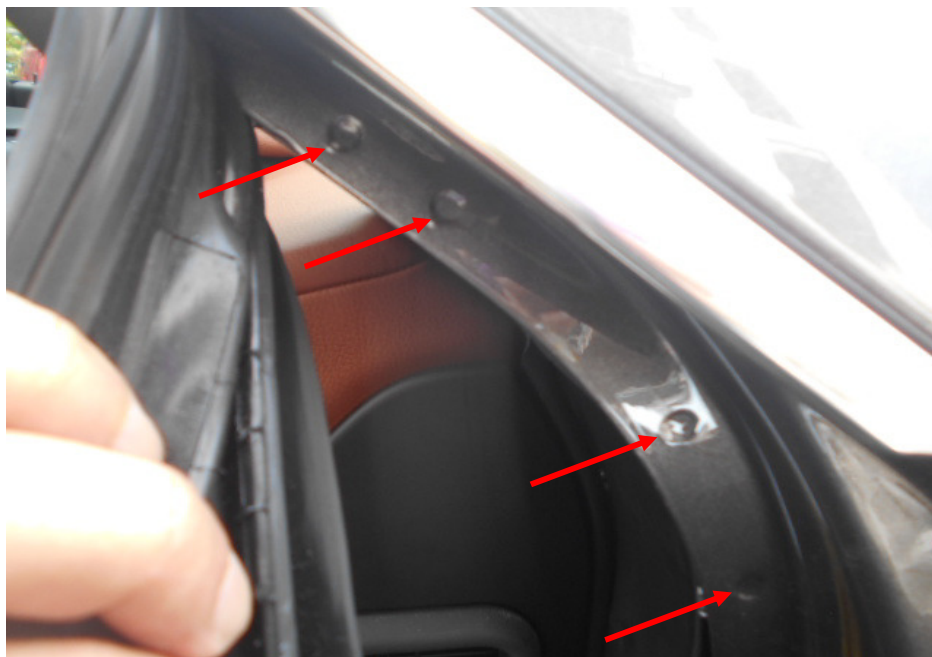
Photo 17 shows the right "A" pillar of the Motor Car. I did not find any weld marks other than original spot weld marks (arrowed) on the non-detachable body panels of the Motor Car, indicating that there was no re-welding works carried out; and that the non-detachable body panels of the Motor Car were originally fitted.
