Your Ref: TP/IP/68527/2019
Our Ref : CI/TPD19020443/P

Fatal Accident Investigation Team

MECHANICAL INSPECTION REPORT OF MOTOR TRAILER XB 6778E

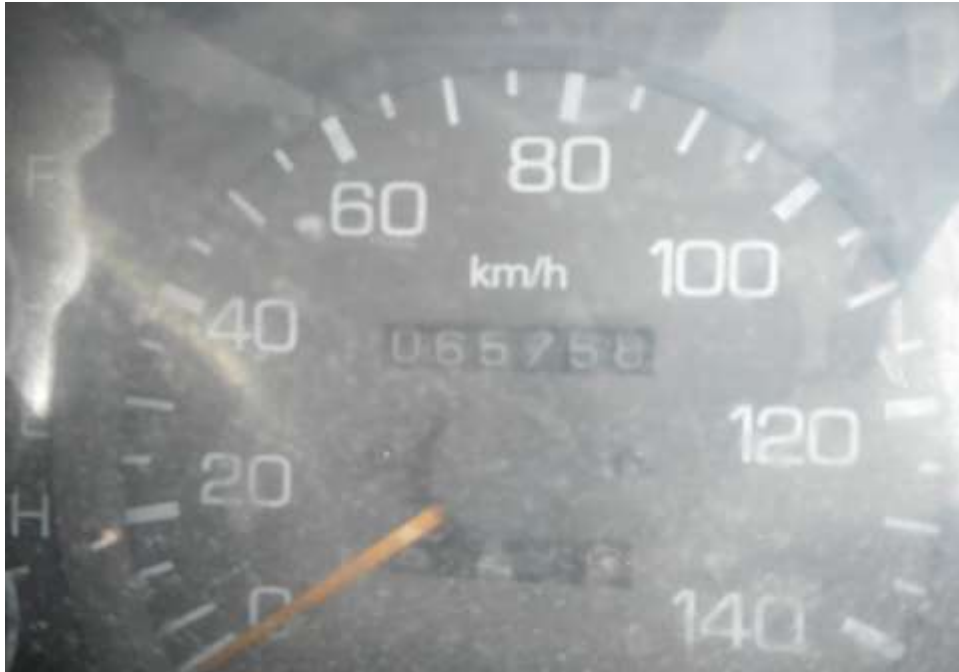
Photo 1 shows a general view of the instrument cluster of the Motor Trailer at the time of my inspection. The mileage of the Motor Trailer was 65,758km

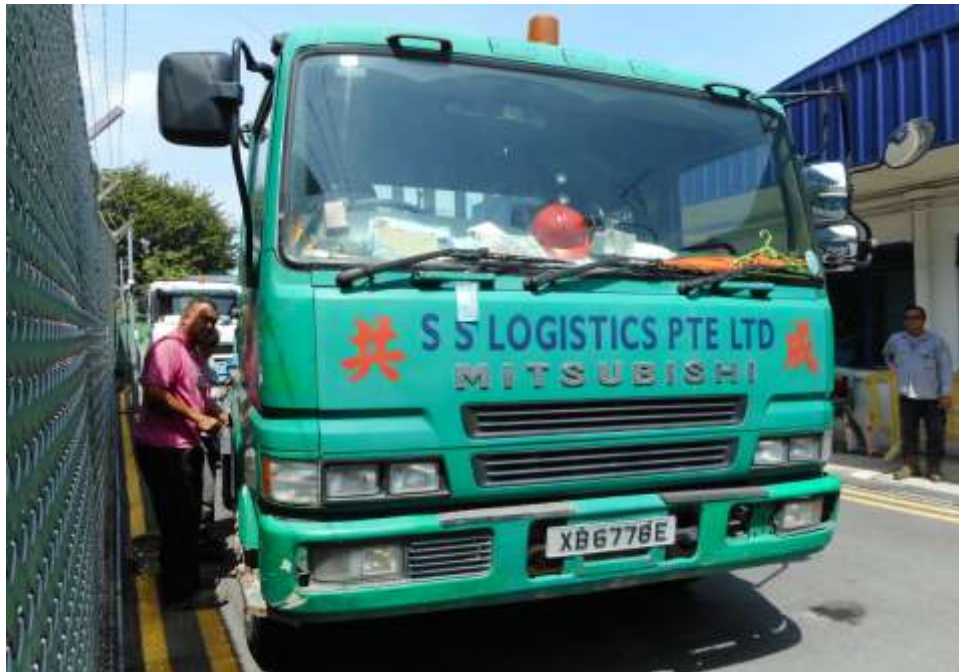
Photo 2 shows a general view of the front body of the Motor Trailer at the time of my inspection. The Motor Trailer was observed to be intact and unaffected by the accident.

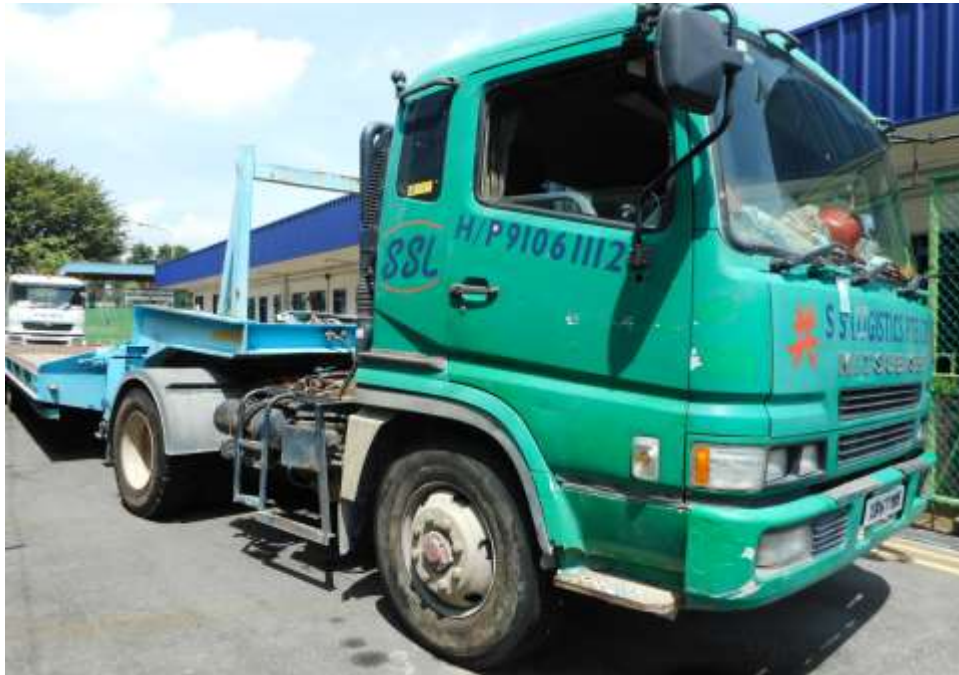
Photo 3 shows a general view of the front right body of the Motor Trailer at the time of my inspection. The Motor Trailer was observed to be intact and unaffected by the accident.

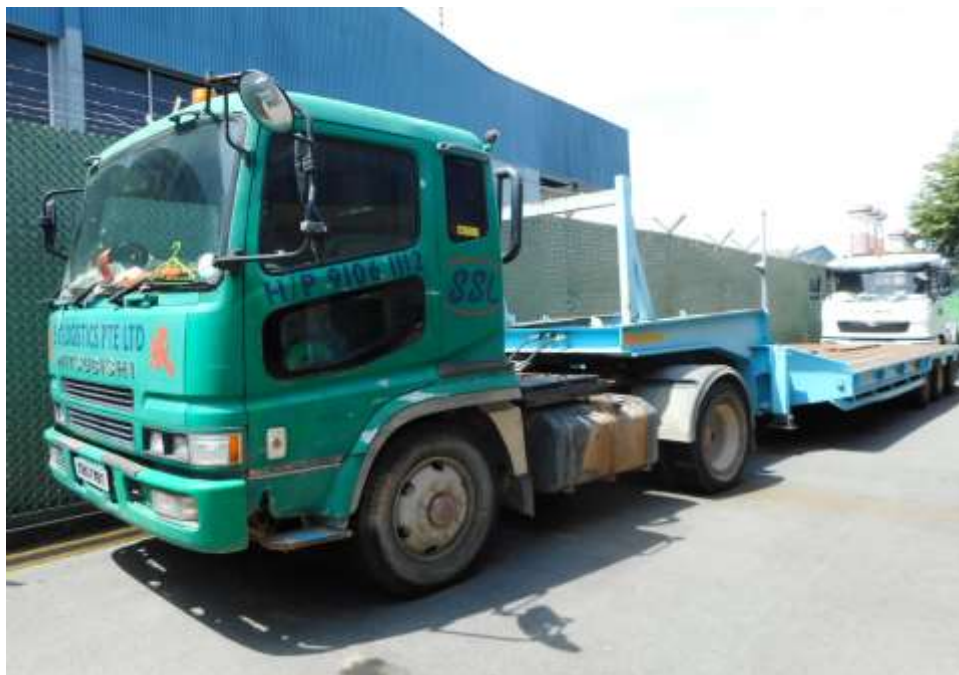
Photo 4 shows a general view of the front left body of the Motor Trailer at the time of my inspection. The Motor Trailer was observed to be intact and unaffected by the accident.

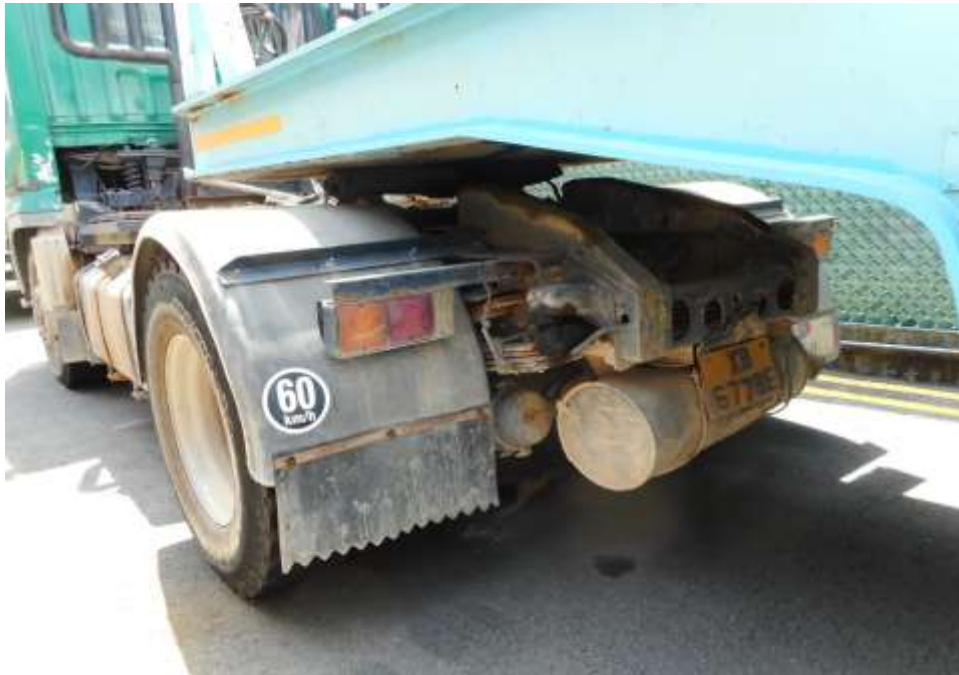
Photo 5 shows a general view of the Motor Trailer's rear body at the time of my inspection. The Motor Trailer was observed to be intact and unaffected by the accident.

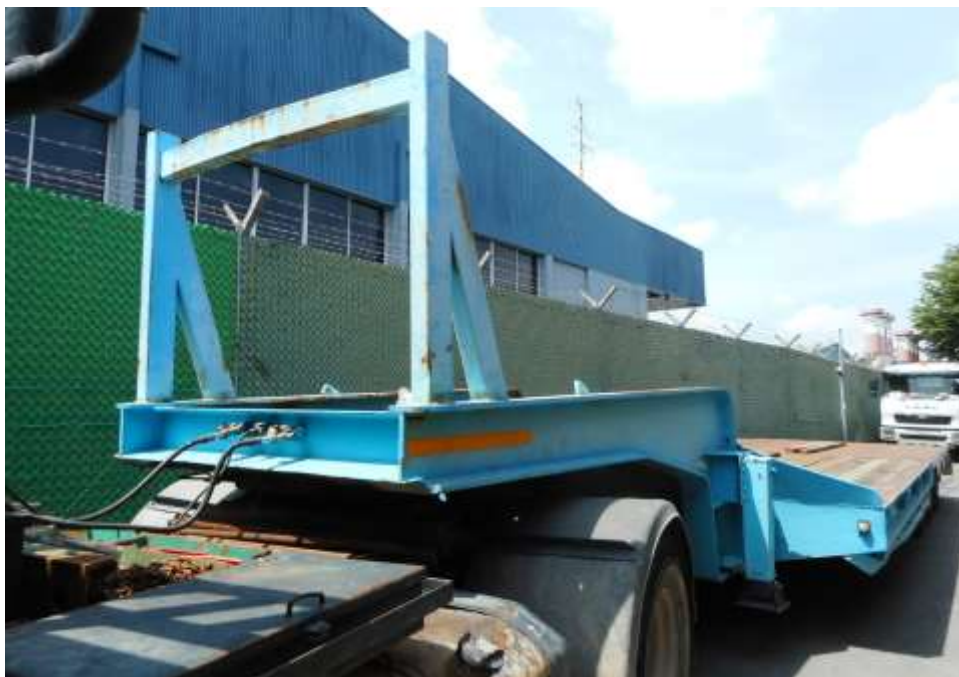
Photo 6 shows a general view of the front body of the trailer at the time of my inspection. The Motor Trailer was observed to be intact and unaffected by the accident.

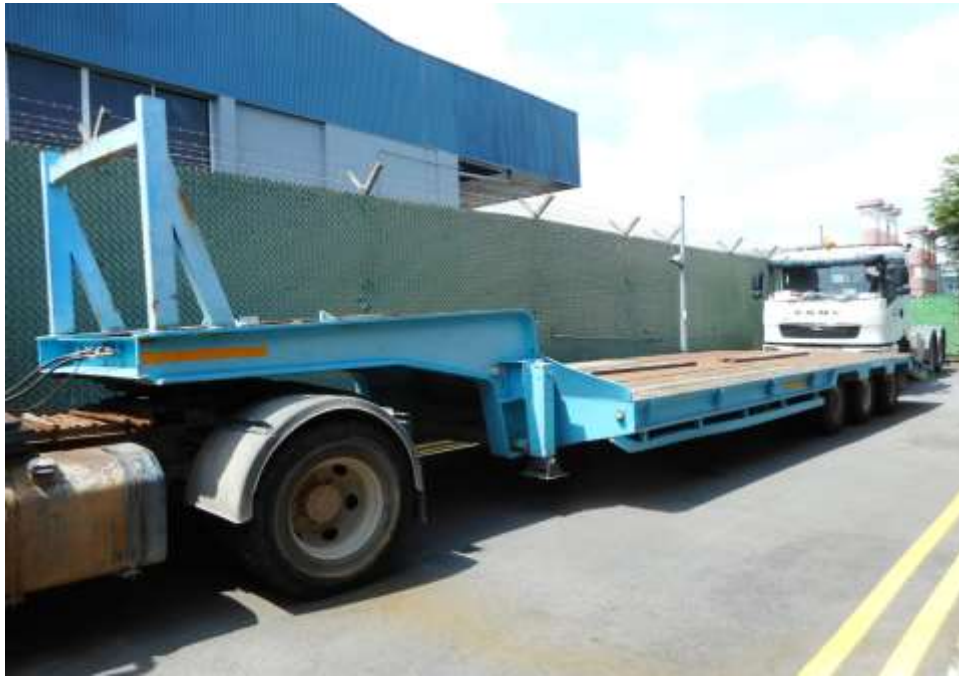
Photo 7 shows a general view of the trailer's left body at the time of my inspection. The Motor Trailer was observed to be intact and unaffected by the accident.

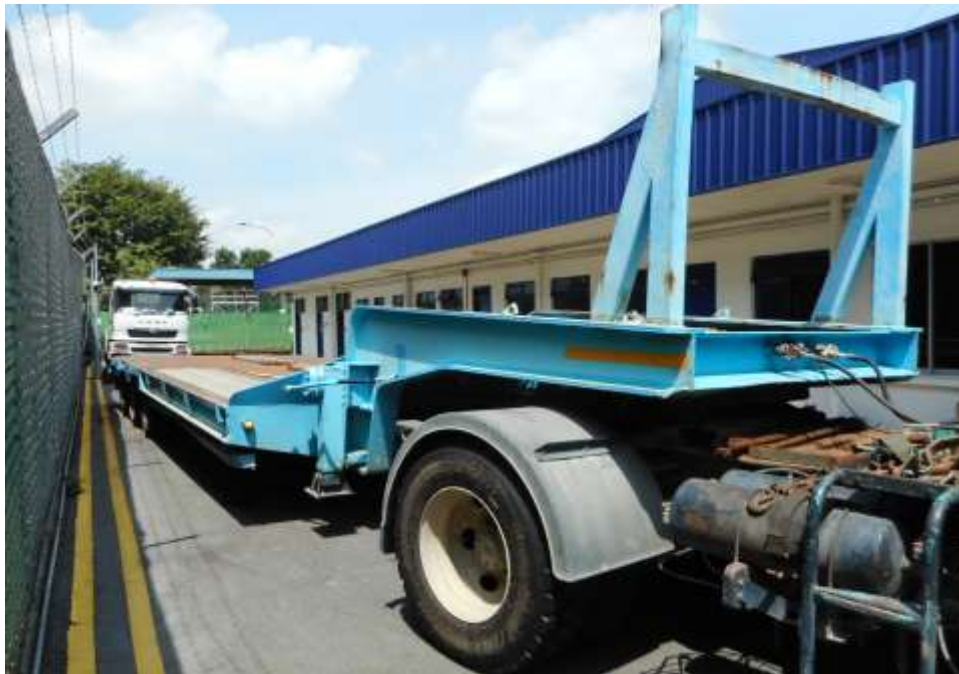
Photo 8 shows a general view of the trailer's right body at the time of my inspection. The Motor Trailer was observed to be intact and unaffected by the accident.

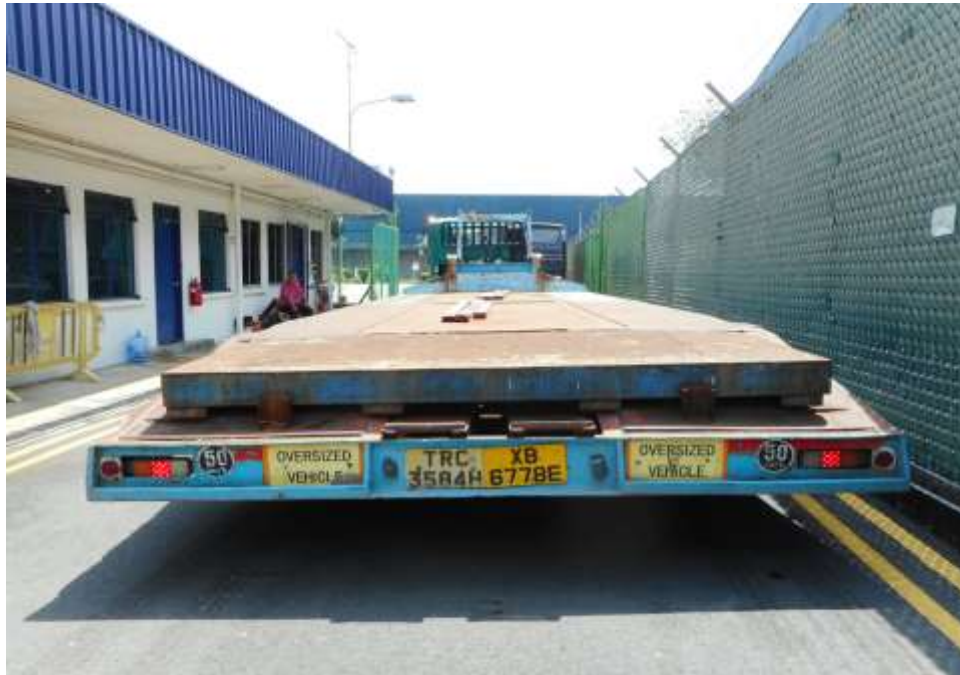
Photo 9 shows a general view of the trailer's rear body at the time of my inspection. The Motor Trailer was observed to be intact.

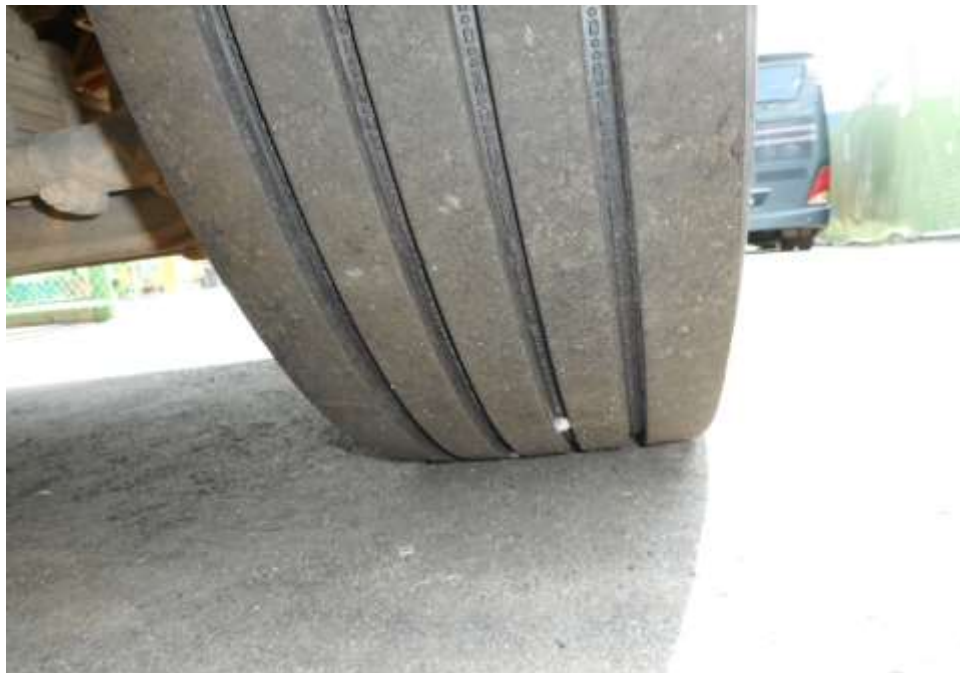
Photo 10 shows the condition of the front right tyre of the Motor Trailer, which was observed to be in serviceable condition with remaining tread depth of approximately 9.8 mm. The tyre, which was wrapped around standard steel wheel rim, was also observed to be sufficiently inflated for vehicular operation. There was no tear, cut or burst mark(s) on the outer and the inner sidewalls as well as across the tread of the 6 tyres that were fitted on the Motor Trailer.

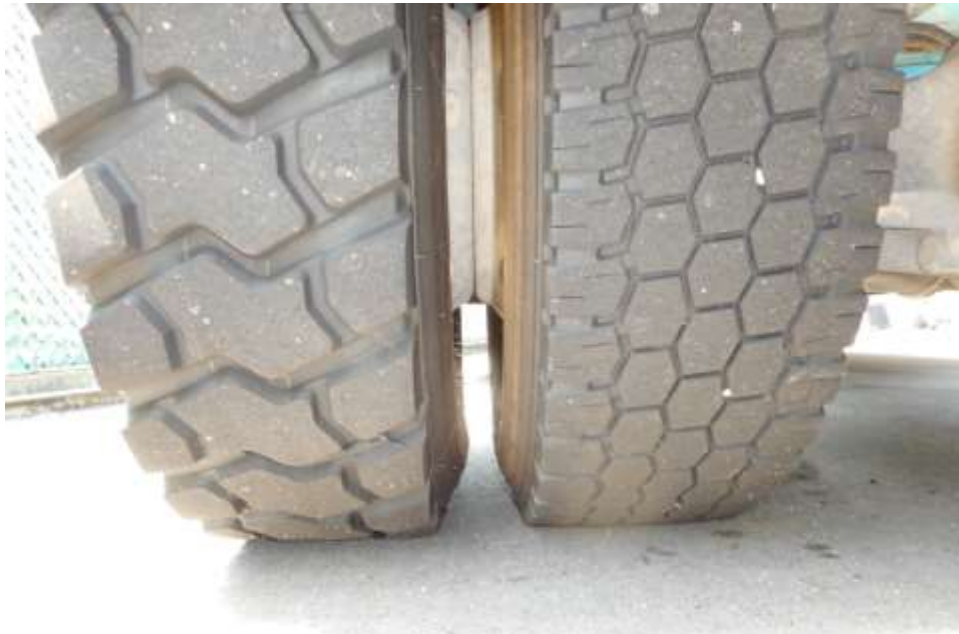
Photo 11 shows the condition of the rear right tyre of the Motor Trailer, which was observed to be in serviceable condition with remaining tread depth of approximately 11.3mm. The tyre, which was wrapped around standard steel wheel rim, was also observed to be sufficiently inflated for vehicular operation.

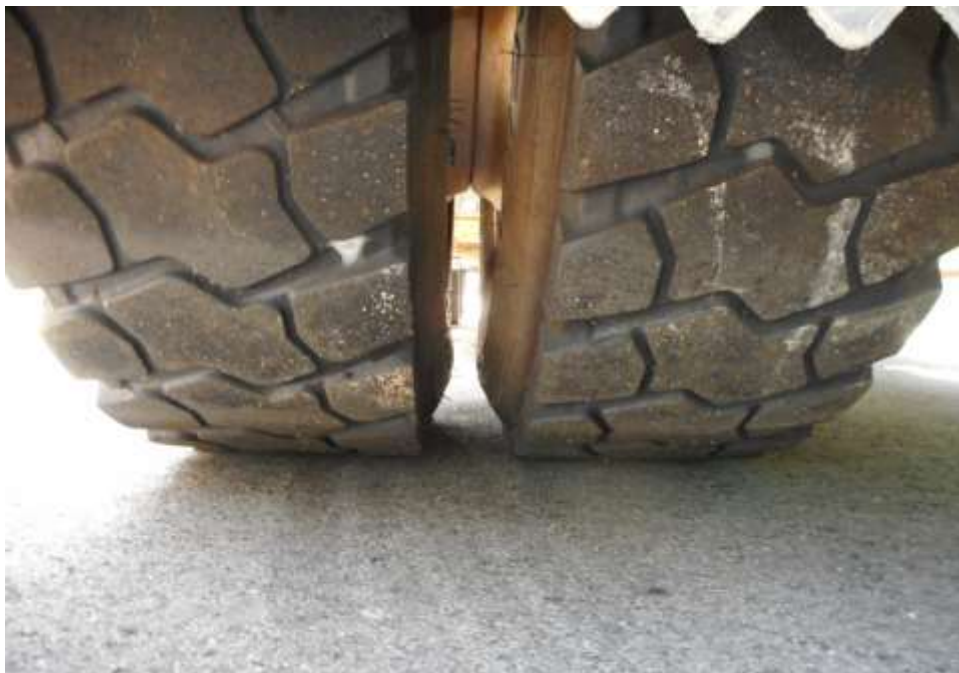
Photo 12 shows the condition of the rear left tyres of the Motor Trailer, which was observed to be in serviceable condition with remaining tread depth of approximately 5.4mm. The tyres, which were wrapped around standard steel wheel rim, were also observed to be sufficiently inflated for vehicular operation. There was also no damage found on all 6 steel wheel rims of the Motor Trailer.

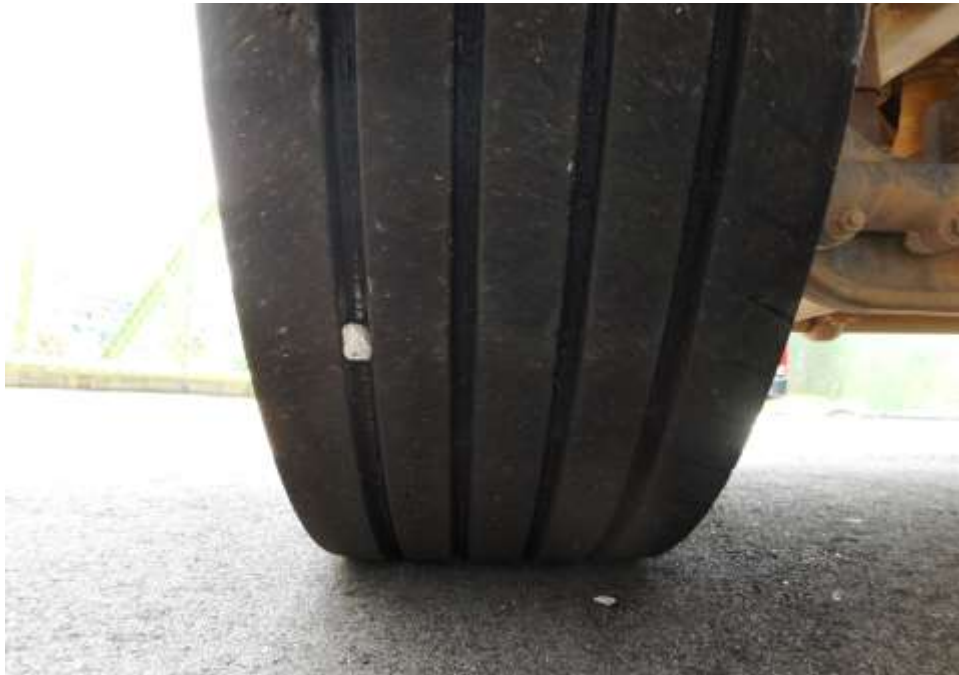
Photo 13 shows the condition of the front left tyres of the Motor Trailer, which were observed to be in serviceable condition with remaining tread depth of approximately 7.6mm. There was also no tear, cut or burst mark(s) on the outer and the inner sidewalls as well as across the tread of the 6 tyres that were fitted on the Motor Trailer.

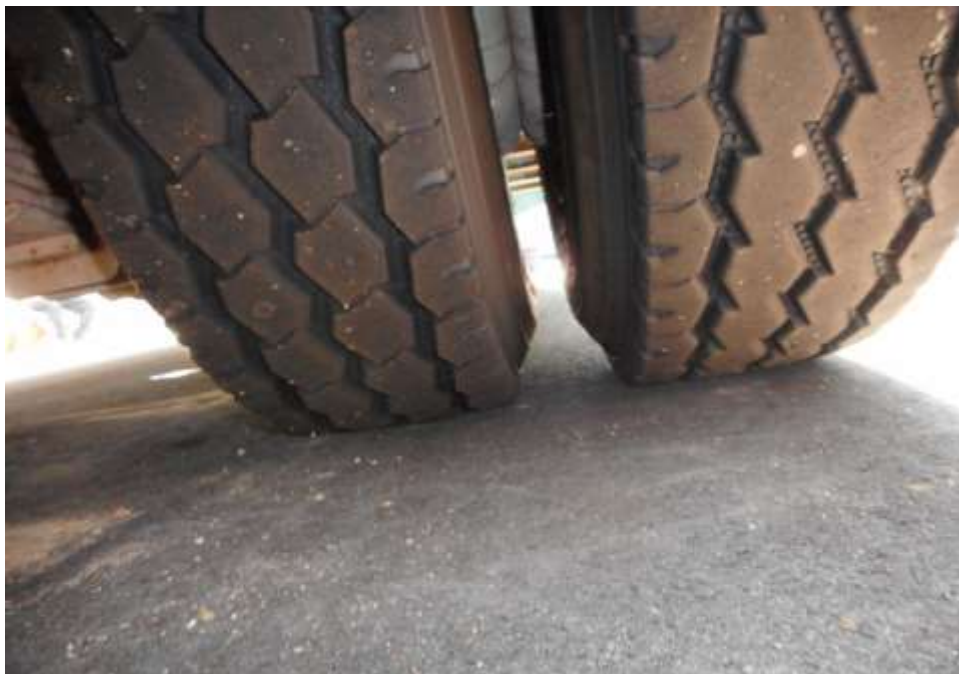
Photo 14 shows the condition of the right tyres of the trailer, which was observed to be in serviceable condition with remaining, tread depth of approximately 9.7mm. The tyre, which was wrapped around standard steel wheel rim, was also observed to be sufficiently inflated for vehicular operation.

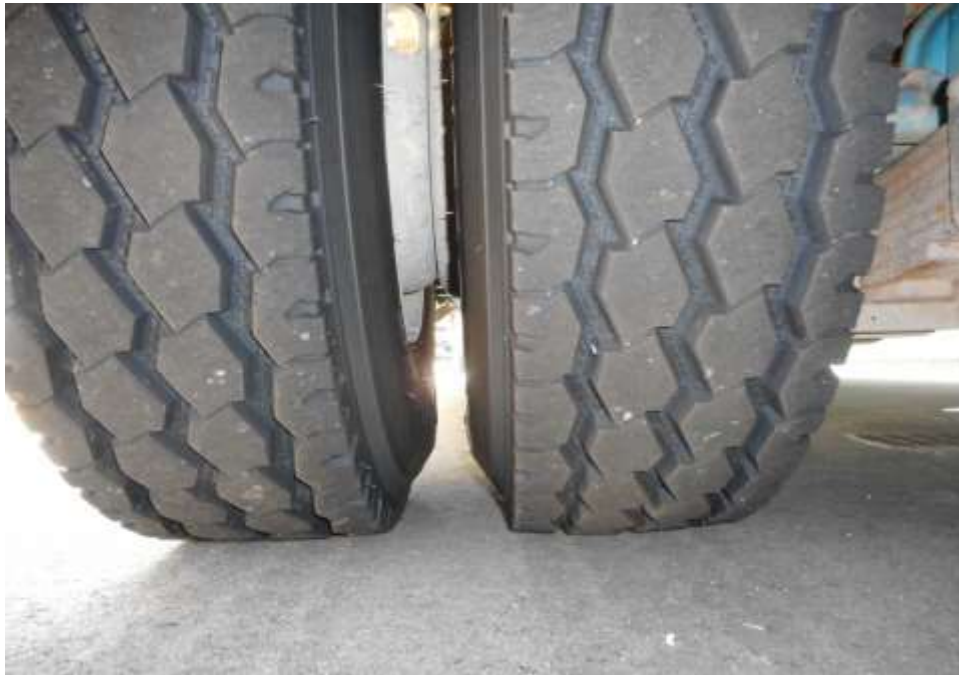
Photo 15 shows the condition of the left tyres of the trailer, which was observed to be in serviceable condition with remaining tread depth of approximately 10.9mm. The tyres, which were wrapped around standard steel wheel rim, were also observed to be sufficiently inflated for vehicular operation. There was also no damage found on all 6 steel wheel rims of the Motor Trailer.

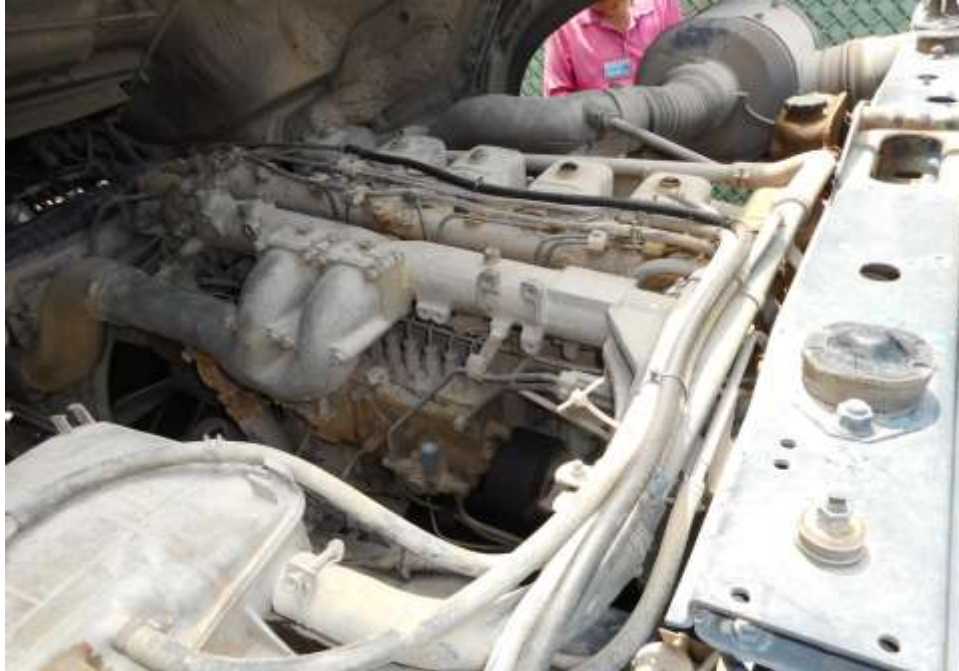
Photo 16 shows a general view of the Motor Trailer's engine compartment, which was accessed by lifting the front cabin of the Motor Trailer. The various parts and components inside the engine compartment were unaffected by the accident. There was also no sign(s) or indication(s) of fresh fluid leakage and/or fluid stain within the engine compartment

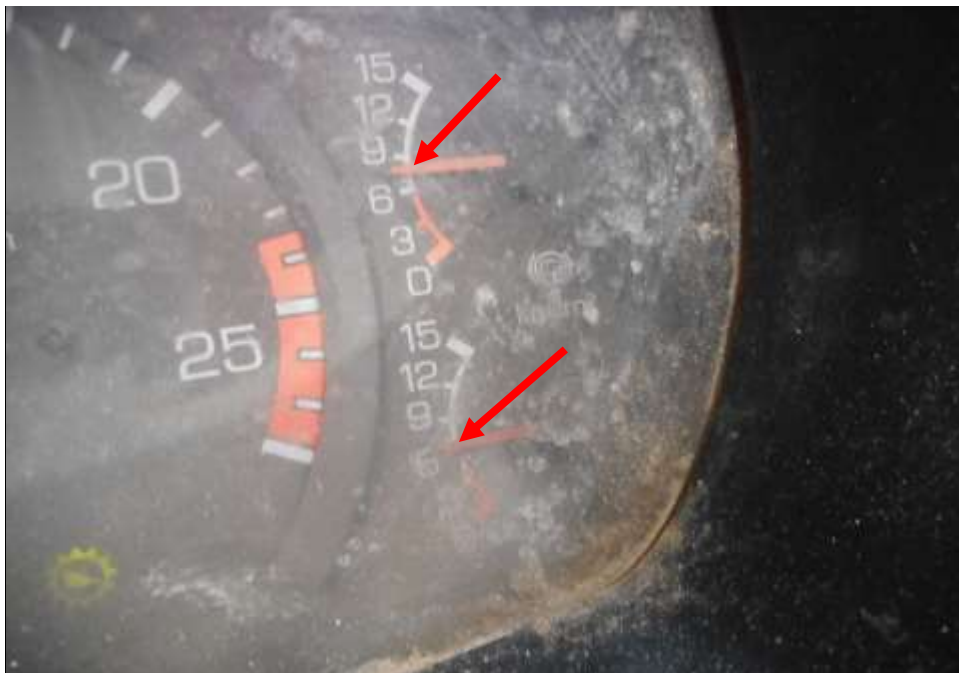
Photo 17 shows the air in the air brake cylinders of the Motor Trailer at the time of my inspection. The air in the cylinder was observed to be of sufficient level & serviceable at the time of the accident.

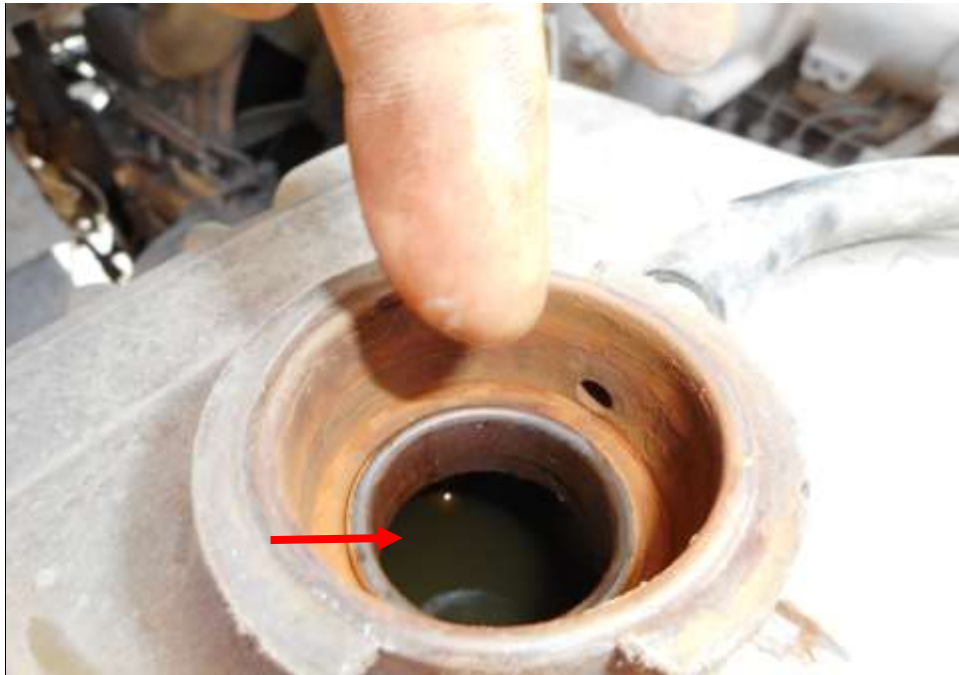
Photo 18 shows the engine coolant reservoir of the Motor Trailer at the time of my inspection. The engine coolant was observed to be of sufficient level (arrowed) and without any visible contamination.

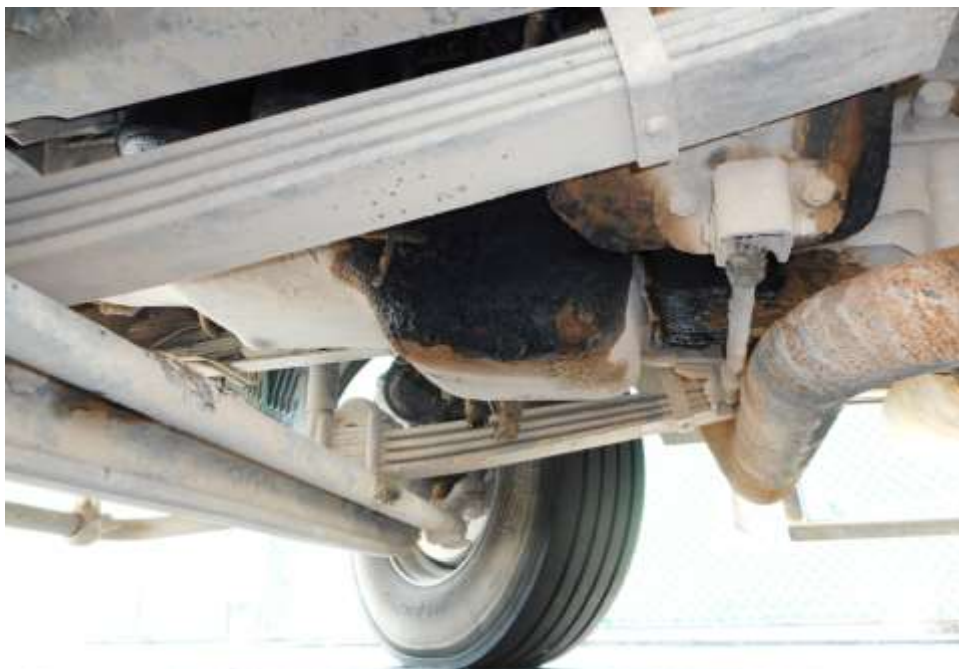
Photo 21 shows the undercarriage of the Motor Trailer, at the area where the engine housing located. I did not find any sign(s) or indication(s) of fluid leak, however old fluid stain(s) was observed on the underside of the Motor Trailer.

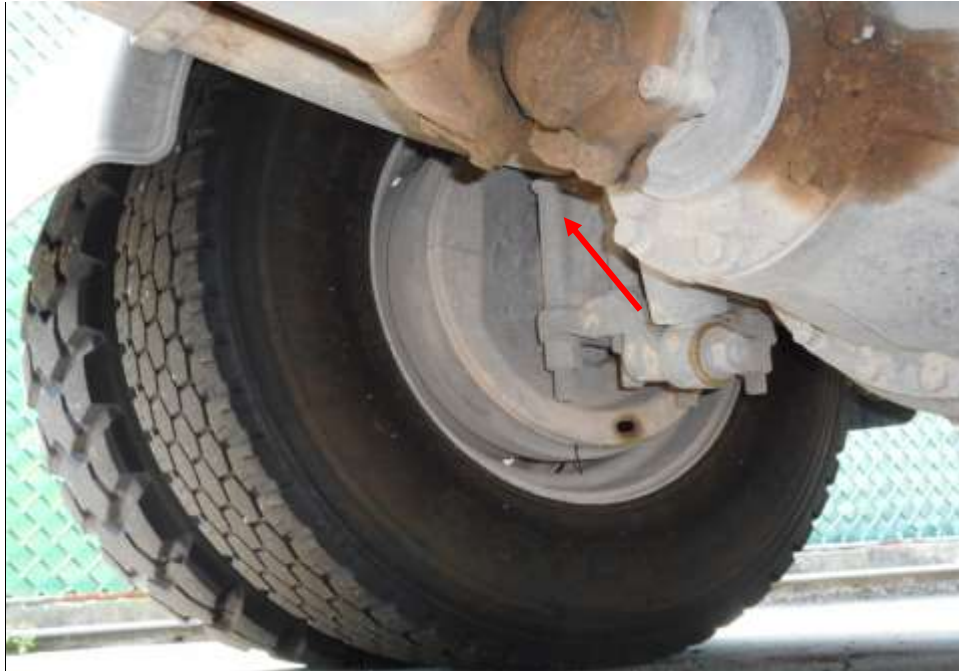
Photo 22 shows the brake pipe (arrowed) at the rear right wheel of the Motor Trailer. I did not observe any leakage of brake fluid at the time of my inspection of the Motor Trailer. My static tests of the Motor Trailer's braking system, along with my visual examination of the various mechanical components in the braking system, had indicated that there was no internal leakage of pressure/vacuum. Hence the braking system of the Motor Trailer was likely to be in serviceable condition at the material time of accident.

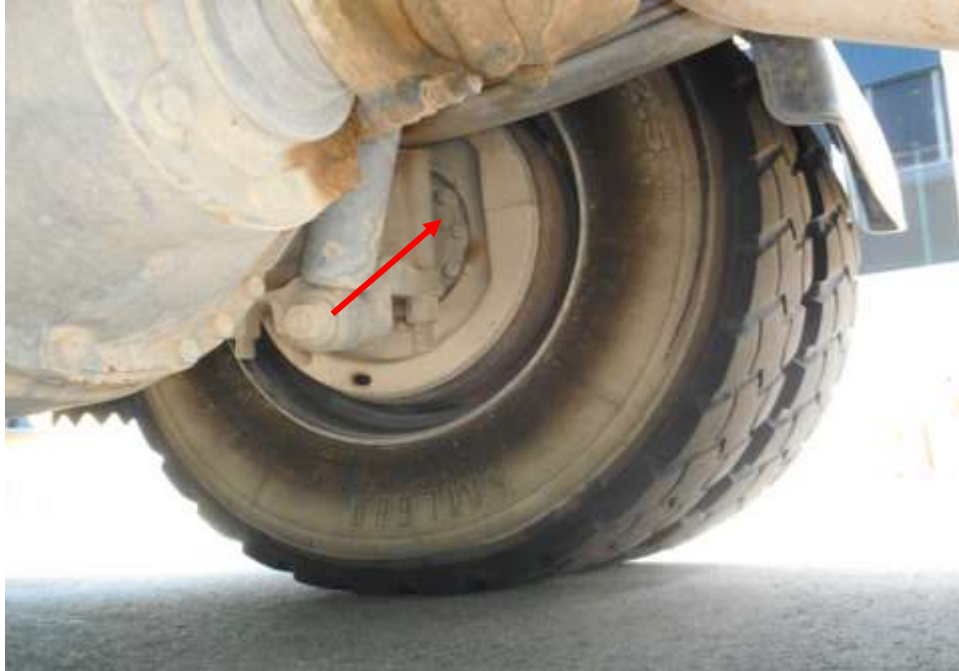
Photo 23 shows the brake pipe (arrowed) at the rear left wheel of the Motor Trailer. I did not observe any leakage of brake fluid at the time of my inspection of the Motor Trailer. My static tests of the Motor Trailer's braking system, along with my visual examination of the various mechanical components in the braking system, had indicated that there was no internal leakage of pressure/vacuum. Hence the braking system of the Motor Trailer was likely to be in serviceable condition at the material time of accident.

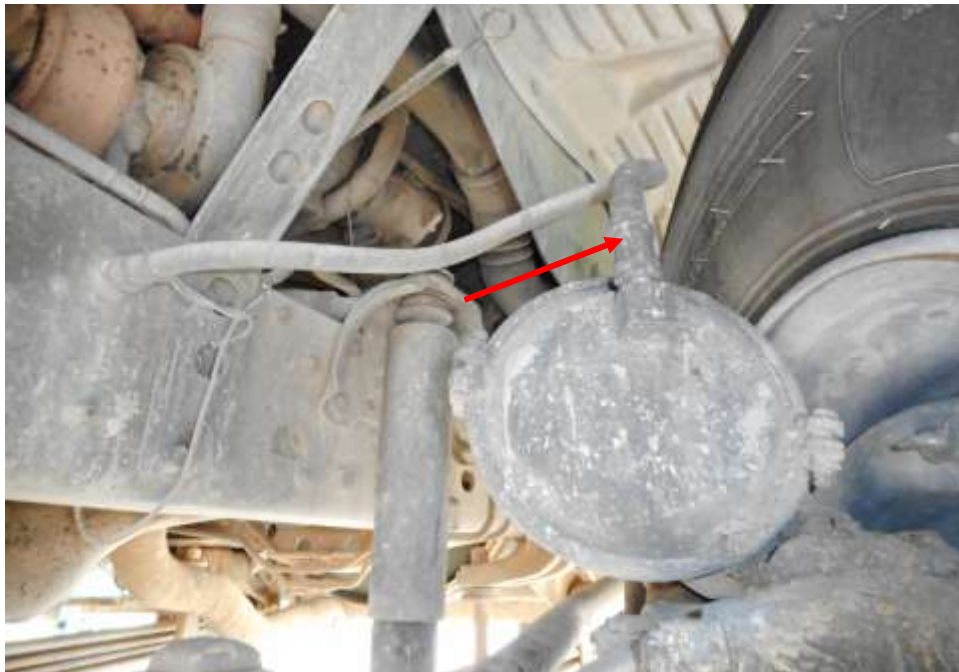
Photo 24 shows the brake pipe (arrowed) at the front right wheel of the Motor Trailer. I did not observe any leakage of brake fluid at the time of my inspection of the Motor Trailer. My static tests of the Motor Trailer's braking system, along with my visual examination of the various mechanical components in the braking system, had indicated that there was no internal leakage of pressure/vacuum. Hence the braking system of the Motor Trailer was likely to be in serviceable condition at the material time of accident.

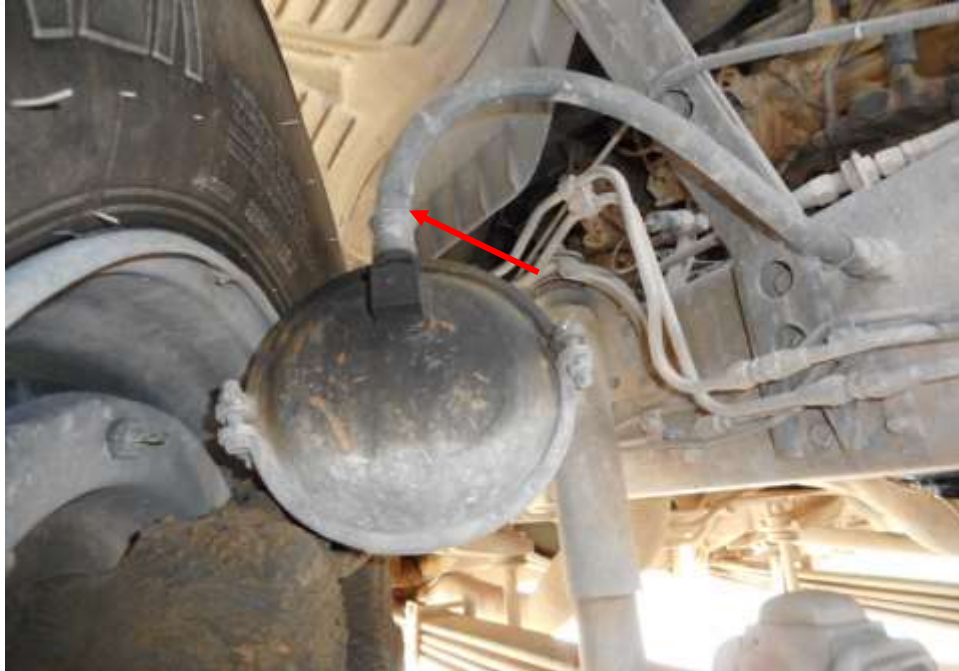
Photo 25 shows the brake pipe (arrowed) at the front left wheel of the Motor Trailer. I did not observe any leakage of brake fluid at the time of my inspection of the Motor Trailer. My static tests of the Motor Trailer's braking system, along with my visual examination of the various mechanical components in the braking system had indicated that there was no internal leakage of pressure/vacuum. Hence the braking system of the Motor Trailer was likely to be in serviceable condition at the material time of accident.

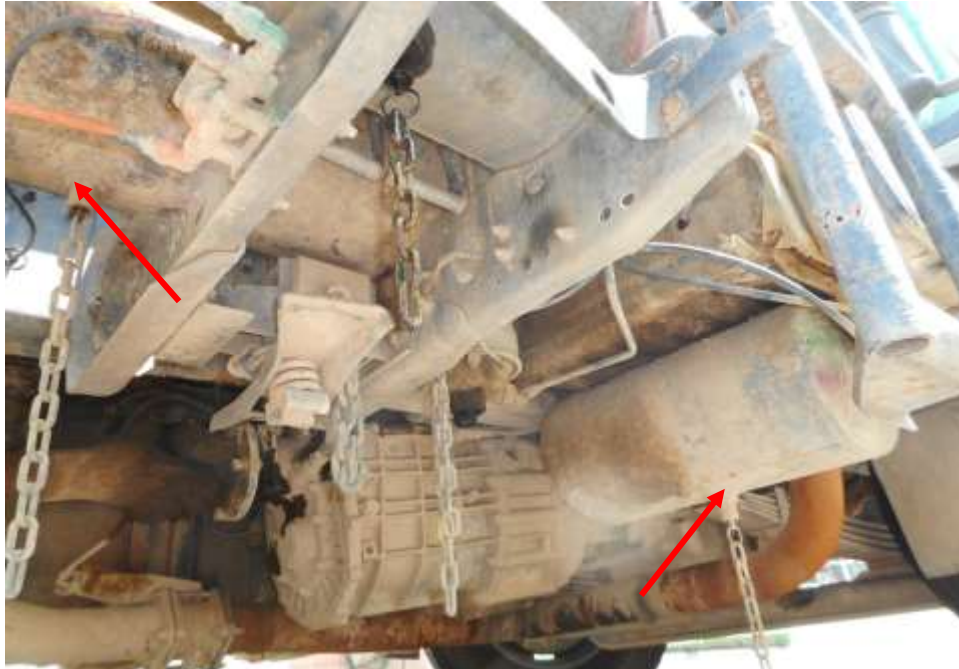
Photo 26 shows the air brake cylinders (arrowed) at the undercarriage of the Motor Trailer. I did not observe any leakage of air brake fluid at the time of my inspection of the Motor Trailer. My static tests of the Motor Trailer's braking system, along with my visual examination of the various mechanical components in the braking system had indicated that there was no internal leakage of pressure/vacuum. Hence the braking system of the Motor Trailer was likely to be in serviceable condition at the material time of accident.

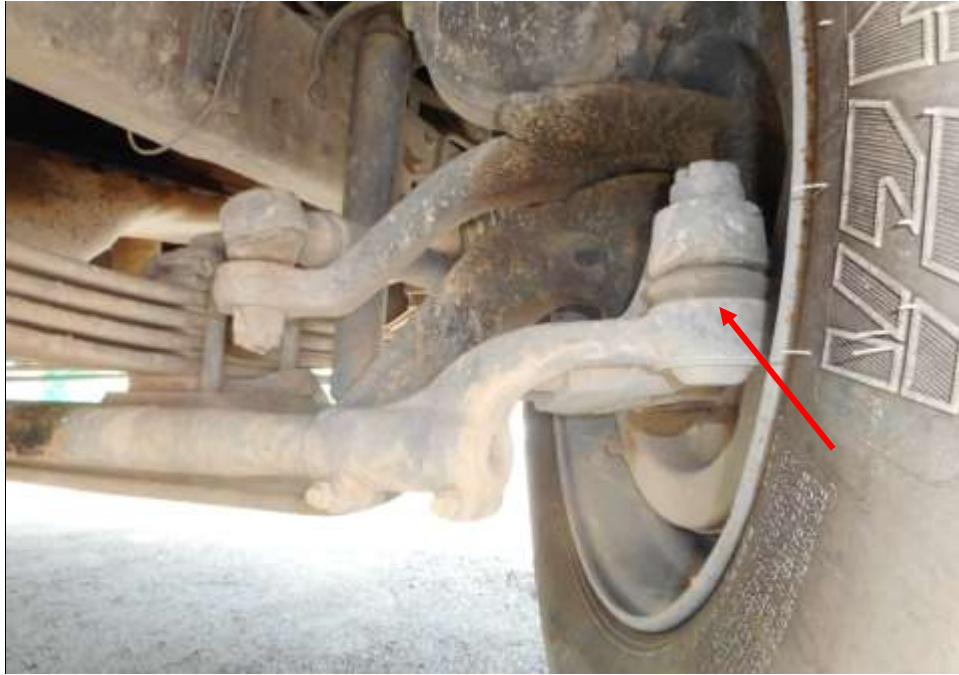
Photo 27 shows the various undercarriage components at the front right wheel of the Motor Trailer, in particular the steering tie rod end (arrowed). The various steering components were all found to be intact, suggesting that the steering system of the Motor Trailer was likely to be in serviceable condition at the material time of accident. There was also no sign of fluid stain(s) observed on the various undercarriage components.

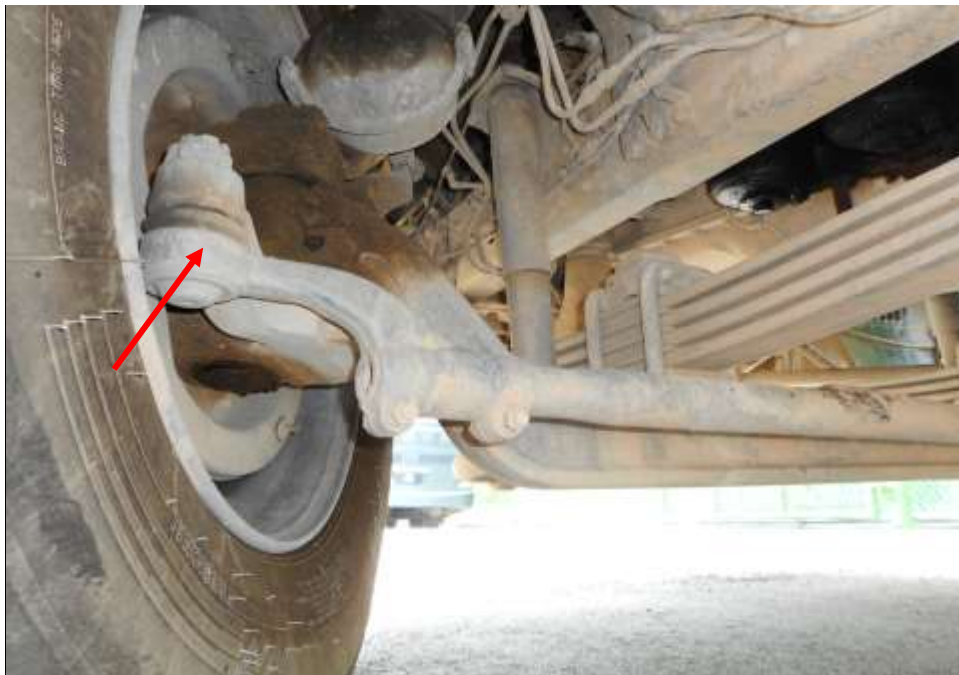
Photo 28 shows the various undercarriage components at the front left wheel of the Motor Trailer, in particular the steering tie rod end (arrowed). The various undercarriage components of the Motor Trailer were all found to be intact without any visible damage. There was also no sign of fluid stain(s) observed on the various undercarriage components.

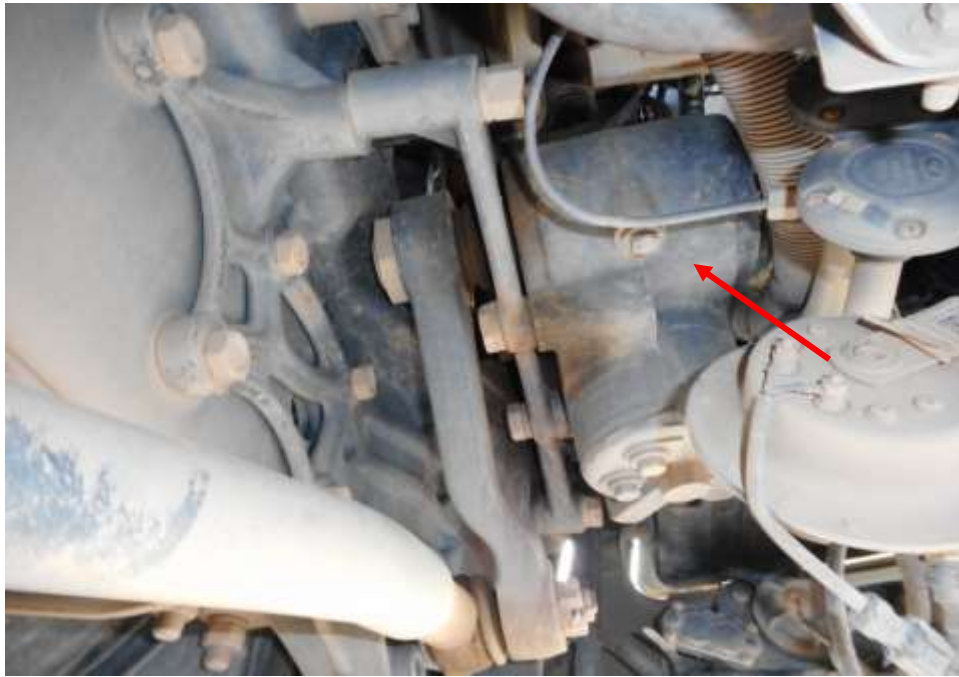
Photo 29 shows the steering box component (arrowed) at the undercarriage of the Motor Trailer was found to be intact without any visible damage. There was also no sign of fluid stain(s) observed on the various undercarriage components.

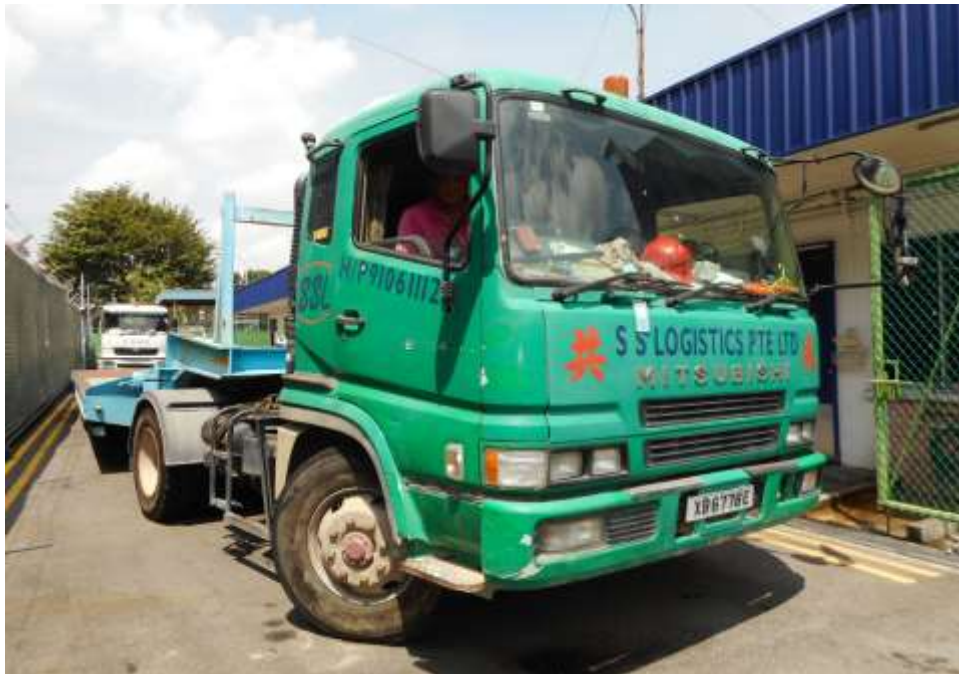
Photo 30 shows the front right wheel of the Motor Trailer turned to its full left. During my steering system test, I did not experience any abnormal free play and/or resistance when I had turned the steering wheel towards full left and full right. This would suggest that the steering system of the Motor Trailer was likely to be in serviceable condition at the material time of accident.
