Your Ref: TP/IP/69653/2019
Our Ref : CI/TPD19020444/P

30th December 2019

MECHANICAL INSPECTION REPORT OF MOTOR BUS SBS 6430D

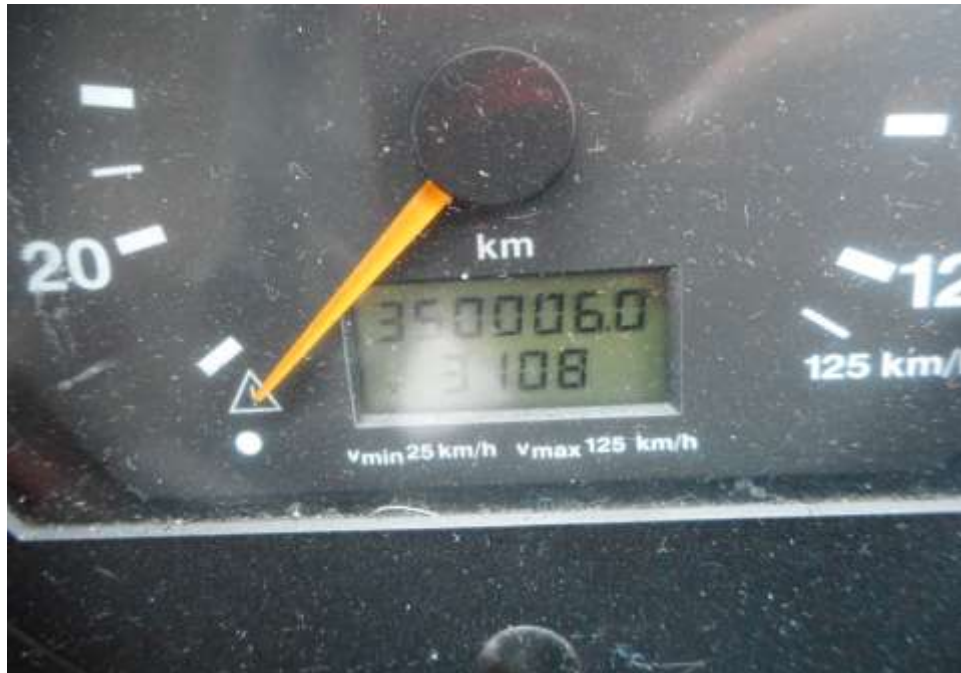
4. The mileage of the Motor Bus at the time of my inspection was 350,006km.
5. The Motor Bus was observed to have sustained damages at its front, left rear and undercarriage portion. Its front bumper, left rear body panel, rear left headlamp and undercarriage diesel fuel hose was damaged as a result of the accident at the time of my inspection.

Photo 1 shows a general view of the instrument cluster of the Motor Bus at the time of my inspection. The mileage of the Motor Bus was 350,006km

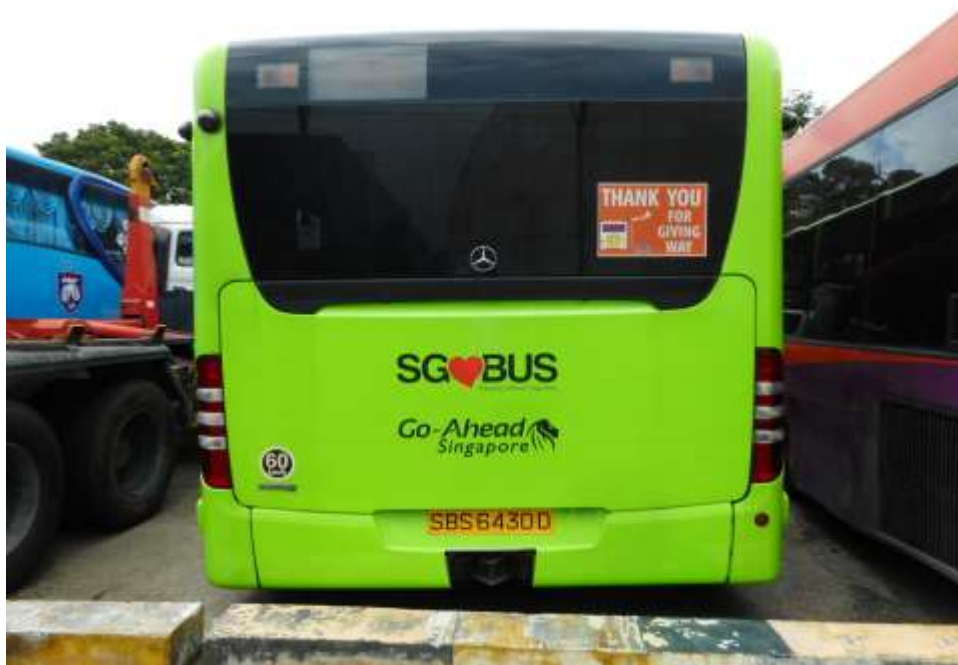
Photo 2 shows a general view of the rear body of the Motor Bus at the time of my inspection. The Motor Bus sustained damages at its front, left rear and undercarriage portion. Its front bumper, left rear body panel and rear left headlamp was damaged as a result of the accident at the time of my inspection.

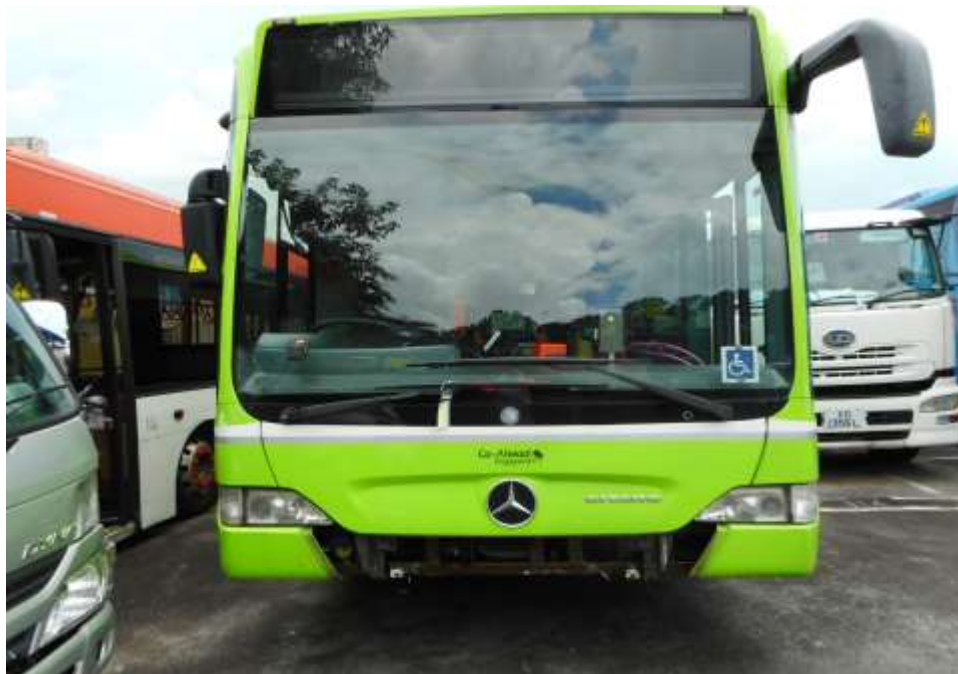
Photo 3 shows a general view of the front body of the Motor Bus at the time of my inspection. Its front bumper was damaged as a result of the accident at the time of my inspection.

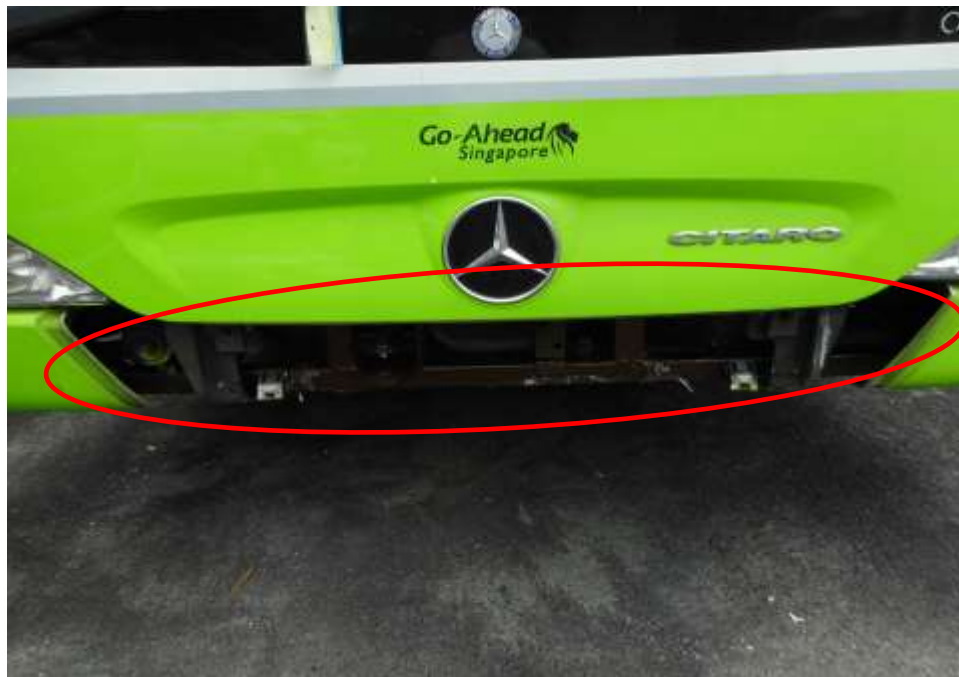
Photo 4 shows a close up view of the front body of the Motor Bus at the time of my inspection. Its front bumper (circled) was damaged as a result of the accident at the time of my inspection.

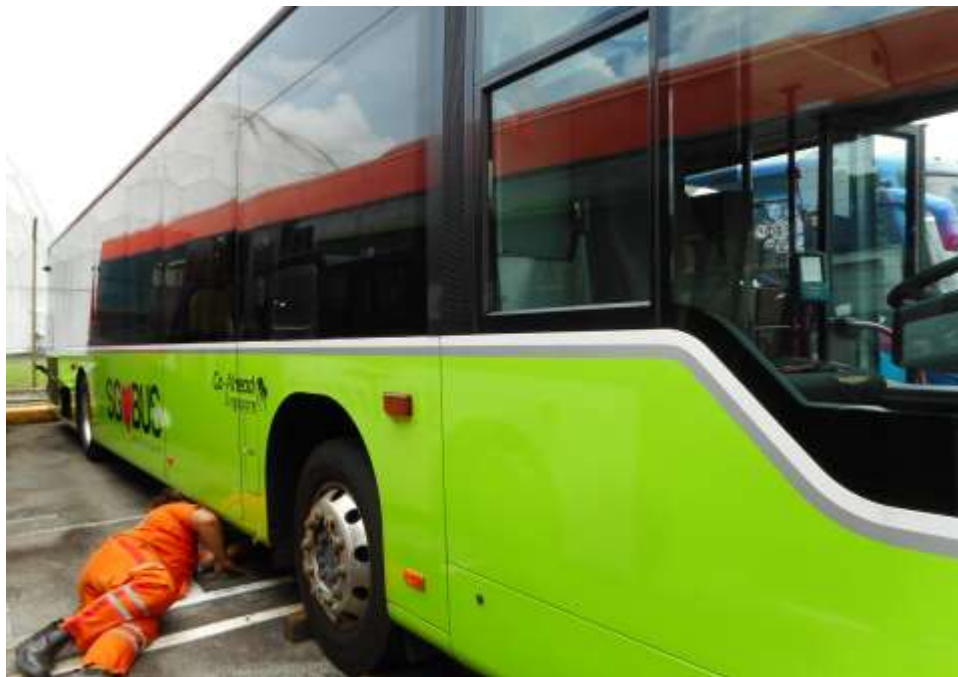
Photo 5 shows a general view of the right body of the Motor Bus at the time of my inspection. The Motor Bus was observed to be in good general condition and unaffected by the accident.

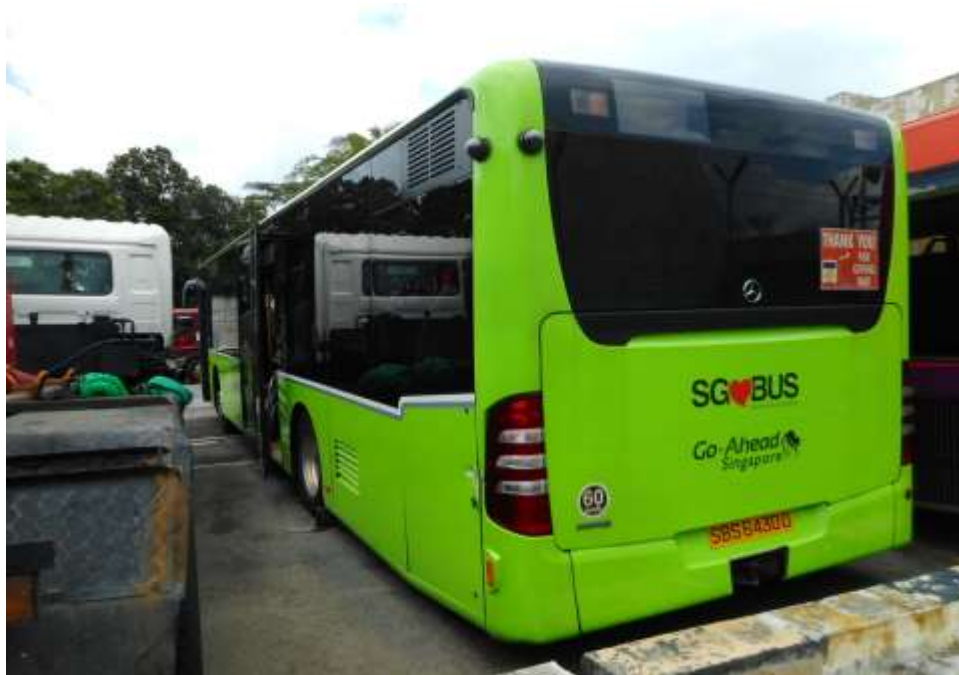
Photo 6 shows a general view of the left rear body of the Motor Bus at the time of my inspection. Its body panel and rear left headlamp was damaged as a result of the accident.

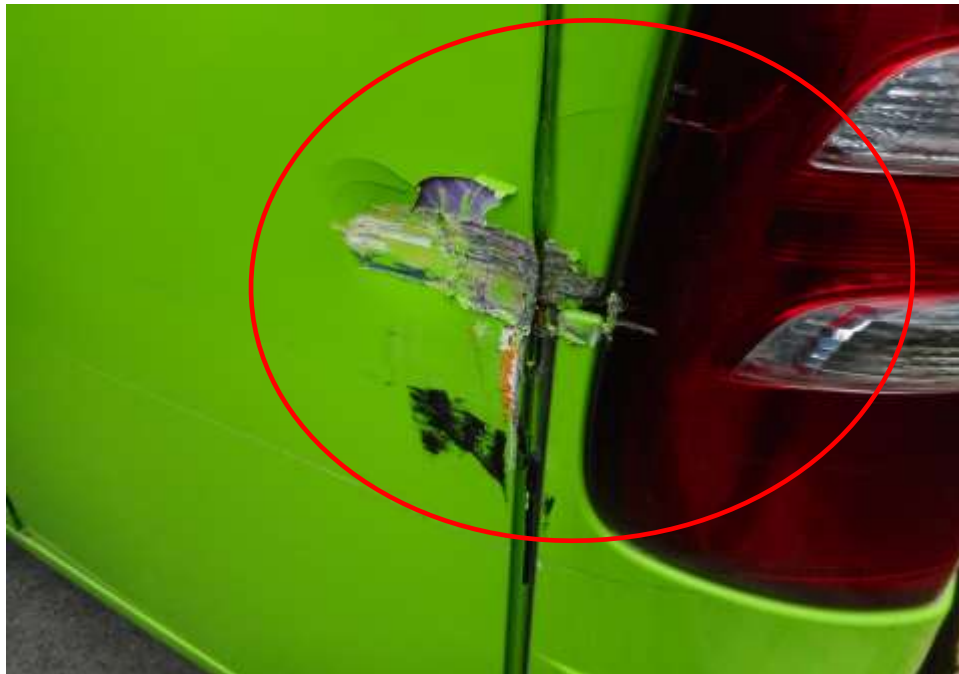
Photo 7 shows a close up view of the left rear body of the Motor Bus at the time of my inspection. Its body panel and rear left headlamp (circled) was damaged as a result of the accident.

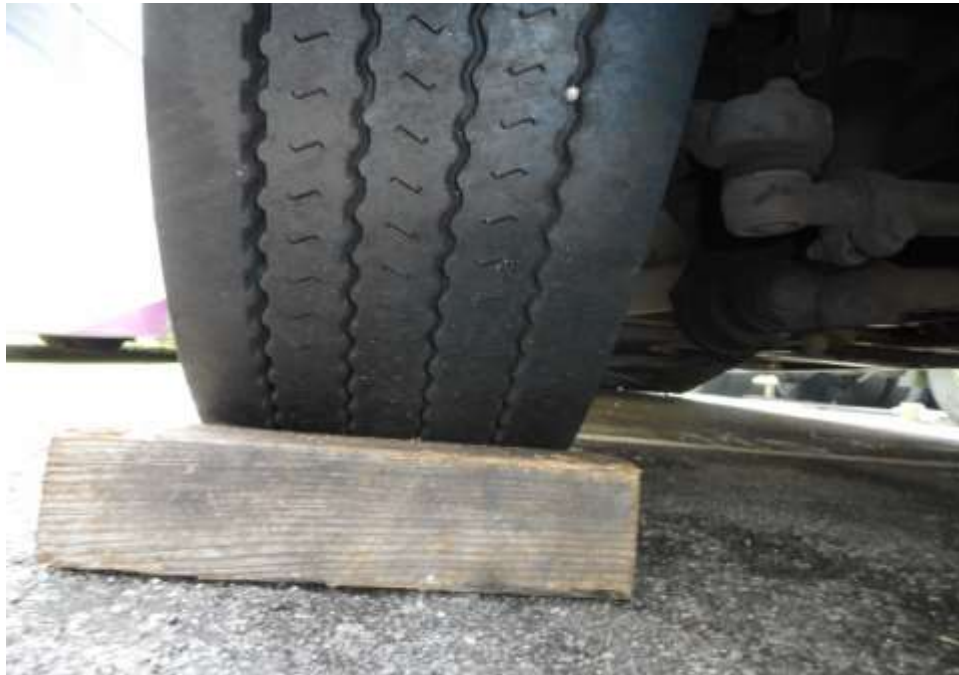
Photo 8 shows the condition of the front right tyre of the Motor Bus, which was observed to be in serviceable condition with remaining tread depth of approximately 11.7mm. The tyre, which was wrapped around standard steel wheel rim, was also observed to be sufficiently inflated for vehicular operation. There was no tear, cut or burst mark(s) on the outer and the inner sidewalls as well as across the tread of the 8 tyres that were fitted on the Motor Bus.

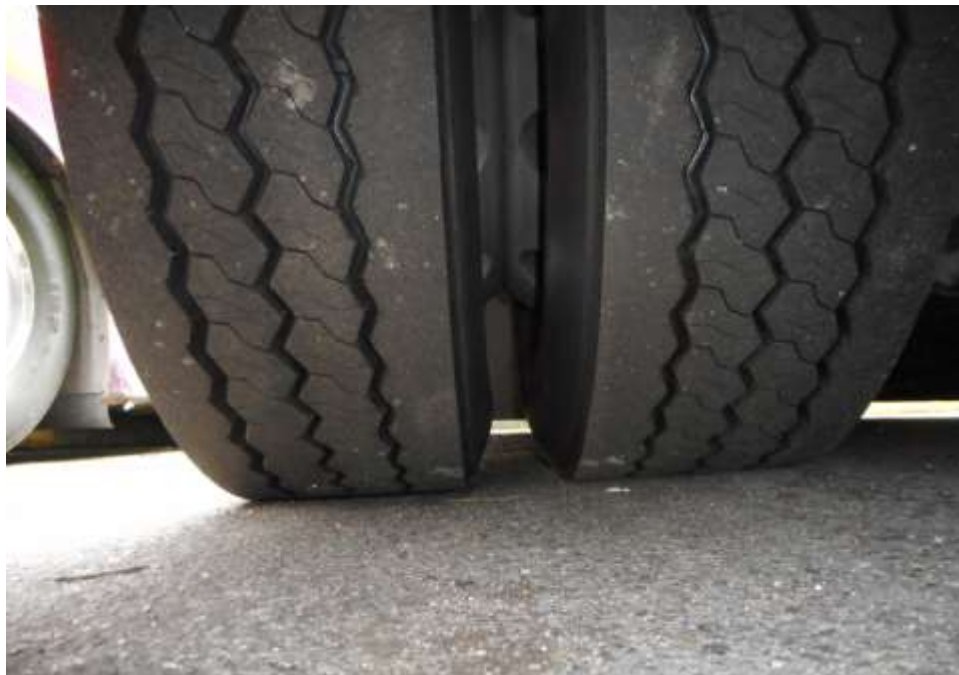
Photo 9 shows the condition of the rear right tyre of the Motor Bus, which was observed to be in serviceable condition with remaining tread depth of approximately 11.8mm. The tyre, which was wrapped around standard steel wheel rim, was also observed to be sufficiently inflated for vehicular operation.

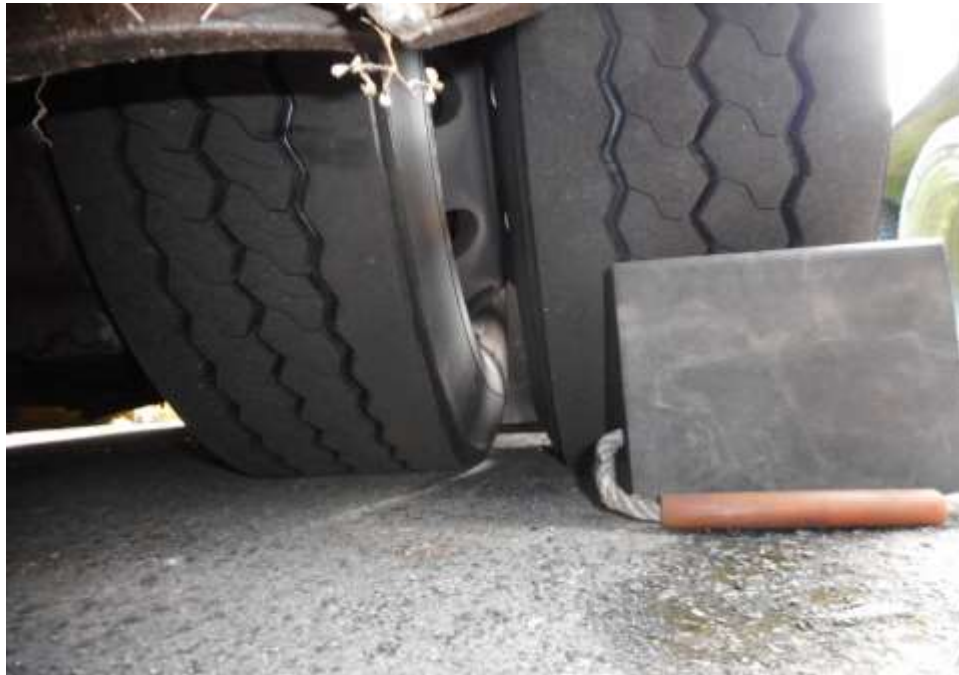
Photo 10 shows the condition of the rear left tyres of the Motor Bus, which was observed to be in serviceable condition with remaining tread depth of approximately 12.6mm. The tyres, which were wrapped around standard steel wheel rim, were also observed to be sufficiently inflated for vehicular operation. There was also no damage found on all 8 steel wheel rims of the Motor Bus.

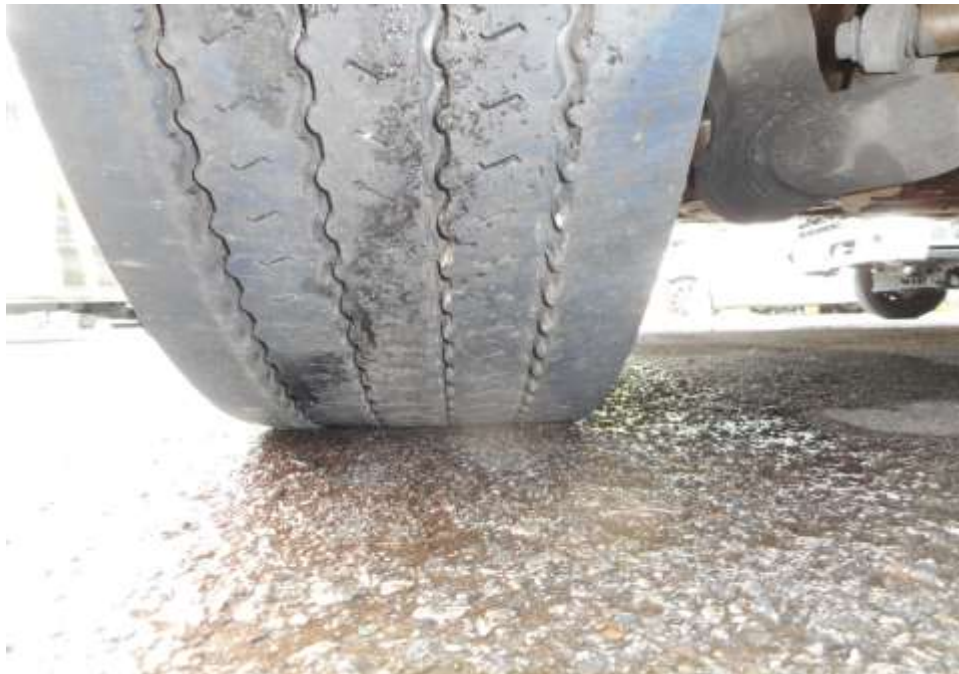
Photo 11 shows the condition of the front left tyres of the Motor Bus, which were observed to be in serviceable condition with remaining tread depth of approximately 12.3mm. There was also no tear, cut or burst mark(s) on the outer and the inner sidewalls as well as across the tread of the 8 tyres that were fitted on the Motor Bus.

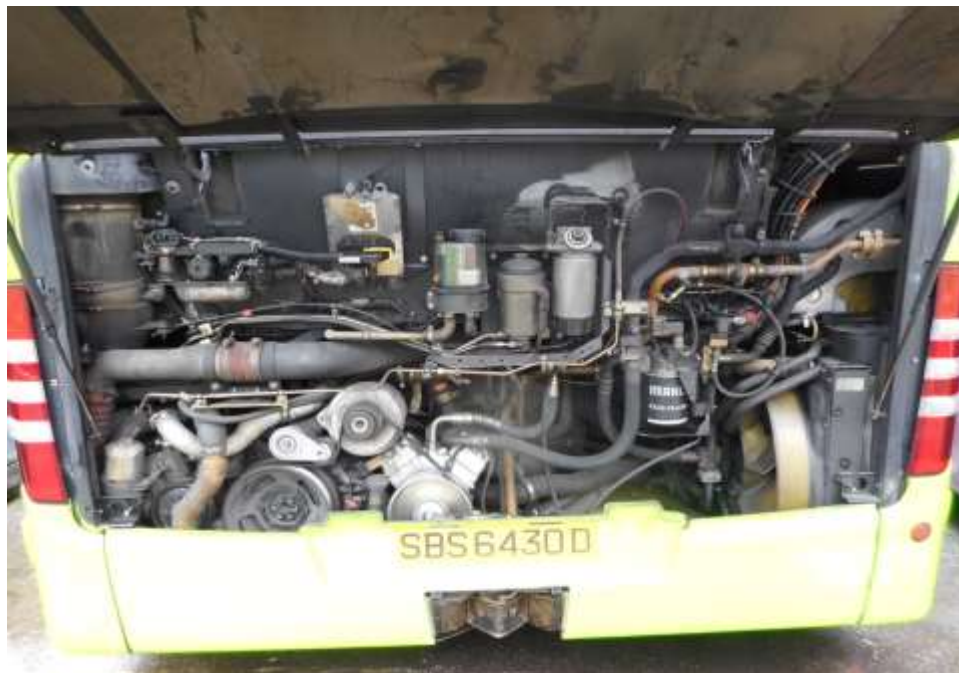
9. Further examination of the engine compartment revealed, there was no sign(s) or indication(s) of fresh fluid leakage and/or fluid stain within the engine compartment of the Motor Bus.

Photo 12 shows a general view of the Motor Bus's engine compartment, which was accessed by lifting the rear of the Motor Bus. The various parts and components inside the engine compartment were unaffected by the accident. There was also no sign(s) or indication(s) of fresh fluid leakage and/or fluid stain within the engine compartment

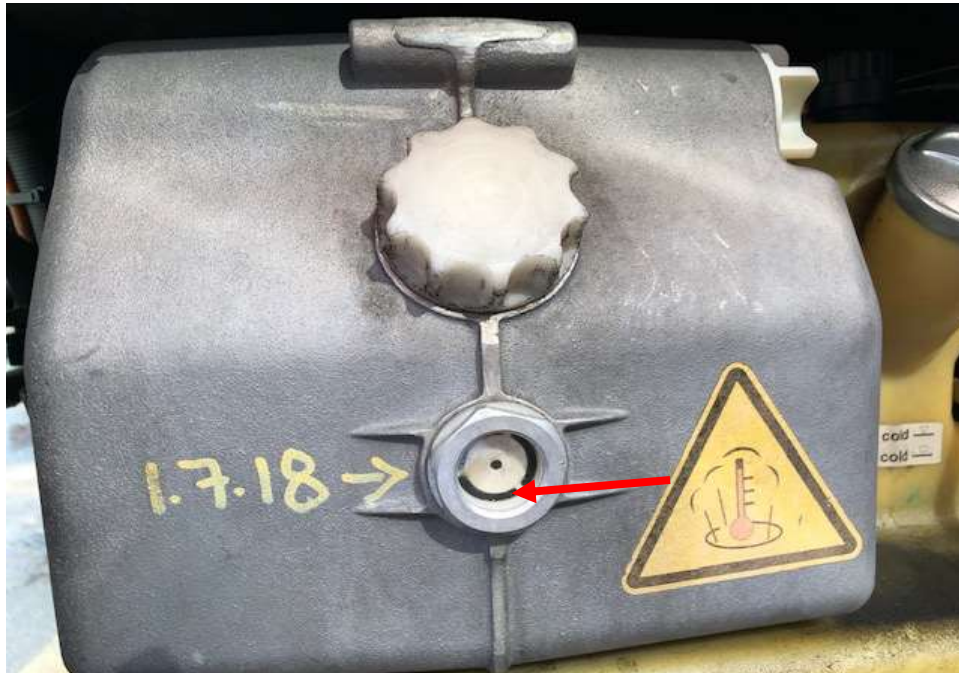
8. Upon examination of the Motor Bus's engine compartment, I had observed all the parts and components inside the engine compartment to be intact and unaffected by the accident. The engine oil was observed to be sufficient. However, the power steering fluid and the engine coolant was observed to be insufficient. The checks to the air in the air brake cylinders unable to be conducted due to the damage to the undercarriage diesel fuel hose causing a fuel leakage in which cuts the supply of fuel to the Motor Bus's engine resulting it unable to be started up to have the air compressor generating air to the air brake system of the Motor Bus.

Photo 13 shows the engine coolant reservoir of the Motor Bus at the time of my inspection. The engine coolant was observed to be of insufficient level (arrowed).

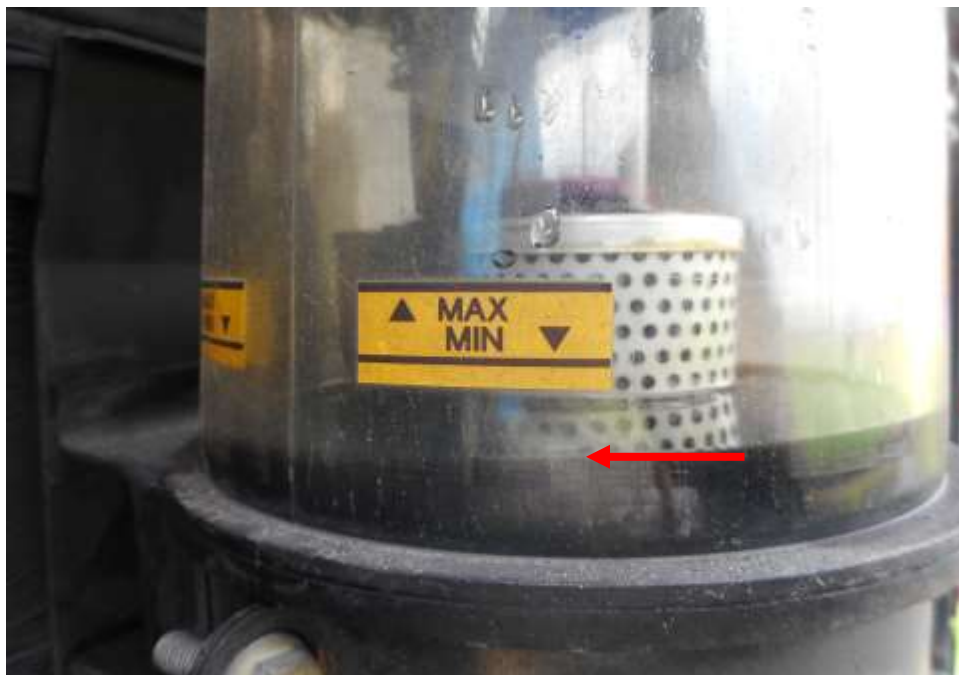
Photo 14 shows the power steering fluid reservoir of the Motor Bus at the time of my inspection. The power steering fluid was observed to be of insufficient level (arrowed).

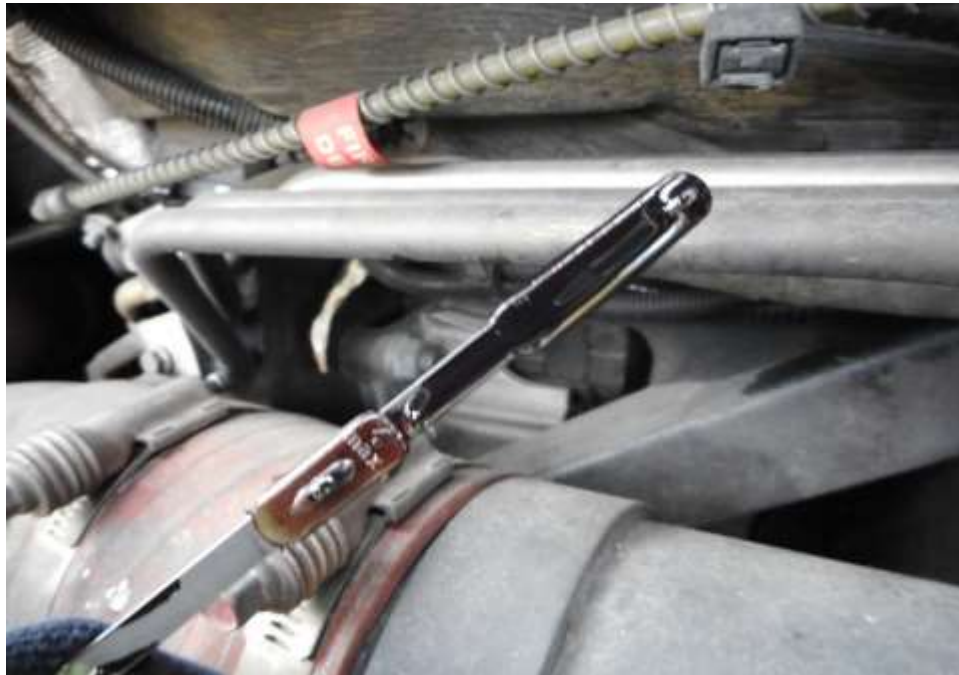
Photo 15 shows the engine oil dip stick system of the Motor Bus at the time of inspection. The engine oil was observed to be of sufficient level for operation and without any visible contamination.

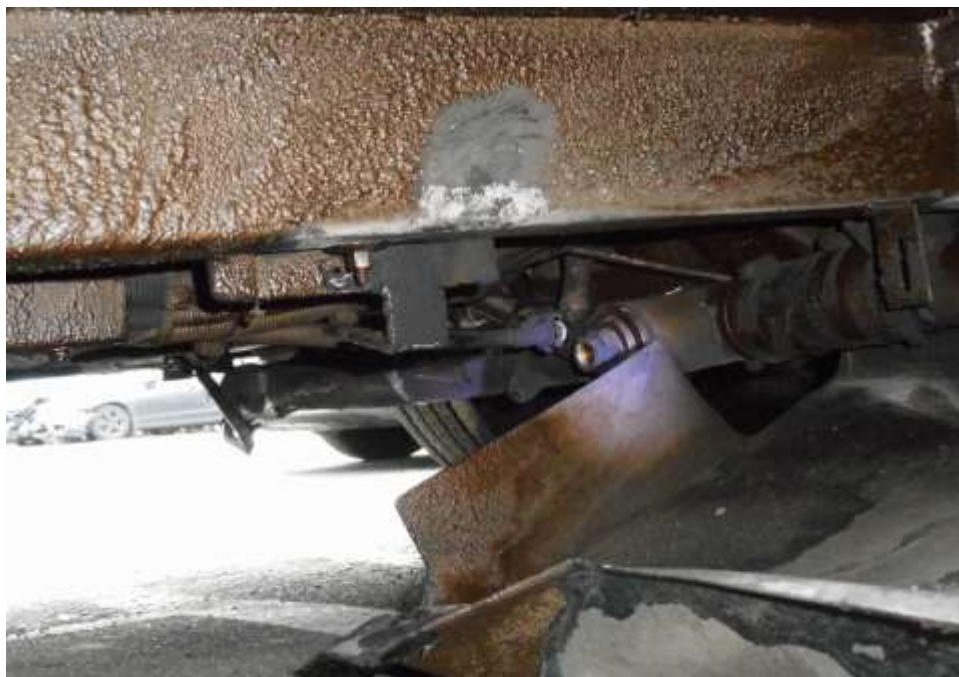
10. My subsequent checks on the underside of the Motor Bus also revealed the various undercarriage diesel fuel hose of the Motor Bus were damaged as a result of the accident. See photo 12 – 16 below.

Photo 16 shows the undercarriage diesel fuel hose of the Motor Bus at the time of inspection. The fuel hose was observed to be damaged as a result of the accident.

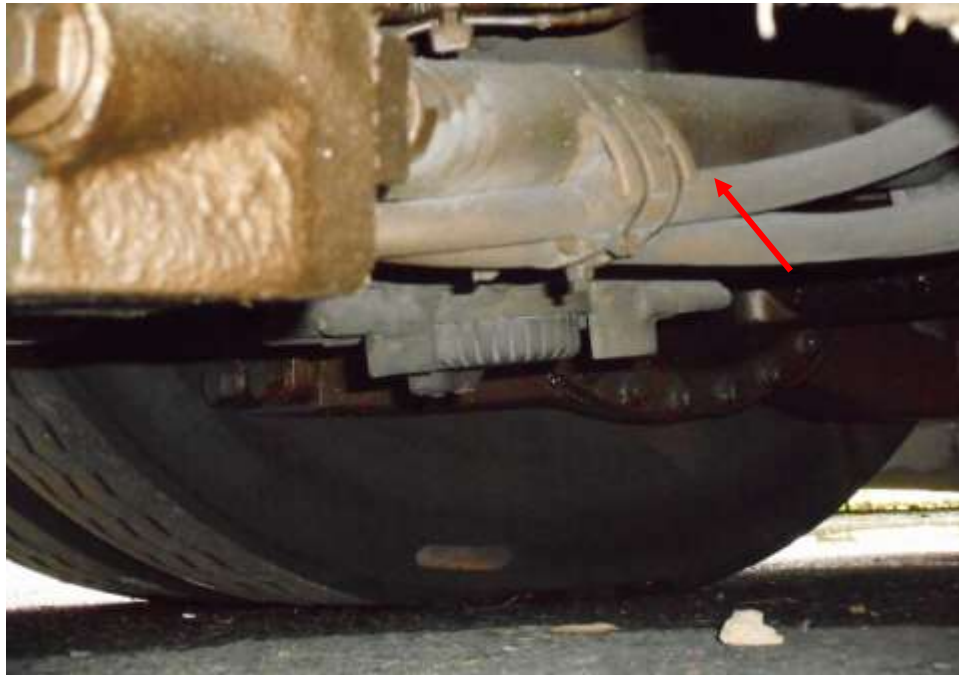
Photo 17 shows the brake pipe (arrowed) at the rear right wheel of the Motor Bus. The braking components were observed to be intact at the time of my inspection of the Motor Bus.

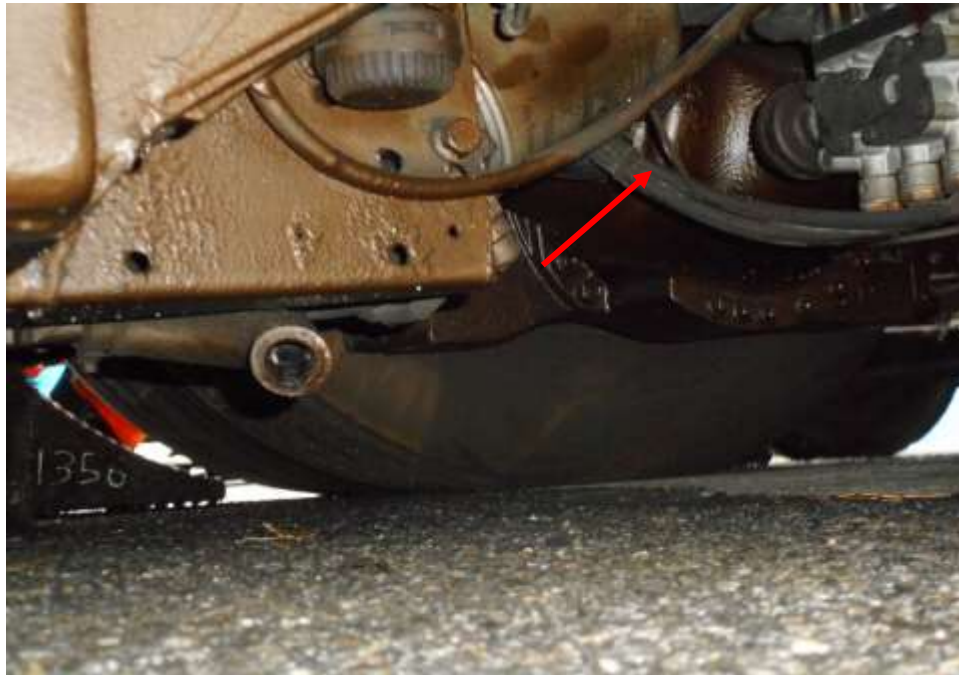
Photo 18 shows the brake pipe (arrowed) at the rear left wheel of the Motor Bus. The braking components were observed to be intact at the time of my inspection of the Motor Bus.

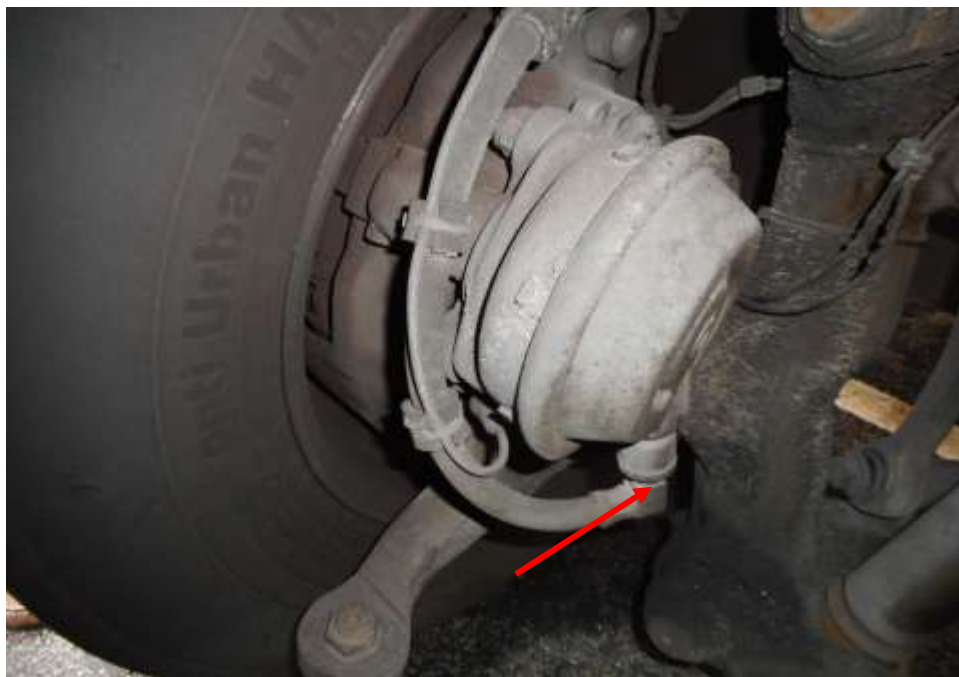
Photo 19 shows the brake pipe (arrowed) at the front right wheel of the Motor Bus. The braking components were observed to be intact at the time of my inspection of the Motor Bus.

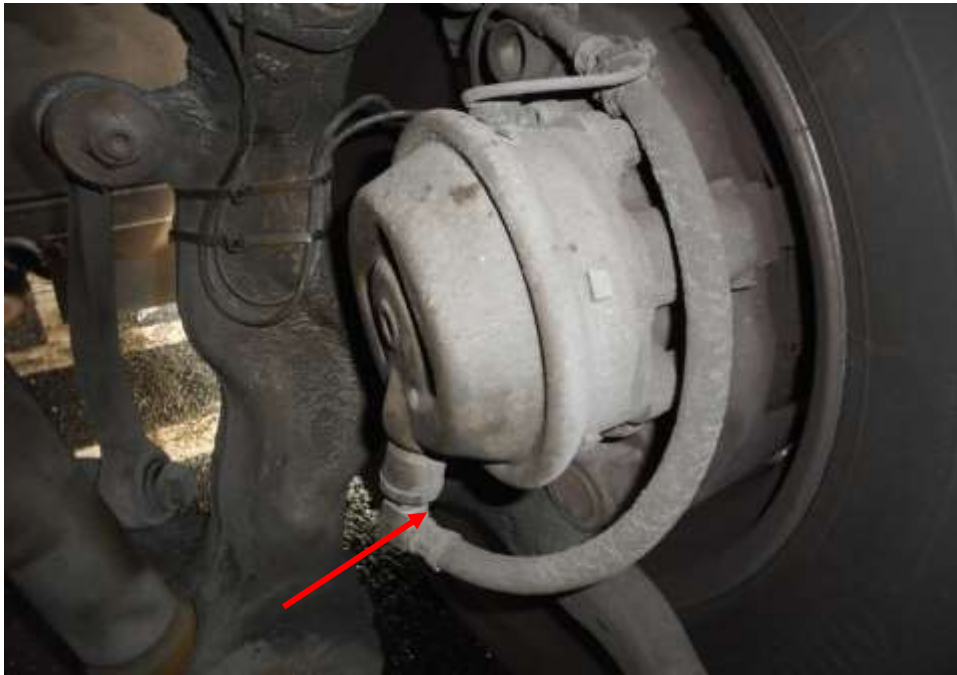
Photo 20 shows the brake pipe (arrowed) at the front left wheel of the Motor Bus. The braking components were observed to be intact at the time of my inspection of the Motor Bus.

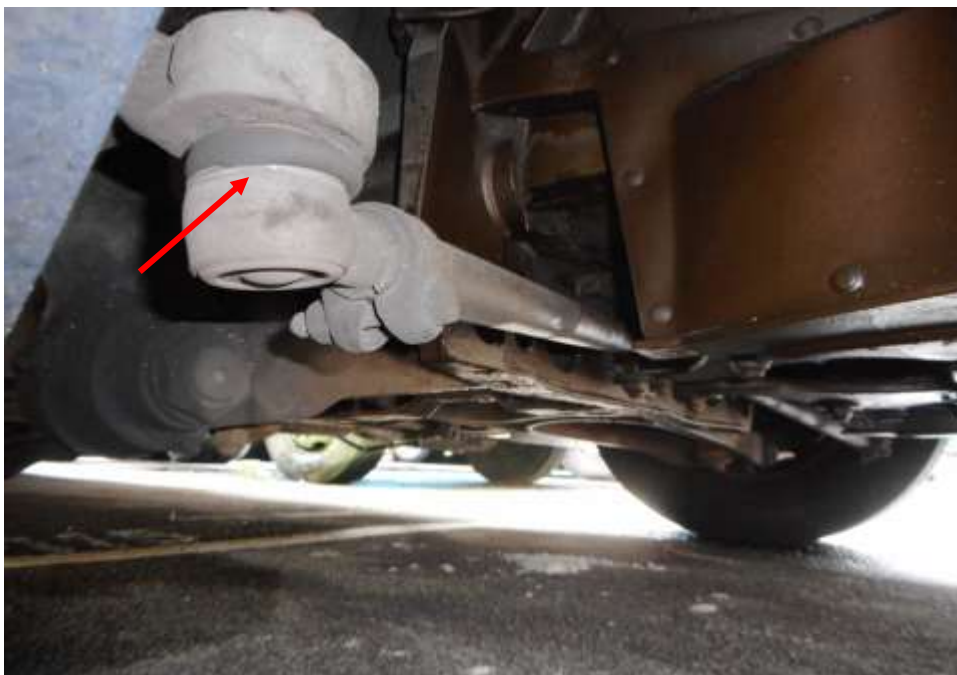
Photo 21 shows the various undercarriage components at the front right wheel of the Motor Bus, in particular the steering tie rod end (arrowed). The various steering components were all found to be intact without any visible damage. There was also no sign of fluid stain(s) observed on the various undercarriage components.

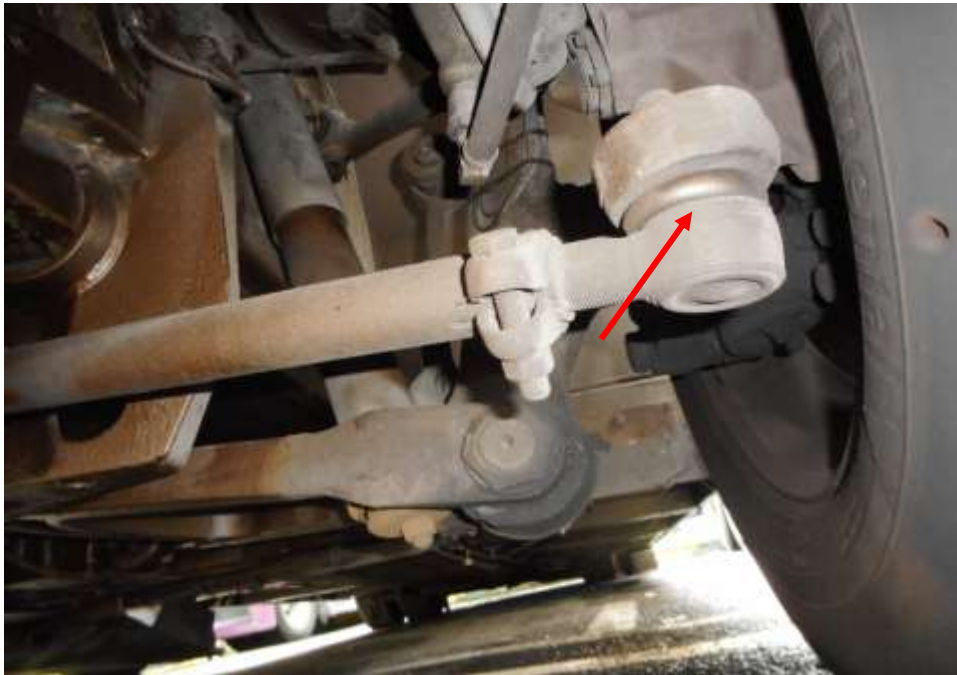
Photo 22 shows the various undercarriage components at the front left wheel of the Motor Bus, in particular the steering tie rod end (arrowed). The various undercarriage components of the Motor Bus were all found to be intact without any visible damage. There was also no sign of fluid stain(s) observed on the various undercarriage components.

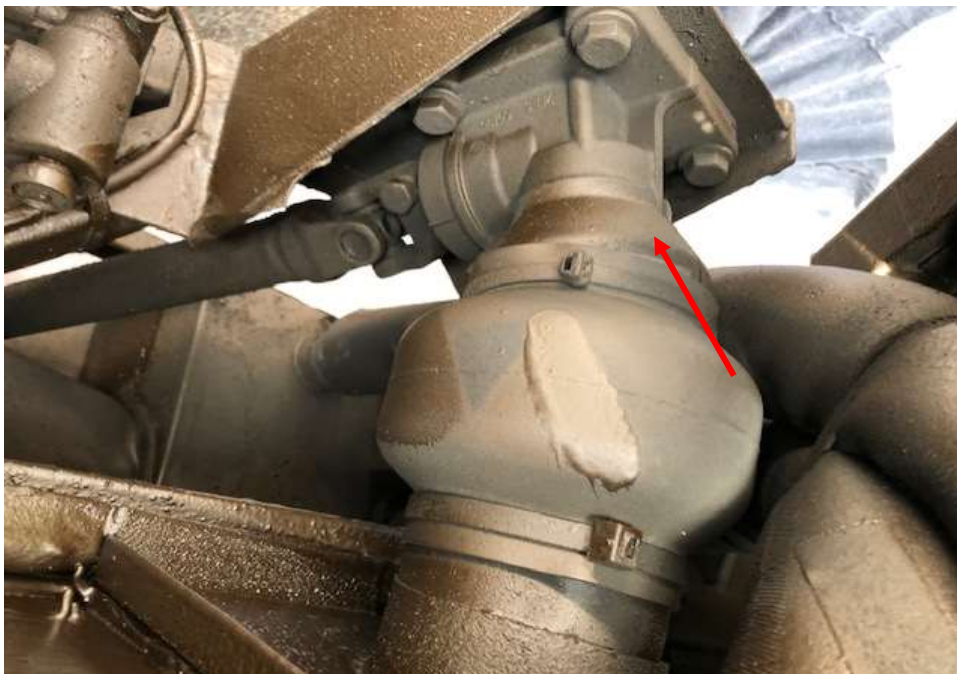
Photo 23 shows the steering box component (arrowed) at the undercarriage of the Motor Bus was found to be intact without any visible damage. There was also no sign of fluid stain(s) observed on the various undercarriage components.
