Your Ref: TP/IP/66937/2019  
Our Ref : CI/TPD19020445/P

**Fatal Accident Investigation Team**

**MECHANICAL INSPECTION REPORT OF MOTOR BUS SMB 3591B**

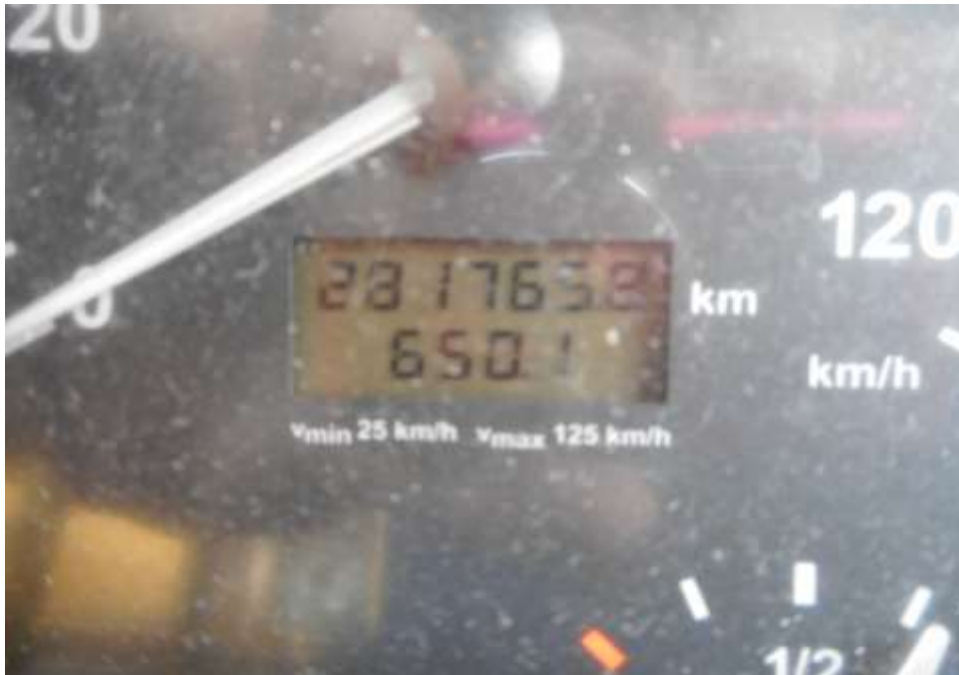
4. The mileage of the Motor Bus at the time of my inspection was 281,765km.
5. There was no visible damage observed on the Motor Bus at the time of my inspection.

**Photo 1** shows a general view of the instrument cluster of the Motor Bus at the time of my inspection. The mileage of the Motor Bus was 281,765km

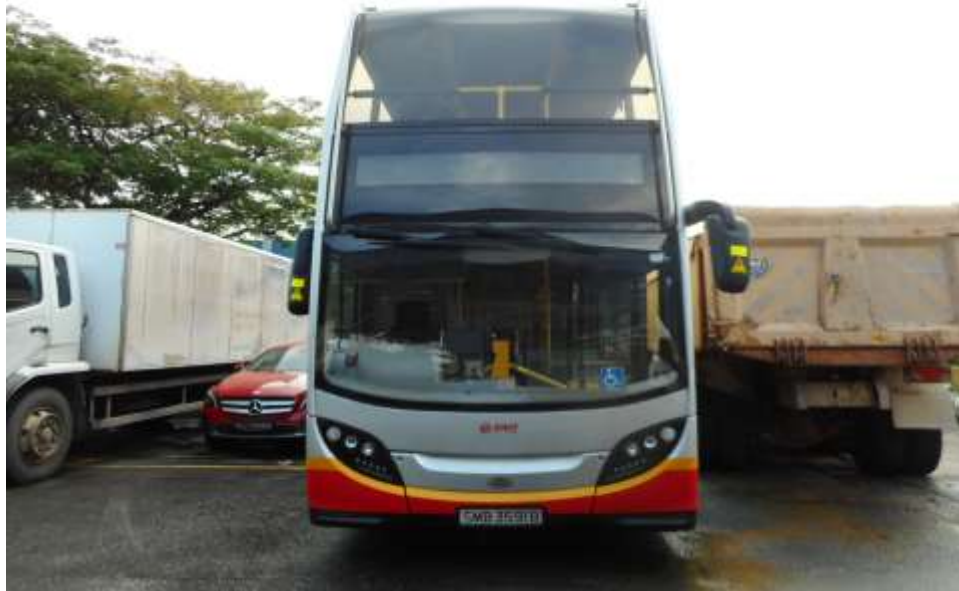
**Photo 2** shows a general view of the front body of the Motor Bus at the time of my inspection. The Motor Bus was observed to be intact and unaffected by the accident.

14. A short operational test to the Motor Bus, to primarily determine whether there was any abnormality to its various operating systems like its engine system, its transmission system, steering system and braking system was subsequently carried out. The test was conducted by driving the Motor Bus forward, stopping, before reversing and coming to a stop again.
15. During the operational test, the various transmission gears of the Motor Bus were able to be engaged without any difficulty by stepping on the clutch pedal and manually shifting the gear lever. There were no abnormal sounds heard and/or abnormal behaviour of the Motor Bus's engine system. It was able to move forward and backward normally. The braking system was also found to be in working condition as the Motor Bus was able to slow down and come to a complete stop upon depressing of the brake pedal. Refer to photo 2 and 24.

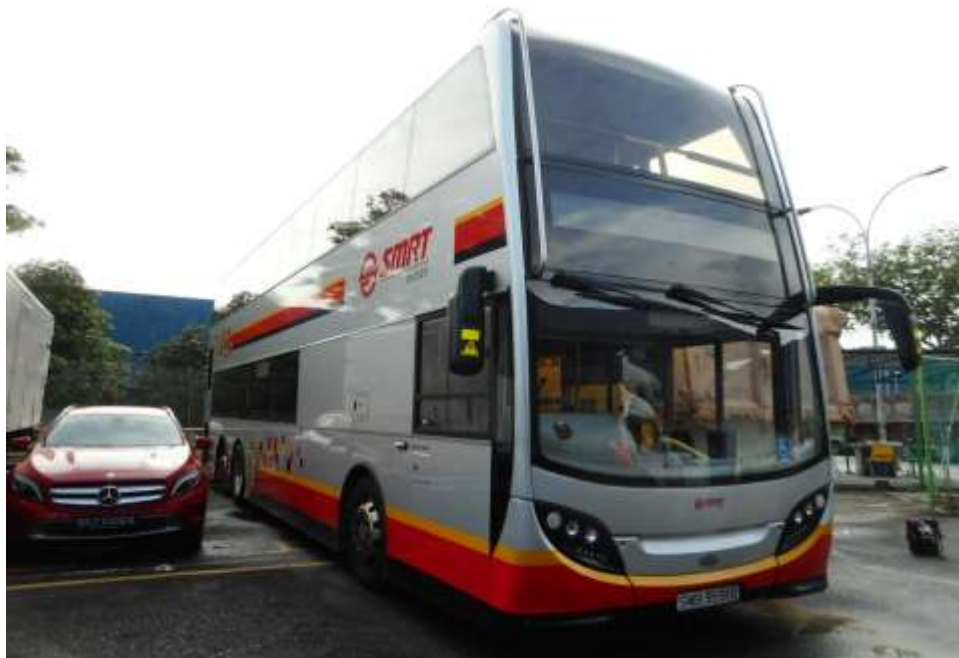
**Photo 3** shows a general view of the right body of the Motor Bus at the time of my inspection. The Motor Bus was observed to be intact and unaffected by the accident.

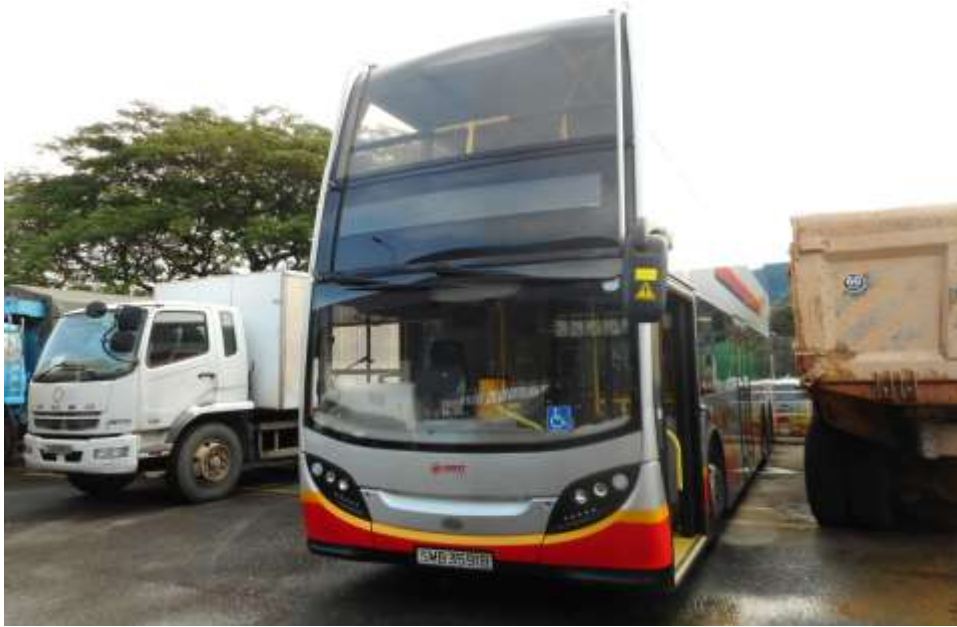
**Photo 4** shows a general view of the left body of the Motor Bus at the time of my inspection. The Motor Bus was observed to be intact and unaffected by the accident.

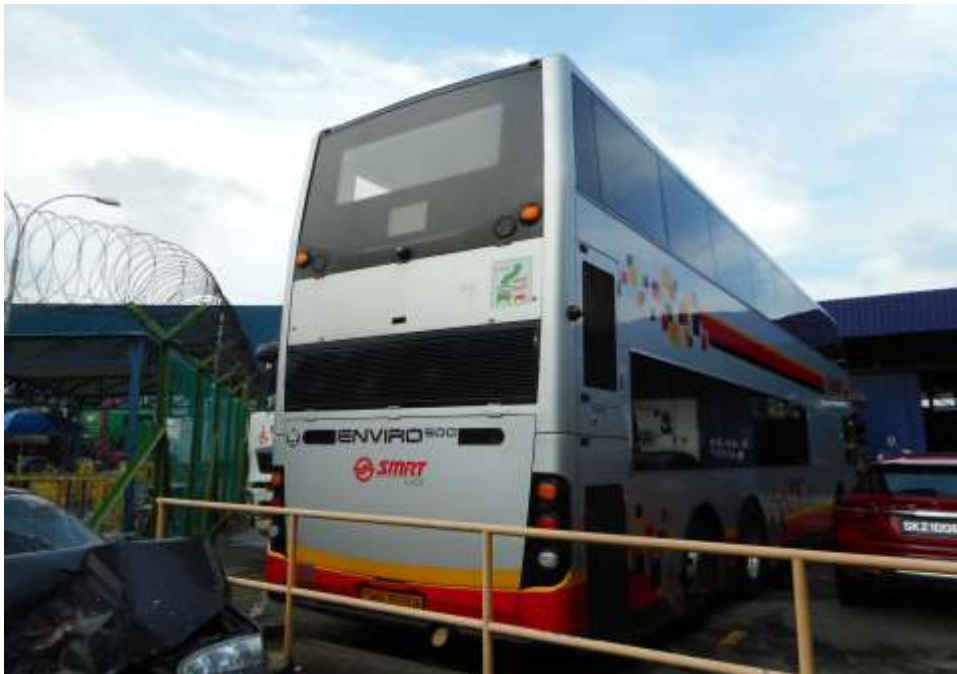
**Photo 5** shows a general view of the Motor Bus's rear body at the time of my inspection. The Motor Bus was observed to be intact and unaffected to by the accident.

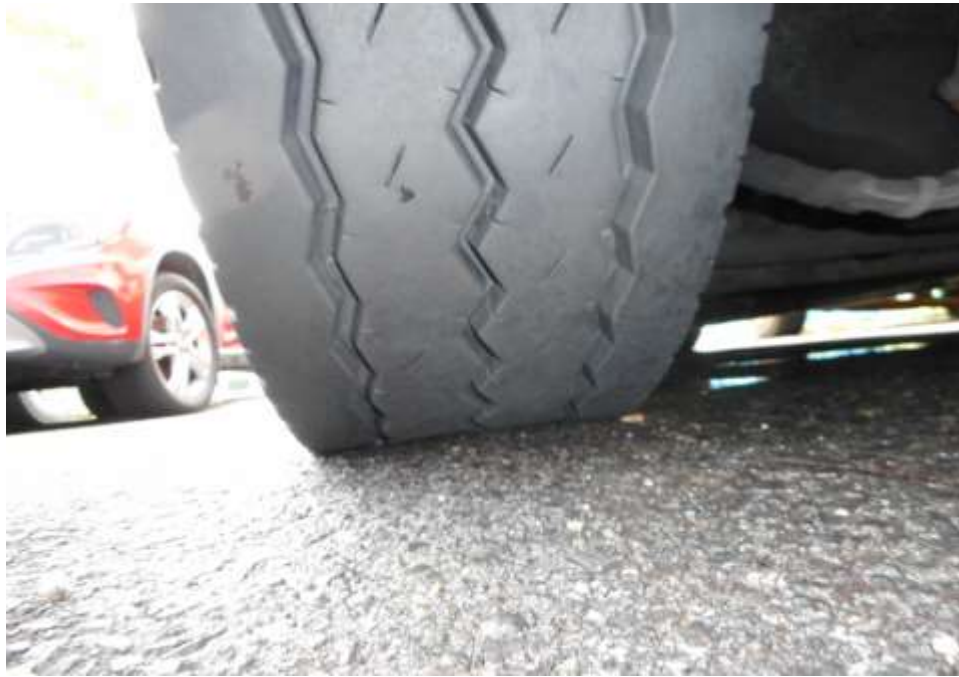
**Photo 6** shows the condition of the front right tyre of the Motor Bus, which was observed to be in serviceable condition with remaining tread depth of approximately 11mm. The tyre, which was wrapped around standard steel wheel rim, was also observed to be sufficiently inflated for vehicular operation. There was no tear, cut or burst mark(s) on the outer and the inner sidewalls as well as across the tread of the 10 tyres that were fitted on the Motor Bus.

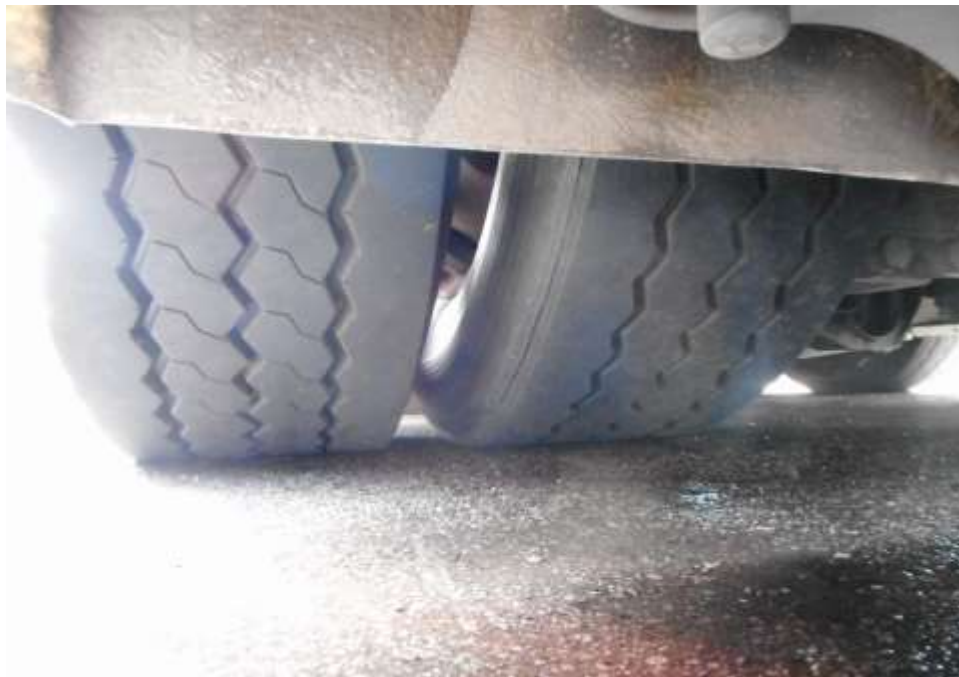
**Photo 7** shows the condition of the rear right tyre of the Motor Bus, which was observed to be in serviceable condition with remaining tread depth of approximately 10.6mm. The tyre, which was wrapped around standard steel wheel rim, was also observed to be sufficiently inflated for vehicular operation.

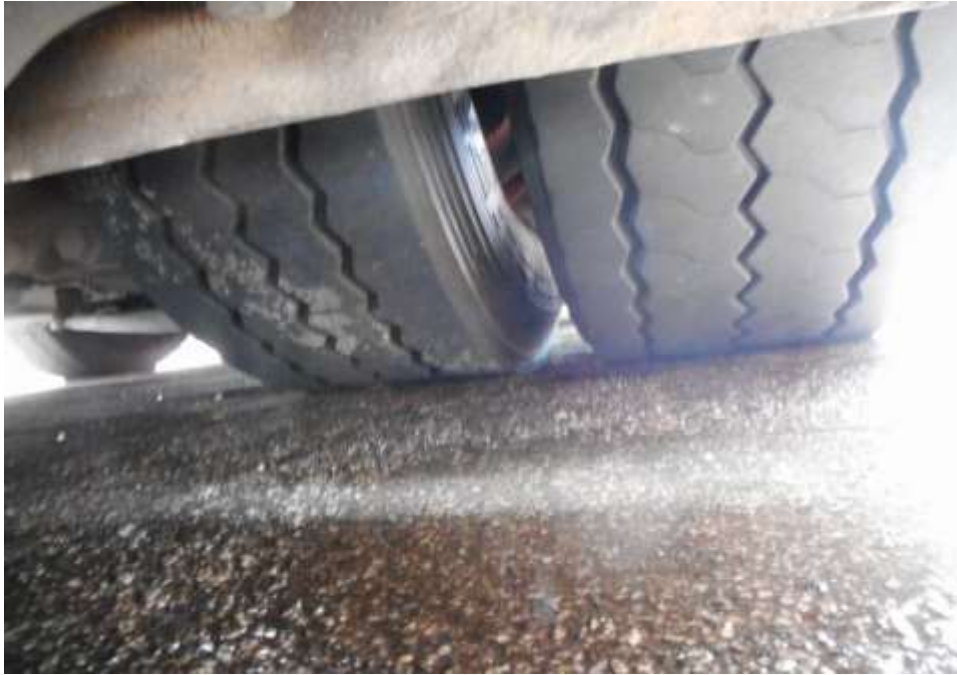
**Photo 8** shows the condition of the rear left tyres of the Motor Bus, which was observed to be in serviceable condition with remaining tread depth of approximately 9.5mm. The tyres, which were wrapped around standard steel wheel rim, were also observed to be sufficiently inflated for vehicular operation. There was also no damage found on all 10 steel wheel rims of the Motor Bus.

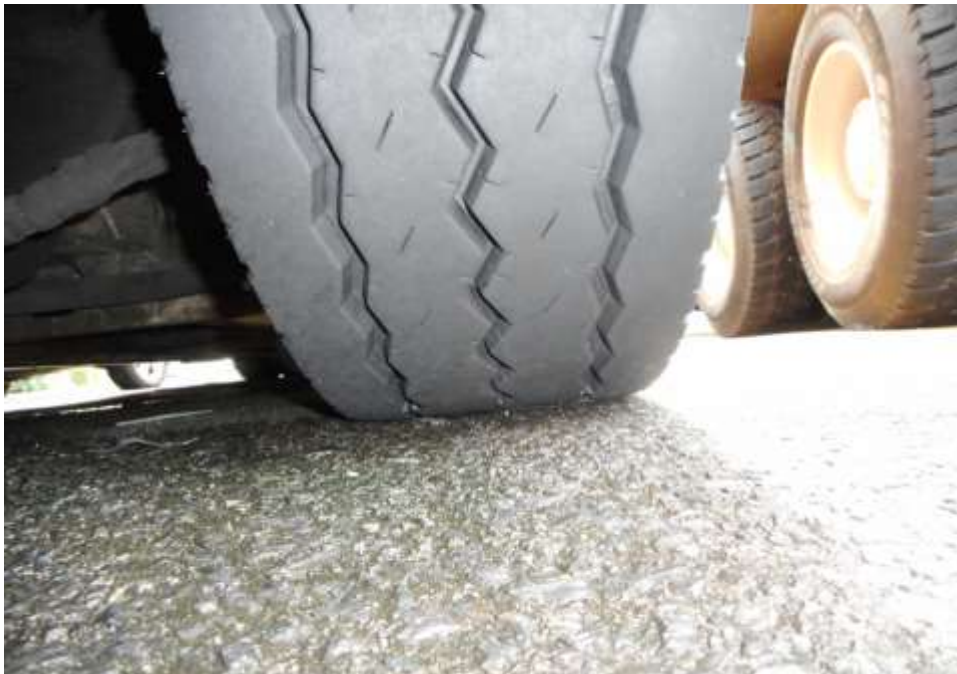
**Photo 9** shows the condition of the front left tyres of the Motor Bus, which were observed to be in serviceable condition with remaining tread depth of approximately 10.8mm. There was also no tear, cut or burst mark(s) on the outer and the inner sidewalls as well as across the tread of the 10 tyres that were fitted on the Motor Bus.

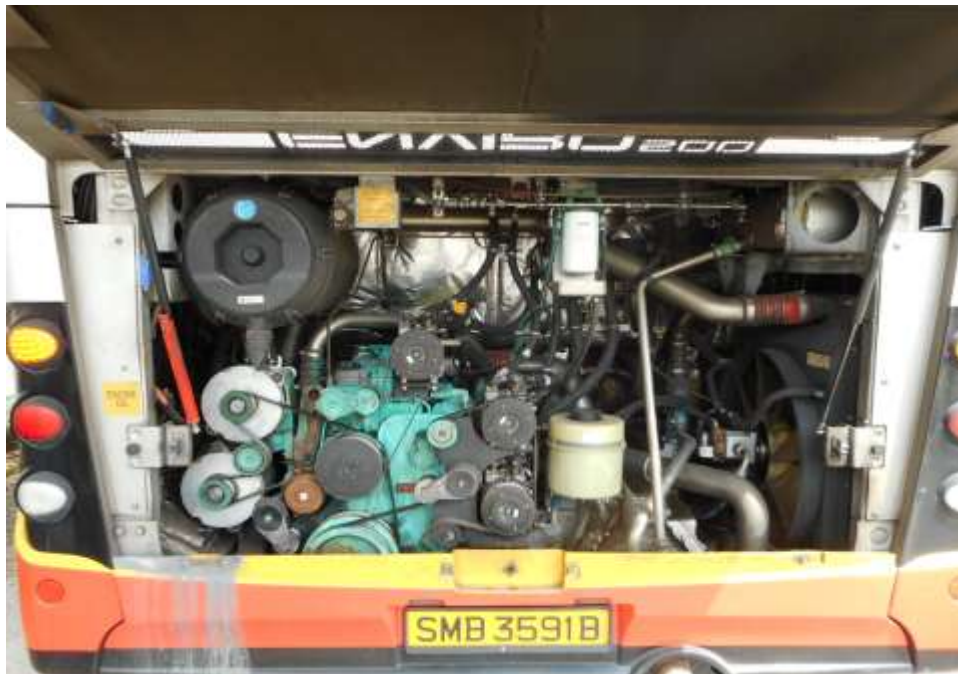
**Photo 10** shows a general view of the Motor Bus's engine compartment, which was accessed by lifting the rear of the Motor Bus. The various parts and components inside the engine compartment were unaffected by the accident. There was also no sign(s) or indication(s) of fresh fluid leakage and/or fluid stain within the engine compartment

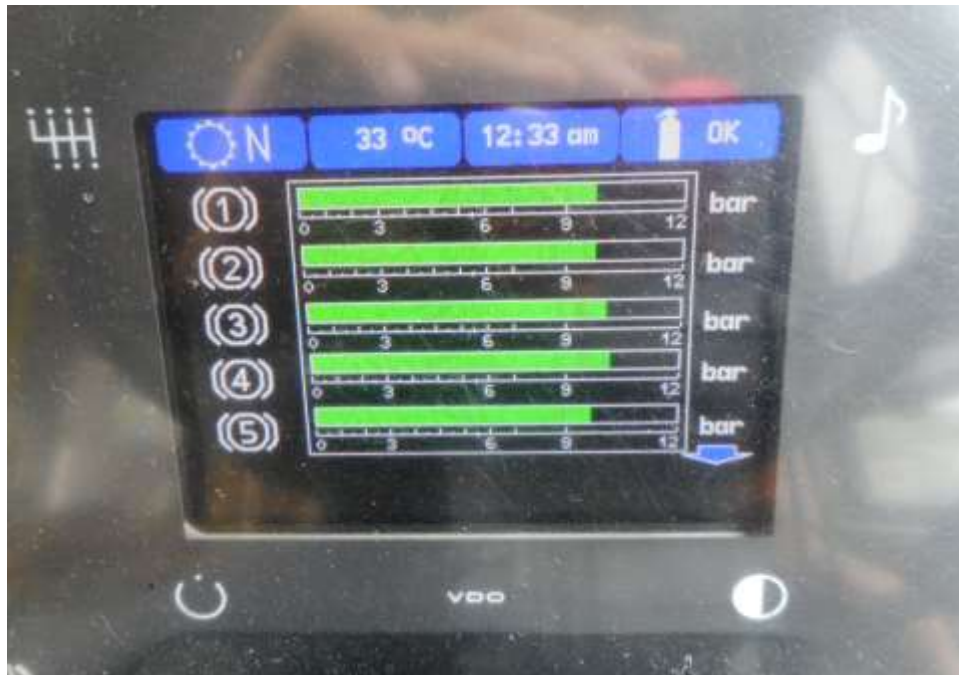
**Photo 11** shows the air in the air brake cylinder of the Motor Bus at the time of my inspection. The air in the cylinder was observed to be of sufficient level & serviceable at the time of the accident.

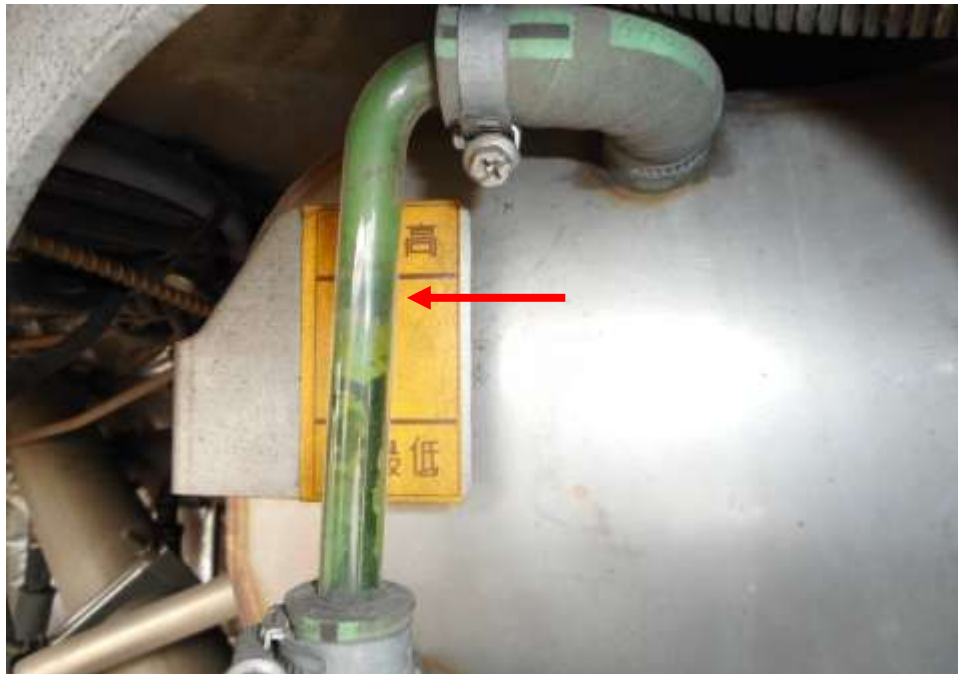
**Photo 12** shows the engine coolant reservoir of the Motor Bus at the time of my inspection. The engine coolant was observed to be of sufficient level (arrowed) and without any visible contamination.

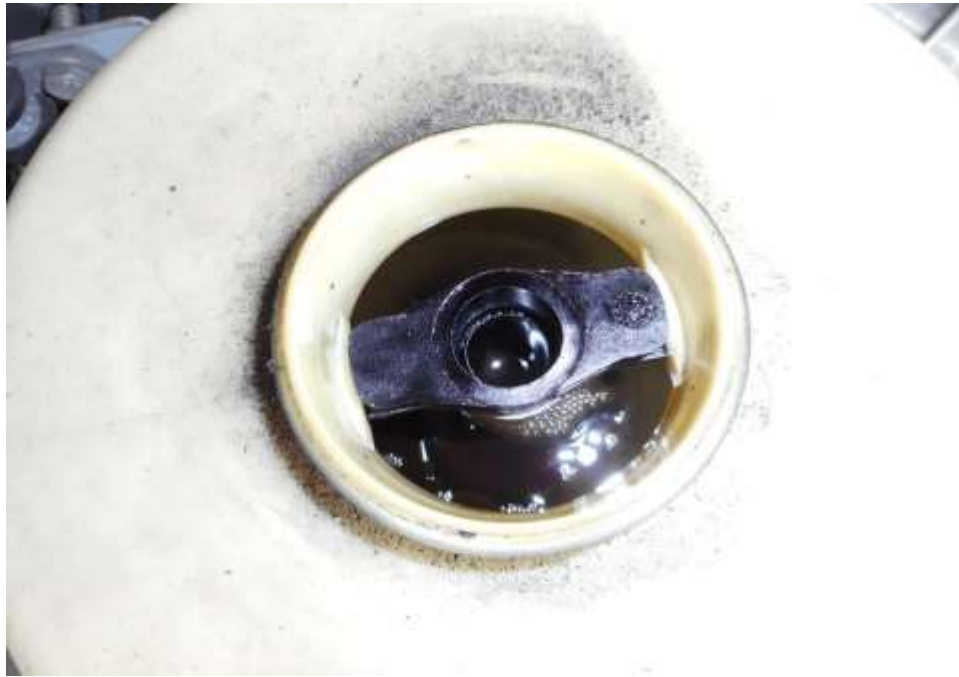
**Photo 13** shows the power steering fluid reservoir of the Motor Bus at the time of my inspection. The power steering fluid was observed to be of sufficient level and without any visible contamination.

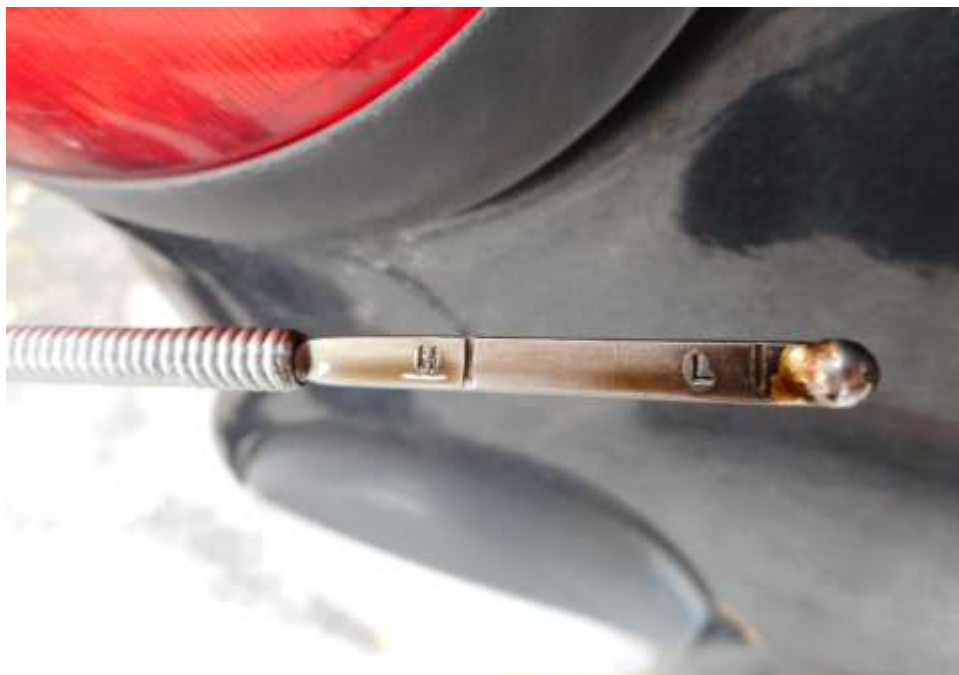
**Photo 14** shows the engine oil dip stick system of the Motor Bus at the time of my inspection. The engine oil was observed to be sufficient for operation and without any visible contamination.

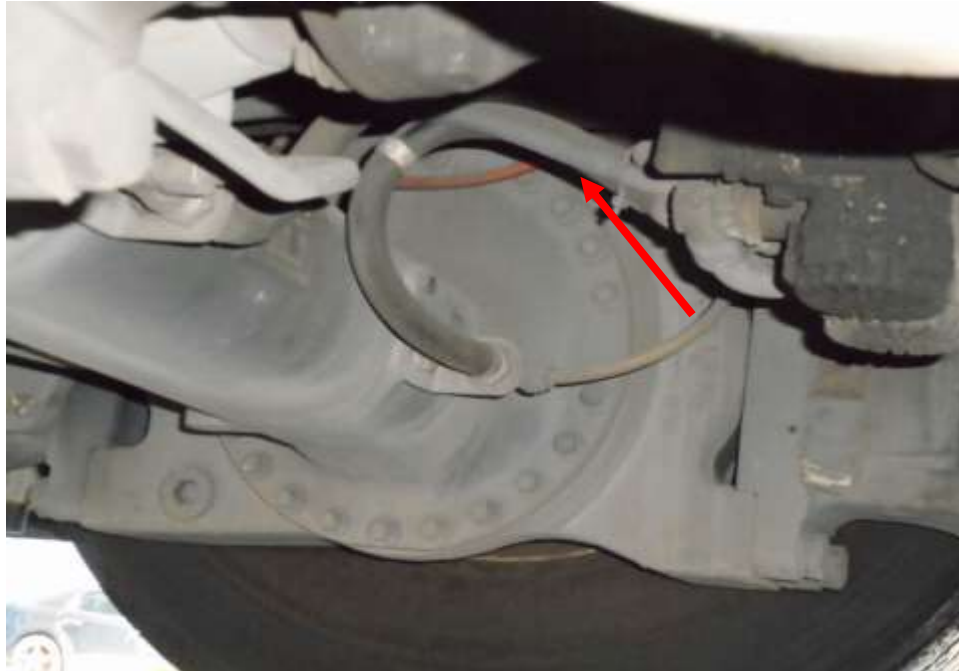
**Photo 15** shows the brake pipe (arrowed) at the rear right wheel of the Motor Bus. I did not observe any leakage of brake fluid at the time of my inspection of the Motor Bus. My static tests of the Motor Bus's braking system, along with my visual examination of the various mechanical components in the braking system, had indicated that there was no internal leakage of pressure/vacuum. Hence the braking system of the Motor Bus was likely to be in serviceable condition at the material time of accident.

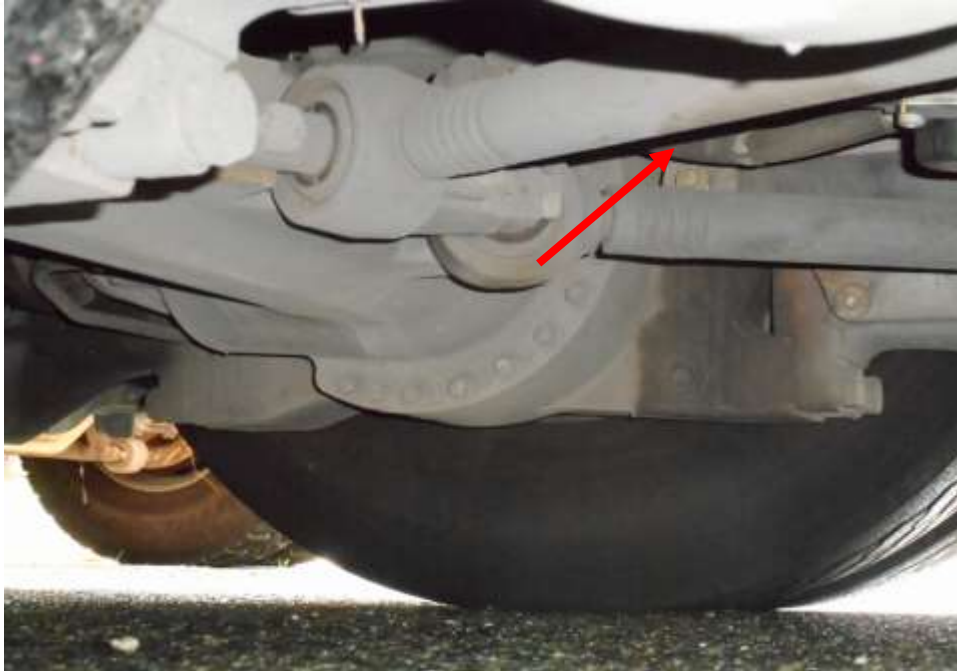
**Photo 16** shows the brake pipe (arrowed) at the rear left wheel of the Motor Bus. I did not observe any leakage of brake fluid at the time of my inspection of the Motor Bus. My static tests of the Motor Bus's braking system, along with my visual examination of the various mechanical components in the braking system, had indicated that there was no internal leakage of pressure/vacuum. Hence the braking system of the Motor Bus was likely to be in serviceable condition at the material time of accident.

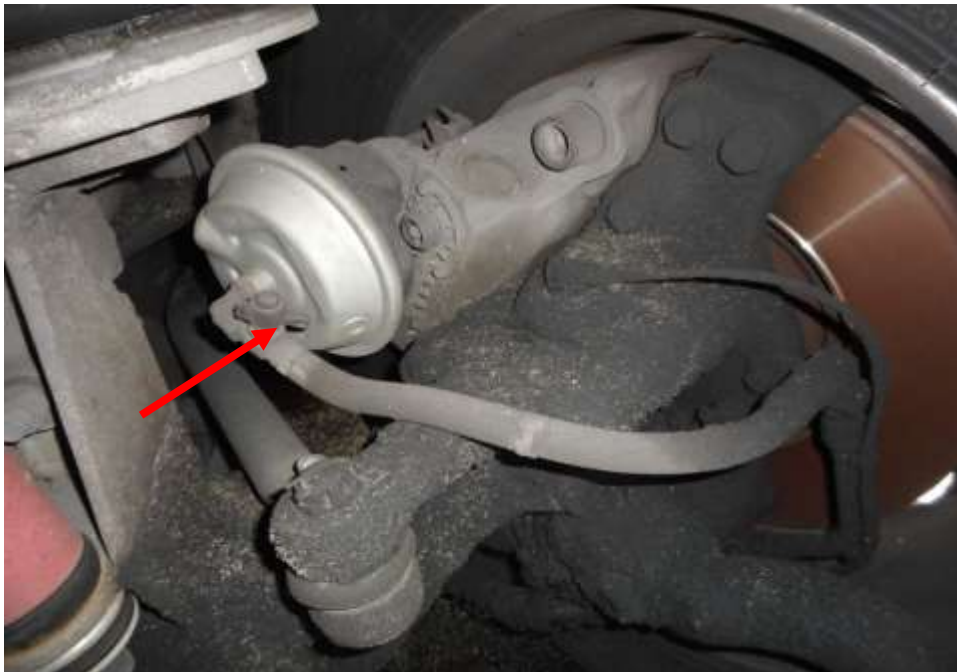
**Photo 17** shows the brake pipe (arrowed) at the front right wheel of the Motor Bus. I did not observe any leakage of brake fluid at the time of my inspection of the Motor Bus. My static tests of the Motor Bus's braking system, along with my visual examination of the various mechanical components in the braking system, had indicated that there was no internal leakage of pressure/vacuum. Hence the braking system of the Motor Bus was likely to be in serviceable condition at the material time of accident.

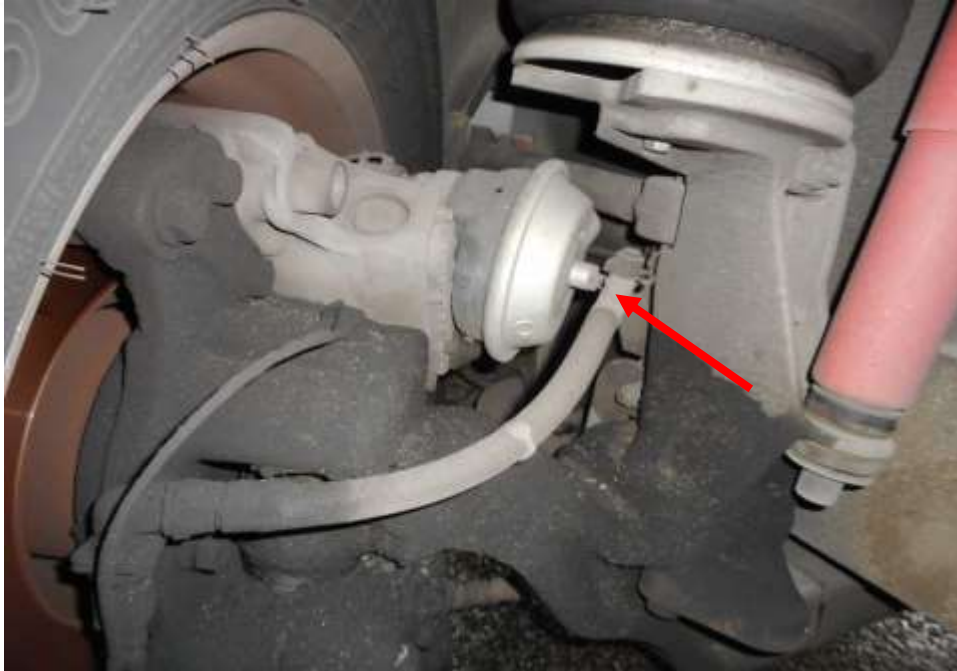
**Photo 18** shows the brake pipe (arrowed) at the front left wheel of the Motor Bus. I did not observe any leakage of brake fluid at the time of my inspection of the Motor Bus. My static tests of the Motor Bus's braking system, along with my visual examination of the various mechanical components in the braking system had indicated that there was no internal leakage of pressure/vacuum. Hence the braking system of the Motor Bus was likely to be in serviceable condition at the material time of accident.

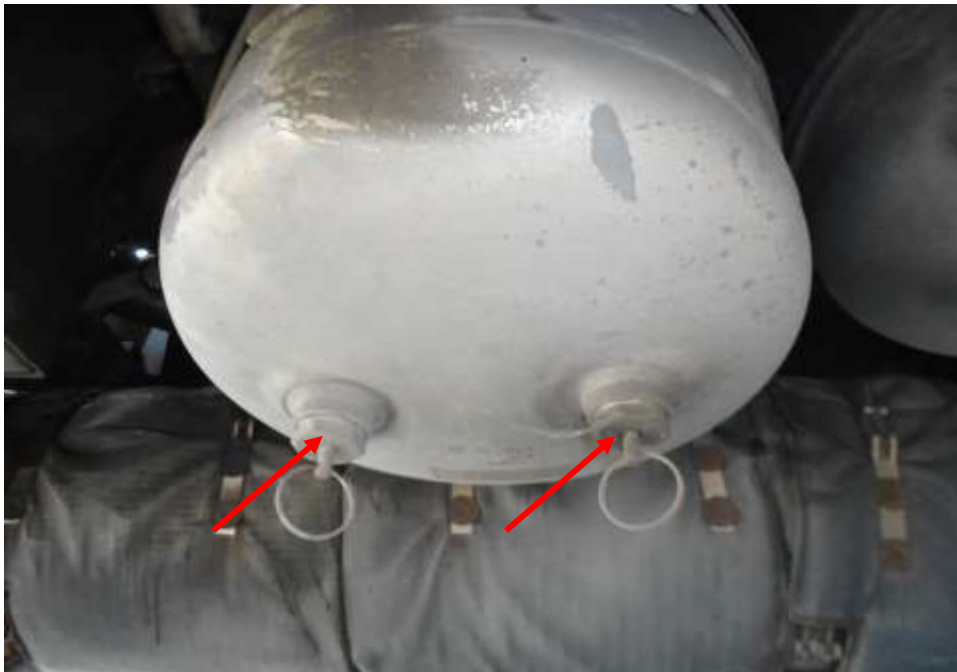
**Photo 19** shows the air brake cylinder (arrowed) at the undercarriage of the Motor Bus. I did not observe any leakage of air brake fluid at the time of my inspection of the Motor Bus. My static tests of the Motor Bus's braking system, along with my visual examination of the various mechanical components in the braking system had indicated that there was no internal leakage of pressure/vacuum. Hence the braking system of the Motor Bus was likely to be in serviceable condition at the material time of accident.

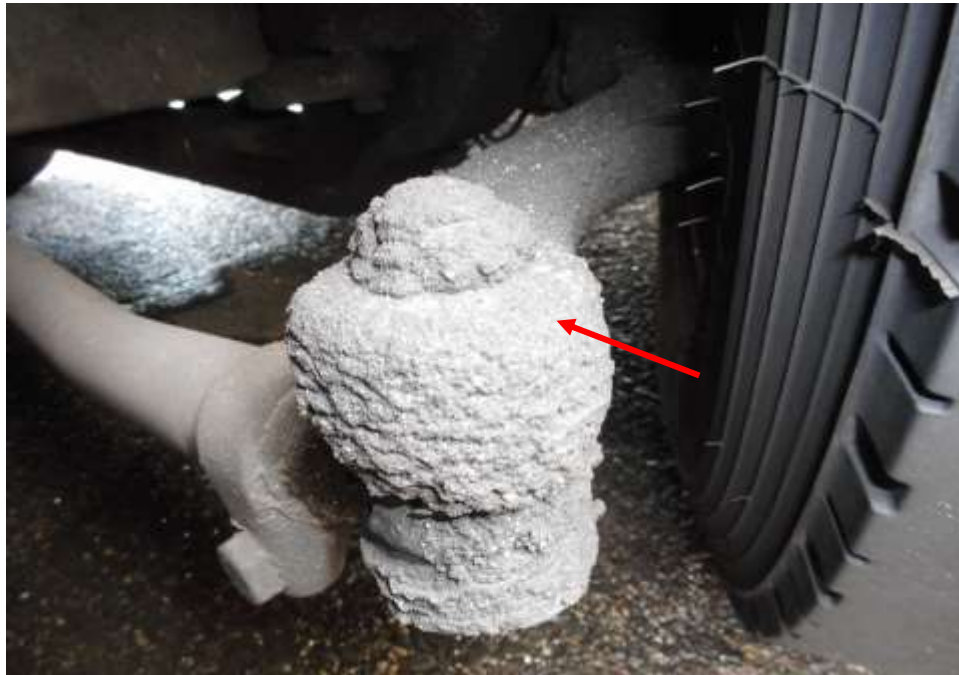
**Photo 20** shows the various undercarriage components at the front right wheel of the Motor Bus, in particular the steering tie rod end (arrowed). The various steering components were all found to be intact, suggesting that the steering system of the Motor Bus was likely to be in serviceable condition at the material time of accident. There was also no sign of fluid stain(s) observed on the various undercarriage components.

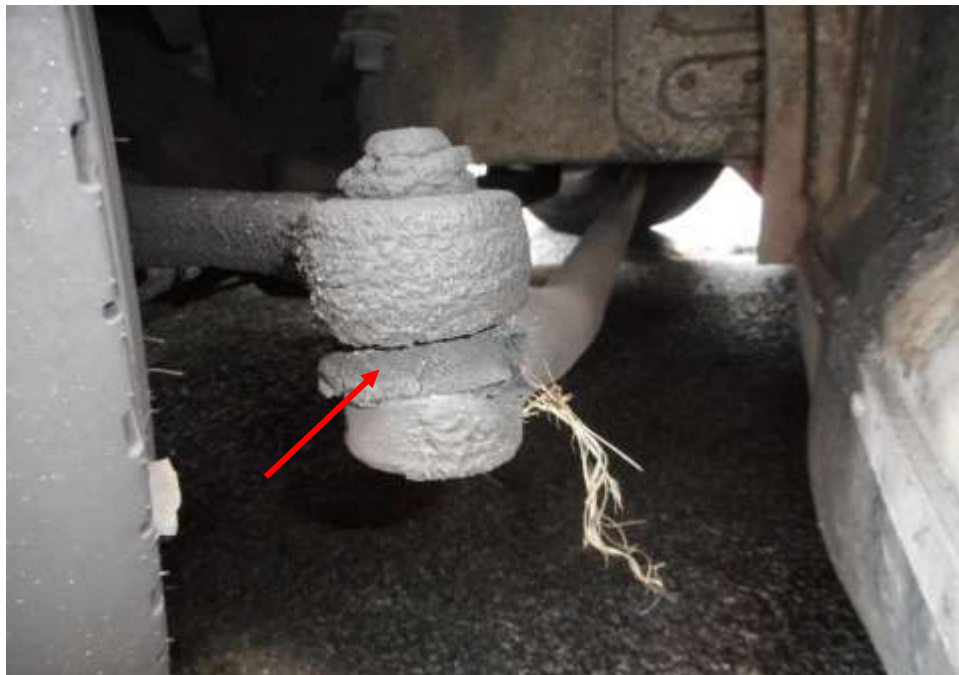
**Photo 21** shows the various undercarriage components at the front left wheel of the Motor Bus, in particular the steering tie rod end (arrowed). The various undercarriage components of the Motor Bus were all found to be intact without any visible damage. There was also no sign of fluid stain(s) observed on the various undercarriage components.

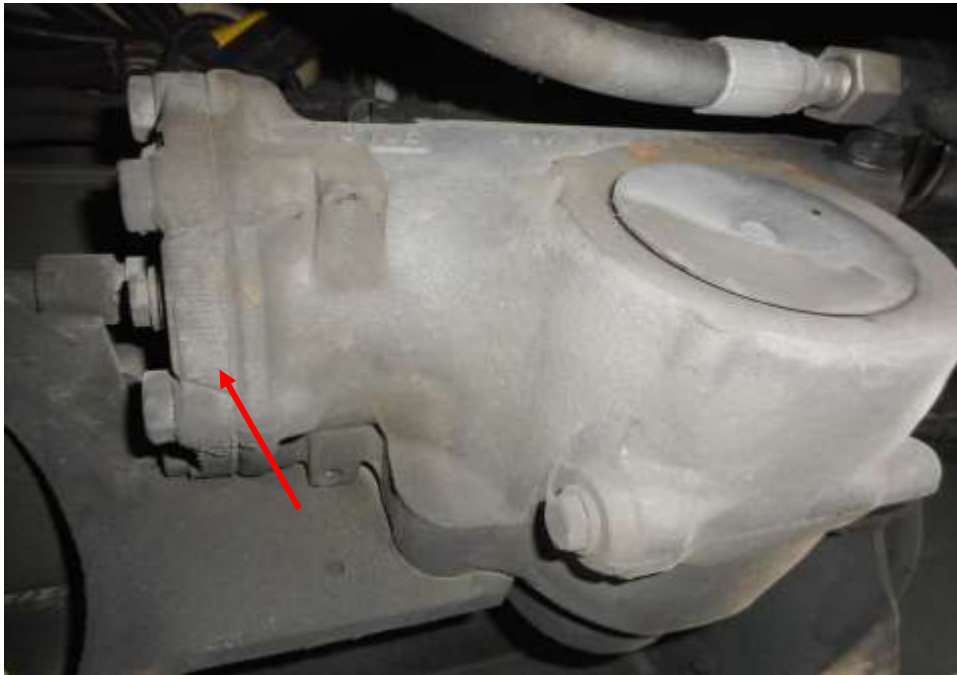
**Photo 22** shows the steering box component (arrowed) at the undercarriage of the Motor Bus was found to be intact without any visible damage. There was also no sign of fluid stain(s) observed on the various undercarriage components.

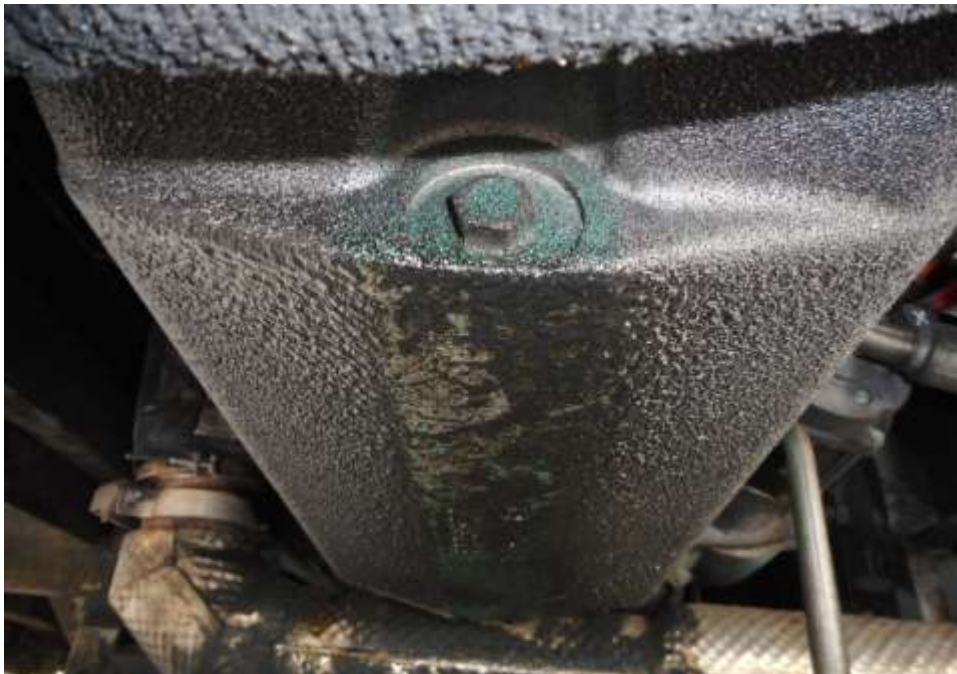
**Photo 23** shows the undercarriage of the Motor Bus, at the area where the engine housing located. We observed minor old fluid stains on the surface of the engine oil sump. However the Motor Bus is still in serviceable condition.

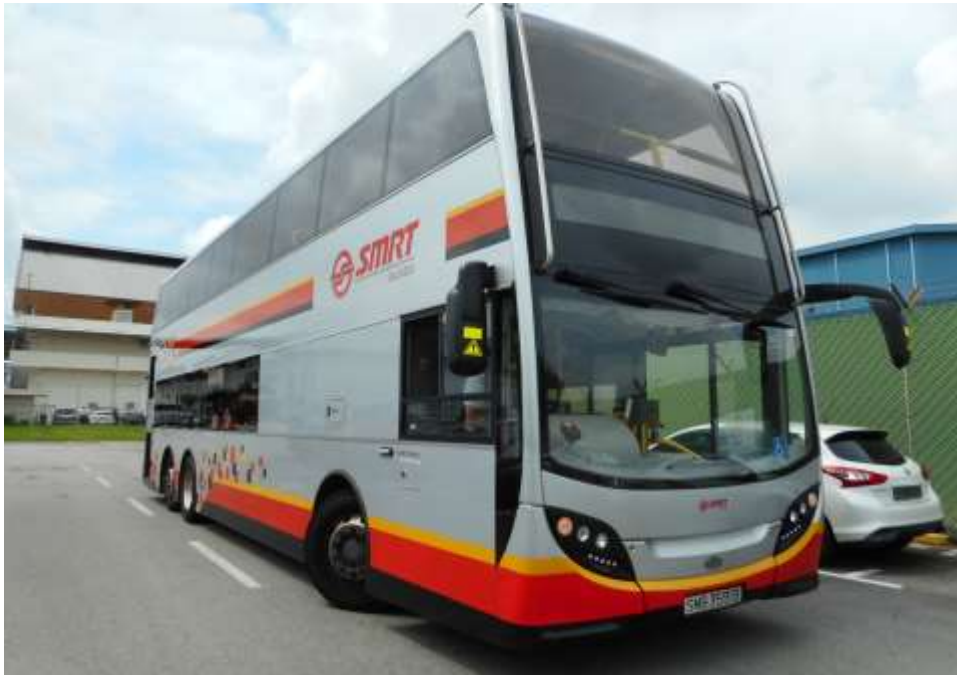
**Photo 24** shows the front right wheel of the Motor Bus turned to its full left. During my steering system test, I did not experience any abnormal free play and/or resistance when I had turned the steering wheel towards full left and full right. This would suggest that the steering system of the Motor Bus was likely to be in serviceable condition at the material time of accident.

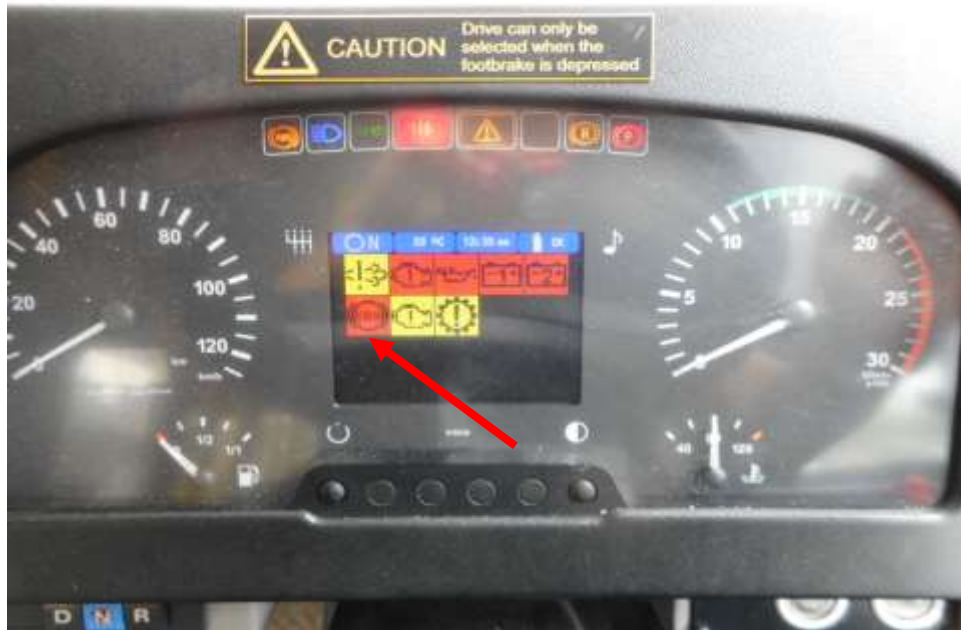
**Photo 25** shows the warning light for Anti-Lock Brake System (ABS) appearing on the instrument panel of the Motor Bus during the self-test of its various electronic operating systems when its engine was cranked.

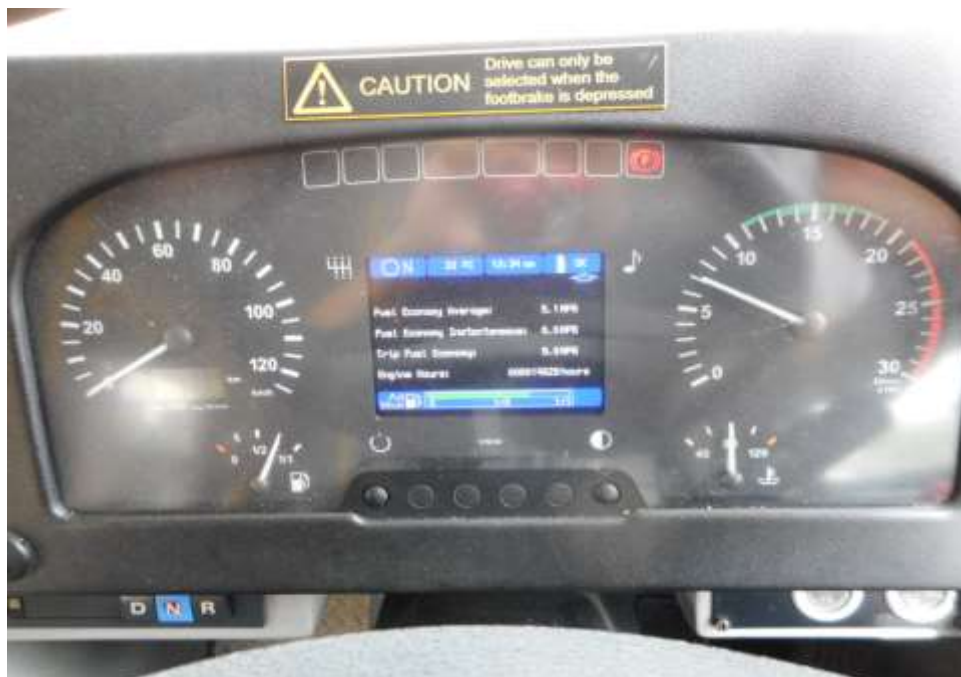
**Photo 26** shows no warning lights illuminated on the instrument panel of the Motor Bus after the engine was cranked. This would suggest that there was no abnormality to the various electronic operating systems of the Motor Bus, like the ABS
