Your Ref: TP/IP/57819/2019  
Our Ref : CI/TPD19020446/P

29<sup>th</sup> November 2019

### **MECHANICAL INSPECTION REPORT OF MOTOR CAR SJC 6575J**

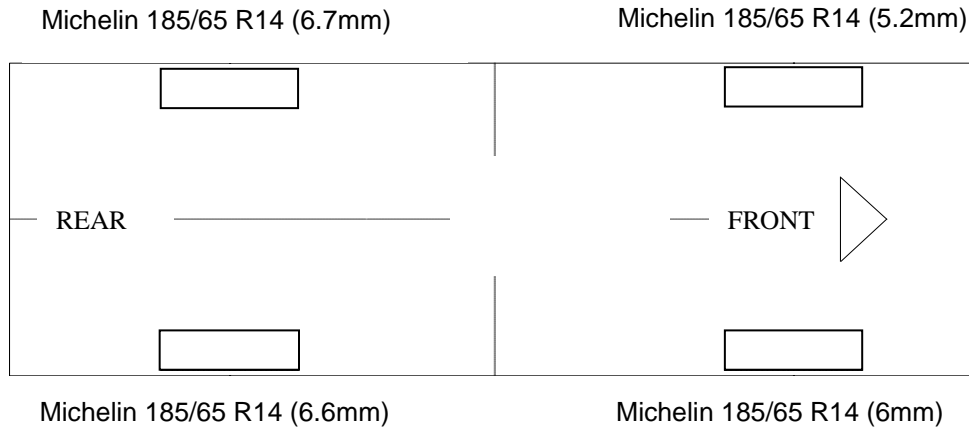
6. The 4 tyres of the Motor Car were observed to be in serviceable condition and sufficiently inflated for vehicular operation. I did not find any tear, cut or burst mark(s) on the outer and the inner sidewalls as well as across the tread of the 4 tyres. The tyre brand, tyre size and remaining tread depth of the 4 tyres of the Motor Car were recorded as follows:-

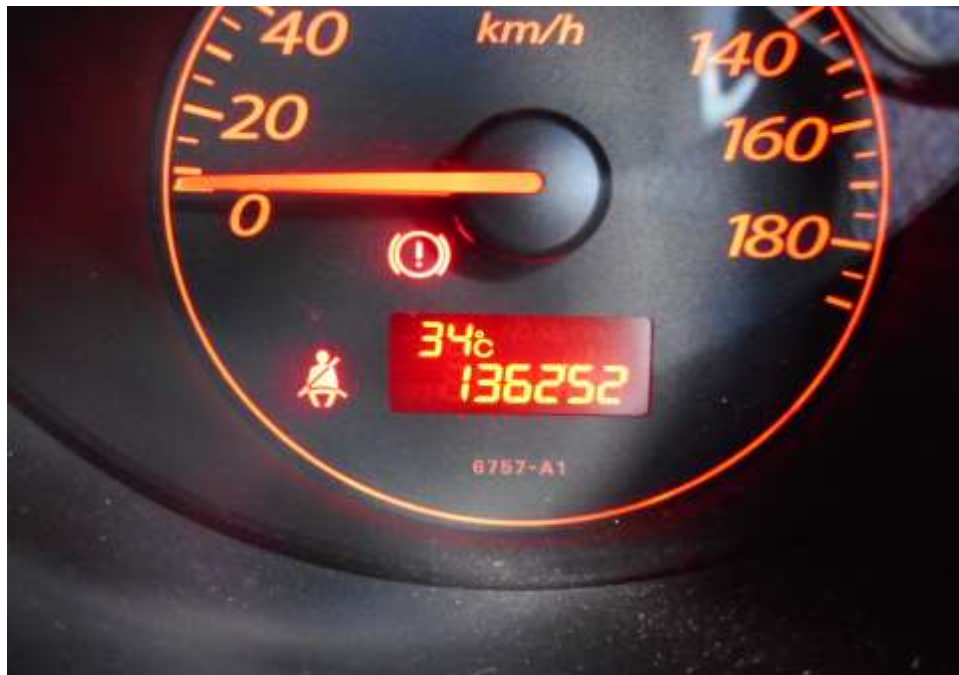
**Photo 1** shows a general view of the instrument cluster of the Motor Car at the time of my inspection. The mileage of the Motor Car was 136,252km

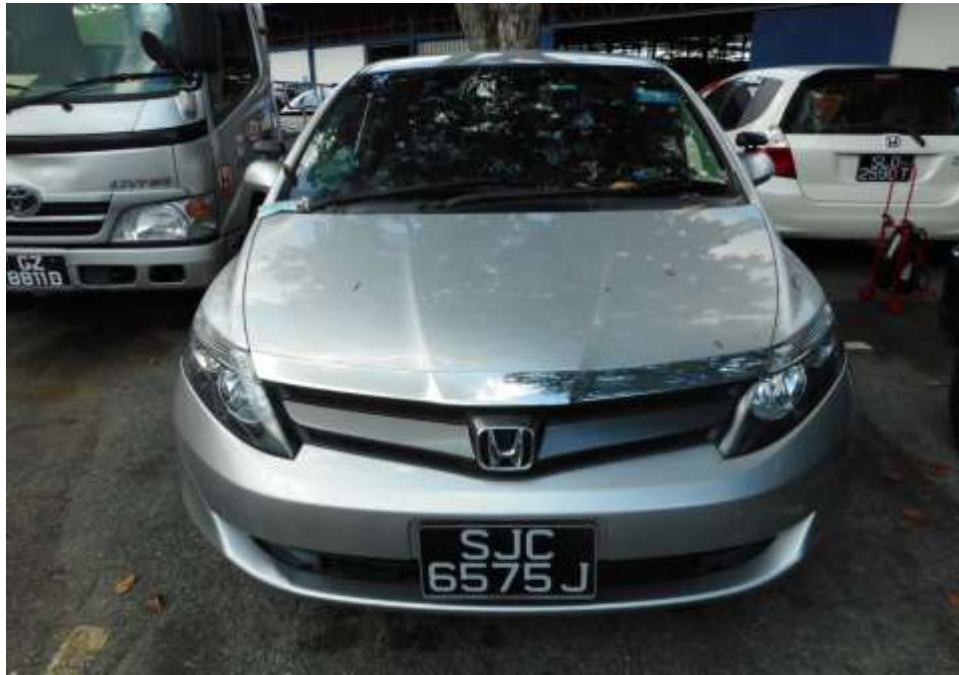
**Photo 2** shows a general view of the Motor Car at the time of my inspection. The Motor Car was observed to be intact and unaffected by the accident.

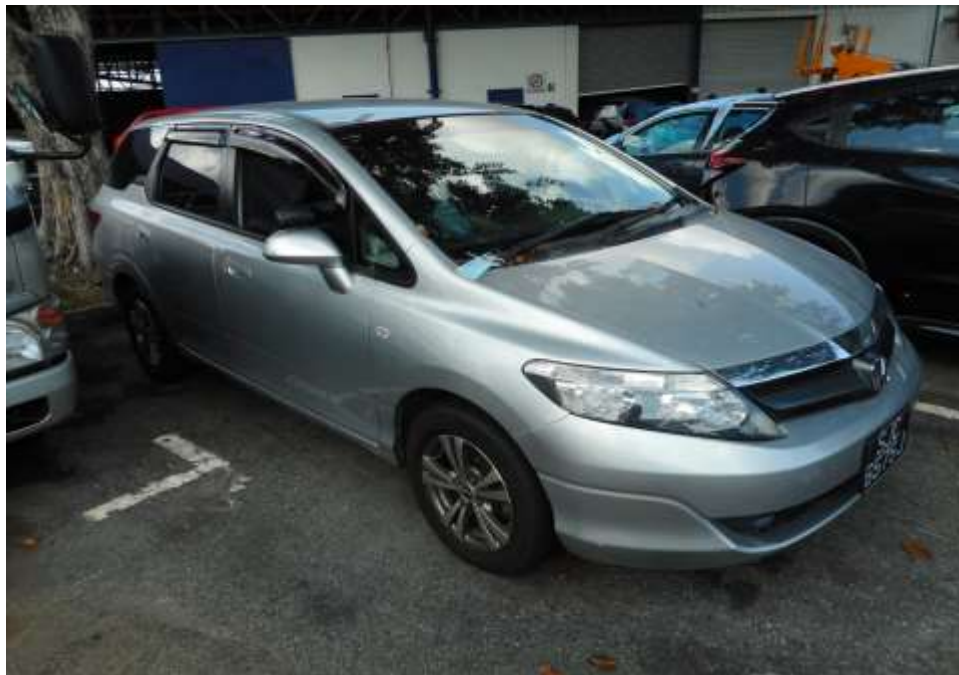
**Photo 3** shows a general view of the right body of the Motor Car at the time of my inspection. The Motor Car was observed to be intact and unaffected by the accident.

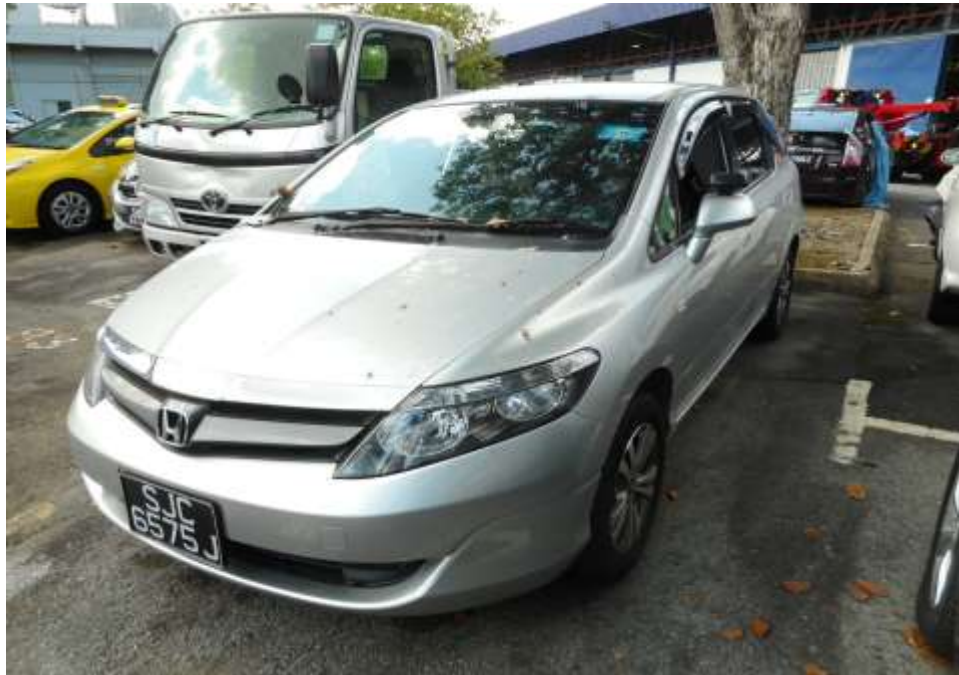
**Photo 4** shows a general view of the left body of the Motor Car at the time of my inspection. The Motor Car was observed to be intact and unaffected by the accident.

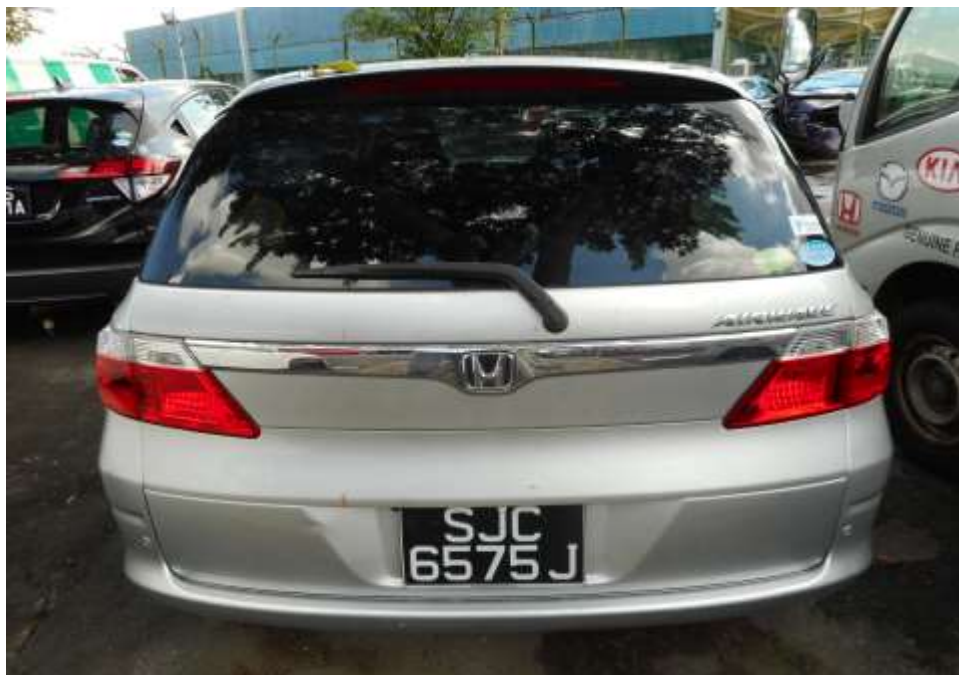
**Photo 5** shows a general view of the rear body of the Motor Car at the time of my inspection. The Motor Car was observed to be intact and unaffected by the accident.

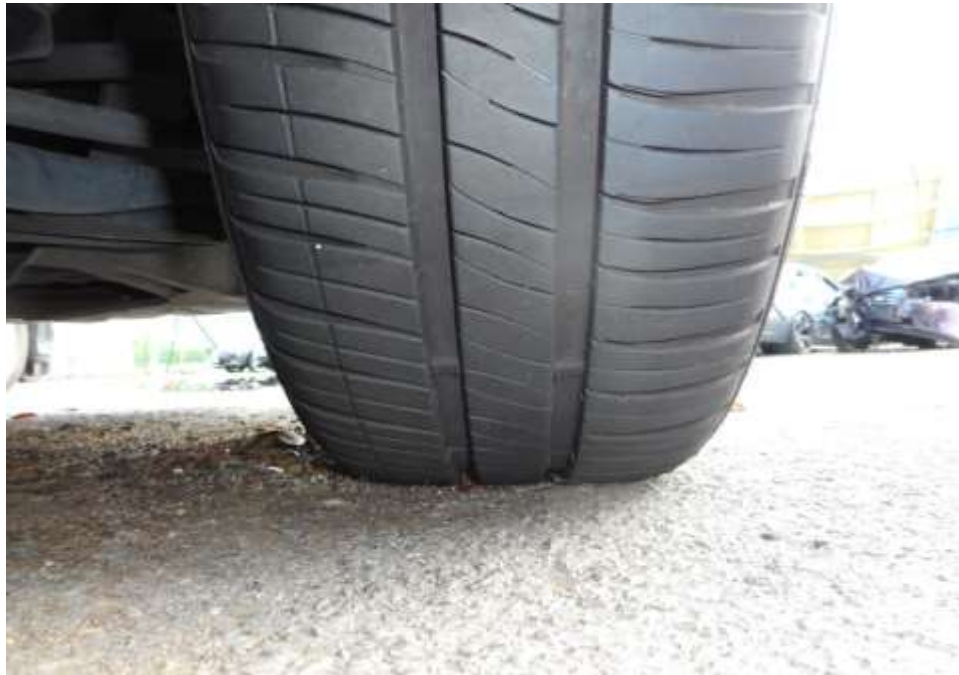
**Photo 6** shows the condition of the front right tyre of the Motor Car, which was observed to be in serviceable condition with remaining tread depth of approximately 6mm. The tyre, which was wrapped around standard alloy wheel rim, was also observed to be sufficiently inflated for vehicular operation. There was no tear, cut or burst mark(s) on the outer and the inner sidewalls as well as across the tread of the 4 tyres that were fitted on the Motor Car.

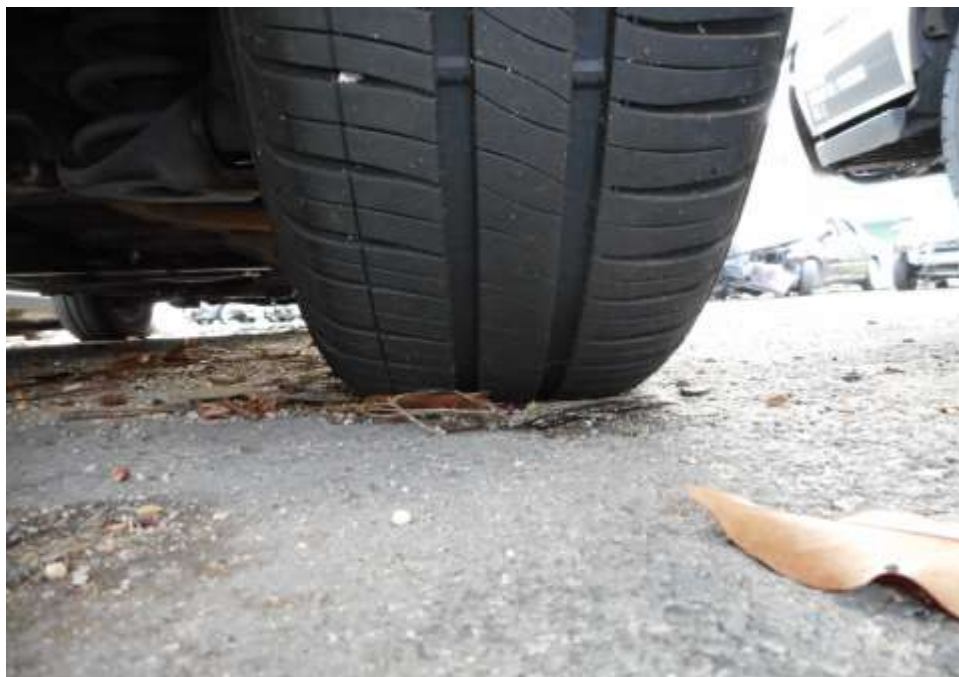
**Photo 7** shows the condition of the rear right tyre of the Motor Car, which was observed to be in serviceable condition with remaining tread depth of approximately 6.6mm. The tyre, which was wrapped around standard alloy wheel rim, was also observed to be sufficiently inflated for vehicular operation.

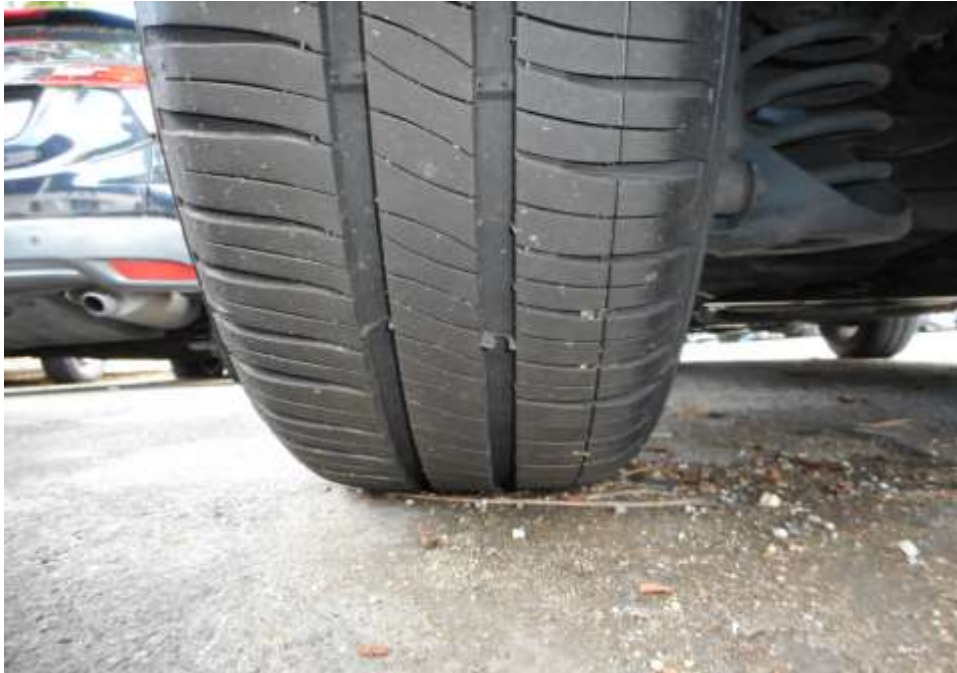
**Photo 8** shows the condition of the rear left tyres of the Motor Car, which was observed to be in serviceable condition with remaining tread depth of approximately 6.7mm. The tyres, which were wrapped around standard alloy wheel rim, were also observed to be sufficiently inflated for vehicular operation. There was also no damage found on all 4 alloy wheel rims of the Motor Car.

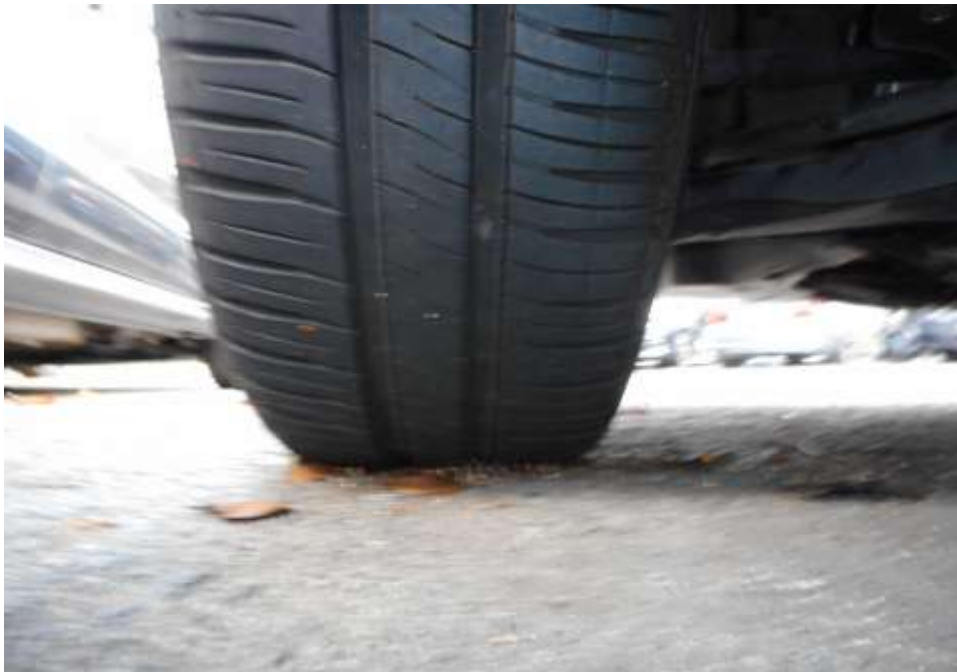
**Photo 9** shows the condition of the rear right tyres of the Motor Car, which were observed to be in serviceable condition with remaining, tread depth of approximately 5.2mm. There was also no tear, cut or burst mark(s) on the outer and the inner sidewalls as well as across the tread of the 4 tyres that were fitted on the Motor Car.

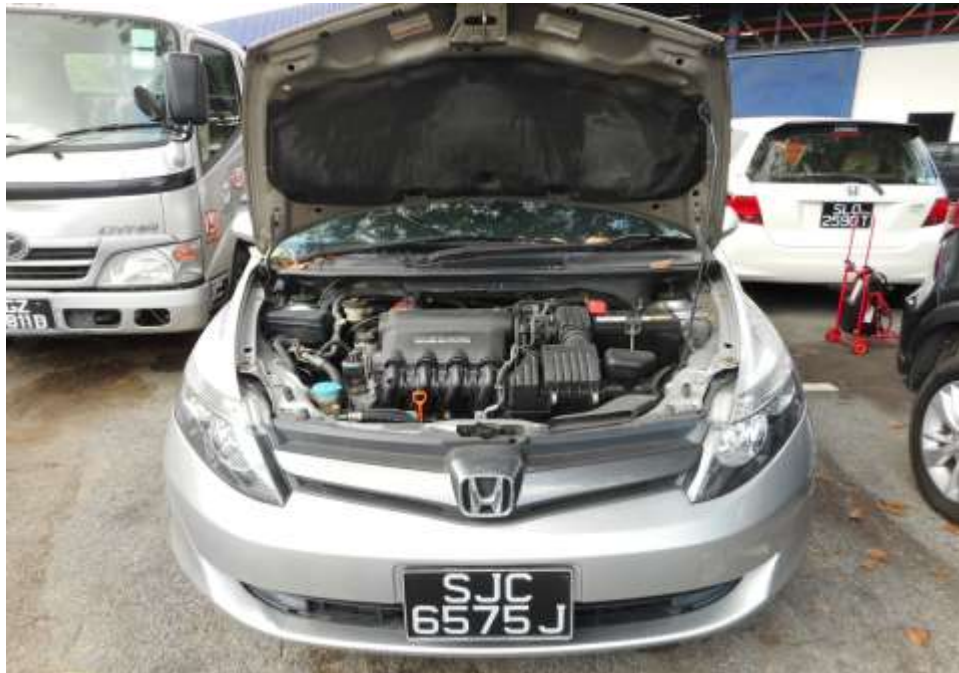
**Photo 10** shows a general view of the Motor Car's engine compartment, which was accessed by lifting the front cabin of the Motor Car. The various parts and components inside the engine compartment were unaffected by the accident. There was also no sign(s) or indication(s) of fresh fluid leakage and/or fluid stain within the engine compartment

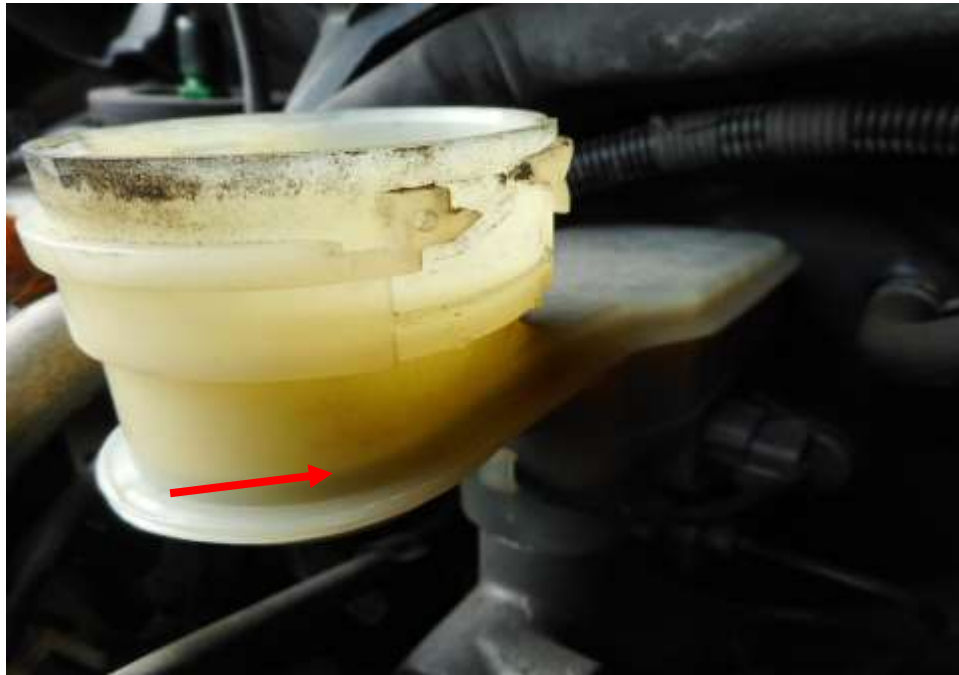
**Photo 11** shows the brake fluid reservoir of the Motor Car at the time of my inspection. The brake fluid was observed to be of sufficient level (arrowed) and without any visible contamination.

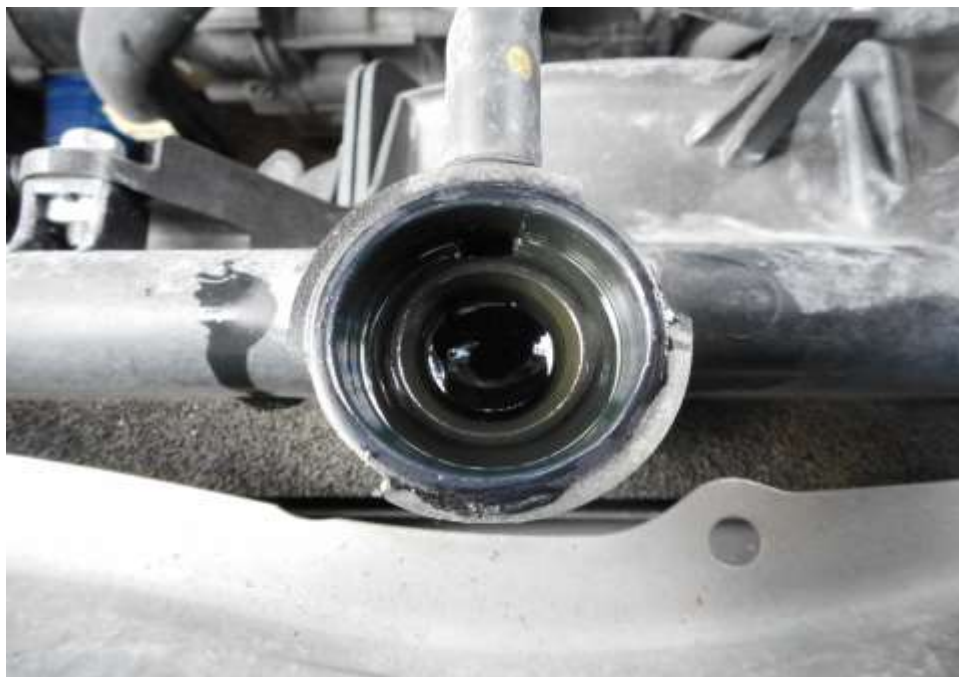
**Photo 12** shows the engine coolant reservoir of the Motor Car at the time of my inspection. The engine coolant was observed to be of sufficient level and without any visible contamination.

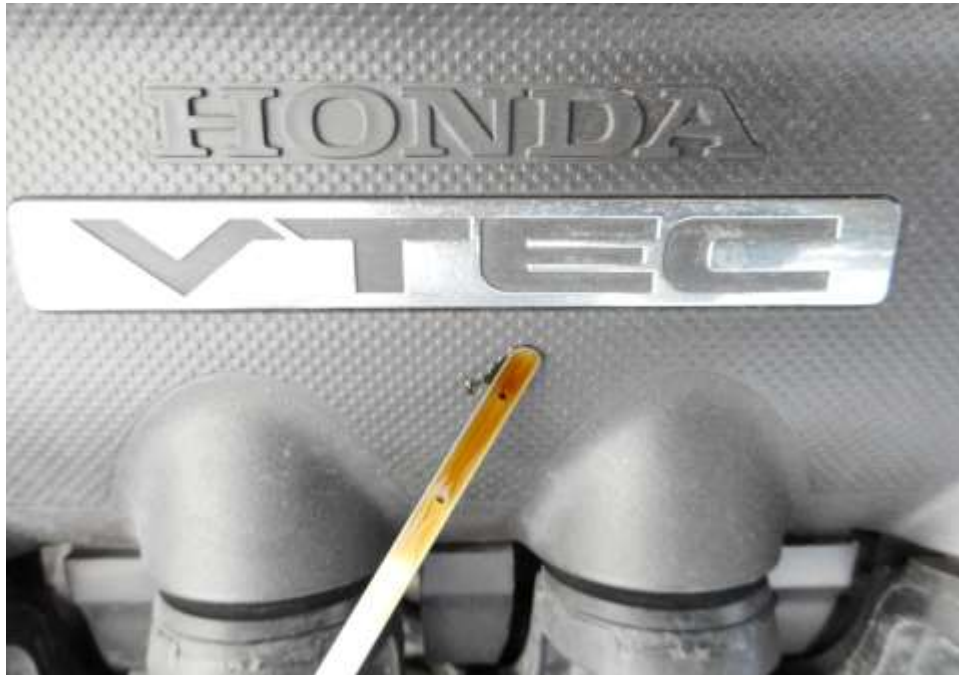
**Photo 13** shows the engine oil dip stick of the Motor Car at the time of my inspection. The engine oil was observed to be of sufficient level and without any visible contamination.

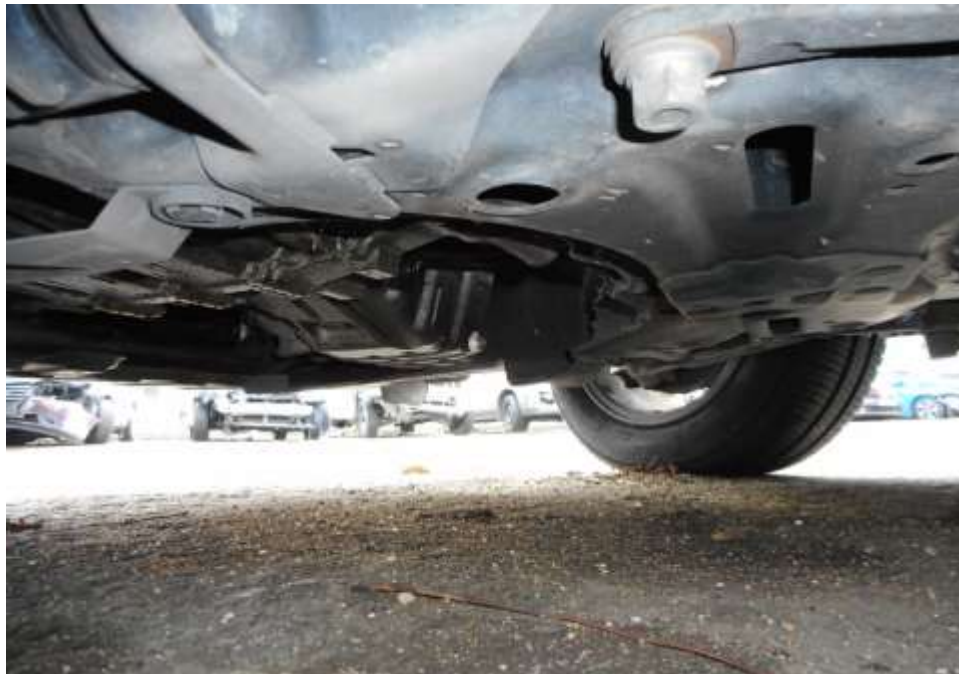
**Photo 14** shows the undercarriage of the Motor Car, at the area where the engine housing and transmission housing are located. . I did not find any sign(s) or indication(s) of fluid leak and/or fluid stain(s) on the underside of the Motor Car.

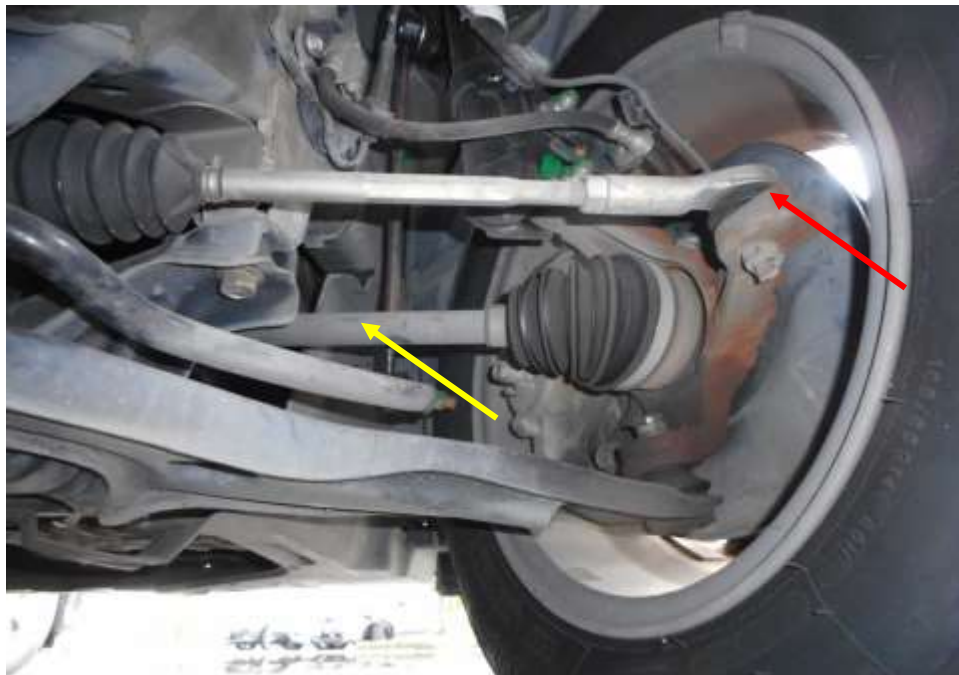
**Photo 15** shows the various undercarriage components at the front right wheel of the Motor Car, in particular the steering tie rod end (arrowed) and drive shaft (yellow arrow). The various steering components were all found to be intact, suggesting that the steering system of the Motor Car was likely to be in serviceable condition at the material time of accident. There was also no sign of fluid stain(s) observed on the various undercarriage components.

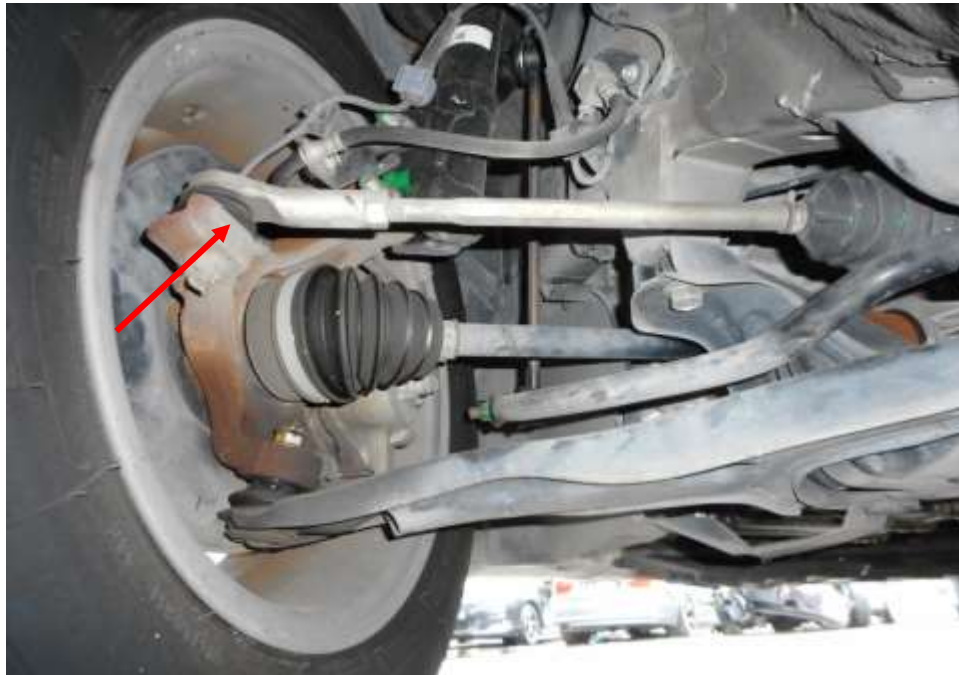
**Photo 16** shows the various undercarriage components at the front left wheel of the Motor Car, in particular the steering tie rod end (arrowed). The various Undercarriage components of the Motor Car were all found to be intact without any visible damage. There was also no sign of fluid stain(s) observed on the various undercarriage components.

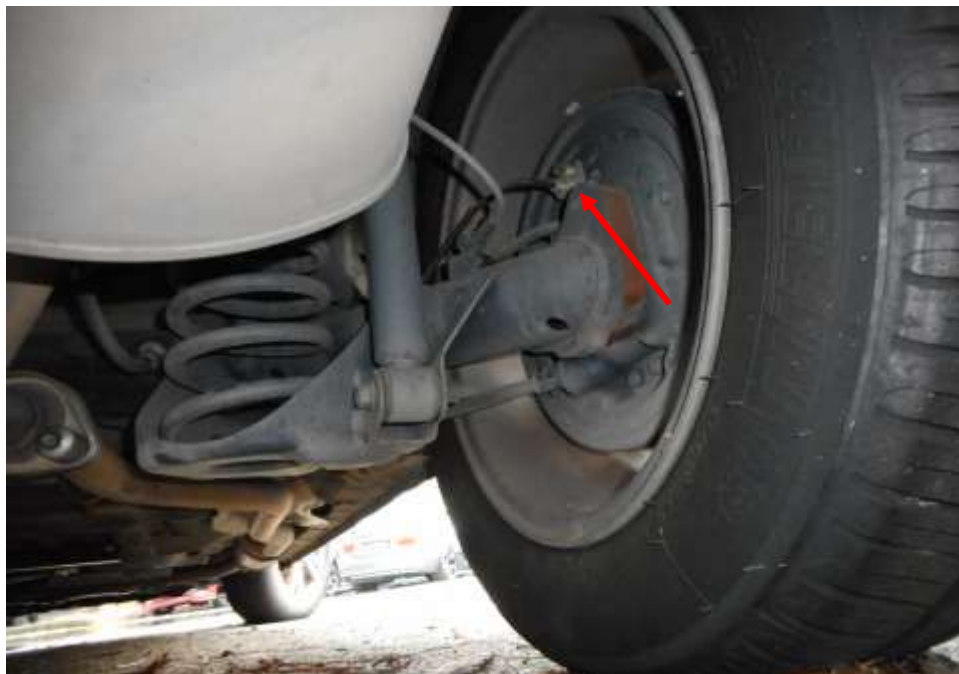
**Photo 17** shows the brake pipe (arrowed) at the rear right wheel of the Motor Car. I did not observe any leakage of brake fluid at the time of my inspection of the Motor Car. My static tests of the Motor Car's braking system, along with my visual examination of the various mechanical components in the braking system, had indicated that there was no internal leakage of pressure/vacuum. Hence the braking system of the Motor Car was likely to be in serviceable condition at the material time of accident.

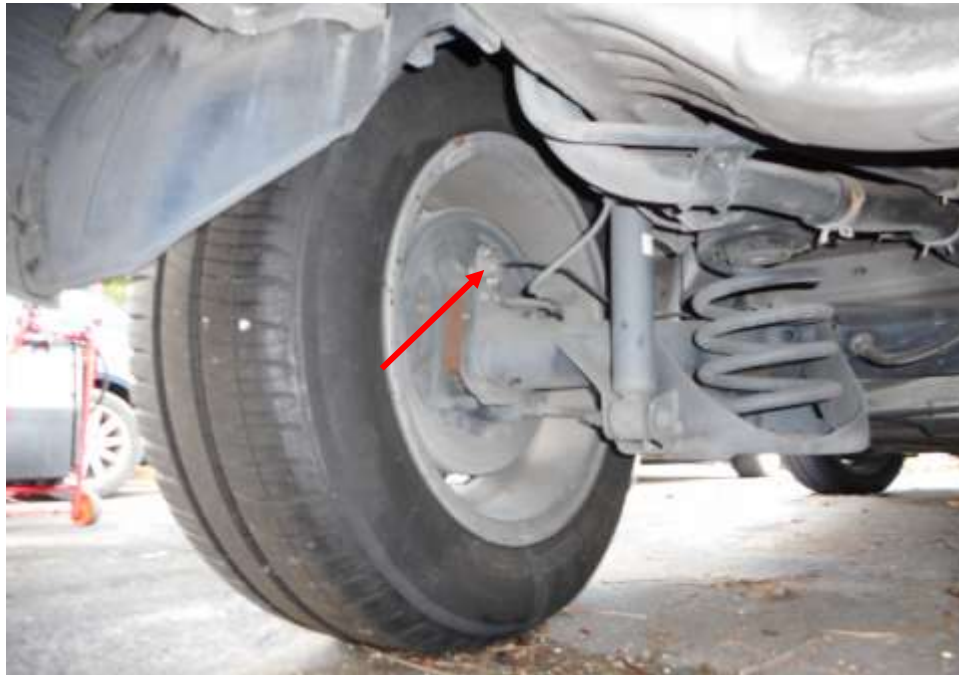
**Photo 18** shows the brake pipe (arrowed) at the rear left wheel of the Motor Car. I did not observe any leakage of brake fluid at the time of my inspection of the Motor Car. My static tests of the Motor Car's braking system, along with my visual examination of the various mechanical components in the braking system had indicated that there was no internal leakage of pressure/vacuum. Hence the braking system of the Motor Car was likely to be in serviceable condition at the material time of accident.

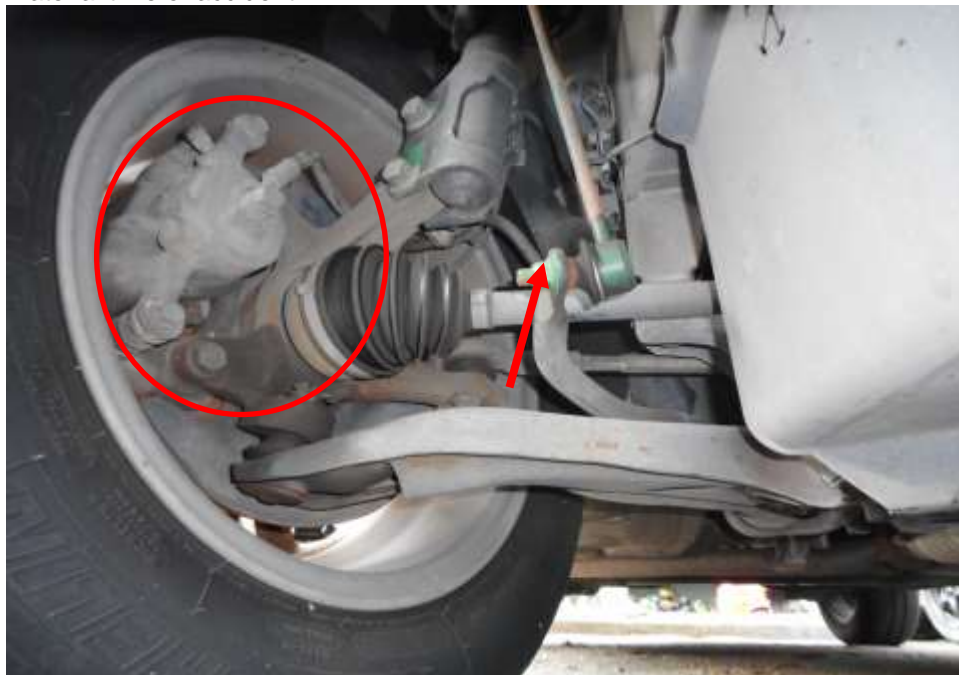
**Photo 19** shows the brake hose/pipe (arrowed) at the front right wheel of the Motor Car. No leakage of brake fluid was observed. Visual examination of the various components of the braking system like the brake caliper (circled), brake booster, brake pedal etc had revealed all to be intact and without visible damage at the time of accident. There was also no sign of fluid stain(s) observed on the various undercarriage components.

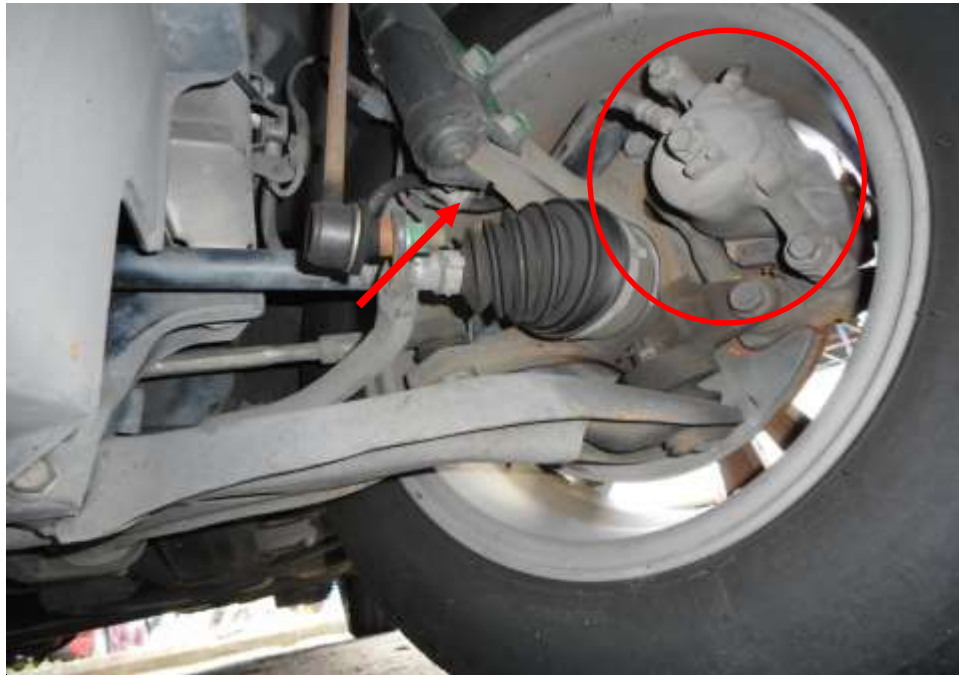
**Photo 20** shows the brake hose/pipe (arrowed) at the front left wheel of the Motor Car. No leakage of brake fluid was observed. Visual examination of the various components of the braking system like the brake caliper (circled), brake booster, brake pedal etc had revealed all to be intact and without visible damage at the time of accident. There was also no sign of fluid stain(s) observed on the various undercarriage components.

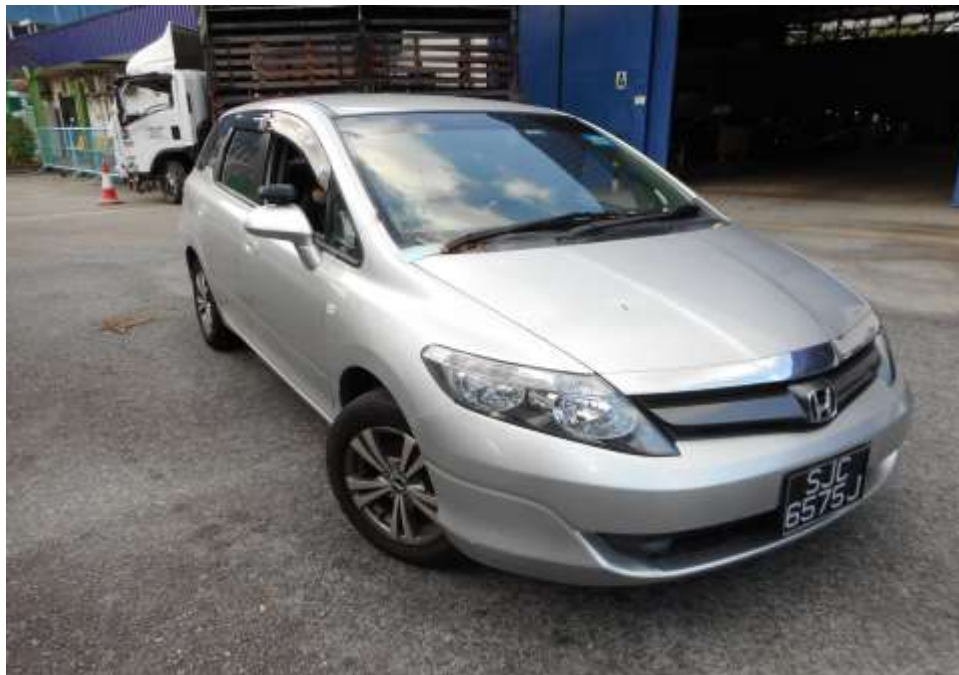
**Photo 21** shows the front right wheel of the Motor Car turned to its full left. During my steering system test, I did not experience any abnormal free play and/or resistance when I had turned the steering wheel towards full left and full right. This would suggest that the steering system of the Motor Car was likely to be in serviceable condition at the material time of accident.

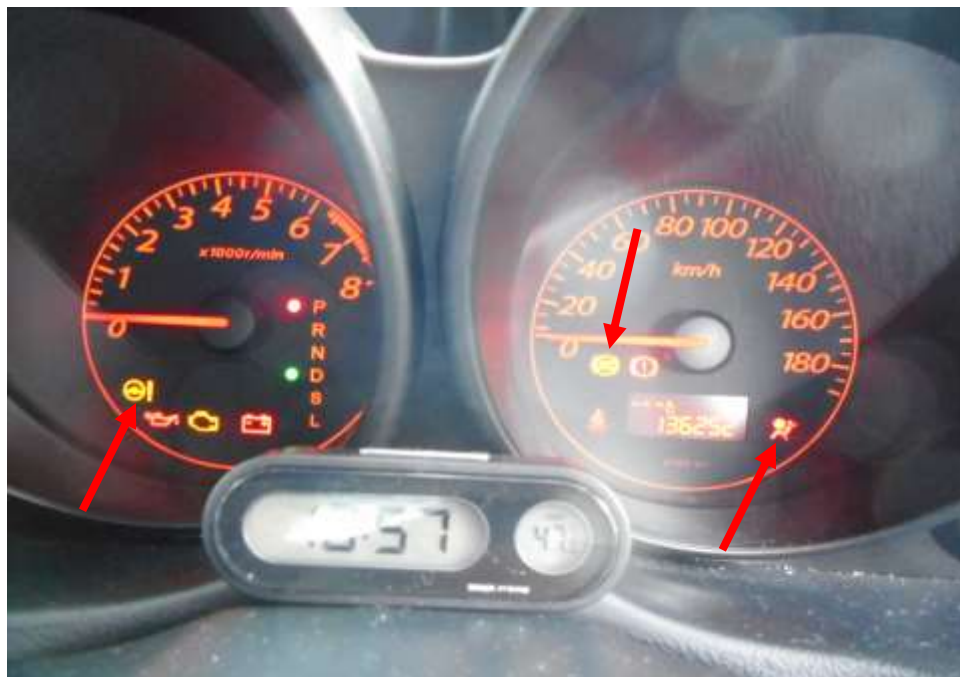
**Photo 22** shows the warning light for Anti-Lock Brake System (ABS) and Supplemental Restraint System (SRS) and Electric Power Steering System (EPS) appearing on the instrument panel of the Motor Car during the self-test of its various electronic operating systems when its engine was cranked.

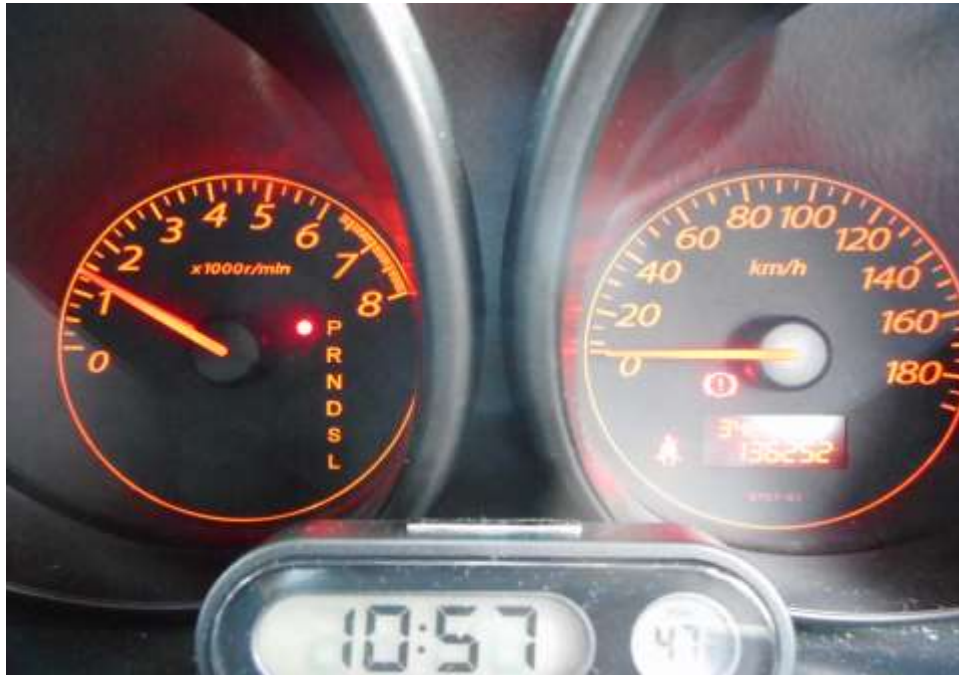
**Photo 23** shows no warning lights illuminated on the instrument panel of the Motor Car after the engine was cranked. This would suggest that there was no abnormality to the various electronic operating systems of the Motor Car, like the ABS, SRS and EPS.
