DAMAGE ASSESSMENT REPORT

NTUC INCOME INSURANCE CO-OPERATIVE LTD Ref: CS/INC19020493/Gtd3n2

ADJUSTMENT ON REPAIR COST FOR VEHICLE NO. SMG 4160D

PHOTOGRAPHS FOR VEHICLE NO. SMG 4160D

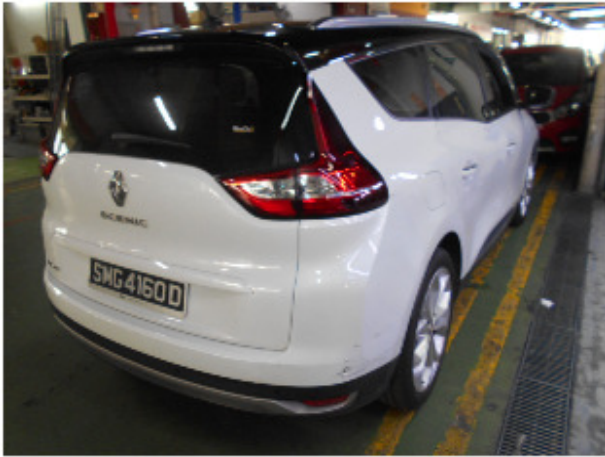
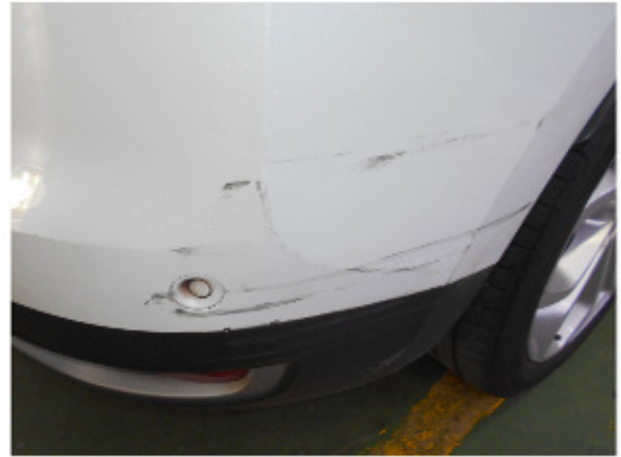
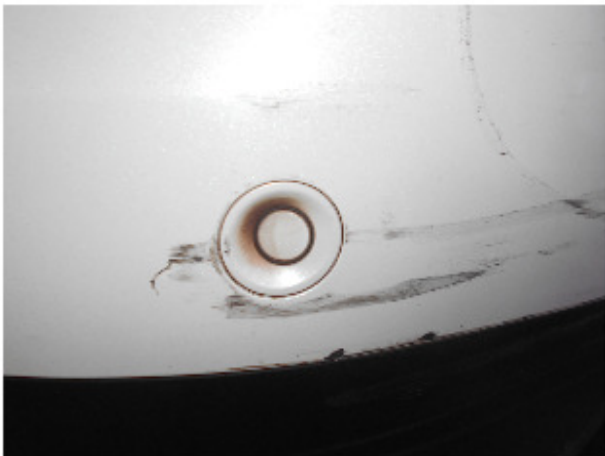
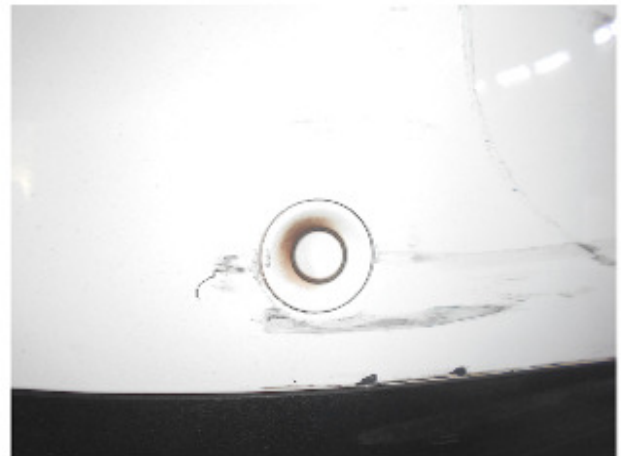
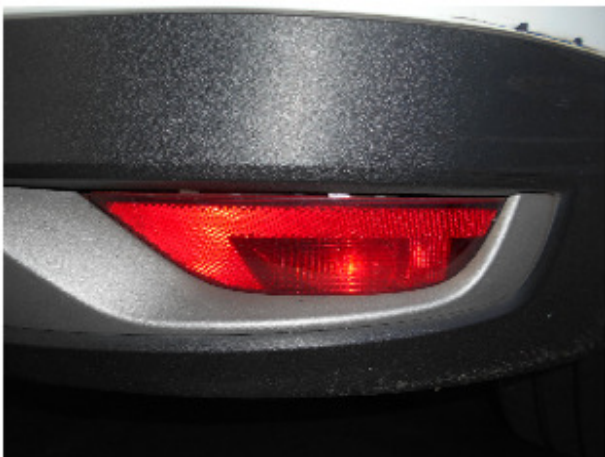
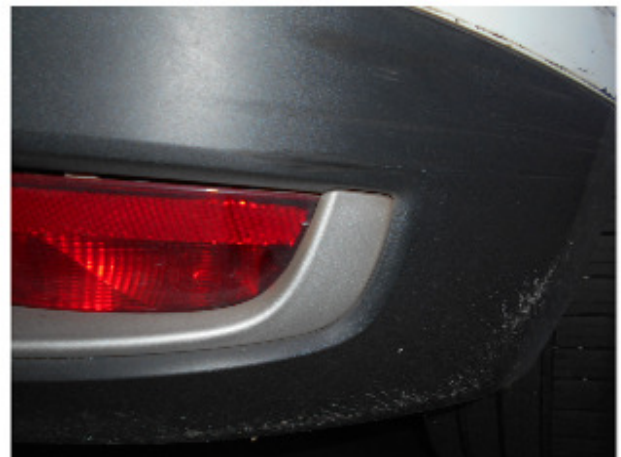
INSPECTION

THE VEHICLE SUSTAINED DAMAGES AT THE O/S REAR PORTION. DAMAGES SEE DETAILS.
--
