## LKK Auto Consultants Pte Ltd

## ADJUSTMENT ON REPAIR COST FOR VEHICLE NO. GBC 2715T

PHOTOGRAPHS FOR VEHICLE NO. GBC 2715T

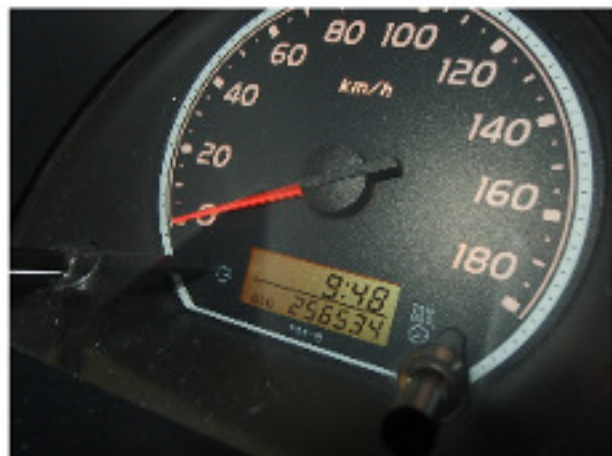
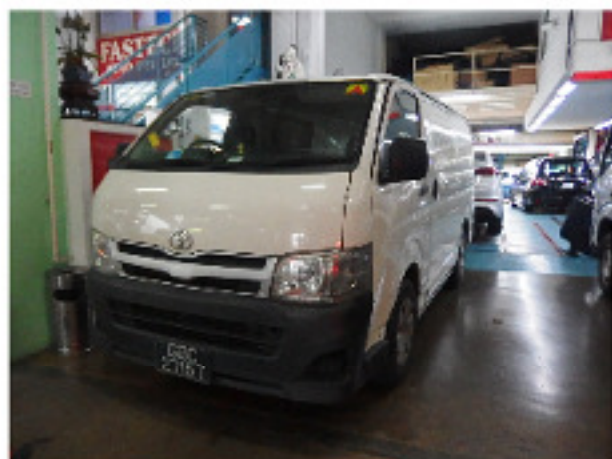
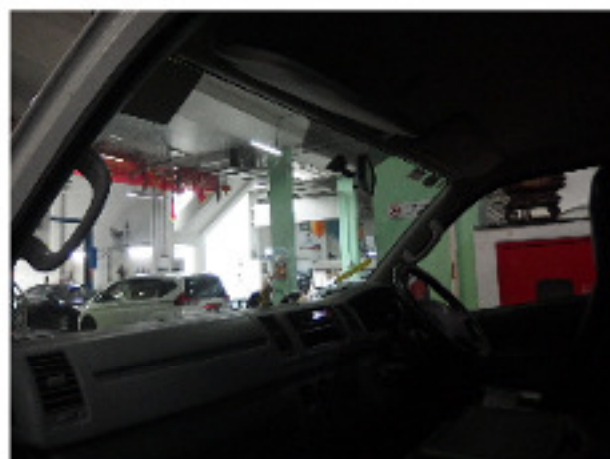
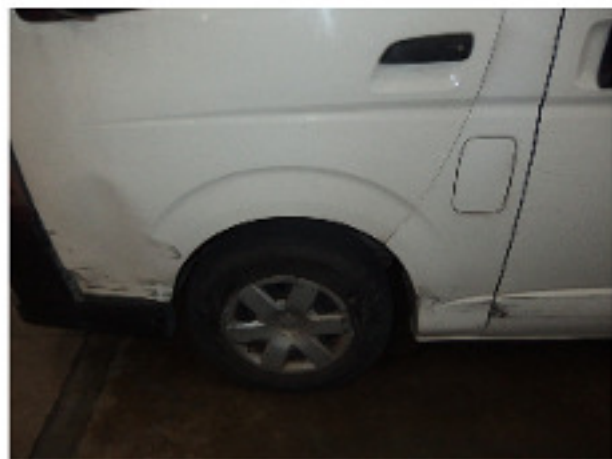
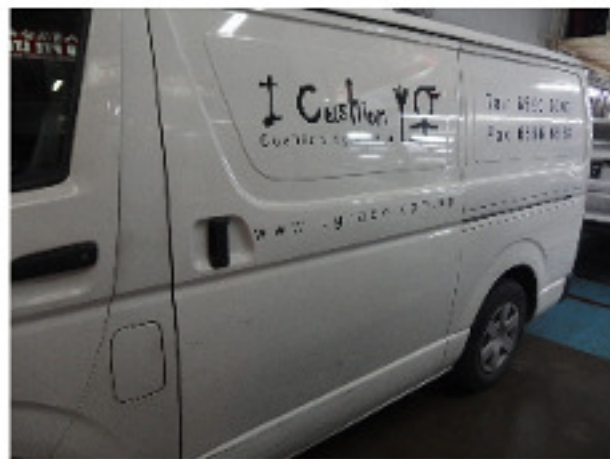
INSPECTION

THE VEHICLE SUSTAINED DAMAGES AT THE N/S FRONT PORTION AND N/S BODY. THE UNDERCARRIAGE AFFECTED DUE TO COLLISION.  DAMAGES SEE DETAILS.
---
