Your Ref: TP/IP/57869/2019
Our Ref : CI/TPD19020634/N

INSPECTION REPORT OF MOTORCYCLE FX 7596D

1. We refer to your request dated 22 October 2019 to conduct a physical inspection of a motorcycle bearing registration number FX 7596D (herein referred to as “**Motorcycle**”), which was involved in a fatal road traffic accident on 13 September 2019.
2. The purpose of this inspection is to primarily determine if there was any possible mechanical failure to the Motorcycle that may have contributed to the accident.
3. Following the request, we had carried out a physical inspection of the Motorcycle on 22 November 2019 at the premises of Traffic Police vehicle pound, 517 Airport Road Singapore 539942. We now set out below our observations and comments with respect to this inspection.

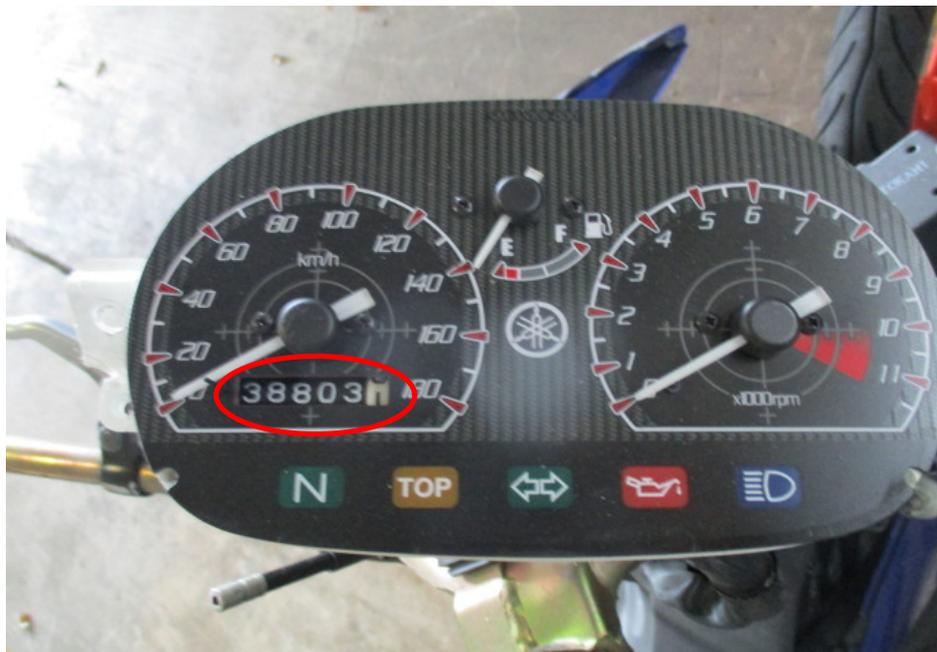
Photo 1 shows the speedometer gauge of the Motorcycle. The mileage of the Motorcycle at the time of our inspection was 38, 803km (circled).

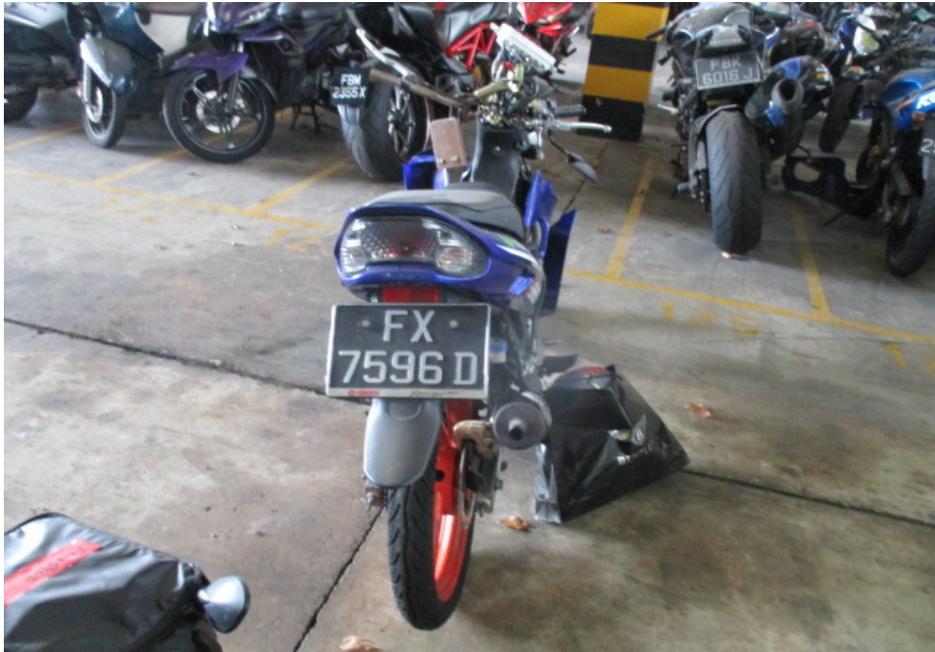
Photo 2 shows a general view of the rear body of the Motorcycle at the time of our inspection. The Motorcycle was observed to have sustained damages along its frontal portion and right body.

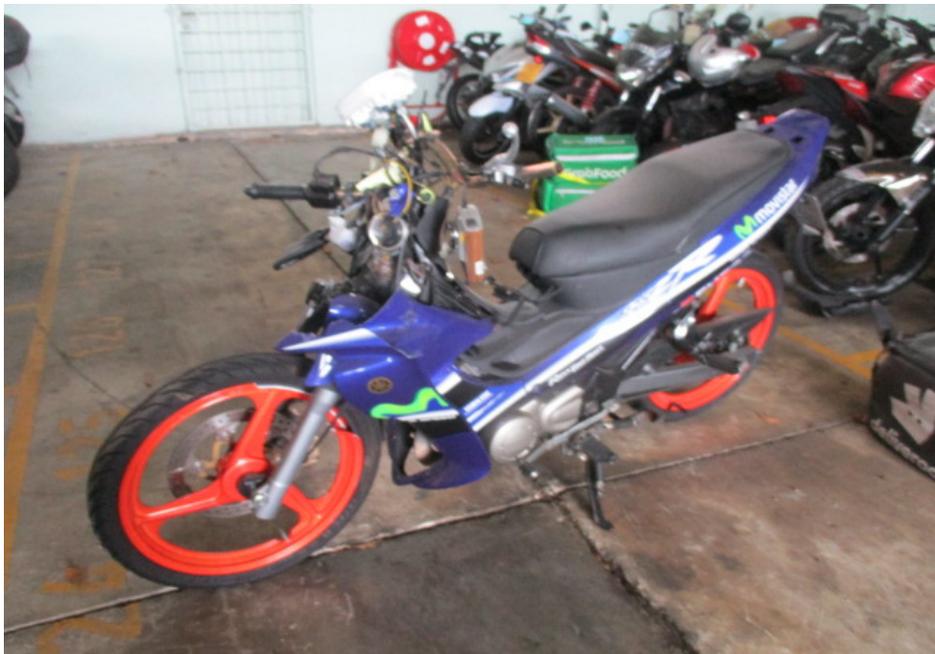
Photo 3 shows a general view of the left body of the Motorcycle at the time of our inspection. The Motorcycle was observed to have sustained damages along its frontal portion and right body.

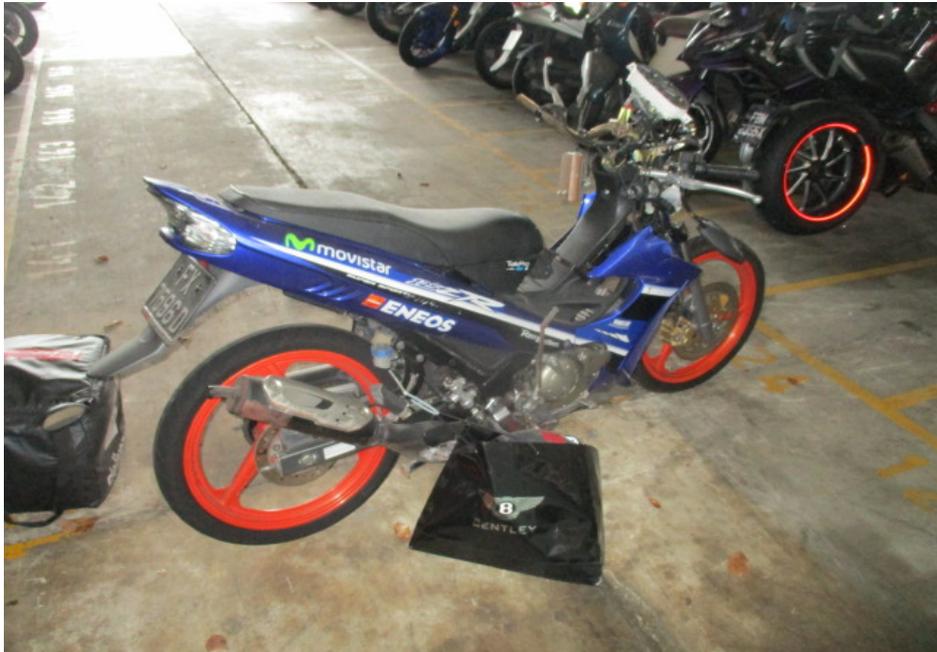
4. The mileage of the Motorcycle at the time of our inspection was 38,803km
5. The Motorcycle was observed to have sustained damages along its frontal portion and right body. The body parts that were found to have been damaged include its front cowling, right cowling, front mudguard, front brake lever, right side mirror, rear brake pedal, right front footrest, exhaust muffler and top box, amongst others.

Photo 4 shows a general view of the right body of the Motorcycle at the time of our inspection. The Motorcycle was observed to have sustained damages along its frontal portion and right body. Amongst the body parts that were found to have been damaged include its front cowling, right cowling, front mudguard, front brake lever, right side mirror, rear brake pedal, right front footrest, exhaust muffler, and top box, amongst others.

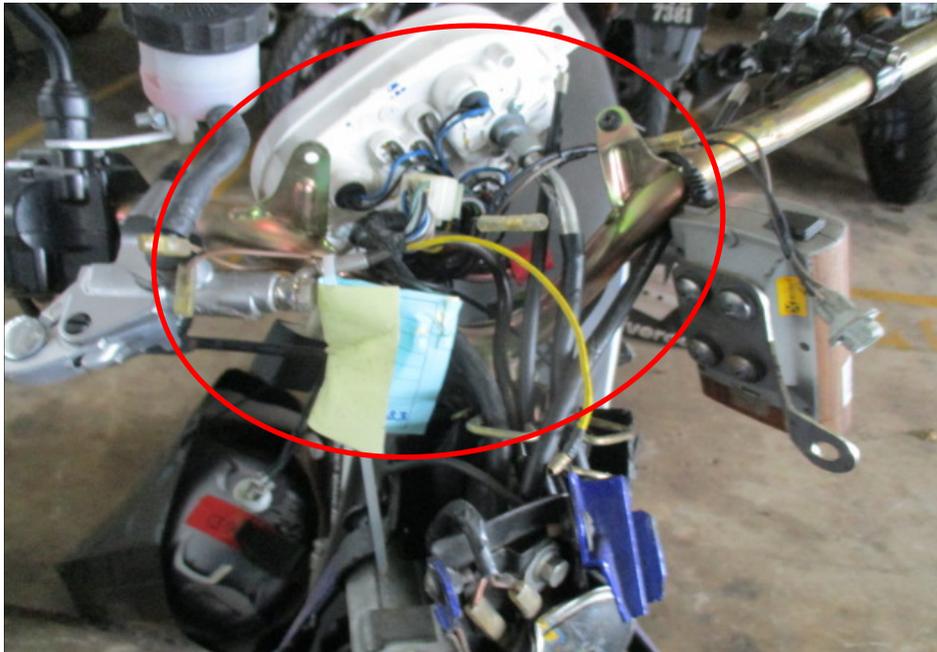
Photo 5 shows a close up view of the speedometer gauge and headlamp assembly (circled) which was amongst the body parts of the Motorcycle that had sustained damage as a result of the accident.

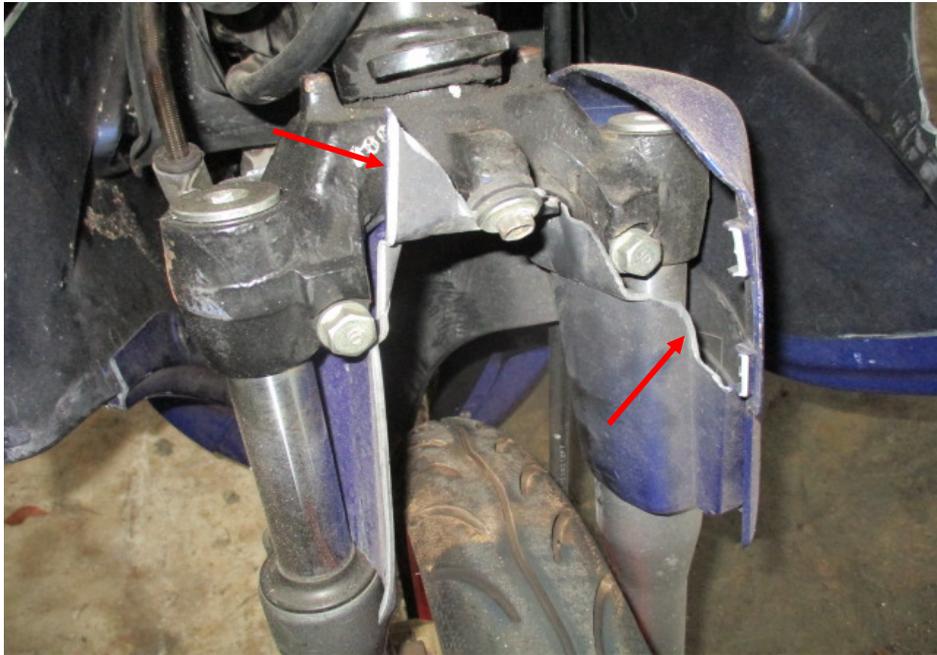
Photo 6 shows a closer view of the front mudguard (arrowed) which was amongst the body parts at the front body of the Motorcycle that had sustained damage as a result of the accident.

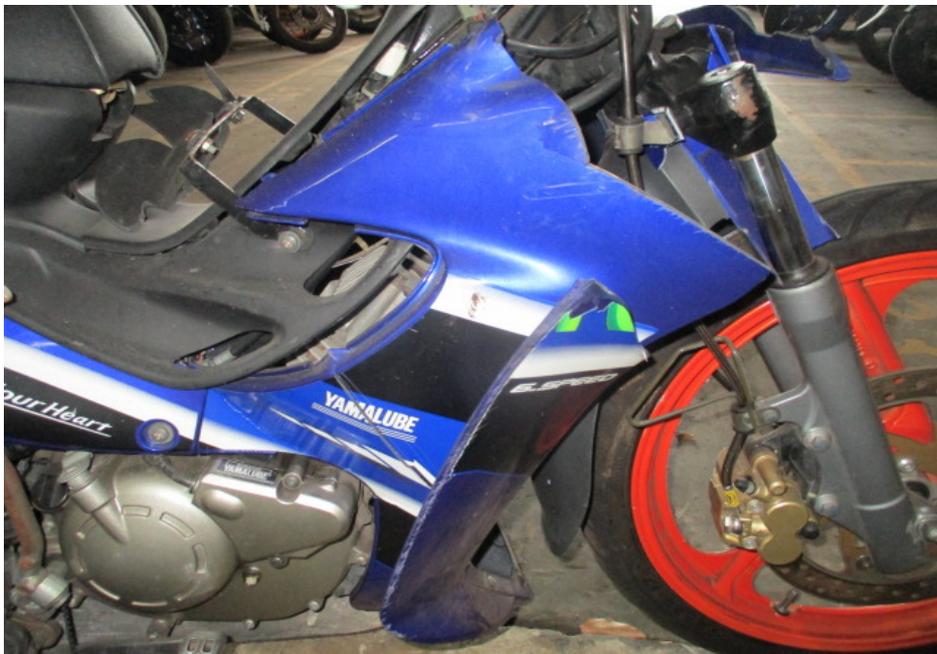
Photo 7 shows a closer view of the right cowling which was amongst the body parts of the Motorcycle that had sustained damage as a result of the accident.

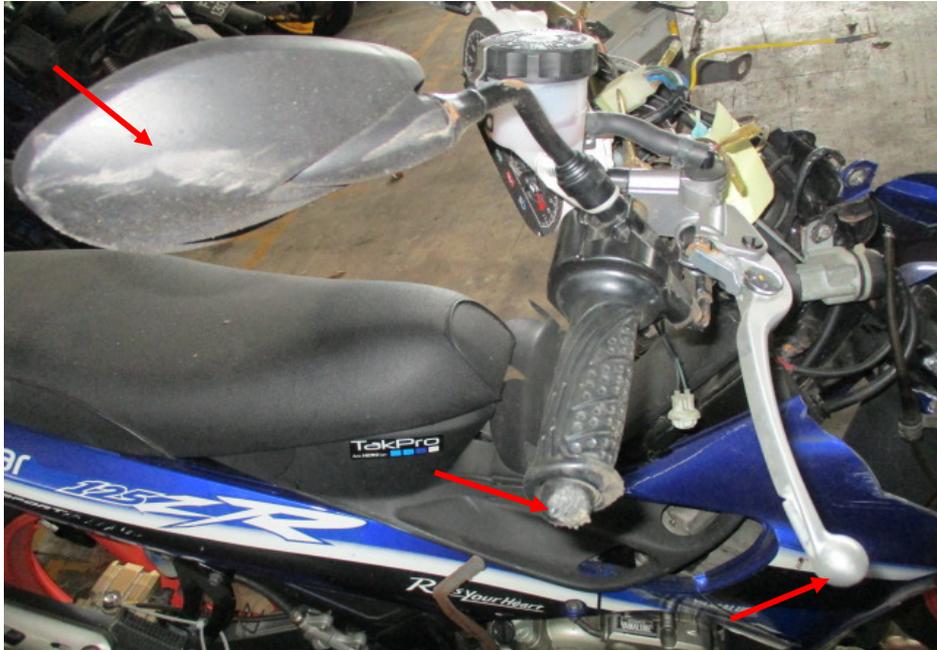
Photo 8 shows the front brake lever, right handlebar end and right side mirror (arrowed), which were amongst the body parts of the Motorcycle that had sustained damage as a result of the accident.

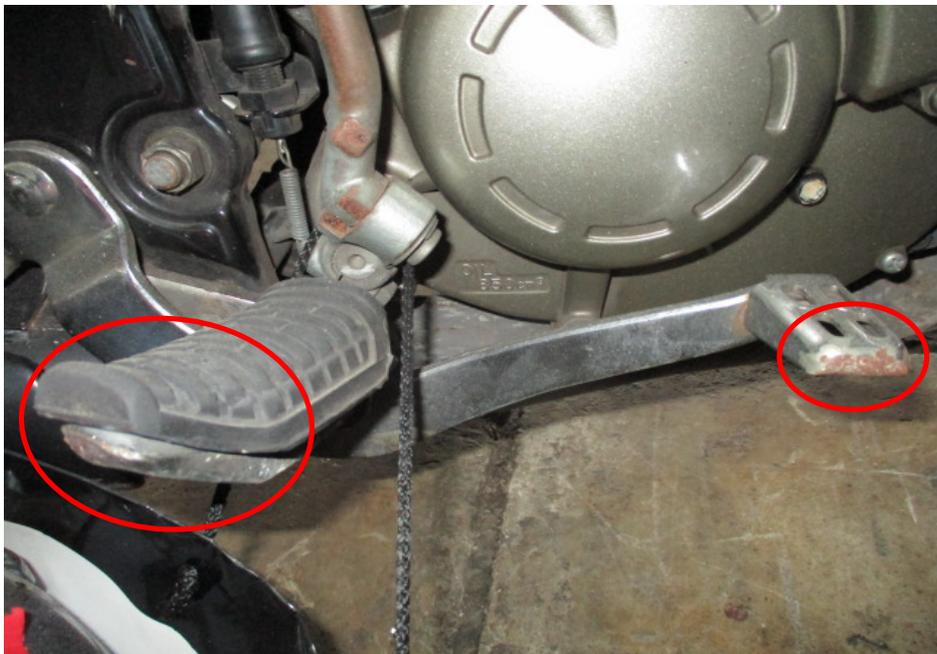
Photo 9 shows a closer view of the rear brake pedal and right front footrest (circled) which were amongst the body parts of the Motorcycle that had sustained damage as a result of the accident.

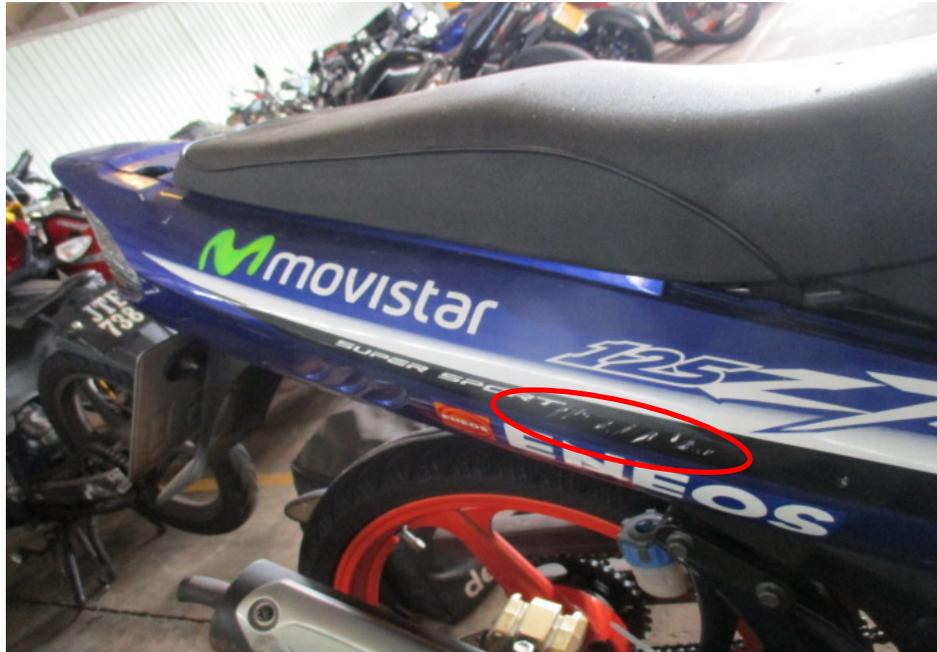
Photo 10 shows a closer view of right rear side cover which was amongst the body parts of the Motorcycle that had sustained damages of grazing nature as a result of the accident (circled).

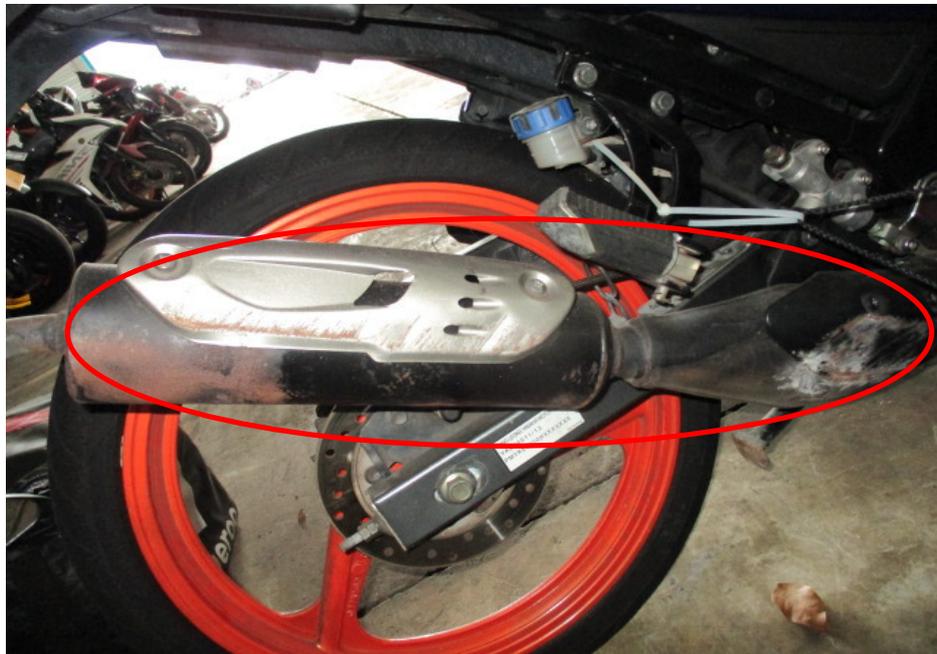
Photo 11 shows the exhaust muffler and exhaust muffler heat shield (circled) of the Motorcycle that had sustained damage as a result of the accident.

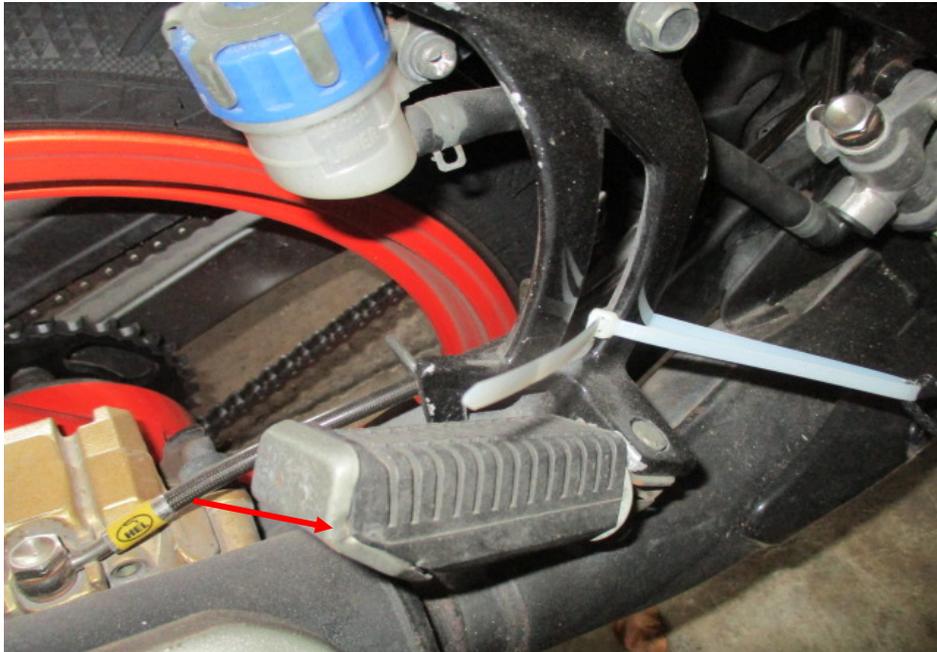
Photo 12 shows the right pillion footrest which was amongst the body parts of the Motorcycle that had sustained damage as a result of the accident (arrowed).

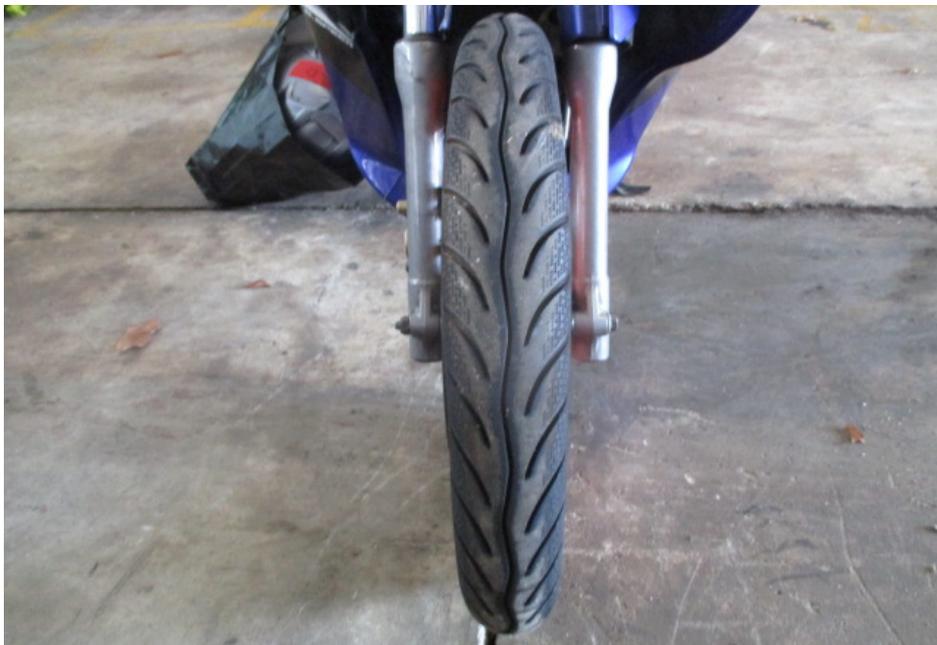
Photo 13 shows the front tyre of the Motorcycle at the time of our inspection. The front tyre was observed to be in serviceable condition with remaining tread depth of approximately 3mm. The pattern of the tread was also clearly visible. There was no tear, burst mark(s) and/or punctured hole(s) on the sidewalls as well as across the tread of the front tyre.

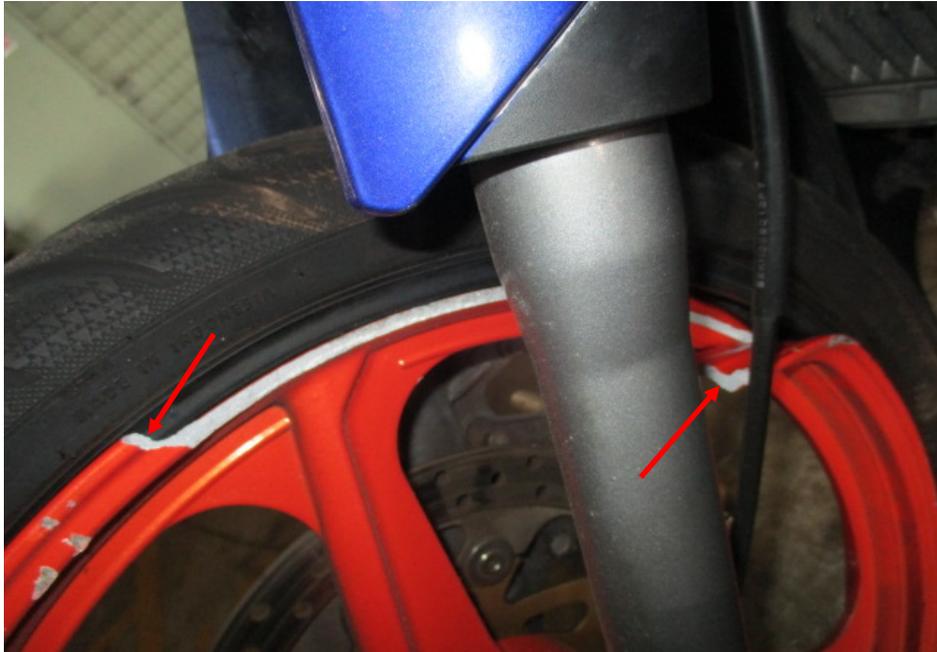
8. The 2 tyres were wrapped around alloy wheel rims. At the time of our inspection, we did not observe any visible damage on the rear wheel rim of the Motorcycle. However we did observe that the front wheel rim was broken. See photos 1 – 16 below.

Photo 14 shows the broken front wheel rim of the Motorcycle at the time of our inspection (arrowed).

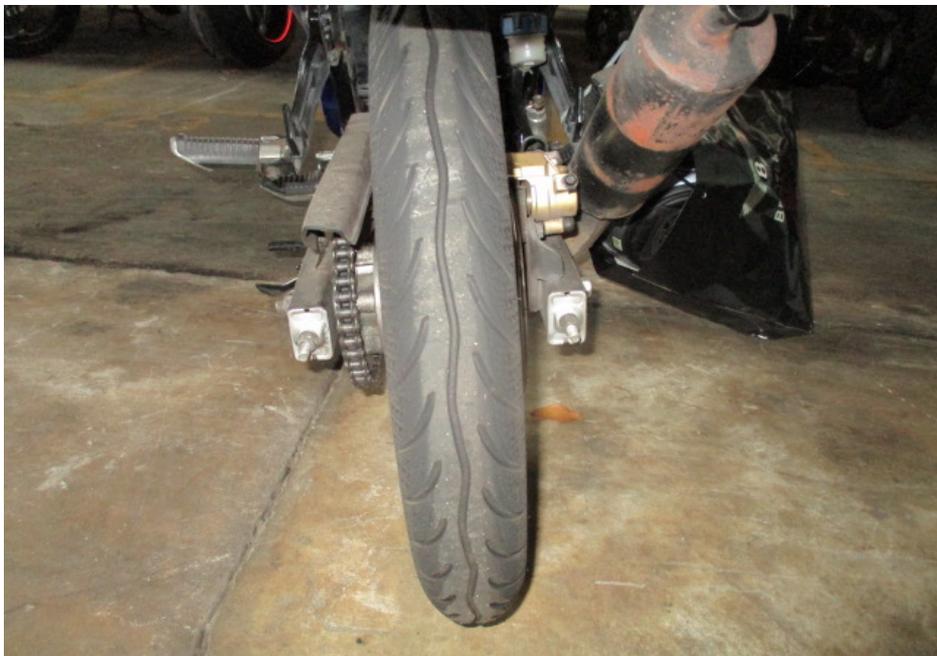
Photo 15 shows the condition of the Motorcycle's rear tyre. The rear tyre was observed to be in serviceable condition with remaining tread depth of approximately 4mm. The tyre was also observed to be sufficiently inflated for vehicular operation. We did not observe any tear, burst mark(s) and/or punctured hole(s) on the sidewalls as well as across the tread of the rear tyre.

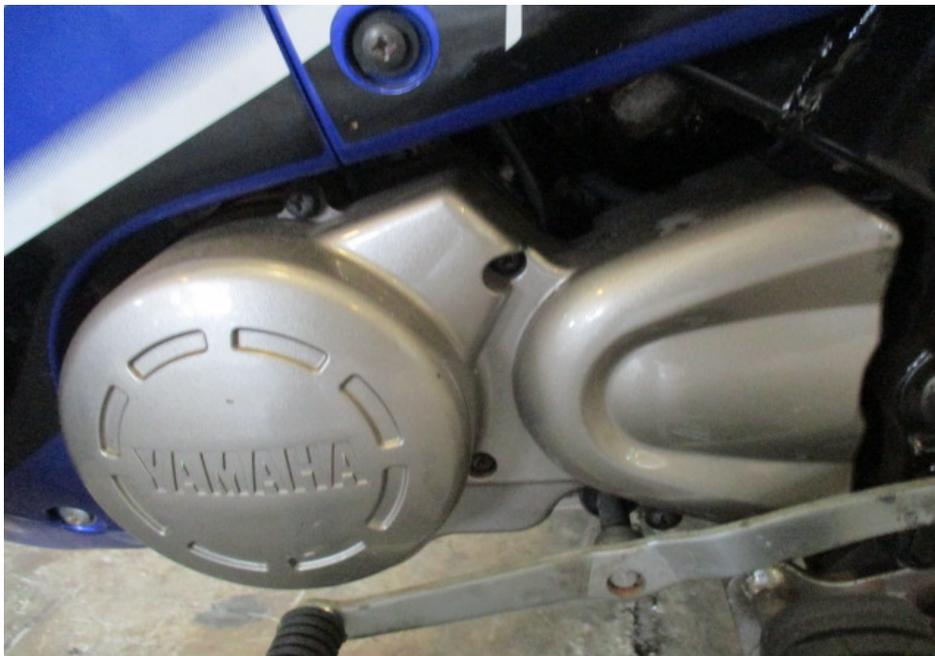
Photo 16 shows the left side of the engine of the Motorcycle at the time of our inspection. The various engine related parts and components were found to be intact with no visible damage. There was also no sign(s) or indication(s) of fluid leak observed around the left engine area of the Motorcycle.

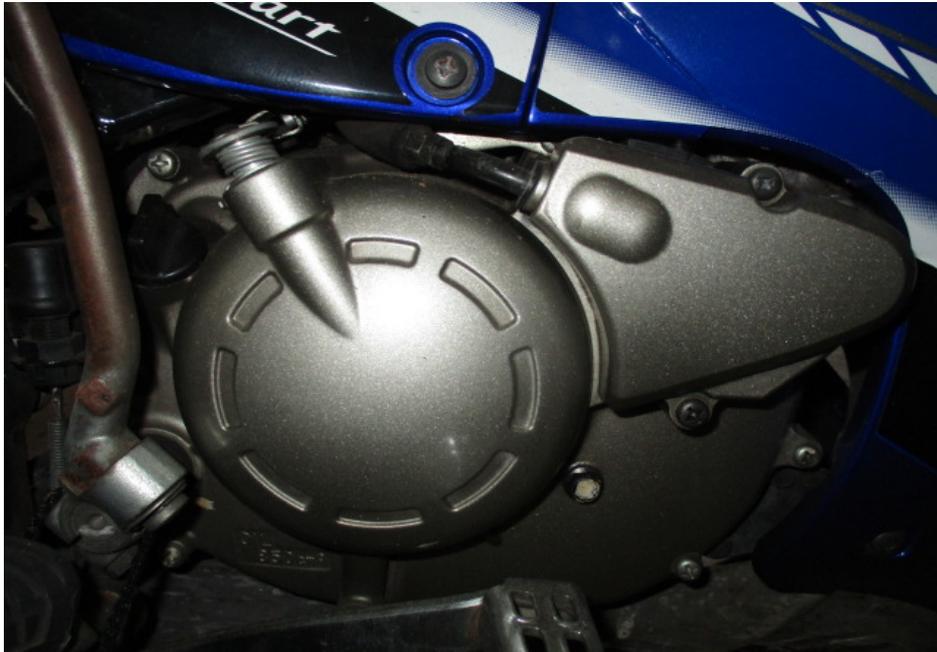
Photo 17 shows the right side of the engine of the Motorcycle at the time of our inspection. The various engine related parts and components were found to be intact with no visible damage. There was also no sign(s) or indication(s) of fluid leak observed around the right engine area of the Motorcycle.

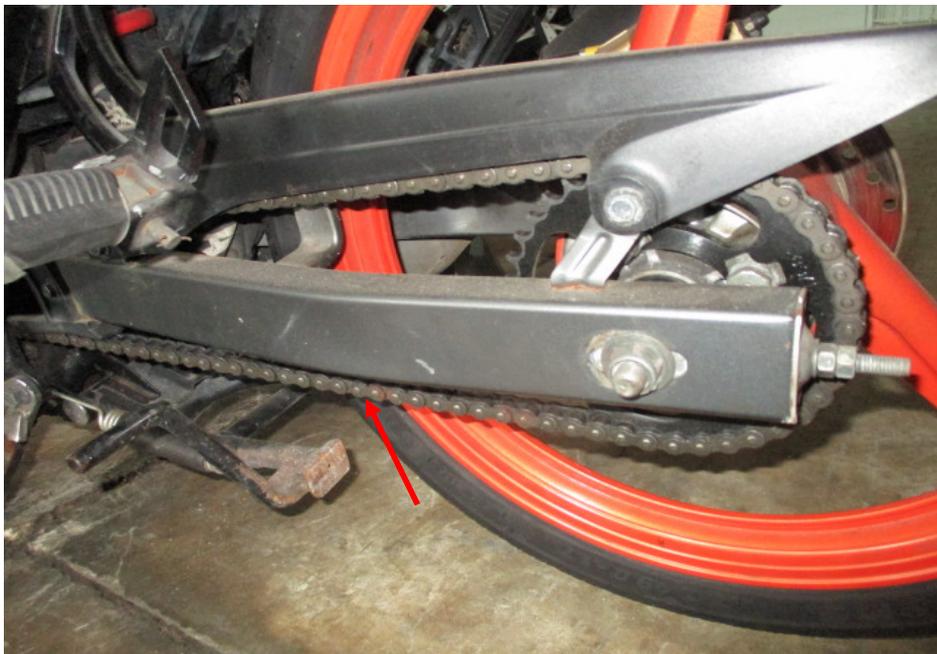
Photo 18 shows the general view of the gear train (arrowed) of the Motorcycle, which was observed to be intact with no misalignment. It was also adequately lubricated for operating purposes.

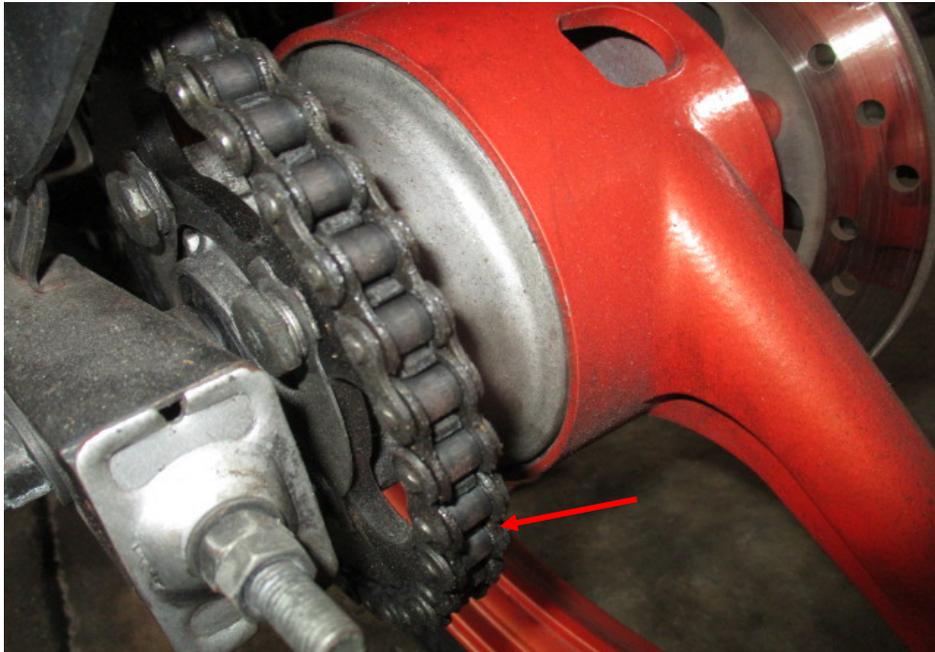
Photo 19 shows a closer view of the gear train (arrowed) of the Motorcycle, which was observed to be intact with no misalignment. It was also adequately lubricated for operating purposes.

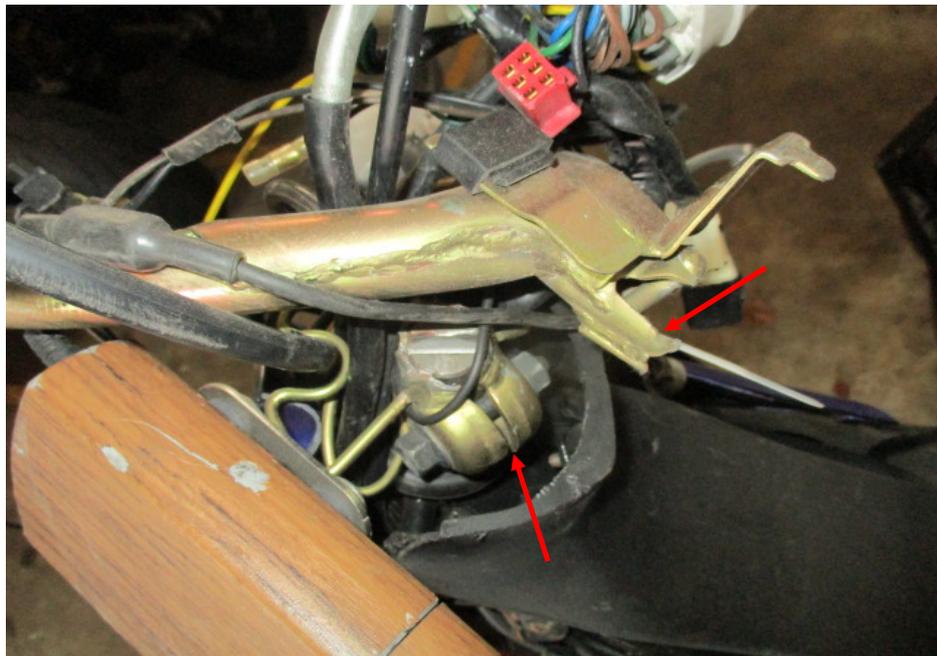
11. For this case, we were not able to conduct any test(s) on the steering system of the Motorcycle due to the damage of its front fork. The left front fork was found to be bent inwards as a result of the accident. The steering column was also observed to be broken as a result of the accident.

Photo 20 shows the broken steering column of the Motorcycle (arrowed) as a result of the accident. We were hence not able to conduct any tests on the steering system of the Motorcycle.

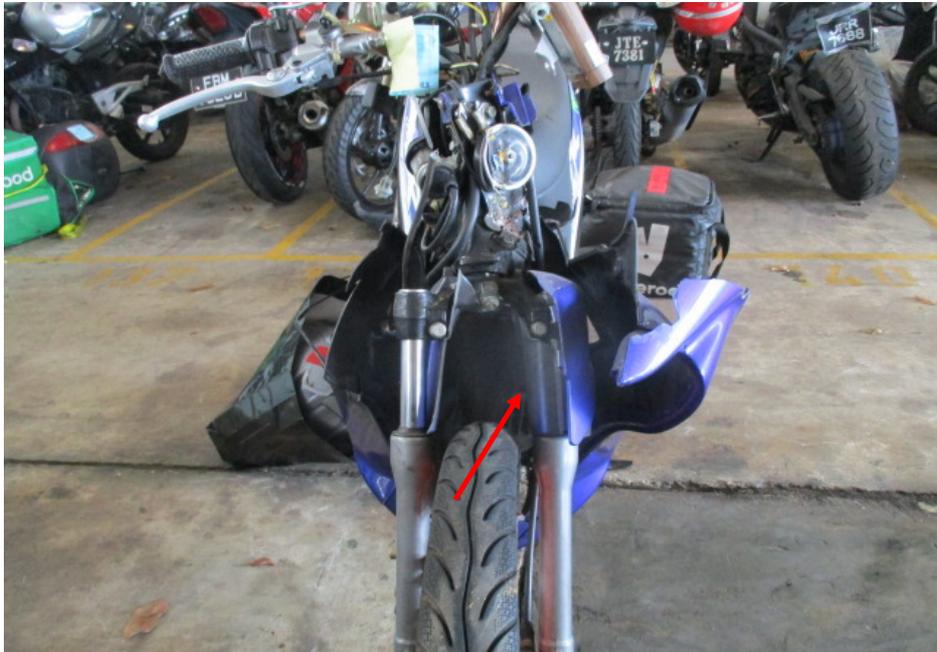
Photo 21 shows the front fork of the Motorcycle. The front left fork was observed to be bent inwards as a result of the accident (arrowed). We were hence not able to conduct any tests on the steering system of the Motorcycle.

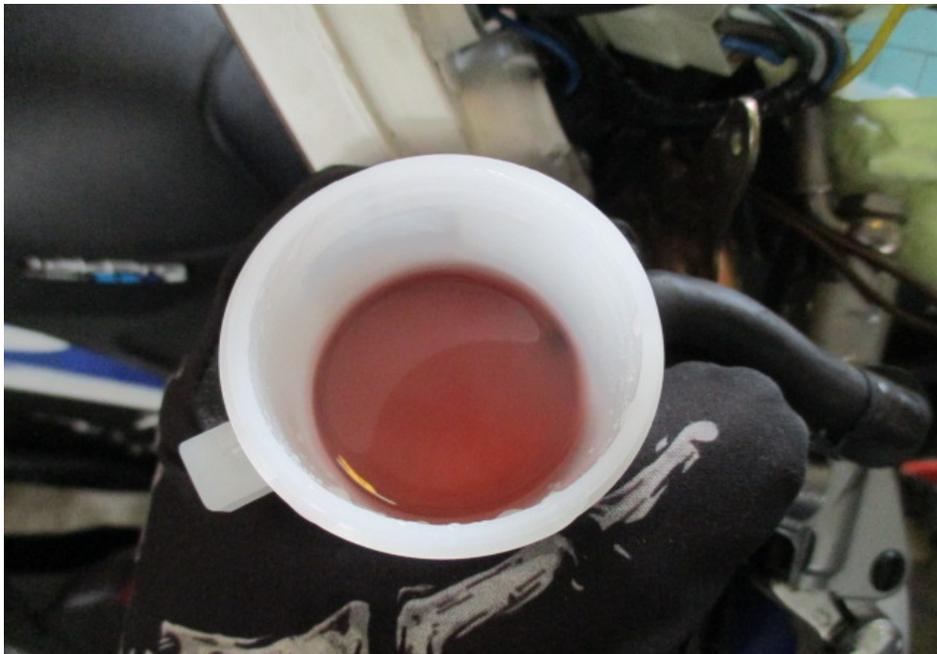
13. Our visual examination of the various components in the Motorcycle's front braking system like the brake disc, brake caliper and brake lever revealed all to be intact and without damage. We did observe that the front brake hose was cut as a result of the accident. Our checks on the brake fluid for the front brake of the Motorcycle revealed it to be at an insufficient level for operating purposes due to the leakage of brake fluid caused by the cut front brake hose as a result of the accident.

Photo 22 shows the brake fluid reservoir for the front brake of the Motorcycle. The brake fluid was not contaminated however it was observed to be at an insufficient level for operating purposes due to the brake fluid leak caused by the cut front brake hose as a result of the accident.

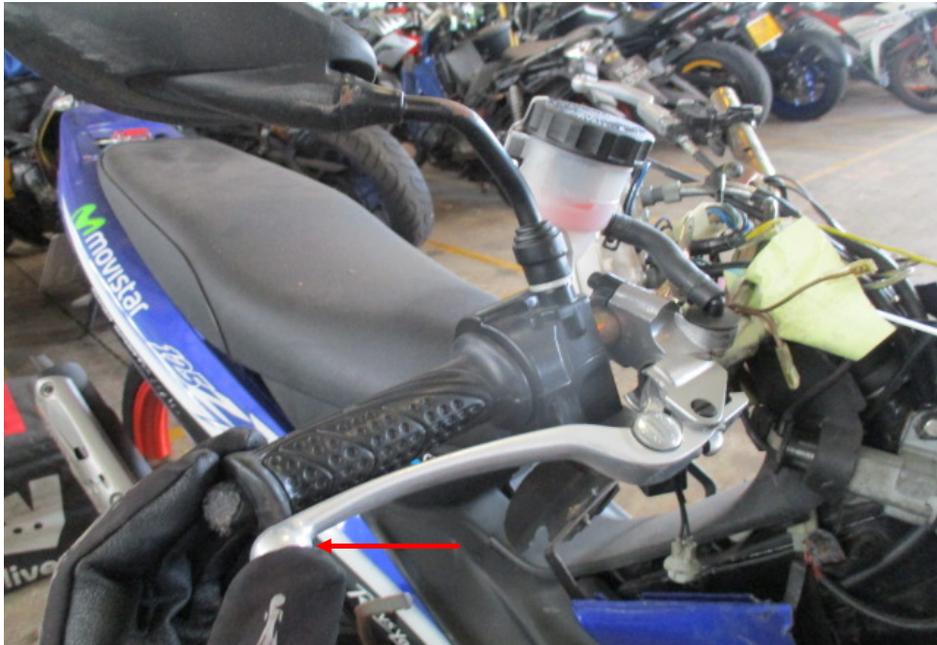
Photo 23 shows the front brake lever being depressed. There was no resistance felt (spongy like feel) upon pressing the front brake lever (arrowed). This would indicate that there is a leakage of pressure/vacuum in the brake system due to the cut front brake hose as a result of the accident.

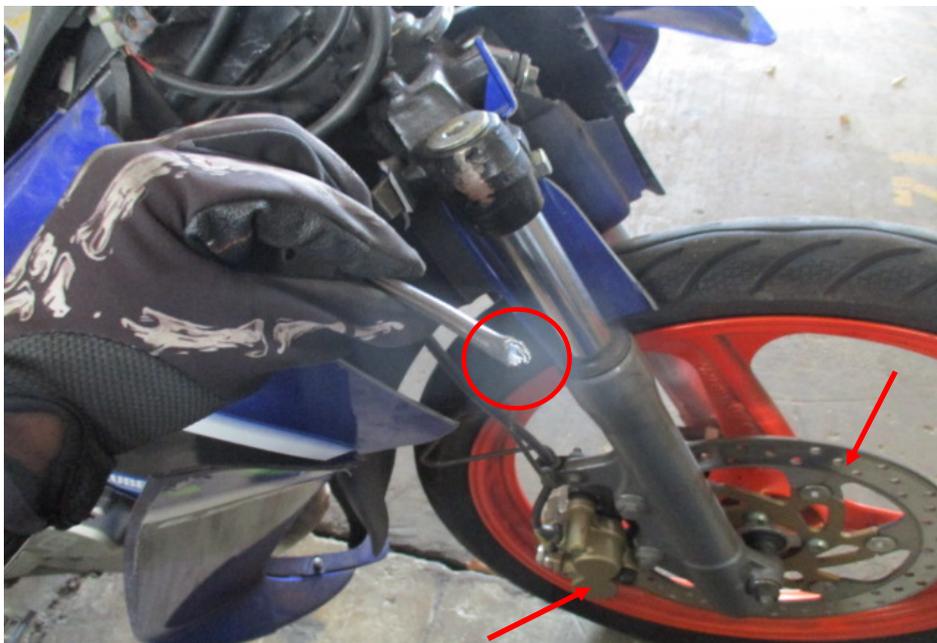
Photo 24 shows a close up view of the front brake caliper, front brake disc (arrowed) and front brake hose of the Motorcycle, which are all part of the components in the hydraulic front brake system of the Motorcycle. Our visual checks of the front brake caliper and front brake disc had revealed all to be intact with no visible damage. However we did observe that the front brake hose had been cut as a result of the accident (circled).

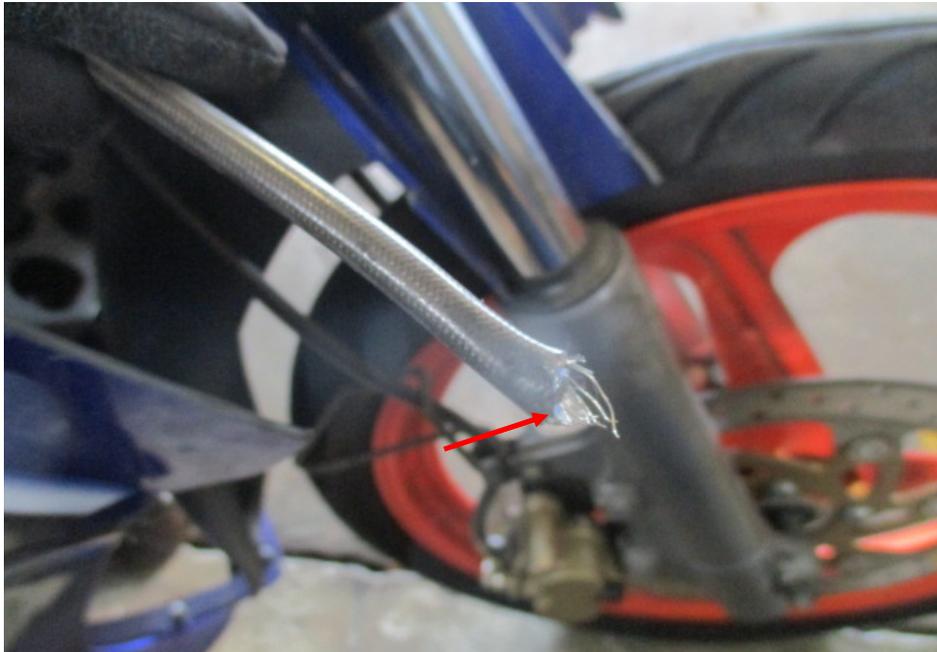
Photo 25 shows a close up view of the front brake hose which was observed to be cut as a result of the accident (arrowed).

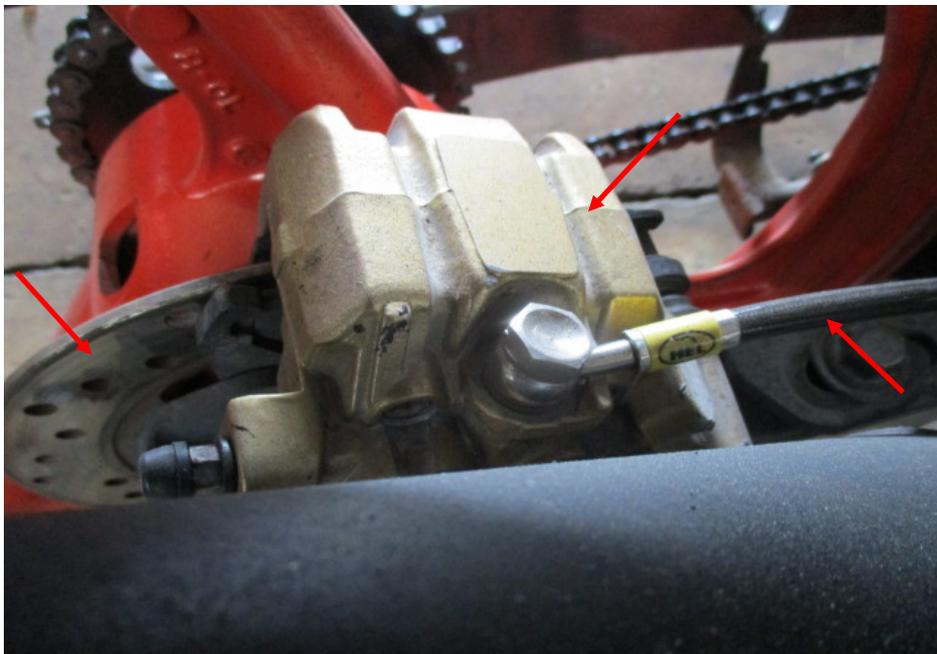
14. Our visual examination of the various components in the Motorcycle's rear braking system like the brake disc, brake caliper, brake foot pedal and brake hose revealed all to be intact and without damage. There was also no leakage of brake fluid observed along the brake hose. This was from the respective brake fluid reservoir to the rear brake caliper of the Motorcycle. The brake fluid for the rear brake was also found to be of sufficiently level and without any contamination.

Photo 26 shows a close up view of the rear brake caliper, rear brake disc and rear brake hose (arrowed) of the Motorcycle, which are all part of the components in the hydraulic rear brake system of the Motorcycle. Our visual checks of these various components had revealed all to be intact with no visible damage. No leakage of brake fluid was also observed.

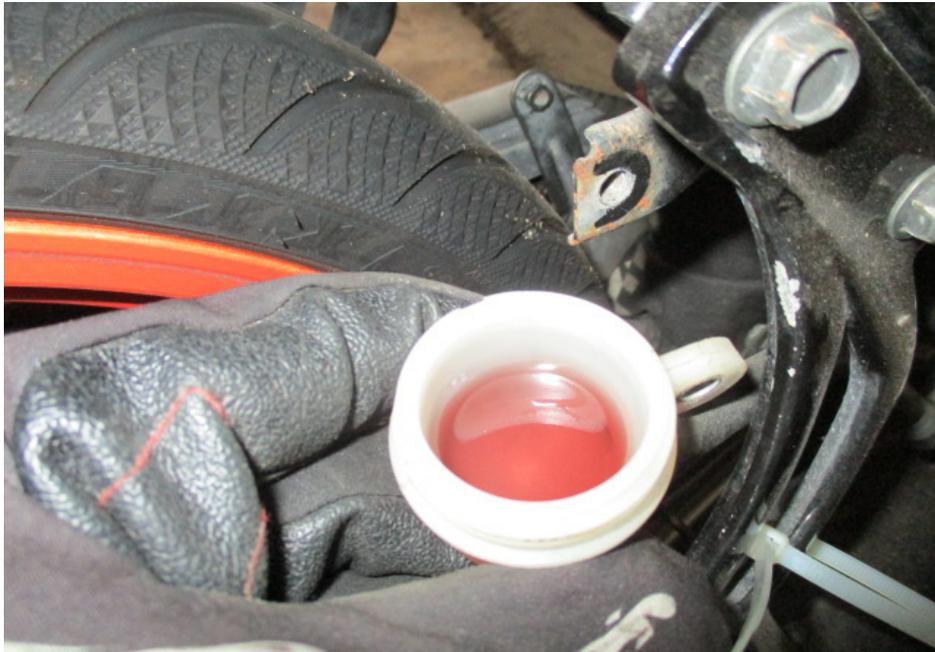
Photo 27 shows the brake fluid reservoir for the rear brake of the Motorcycle. The brake fluid was observed to be of sufficient level and without contamination for operational purposes.
