Your Ref: TP/IP/55759/2019
Our Ref : CI/TPD19020635/N

Fatal Accident Investigation Team

Traffic Police Department
Singapore Police Force
10 Ubi Avenue 3
Singapore 408865

INSPECTION REPORT OF MOTORCYCLE FBK 7189L

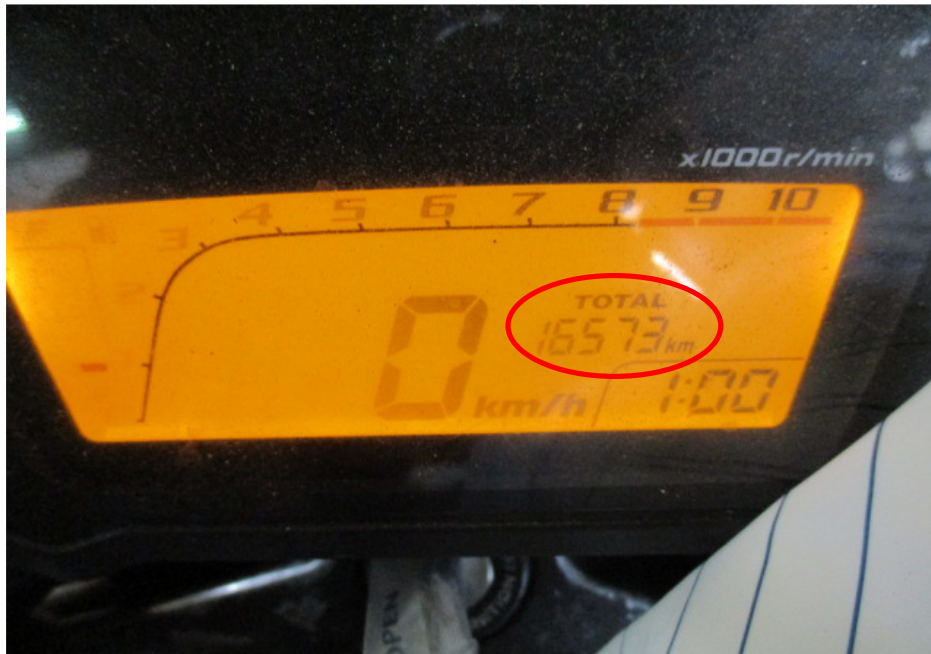
Photo 1 shows the speedometer gauge of the Motorcycle where the mileage recorded at the time of our inspection was 16, 573km (circled).

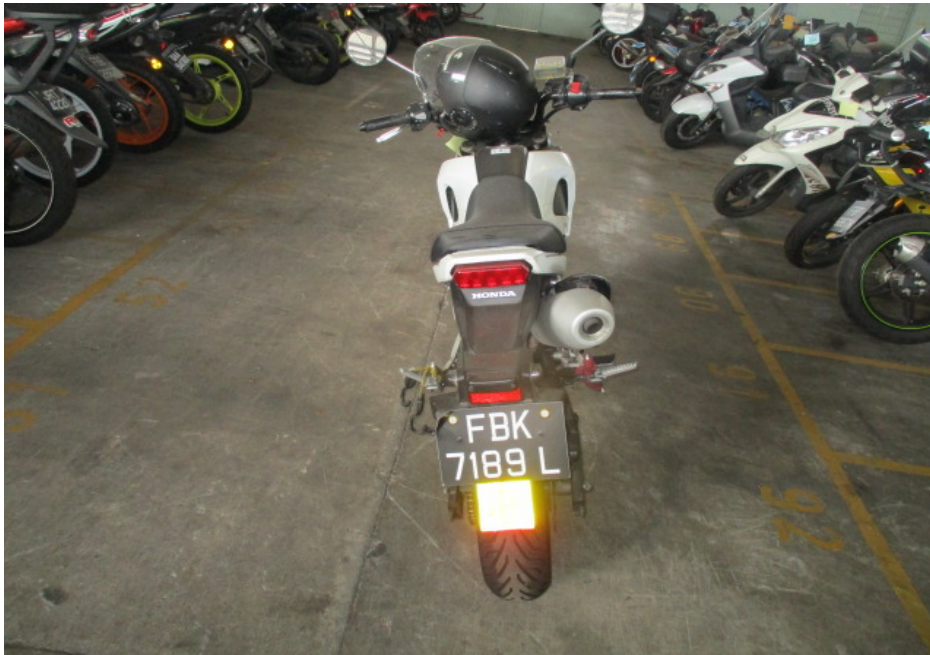
Photo 2 shows a general view of the rear body of the Motorcycle at the time of our inspection. The Motorcycle was observed to have sustained damages along its frontal and left portion.

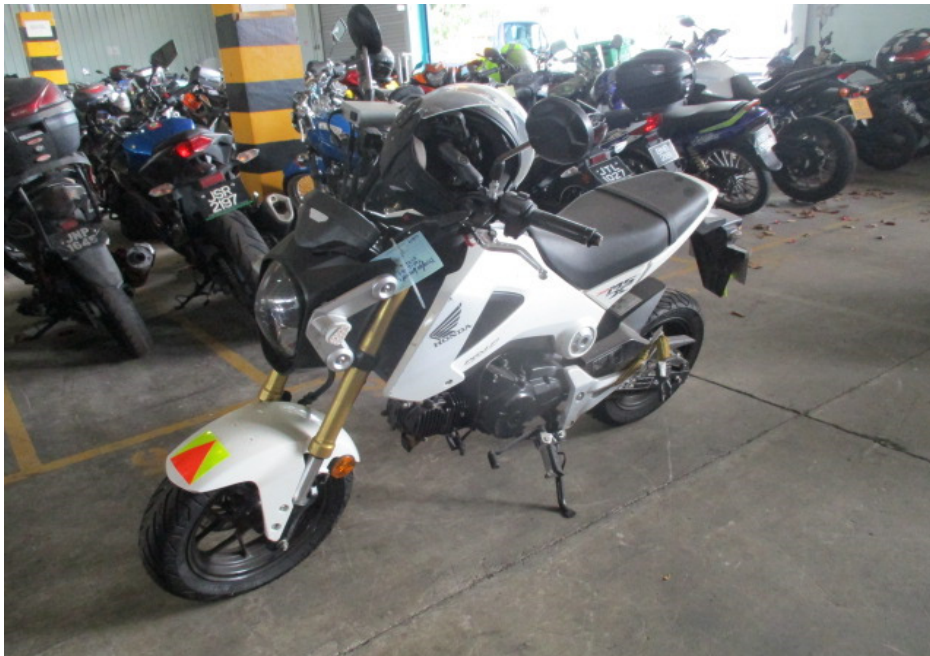
4. The mileage of the Motorcycle at the time of our inspection was 16, 573km.
5. The Motorcycle was observed to have sustained damages along its frontal and left portion. The body parts that were found to have been damaged include its front number plate, headlight assembly, left front signal lamp, front mudguard, left cowling, clutch lever, gear shift rod, gear shift pedal, left front footrest and left front footrest bracket, amongst others.

Photo 3 shows a general view of the left body of the Motorcycle at the time of our inspection. The Motorcycle was observed to have sustained damages along its frontal and left portion. Amongst the body parts that were found to have been damaged include its front number plate, headlight assembly, left front signal lamp, front mudguard, left cowling, clutch lever, gear shift rod, gear shift pedal, left front footrest and left front footrest bracket, amongst others.

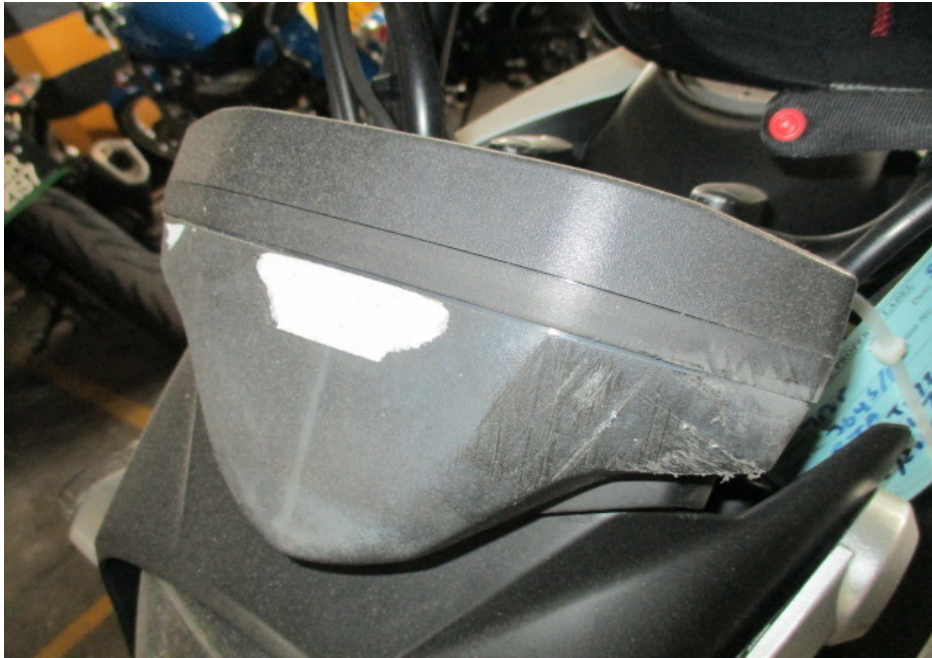
Photo 4 shows a closer view of the speedometer outer cover which was amongst the body parts at the front body of the Motorcycle that had sustained damage as a result of the accident.

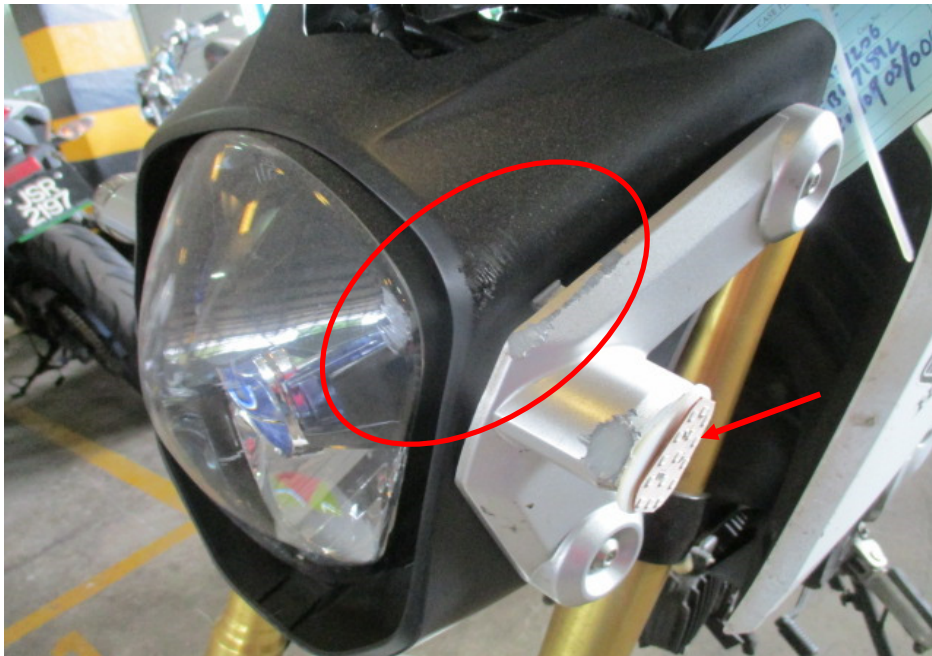
Photo 5 shows a close up view of the headlight assembly (circled) and left front signal lamp (arrowed) which were amongst the body parts of the Motorcycle that had sustained damage as a result of the accident.

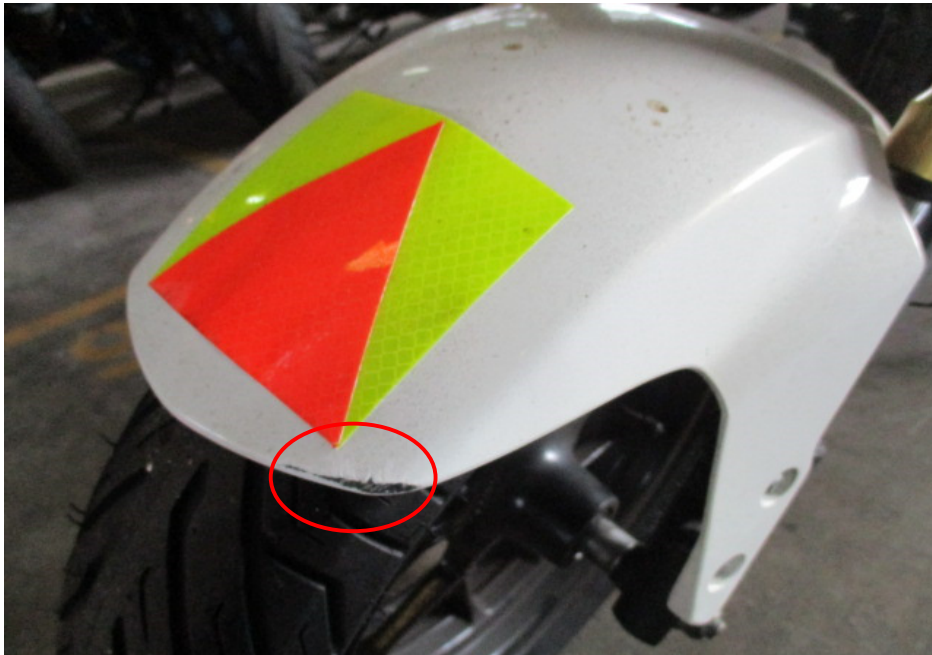
Photo 6 shows a closer view of the front mudguard which was amongst the body parts at the front body of the Motorcycle that had sustained damage as a result of the accident (circled).

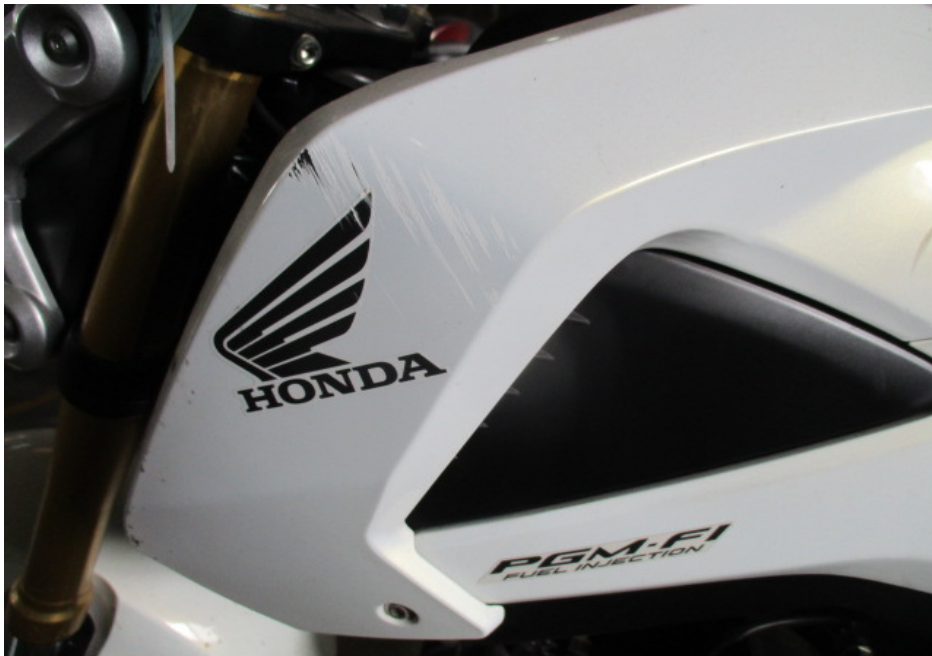
Photo 7 shows a closer view of the left cowling of the Motorcycle that had sustained damage as a result of the accident.

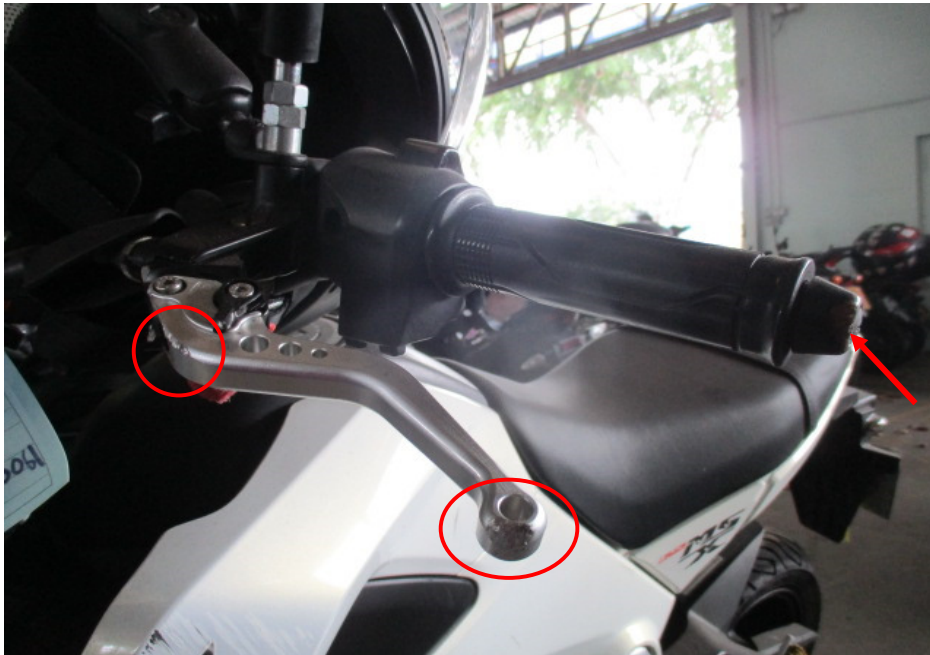
Photo 8 shows a closer view of the clutch lever (circled) and left handlebar end (arrowed) which were amongst the body parts of the Motorcycle that had sustained damage as a result of the accident.

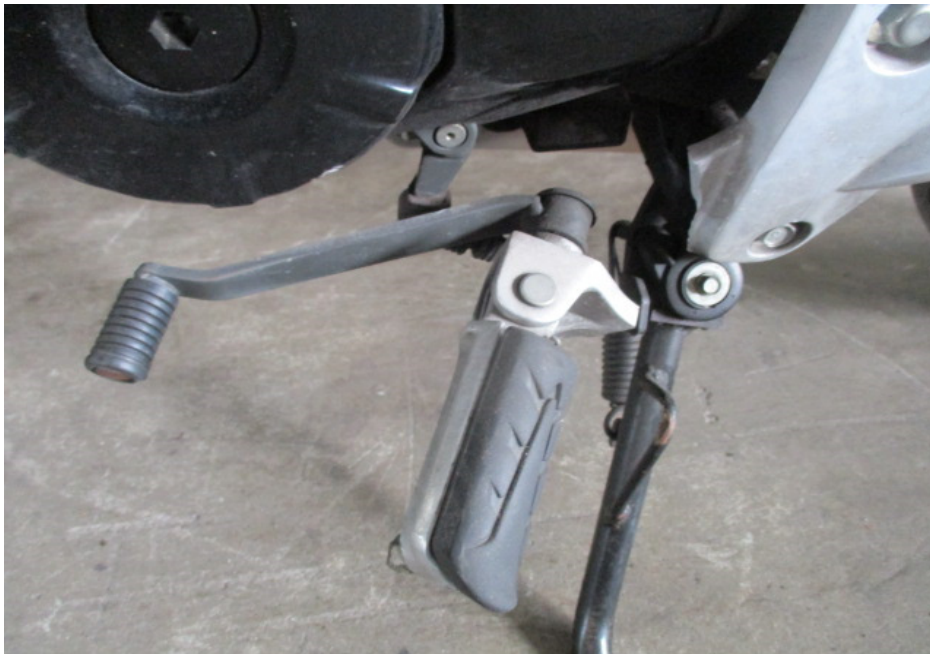
Photo 9 shows a closer view of the broken gear shift rod, gear shift pedal, left front footrest and left front footrest bracket, which were amongst the body parts of the Motorcycle that had sustained damage as a result of the accident.

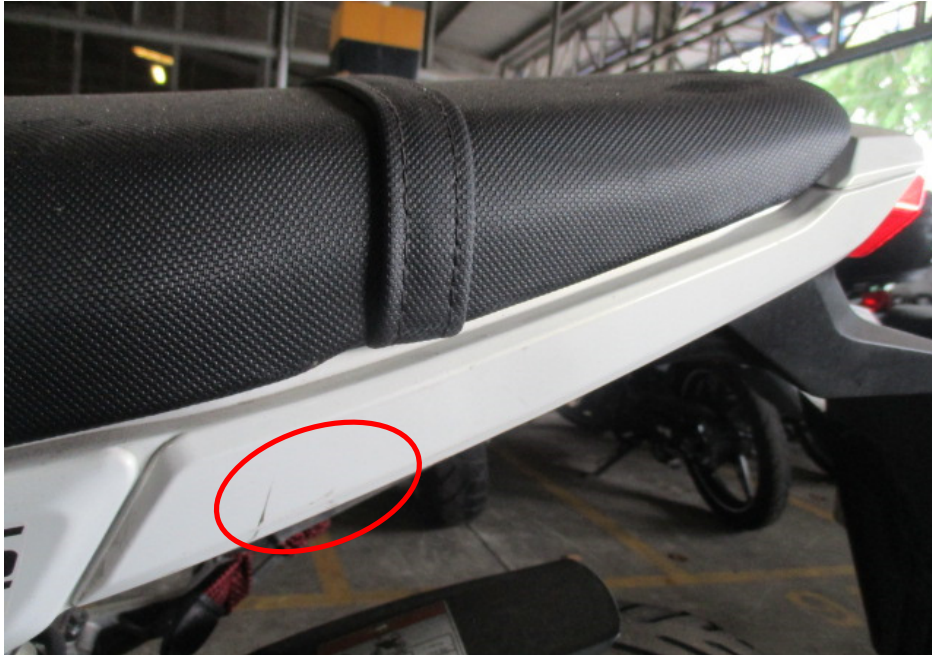
Photo 10 shows the left rear side cover of the Motorcycle which was observed to be damaged as a result of the accident (circled).

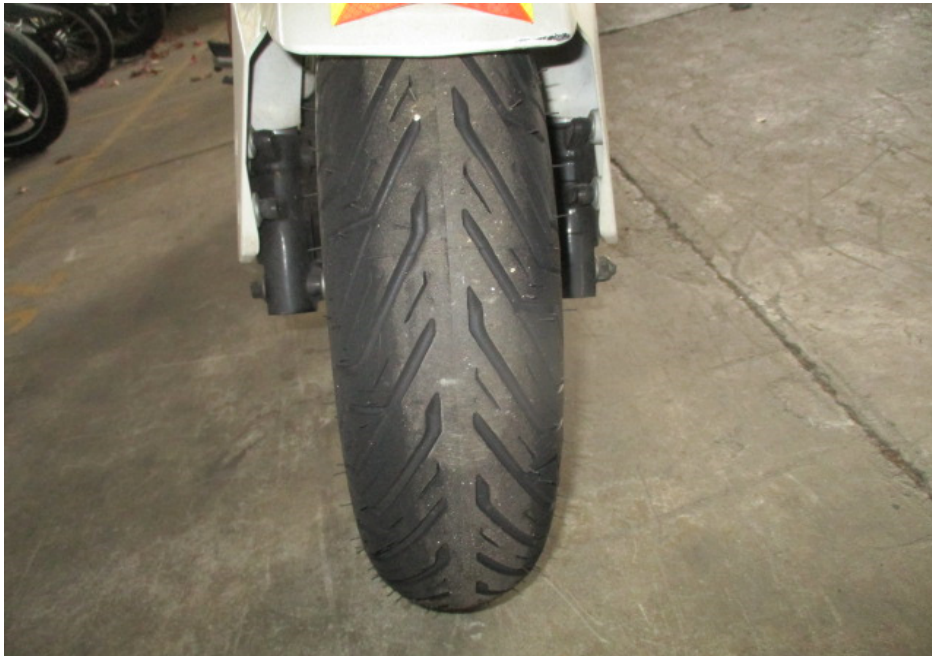
Photo 11 shows the condition of the Motorcycle's front tyre. The front tyre was observed to be in serviceable condition with remaining tread depth of approximately 4mm. There was no tear, burst mark(s) and/or punctured hole(s) on the sidewalls as well as across the tread of the front tyre.

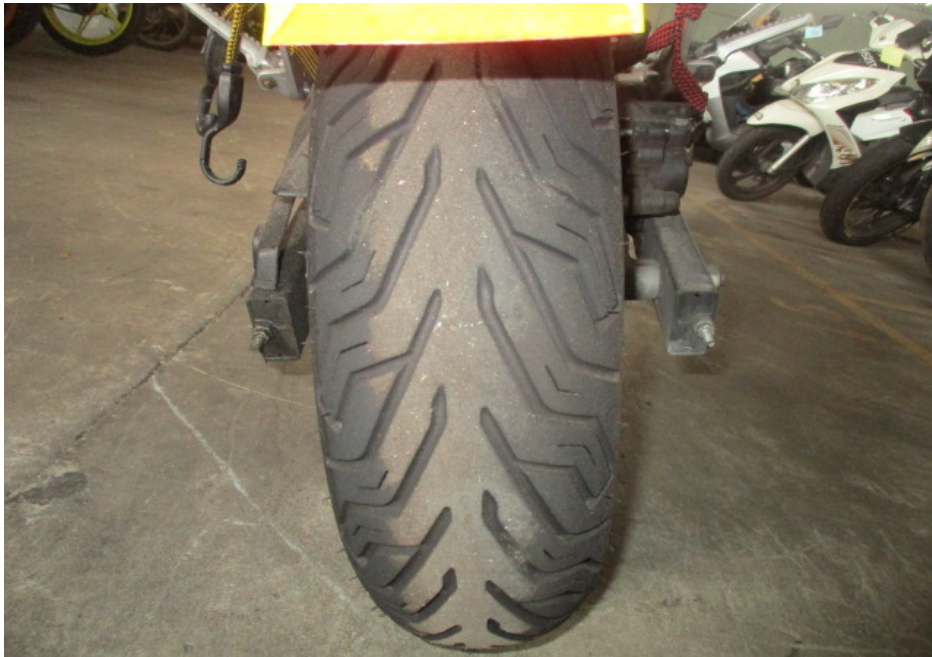
Photo 12 shows the condition of the Motorcycle's rear tyre. The rear tyre was observed to be in serviceable condition with remaining tread depth of approximately 4mm. The tyre was also observed to be sufficiently inflated for vehicular operation. We did not observe any tear, burst mark(s) and/or punctured hole(s) on the sidewalls as well as across the tread of the rear tyre.

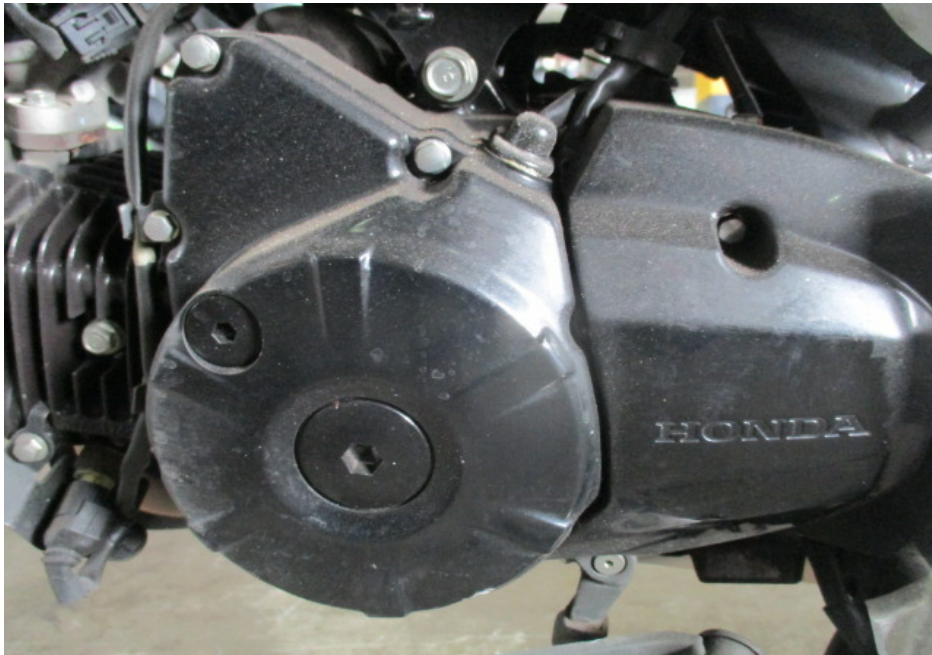
Photo 13 shows the left side of the engine of the Motorcycle at the time of our inspection. The various engine related parts and components were found to be intact with no visible damage. There was also no sign(s) or indication(s) of fluid leak observed around the left engine area of the Motorcycle.

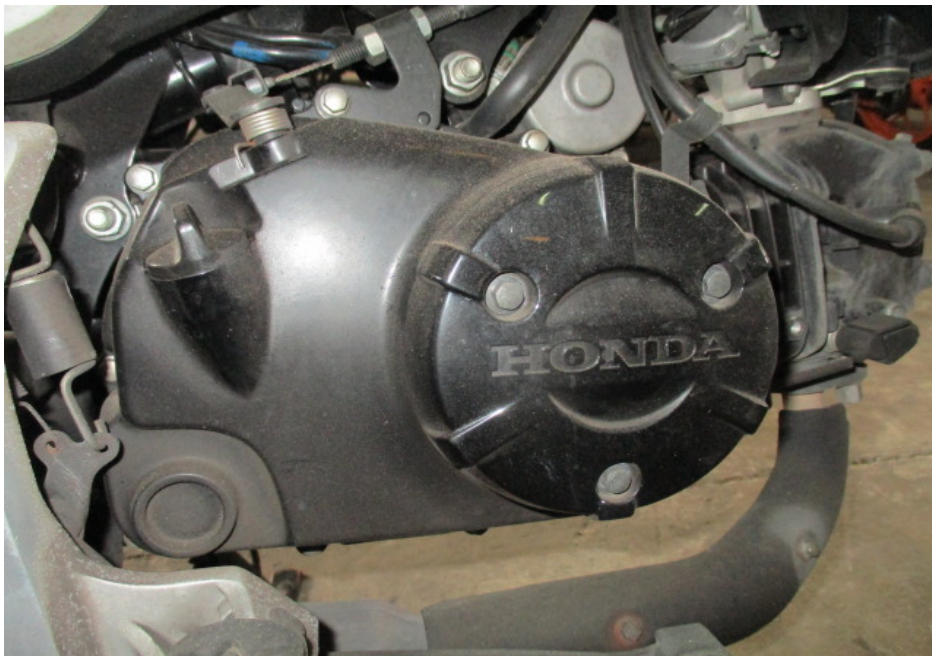
Photo 14 shows the right side of the engine of the Motorcycle at the time of our inspection. The various engine related parts and components were found to be intact with no visible damage. There was also no sign(s) or indication(s) of fluid leak observed around the right engine area of the Motorcycle.

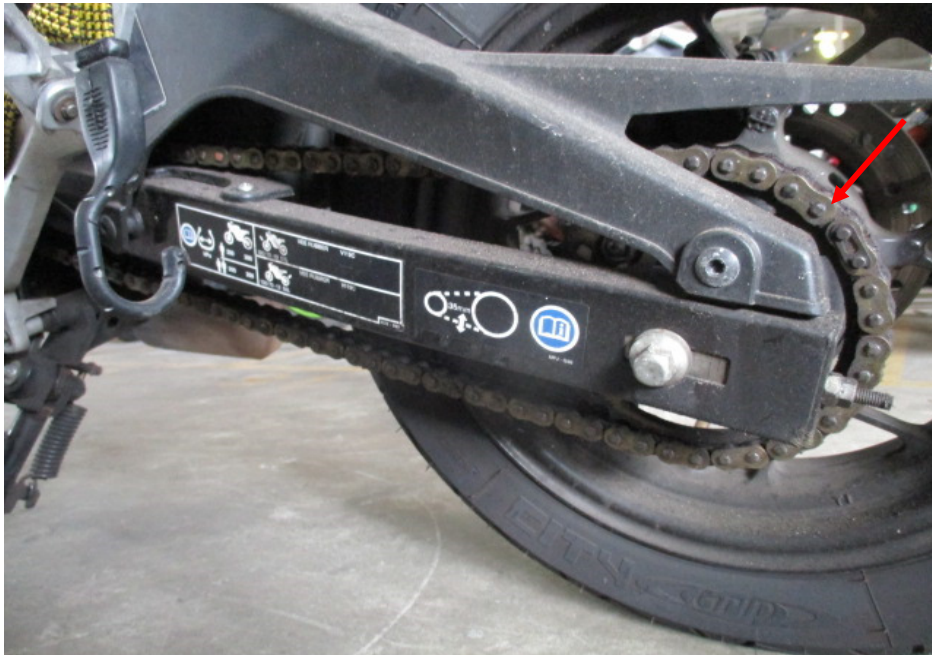
Photo 15 shows the general view of the gear train (arrowed) of the Motorcycle, which was observed to be intact with no misalignment. It was also adequately lubricated for operating purposes.

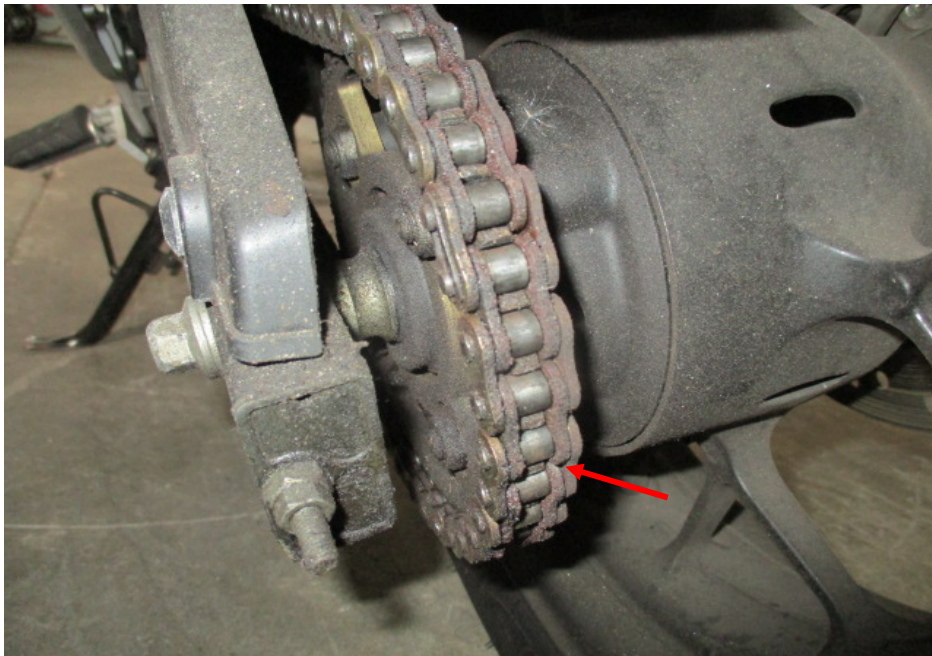
Photo 16 shows a closer view of the gear train (arrowed) of the Motorcycle, which was observed to be intact with no misalignment. It was also adequately lubricated for operating purposes.

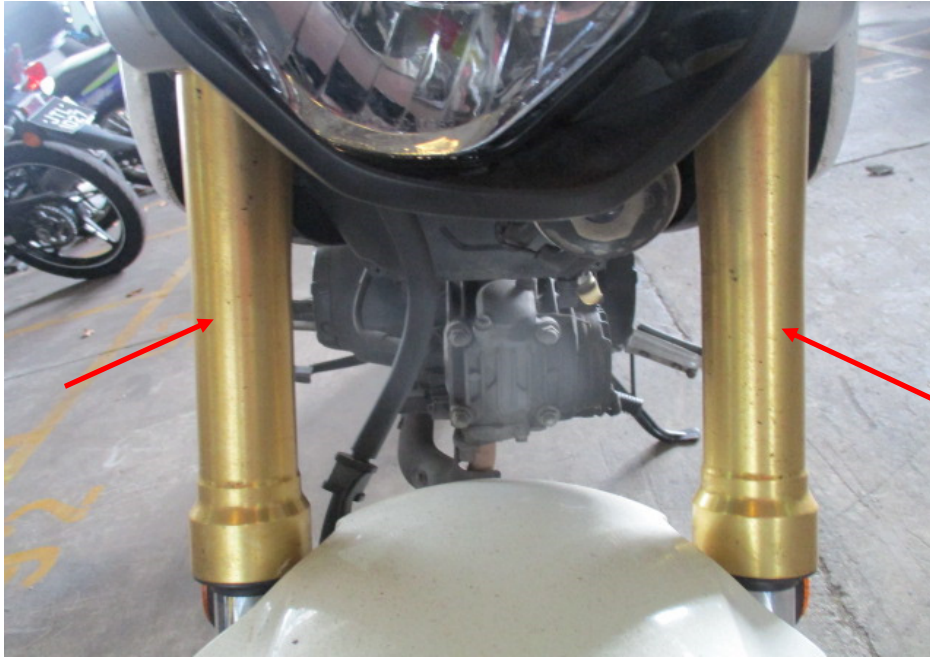
Photo 17 shows the front fork (arrowed) of the Motorcycle. The front fork and fork bracket of the Motorcycle were both found to be intact and undamaged. Turning the Motorcycle's handle bar towards the left and right did not produce any abnormal free play and/or resistance. The steering system of the Motorcycle was in serviceable condition at the time of our inspection.

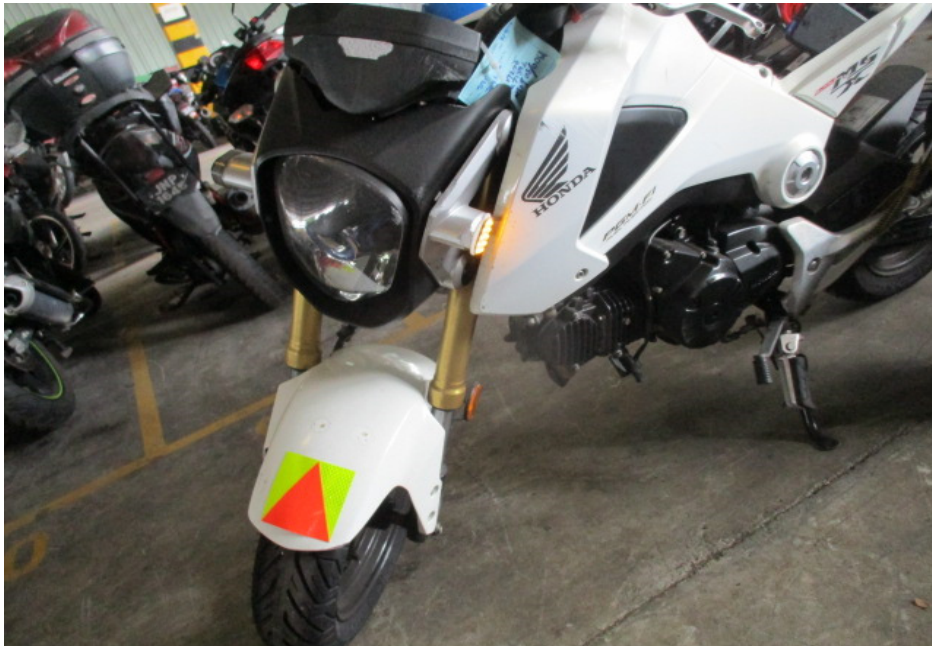
Photo 18 shows the front wheel of the Motorcycle turned towards its full left. Turning the Motorcycle's handle bar towards the left and right did not produce any abnormal free play and/or resistance. This would indicate that the steering system of the Motorcycle was in serviceable condition at the time of our inspection.

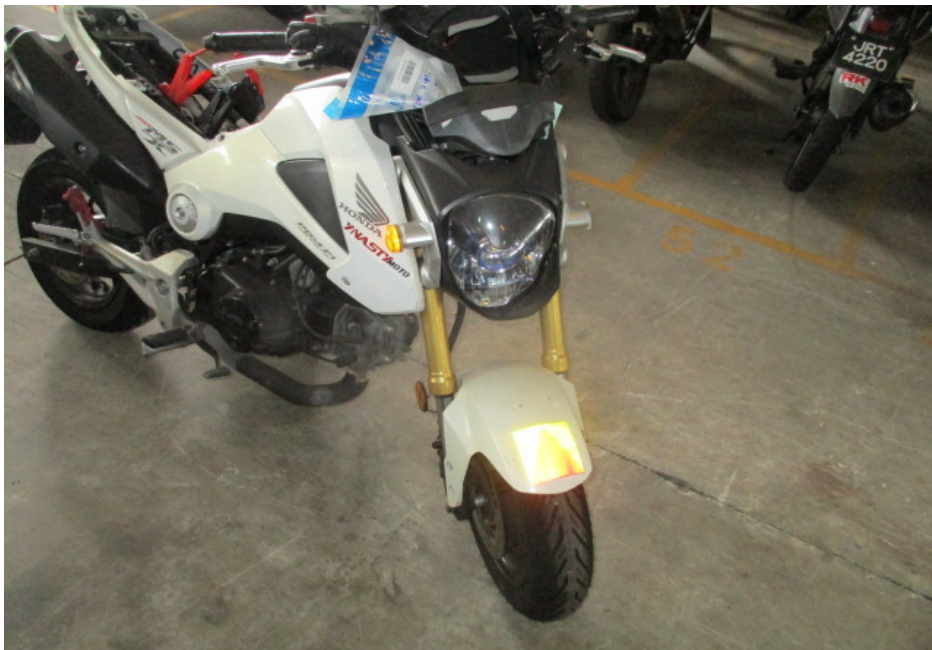
Photo 19 shows the front wheel of the Motorcycle turned towards its full right. Turning the Motorcycle's handle bar towards the left and right did not produce any abnormal free play and/or resistance. This would indicate that the steering system of the Motorcycle was in serviceable condition at the time of our inspection.

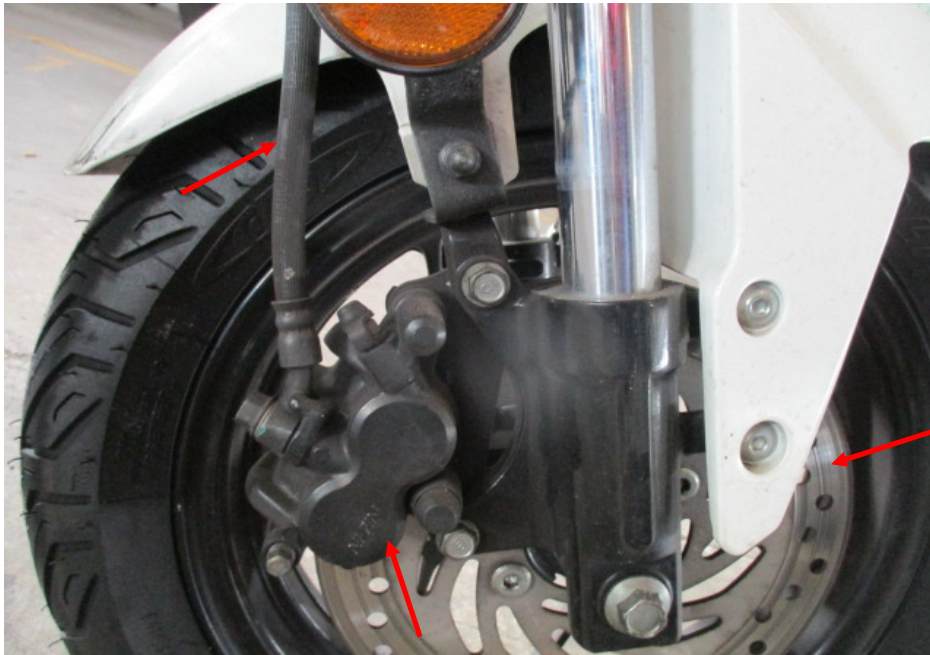
Photo 20 shows a close up view of the front brake caliper, front brake disc and front brake hose (arrowed) of the Motorcycle, which are all part of the components in the hydraulic front brake system of the Motorcycle. Our visual checks of these various components had revealed all to be intact with no visible damage. No leakage of brake fluid was also observed.

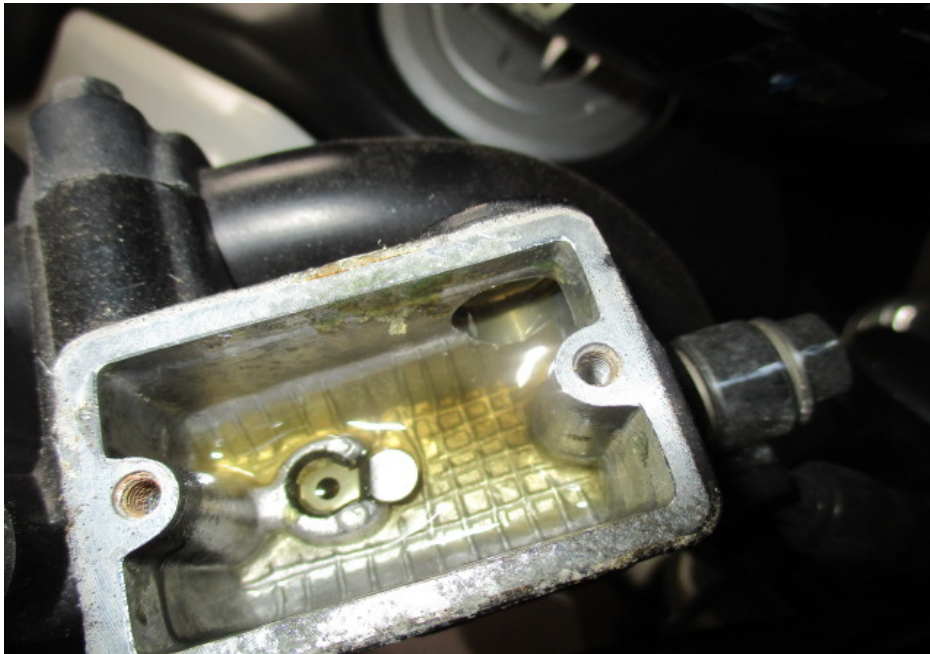
13. Our visual examination of the various components in the Motorcycle's braking system like the brake discs, brake calipers, brake lever, brake foot pedal and brake hoses revealed all to be intact and without damage. There was also no leakage of brake fluid observed along the brake hoses. This was from the respective brake fluid reservoirs to the front brake caliper and rear brake caliper of the Motorcycle. The brake fluid for the rear brake was found to be of sufficiently level and without any contamination. The brake fluid for the front brake was also found to be without any contamination however we had observed that it was of insufficient level for operational purposes.

Photo 21 shows the brake fluid reservoir for the front brake of the Motorcycle. The brake fluid was observed to be without contamination. However it was found to be of insufficient level for operational purposes.

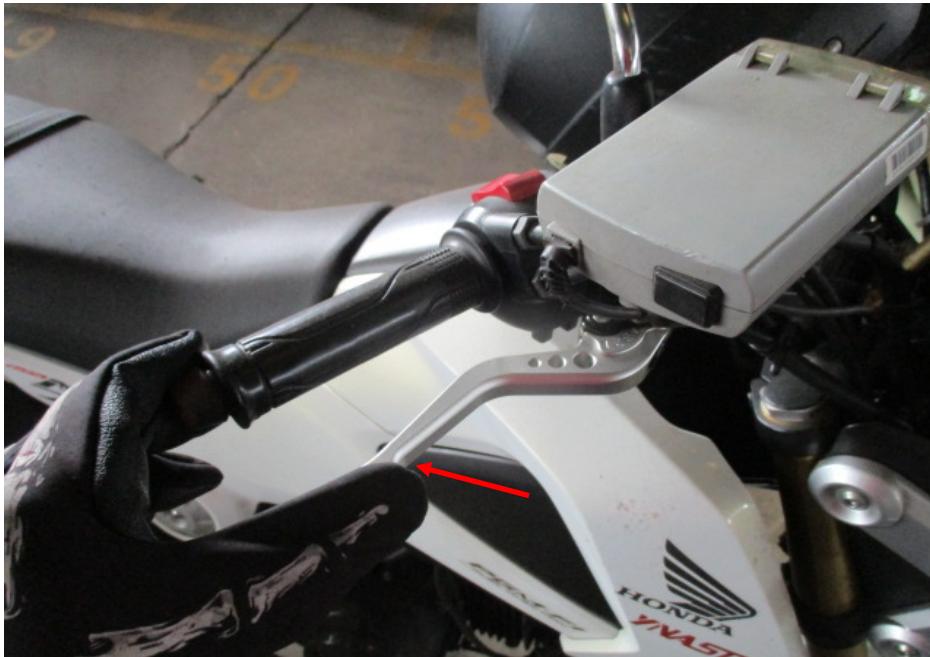
Photo 22 shows the front brake lever being depressed. There was some resistance felt (spongy like feel) upon pressing the front brake lever (arrowed). This would indicate that there is no leakage of pressure/vacuum in the brake system.

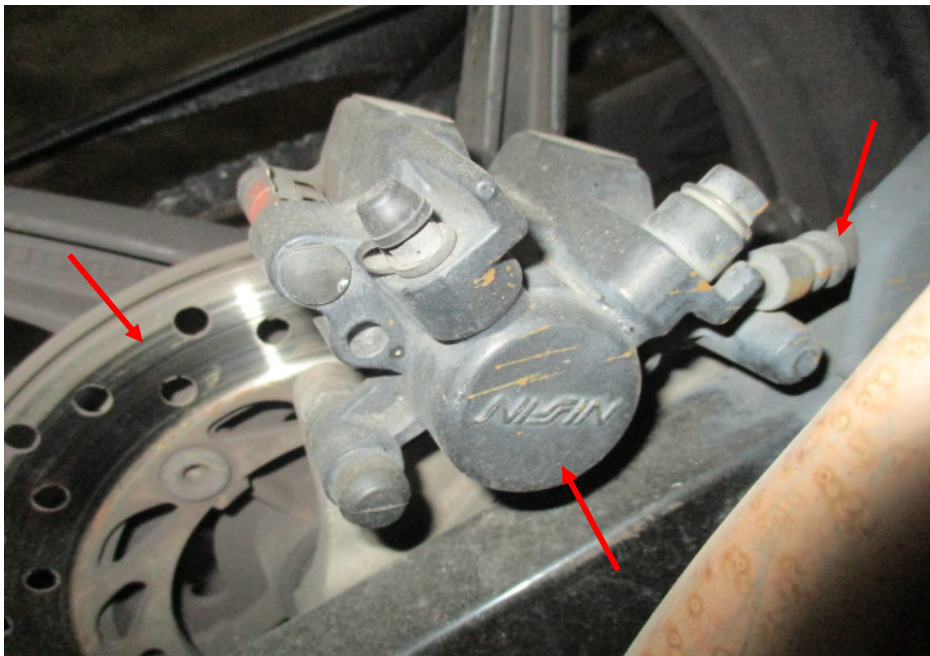
Photo 23 shows a close up view of the rear brake caliper, rear brake disc and rear brake hose (arrowed) of the Motorcycle, which are all part of the components in the hydraulic rear brake system of the Motorcycle. Our visual checks of these various components had revealed all to be intact with no visible damage. No leakage of brake fluid was also observed.
