Your Ref: BMW 530i  
(chassis number WBAJA52060WC08148)  
Our Ref : CI/TP19020680/D

21 November 2019

**INSPECTION REPORT OF AN UNREGISTERD BMW 530i MOTOR CAR WITH CHASSIS NUMBER WBAJA52060WC08148**

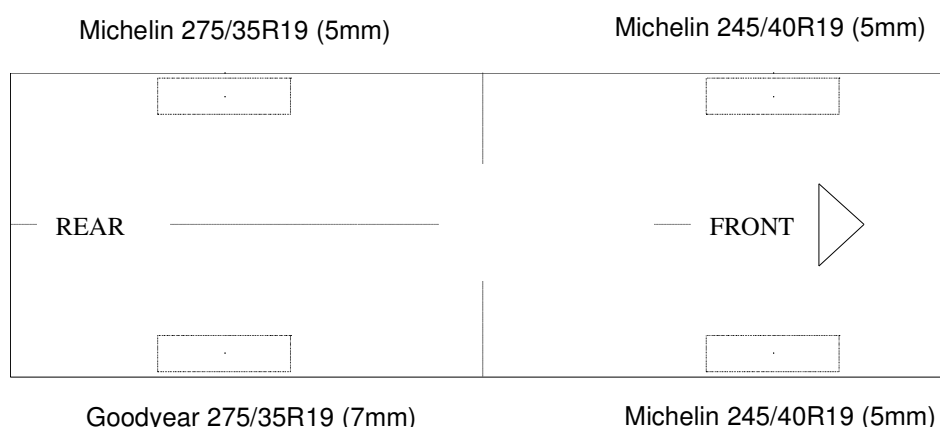
6. It was fitted with 19inch sport wheel rims that were wrapped with tyres that were observed to be of serviceable condition. The tyres were also sufficiently inflated for vehicular operation. The tyre brand, tyre size and approximate remaining tread depth of the 4 tyres of the Motor Car were recorded as follows: -

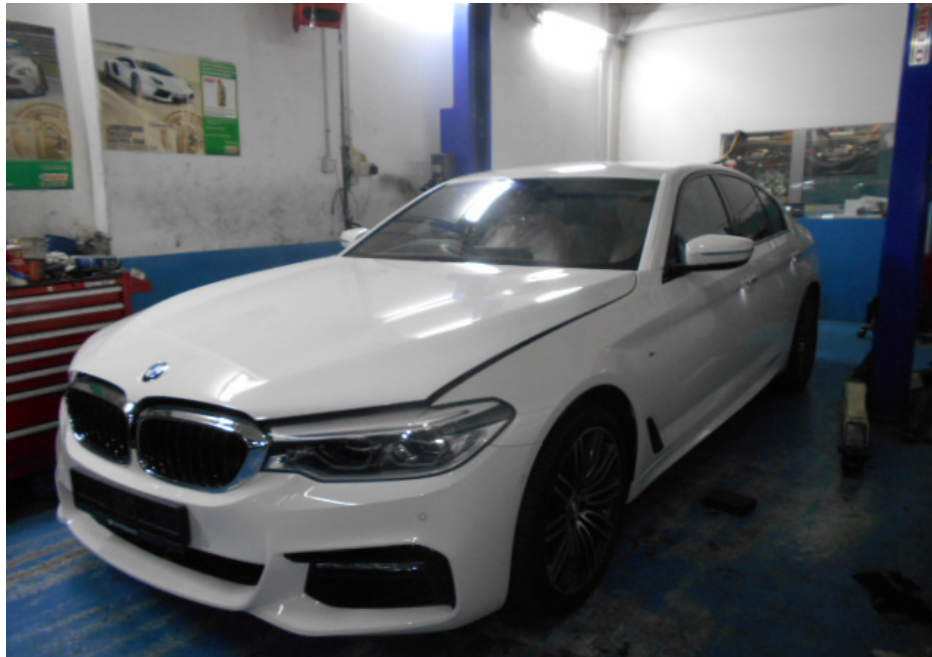
5. The Motor Car was observed to be in a relatively good general condition with no loose exterior fittings observed.

**Photo 1** shows a general view of the front left body of the Motor Car at the time of my inspection. The Motor Car was observed to be in relatively good general condition with no loose exterior fittings observed.

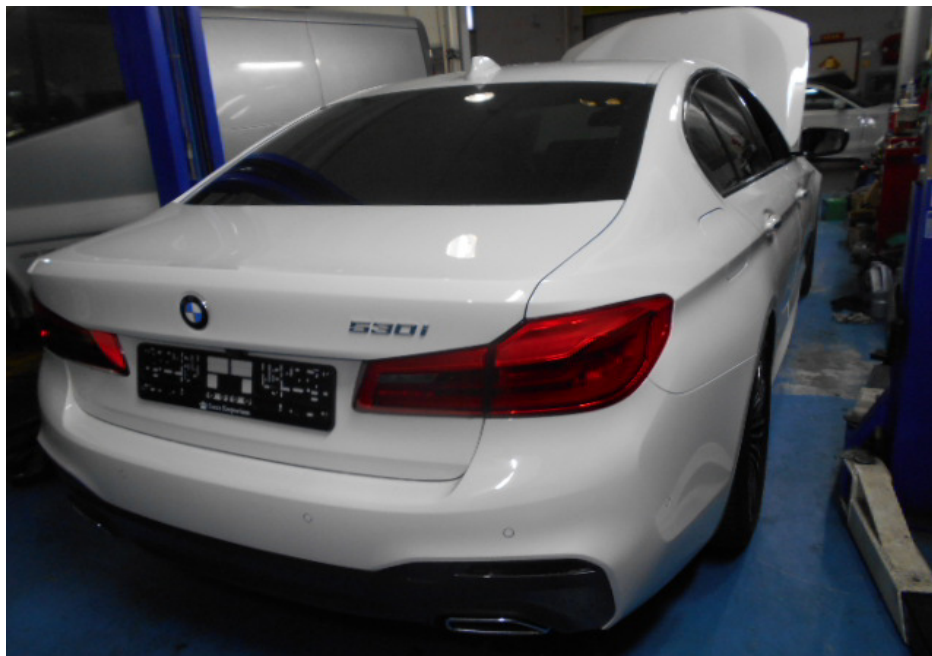
**Photo 2** shows a general view of the rear right body of the Motor Car at the time of my inspection. The Motor Car was observed to be in relatively good general condition with no loose exterior fittings observed.

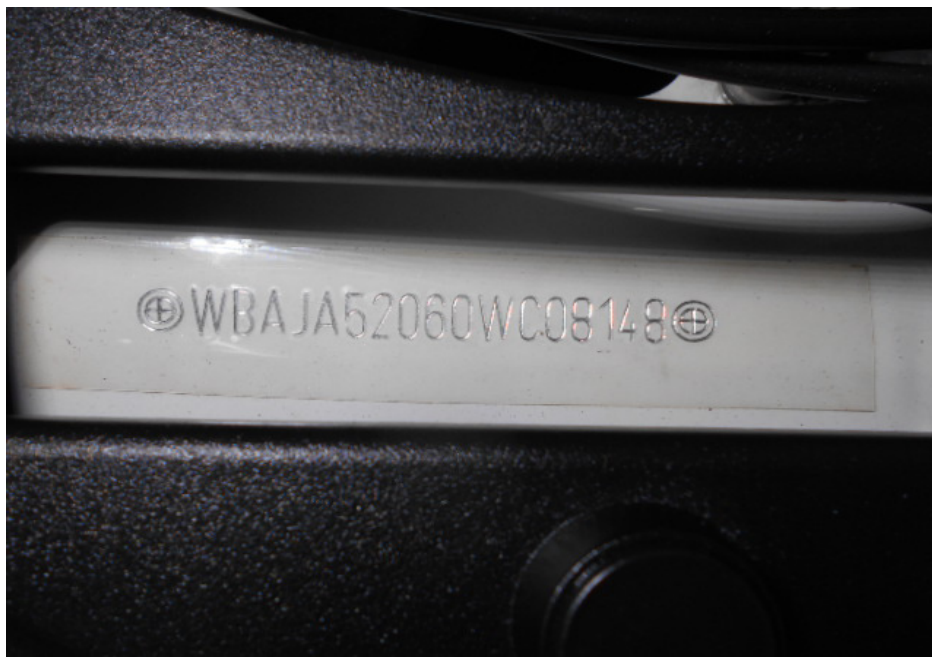
**Photo 3** shows the chassis number of the Motor Car. The chassis number recorded was WBAJA52060WC08148.

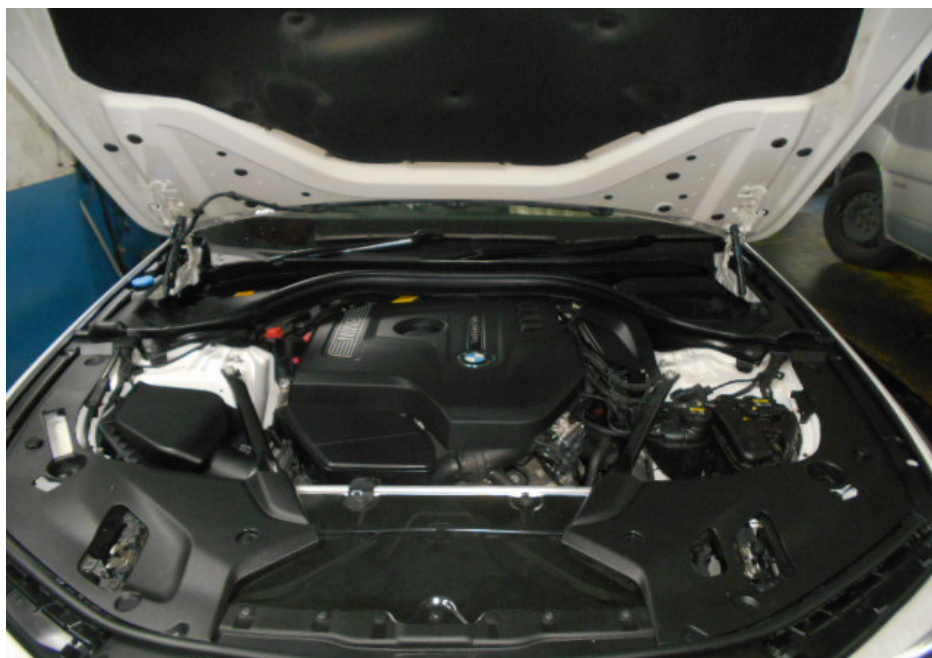
12. My examination of the engine compartment of the Motor Car revealed that the various parts and components inside the engine compartment were all intact and properly fitted. The engine oil, brake fluid and engine coolant were all found to be of sufficient level for operating purposes. Visually, there was also no contamination found to these fluids.
13. My checks on the underside of the Motor Car revealed no sign(s) or indication(s) of fluid leakage and/or fluid stain(s). The engine block and automatic transmission assembly were both secured properly. They were not mounted onto the chassis/structure body or any integral body part of the Motor Car. All undercarriage components of the Motor Car were also observed to be intact and secured in an appropriate manner.

**Photo 4** shows a general view of the engine compartment of the Motor Car at the time of my inspection. The various parts and components inside the engine compartment were all observed to be intact and properly fitted. There was also no sign(s) or indication(s) of fluid leak and/or fluid stain found inside the engine compartment.

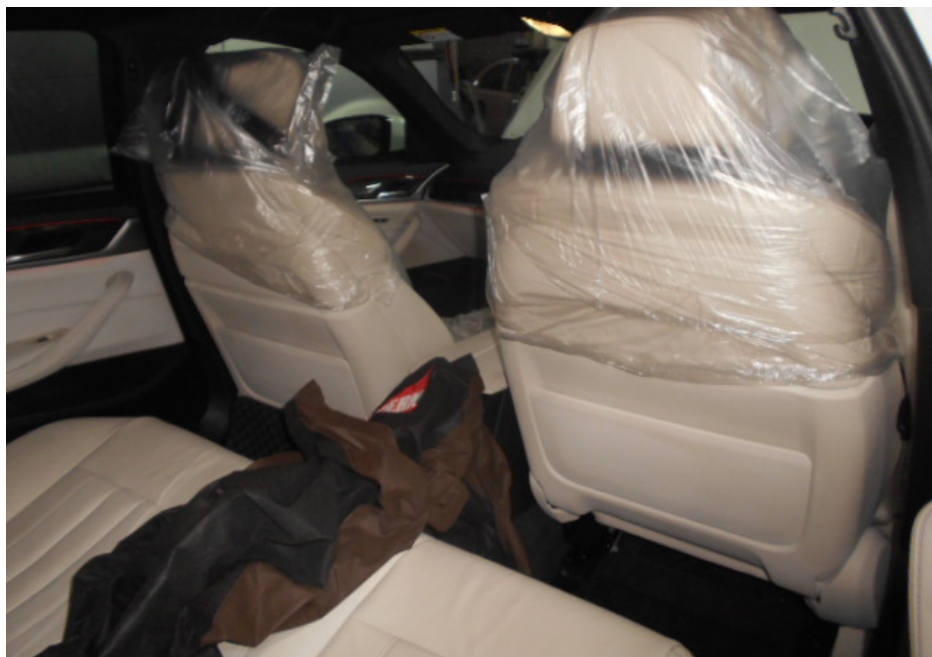
10. The seats of the Motor Car were found to be secured to the floor board of the Motor Car via seat rails bolted onto the floor board. Retractable seat belt reels and pre-tensioners were fitted on all seats of the Motor Car. The seat belt reels were able to be fastened securely into the respective pre-tensioners that were fixed to the side of all the seats.

**Photo 5** shows the seats of the Motor Car, which were secured via seat rails to the floor board. All the seats of the Motor Car were fitted with a retractable seat belt reel and pre-tensioner. The seat belts were also able to be fastened into the respective pre-tensions that were fitted on the side of each individual seat.

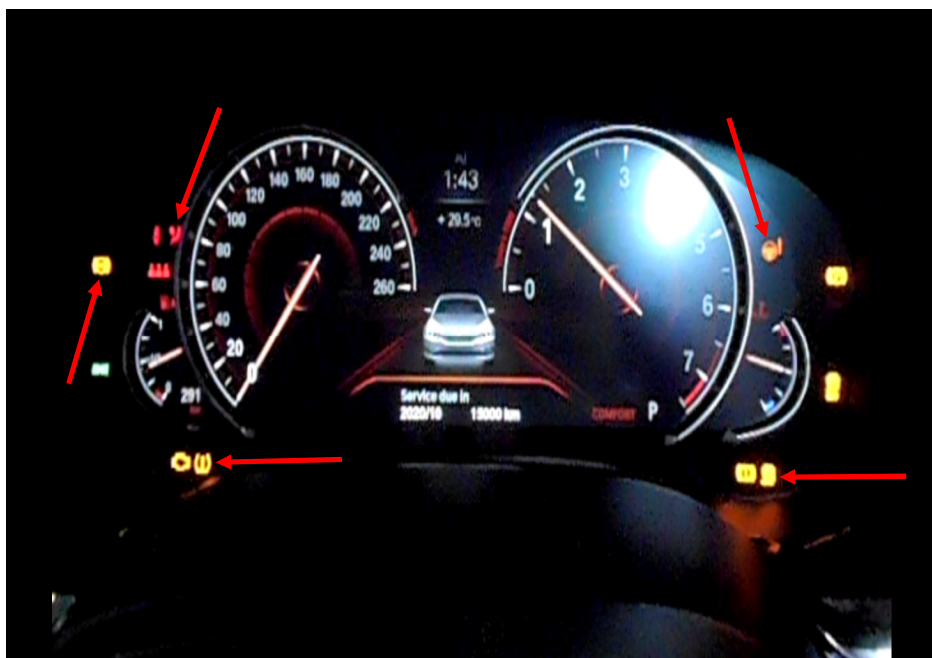
**Photo 6** shows the warning lights for the various electronic safety features appearing on the instrument panel of the Motor Car during its self-test when the engine is cranked, in particular the ABS, SRS, IAS, TPM and DSC lights (arrowed).

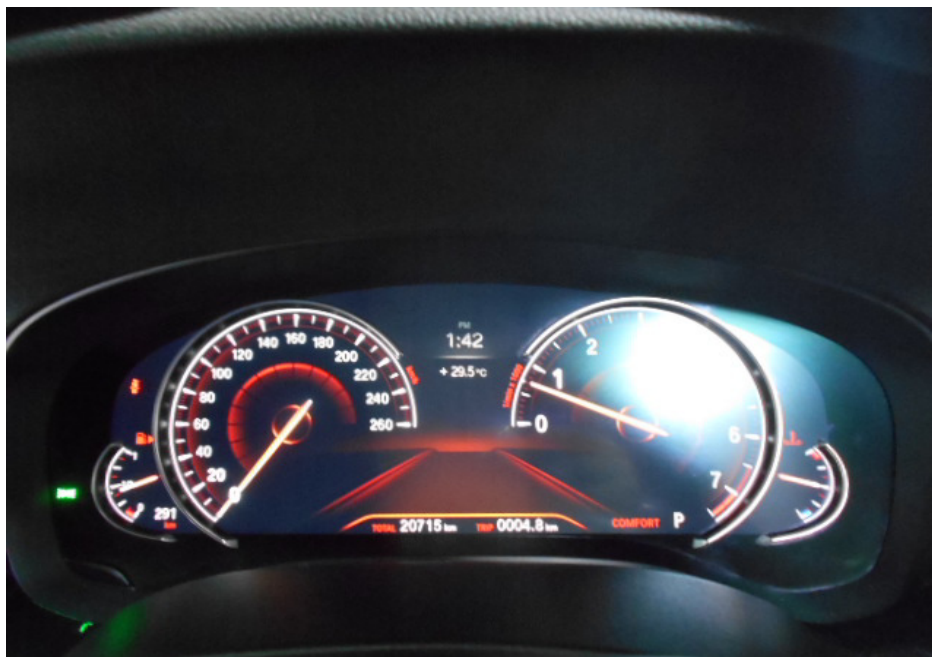
11. The Motor Car's automatic self-test of the functionality of its various electronic safety features like the Anti-Lock Brake System (ABS), Supplemental Restraint System (SRS), Integral Active Steering (IAS), Tyre Pressure Monitor (TPM) and Dynamic Stability Control (DSC) during cranking of the engine had indicated that these electronic systems were in working condition. This was determined from the respective warning lights disappearing from the instrument panel after the self-test.

**Photo 7** shows the respective warning lights no longer illuminated after the engine was started, indicating that there was no fault detected to the ABS, SRS, IAS, TPM and DSC systems of the Motor Car during the self-test. These electronic systems were hence in working condition at the time of my inspection.

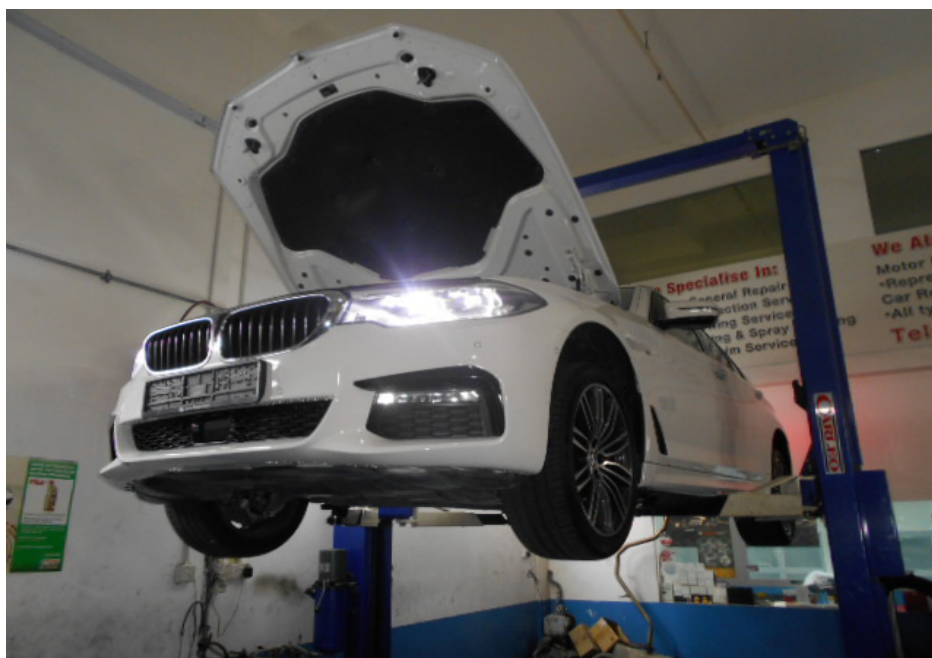
**Photo 8** shows the Motor Car hoisted up for checks on its undercarriage. There was no sign(s) or indication(s) of fluid leakage and/or fluid stain(s) on the underside of the Motor Car. The undercarriage components of the Motor Car were also all observed to be intact and secured in an appropriate manner.

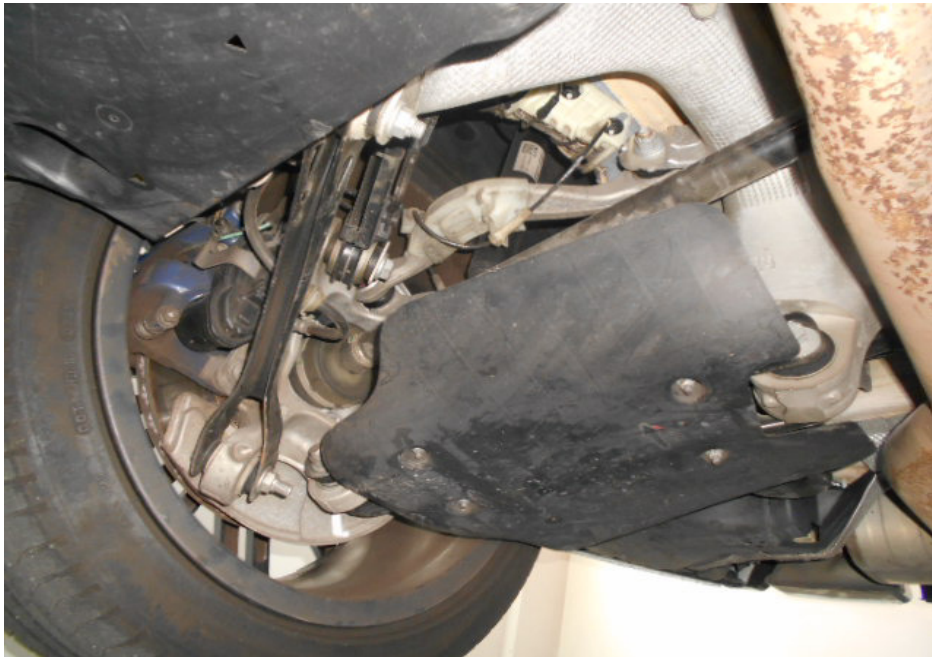
**Photo 9** shows a general view of the control arms and linkages at the rear right wheel of the Motor Car. I did not observe any fluid leak and/or fluid stain on the underside of the Motor Car. All of the Motor Car's undercarriage components were observed to be intact and secured in an appropriate manner.

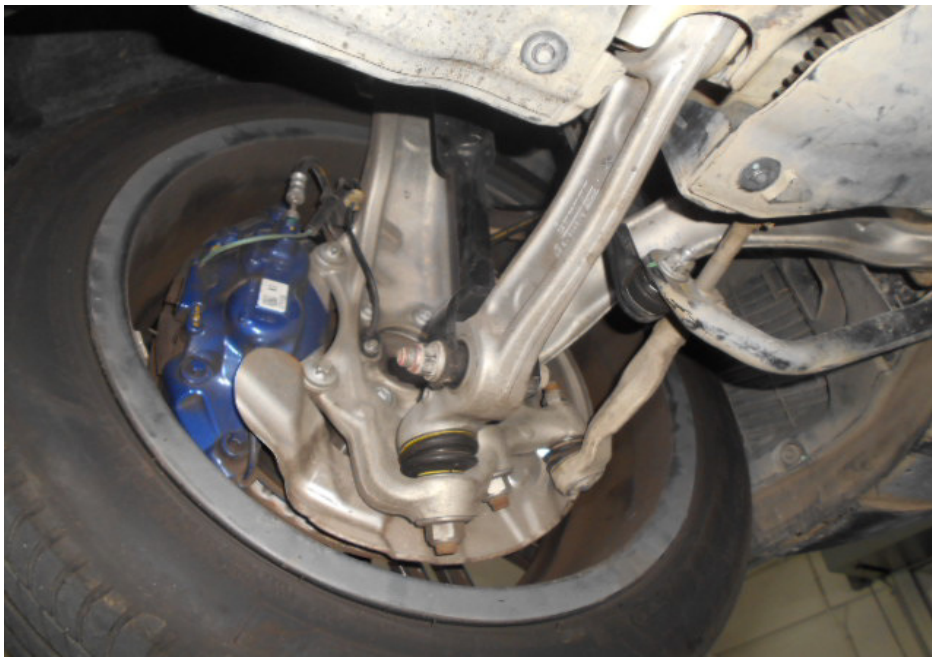
**Photo 10** shows the various undercarriage components at the front left wheel of the Motor Car. The mechanical components, control arms and linkages were all found to be intact and secured in an appropriate manner.

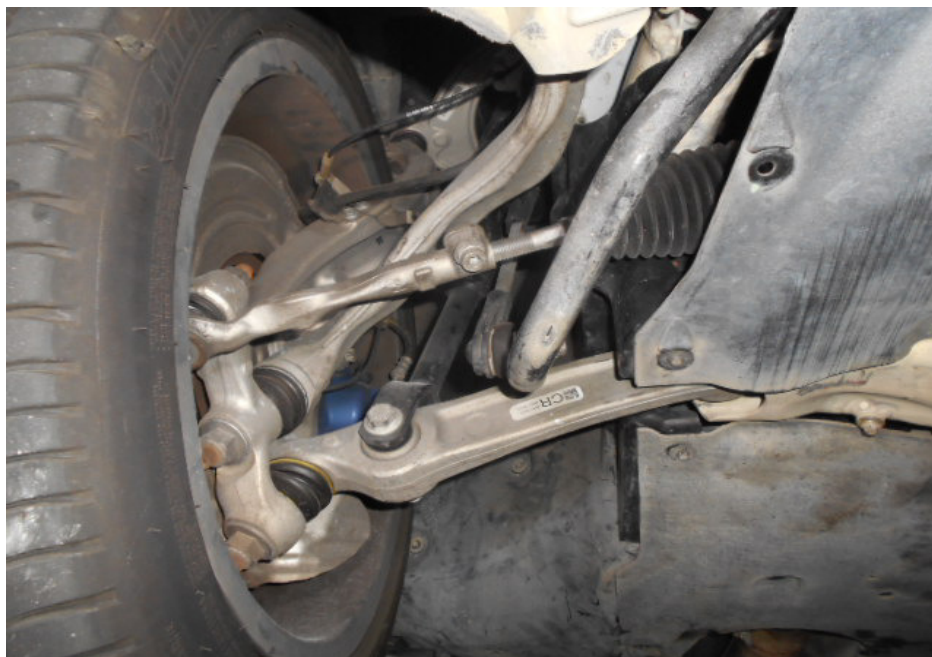
**Photo 11** shows the various undercarriage components at the front right wheel of the Motor Car. The mechanical components, control arms and linkages were all found to be intact and secured in an appropriate manner.

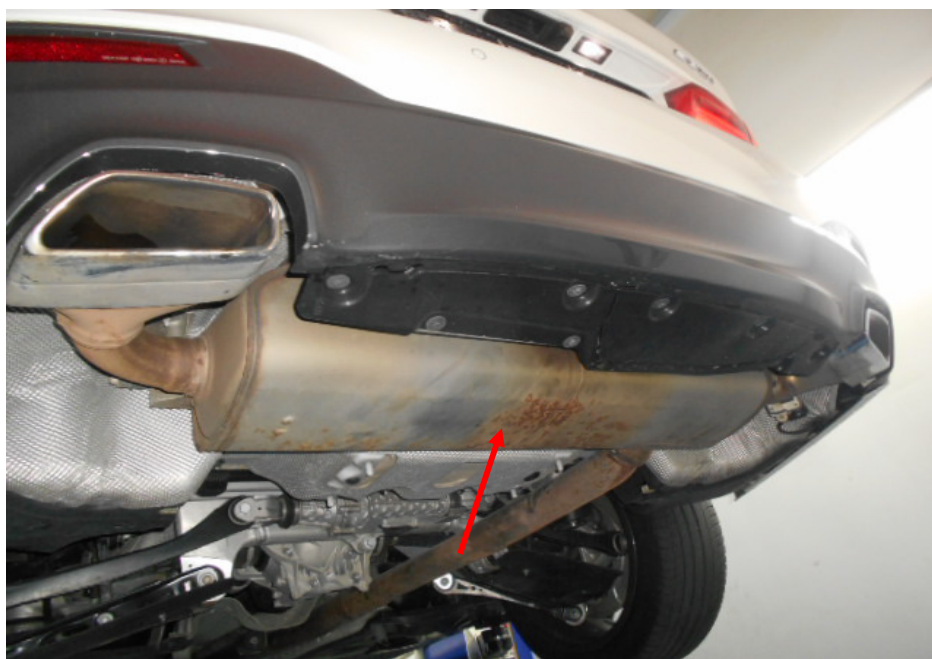
**Photo 12** shows the Motor Car's rear exhaust muffler (arrowed). My examination of the Motor Car's exhaust system revealed no sign(s) or indication(s) of any cut or weld marks along its exhaust pipes and on its rear muffler.

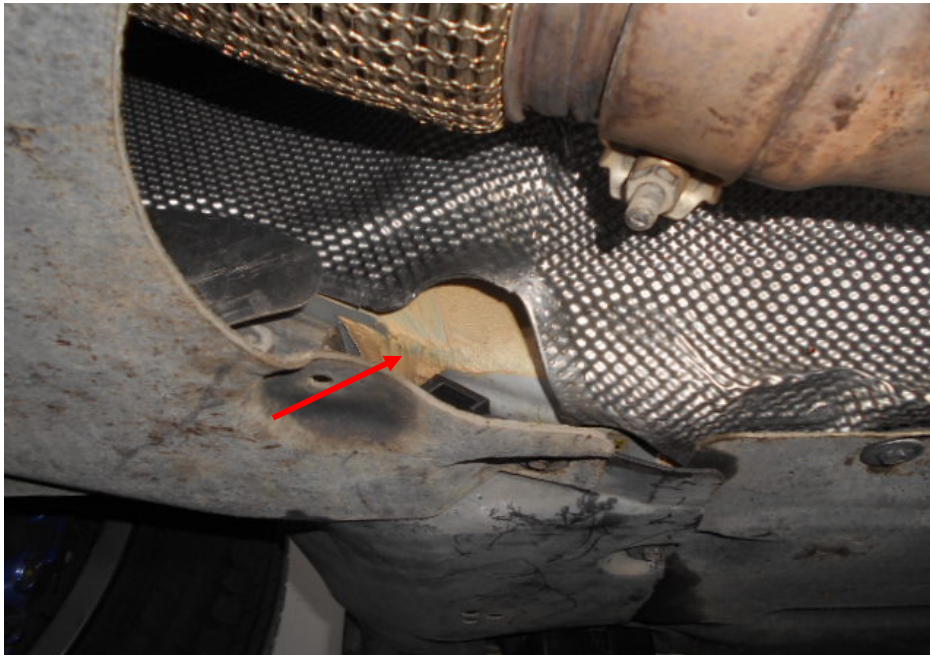
**Photo 13** shows the floor board at the underside right front of the Motor Car. The original factory sealant (arrowed) at the joints along the non-detachable body panels were untouched, indicating no work was done on the non-detachable body panels of the Motor Car; and that these body panels were originally fitted.

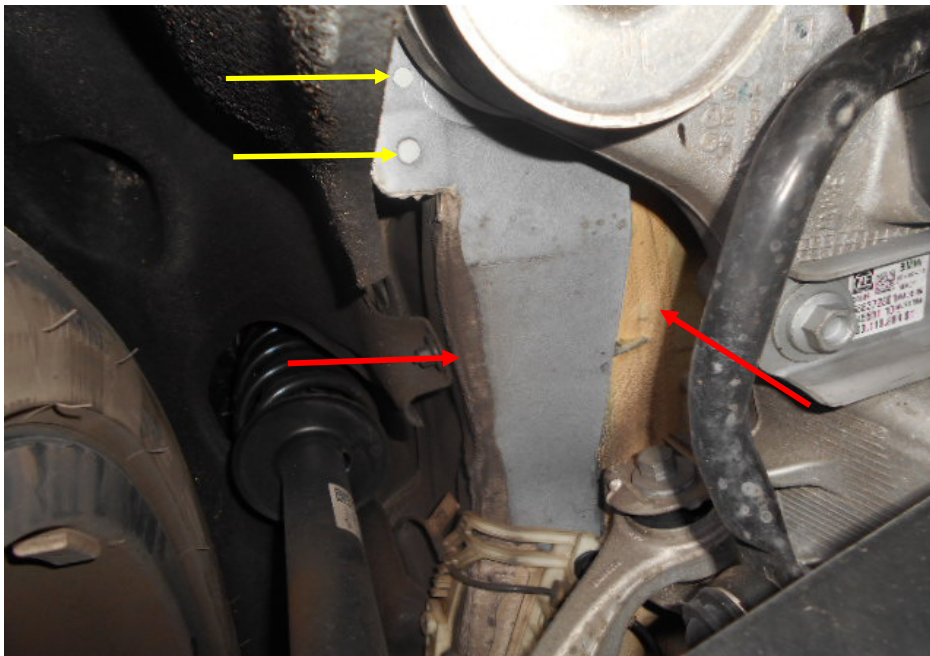
9. Visually, I did not find any weld marks, other than the original spot weld marks, on the chassis/structure body of the Motor Car. The original factory sealant at the joints along the chassis/structure body was also untouched, again indicating that no replacement of the chassis/structure body was carried out; and that the chassis/structure body was originally fitted.

**Photo 14** shows the chassis/structure body at the underside rear left of the Motor Car. Visually, I did not find any weld marks other than original spot weld marks (yellow arrow) on the chassis/structure body of the Motor Car. The original factory sealant (red arrow) at the joints along the chassis/structure body was also untouched, indicating no work was done on the chassis/structure body of the Motor Car and that the chassis/structure body was originally fitted.

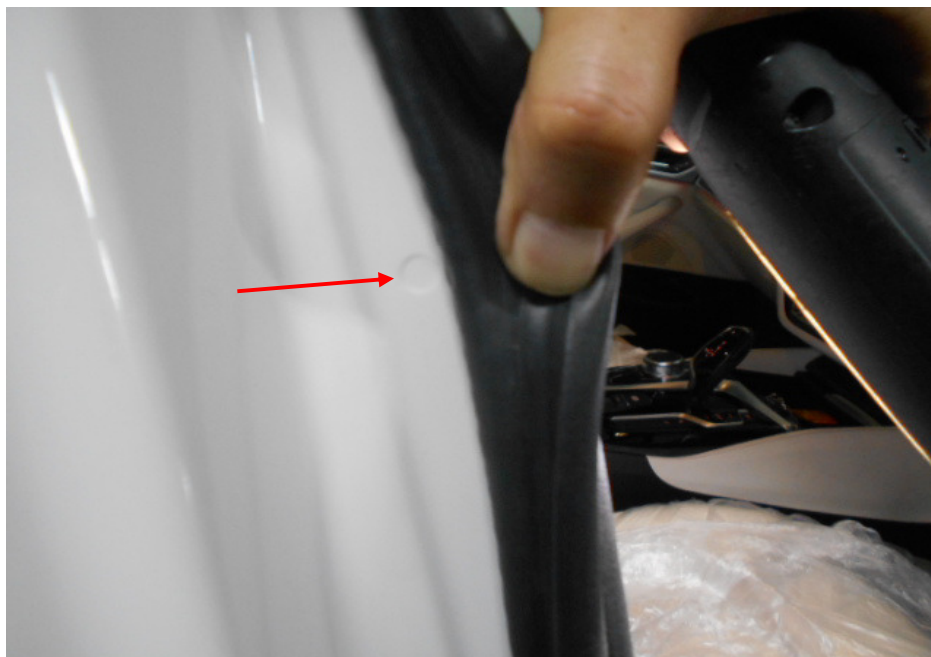
**Photo 15** shows the right “B” pillar of the Motor Car. I did not find any weld marks other than original spot weld marks (arrowed) on the non-detachable body panels of the Motor Car, indicating that there was no re-welding works carried out; and that the non-detachable body panels of the Motor Car were originally fitted.
