Vehicle No. SHD 14U  
Insured Veh. GBE 2536H  
Claim No. SNM19D205530  
Policy No. DMCVSN1669921903  
Accident Date 19/11/2019  
Inspection Date 21/11/2019

### 1. Policy Particulars :- THIRD PARTY CLAIM

### ADJUSTMENT ON REPAIR COST FOR VEHICLE NO. SHD 14U

PHOTOGRAPHS FOR VEHICLE NO. SHD 14U

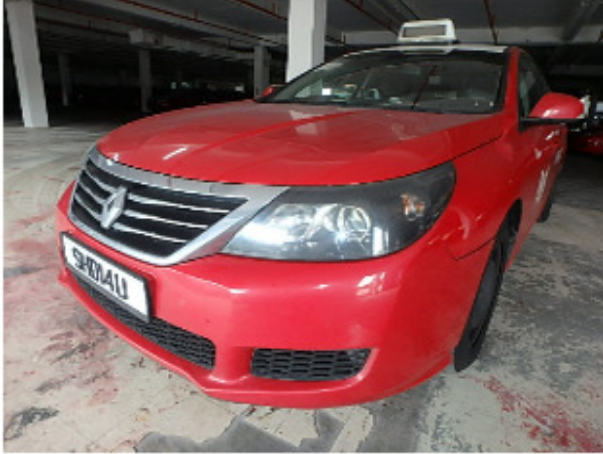
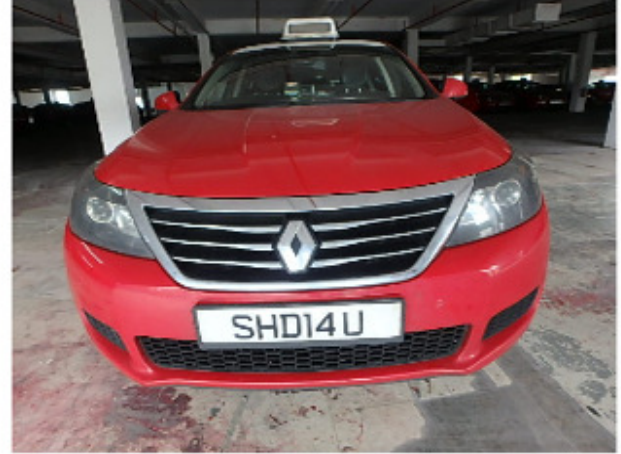
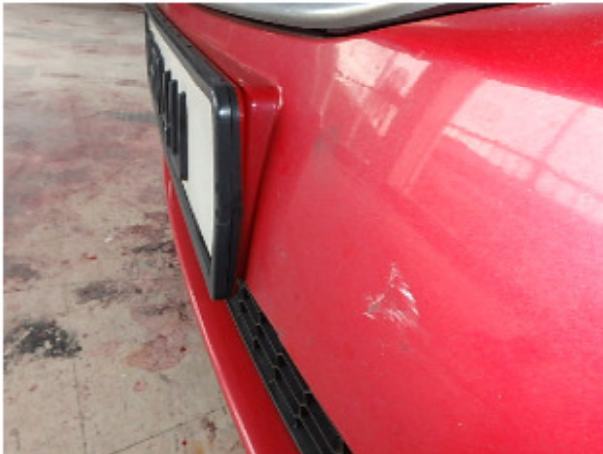
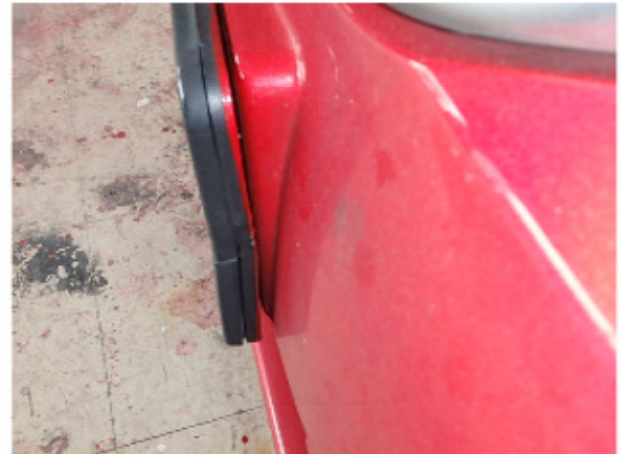
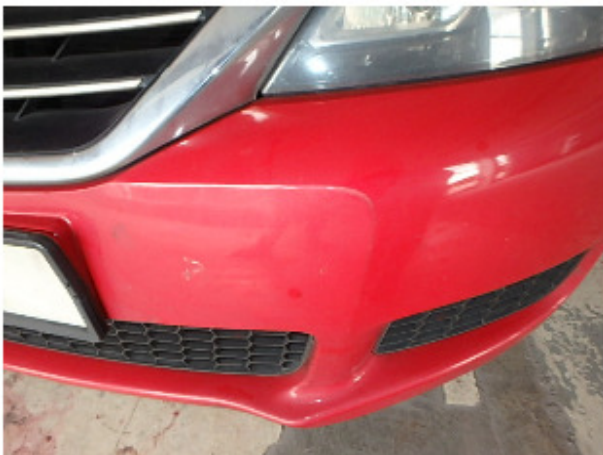
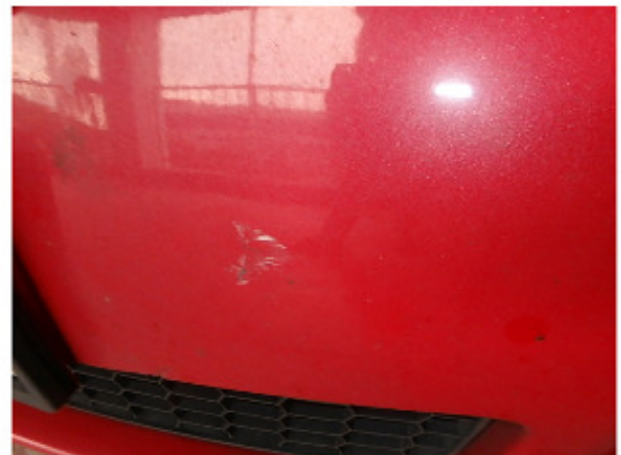
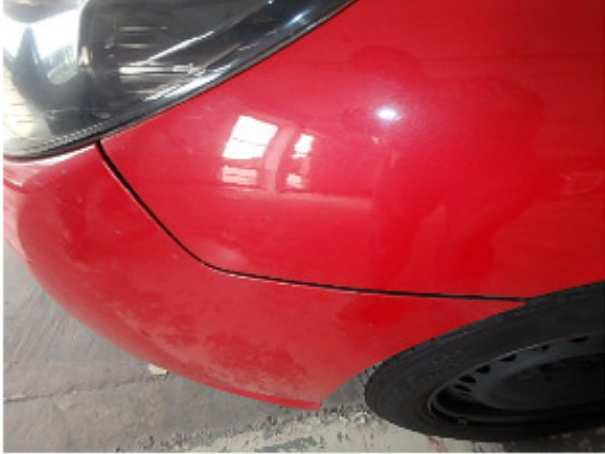
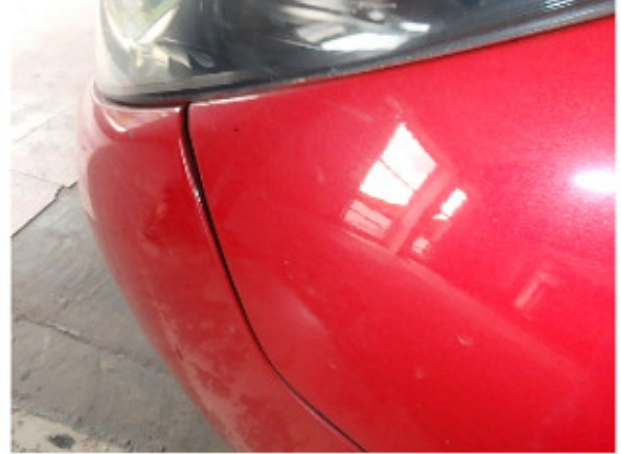
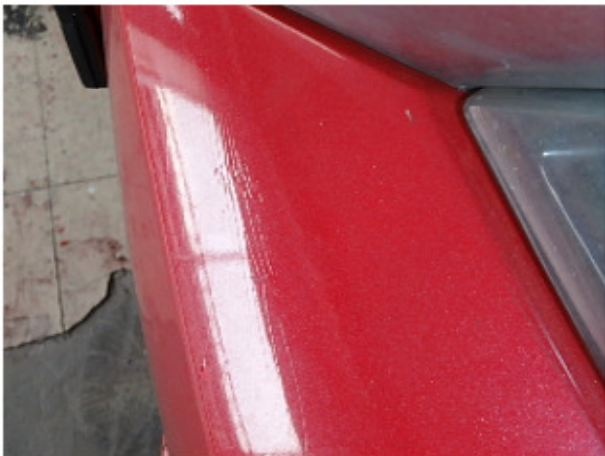
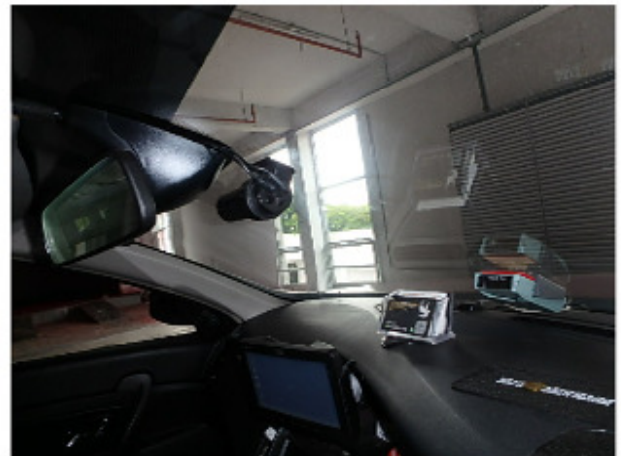
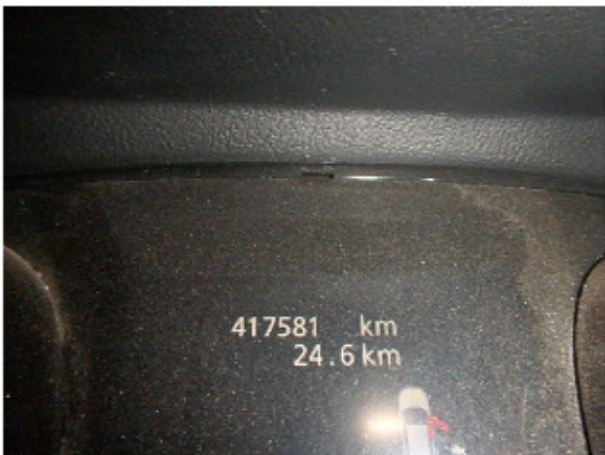
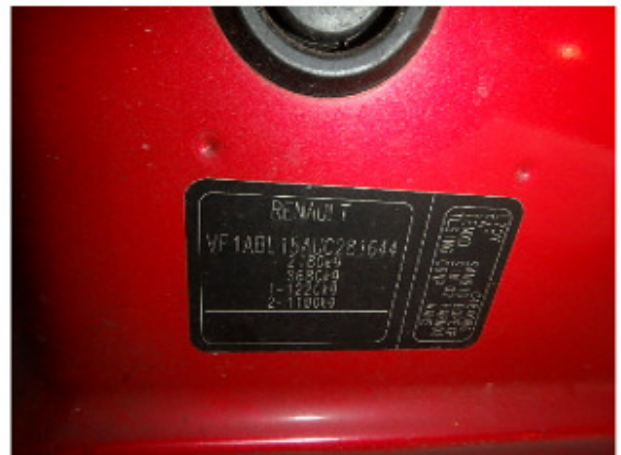
THE VEHICLE SUSTAINED DAMAGES AT THE FRONT N/S PORTION.

DAMAGES SEE DETAILS.
