Your Ref: TP/IP/70383/2019  
Our Ref : CI/TPD19020755/P

29<sup>th</sup> November 2019

**MECHANICAL INSPECTION REPORT OF MOTOR LORRY GBB 5556X**

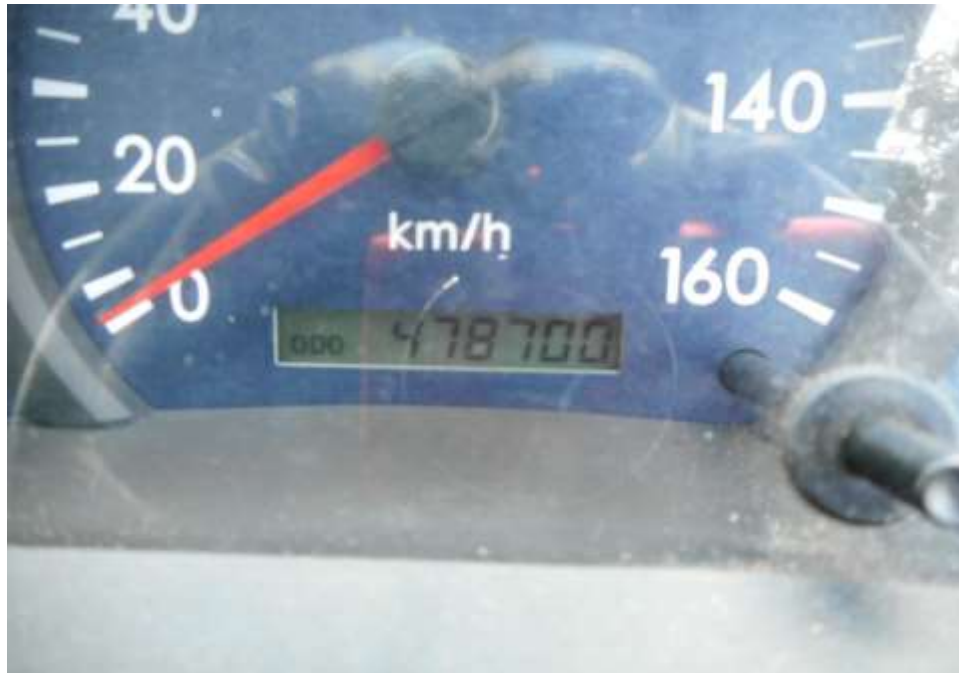
**Photo 1** shows a general view of the instrument cluster of the Motor Lorry at the time of my inspection. The mileage of the Motor Lorry was 478,700km

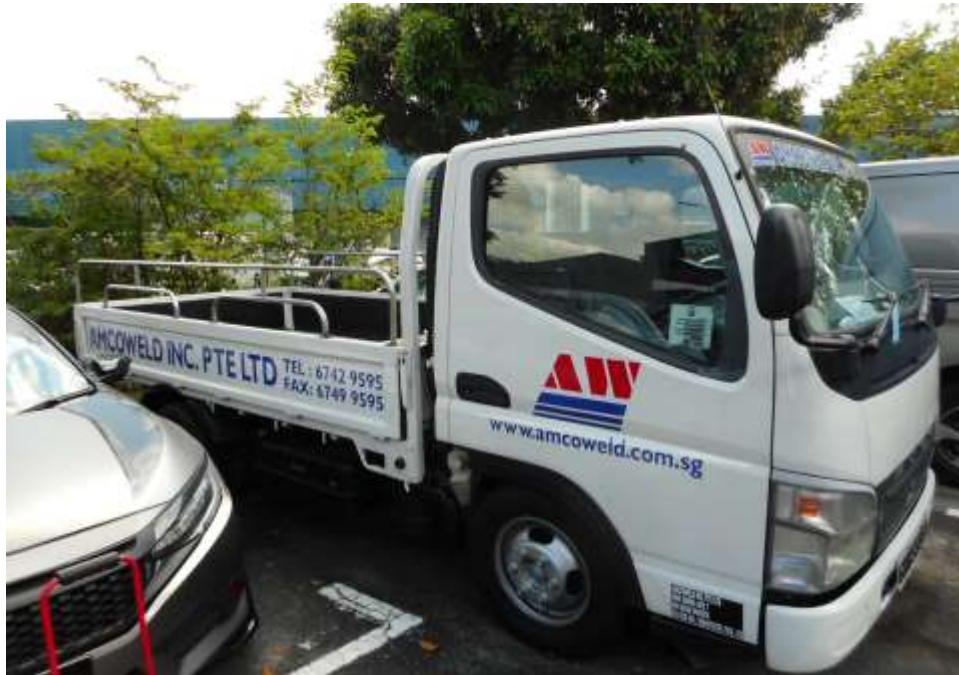
4. The mileage of the Motor Lorry at the time of my inspection was 478,700km.
5. The Motor Lorry appeared to have sustained moderate damage at its cabin portion. Its cabin body panel and air filter box were damaged as a result of the accident at the time of my inspection.

**Photo 2** shows a general view of the Motor Lorry's right portion at the time of my inspection. Its cabin body panel and filter box were damage as a result of the accident at the time of my inspection.

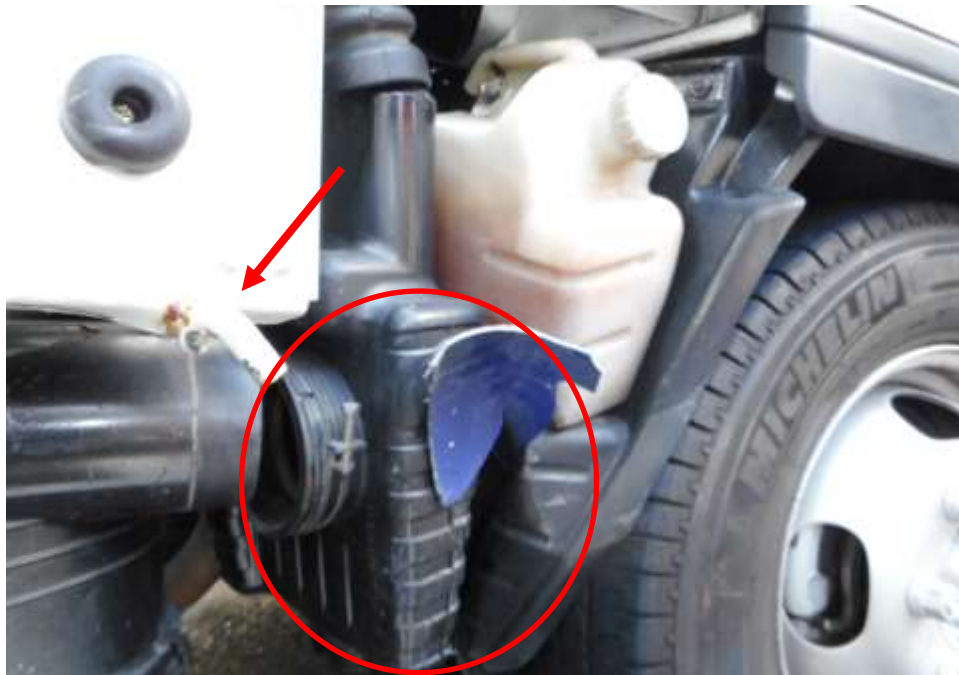
**Photo 3** shows a close up view of the Motor Lorry's rear portion at the time of my inspection. Its cabin body panel (arrowed) and air filter box (circled) were damage as a result of the accident at the time of my inspection.

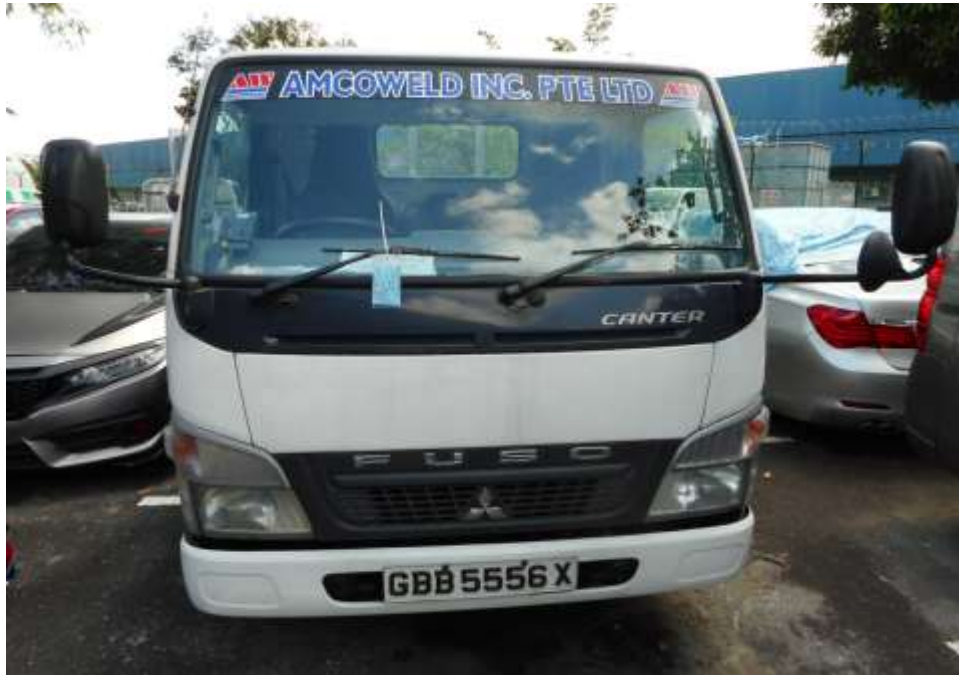
**Photo 4** shows a general view of the front portion of the Motor Lorry at the time of my inspection. The Motor Lorry was observed to be intact and unaffected by the accident.

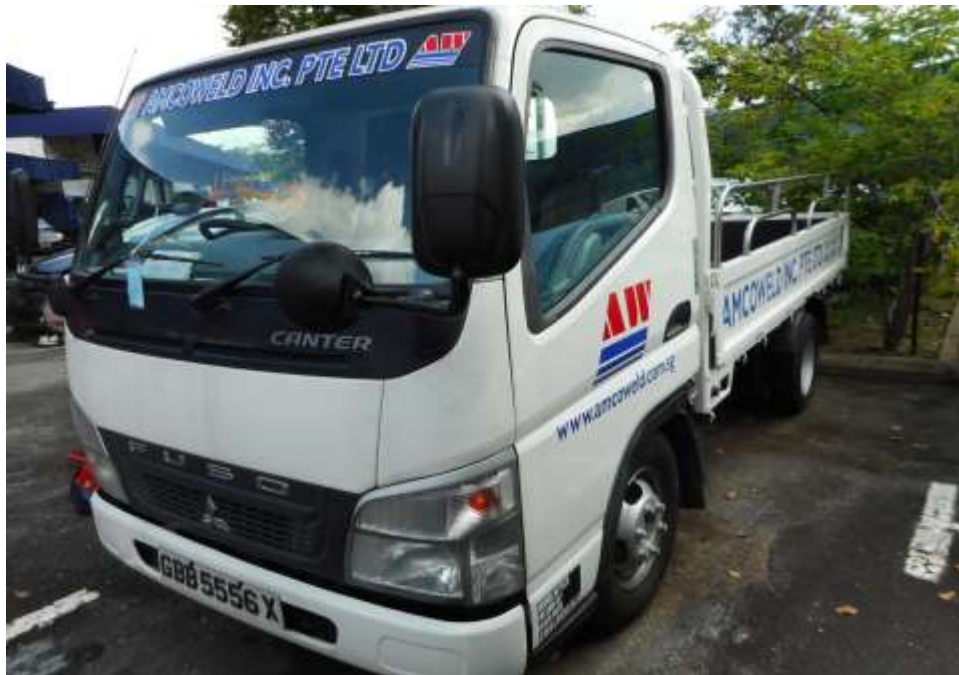
**Photo 5** shows a general view of the left portion body of the Motor Lorry at the time of my inspection. The Motor Lorry was observed to be intact and unaffected by the accident.

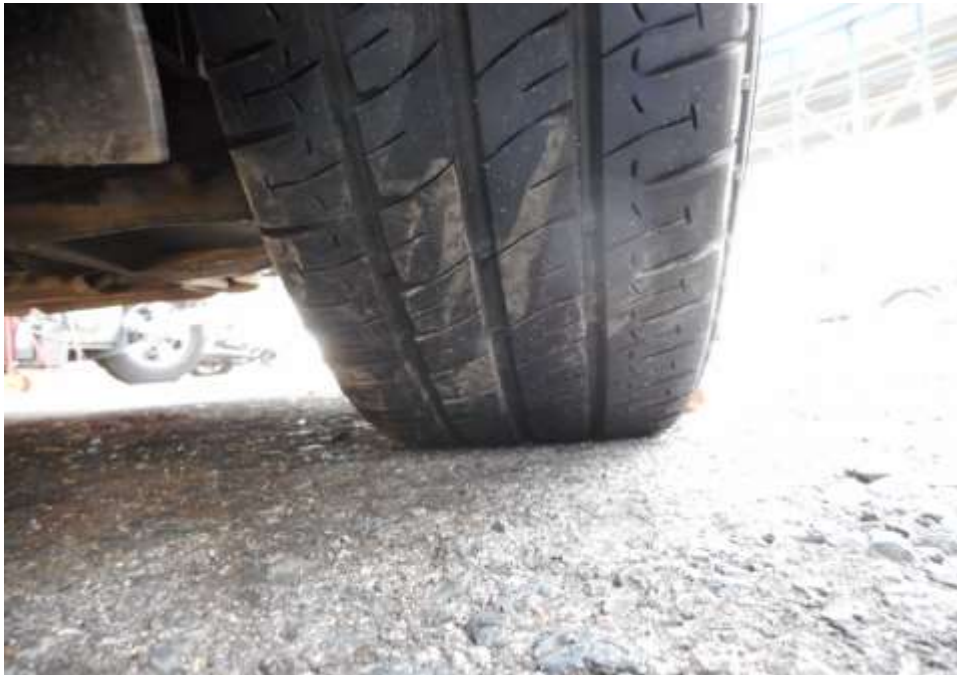
**Photo 6** shows the condition of the front right tyre of the Motor Lorry, which was observed to be in serviceable condition with remaining tread depth of approximately 6.9mm. The tyre, which was wrapped around standard steel wheel rim, was also observed to be sufficiently inflated for vehicular operation. There was no tear, cut or burst mark(s) on the outer and the inner sidewalls as well as across the tread of the 6 tyres that were fitted on the Motor Lorry.

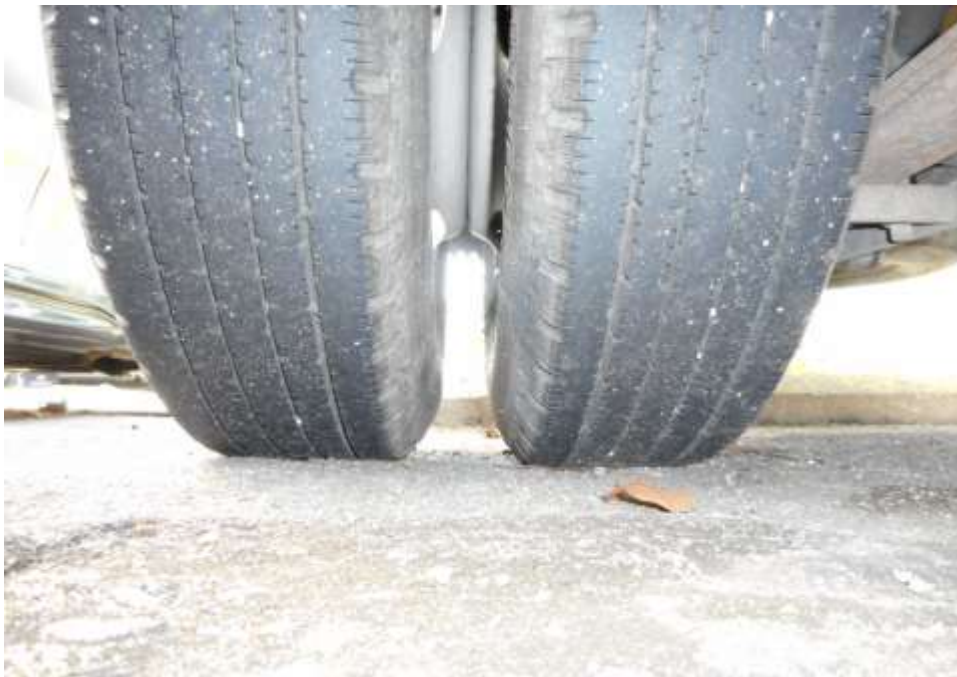
**Photo 7** shows the condition of the rear right tyre of the Motor Lorry, which was observed to be in serviceable condition with remaining tread depth of approximately 4.8mm. The tyre, which was wrapped around standard steel wheel rim, was also observed to be sufficiently inflated for vehicular operation.

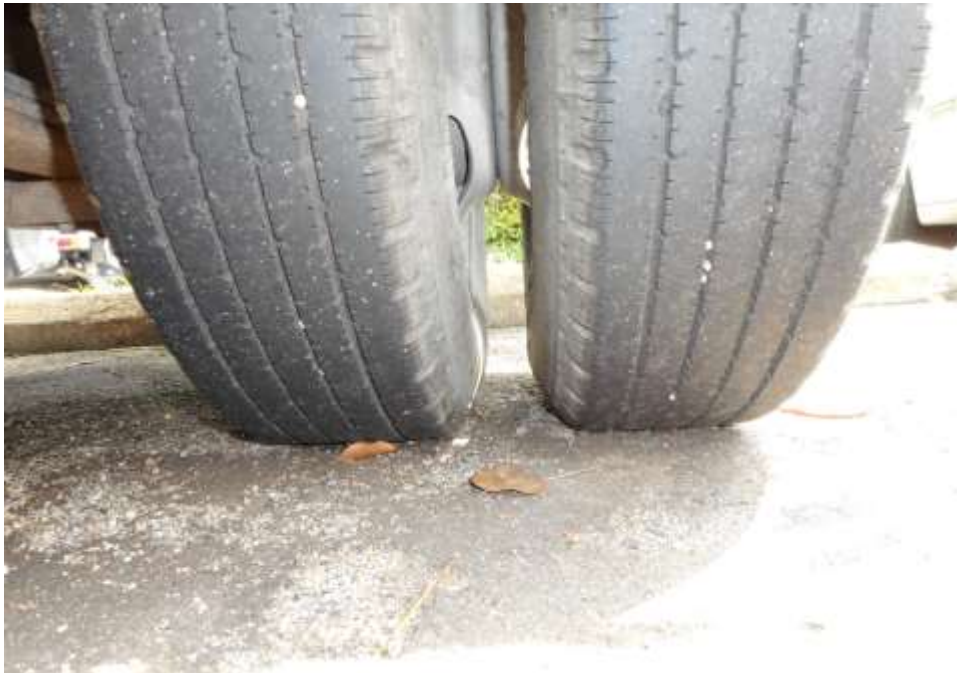
**Photo 8** shows the condition of the rear left tyres of the Motor Lorry, which was observed to be in serviceable condition with remaining tread depth of approximately 5.1mm. The tyres, which were wrapped around standard steel wheel rim, were also observed to be sufficiently inflated for vehicular operation. There was also no damage found on all 6 steel wheel rims of the Motor Lorry.

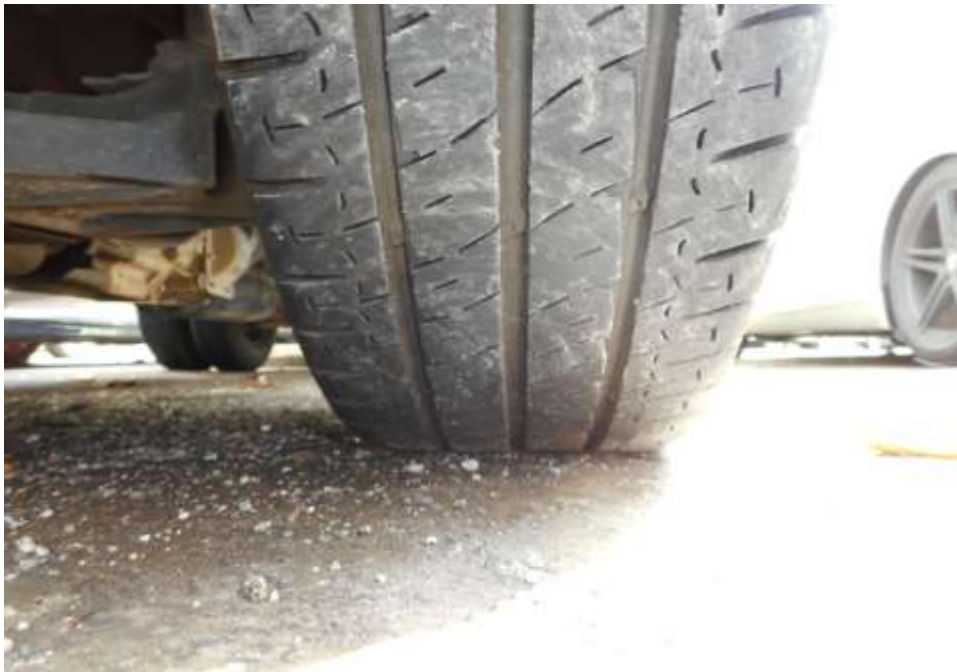
**Photo 9** shows the condition of the rear right tyres of the Motor Lorry, which were observed to be in serviceable condition with remaining, tread depth of approximately 5.5mm. There was also no tear, cut or burst mark(s) on the outer and the inner sidewalls as well as across the tread of the 6 tyres that were fitted on the Motor Lorry.

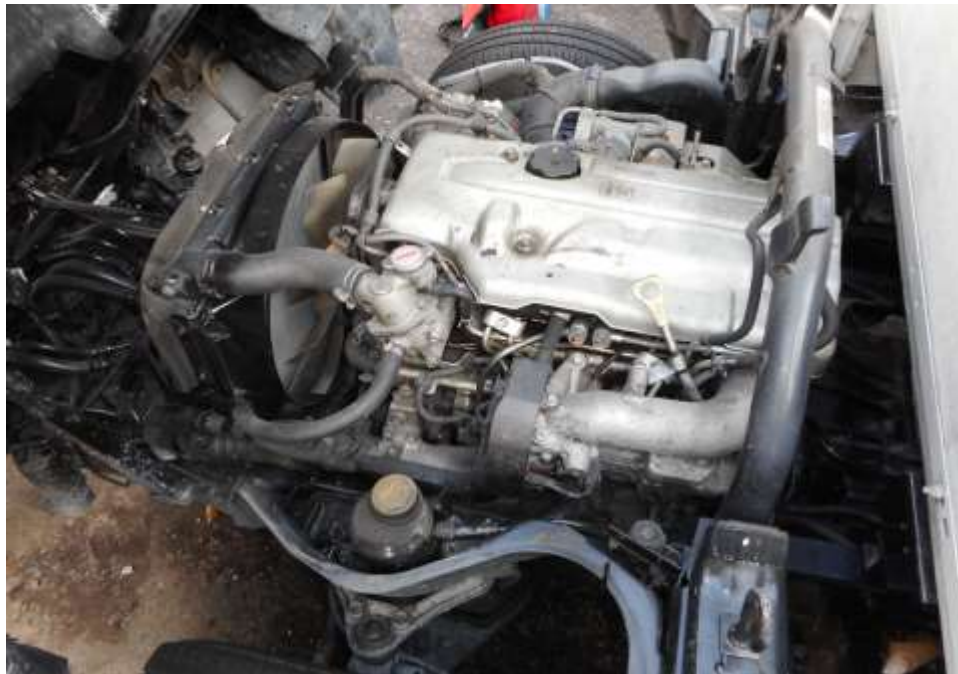
**Photo 10** shows a general view of the Motor Lorry's engine compartment, which was accessed by lifting the front cabin of the Motor Lorry. The various parts and components inside the engine compartment were unaffected by the accident. There was also no sign(s) or indication(s) of fresh fluid leakage and/or fluid stain within the engine compartment (photograph shows the engine compartment as viewed from the right front side of the Motor Lorry).

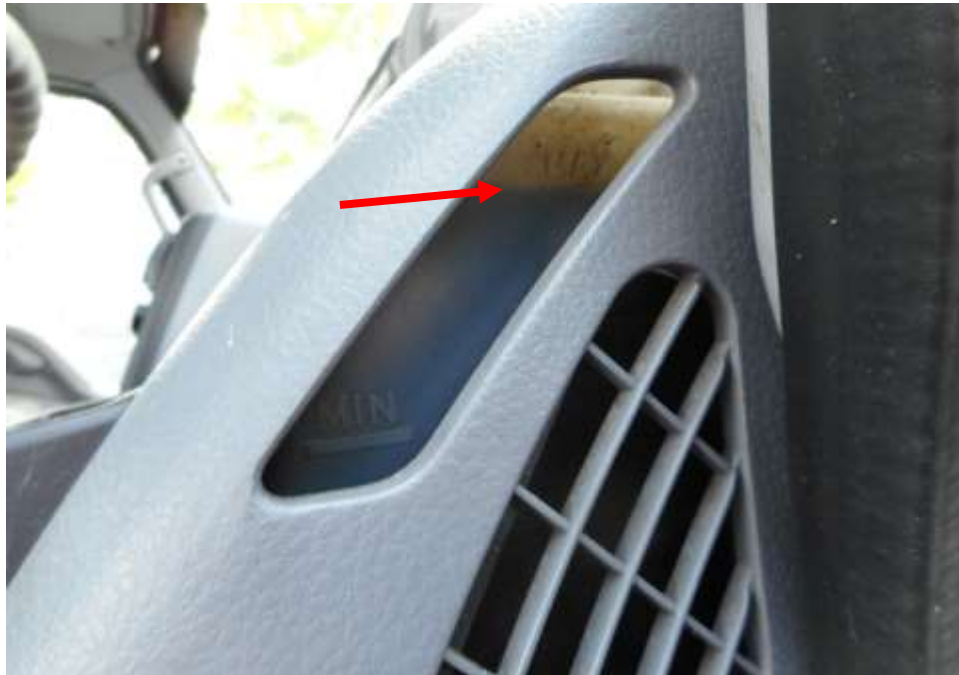
**Photo 11** shows the brake fluid reservoir of the Motor Lorry at the time of my inspection. The brake fluid was observed to be of sufficient level (arrowed) and without any visible contamination.

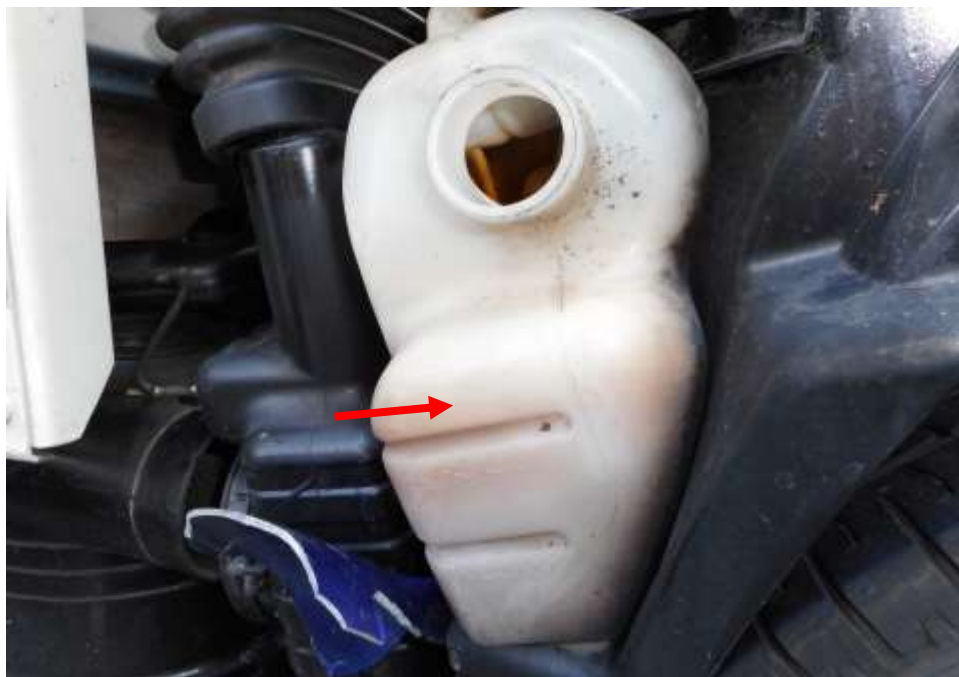
**Photo 12** shows the engine coolant reservoir of the Motor Lorry at the time of my inspection. The engine coolant was observed to be of sufficient level (arrowed) and without any visible contamination.

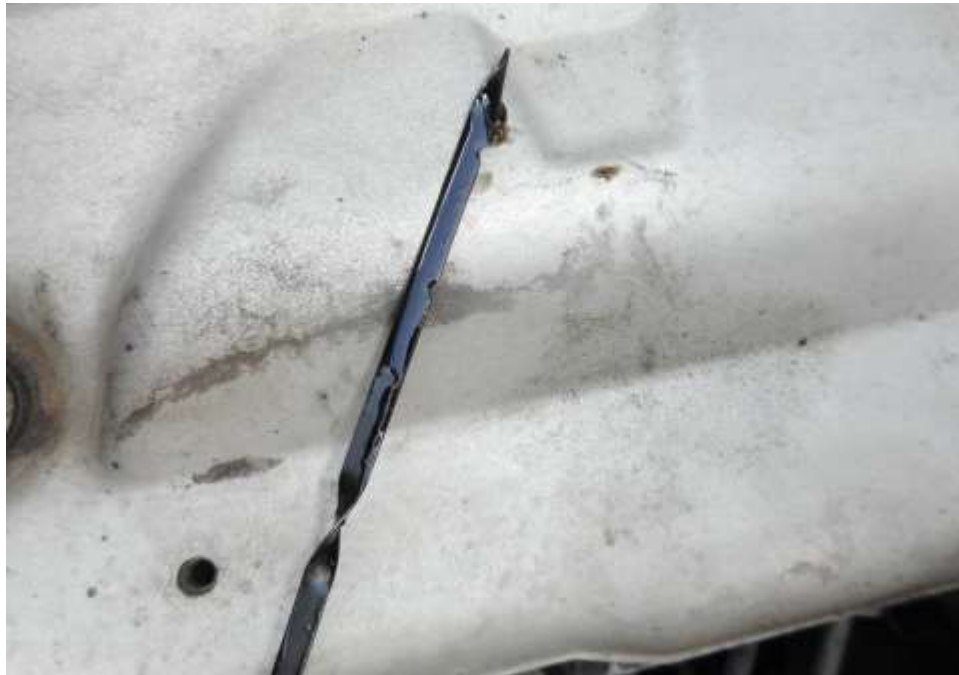
**Photo 13** shows the engine oil dipstick of the Motor Lorry at the time of my inspection. The engine oil was observed to be of sufficient level and without any visible contamination.

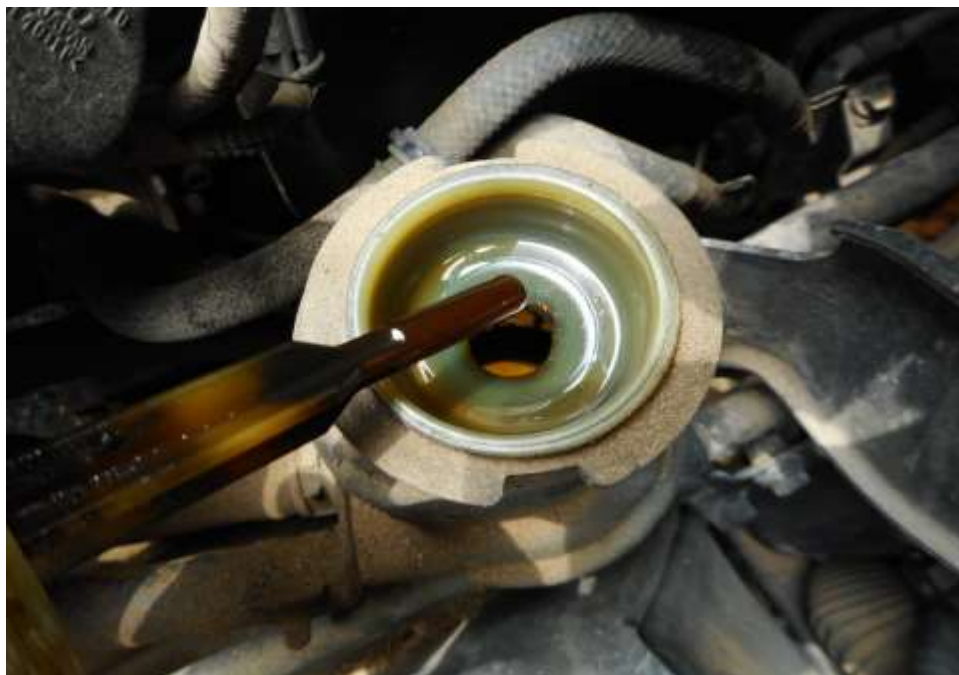
**Photo 14** shows the power steering fluid reservoir of the Motor Lorry at the time of my inspection. The power steering fluid was observed to be of sufficient level and without any visible contamination.

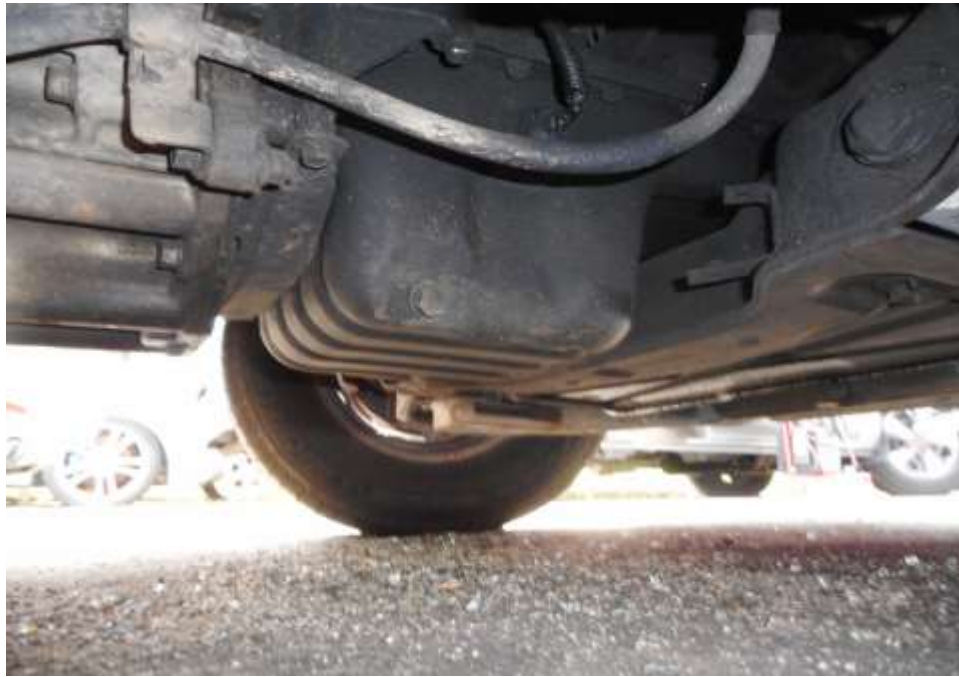
**Photo 15** shows the undercarriage of the Motor Lorry, at the area where the engine housing and transmission housing are located. Observed was minor old engine oil stain on the housing of the engine oil sump

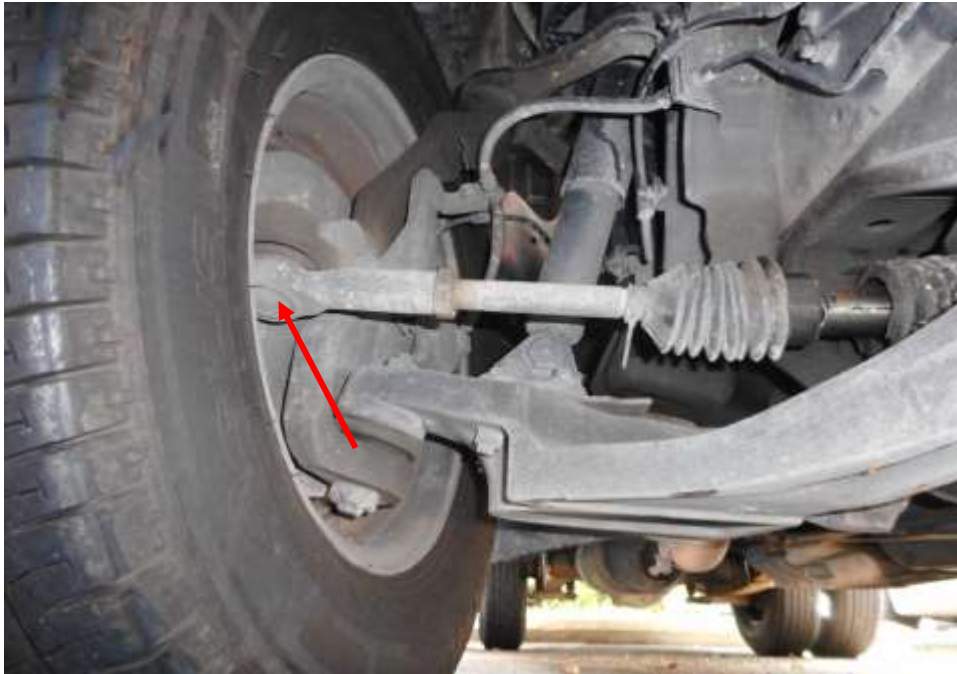
**Photo 16** shows the various undercarriage components at the front right wheel of the Motor Lorry, in particular the steering tie rod end (arrowed). The various steering components were all found to be intact, suggesting that the steering system of the Motor Lorry was likely to be in serviceable condition at the material time of accident. There was also no sign of fluid stain(s) observed on the various undercarriage components.

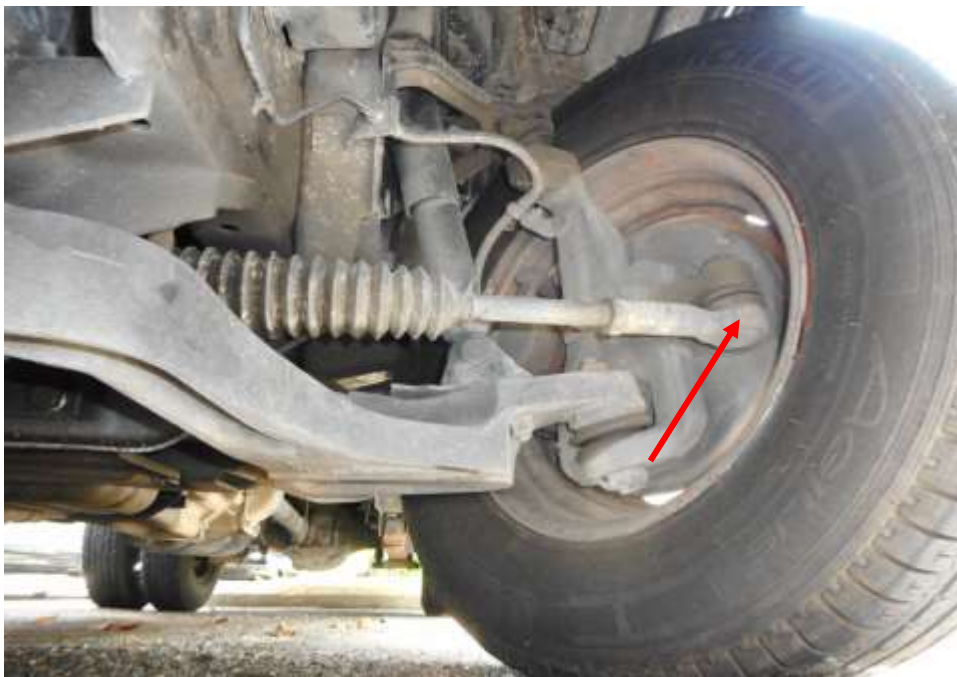
**Photo 17** shows the various undercarriage components at the front left wheel of the Motor Lorry, in particular the steering tie rod end (arrowed). The various Undercarriage components of the Motor Lorry were all found to be intact without any visible damage. There was also no sign of fluid stain(s) observed on the various undercarriage components.

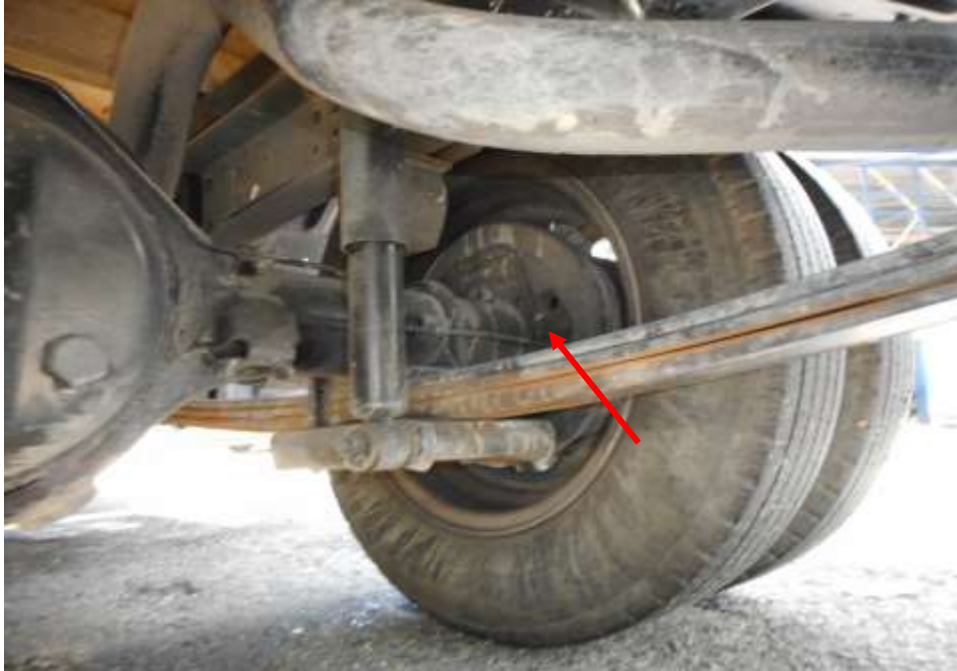
**Photo 18** shows the brake pipe (arrowed) at the rear right wheel of the Motor Lorry. I did not observe any leakage of brake fluid at the time of my inspection of the Motor Lorry. My static tests of the Motor Lorry's braking system, along with my visual examination of the various mechanical components in the braking system, had indicated that there was no internal leakage of pressure/vacuum. Hence the braking system of the Motor Lorry was likely to be in serviceable condition at the material time of accident.

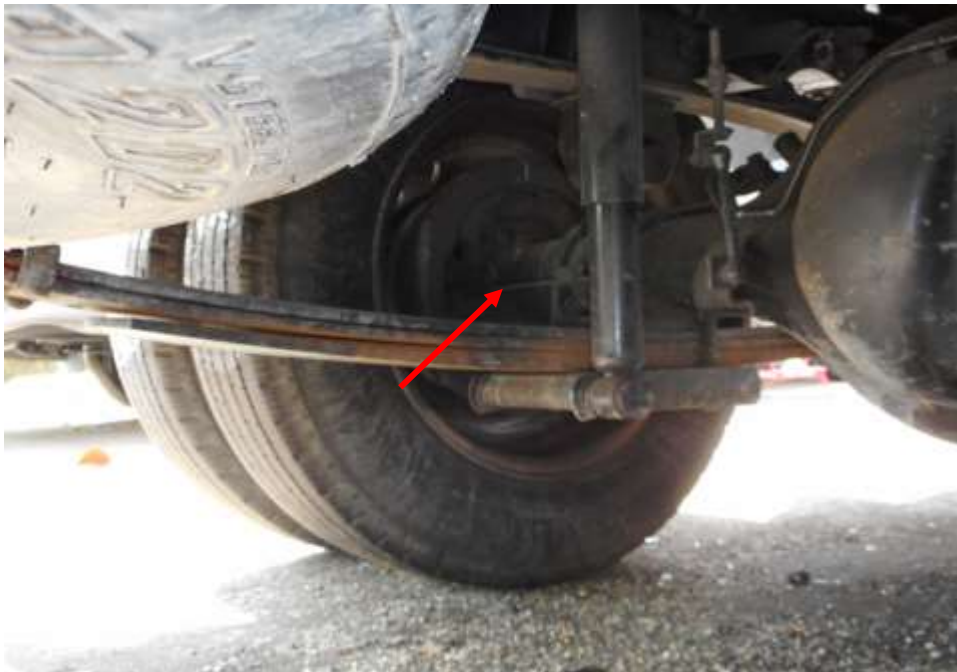
**Photo 19** shows the brake pipe (arrowed) at the rear left wheel of the Motor Lorry. I did not observe any leakage of brake fluid at the time of my inspection of the Motor Lorry. My static tests of the Motor Lorry's braking system, along with my visual examination of the various mechanical components in the braking System had indicated that there was no internal leakage of pressure/vacuum. Hence the braking system of the Motor Lorry was likely to be in serviceable condition at the material time of accident.

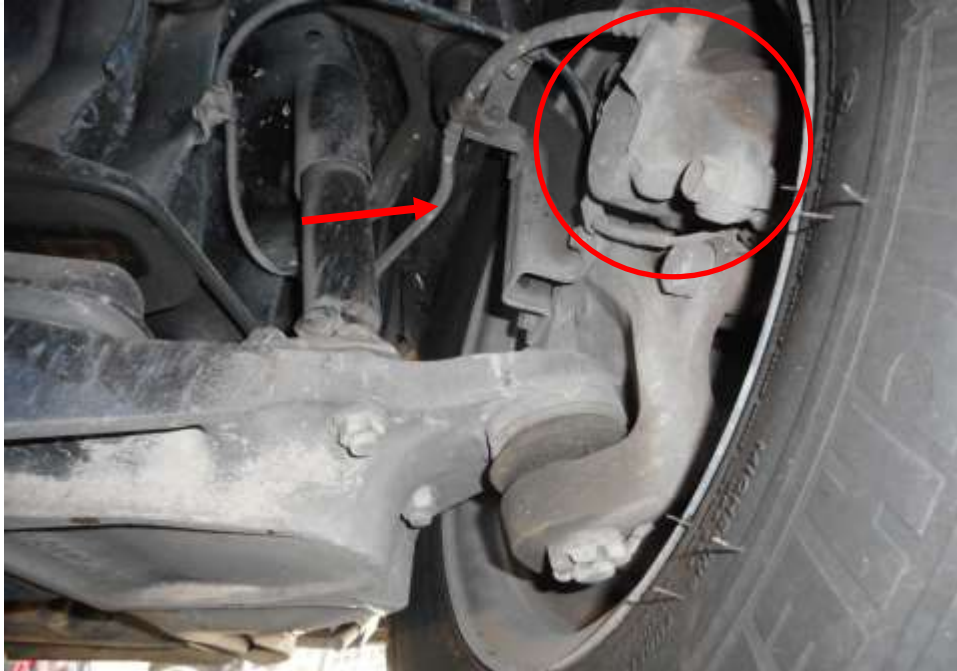
**Photo 20** shows the brake hose/pipe (arrowed) at the front right wheel of the Motor Lorry. No leakage of brake fluid was observed. Visual examination of the various components of the braking system like the brake caliper (circled), brake booster, brake pedal etc had revealed all to be intact and without visible damage at the time of accident. There was also no sign of fluid stain(s) observed on the various undercarriage components.

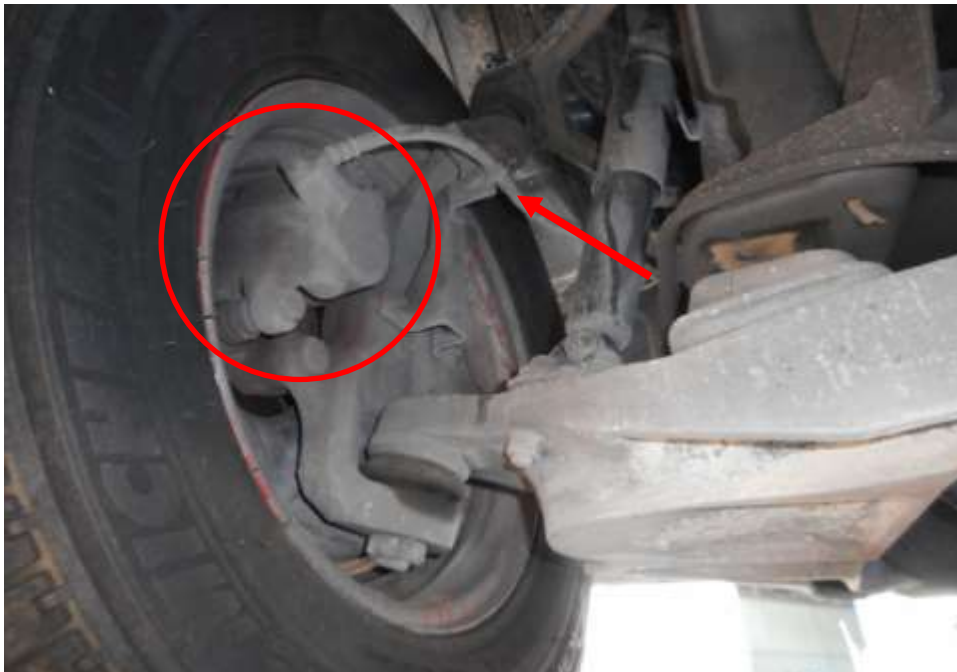
**Photo 21** shows the brake hose/pipe (arrowed) at the front left wheel of the Motor Lorry. No leakage of brake fluid was observed. Visual examination of the various components of the braking system like the brake caliper (circled), brake booster, brake pedal etc had revealed all to be intact and without visible damage at the time of accident. There was also no sign of fluid stain(s) observed on the various undercarriage components.

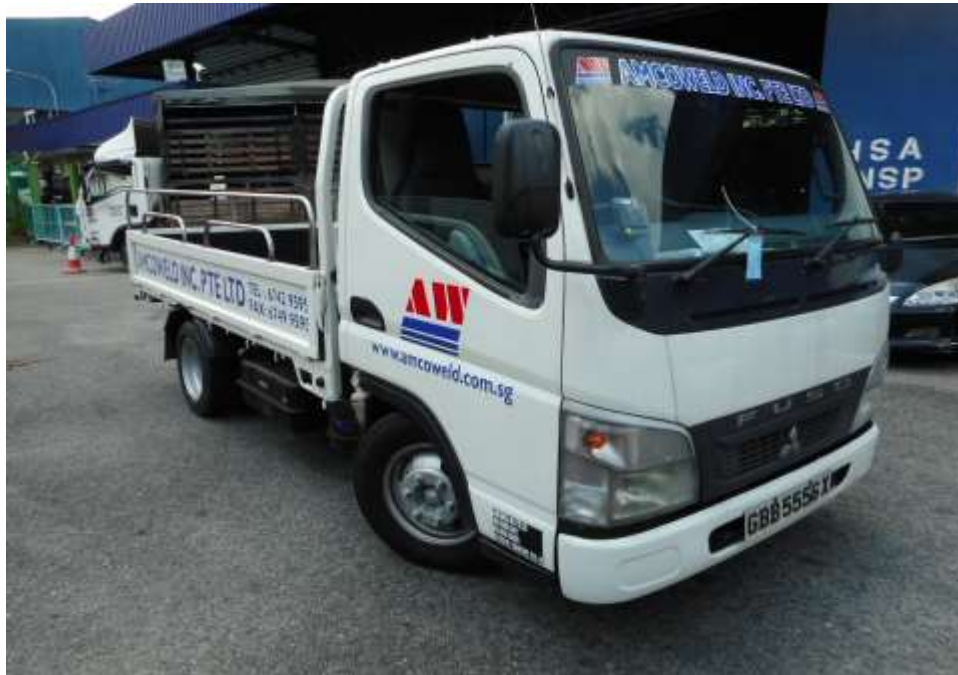
**Photo 22** shows the front right wheel of the Motor Lorry turned to its full right. During my steering system test, I did not experience any abnormal free play and/or resistance when I had turned the steering wheel towards full left and full right. This would suggest that the steering system of the Motor Lorry was likely to be in serviceable condition at the material time of accident.
