Your Ref: TP/IP/60507/2019
Our Ref : CI/TPD19020758/P

4th December 2019

Fatal Accident Investigation Team

MECHANICAL INSPECTION REPORT OF MOTOR CAR SMA 1288X

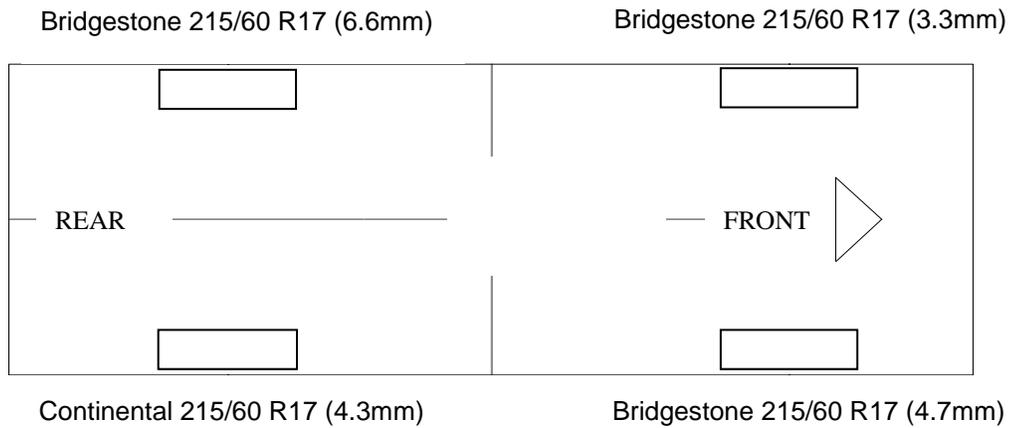
6. The 4 tyres of the Motor Car were observed to be in serviceable condition and sufficiently inflated for vehicular operation. I did not find any tear, cut or burst mark(s) on the outer and the inner sidewalls as well as across the tread of the 4 tyres. The tyre brand, tyre size and remaining tread depth of the 4 tyres of the Motor Car were recorded as follows:-

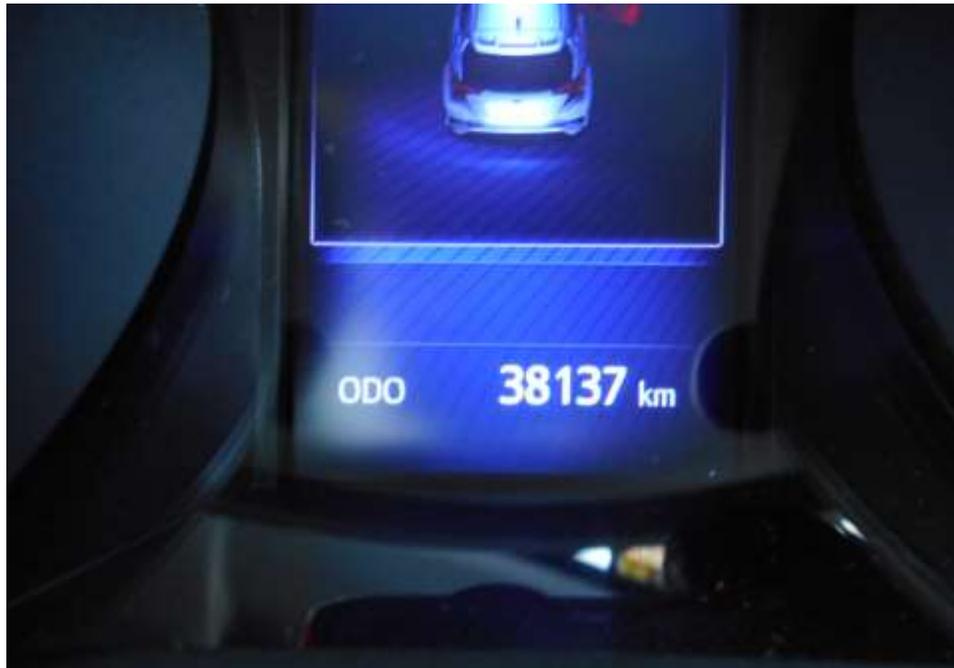
4. The mileage of the Motor Car at the time of my inspection was 38,137km.
5. There was no visible damage observed on Motor Car at the time of my inspection.

Photo 1 shows a general view of the instrument cluster of the Motor Car at the time of my inspection. The mileage of the Motor Car was 38,137km

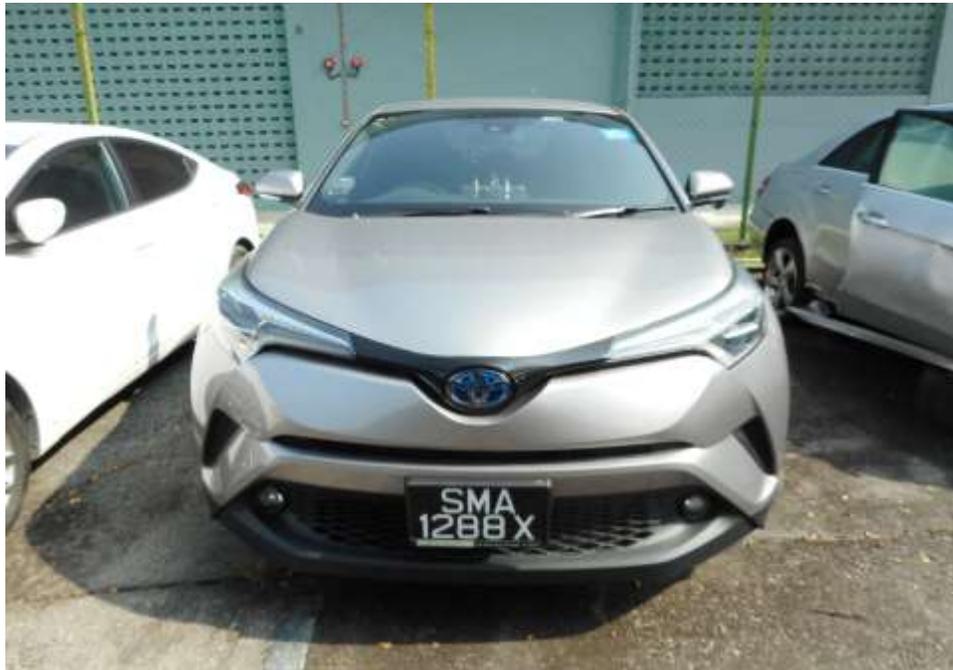
Photo 2 shows a general view of the Motor Car at the time of my inspection. The Motor Car was observed to be intact and unaffected by the accident.

14. A short operational test of the Motor Car, to primarily determine whether there was any abnormality to its various operating systems like its engine system, its transmission system, steering system and braking system was subsequently carried out. The test was conducted by driving the Motor Car forward, stopping, before reversing and coming to a stop again.
15. During the operational test, the transmission system of the Motor Car was able to be shifted to drive mode and reverse mode without any difficulty. There was no abnormal sounds heard and/or abnormal behaviour of the Motor Car's engine system. It was able to move forward and backward normally. The braking system was also found to be in working condition as the Motor Car was able to slow down and come to a complete stop upon depressing of the brake pedal. (Refer to photo 2 & 21)

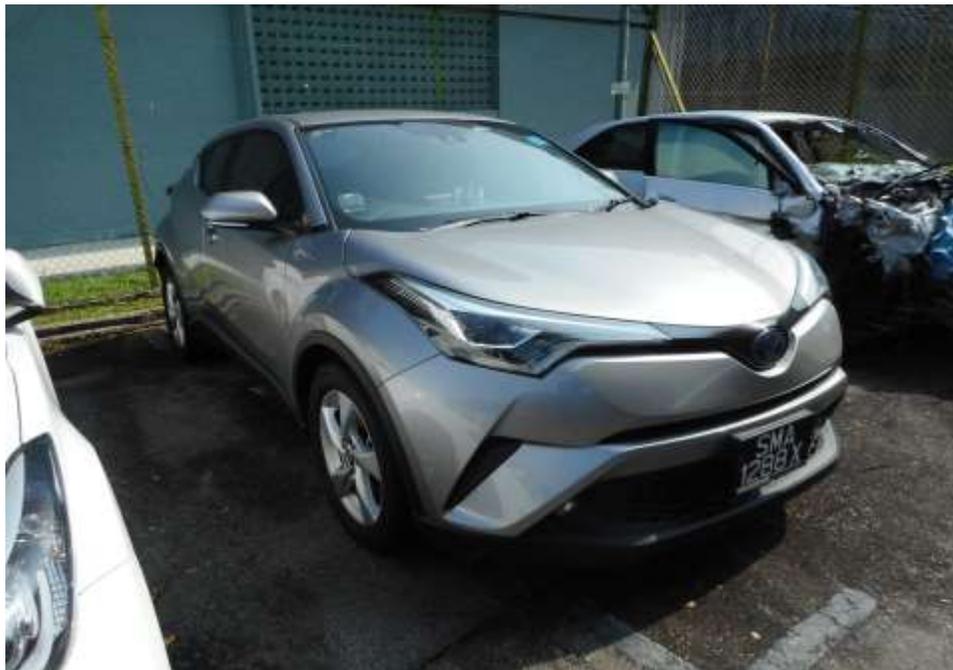
Photo 3 shows a general view of the right body of the Motor Car at the time of my inspection. The Motor Car was observed to be intact and unaffected by the accident.

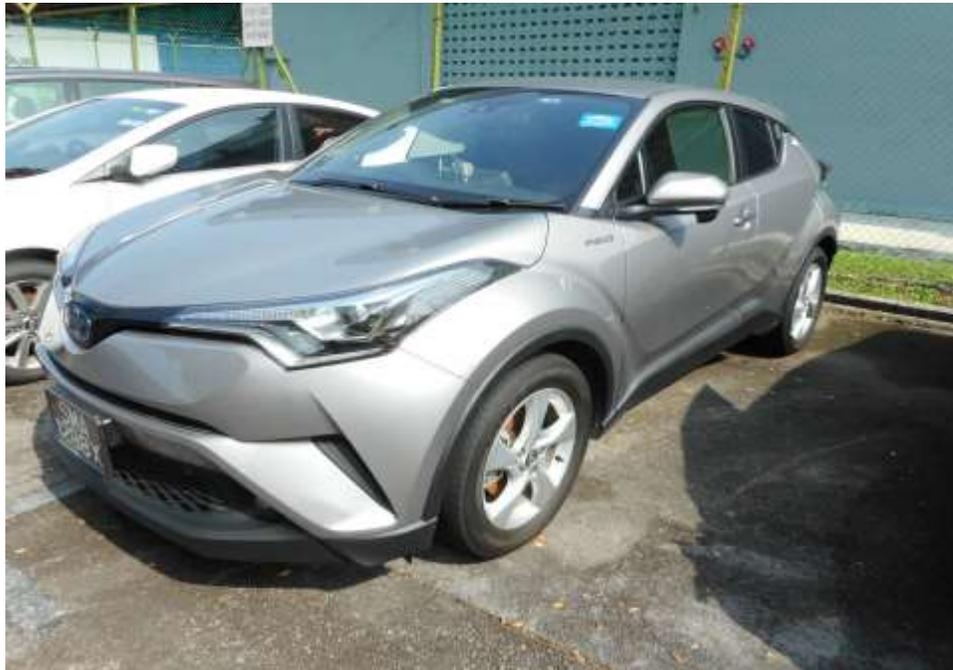
Photo 4 shows a general view of the left body of the Motor Car at the time of my inspection. The Motor Car was observed to be intact and unaffected by the accident.

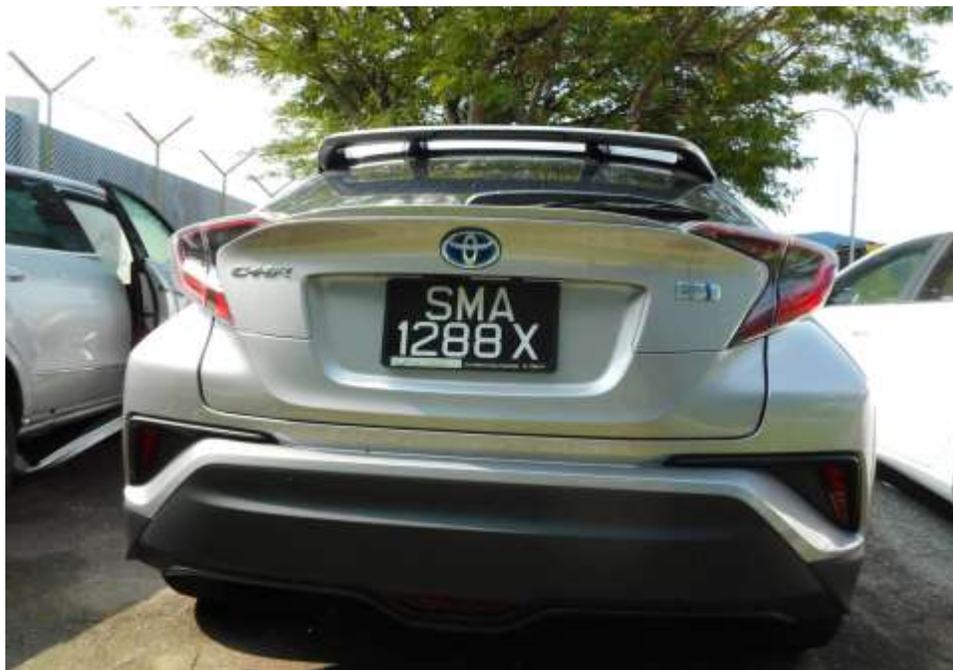
Photo 5 shows a general view of the rear body of the Motor Car at the time of my inspection. The Motor Car was observed to be intact and unaffected by the accident.

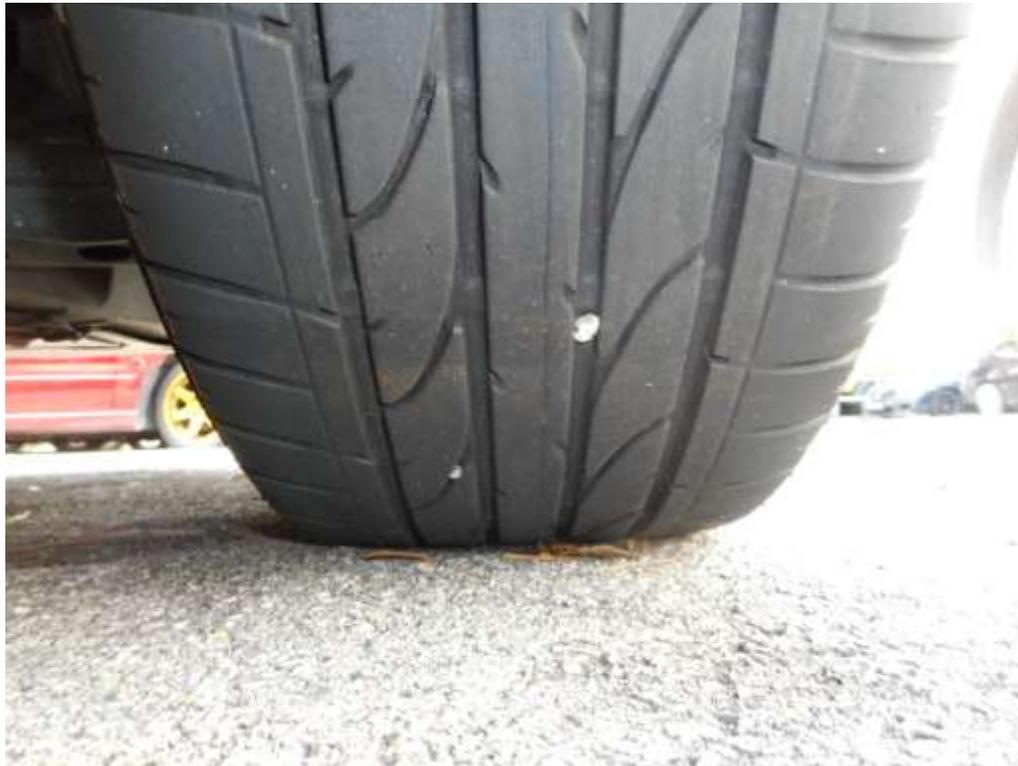
Photo 6 shows the condition of the front right tyre of the Motor Car, which was observed to be in serviceable condition with remaining tread depth of approximately 4.7mm. The tyre, which was wrapped around standard alloy wheel rim, was also observed to be sufficiently inflated for vehicular operation. There was no tear, cut or burst mark(s) on the outer and the inner sidewalls as well as across the tread of the 4 tyres that were fitted on the Motor Car.

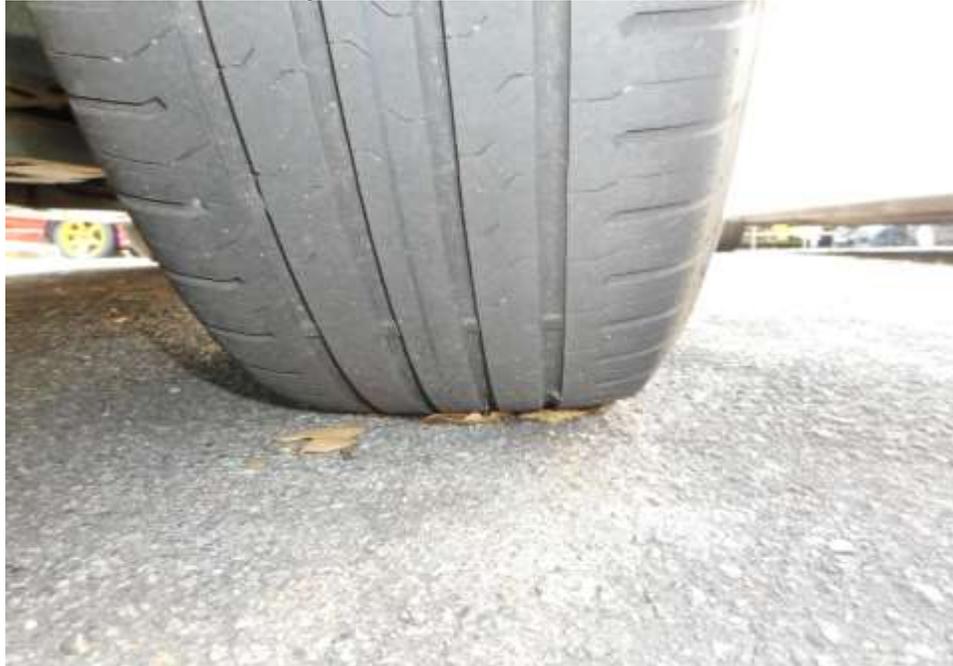
Photo 7 shows the condition of the rear right tyre of the Motor Car, which was observed to be in serviceable condition with remaining tread depth of approximately 4.3mm. The tyre, which was wrapped around standard alloy wheel rim, was also observed to be sufficiently inflated for vehicular operation.

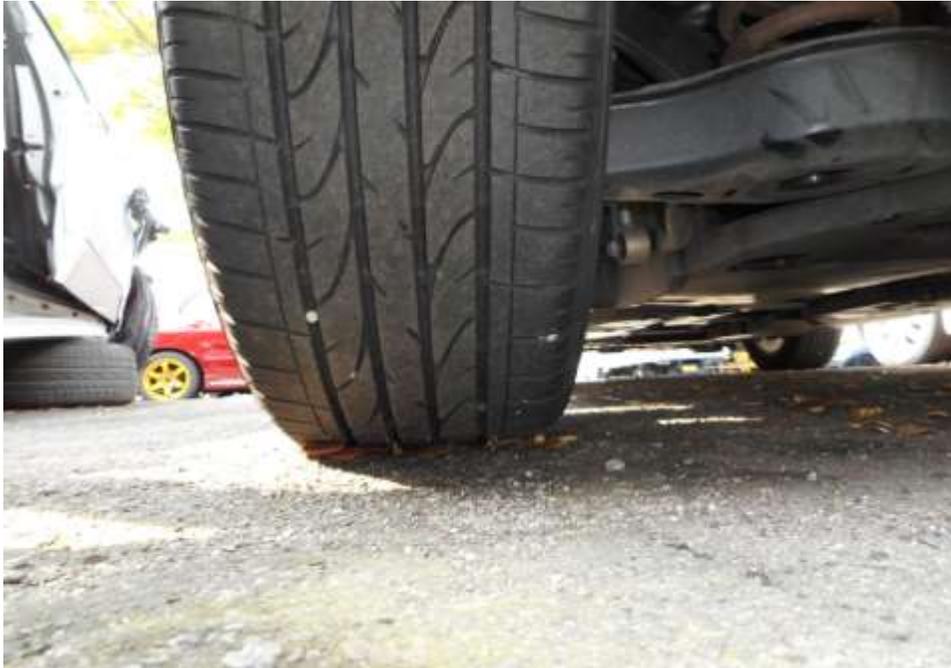
Photo 8 shows the condition of the rear left tyres of the Motor Car, which was observed to be in serviceable condition with remaining tread depth of approximately 6.6mm. The tyres, which were wrapped around standard alloy wheel rim, were also observed to be sufficiently inflated for vehicular operation. There was also no damage found on all 4 alloy wheel rims of the Motor Car.

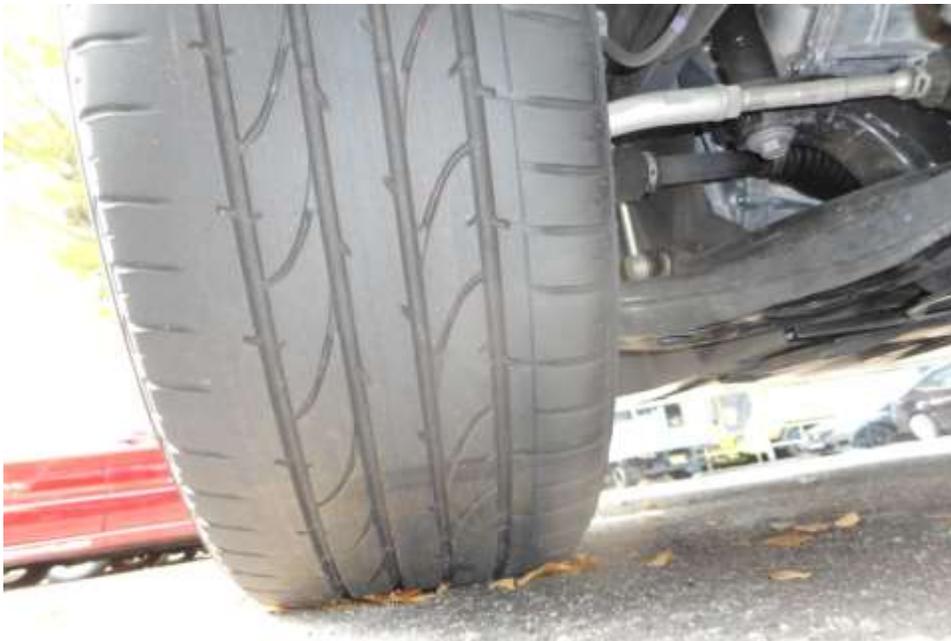
Photo 9 shows the condition of the rear right tyres of the Motor Car, which were observed to be in serviceable condition with remaining, tread depth of approximately 3.3mm. There was also no tear, cut or burst mark(s) on the outer and the inner sidewalls as well as across the tread of the 4 tyres that were fitted on the Motor Car.

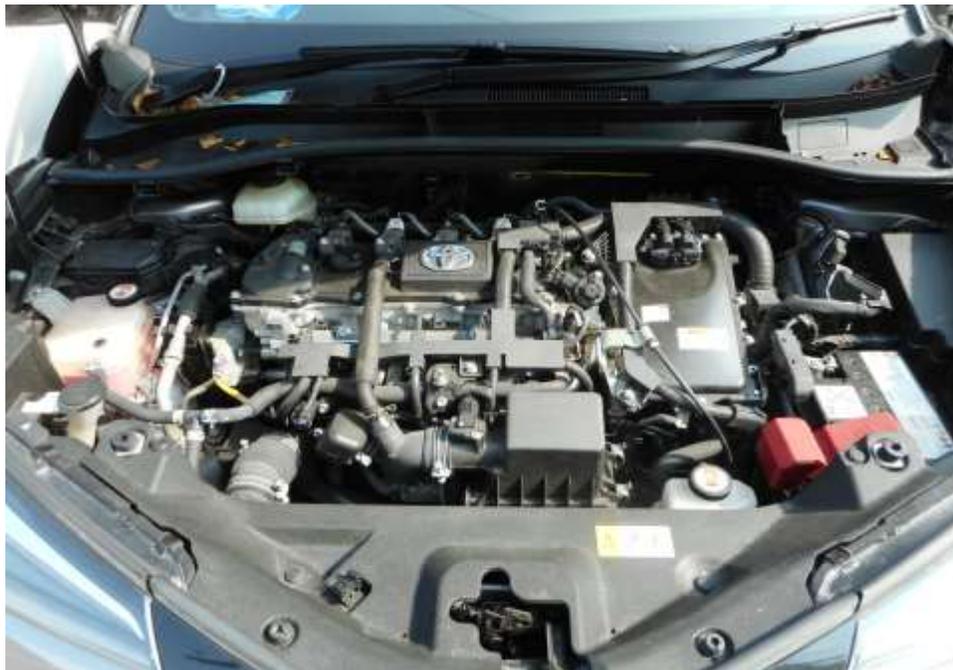
8. Upon examination of the Motor Car's engine compartment, I had observed all the parts and components inside the engine compartment to be intact and unaffected by the accident. The brake fluid, engine oil and engine coolant were all found to be of sufficient level for operating purposes. Visually, there was also no contamination found to these fluids.
9. Further examination of the engine compartment revealed, there was no sign(s) or indication(s) of fresh fluid leakage and/or fluid stain within the engine compartment of the Motor Car.
10. My subsequent checks on the underside of the Motor Car also revealed no fluid stain. Visually, the various undercarriage components of the Motor Car were all observed to be intact and without any visible damage. See photo 10 – 14 below.

Photo 10 shows a general view of the Motor Car's engine compartment, which was accessed by lifting the front cabin of the Motor Car. The various parts and components inside the engine compartment were unaffected by the accident. There was also no sign(s) or indication(s) of fresh fluid leakage and/or fluid stain within the engine compartment

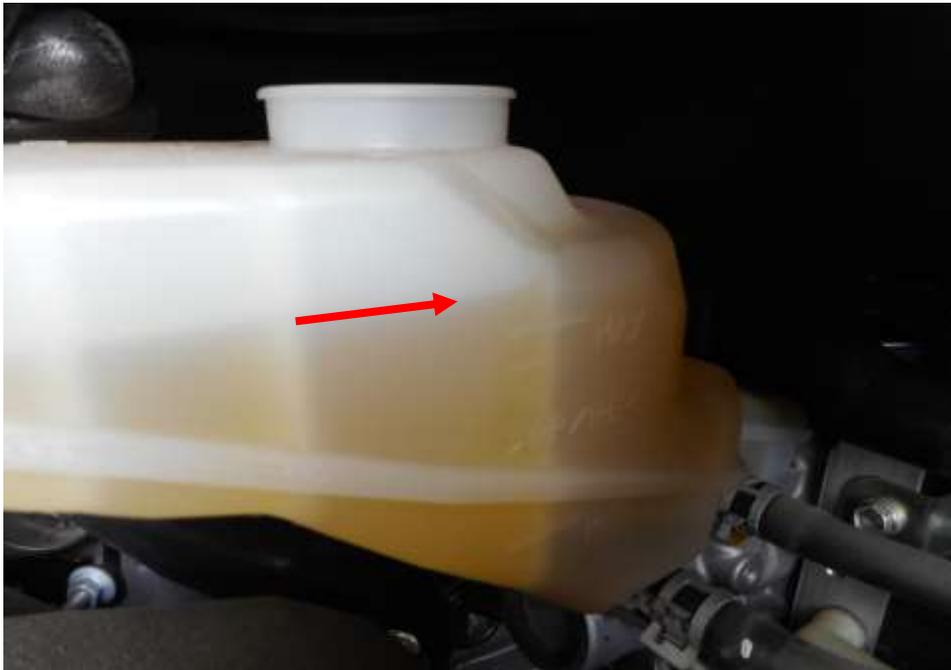
Photo 11 shows the brake fluid reservoir of the Motor Car at the time of my inspection. The brake fluid was observed to be of sufficient level (arrowed) and without any visible contamination.

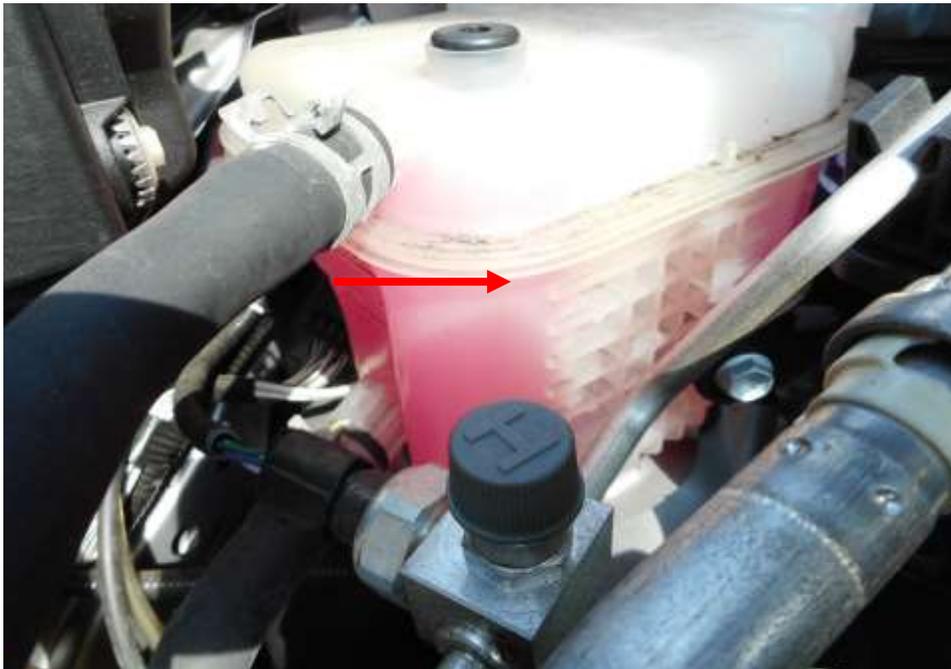
Photo 12 shows the engine coolant reservoir of the Motor Car at the time of my inspection. The engine coolant was observed to be of sufficient level (arrowed) and without any visible contamination.

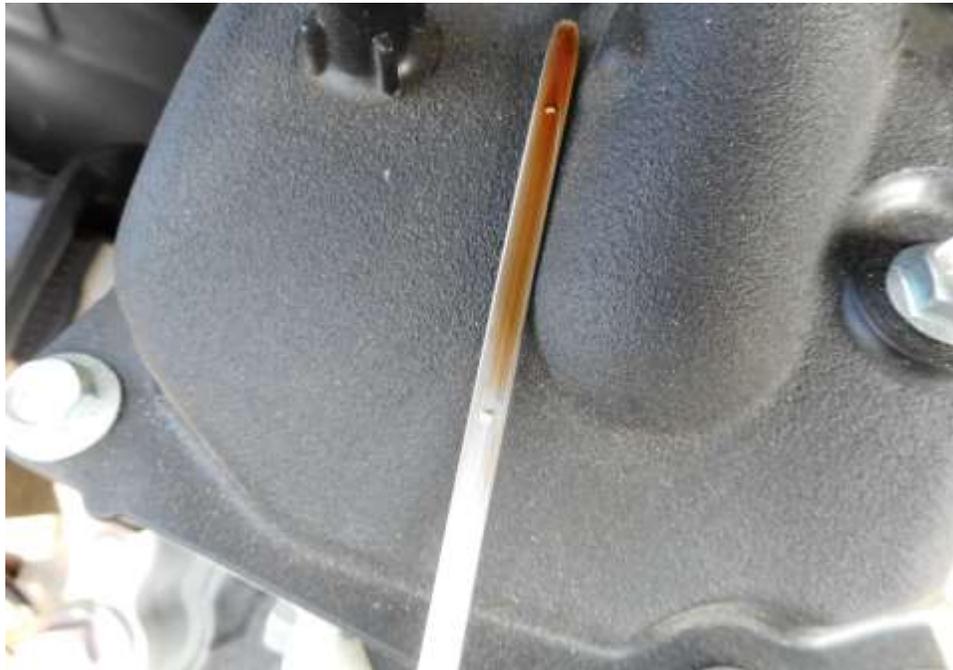
Photo 13 shows the engine oil dip stick of the Motor Car at the time of my inspection. The engine oil was observed to be of sufficient level and without any visible contamination.

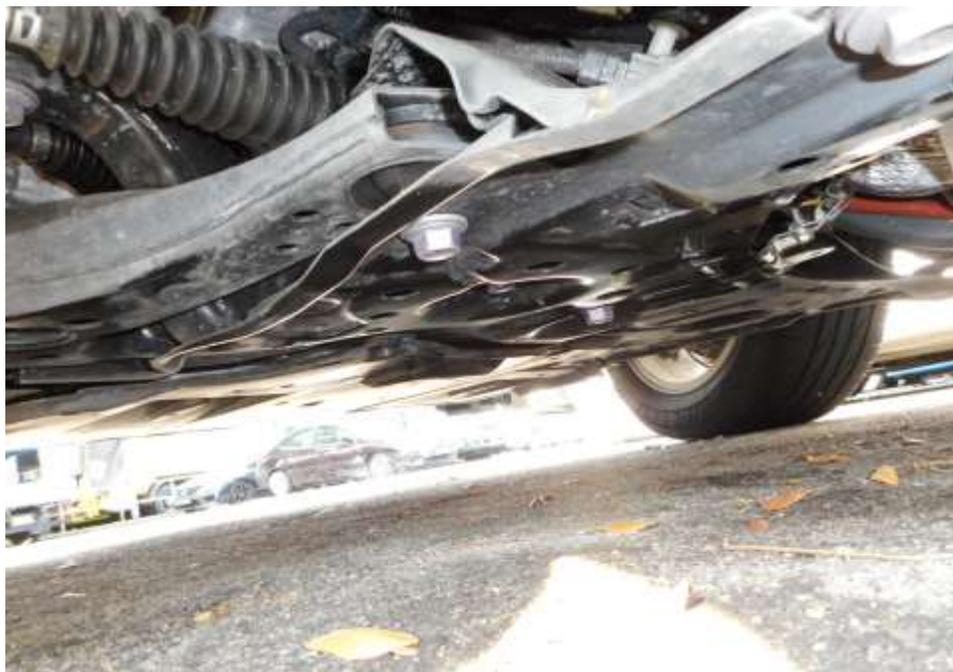
Photo 14 shows the undercarriage of the Motor Car, at the area where the engine housing and transmission housing are located. . I did not find any sign(s) or indication(s) of fluid leak and/or fluid stain(s) on the underside of the Motor Car.

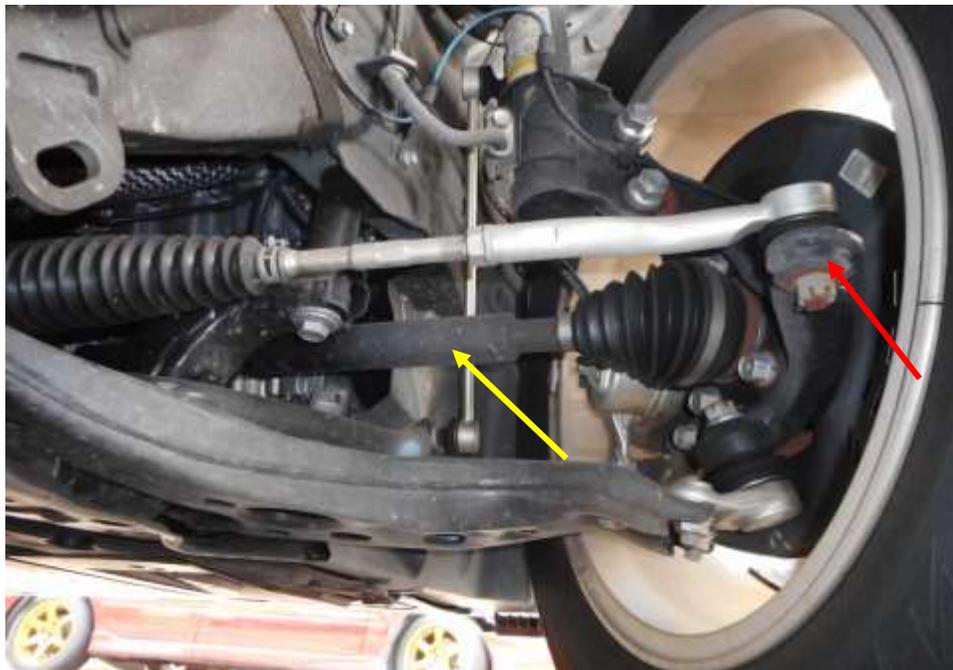
Photo 15 shows the various undercarriage components at the front right wheel of the Motor Car, in particular the steering tie rod end (arrowed) and drive shaft (yellow arrow). The various steering components were all found to be intact, suggesting that the steering system of the Motor Car was likely to be in serviceable condition at the material time of accident. There was also no sign of fluid stain(s) observed on the various undercarriage components.

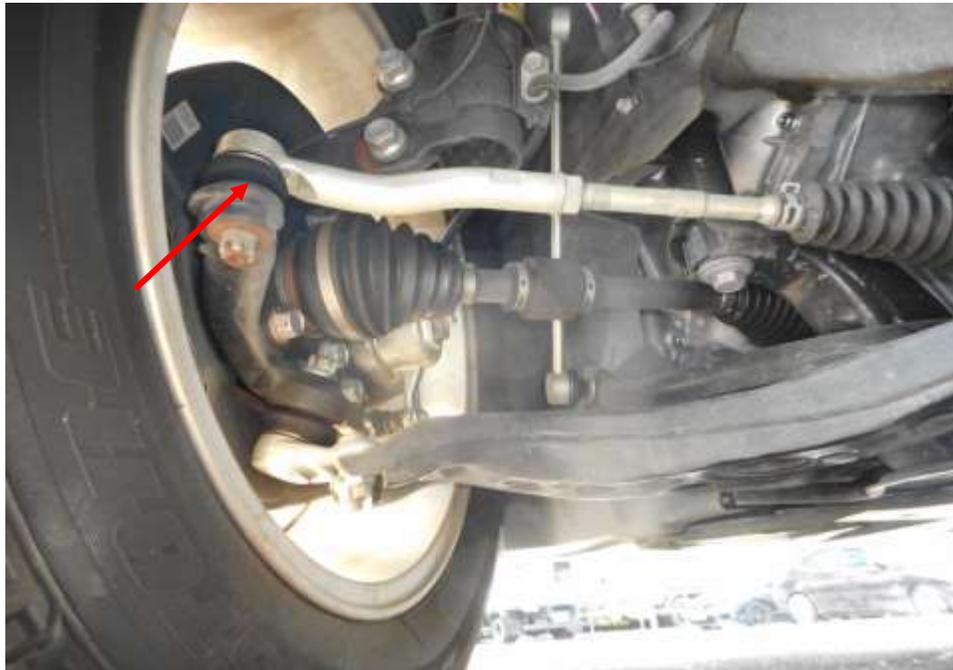
Photo 16 shows the various undercarriage components at the front left wheel of the Motor Car, in particular the steering tie rod end (arrowed). The various Undercarriage components of the Motor Car were all found to be intact without any visible damage. There was also no sign of fluid stain(s) observed on the various undercarriage components.

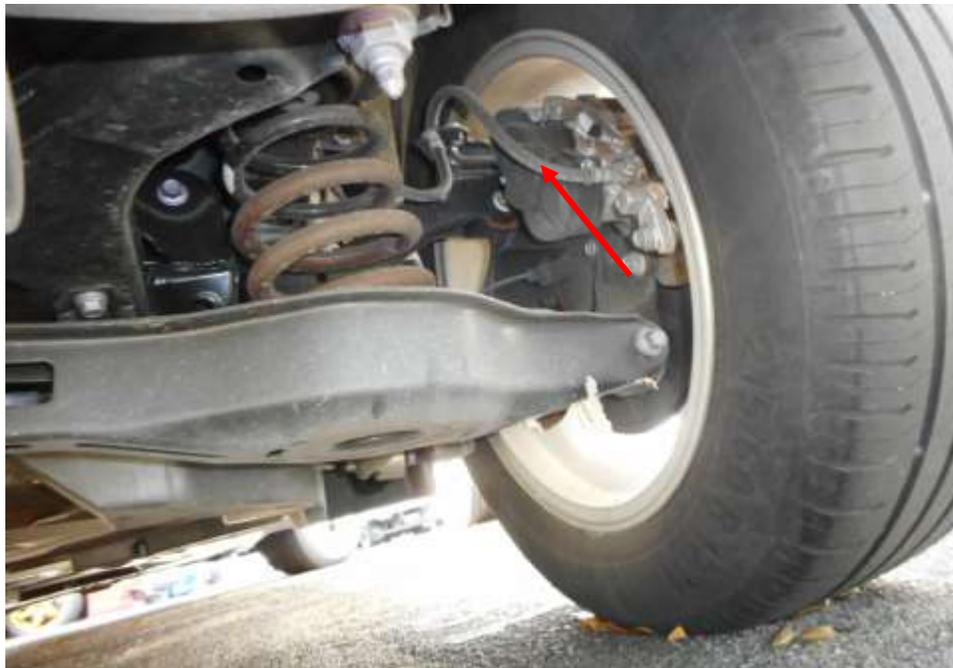
Photo 17 shows the brake pipe (arrowed) at the rear right wheel of the Motor Car. I did not observe any leakage of brake fluid at the time of my inspection of the Motor Car. My static tests of the Motor Car's braking system, along with my visual examination of the various mechanical components in the braking system, had indicated that there was no internal leakage of pressure/vacuum. Hence the braking system of the Motor Car was likely to be in serviceable condition at the material time of accident.

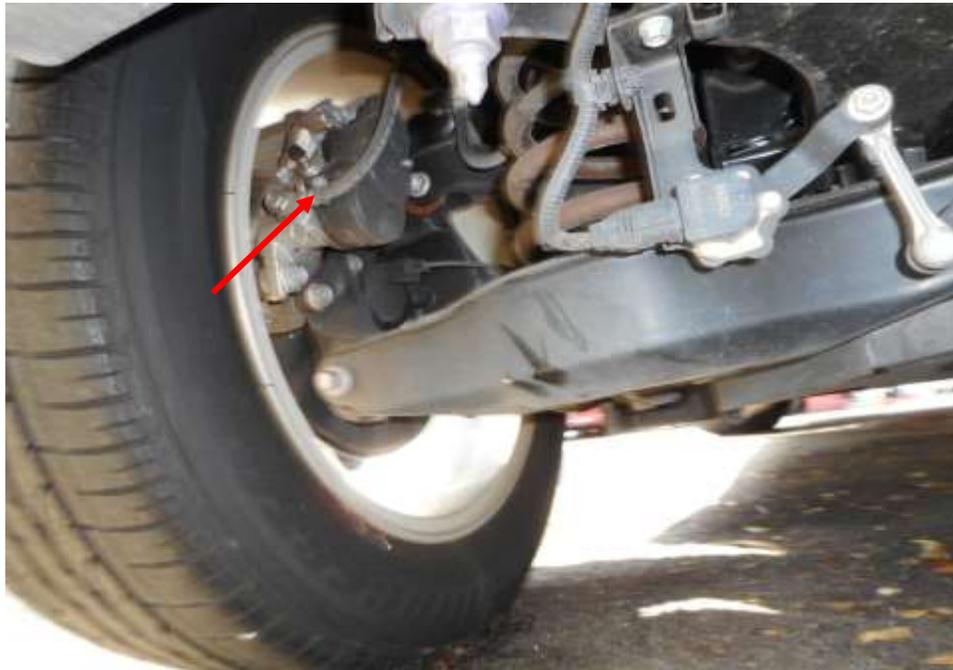
Photo 18 shows the brake pipe (arrowed) at the rear left wheel of the Motor Car. I did not observe any leakage of brake fluid at the time of my inspection of the Motor Car. My static tests of the Motor Car's braking system, along with my visual examination of the various mechanical components in the braking system had indicated that there was no internal leakage of pressure/vacuum. Hence the braking system of the Motor Car was likely to be in serviceable condition at the material time of accident.

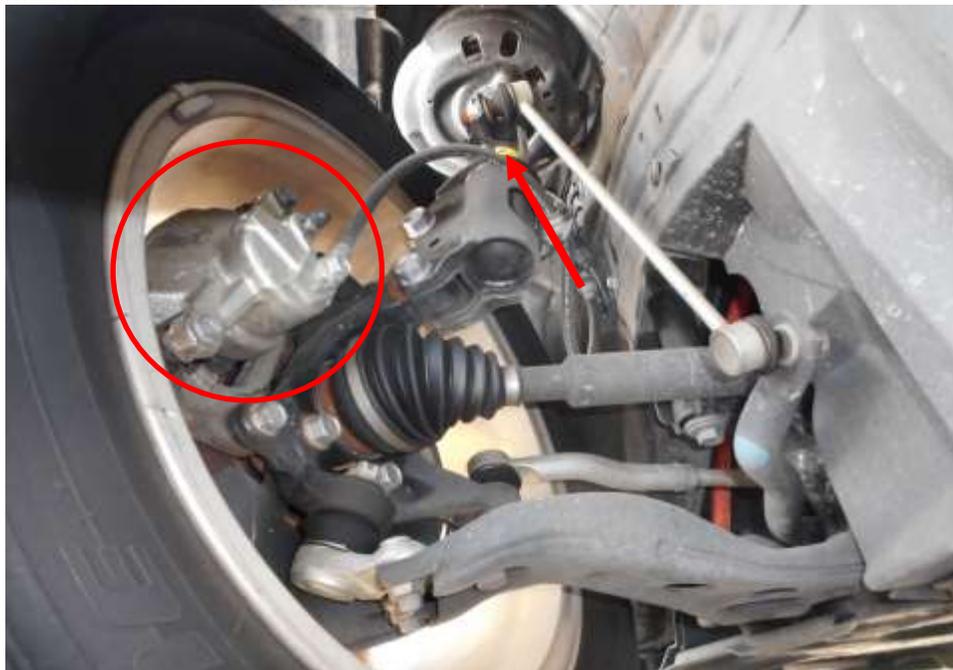
Photo 19 shows the brake hose/pipe (arrowed) at the front right wheel of the Motor Car. No leakage of brake fluid was observed. Visual examination of the various components of the braking system like the brake caliper (circled), brake booster, brake pedal etc had revealed all to be intact and without visible damage at the time of accident. There was also no sign of fluid stain(s) observed on the various undercarriage components.

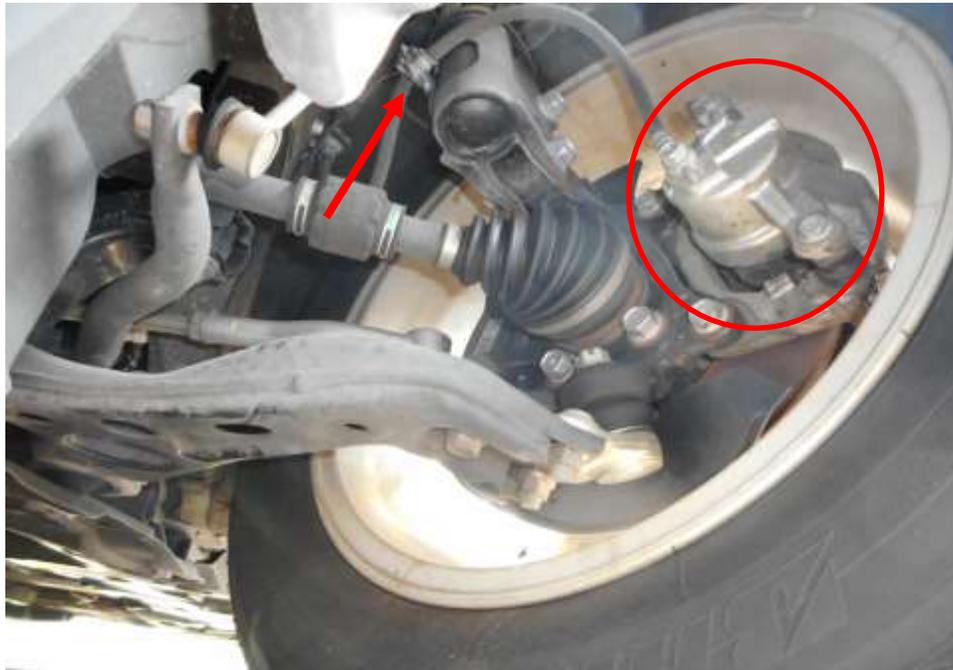
Photo 20 shows the brake hose/pipe (arrowed) at the front left wheel of the Motor Car. No leakage of brake fluid was observed. Visual examination of the various components of the braking system like the brake caliper (circled), brake booster, brake pedal etc had revealed all to be intact and without visible damage at the time of accident. There was also no sign of fluid stain(s) observed on the various undercarriage components.

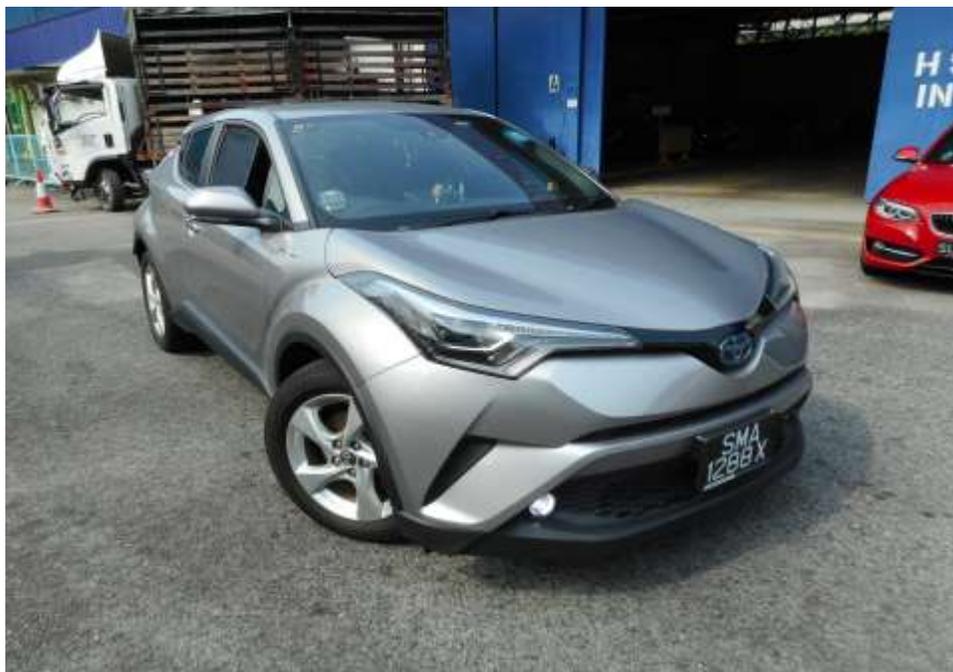
Photo 21 shows the front right wheel of the Motor Car turned to its full left. During my steering system test, I did not experience any abnormal free play and/or resistance when I had turned the steering wheel towards full left and full right. This would suggest that the steering system of the Motor Car was likely to be in serviceable condition at the material time of accident.

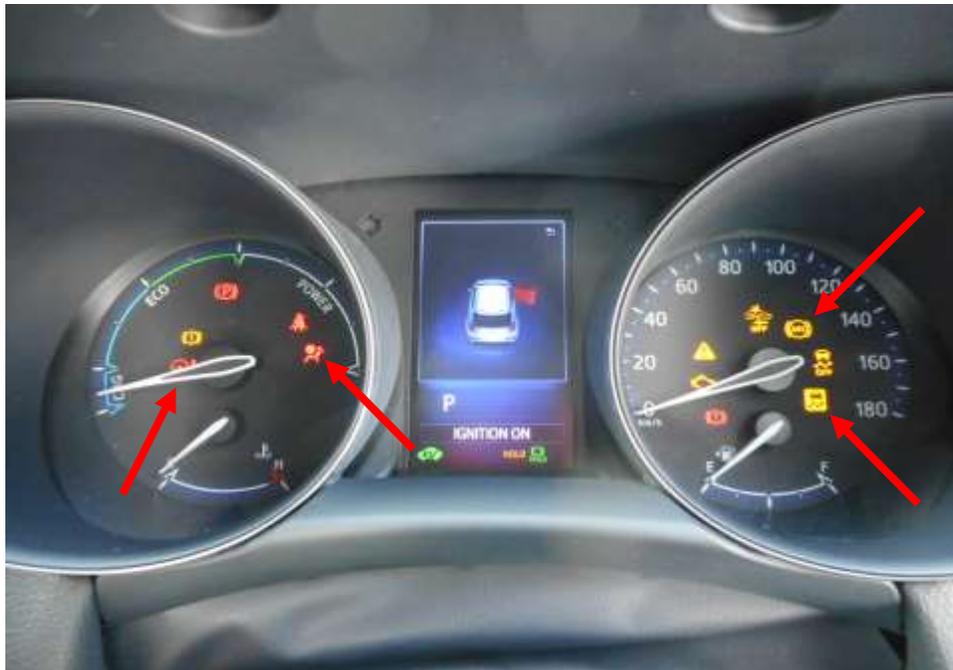
13. Motor Car's automatic self-test of the functionality of its various electronic operating systems like the Anti-Lock Brake System (ABS), Traction Control (TC), Supplemental Restraint System (SRS) and Electric Power Steering System (EPS) during cranking of the engine had indicated that these systems were in working condition and without abnormality. This can be established from the warning lights disappearing from the instrument panel after the self-test. See photo 22 & 23 below.

Photo 22 shows the warning light for Anti-Lock Brake System (ABS), Traction Control (TC), Supplemental Restraint System (SRS) and Electric Power Steering System (EPS) appearing on the instrument panel of the Motor Car during the self-test of its various electronic operating systems when its engine was cranked.

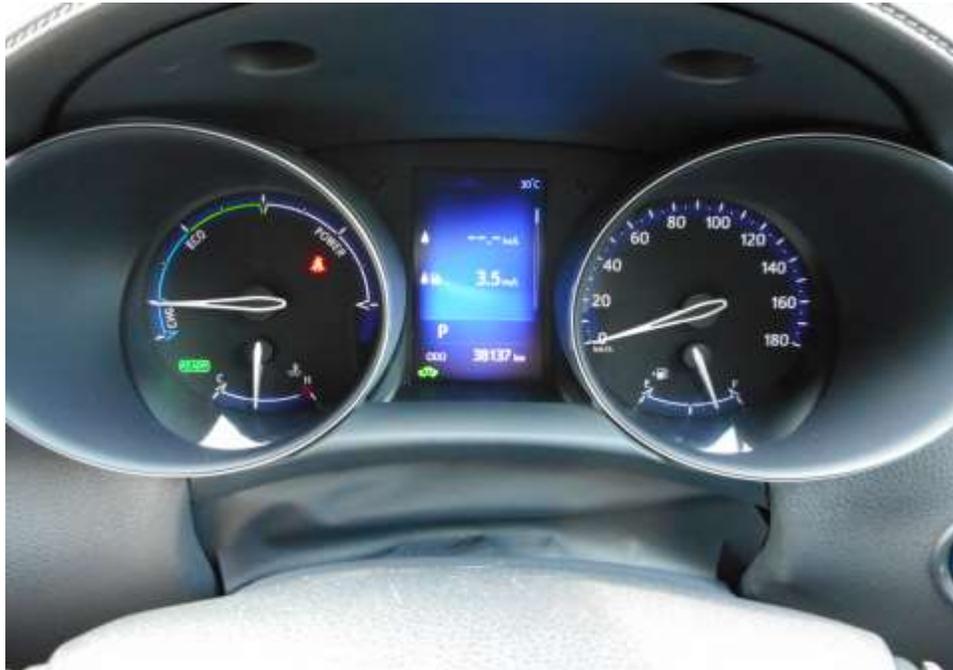
Photo 23 shows no warning lights illuminated on the instrument panel of the Motor Car after the engine was cranked. This would suggest that there was no abnormality to the various electronic operating systems of the Motor Car, like the ABS, TC, SRS and EPS.
