Your Ref: TP/IP/69597/2019  
Our Ref : CI/TPD19020760/P

**Fatal Accident Investigation Team**

**MECHANICAL INSPECTION REPORT OF MOTOR CAR SMJ 1564B**

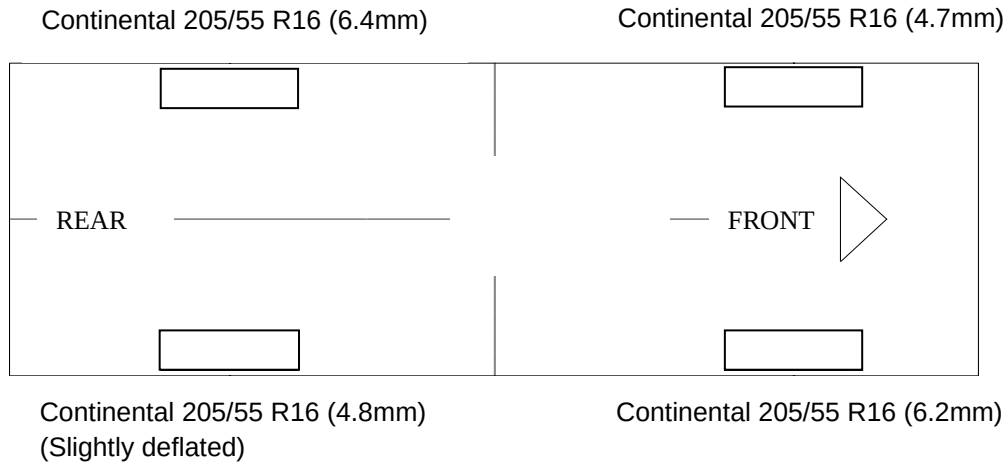
6. The rear right tyre was observed to be slightly deflated as a result of the accident. However, the 4 tyres of the Motor Car were observed to be in serviceable condition for vehicular operation. I did not find any tear, cut or burst mark(s) on the outer and the inner sidewalls as well as across the tread of the 4 tyres. The tyre brand, tyre size and remaining tread depth of the 4 tyres of the Motor Car were recorded as follows:-

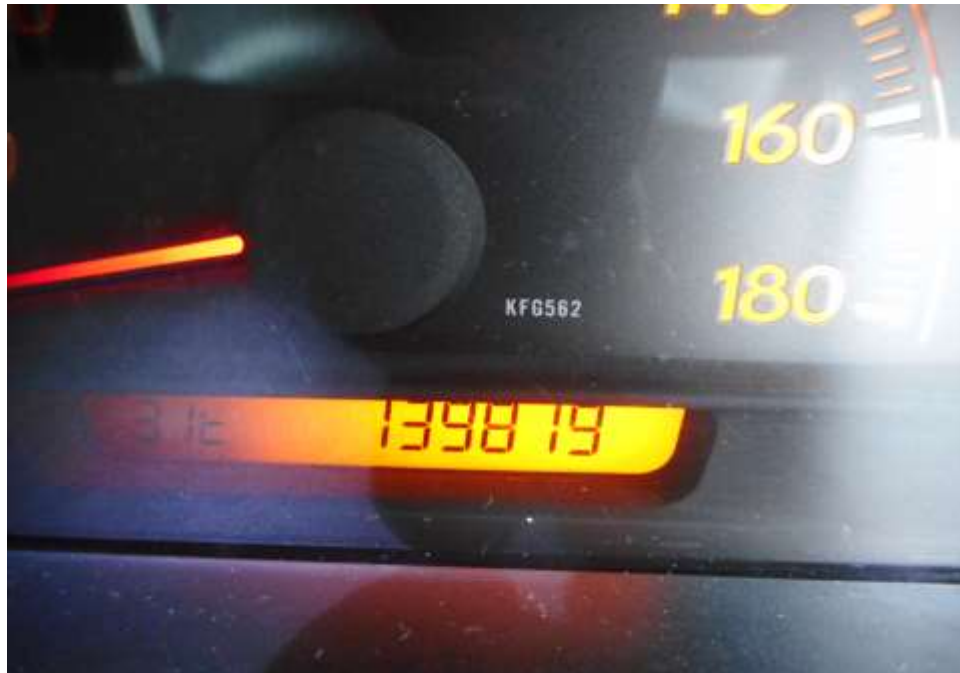
**Photo 1** shows a general view of the instrument cluster of the Motor Car at the time of my inspection. The mileage of the Motor Car was 139,819km

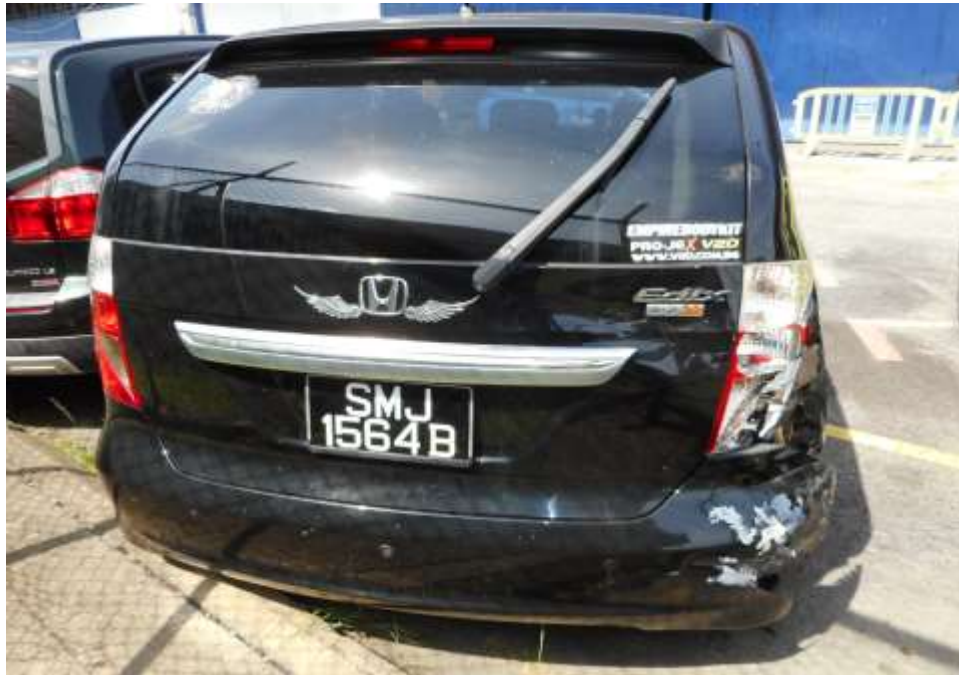
4. The mileage of the Motor Car at the time of my inspection was 139,819km.
5. Motor car was observed to have sustained damage at its rear portion. Its rear bonnet, rear bumper, rear right brake lamp, rear right fender was amongst the body parts damaged as a result of the accident.

**Photo 2** shows a general view of the rear body of the Motor Car at the time of my inspection. The Motor Car was observed to have sustained damage at its rear portion. Its rear bonnet, rear bumper, rear right brake lamp, rear right fender was amongst the body parts damaged as a result of the accident.

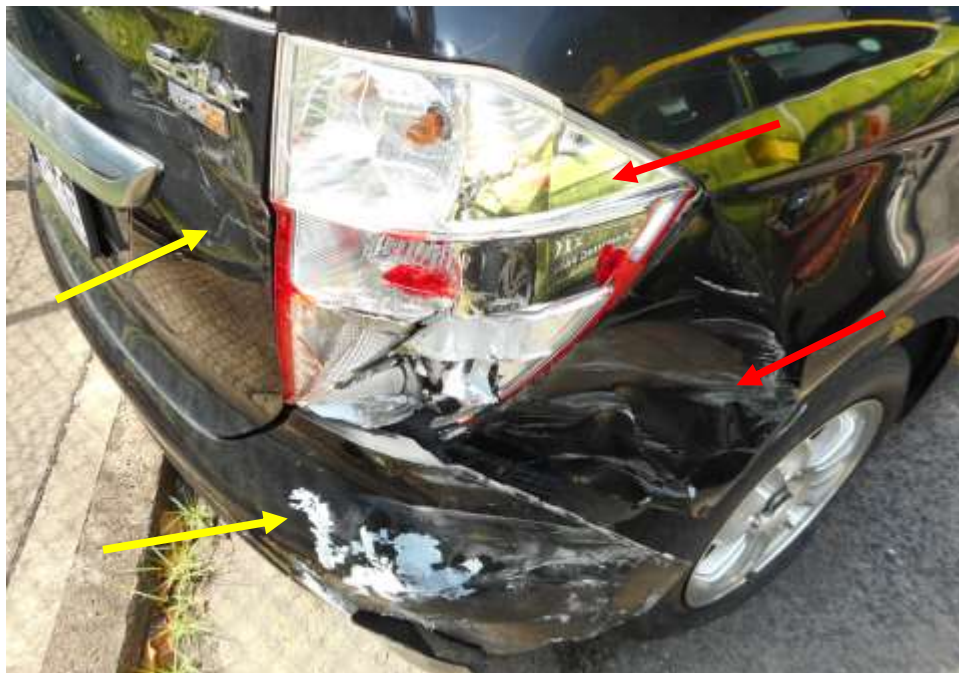
**Photo 3** shows a close up view of the rear body of the Motor Car at the time of my inspection. The Motor Car was observed to have sustained damage at its rear portion. Its rear bonnet (yellow arrow), rear bumper (yellow arrow), rear right brake lamp (red arrow), rear right fender (red arrow) was amongst the body parts damaged as a result of the accident.

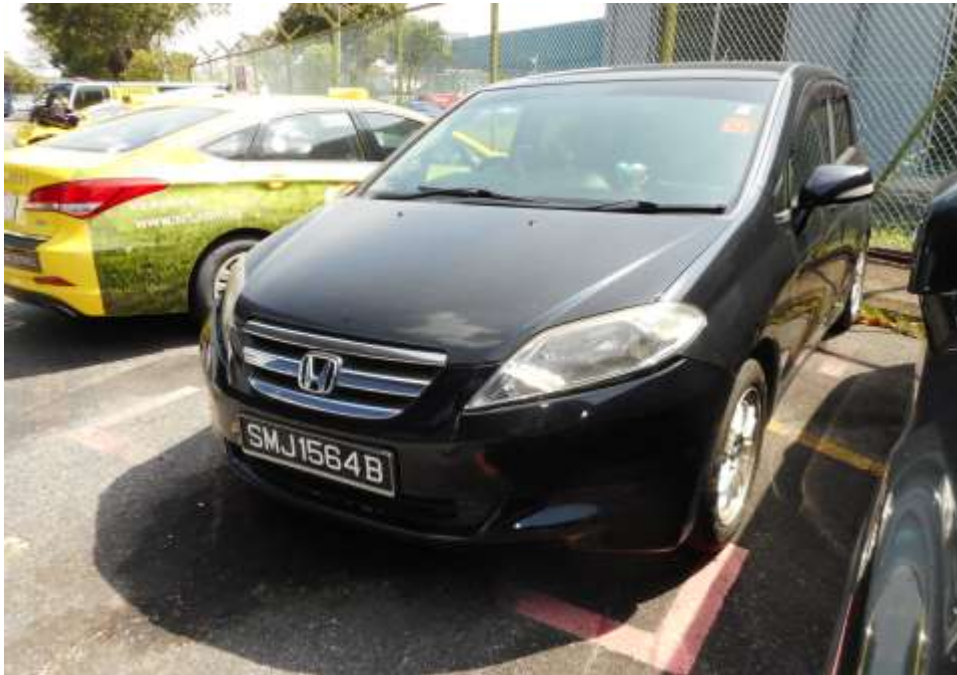
**Photo 4** shows a general view of the front and left body Motor Car at the time of my inspection. The Motor Car was observed to be intact and unaffected by the accident.

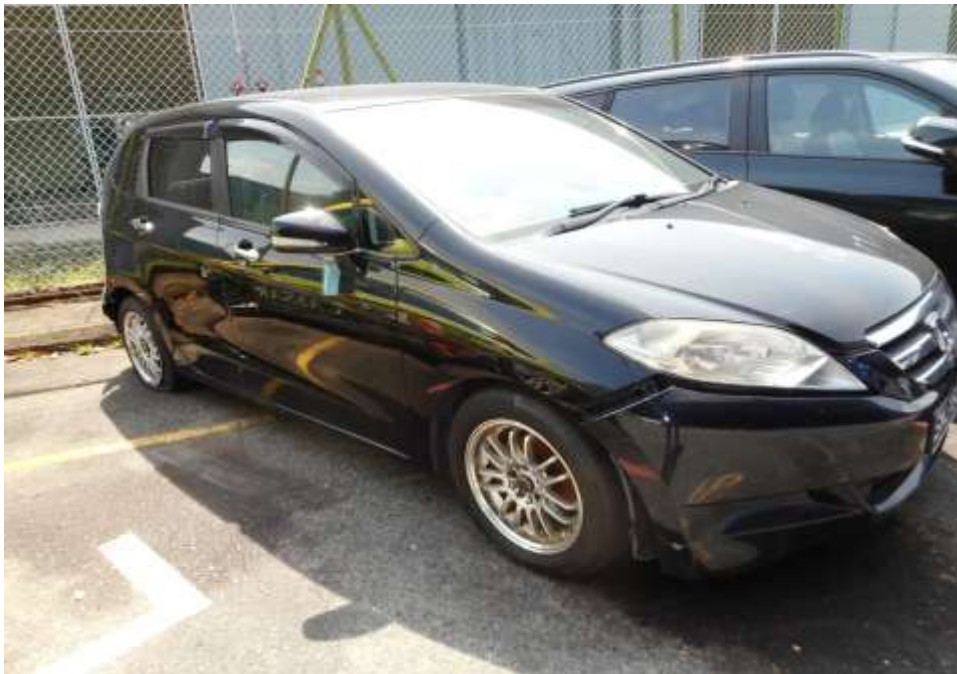
**Photo 5** shows a general view of the right body of the Motor Car at the time of my inspection. The Motor Car was observed to be intact and unaffected by the accident.

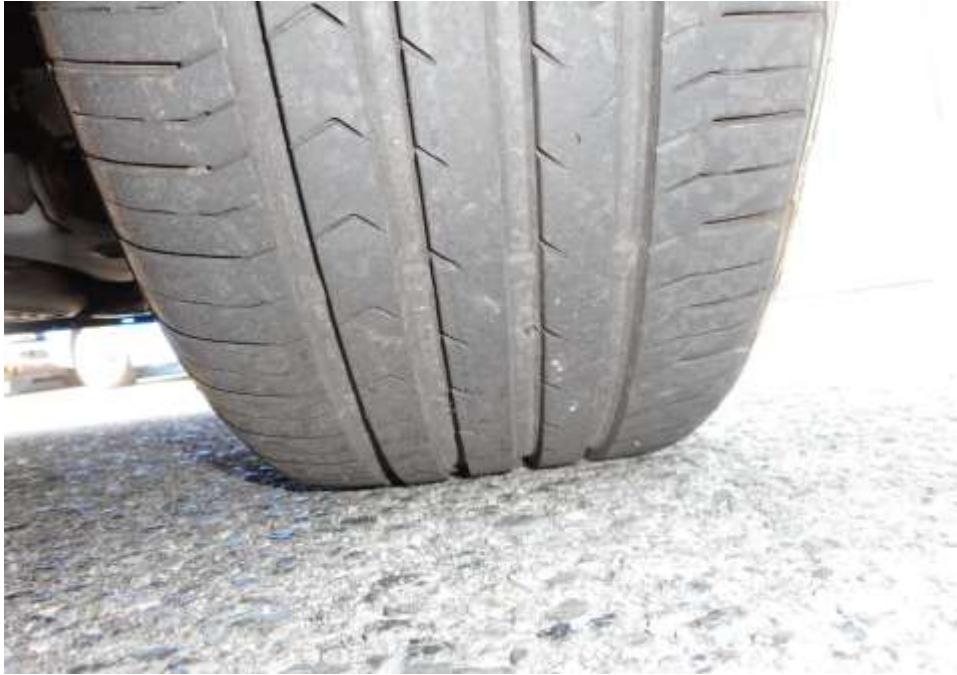
**Photo 6** shows the condition of the front right tyre of the Motor Car, which was observed to be in serviceable condition with remaining tread depth of approximately 6.2mm. The tyre, which was wrapped around standard alloy wheel rim, was also observed to be sufficiently inflated for vehicular operation. There was no tear, cut or burst mark(s) on the outer and the inner sidewalls as well as across the tread of the 4 tyres that were fitted on the Motor Car.

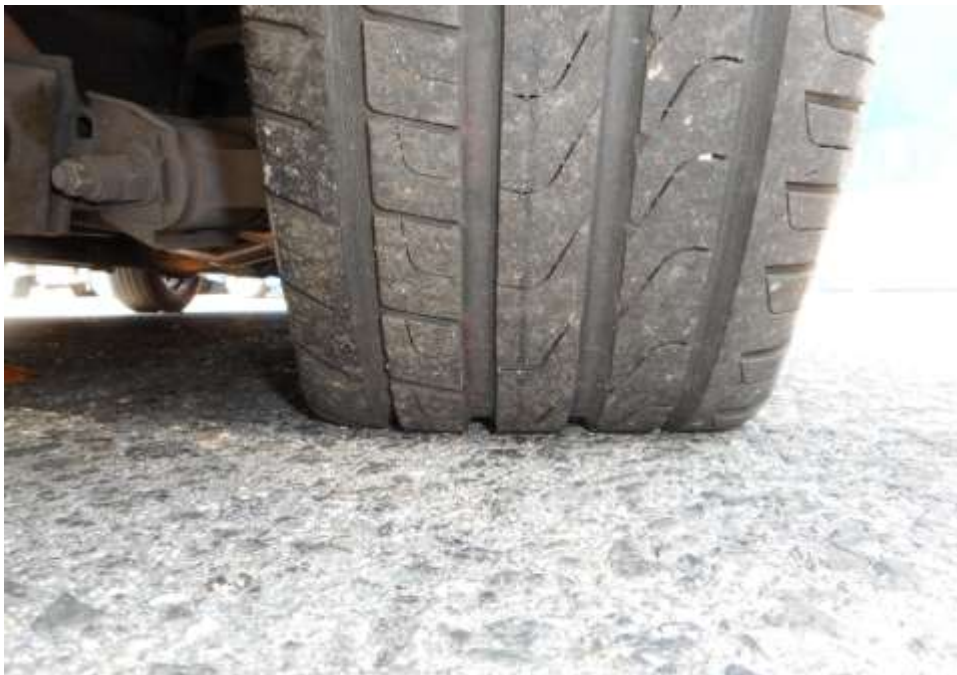
**Photo 7** shows the condition of the rear right tyre of the Motor Car, which was observed to be slightly deflated however in serviceable condition with remaining tread depth of approximately 4.8mm. The tyre, which was wrapped around standard alloy wheel rim

17. The rear right tyre was observed to be slightly deflated however all 4 tyres fitted on the Motor Car were also found to be in serviceable condition. I did not find any tear, cut or burst mark(s) on the outer and the inner sidewalls as well as across the tread of the 4 tyres. The 4 tyres were also observed to be serviceable condition for vehicular operation with remaining tread depth of approximately 4.8mm – 6.4mm.

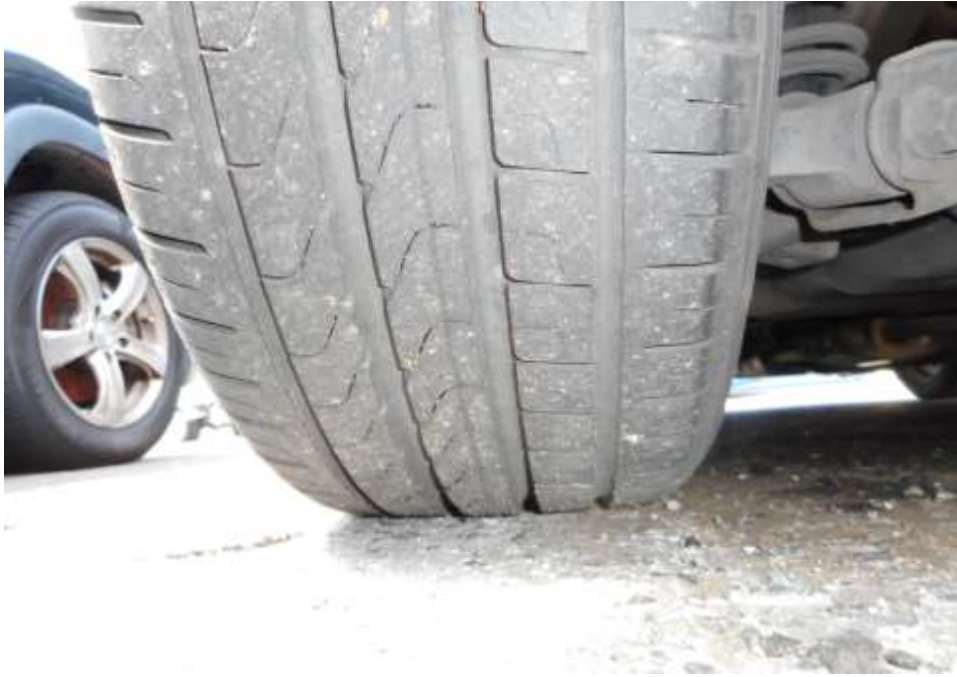
**Photo 8** shows the condition of the rear left tyres of the Motor Car, which was observed to be in serviceable condition with remaining tread depth of approximately 6.4mm. The tyres, which were wrapped around standard alloy wheel rim, were also observed to be sufficiently inflated for vehicular operation. There was also no damage found on all 4 alloy wheel rims of the Motor Car.

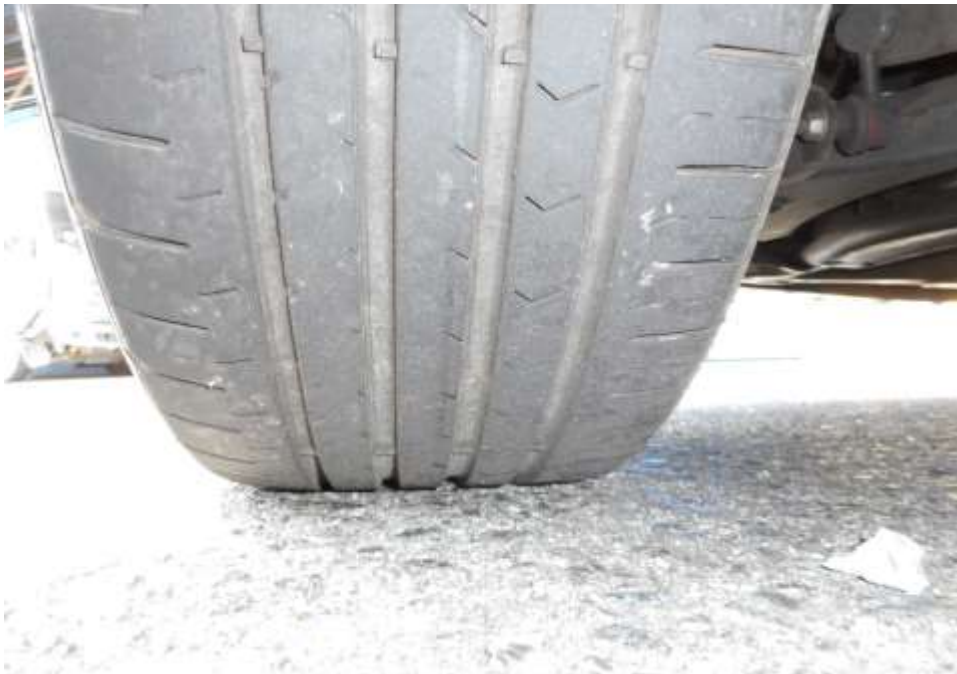
**Photo 9** shows the condition of the rear right tyres of the Motor Car, which were observed to be in serviceable condition with remaining, tread depth of approximately 4.7mm. There was also no tear, cut or burst mark(s) on the outer and the inner sidewalls as well as across the tread of the 4 tyres that were fitted on the Motor Car.

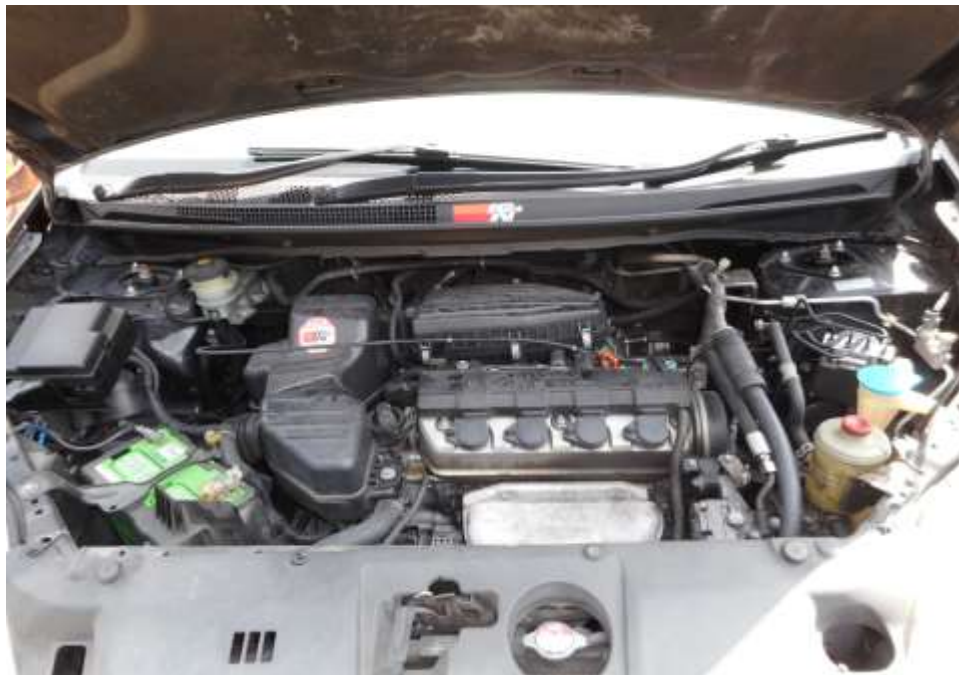
**Photo 10** shows a general view of the Motor Car's engine compartment, which was accessed by lifting the front cabin of the Motor Car. The various parts and components inside the engine compartment were unaffected by the accident. There was also no sign(s) or indication(s) of fresh fluid leakage and/or fluid stain within the engine compartment

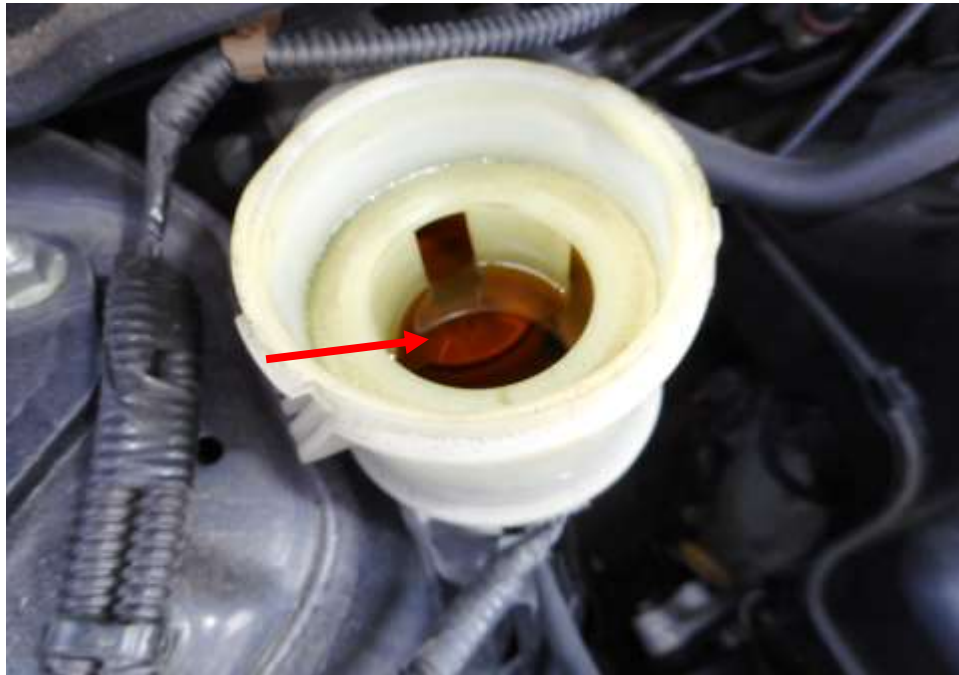
**Photo 11** shows the brake fluid reservoir of the Motor Car at the time of my inspection. The brake fluid was observed to be of sufficient level (arrowed) and without any visible contamination.

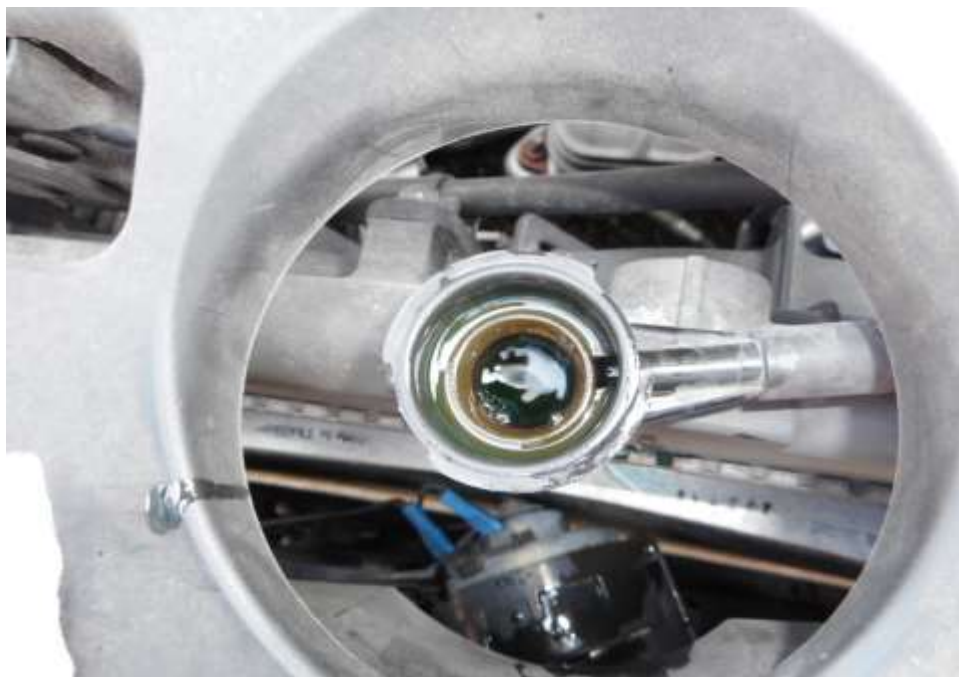
**Photo 12** shows the engine coolant reservoir of the Motor Car at the time of my inspection. The engine coolant was observed to be of sufficient level and without any visible contamination.

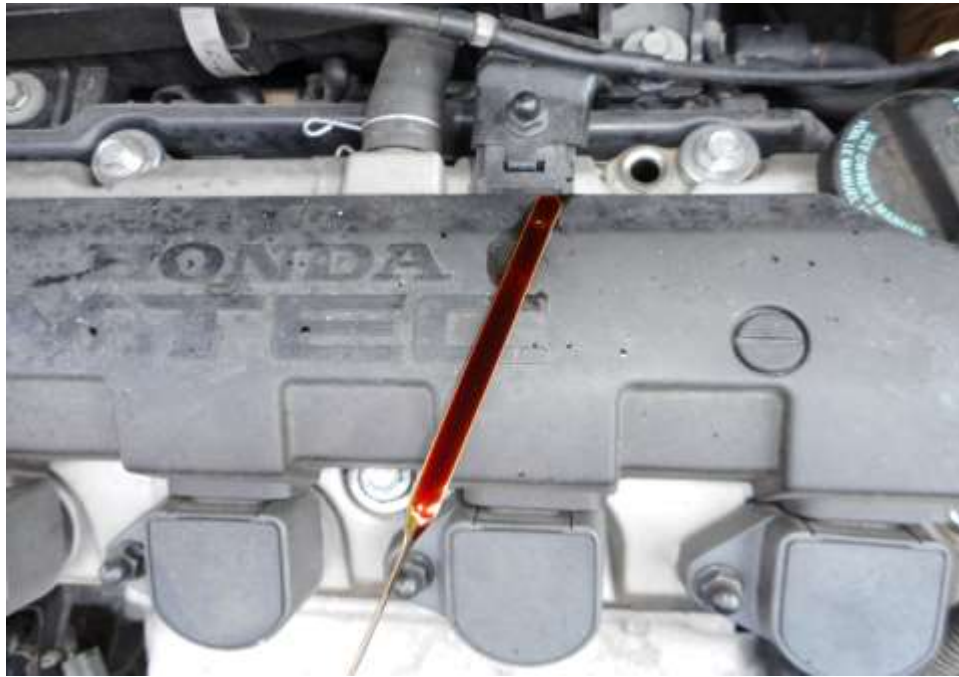
**Photo 13** shows the engine oil dip stick of the Motor Car at the time of my inspection. The engine oil was observed to be of sufficient level and without any visible contamination.

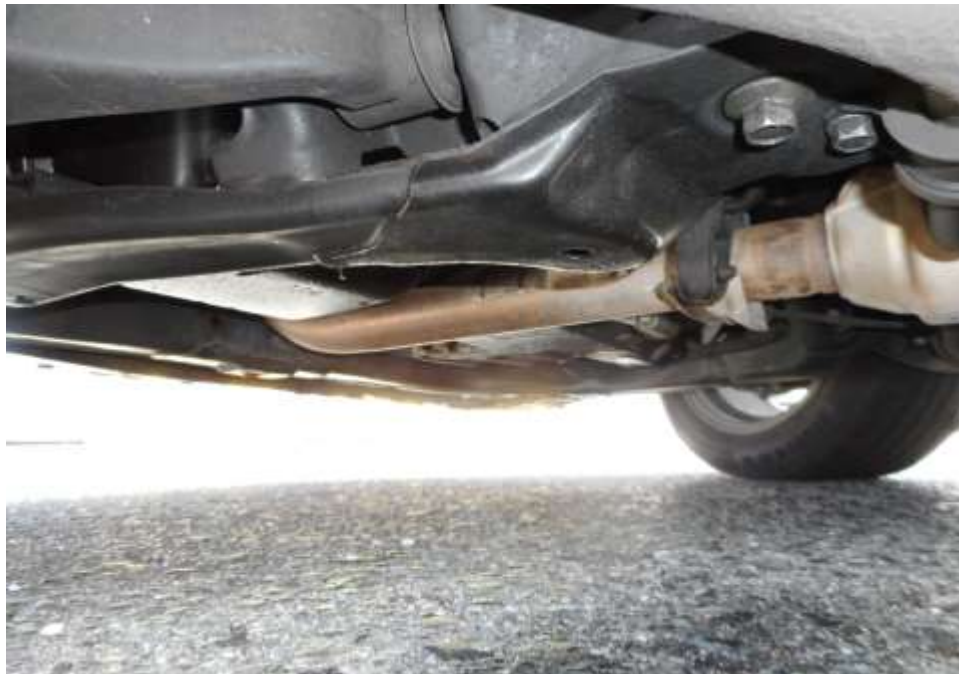
**Photo 14** shows the undercarriage of the Motor Car, at the area where the engine housing and transmission housing are located. . I did not find any sign(s) or indication(s) of fluid leak and/or fluid stain(s) on the underside of the Motor Car.

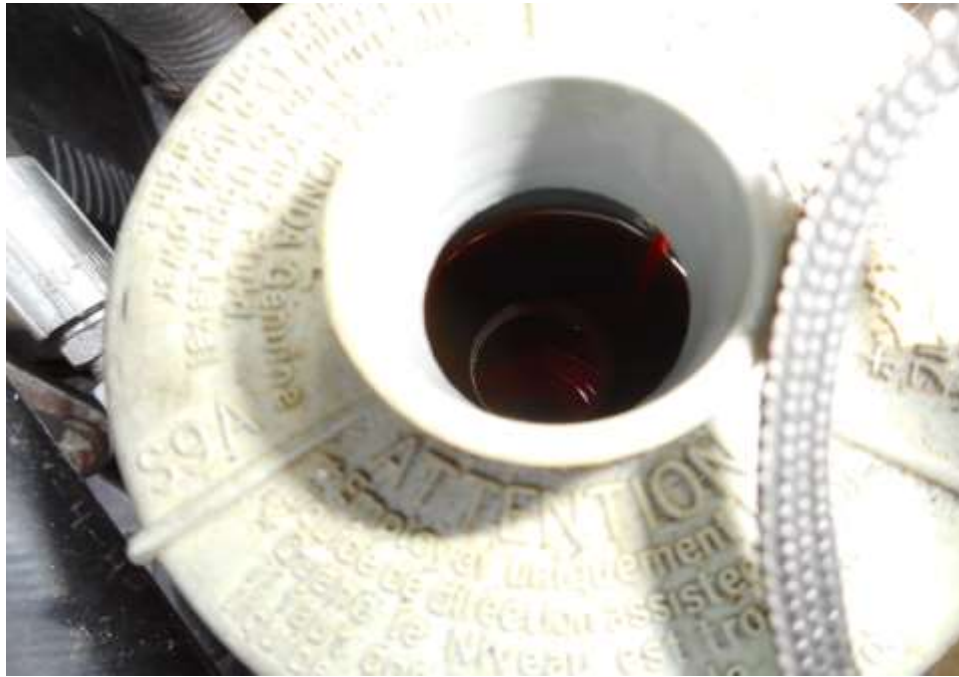
**Photo 15** shows the power steering reservoir of the Motor Car at the time of my inspection. The power steering fluid was observed to be of sufficient level and without any visible contamination.

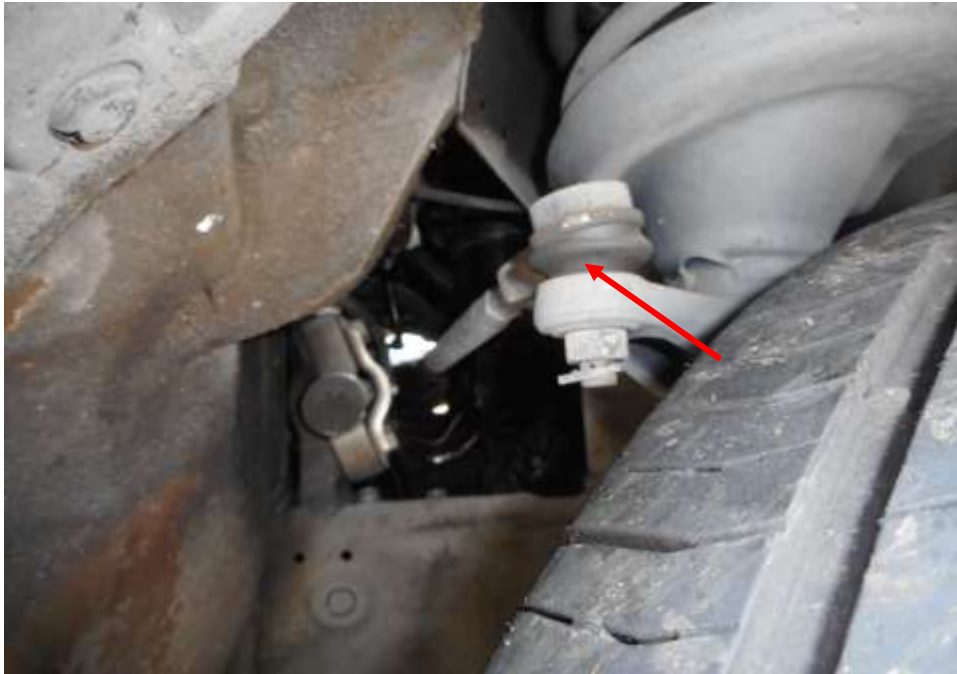
**Photo 16** shows the various undercarriage components at the front right wheel of the Motor Car, in particular the steering tie rod end (red arrowed). The various steering components were all found to be intact, suggesting that the steering system of the Motor Car was likely to be in serviceable condition at the material time of accident. There was also no sign of fluid stain(s) observed on the various undercarriage components.

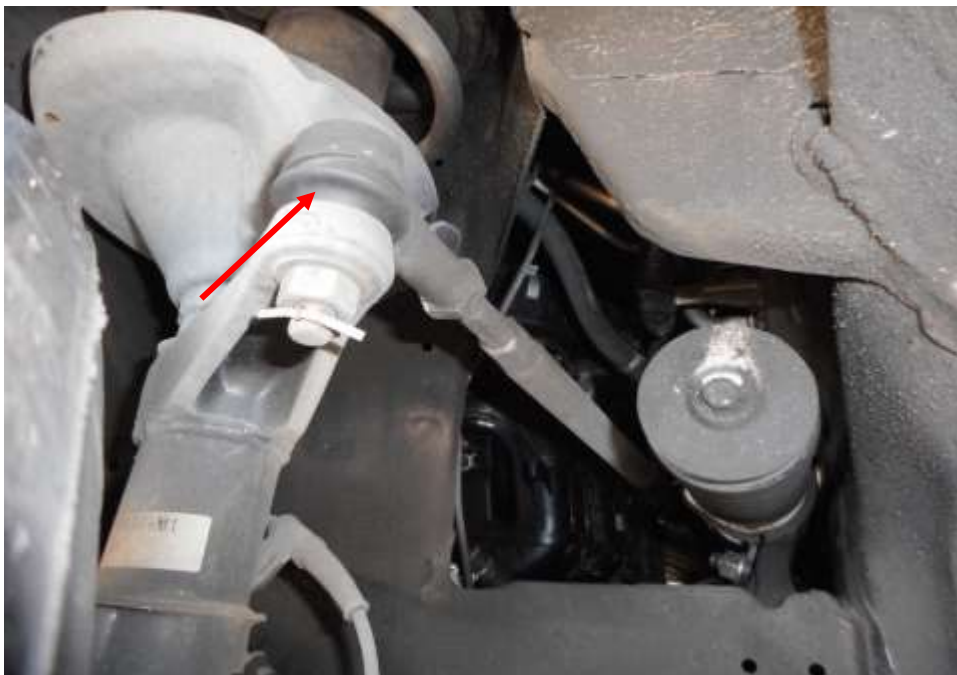
**Photo 17** shows the various undercarriage components at the front left wheel of the Motor Car, in particular the steering tie rod end (arrowed). The various undercarriage components of the Motor Car were all found to be intact without any visible damage. There was also no sign of fluid stain(s) observed on the various undercarriage components.

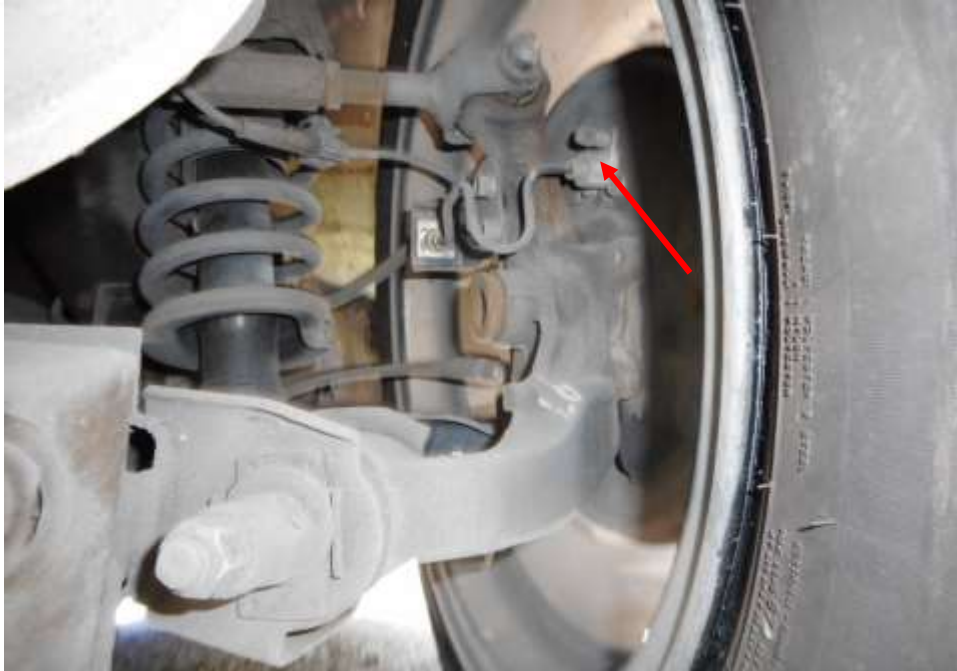
**Photo 18** shows the brake pipe (arrowed) at the rear right wheel of the Motor Car. I did not observe any leakage of brake fluid at the time of my inspection of the Motor Car. My static tests of the Motor Car's braking system, along with my visual examination of the various mechanical components in the braking system, had indicated that there was no internal leakage of pressure/vacuum. Hence the braking system of the Motor Car was likely to be in serviceable condition at the material time of accident.

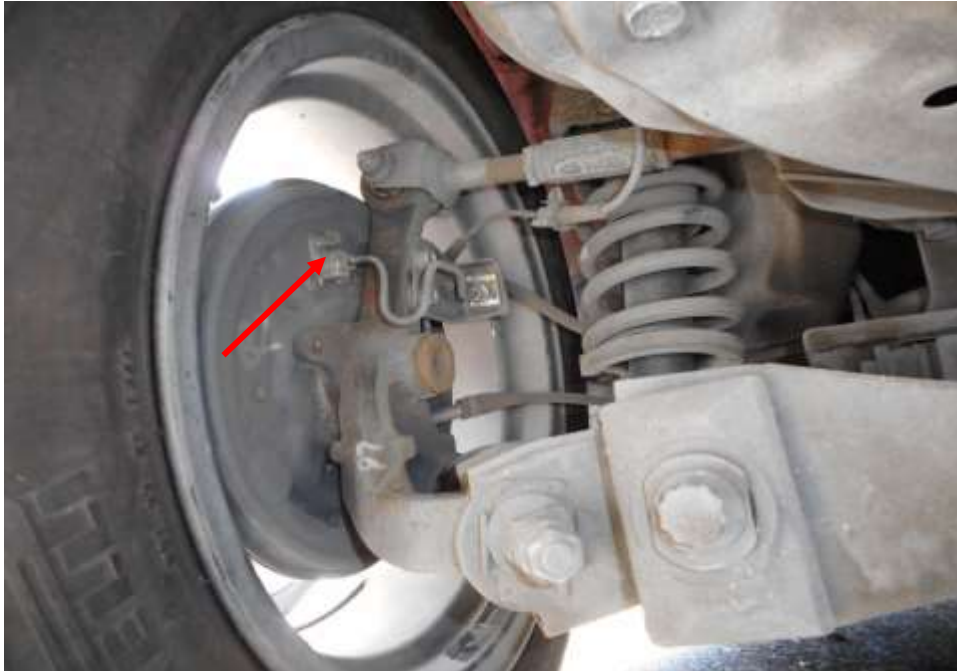
**Photo 19** shows the brake pipe (arrowed) at the rear left wheel of the Motor Car. I did not observe any leakage of brake fluid at the time of my inspection of the Motor Car. My static tests of the Motor Car's braking system, along with my visual examination of the various mechanical components in the braking system had indicated that there was no internal leakage of pressure/vacuum. Hence the braking system of the Motor Car was likely to be in serviceable condition at the material time of accident.

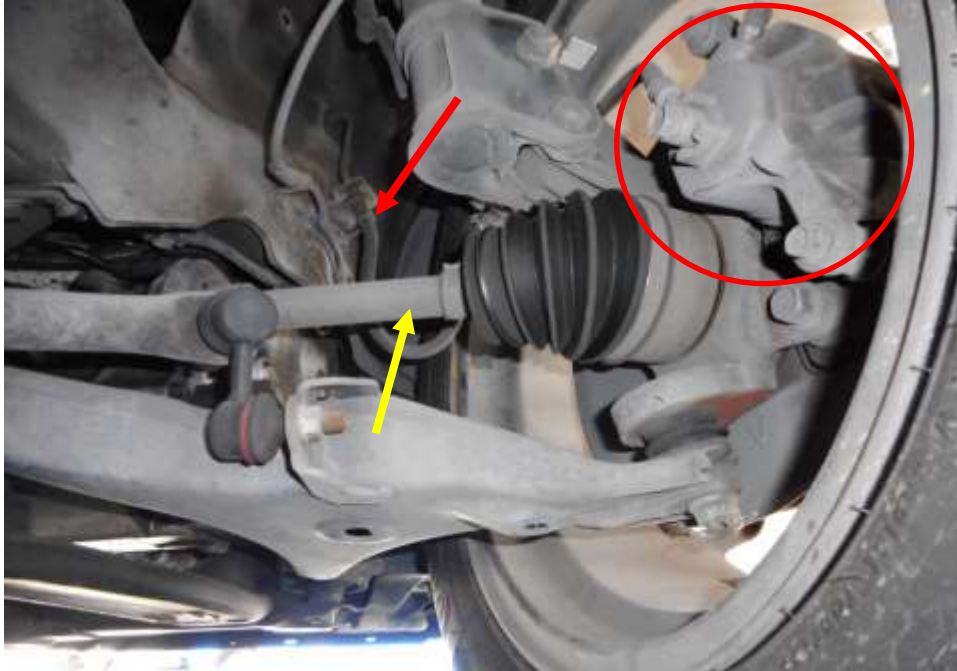
**Photo 20** shows the brake hose/pipe (red arrowed) and drive shaft (yellow arrow) at the front right wheel of the Motor Car. No leakage of brake fluid was observed. Visual examination of the various components of the braking system like the brake caliper (circled), brake booster, brake pedal etc had revealed all to be intact and without visible damage at the time of accident. There was also no sign of fluid stain(s) observed on the various undercarriage components.

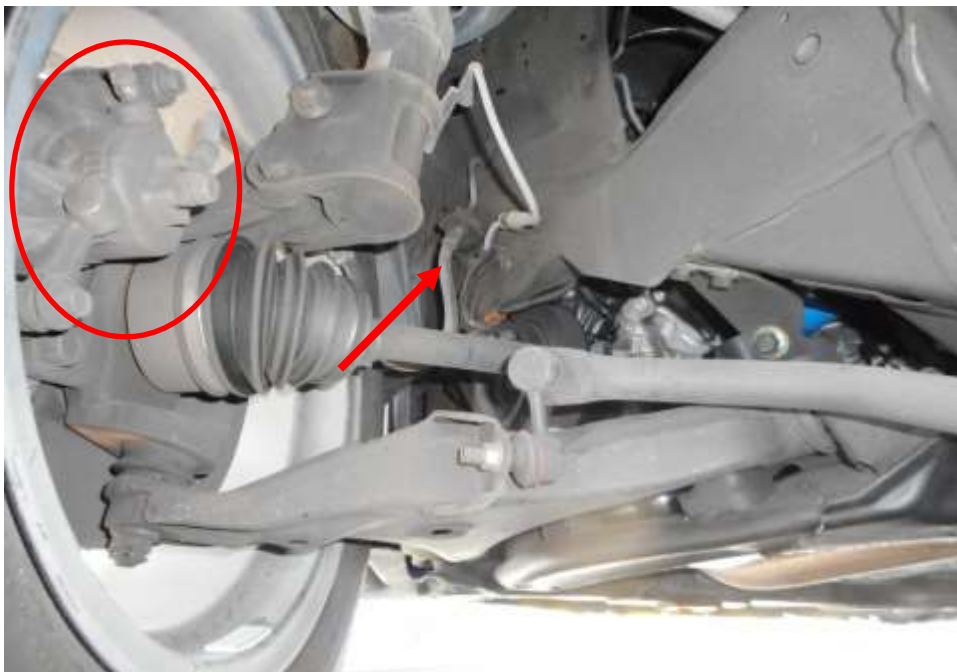
**Photo 21** shows the brake hose/pipe (arrowed) at the front left wheel of the Motor Car. No leakage of brake fluid was observed. Visual examination of the various components of the braking system like the brake caliper (circled), brake booster, brake pedal etc had revealed all to be intact and without visible damage at the time of accident. There was also no sign of fluid stain(s) observed on the various undercarriage components.

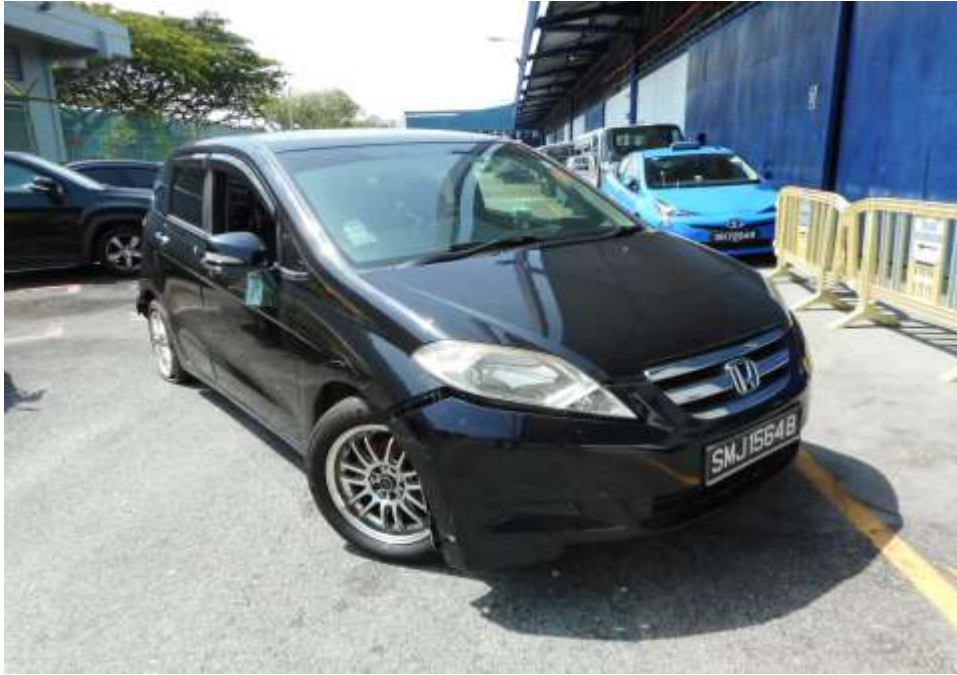
**Photo 22** shows the front right wheel of the Motor Car turned to its full left. During my steering system test, I did not experience any abnormal free play and/or resistance when I had turned the steering wheel towards full left and full right. This would suggest that the steering system of the Motor Car was likely to be in serviceable condition at the material time of accident.

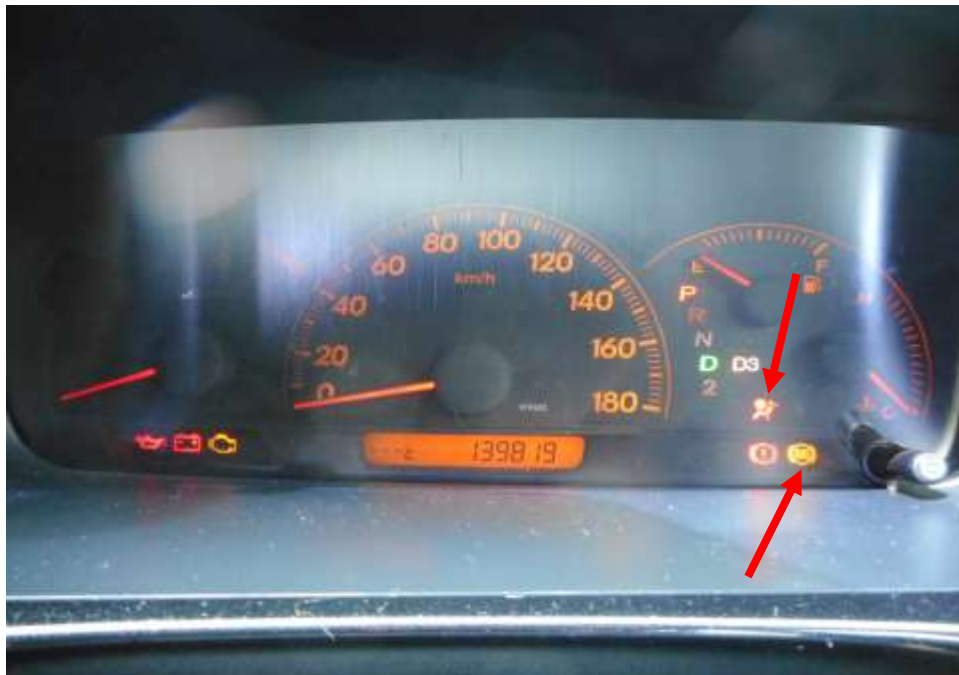
**Photo 23** shows the warning light for Anti-Lock Brake System (ABS) and Supplemental Restraint System (SRS) appearing on the instrument panel of the Motor Car during the self-test of its various electronic operating systems when its engine was cranked.

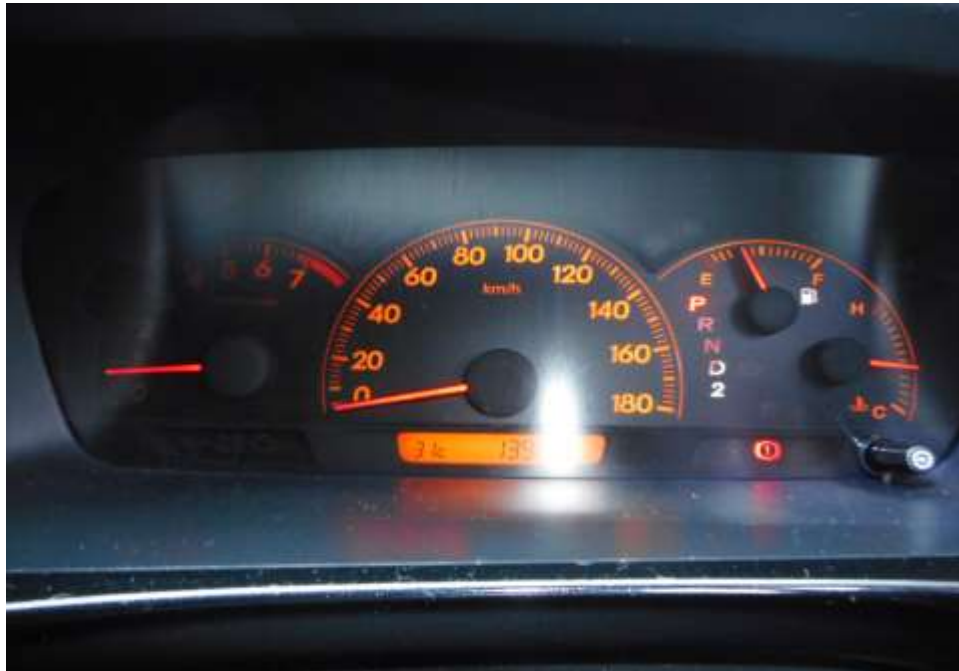
**Photo 24** shows no warning lights illuminated on the instrument panel of the Motor Car after the engine was cranked. This would suggest that there was no abnormality to the various electronic operating systems of the Motor Car, like the ABS and SRS.
