Your Ref: TP/IP/63795/2019  
Our Ref : CI/TPD19020761/P

**Fatal Accident Investigation Team**

**MECHANICAL INSPECTION REPORT OF MOTOR LORRY JAH 1469**

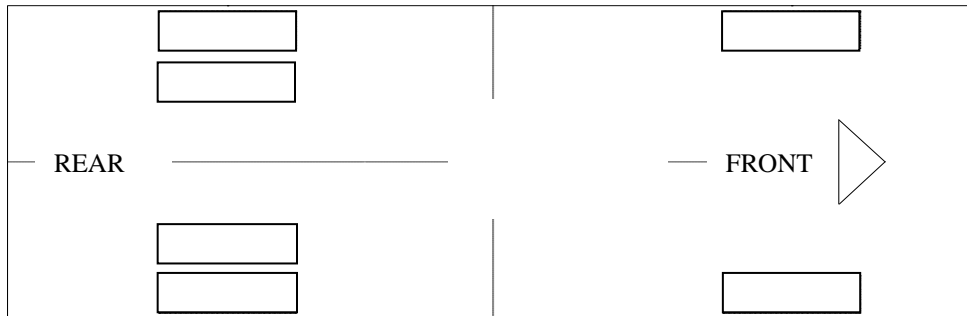
6. The 6 tyres fitted on the Motor Lorry were all observed to be in serviceable condition and sufficiently inflated for vehicular operation. I did not find any tear, cut or burst mark(s) on the outer and the inner sidewalls as well as across the tread of the 6 tyres. The tyre brand, tyre size and remaining tread depth of the Motor Lorry's 6 tyres were recorded as follows:-

Bridgestone 295/ 80 R22.5 (7.4mm)

Bridgestone 295/ 80 R22.5 (11mm)

Firestone 295/ 80 R22.5 (8.7mm)

Bridgestone 295/ 80 R22.5 (9.6mm)

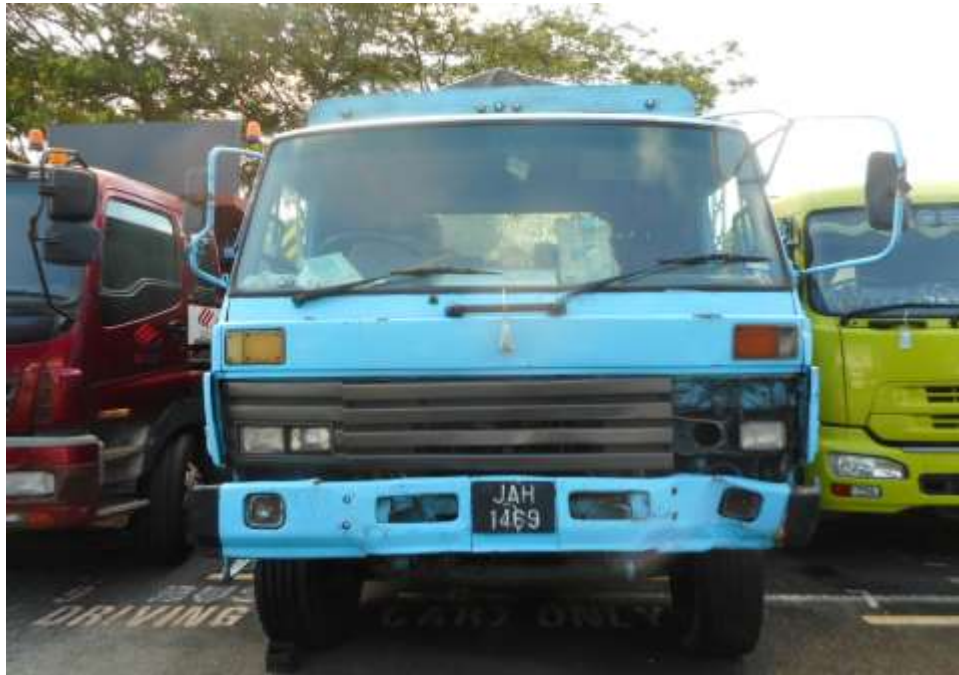
**Photo 1** shows a general view of the front body of the Motor Lorry at the time of my inspection. The Motor Lorry was observed to have sustained relatively minor impact damage at its front portion. Its front bumper, front left headlight and front grille was observed to be damaged as a result of the accident.

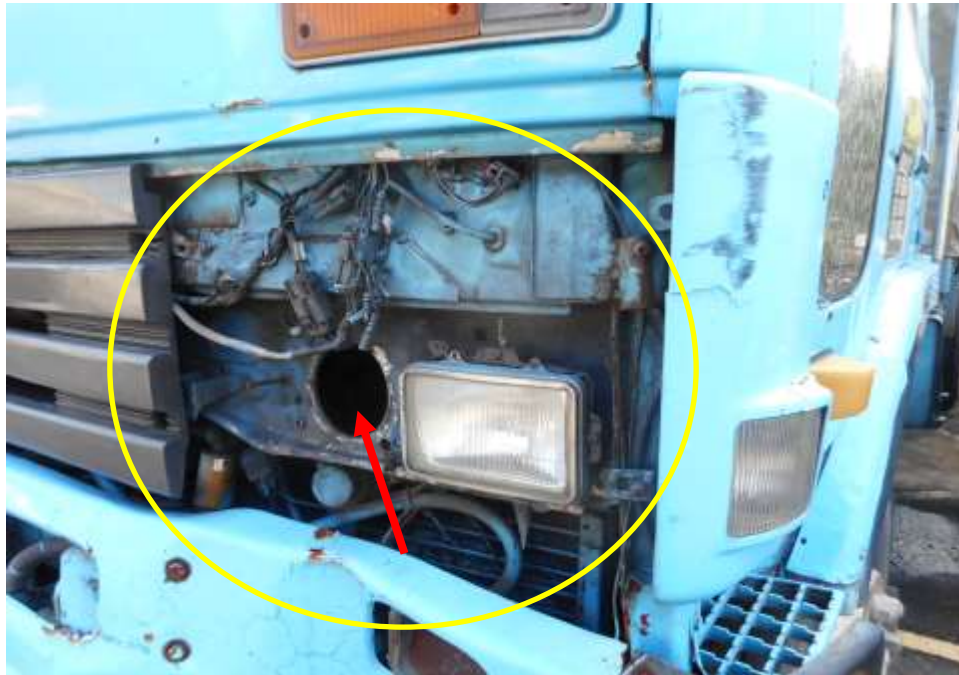
**Photo 2** shows a close up view of the front body of the Motor Lorry at the time of my inspection. The Motor Lorry was observed to have sustained relatively minor impact damage at its front portion. Its front left headlight (arrowed) and front grille (circled) was observed to be damaged as a result of the accident.

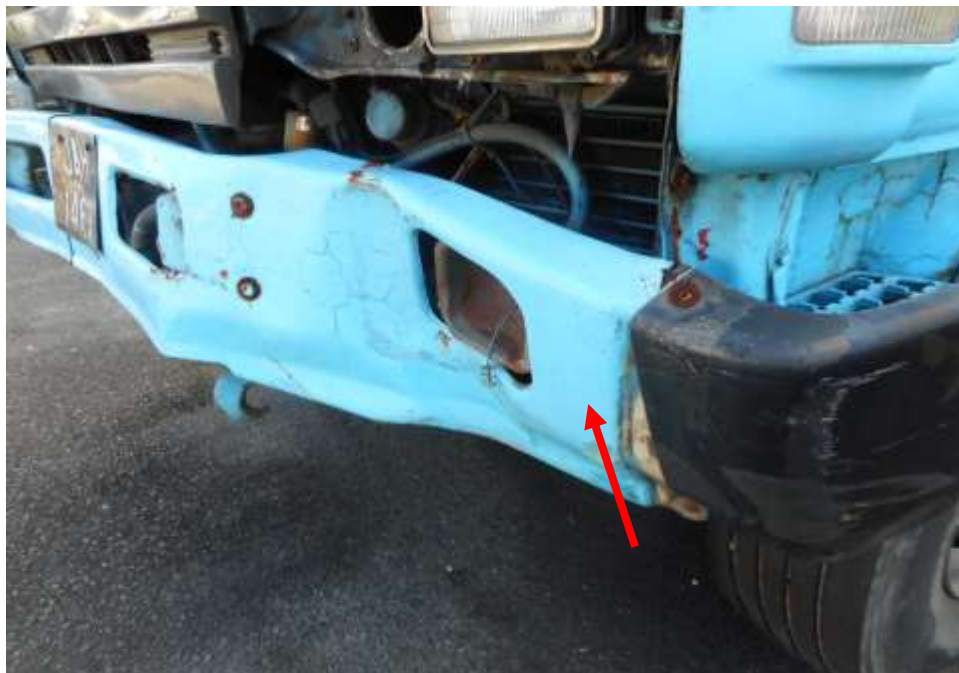
**Photo 3** shows a close up view of the front body of the Motor Lorry at the time of my inspection. The Motor Lorry was observed to have sustained relatively minor impact damage at its front portion. Its front bumper (arrowed) was observed to be damaged as a result of the accident.

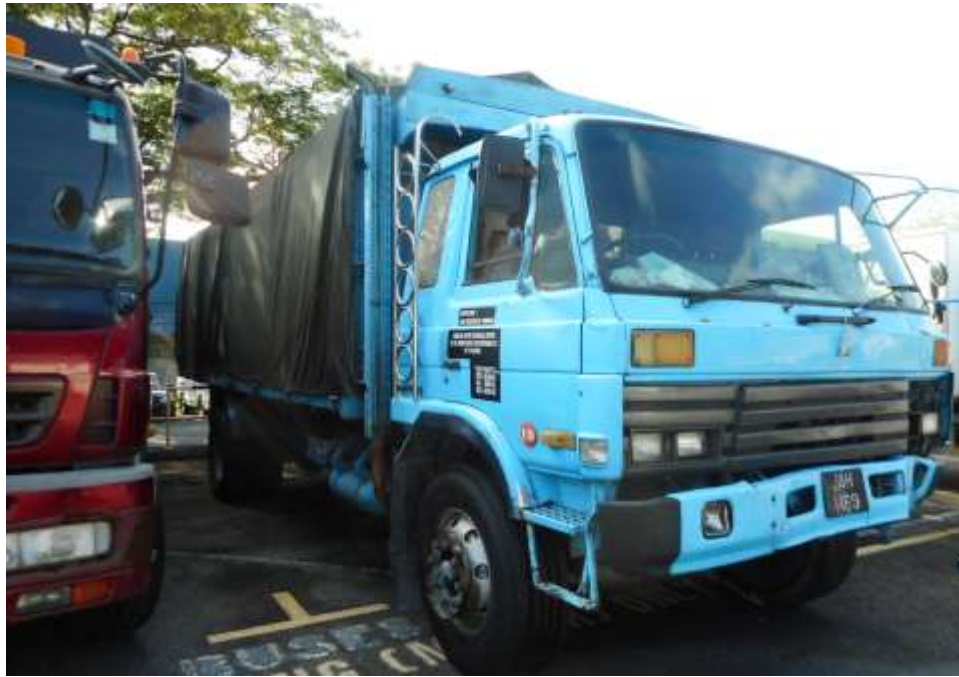
**Photo 4** shows a general view of the left body of the Motor Lorry at the time of my inspection. The Motor Lorry was observed to be intact and unaffected by the accident.

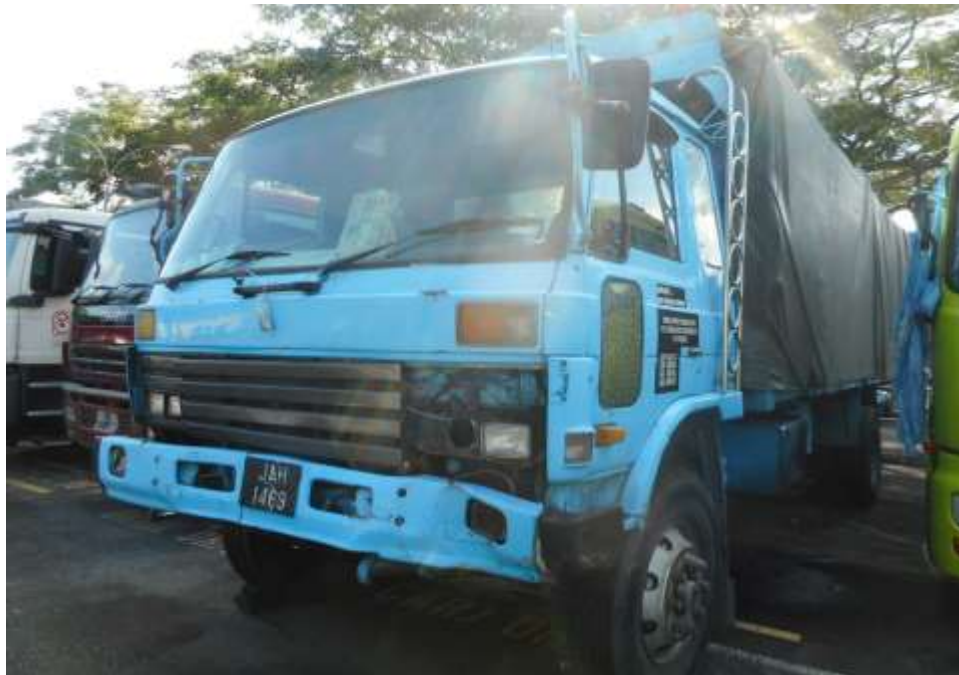
**Photo 5** shows a general view of the right body of the Motor Lorry at the time of my inspection. The Motor Lorry was observed to be intact and unaffected by the accident.

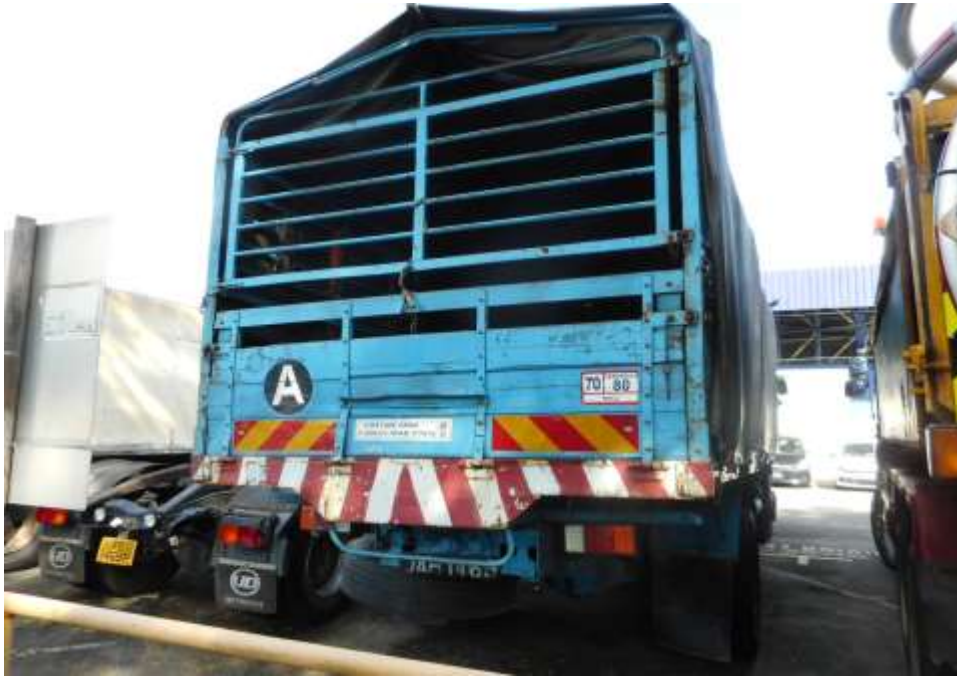
**Photo 6** shows a general view of the Motor Lorry's rear left body at the time of my inspection. There was no impact damage found at the rear portion of the Motor Lorry.

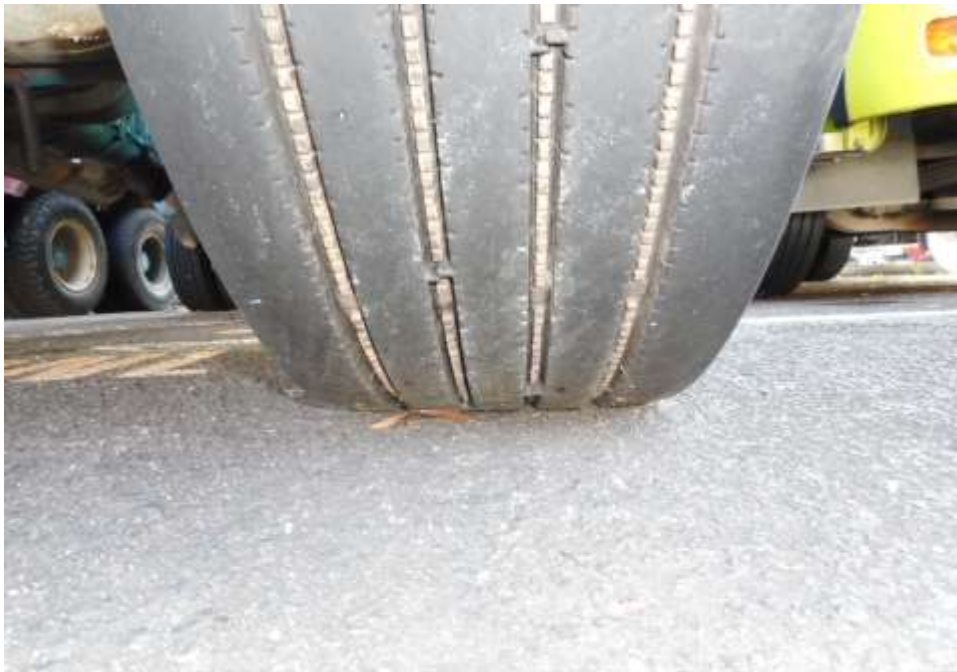
**Photo 7** shows the condition of the front left tyre of the Motor Lorry, which was observed to be in serviceable condition with remaining tread depth of approximately 11mm. The tyre, which was wrapped around standard alloy wheel rim, was also observed to be sufficiently inflated for vehicular operation with no tear, cut or burst mark(s) on the outer and the inner sidewalls.

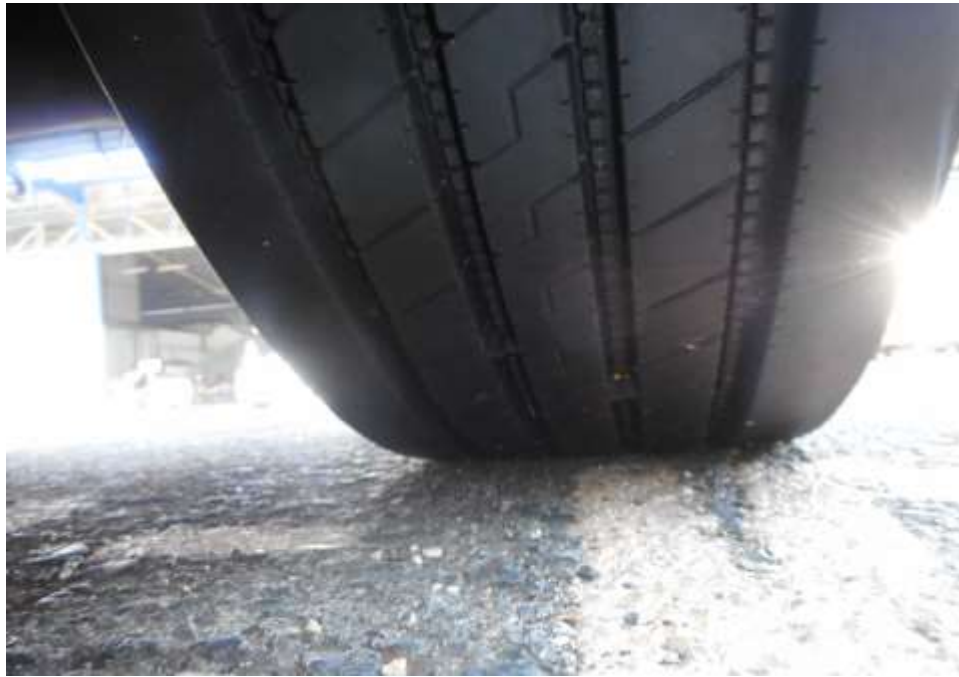
**Photo 8** shows the condition of the front right tyre of the Motor Lorry, which was observed to be in serviceable condition with remaining tread depth of approximately 9.6mm. The tyre, which was wrapped around standard alloy wheel rim, was also observed to be sufficiently inflated for vehicular operation with no tear, cut or burst mark(s) on the outer and the inner sidewalls.

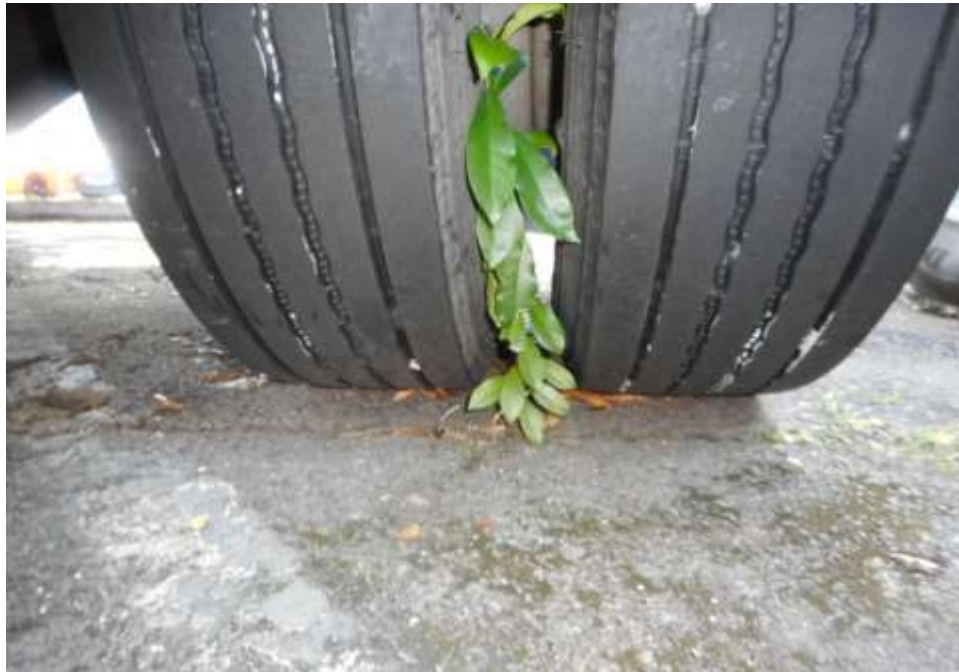
**Photo 9** shows the condition of the rear left tyres of the Motor Lorry, which were observed to be in serviceable condition with remaining tread depth of approximately 7.4mm. The tyres, which were wrapped around standard alloy wheels rims, were also observed to be sufficiently inflated for vehicular operation. There was also no damage found on all the 6 alloy wheel rims of the Motor Lorry.

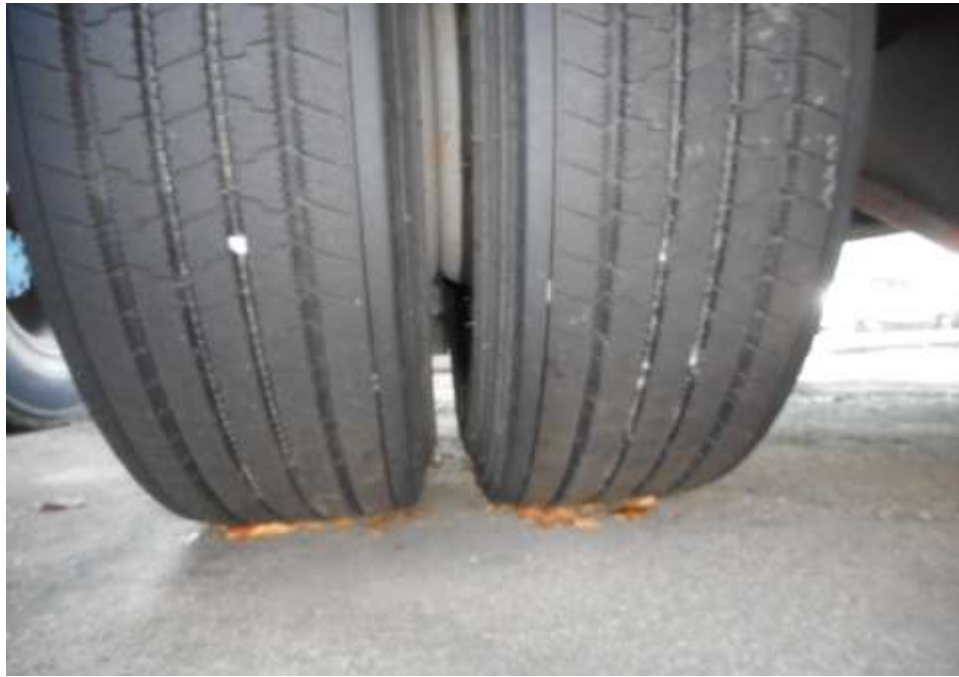
**Photo 10** shows the condition of the rear right tyres of the Motor Lorry, which were observed to be in serviceable condition with remaining tread depth of approximately 8.7mm. The tyres, which were wrapped around standard alloy wheel rims, were also observed to be sufficiently inflated for vehicular operation with no tear, cut or burst mark(s) on the outer and the inner sidewalls. There was also no damage found on all the 6 alloy wheel rims of the Motor Lorry.

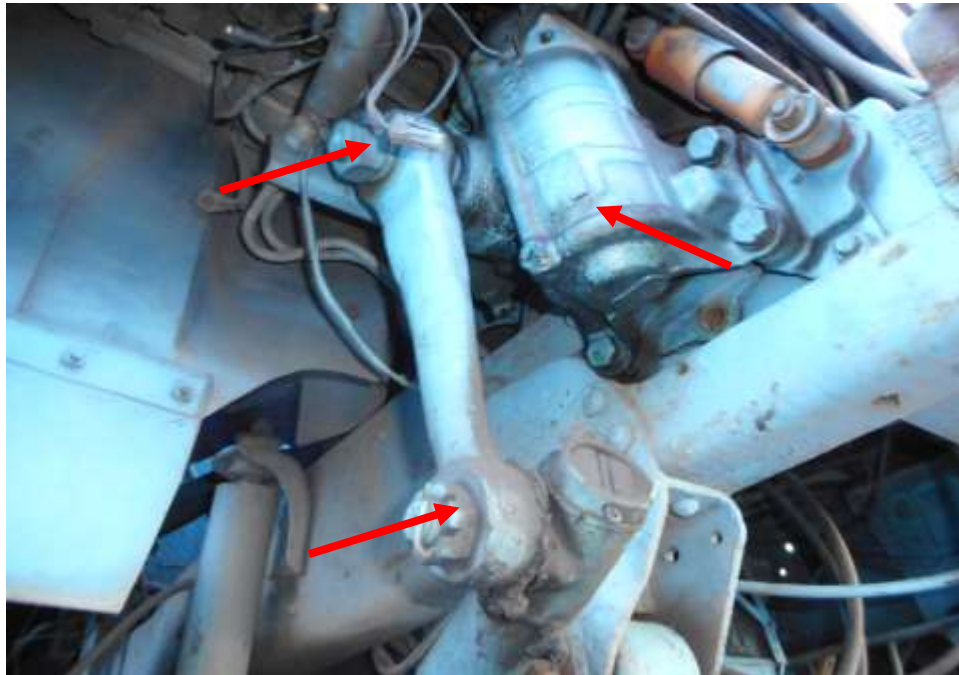
**Photo 11** shows the front underside of the Motor Lorry. I was not able to conduct any test(s) on the steering system of the Motor Lorry as the engine of the Motor Lorry could not be started. However my visual checks on the various mechanical components of the steering system like the steering box, steering shaft and steering linkages (arrowed) amongst others revealed all to be intact and in good condition.

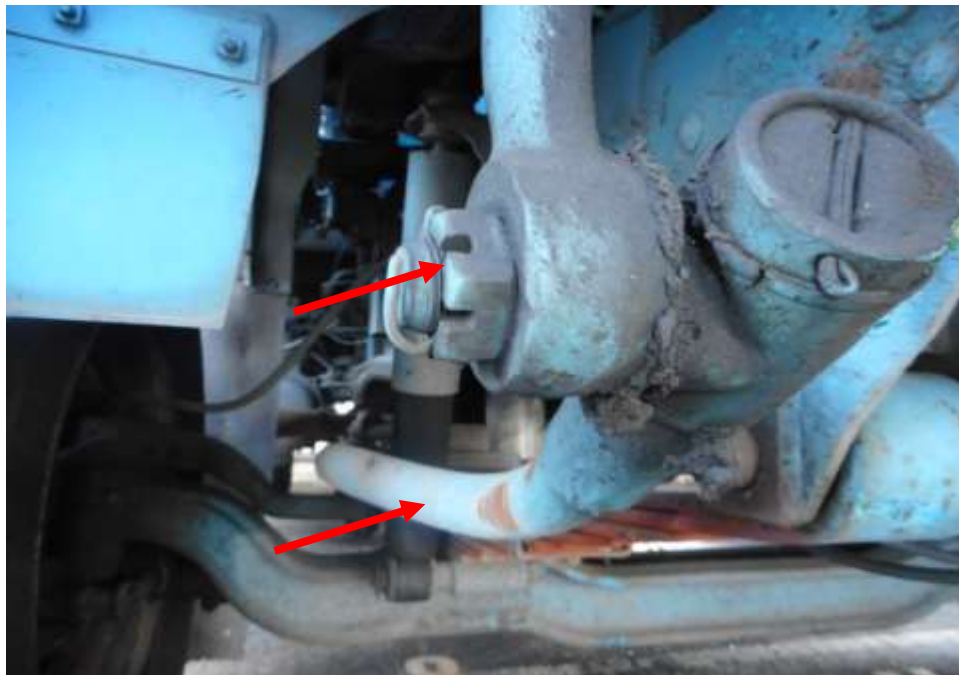
**Photo 12** shows the front underside of the Motor Lorry. The various mechanical components of the Motor Lorry's steering system like the steering shaft and steering linkages (arrowed) were all observed to be intact and in good condition.

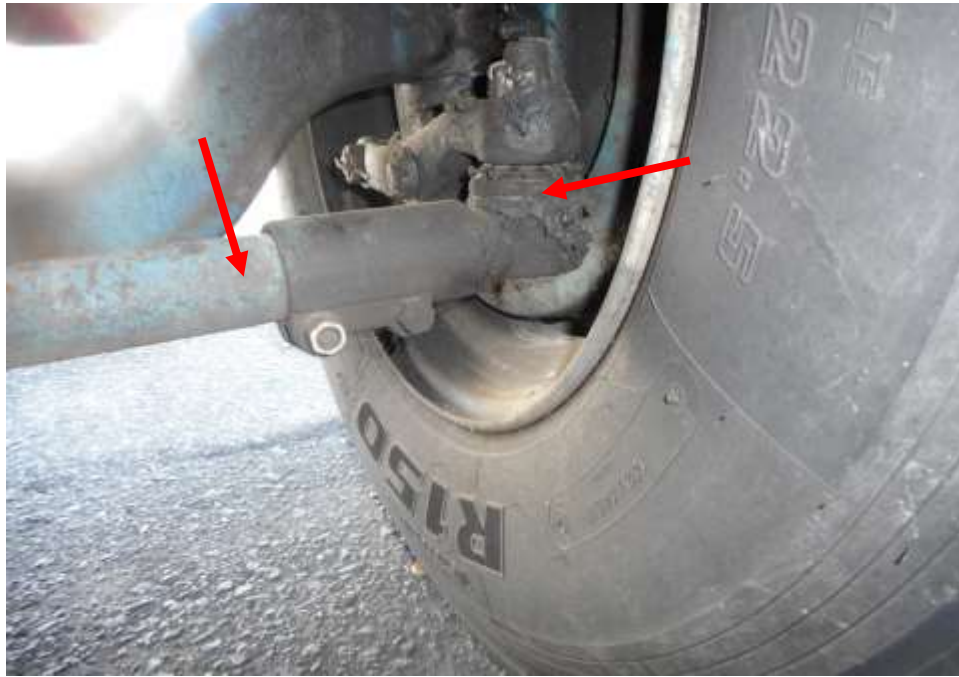
**Photo 13** shows the undercarriage components at the front right wheel of the Motor Lorry. The various undercarriage components of the Motor Lorry were all observed to be intact and without any visible damage. This had included the steering rack and steering ball joints (arrowed) of the Motor Lorry. Visual examinations of the mechanical components of the steering system appear to indicate that the Motor Lorry's steering system was in serviceable condition.

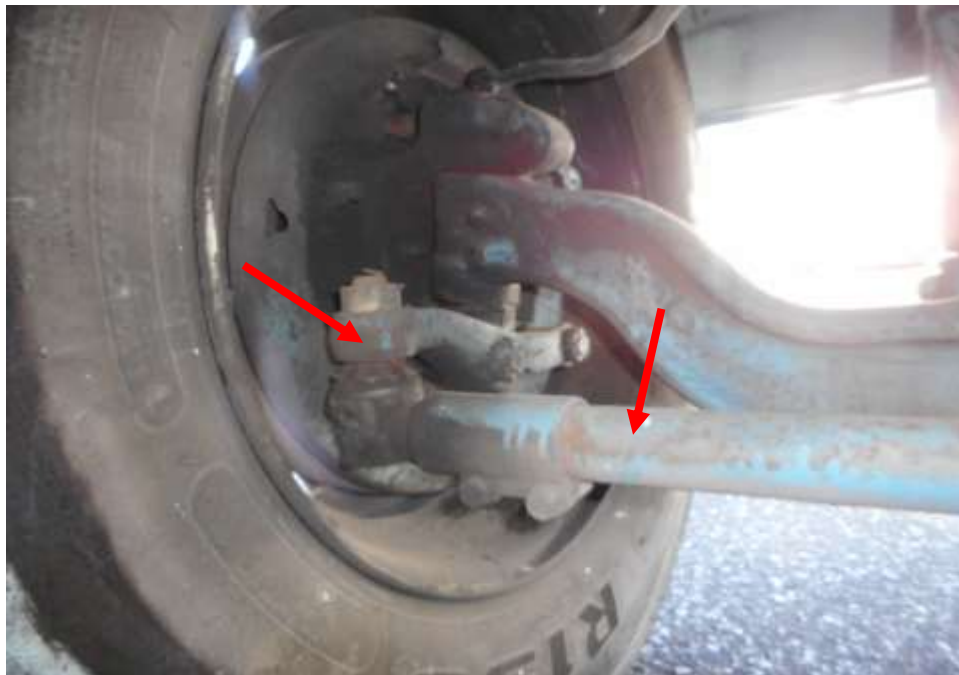
**Photo 14** shows the undercarriage components at the front left wheel of the Motor Lorry. The various undercarriage components of the Motor Lorry were all observed to be intact and without any visible damage. This had included the steering rack and steering ball joints (arrowed) of the Motor Lorry, which were observed to be securely attached to the front left wheel and front right wheel.

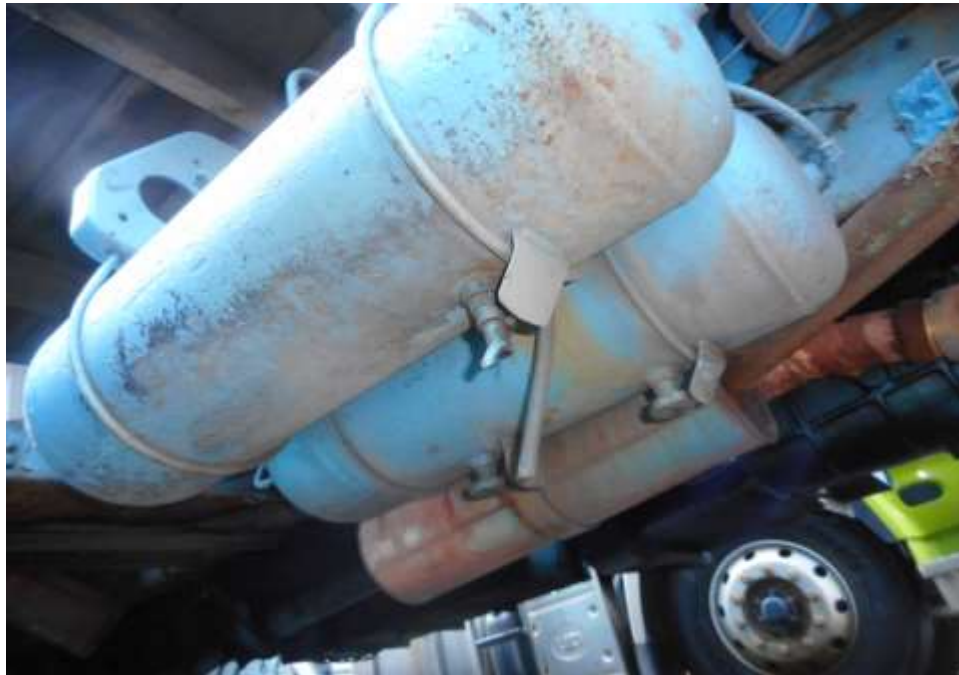
12. Since the engine of the Motor Lorry could not be started, I was hence not able to carry out test(s) on whether there was any leakage of compressed air that could have affected the braking efficiency of the Motor Lorry. However the air pipes, air tanks and connecting valves had all appear to be in good general condition and securely fitted upon my visual examination of these parts.

**Photo 15** shows a general view of the air tank, valves, pipes and hoses, which are some of the components for the air-assisted braking system of the Motor Lorry. I was however not able to carry out any operational test(s) to the braking system of the Motor Lorry as its engine was unable to be started.

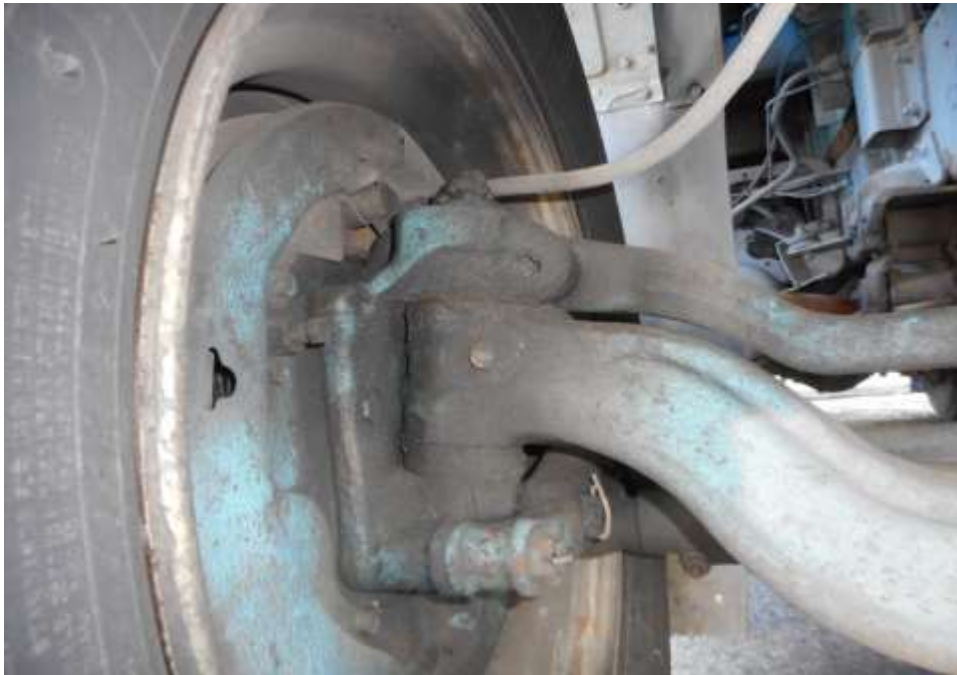
**Photo 16** shows the brake air cylinder and air pipes at the front left wheel of the Motor Lorry. My visual inspection of the mechanical components of the Motor Lorry's braking system appear to suggest that its braking system was in serviceable condition at the material time of accident.

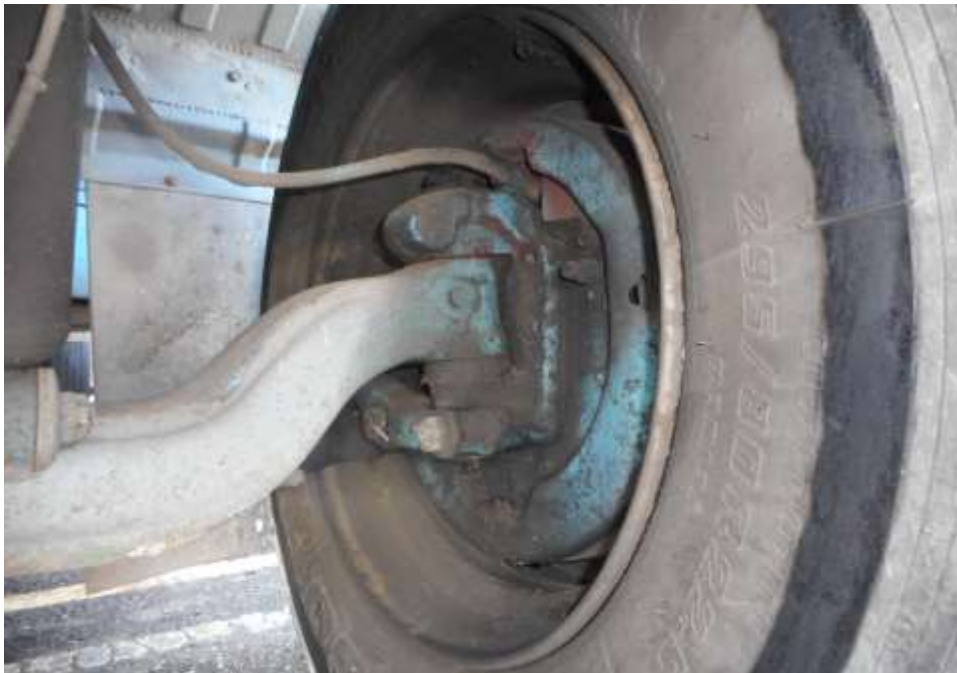
**Photo 17** shows the brake air cylinder and air pipes at the front right wheel of the Motor Lorry. My visual inspection of the mechanical components of the Motor Lorry's braking system appear to suggest that its braking system was in serviceable condition at the material time of accident.
