Your Ref: TP/IP/65989/2019  
Our Ref : CI/TPD19020762/P

**Fatal Accident Investigation Team**

**MECHANICAL INSPECTION REPORT OF MOTOR LORRY YP 9377Z**

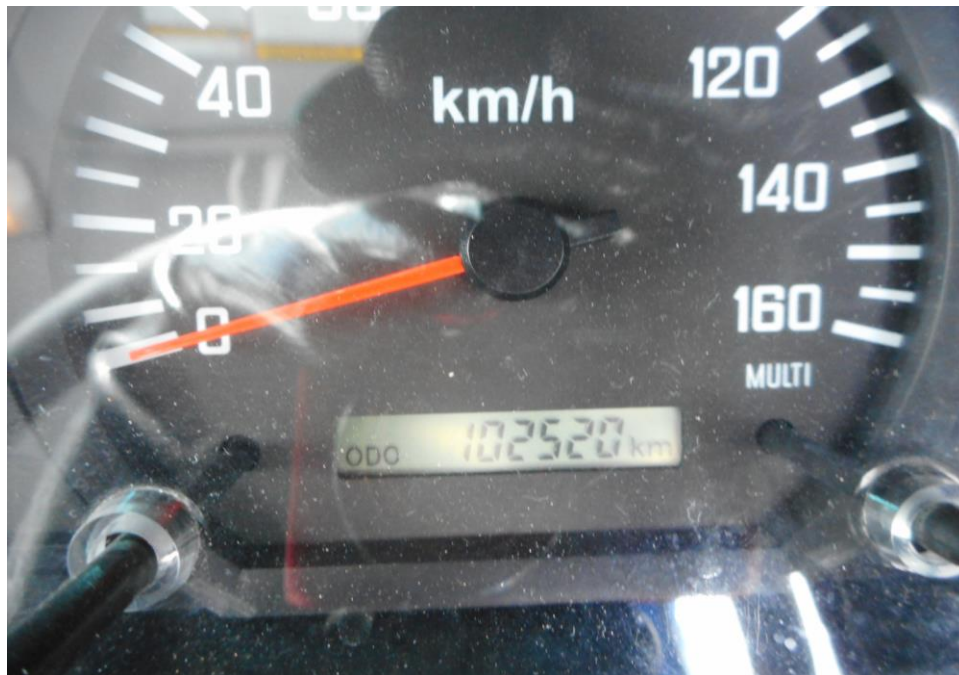
4. The mileage of the Motor Lorry at the time of my inspection was 102,520km.
5. There was no visible damage observed on Motor Lorry at the time of my inspection.

**Photo 1** shows a general view of the instrument cluster of the Motor Lorry at the time of my inspection. The mileage of the Motor Lorry was 102,520km

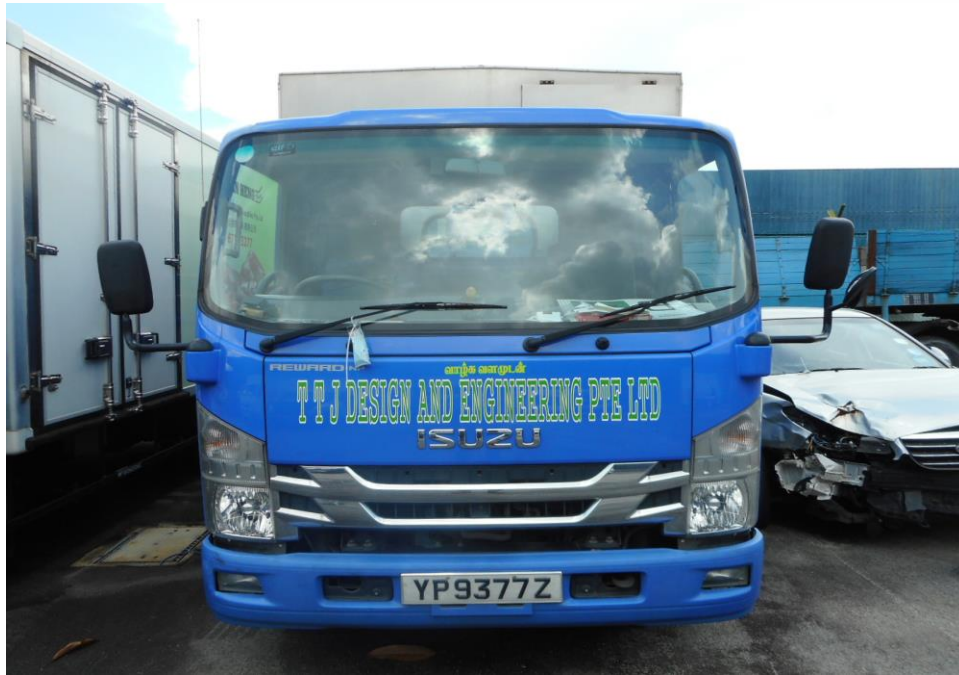
**Photo 2** shows a general view of the Motor Lorry's frontal portion at the time of my inspection. The Motor Lorry was observed to be intact and unaffected by the accident.

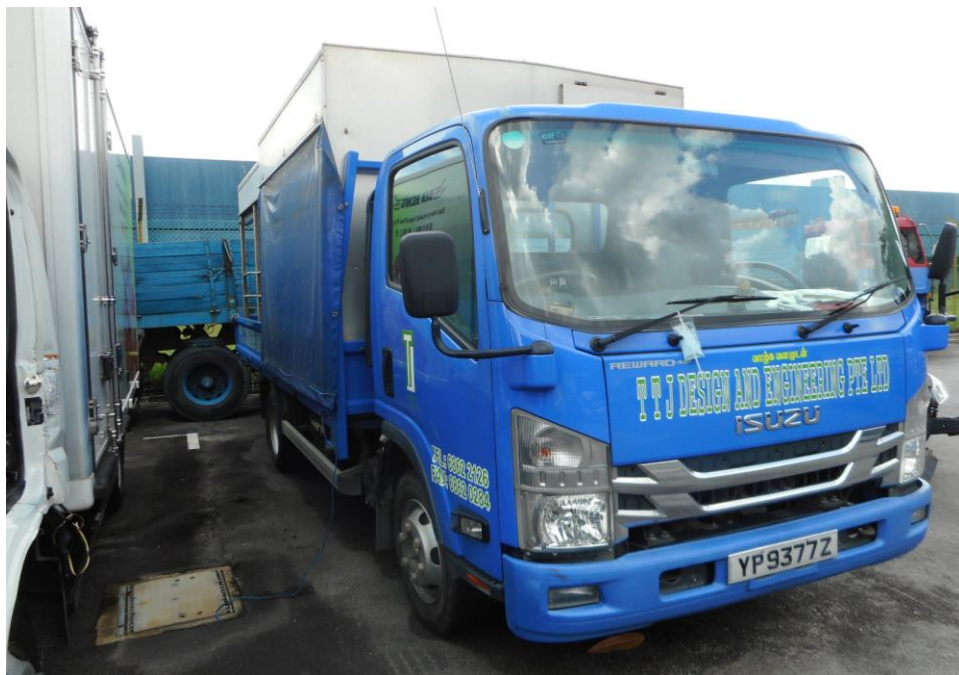
**Photo 3** shows a general view of the front right body of the Motor Lorry at the time of my inspection. The Motor Lorry was observed to be intact and unaffected by the accident.

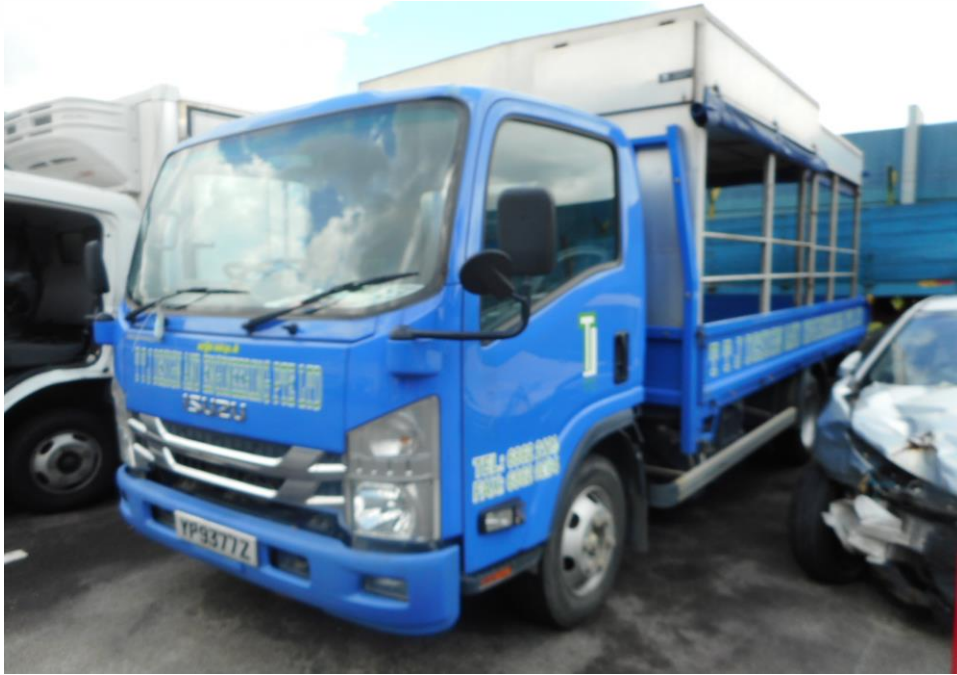
**Photo 4** shows a general view of the front left body of the Motor Lorry at the time of my inspection. The Motor Lorry was observed to be intact and unaffected by the accident.

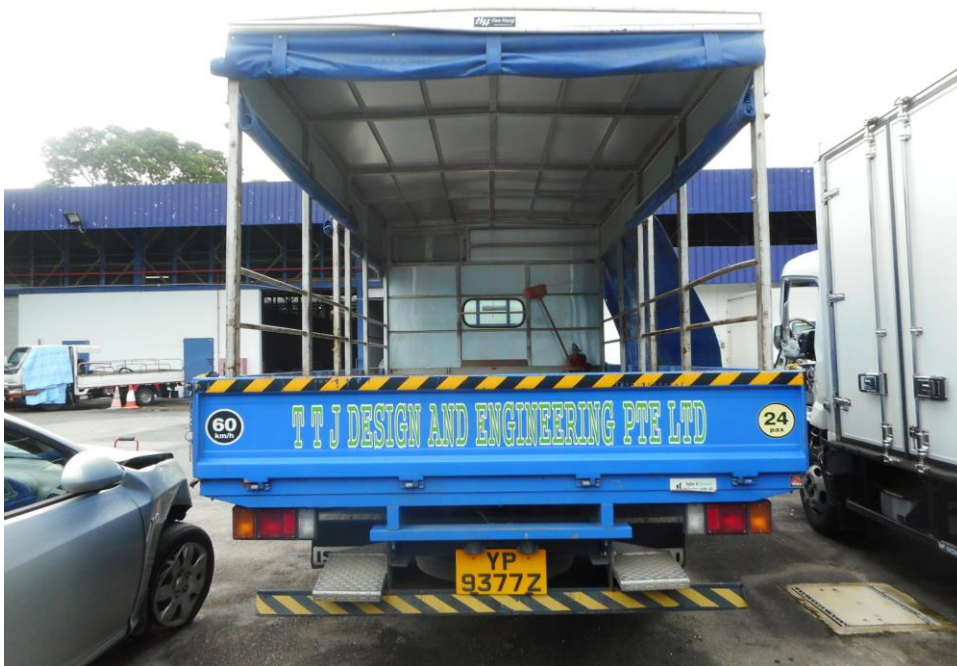
**Photo 5** shows a general view of the rear body of the Motor Lorry at the time of my inspection. The Motor Lorry was observed to be intact and unaffected by the accident.

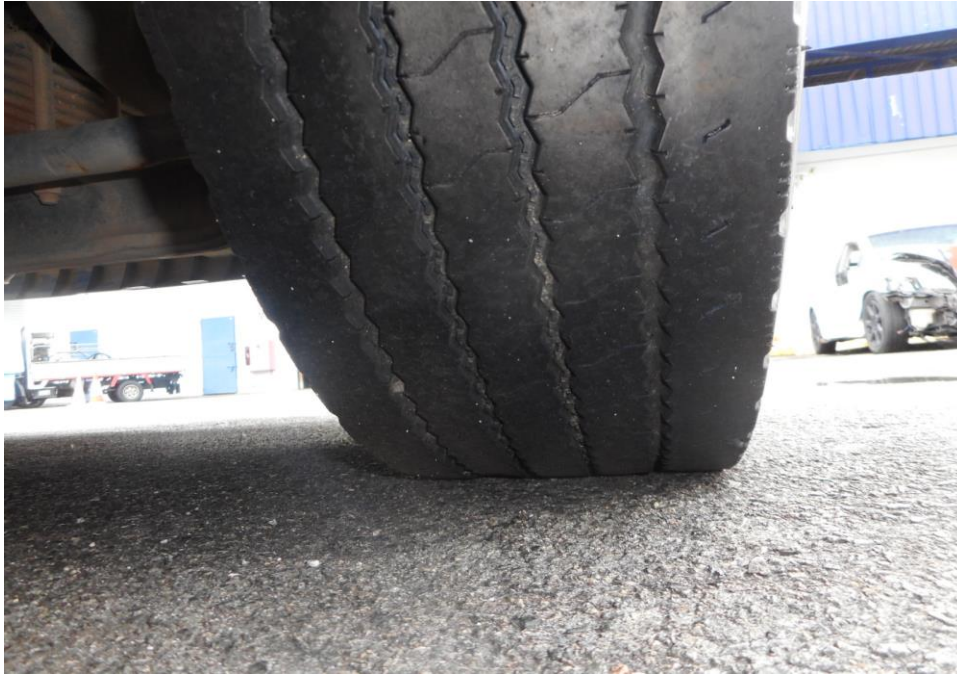
**Photo 6** shows the condition of the front right tyre of the Motor Lorry, which was observed to be in serviceable condition with remaining tread depth of approximately 4.9mm. The tyre, which was wrapped around standard steel wheel rim, was also observed to be sufficiently inflated for vehicular operation. There was no tear, cut or burst mark(s) on the outer and the inner sidewalls as well as across the tread of the 6 tyres that were fitted on the Motor Lorry.

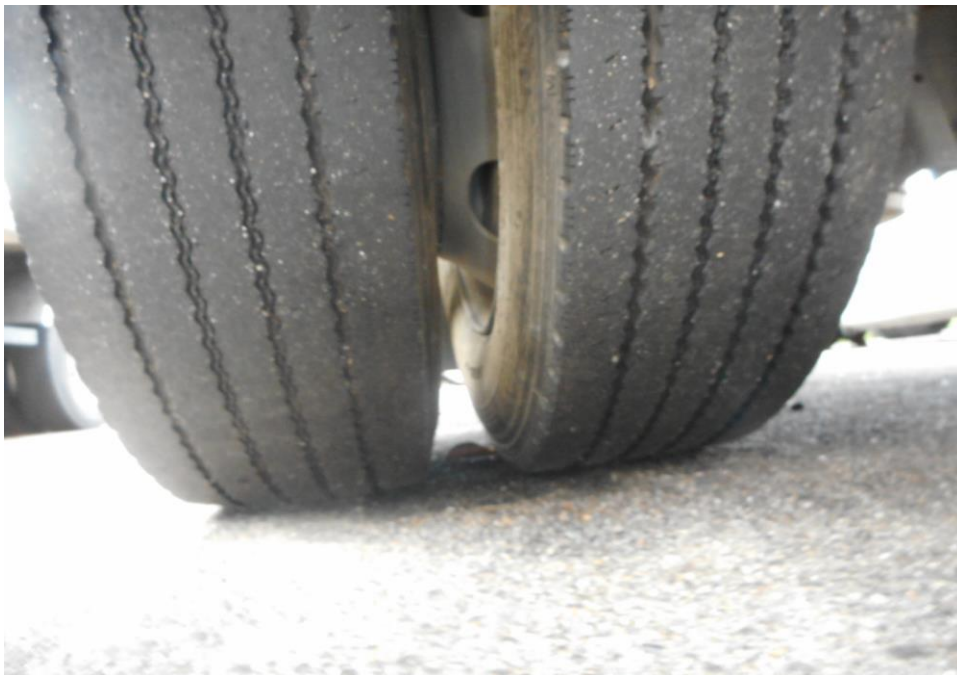
**Photo 7** shows the condition of the rear right tyres of the Motor Lorry, which was observed to be in serviceable condition with remaining, tread depth of approximately 4.7mm. The tyres, which were wrapped around standard steel wheel rim, were also observed to be sufficiently inflated for vehicular operation. There was also no damage found on all 6 steel wheel rims of the Motor Lorry.

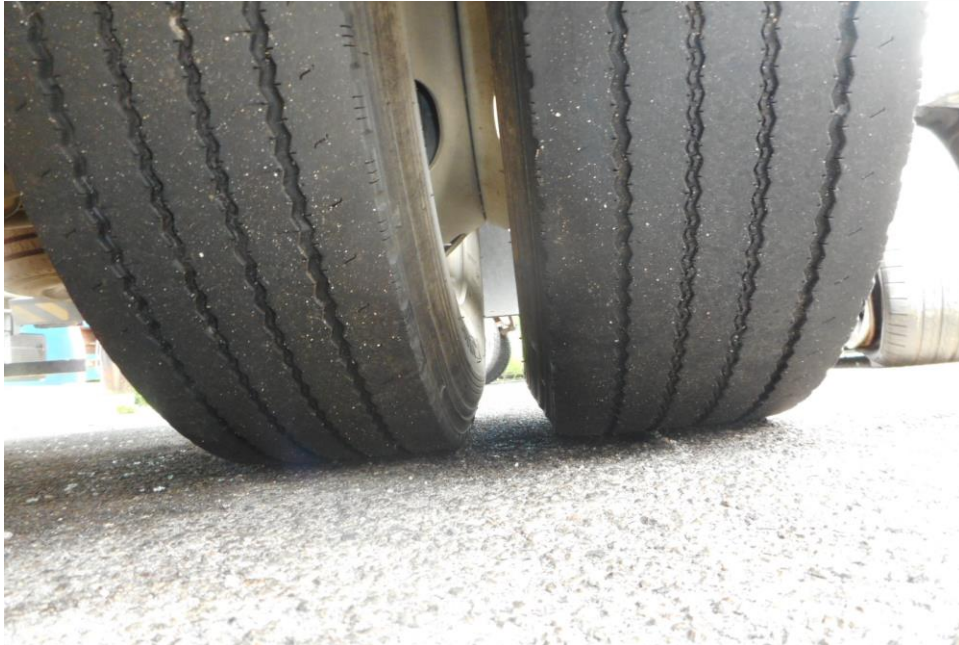
**Photo 8** the condition of the rear left tyres of the Motor Lorry, which was observed to be in serviceable condition with remaining, tread depth of approximately 4.8mm. The tyres, which were wrapped around standard steel wheel rim, were also observed to be sufficiently inflated for vehicular operation. There was also no damage found on all 6 steel wheel rims of the Motor Lorry.

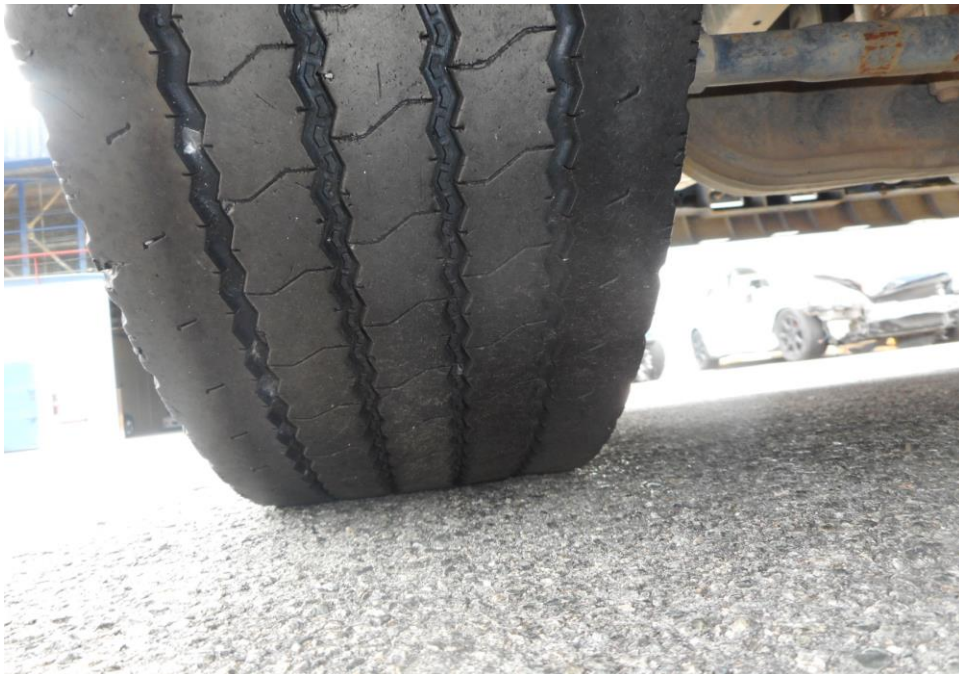
**Photo 9** shows the condition of the front left tyre of the Motor Lorry, which were observed to be in serviceable condition with remaining, tread depth of approximately 4.8mm. There was also no tear, cut or burst mark(s) on the outer and the inner sidewalls as well as across the tread of the 6 tyres that were fitted on the Motor Lorry.

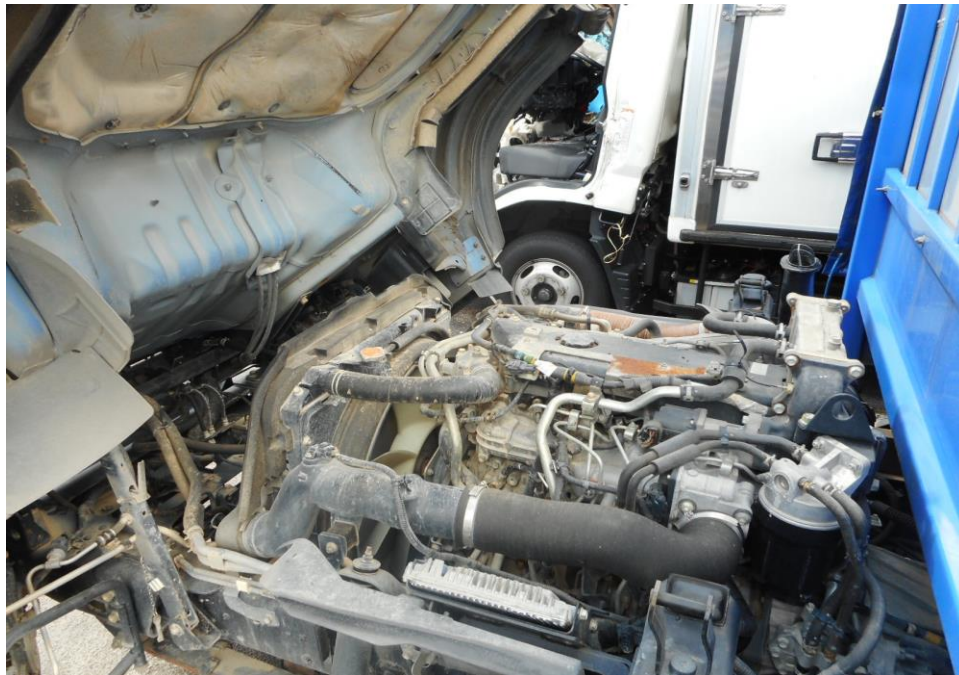
**Photo 10** shows a general view of the Motor Lorry's engine compartment, which was accessed by lifting the front cabin of the Motor Lorry. The various parts and components inside the engine compartment were unaffected by the accident. There was also no sign(s) or indication(s) of fresh fluid leakage and/or fluid stain within the engine compartment

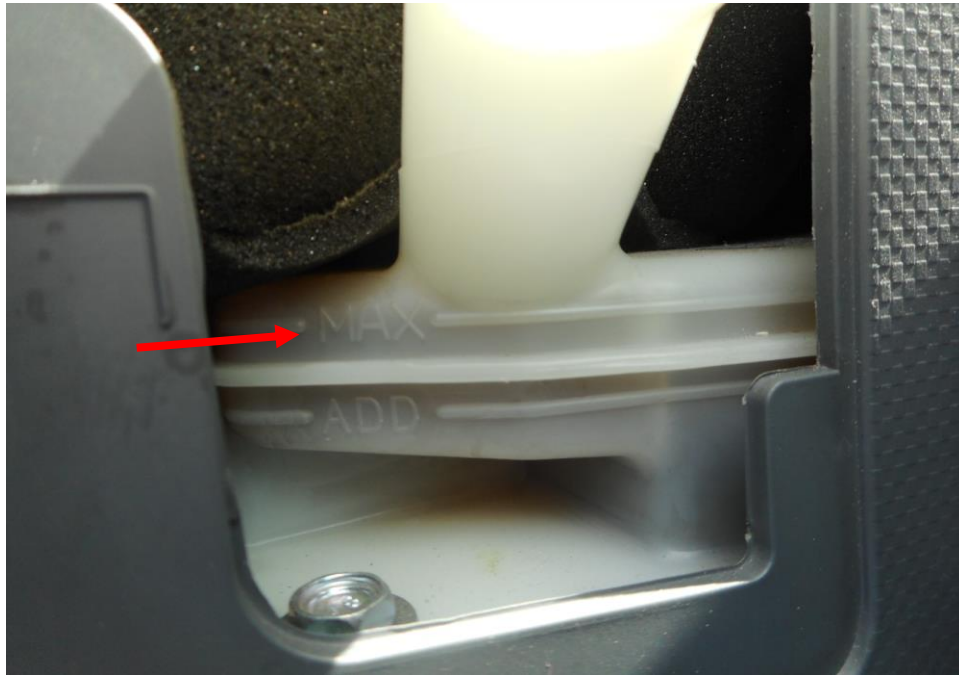
**Photo 11** shows the brake fluid reservoir of the Motor Lorry at the time of my inspection. The brake fluid was observed to be of sufficient level (arrowed) and without any visible contamination.

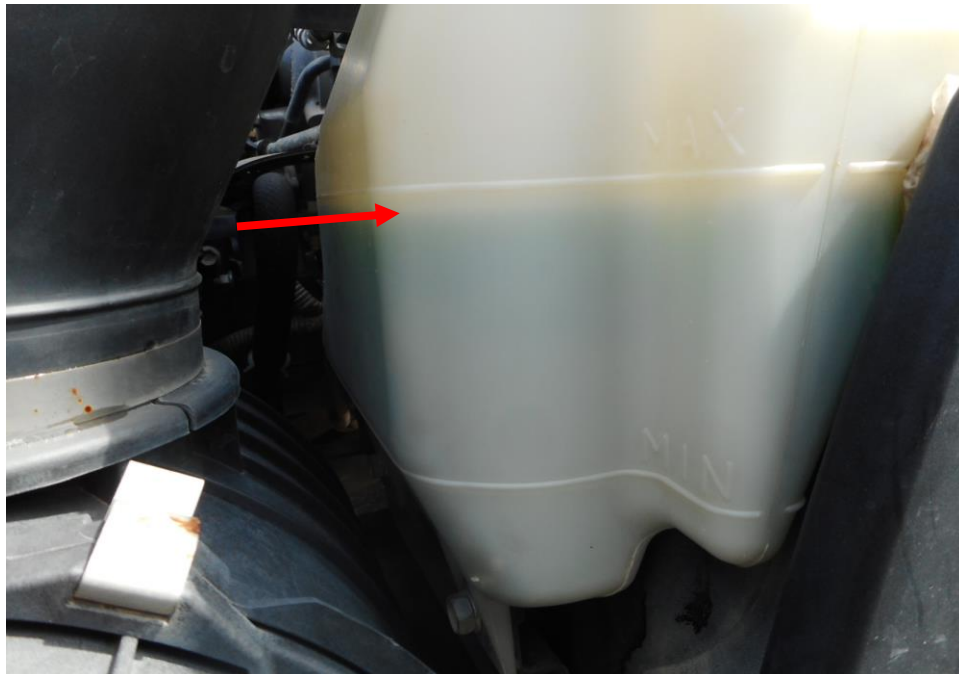
**Photo 12** shows the engine coolant reservoir of the Motor Lorry at the time of my inspection. The engine coolant was observed to be of sufficient level (arrowed) and without any visible contamination.

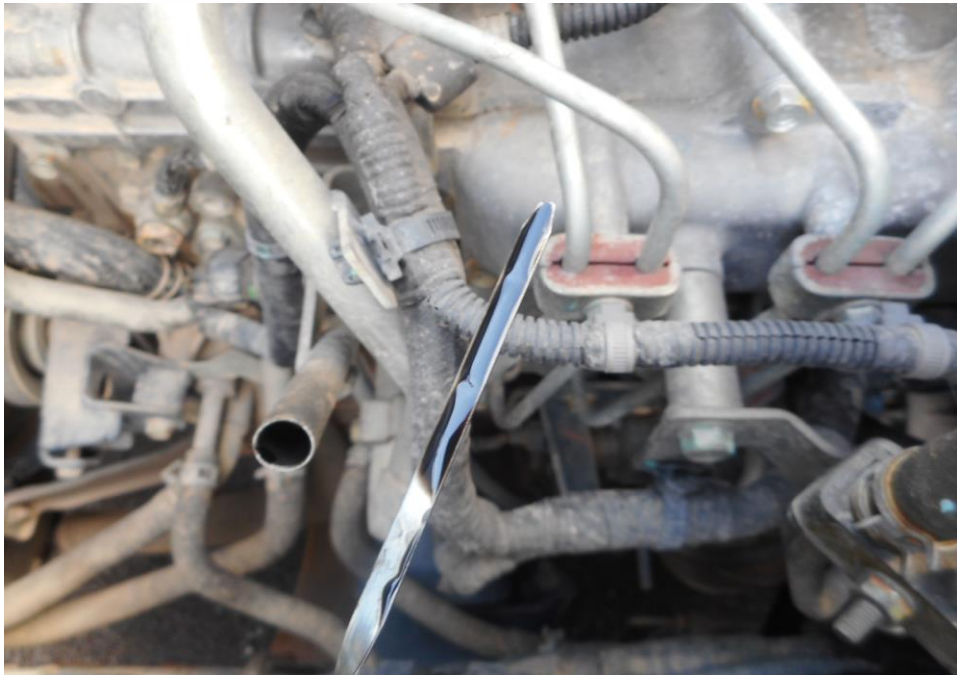
**Photo 13** shows the engine oil dip stick of the Motor Lorry at the time of my inspection. The engine oil was observed to be of sufficient level and without any visible contamination.

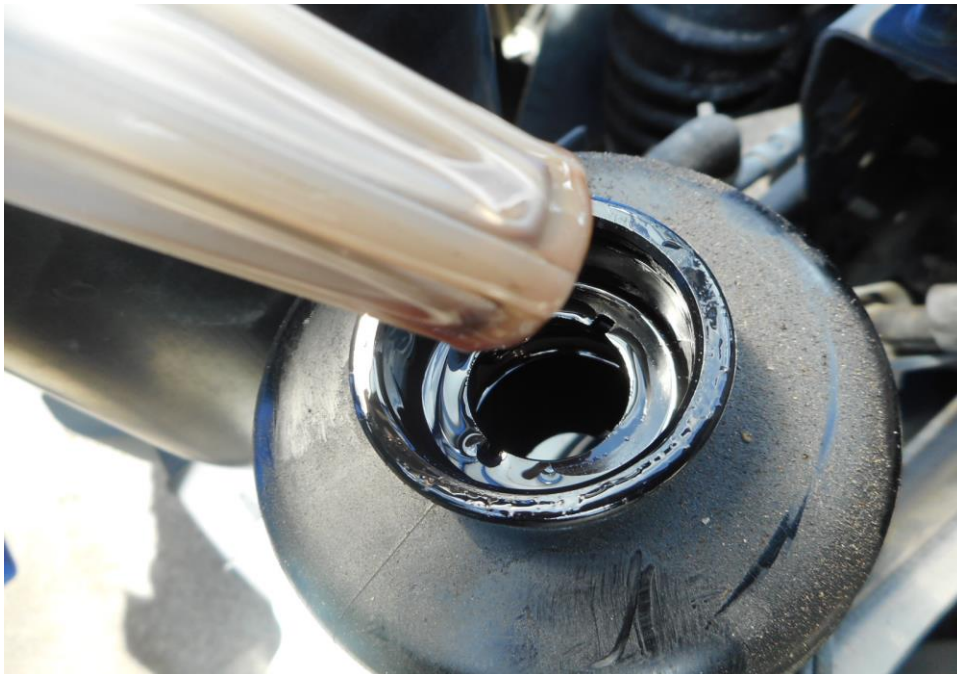
**Photo 14** shows the power steering fluid dip stick of the Motor Lorry at the time of my inspection. The power steering fluid was observed to be of sufficient level and without any visible contamination.

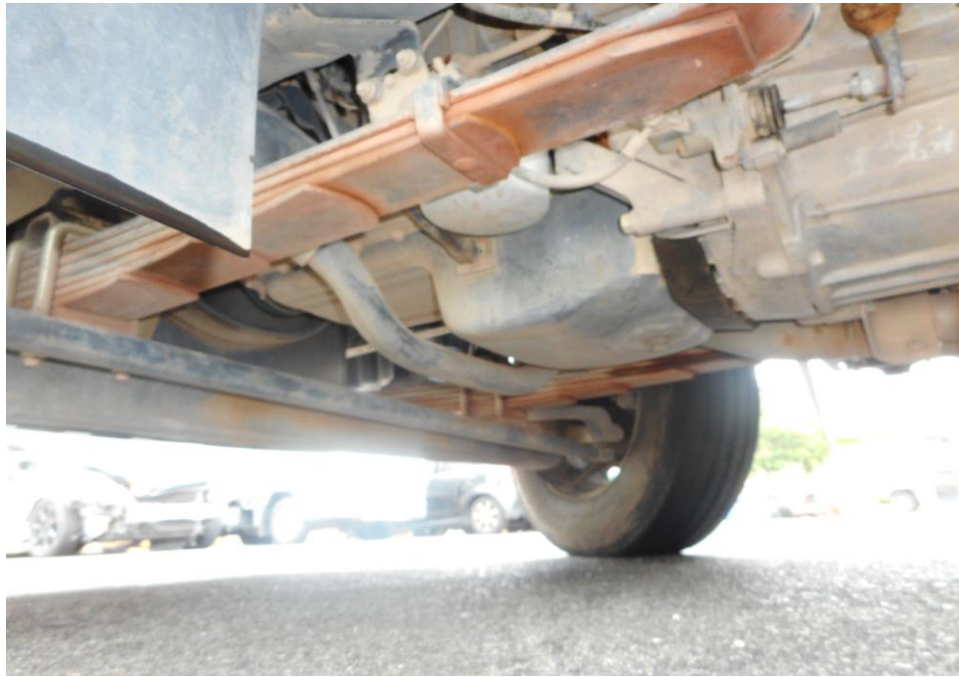
**Photo 15** shows the undercarriage of the Motor Lorry, at the area where the engine housing and transmission housing are located. I did find old fluid stain on the underside of the Motor Lorry.

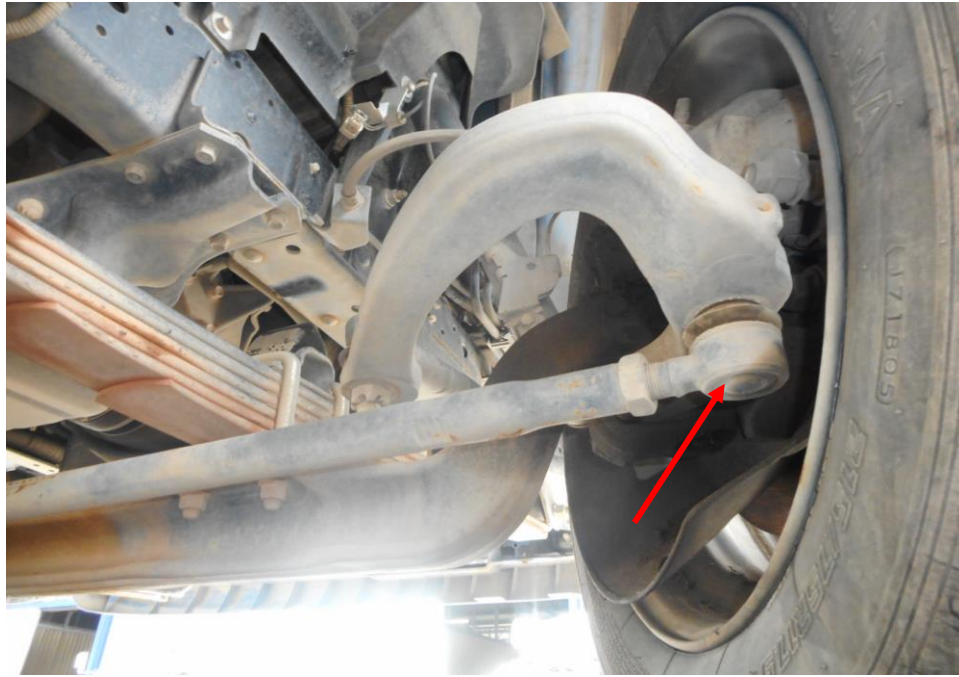
**Photo 16** shows the various undercarriage components at the front right wheel of the Motor Lorry, in particular the steering tie rod end (arrowed). The various steering components were all found to be intact, suggesting that the steering system of the Motor Lorry was likely to be in serviceable condition at the material time of accident. There was also no sign of fluid stain(s) observed on the various undercarriage components.

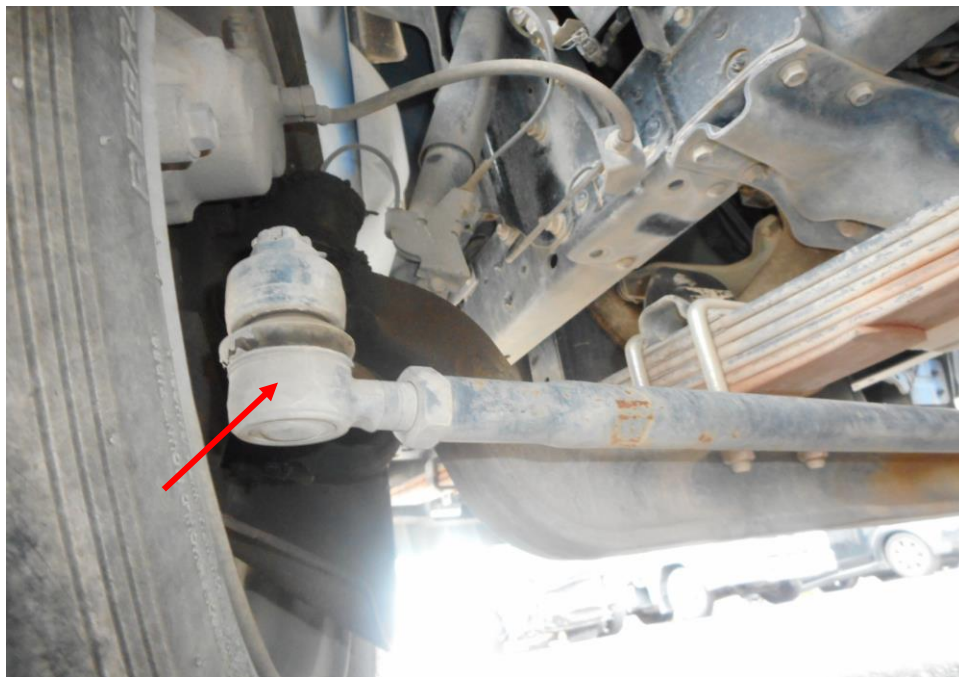
**Photo 17** shows the various undercarriage components at the front left wheel of the Motor Lorry, in particular the steering tie rod end (arrowed). The various Undercarriage components of the Motor Lorry were all found to be intact without any visible damage. There was also no sign of fluid stain(s) observed on the various undercarriage components.

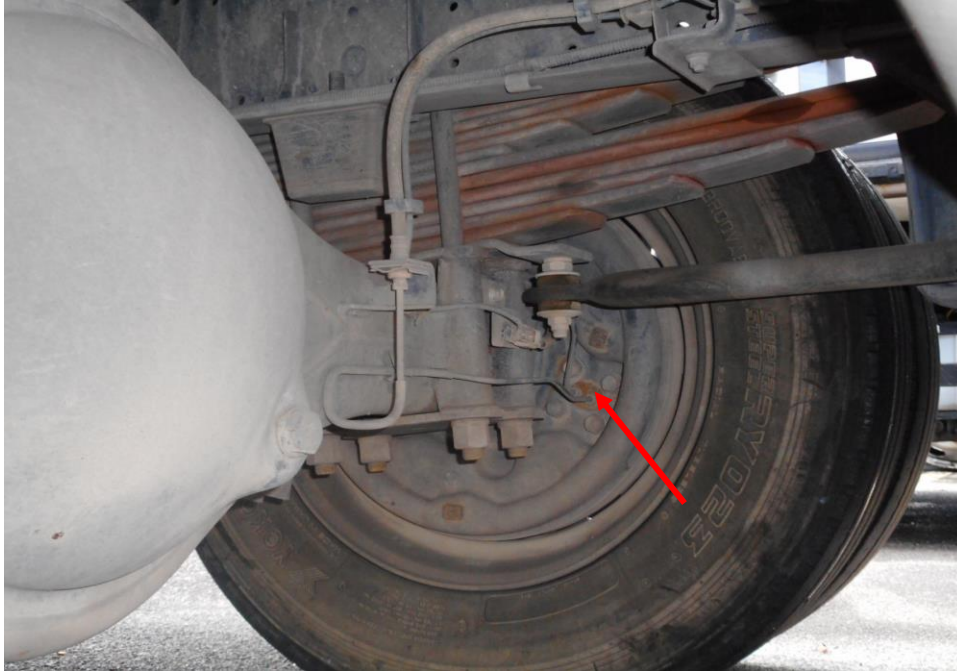
**Photo 18** shows the brake pipe (arrowed) at the rear right wheel of the Motor Lorry. I did not observe any leakage of brake fluid at the time of my inspection of the Motor Lorry. My static tests of the Motor Lorry's braking system, along with my visual examination of the various mechanical components in the braking system, had indicated that there was no internal leakage of pressure/vacuum. Hence the braking system of the Motor Lorry was likely to be in serviceable condition at the material time of accident.

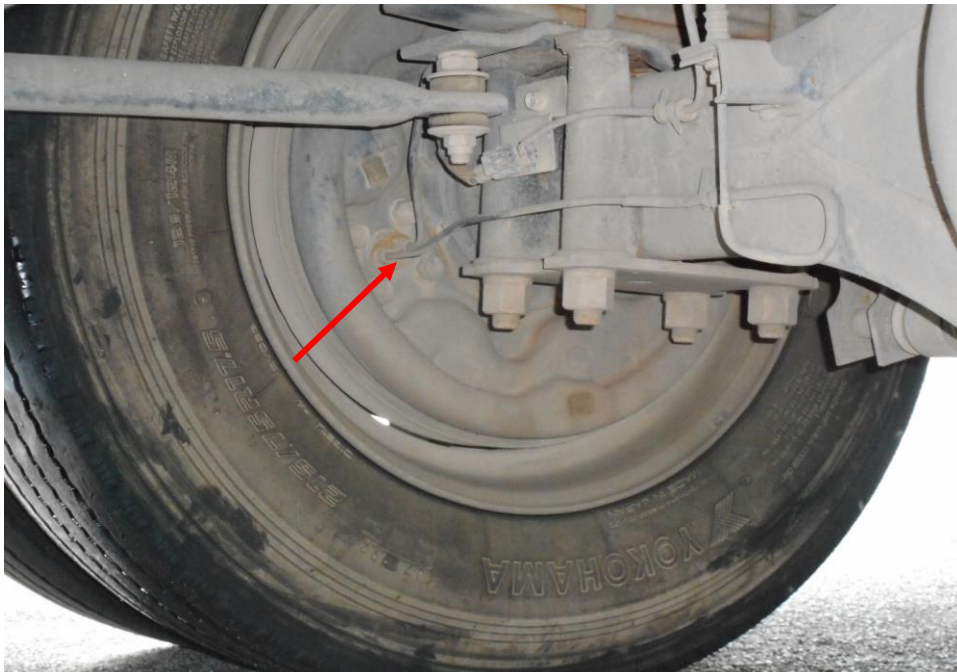
**Photo 19** shows the brake pipe (arrowed) at the rear left wheel of the Motor Lorry. I did not observe any leakage of brake fluid at the time of my inspection of the Motor Lorry. My static tests of the Motor Lorry's braking system, along with my visual examination of the various mechanical components in the braking system had indicated that there was no internal leakage of pressure/vacuum. Hence the braking system of the Motor Lorry was likely to be in serviceable condition at the material time of accident.

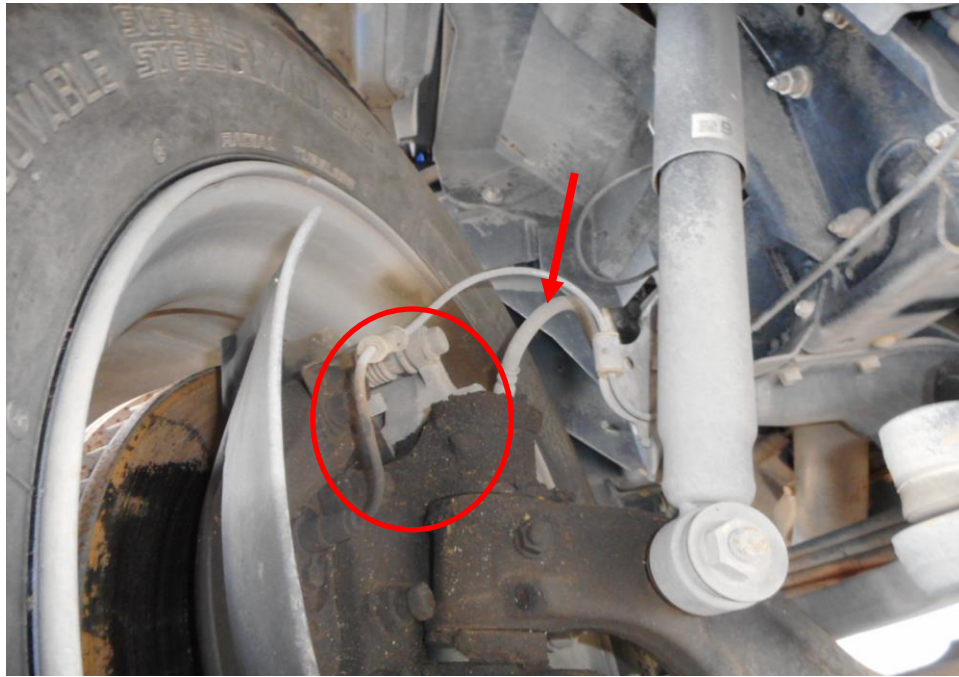
**Photo 20** shows the brake hose/pipe (arrowed) at the front right wheel of the Motor Lorry. No leakage of brake fluid was observed. Visual examination of the various components of the braking system like the brake caliper (circled), brake booster, brake pedal etc had revealed all to be intact and without visible damage at the time of accident. There was also no sign of fluid stain(s) observed on the various undercarriage components.

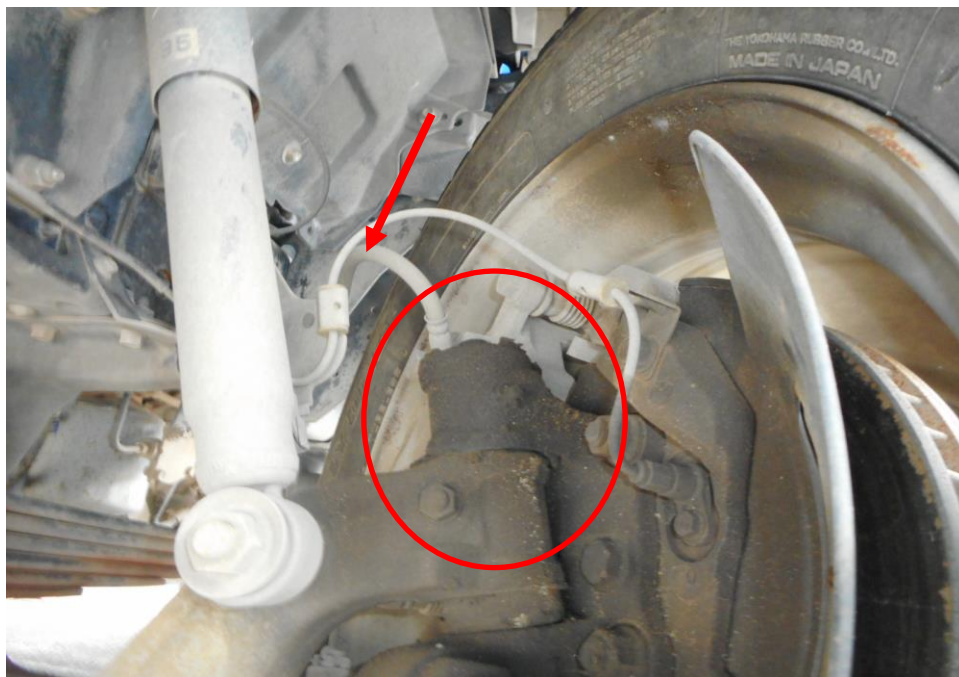
**Photo 21** shows the brake hose/pipe (arrowed) at the front left wheel of the Motor Lorry. No leakage of brake fluid was observed. Visual examination of the various components of the braking system like the brake caliper (circled), brake booster, brake pedal etc had revealed all to be intact and without visible damage at the time of accident. There was also no sign of fluid stain(s) observed on the various undercarriage components.

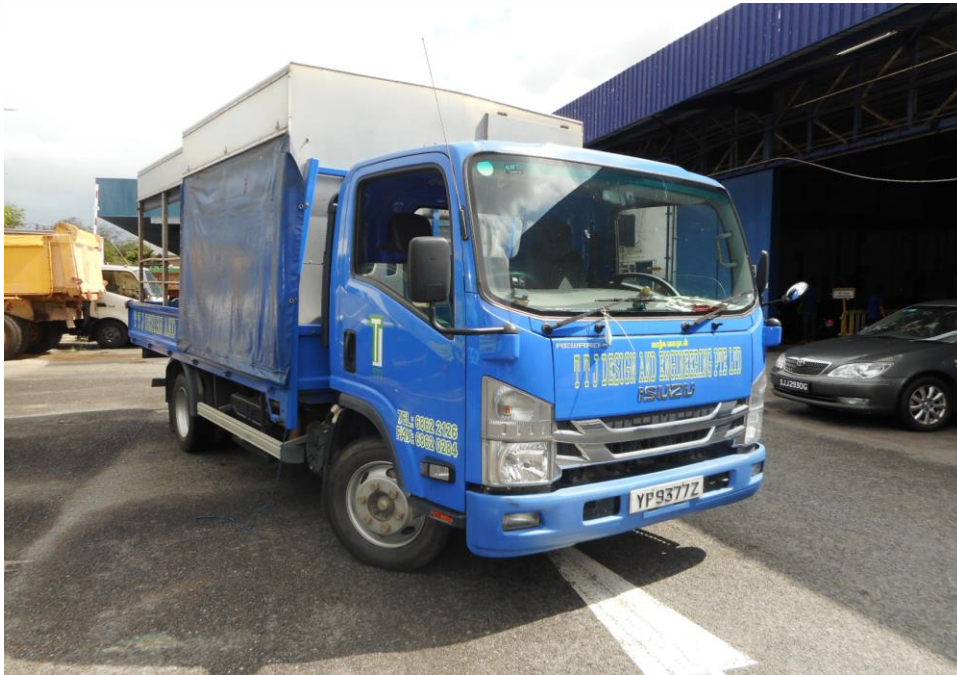
**Photo 22** shows the front right wheel of the Motor Lorry turned to its full left. During my steering system test, I did not experience any abnormal free play and/or resistance when I had turned the steering wheel towards full left and full right. This would suggest that the steering system of the Motor Lorry was likely to be in serviceable condition at the material time of accident.

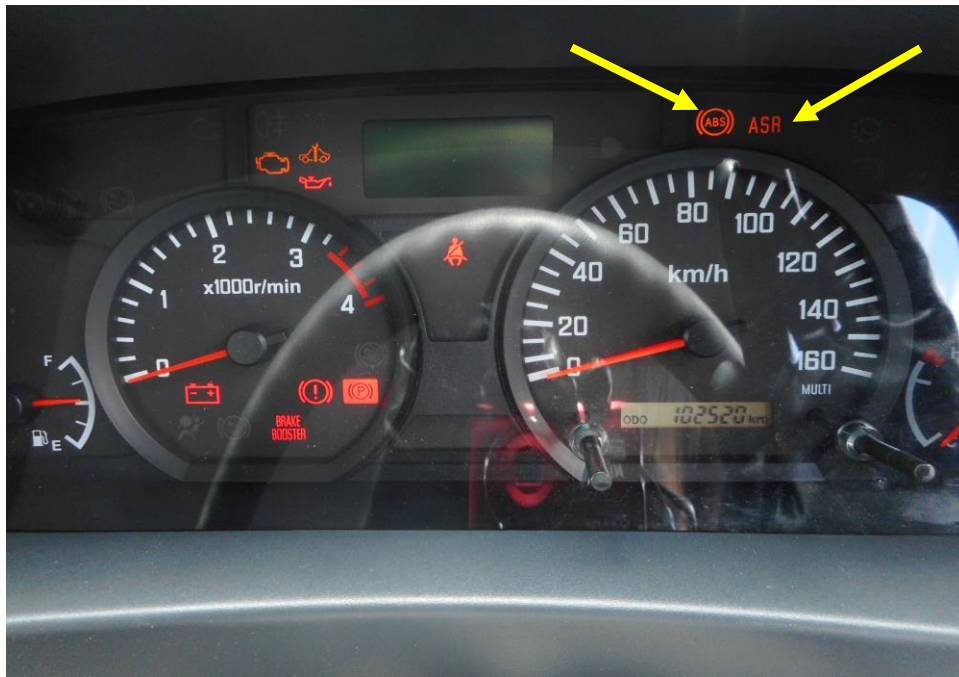
**Photo 23** shows the warning light for Anti-Lock Brake System (ABS) and Traction Control System (SRS/ASR) (arrowed) appearing on the instrument panel of the Motor Lorry during the self-test of its various electronic operating systems when its engine was cranked.

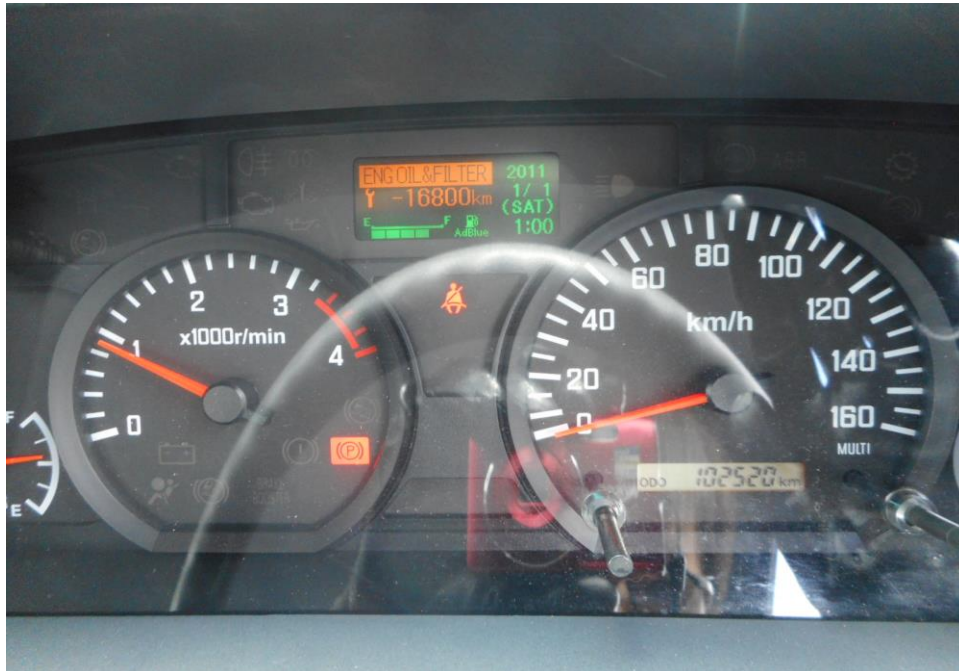
**Photo 24** shows no warning lights illuminated on the instrument panel of the Motor Lorry after the engine was cranked. This would suggest that there was no abnormality to the electronic operating system of the Motor Lorry, like the ABS, TC/ASR and etc.
