Your Ref: TP/IP/71957/2019  
Our Ref : CI/TPD19020811/P

28<sup>th</sup> November 2019

**MECHANICAL INSPECTION REPORT OF MOTOR CAR SDX 35B**

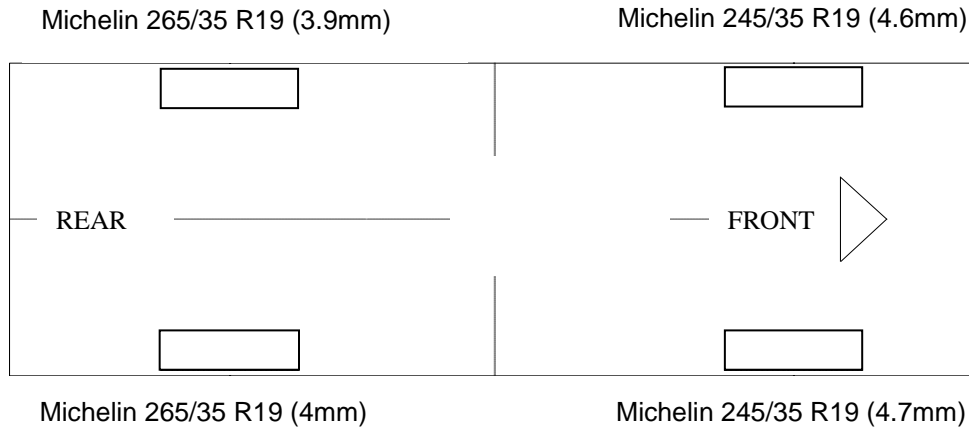
6. The 4 tyres of the Motor Car were observed to be in serviceable condition and sufficiently inflated for vehicular operation. I did not find any tear, cut or burst mark(s) on the outer and the inner sidewalls as well as across the tread of the 4 tyres. The tyre brand, tyre size and remaining tread depth of the 4 tyres of the Motor Car were recorded as follows:-

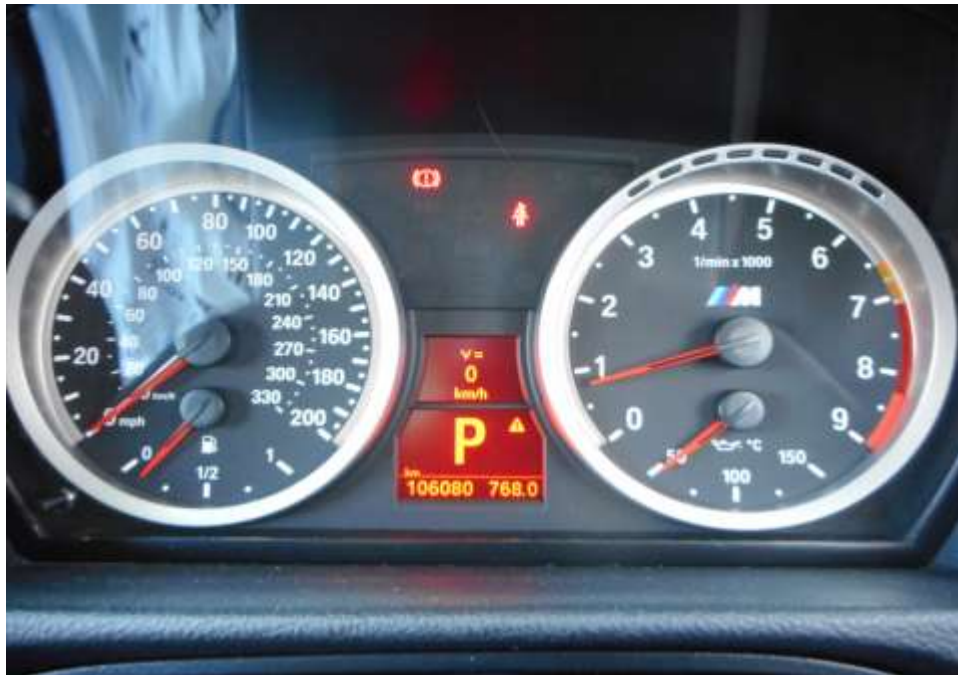
4. The mileage of the Motor Car at the time of my inspection was 106,080km.
5. The Motor Car was observed to have sustained minor damage at its rear left portion. Its rear left wheel fender was damaged as a result of the accident.

**Photo 1** shows a general view of the instrument cluster of the Motor Car at the time of my inspection. The mileage of the Motor Car was 106,080km

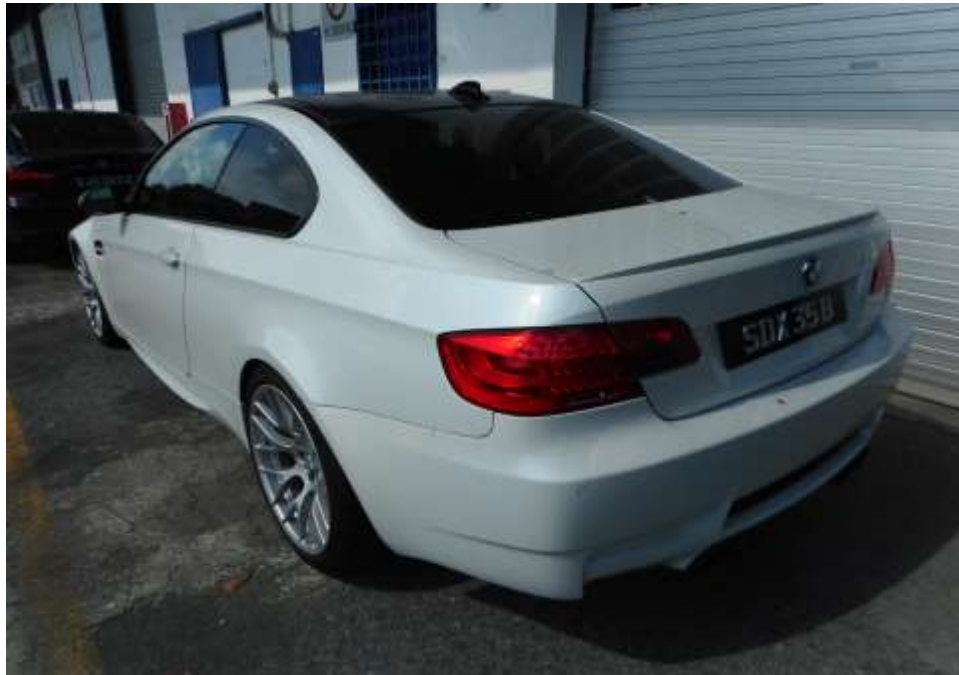
**Photo 2** shows a general view of the left body of the Motor Car at the time of my inspection. The Motor Car was observed to have sustained minor damage at its rear left portion. Its rear left wheel fender was damaged as a result of the accident.

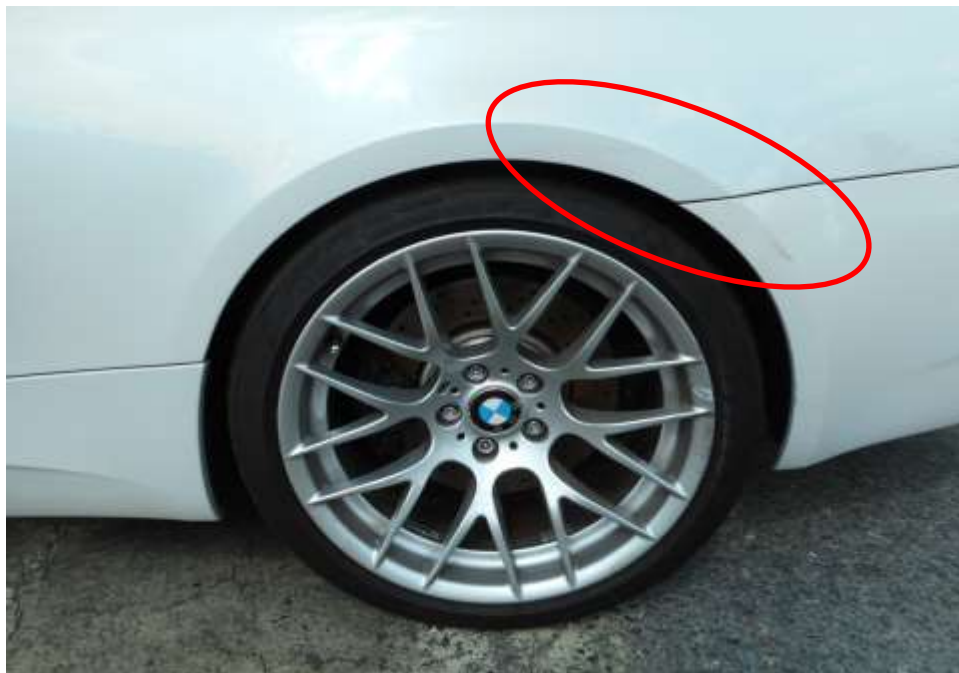
**Photo 3** shows a general view of the left body of the Motor Car at the time of my inspection. Its rear left wheel fender (circled) was damaged as a result of the accident.

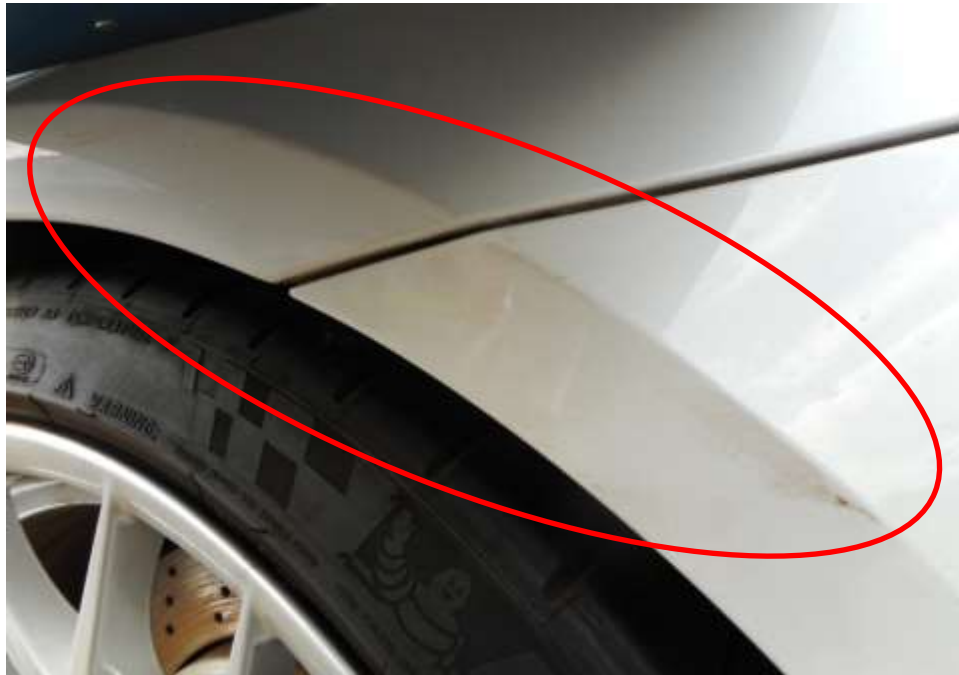
**Photo 4** shows a close up view of the left body of the Motor Car at the time of my inspection. Its rear left wheel fender (circled) was damaged as a result of the accident.

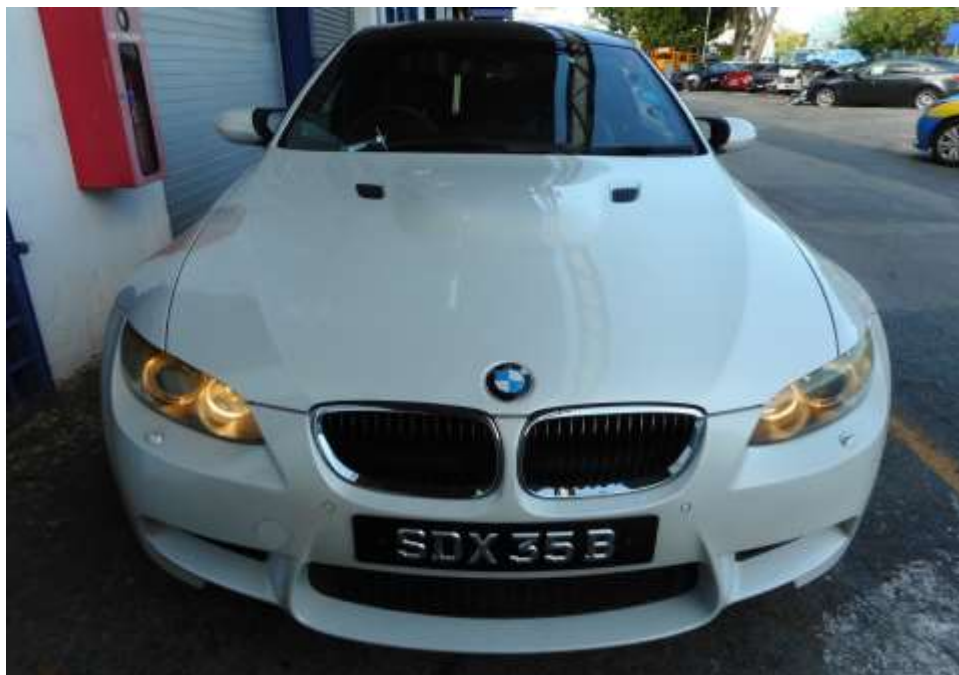
**Photo 5** shows a general view of the front Motor Car at the time of my inspection. The Motor Car was observed to be intact and unaffected by the accident.

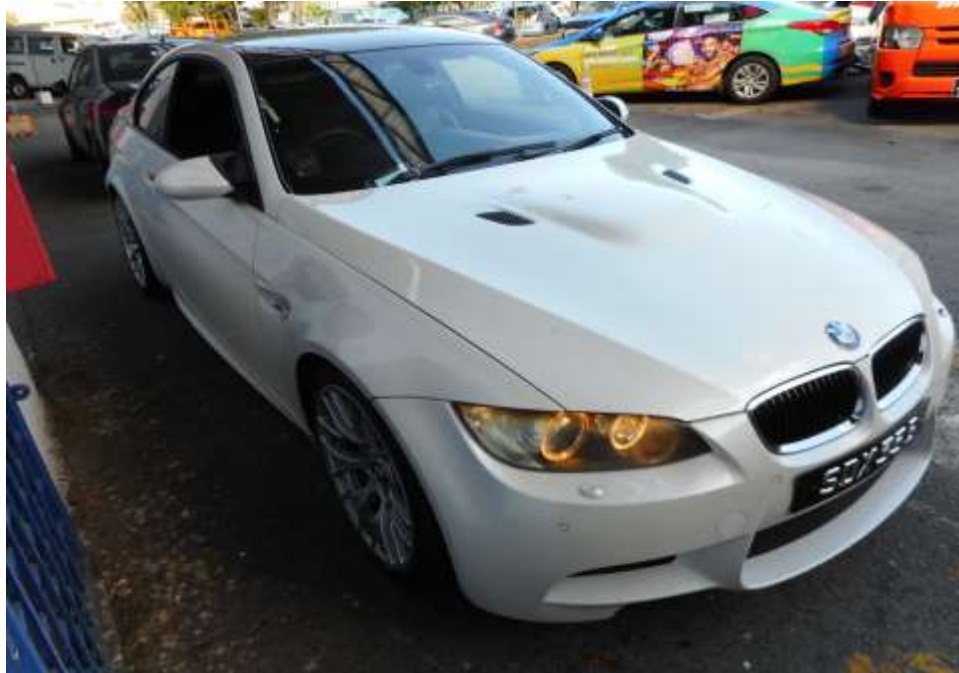
**Photo 6** shows a general view of the right body of the Motor Car at the time of my inspection. The Motor Car was observed to be intact and unaffected by the accident.

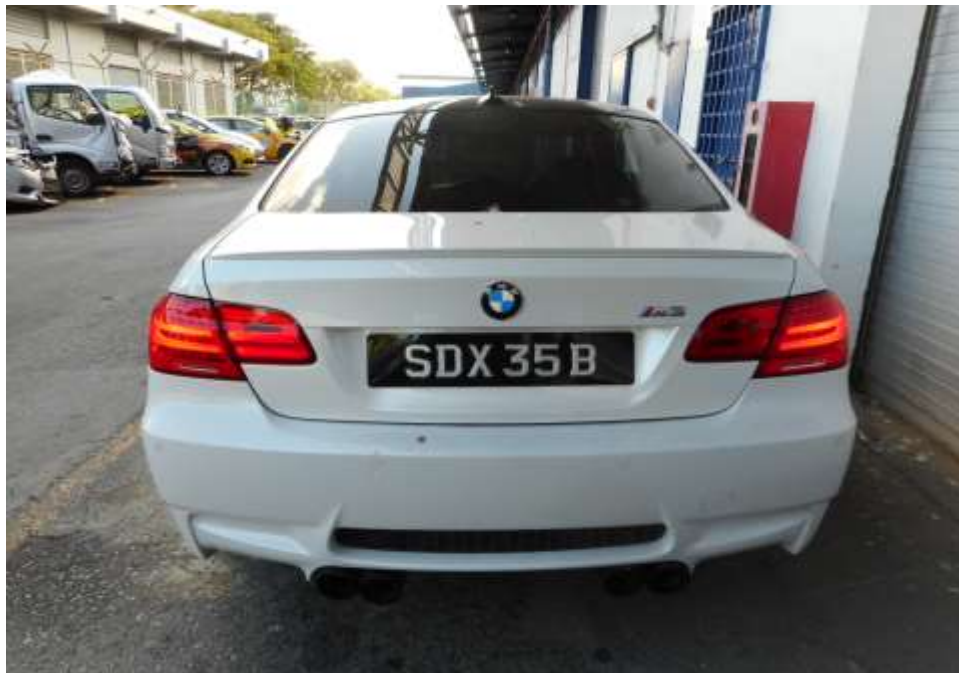
**Photo 7** shows a general view of the rear body of the Motor Car at the time of my inspection. The Motor Car was observed to be intact and unaffected by the accident.

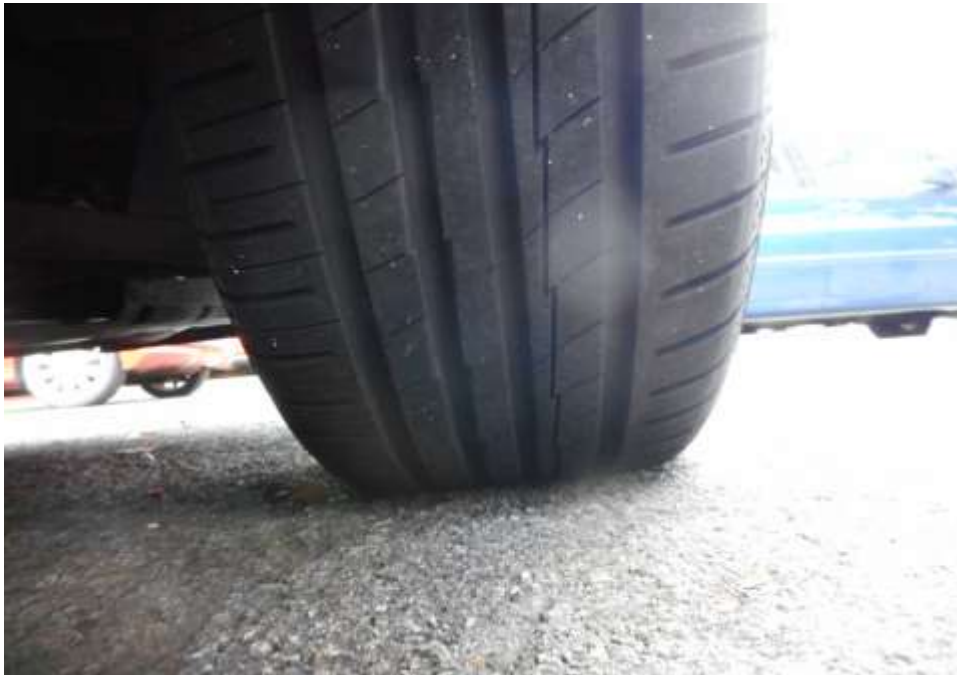
**Photo 8** shows the condition of the front right tyre of the Motor Car, which was observed to be in serviceable condition with remaining tread depth of approximately 4.7mm. The tyre, which was wrapped around standard alloy wheel rim, was also observed to be sufficiently inflated for vehicular operation. There was no tear, cut or burst mark(s) on the outer and the inner sidewalls as well as across the tread of the 4 tyres that were fitted on the Motor Car.

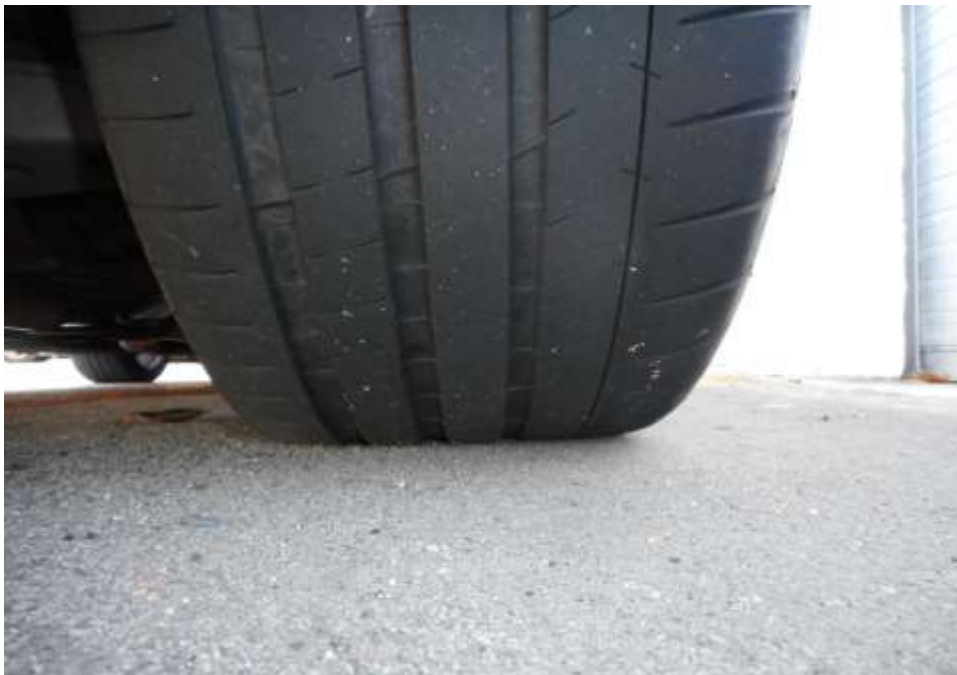
**Photo 9** shows the condition of the rear right tyre of the Motor Car, which was observed to be in serviceable condition with remaining tread depth of approximately 4mm. The tyre, which was wrapped around standard alloy wheel rim, was also observed to be sufficiently inflated for vehicular operation.

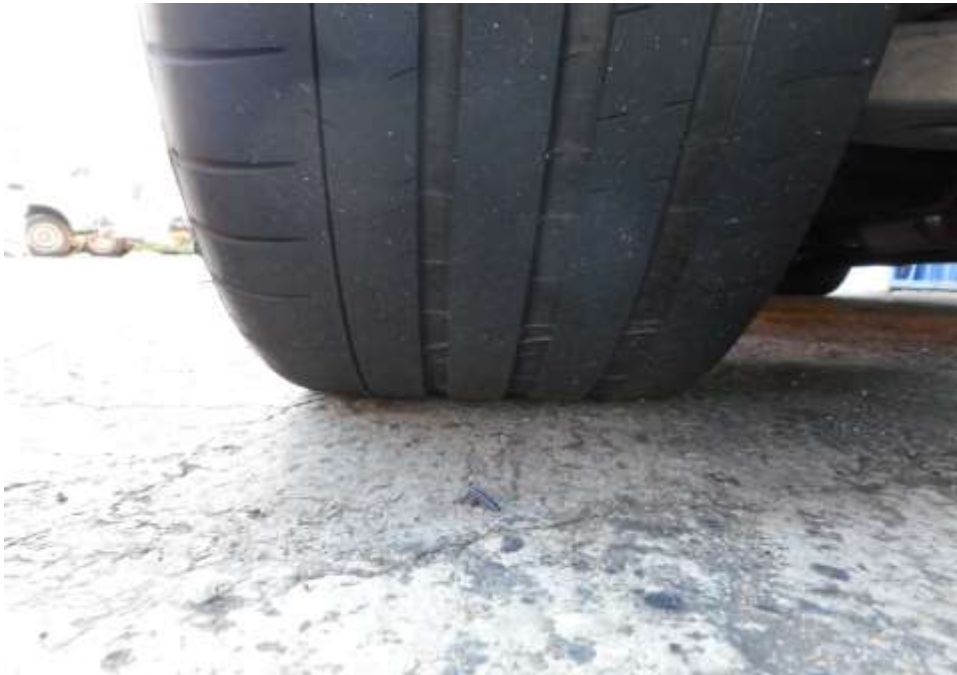
**Photo 10** shows the condition of the rear left tyres of the Motor Car, which was observed to be in serviceable condition with remaining tread depth of approximately 3.9mm. The tyres, which were wrapped around standard alloy wheel rim, were also observed to be sufficiently inflated for vehicular operation. There was also no damage found on all 4 alloy wheel rims of the Motor Car.

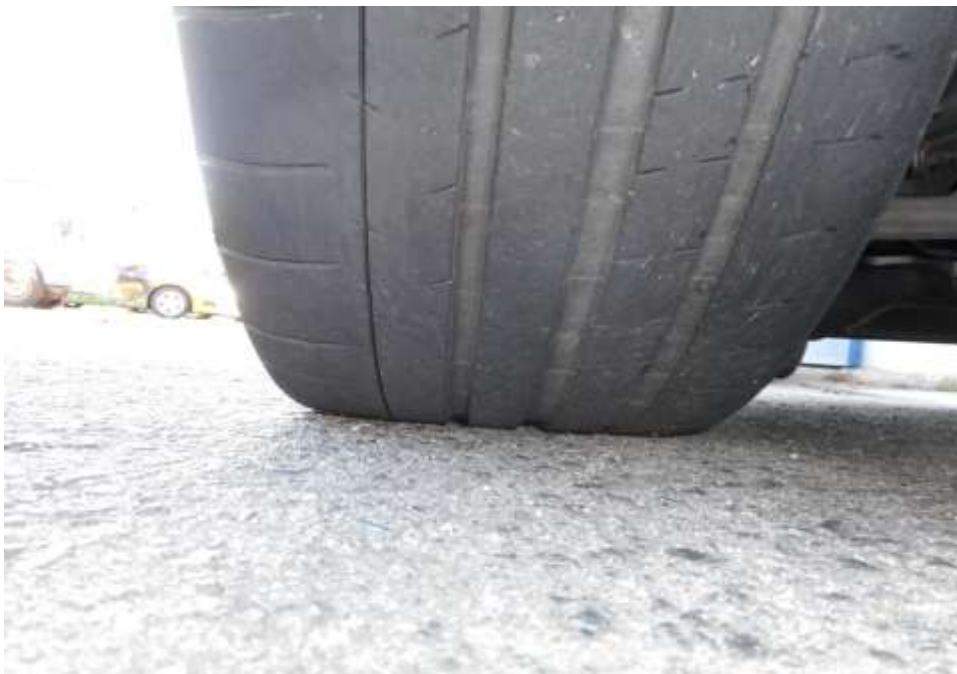
**Photo 11** shows the condition of the rear right tyres of the Motor Car, which were observed to be in serviceable condition with remaining, tread depth of approximately 6.6mm. There was also no tear, cut or burst mark(s) on the outer and the inner sidewalls as well as across the tread of the 4 tyres that were fitted on the Motor Car.

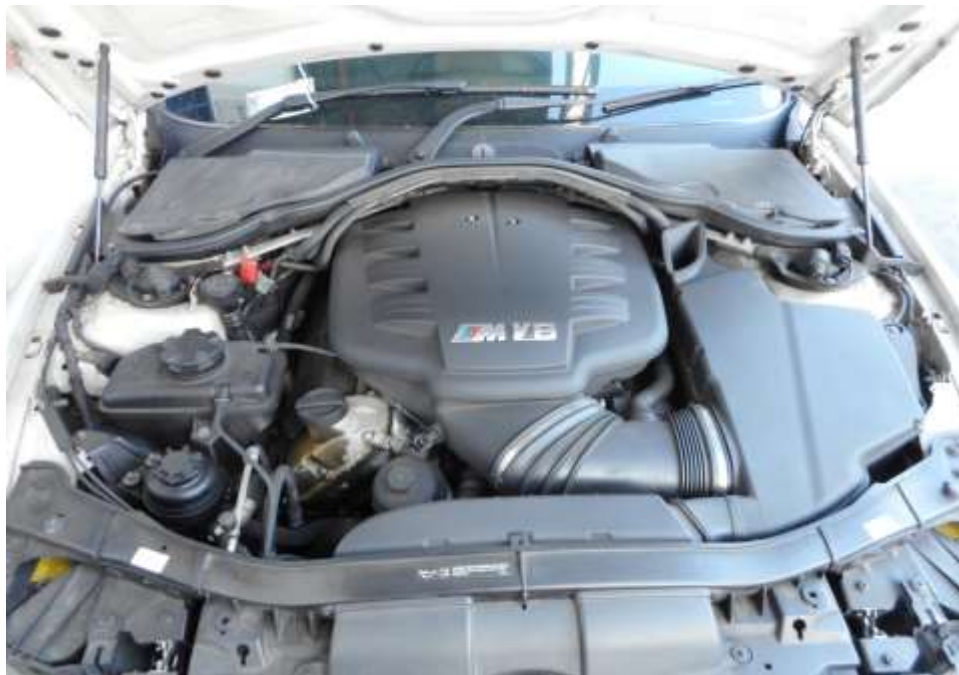
**Photo 12** shows a general view of the Motor Car's engine compartment, which was accessed by lifting the front cabin of the Motor Car. The various parts and components inside the engine compartment were unaffected by the accident. There was also no sign(s) or indication(s) of fresh fluid leakage, however there was old fluid stain observed at the engine cover within the engine compartment

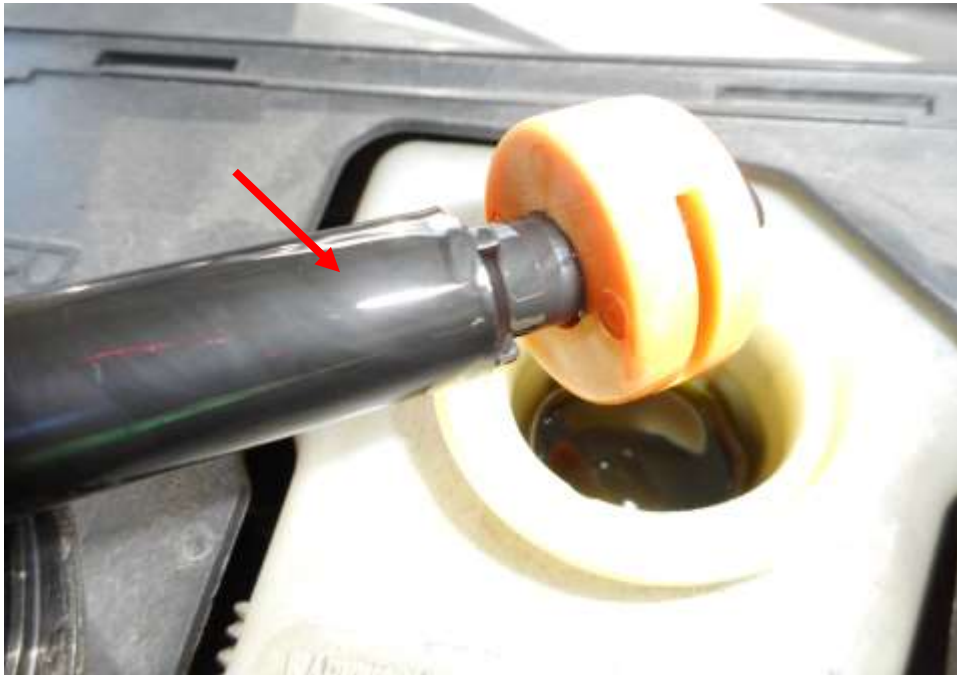
**Photo 13** shows the brake fluid reservoir of the Motor Car at the time of my inspection. The brake fluid was observed to be of sufficient level (arrowed) and without any visible contamination.

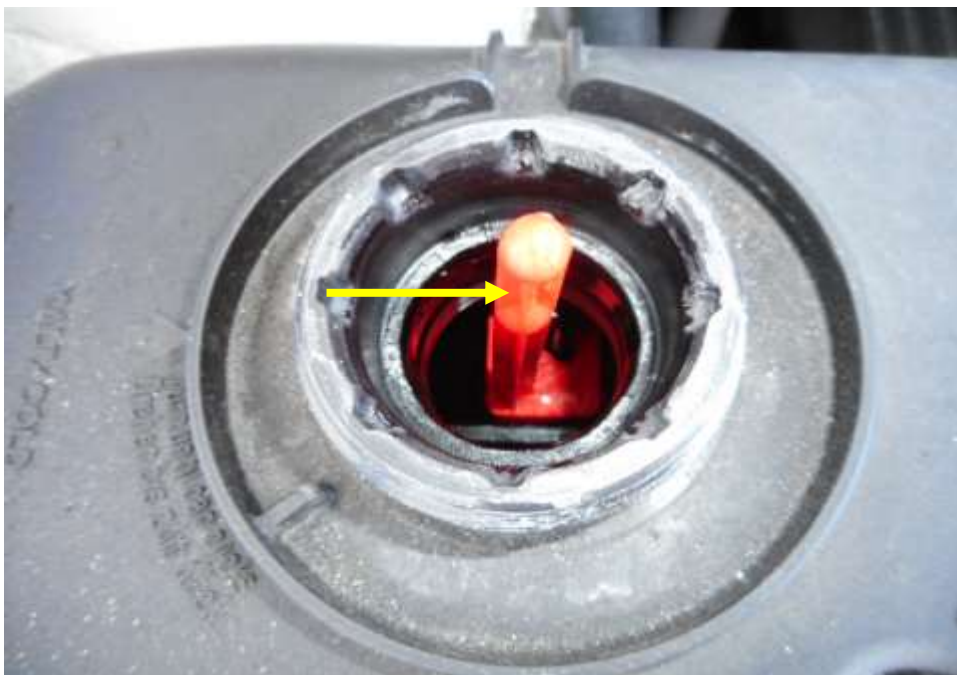
**Photo 14** shows the engine coolant reservoir of the Motor Car at the time of my inspection. The engine coolant was observed to be of sufficient level (arrowed) and without any visible contamination.

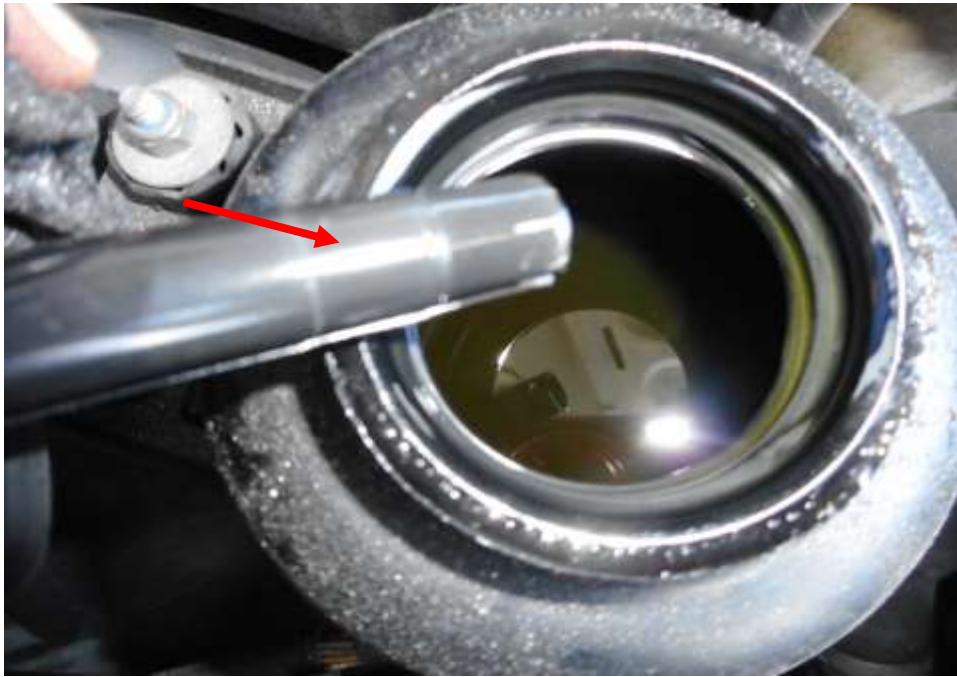
**Photo 15** shows the power steering dipstick and reservoir of the Motor Car at the time of my inspection. The steering fluid was observed to be of sufficient level (arrowed) and without any visible contamination.

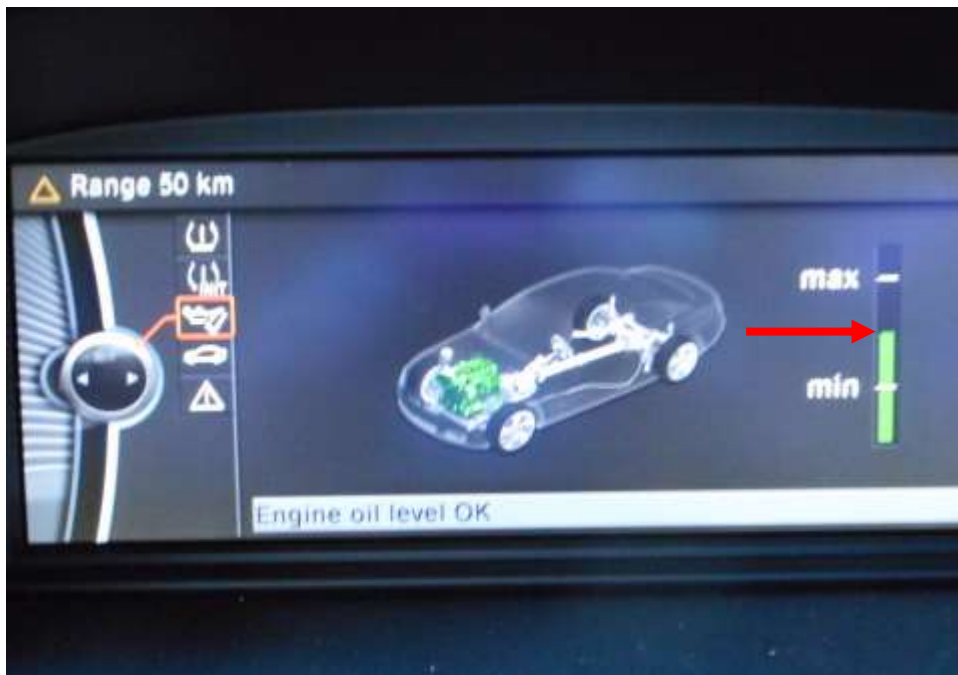
**Photo 16** shows the engine level of the Motor Car at the time of my inspection. The engine oil was observed to be of sufficient level (arrowed) and without any visible contamination.

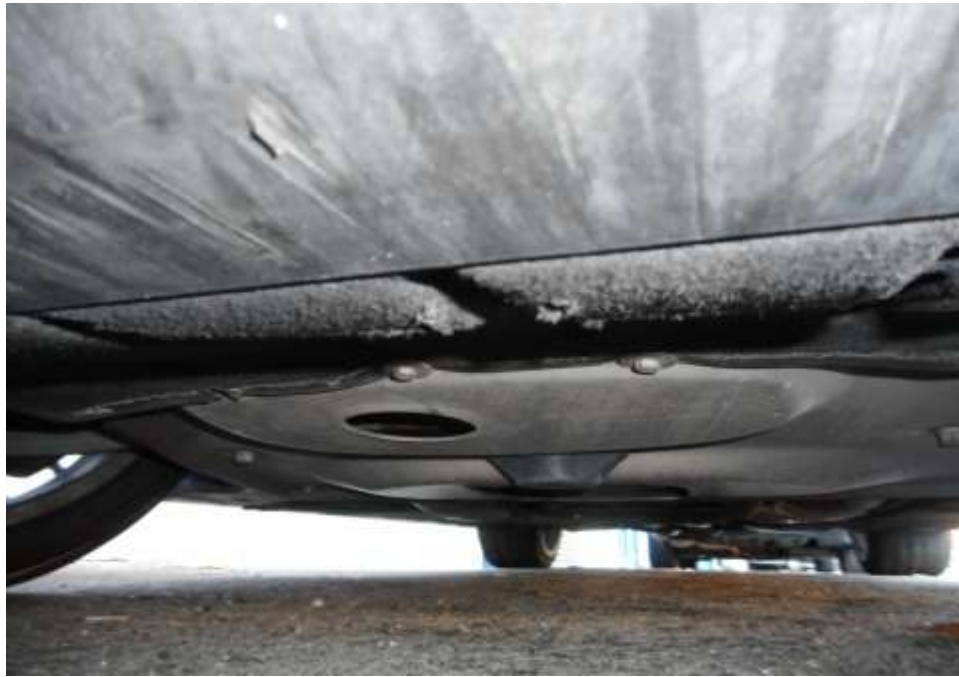
**Photo 17** shows the undercarriage of the Motor Car, at the area where the engine housing and transmission housing are located. . I did not find any sign(s) or indication(s) of fluid leak and/or fluid stain(s) on the underside of the Motor Car.

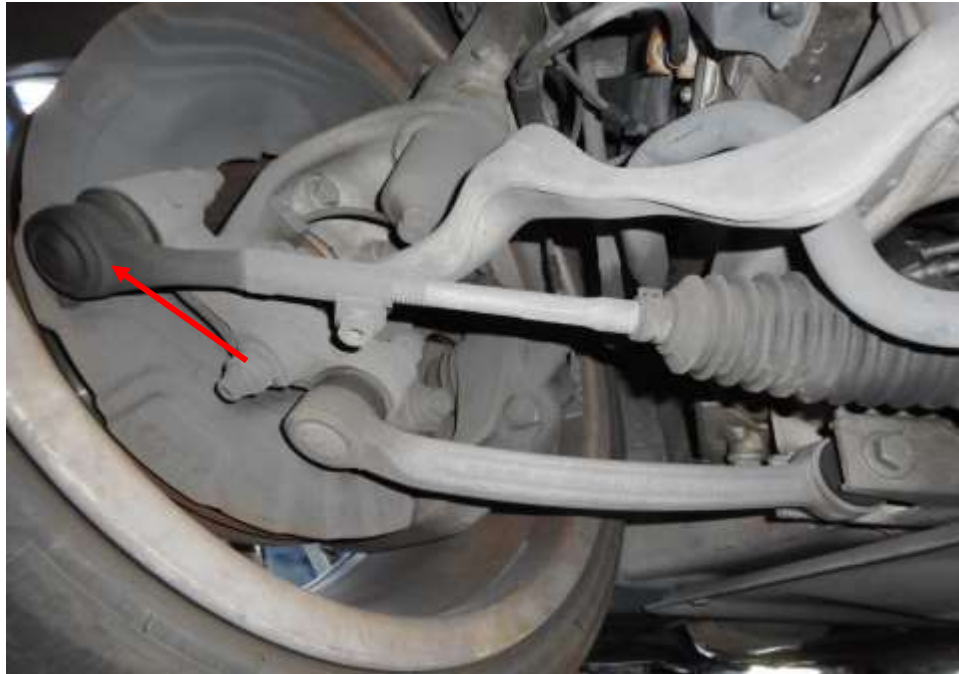
**Photo 18** shows the various undercarriage components at the front right wheel of the Motor Car, in particular the steering tie rod end (arrowed) and drive shaft (yellow arrow). The various steering components were all found to be intact, suggesting that the steering system of the Motor Car was likely to be in serviceable condition at the material time of accident. There was also no sign of fluid stain(s) observed on the various undercarriage components.

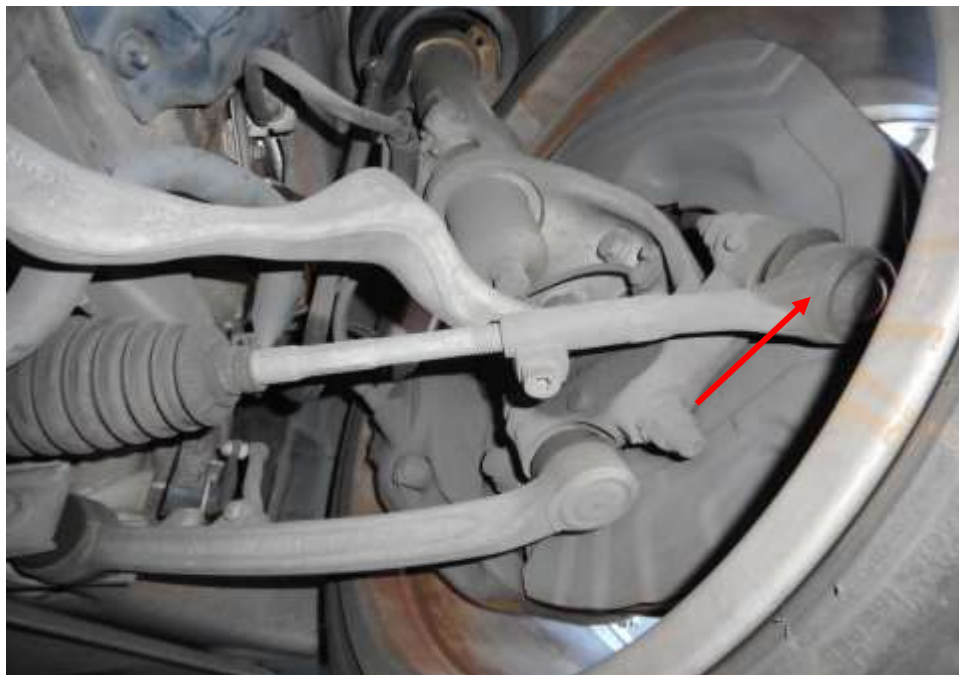
**Photo 19** shows the various undercarriage components at the front left wheel of the Motor Car, in particular the steering tie rod end (arrowed). The various undercarriage components of the Motor Car were all found to be intact without any visible damage. There was also no sign of fluid stain(s) observed on the various undercarriage components.

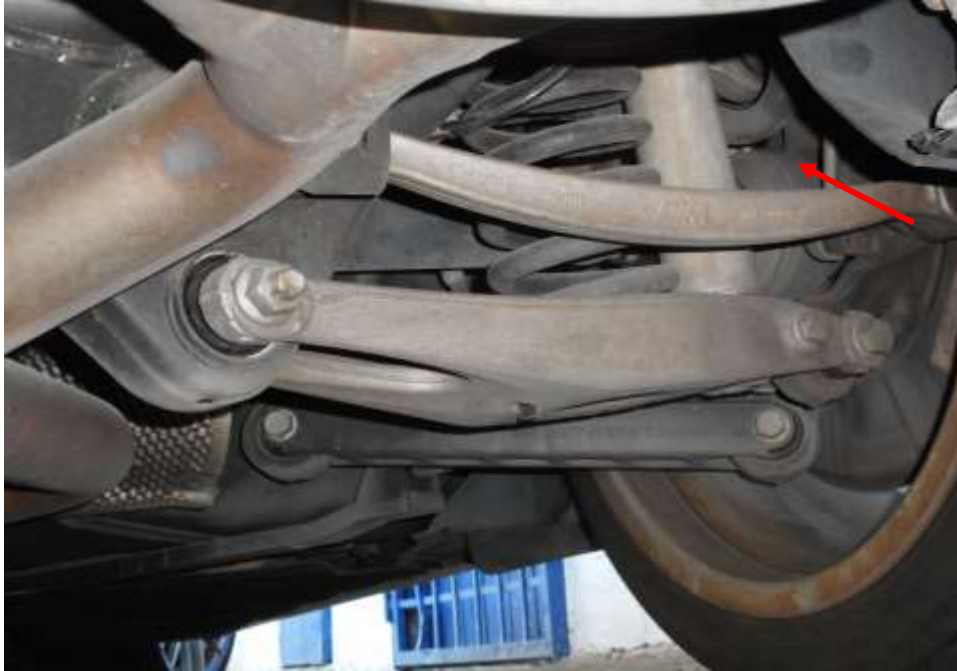
**Photo 20** shows the brake pipe (arrowed) at the rear right wheel of the Motor Car. I did not observe any leakage of brake fluid at the time of my inspection of the Motor Car. My static tests of the Motor Car's braking system, along with my visual examination of the various mechanical components in the braking system, had indicated that there was no internal leakage of pressure/vacuum. Hence the braking system of the Motor Car was likely to be in serviceable condition at the material time of accident.

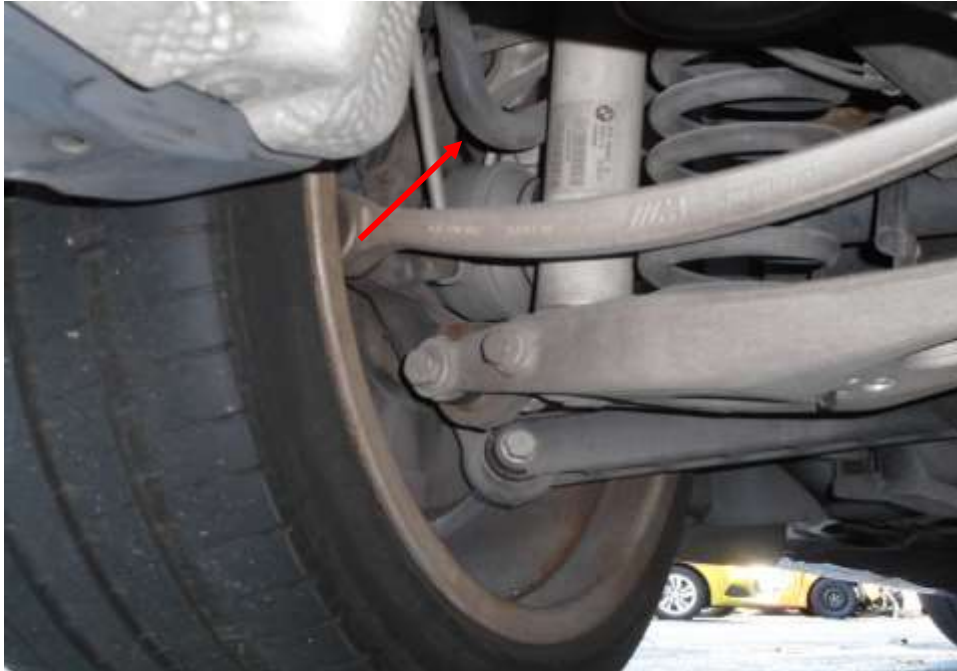
**Photo 21** shows the brake pipe (arrowed) at the rear left wheel of the Motor Car. I did not observe any leakage of brake fluid at the time of my inspection of the Motor Car. My static tests of the Motor Car's braking system, along with my visual examination of the various mechanical components in the braking system had indicated that there was no internal leakage of pressure/vacuum. Hence the braking system of the Motor Car was likely to be in serviceable condition at the material time of accident.

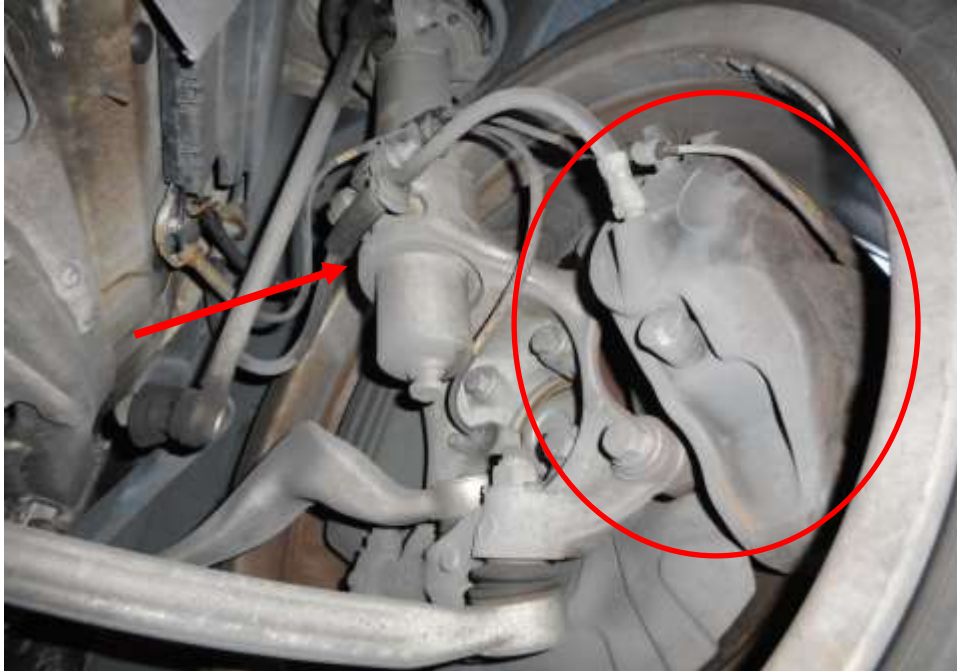
**Photo 22** shows the brake hose/pipe (arrowed) at the front right wheel of the Motor Car. No leakage of brake fluid was observed. Visual examination of the various components of the braking system like the brake caliper (circled), brake booster, brake pedal etc had revealed all to be intact and without visible damage at the time of accident. There was also no sign of fluid stain(s) observed on the various undercarriage components.

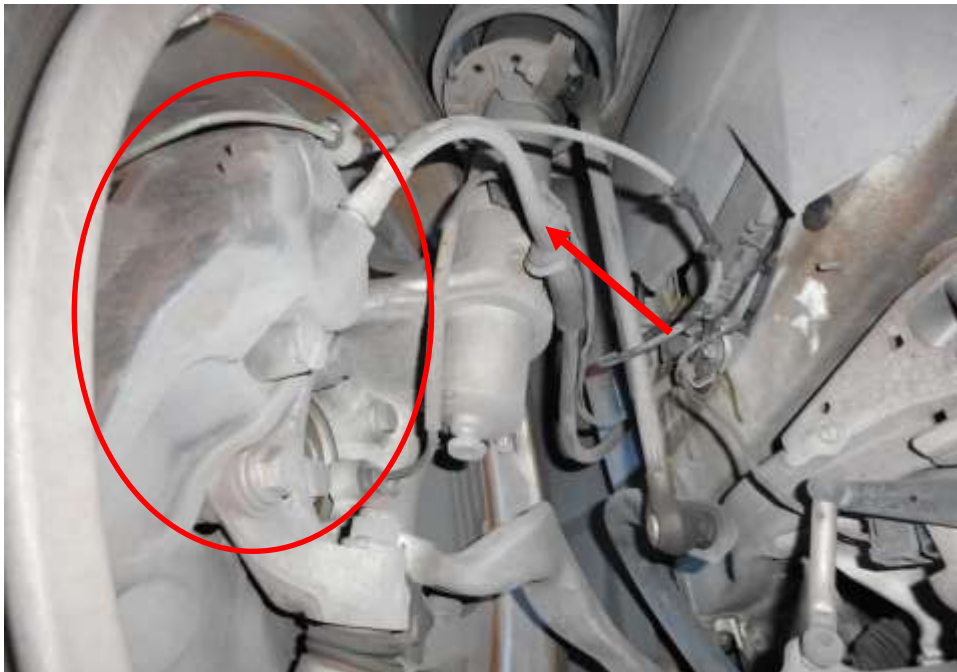
**Photo 23** shows the brake hose/pipe (arrowed) at the front left wheel of the Motor Car. No leakage of brake fluid was observed. Visual examination of the various components of the braking system like the brake caliper (circled), brake booster, brake pedal etc had revealed all to be intact and without visible damage at the time of accident. There was also no sign of fluid stain(s) observed on the various undercarriage components.

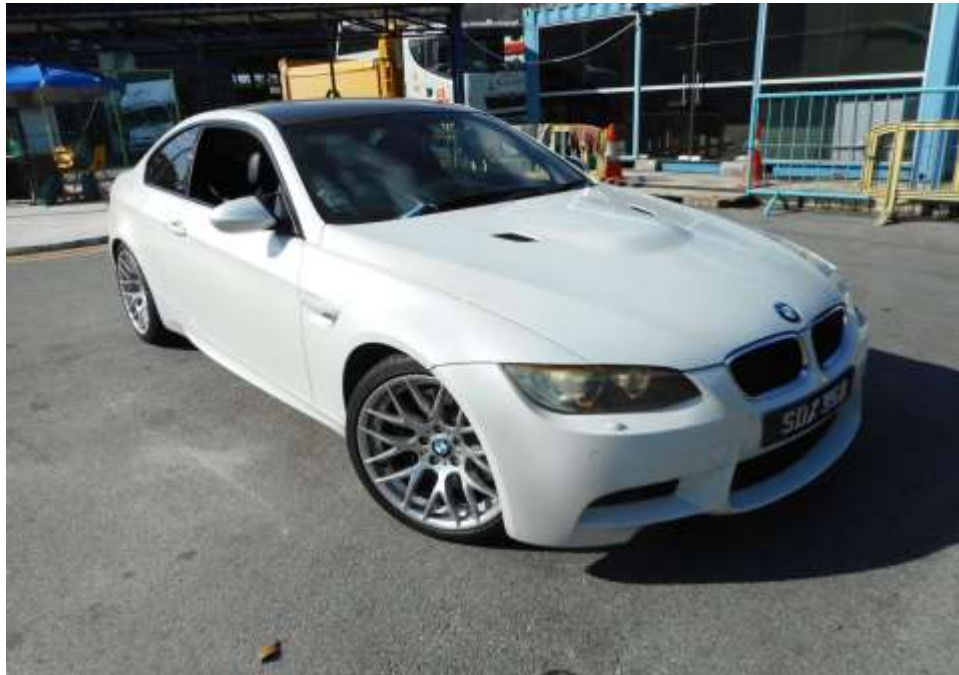
**Photo 24** shows the front right wheel of the Motor Car turned to its full left. During my steering system test, I did not experience any abnormal free play and/or resistance when I had turned the steering wheel towards full left and full right. This would suggest that the steering system of the Motor Car was likely to be in serviceable condition at the material time of accident.

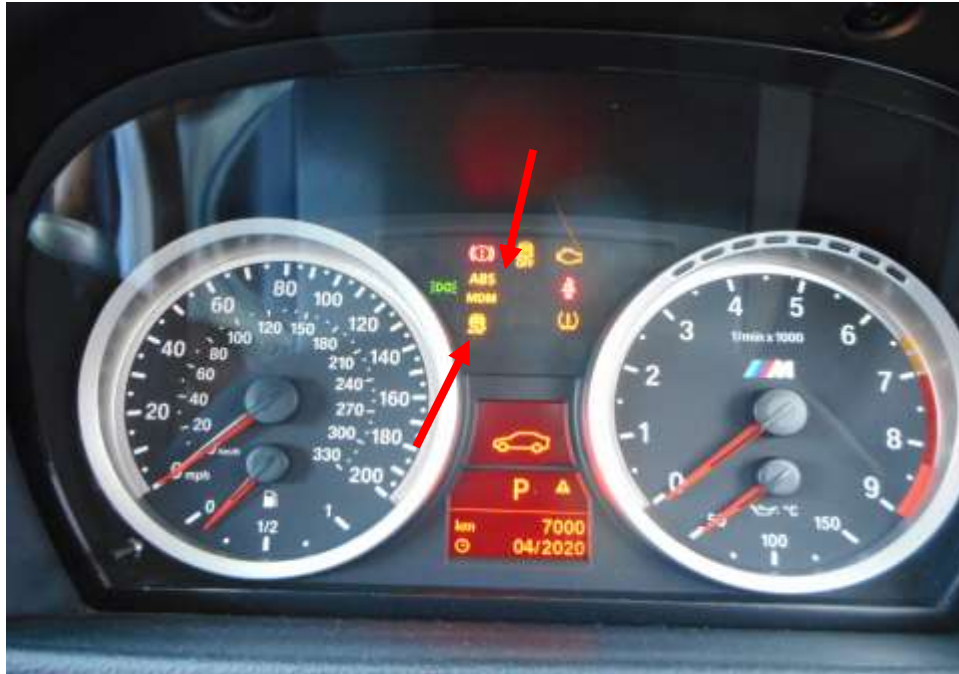
**Photo 25** shows the warning light for Anti-Lock Brake System (ABS) and Traction Control System (TC) appearing on the instrument panel of the Motor Car during the self-test of its various electronic operating systems when its engine was cranked.

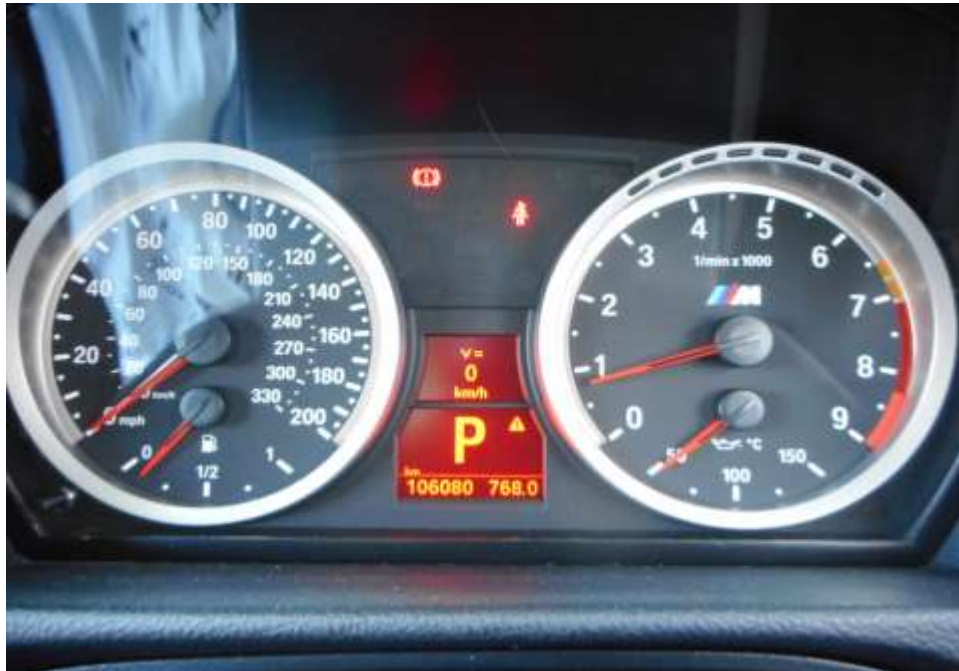
**Photo 26** shows no warning lights illuminated on the instrument panel of the Motor Car after the engine was cranked. This would suggest that there was no abnormality to the various electronic operating systems of the Motor Car, like the ABS and TC...
