Auto
Consultants
Pte Ltd

Automobile Inspection Report of a Motor Car SMA 1533M

**Requested By
Mr Kung Ming Ern
5A Balmoral Park
Singapore 259829
(Owner of Motor Car SMA 1533M)**

10. For this report, I was requested to provide my opinions and comments on whether a Jaguar XE Prestige (2.0 litre) motor car with registration number SMA 1533M (herein referred to as "**Motor Car**") can reasonably be considered to be of a satisfactory quality to an ordinary customer.

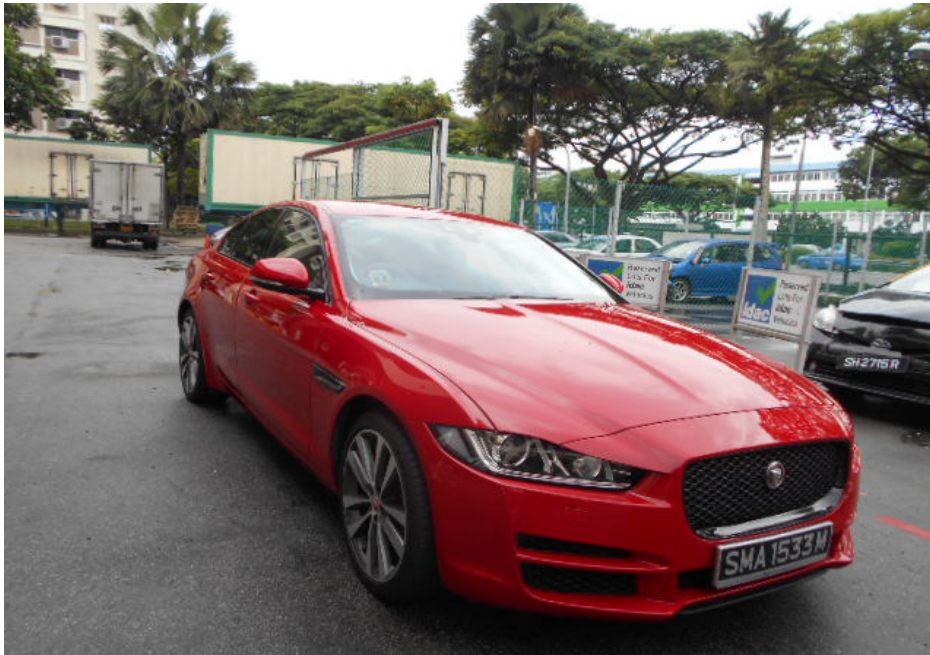
Photo 1 shows a general view of the front right body of the Motor Car at the time of my inspection on 06 June 2019. The Motor Car was observed to be in relatively good physical condition with no loose exterior fittings observed.

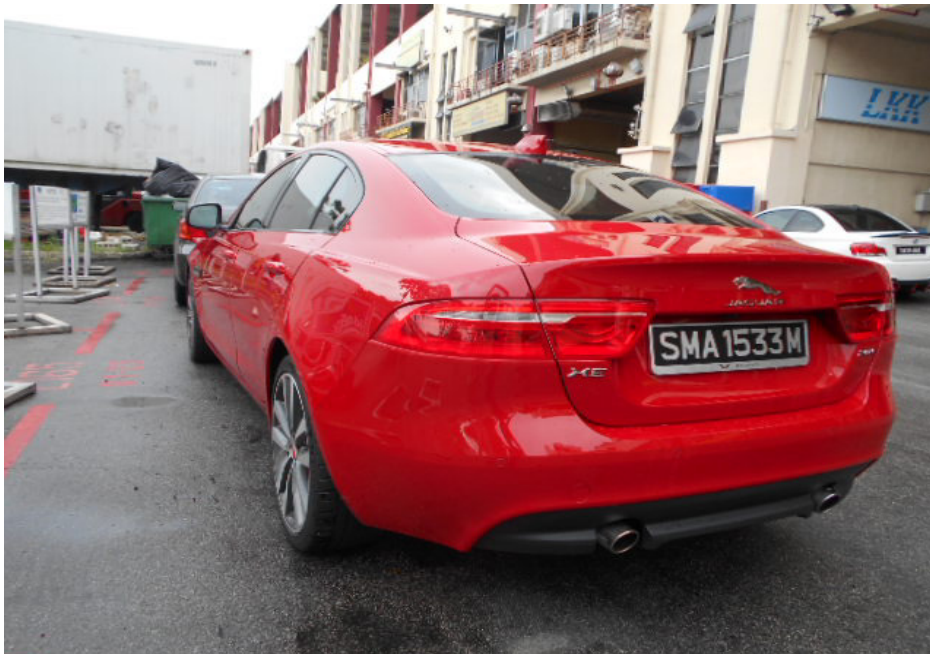
Photo 2 shows a general view of the rear left body of the Motor Car at the time of my inspection on 06 June 2019. The Motor Car was observed to be in relatively good physical condition with no loose exterior fittings observed. There was no modification(s) observed on the Motor Car. The size of the 4 tyres and wheel rims were observed to be of the allowable size range.

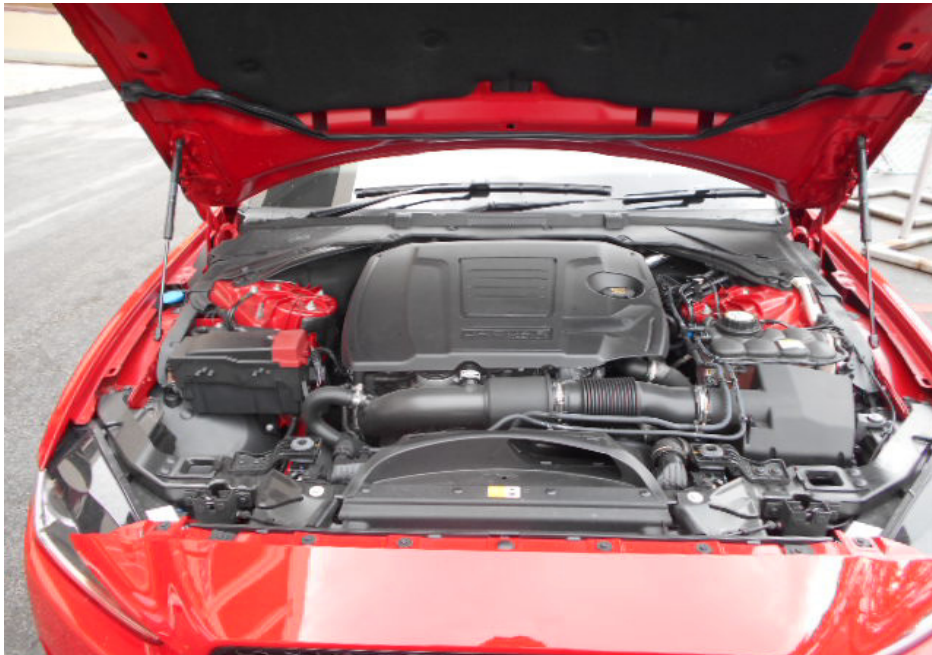
Photo 3 shows a general view of the engine compartment of the Motor Car at the time of my inspection on 06 June 2019. The various operating fluids like the engine oil, brake fluid and engine coolant were checked and found to be of sufficient level and without contamination for operating purposes. The various parts and components inside the engine compartment were all observed to be intact and properly fitted.

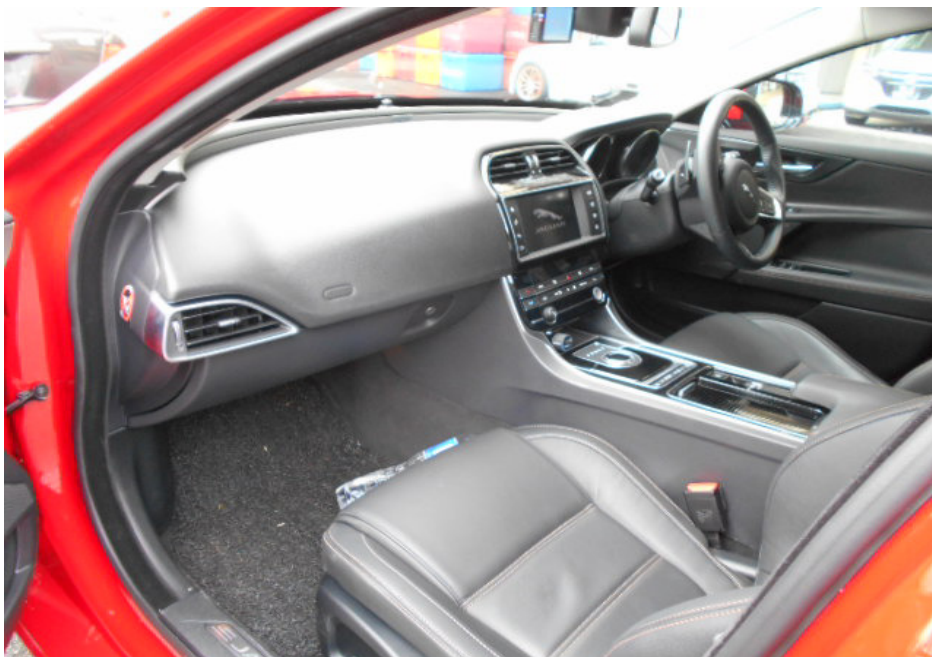
Photo 4 shows the interior compartment of the Motor Car. The mileage of the Motor Car recorded at the time of my inspection on 06 June 2019 was 7,315km.

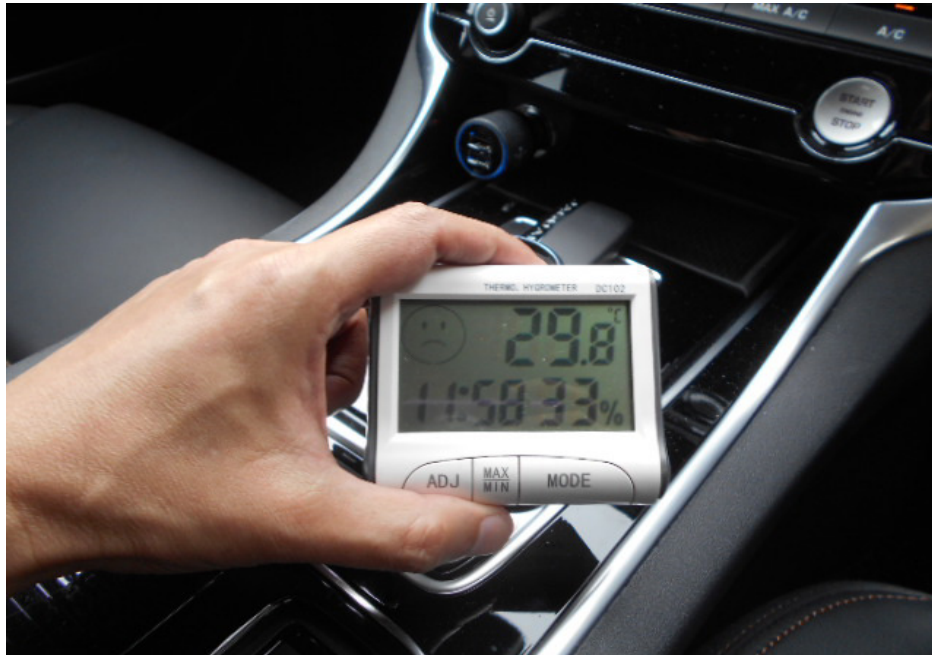
Photo 5 shows the digital temperature gauge that was used to verify the complaint of hot air being blown from the air-conditioning vents at the driver and front left passenger footwell area of the Motor Car during a test drive that was carried out on 06 June 2019.

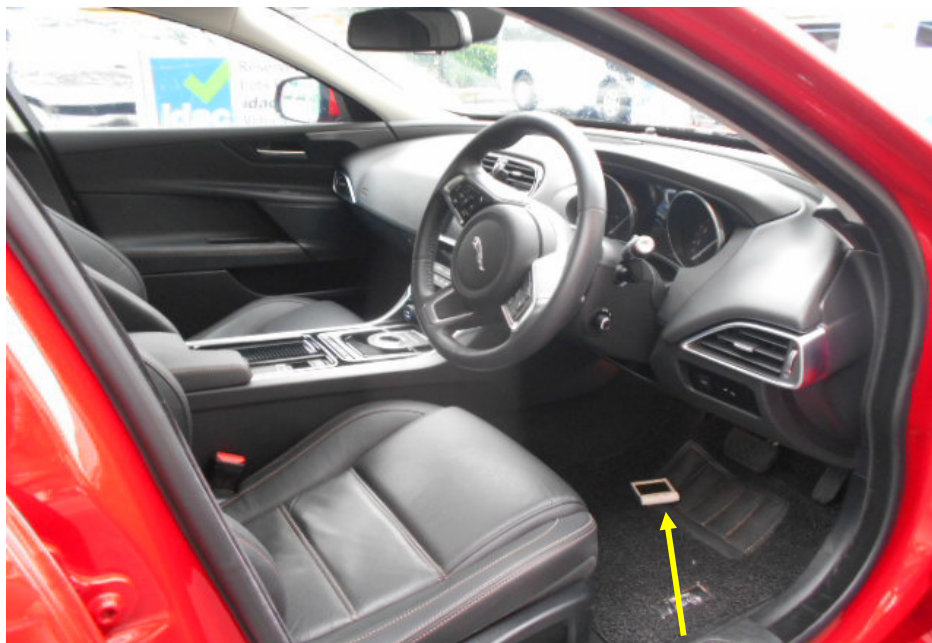
Photo 6 shows the digital temperature gauge placed at the driver footwell area of the Motor Car. Temperatures at the driver and front left passenger footwell areas were periodically checked during the test drive of the Motor Car. The temperature of the air-conditioning system of the Motor Car was set to the range of 20°C to 23°C, which is around the 22°C to 23°C temperature range that Mr Kung would usually set whilst driving the Motor Car.

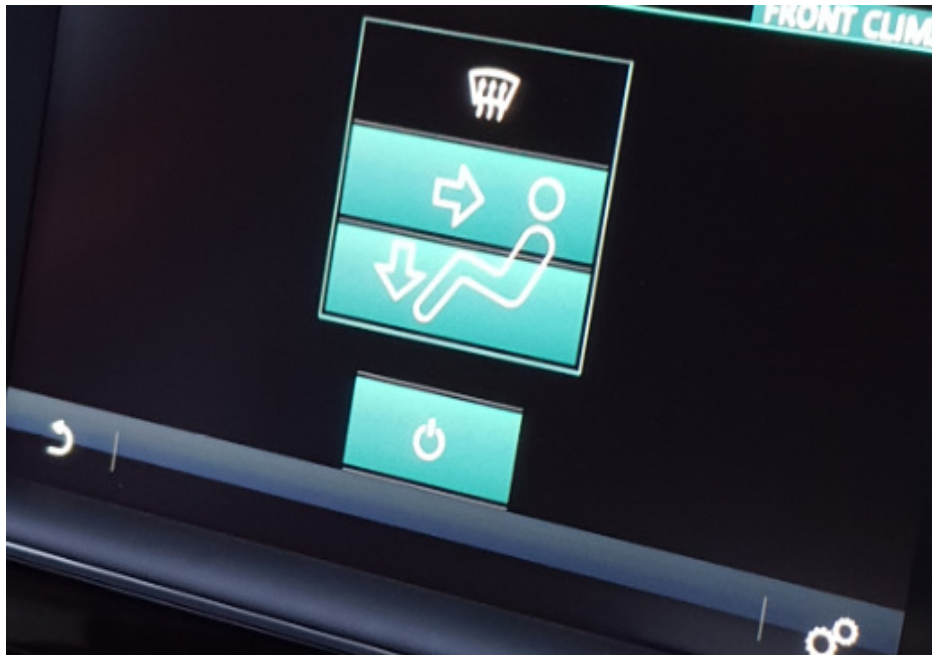
Photo 7 shows the default air-distribution settings, with both the upper (face distribution) and lower (body/feet distribution) areas selected during the test drive on 06 June 2019.

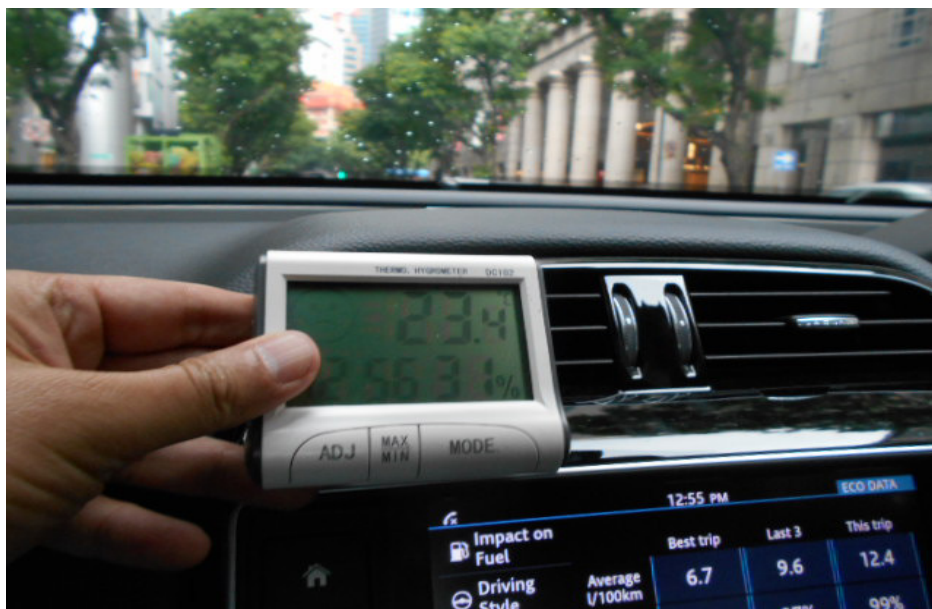
Photo 8 shows the digital temperature gauge placed near the front of the upper air-conditioning vents at the centre of the front dashboard. This was to check on the accuracy of the temperature displayed by the gauge. At the 22°C temperature that was set for the Motor Car's air-conditioning system, the temperature displayed by the gauge was 23.4°C. This would indicate that the temperature gauge was in a normal working condition and that temperatures displayed by the temperature gauge are relatively accurate.

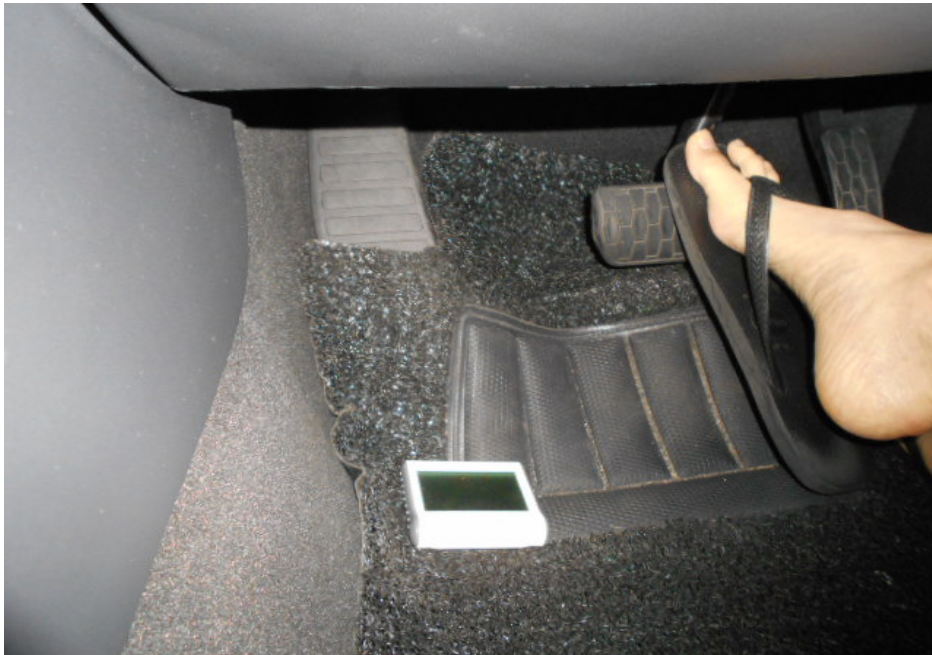
Photo 9 shows the digital temperature gauge placed near the air-conditioning vent at the driver footwell area of the Motor Car during the test drive. The temperature displayed by the temperature gauge was periodically checked and it was observed that the temperature at the driver footwell area throughout the test drive was in the above 30°C range.

23. Throughout the entire test drive, the digital temperature gauge had constantly displayed temperatures that were above 30°C range at both the driver and front left passenger footwell areas of the Motor Car. Generally, the temperatures at both footwell areas were $\pm 10^\circ\text{C}$ above the 20°C to 23°C temperature range that was set for the air-conditioning system of the Motor Car. Such significant difference in temperature cannot be considered to be normal given that the air-conditioning system was operating within a small confined space i.e. interior compartment of the Motor Car.

24. Whilst it is normal to expect some slight difference in temperature between the temperature set for an air-conditioning system and the actual temperature of the air that is being blown out from the air-conditioning vents (due to weather condition, heat from engine etc), the observations gathered from the temperature displayed by the digital temperature gauge indicates that hot air instead of cool air was being blown out from the air-conditioning vents at the driver and front left passenger footwell areas of the Motor Car.

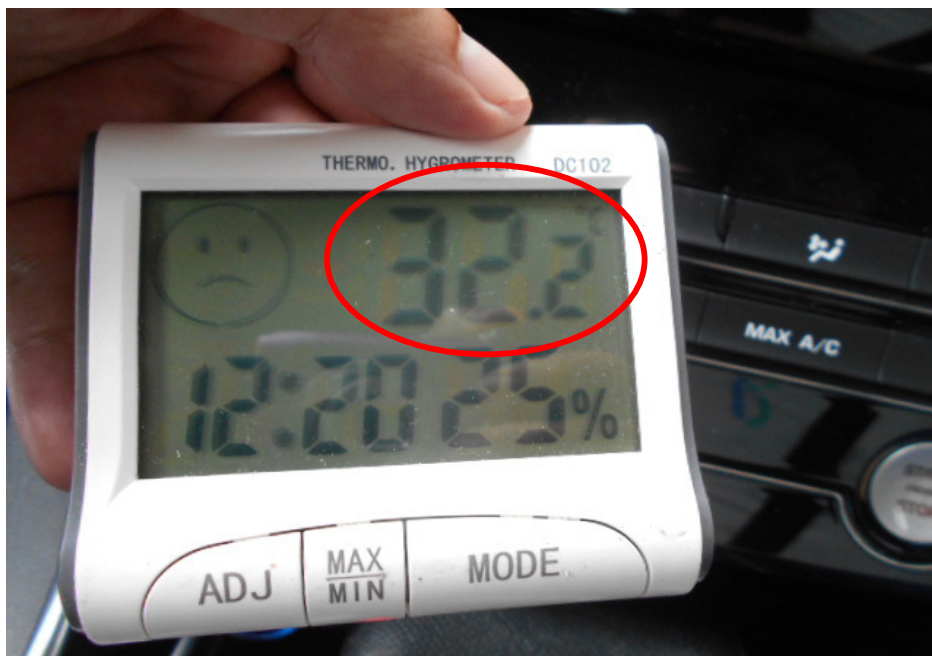
Photo 10 shows the temperature (circled) displayed by the temperature gauge at the driver footwell area. Generally, it was observed that although the Motor Car's air-conditioning system was in the range of 20°C to 23°C, the temperature at the driver footwell area was in the above 30°C range throughout my test drive of the Motor Car.

27. To summarize, my observations during the test drive of the Motor Car and my review of Mr Kung's own testing of the Motor Car and 2 loaned motor cars indicates that the air-conditioning system of the Motor Car was blowing hot air instead of cool air at the air-conditioning vents at the driver and front left passenger footwell area of the Motor Car; and this cannot be considered to be a normal operating characteristic for an air-conditioning system.

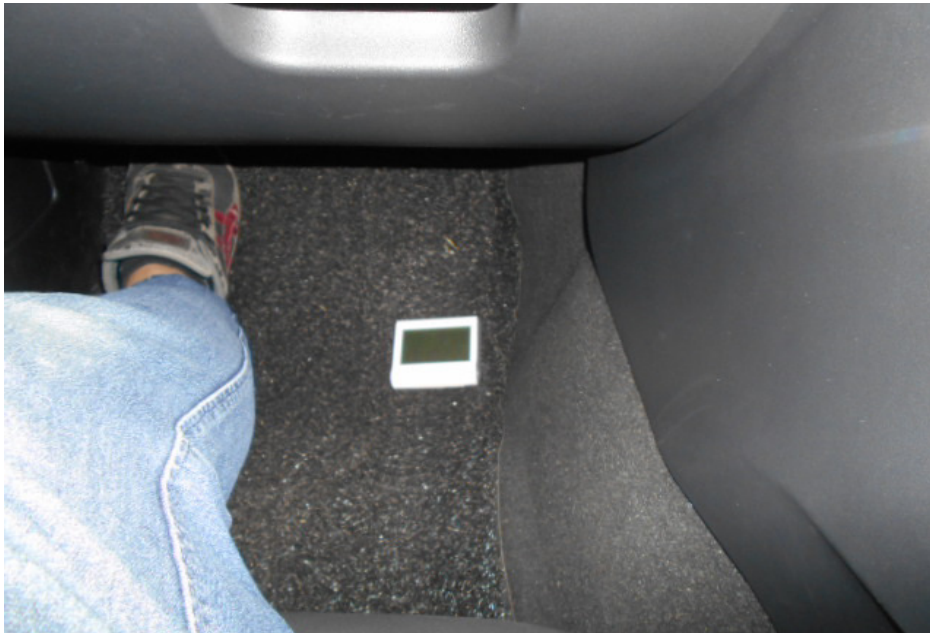
Photo 11 shows the digital temperature gauge placed near the air-conditioning vent at the front left passenger footwell area of the Motor Car during the test drive. The temperature displayed by the temperature gauge was periodically checked and it was observed that the temperature at the front left passenger footwell area was in the above 30°C range, similar to the temperature at the driver footwell area of the Motor Car.

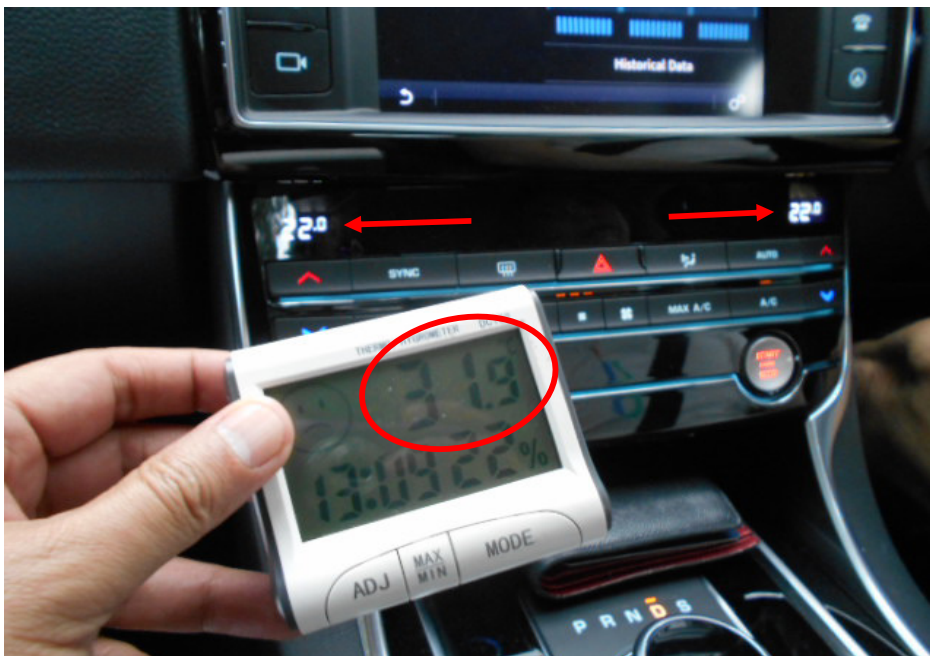
Photo 12 shows the temperature (circled) displayed by the temperature gauge at the front left passenger footwell area. Generally, it was observed that the temperature at the driver footwell area was in the above 30°C range during my test drive of the Motor Car. The temperature of the Motor Car's air-conditioning system can be seen to be at 22°C (arrowed).

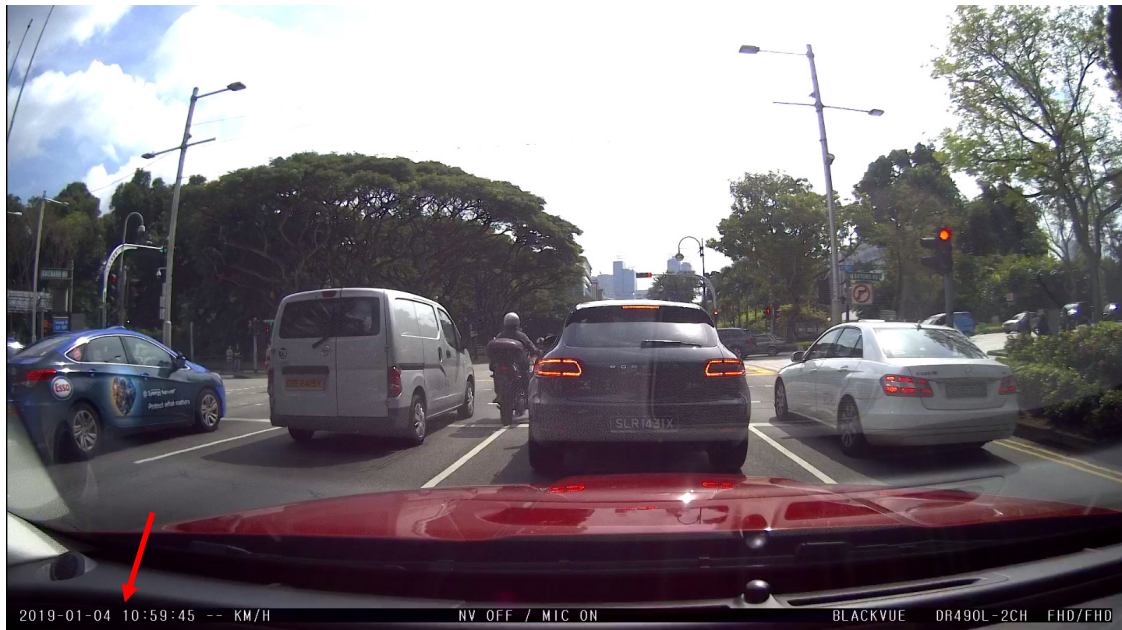
30. However, if one was to view the video recordings provided by Mr Kung, it can be noted that beeping sounds from the triggering of the front proximity sensors of the Motor Car were heard largely after the Motor Car came to a stop due to red traffic light. On some occasions, the beeping sounds were even heard after the Motor Car had stopped for a few seconds with no positioning change of the Motor Car and/or other immediate surrounding motor vehicles or objects.

31. From the video recordings, distances between the front of the Motor Car and the rear of the motor vehicle(s) in front were not close (entire rear portion of the motor vehicle(s) in front could be seen). Other motor vehicles in the immediate left and/or right lane were also within their respective lanes. In summary, the front proximity sensors of the Motor Car had triggered when there did not seem to be reasonable cause(s) for them to be triggered. Triggering of the front proximity sensors under such situation does not represent a normal operating characteristic for front proximity sensors of a motor vehicle. See photo 13 & 14 below, extracted from one of the video recordings and photographs that were provided by Mr Kung.

Photo 13 shows a screenshot extracted from one of the video recordings that were provided by Mr Kung for my review. At this time stamp of 10:59:45 on 04 January 2019 (arrowed), the front proximity sensors of the Motor Car were triggered. Beeping sounds can be heard from the video recording however from what can be seen, there was no object(s) close to the front of the Motor Car. The 3 motor vehicles ahead of the Motor Car were not close to the front of the Motor Car (entire rear portion of the 3 motor vehicles can be seen).

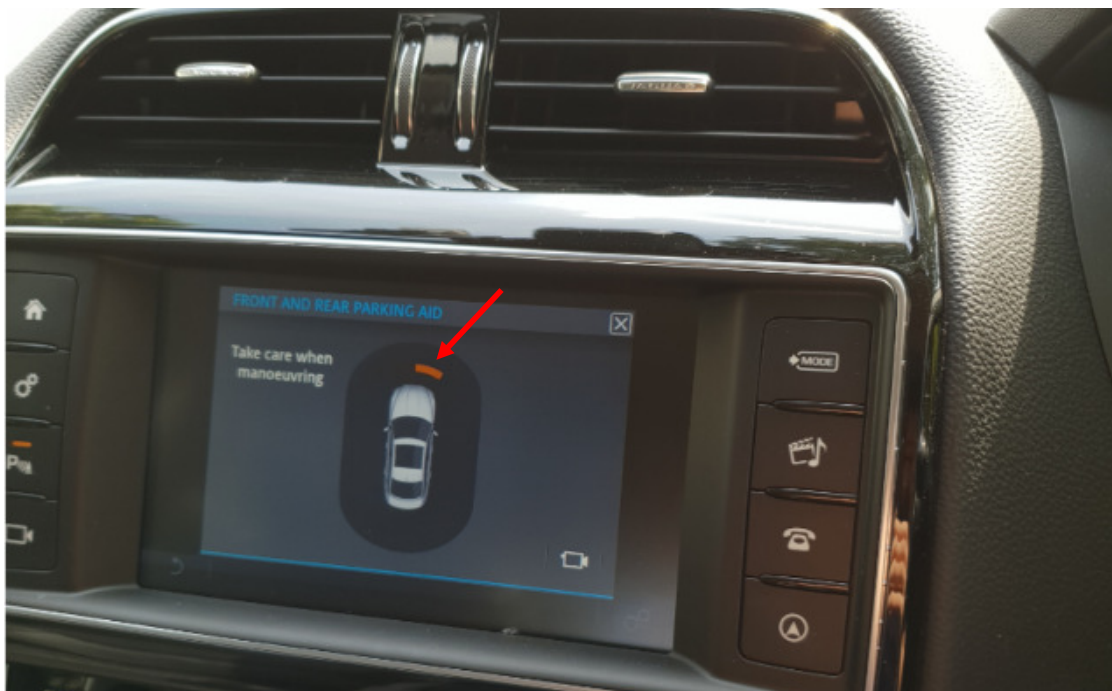
Photo 14 shows the infotainment screen of the Motor Car at the time when the front proximity sensors of the Motor Car was triggered as per photograph 13 above. The indication (arrowed) of the illustration shows an object(s) that is close to the front right of the Motor Car. However as seen from photograph 13 above, there was no object(s) close to the front right of the Motor Car.

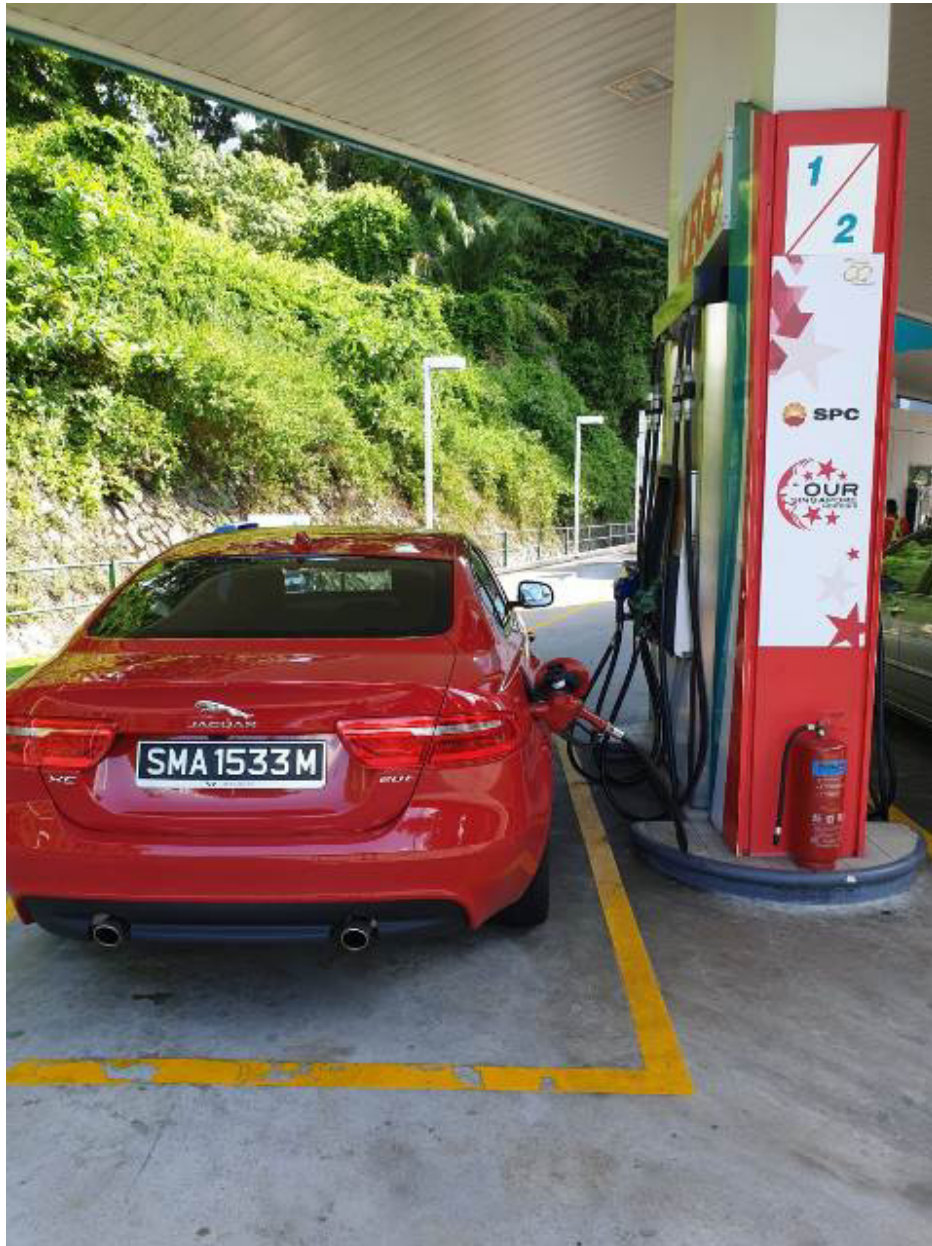
Photo 15 shows the Motor Car during the fill up at a SPC petrol station along Havelock Road on 13 July 2019. This was at the start of my fuel consumption test of the Motor Car. The fill up (to full tank) was up to the first click of the pump. Fuel consumption testing with a full tank of petrol would yield measurements that are more accurate as compared to testing done by driving for a short specific distance where such short specific distance method does not utilize a full tank of petrol.

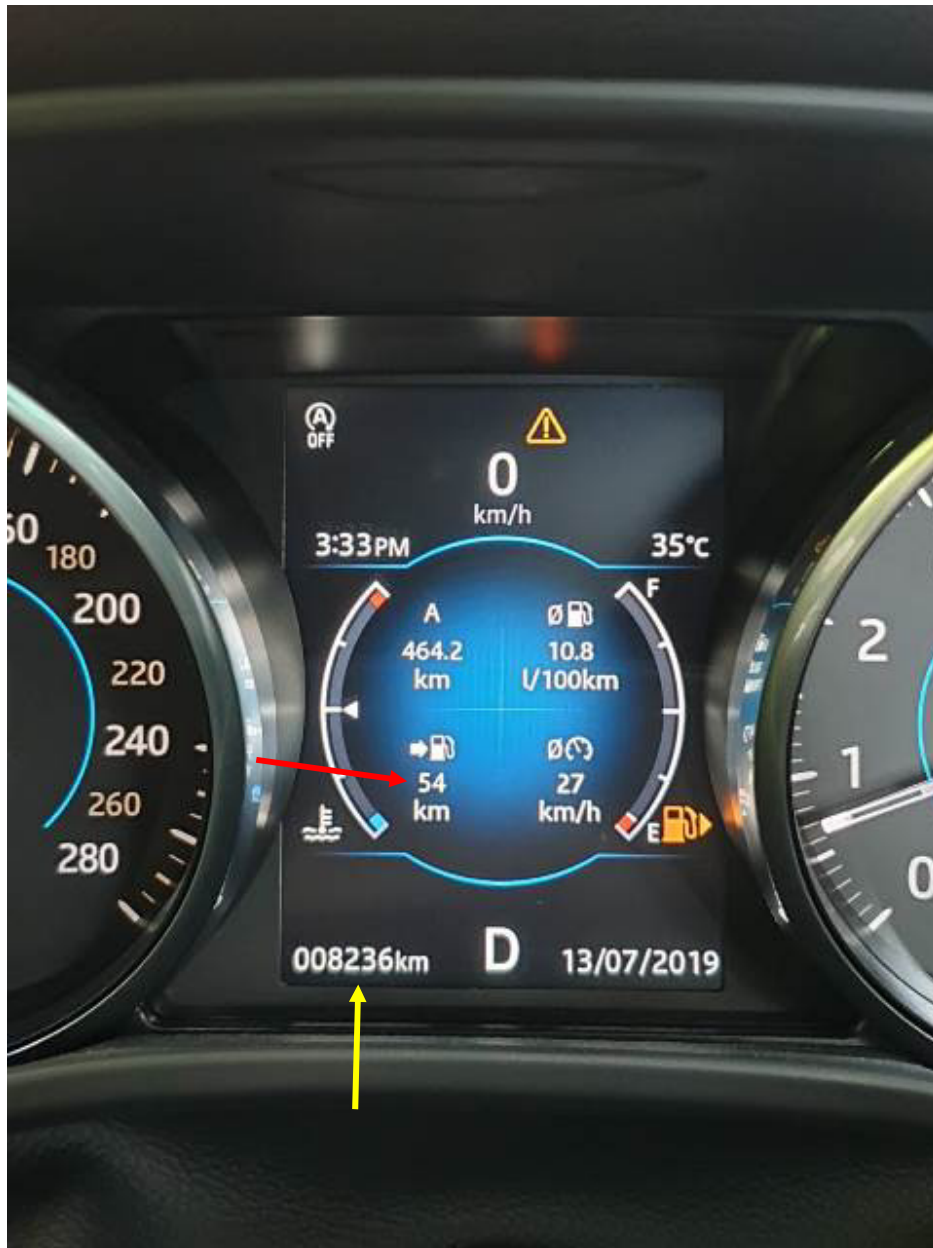
Photo 16 shows the dashboard panel of the Motor Car prior to the fill up on 13 July 2019. The distance to empty tank, as seen from the dashboard panel prior to the fill up, was 54km (red arrow) while the mileage of the Motor Car was at 8,236km (yellow arrow).

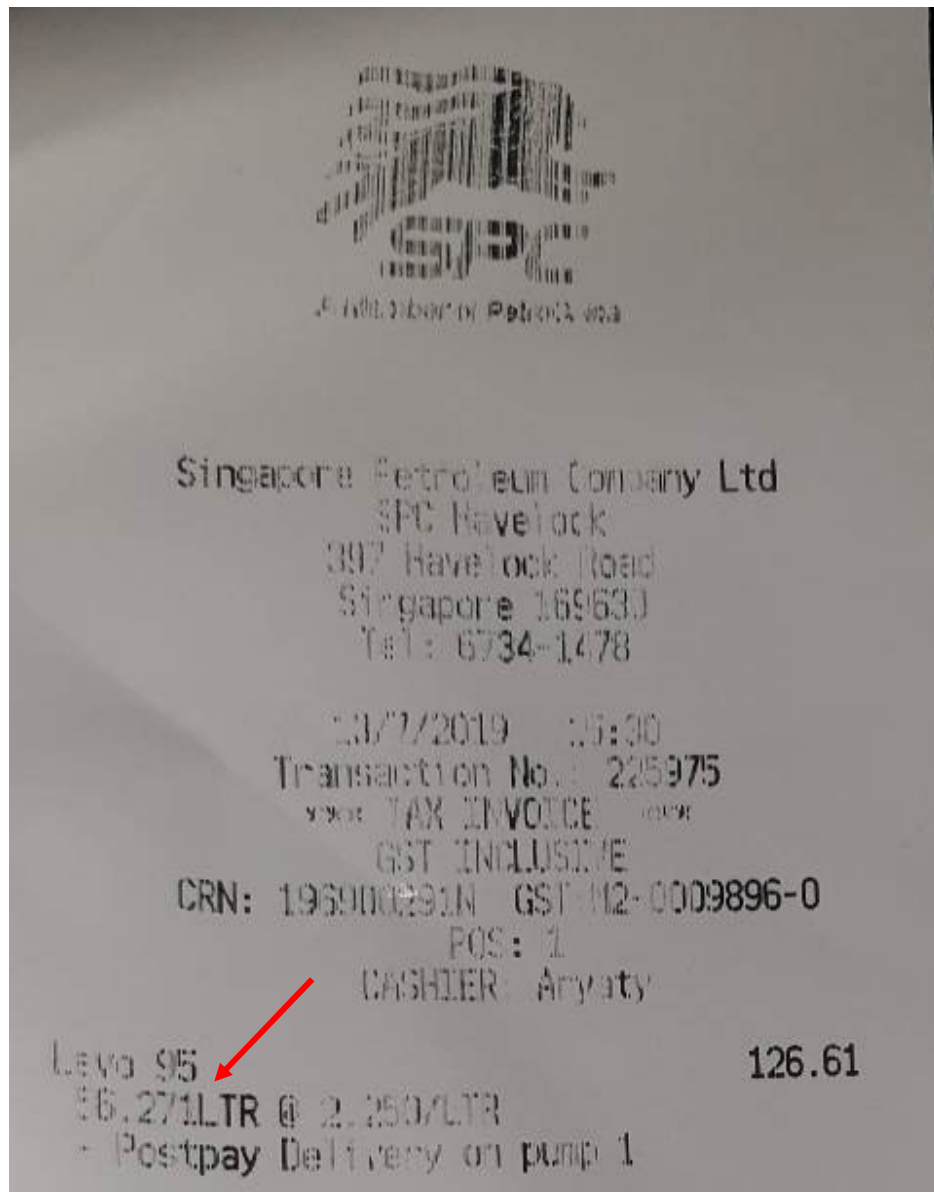
Photo 17 shows the receipt for the fill up on 13 July 2019. The petrol of the Motor Car was filled up to the first click of the pump. From the receipt provided, 56.271 litres (arrowed) of petrol was used for this fill up.

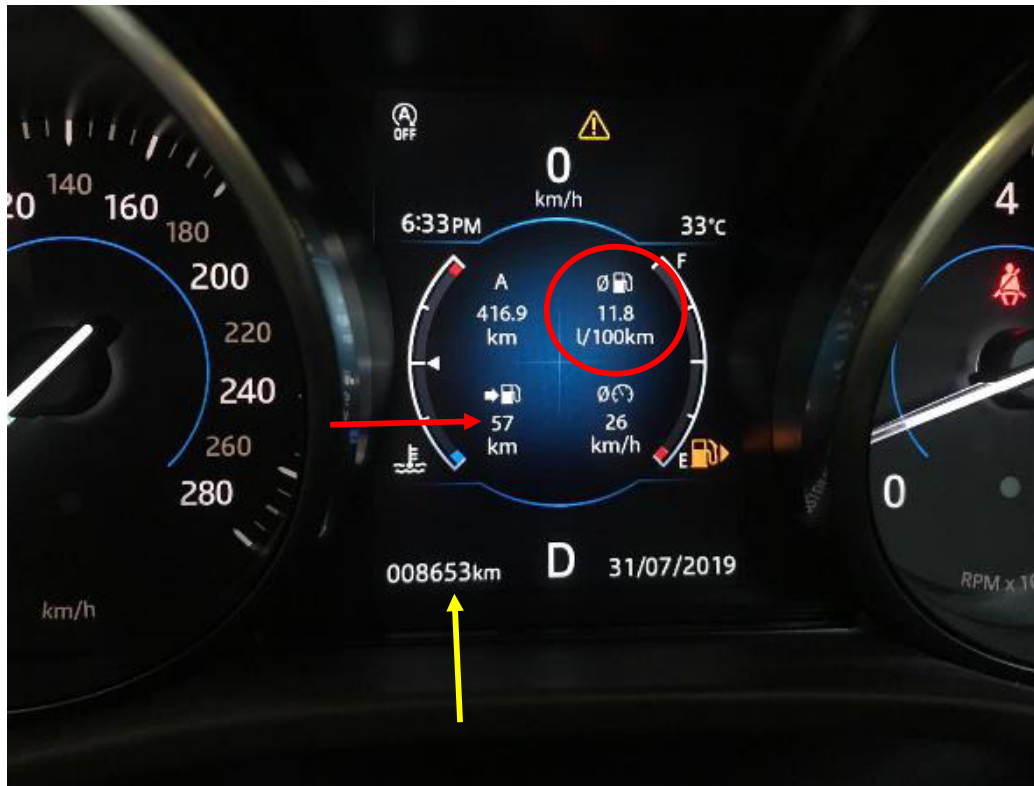
Photo 19 shows the dashboard panel of the Motor Car prior to the fill up on 31 July 2019. The distance to empty tank, as seen from the dashboard panel prior to the fill up, was 57km (red arrow), close to the 54km before the test. The mileage of the Motor Car was at 8,653km (yellow arrow). The fuel consumption displayed on the dashboard panel was 11.8 litres per 100km (circled).

36. I note in page 57 of the Jaguar XE sales brochure that the combined fuel consumption stated is 6.3 litres per 100km for the same engine specifications as the Motor Car whereas my fuel consumption test carried out by driving the Motor Car in a real-world scenario produced 13.5 litres per 100km. This represents about 114% more than the stated 6.3 litres per 100km in the sales brochure. The fuel consumption of the Motor Car displayed on the dashboard panel after my fuel consumption test was 11.8 litres per 100km, which is about 87% more than the stated 6.3 litres per 100km.

37. Whilst it is normal to expect that actual fuel consumption of a motor vehicle will exceed the fuel consumption stated in a sales brochure and/or owner's manual, given that fuel consumption tests carried out by vehicle manufacturers do not typically involve real world testing and instead are mostly carried out in laboratories; to exceed by 87% from computerized monitoring/calculation (dashboard panel) and over 100% from actual driving cannot be considered to be a reasonable difference.
