Your Ref: Honda Engine
(number B16A5421769)
Our Ref : CI/TP19020900/D

23 November 2019

INSPECTION REPORT OF A HONDA ENGINE WITH NUMBER B16A5421769

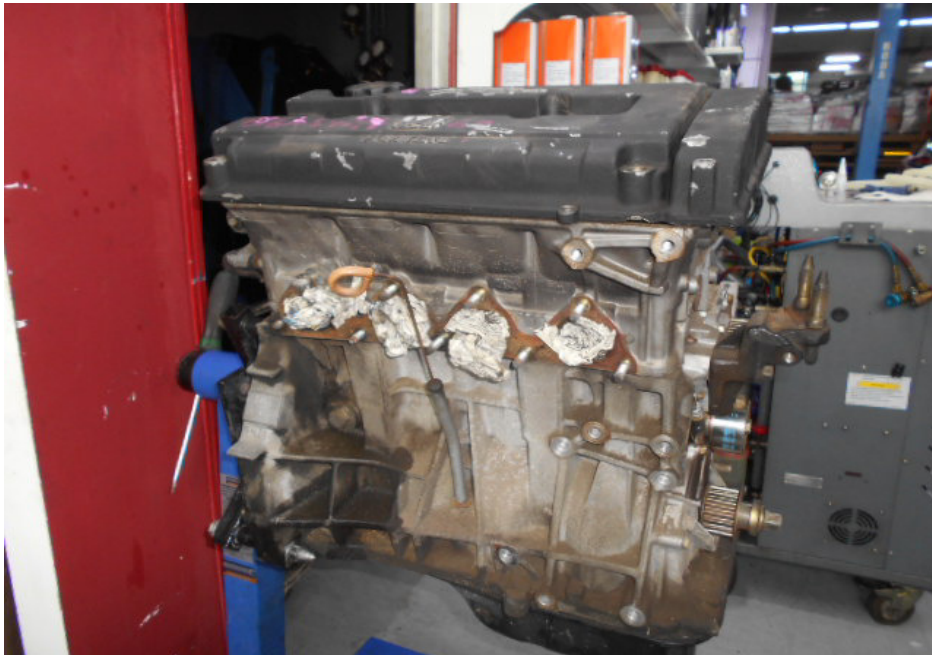
Photo 1 shows a general view of the Honda engine that I had inspected. The Honda engine was observed to be a used engine and was not fitted on any motor car. My visual examination of the engine housing revealed the housing to be of serviceable/satisfactory condition. There was no crack and/or hole observed on the engine housing.

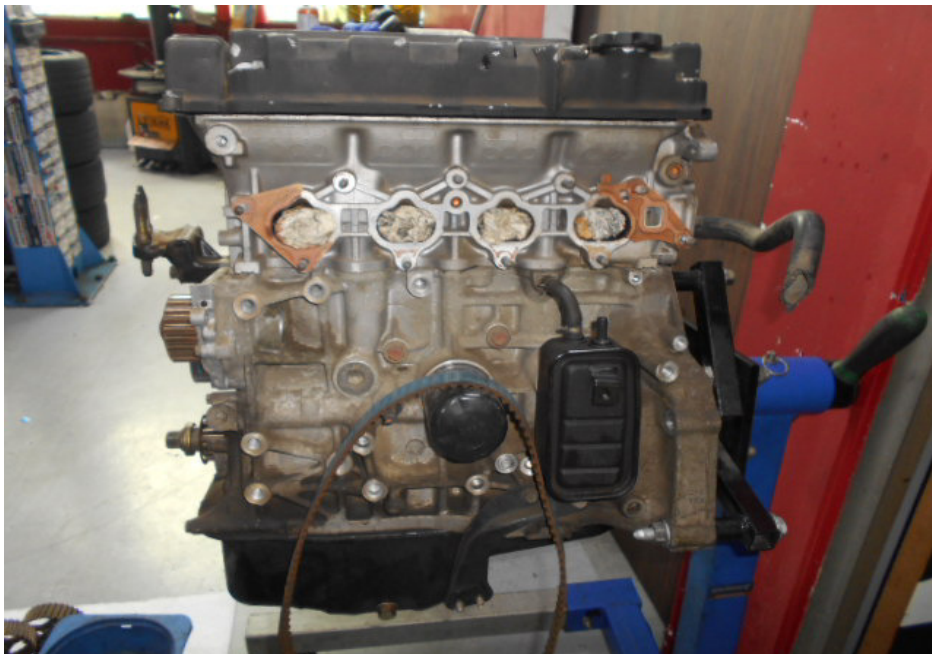
Photo 2 shows a general view of the Honda engine that I had inspected. My visual examination of the engine housing revealed the housing to be of serviceable/satisfactory condition. There was no crack and/or hole observed on the engine housing.

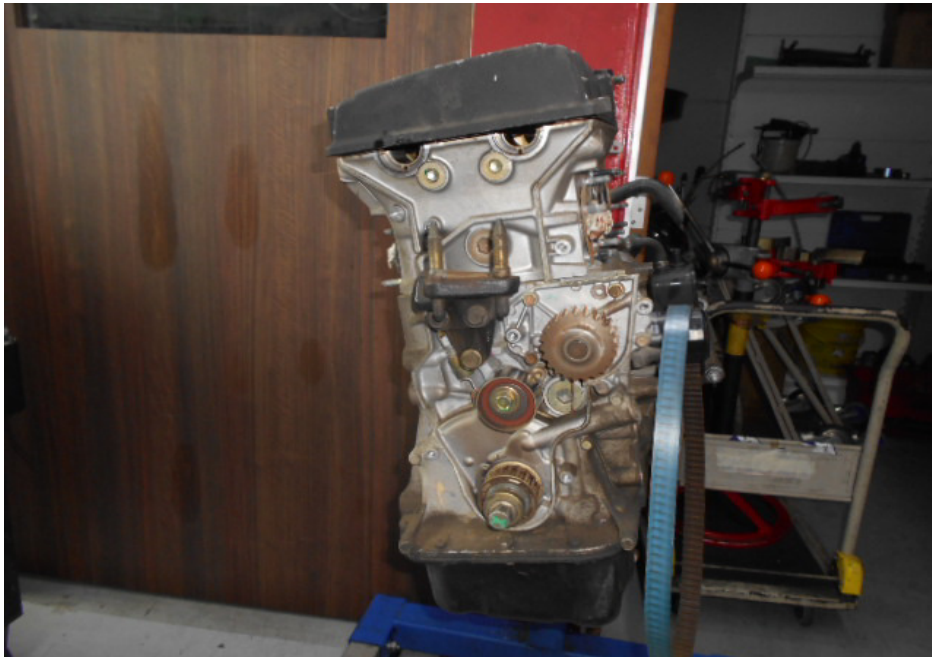
Photo 3 shows a general view of the Honda engine that I had inspected. My visual examination of the engine housing revealed the housing to be of serviceable/satisfactory condition. There was no crack and/or hole observed on the engine housing.

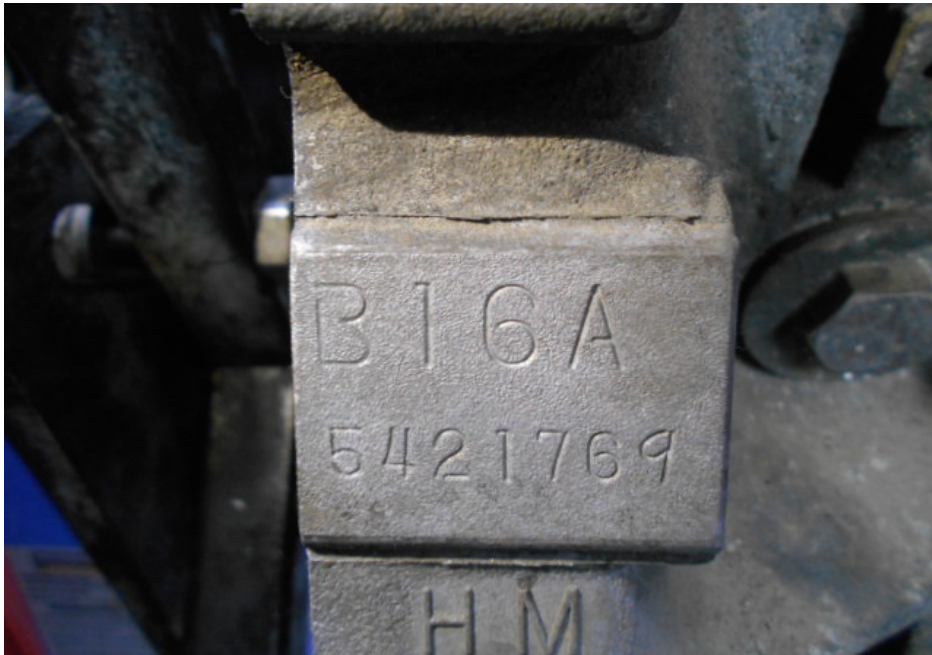
Photo 4 shows the engine number engraved on the housing of the Honda engine that I had inspected. The engine number was B16A5421769.

13. In summary, the Honda engine that I had inspected is a Honda B16A model engine. The engine number engraved on the housing of this Honda engine was B16A5421769.

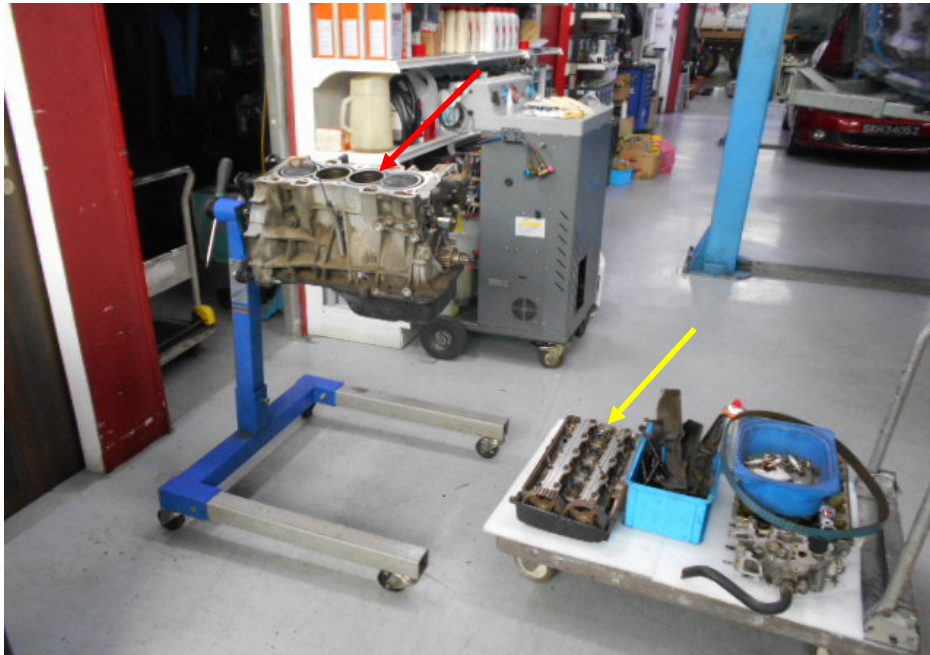
Photo 5 shows the top block (yellow arrow) of the Honda engine separated from its bottom block (red arrow). This was to enable me to carry out measurements of its cylinders, in particular the bore and stroke measurements of each cylinder, which typically can be used to determine the engine displacement or more commonly referred to as engine cc.

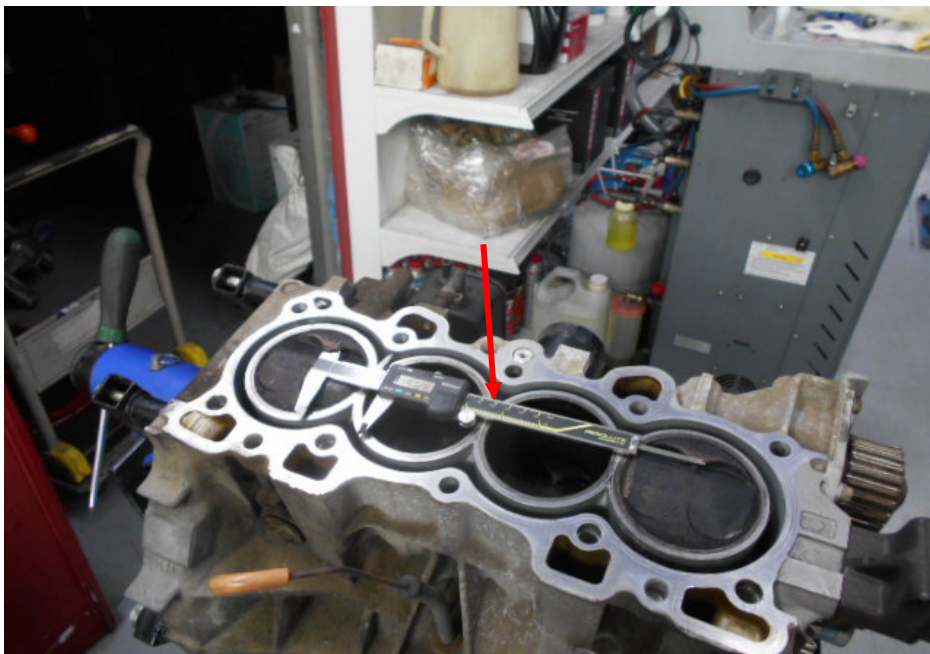
Photo 6 shows the bottom block of the Honda engine and the digital Vernier Caliper (arrowed) that was used to measure the bore and stroke measurements of each cylinder, which typically can be used to determine the engine displacement or more commonly referred to as engine cc. The digital Vernier Caliper was calibrated before the start of the measurements.

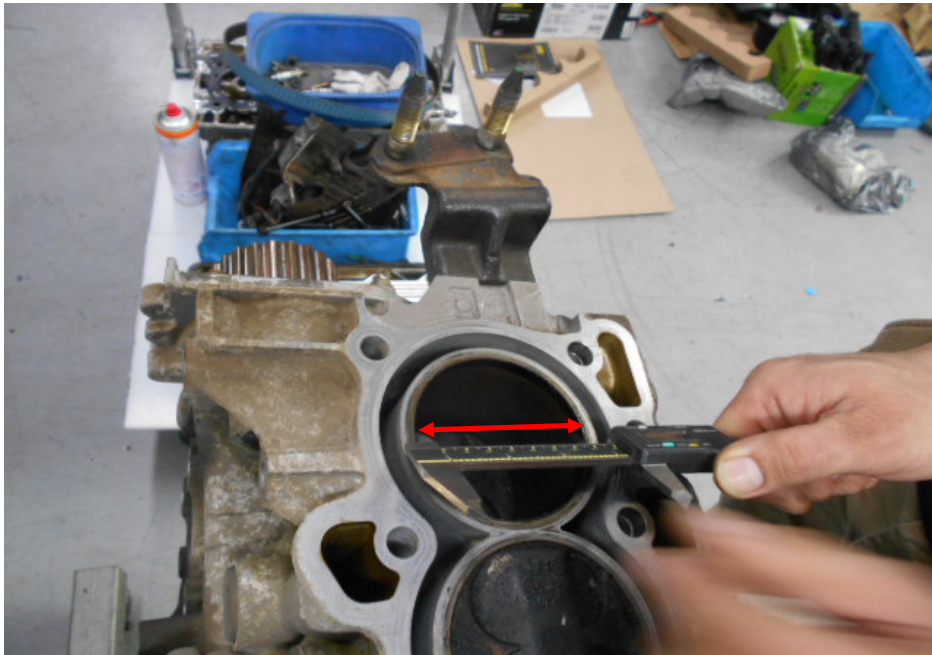
Photo 7 shows measurement being carried out to the bore (arrowed) of cylinder 1 of the Honda engine. The bore measurement of cylinder 1 was recorded to be 80.45mm.

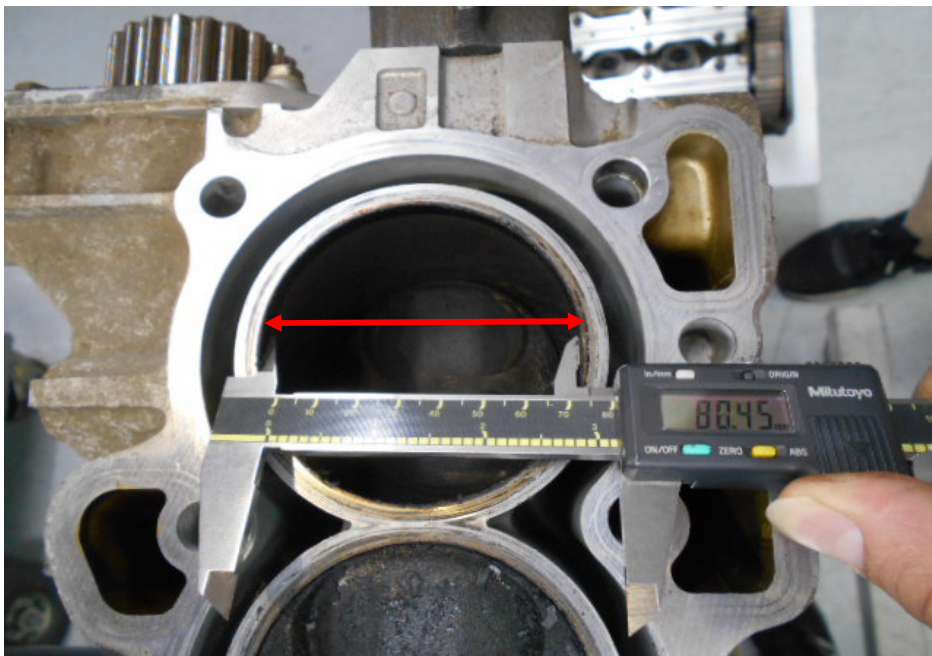
Photo 8 shows the bore measurement (arrowed) of cylinder 1, which was recorded to be 80.45mm.

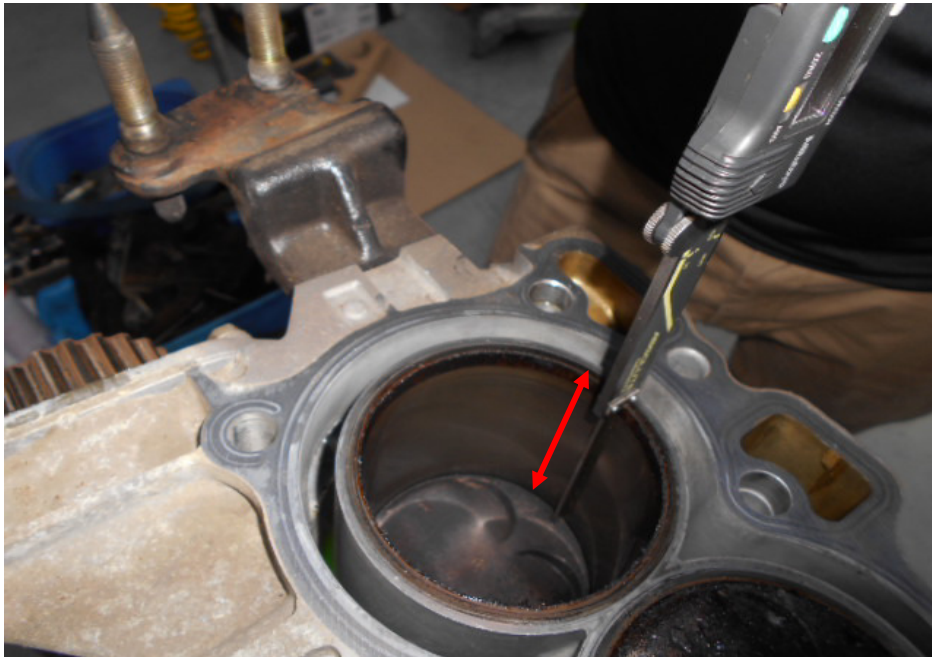
Photo 9 shows measurement being carried out to the stroke (arrowed) of cylinder 1 of the Honda engine. The bore and stroke measurements of the Honda engine were carried out using a digital Vernier Caliper that was calibrated before the start of the measurements.

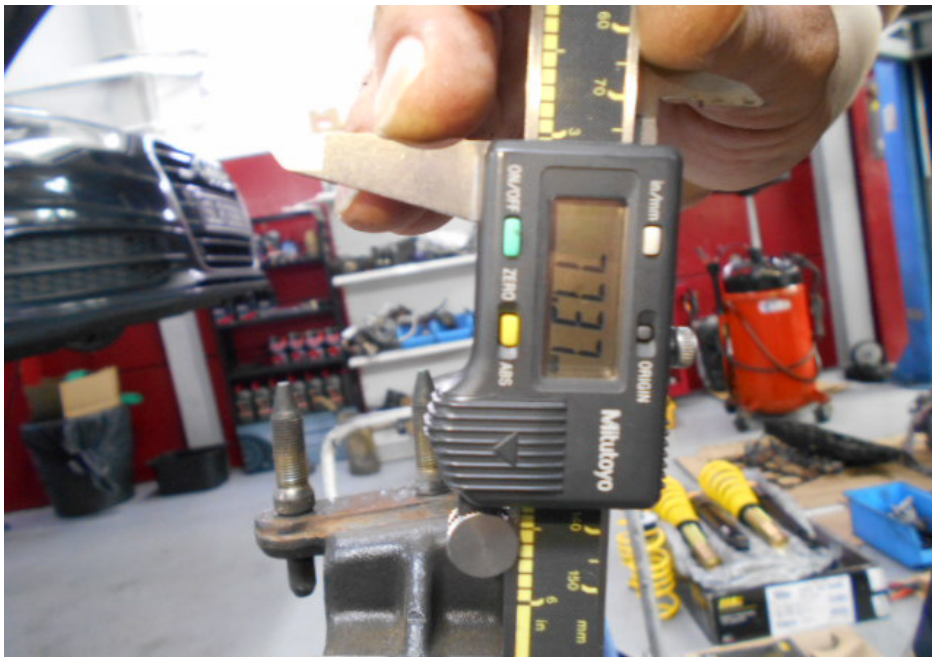
Photo 10 shows the stroke measurement of cylinder 1, which was recorded to be 77.37mm.

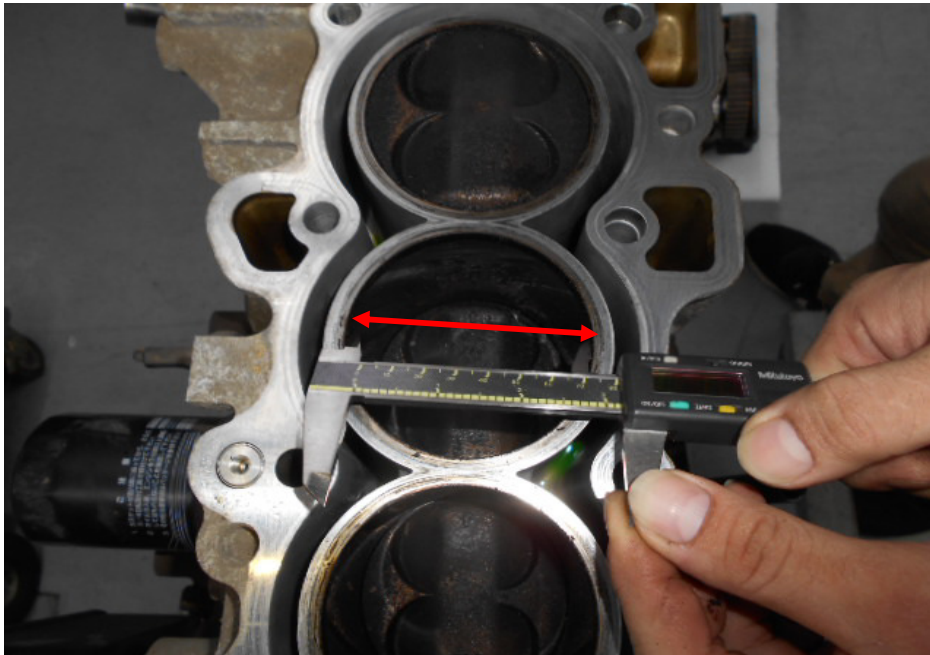
Photo 11 shows measurement being carried out to the bore (arrowed) of cylinder 2 of the Honda engine. The bore measurement of cylinder 2 was recorded to be 80.37mm.

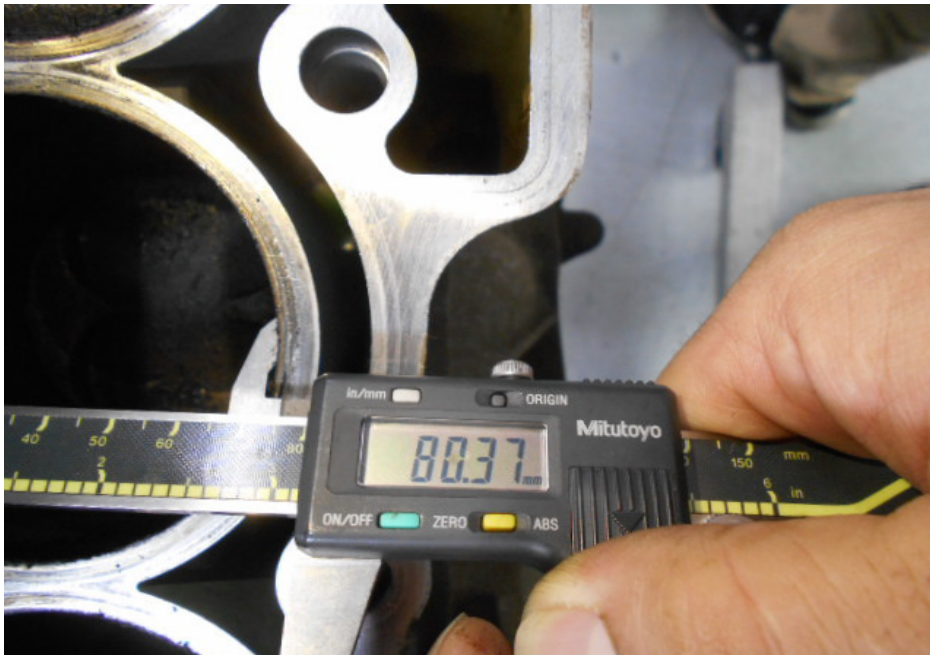
Photo 12 shows the bore measurement of cylinder 2, which was recorded to be 80.37mm.

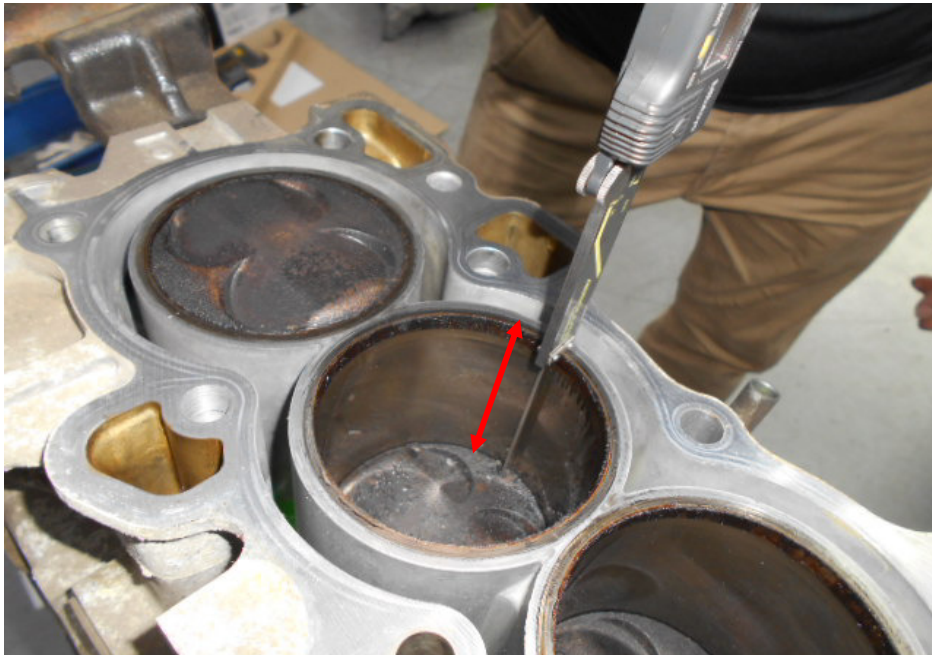
Photo 13 shows measurement of the stroke (arrowed) of cylinder 2 of the Honda engine that I had inspected. The bore and stroke measurements of the Honda engine were carried out using a digital Vernier Caliper that was calibrated before the start of measurements.

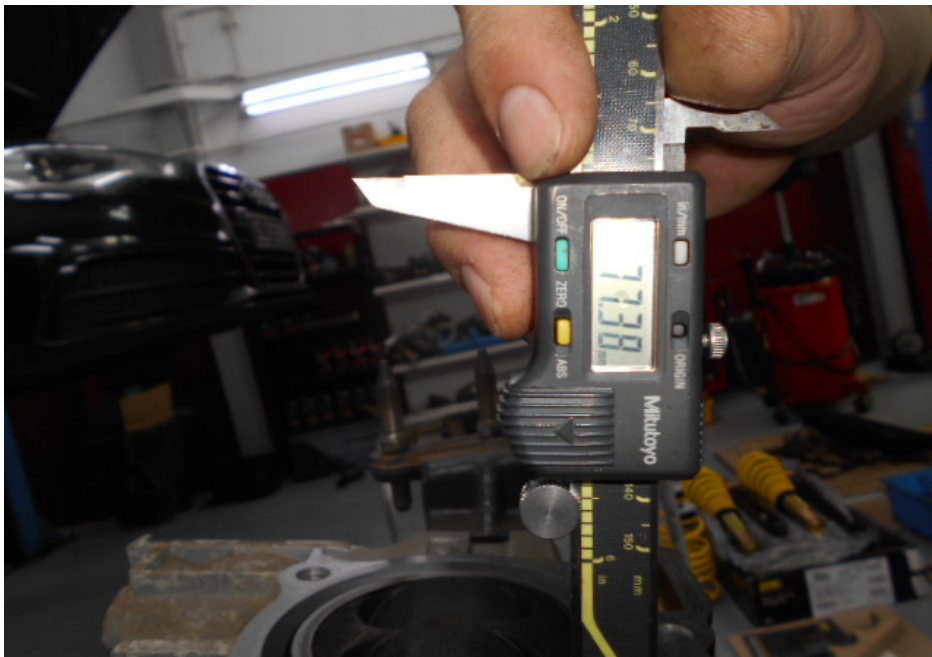
Photo 14 shows the stroke measurement of cylinder 2, which was recorded to be 77.38mm.

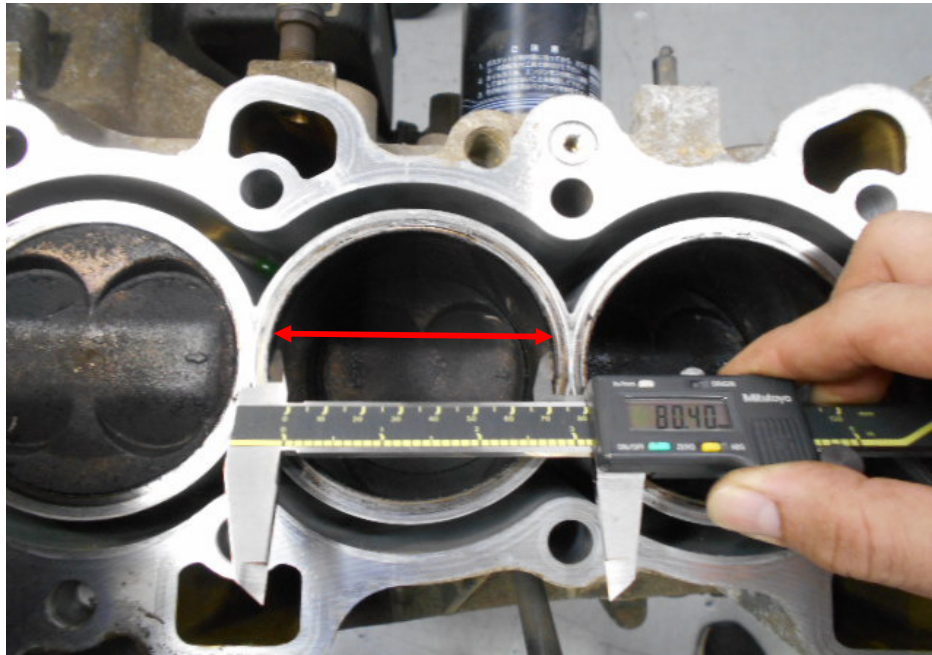
Photo 15 shows measurement being carried out to the bore (arrowed) of cylinder 3 of the Honda engine. The bore and stroke measurements of the Honda engine were carried out using a digital Vernier Caliper that was calibrated before the start of measurements. The bore measurement of cylinder 3, which was recorded to be 80.40mm.

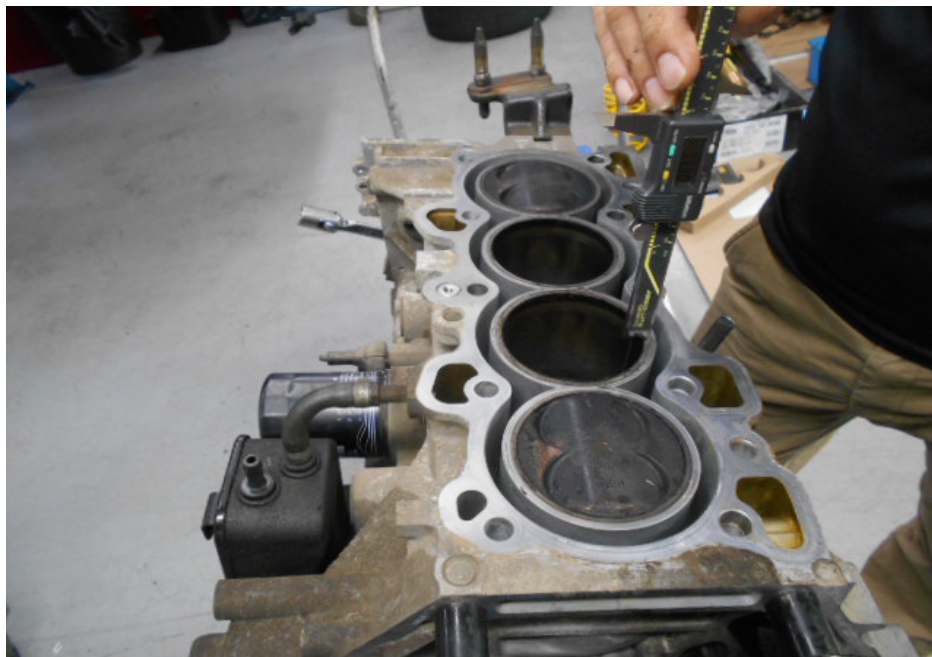
Photo 16 shows measurement of the stroke (arrowed) of cylinder 3 of the Honda engine that I had inspected. The stroke measurement of cylinder 3, which was recorded to be 77.29mm.

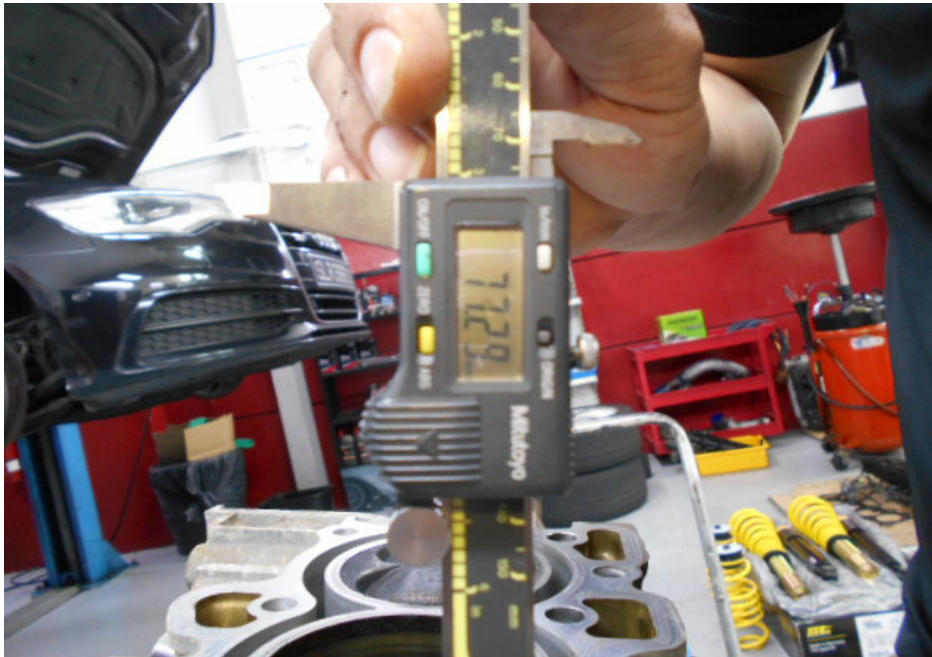
Photo 17 shows the stroke measurement of cylinder 3, which was recorded to be 77.29mm.

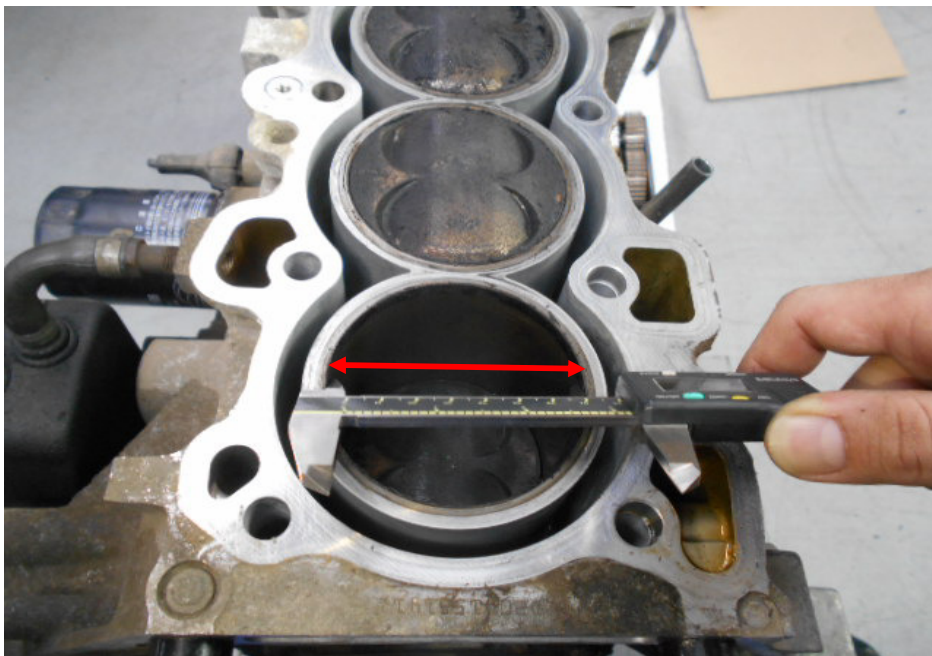
Photo 18 shows measurement being carried out to the bore (arrowed) of cylinder 4 of the Honda engine. The bore and stroke measurements of the Honda engine were carried out using a digital Vernier Caliper. The bore measurement of cylinder 4 was recorded to be 80.58mm.

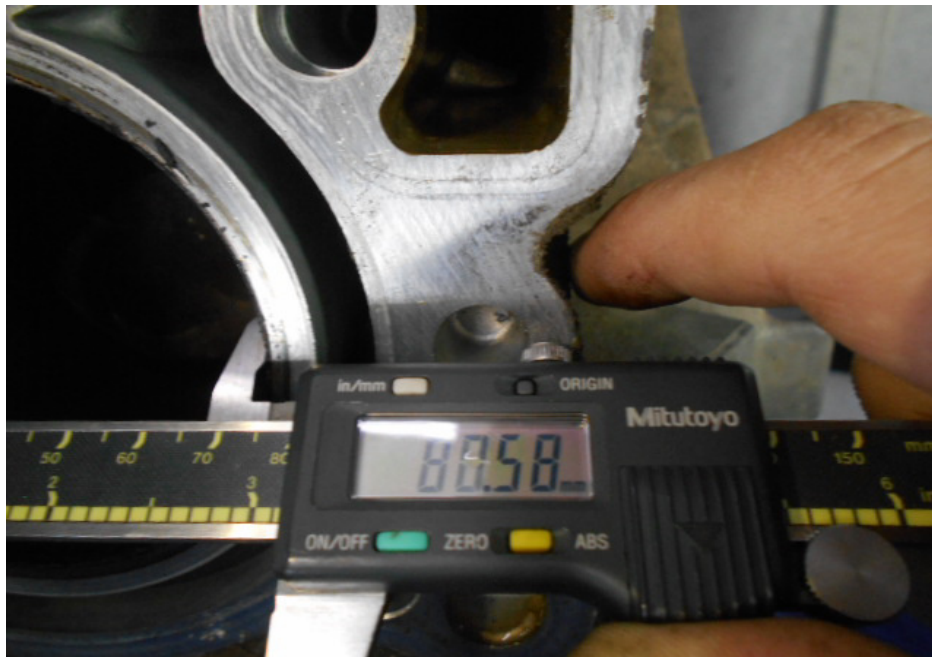
Photo 19 shows the bore measurement of cylinder 4, which was recorded to be 80.58mm.

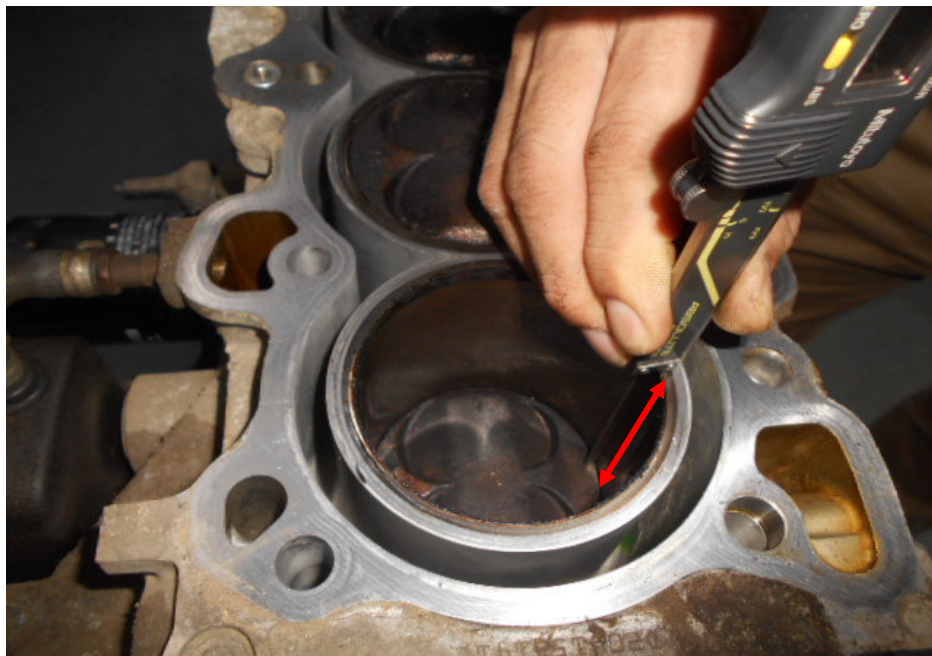
Photo 20 shows measurement being carried out to the stroke (arrowed) of cylinder 4 of the Honda engine. The bore and stroke measurements of the Honda engine were carried out using a digital Vernier Caliper that was calibrated before the start of measurements.

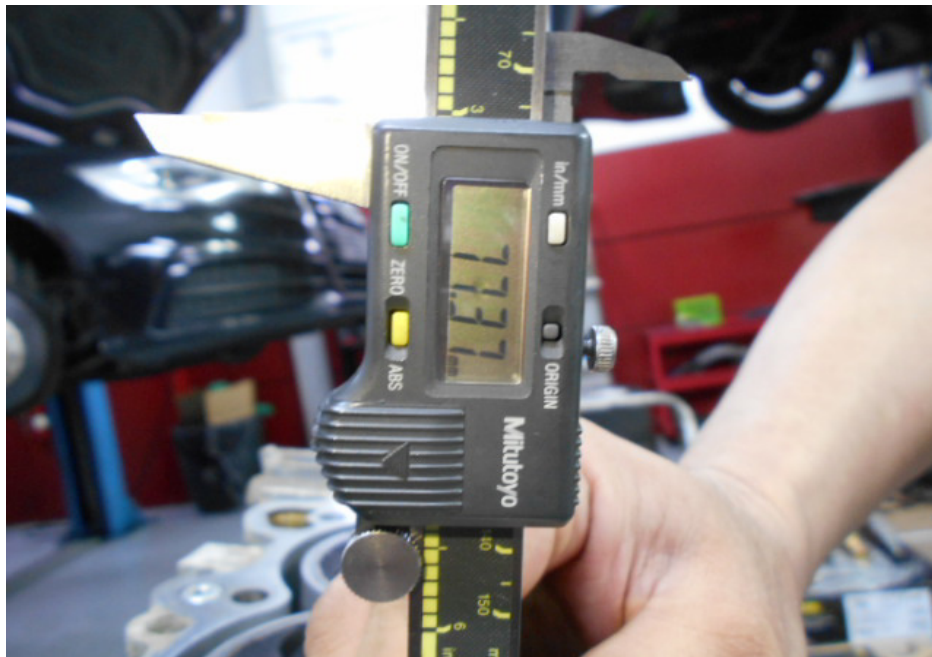
Photo 21 shows the stroke measurement of cylinder 4, which was recorded to be 77.37mm.
