## ASSIGNMENT (Office)

QX 793S

Hyundai Avante c.c 1591

**Subject:** Appraisal Services for SPF vehicle at INDECO - QX793S

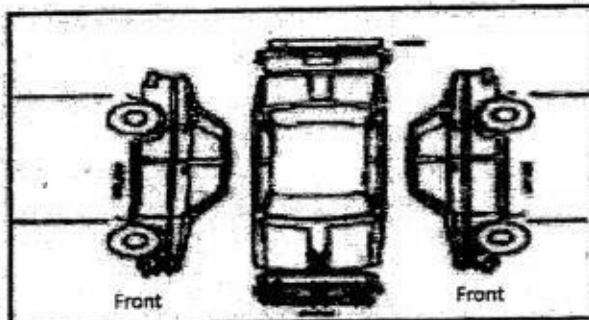
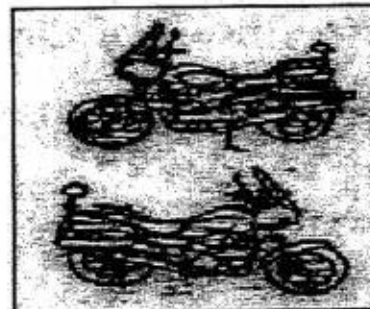
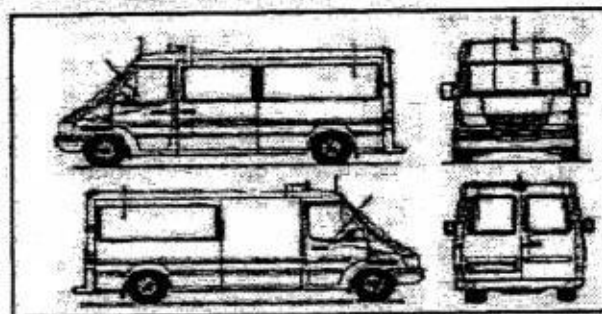
**Description of affected area/required works** (e.g. dented, cracked, grazed etc)

**Front bumper and hood badly damaged/caved in.**

**Airbags deployed because of collision.**
