Your Ref: TP/IP/68415/2019
Our Ref : CI/TPD19021038/N

Fatal Accident Investigation Team

MECHANICAL INSPECTION REPORT OF MOTORCYCLE FBJ 1030E

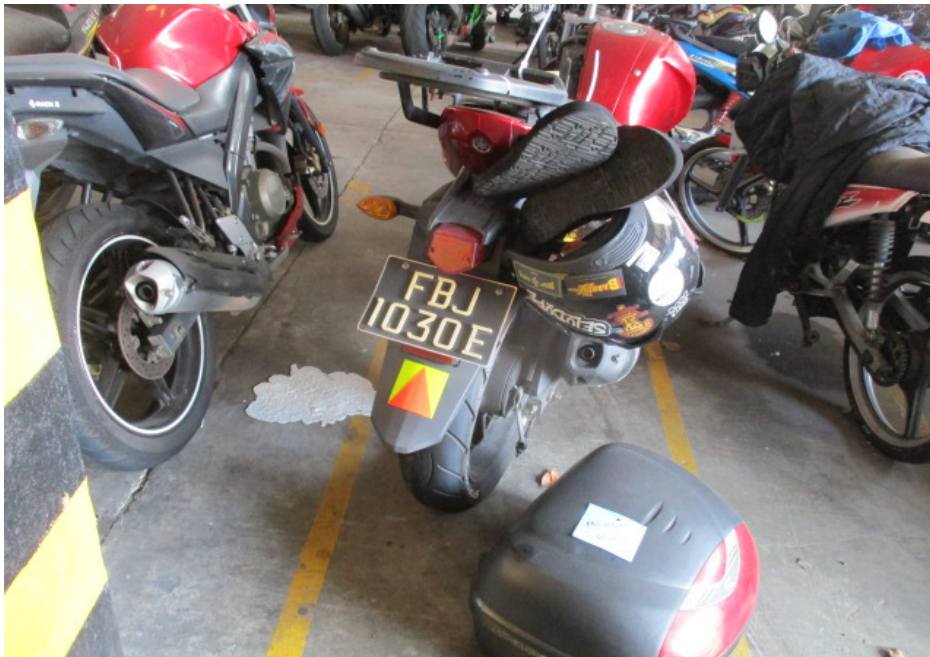
Photo 1 shows a general view of the rear body of the Motorcycle at the time of our inspection. The Motorcycle had sustained damages at its frontal portion and right body.

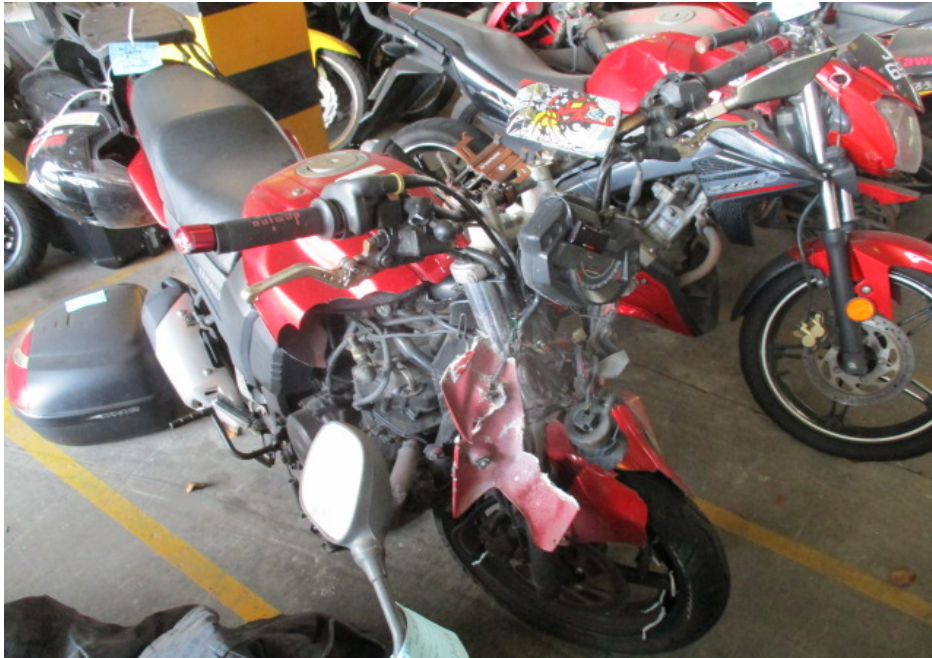
4. The mileage of the Motorcycle could not be recorded at the time of our inspection due to the damages sustained to the speedometer gauge.
5. The Motorcycle had sustained damages at its frontal portion and right body. Body parts that were found to have been damaged include its headlamp assembly, front fork assembly, front wheel rim, side mirrors, clutch lever, fuel tank, right rear side cover, rear brake pedal and exhaust muffler, amongst others.

Photo 2 shows a general view of the right front body of the Motorcycle at the time of our inspection. Body parts that were found to have been damaged include its headlamp assembly, front fork assembly, front wheel rim, side mirrors, clutch lever, fuel tank, right rear side cover, rear brake pedal and exhaust muffler, amongst others.

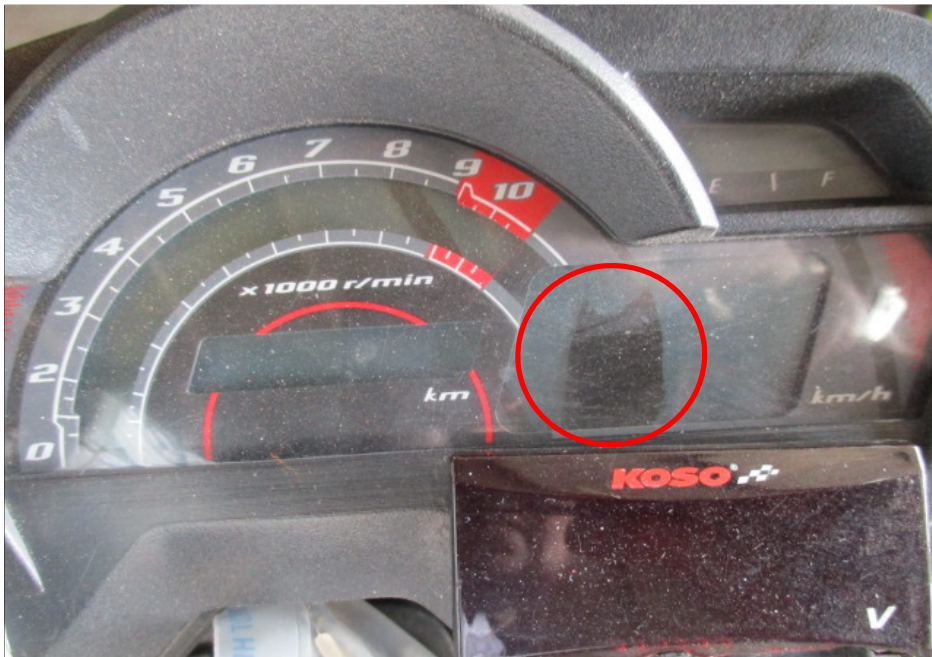
Photo 3 shows the speedometer gauge of the Motorcycle. The mileage of the Motorcycle could not be recorded at the time of our inspection due to the damages sustained to the speedometer gauge (circled).

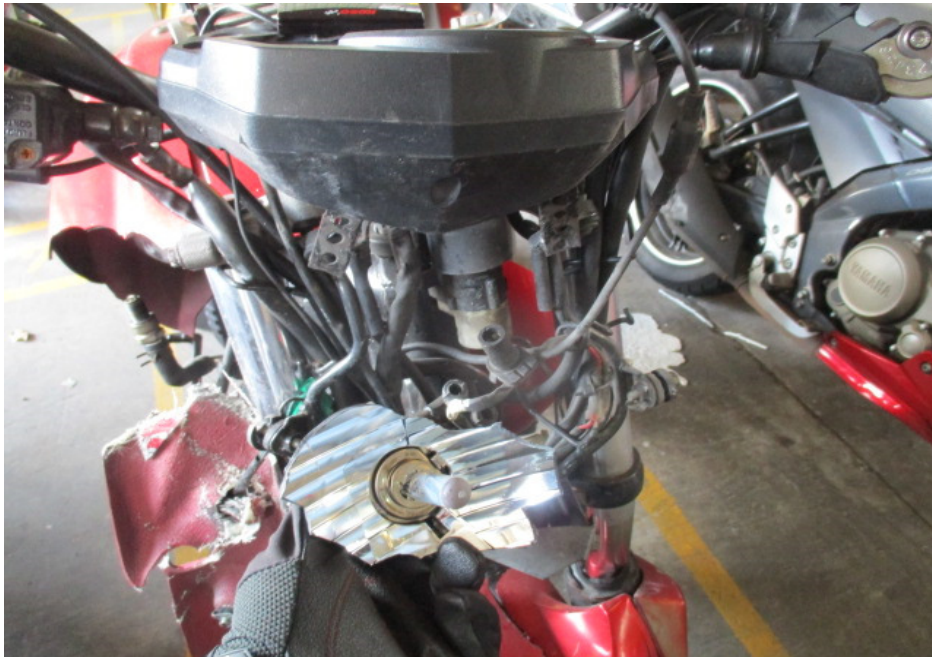
Photo 4 shows a general view of the front body of the Motorcycle at the time of our inspection. Body parts that were found to have been damaged include its headlamp assembly, fork assembly and speedometer gauge amongst others.

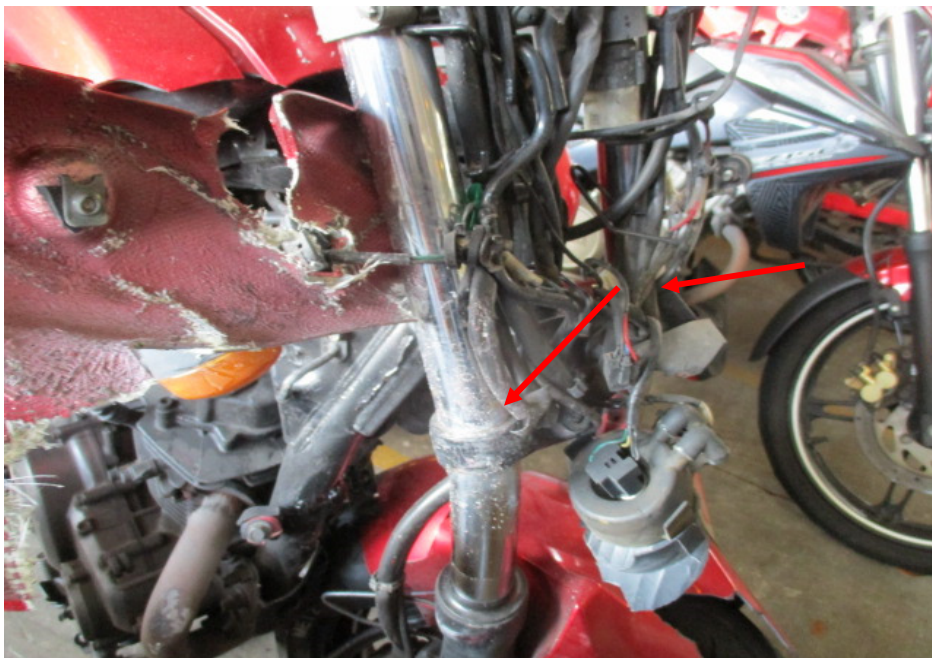
Photo 5 shows a closer view of the front forks (arrowed) which were amongst the body parts at the front body of the Motorcycle that had sustained damage as a result of the accident.

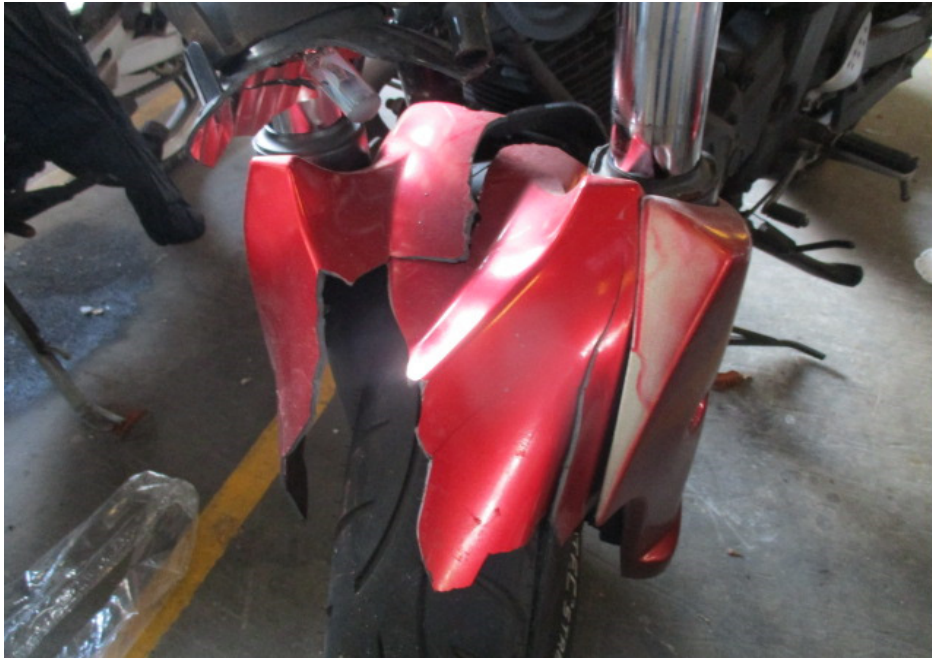
Photo 6 shows a closer view of the front mudguard which was amongst the body parts at the front body of the Motorcycle that had sustained damage as a result of the accident.

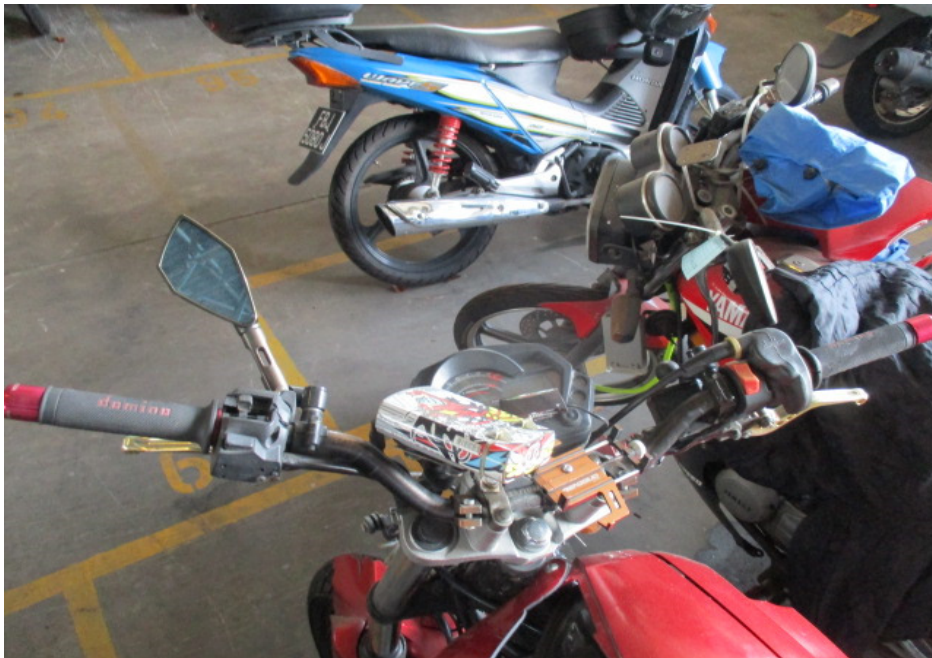
Photo 7 shows a closer view of the side mirrors, clutch lever, front brake lever, handlebars, handlebar grips and handlebar ends of the Motorcycle. These parts were amongst the body parts of the Motorcycle which were damaged as a result of the accident.

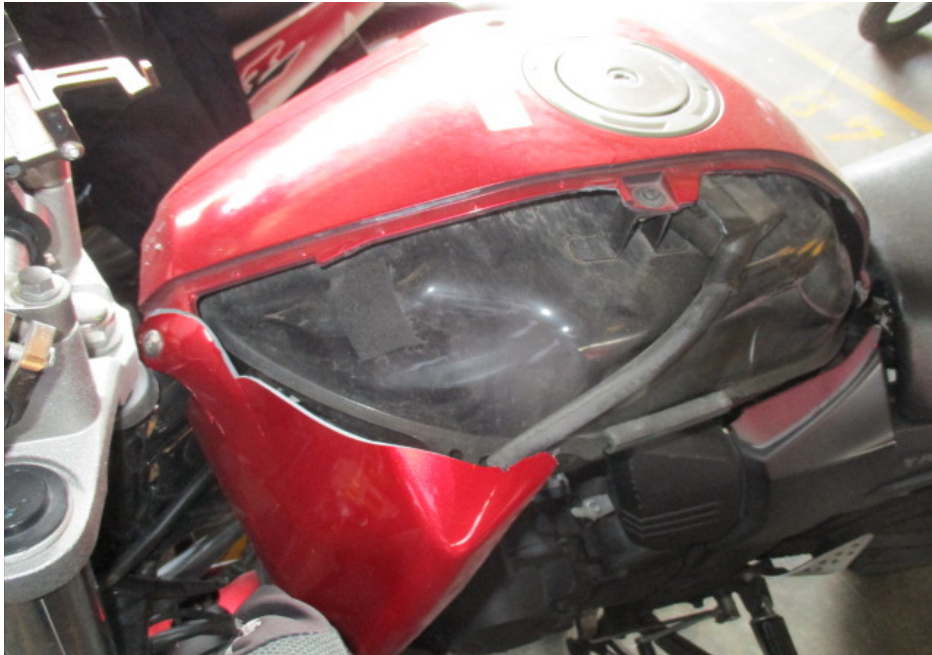
Photo 8 shows a closer view of the petrol tank which was amongst the body parts of the Motorcycle that had sustained damage as a result of the accident.

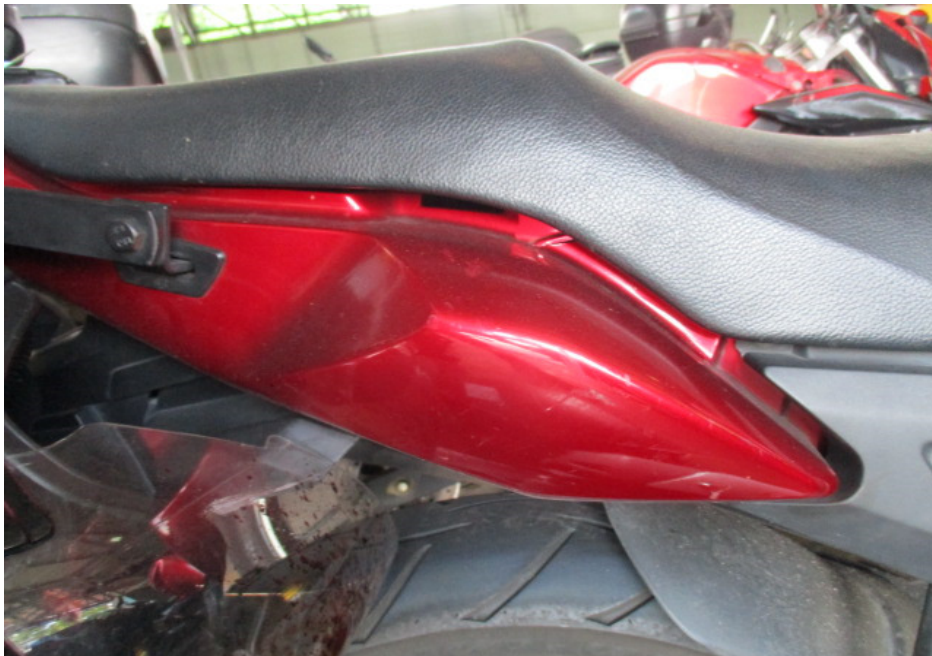
Photo 9 shows a closer view of the right rear side cover, which was amongst the body parts of the Motorcycle that had sustained damages of grazing nature as a result of the accident.

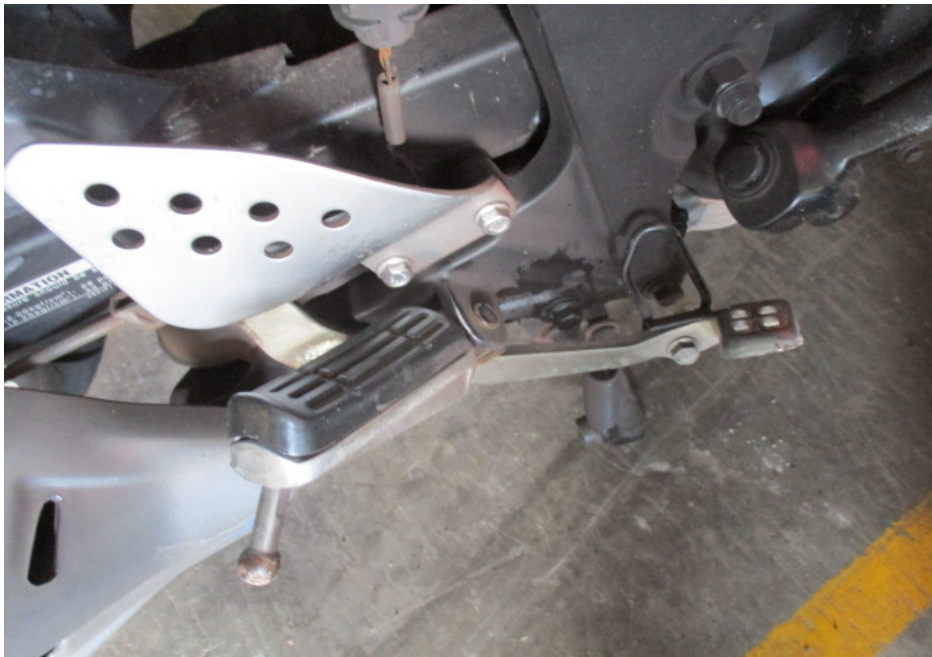
Photo 10 shows a closer view of the rear brake pedal and right front footrest which were amongst the body parts of the Motorcycle that had sustained damage as a result of the accident.

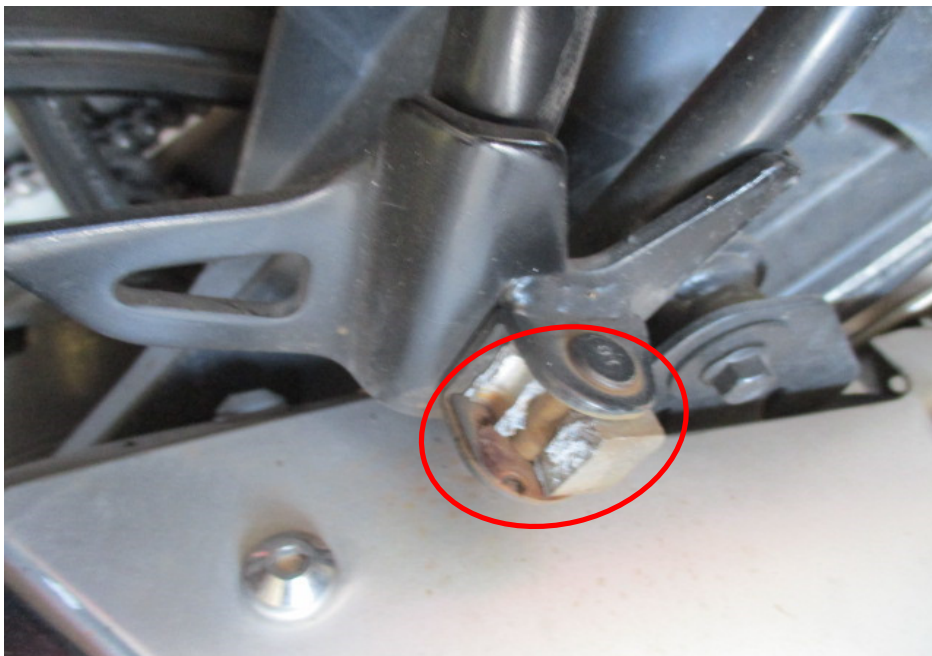
Photo 11 shows a closer view of the broken right pillion footrest which was amongst the body parts of the Motorcycle that had sustained damage as a result of the accident (circled).

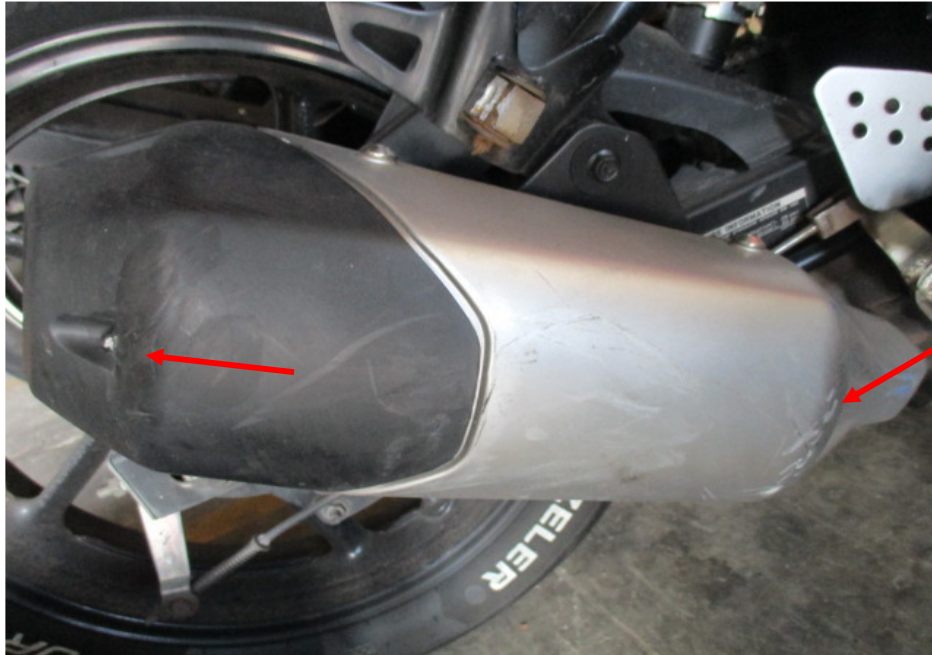
Photo 12 shows the exhaust muffler of the Motorcycle which had sustained damage as a result of the accident (arrowed).

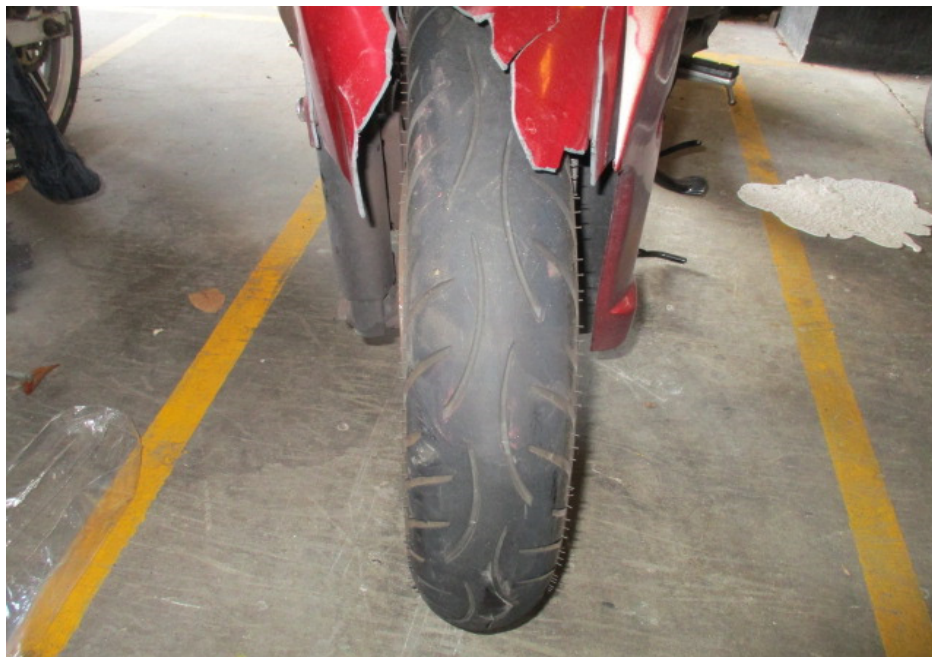
6. We did not observe any tear, burst mark(s) and/or punctured hole(s) on the sidewalls as well as across the tread of the rear tyre. However we did observe that the front tyre was deflated.

Photo 13 shows the front tyre of the Motorcycle at the time of our inspection. The pattern of the tread was clearly visible with remaining tread depth of approximately 3mm. We did not observe any tear, burst mark(s) and/or punctured hole(s) on the sidewalls as well as across the tread of the front tyre. However we did observe that the front tyre was deflated due to the broken front wheel rim.

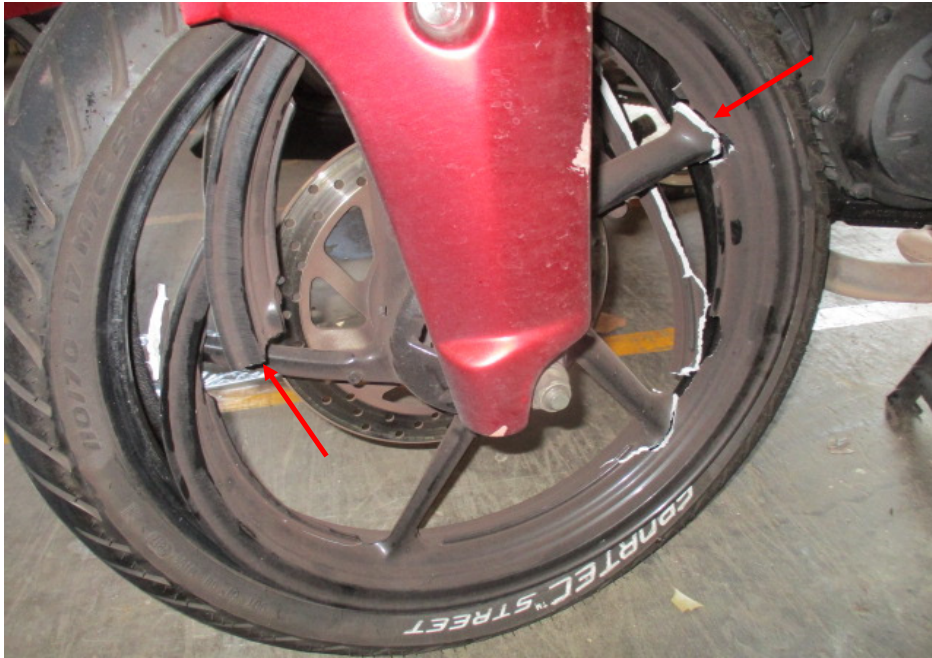
8. The 2 tyres were wrapped around alloy wheel rims. At the time of our inspection, we observed that front wheel rim was broken. See photos 1 – 15 below.

Photo 14 shows the broken front wheel rim of the Motorcycle at the time of our inspection (arrowed).

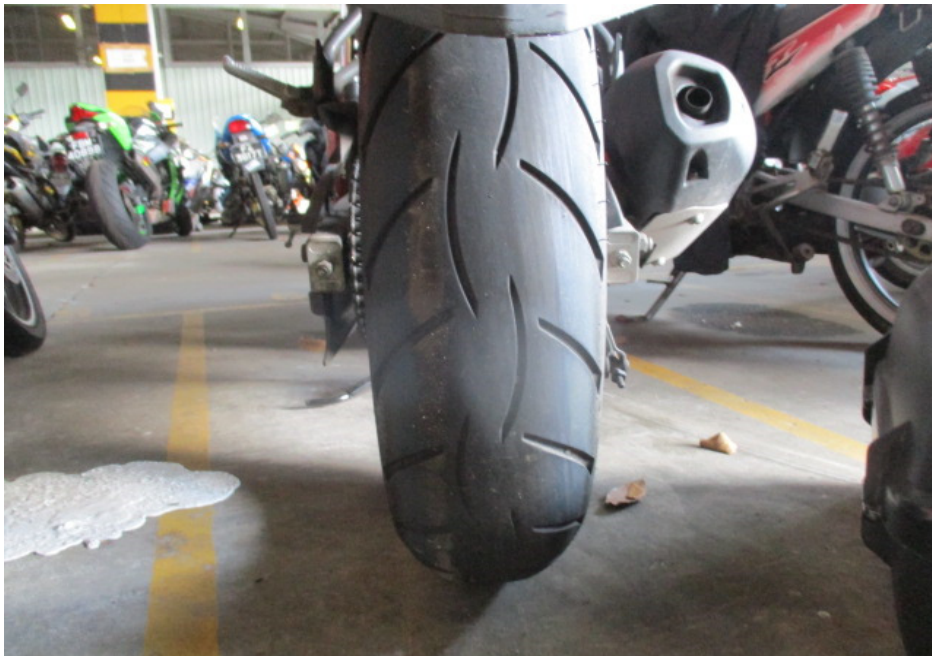
Photo 15 shows the condition of the Motorcycle's rear tyre. The pattern of the tread was clearly visible with remaining tread depth of approximately 3mm. We did not observe any tear, burst mark(s) and/or punctured hole(s) on the sidewalls as well as across the tread of the rear tyre.

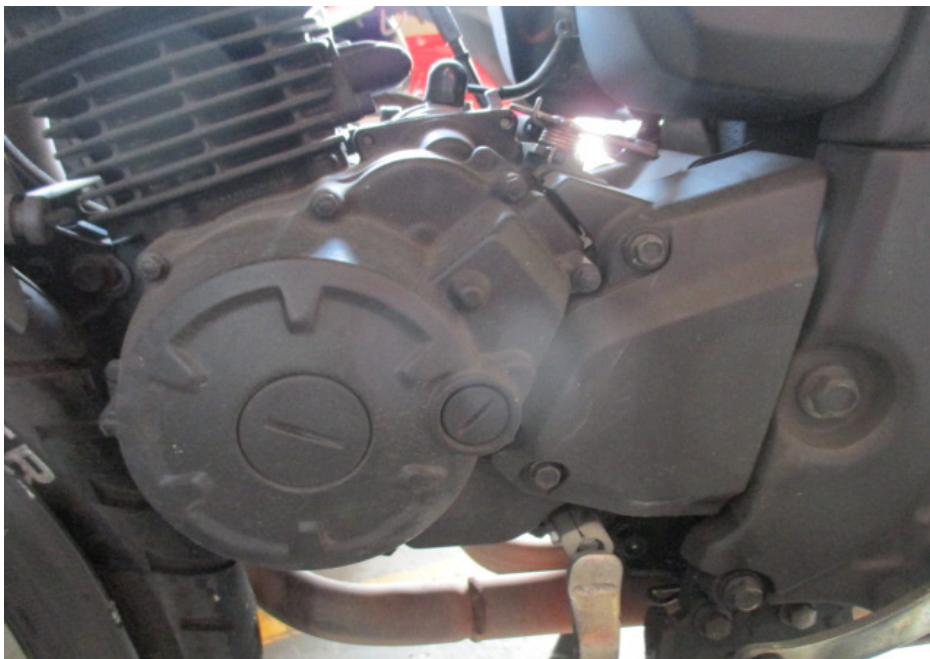
Photo 16 shows the left side of the engine of the Motorcycle at the time of our inspection. The various engine related parts and components were found to be intact with no visible damage. There was also no sign(s) or indication(s) of fluid leak observed around the left engine area of the Motorcycle.

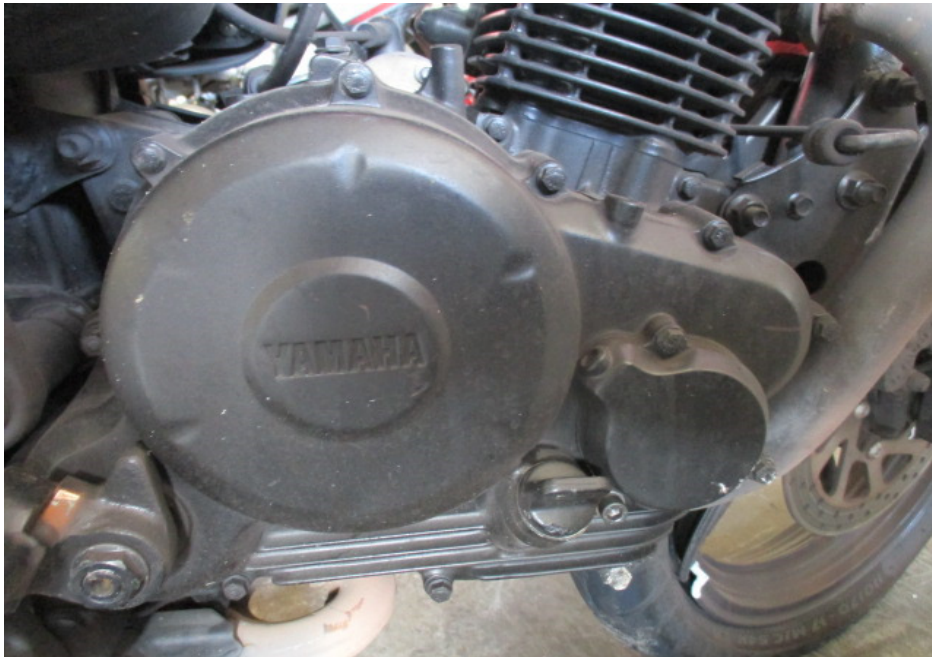
Photo 17 shows the right side of the engine of the Motorcycle at the time of our inspection. The various engine related parts and components were found to be intact with no visible damage. There was also no sign(s) or indication(s) of fluid leak observed around the right engine area of the Motorcycle.

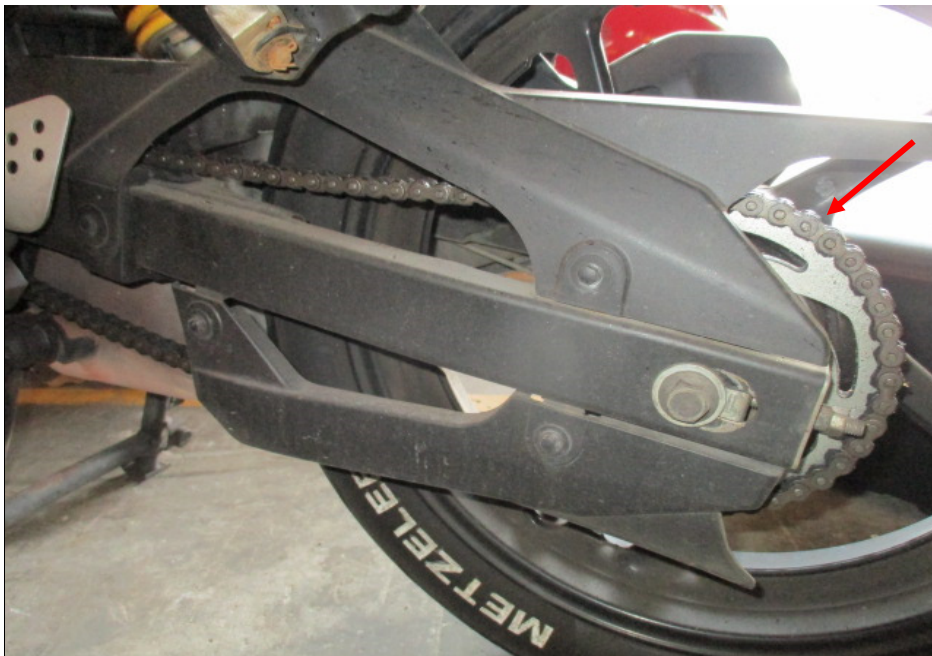
Photo 18 shows the gear chain (arrowed) of the Motorcycle, which was observed to be intact with no misalignment. It was also adequately lubricated for operating purposes. The gear chain rotates the rear wheel of the Motorcycle.

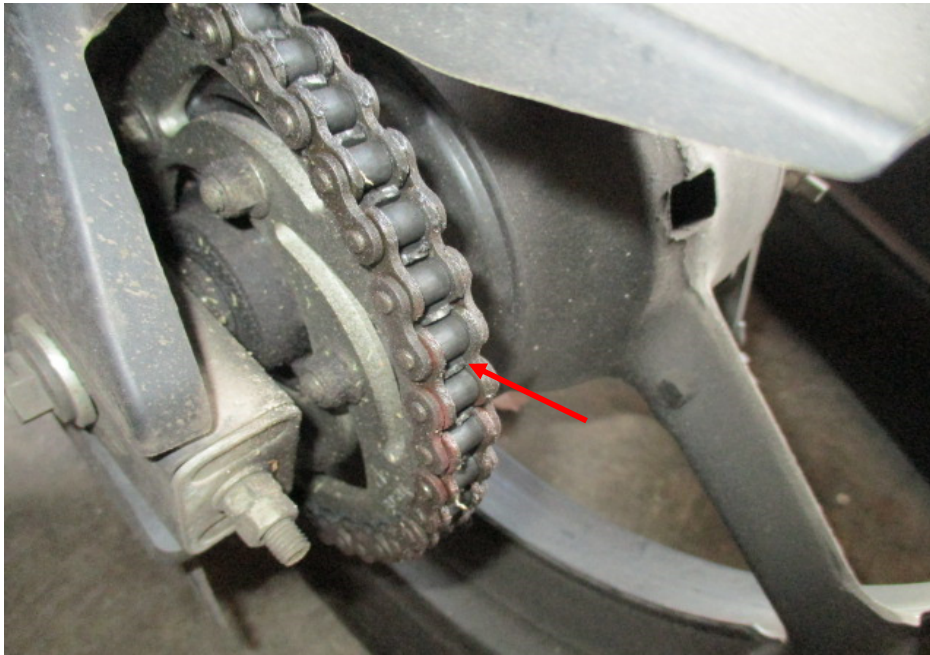
Photo 19 shows the closer view of the gear chain (arrowed) of the Motorcycle, which was observed to be intact with no misalignment. It was also adequately lubricated for operating purposes.

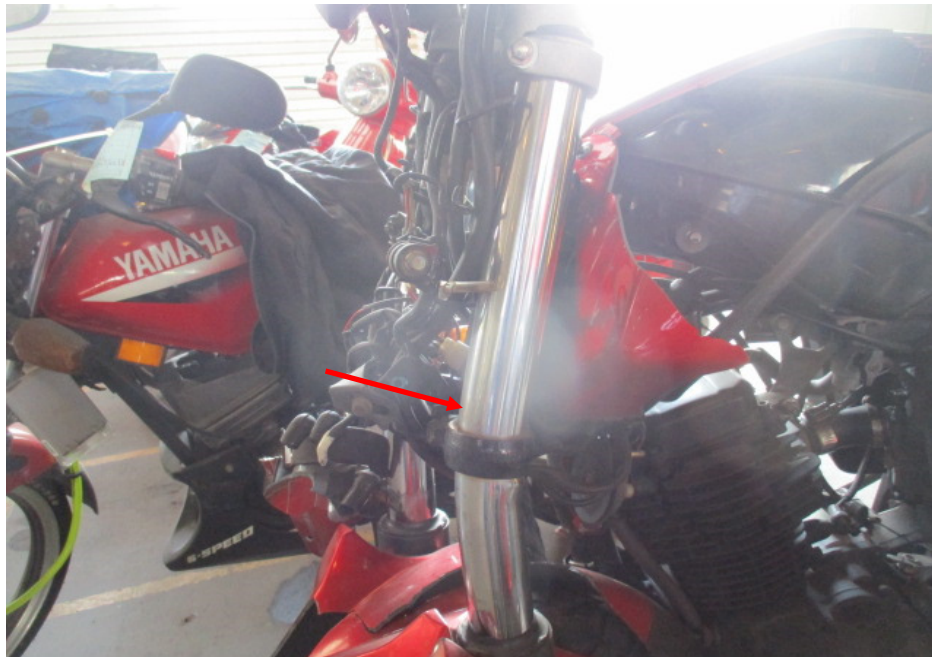
11. For this case, we were not able to conduct any test(s) on the steering system of the Motorcycle due to the damage of its front fork. The front fork was found to be bent as a result of the accident.

14. For this case, we were not able to carry out any operational tests to the steering system and braking system of the Motorcycle due to the damage of its front fork, which had rendered the Motorcycle immobile for the operational tests. We were not able to push the motorcycle manually forward and backward, simulating movement of the Motorcycle, for the operational tests. See photos 20 – 24 below.

Photo 20 shows the front left fork of the Motorcycle. The front left fork was observed to be bent as a result of the accident (arrowed). We were hence not able to conduct any tests on the steering system of the Motorcycle.

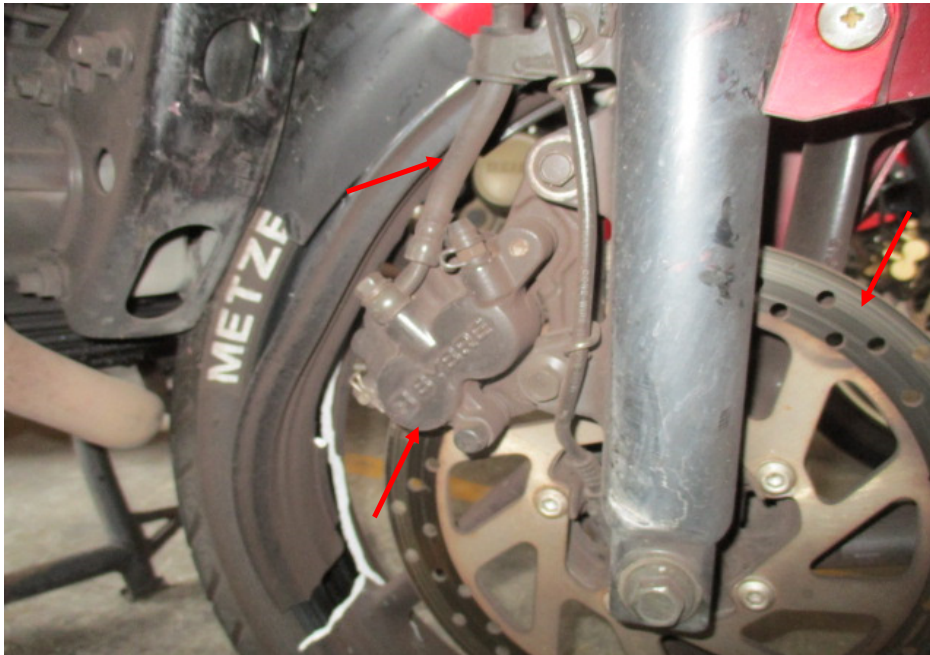
12. The brake system of the Motorcycle was of a semi-hydraulic type, where hydraulic (brake fluid) pressure controls the brake for the front wheel while the brake for the rear wheel is controlled by mechanical means (cables and springs). Our visual examination of the various components in the brake system, like the brake disc, brake caliper, drum, brake lever and brake foot pedal, revealed all to be intact and without damage. There was also no visible tear or cut observed on the connecting cables. The brake fluid for the front brake was also found to be of sufficiently level and without any contamination.

Photo 21 shows a close up view of the front brake caliper, front brake disc and front brake hose (arrowed) of the Motorcycle, which are all part of the components in the hydraulic front brake system of the Motorcycle. Our visual checks of these various components had revealed all to be intact with no visible damage. No leakage of brake fluid was also observed.

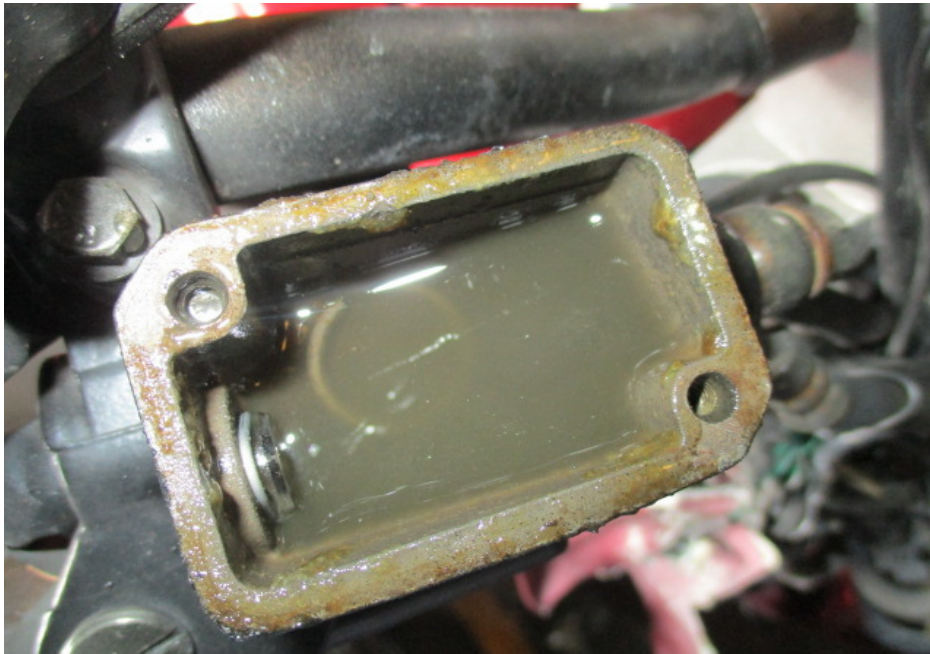
Photo 22 shows the brake fluid reservoir for the front brake of the Motorcycle. The brake fluid was observed to be without contamination and of sufficient level for operational purposes.

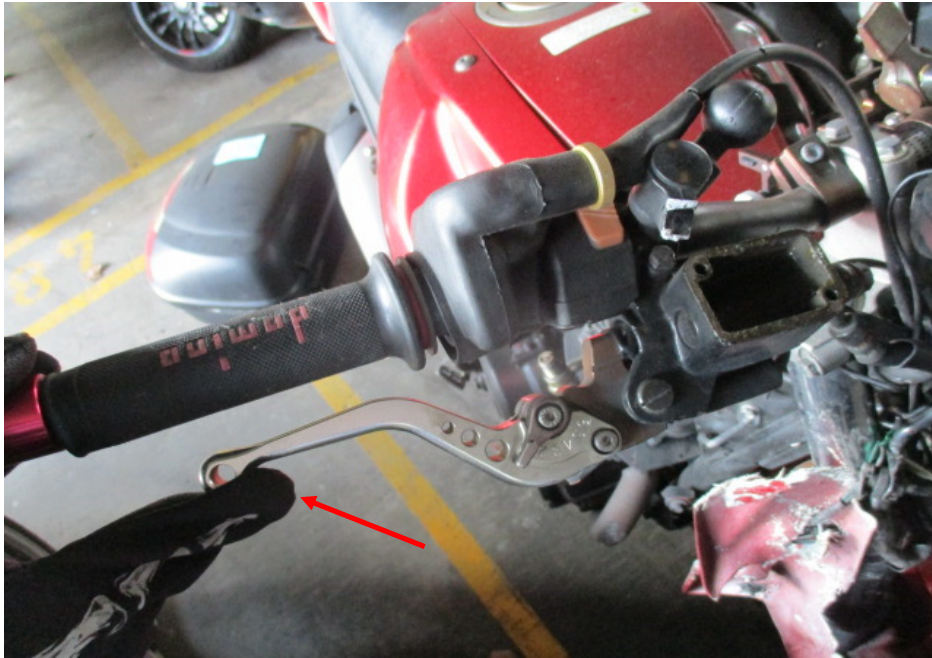
13. Static brake tests conducted on the Motorcycle had appear to indicate that the braking system of the Motorcycle was in serviceable condition. There was some resistance felt (spongy like feel) upon pressing the brake lever. This would indicate that there was no leakage of pressure/vacuum in the brake system.

Photo 23 shows the front brake lever being depressed. There was some resistance felt (spongy like feel) upon pressing the front brake lever (arrowed). This would indicate that there is no leakage of pressure/vacuum in the brake system.

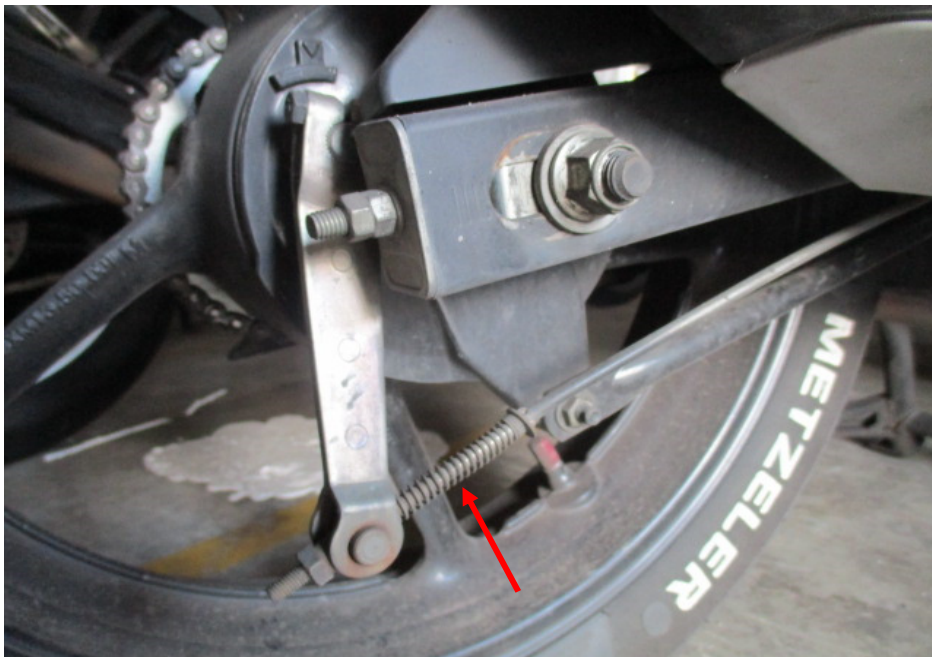
Photo 24 shows the rear wheel of the Motorcycle. The type of brake system for the rear wheel was of a mechanical type, controlled by the brake foot pedal of the Motorcycle. Our checks of the cable (arrowed), spring and drum which are all part of the components in the rear brake system of the Motorcycle reveal all to be intact and without damage.
