Your Ref: TP/IP/68415/2019
Our Ref : CI/TPD19021040/N

28 November 2019

MECHANICAL INSPECTION REPORT OF MOTOR CAR SKG 5264E

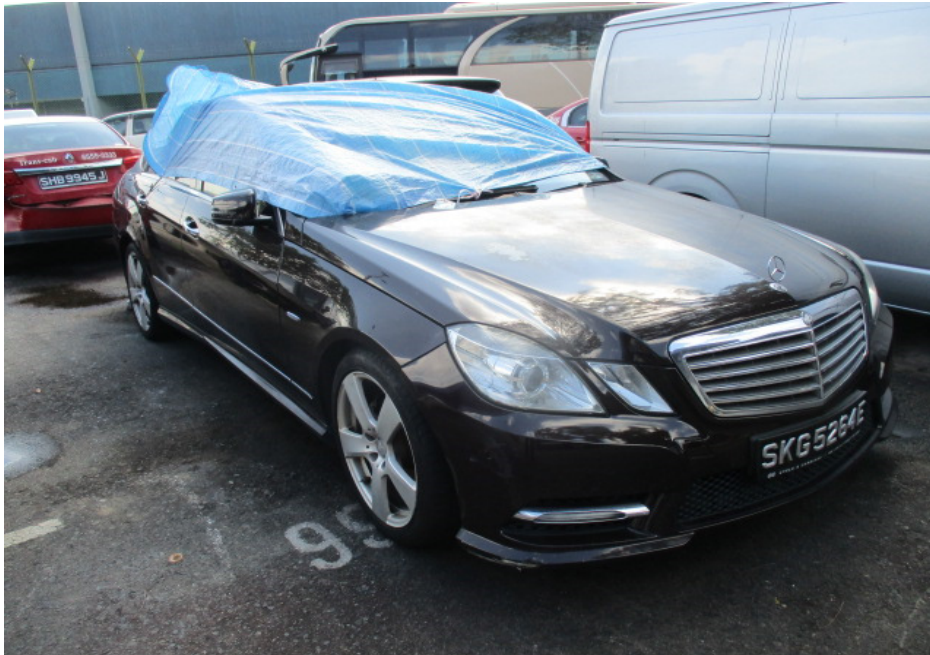
Photo 1 shows a general view of the front right body of the Motor Car at the time of our inspection. The Motor Car was observed to be in good general condition except for impact damage at its left portion. The mileage of the Motor Car was recorded to be 196, 297km.

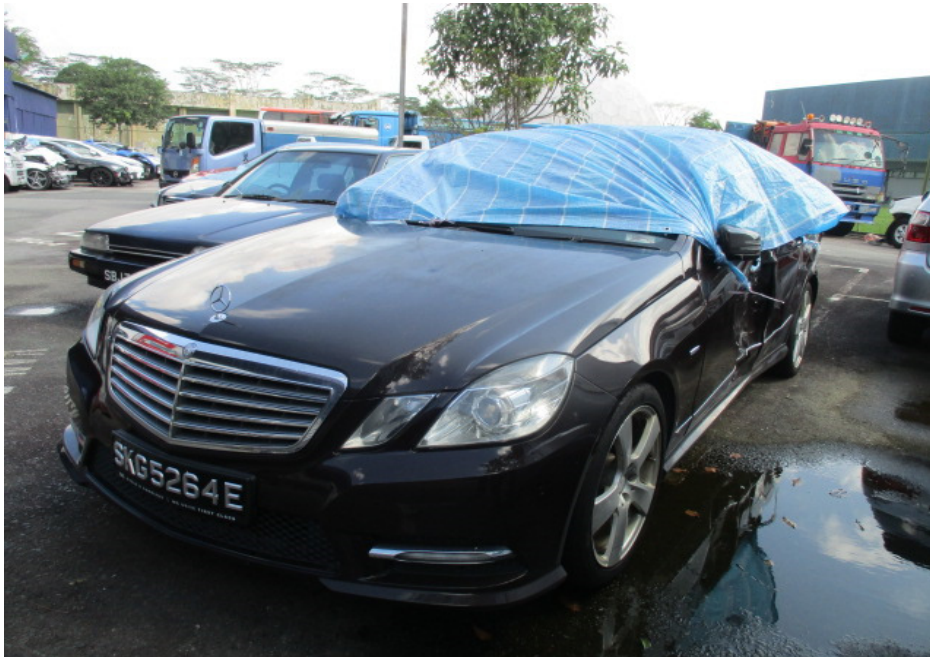
4. The mileage of the Motor Car at the time of our inspection was 196, 297km.
5. The Motor Car had sustained impact damage that was confined to its left portion. Its front windscreen was observed to have cracked; its left front passenger and left rear passenger doors were observed to have been dented; its front bumper was observed to be grazed while its left front passenger door glass was observed to have shattered.

Photo 2 shows a general view of the front left body of the Motor Car at the time of our inspection. The Motor Car was observed to be in good general condition. However we had observed impact damage that was confined to its left portion. Its front windscreen was observed to have cracked; its left front passenger and left rear passenger doors were observed to have been dented; its front bumper was observed to be grazed while its left front passenger door glass was observed to have shattered.

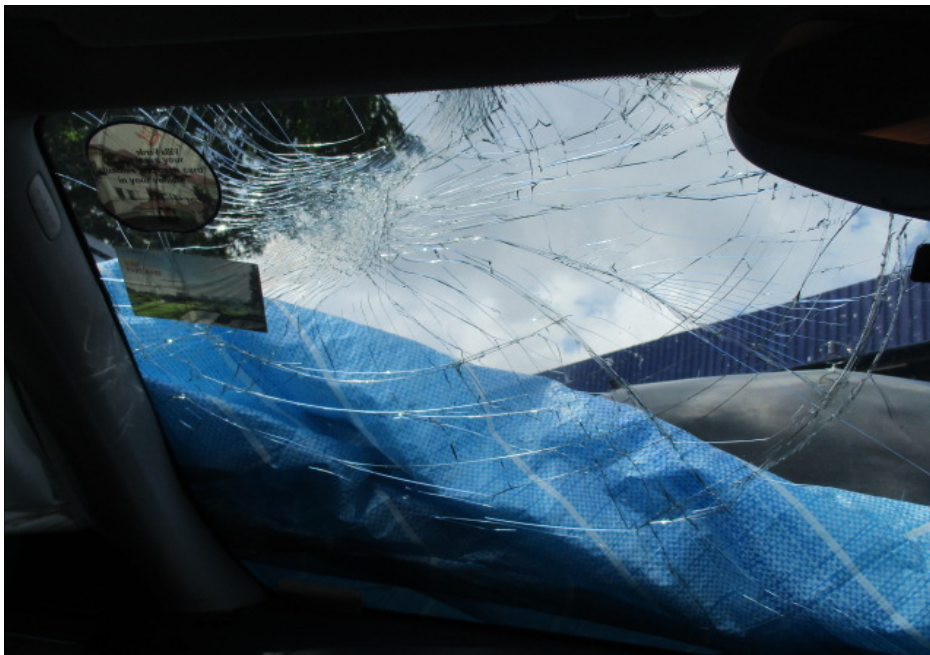
Photo 3 shows a closer view of the cracked front windscreen of the Motor Car at the time of our inspection (as viewed from within the interior compartment).

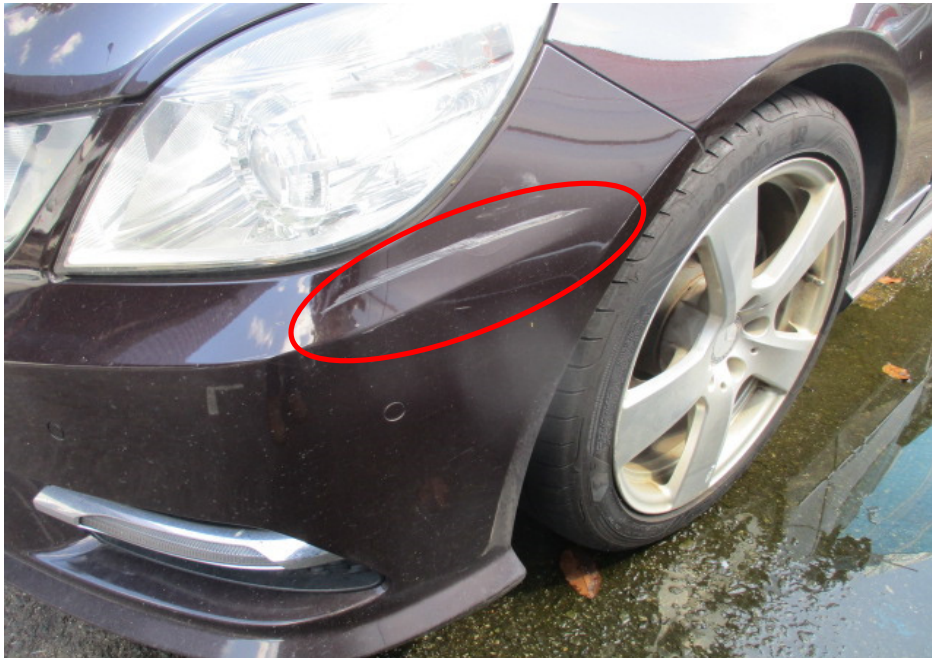
Photo 4 shows a closer view of the grazed front bumper of the Motor Car at the time of our inspection (circled).

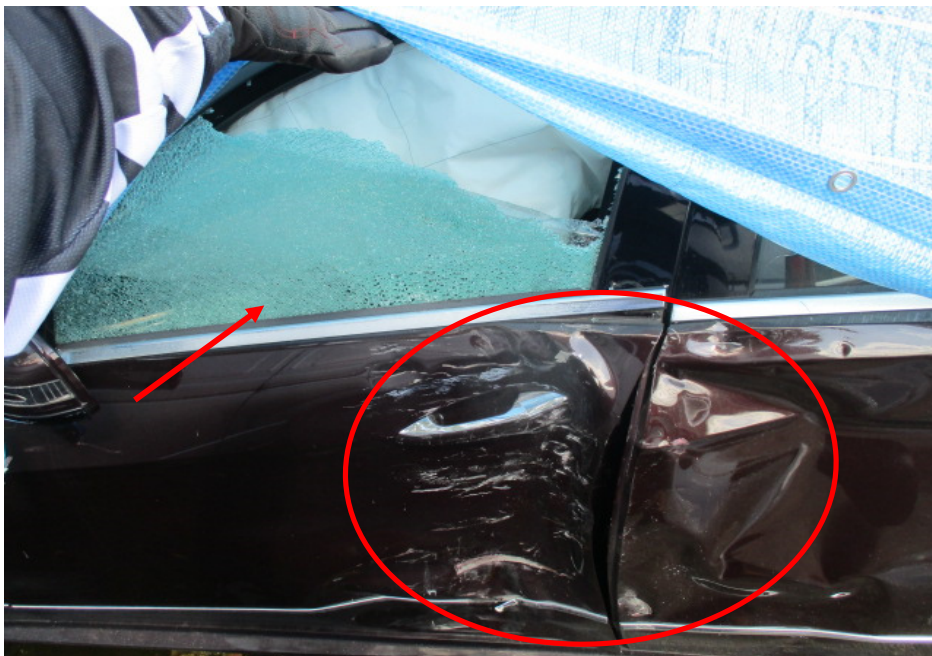
Photo 5 shows a closer view of the shattered left front passenger door glass (arrowed) as well as the dented left front and rear passenger doors (circled) of the Motor Car at the time of our inspection.

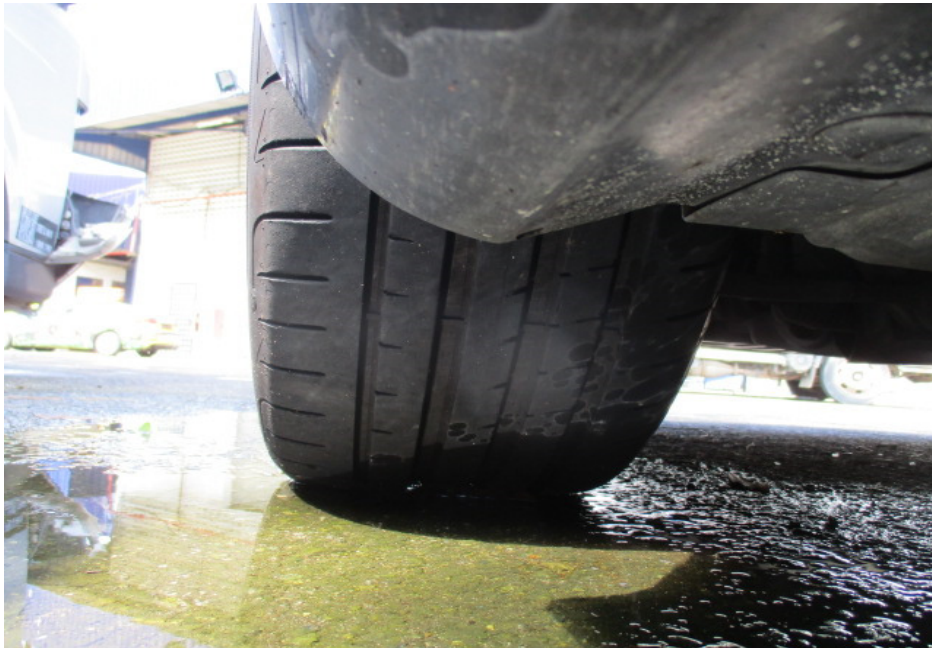
Photo 6 shows the condition of the front left tyre of the Motor Car, which was observed to be in serviceable condition with remaining tread depth of approximately 5mm. The tyre, which was wrapped around alloy wheel rim, was also observed to be sufficiently inflated for vehicular operation. There was no tear, cut or burst mark(s) on the outer and the inner sidewalls as well as across the tread of the 4 tyres.

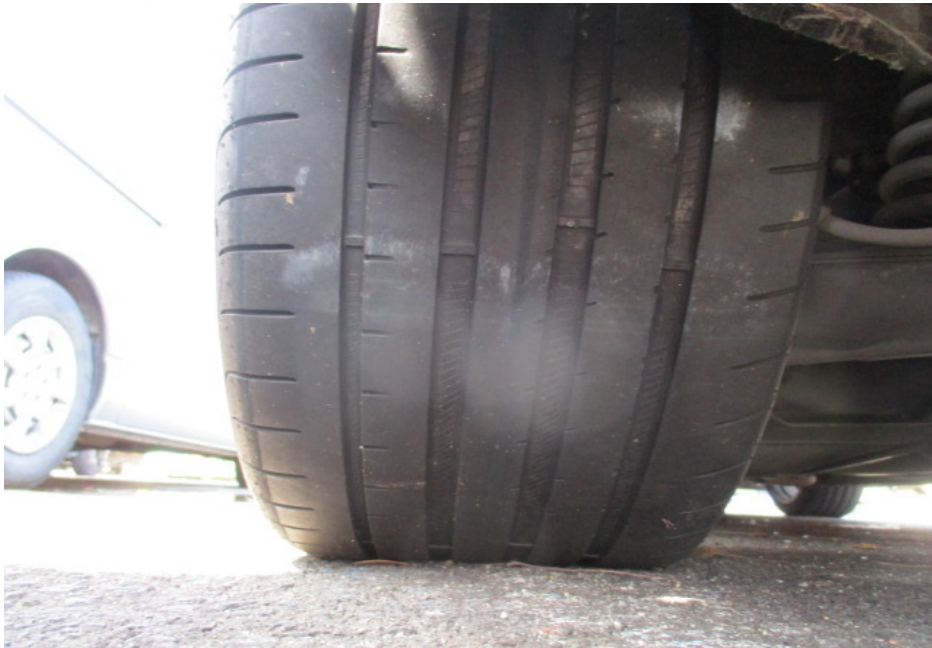
Photo 7 shows the condition of the front right tyre of the Motor Car, which was observed to be in serviceable condition with remaining tread depth of approximately 4mm. The tyre, which was wrapped around alloy wheel rim, was also observed to be sufficiently inflated for vehicular operation.

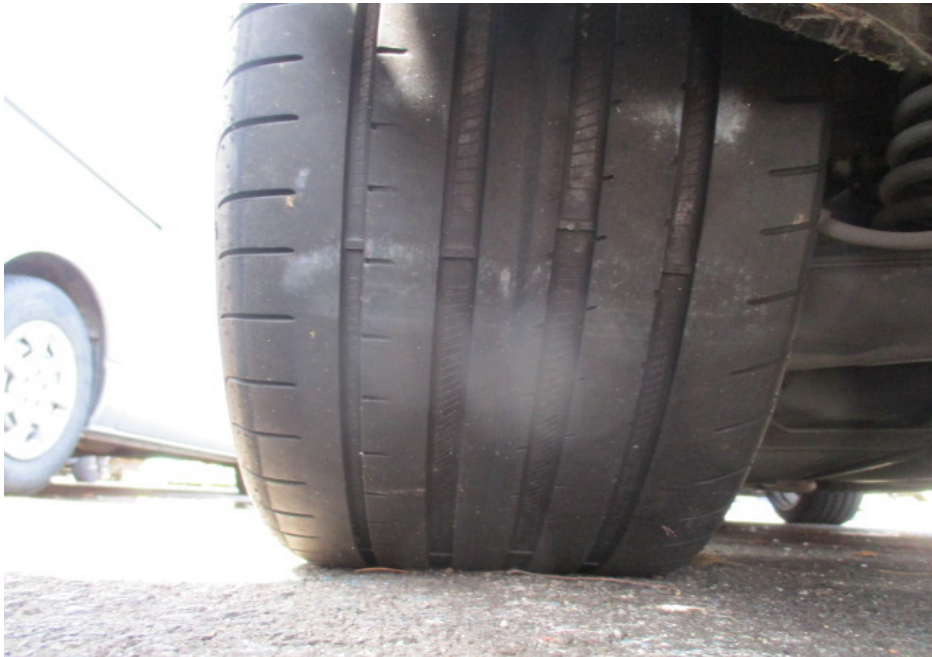
Photo 8 shows the condition of the rear left tyre of the Motor Car, which was observed to be in serviceable condition with remaining tread depth of approximately 5mm. The tyre, which was wrapped around alloy wheel rim, was also observed to be sufficiently inflated for vehicular operation. There was also no damage found on the 4 wheel rims of the Motor Car.

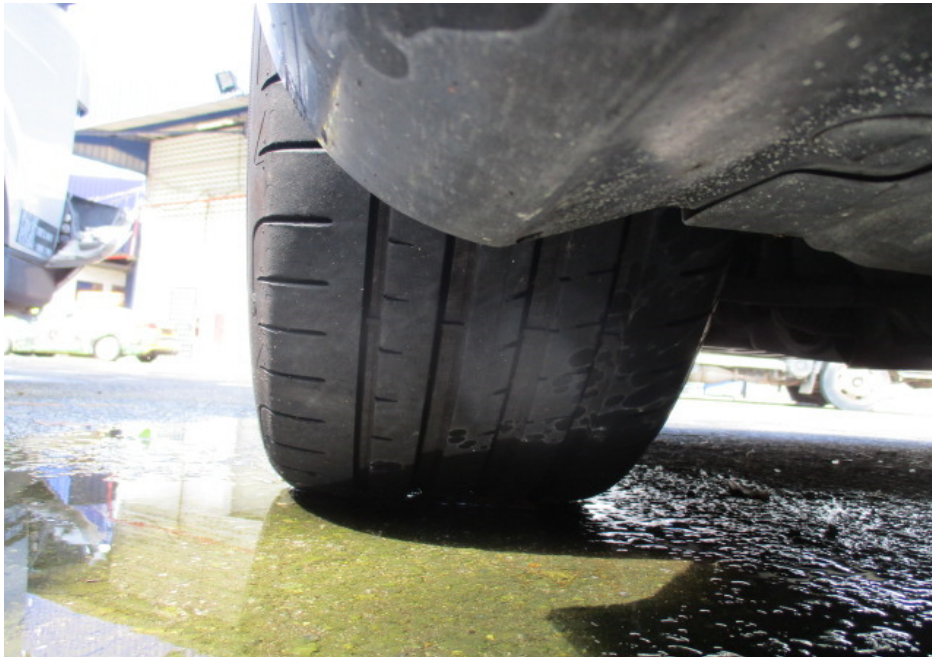
Photo 9 shows the condition of the rear right tyre of the Motor Car, which was observed to be in serviceable condition with remaining tread depth of approximately 5mm. There was also no tear, cut or burst mark(s) on the outer and the inner sidewalls as well as across the tread of the 4 tyres.

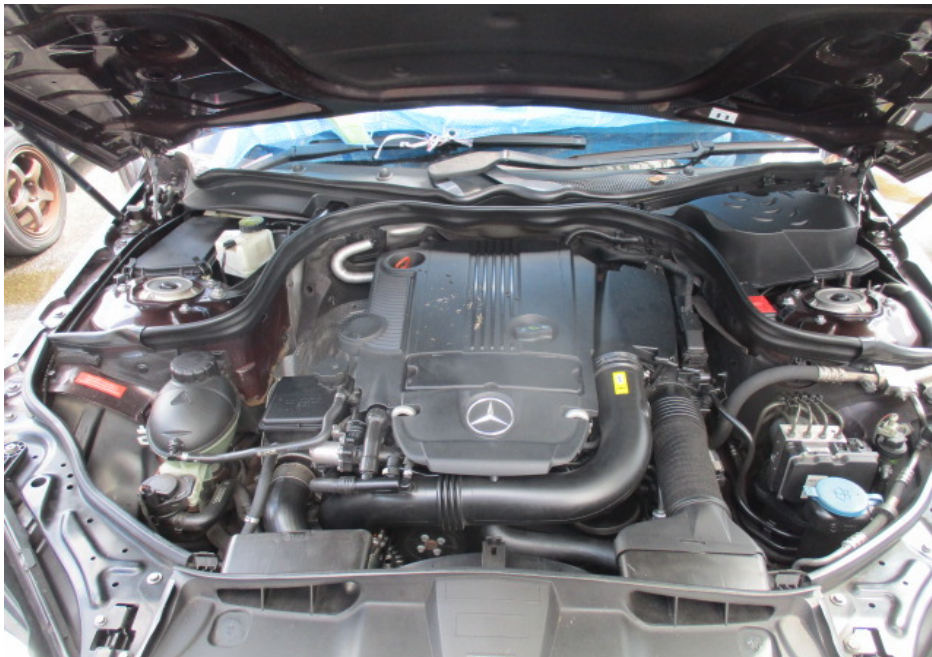
Photo 10 shows a general view of the Motor Car's engine compartment. The various parts and components inside the engine compartment were unaffected by the accident. There was also no sign(s) or indication(s) of fluid leakage and/or fluid stain within the engine compartment.

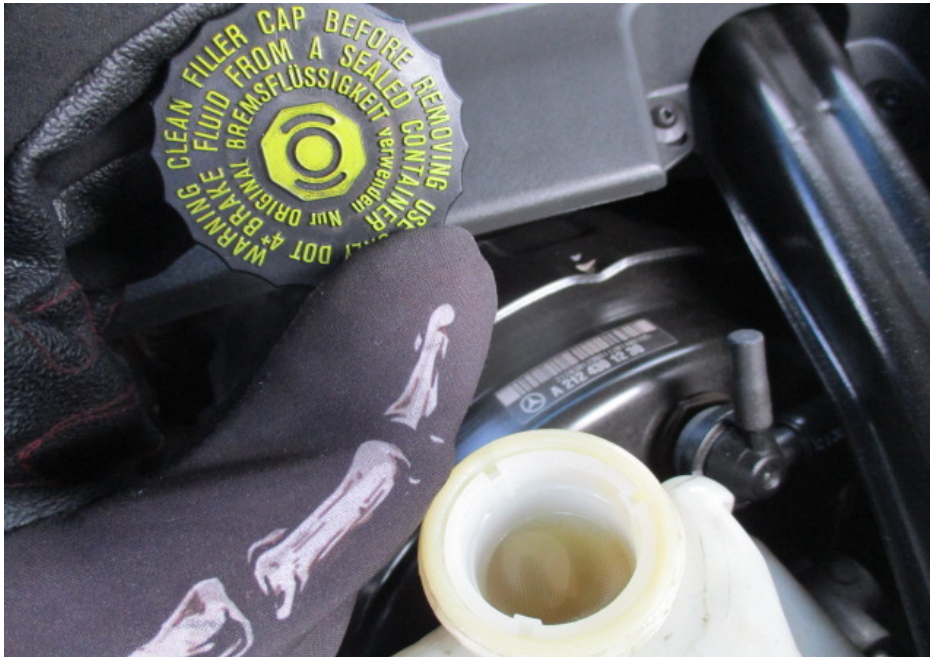
Photo 11 shows the brake fluid reservoir of the Motor Car at the time of our inspection. The brake fluid was observed to be of sufficient level and without any visible contamination.

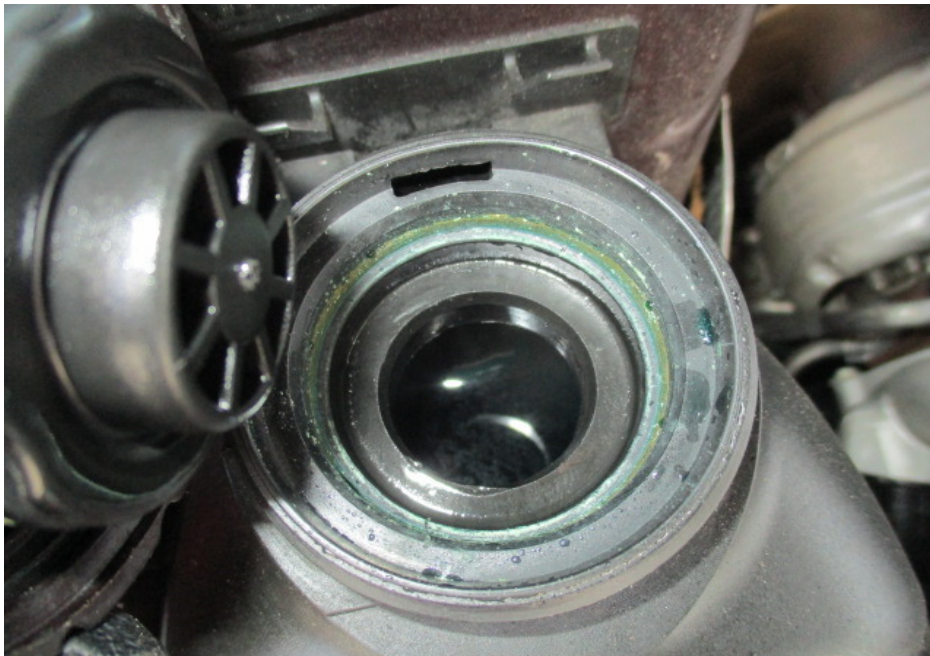
Photo 12 shows checks being carried out to the engine coolant of the Motor Car at the time of our inspection. The engine coolant was observed to be of sufficient level and without any visible contamination.

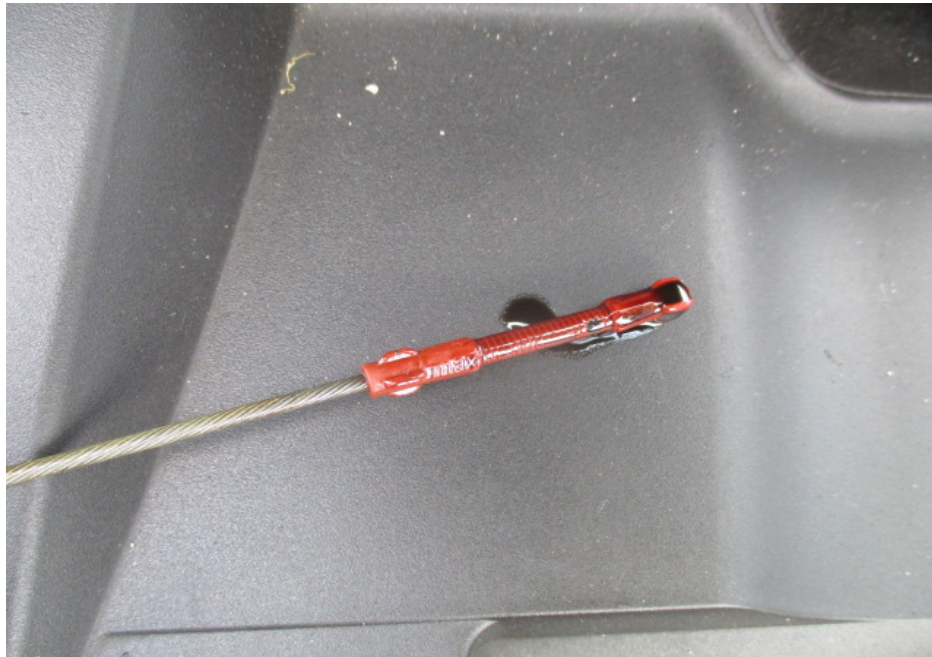
Photo 13 shows the engine oil dip stick of the Motor Car at the time of our inspection. The engine oil was observed to be of sufficient level and without any visible contamination.

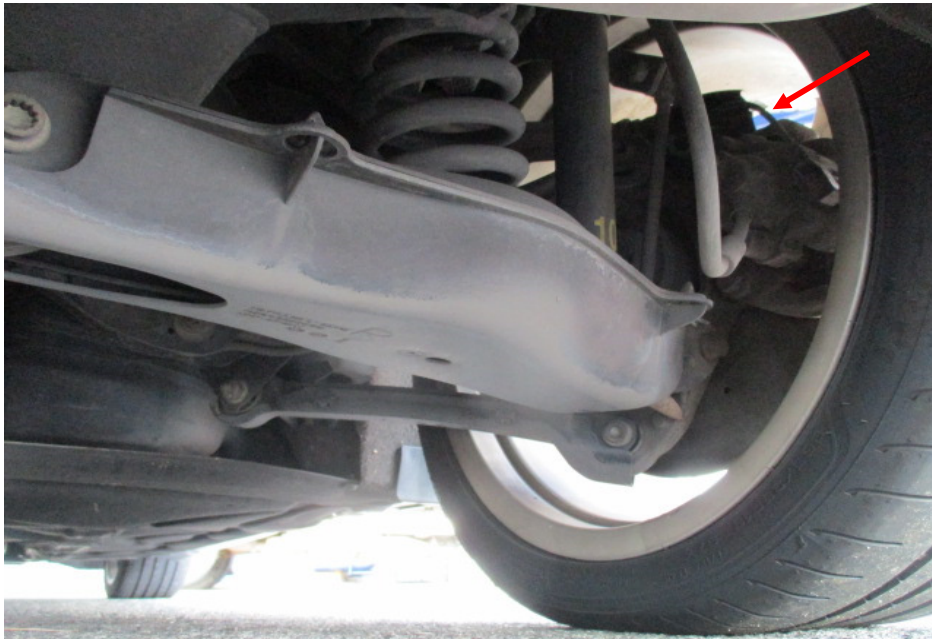
Photo 14 shows the brake hose/pipe (arrowed) at the rear right wheel of the Motor Car. We did not observe any leakage of brake fluid at the time of our inspection of the Motor Car. Static tests of the Motor Car's braking system had indicated that there was no internal leakage of pressure/vacuum. Hence the braking system was likely to be in serviceable condition at the material time of accident. The undercarriage components of the Motor Car were also all found to be intact and without any visible damage.

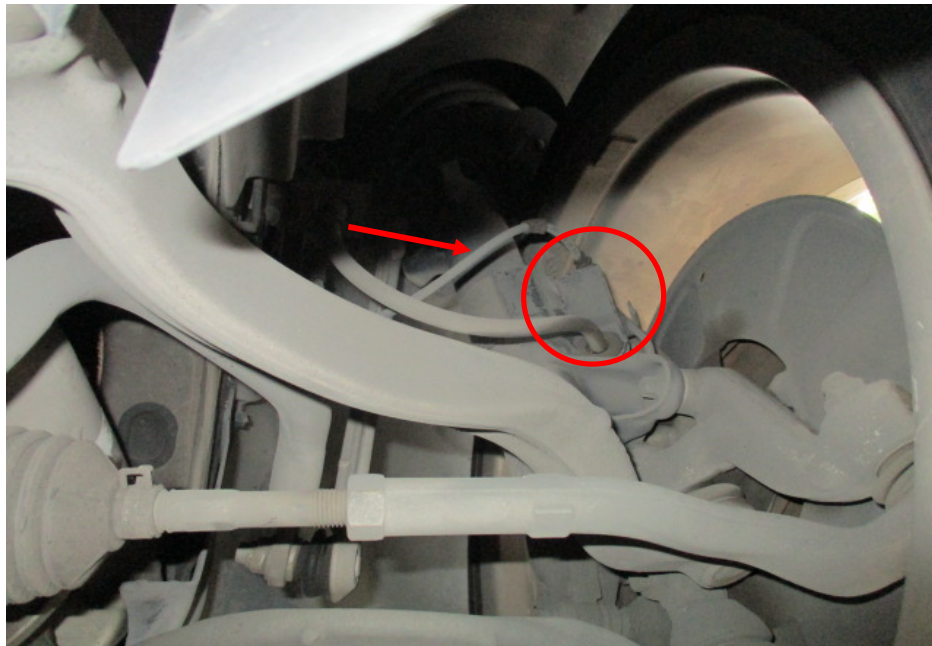
Photo 15 shows the brake hose/pipe (arrowed) at the front left wheel of the Motor Car. No leakage of brake fluid was observed. Visual examination of the various components of the braking system like the brake caliper (circled), brake pedal etc. had revealed all to be intact and without visible damage.

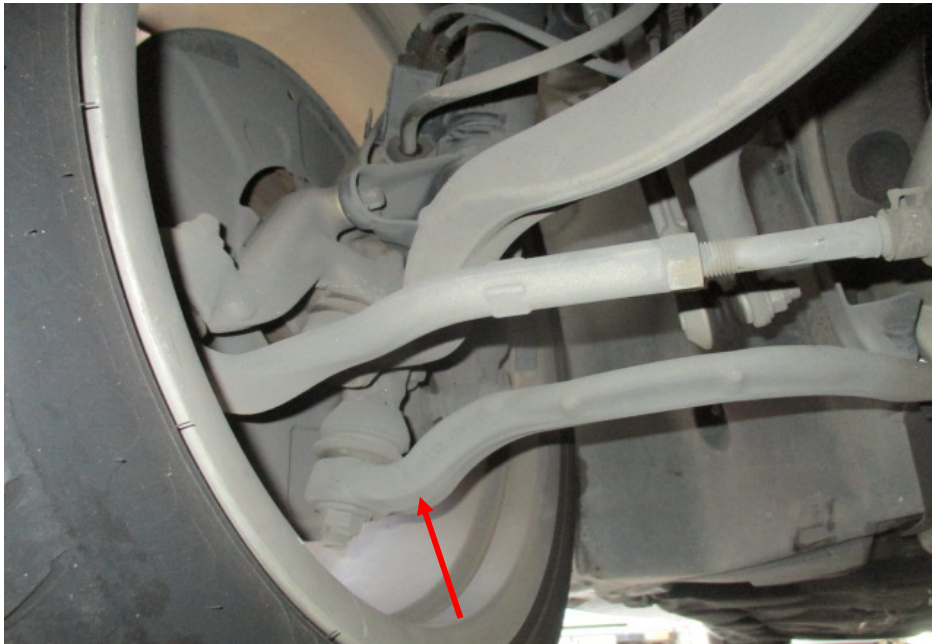
Photo 16 shows the various undercarriage components at the front right wheel of the Motor Car, in particular the steering tie rod (arrowed). The various steering components were all found to be intact, suggesting that the steering system of the Motor Car was likely to be in serviceable condition at the material time of accident. There was also no sign of fluid stain observed on the various undercarriage components at the front right wheel of the Motor Car.

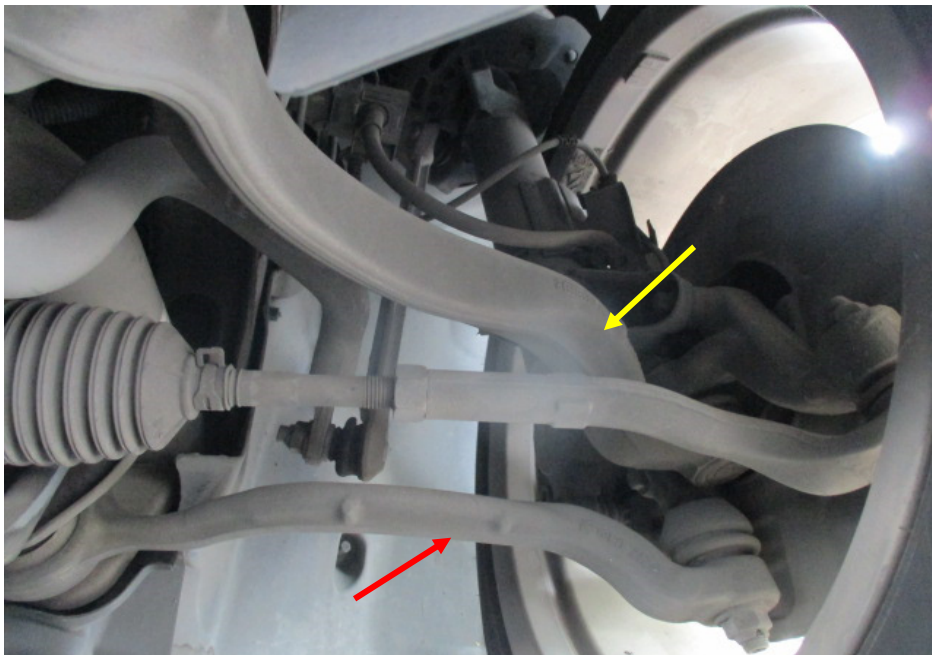
Photo 17 shows the various undercarriage components at the front left wheel of the Motor Car, which had included the steering tie rod (red arrow) and left drive shaft (yellow arrow). The various undercarriage components of the Motor Car were all found to be intact without any visible damage.

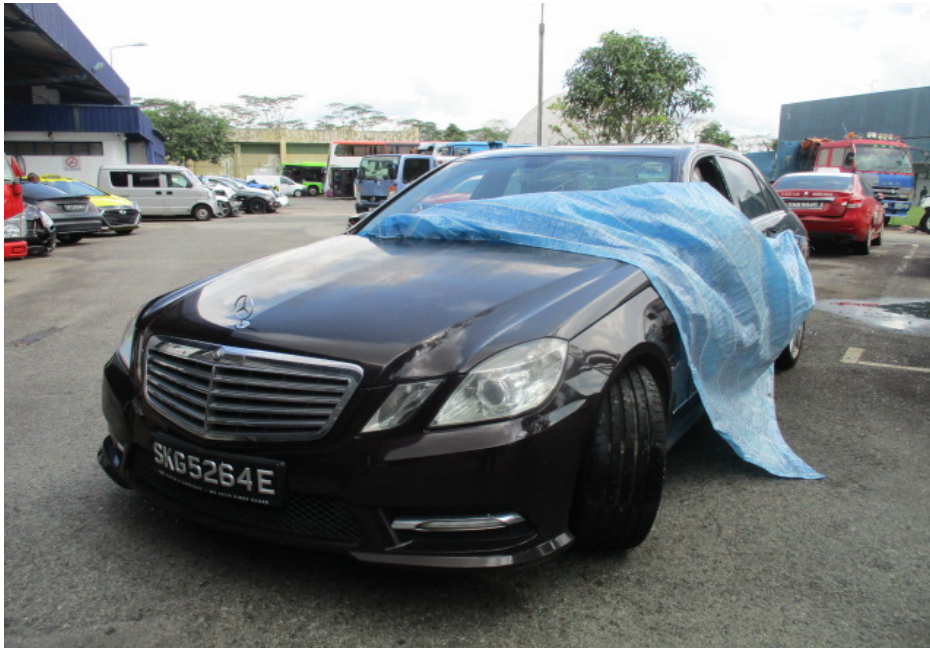
Photo 18 shows the front left wheel of the Motor Car turned to its full left. During our steering system test, we did not experience any abnormal free play and/or resistance when we had turned the steering wheel towards the left and right. This would suggest that the steering system of the Motor Car was likely to be in serviceable condition at the material time of accident.

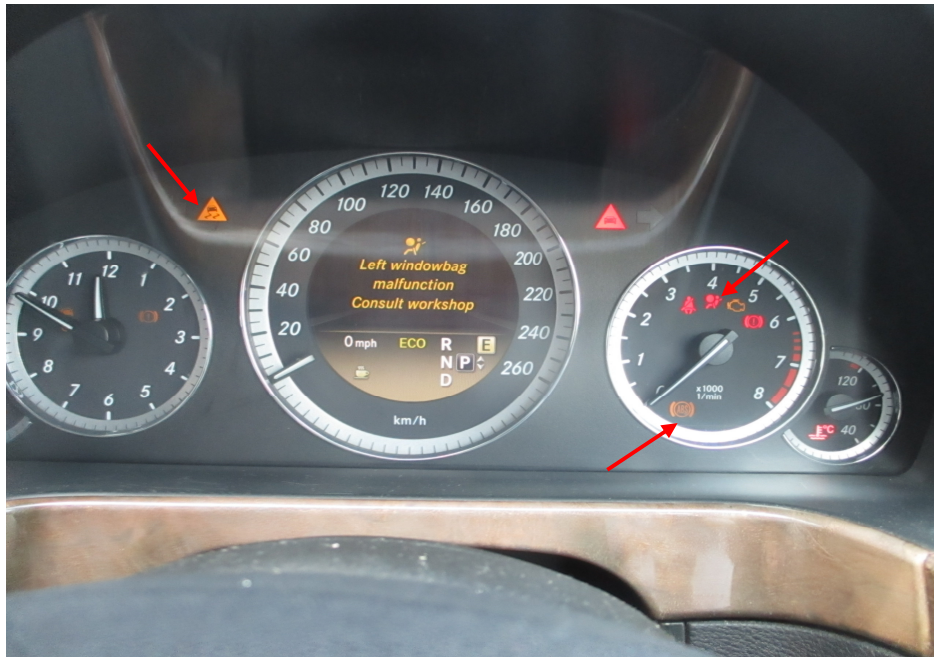
Photo 20 shows the warning lights for the various electronic operating systems of the Motor Car appearing on its instrument panel during the self-test when the engine is cranked, in particular the ABS light, ESC light and SRS light (arrowed).

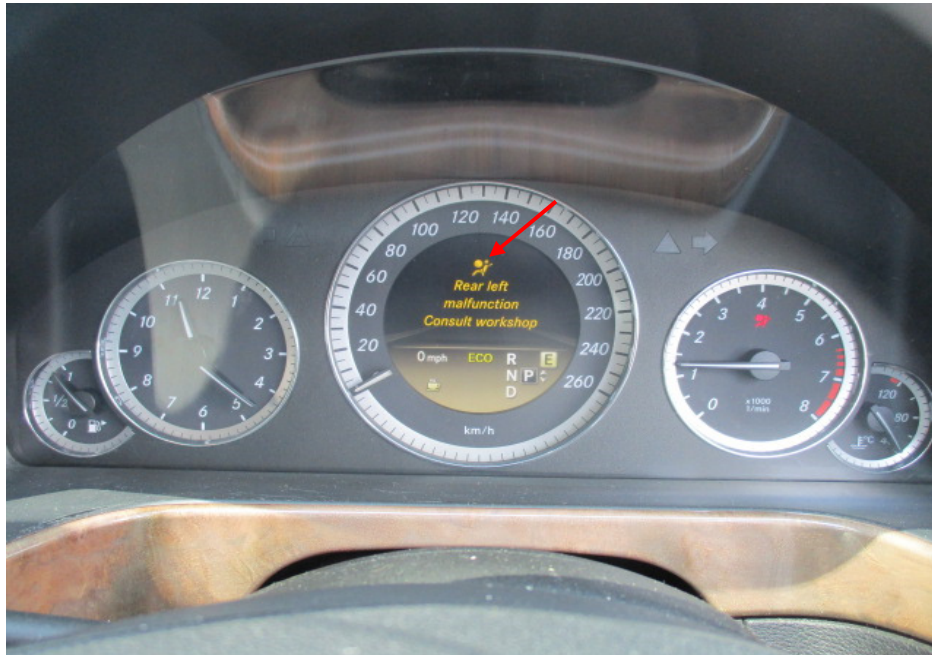
Photo 21 shows no warning lights illuminated on the instrument panel of the Motor Car after the engine was cranked. This would suggest that there was no abnormality to the various electronic operating systems of the Motor Car, like the ABS, ESC and SRS etc. The left window bag SRS warning light had however remained illuminated after the self-test (arrowed). This was due to the activation of the left front passenger and left rear passenger airbags as a result of the accident.
