Your Ref: TP/IP/67665/2019
Our Ref :CI/TPD19021043/N

Fatal Accident Investigation Team

INSPECTION REPORT OF MOTORCYCLE FBP 732M

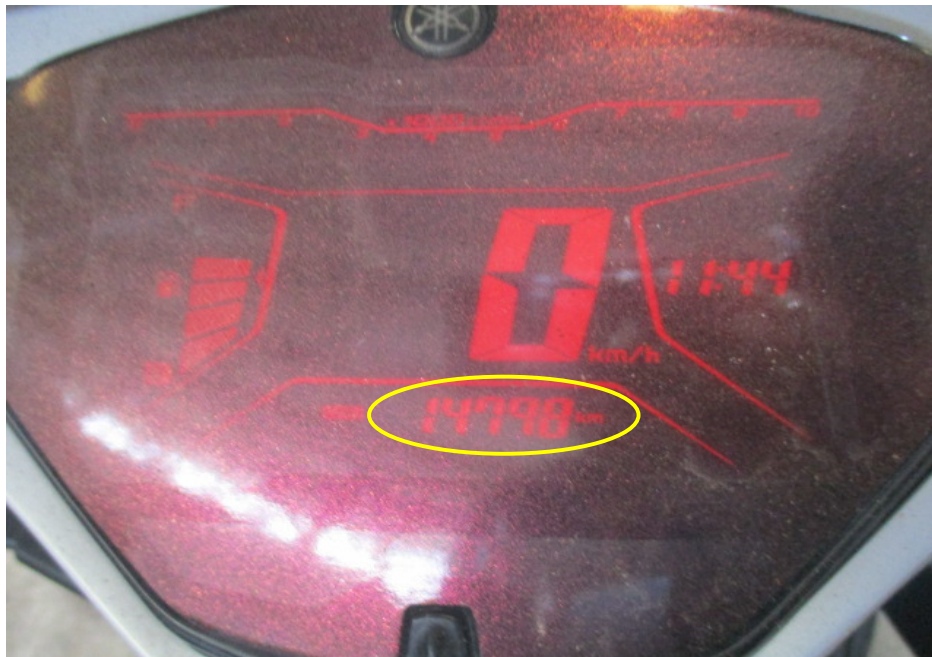
Photo 1 shows the speedometer gauge of the Motorcycle where the mileage recorded at the time of our inspection was 14, 798km (circled).

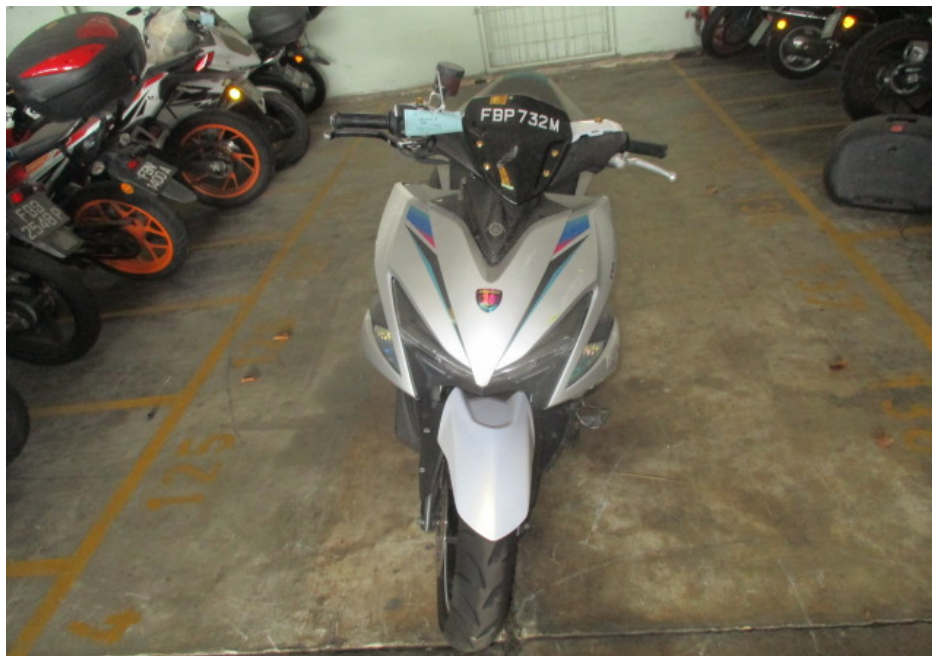
Photo 2 shows a general view of the front body of the Motorcycle at the time of our inspection. The Motorcycle was observed to have sustained damages all around.

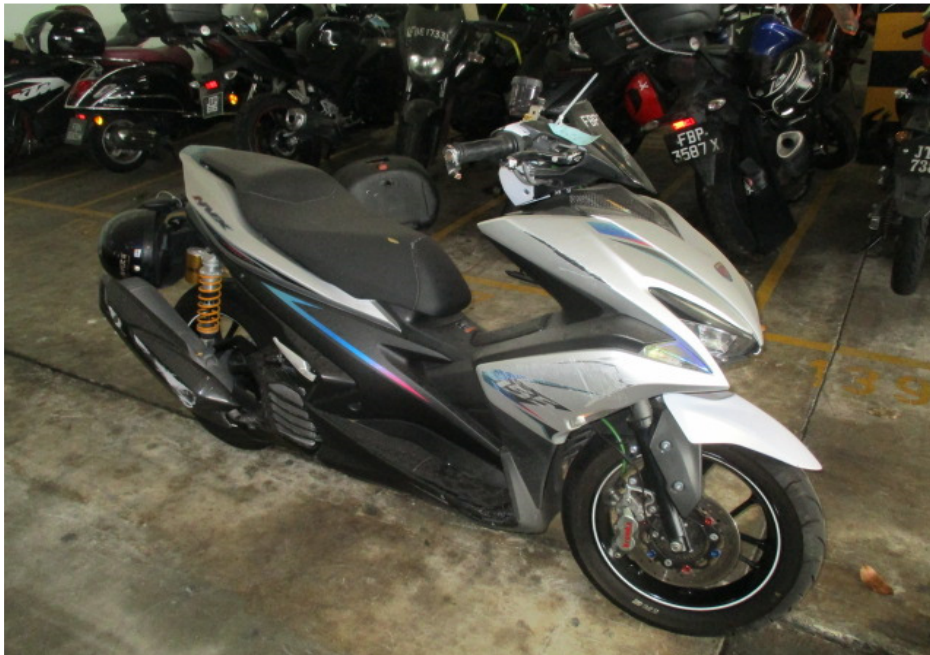
Photo 3 shows a general view of the right front body of the Motorcycle at the time of our inspection. The Motorcycle was observed to have sustained damages all around. The body parts that were found to have been damaged include its windshield, side cowlings, front mudguard, brake levers, drive train cover, exhaust muffler heat shield, left rear signal lamp and left pillion footrest, amongst others as a result of the accident.

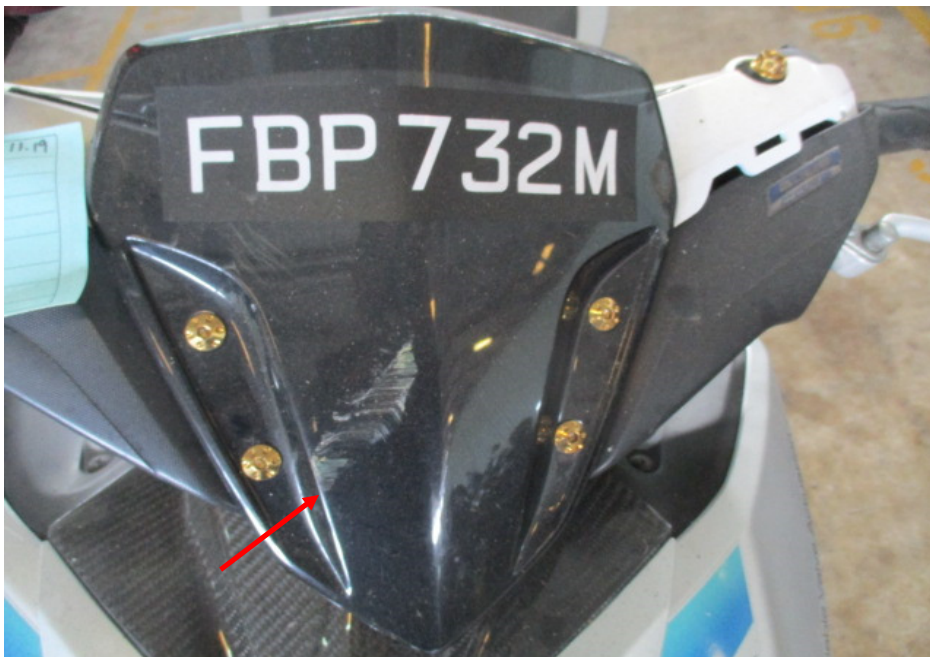
Photo 4 shows a closer view of the grazed windshield (arrowed) which was amongst the body parts at the front body of the Motorcycle that had sustained damage as a result of the accident.

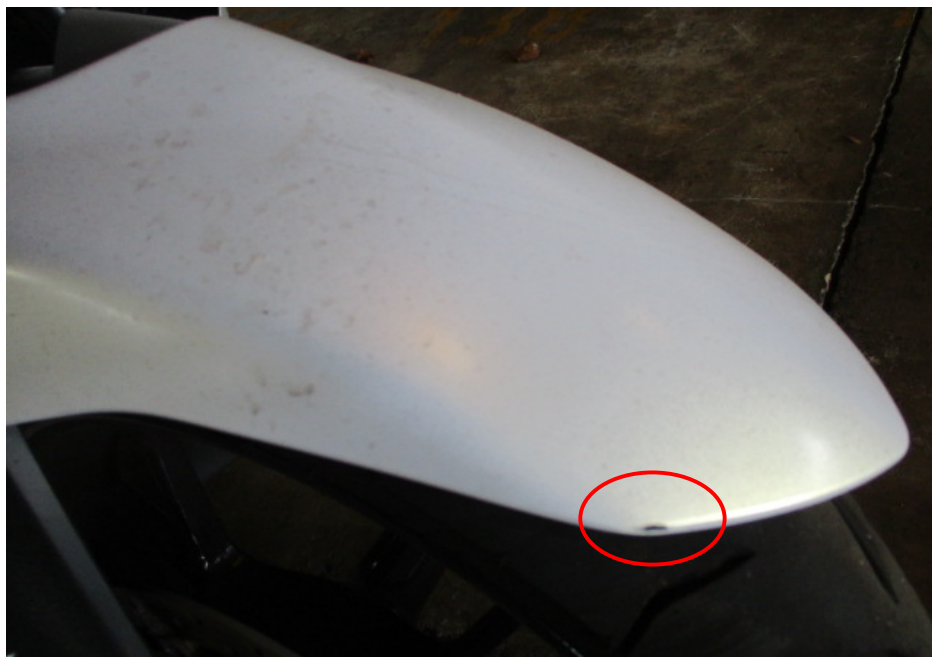
Photo 5 shows a closer view of the front mudguard (circled) which was amongst the body parts at the front body of the Motorcycle that had sustained damage as a result of the accident.

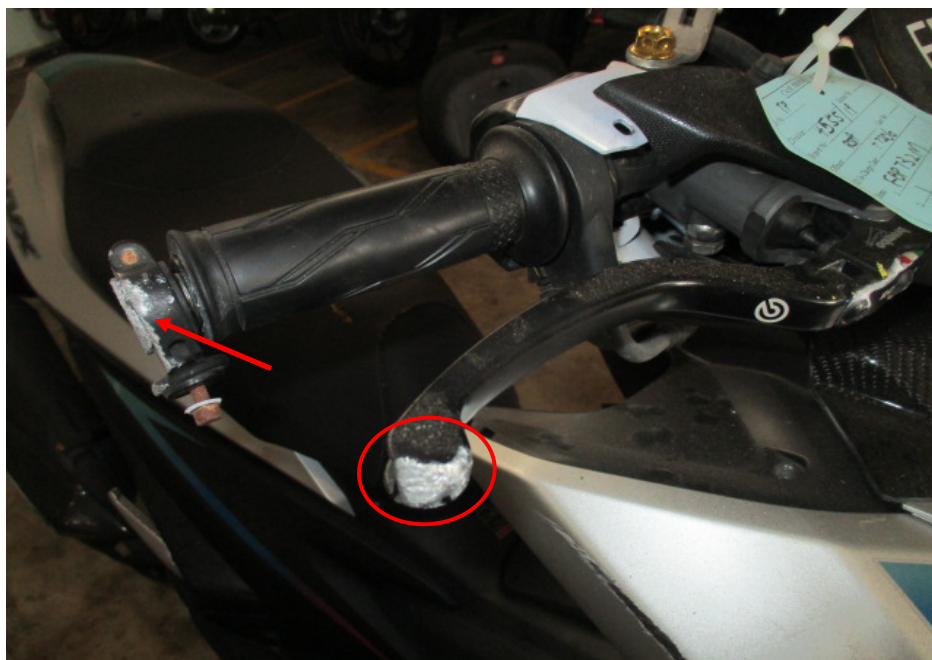
Photo 6 shows a closer view of the front brake lever (circled) and right handlebar end (arrowed) of the Motorcycle which were observed to be damaged due to the accident

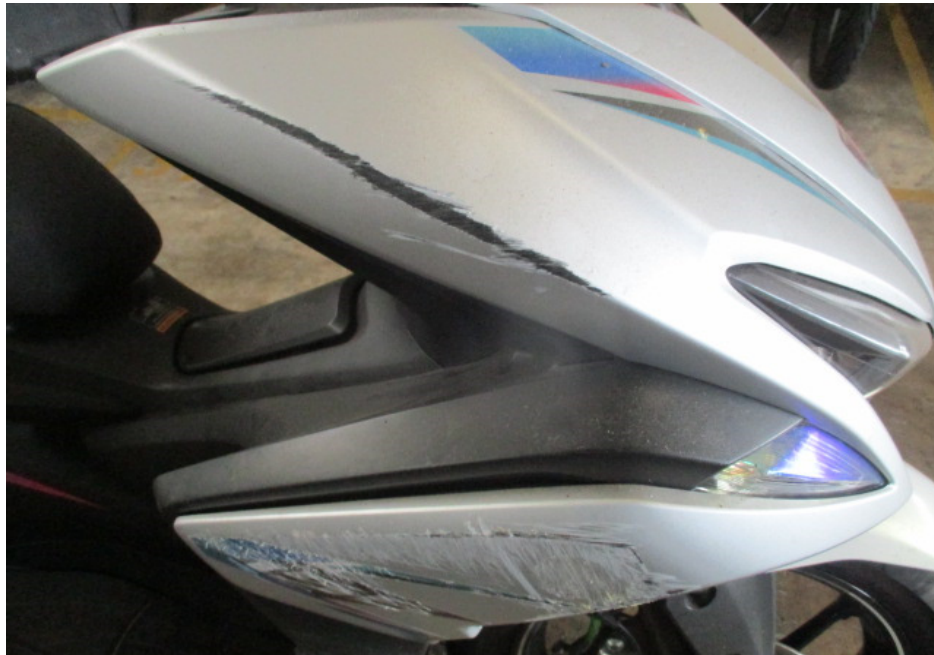
Photo 7 shows a closer view of the right cowling which was amongst the body parts at the front body of the Motorcycle that had sustained damage as a result of the accident.

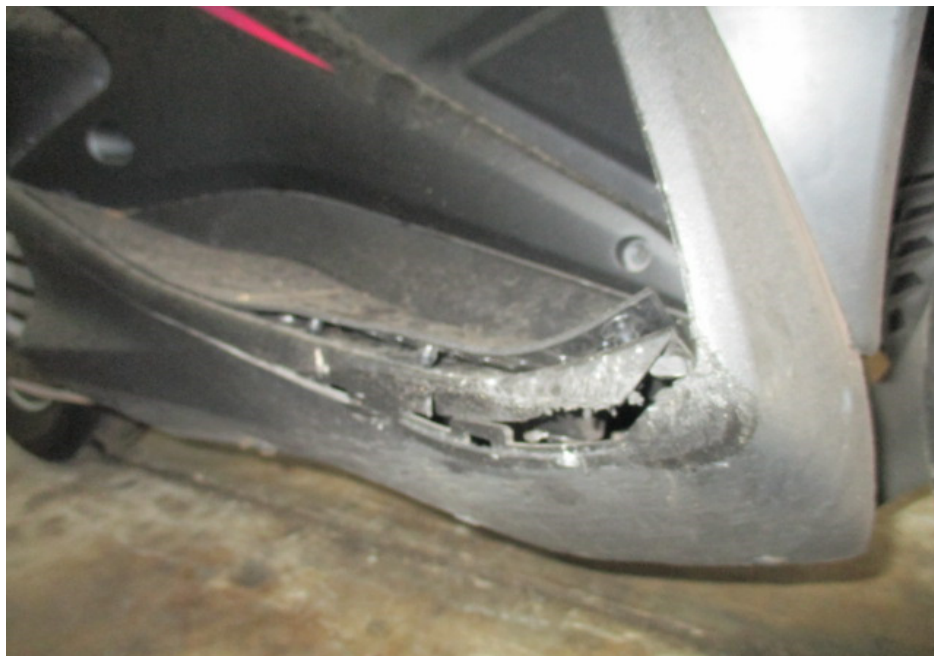
Photo 8 shows a closer view of the right bottom cowling of the Motorcycle which was observed to be damaged due to the accident.

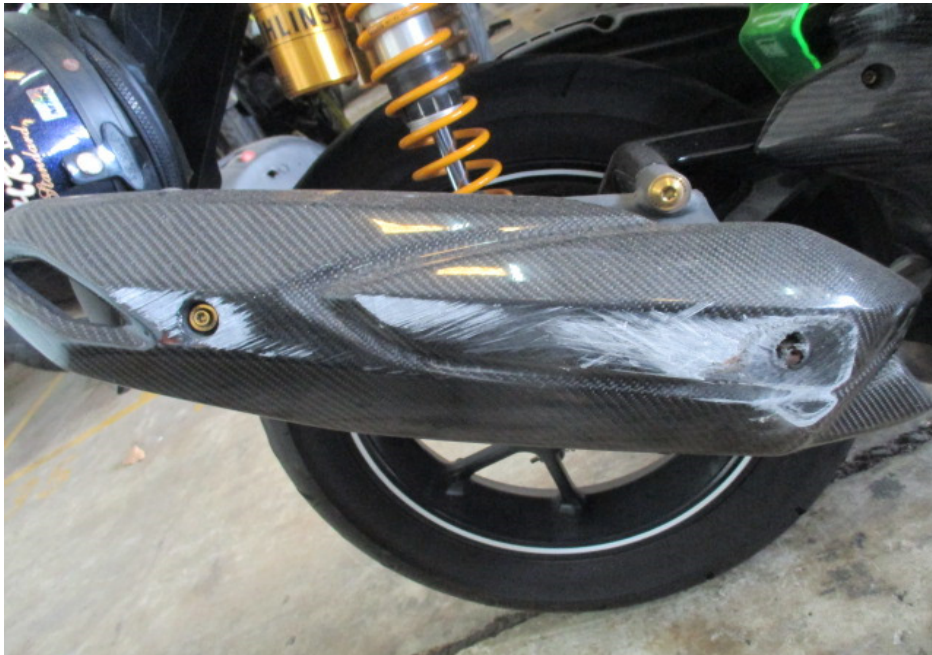
Photo 9 shows a closer view of the exhaust muffler heat shield of the Motorcycle which had sustained damage due to the accident.

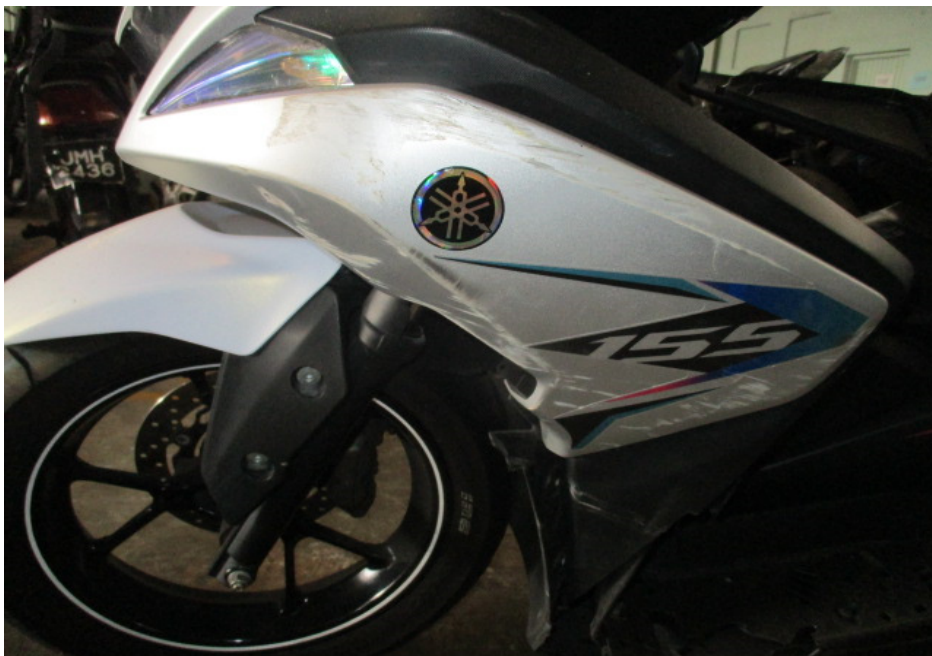
Photo 10 shows a closer view of the left cowling which was amongst the body parts at the front body of the Motorcycle that had sustained damage as a result of the accident.

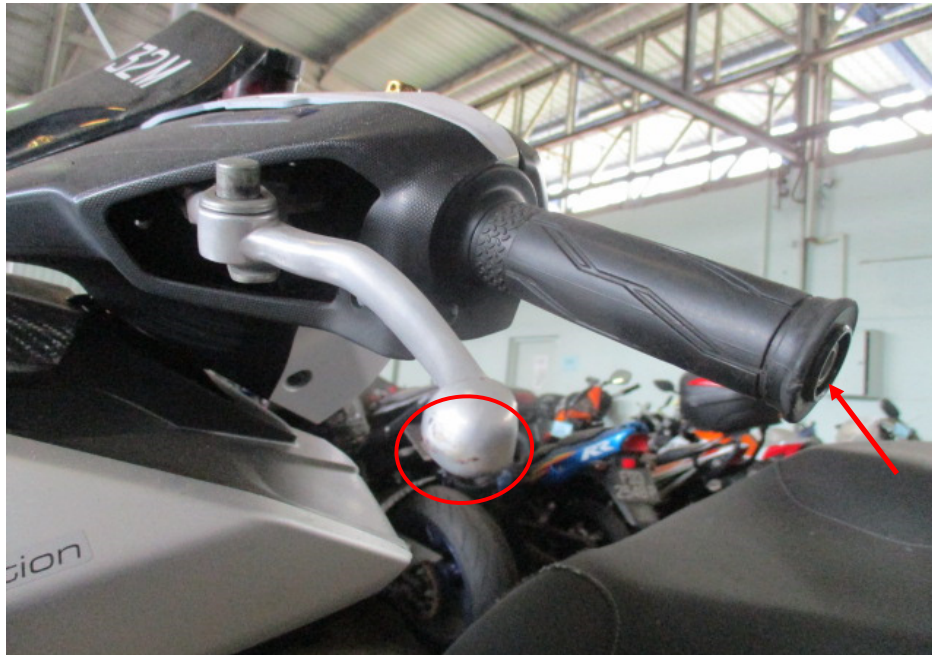
Photo 11 shows a closer view of the rear brake lever (circled) and right handlebar end (arrowed) of the Motorcycle which were observed to be damaged due to the accident

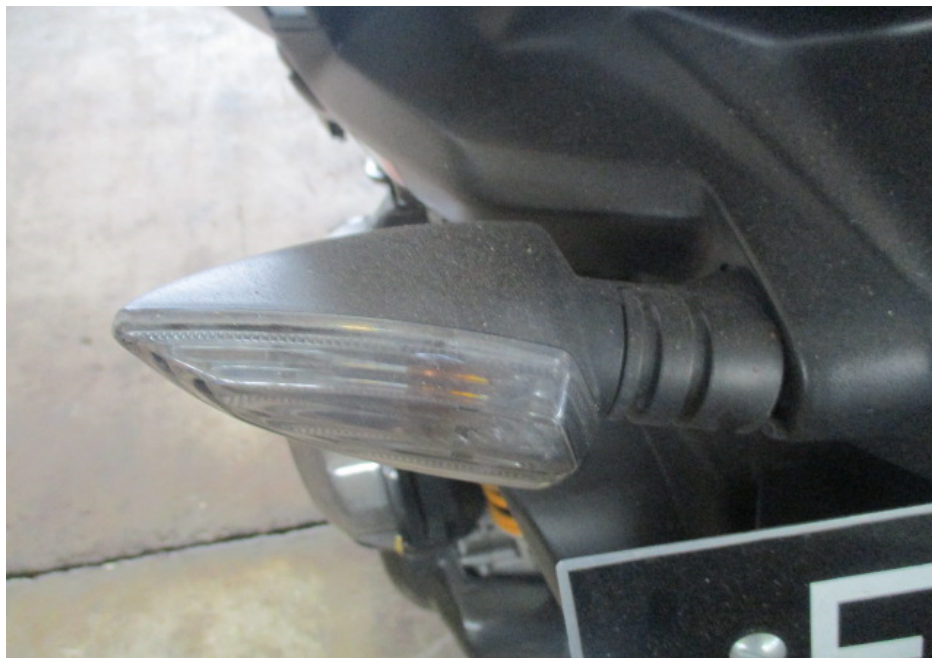
Photo 12 shows the broken left rear signal lamp of the Motorcycle.

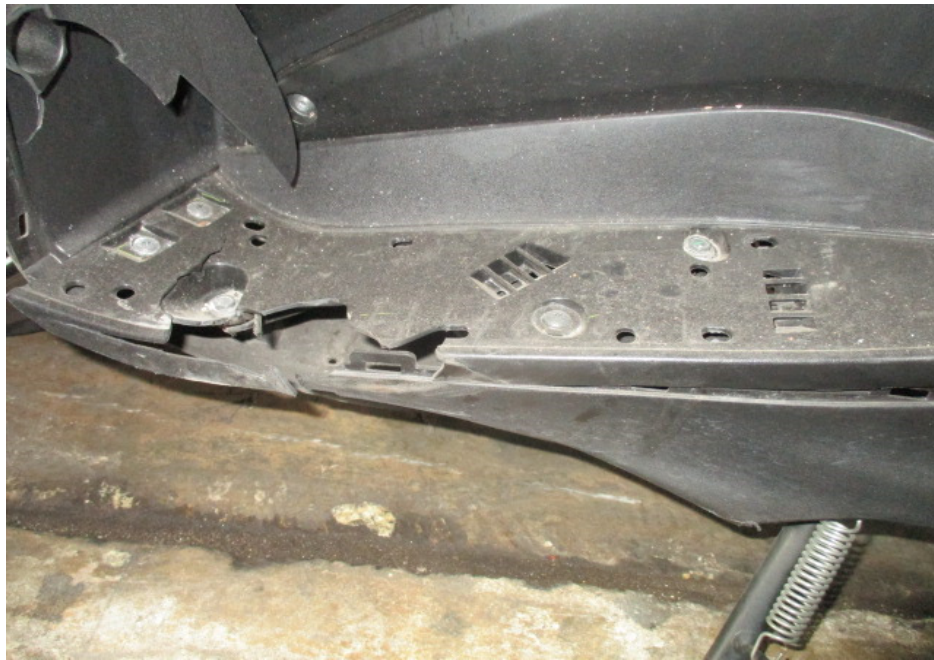
Photo 13 show a closer view of the left bottom cowling of the Motorcycle which was observed to be damaged due to the accident.

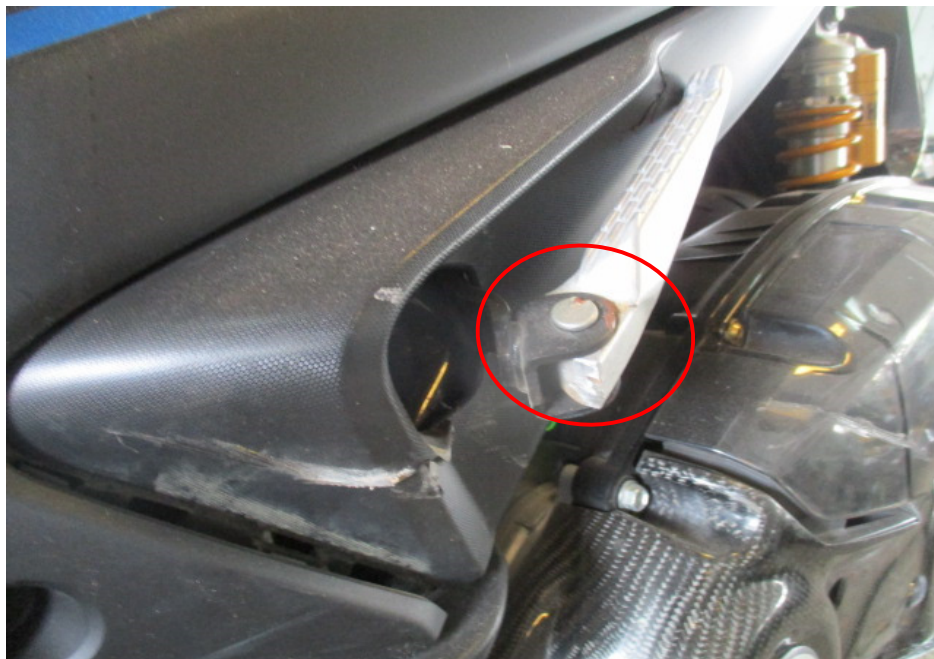
Photo 14 shows a closer view of the grazed left pillion footrest (circled) of the Motorcycle at the time of our inspection.

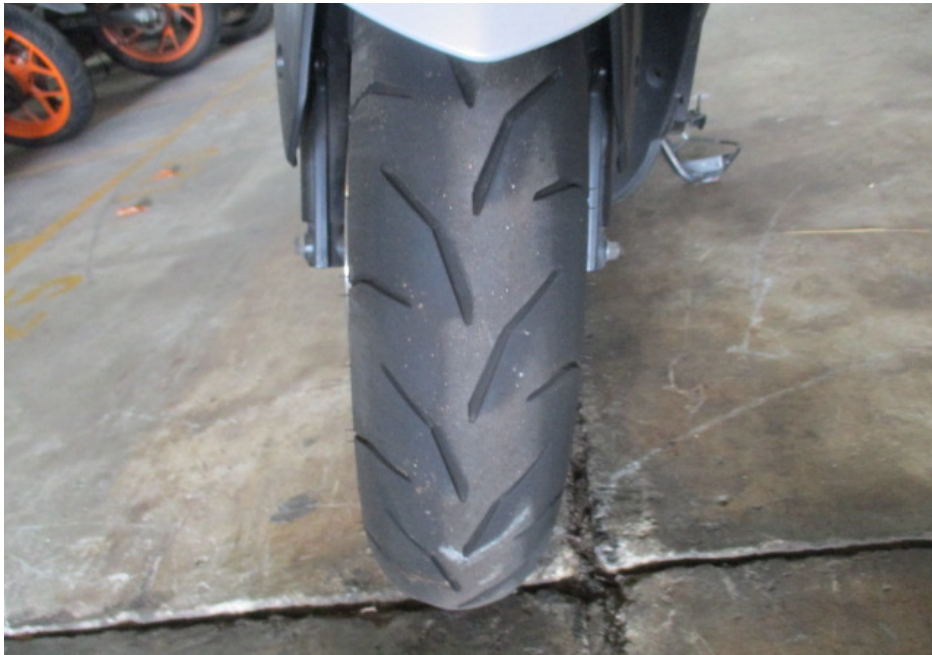
Photo 15 shows the condition of the Motorcycle's front tyre. The front tyre was observed to be in serviceable condition with remaining tread depth of approximately 3mm. There was no tear, burst mark(s) and/or punctured hole(s) on the sidewalls as well as across the tread of the front tyre.

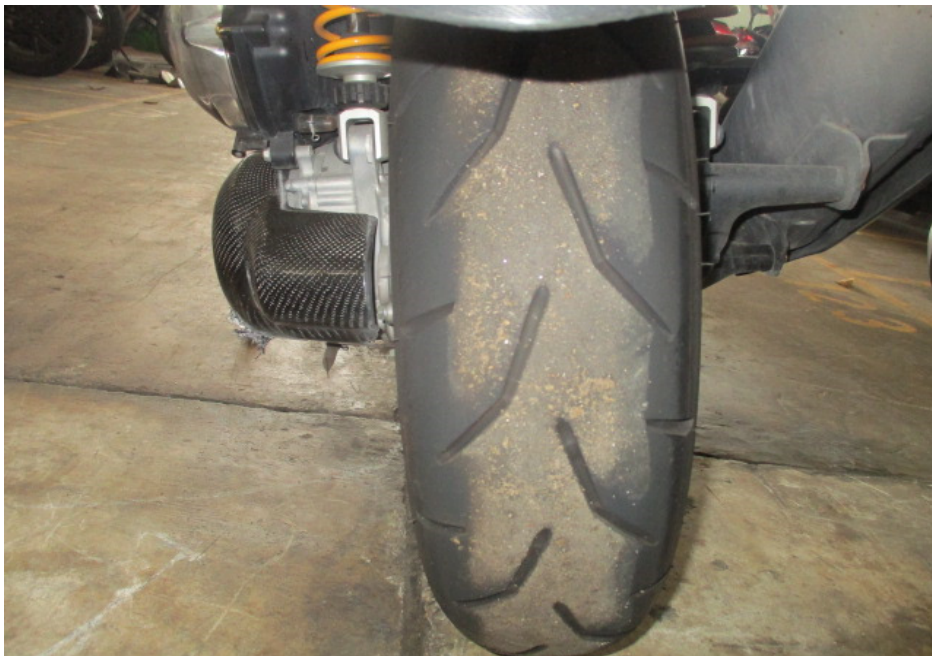
Photo 16 shows the condition of the Motorcycle's rear tyre. The rear tyre was observed to be in serviceable condition with remaining tread depth of approximately 3mm. The tyre was also observed to be sufficiently inflated for vehicular operation. We did not observe any tear, burst mark(s) and/or punctured hole(s) on the sidewalls as well as across the tread of the rear tyre.

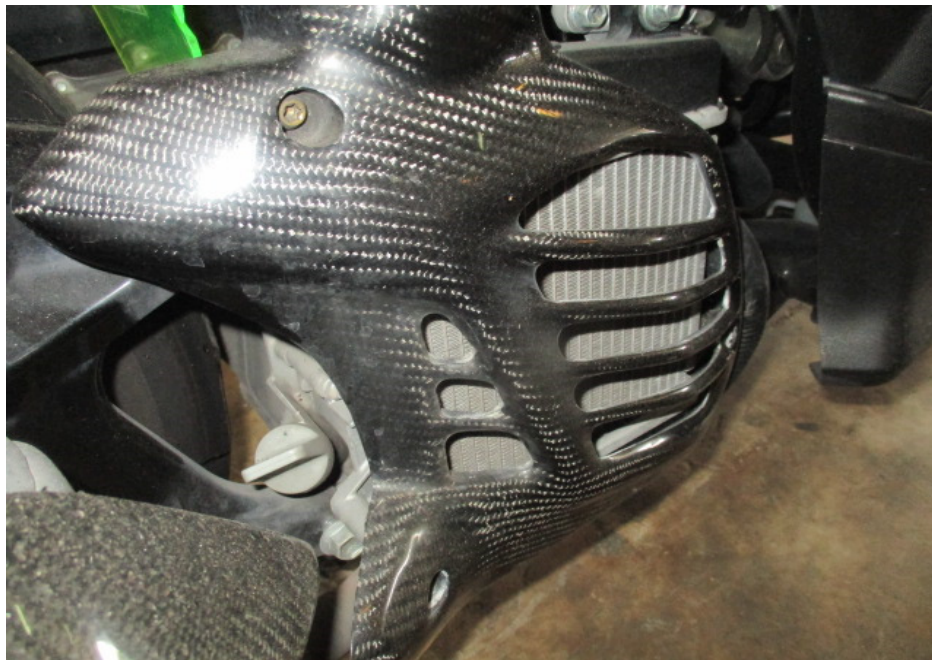
Photo 17 shows the radiator of the Motorcycle at the time of our inspection. The radiator was found to be intact with no visible damage. There was also no sign(s) or indication(s) of fluid leak observed around the radiator of the Motorcycle.

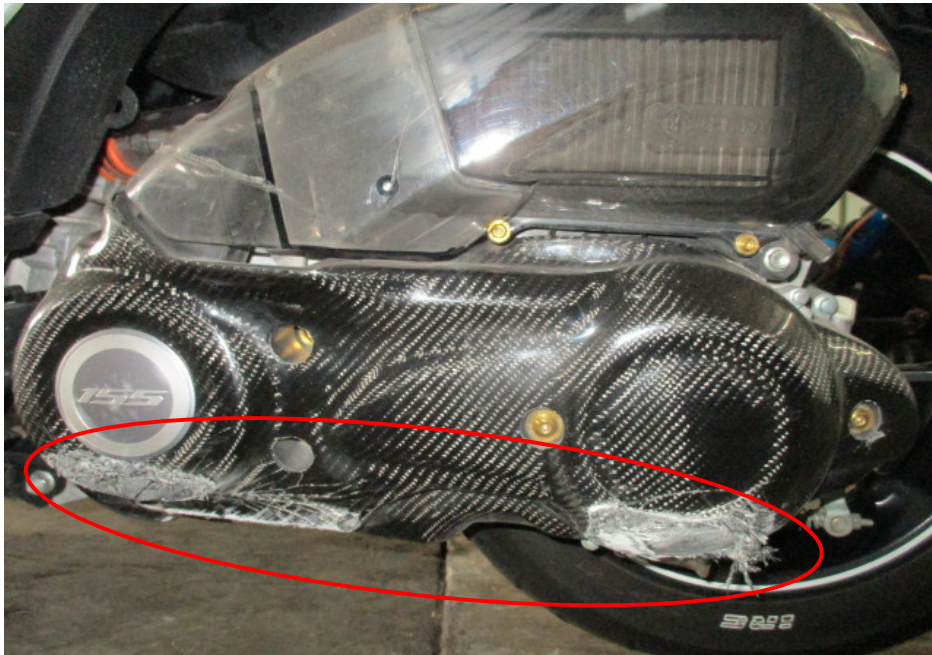
Photo 18 shows the drive train cover of the Motorcycle which had sustained cracks and damages of grazing nature as a result of the accident (circled) however the engine components were still intact.

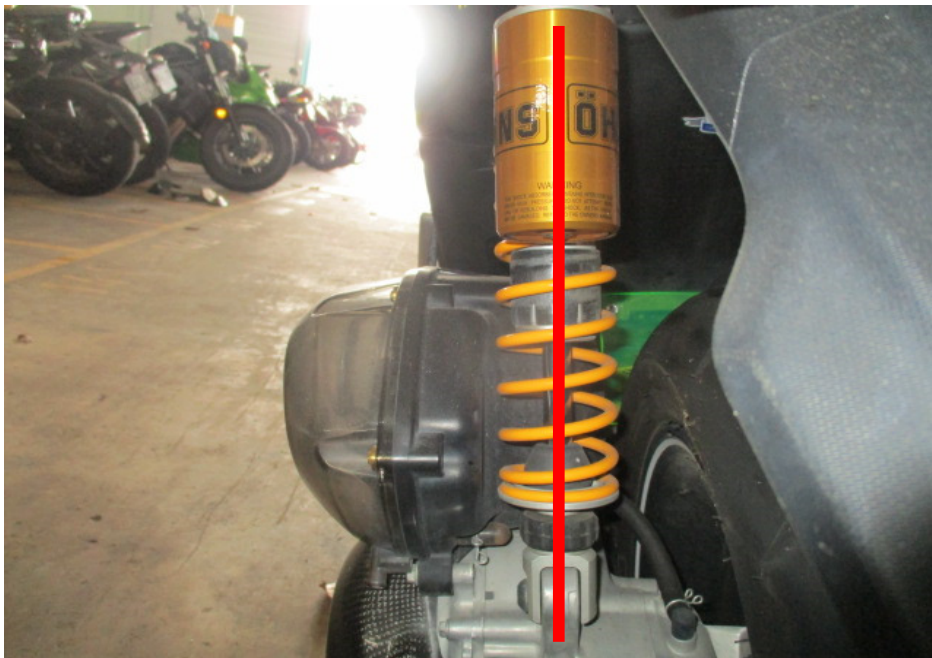
Photo 19 shows the left shock absorber of the Motorcycle which was found to be intact without any misalignment.

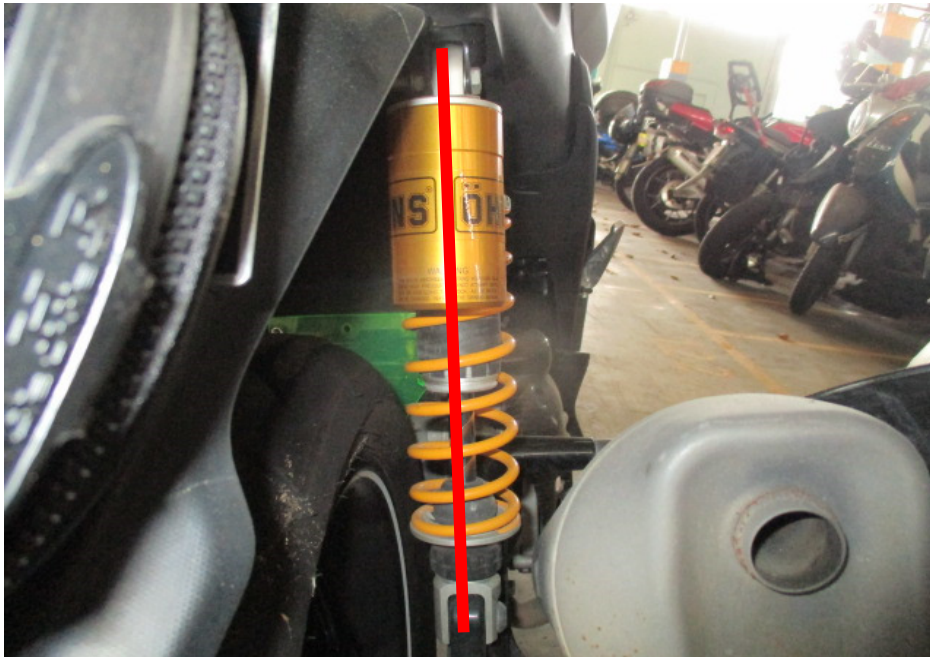
Photo 20 shows the right shock absorber of the Motorcycle which was found to be intact without any misalignment.

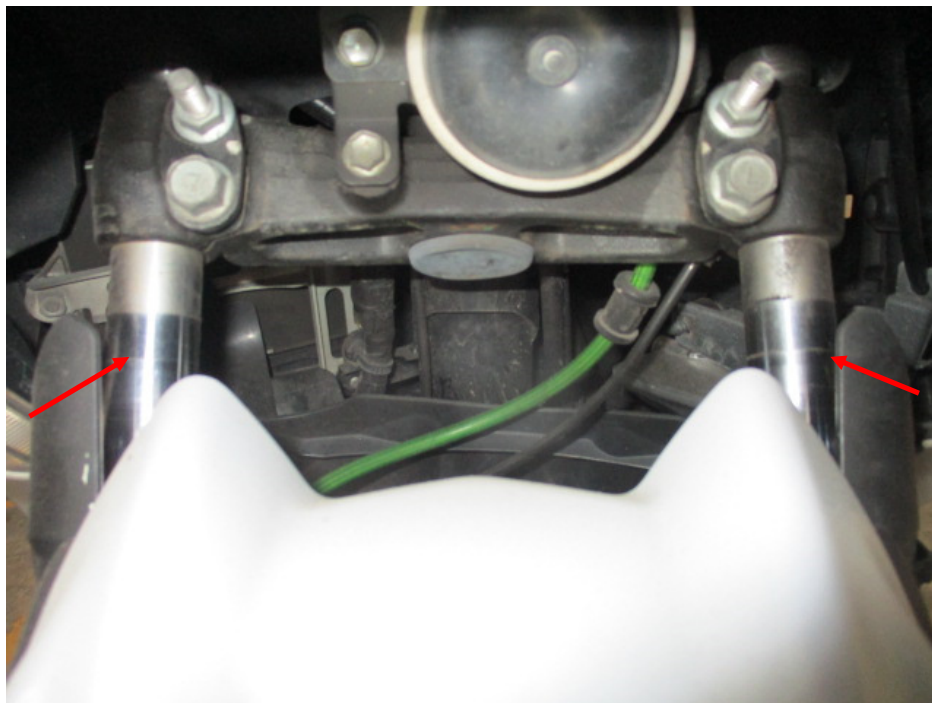
Photo 21 shows the front forks (arrowed) of the Motorcycle. The front forks and fork brackets of the Motorcycle were both found to be intact and undamaged. Turning the Motorcycle's handle bar towards the left and right did not produce any abnormal free play and/or resistance. The steering system of the Motorcycle was in serviceable condition at the time of our inspection.

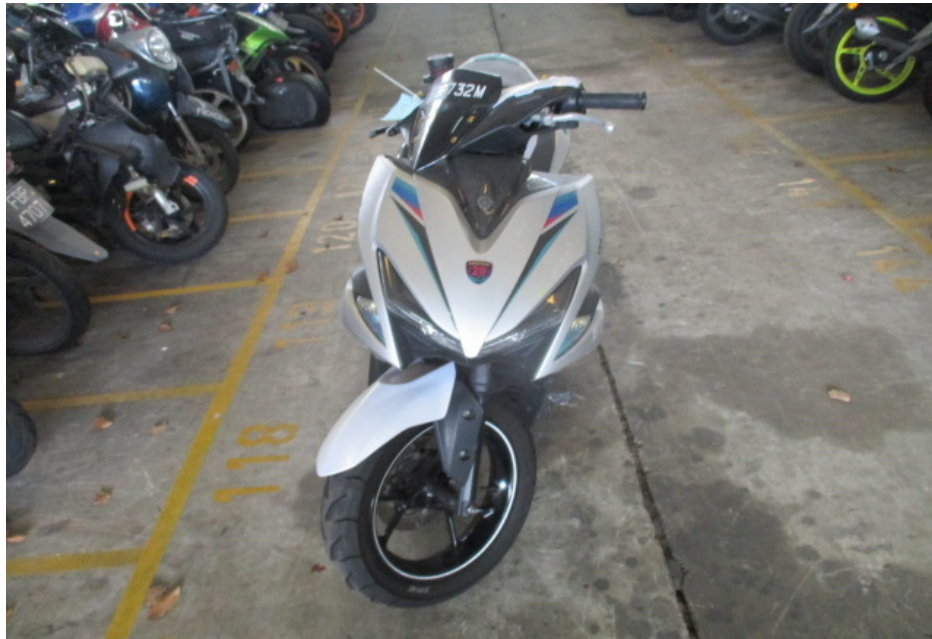
Photo 22 shows the front wheel of the Motorcycle turned towards its full right. Turning the Motorcycle's handle bar towards the left and right did not produce any abnormal free play and/or resistance. This would indicate that the steering system of the Motorcycle was in serviceable condition at the time of our inspection.

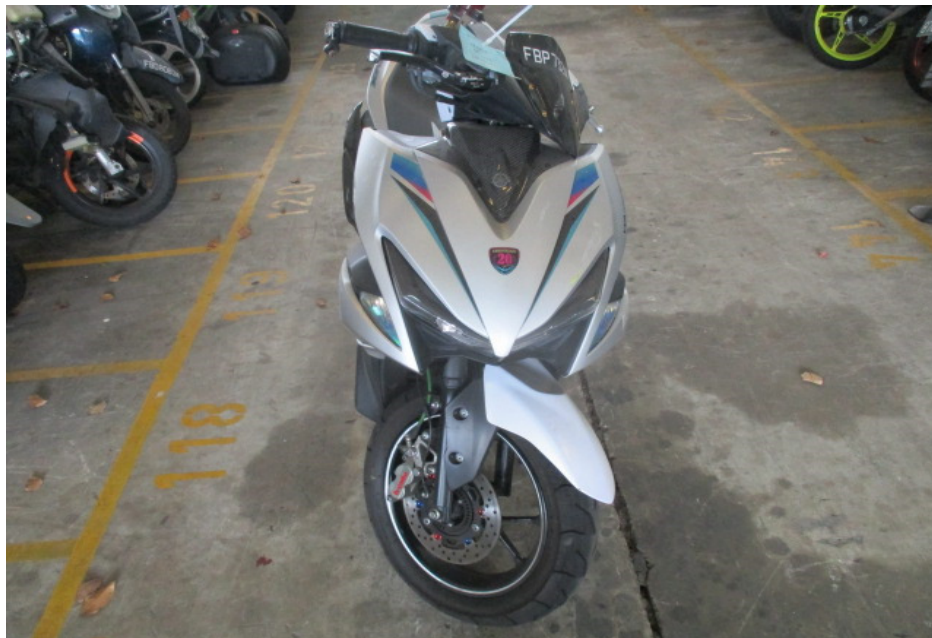
Photo 23 shows the front wheel of the Motorcycle turned towards its full left. Turning the Motorcycle's handle bar towards the left and right did not produce any abnormal free play and/or resistance. This would indicate that the steering system of the Motorcycle was in serviceable condition at the time of our inspection.

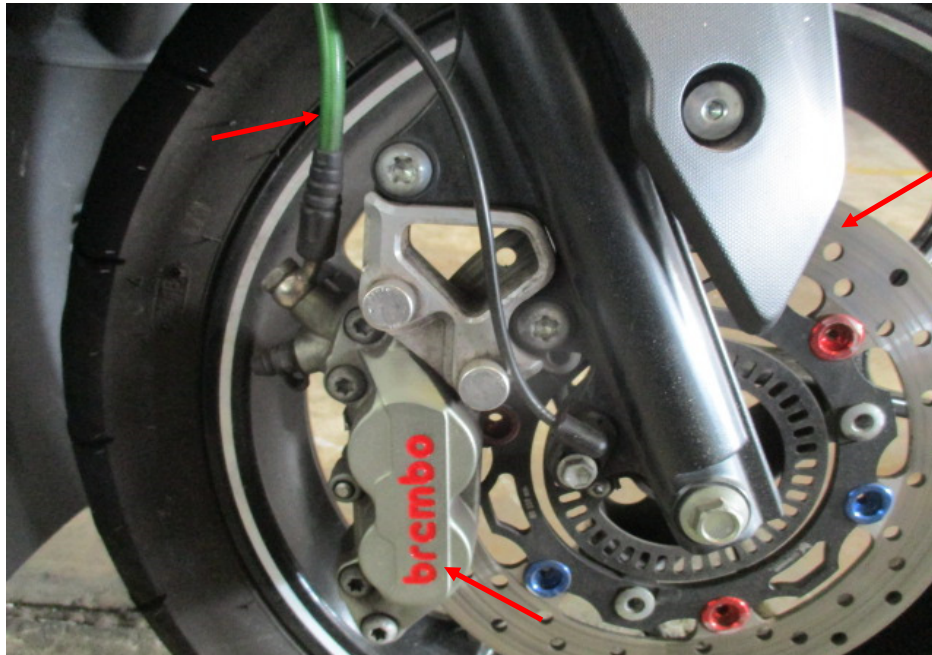
Photo 24 shows a close up view of the front brake caliper, front brake disc and front brake hose (arrowed) of the Motorcycle, which are all part of the components in the hydraulic front brake system of the Motorcycle. Our visual checks of these various components had revealed all to be intact with no visible damage. No leakage of brake fluid was also observed.

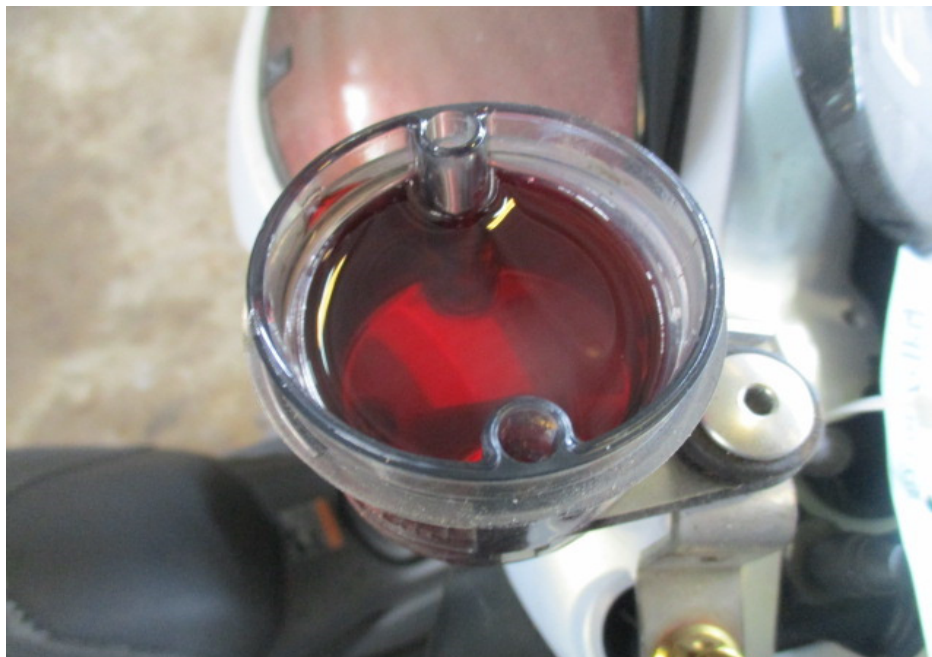
Photo 25 shows a close up view of the brake fluid reservoir for the front brake of the Motorcycle. The brake fluid was observed to be of sufficient level and without contamination for operational purposes.

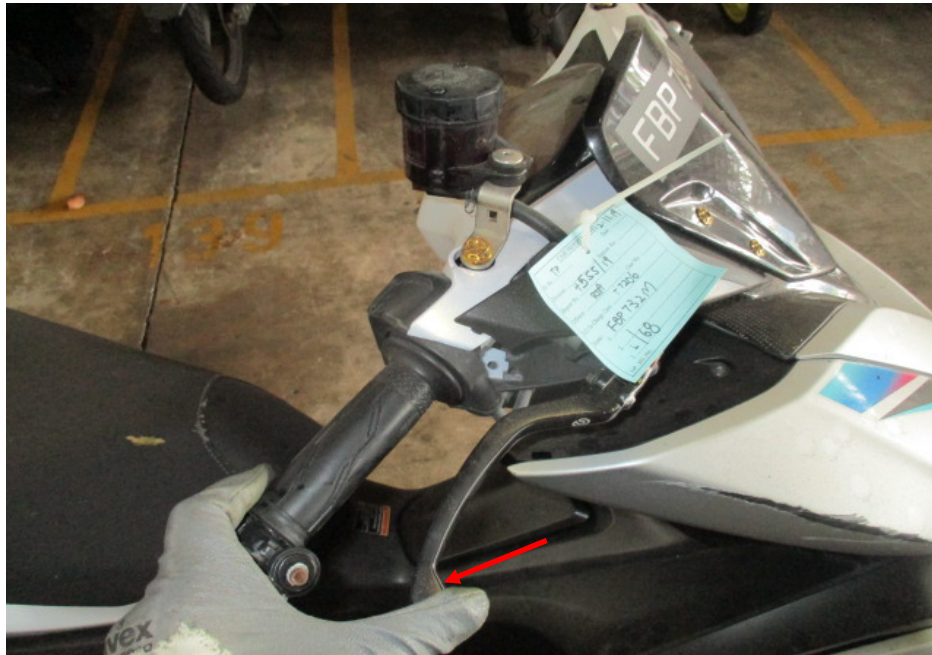
12. Static brake tests conducted on the Motorcycle had appeared to indicate that the brake system of the Motorcycle was in serviceable condition. There was some resistance felt (spongy like feel) upon pressing the front brake lever. This would indicate that there's no leakage of pressure/vacuum in the front brake system.

Photo 26 shows the front brake lever being depressed. There was some resistance felt (spongy like feel) upon pressing the front brake lever (arrowed). This would indicate that there is no leakage of pressure/vacuum in the brake system.

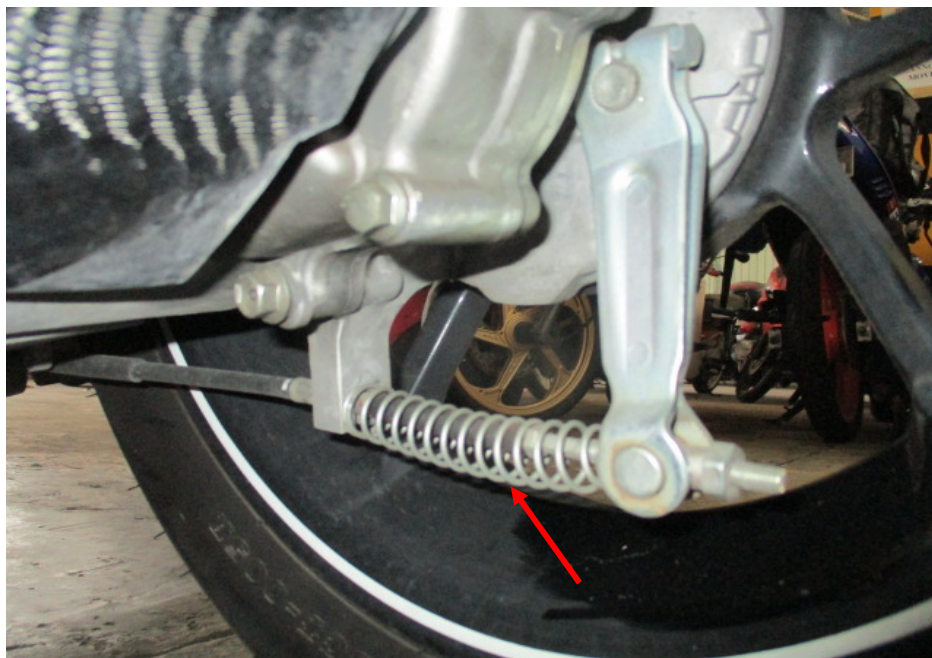
Photo 27 shows the rear wheel of the Motorcycle. The type of brake system for the rear wheel was of a mechanical type, controlled by the brake foot pedal of the Motorcycle. Our checks of the cable (arrowed), spring and drum which are all part of the components in the rear brake system of the Motorcycle reveal all to be intact and without damage.
