Your Ref: S9M0277K  
Our Ref : CI/ASM19021204/D

### **AUTOMOBILE INSPECTION REPORT OF INSURED VEHICLE SLH 6518A**

Vehicle Registration No. : SLH 6518A  
Make / Model : Volkswagen Golf R 2.0L 5DR  
Chassis No : WVVZZZ1KZBW130168  
Year of Registration : 2011 (January)  
Mileage : 165,587km

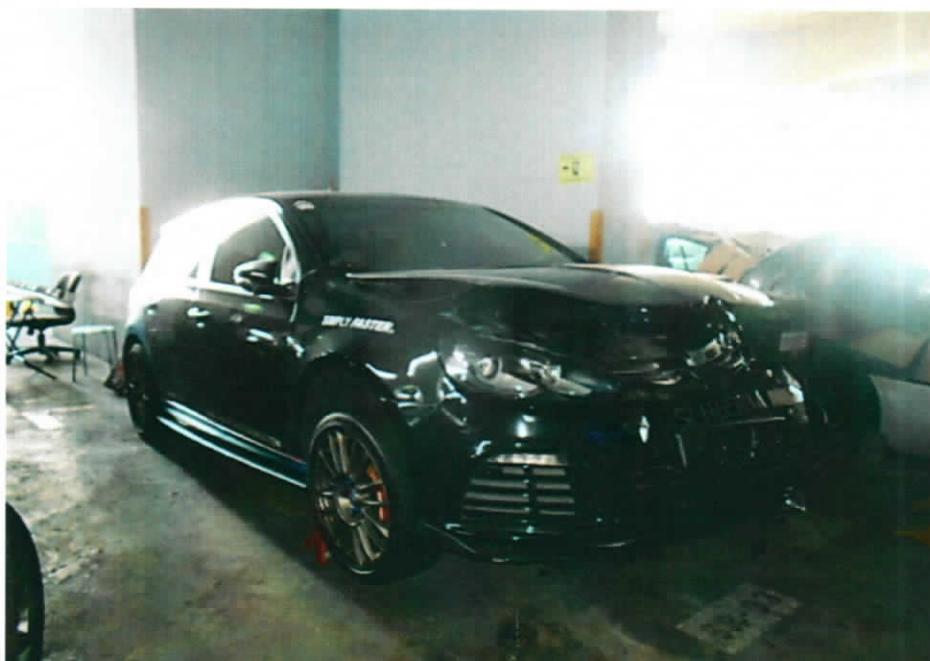
**Photo 1** shows the front right body of the insured vehicle at the time of my inspection. The insured vehicle sustained relatively moderate damage at its frontal portion. Its front bumper and front bonnet were amongst the parts that were found have to be damaged.

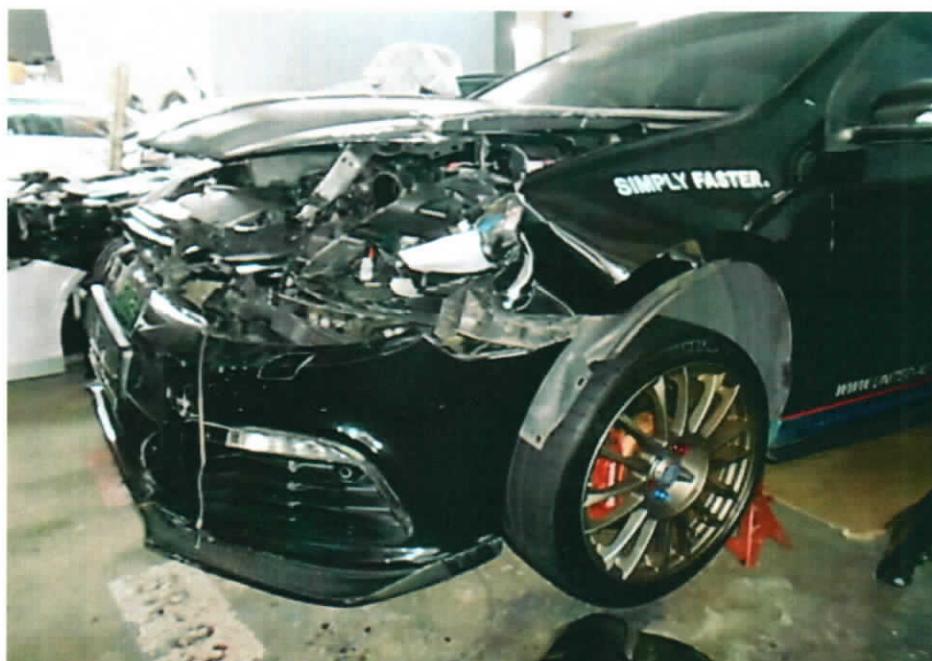
**Photo 2** shows the front left body of the insured vehicle at the time of my inspection. The insured vehicle sustained relatively moderate damage at its frontal portion. Without dismantling of any exterior body parts, I had observed damage to its front bumper, front left headlamp, front left fender and front bonnet amongst others.

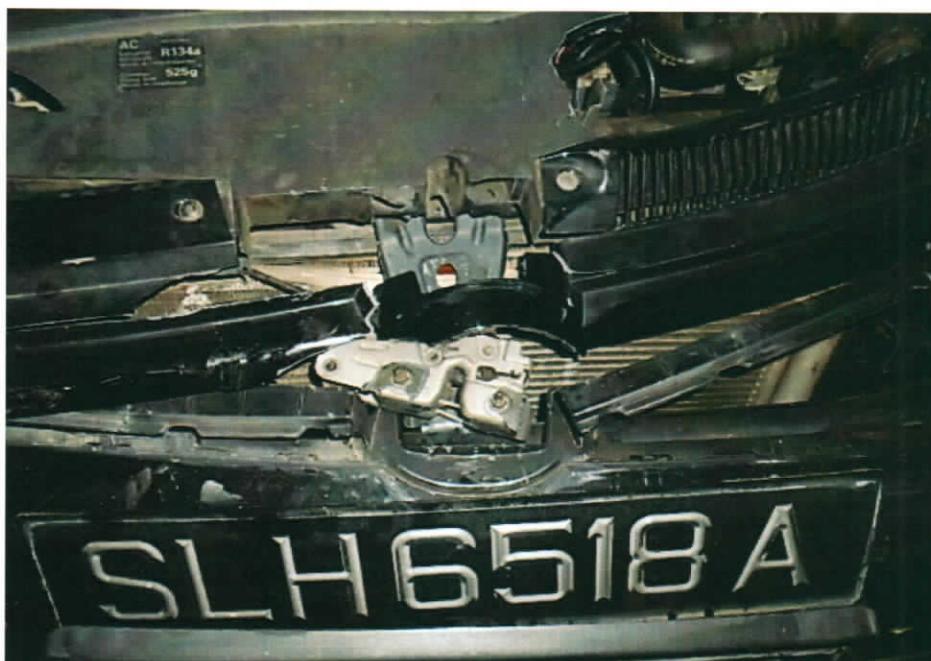
**Photo 3** shows the damage to the front grille, front number plate and front bonnet lock of the insured vehicle. These were amongst the parts at the frontal portion of the insured vehicle that were observed to be damaged.

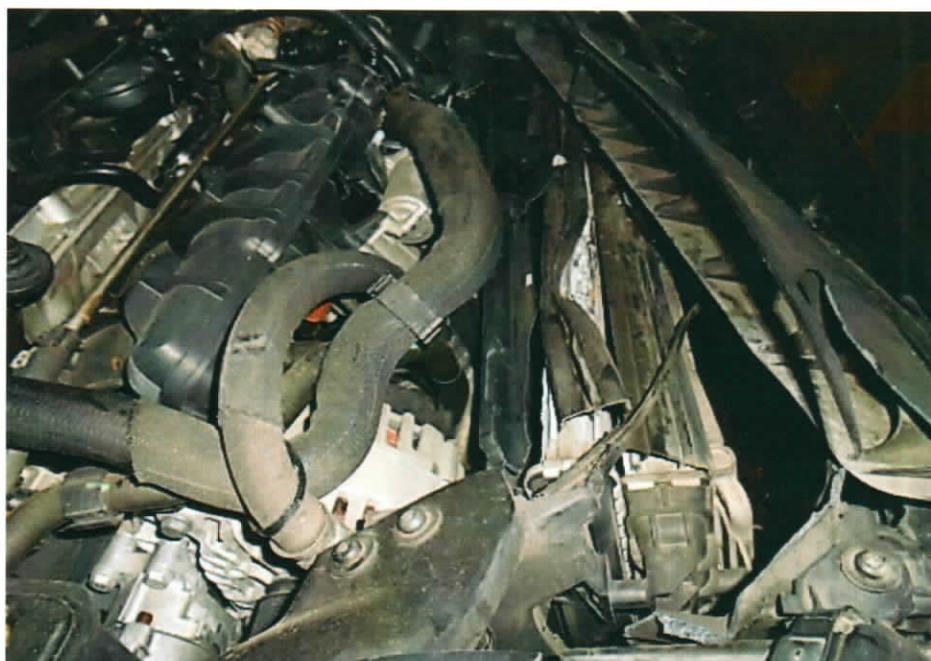
**Photo 4** shows the aircon condenser, radiator and cooling fan of the insured vehicle pushed inwards. These were amongst the parts at the frontal portion of the insured vehicle that were observed to be damaged.

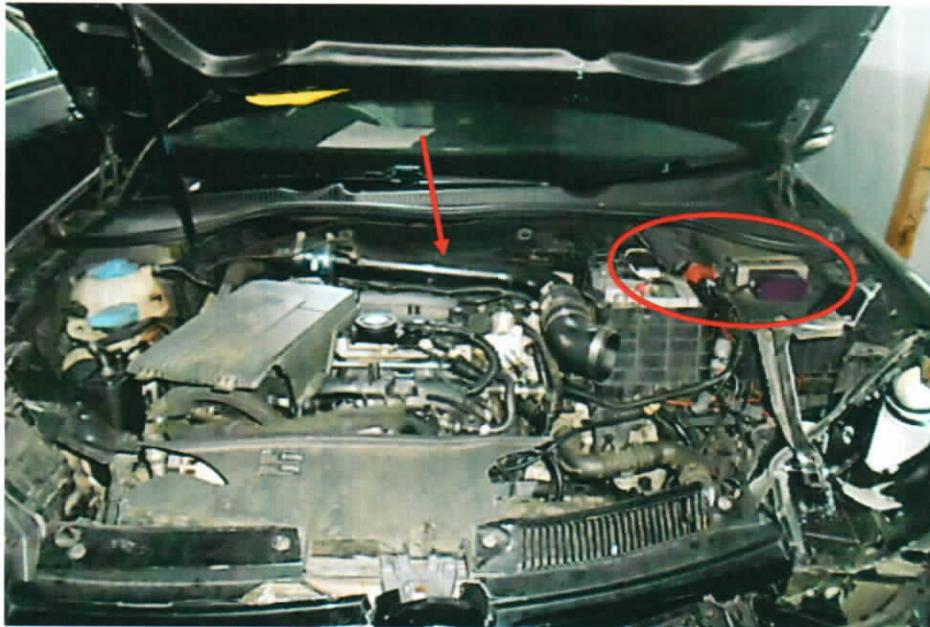
Photo 5 shows a general view of the engine compartment of the insured vehicle. Several modifications and additional non-standard parts were found fitted. This includes an aftermarket air intake system with piping (arrowed) and several additionally fitted electronic components (circled).

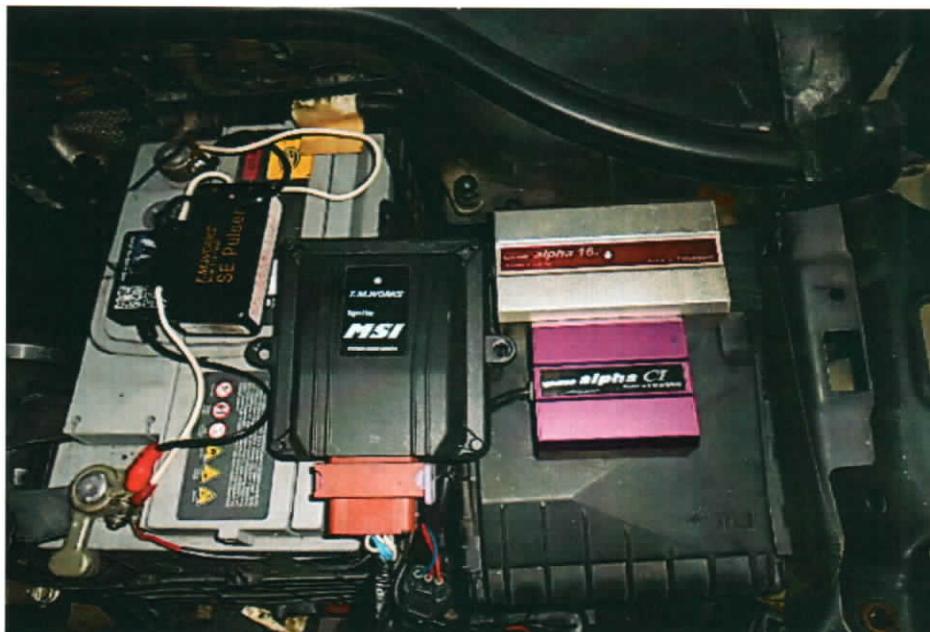
Photo 6 shows a general view of the additionally fitted electronic components that were found inside the engine compartment of the insured vehicle.

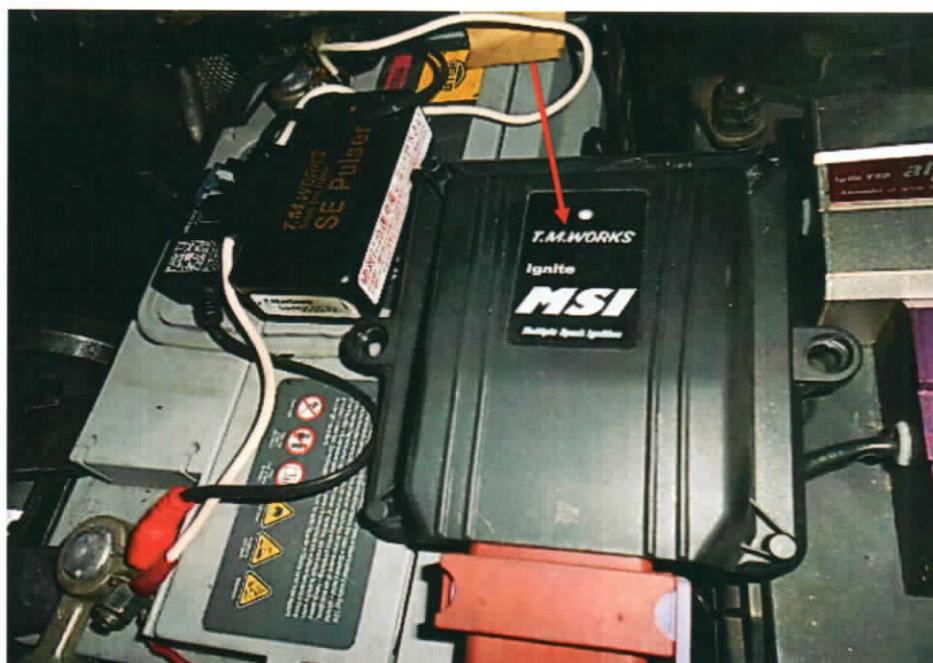
Photo 7 shows a closer view of some of the additionally fitted electronic components that were found inside the engine compartment of the insured vehicle. From my observations, the brand of the components was all T.M. Works (arrowed); and from my research these electronic components are collectively advertised to be able to improve acceleration response whilst improving fuel efficiency through stabilization of the ignition coil system of a motor car.

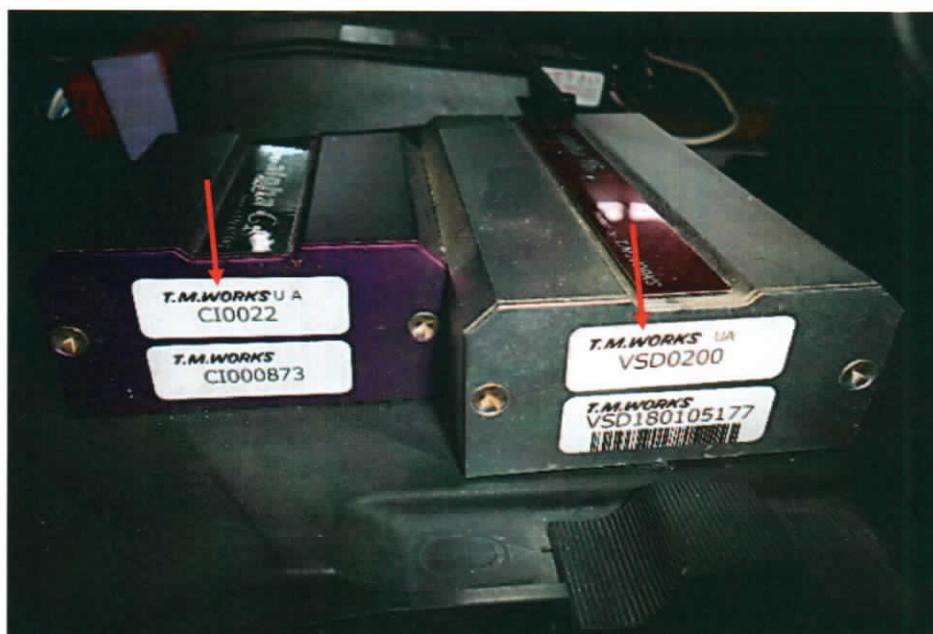
Photo 8 shows a closer view of the other additionally fitted electronic components inside the engine compartment of the insured vehicle. The brand of the components was all T.M. Works (arrowed). Collectively, these electronic components improve the acceleration response whilst improving fuel efficiency through stabilization of the ignition coil system of the insured vehicle.

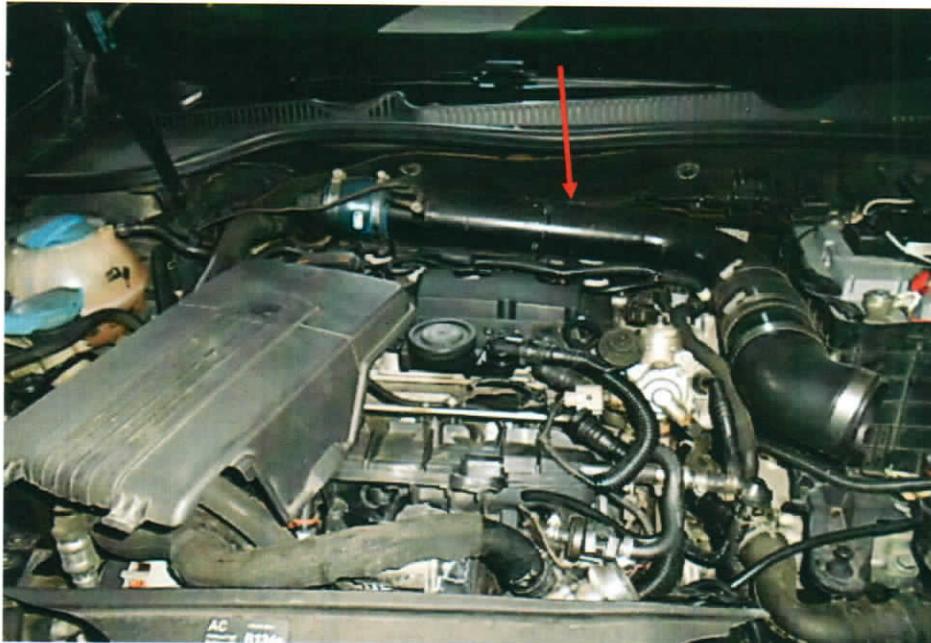
**Photo 9** shows the aftermarket air intake system with piping (arrowed) that was fitted on the insured vehicle at the time of my inspection. Although the air-filter was observed to be dislodged however, from the silicon type piping of the air intake system, it can be established that the air intake system of the insured vehicle was non-original. This air intake system is LTA compliant. The overall engine performance of the insured vehicle will be improved.

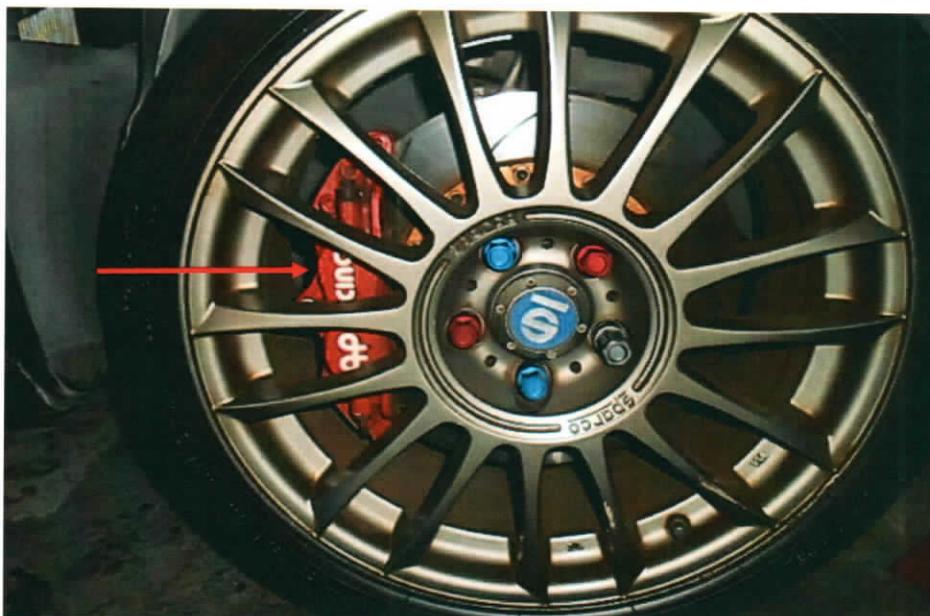
**Photo 10** shows the aftermarket front brake caliper (arrowed) that was fitted on the front left wheel of the insured vehicle. The front brake system of the insured vehicle was observed to be of an aftermarket brand.

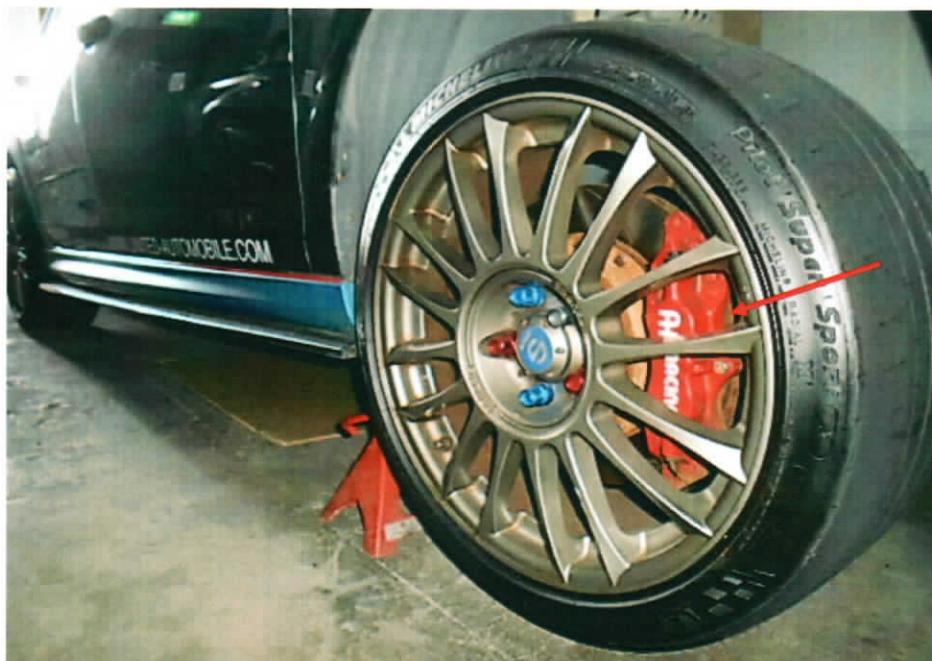
**Photo 11** shows the aftermarket front brake caliper (arrowed) that was fitted on the front right wheel of the insured vehicle. The front brake system of the insured vehicle is LTA compliant. The overall braking efficiency will be enhanced.

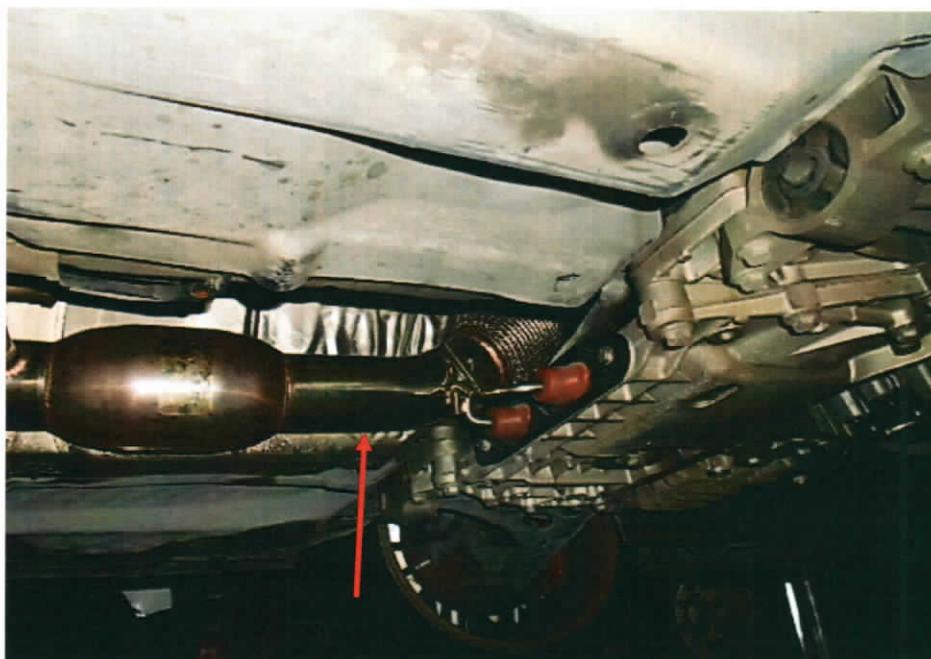
**Photo 12** shows the exhaust pipe (arrowed) that was fitted on the insured vehicle at the time of my inspection. This was the section at the front, at the exhaust manifold side of the insured vehicle. From my observations, the exhaust system fitted on the insured vehicle was a straight through exhaust system and is not LTA compliant.

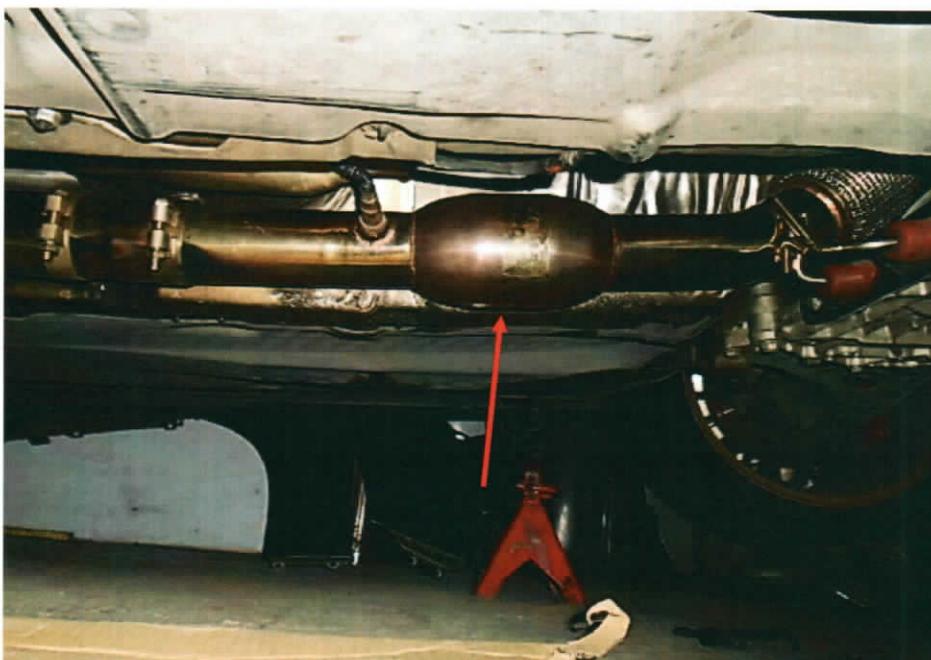
**Photo 13** shows the exhaust pipe that was fitted on the insured vehicle at the time of my inspection. This was at the centre section. The centre catalytic converter (arrowed) was observed to be of non-original type. From my observations, the exhaust system fitted on the insured vehicle was a straight through exhaust system and is not LTA compliant.

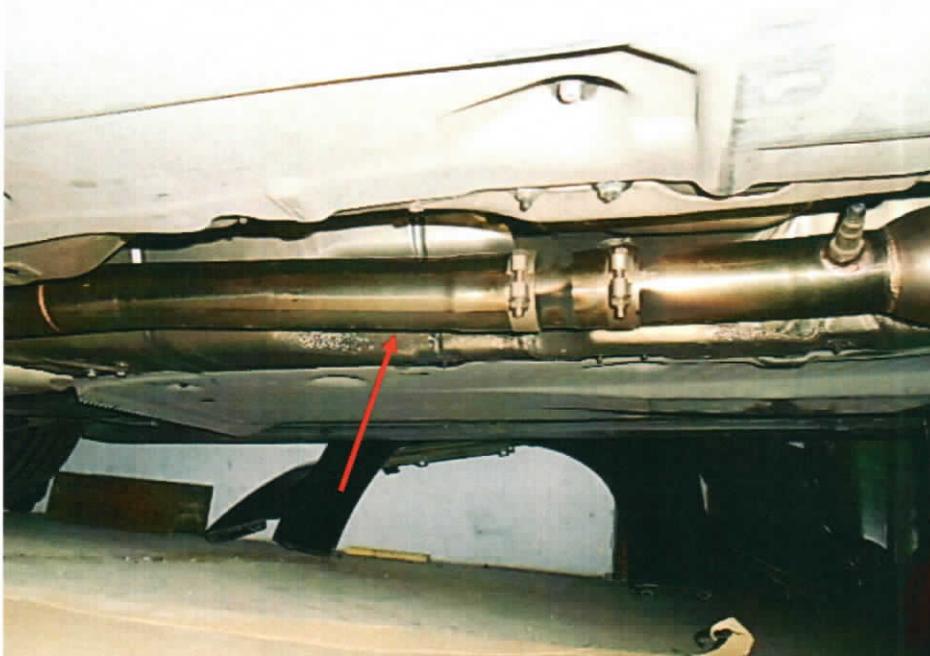
**Photo 14** shows the exhaust pipe (arrowed) that was fitted on the insured vehicle at the time of my inspection. This was at the centre section. From my observations, the exhaust system fitted on the insured vehicle was a straight through exhaust system and is not LTA compliant.

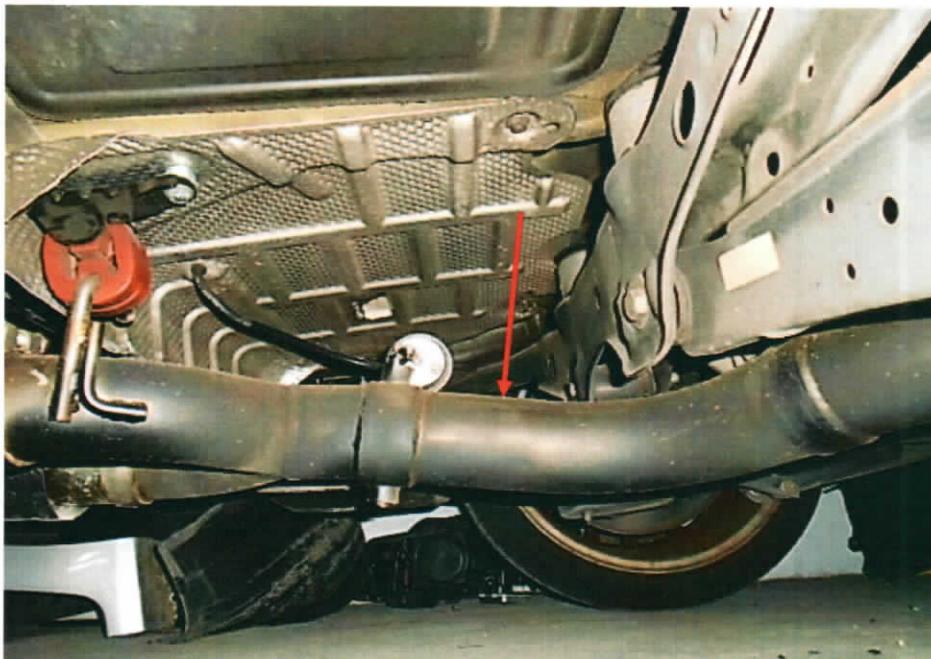
**Photo 15** shows the exhaust pipe (arrowed) that was fitted on the insured vehicle at the time of my inspection. This was at the rear section where it was noted that there was no rear silencer fitted. From my observations, the exhaust system fitted on the insured vehicle was a straight through exhaust system and is not LTA compliant.

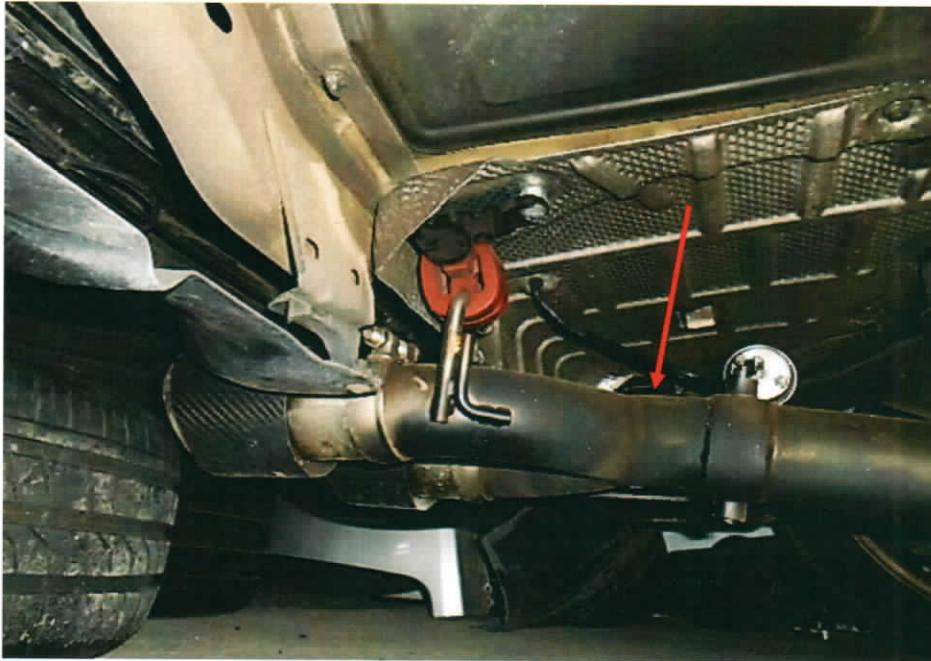
**Photo 16** shows the exhaust pipe (arrowed) that was fitted on the insured vehicle at the time of my inspection. This was at the tailpipe section, at the rear of the insured vehicle. It was noted that there was no rear silencer fitted. From my observations, the exhaust system fitted on the insured vehicle was a straight through exhaust system and is not LTA compliant.

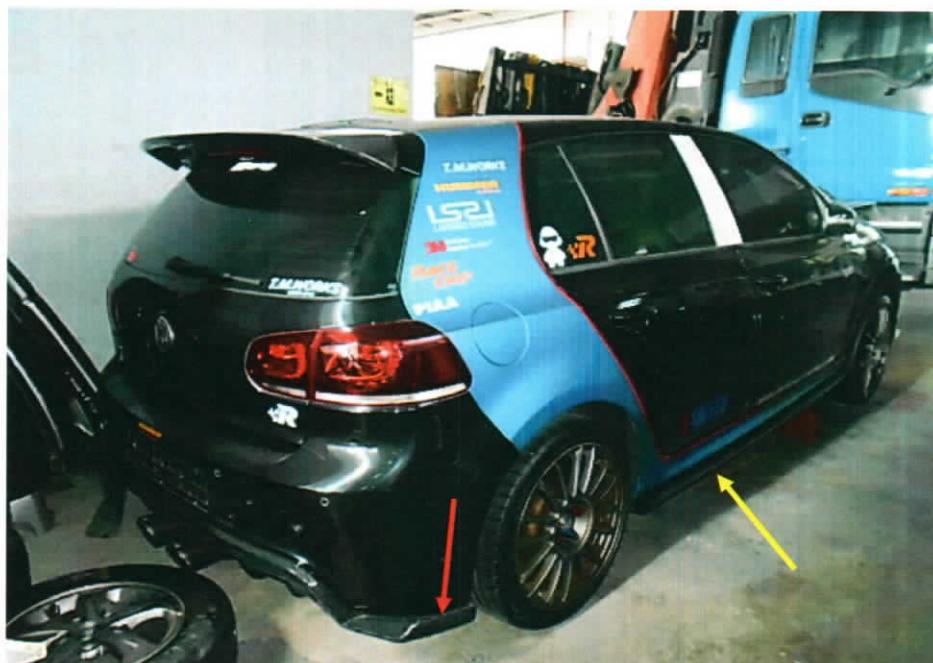
**Photo 17** shows the rear right body of the insured vehicle. Exteriously, the insured vehicle was fitted with a full set of body kit, which includes a front bumper lower spoiler, rear bumper lower spoiler (red arrow) and side skirts (yellow arrow). These are all LTA complaint and generally referred to as cosmetic type of modifications.

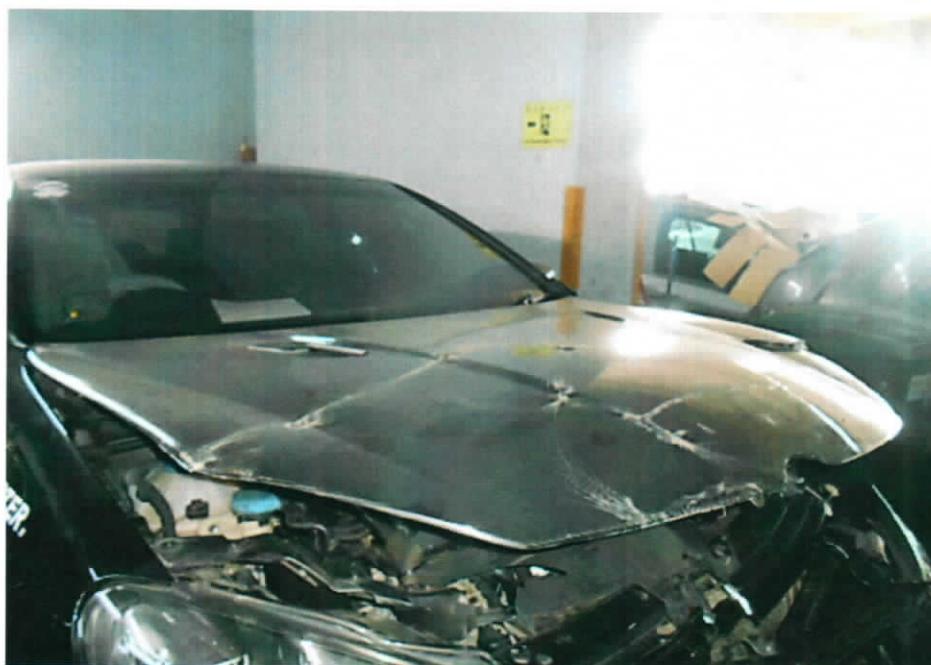
**Photo 18** shows the carbon fiber front bonnet that was fitted on the insured vehicle. The front bonnet was non-original but is LTA complaint. A cosmetic type of modification.
