Your Ref: Honda Engine  
(number R18A1748243)  
Our Ref : CI/TP19021207/D

02 December 2019

### **INSPECTION REPORT OF A HONDA ENGINE WITH NUMBER R18A1748243**

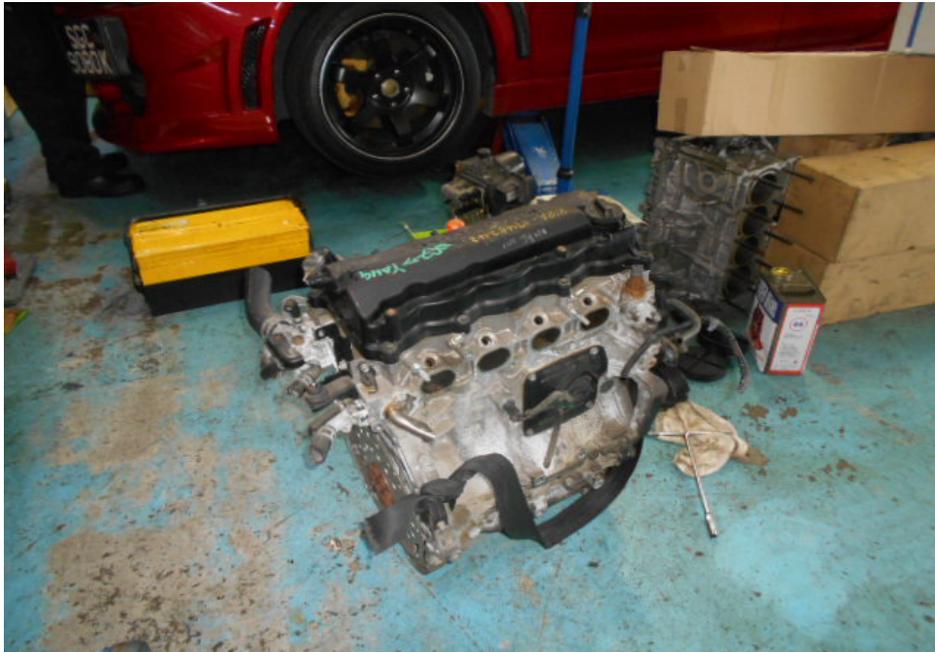
**Photo 1** shows a general view of the Honda engine that I had inspected. The Honda engine was observed to be a used engine and was not fitted on any motor car. My visual examination of the engine housing revealed the housing to be of serviceable/satisfactory condition. There was no crack and/or hole observed on the engine housing.

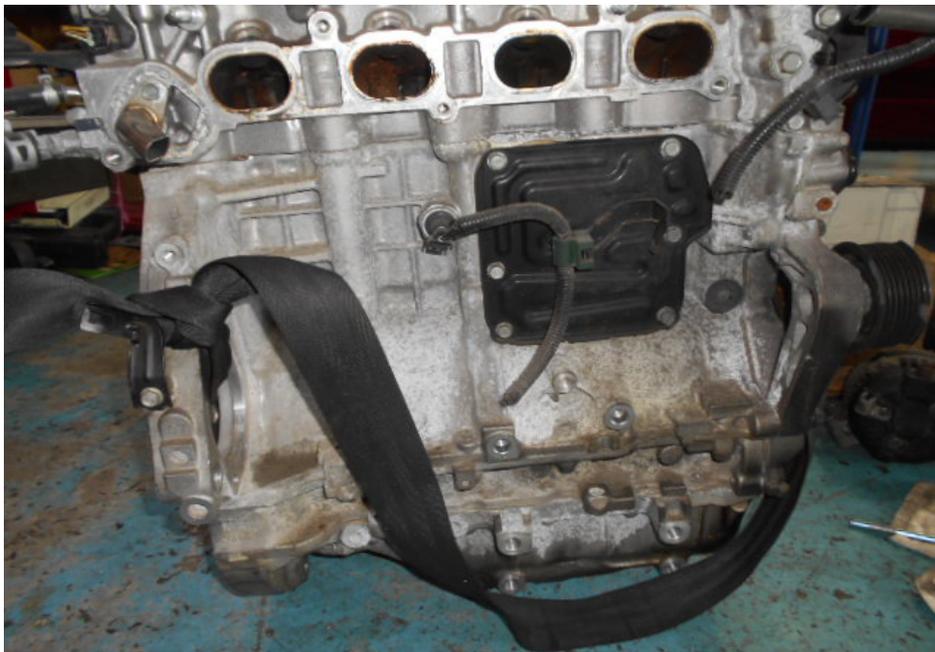
**Photo 2** shows a closer view of the Honda engine that I had inspected. My visual examination of the engine housing revealed the housing to be of serviceable/satisfactory condition. There was no crack and/or hole observed on the engine housing.

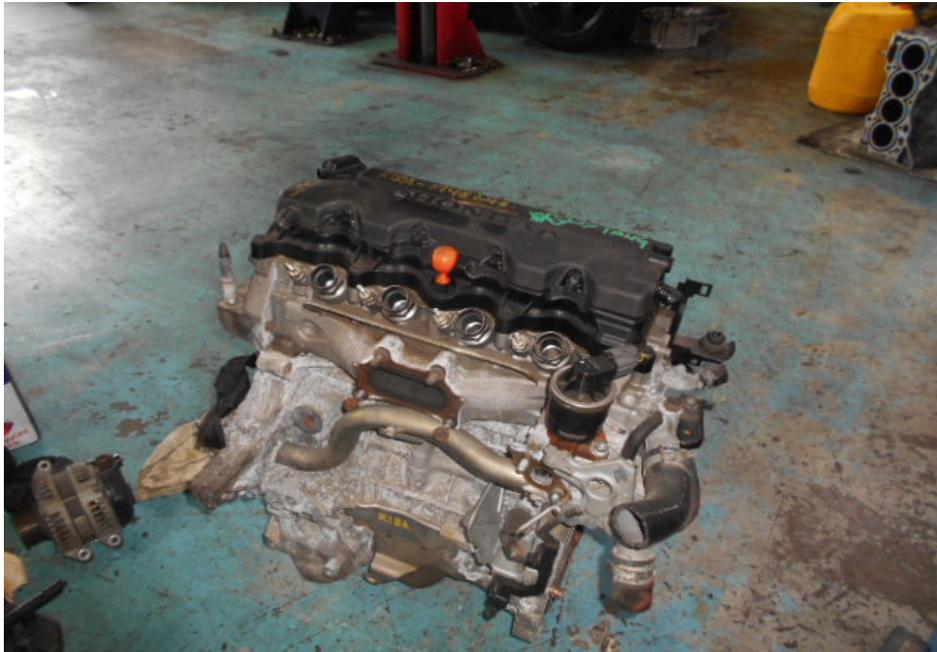
**Photo 3** shows a general view of the Honda engine that I had inspected. My visual examination of the engine housing revealed the housing to be of serviceable/satisfactory condition. There was no crack and/or hole observed on the engine housing.

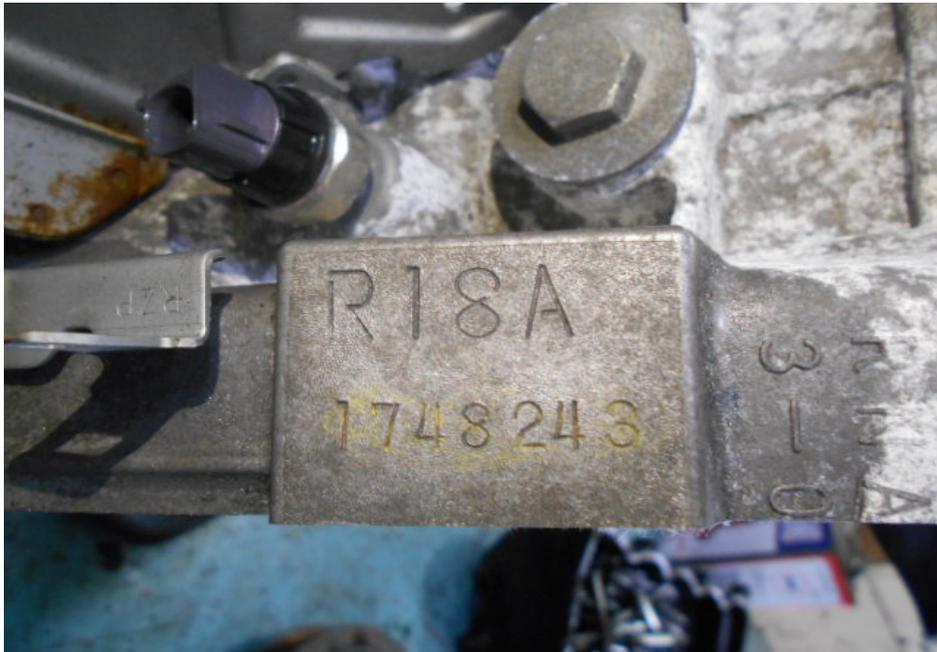
**Photo 4** shows the engine number engraved on the housing of the Honda engine that I had inspected. The engine number was R18A1748243.

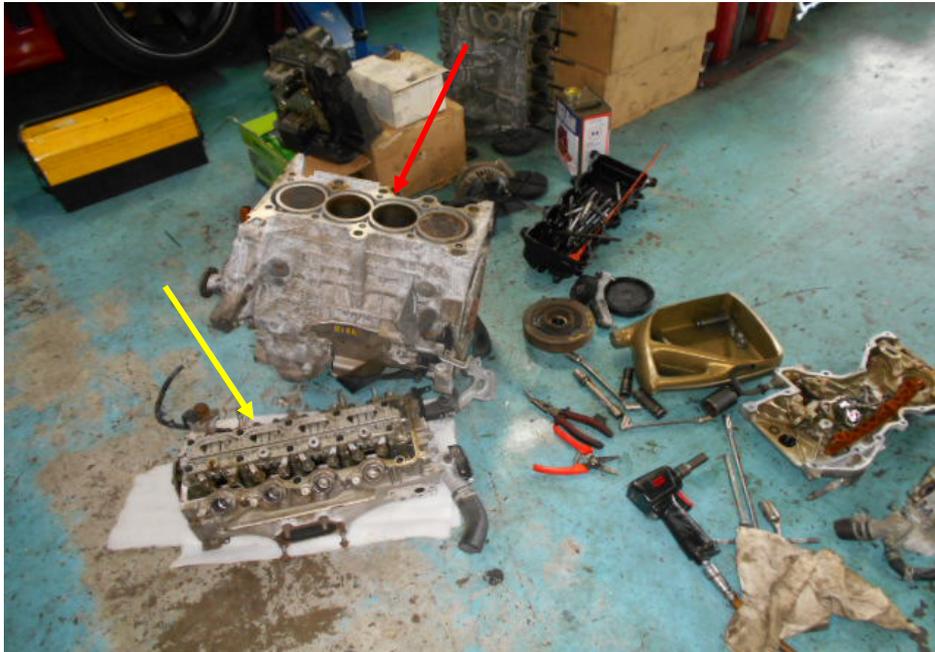
**Photo 5** shows the top block (yellow arrow) of the Honda engine separated from its bottom block (red arrow). This was to enable me to carry out measurements of its cylinders, in particular the bore and stroke measurements of each cylinder, which typically can be used to determine the engine displacement or more commonly referred to as engine cc.

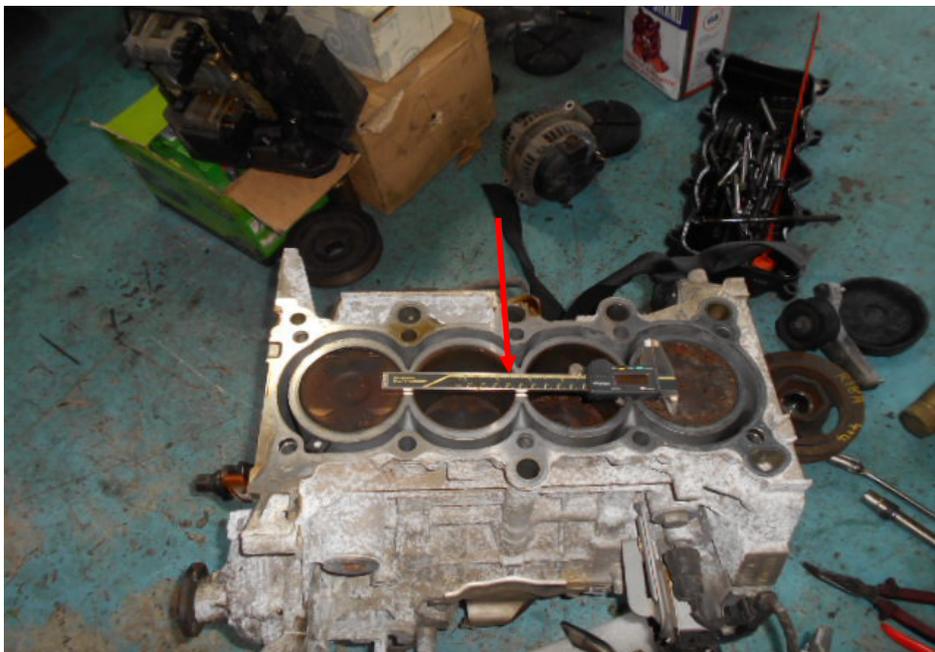
**Photo 6** shows the bottom block of the Honda engine and the digital Vernier Caliper (arrowed) that was used to measure the bore and stroke measurements of each cylinder, which typically can be used to determine the engine displacement or more commonly referred to as engine cc. The digital Vernier Caliper was calibrated before the start of the measurements.

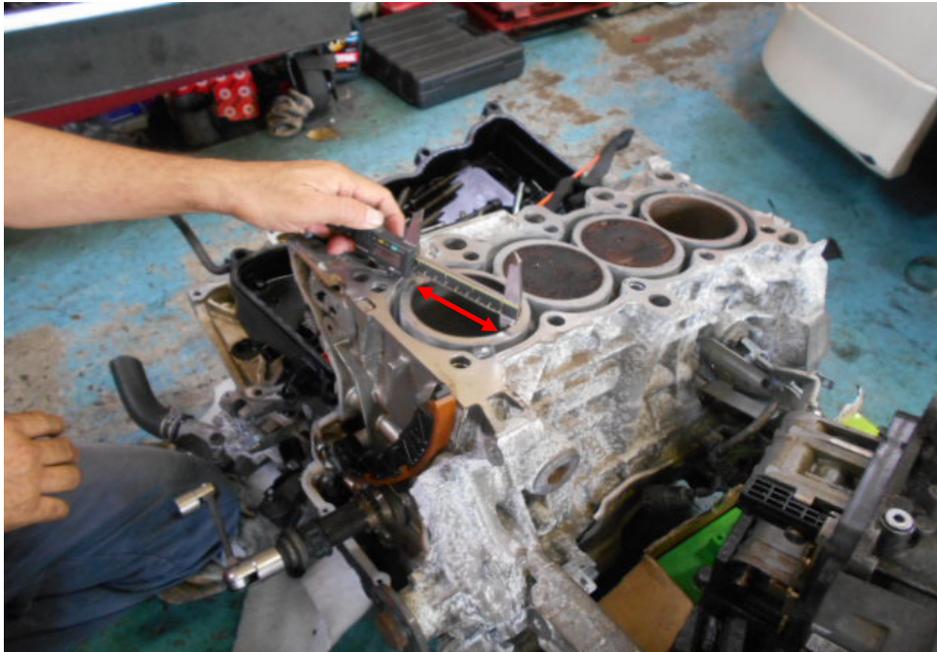
**Photo 7** shows measurement being carried out to the bore (arrowed) of cylinder 1 of the Honda engine. The bore measurement of cylinder 1 was recorded to be 80.67mm.

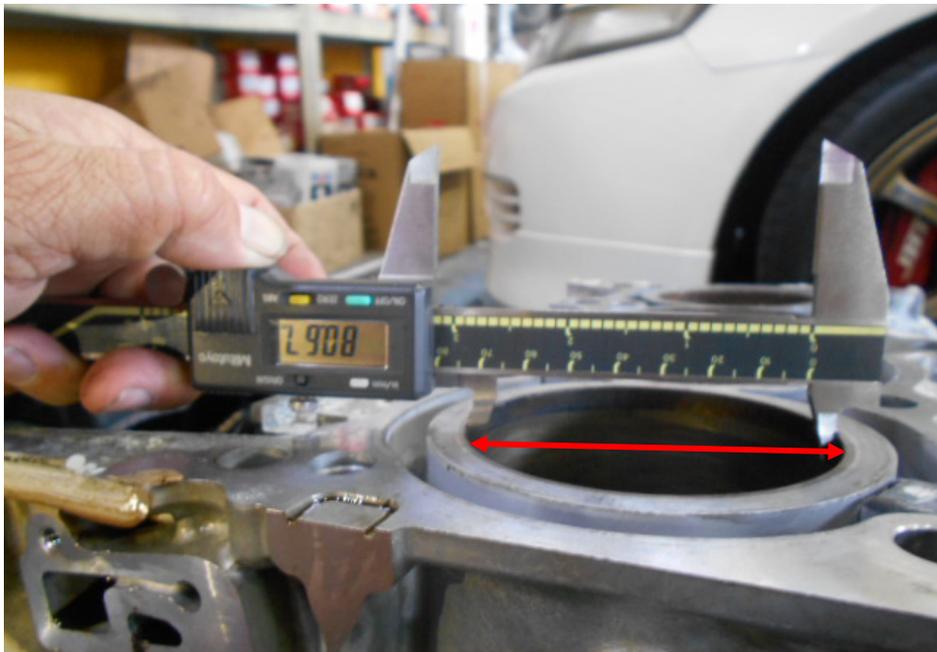
**Photo 8** shows the bore measurement (arrowed) of cylinder 1, which was recorded to be 80.67mm.

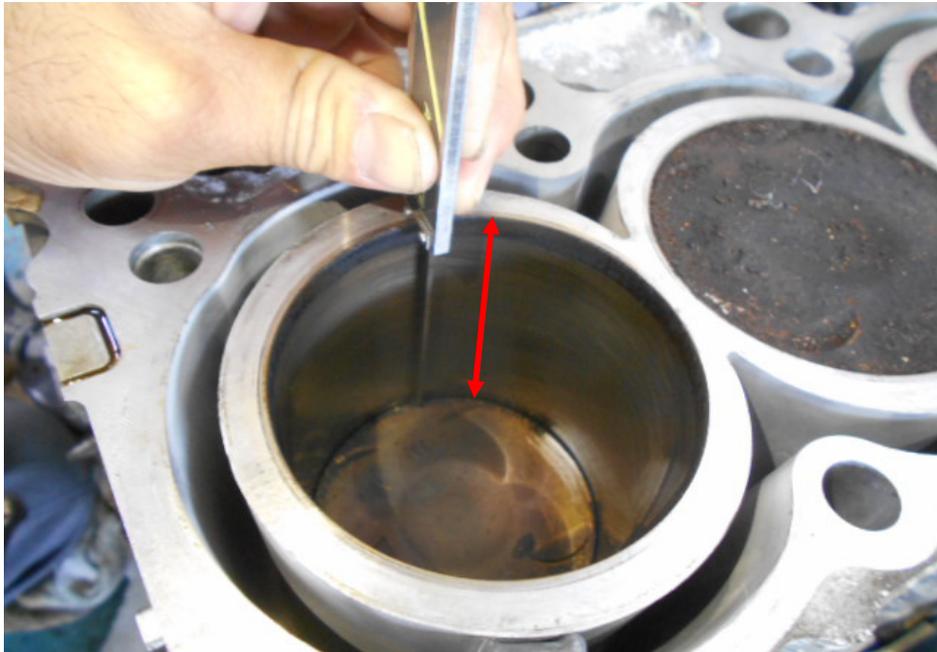
**Photo 9** shows measurement being carried out to the stroke (arrowed) of cylinder 1 of the Honda engine. The bore and stroke measurements of the Honda engine were carried out using a digital Vernier Caliper that was calibrated before the start of the measurements.

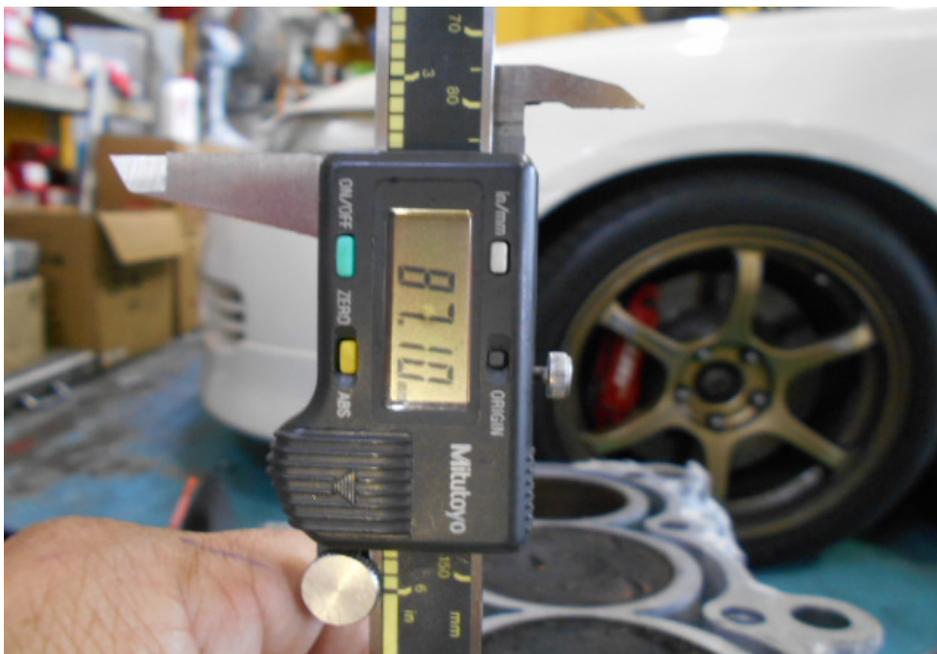
**Photo 10** shows the stroke measurement of cylinder 1, which was recorded to be 87.10mm.

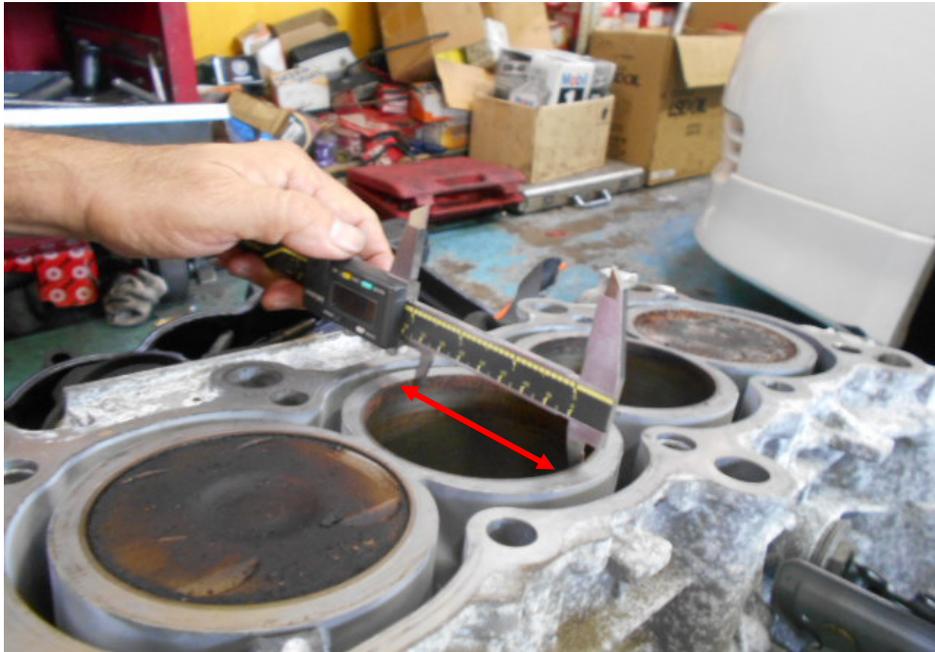
**Photo 11** shows measurement being carried out to the bore (arrowed) of cylinder 2 of the Honda engine. The bore measurement of cylinder 2 was recorded to be 80.40mm.

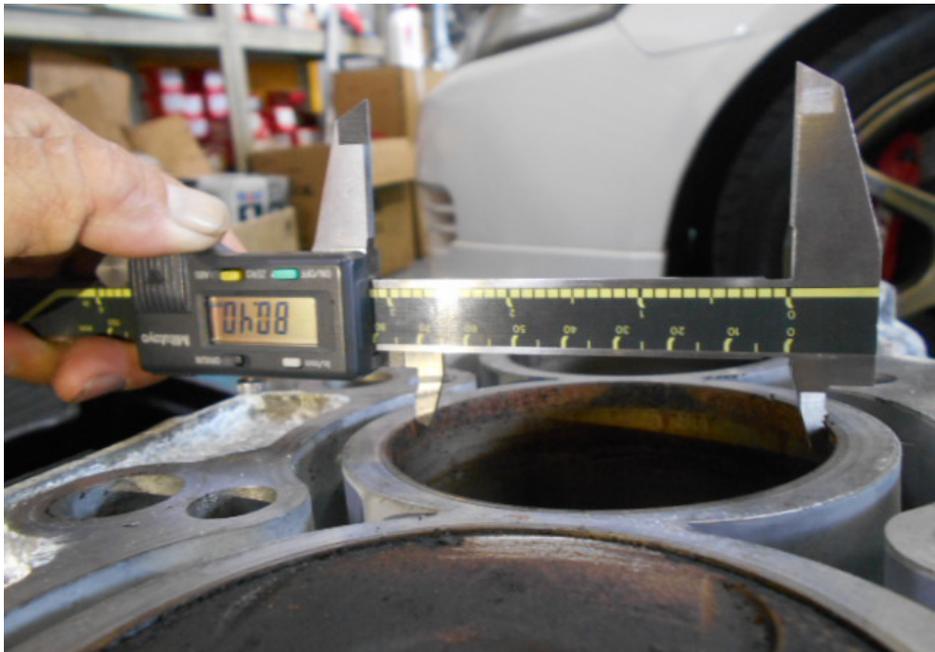
**Photo 12** shows the bore measurement of cylinder 2, which was recorded to be 80.40mm.

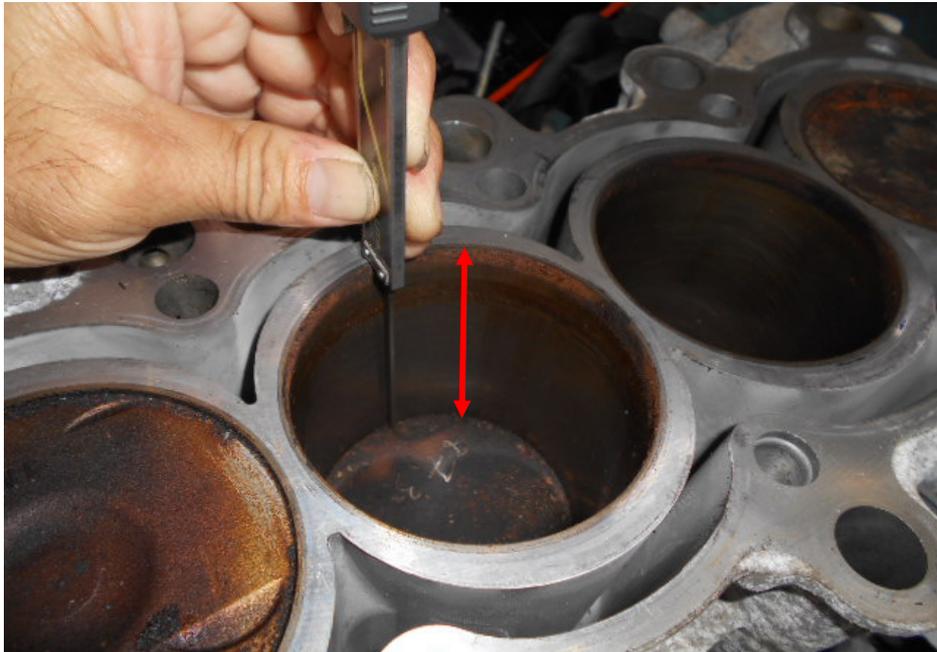
**Photo 13** shows measurement of the stroke (arrowed) of cylinder 2 of the Honda engine that I had inspected. The bore and stroke measurements of the Honda engine were carried out using a digital Vernier Caliper that was calibrated before the start of measurements.

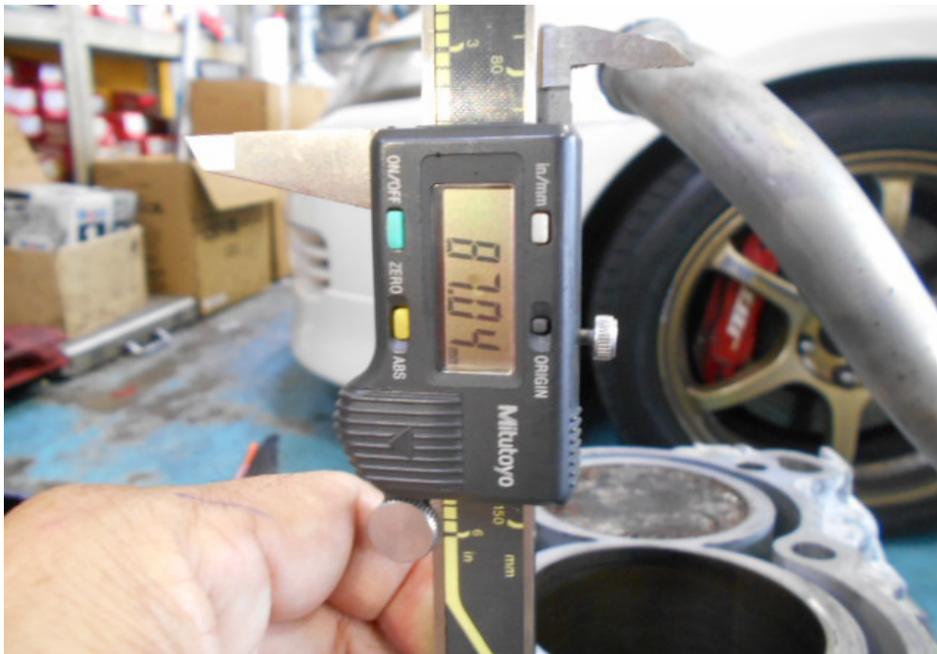
**Photo 14** shows the stroke measurement of cylinder 2, which was recorded to be 87.04mm.

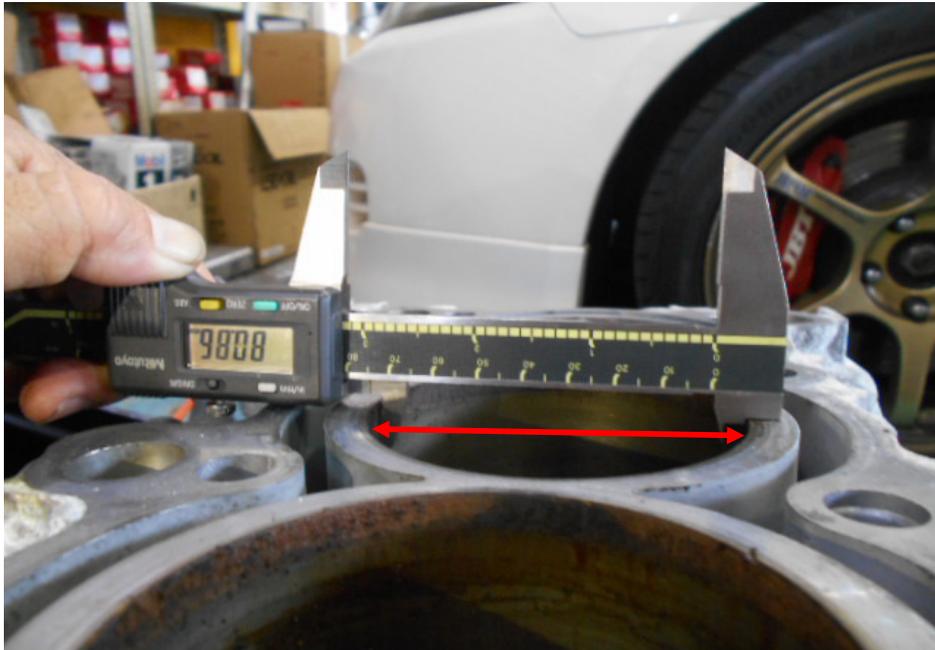
**Photo 15** shows measurement being carried out to the bore (arrowed) of cylinder 3 of the Honda engine. The bore and stroke measurements of the Honda engine were carried out using a digital Vernier Caliper that was calibrated before the start of measurements. The bore measurement of cylinder 3, which was recorded to be 80.86mm.

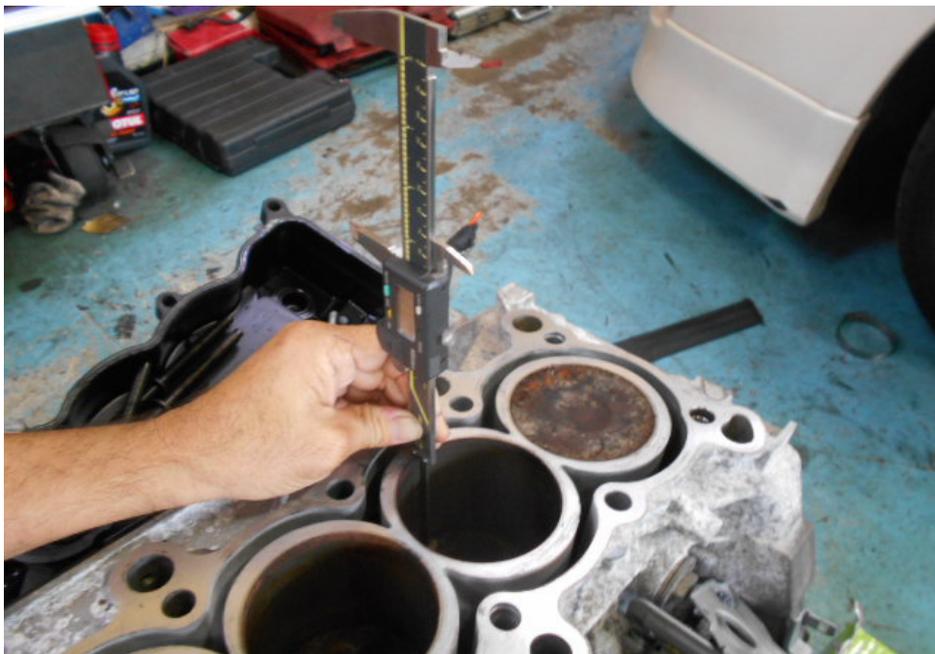
**Photo 16** shows measurement of the stroke of cylinder 3 of the Honda engine that I had inspected. The stroke measurement of cylinder 3, which was recorded to be 87.13mm.

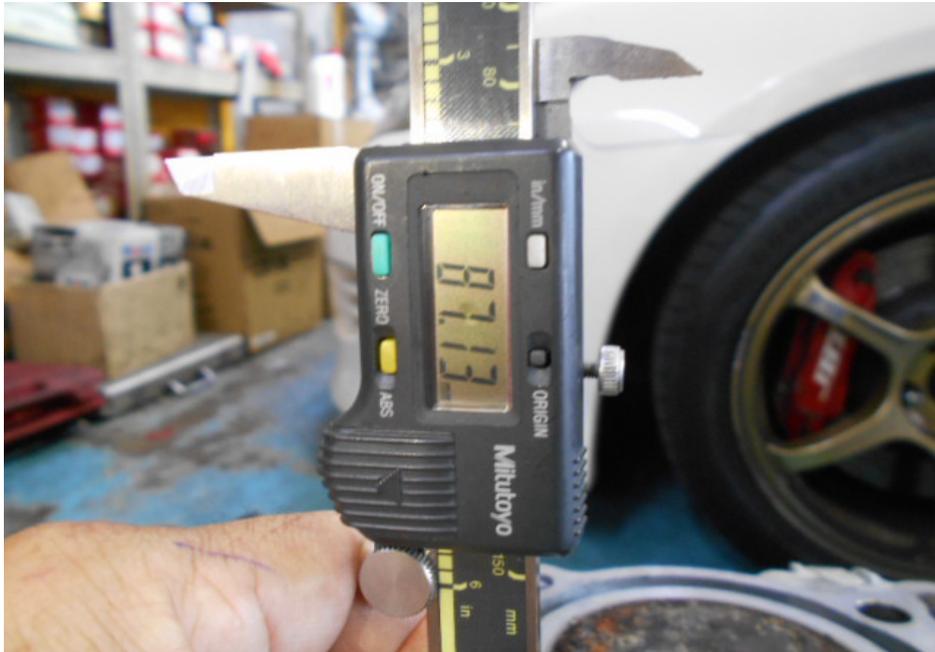
**Photo 17** shows the stroke measurement of cylinder 3, which was recorded to be 87.13mm.

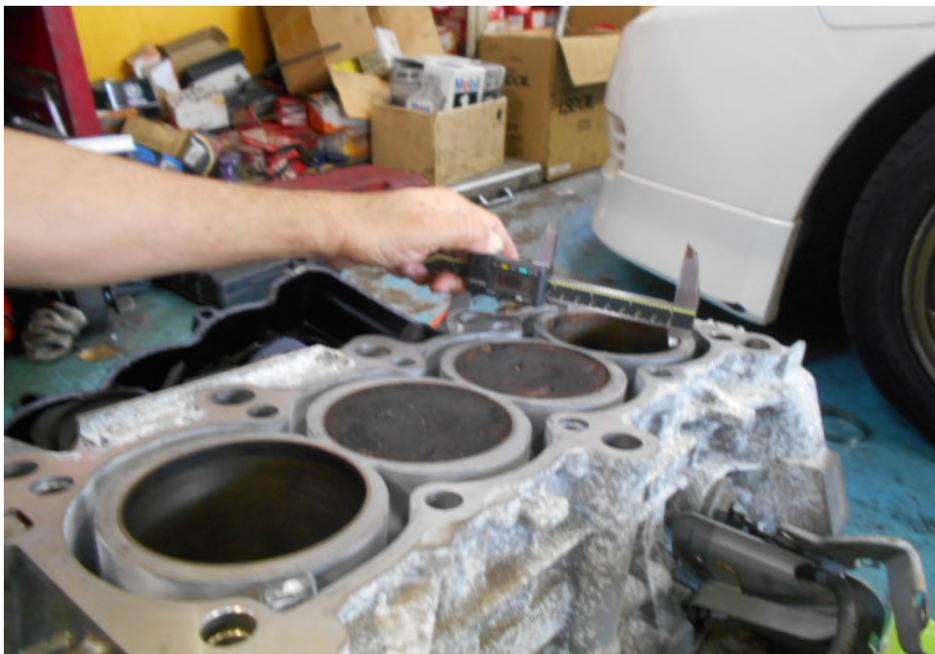
**Photo 18** shows measurement being carried out to the bore of cylinder 4 of the Honda engine. The bore and stroke measurements of the Honda engine were carried out using a digital Vernier Caliper. The bore measurement of cylinder 4 was recorded to be 80.75mm.

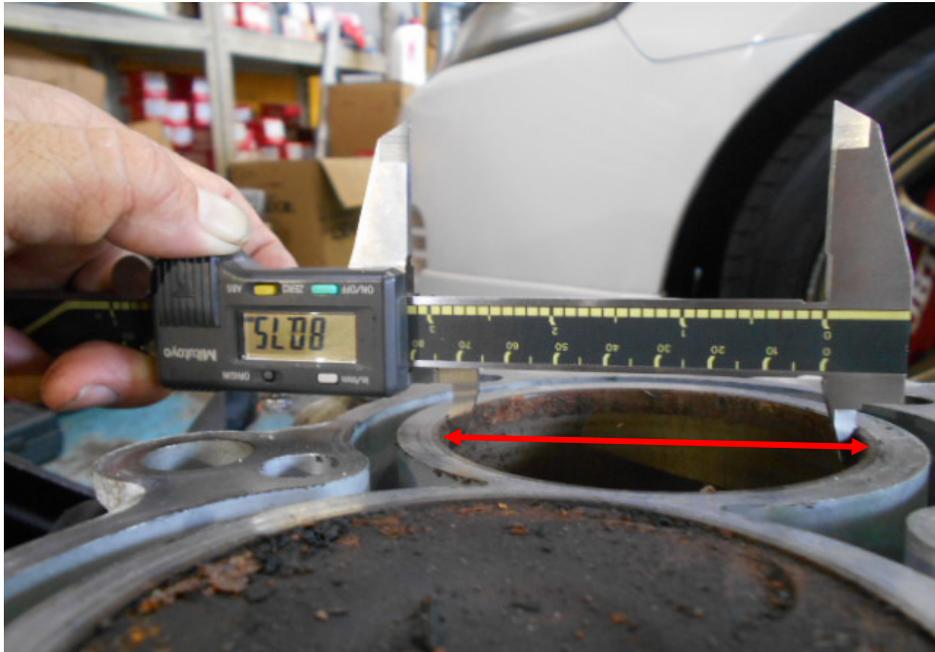
**Photo 19** shows the bore (arrowed) measurement of cylinder 4, which was recorded to be 80.75mm.

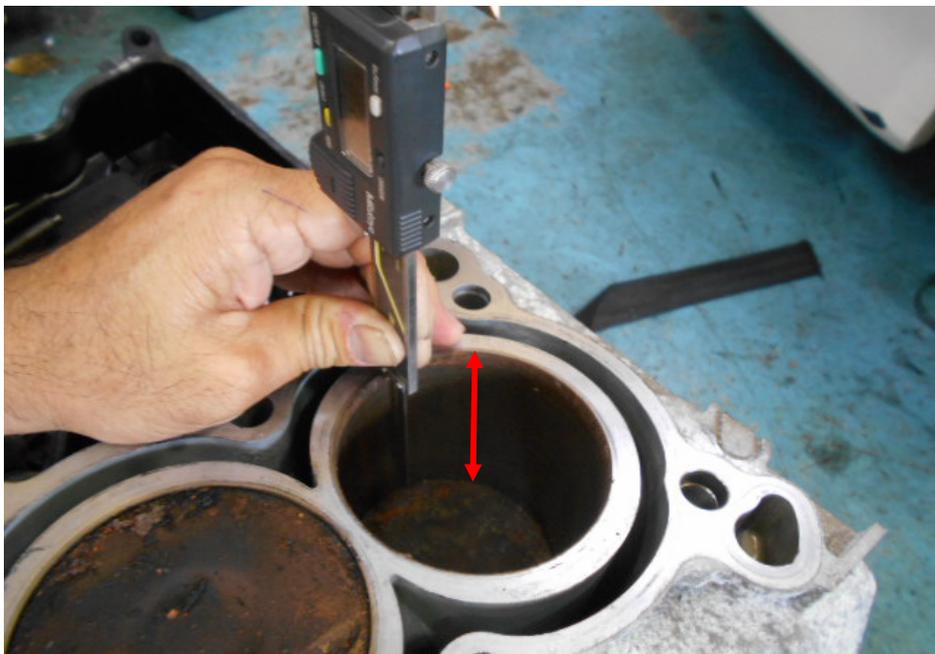
**Photo 20** shows measurement being carried out to the stroke (arrowed) of cylinder 4 of the Honda engine. The bore and stroke measurements of the Honda engine were carried out using a digital Vernier Caliper that was calibrated before the start of measurements.

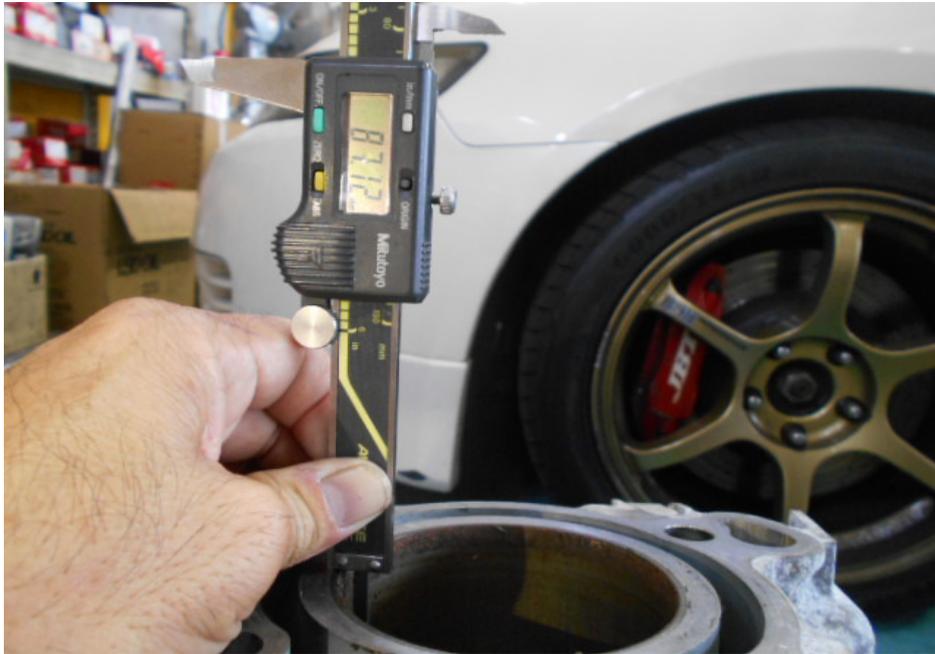
**Photo 21** shows the stroke measurement of cylinder 4, which was recorded to be 87.12mm.
