Your Ref: S9M028QM  
Our Ref : CS/ASM19021233/P

**TECHNICAL INVESTIGATION REPORT OF FIRE INCIDENT INVOLVING THE  
INSURED VEHICLE SJZ 618M ON 29<sup>th</sup> NOVEMBER 2019**

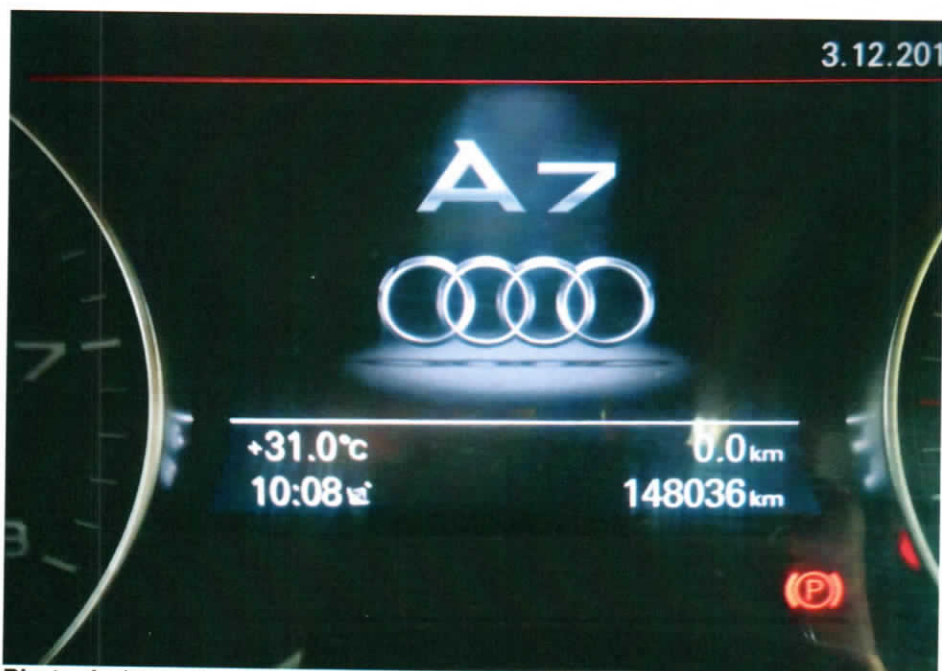
**Photo 1** shows the mileage of the Insured Vehicle at the time of our inspection 148,036KM.

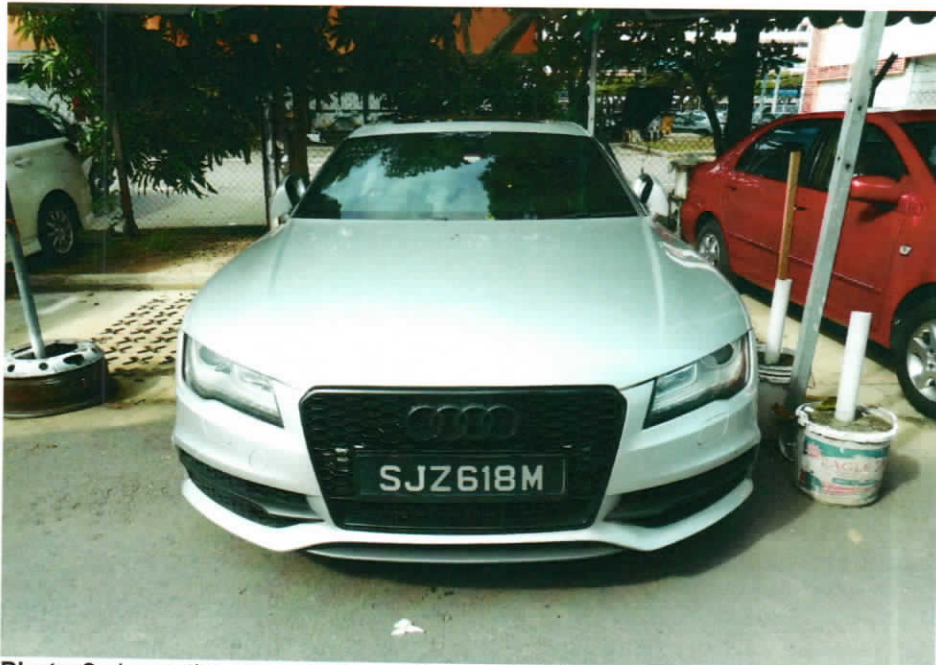
**Photo 2** shows the general view of the front portion of the Insured Vehicle at the time of our inspection. The fire damage to the Insured Vehicle was confined to its interior portion. Its exterior is observed to be unaffected by the fire.

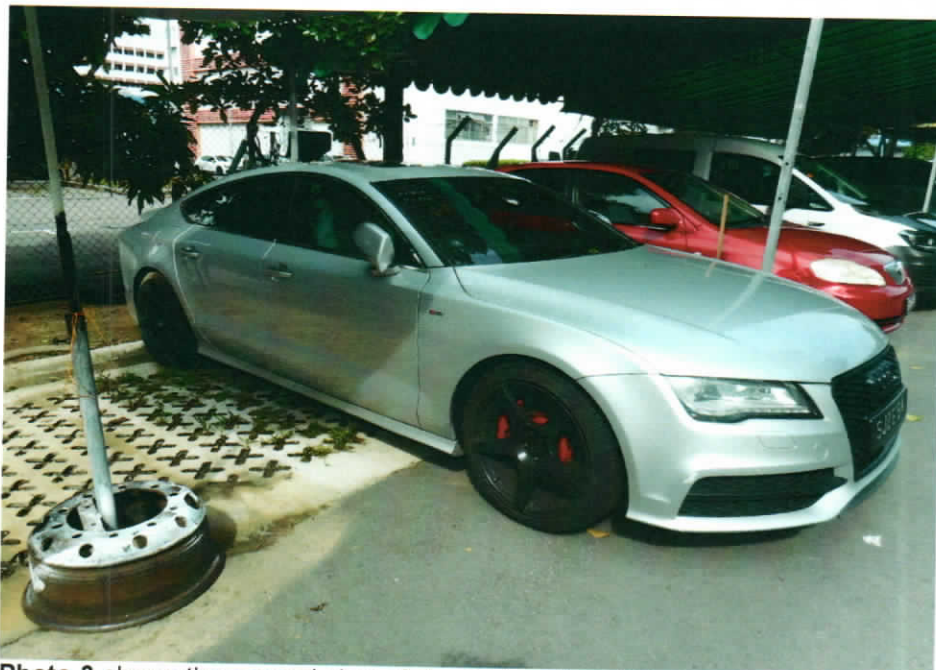
**Photo 3** shows the general view of the right portion of the Insured Vehicle at the time of our inspection. The fire damage to the Insured Vehicle was confined to its interior portion. Its exterior is observed to be unaffected by the fire.

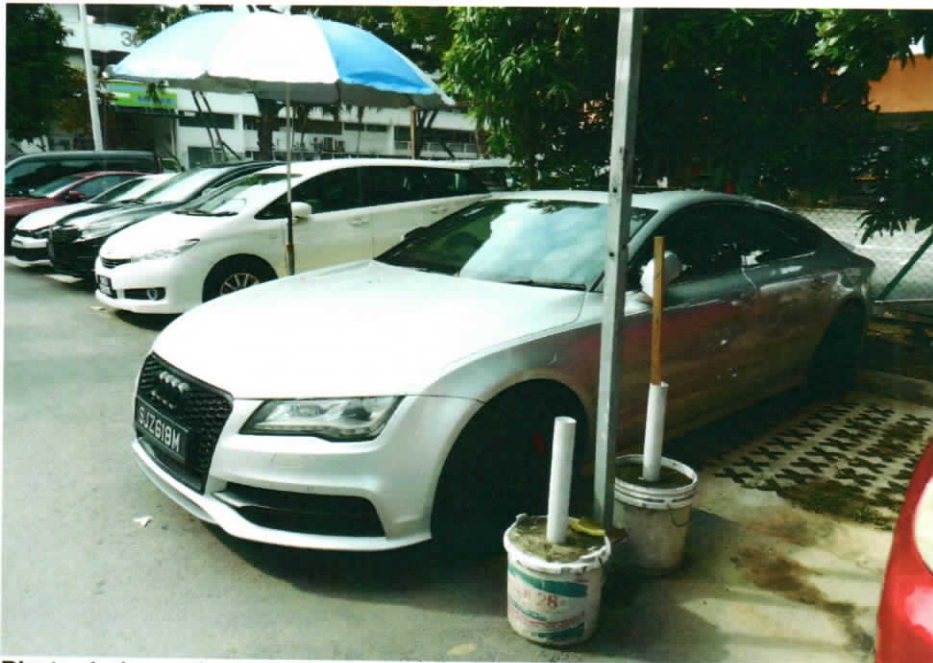
**Photo 4** shows the general view of the left portion of the Insured Vehicle at the time of our inspection. The fire damage to the Insured Vehicle was confined to its interior portion. Its exterior is observed to be unaffected by the fire.

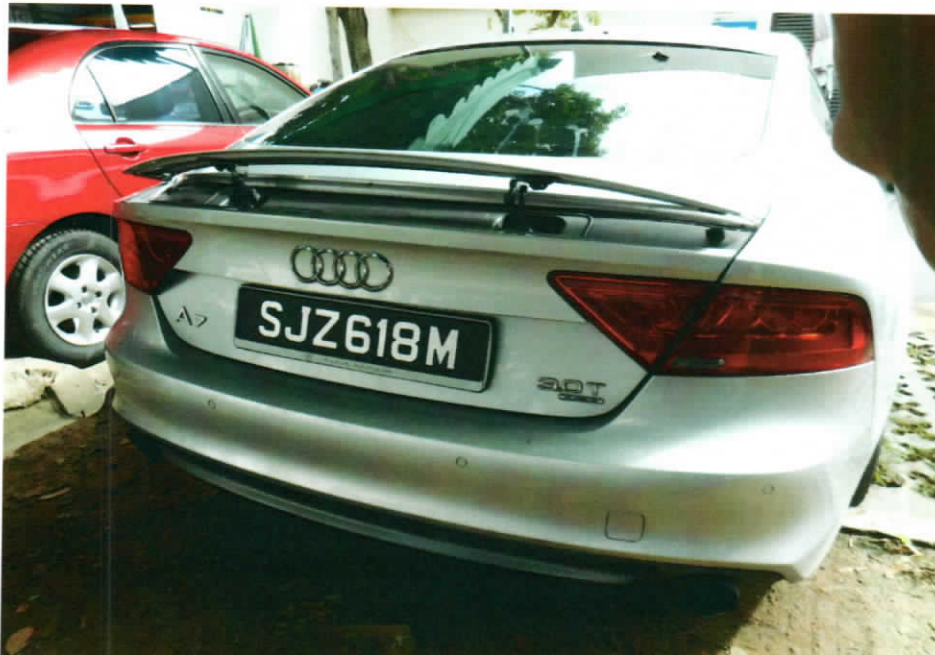
**Photo 5** shows the general view of the rear portion of the Insured Vehicle at the time of our inspection. The fire damage to the Insured Vehicle was confined to its interior portion. Its exterior is observed to be unaffected by the fire.

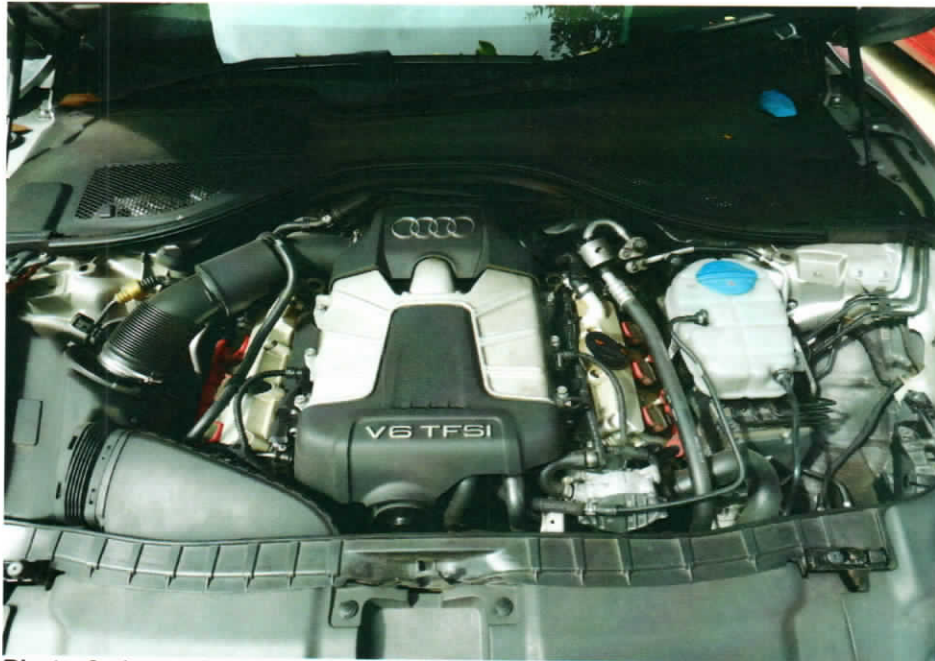
**Photo 6** shows the general view of the engine portion of the Insured Vehicle at the time of our inspection. The fire damage to the Insured Vehicle was confined to its interior portion. Its engine compartment is observed to be unaffected by the fire.

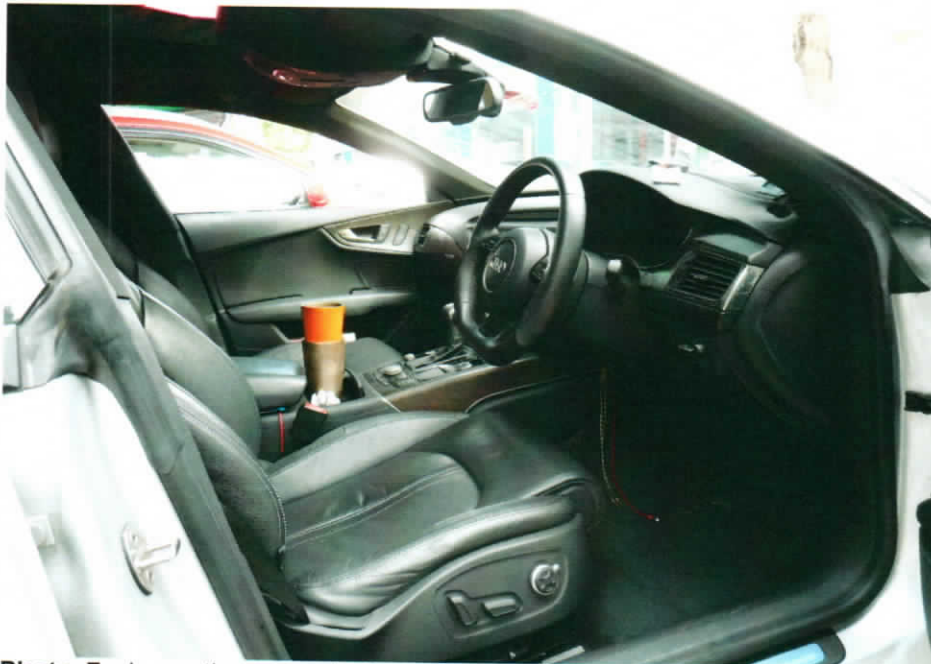
6. The fire was confined to its rear left passenger seat portion, however the fire had resulted in the various components located in the interior of the Insured Vehicle suffer from heat and smoke damages, this includes the driver instrument panel, multimedia infotainment head-unit, driver steering, signalling equipment's, electronic components and several parts inside the other interior compartment that were also observed to sustain damages included centre console armrest, front left seat and dashboard trims. See photos 1 – 11 below.

**Photo 7** shows the general view of the interior compartment of the Insured Vehicle at the time of our inspection. The fire was confined to its rear left passenger seat portion, however the fire had resulted in the various components located in the interior of the Insured Vehicle suffer from heat and smoke damages, this includes the driver instrument panel, multimedia infotainment head-unit, driver steering, signalling equipment's, electronic components and several parts inside the other interior compartment that were also observed to sustain damages included centre console armrest, front left seat and dashboard trims.

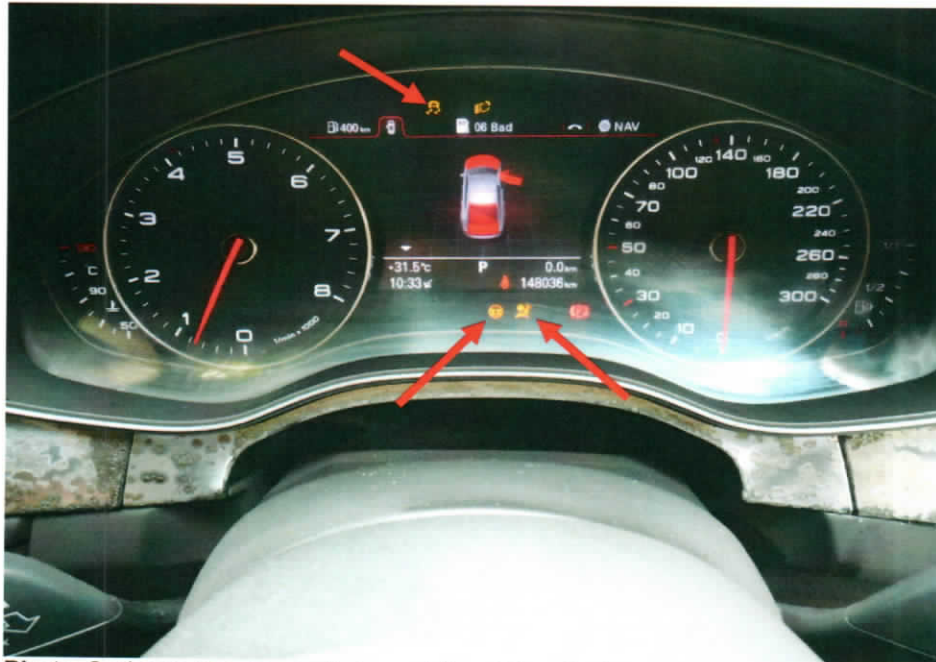
**Photo 8** shows the general view of the driver instrument panel of the Insured Vehicle at the time of our inspection. The various error codes (arrowed) on the Insured Vehicle were lighted up due to the smoke and heat damages that had inference sensors of the electronic components causing them to be illuminated.

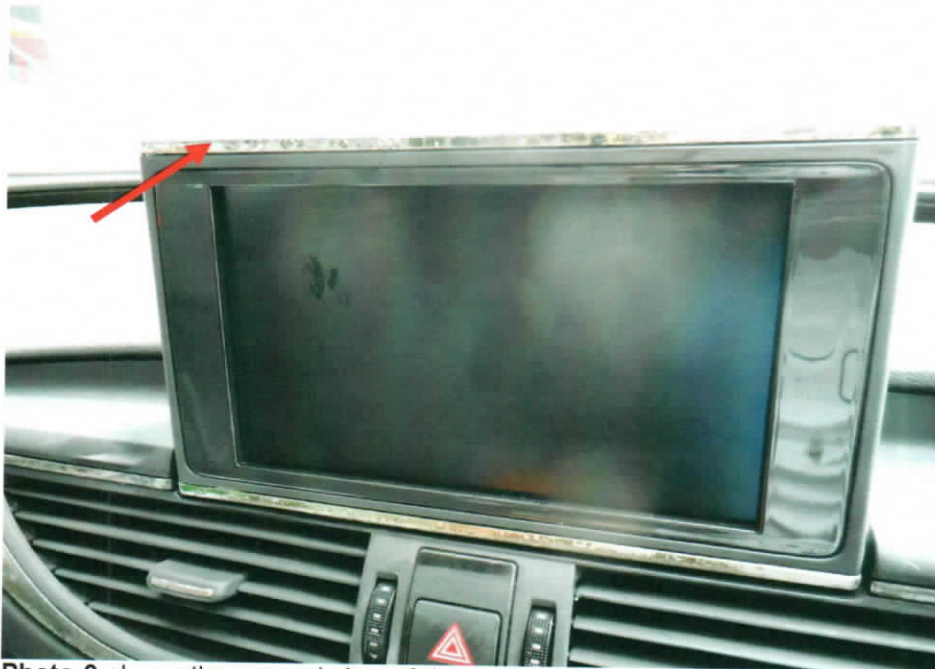
**Photo 9** shows the general view of the multimedia infotainment head-unit of the Insured Vehicle at the time of our inspection. The unit was not illuminated when turned on and the surface on it had suffered heat and smoke damages (arrowed) as a result of the fire.

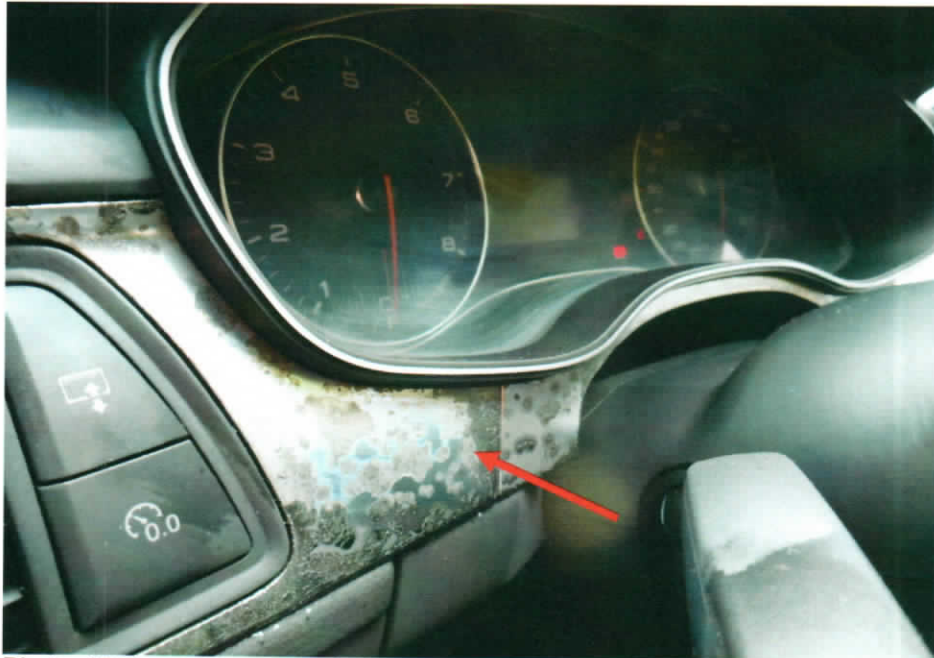
**Photo 10** shows the general view of the dashboard trims of the Insured Vehicle at the time of our inspection. The surface had suffered heat and smoke damages (arrowed) as a result of the fire.

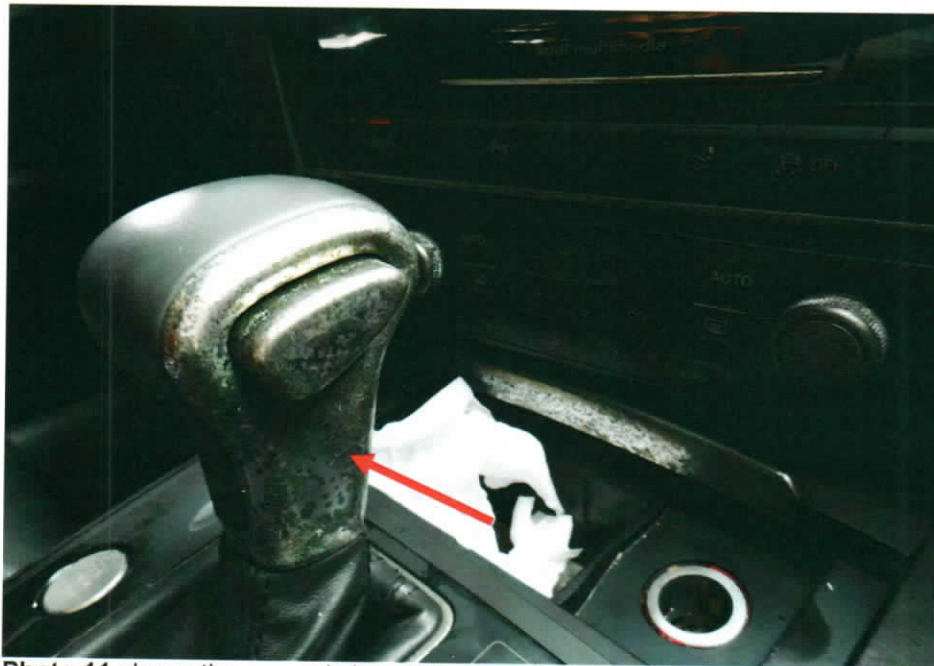
**Photo 11** shows the general view of the gear knob trims of the Insured Vehicle at the time of our inspection. The surface had also suffered heat and smoke damages (arrowed) as a result of the fire.

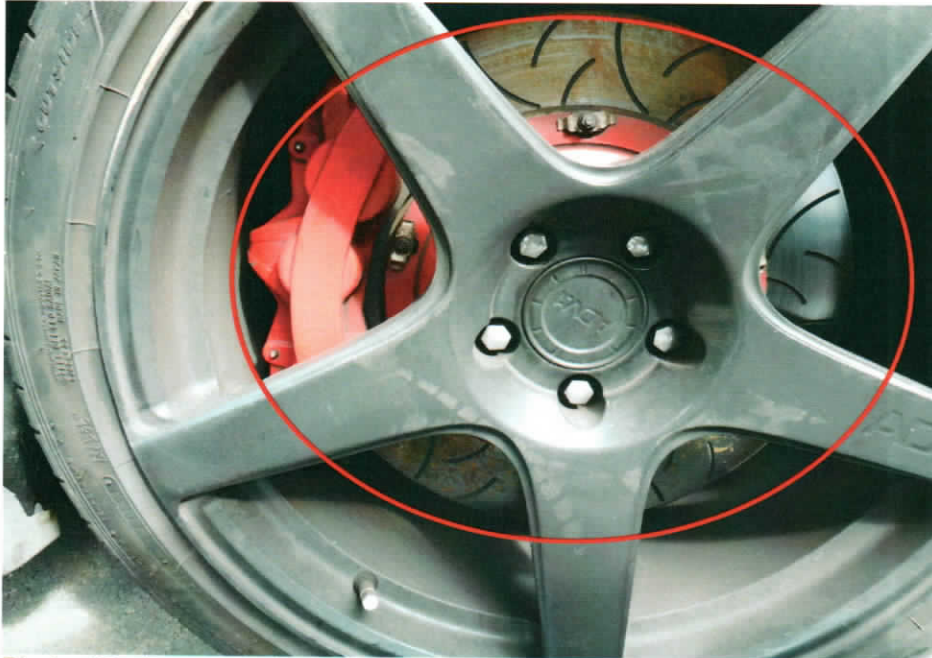
7. At the time of inspection of the Insured Vehicle, we observed a set of aftermarket brake calipers and disc brakes fitted on the Insured Vehicle. See photo 12 below.

**Photo 12** shows a set of aftermarket brake calipers and disc brakes on the Insured Vehicle, which was observed to be unaffected by the fire.

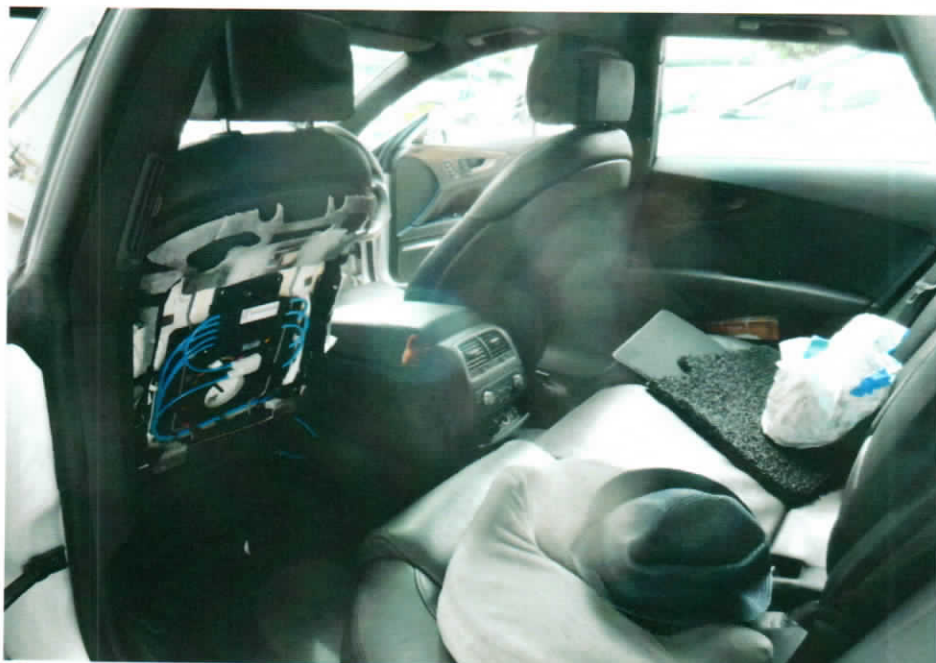
8. Based on the circumstances for this particular case, the fire appears to have originated from the interior portion of the Insured Vehicle, somewhere around the rear left passenger foot well. This can be determined basing on the area where the extent of fire damage was most severe, the circumstances of the fires' origin at the material time of incident and also the burn marks and melting of material that were found on the surface on the foot well, centre console armrest and the rear of the front left seat.
9. These burn marks are a result of exposure to heat intensity. In the immediate vicinity of where these burn marks were found, would also support our findings of where the fire to the Insured Vehicle had originated. This physical evidence would then appear to suggest that the cause of fire to the Insured Vehicle could have possibly been due to external factor. See photo 13-18 below.

Photo 13 shows the general view of the rear passenger seating compartment of the Insured Vehicle at the time of our inspection. The fire damage to the Insured Vehicle was confined to its left seating portion. Its centre console armrest and rear of the front left seat are amongst the body parts that were found to have been affected as a result of the fire.

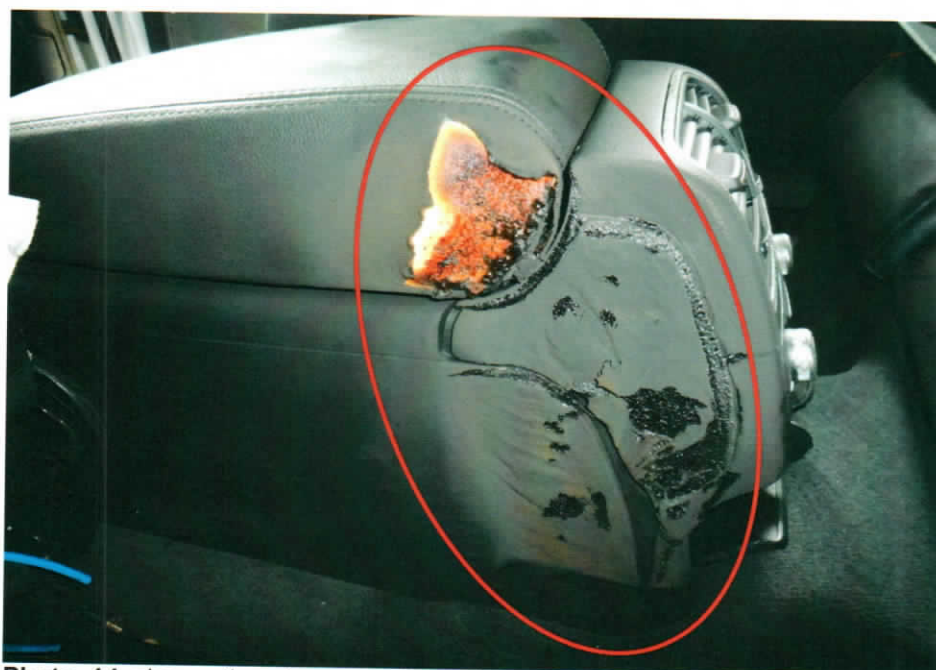
Photo 14 shows the close up view of the rear left passenger seating compartment of the Insured Vehicle at the time of our inspection. Its centre console armrest (circled) was found to have been burnt and melt as a result of the fire.

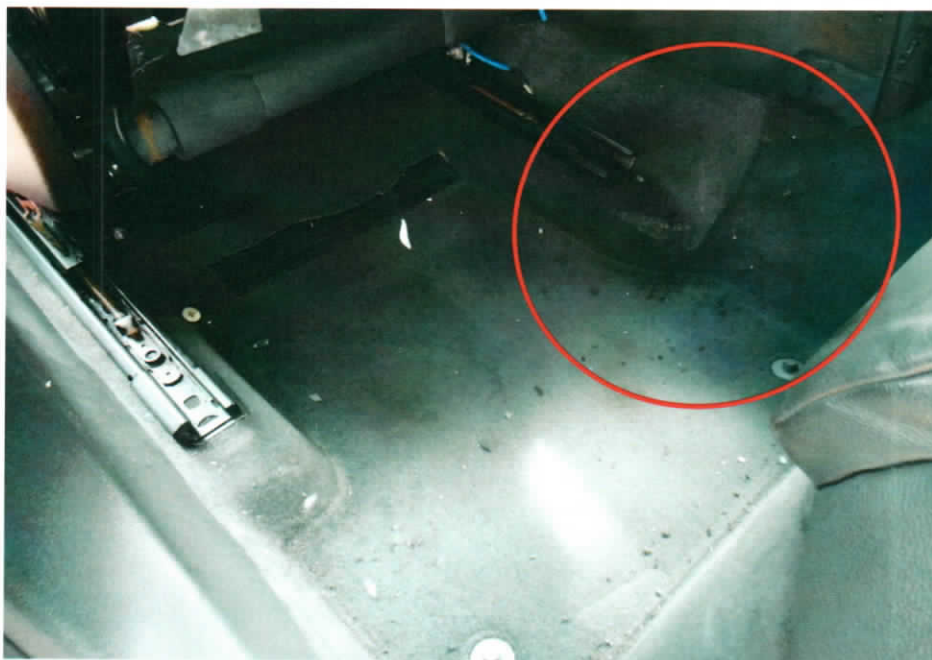
**Photo 15** shows the close up view of the from rear left passenger seating compartment of the Insured Vehicle at the time of our inspection. Its rear left foot well (circled) was found to have been burnt as a result of the fire.

13. Mr Muharrem informed us that upon closer examination of the Insured Vehicle's interior he found the aftermath of a an exploded powerbank which was placed at the rear left passenger foot well, located right beside the rear centre console armrest close to rear of the front left passenger seat. The explosion had damaged the various components in the Insured Vehicle.

19. Having investigated and technically analysed the damages of burnt nature to the Insured Vehicle. We are in view that, the fire had originated from a powerbank placed at the rear left passenger foot well area of the Insured Vehicle. Fire to the Insured Vehicle was hence due to external factor.
20. We observed aftermarket brake capliers and brake disc component(s) fitted on the Insured Vehicle at the time of our inspection of the Insured Vehicle. There components did not cause or contribute to the fire incident.
21. Our investigations had also revealed that at the time of writing this report, there is no manufacturer recall to similar make and model vehicle as the Insured Vehicle that may possibly be related to this incident.

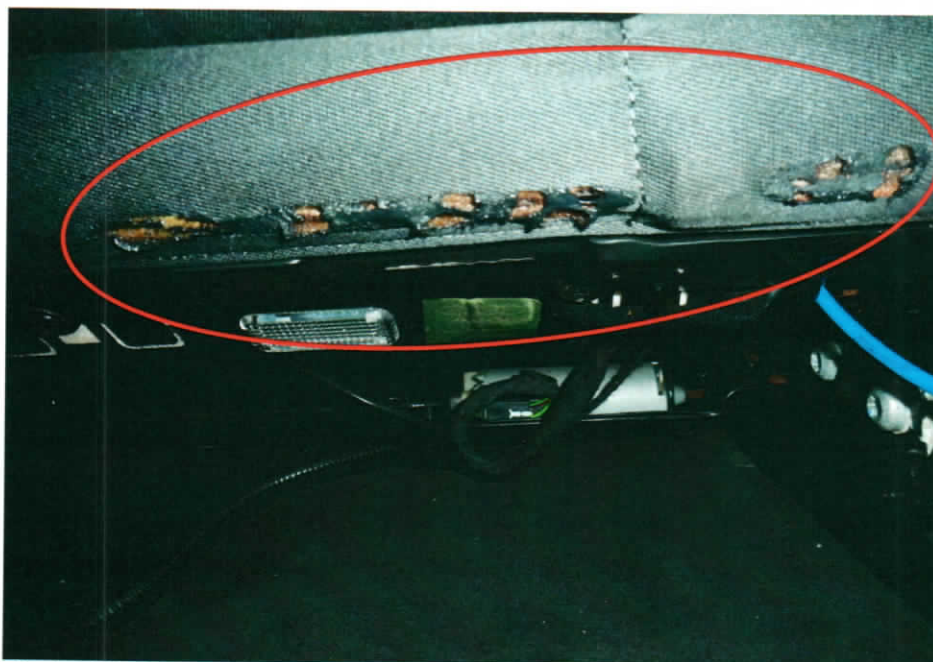
**Photo 16** shows the close up view of the from rear left passenger seating compartment of the Insured Vehicle at the time of our inspection. The rear of the left seat (circled) was found to have been burnt as a result of the fire.

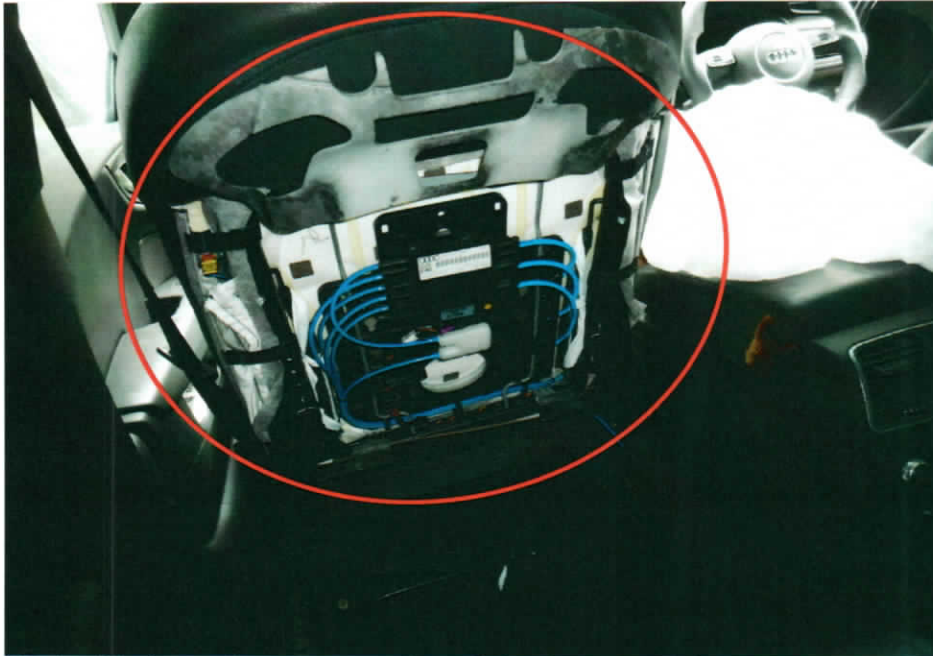
**Photo 17** shows the close up view of the from rear left passenger seating compartment of the Insured Vehicle at the time of our inspection. The rear of left seat backing cover (circled) was found to have been missing at the time of the inspection.

14. Mr Muharrem mentioned that, due to the emitting of toxic smell from the exploded powerbank and the melted rear seat plastic backing cover he had disposed them from the Insured Vehicle. He also informed us that there was no SCDF activation as there was no fire spotted at the material time. Subsequently Mr Muharrem started up the Insured Vehicle but however observed that the instrument display panel was not illuminated up and so he left Insured Vehicle parked and locked and carried on to his daily activities.

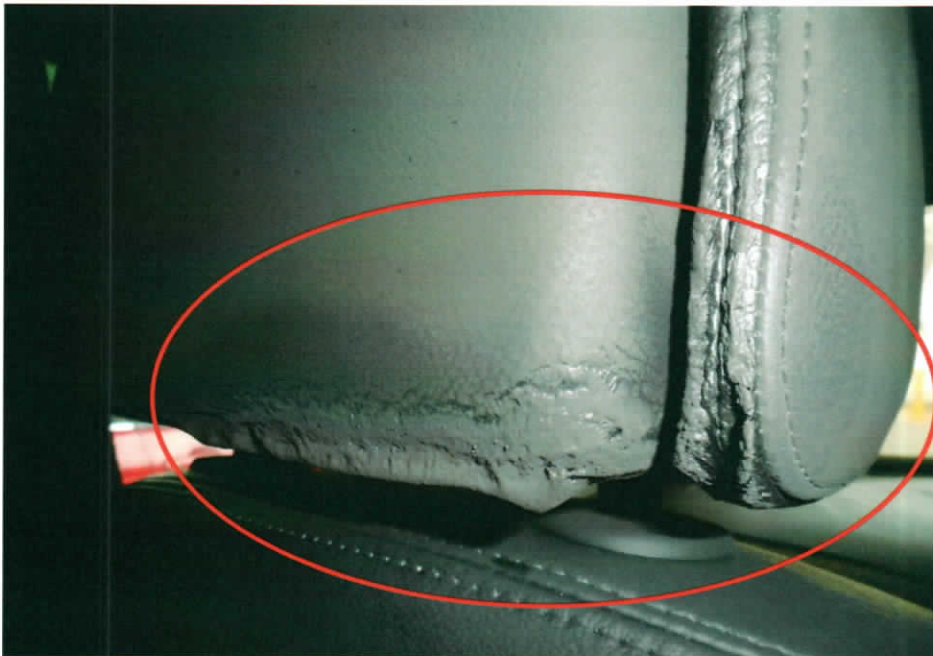
**Photo 18** shows the close up view of the from rear left passenger seating compartment of the Insured Vehicle at the time of our inspection. The rear of the left seat headrest (circled) was found to have been burnt and melted as a result of the fire.
