Your Ref: S9M028QM
Our Ref : CS/ASM19021233/P

**TECHNICAL INVESTIGATION REPORT OF FIRE INCIDENT INVOLVING THE
INSURED VEHICLE SJZ 618M ON 29th NOVEMBER 2019**

Vehicle Registration No.	: SJZ 618M
Make / Model	: AUDI A7 SPORTBACK 3.0 TFSI QU
Chassis No	: WAUZZZ4G6BN023228
Year of Registration	: MAY 2011
Mileage	: 148,036KM

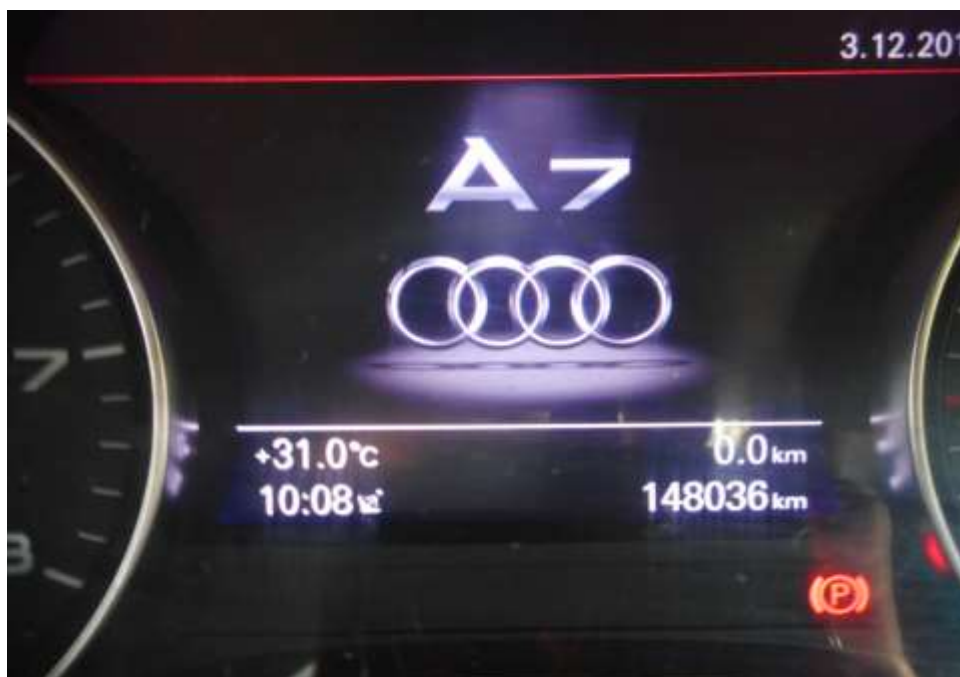
Photo 1 shows the mileage of the Insured Vehicle at the time of our inspection 148,036KM.

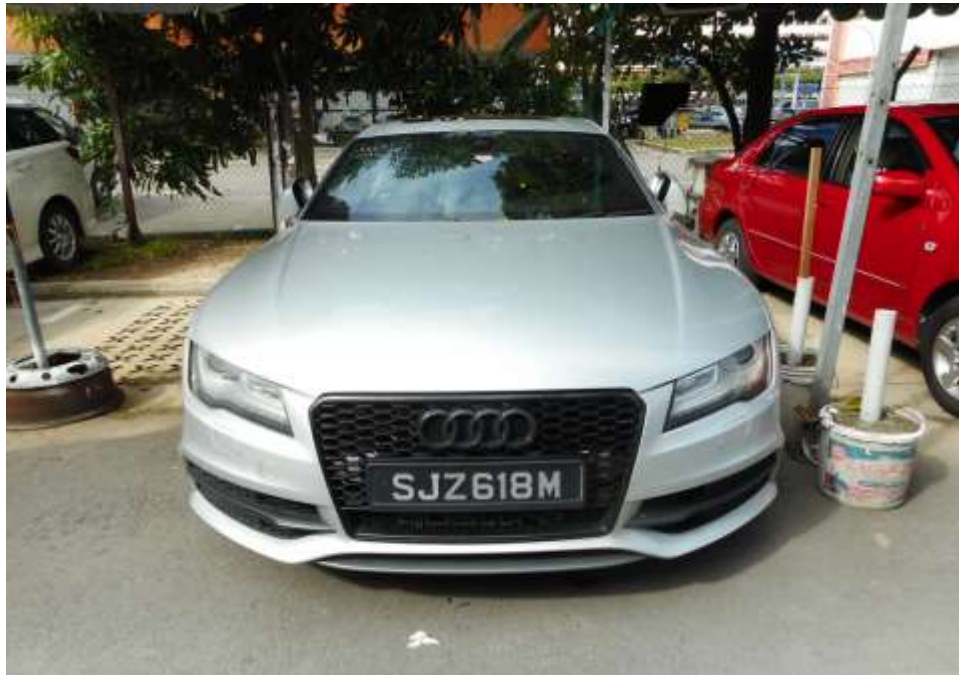
Photo 2 shows the general view of the front portion of the Insured Vehicle at the time of our inspection. The fire damage to the Insured Vehicle was confined to its interior portion. Its exterior is observed to be unaffected by the fire.

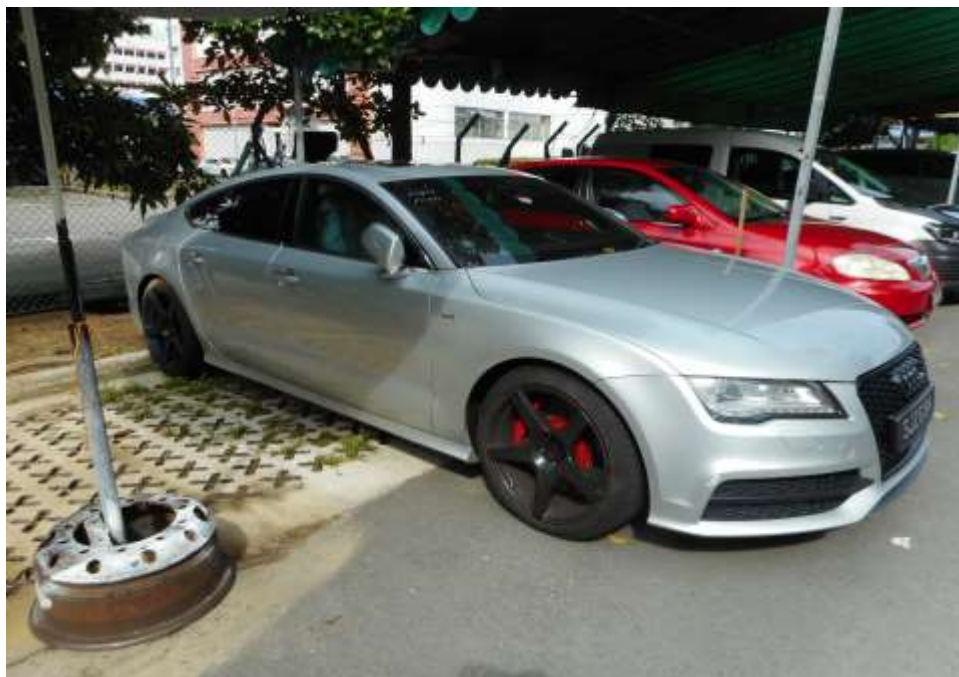
Photo 3 shows the general view of the right portion of the Insured Vehicle at the time of our inspection. The fire damage to the Insured Vehicle was confined to its interior portion. Its exterior is observed to be unaffected by the fire.

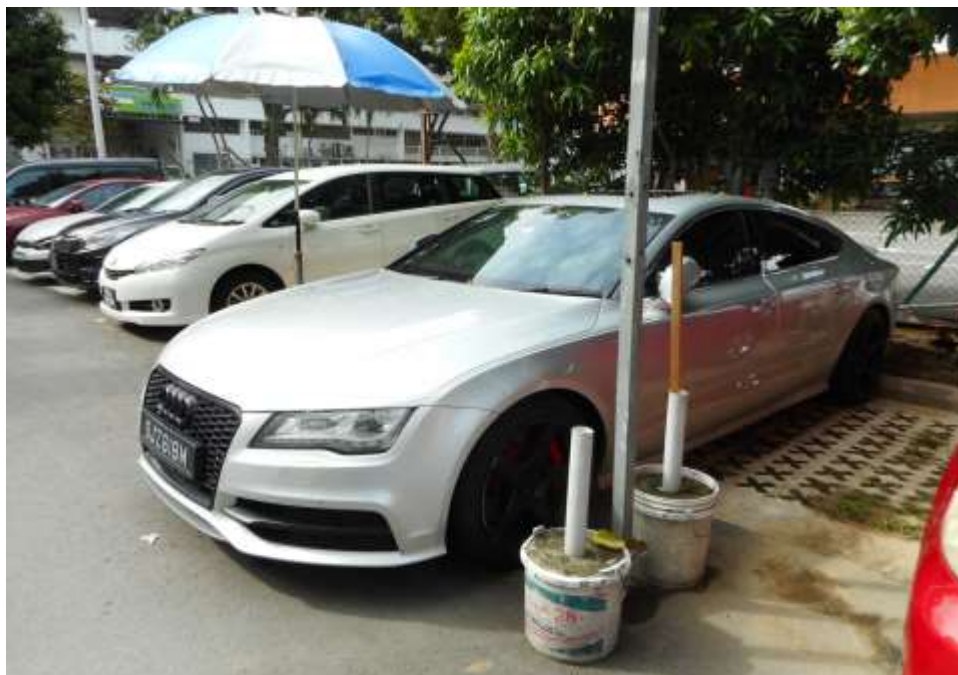
Photo 4 shows the general view of the left portion of the Insured Vehicle at the time of our inspection. The fire damage to the Insured Vehicle was confined to its interior portion. Its exterior is observed to be unaffected by the fire.

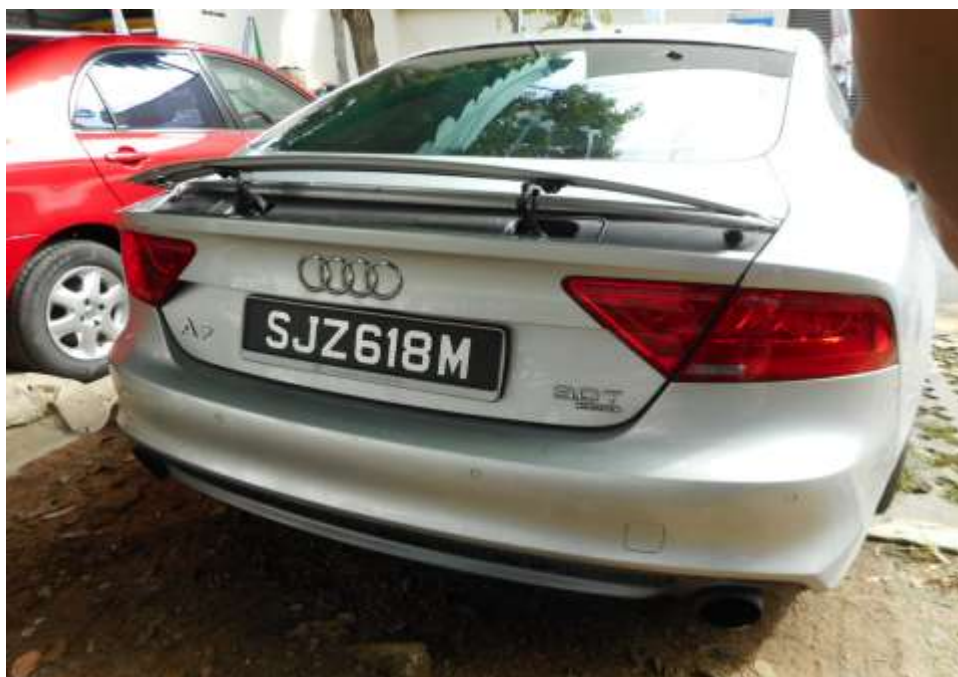
Photo 5 shows the general view of the rear portion of the Insured Vehicle at the time of our inspection. The fire damage to the Insured Vehicle was confined to its interior portion. Its exterior is observed to be unaffected by the fire.

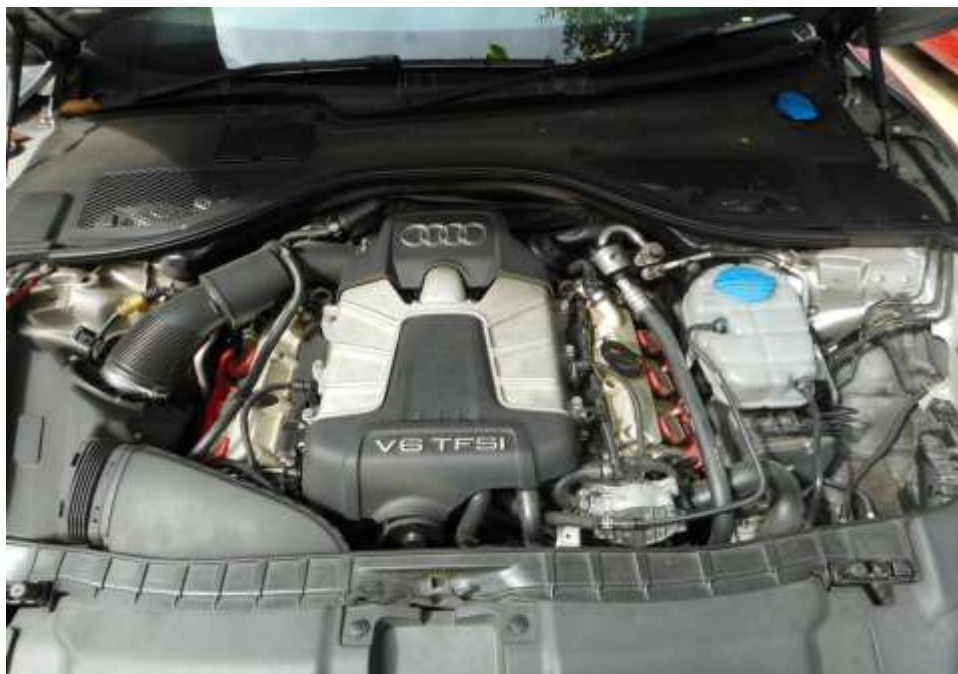
Photo 6 shows the general view of the engine portion of the Insured Vehicle at the time of our inspection. The fire damage to the Insured Vehicle was confined to its interior portion. Its engine compartment is observed to be unaffected by the fire.

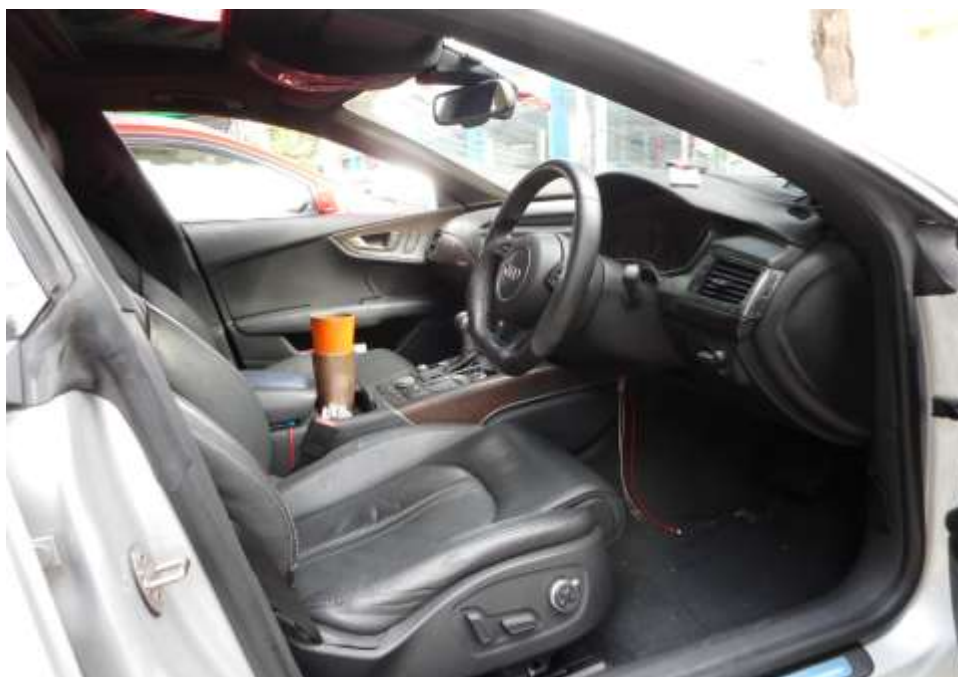
6. The fire was confined to its rear left passenger seat portion, however the fire had resulted in the various components located in the interior of the Insured Vehicle suffer from heat and smoke damages, this includes the driver instrument panel, multimedia infotainment head-unit, driver steering, signalling equipment's, electronic components and several parts inside the other interior compartment that were also observed to sustain damages included centre console armrest, front left seat and dashboard trims. See photos 1 – 11 below.

Photo 7 shows the general view of the interior compartment of the Insured Vehicle at the time of our inspection. The fire was confined to its rear left passenger seat portion, however the fire had resulted in the various components located in the interior of the Insured Vehicle suffer from heat and smoke damages, this includes the driver instrument panel, multimedia infotainment head-unit, driver steering, signalling equipment's, electronic components and several parts inside the other interior compartment that were also observed to sustain damages included centre console armrest, front left seat and dashboard trims.

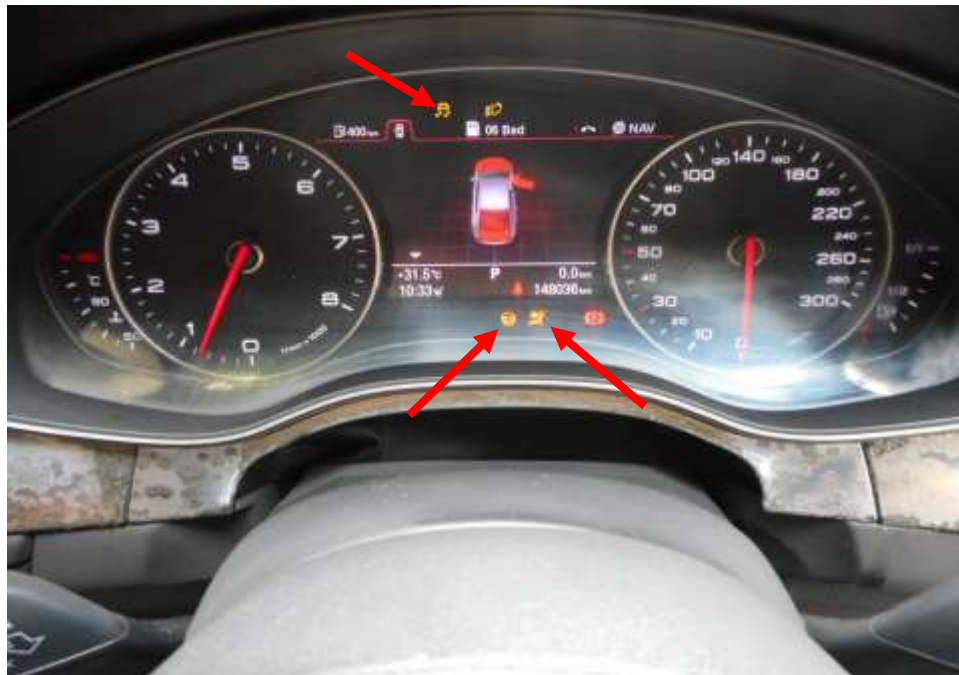
Photo 8 shows the general view of the driver instrument panel of the Insured Vehicle at the time of our inspection. The various error codes (arrowed) on the Insured Vehicle were lighted up due to the smoke and heat damages that had inference sensors of the electronic components causing them to be illuminated.

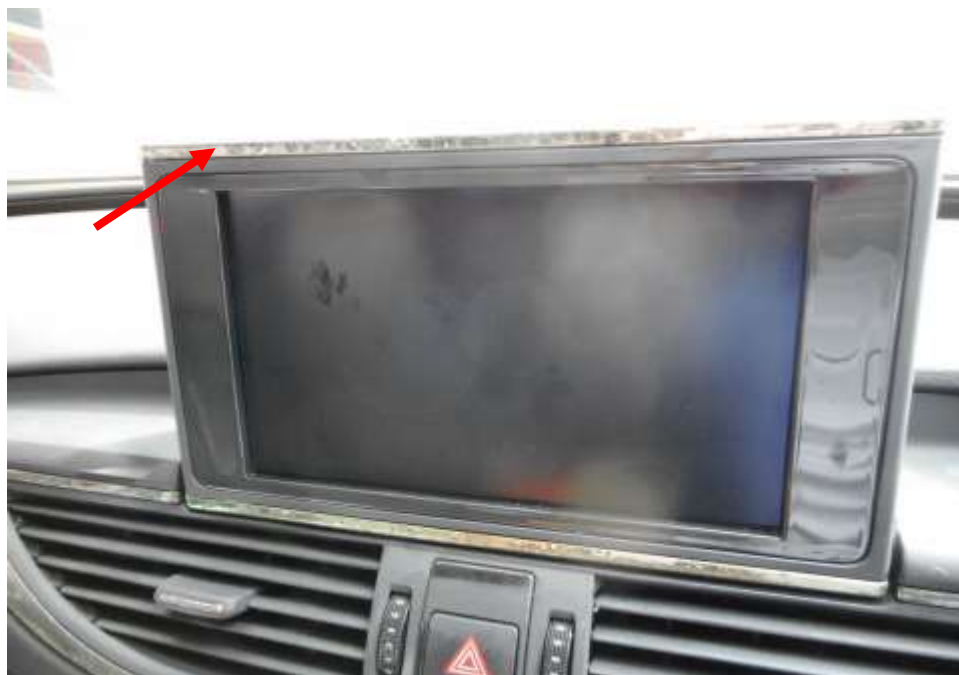
Photo 9 shows the general view of the multimedia infotainment head-unit of the Insured Vehicle at the time of our inspection. The unit was not illuminated when turned on and the surface on it had suffered heat and smoke damages (arrowed) as a result of the fire.

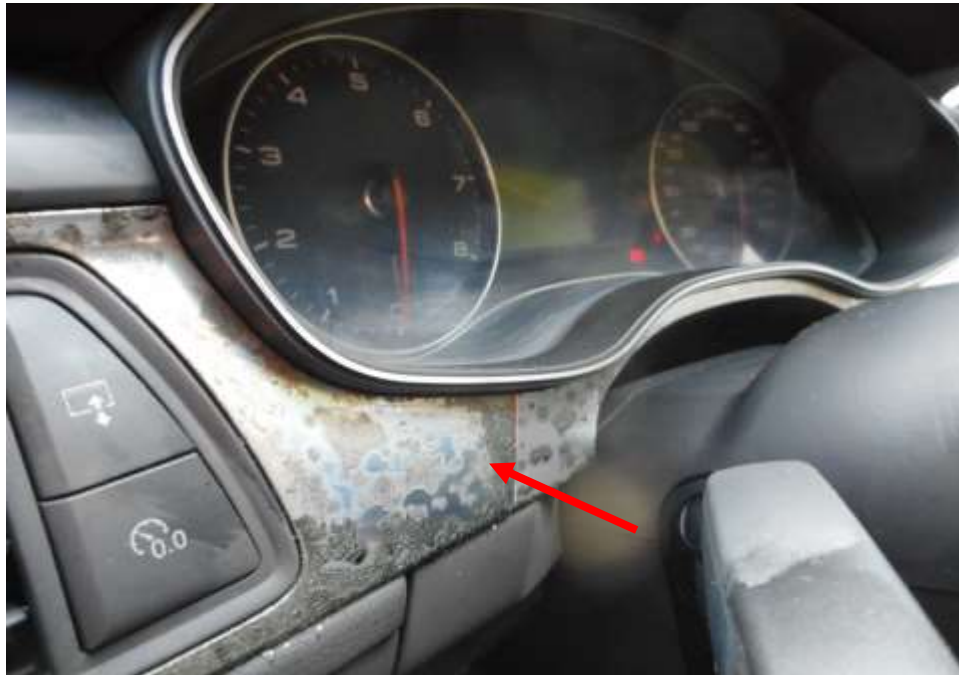
Photo 10 shows the general view of the dashboard trims of the Insured Vehicle at the time of our inspection. The surface had suffered heat and smoke damages (arrowed) as a result of the fire.

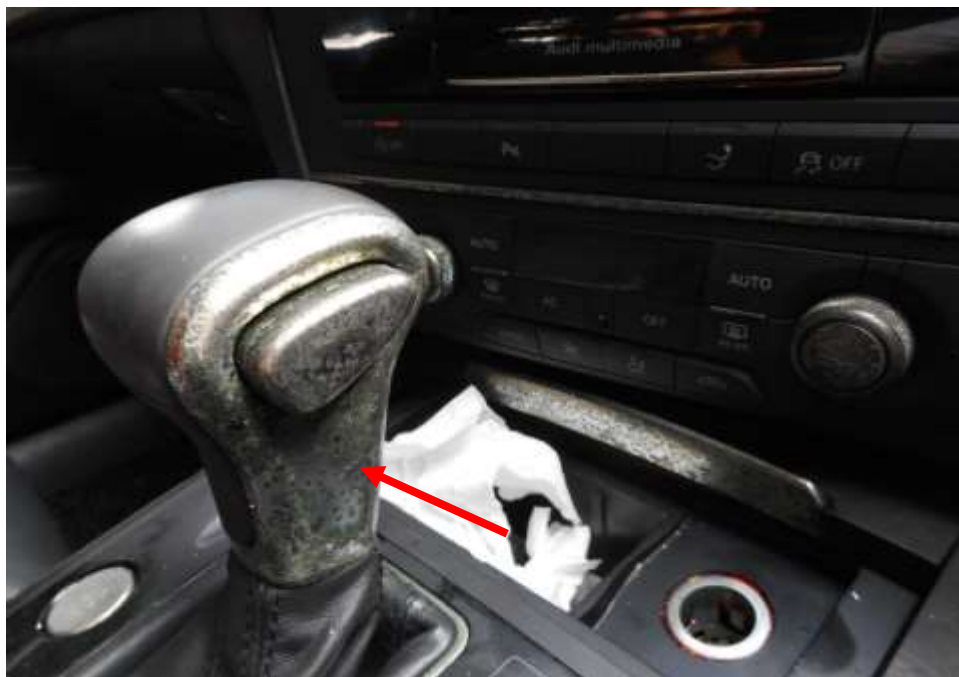
Photo 11 shows the general view of the gear knob trims of the Insured Vehicle at the time of our inspection. The surface had also suffered heat and smoke damages (arrowed) as a result of the fire.

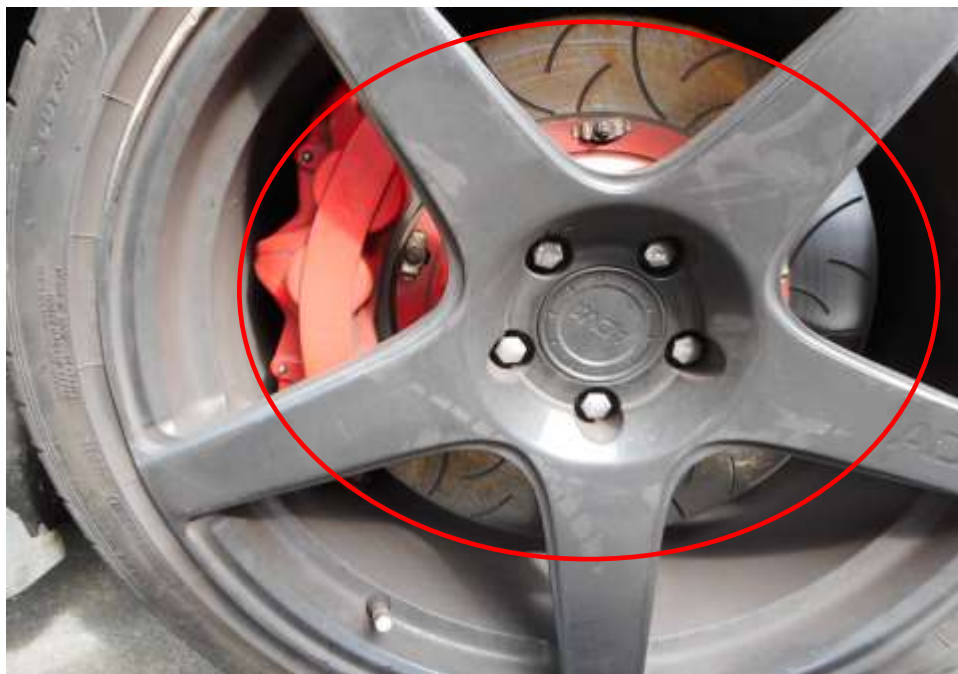
7. At the time of inspection of the Insured Vehicle, we observed a set of aftermarket brake calipers and disc brakes fitted on the Insured Vehicle. See photo 12 below.

Photo 12 shows a set of aftermarket brake calipers and disc brakes on the Insured Vehicle, which was observed to be unaffected by the fire.

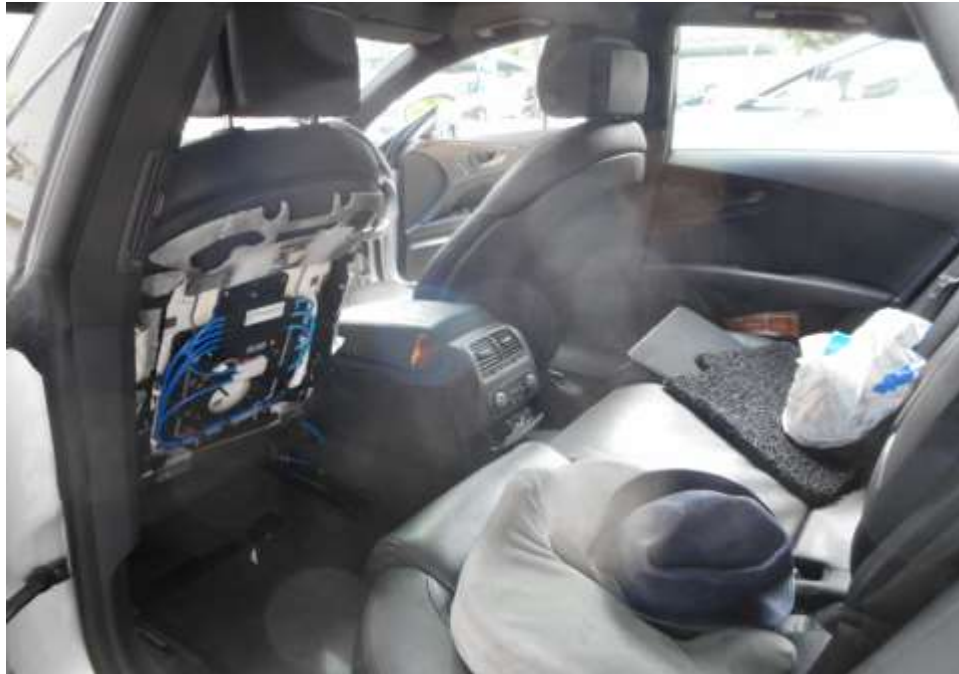
8. Based on the circumstances for this particular case, the fire appears to have originated from the interior portion of the Insured Vehicle, somewhere around the rear left passenger foot well. This can be determined basing on the area where the extent of fire damage was most severe, the circumstances of the fires' origin at the material time of incident and also the burn marks and melting of material that were found on the surface on the foot well, centre console armrest and the rear of the front left seat.
9. These burn marks are a result of exposure to heat intensity. In the immediate vicinity of where these burn marks were found, would also support our findings of where the fire to the Insured Vehicle had originated. This physical evidence would then appear to suggest that the cause of fire to the Insured Vehicle could have possibly been due to external factor. See photo 13-18 below.

Photo 13 shows the general view of the rear passenger seating compartment of the Insured Vehicle at the time of our inspection. The fire damage to the Insured Vehicle was confined to its left seating portion. Its centre console armrest and rear of the front left seat are amongst the body parts that were found to have been affected as a result of the fire.

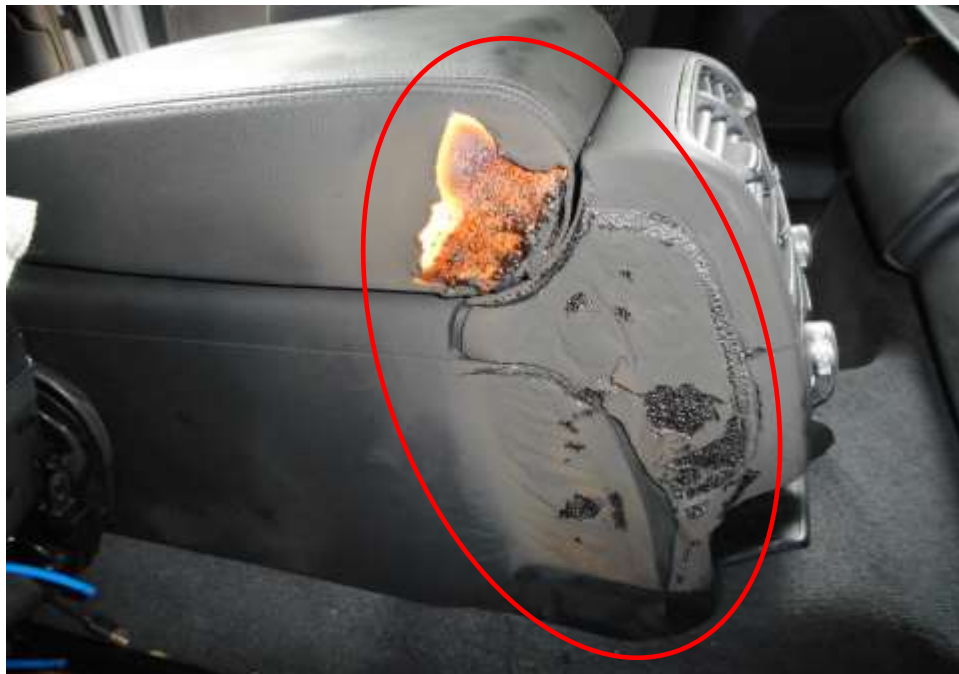
Photo 14 shows the close up view of the from rear left passenger seating compartment of the Insured Vehicle at the time of our inspection. Its centre console armrest (circled) was found to have been burnt and melt as a result of the fire.

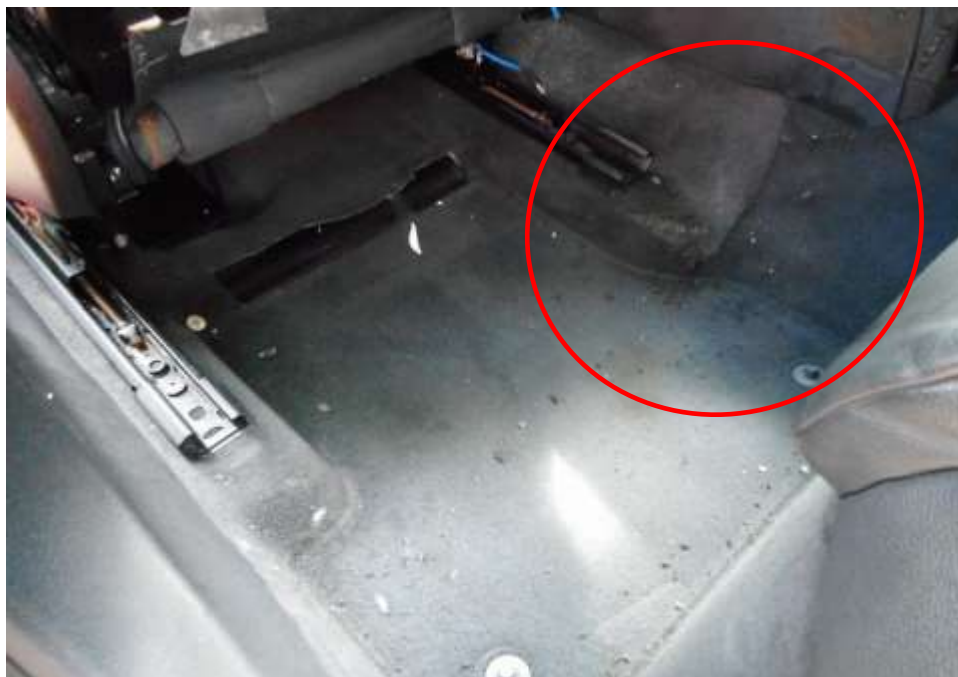
Photo 15 shows the close up view of the from rear left passenger seating compartment of the Insured Vehicle at the time of our inspection. Its rear left foot well (circled) was found to have been burnt as a result of the fire.

13. Mr Muharrem informed us that upon closer examination of the Insured Vehicle’s interior he found the aftermath of a an exploded powerbank which was placed at the rear left passenger foot well, located right beside the rear centre console armrest close to rear of the front left passenger seat. The explosion had damaged the various components in the Insured Vehicle.

19. Having investigated and technically analysed the damages of burnt nature to the Insured Vehicle. We are in view that, the fire had originated from a powerbank placed at the rear left passenger foot well area of the Insured Vehicle. Fire to the Insured Vehicle was hence due to external factor.
20. We observed aftermarket brake capliers and brake disc component(s) fitted on the Insured Vehicle at the time of our inspection of the Insured Vehicle. There components did not cause or contribute to the fire incident.
21. Our investigations had also revealed that at the time of writing this report, there is no manufacturer recall to similar make and model vehicle as the Insured Vehicle that may possibly be related to this incident.

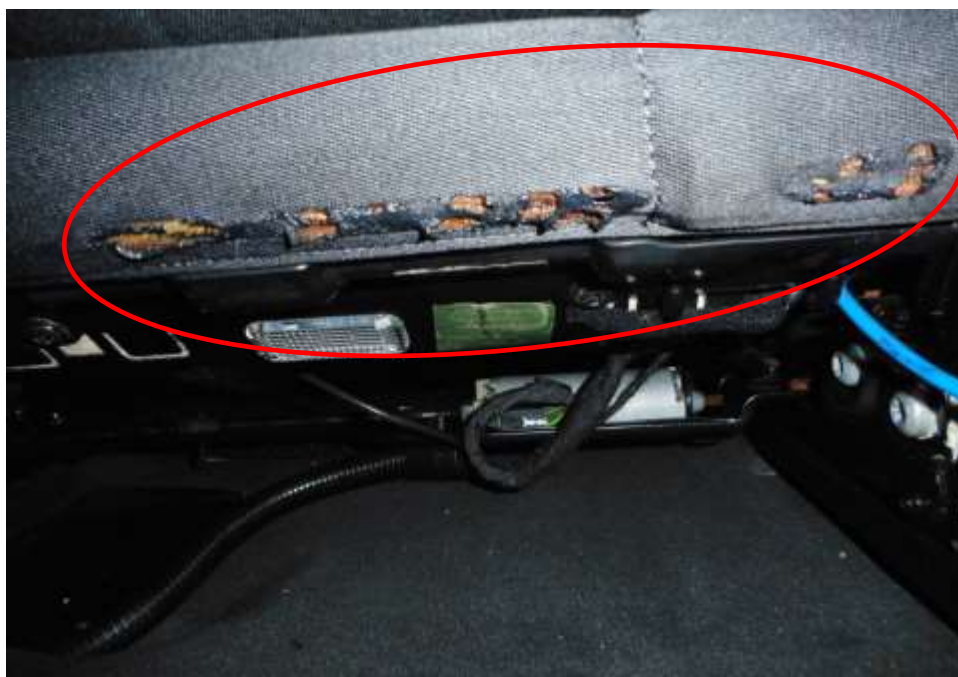
Photo 16 shows the close up view of the from rear left passenger seating compartment of the Insured Vehicle at the time of our inspection. The rear of the left seat (circled) was found to have been burnt as a result of the fire.

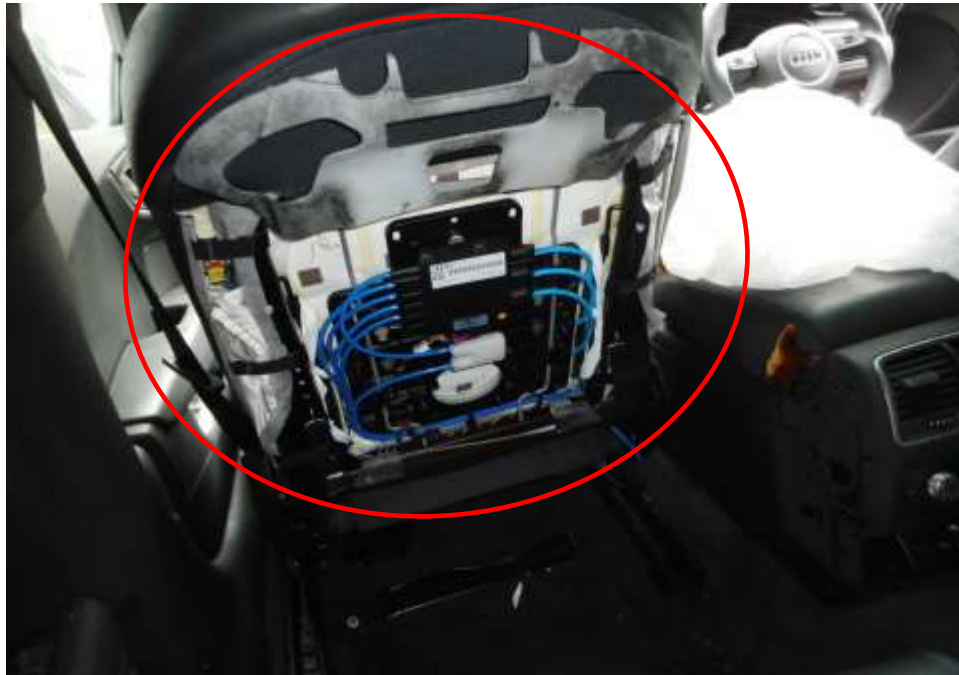
Photo 17 shows the close up view of the from rear left passenger seating compartment of the Insured Vehicle at the time of our inspection. The rear of left seat backing cover (circled) was found to have been missing at the time of the inspection.

14. Mr Muharrem mentioned that, due to the emitting of toxic smell from the exploded powerbank and the melted rear seat plastic backing cover he had disposed them from the Insured Vehicle. He also informed us that there was no SCDF activation as there was no fire spotted at the material time. Subsequently Mr Muharrem started up the Insured Vehicle but however observed that the instrument display panel was not illuminated up and so he left Insured Vehicle parked and locked and carried on to his daily activities.

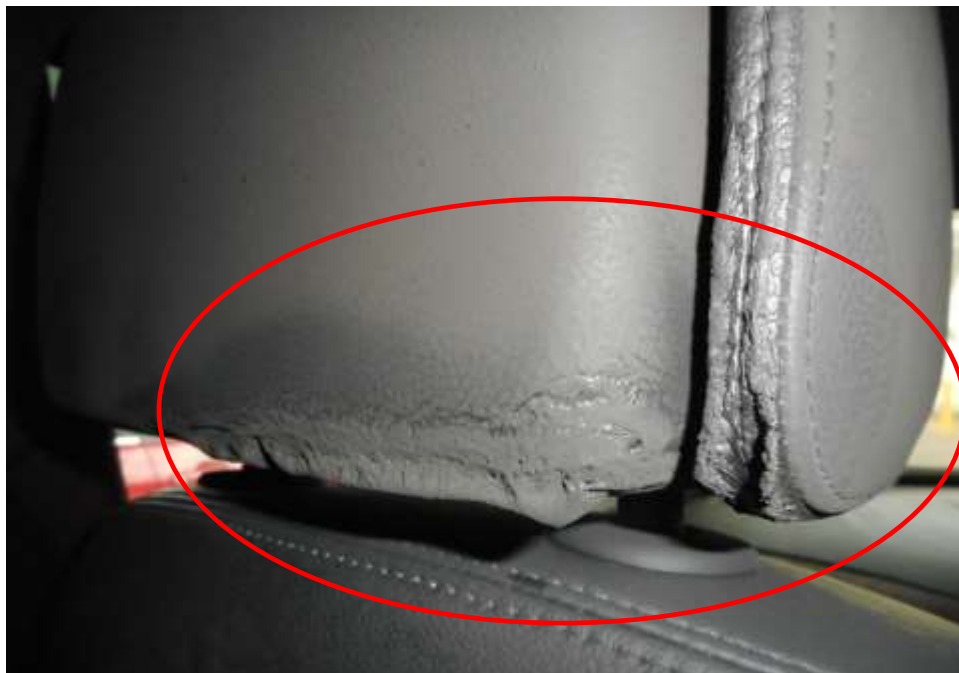
Photo 18 shows the close up view of the from rear left passenger seating compartment of the Insured Vehicle at the time of our inspection. The rear of the left seat headrest (circled) was found to have been burnt and melted as a result of the fire.
