Your Ref: TP/IP/74669/2019
Our Ref : CI/TPD19021255/N

19 December 2019

MECHANICAL INSPECTION REPORT OF MOTOR TAXI SHB 1982D

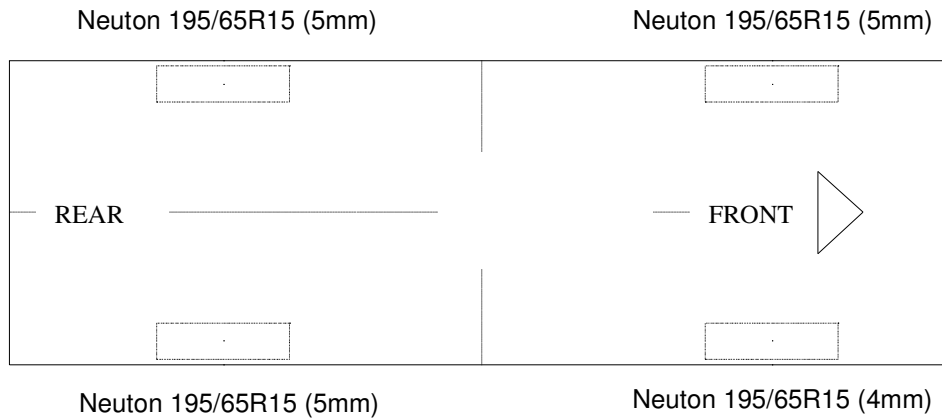
6. The condition of the Motor Taxi's 4 tyres was observed to be in serviceable condition. We did not find any tear, cut or burst mark(s) on the outer and the inner sidewalls as well as across the tread of the 4 tyres. The 4 tyres were also observed to be sufficiently inflated for vehicular operation. The tyre brand, tyre size and remaining tread depth of the 4 tyres were recorded as follows:-

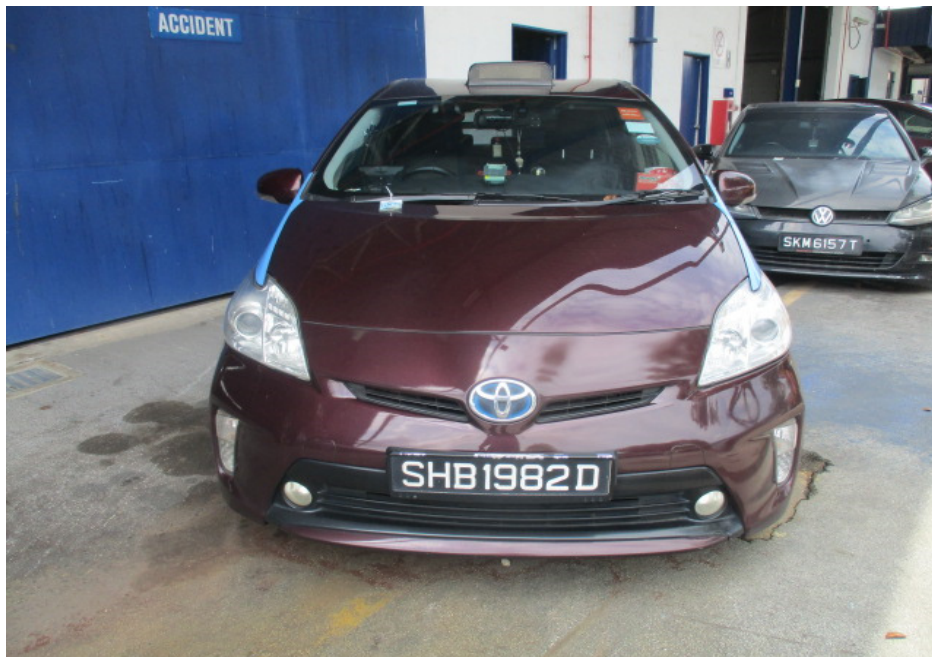
4. The mileage of the Motor Taxi at the time of our inspection was 783,873km.
5. The Motor Taxi had sustained relatively minor impact damage that was confined to its rear portion. The rear bumper and rear bumper undercover were observed to be deformed.

Photo 1 shows a general view of the front left body of the Motor Taxi at the time of our inspection. The Motor Taxi was observed to be in good general condition except for some relatively minor impact damage at its rear portion. The mileage of the Motor Taxi was recorded to be 783, 873km.

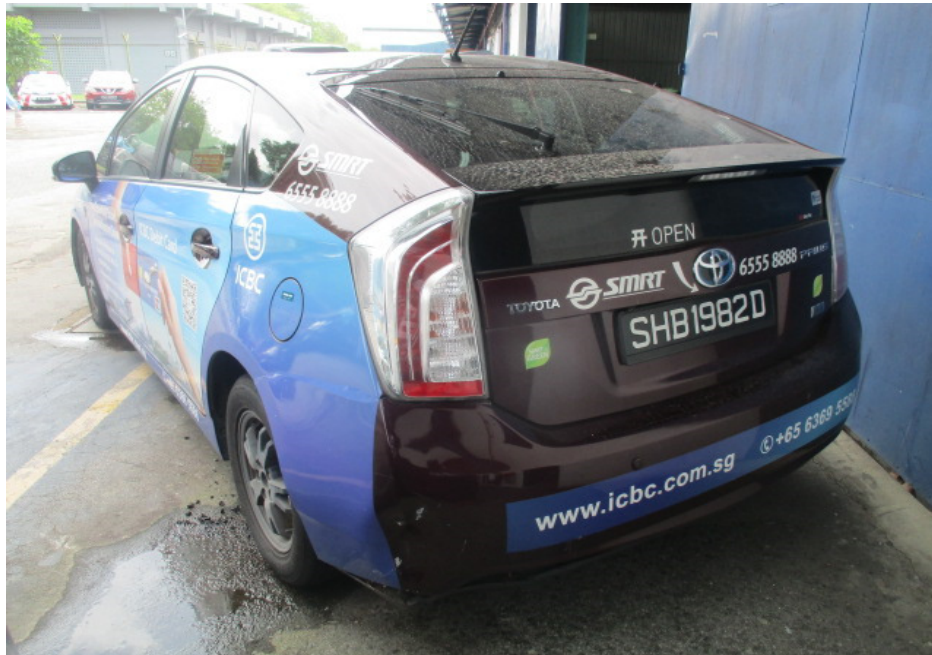
Photo 2 shows a general view of the left rear body of the Motor Taxi at the time of our inspection. The Motor Taxi was observed to be in good general condition. However we had observed relatively minor impact damage that was confined to its rear portion. The rear bumper and rear bumper undercover were observed to be deformed.

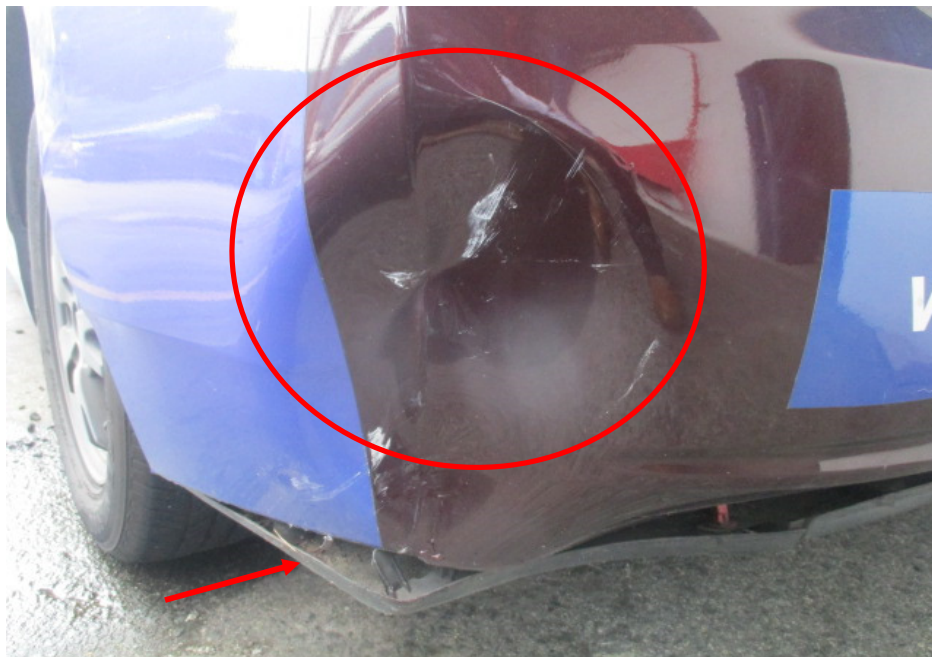
Photo 3 shows a closer view of the deformed rear bumper (circled) and rear bumper under cover (arrowed).

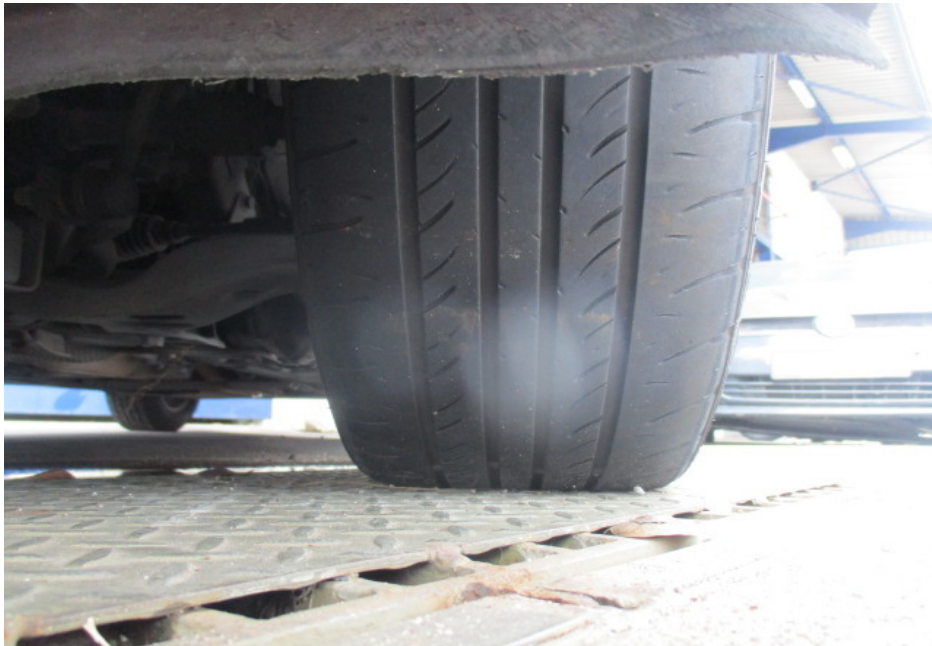
Photo 4 shows the condition of the front left tyre of the Motor Taxi, which was observed to be in serviceable condition with remaining tread depth of approximately 5mm. The tyre, which was wrapped around alloy wheel rim, was also observed to be sufficiently inflated for vehicular operation. There was no tear, cut or burst mark(s) on the outer and the inner sidewalls as well as across the tread of the 4 tyres.

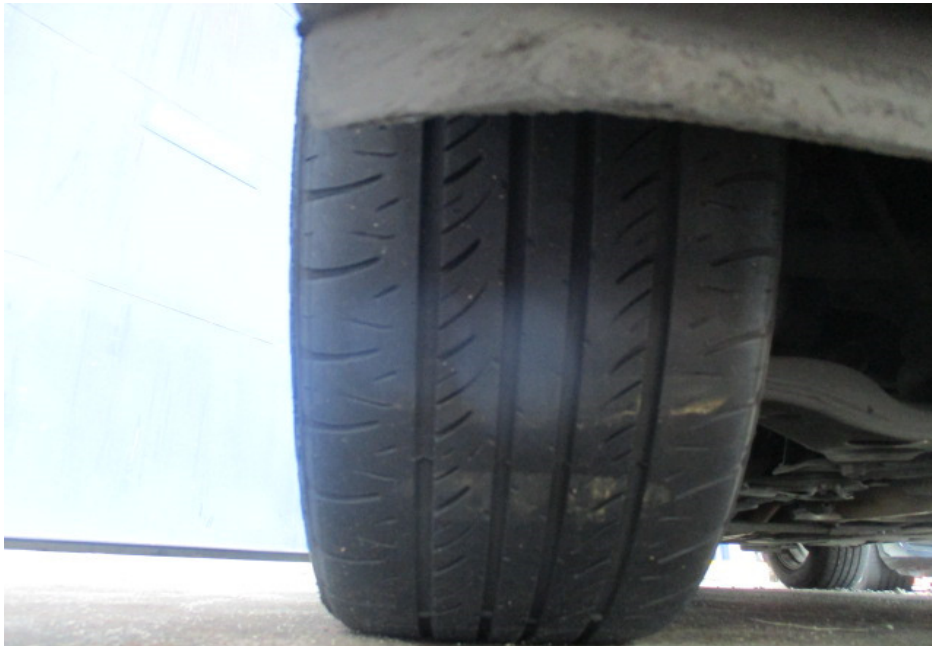
Photo 5 shows the condition of the front right tyre of the Motor Taxi, which was observed to be in serviceable condition with remaining tread depth of approximately 4mm. The tyre, which was wrapped around alloy wheel rim, was also observed to be sufficiently inflated for vehicular operation.

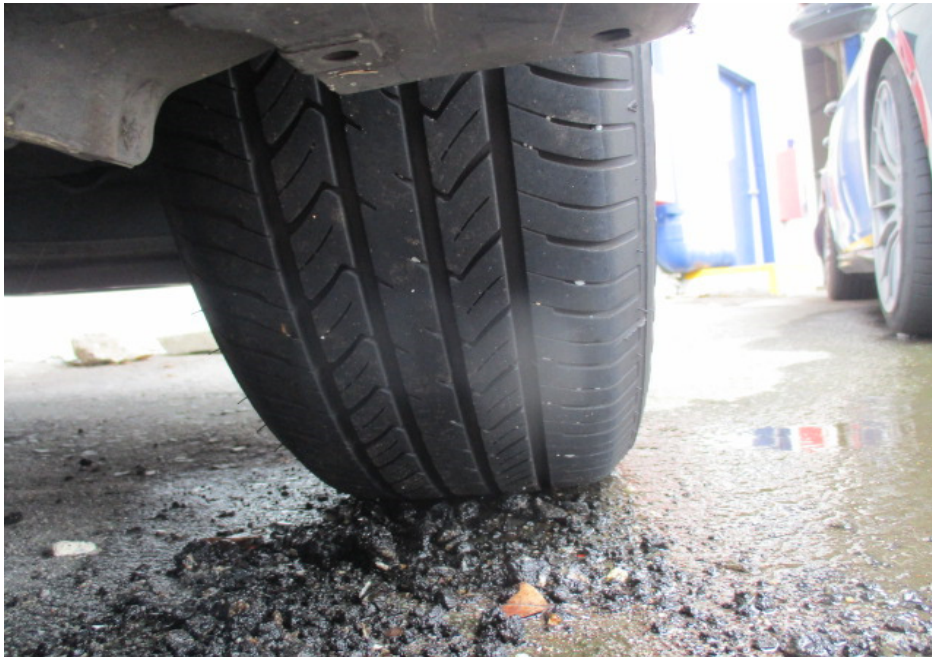
Photo 6 shows the condition of the rear left tyre of the Motor Taxi, which was observed to be in serviceable condition with remaining tread depth of approximately 5mm. The tyre, which was wrapped around alloy wheel rim, was also observed to be sufficiently inflated for vehicular operation. There was also no damage found on the 4 wheel rims of the Motor Taxi.

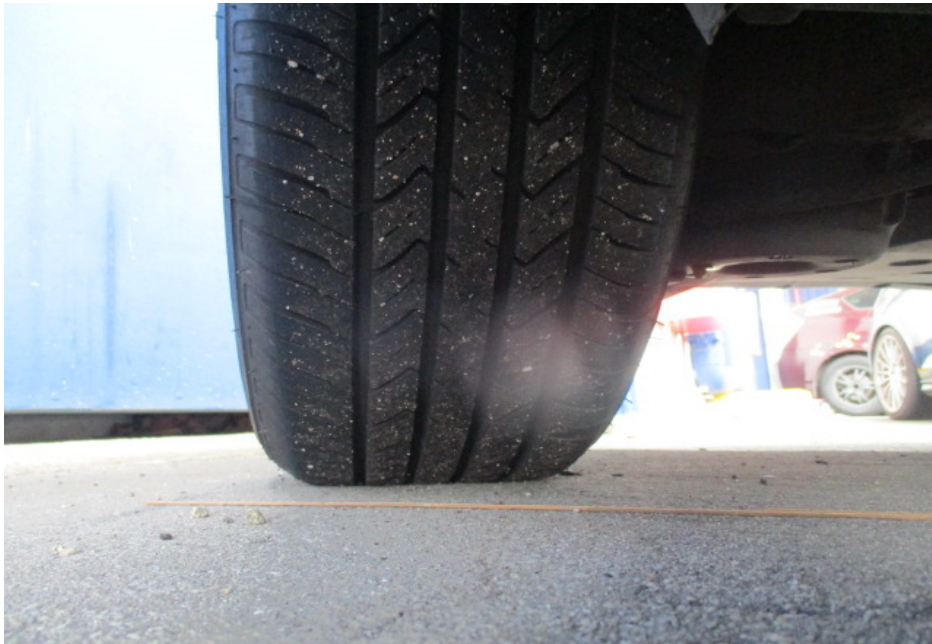
Photo 7 shows the condition of the rear right tyre of the Motor Taxi, which was observed to be in serviceable condition with remaining tread depth of approximately 5mm. There was also no tear, cut or burst mark(s) on the outer and the inner sidewalls as well as across the tread of the 4 tyres.

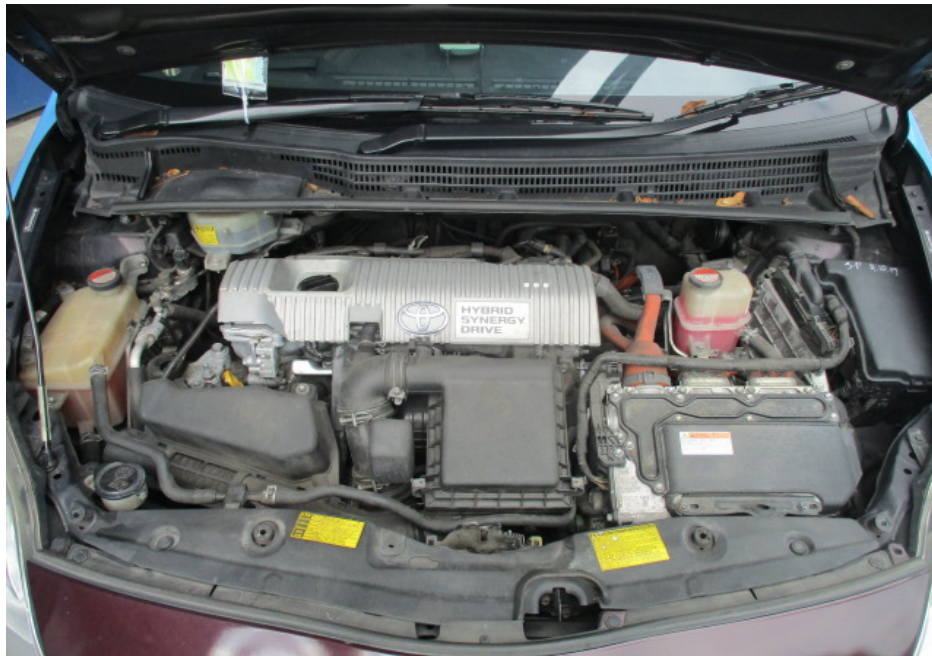
8. Upon examination of the engine compartment of the Motor Taxi, we had observed all the parts and components inside the engine compartment to be intact and unaffected by the accident. The brake fluid, engine oil and engine coolants were all found to be of sufficient level for operating purposes. Visually, there was also no contamination found to these operating fluids.

9. Further examination of the engine compartment revealed no sign(s) or indication(s) of fluid leakage and/or fluid stain within the engine compartment of the Motor Taxi. The wirings and cables for the Motor Taxi's hybrid system were all found to be intact and adequately secured to their respective terminals and/or connecting ports.

Photo 8 shows a general view of the Motor Taxi's engine compartment. The various parts and components inside the engine compartment were unaffected by the accident. The wirings and cables for the hybrid system were all further observed to be intact and adequately secured to their respective terminals and/or connecting ports. There was also no sign(s) or indication(s) of fluid leakage and/or fluid stain within the engine compartment.

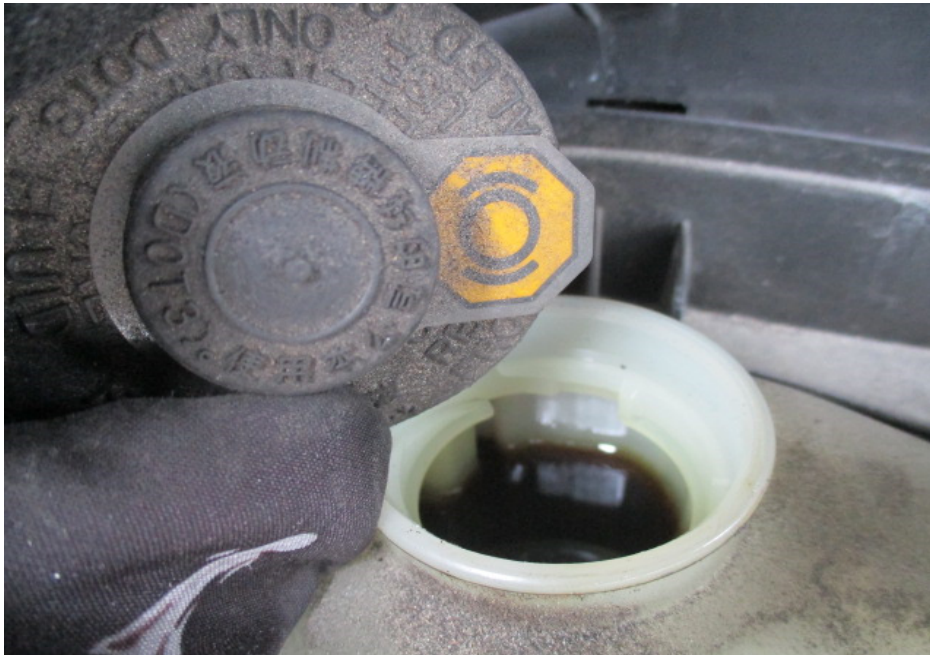
Photo 9 shows the brake fluid reservoir of the Motor Taxi at the time of our inspection. The brake fluid was observed to be of sufficient level and without any visible contamination.

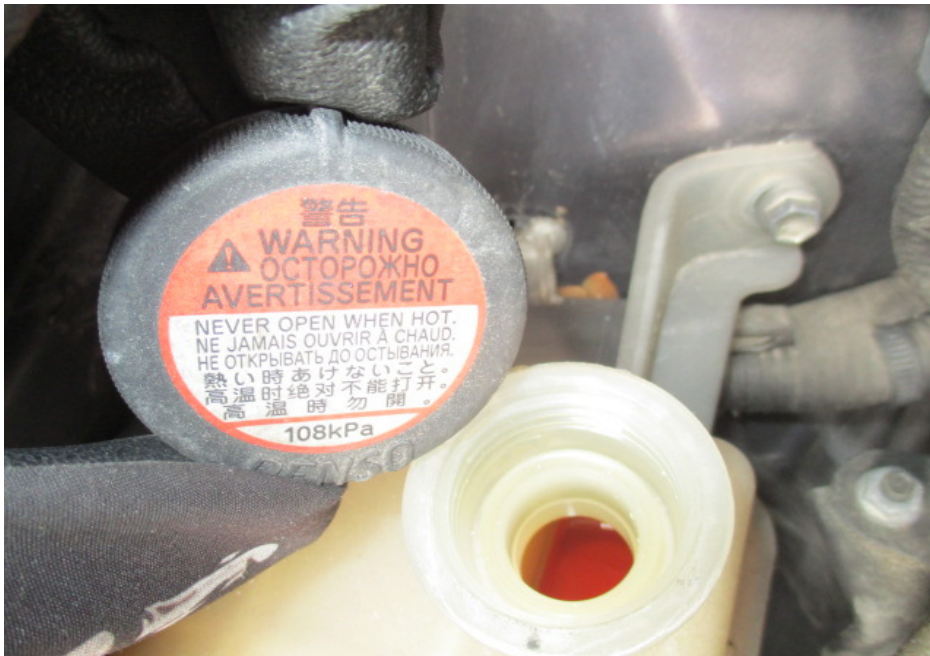
Photo 10 shows checks being carried out to the engine coolant of the Motor Taxi at the time of our inspection. The engine coolant was observed to be of sufficient level and without any visible contamination.

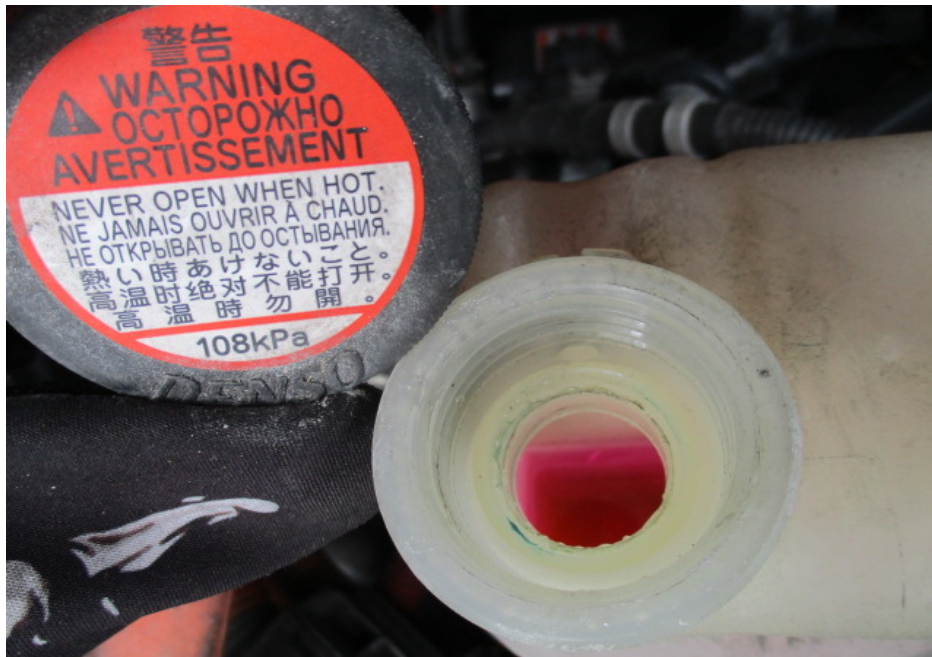
Photo 11 shows the coolant reservoir for the hybrid system of the Motor Taxi at the time of our inspection. The hybrid system coolant was observed to be of sufficient level and without any visible contamination

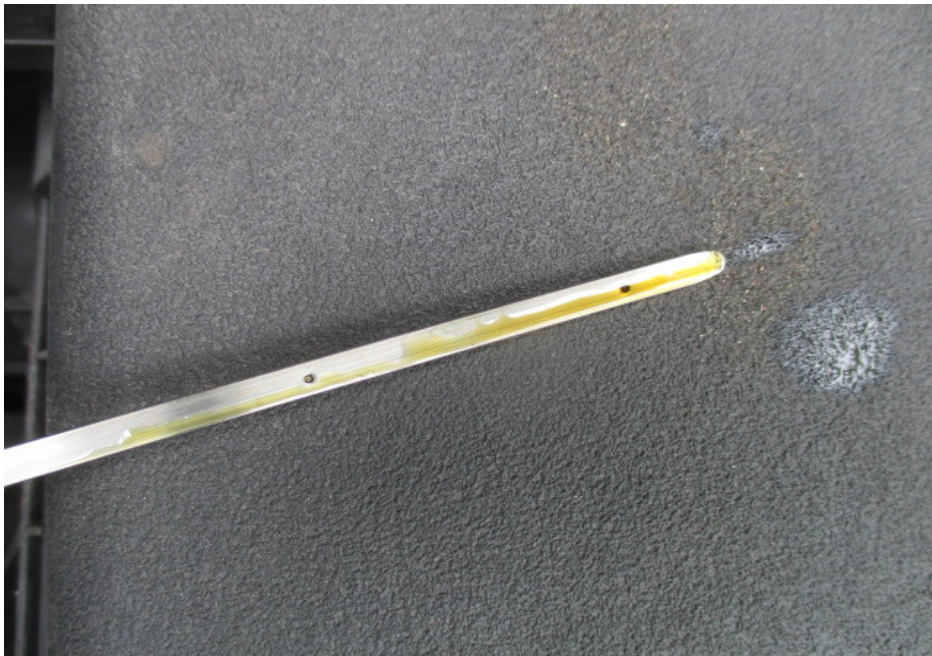
Photo 12 shows the engine oil dip stick of the Motor Taxi at the time of our inspection. The engine oil was observed to be of sufficient level and without any visible contamination.

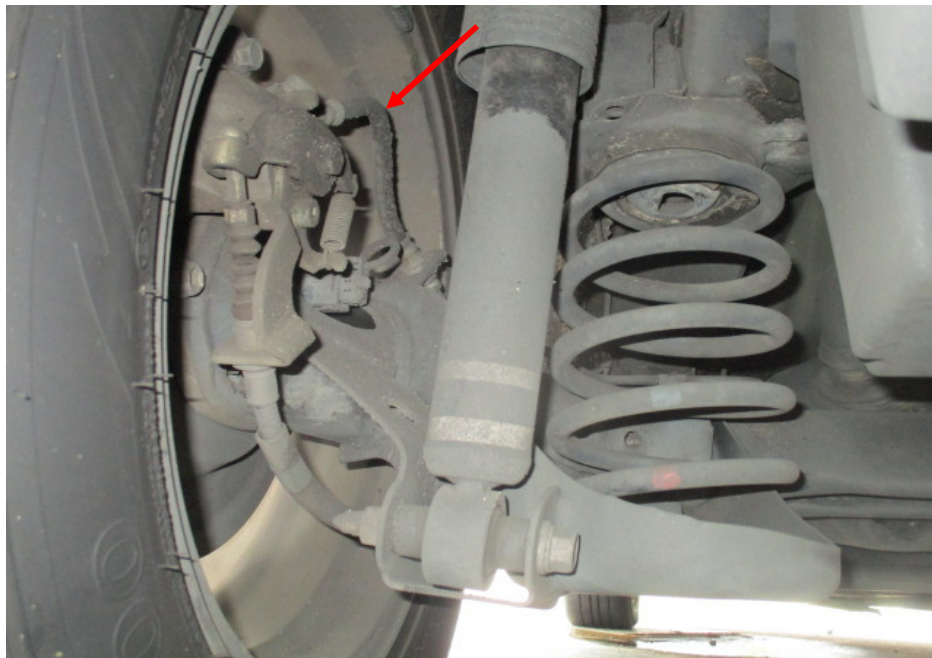
11. Static brake tests conducted on the Motor Taxi revealed no abnormality. There was no abnormal movement of the brake pedal when it was depressed. In general, the static brake tests had suggested that there was no internal leakage of pressure/vacuum in the braking system of the Motor Taxi. The braking system of the Motor Taxi was likely to be in serviceable condition at the material time. This was taking into consideration that the brake fluid was of sufficient level, and also that there was no sign(s) of brake fluid leakage along the brake hoses and brake pipes.

Photo 13 shows the brake hose/pipe (arrowed) at the rear left wheel of the Motor Taxi. We did not observe any leakage of brake fluid at the time of our inspection of the Motor Taxi. Static tests of the Motor Taxi's braking system had indicated that there was no internal leakage of pressure/vacuum. Hence the braking system was likely to be in serviceable condition at the material time of accident. The undercarriage components of the Motor Taxi were also all found to be intact and without any visible damage.

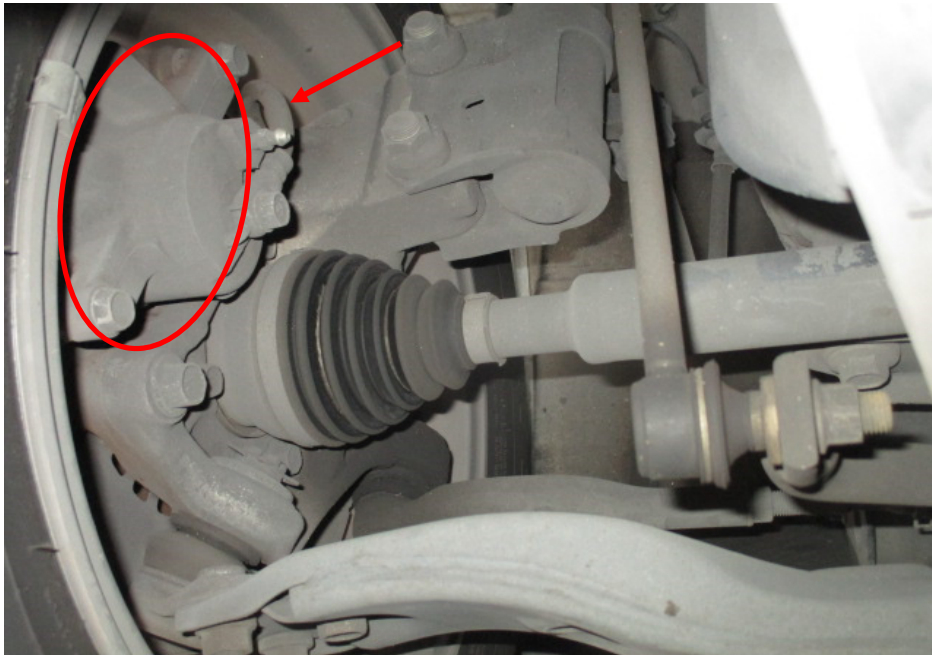
Photo 14 shows the brake hose/pipe (arrowed) at the front right wheel of the Motor Taxi. No leakage of brake fluid was observed. Visual examination of the various components of the braking system like the brake caliper (circled), brake pedal etc. had revealed all to be intact and without visible damage.

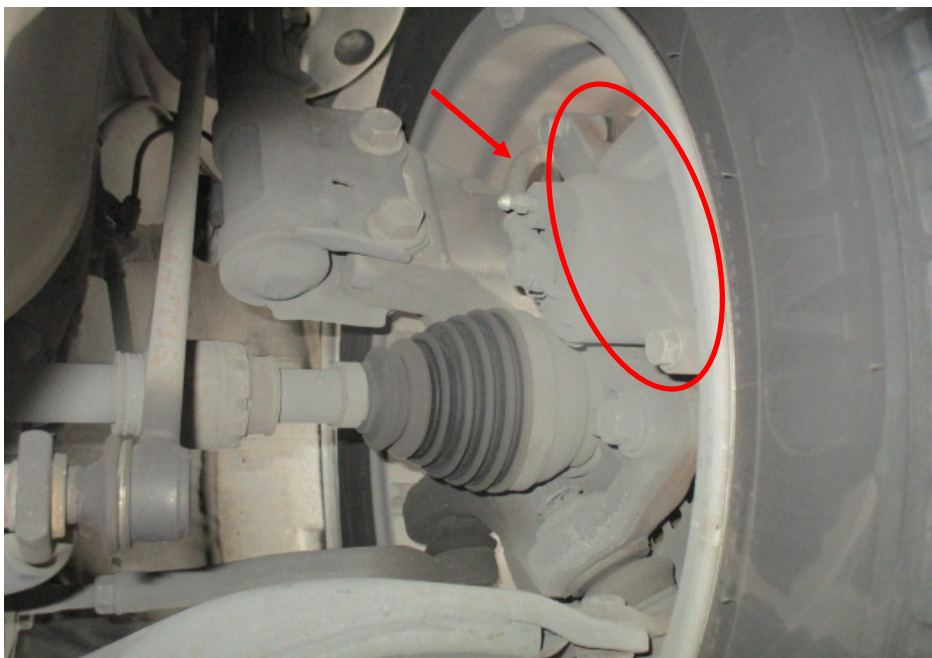
Photo 15 shows the brake hose/pipe (arrowed) at the front left wheel of the Motor Taxi. No leakage of brake fluid was observed. Visual examination of the various components of the braking system like the brake caliper (circled), brake pedal etc. had revealed all to be intact and without visible damage.

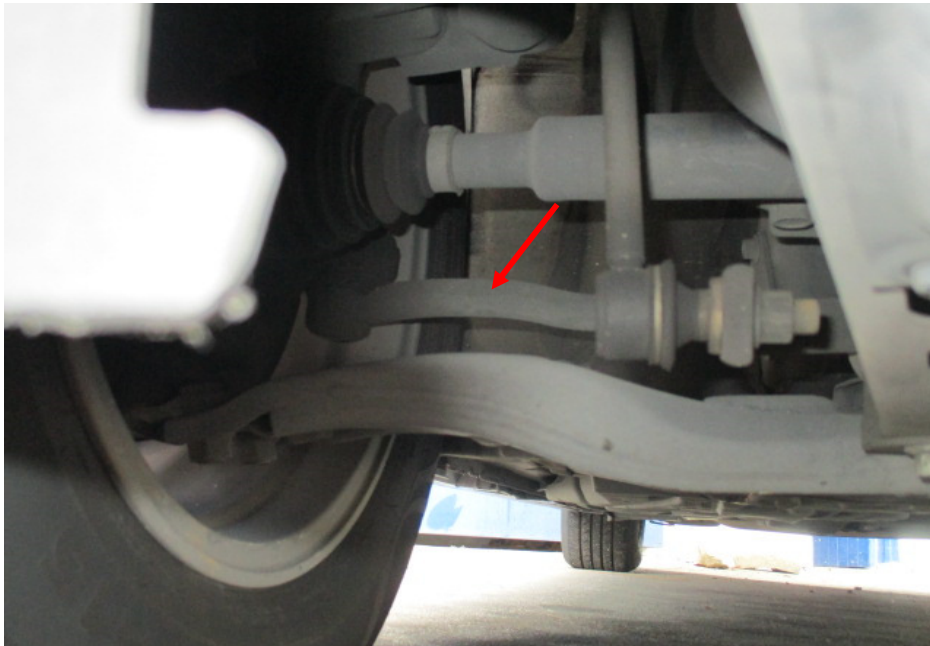
Photo 16 shows the various undercarriage components at the front right wheel of the Motor Taxi, in particular the steering tie rod (arrowed). The various steering components were all found to be intact, suggesting that the steering system of the Motor Taxi was likely to be in serviceable condition at the material time of accident. There was also no sign of fluid stain observed on the various undercarriage components at the front right wheel of the Motor Taxi.

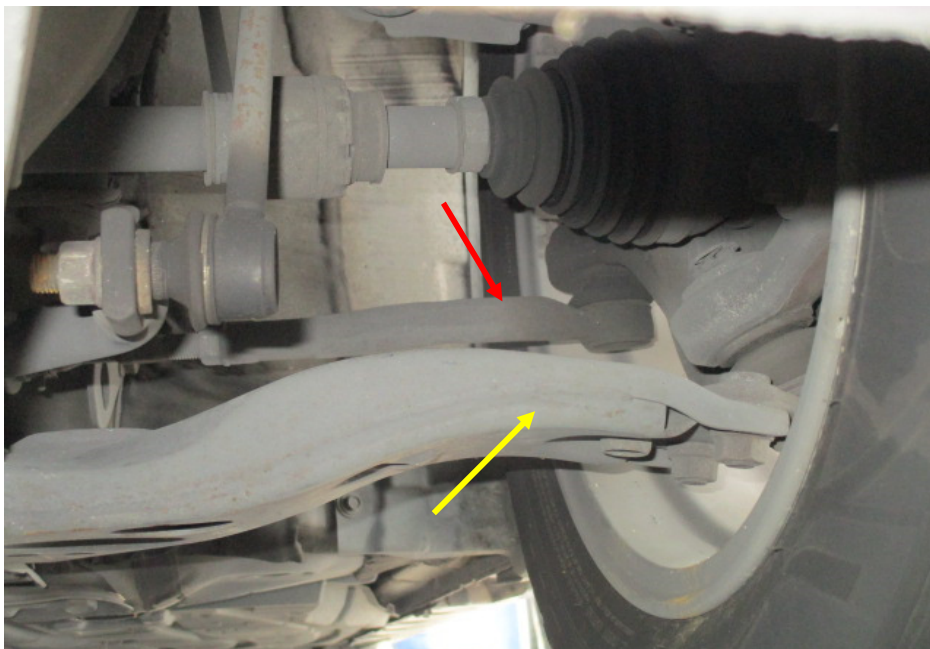
Photo 17 shows the various undercarriage components at the front left wheel of the Motor Taxi, which had included the steering tie rod (red arrow) and left drive shaft (yellow arrow). The various undercarriage components of the Motor Taxi were all found to be intact without any visible damage.

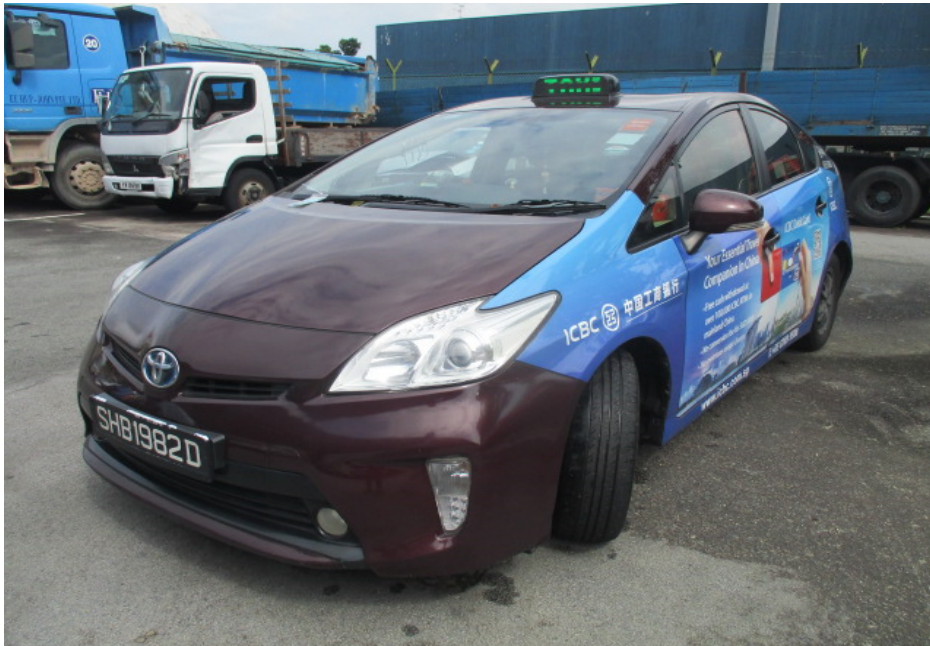
12. Static test on the steering system of the Motor Taxi also revealed no abnormality to the steering system. We did not experience any abnormal free play and/or other resistance when turning the steering wheel left and right to full lock positions. Our visual examination of the various steering components which had included the steering rack and pinion, tie rods, tie rod ends and ball joints revealed that these components were all generally in good condition. See photos 13 - 19 below.

Photo 18 shows the front left wheel of the Motor Taxi turned to its full left. During our steering system test, we did not experience any abnormal free play and/or resistance when we had turned the steering wheel towards the left and right. This would suggest that the steering system of the Motor Taxi was likely to be in serviceable condition at the material time of accident.

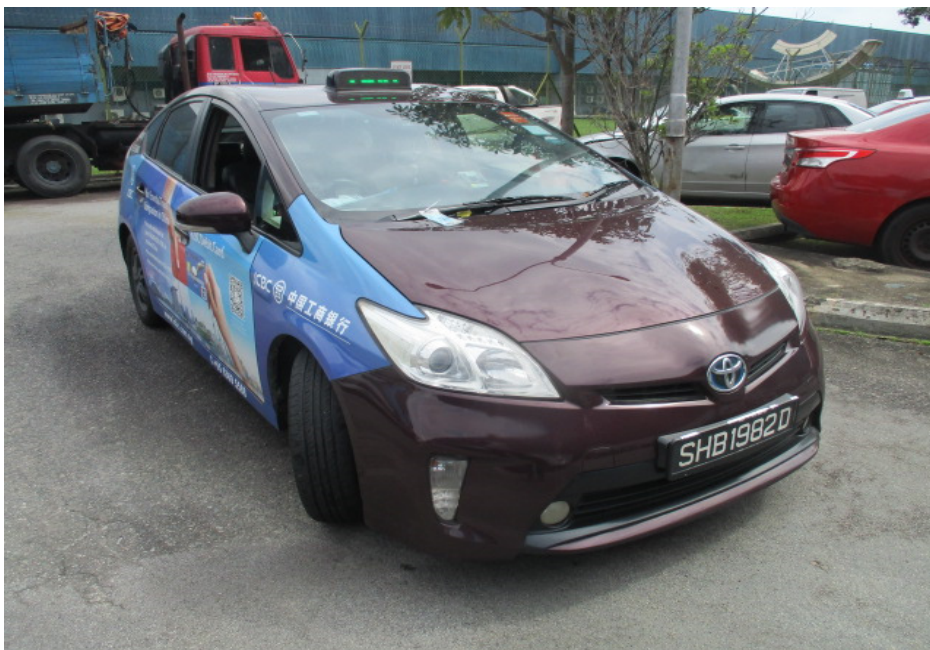
Photo 19 shows the front right wheel of the Motor Taxi turned to its full right. During our steering system test, we did not experience any abnormal free play and/or resistance when we had turned the steering wheel towards the left and right. This would suggest that the steering system of the Motor Taxi was likely to be in serviceable condition at the material time of accident.

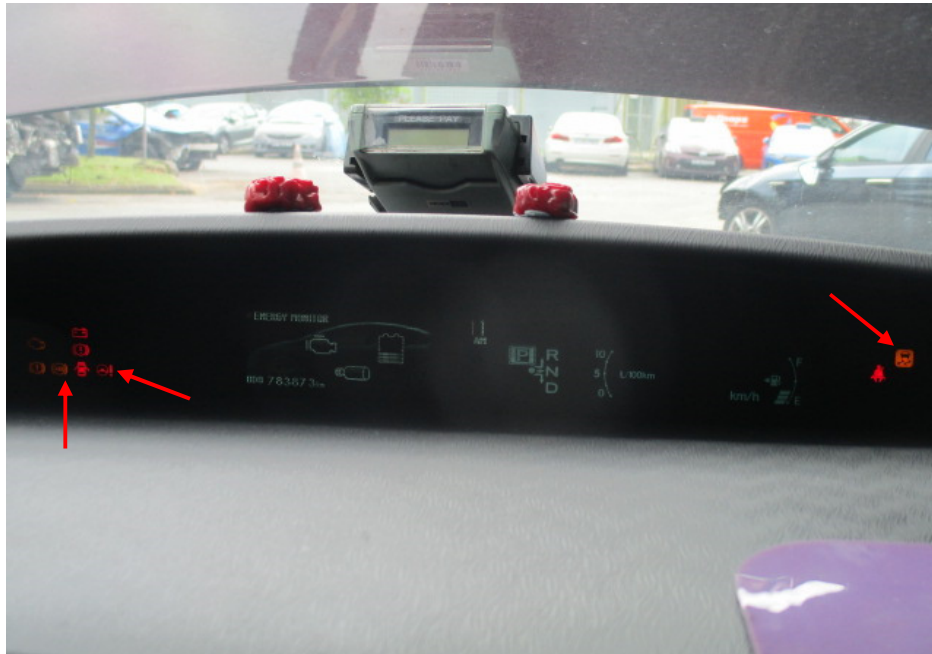
13. The Motor Taxi's automatic self-test of the functionality of its various electronic operating systems like the Electronic Power Steering (EPS), Anti-Brake Lock System (ABS) and Electronic Stability Control (ESC) during cranking of the engine had indicated that these systems were in working condition and without abnormality. This can be established from the warning lights disappearing from the instrument panel after the self-test. See photos 20 & 21 below.

Photo 20 shows the warning lights for the various electronic operating systems of the Motor Taxi appearing on its instrument panel during the self-test when the engine is cranked, in particular the EPS light, ABS light and ESC light (arrowed).

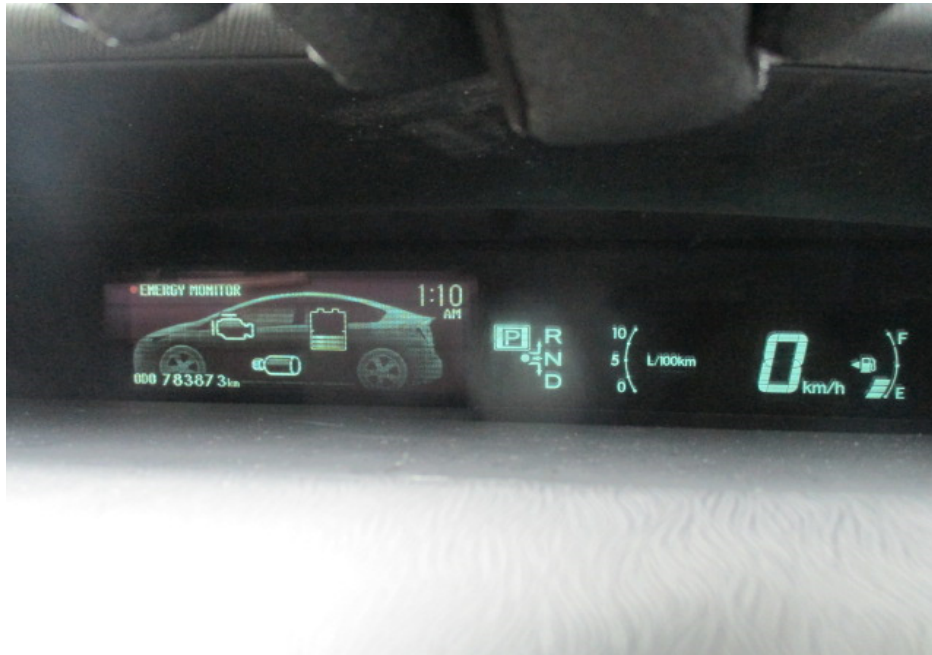
Photo 21 shows no warning lights illuminated on the instrument panel of the Motor Taxi after the engine was cranked. This would suggest that there was no abnormality to the various electronic operating systems of the Motor Taxi, like the EPS, ABS and ESC etc.
