Your Ref: A-190617230642-S
Our Ref : CI/TPD19021325/P

15th January 2020

MECHANICAL INSPECTION REPORT OF MITSUBISHI FORKLIFT

MECHANICAL INSPECTION REPORT OF KOMATSU FORKLIFT

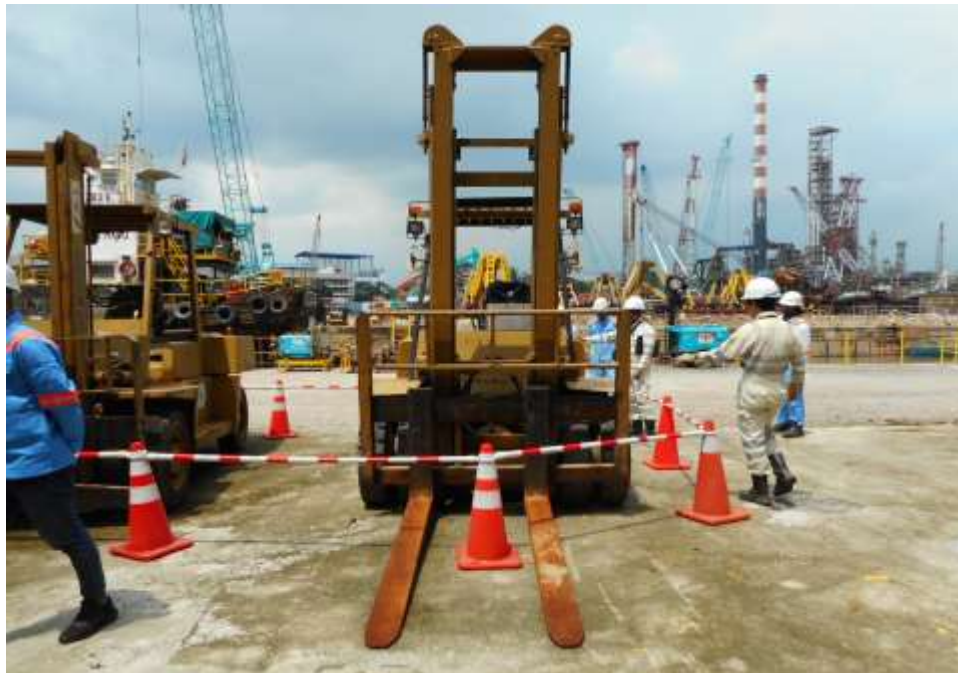
Photo 1 shows a general view of the Mitsubishi Forklift's front at the time of my inspection. The front portion of the Mitsubishi Forklift was observed to have been unaffected by the accident.

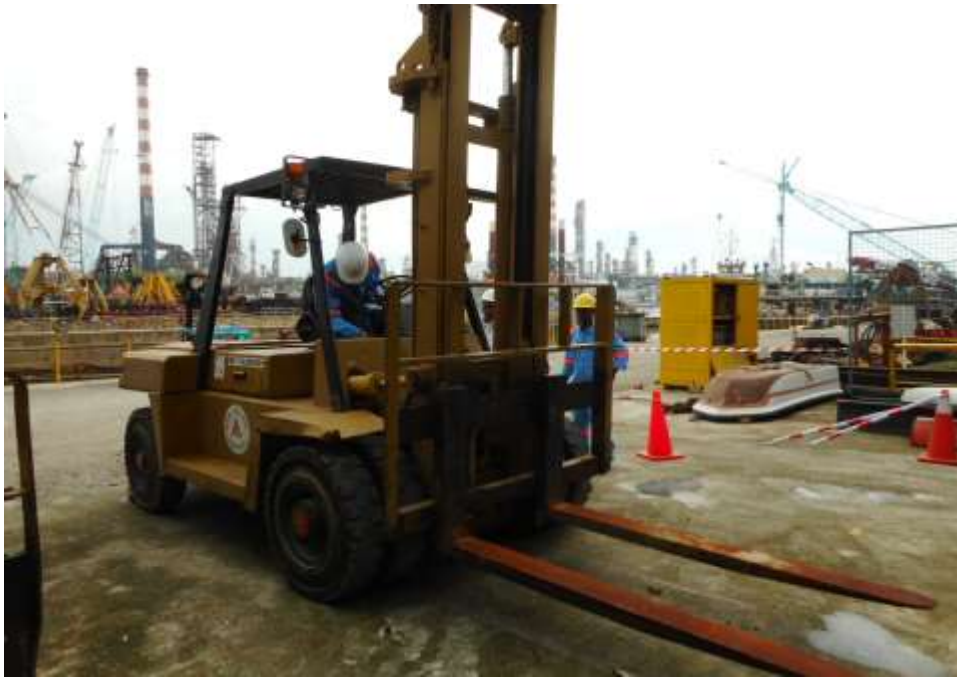
Photo 2 shows a general view of the Mitsubishi Forklift's right body at the time of my inspection. The right portion of the Mitsubishi Forklift was observed to have been unaffected by the accident.

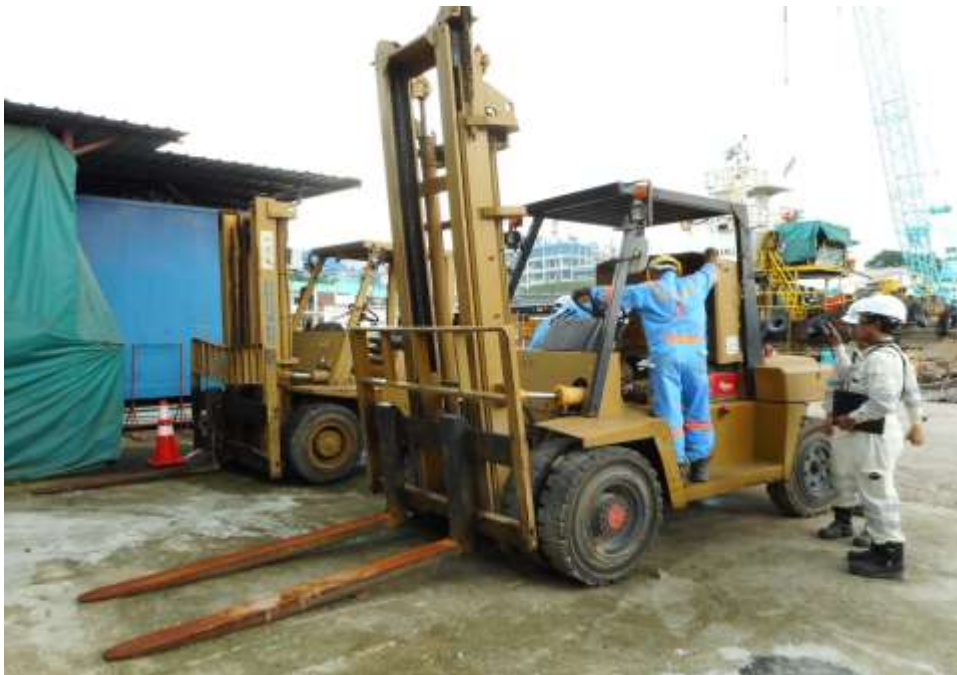
Photo 3 shows a general view of the Mitsubishi Forklift's left body at the time of my inspection. The left portion of the Mitsubishi Forklift was observed to have been unaffected by the accident.

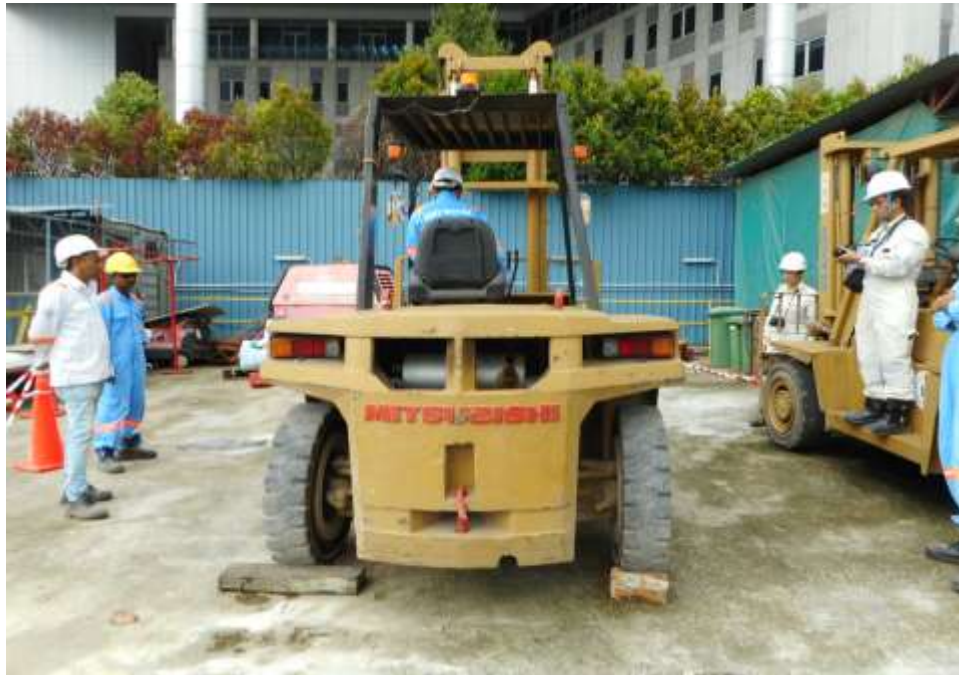
Photo 4 shows a general view of the Mitsubishi Forklift's rear body at the time of my inspection. The rear portion of the Mitsubishi Forklift was observed to have been unaffected by the accident.

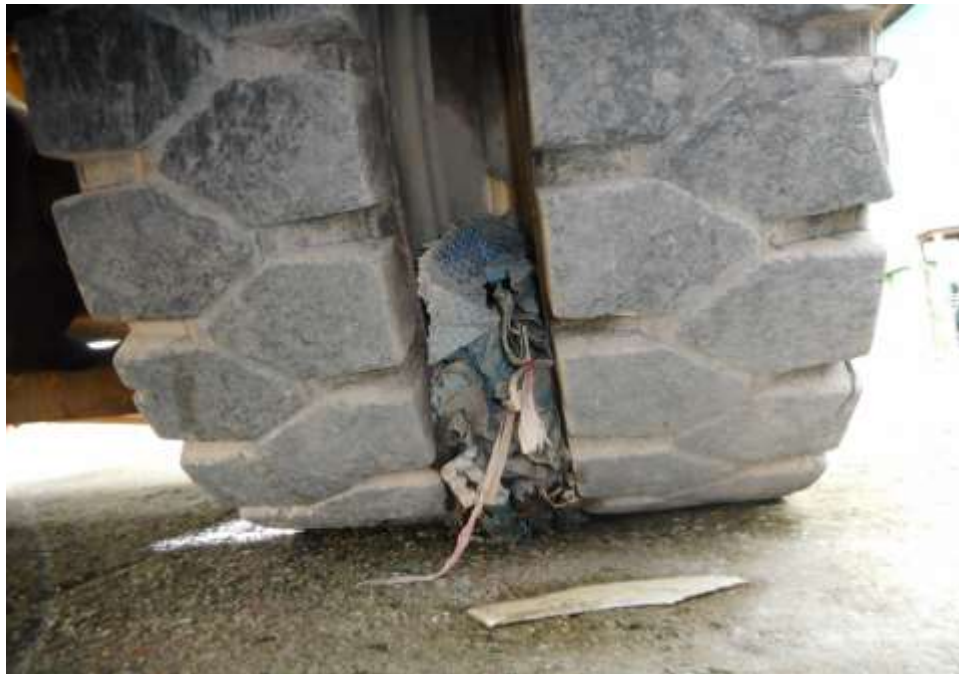
Photo 5 shows the condition of the front right tyre of the Mitsubishi Forklift, which was observed to be in serviceable condition with remaining tread depth of approximately 10.6mm. The tyre was sufficiently inflated for vehicular operation with no tear, cut or burst mark(s) on the outer and the inner sidewalls as well as across the tread. The 6 tyres of the Mitsubishi Forklift were wrapped around standard steel wheel rims without any damage.

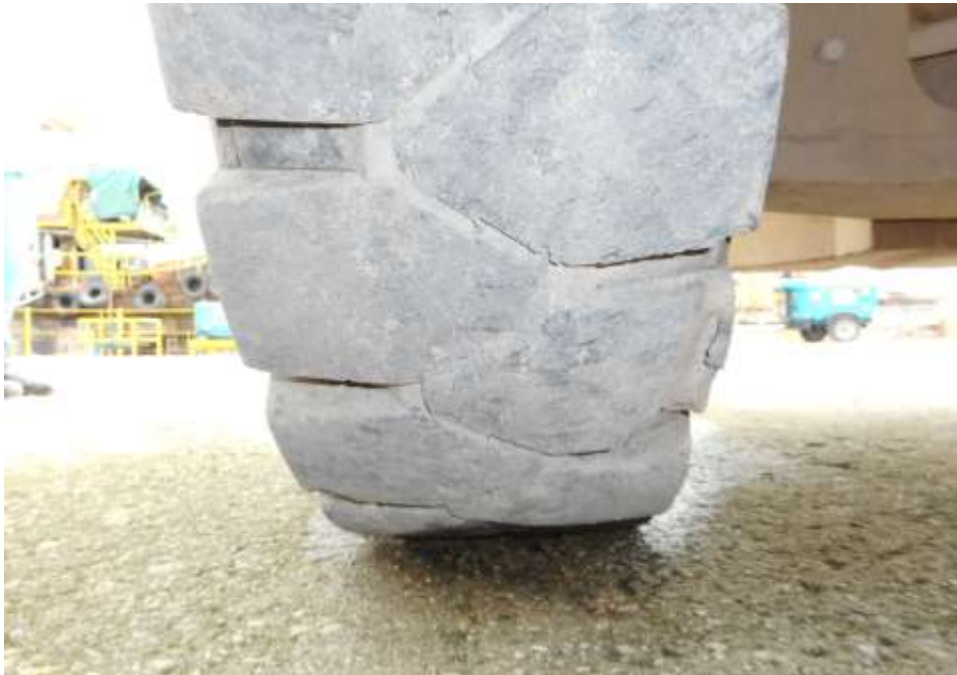
Photo 6 shows the condition of the rear right tyre of the Mitsubishi Forklift, which was observed to be in serviceable condition with remaining tread depth of approximately 8.5mm. The tyre was also observed to be sufficiently inflated for vehicular operation with no tear, cut or burst mark(s).

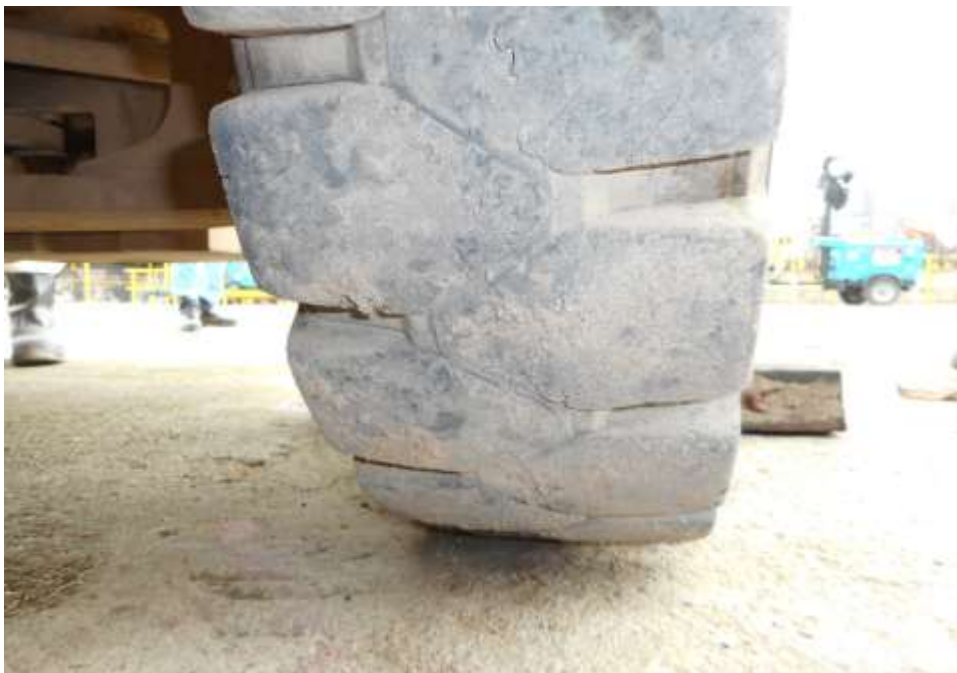
Photo 7 shows the condition of the rear left tyre of the Mitsubishi Forklift, which was observed to be in serviceable condition with remaining tread depth of approximately 7mm. The tyre, which was wrapped around steel wheel rim, was also observed to be sufficiently inflated for vehicular operation. The 6 tyres of the Mitsubishi Forklift were wrapped around standard steel wheel rims.

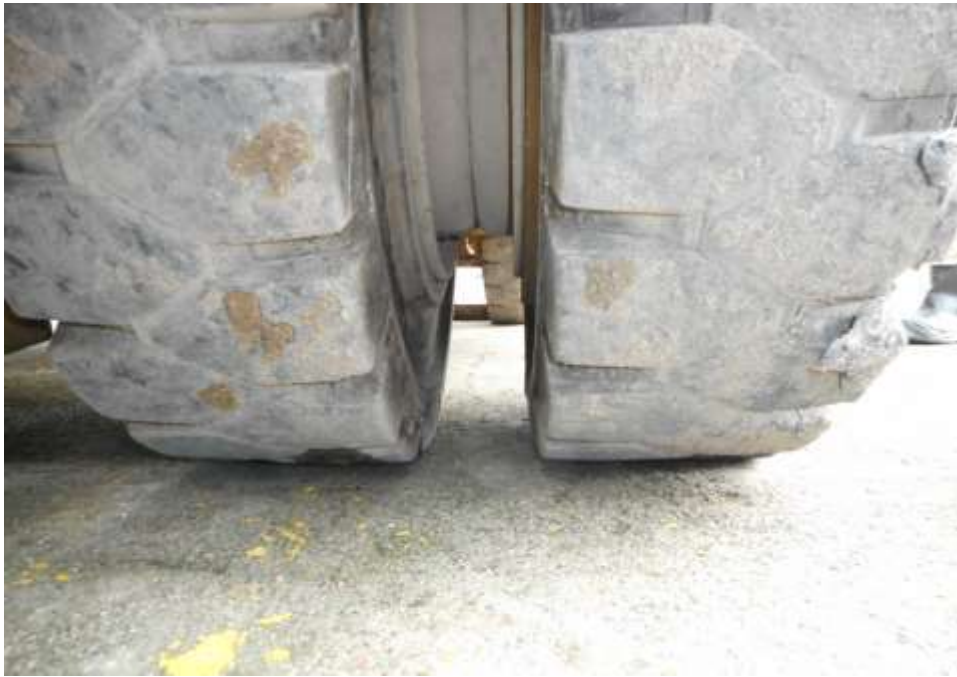
Photo 8 shows the condition of the front left tyre of the Mitsubishi Forklift, which was observed to be in serviceable condition with remaining tread depth of approximately 10.6mm. There was also no tear, cut or burst mark(s) on the outer and the inner sidewalls as well as across the tread of the Mitsubishi Forklift's 6 tyres.

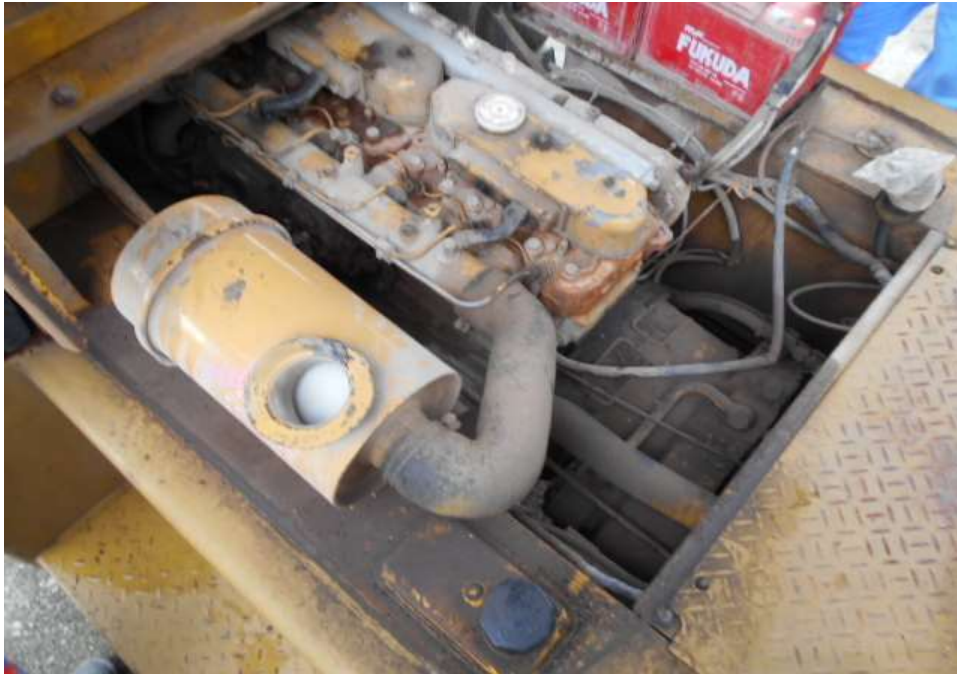
Photo 9 shows a general view of the Mitsubishi Forklift's engine compartment. The various parts and components inside the engine compartment were unaffected by the accident. There was also no sign(s) or indication(s) of fluid leakage and/or fluid stain within the engine compartment.

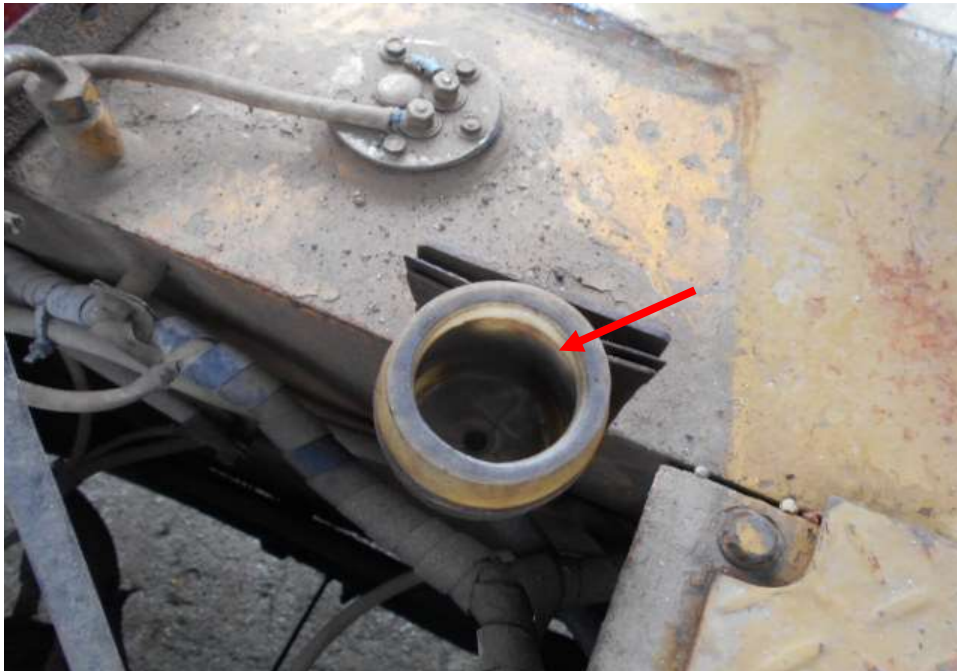
9. However, the engine oil and brake fluid was observed to be insufficient level at the time of our inspection.
10. Further examination of the engine compartment revealed no sign(s) or indication(s) of fluid leakage and/or fluid stain within the engine compartment of the Mitsubishi Forklift.

Photo 10 shows the brake fluid reservoir of the Mitsubishi Forklift at the time of my inspection. The brake fluid was observed to be insufficient level (arrowed)

20. A short operational test of the Mitsubishi Forklift, which I had conducted, revealed that applying of the foot brake was not able to slow down and bring the Mitsubishi Forklift to a complete stop and thus the emergency handbrake had to be applied to slow and stop the Forklift. This was due to insufficient brake fluid in the braking system.

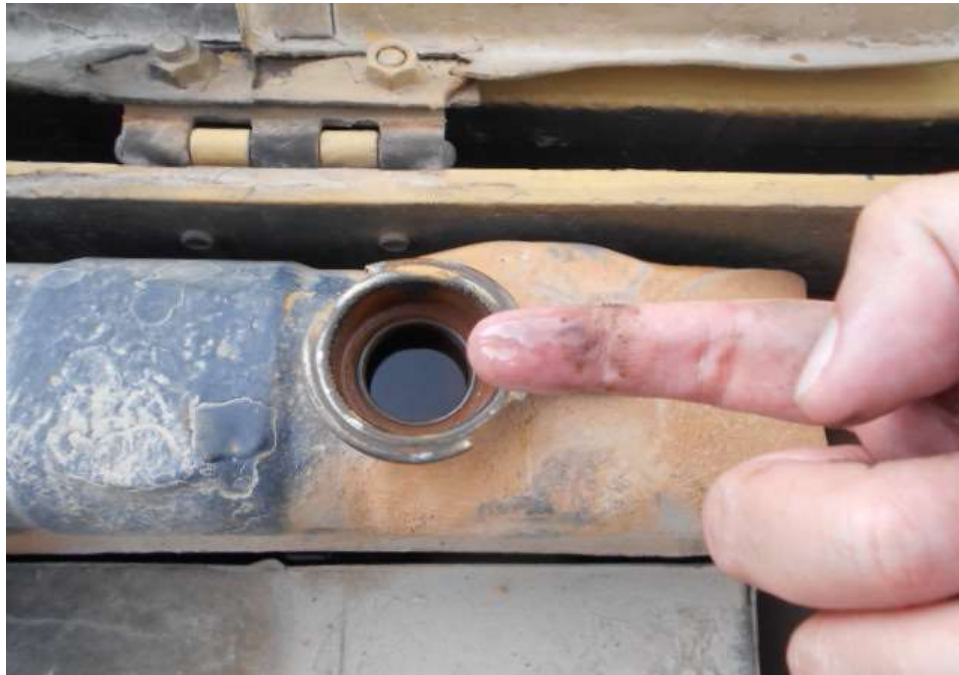
Photo 11 shows checks being carried out to the engine coolant of the Mitsubishi Forklift at the time of my inspection. The engine coolant was observed to be of sufficient level without any visible contamination.

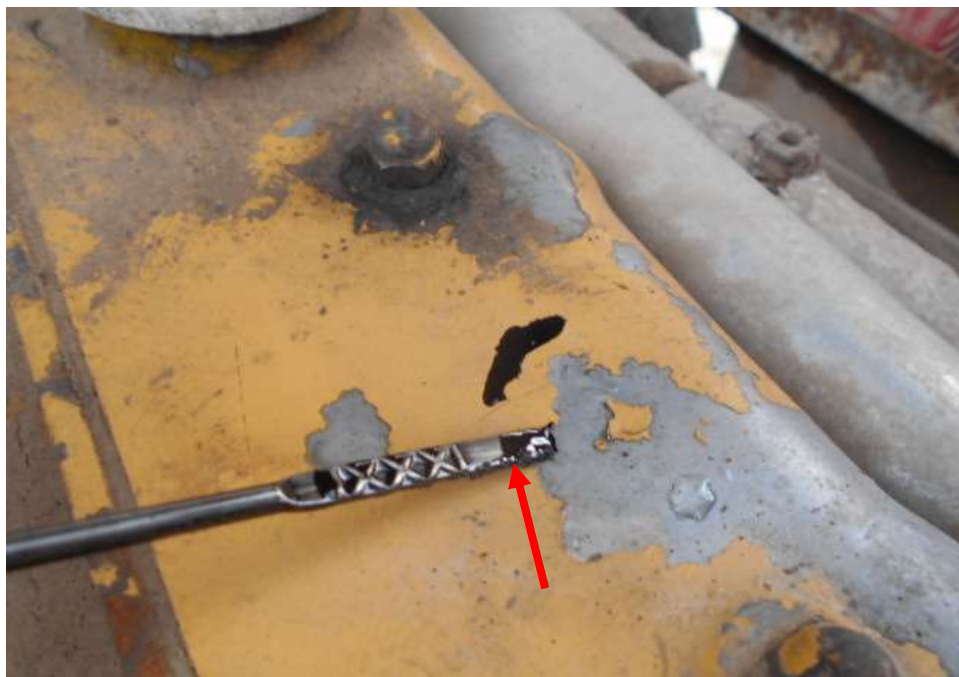
Photo 12 shows the engine oil dip stick of the Mitsubishi Forklift at the time of my inspection. The engine oil was observed to be of insufficient level (arrowed)

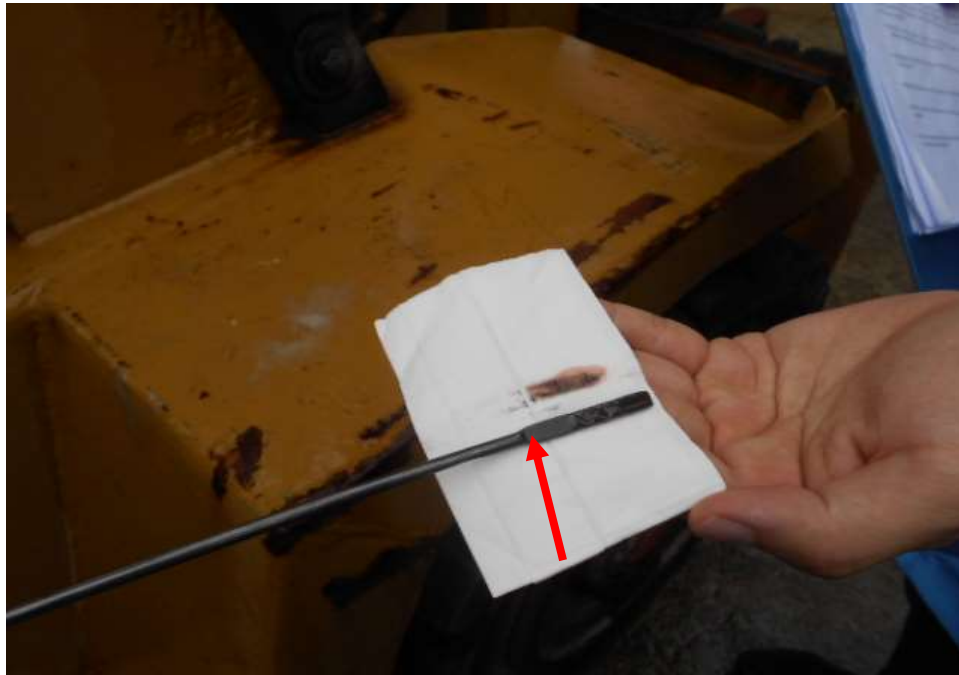
Photo 13 shows the ATF transmission fluid dip stick of the Mitsubishi Forklift at the time of my inspection. The ATF transmission fluid (pink colour) was observed to be of sufficient level and without any visible contamination (arrowed)

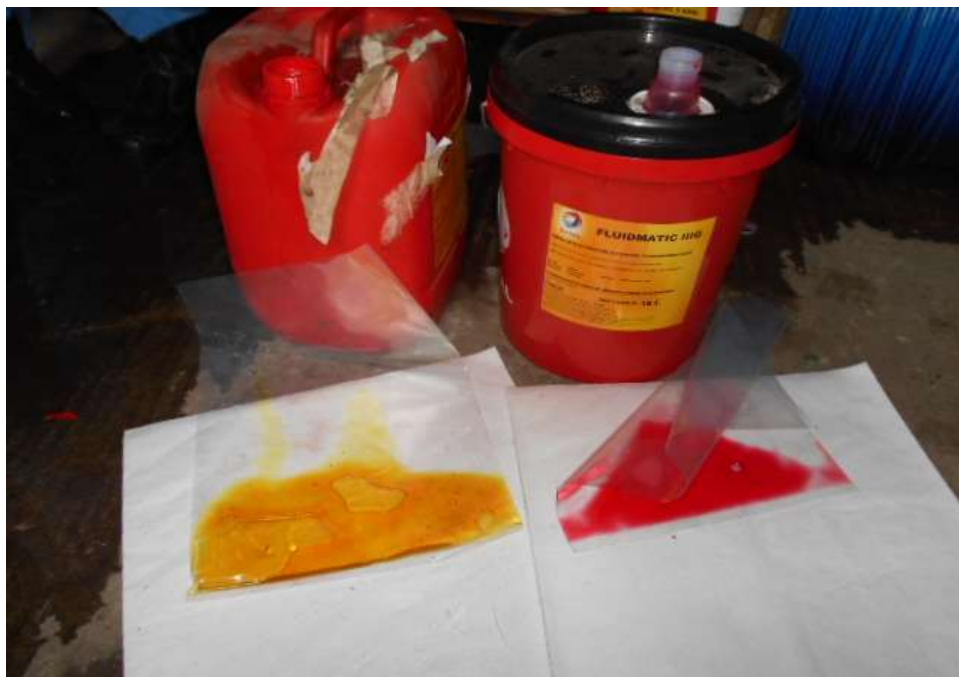
Photo 14 shows the differential gear oil (yellow colour) and the ATF transmission fluid (pink colour) used by the Mitsubishi Forklift and stored at the site warehouse at the time of my inspection.

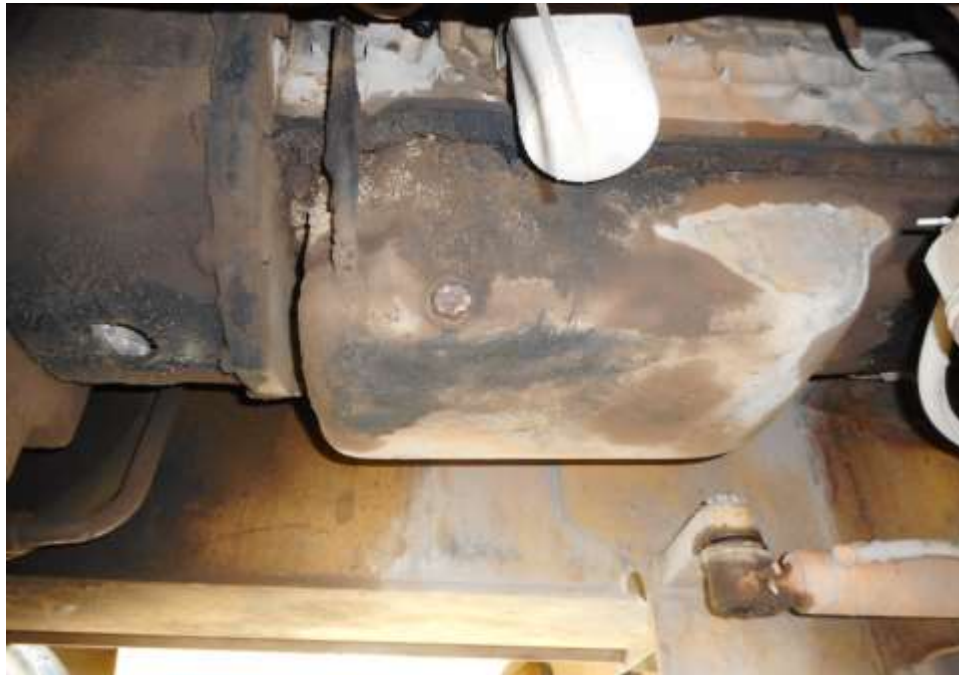
Photo 15 shows the undercarriage of the Mitsubishi Forklift, at the area where the engine housing and transmission housing are located. I did not find any sign(s) or indication(s) of fluid leak and/or fluid stain(s) on the underside of the Mitsubishi Forklift.

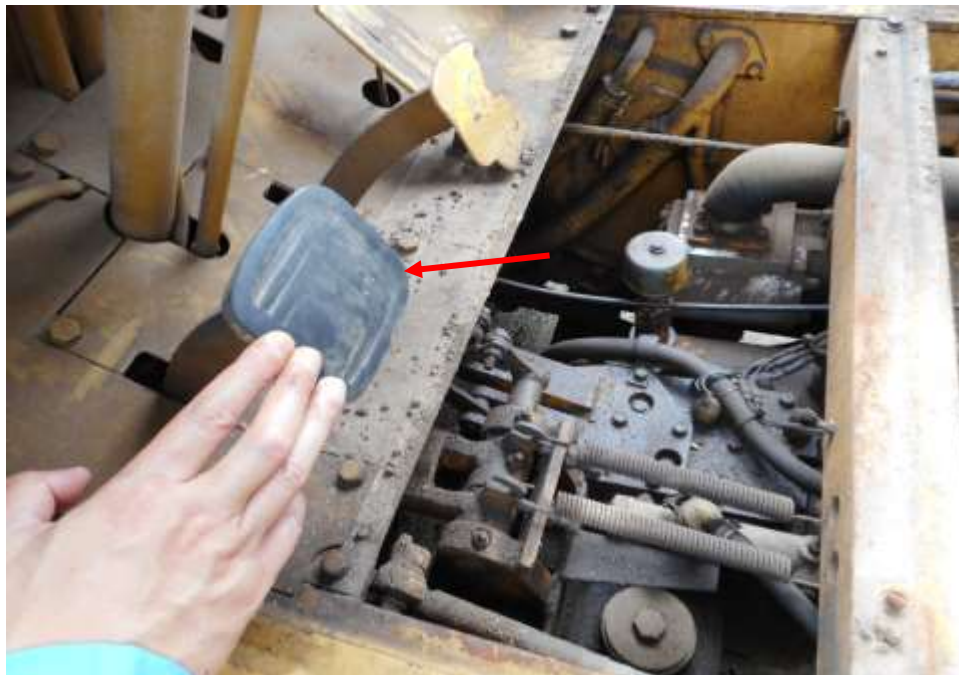
Photo 16 shows the static tests on the Mitsubishi Forklift braking system & brake pedals before depressing (arrowed)

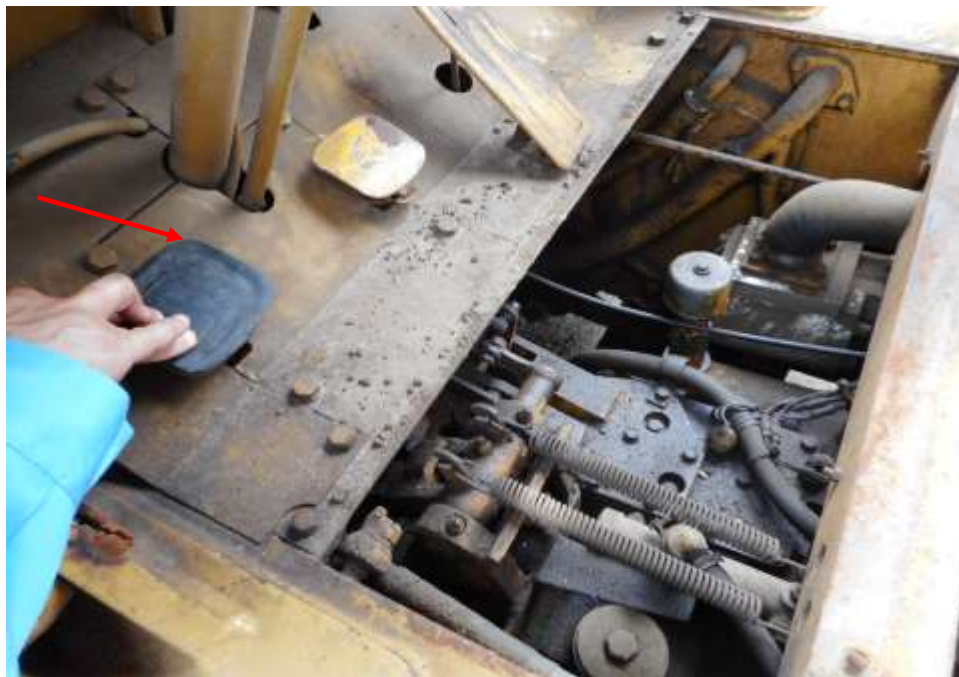
12. Static brake tests conducted on the Mitsubishi Forklift revealed abnormality. The brake booster did not respond well to the various tests conducted. There was abnormal movement to the brake pedal when it was depressed as the brake pedal had sink down onto the floorboard. In general, the static brake tests had suggested that there was internal leakage of pressure/vacuum in the braking system of the Mitsubishi Forklift. The braking system of the Mitsubishi Forklift was in unserviceable condition.

Photo 17 shows the static tests on the Mitsubishi Forklift braking system & brake pedals after depressing (arrowed). There was abnormal movement to the brake pedals when it was depressed as the brake pedal had sink down onto the floorboard. In general, the static brake tests had suggested that there was internal leakage of pressure/vacuum in the braking system of the Mitsubishi Forklift. The braking system of the Mitsubishi Forklift was in unserviceable condition.

17. However the braking system was also found to be unserviceable condition as the Mitsubishi Forklift was unable to fully slow down and come to a complete stop by depressing the brake pedal. The use of emergency handbrake was required to slow down and come to a complete stop, due to the internal leakage of pressure/vacuum and insufficient brake fluid in the brake reservoir of the braking system. A video recording showing the operational test to the Mitsubishi Forklift is enclosed in this report.

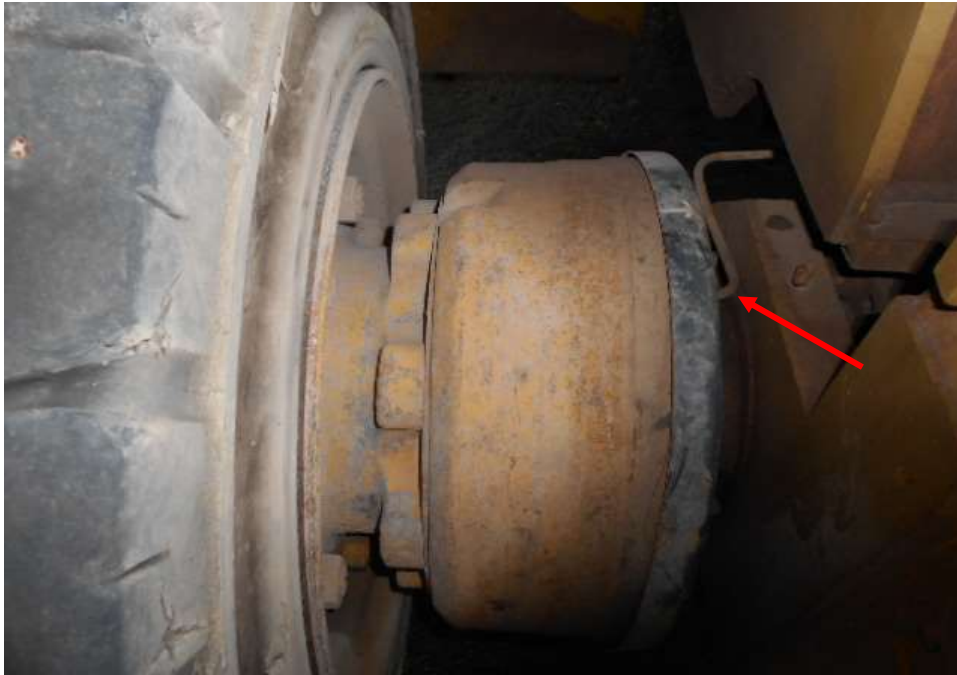
Photo 18 shows the brake hose/pipe (arrowed) at the front right wheel of the Mitsubishi Forklift. I did not observe any leakage of brake fluid at the time of my inspection of the Mitsubishi Forklift.

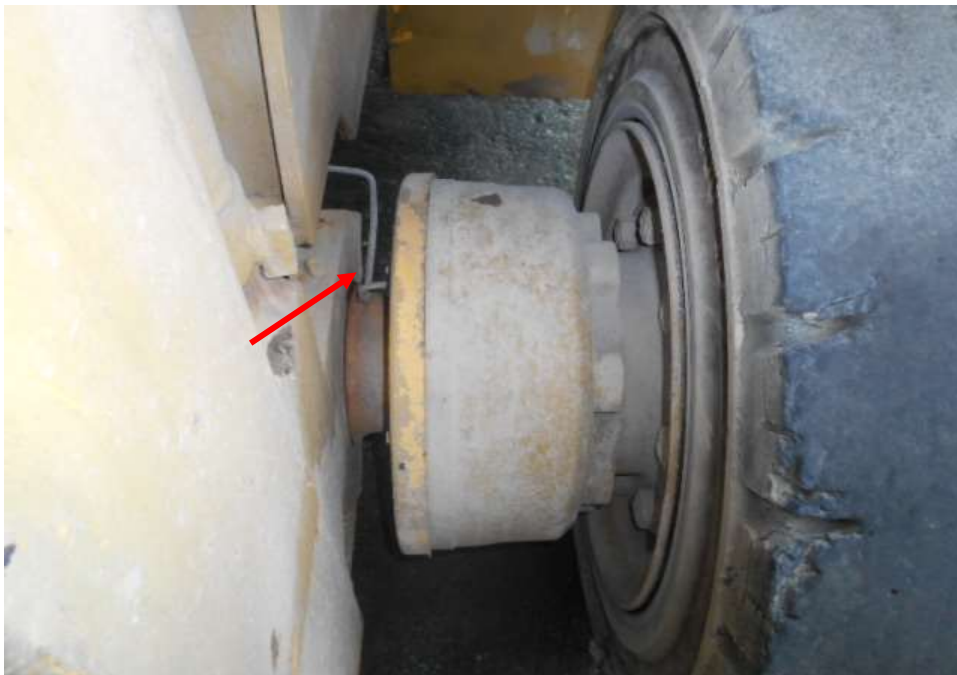
Photo 19 shows the brake hose/pipe (arrowed) at the front left wheel of the Mitsubishi Forklift. I did not observe any leakage of brake fluid at the time of my inspection of the Mitsubishi Forklift.

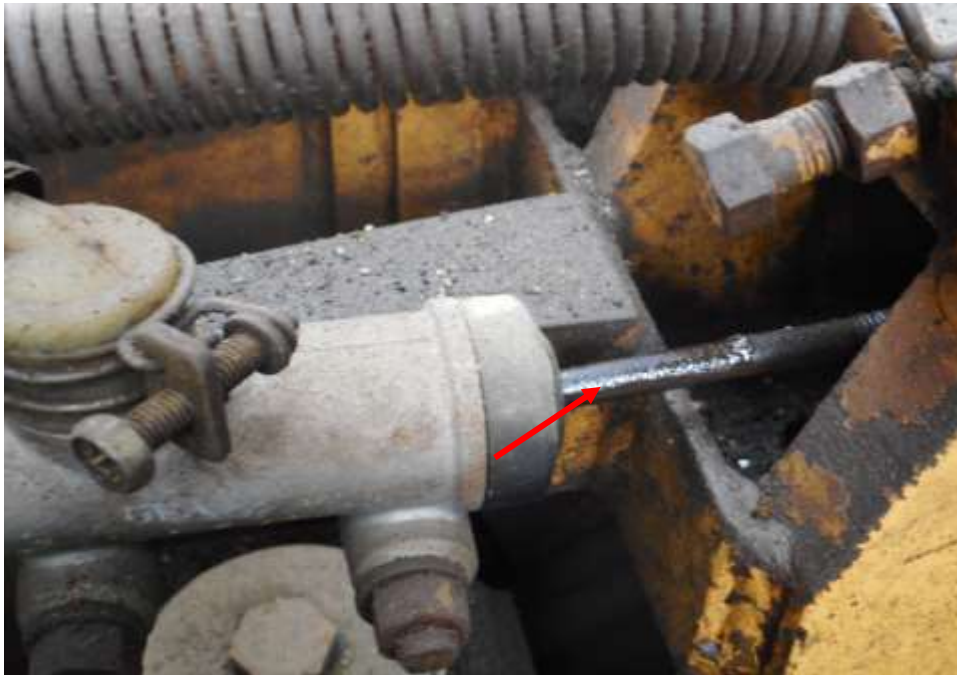
13. The brake fluid was also of insufficient level. There was sign(s) of old and fresh brake fluid stains leaking out from the brake cylinder piston.
14. Static test on the steering system of the Mitsubishi Forklift also revealed no abnormality to the steering system. I did not experience any abnormal free play and/or other resistance when turning the steering wheel left and right to full lock positions. My visual examination of the various steering components which had included the steering rack and pinion, tie rods, tie rod ends and ball joints revealed that these components were all generally in good condition. See photo 16 - 23 below.

Photo 20 shows the brake cylinder piston (arrowed) there were sign(s) of old and fresh brake fluid stains leaking out from the brake cylinder piston.

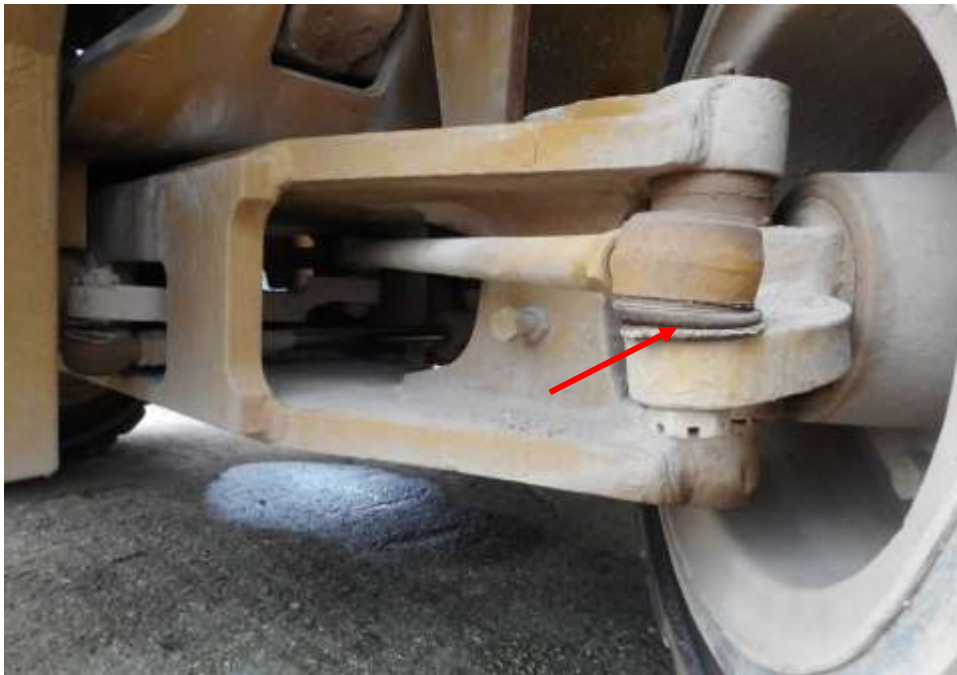
Photo 21 shows the various undercarriage components at the front right wheel of the Mitsubishi Forklift, in particular the steering tie rod (red arrow). The various steering components were all found to be intact, suggesting that the steering system of the Mitsubishi Forklift was likely to be in serviceable condition at the material time of accident. There was also no sign of fluid stain observed on the various undercarriage components at the front right wheel of the Mitsubishi Forklift.

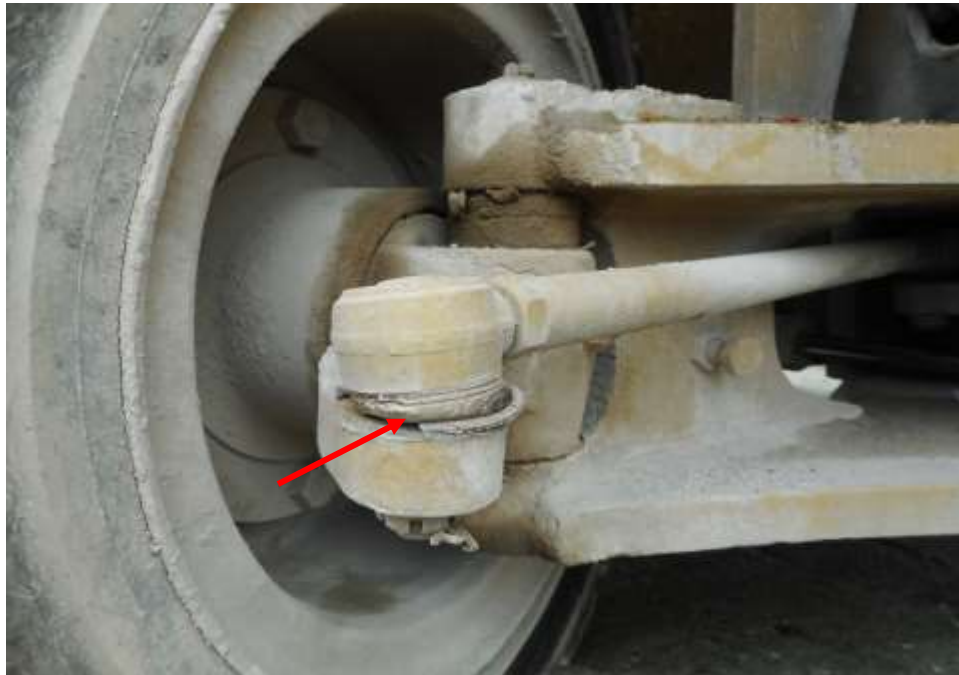
Photo 22 shows the various undercarriage components at the front left wheel of the Mitsubishi Forklift, in particular the steering tie rod (red arrow). The various steering components were all found to be intact, suggesting that the steering system of the Mitsubishi Forklift was likely to be in serviceable condition at the material time of accident. There was also no sign of fluid stain observed on the various undercarriage components at the front left wheel of the Mitsubishi Forklift.

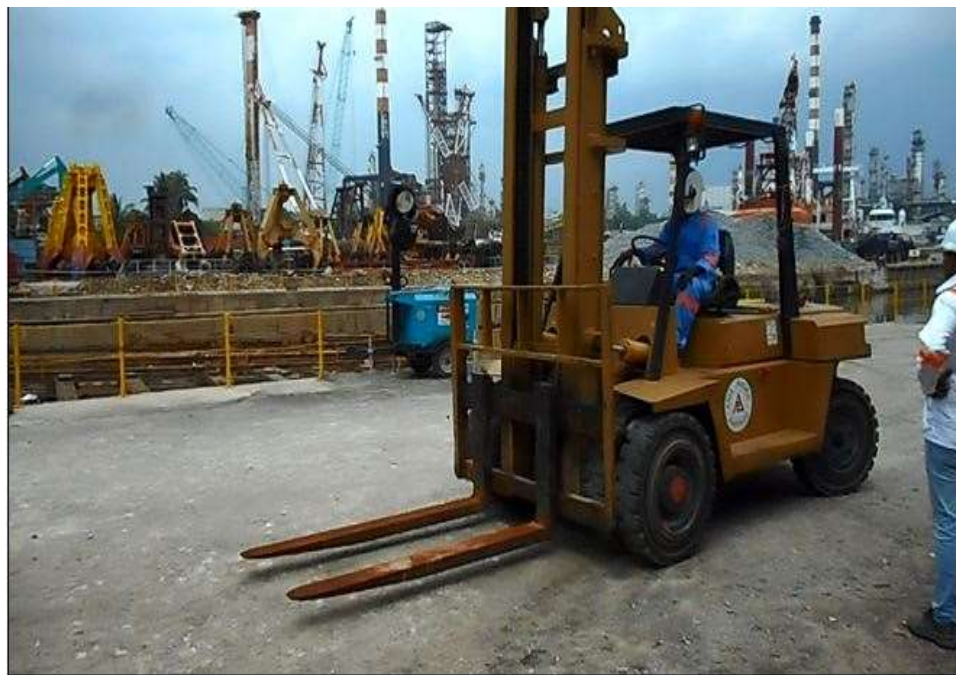
Photo 23 shows the rear left wheel of the Mitsubishi Forklift turned to its full right. During my steering system test, I did not experience any abnormal free play and/or resistance when I had turned the steering wheel towards the left and right. This would suggest that the steering system of the Mitsubishi Forklift was likely to be in serviceable condition at the material time of accident.

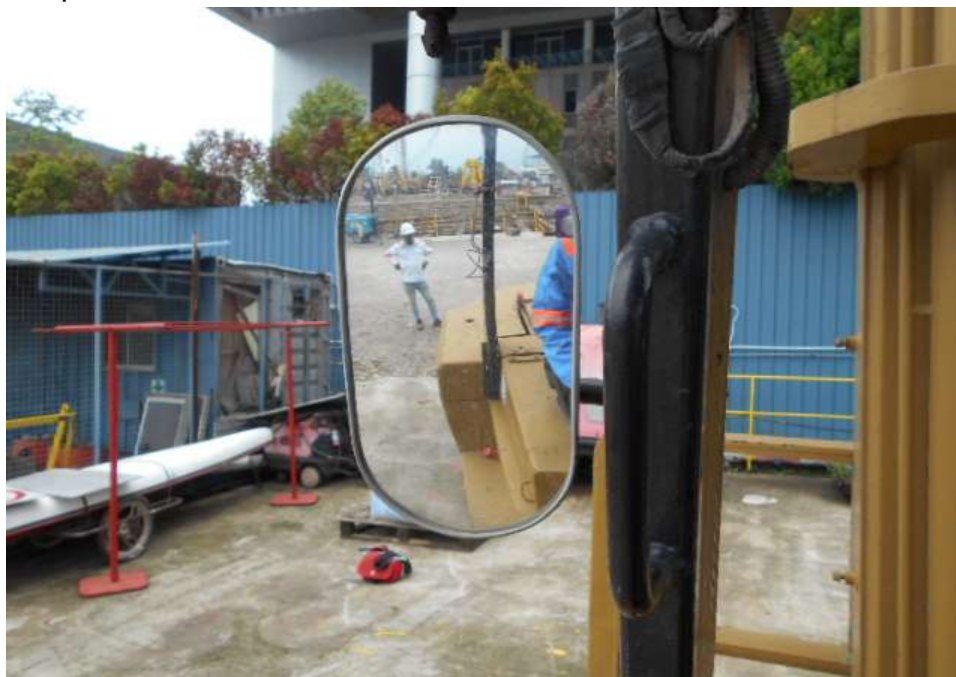
Photo 24 shows the left rear view mirror of the Mitsubishi Forklift to be intact and serviceable condition at the time of inspection.

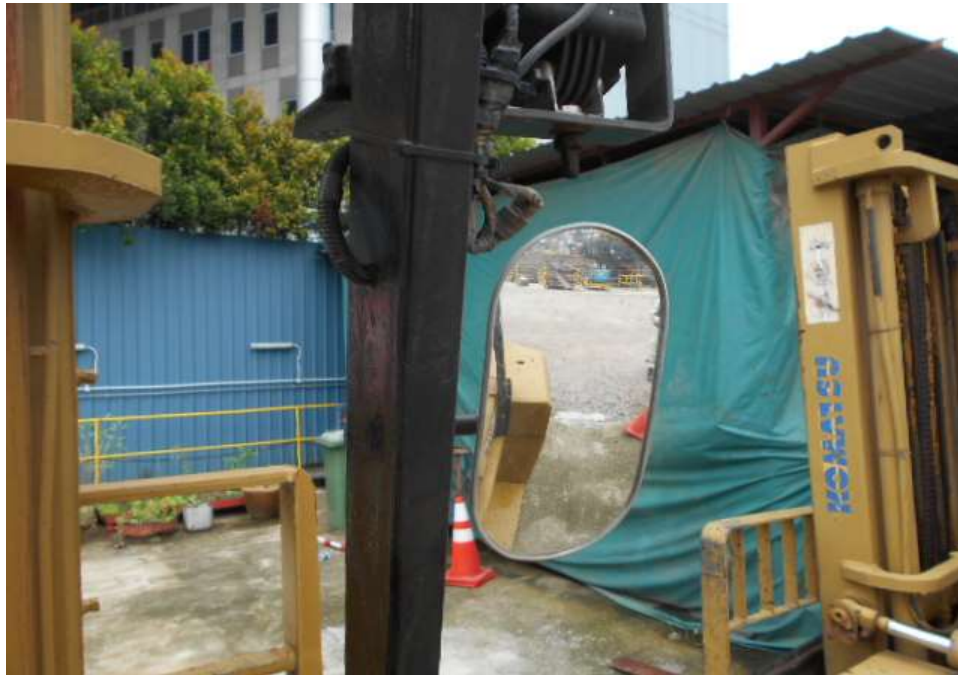
Photo 25 shows the right rear view mirror of the Mitsubishi Forklift to be intact and serviceable condition at the time of inspection.

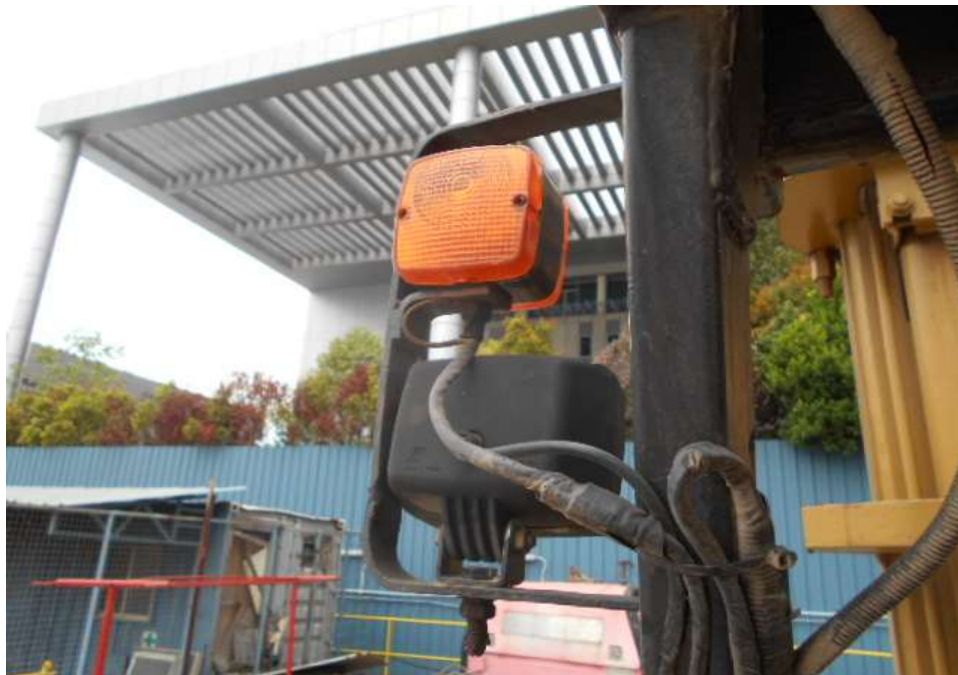
Photo 26 shows the left signal and headlights of the Mitsubishi Forklift to be intact and serviceable condition at the time of inspection.

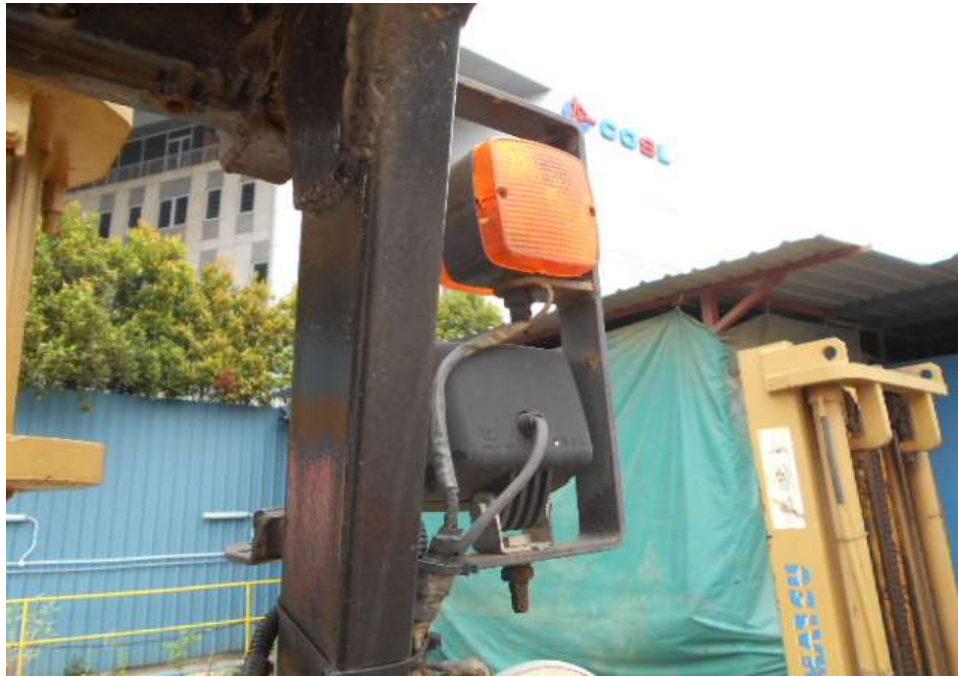
Photo 27 shows the right signal and headlights of the Mitsubishi Forklift to be intact and serviceable condition at the time of inspection.

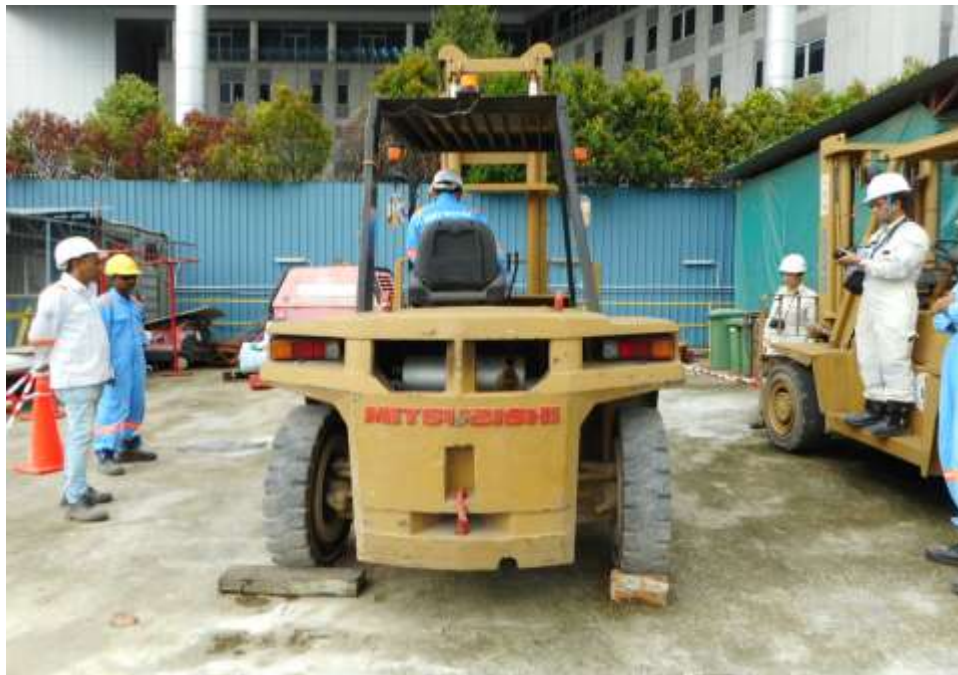
Photo 28 shows the both left and right signal and brake lights of the Mitsubishi Forklift to be intact and serviceable condition at the time of inspection.

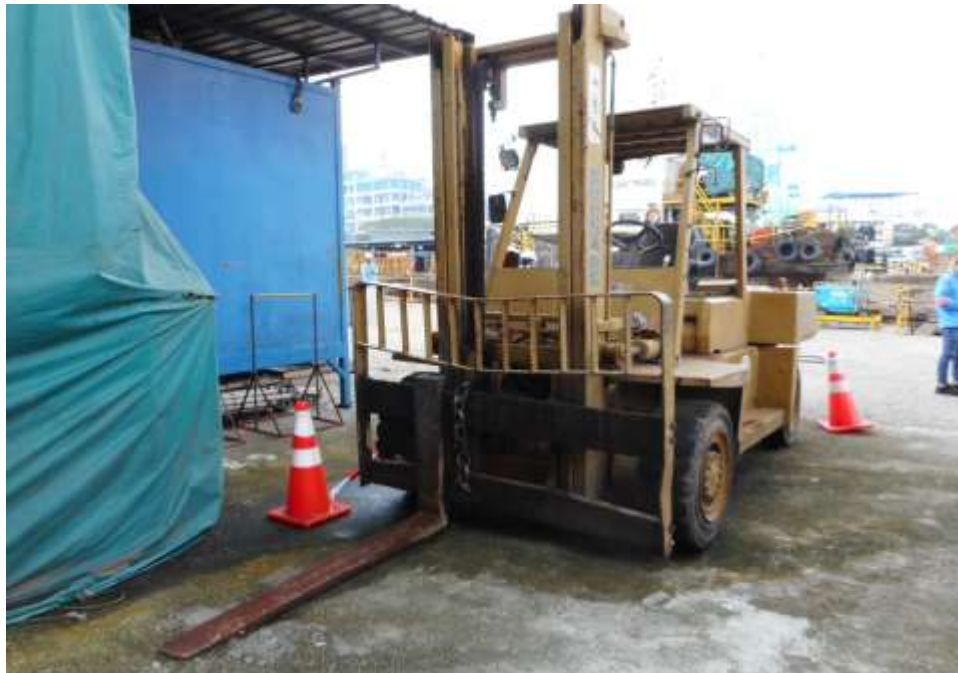
Photo 1 shows a front view of the Komatsu Forklift at the time of my inspection. The Komatsu Forklift was observed to have sustained damage at its front & rear portion. Its left fork and rear frame were amongst the body parts that were damaged as a result of the accident.

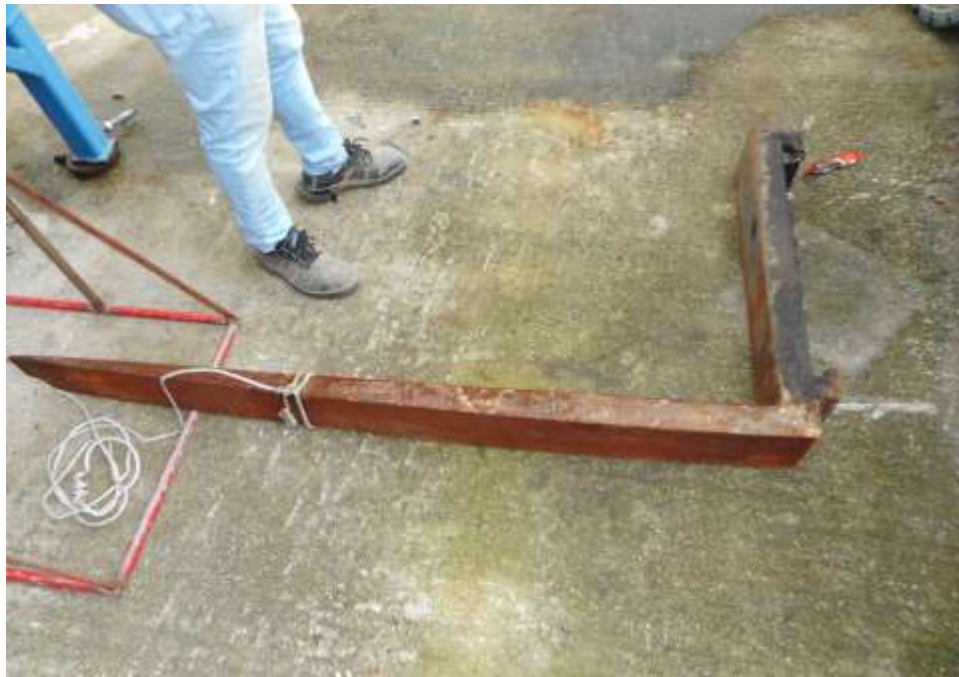
Photo 2 shows a close up view of the Komatsu Forklift's Fork at the time of my inspection. Its left fork was amongst the body parts that were damaged as a result of the accident.

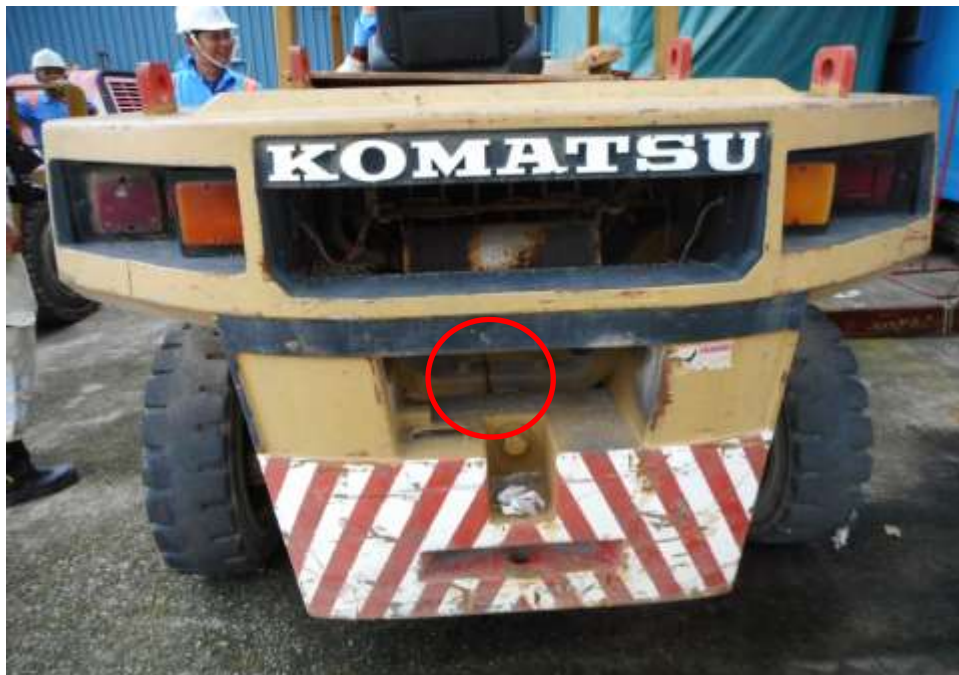
Photo 3 shows a rear view of the Komatsu Forklift's at the time of my inspection. Its rear frame (circled) was amongst the body parts that were damaged as a result of the accident.
