Your Ref: A-190617230642-S
Our Ref : CI/TPD19021325/P

15th January 2020

MECHANICAL INSPECTION REPORT OF MITSUBISHI FORKLIFT

MECHANICAL INSPECTION REPORT OF KOMATSU FORKLIFT

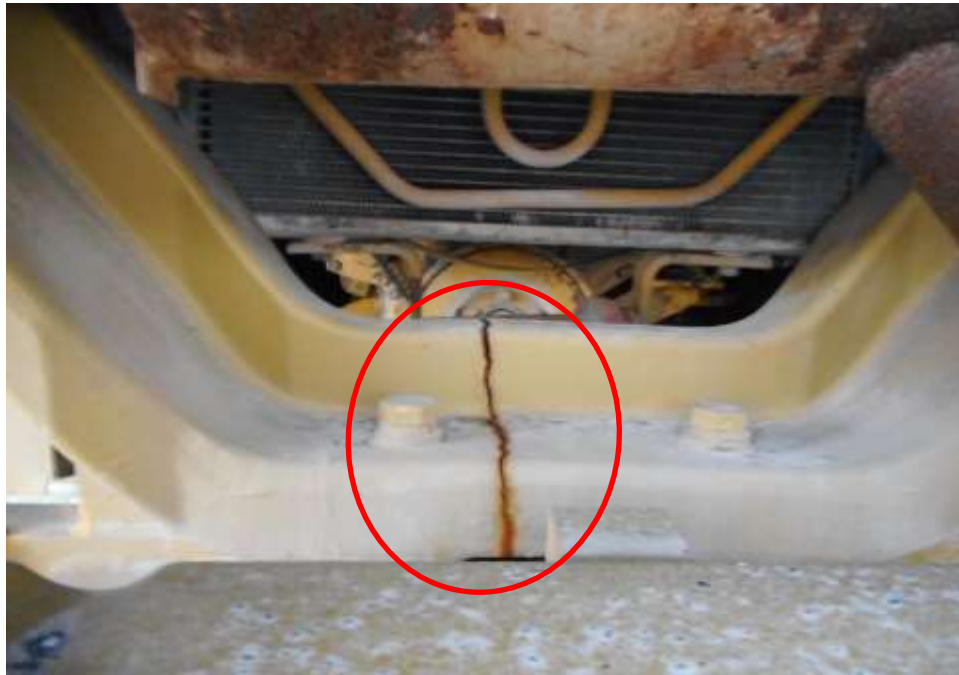
Photo 4 shows a rear view of the Komatsu Forklift's at the time of my inspection. Its rear frame (circled) was amongst the body parts that were damaged as a result of the accident.

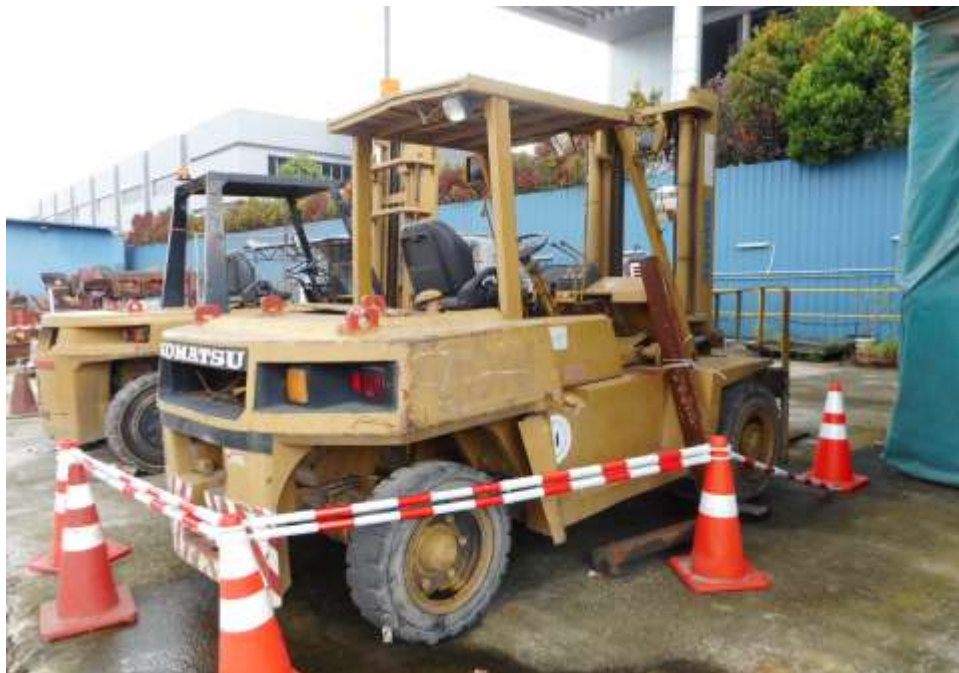
Photo 5 shows a general view of the Komatsu Forklift's right body at the time of my inspection. The right portion of the Komatsu Forklift was observed to have been unaffected by the accident.

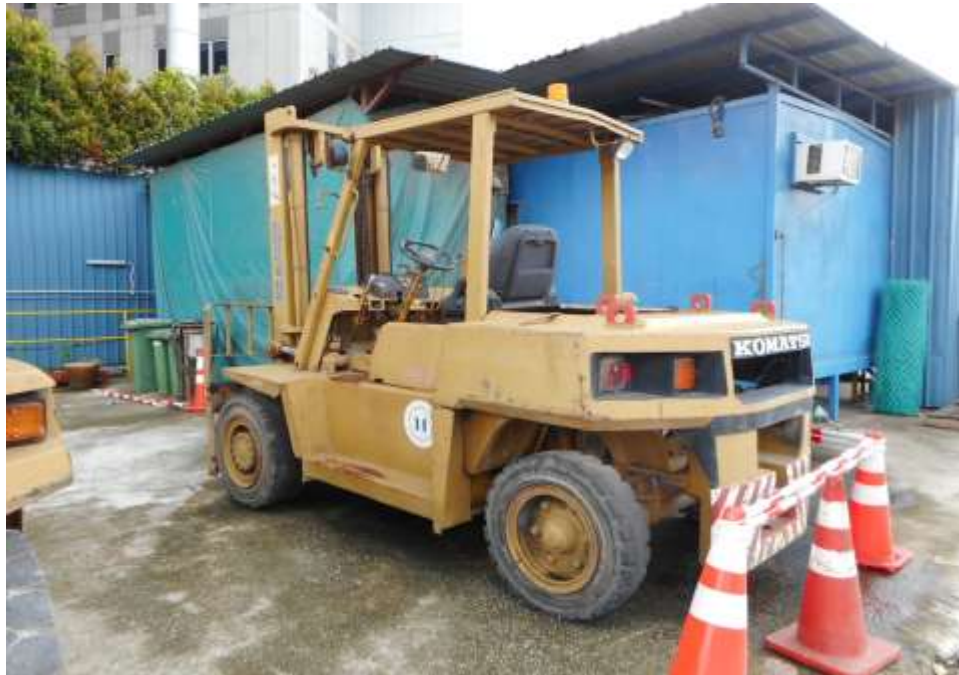
Photo 6 shows a general view of the Komatsu Forklift's left body at the time of my inspection. The left portion of the Komatsu Forklift was observed to have been unaffected by the accident.

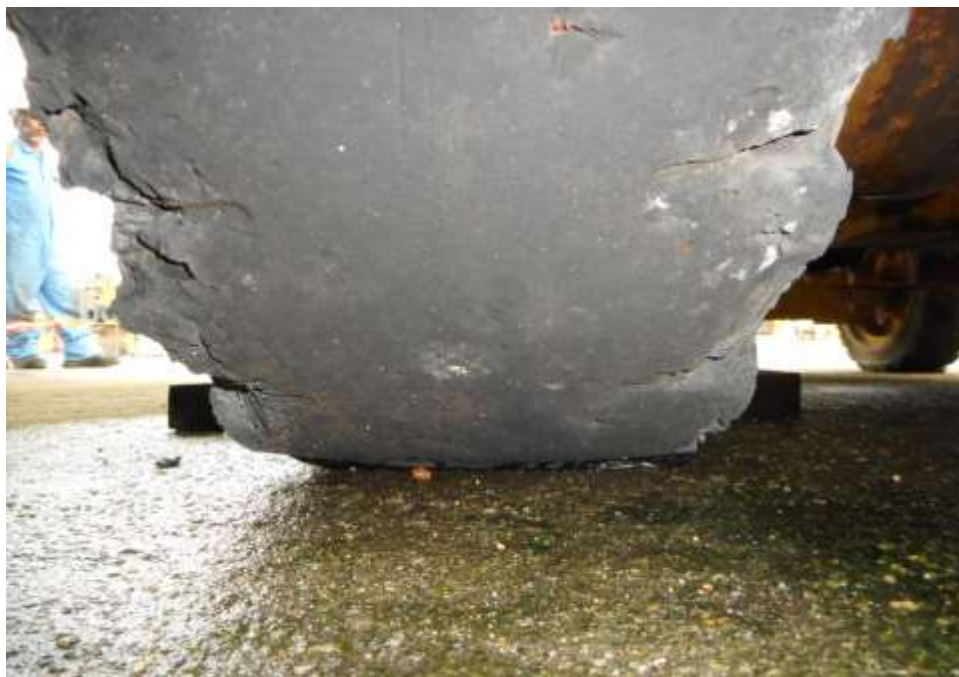
Photo 7 shows the condition of the front right tyre of the Komatsu Forklift, which was observed to be in unserviceable condition with remaining tread depth of approximately 0mm. The tyre was sufficiently inflated for vehicular operation with no tear, cut or burst mark(s) on the outer and the inner sidewalls as well as across the tread. The 4 tyres of the Komatsu Forklift were wrapped around standard steel wheel rims without any damage.

21. The both front left and right 2 tyres were found to be unserviceable due to insufficient tyre tread depth at 0mm. However, the both rear left and right 2 tyres of the Komatsu Forklift were found to be in serviceable condition with remaining tread depth of 9.4mm to 9.6mm. I did not find any tear, cut or burst mark(s) on the outer and the inner sidewalls as well as across the tread of the 4 tyres.

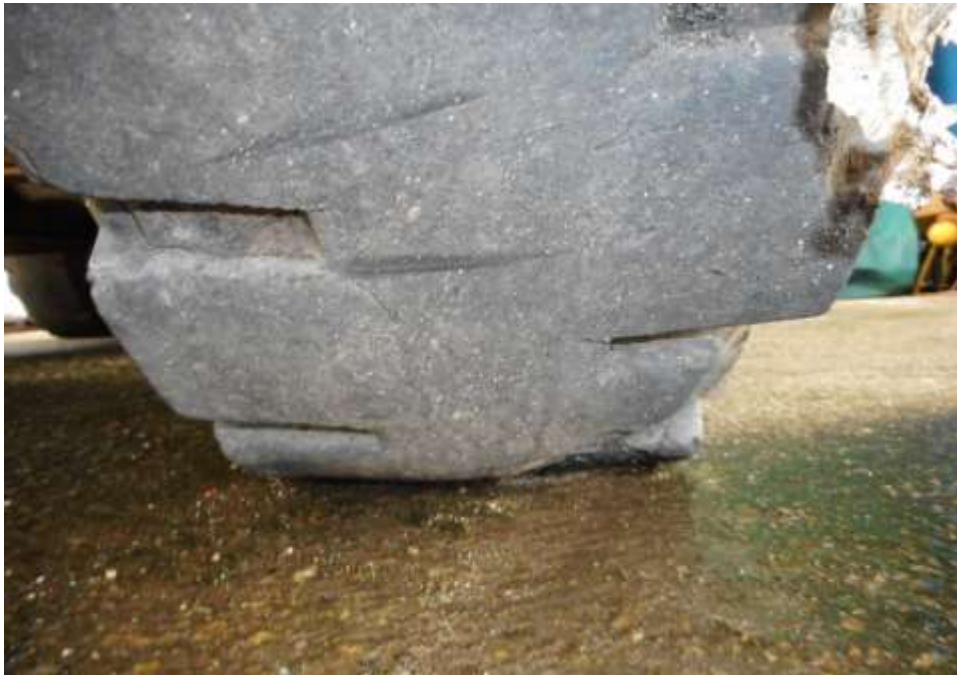
Photo 8 shows the condition of the rear right tyre of the Komatsu Forklift, which was observed to be in serviceable condition with remaining tread depth of approximately 9.4mm. The tyre was also observed to be sufficiently inflated for vehicular operation with no tear, cut or burst mark(s).

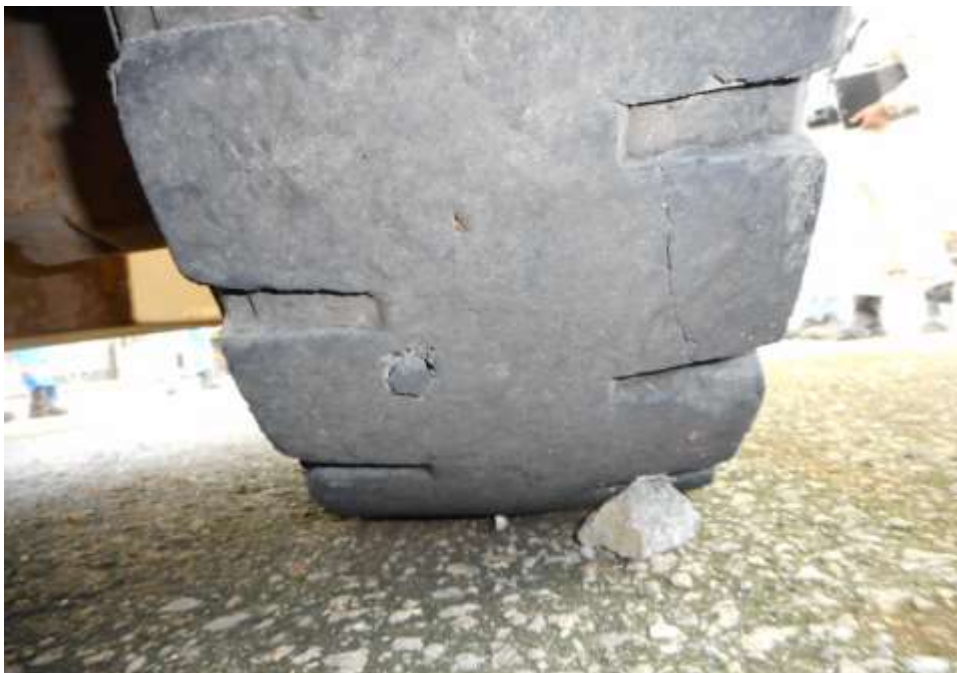
Photo 9 shows the condition of the rear left tyre of the Komatsu Forklift, which was observed to be in serviceable condition with remaining tread depth of approximately 9.6mm. The tyre, which was wrapped around steel wheel rim, was also observed to be sufficiently inflated for vehicular operation. The 4 tyres of the Komatsu Forklift were wrapped around standard steel wheel rims.

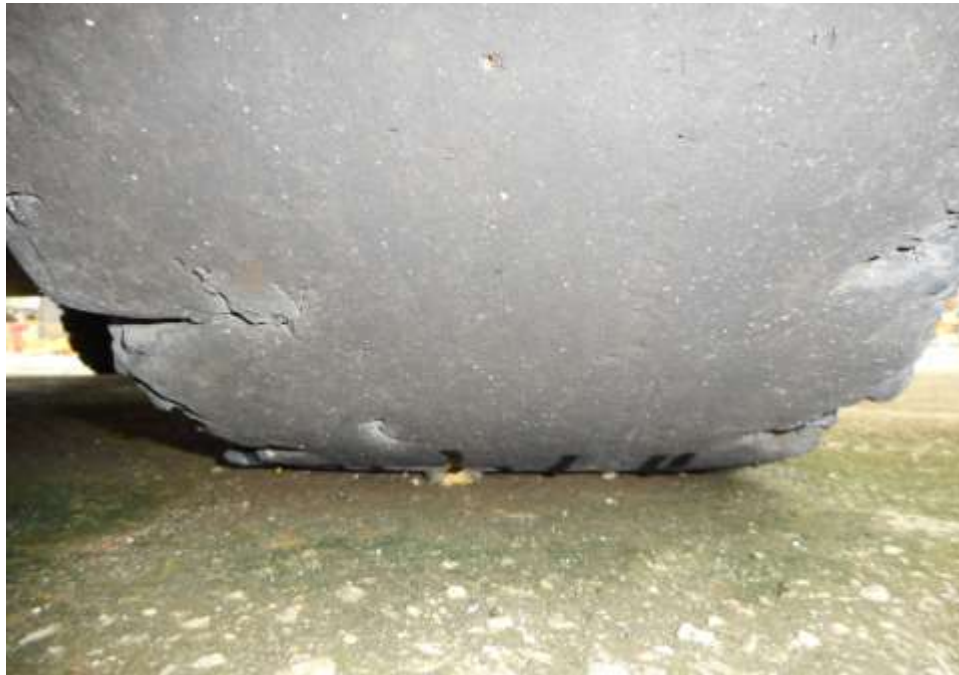
Photo 10 shows the condition of the front left tyre of the Komatsu Forklift, which was observed to be in unserviceable condition with remaining tread depth of approximately 0mm. There was also no tear, cut or burst mark(s) on the outer and the inner sidewalls as well as across the tread of the Komatsu Forklift's 4 tyres.

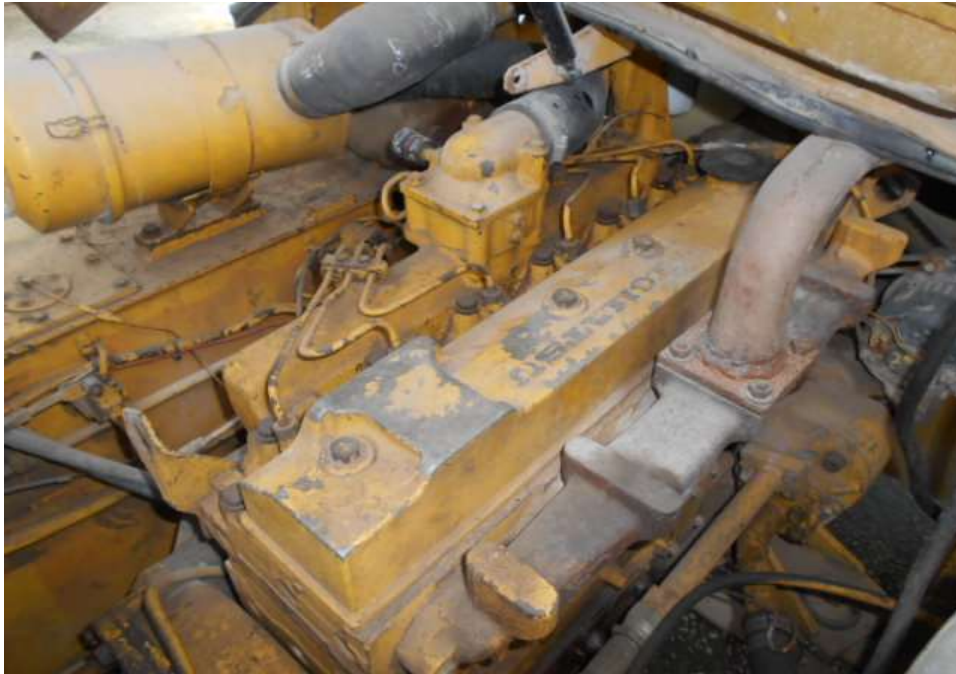
Photo 11 shows a general view of the Komatsu Forklift's engine compartment. The various parts and components inside the engine compartment were unaffected by the accident. There was also no sign(s) or indication(s) of fluid leakage and/or fluid stain within the engine compartment.

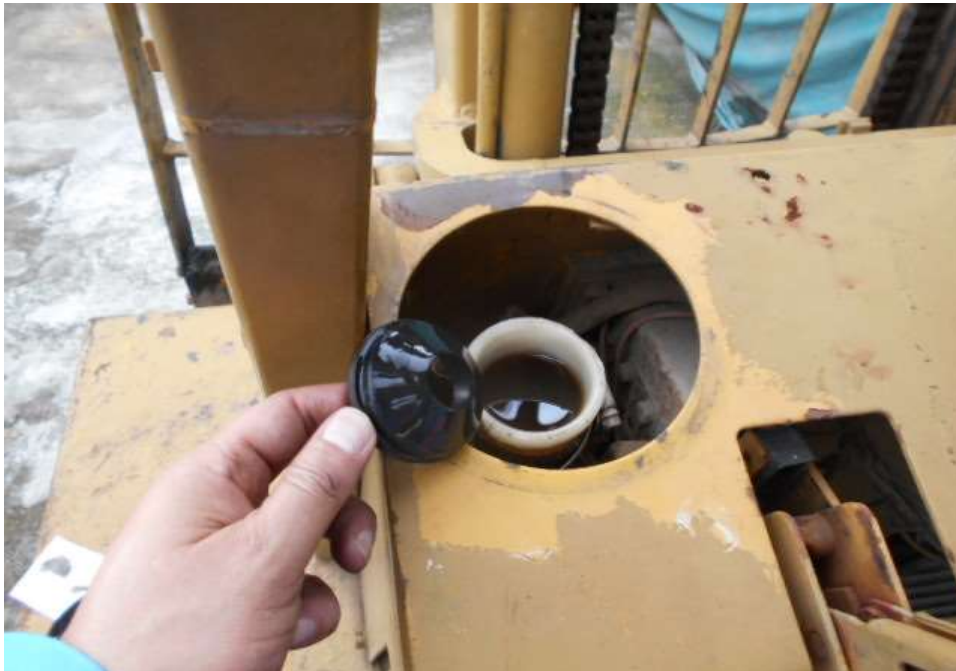
Photo 12 shows checks being carried out to the brake fluid of the Komatsu Forklift at the time of my inspection. The brake fluid was observed to be of sufficient level and without any visible contamination.

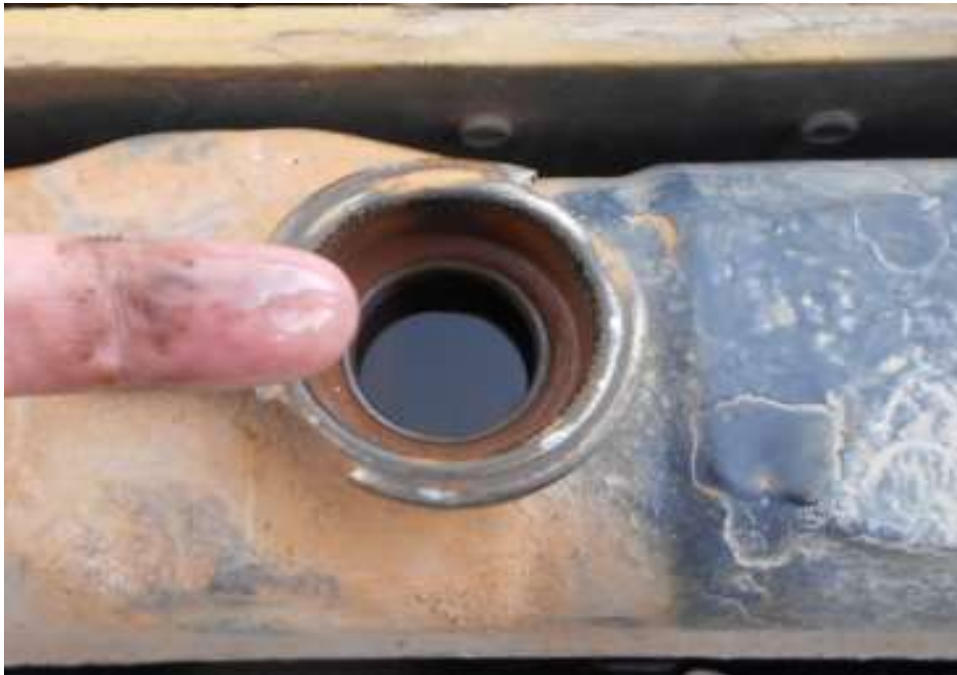
Photo 13 shows checks being carried out to the engine coolant of the Komatsu Forklift at the time of my inspection. The engine coolant was observed to be of sufficient level and without any visible contamination.

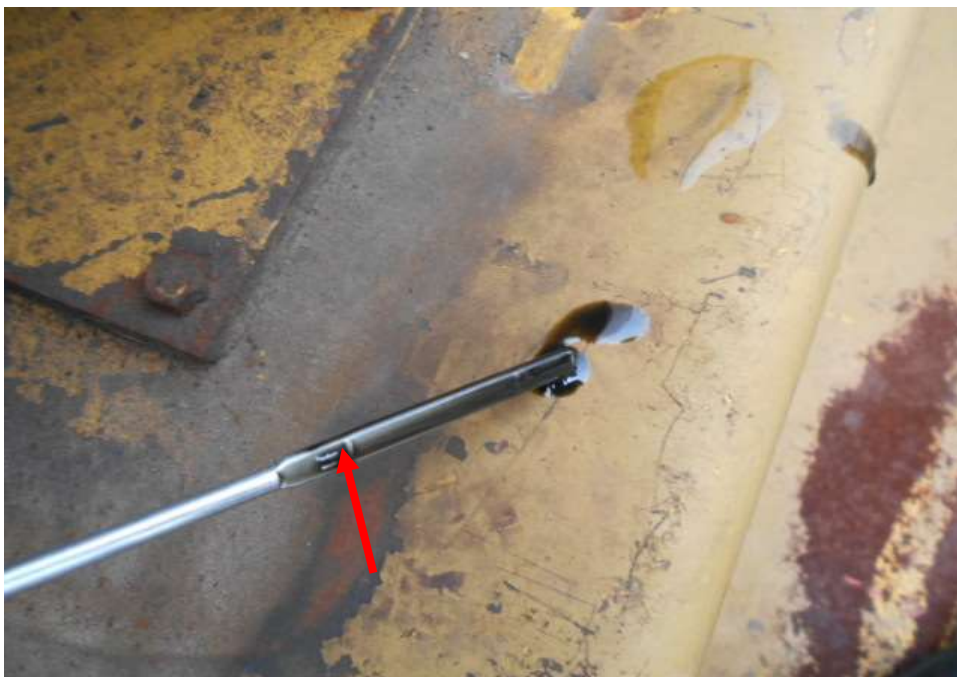
Photo 14 shows the engine oil dip stick of the Komatsu Forklift at the time of my inspection. The engine oil was observed to be of sufficient level (arrowed)

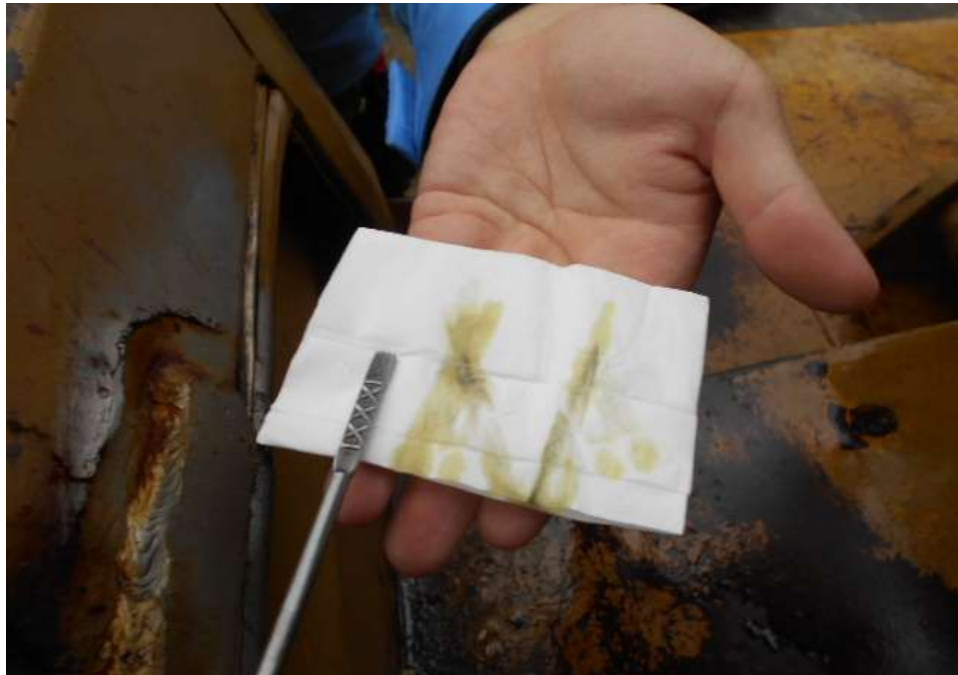
Photo 15 shows the ATF transmission fluid dip stick of the Komatsu Forklift at the time of my inspection. The observed was differential gear oil (yellow colour) instead of the supposed ATF transmission fluid (pink colour) which was the wrong type of fluid used.

18. It was found that fluid in the automatic transmission of the Komatsu Forklift at the time of inspection was Differential gear oil instead of the ATF transmission fluid. Differential gear oil is thicker in viscosity and do not contain all the additives needed to smoothly lubricate and run the automatic transmission and thus result in an unsmooth operation of the Komatsu Forklift. Refer above to photo 15 and 16 of Komatsu Forklift.

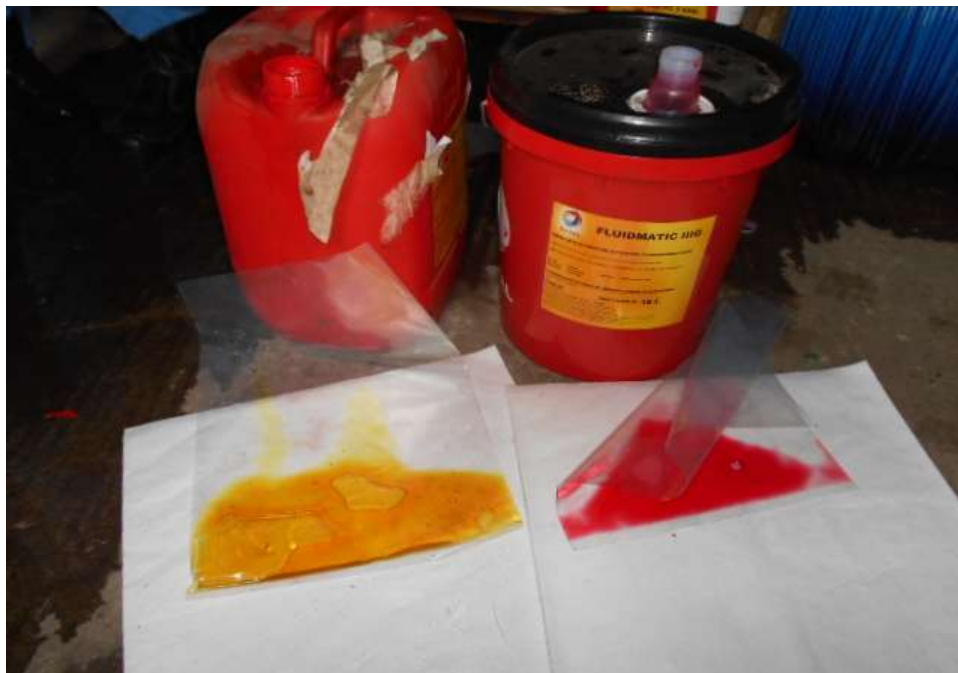
Photo 16 shows the differential gear oil (yellow colour) and the ATF transmission fluid (pink colour) used by the Komatsu Forklift and stored at the site warehouse at the time of my inspection.

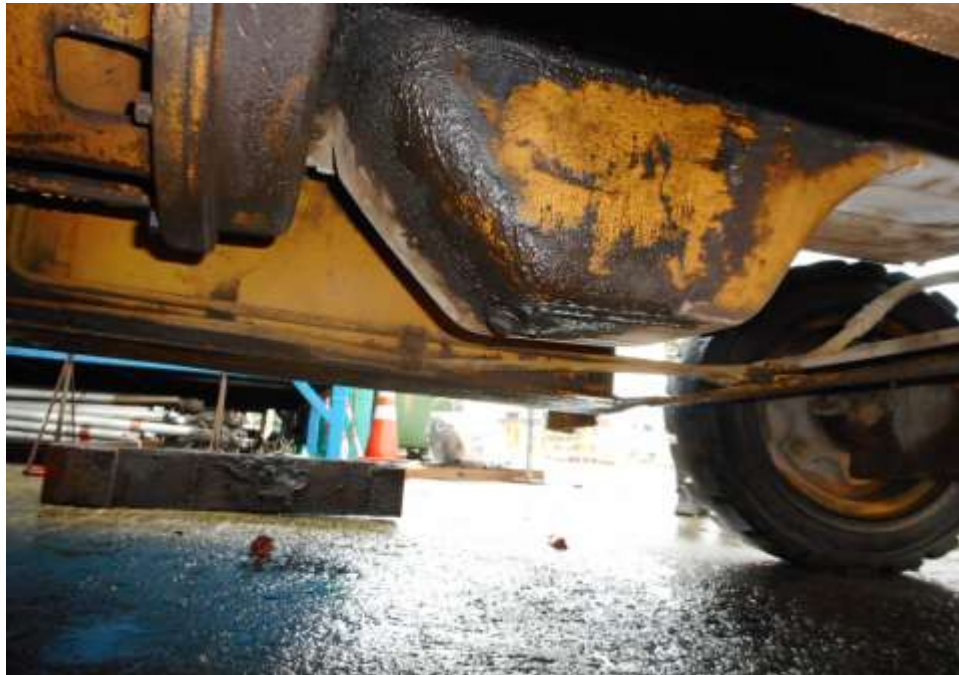
Photo 17 shows the undercarriage of the Komatsu Forklift, at the area where the engine housing and transmission housing are located. I observed old fluid stain(s) on the underside of the Komatsu Forklift.

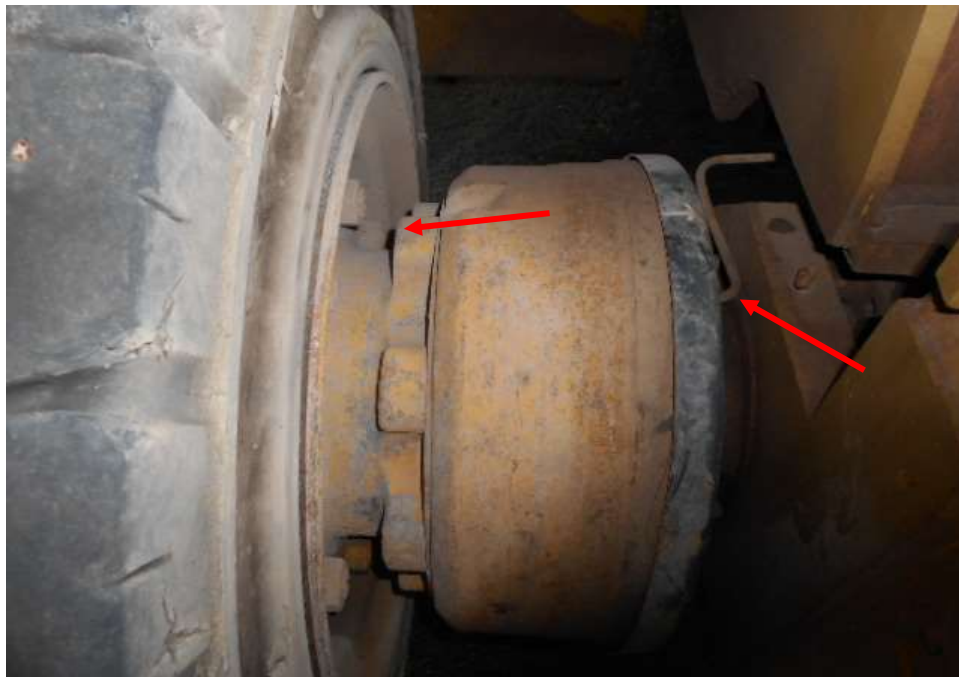
Photo 18 shows the brake hose/pipe (arrowed) at the front right wheel of the Komatsu Forklift. I did not observe any leakage of brake fluid at the time of my inspection of the Komatsu Forklift.

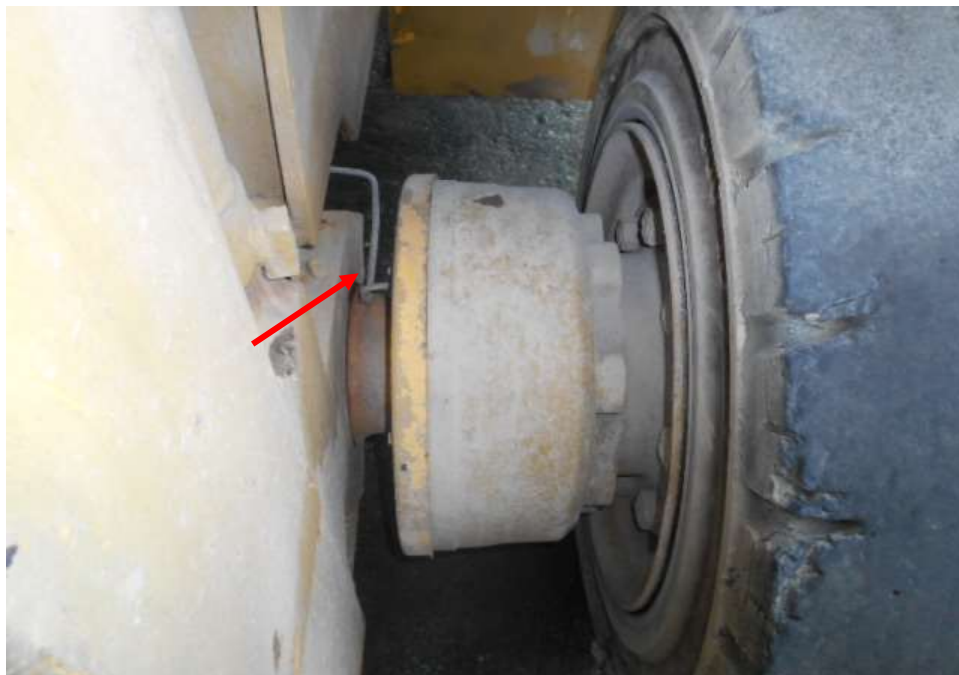
Photo 19 shows the brake hose/pipe (arrowed) at the front left wheel of the Komatsu Forklift. I did not observe any leakage of brake fluid at the time of my inspection of the Komatsu Forklift.

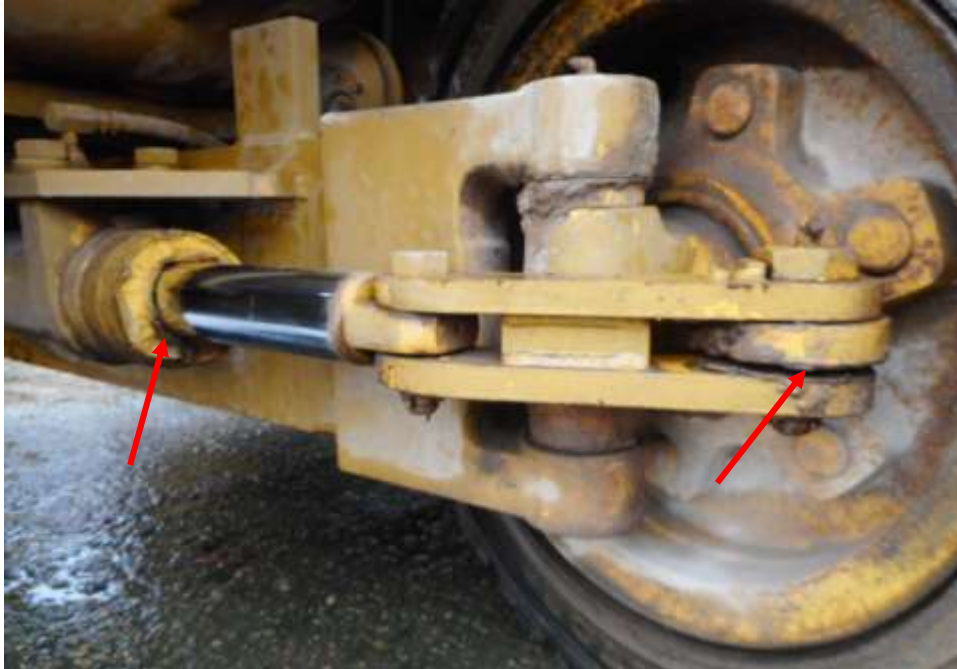
Photo 20 shows the various undercarriage components at the front right wheel of the Komatsu Forklift, in particular the steering cylinder and joints (red arrows). The various steering components were all found to be intact, suggesting that the steering system of the Komatsu Forklift was likely to be in serviceable condition at the material time of accident. There was also no sign of fluid stain observed on the various undercarriage components at the front right wheel of the Komatsu Forklift.

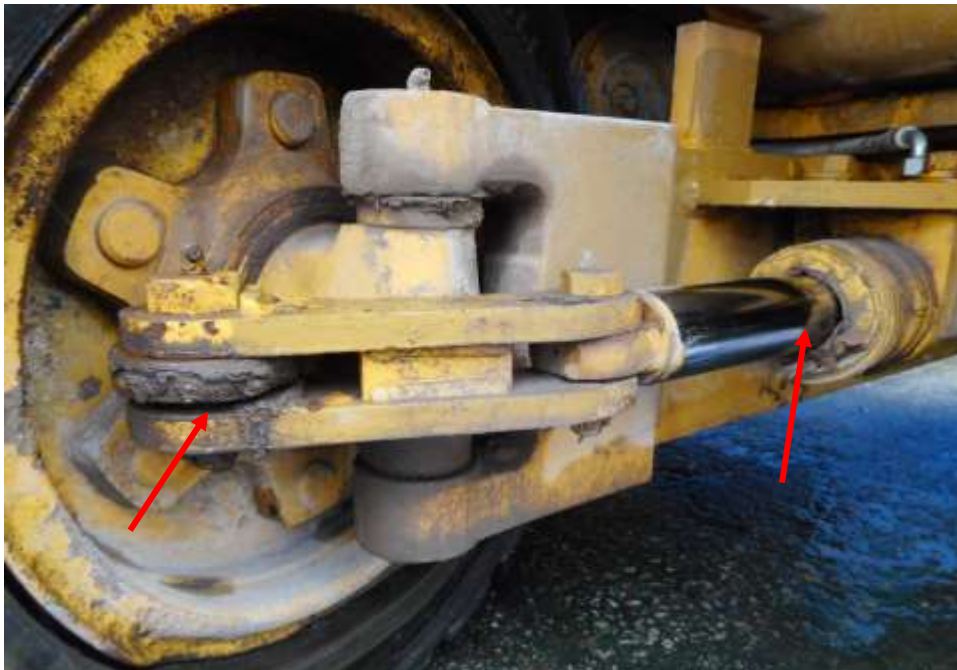
Photo 21 shows the various undercarriage components at the front left wheel of the Komatsu Forklift, in particular the steering cylinder and joints (red arrow). The various steering components were all found to be intact, suggesting that the steering system of the Komatsu Forklift was likely to be in serviceable condition at the material time of accident. There was also no sign of fluid stain observed on the various undercarriage components at the front left wheel of the Komatsu Forklift.

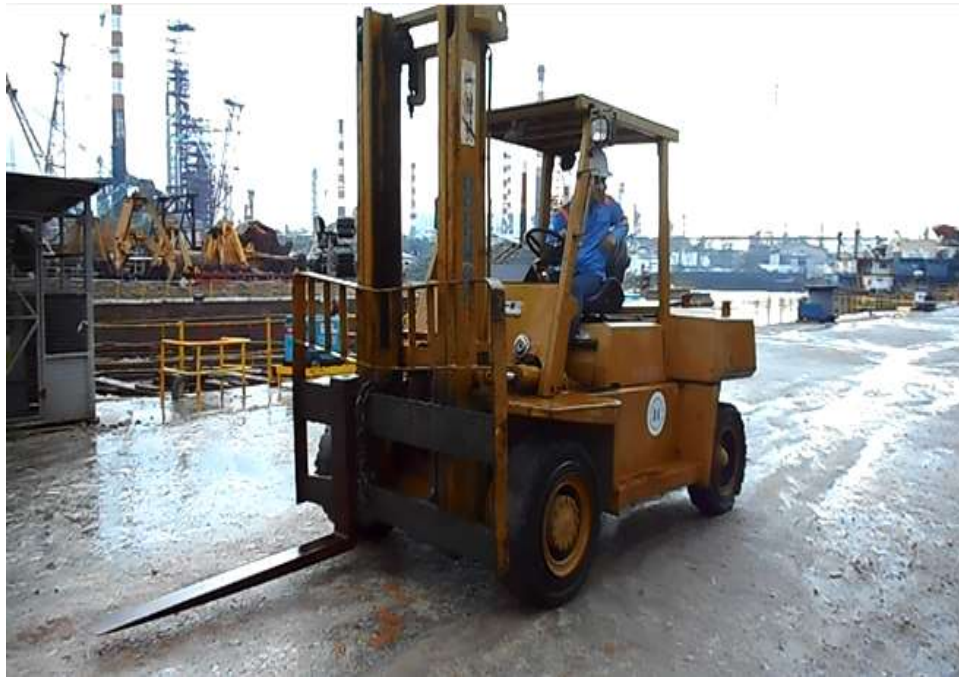
Photo 22 shows the rear left wheel of the Komatsu Forklift turned to its full right. During my steering system test, I did not experience any abnormal free play and/or resistance when I had turned the steering wheel towards the left and right. This would suggest that the steering system of the Komatsu Forklift was likely to be in serviceable condition at the material time of accident.

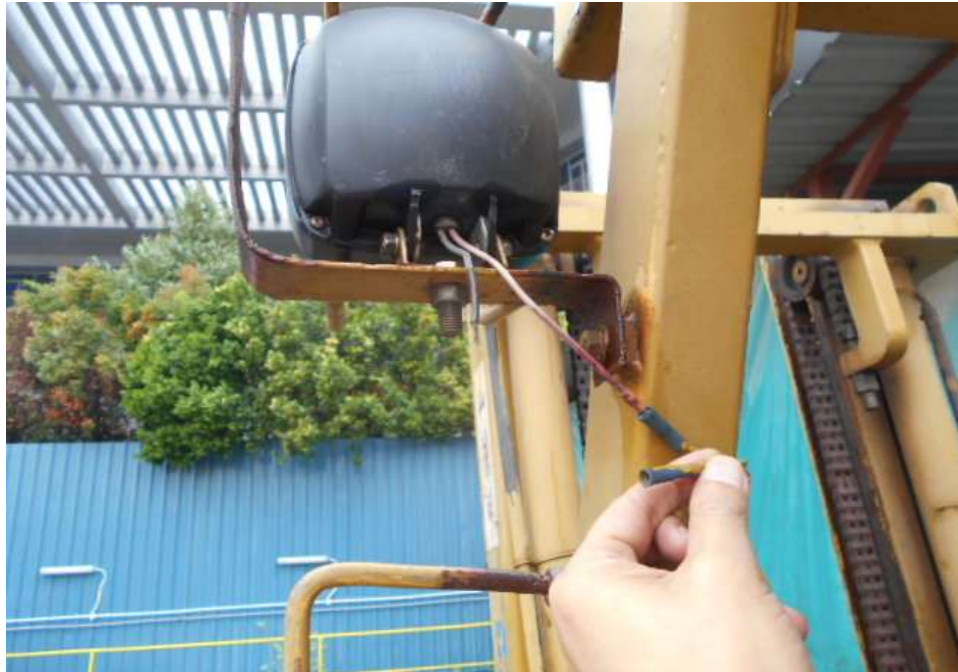
Photo 23 shows a disconnected left headlight. No left rear view mirror and front signal lights were installed on the Komatsu Forklift at the time of inspection.

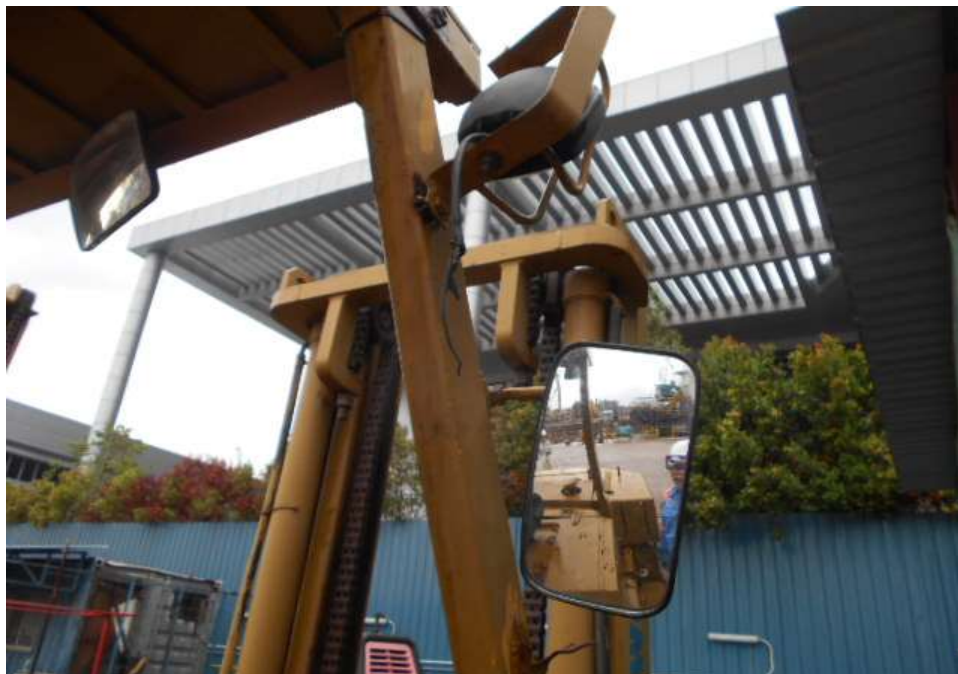
Photo 24 shows a disconnected right headlight and no right signal light installed. However, a right rear view mirror was observed on the Komatsu Forklift at the time of inspection.

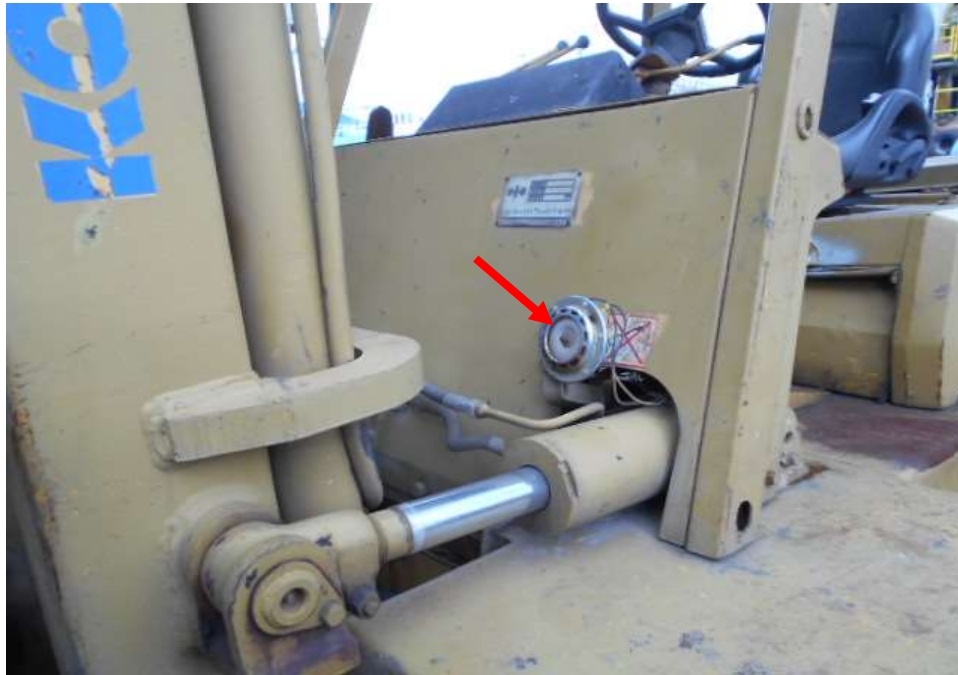
Photo 25 shows the horn (arrowed) of the Komatsu Forklift to be intact and serviceable condition at the time of inspection.

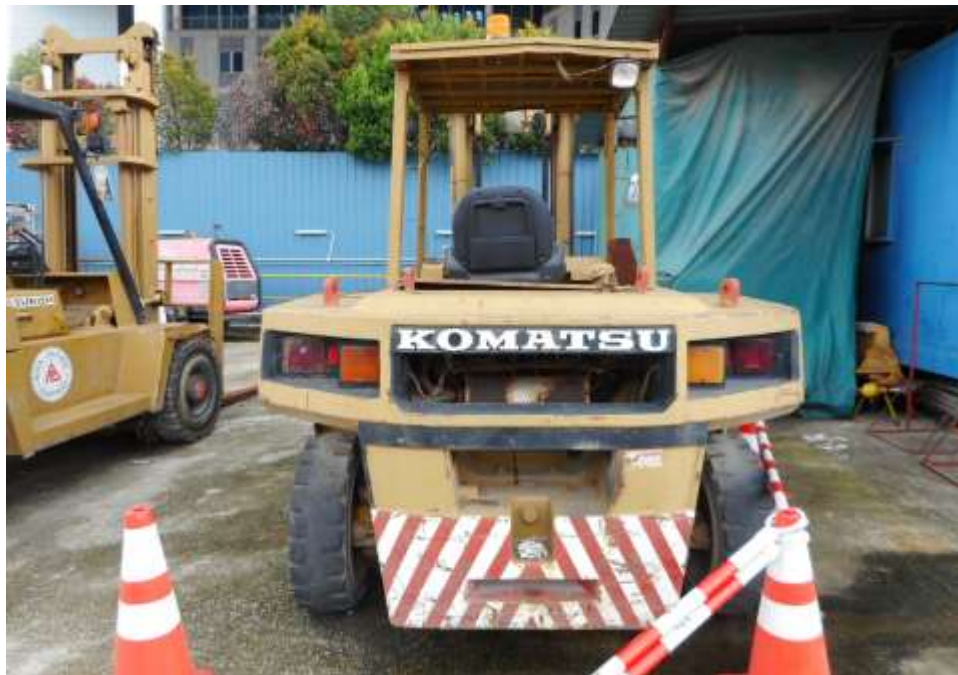
Photo 26 shows the both left and right signal and brake lights of the Komatsu Forklift were observed to be not working at the time of inspection.
