Your Ref: BMW 530i
(chassis number WBAJA52060G886342)
Our Ref : CI/TP19021349/D

04 December 2019

INSPECTION REPORT OF AN UNREGISTERD BMW 530i MOTOR CAR WITH CHASSIS NUMBER WBAJA52060G886342

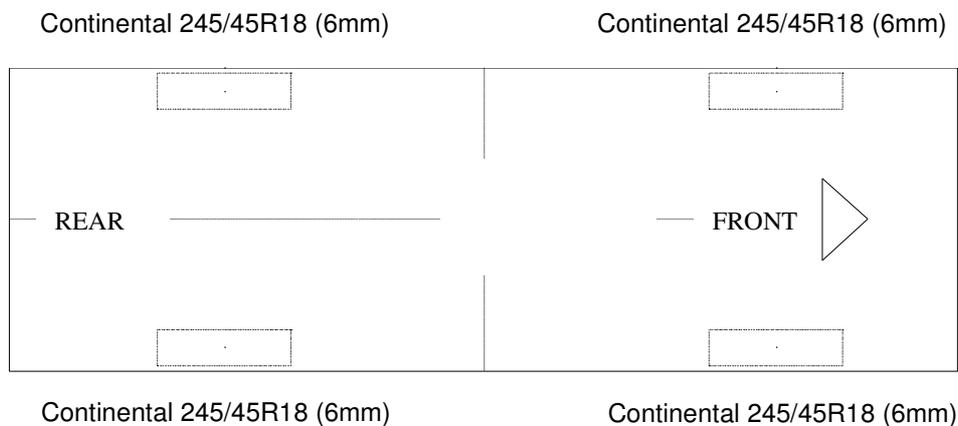
6. It was fitted with 18inch sport wheel rims that were wrapped with tyres that were observed to be of serviceable condition. The tyres were also sufficiently inflated for vehicular operation. The tyre brand, tyre size and approximate remaining tread depth of the 4 tyres of the Motor Car were recorded as follows: -

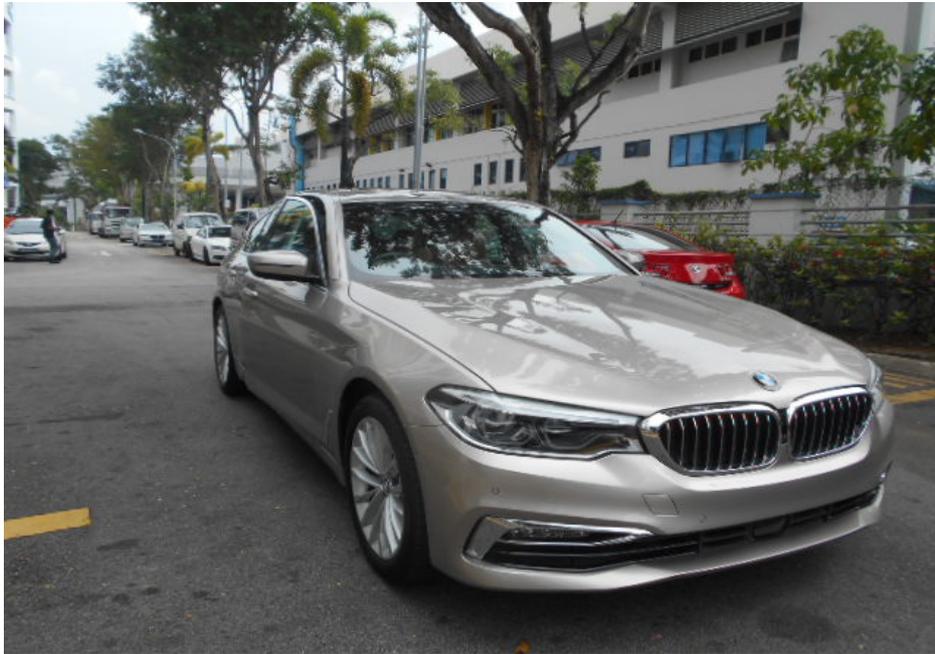
Photo 1 shows a general view of the front right body of the Motor Car at the time of my inspection. The Motor Car was observed to be in relatively good general condition with no loose exterior fittings observed. The mileage of the Motor Car recorded at the time of my inspection was 5,890km.

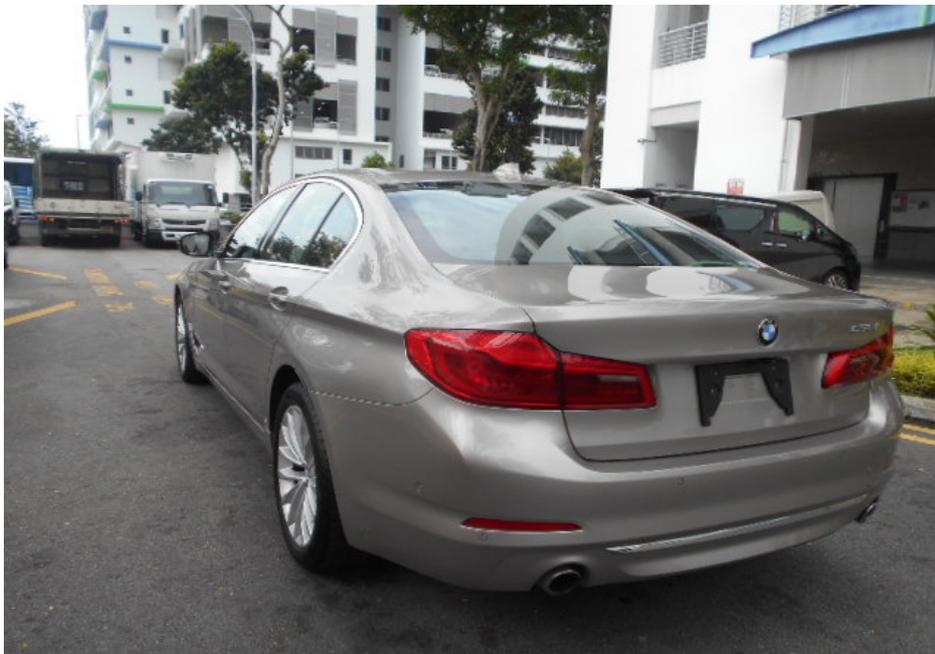
Photo 2 shows a general view of the rear left body of the Motor Car at the time of my inspection. The Motor Car was observed to be in relatively good general condition with no loose exterior fittings observed.

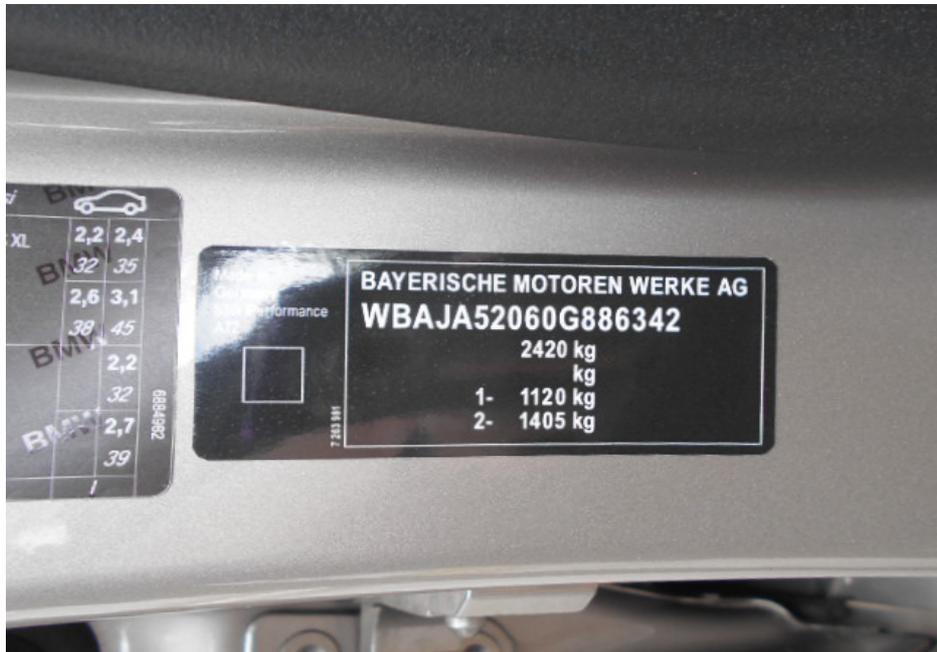
Photo 3 shows the chassis number of the Motor Car. The chassis number recorded was WBAJA52060G886342.

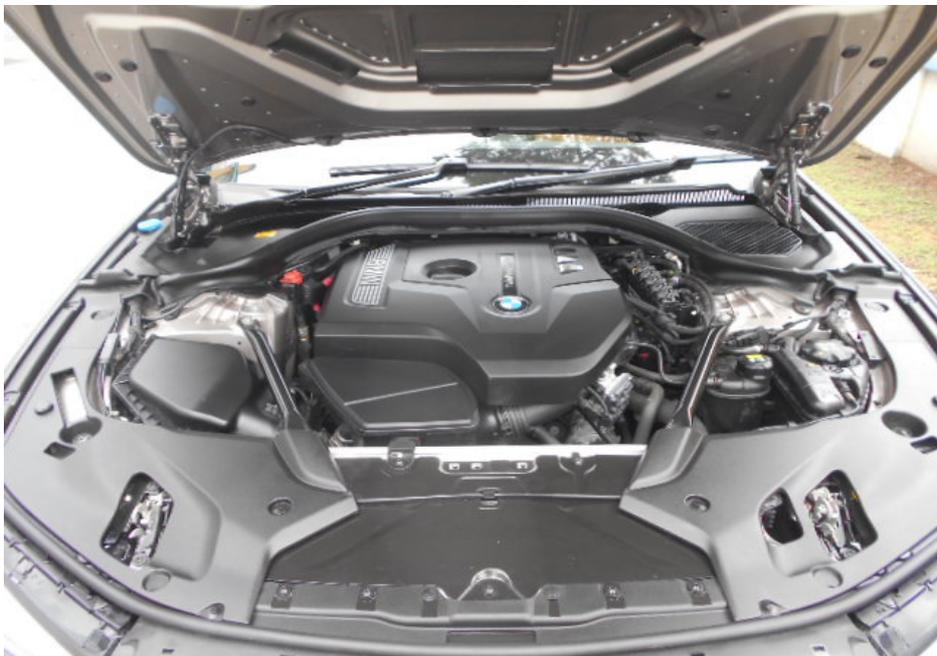
12. My examination of the engine compartment of the Motor Car revealed that the various parts and components inside the engine compartment were all intact and properly fitted. The brake fluid and engine coolant were all found to be of sufficient level for operating purposes. Visually, there was also no contamination found to these fluids.

Photo 4 shows a general view of the engine compartment of the Motor Car at the time of my inspection. The various parts and components inside the engine compartment were all observed to be intact and properly fitted. There was also no sign(s) or indication(s) of fluid leak and/or fluid stain found inside the engine compartment. The brake fluid and engine coolant were all found to be of sufficient level for operating purposes. Visually, there was also no contamination found to these fluids.

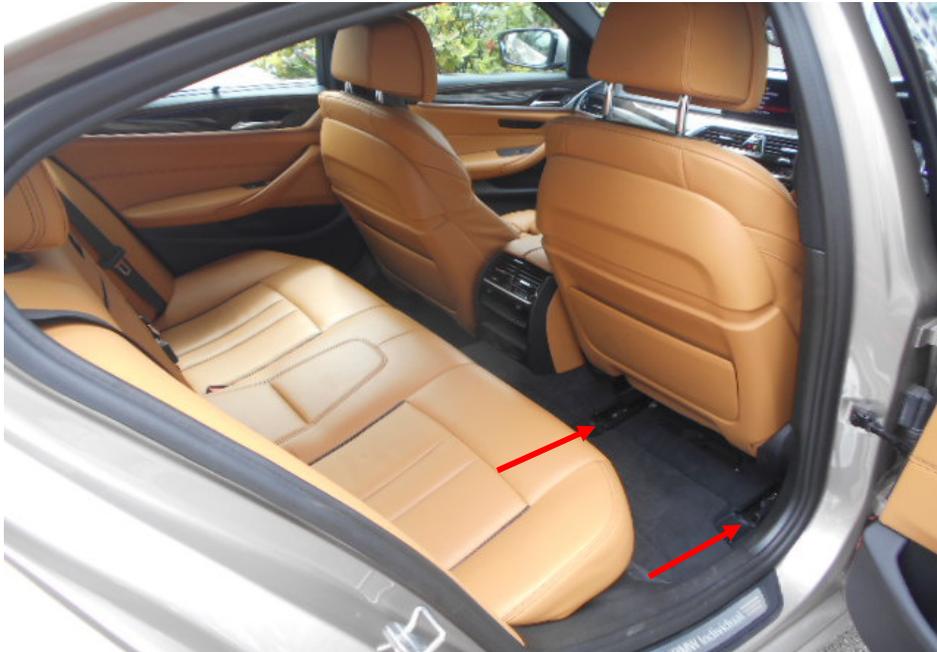
10. The seats of the Motor Car were found to be secured to the floor board of the Motor Car via seat rails bolted onto the floor board. Retractable seat belt reels and pre-tensioners were fitted on all the seats of the Motor Car. The seat belt reels were able to be fastened securely into the respective pre-tensioners that were fixed to the side of all the seats.

Photo 5 shows the rear seats of the Motor Car. All the seats were secured via seat rails (arrowed) to the floor board. The seats were also individually fitted with a retractable seat belt reel and pre-tensioner. The seat belts were tested and able to be fastened to the pretensioners that were fitted on the side of each individual seat.

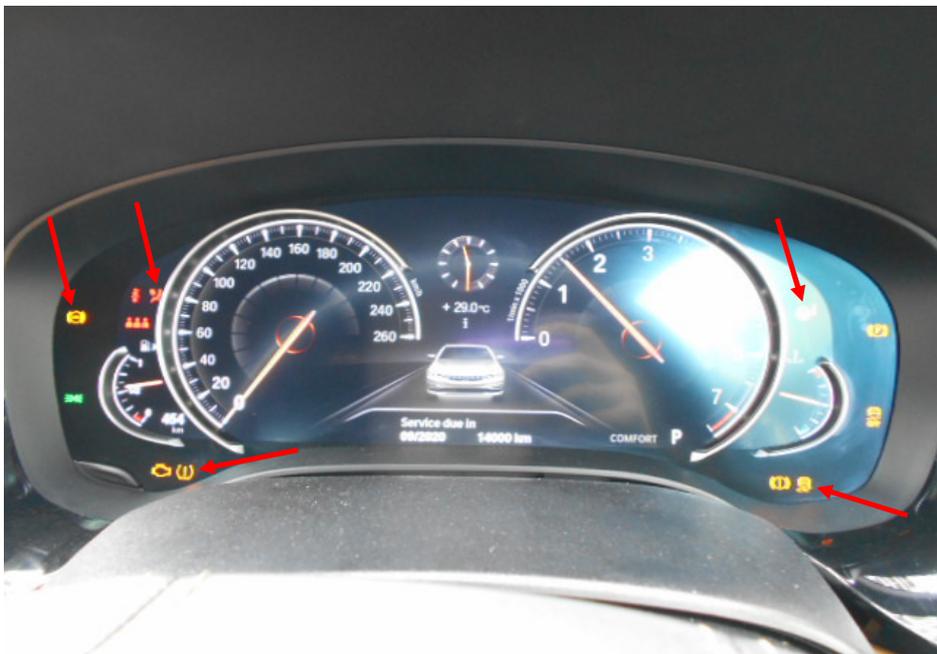
Photo 6 shows the warning lights for the various electronic safety features appearing on the instrument panel of the Motor Car during its self-test when the engine is cranked, in particular the ABS, SRS, IAS, TPM and DSC lights (arrowed).

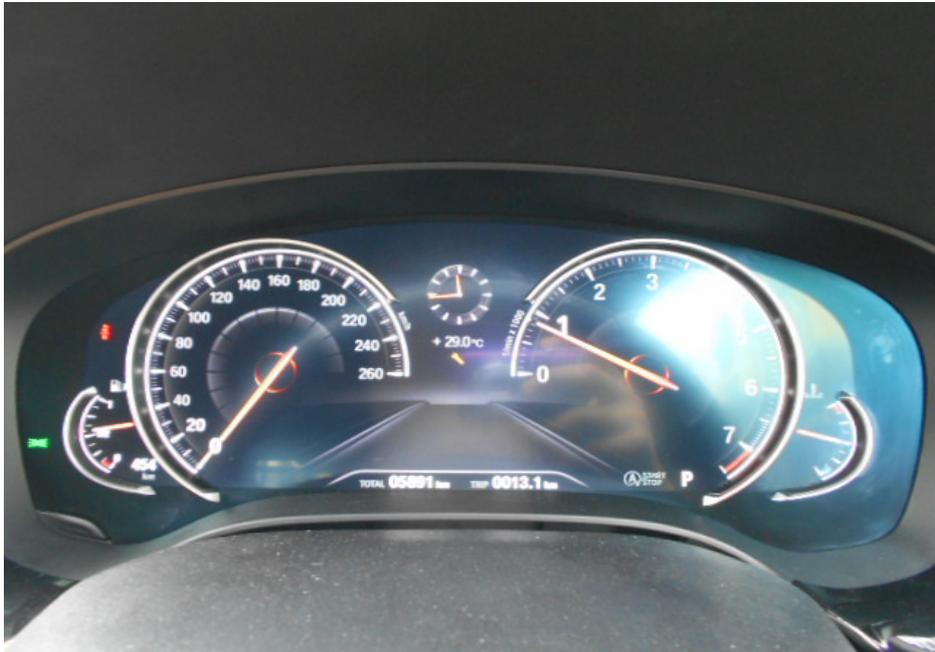
11. The Motor Car's automatic self-test of the functionality of its various electronic safety features like the Anti-Lock Brake System (ABS), Supplemental Restraint System (SRS), Integral Active Steering (IAS), Tyre Pressure Monitor (TPM) and Dynamic Stability Control (DSC) during cranking of the engine had indicated that these electronic systems were in working condition. This was determined from the respective warning lights disappearing from the instrument panel after the self-test.

Photo 7 shows the respective warning lights no longer illuminated after the engine was started, indicating that there was no fault detected to the ABS, SRS, IAS, TPM and DSC systems of the Motor Car during the self-test. These electronic systems were hence in working condition at the time of my inspection.

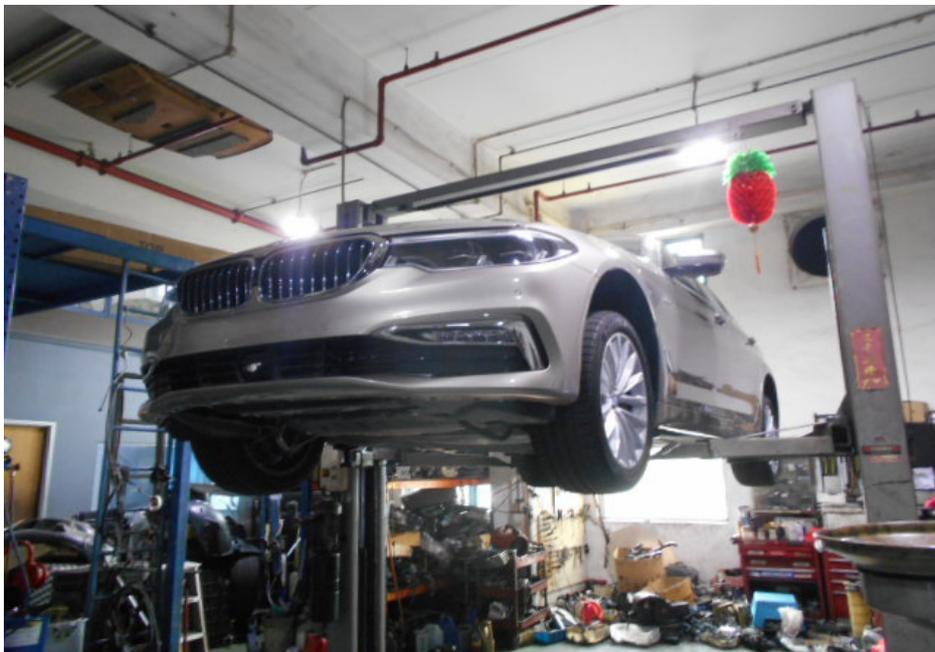
13. My checks on the underside of the Motor Car revealed no sign(s) or indication(s) of fluid leakage and/or fluid stain(s). The engine block and automatic transmission assembly were both secured properly. They were not mounted onto the structure/chassis body or any integral body part of the Motor Car. All undercarriage components of the Motor Car were also observed to be intact and secured in an appropriate manner.

Photo 8 shows the Motor Car hoisted up for checks on its undercarriage. There was no sign(s) or indication(s) of fluid leakage and/or fluid stain(s) on the underside of the Motor Car. The undercarriage components of the Motor Car were also all observed to be intact and secured in an appropriate manner.

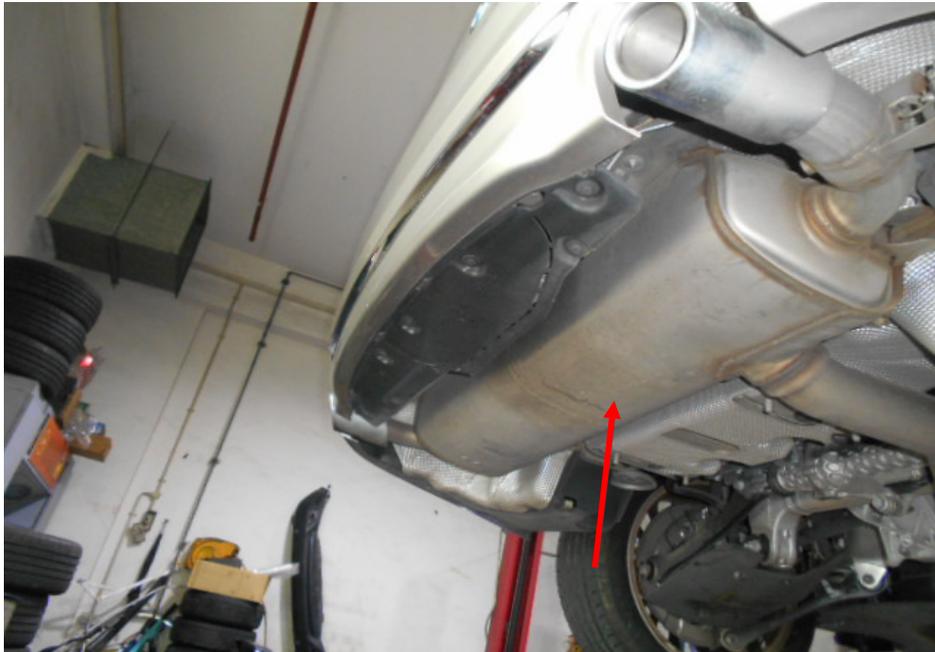
Photo 9 shows the Motor Car's rear exhaust muffler (arrowed). My examination of the Motor Car's exhaust system revealed no sign(s) or indication(s) of any cut or weld marks along its exhaust pipes and on its rear muffler.

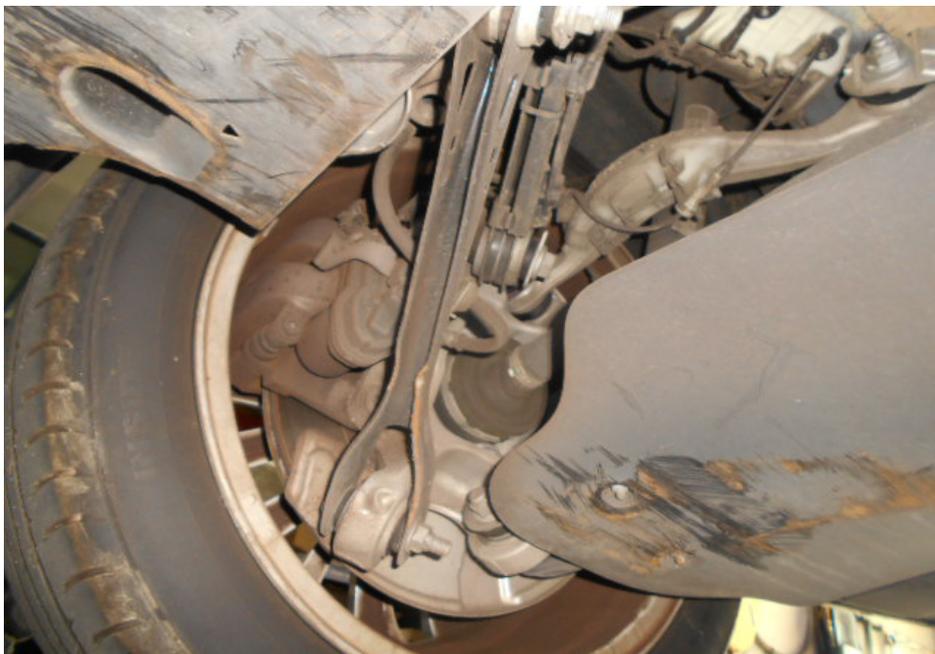
Photo 10 shows a general view of the control arms and linkages at the rear right wheel of the Motor Car. I did not observe any fluid leak and/or fluid stain on the underside of the Motor Car. All of the Motor Car's undercarriage components were observed to be intact and secured in an appropriate manner.

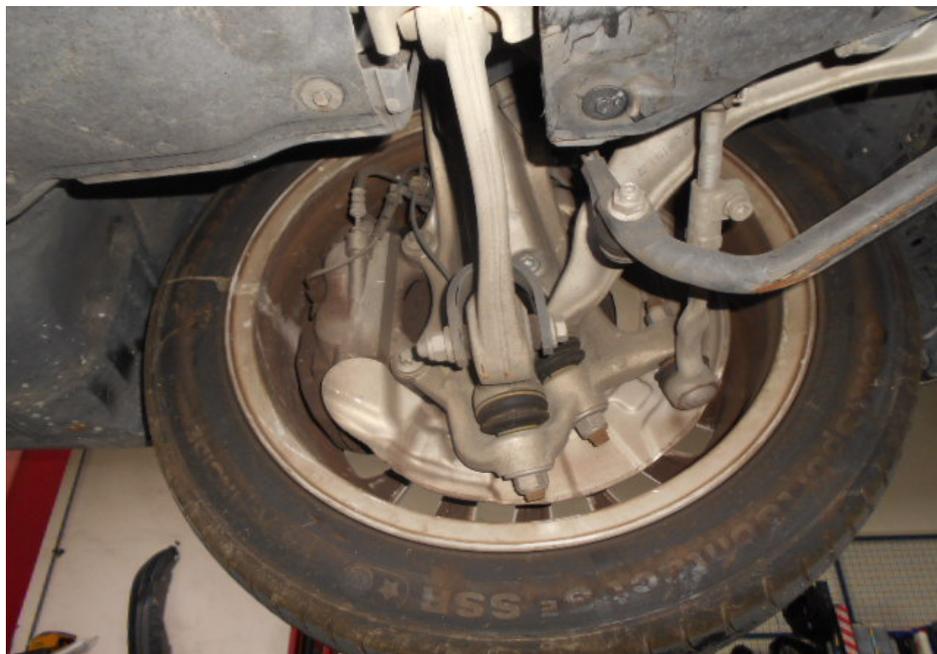
Photo 11 shows the various undercarriage components at the front left wheel of the Motor Car. The mechanical components, control arms and linkages were all found to be intact and secured in an appropriate manner.

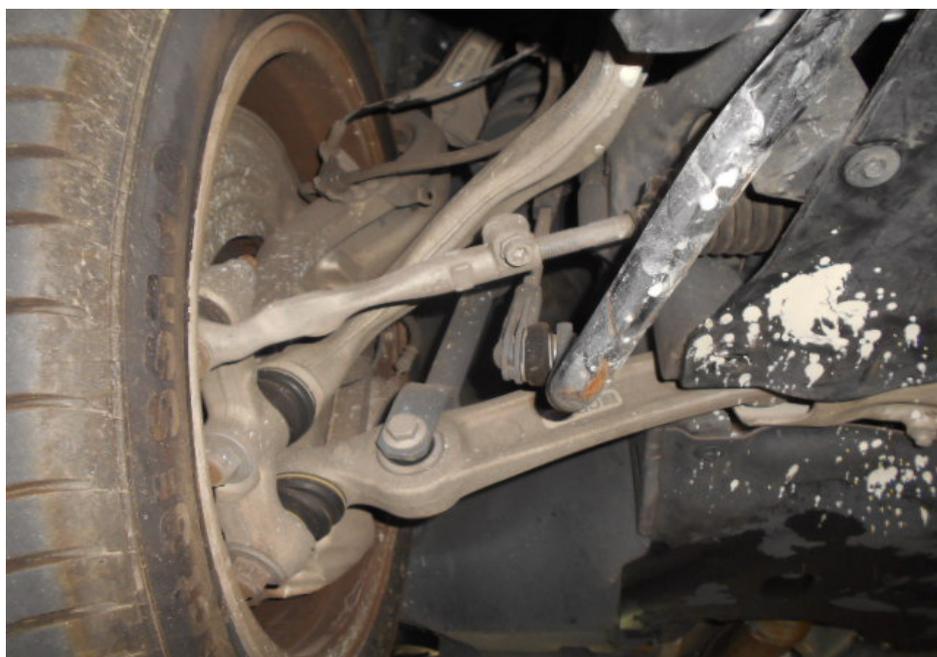
Photo 12 shows the various undercarriage components at the front right wheel of the Motor Car. The mechanical components, control arms and linkages were all found to be intact and secured in an appropriate manner. I also did not observe any fluid leak and/or fluid stain.

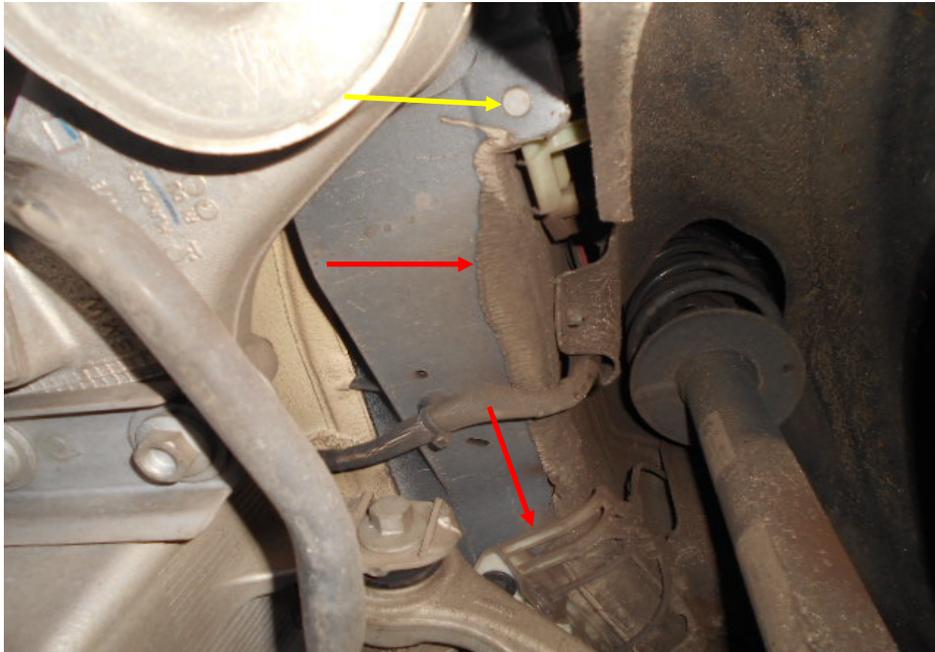
9. Visually, I did not find any weld marks, other than original spot weld marks, on the structure/chassis body of the Motor Car. The original factory sealant at the joints along the structure/chassis body was also untouched, again indicating that no replacement of the structure/chassis body was carried out; and that the structure/chassis body was originally fitted.

Photo 13 shows the structure/chassis body at the rear right underside of the Motor Car. Visually, I did not find any weld marks other than original spot weld marks (yellow arrow) on the structure/chassis body of the Motor Car. The original factory sealant (red arrow) at the joints along the structure/chassis body was also untouched, indicating no work was done on the structure/chassis body of the Motor Car and that the structure/chassis body was originally fitted.

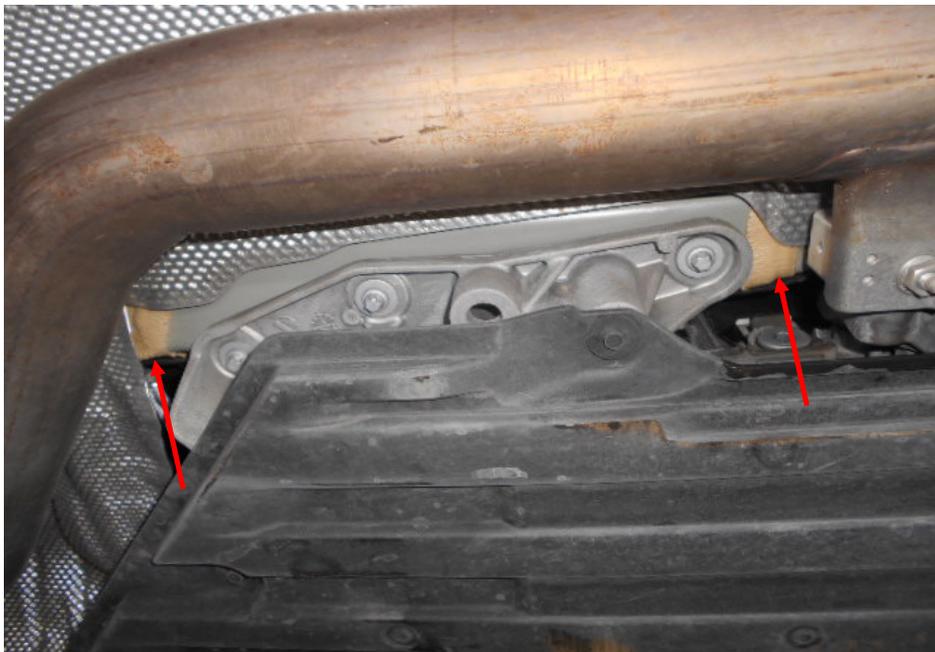
Photo 14 shows the floor board at the centre underside of the Motor Car. The original factory sealant (arrowed) at the joints along the non-detachable body panels were untouched, indicating no work was done on the non-detachable body panels of the Motor Car; and that the non-detachable body panels were originally fitted.

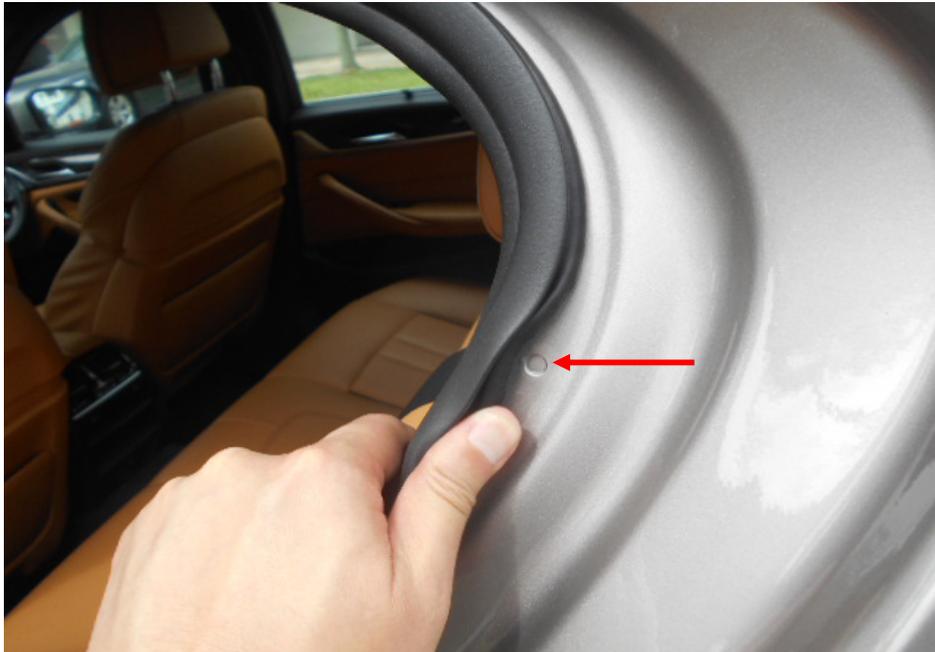
Photo 15 shows the rear left “C” pillar of the Motor Car. I did not find any weld marks other than original spot weld marks (arrowed) on the non-detachable body panels of the Motor Car, indicating that there was no re-welding works carried out; and that the non-detachable body panels of the Motor Car were originally fitted.
