LKK Auto Consultants Pte Ltd

Vehicle No. SDR 811J
Insured Veh. SLM 5498D
Claim No. C10004696/JM
Policy No.
Accident Date 22/11/2019
Inspection Date 24/12/2019

ADJUSTMENT ON REPAIR COST FOR VEHICLE NO. SDR 811J

PHOTOGRAPHS FOR VEHICLE NO. SDR 811J

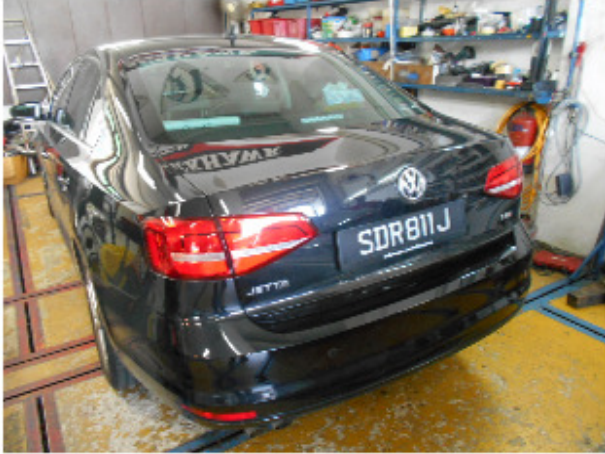
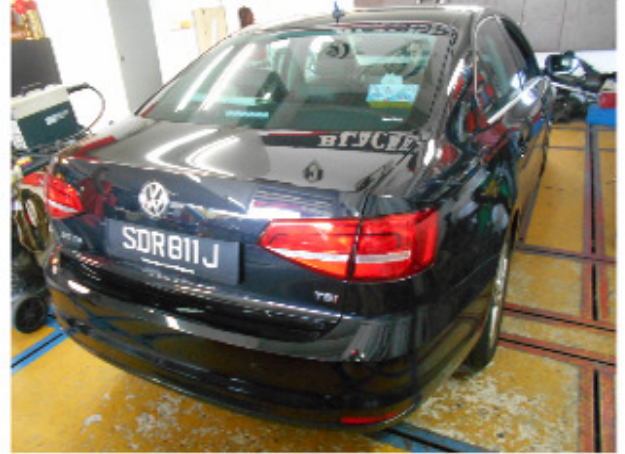
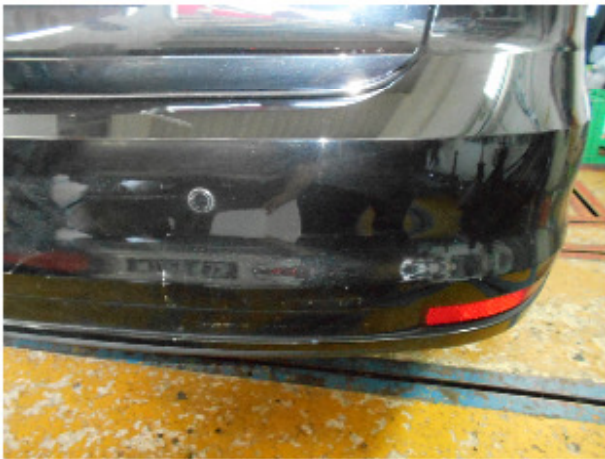
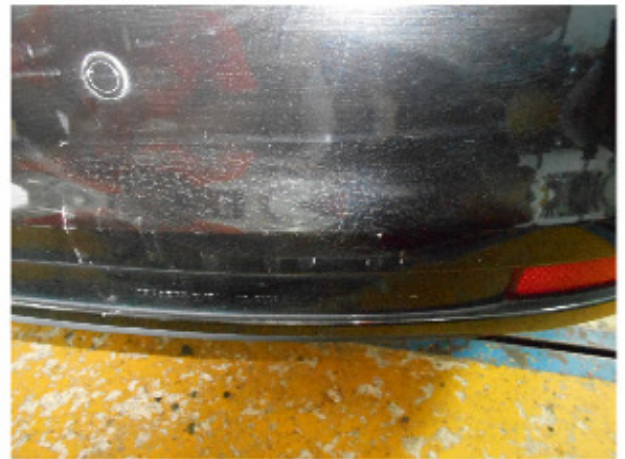
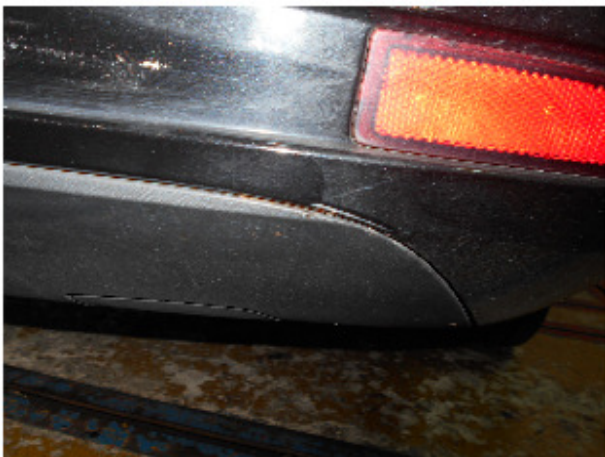
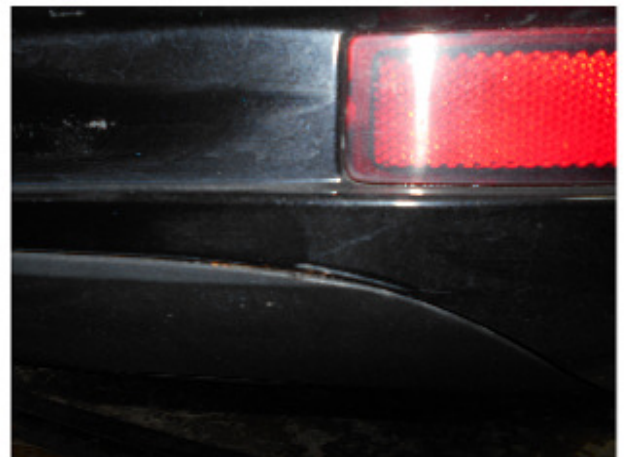
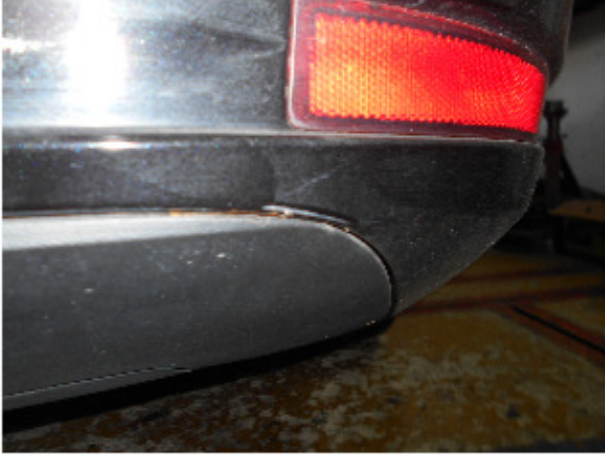
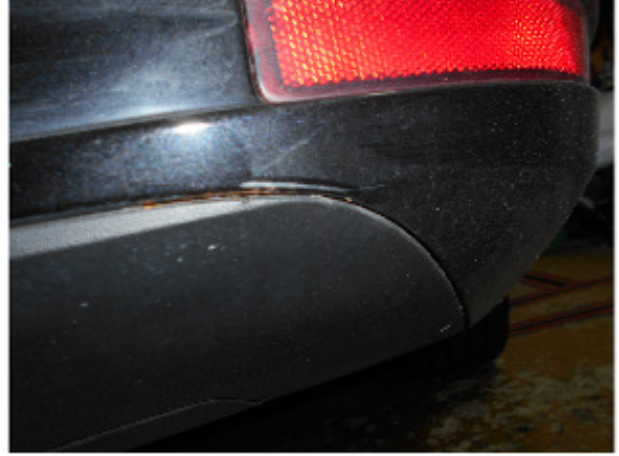
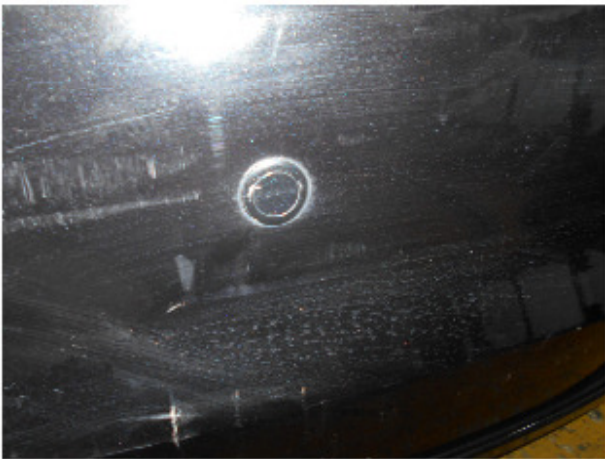
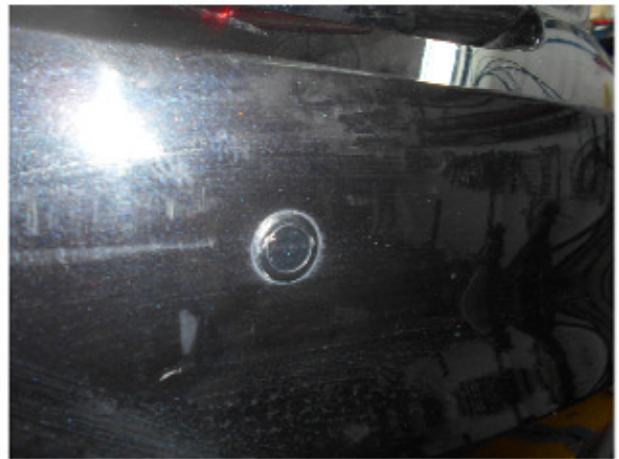
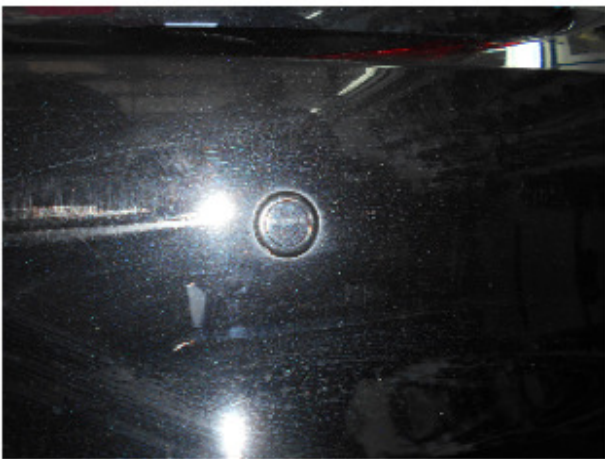
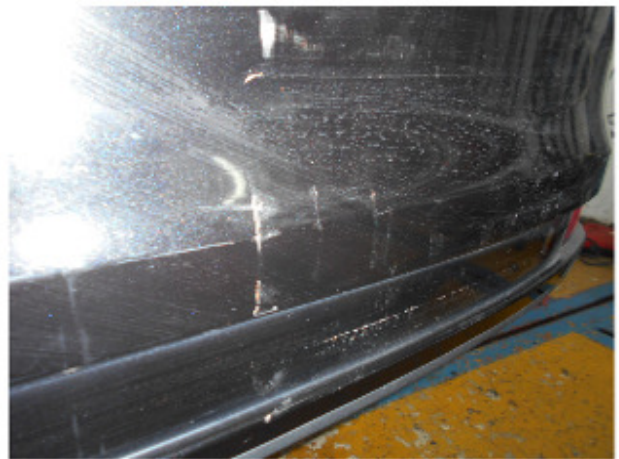
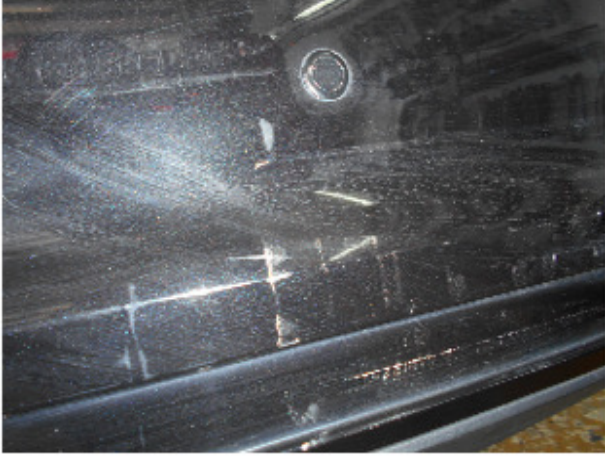
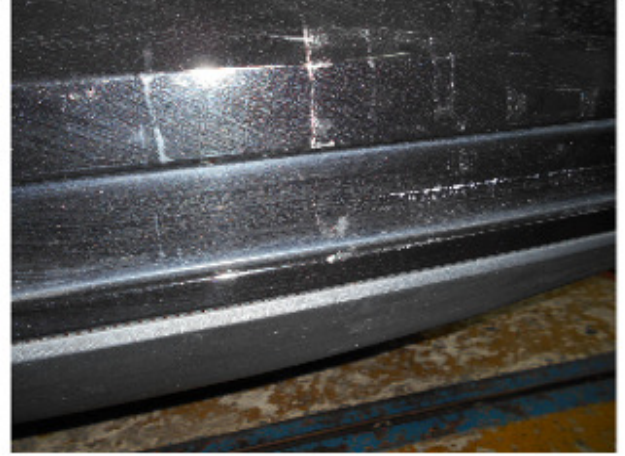
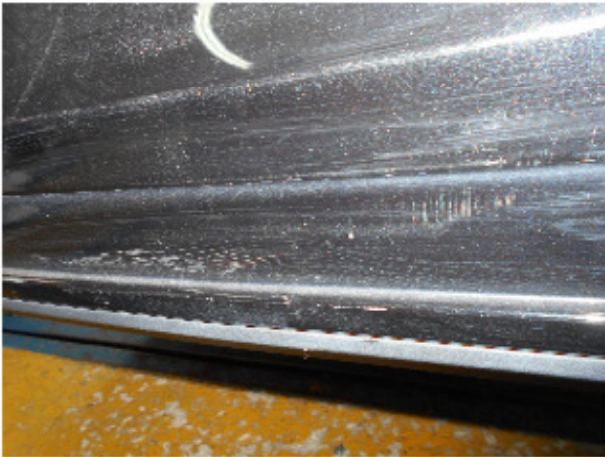
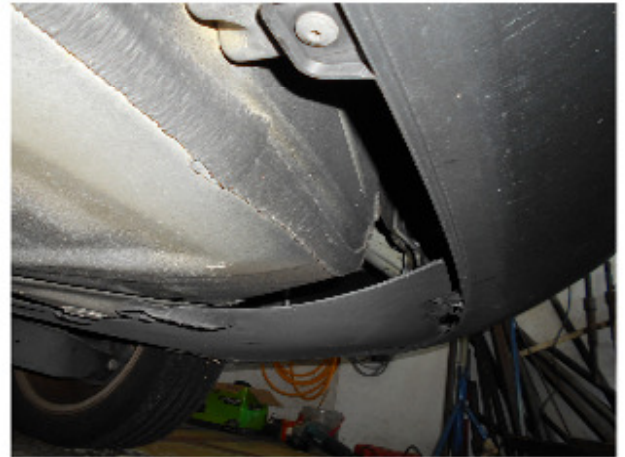
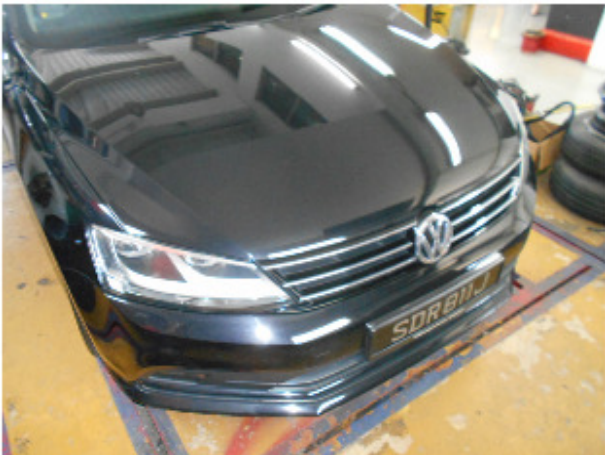
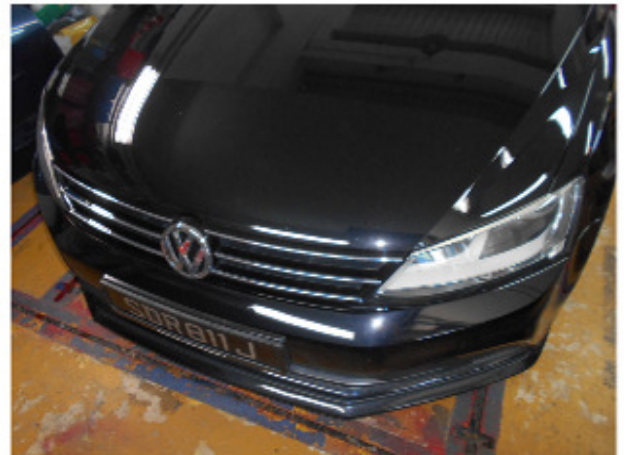
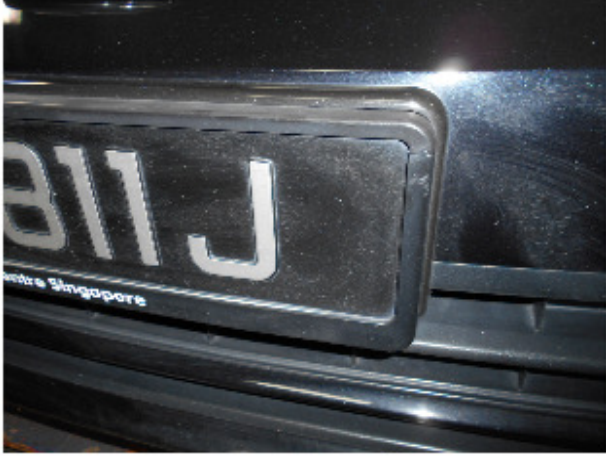
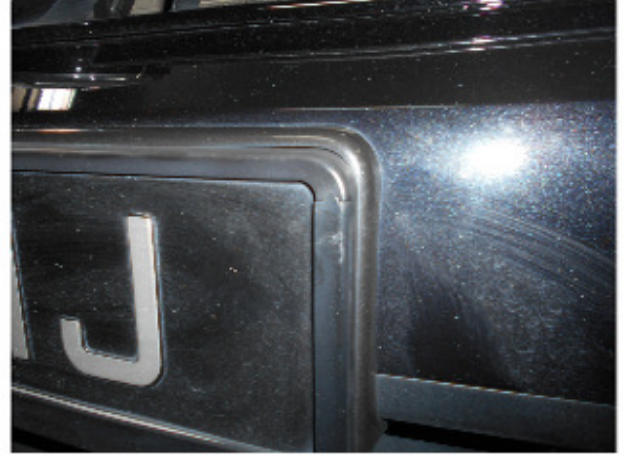
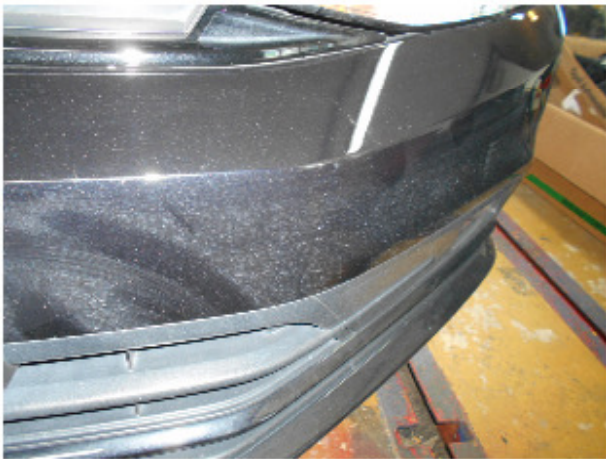
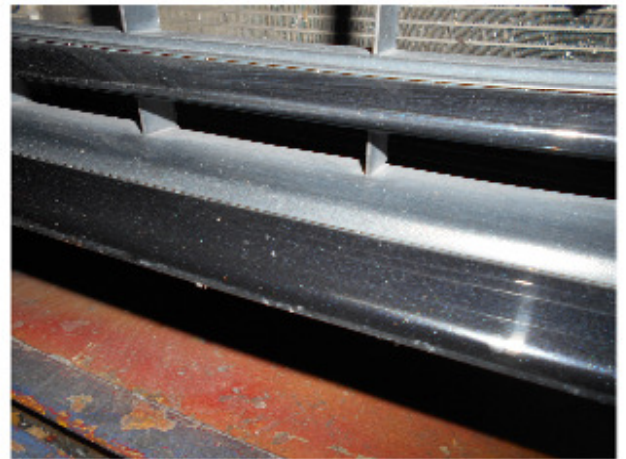
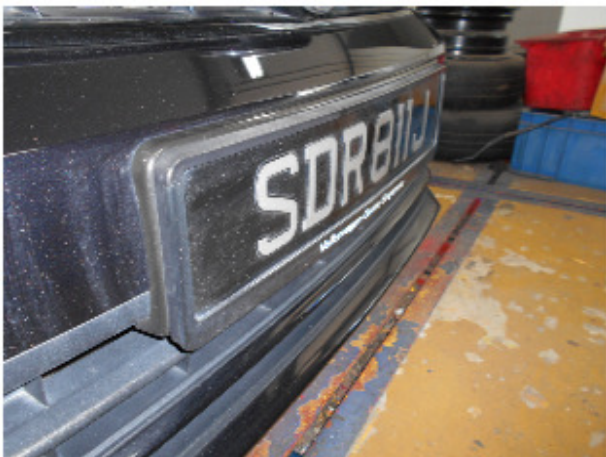
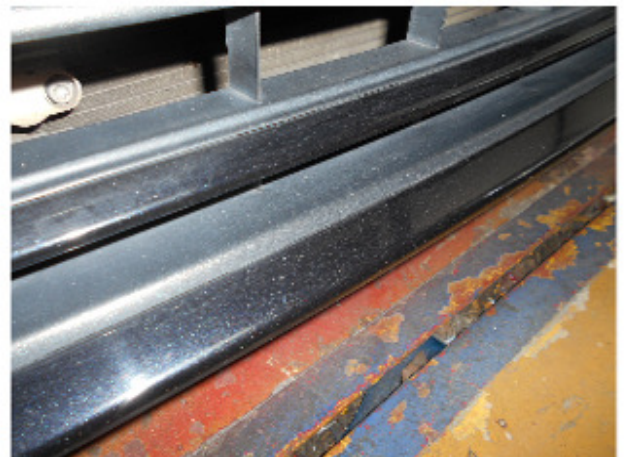
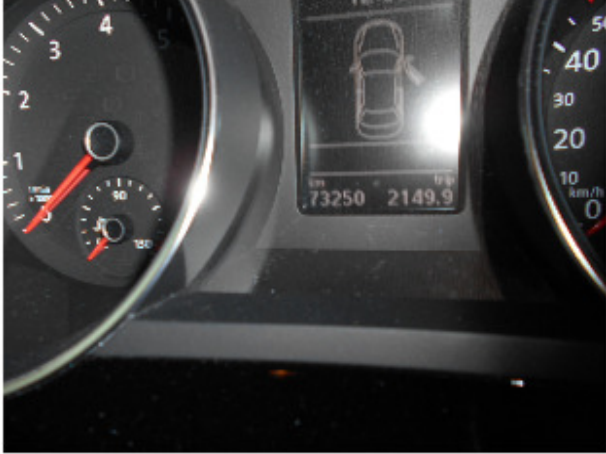
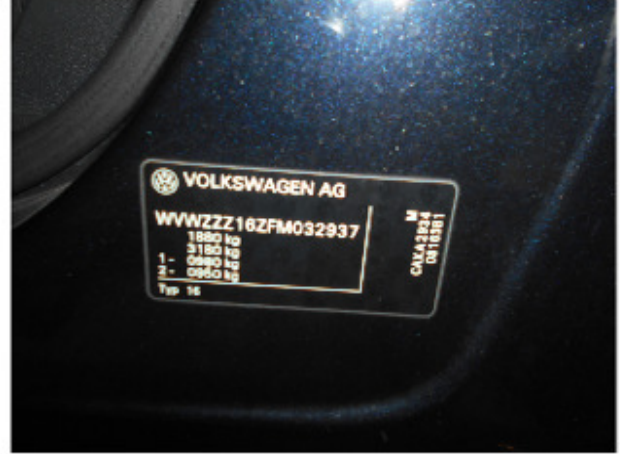
INSPECTION

THE VEHICLE SUSTAINED DAMAGES AT THE FRONT AND REAR PORTION.
DAMAGES SEE DETAILS.
