TP Claims against NTUC Income: Follow-Through Survey

1. Policy Particulars :- THIRD PARTY CLAIM				
Insured Veh.	SGL 6985Y	Veh. Inspected	SHA 3942L	
Policy No.	5088123125-02	Coverage (\$)	0.00	
Claim No.	MT/1074211-002	Excess (\$)	0.00	
Assign From		Assign Date	03/12/2019

4. Description of Damages				
THE VEHICLE SUSTAINED DAMAGES AT THE REAR PORTION. DAMAGES SEE DETAILS.				
5. General Information				
Accident Date	02/12/2019	Inspection Date	03/12/2019	
Survey held at	COMFORTDELGRO ENGINEERING PTE LTD 59 LOYANG DRIVE SINGAPORE 508969			
5a. Remarks				
A)THE INSPECTION WAS CONDUCTED ON A"WITHOUT PREJUDICE" BASIS. B)IN ACCORDANCE TO YOUR INSTRUCTIONS, WE HAVE NOT AUTHORISED REPAIRS.				
5b. Estimate Days of Repair				
ESTIMATED NORMAL PERIOD FOR REPAIR:		2 Working Days

ADJUSTMENT ON REPAIR COST FOR VEHICLE NO. SHA 3942L

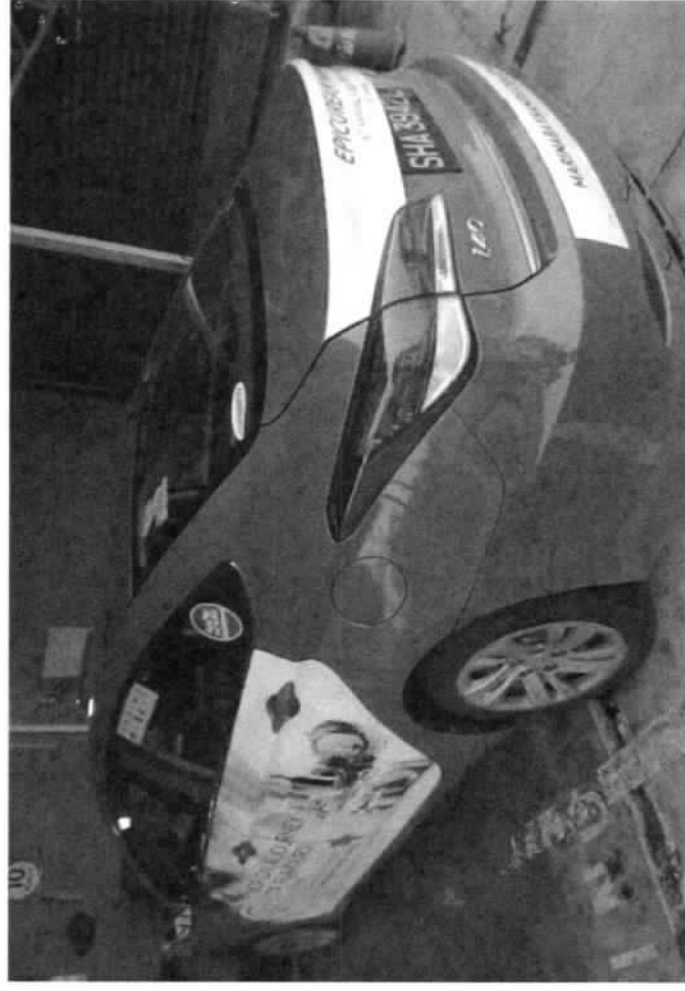
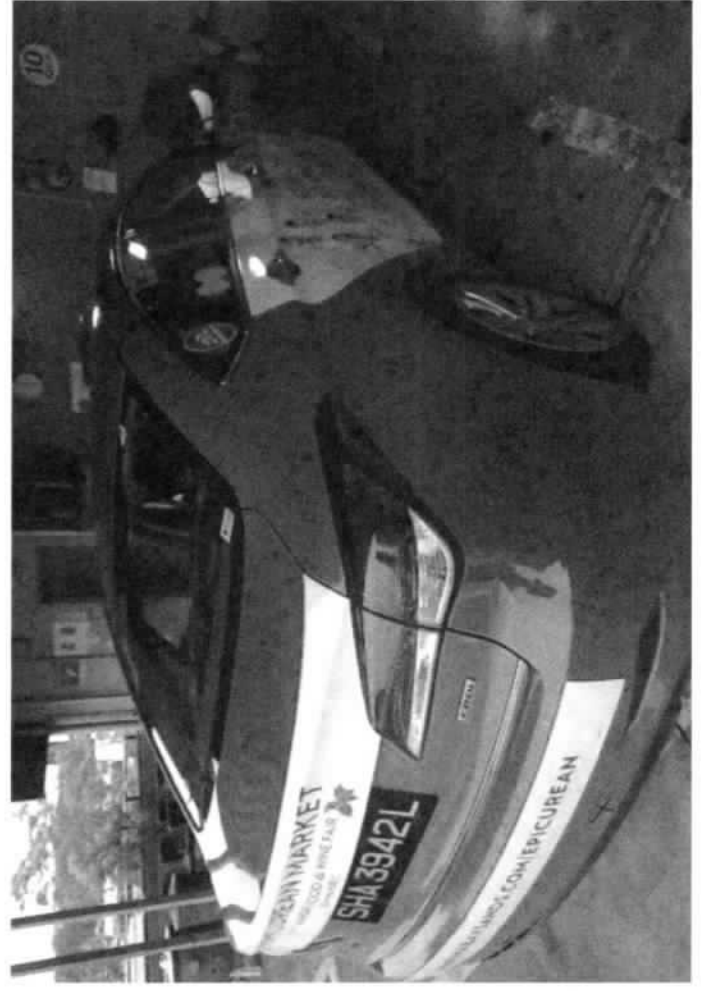
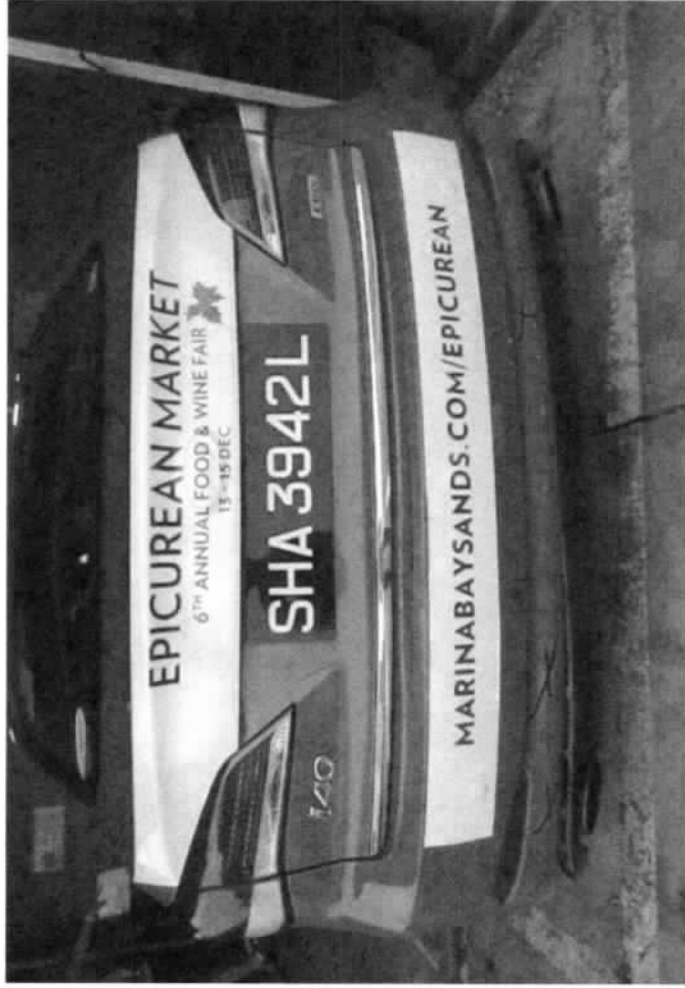
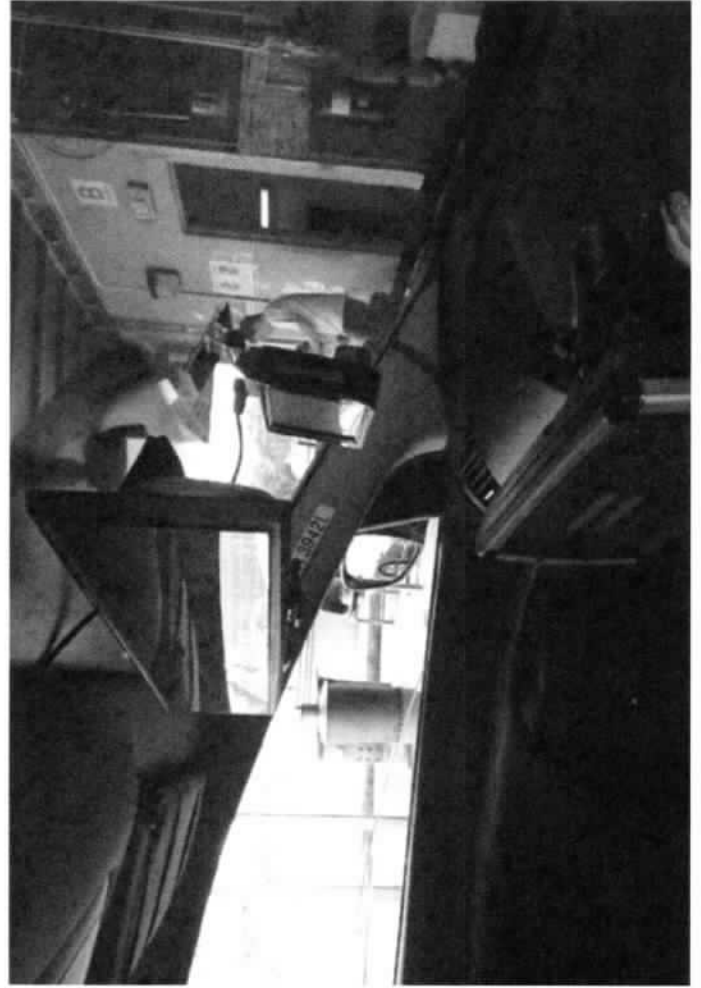
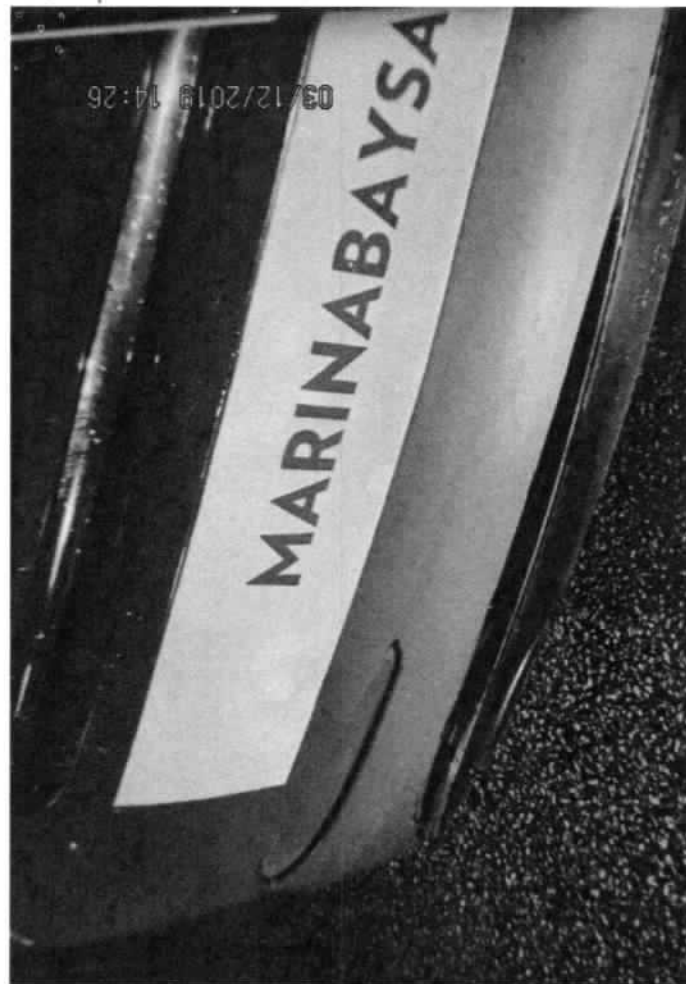
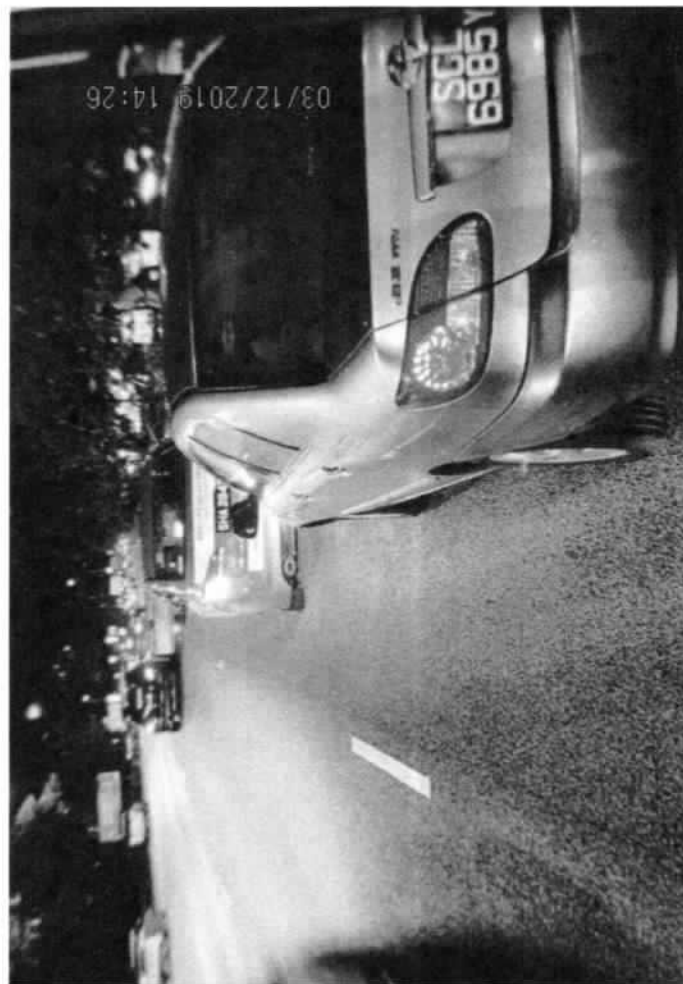
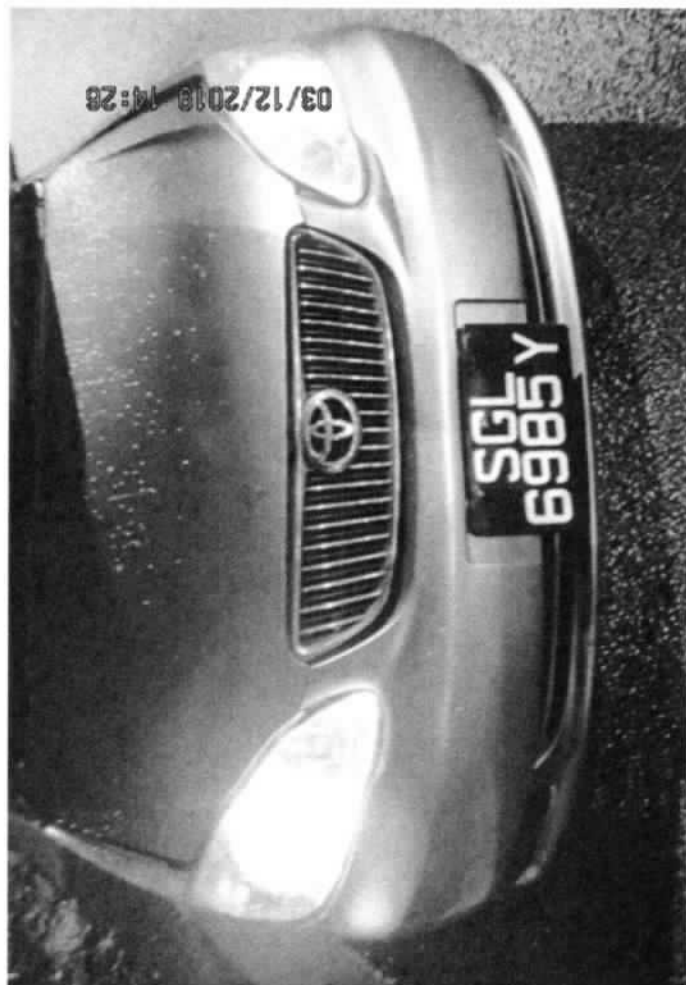
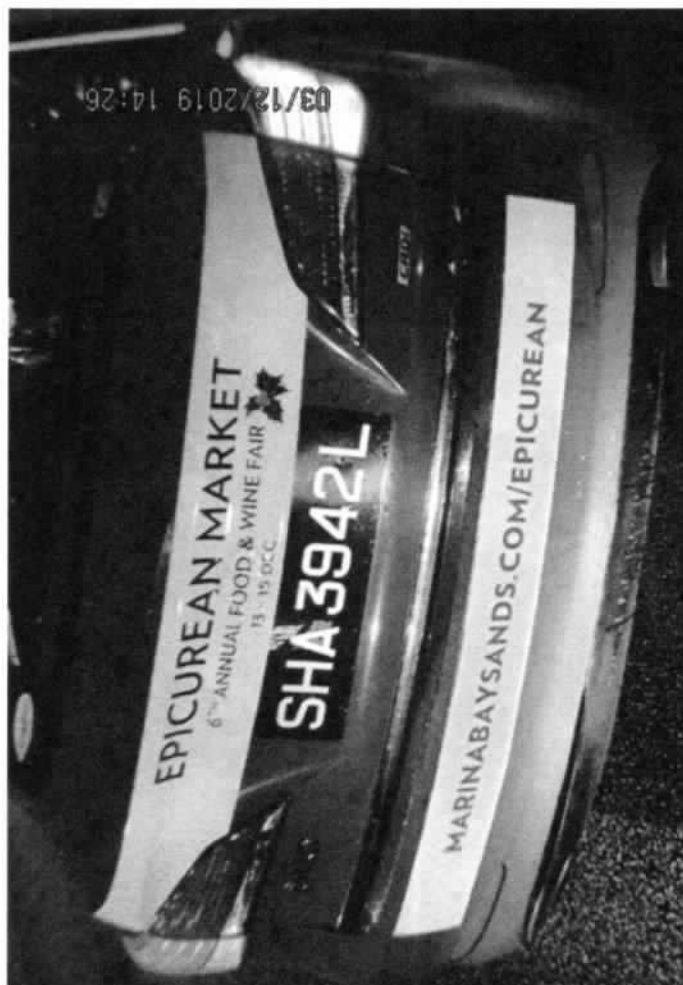
Qty	Description of Parts	Condition	Estimate By Workshop (\$)	Our Adjusted (\$)
<u>REPLACEMENT OF PARTS</u>				
1	REAR BUMPER	DEFORMED	553.00	553.00
10	REAR BUMPER CLIP	NECESSARY	22.00	22.00
2	REAR BUMPER BRACKET @\$35.60	NOT NECESSARY	71.20	-
	LESS 20% DISCOUNT		-129.24	-115.00
			516.96	460.00
<u>SPECIAL NETT ITEMS</u>				
1	REAR BUMPER REVERSE SENSOR (SN)	NOT NECESSARY	135.70	-
1	REAR BUMPER ADVERTISEMENT LOGO (SN)	NECESSARY	50.00	50.00
2	REAR FENDER ADVERTISEMENT LOGO (LH/RH) @\$100.00 (SN)	NECESSARY	200.00	200.00
			385.70	250.00
<u>LABOUR</u>				
	PANEL BEATING.		350.00	280.00
	SPRAY PAINTING CHARGE.		250.00	200.00
	WIRING CHARGE.	NOT NECESSARY	50.00	-
	REMOVE / REFIX REVERSE SENSOR.		80.00	40.00
			730.00	520.00
GRAND TOTAL			1,632.66	1,230.00
RECOMMENDED COST OF LUMP SUM REPAIRS (TO ITS PRE-ACCIDENT CONDITION) (CONFIRMED)				1,000.00
