**From:** Perry HE (HTX) <Perry\_HE@spf.gov.sg>  
**Sent:** Wednesday, 4 December 2019 2:35 PM  
**To:** 'assignments'  
**Cc:** Kim Pang CHAY (HTX); Kwee Huat TAN (HTX); 'Denise Tay (LKKAuto)'  
**Subject:** Appraisal Services for SPF vehicle at INDECO - GBF3172L

# ACCIDENT/DAMAGE REPAIR AND AD HOC WORKS REQUEST FORM

**4. Description of Damages**

| THE VEHICLE SUSTAINED DAMAGES AT THE O/S FRONT PORTION.<br>DAMAGES SEE DETAILS. |

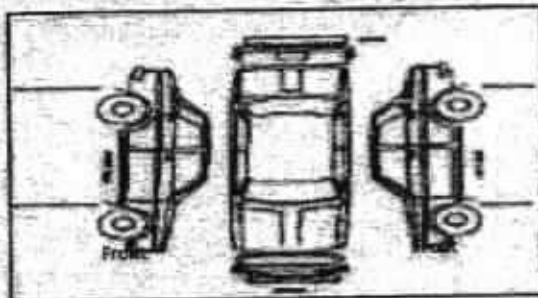
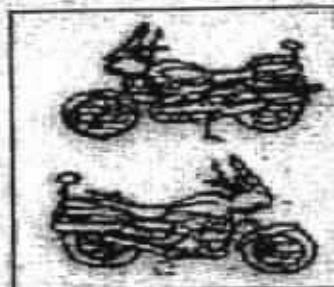
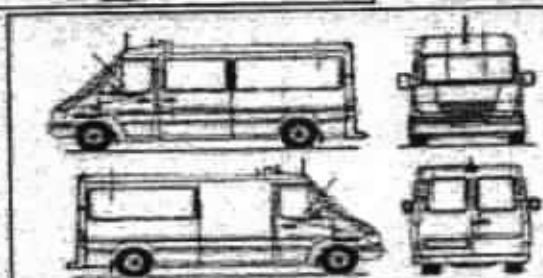
Pls mark affected area with X

FRONT BUMPER DISLOGED

DRIVER DOOR DENTED AND GRAZED

HEADLIGHT CRACKED

FRONT RIGHT RIM DENTED

RIGHT FRONT FENDER DAMAGED

FRONT HOOD DENTED
