Your Ref: OD/613910
Our Ref : CS/MSG19021666/P

30th December 2019

**TECHNICAL INVESTIGATION REPORT OF FIRE INCIDENT INVOLVING THE
INSURED VEHICLE SLX 1805U ON 9th DECEMBER 2019**

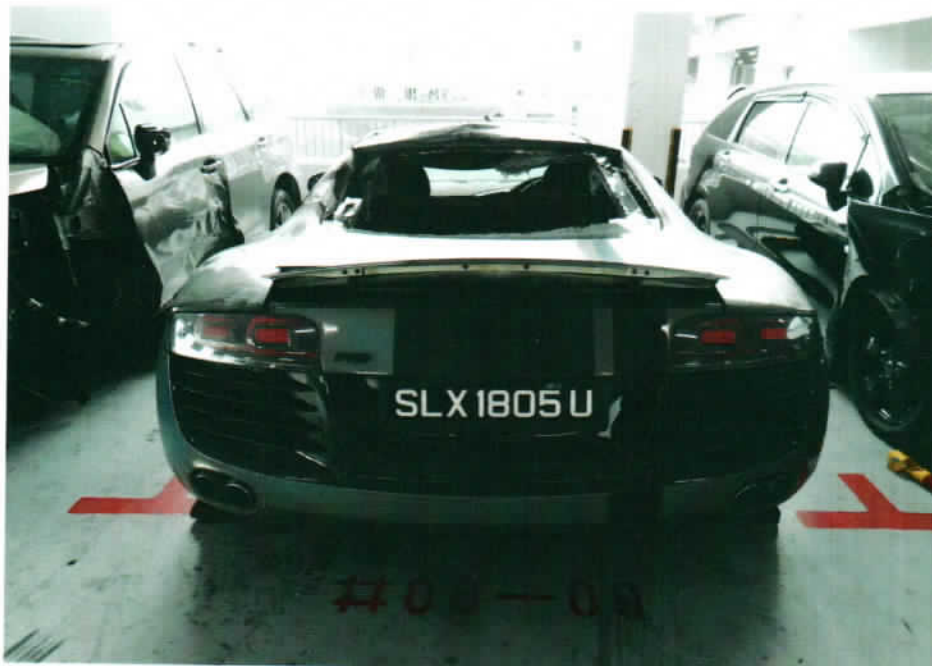
Photo 1 shows the rear portion of the Insured Vehicle, which was observed to be unaffected by the fire.

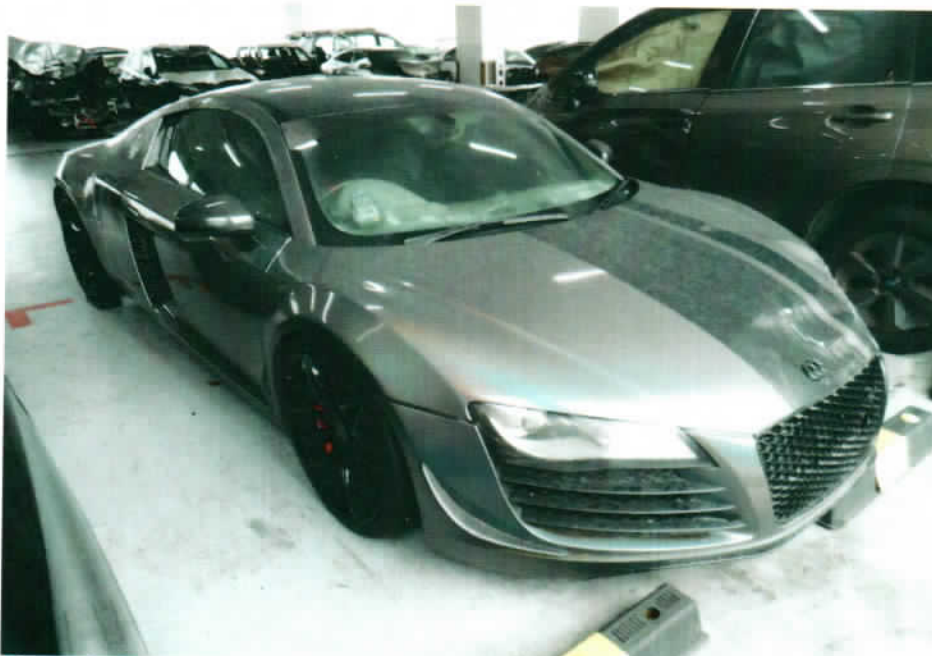
Photo 2 shows the right body of the Insured Vehicle, which was observed to be unaffected by the fire.

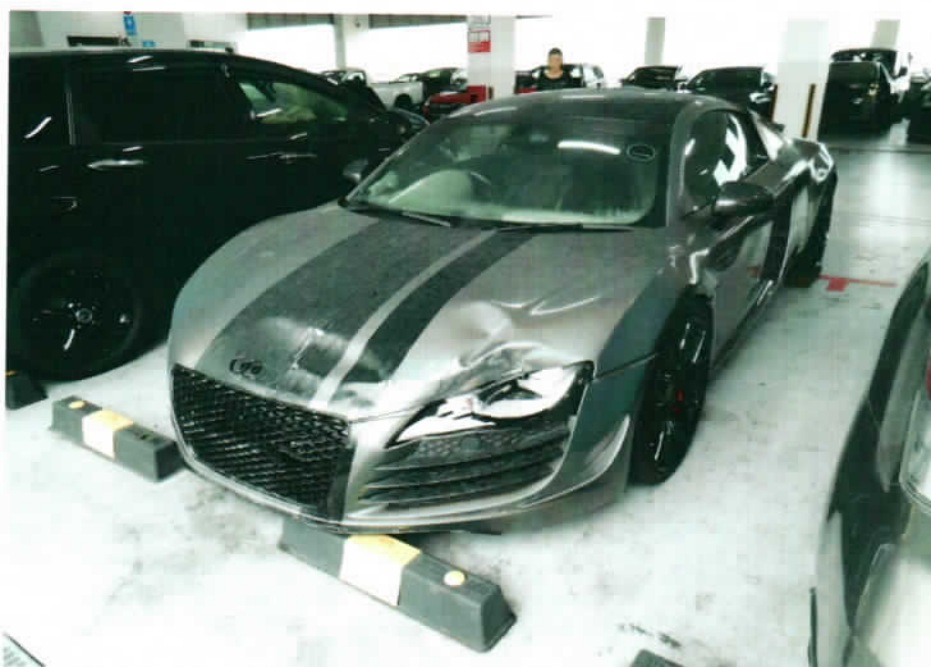
Photo 3 shows the right body of the Insured Vehicle, which was observed to be unaffected by the fire.

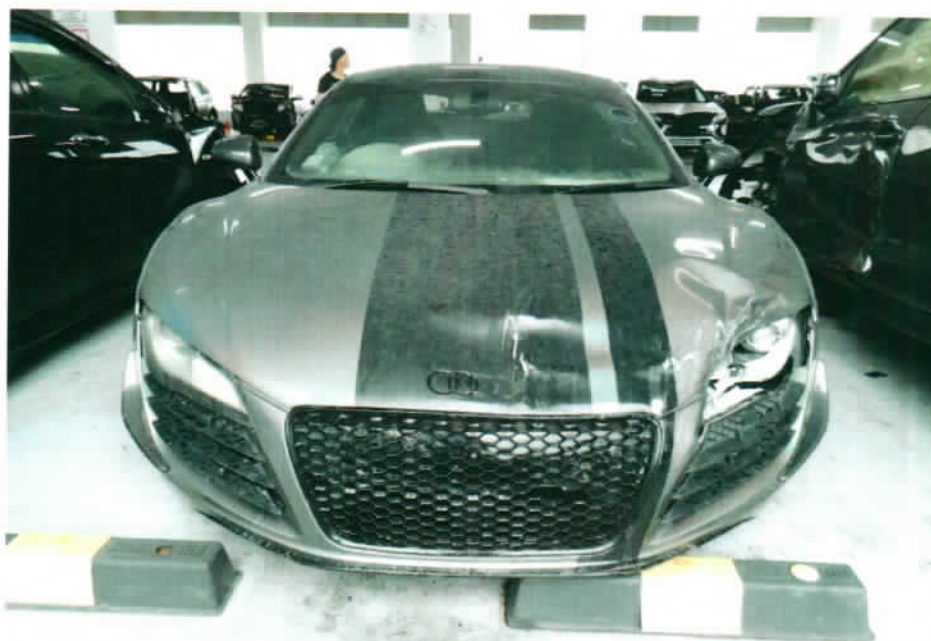
Photo 4 shows the general view of the front portion of the Insured Vehicle, it was unaffected by the fire however its front bonnet and front left headlamp was damaged by a collision accident which was prior to the fire incident.

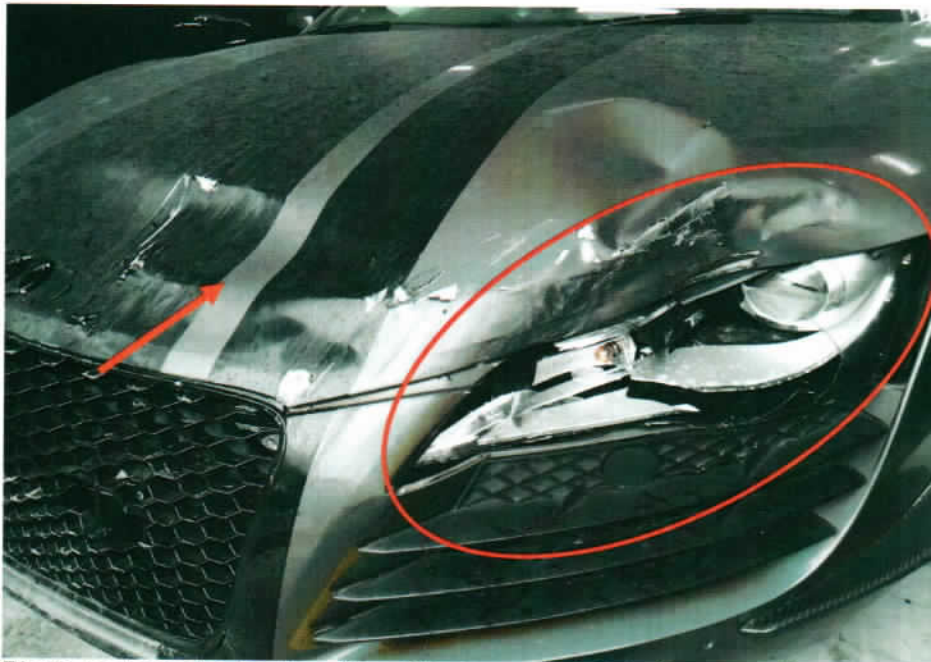
Photo 5 shows the front portion of the Insured Vehicle it was unaffected by the fire however its front bonnet (arrowed) and front left headlamp (circled) was damaged by a collision accident which was prior to the fire incident. (Refer to photo 17-19 below)

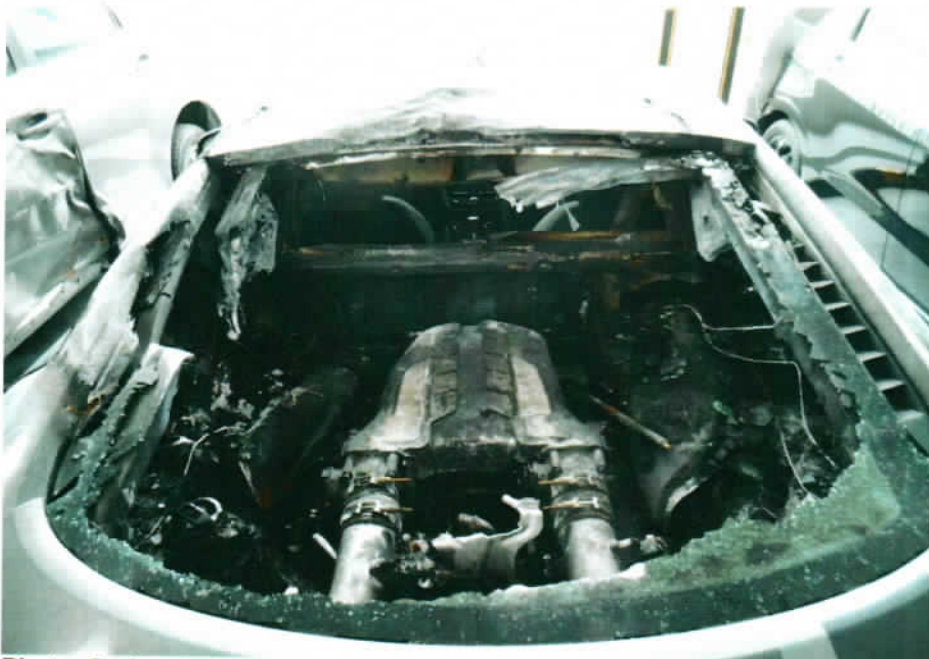
Photo 6 shows the general view of the engine compartment of the Insured Vehicle at the time of our inspection. The Insured Vehicle was observed to have sustained severe fire damage. Its engine cover and engine compartment was completely burnt. Rust had accumulated around the engine compartment of the Insured Vehicle as a result of exposure to environmental condition for a period of time.

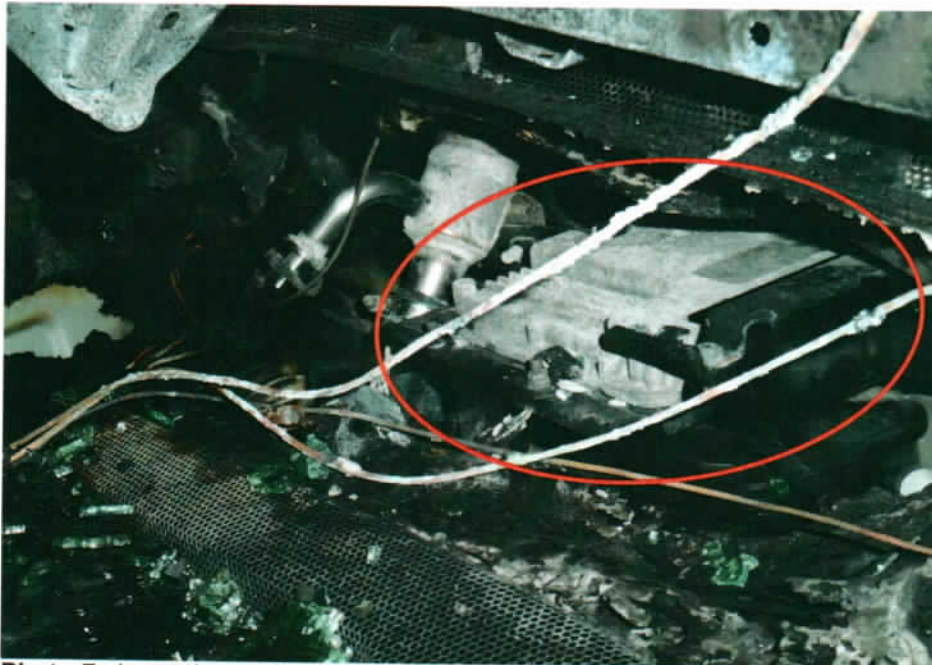
Photo 7 shows the engine compartment of the Insured Vehicle at the time of our inspection. The engine ecu (circled) was observed to be severely burnt. Most of the parts inside the engine compartment were found to be burnt and/or melted as a result of the fire.

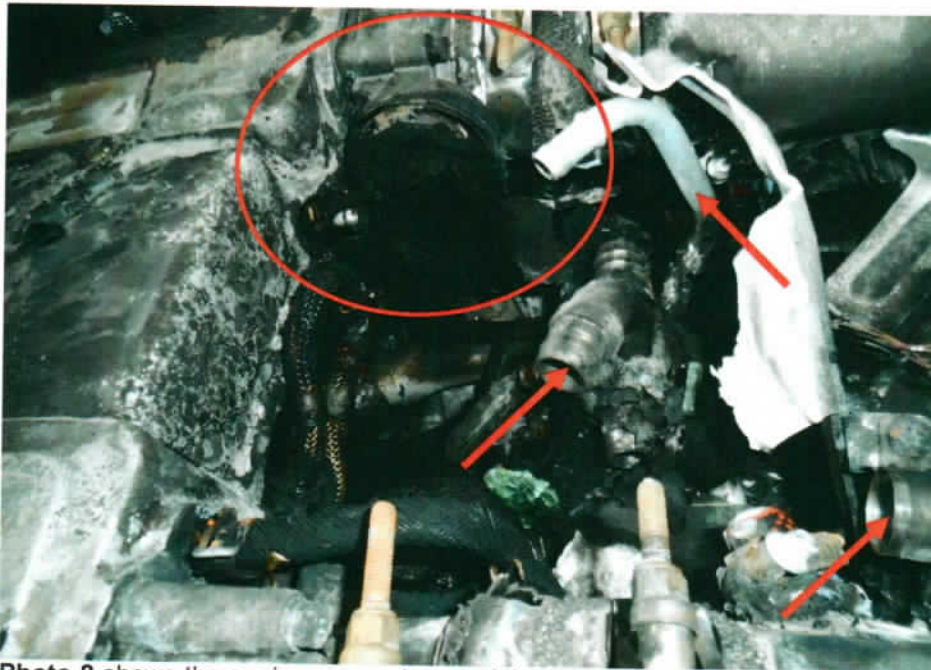
Photo 8 shows the engine compartment of the Insured Vehicle at the time of our inspection. The throttle body (circled) and various air hoses (arrowed) was observed to be burnt and/or melted as a result of the fire.

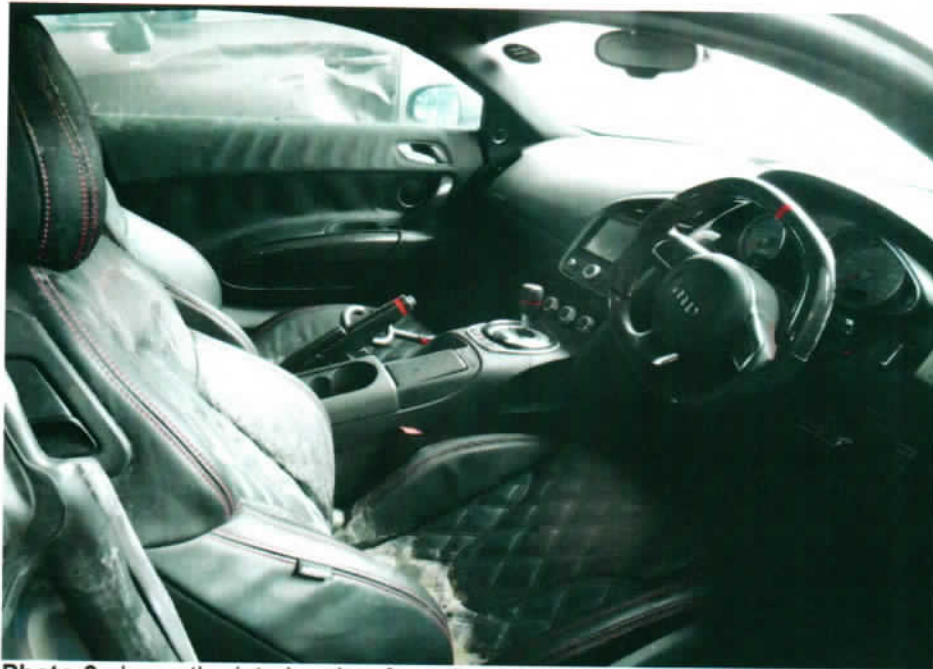
Photo 9 shows the interior view from the right side of the Insured Vehicle at the time of our inspection. The interior fittings of the Insured Vehicle were observed to suffer smoke and heat damage as a result of the fire.

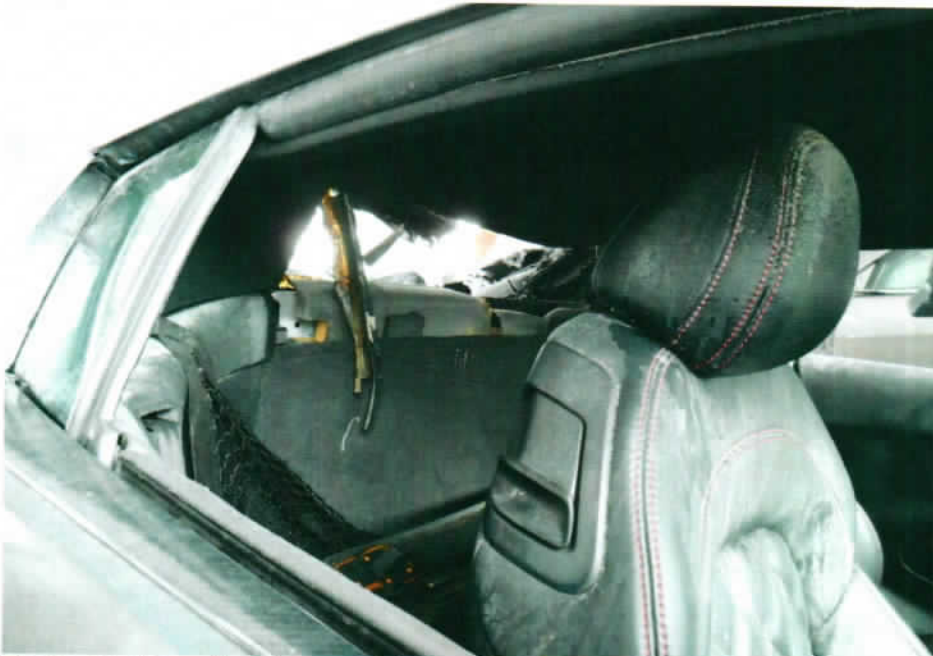
Photo 10 shows the close up interior view from the right side of the Insured Vehicle at the time of our inspection. The rear sight glass, rear seat compartment fittings and the seats material of the Insured Vehicle were observed to suffer smoke and heat damage as a result of the fire.

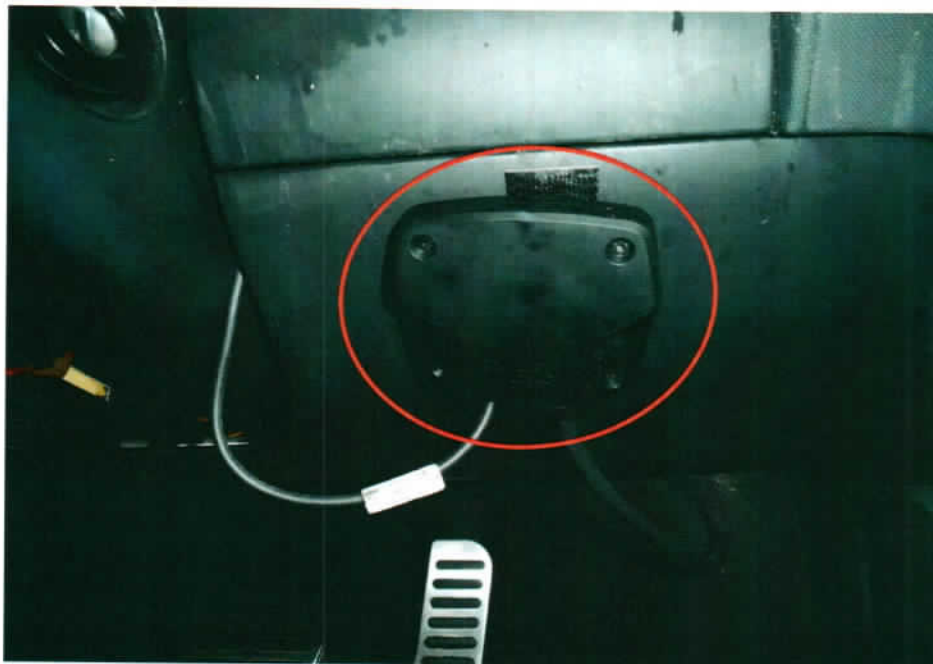
Photo 11 shows the close up view of the interior from the driver side of the Insured Vehicle at the time of our inspection. An electronic throttle pedal controller (circled) was observed to be installed.

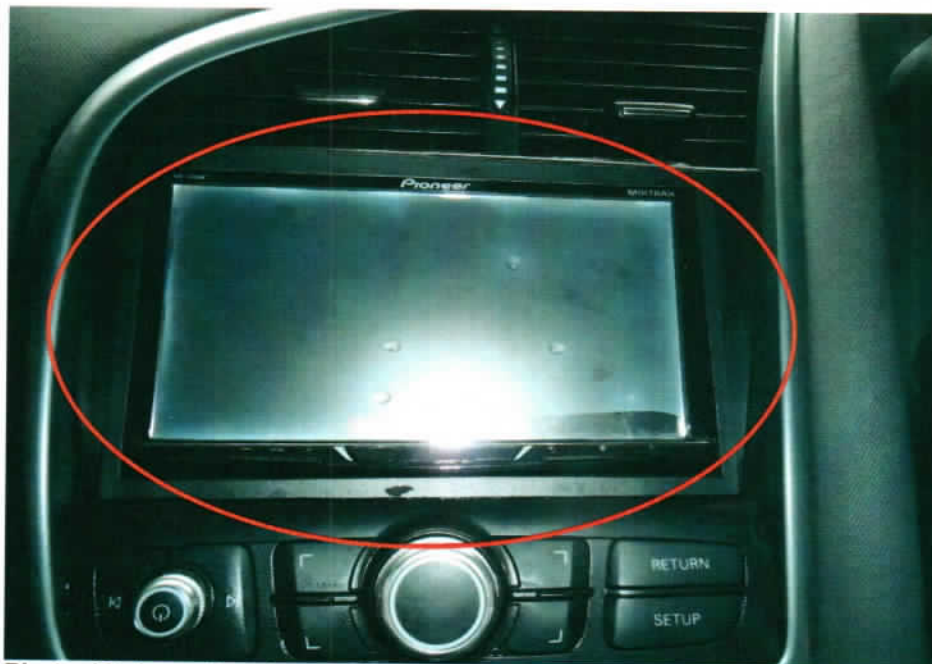
Photo 12 shows the close up interior view of the Insured Vehicle at the time of our inspection. An aftermarket audio head unit (circled) was observed to be installed.

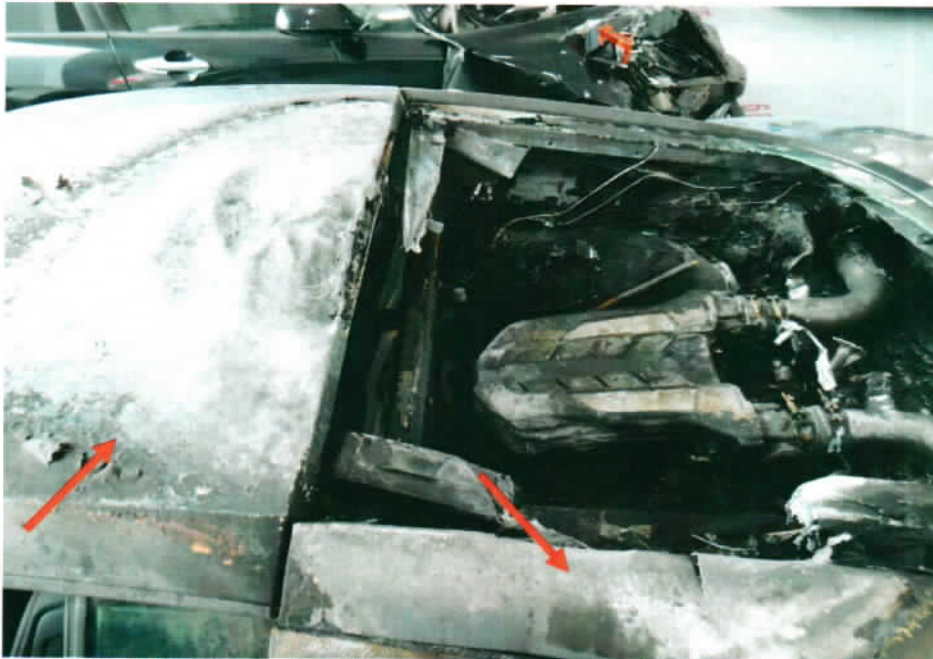
18. For this particular case, the fire appears to have originated from the middle portion of the engine compartment of the Insured Vehicle. This can be determined from the burn pattern of the various components in the engine compartment, which were observed to have been partly melted and burn from the high heat intensity and the high heat intensity burn marks (whitish burn marks) found on the metal parts around the Insured Vehicle. Rust had also developed on these metal parts.

19. The whitish burn marks are a result of exposure to prolonged heat intensity. Rust would normally start to develop around these areas soon after a fire as prolonged exposure to high heat intensity usually causes steel/metal material body parts to be exposed to natural environmental condition. The rust that had developed on the metal body is an indication that roof portion of the Insured Vehicle had sustained exposure to prolonged high heat intensity. See photos 13 & 14 below.

Photo 13 shows the roof and the surrounding of the middle portion (arrowed) of the Insured Vehicle at the time of our inspection. The high heat intensity burn marks (whitish burn marks) and rust that had development found on the exterior surface of the roof metal body and the surrounding area indicates that the fire had originated from the engine compartment of the Insured Vehicle.

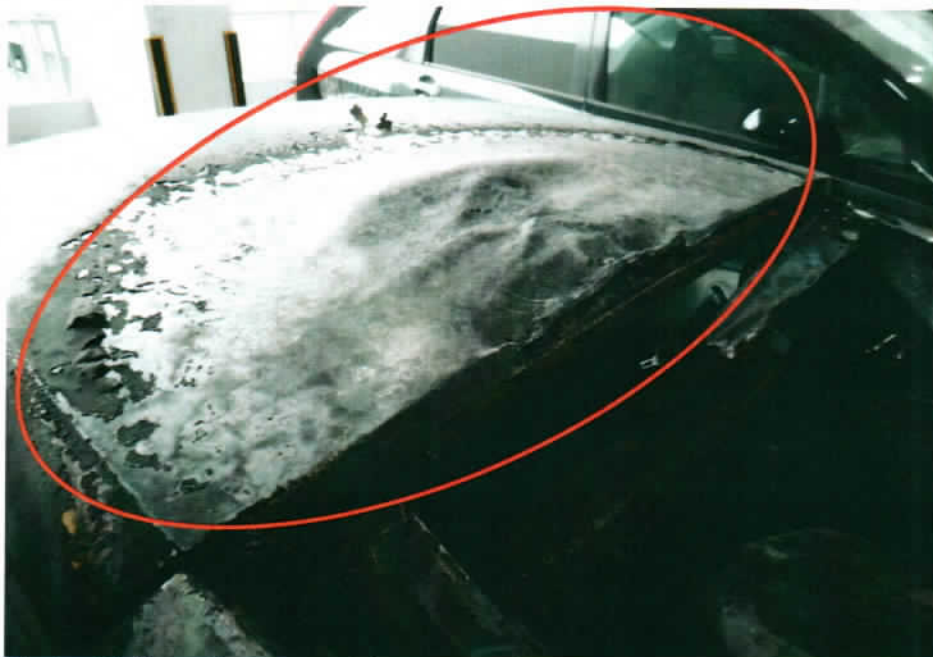
Photo 14 shows the roof and the surrounding of the middle portion (circled) of the Insured Vehicle at the time of our inspection. The high heat intensity burn marks (whitish burn marks) and rust that had development found on the exterior surface of the roof metal body and the surrounding area indicates that the fire had originated from the engine compartment of the Insured Vehicle.

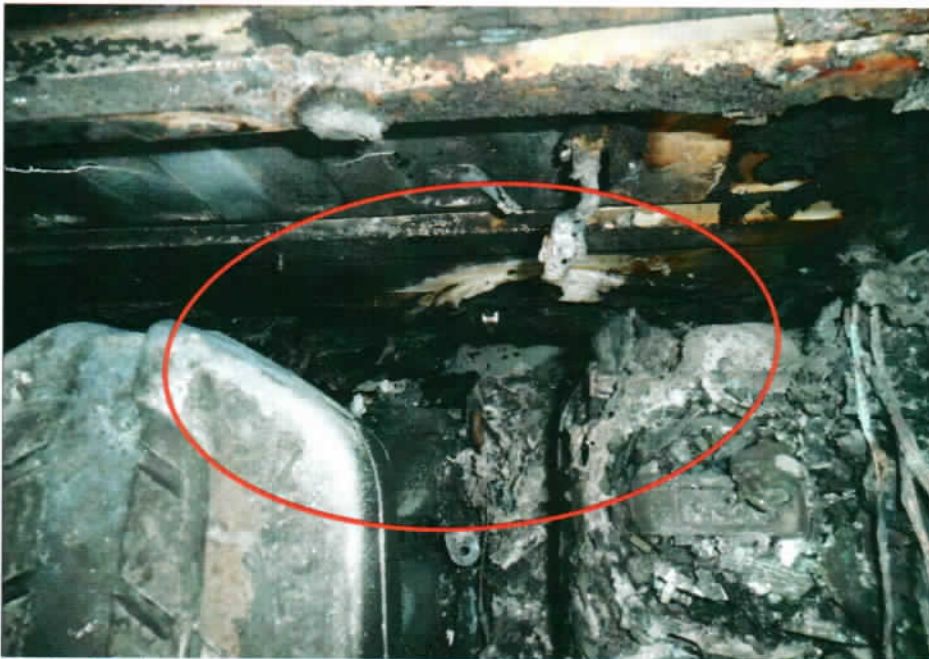
20. Upon closer examination of the engine compartment of the Insured Vehicle which was where the fire had started, we had found high heat intensity burn marks (whitish burn marks) and rust development. Traces of greenish residue and fluid were found on parts of the engine and on the ground at the time of inspection leading from the fuel hoses. The fuel hoses were original hoses fitting from manufacturer.

21. The presence of high heat intensity burn marks (whitish burn marks), greenish residue around the fuel hose area and strong fuel smell upon inspection of the Insured Vehicle would suggest that there was fuel leakage from the fuel hoses that came into contact with hot surface of the running engine compartments, which had caused the fire to be started and the fire spread around the engine compartment of the Insured Vehicle. The greenish residue around the area is normally unburned fuel additives left behind from the fuel leakage. This physical evidence would then appear to suggest that the cause of fire to the Insured Vehicle could have possibly been due to fluid contact onto hot surfaces. See photos 15 - 16 below.

Photo 15 shows the general view of the engine compartment portion of the Insured Vehicle where the fire had likely started. A broken fuel hose, greenish residue was found on the engine components and whitish burn marks due to high heat intensity burn was observed on the body panel of the Insured vehicle (circled)

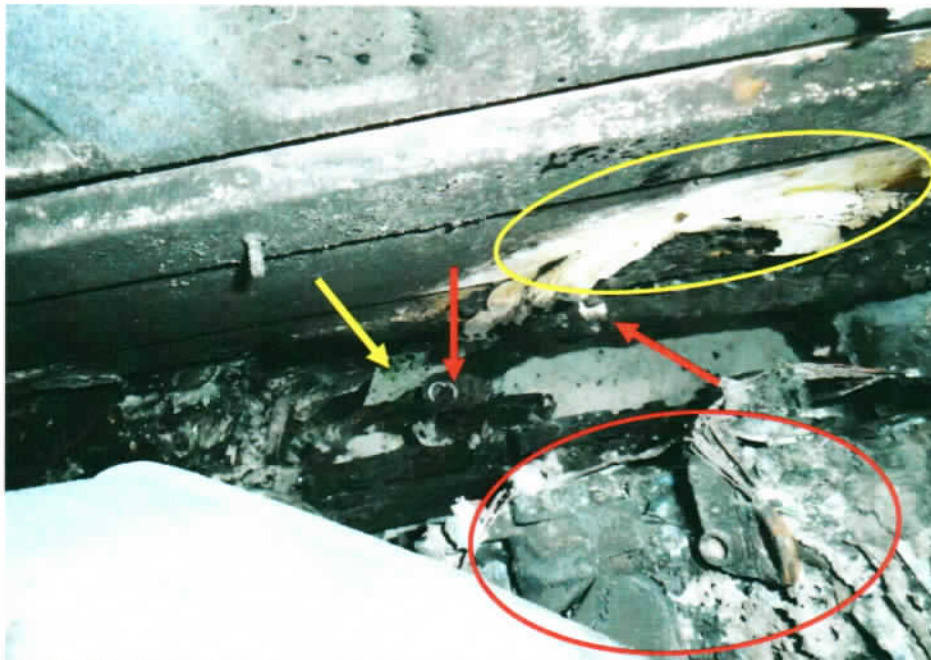
Photo 16 shows the close up view area where the fire had likely started and spread around the engine compartment. Observed was a broken fuel hose (red arrow) which caused a fuel leakage onto and around the hot surface of the running engine components which was likely the caused of fire and left over greenish fuel additives residue (red circle) around the area and on the floor (yellow arrow). The fire's high heat intensity burn had also resulted in (whitish burn marks) on the body panel (yellow circle) of the Insured Vehicle.

26. Since engine overheating and electrical in nature were both unlikely the cause of fire, the most probable cause would then be the leakage of fluid, which was also what we had observed between the broken fuel hose and the running hot surface of the engine components that may cause a fire to be ignited on Insured Vehicle. The leaked fluid comes into contact with hot surfaces; such the heated engine components would possibly have been at a sufficient temperature that could result in leaked fluid to self-ignite and started burning of materials in the engine compartments of the Insured Vehicle which had caused the fire at the engine of the Insured Vehicle.

28. Having investigated and technically analysed the damages of burnt nature to the Insured Vehicle, we are of the view that the cause of fire to the Insured Vehicle was of leakage of fluid which contacted on to hot surface that caused the self-ignition of fire. For this particular case, the fire had originated from the engine compartment area between the broken fuel hose and the engine components, somewhere around the engine's middle portion of the Insured Vehicle.
29. We did not find any evidence which had suggested that the cause of fire to the Insured Vehicle was due to poor maintenance and/or recurring electrical problem.

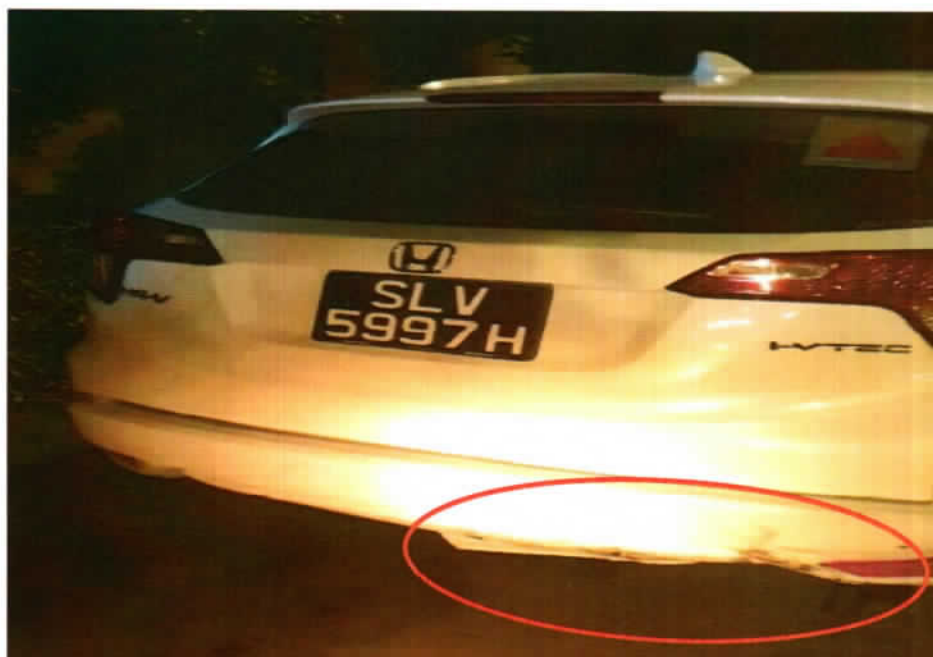
Photo 17 shows collision damage at the rear right bumper on the third party vehicle, which is consistent to the damage sustained on the front left portion of Mr. Brendan's Insured Vehicle.

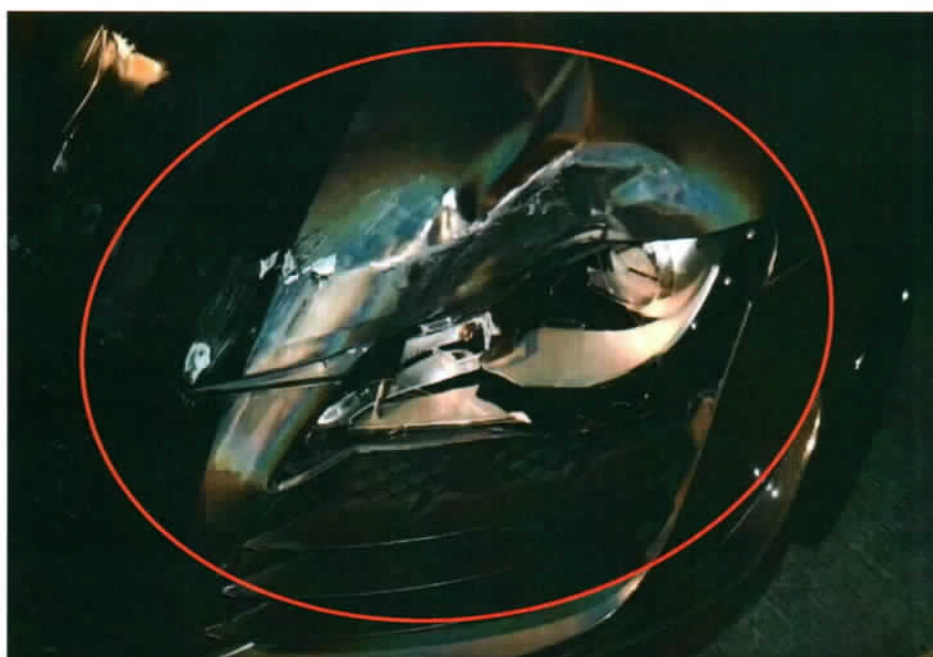
Photo 18 shows collision damage at the front left portion (circled) on the Insured Vehicle, which is consistent to the damage sustained on the rear right portion of the third party vehicle.

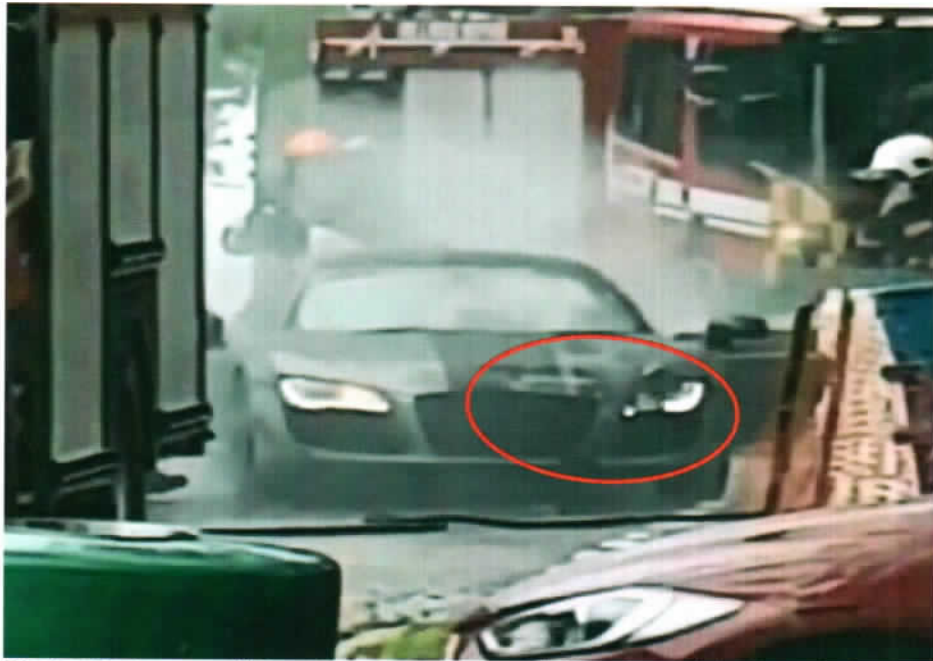
Photo 19 shows collision damage at the front left portion (circled) on the Insured Vehicle at the fire scene, which is consistent to the damage sustained on the rear right portion of the third party vehicle. In general, the information that could be gathered from this photograph had corresponded to the events that were related to us by Mr Brendan.

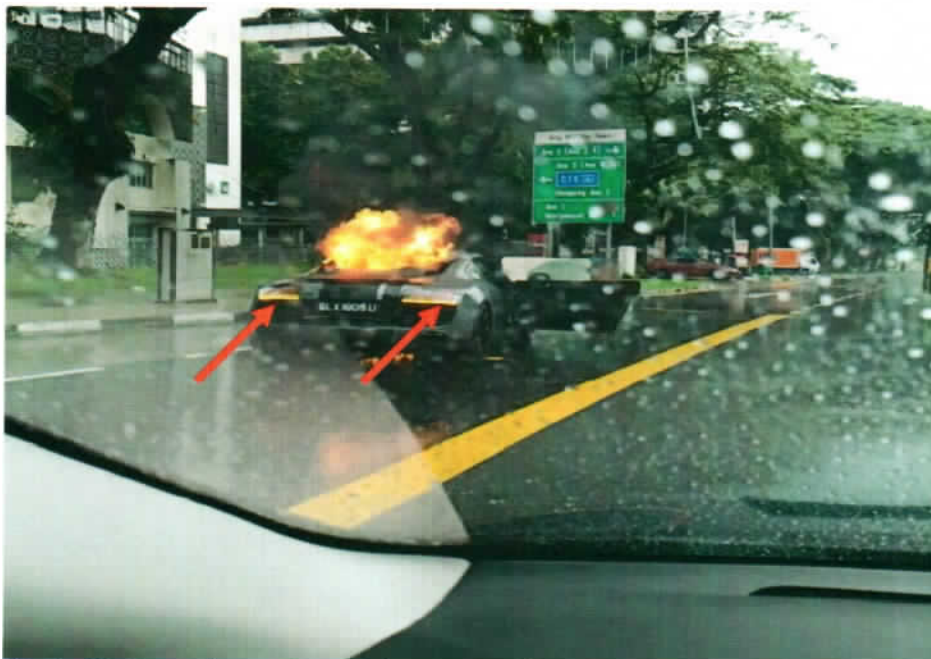
Photo 20 shows the smoke and flames engulfing the middle engine compartment of the Insured Vehicle before the arrival of the SCDF. From the photograph, it was also observed that the signal lights (arrowed) were still lighted up during the fire.

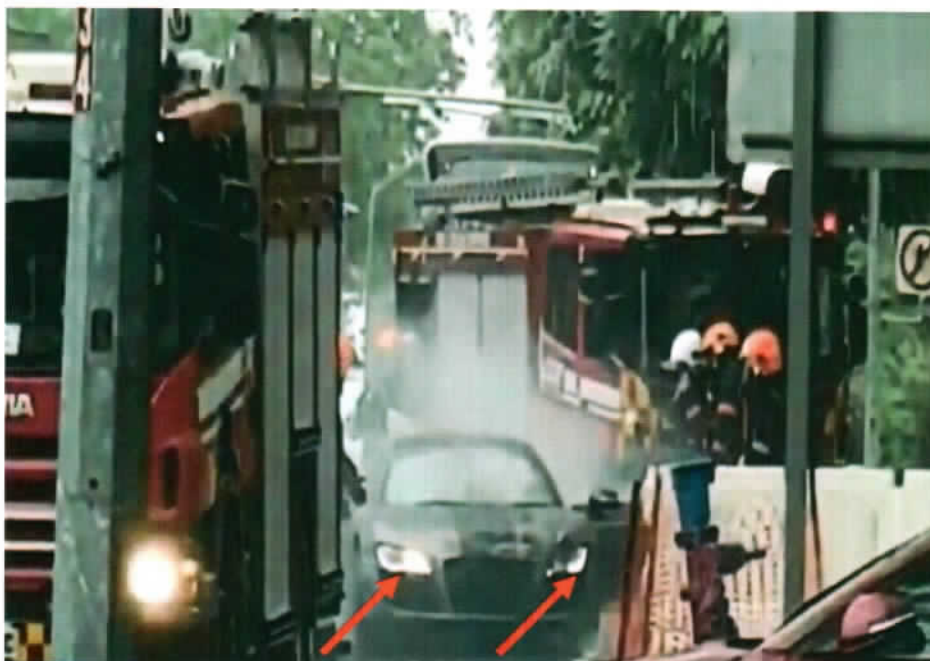
Photo 21 shows the Insured Vehicle at the incident location after the fire was extinguished by SCDF personnel. Firefighters can be seen to be extinguishing the fire and inspecting the extent of damage. The day lights (arrowed) were still lighted up after the fire was extinguished.

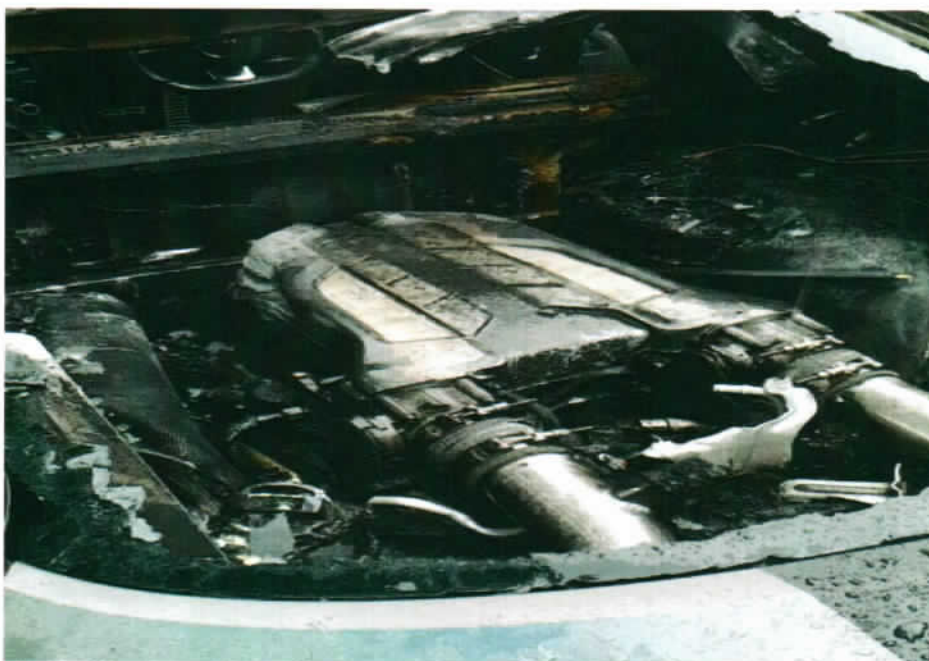
Photo 22 shows the engine compartment of the Insured Vehicle at the incident location after the fire was extinguished by SCDF personnel. In general, the information that could be gathered from this photograph had corresponded to the events that were related to us by Mr Brendan, location when the fire broke out.
