## LKK Auto Consultants Pte Ltd

### 1. Policy Particulars :- THIRD PARTY CLAIM

### ADJUSTMENT ON REPAIR COST FOR VEHICLE NO. SMM 1497X

PHOTOGRAPHS FOR VEHICLE NO. SMM 1497X

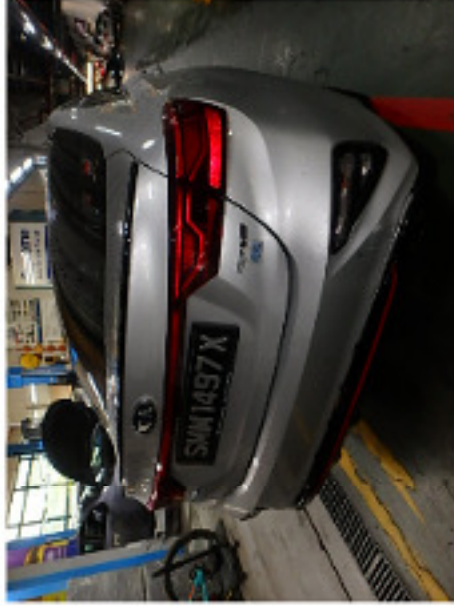
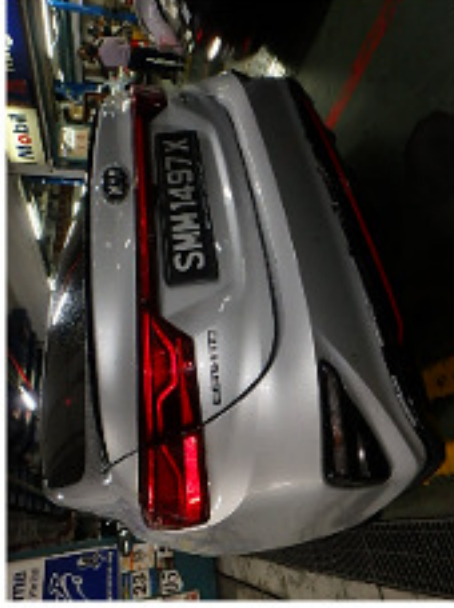
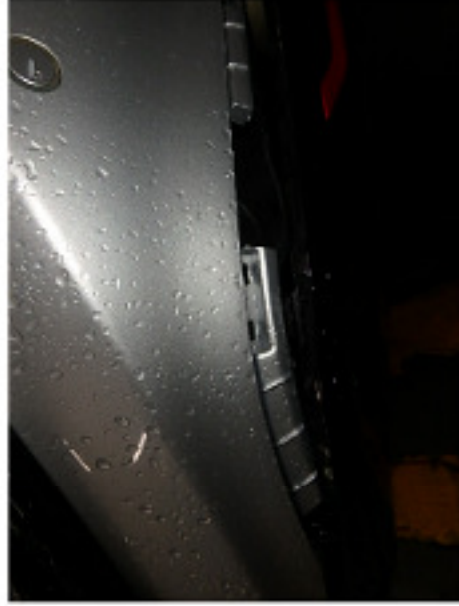
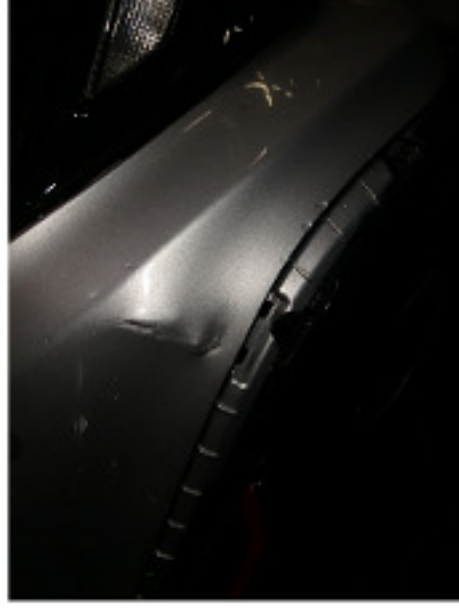
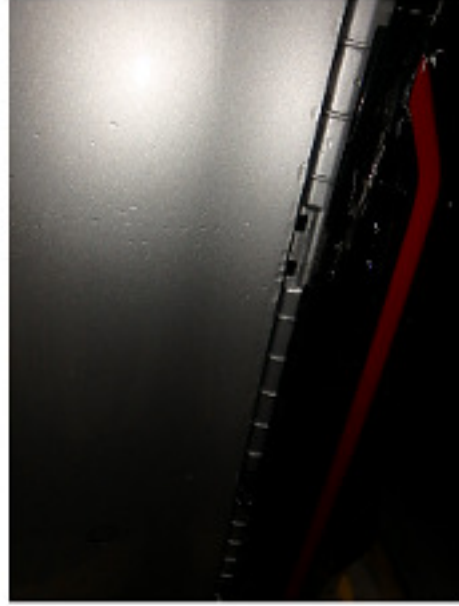
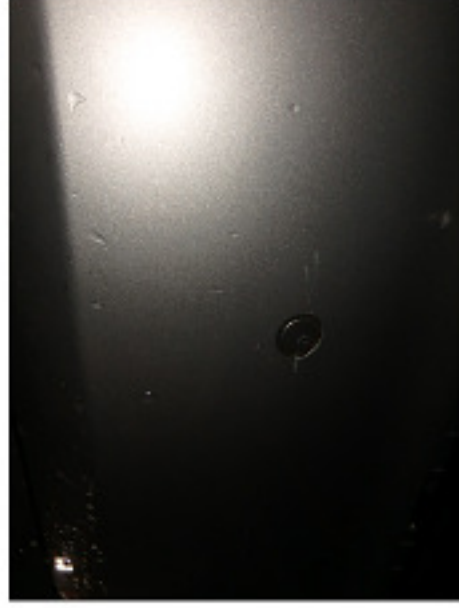
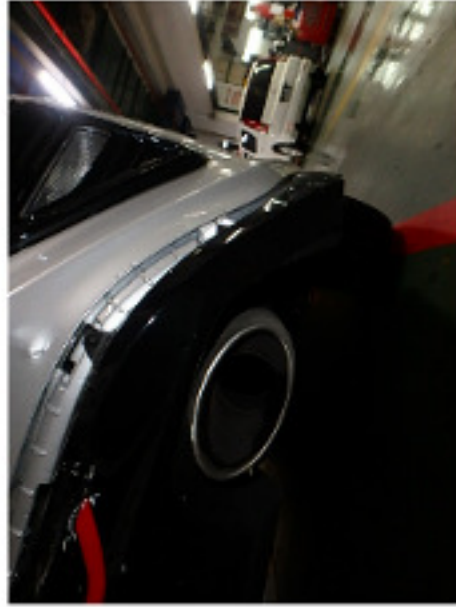
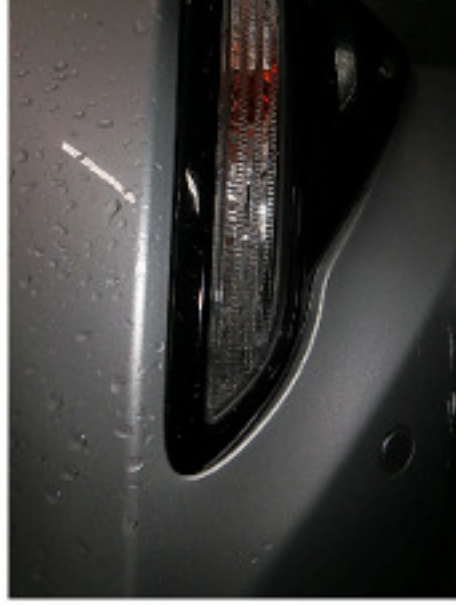
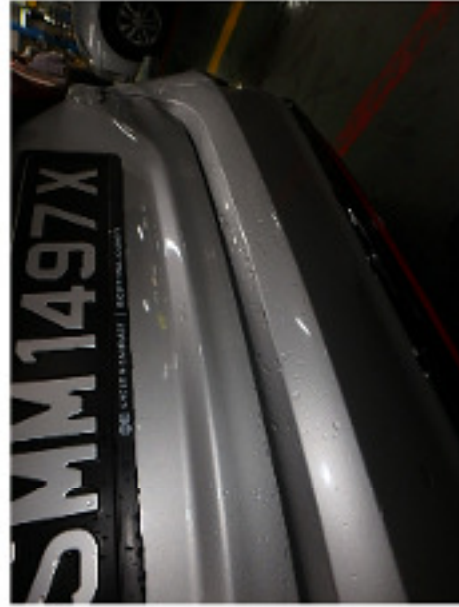
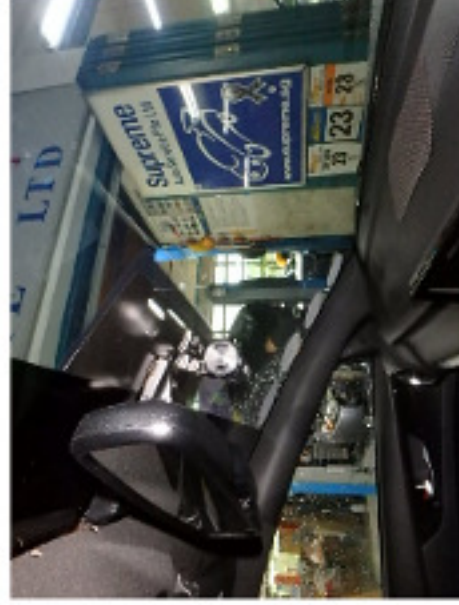
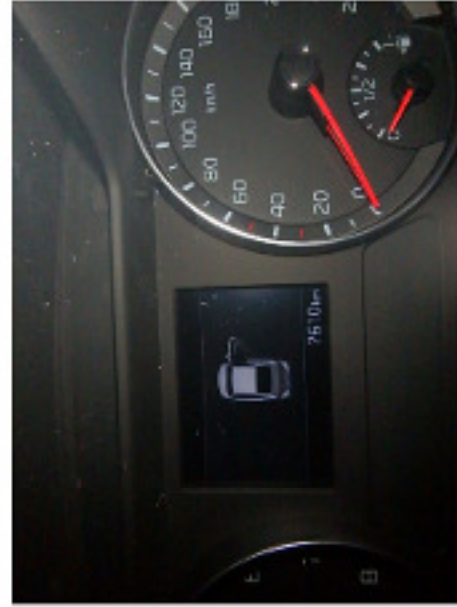
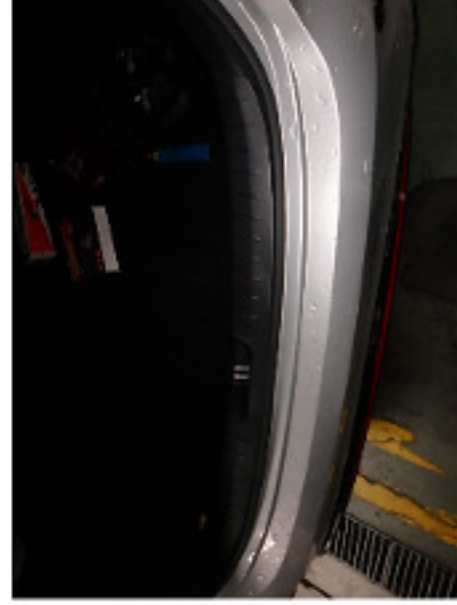
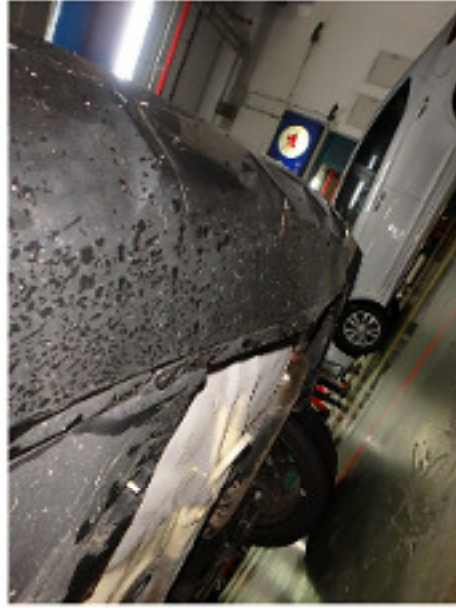
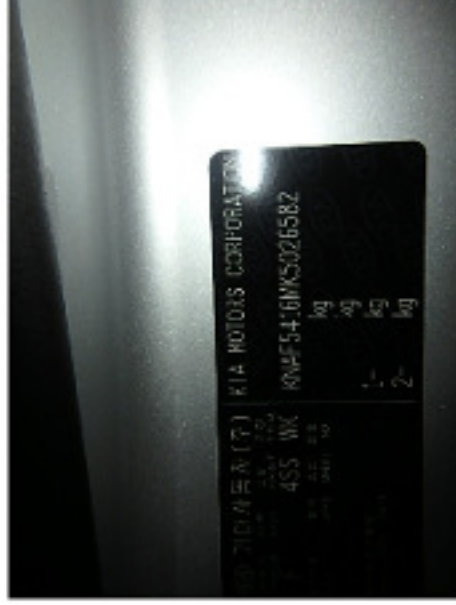
INSPECTION

THE VEHICLE SUSTAINED DAMAGES AT THE REAR PORTION. DAMAGES SEE DETAILS.
--
