Your Ref : D19007774M/CT/RW/OD  
Our Ref : CS/FC19021814/N

13 December 2019

**TECHNICAL INVESTIGATION REPORT OF FIRE INCIDENT INVOLVING THE INSURED VEHICLE SHA 3438B ON 6 DECEMBER 2019**

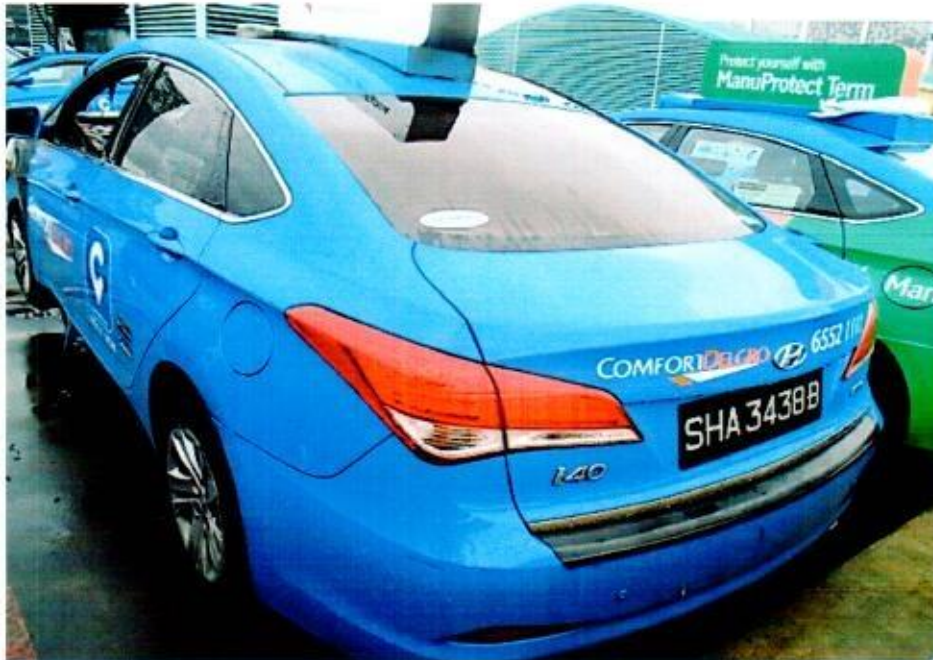
**Photo 1** shows the general view of the rear portion of the Insured Vehicle at the time of our inspection. The rear portion of the Insured Vehicle was relatively unaffected by the fire.

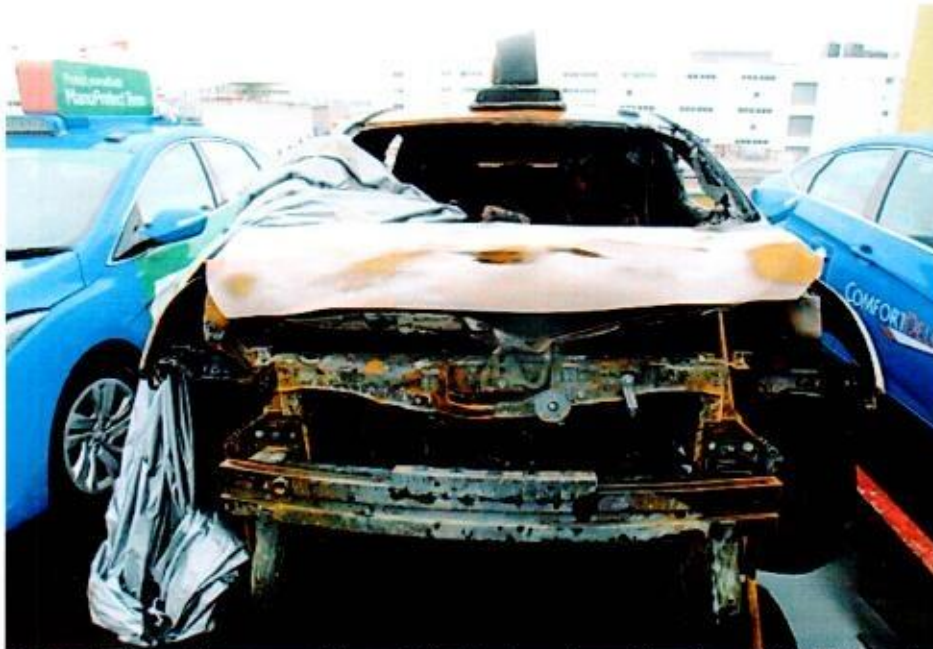
**Photo 2** shows the general view of the front portion of the Insured Vehicle at the time of our inspection. The fire damage to the Insured Vehicle was confined to its front portion. Its front bumper, front bonnet, front support panel, front grille, front headlamps, front windscreen, front rims and front tyres were amongst the body parts that were found to have been affected as a result of the fire.

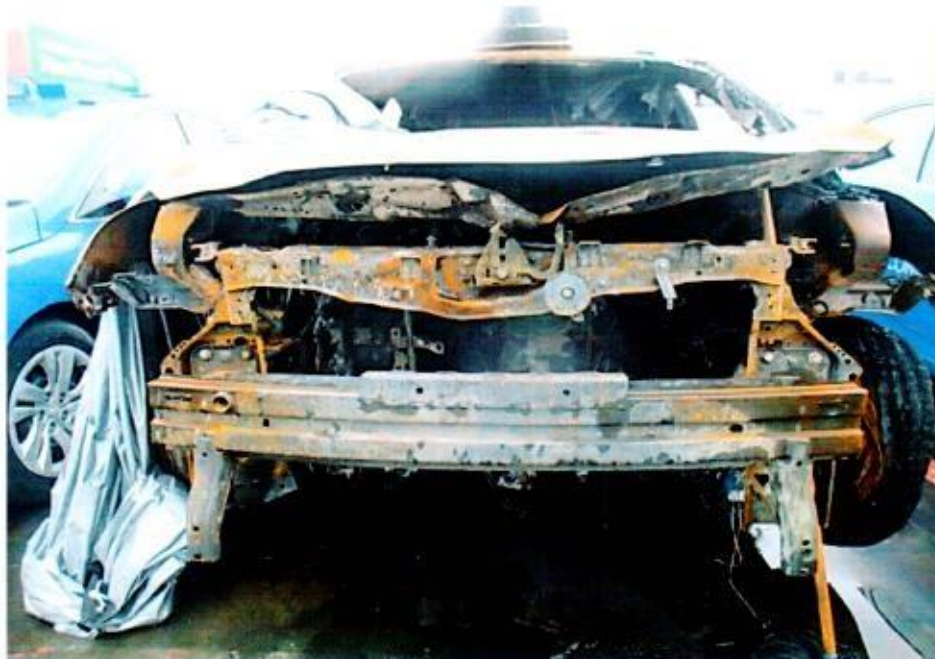
**Photo 3** shows the closer view of the front portion of the Insured Vehicle at the time of our inspection. The fire damage to the Insured Vehicle was confined to its front portion. Its front bumper, front bonnet, front support panel, front tyres and front headlamps were amongst the body parts that were found to have been affected by the fire.

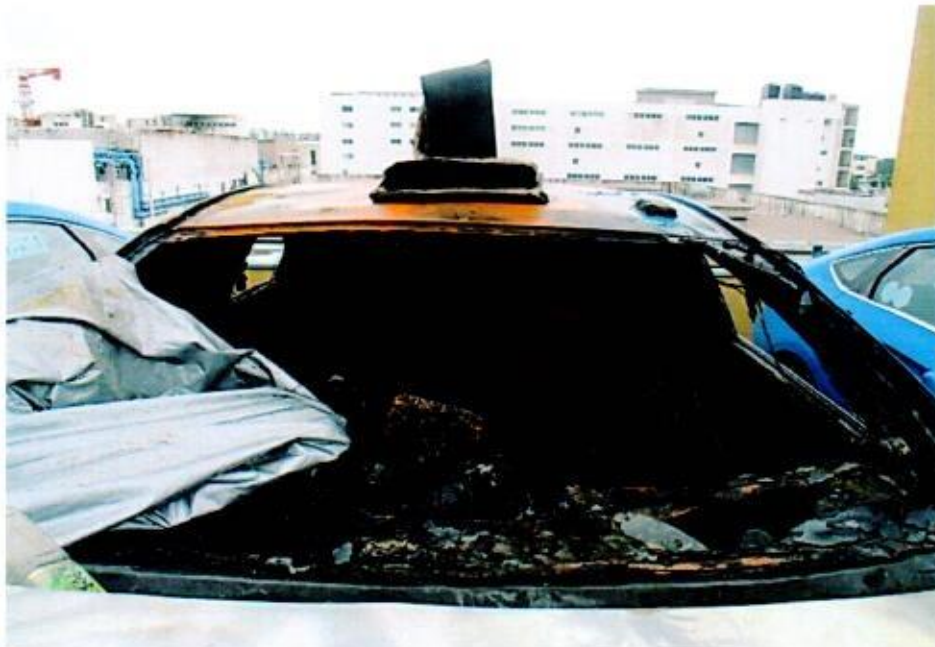
**Photo 4** shows the general view of the front windscreen of the Insured Vehicle at the time of our inspection. The fire damage to the windscreen was extensive.

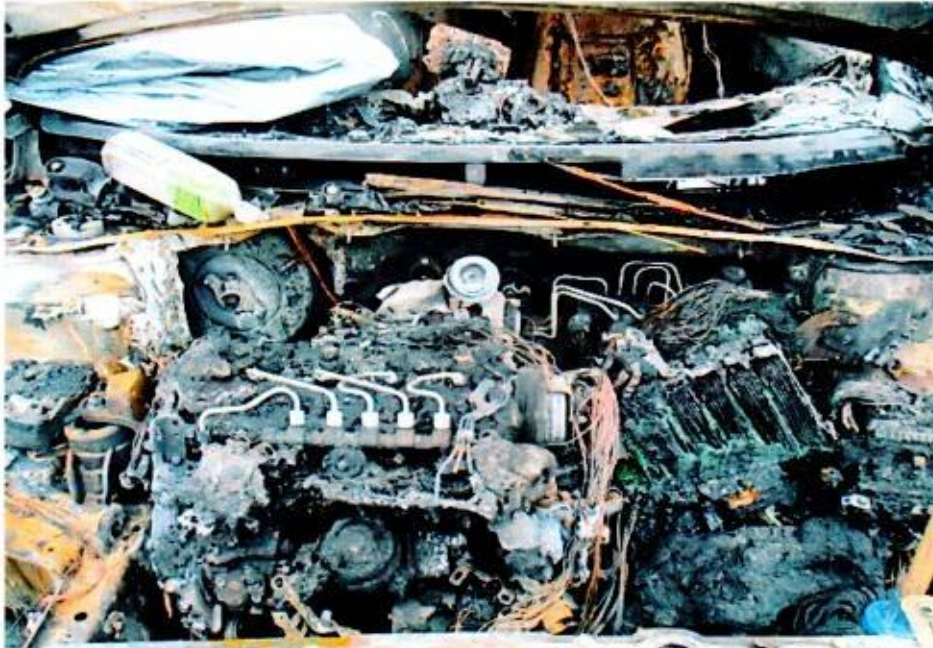
**Photo 5** shows the engine compartment of the Insured Vehicle at the time of our inspection. The entire engine compartment of the Insured Vehicle was observed to be severely burnt. Most of the parts inside the engine compartment were found to be burnt and/or melted as a result of the fire.

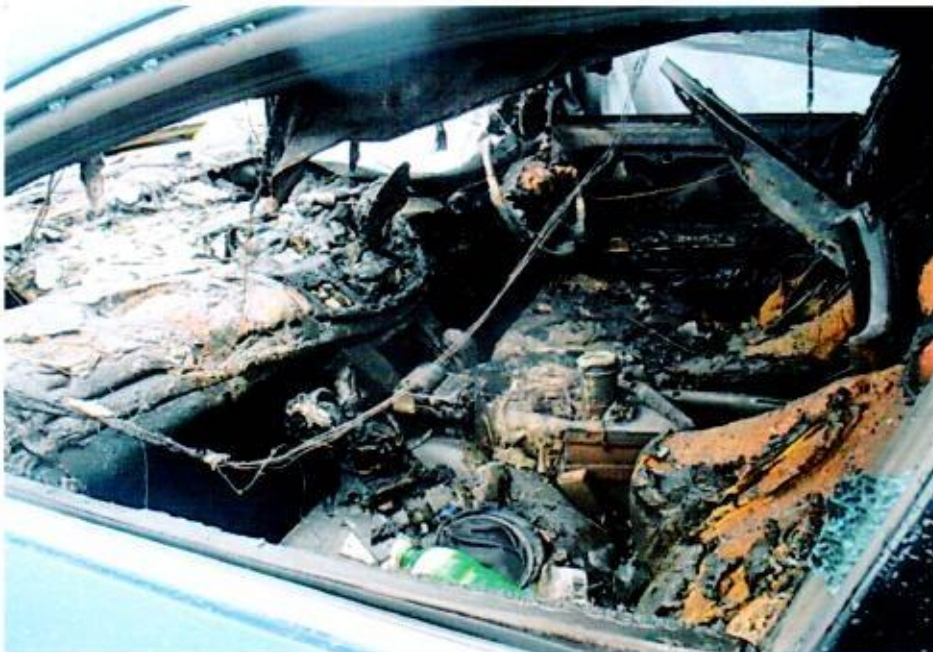
**Photo 6** shows the interior compartment of the Insured Vehicle, which was significantly affected by the fire.

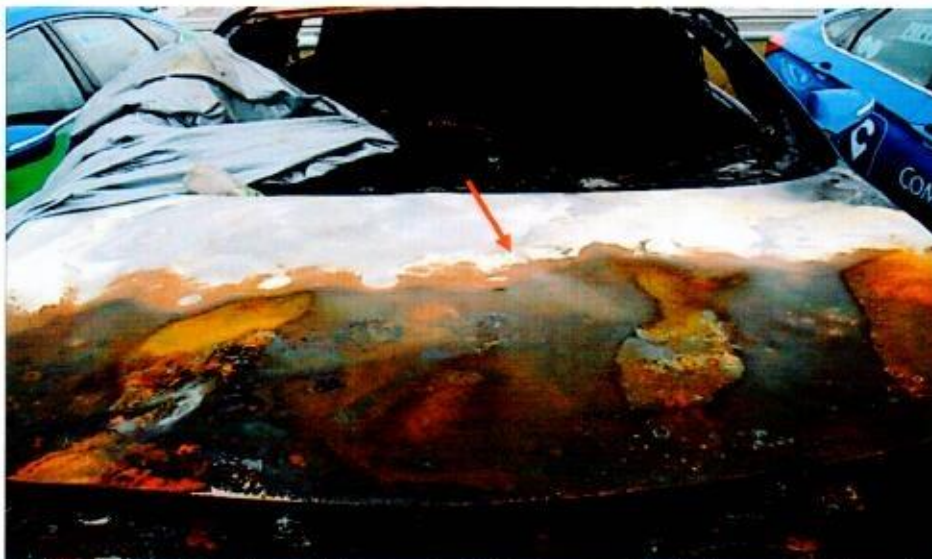
7. For this particular case, the fire appears to have originated within the engine compartment of the Insured Vehicle, somewhere around the centre rear portion of the engine compartment. This can be determined from the burn pattern and the high heat intensity burn marks (whitish burn marks) found on the rear portion of the front bonnet of the Insured Vehicle and also the rust that had developed on the underside of the front bonnet, at the bottom centre portion.

8. The whitish burn marks are a result of exposure to prolonged heat intensity. Rust would normally start to develop around these areas soon after a fire as prolonged exposure to high heat intensity usually causes steel/metal material body parts to be exposed to natural environmental condition. The rust that had developed on the underside of the front bonnet, around the bottom centre portion, is an indication that the centre portion of the engine compartment had sustained exposure to prolonged high heat intensity. See photos 7 & 8 below.

**Photo 7** shows the burn pattern and whitish burn marks that were found on the rear portion of the front bonnet of the Insured Vehicle (arrowed). Such whitish burn marks are a result of exposure to prolonged heat intensity, which may indicate where the fire had started. Rust would also begin to develop on these areas soon after the fire.

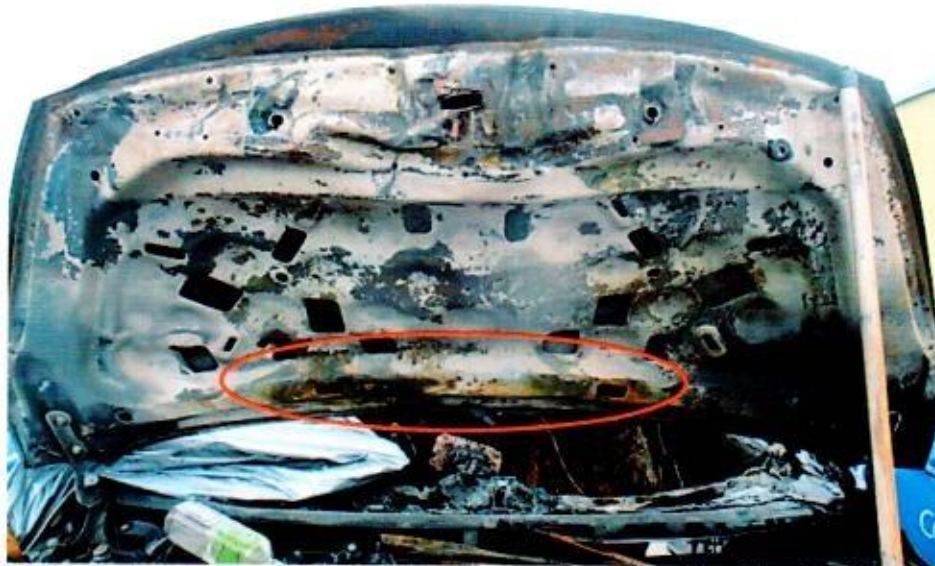
**Photo 8** shows the rust that had developed on the underside of the front bonnet, around the bottom centre portion (circled). The development of rust is an indication that this area was subjected to prolonged exposure to high heat intensity, which had caused the steel/metal material of the front bonnet to be exposed to natural environmental condition. Hence the fire to the Insured Vehicle can be determined to have originated towards the centre rear portion of the engine compartment.

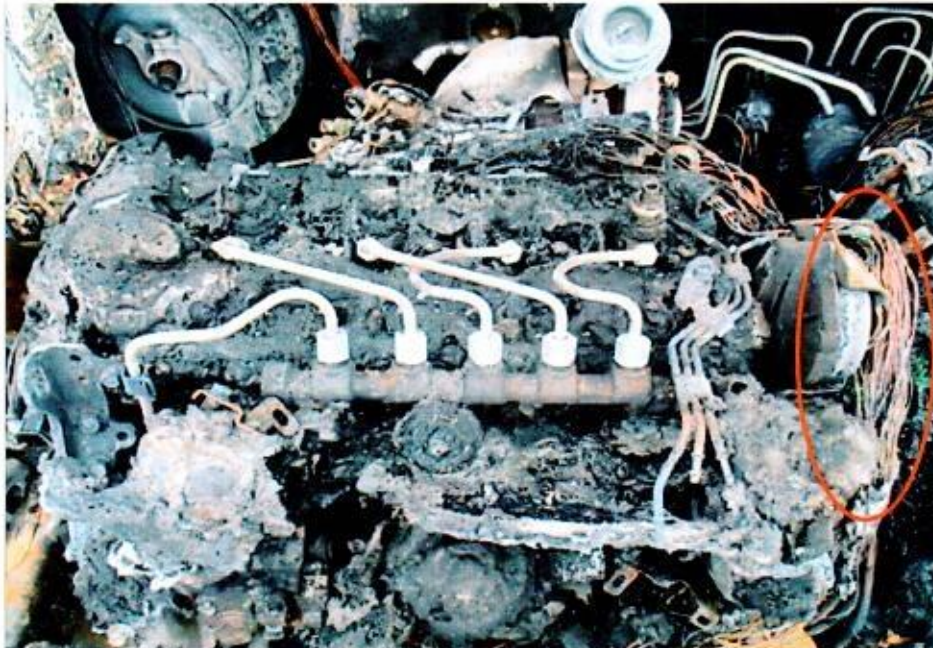
9. Upon closer examination of the centre rear portion of the engine compartment, which was where the fire to the Insured Vehicle had likely started, we had found greenish residue on several burnt stretches of original factory fitted wirings around the centre right portion of the engine compartment. The presence of such greenish residue indicates internal heating of copper wires, a sign of an electrical short circuit occurring. The greenish residue is normally left behind from oxidation as a result of chemical reaction involving the copper wires. This physical evidence would then appear to suggest that the cause of fire to the Insured Vehicle could have possibly been due to electrical in nature. See photos 9 - 12 below.

**Photo 9** shows the original factory fitted wirings around the centre right portion of the engine compartment, which is in the immediate vicinity where the fire to the Insured Vehicle had likely started. We had found greenish residue on several burnt stretches of these wirings (circled). The presence of such greenish residue indicates internal heating of copper wires, a sign of an electrical short circuit occurring. The greenish residue is normally left behind from oxidation as a result of chemical reaction involving the copper wires.

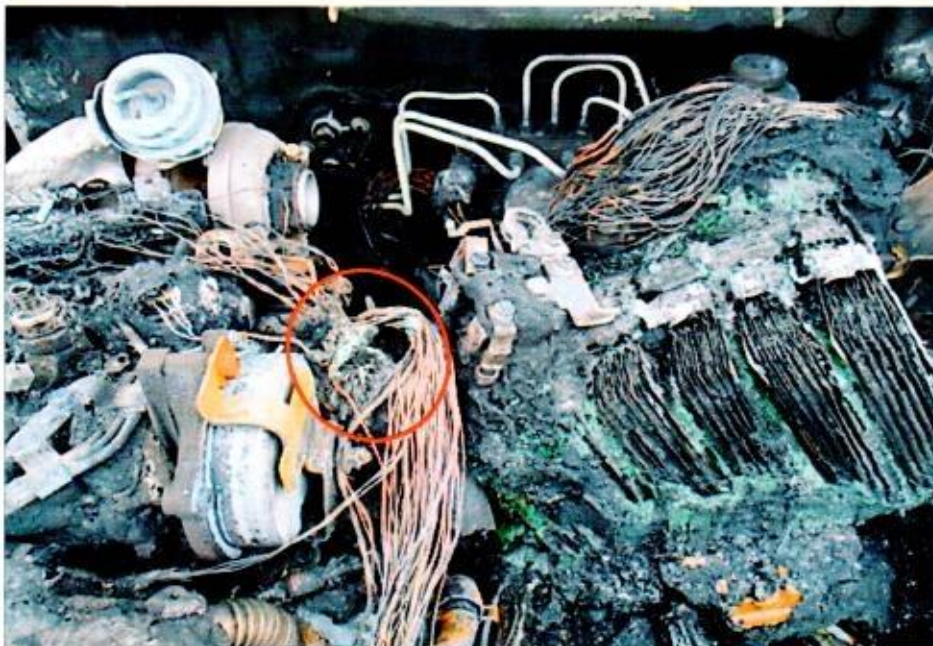
**Photo 10** shows a closer view of the greenish residue found on some of the burnt stretches of original factory fitted wirings (arrowed). The presence of such greenish residue suggests occurrence of an electrical short circuit.

26. Having investigated and technically analysed the damages of burnt nature to the Insured Vehicle, we are of the view that the cause of fire to the Insured Vehicle was of electrical in nature. For this particular case, the fire had originated along the original factory fitted wirings inside the engine compartment, somewhere around the centre portion of the engine compartment.

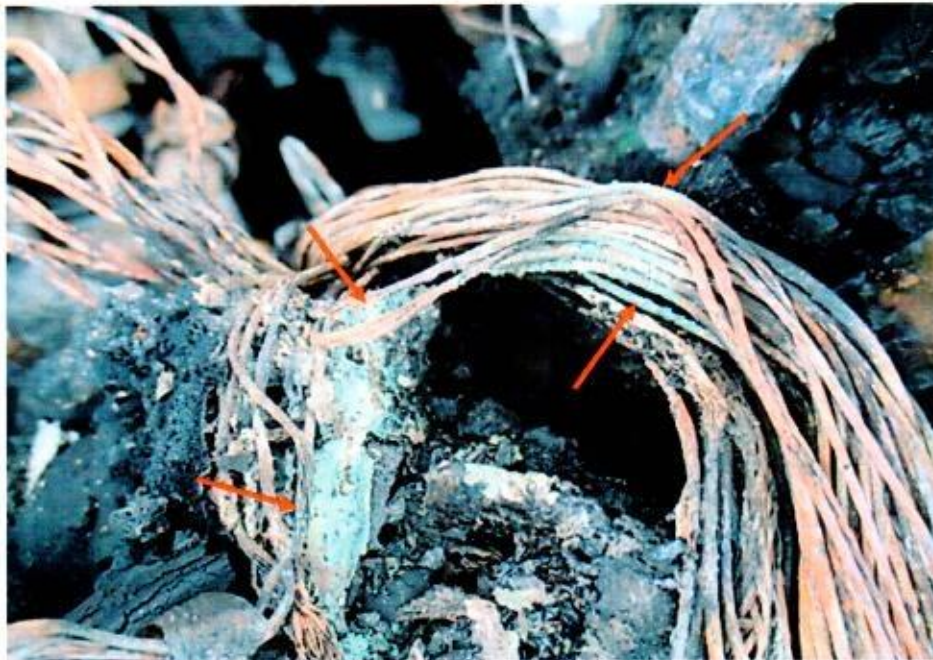
**Photo 11** shows a close up view of the greenish residue found on some of the burnt stretches of original factory fitted wirings (arrowed). The presence of such greenish residue suggests occurrence of an electrical short circuit.

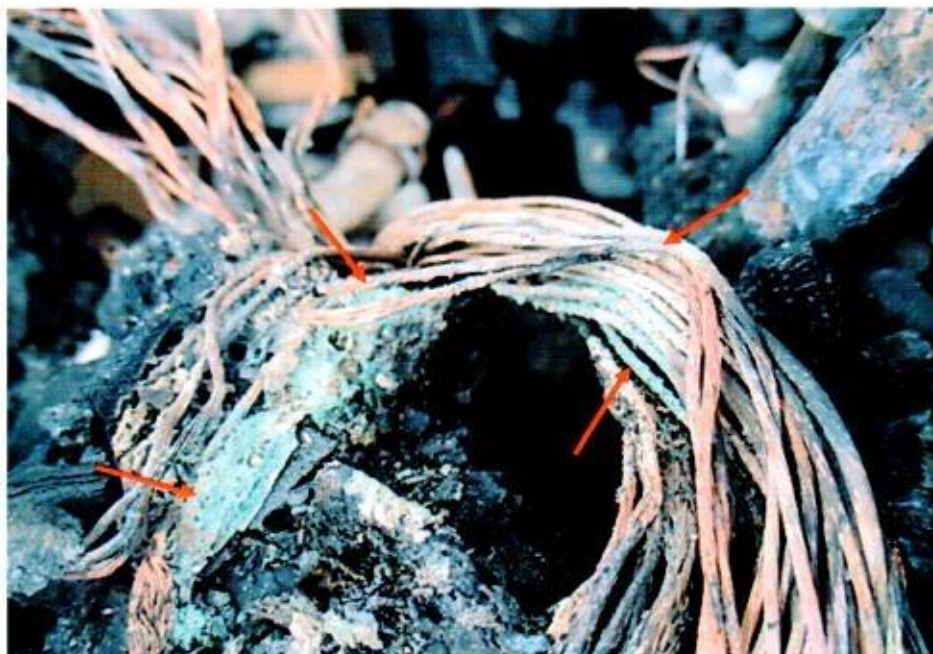
**Photo 12** shows a close up view of the greenish residue found on some of the burnt stretches of original factory fitted wirings (arrowed). The presence of such greenish residue suggests occurrence of an electrical short circuit.

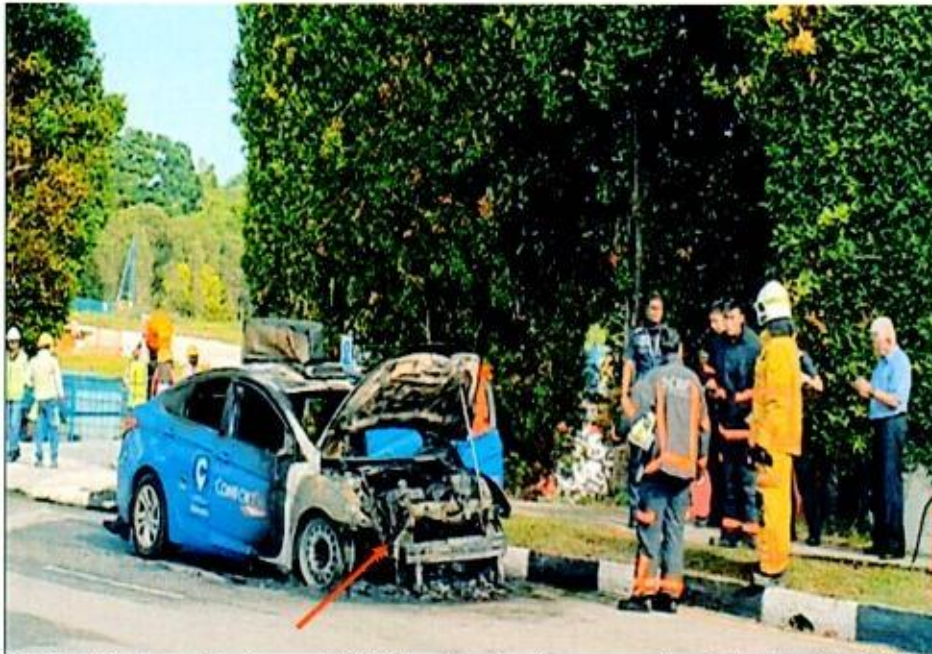
17. We were able to obtain a photograph of the Insured Vehicle which was taken after the fire had been extinguished. In general, the information that could be gathered from this photograph had corresponded to the events that were related to us by Mr Ho. Our close examination of this photograph also showed no unusual foreign material(s) and/or object(s) found on the ground in the immediate area of the road where the Insured Vehicle was positioned. See photo 13 below.

**Photo 13** shows the Insured Vehicle after the fire was extinguished by the SCDF. In general, the information that could be gathered from this photograph had corresponded to the events that were related to us by Mr Ho, which is the fire had started from the engine compartment (arrowed).
