Your Ref : D19007774M/CT/RW/OD
Our Ref : CS/FCI19021814/N

13 December 2019

**TECHNICAL INVESTIGATION REPORT OF FIRE INCIDENT INVOLVING THE
INSURED VEHICLE SHA 3438B ON 6 DECEMBER 2019**

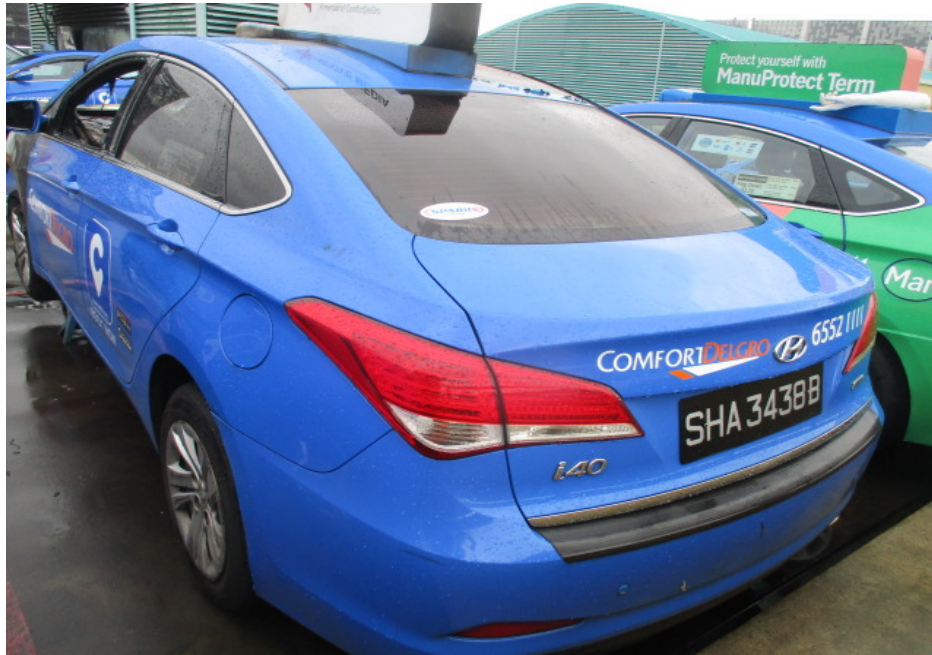
Photo 1 shows the general view of the rear portion of the Insured Vehicle at the time of our inspection. The rear portion of the Insured Vehicle was relatively unaffected by the fire.

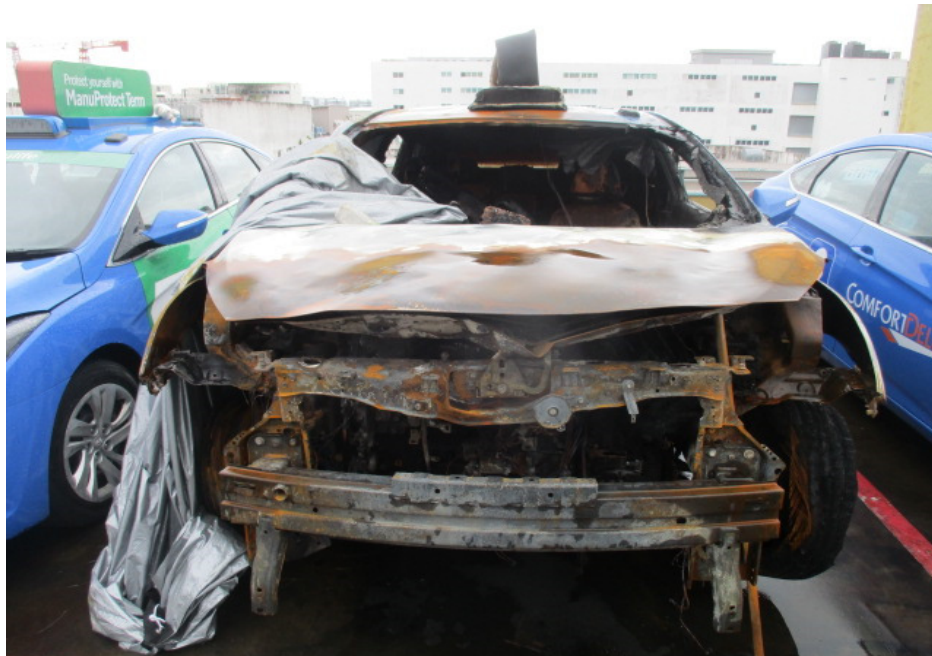
Photo 2 shows the general view of the front portion of the Insured Vehicle at the time of our inspection. The fire damage to the Insured Vehicle was confined to its front portion. Its front bumper, front bonnet, front support panel, front grille, front headlamps, front windscreen, front rims and front tyres were amongst the body parts that were found to have been affected as a result of the fire.

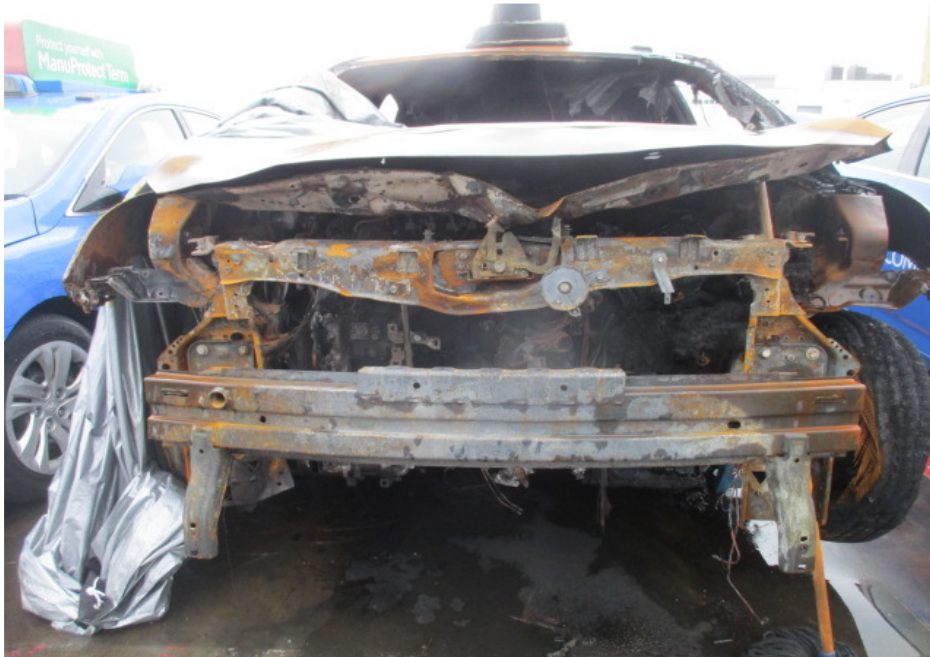
Photo 3 shows the closer view of the front portion of the Insured Vehicle at the time of our inspection. The fire damage to the Insured Vehicle was confined to its front portion. Its front bumper, front bonnet, front support panel, front tyres and front headlamps were amongst the body parts that were found to have been affected by the fire.

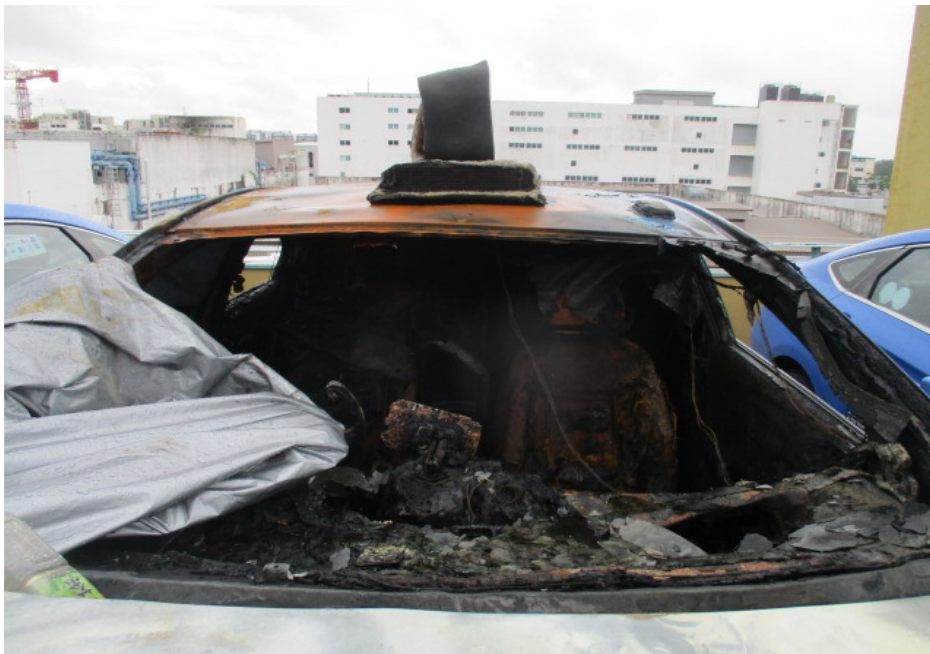
Photo 4 shows the general view of the front windscreen of the Insured Vehicle at the time of our inspection. The fire damage to the windscreen was extensive.

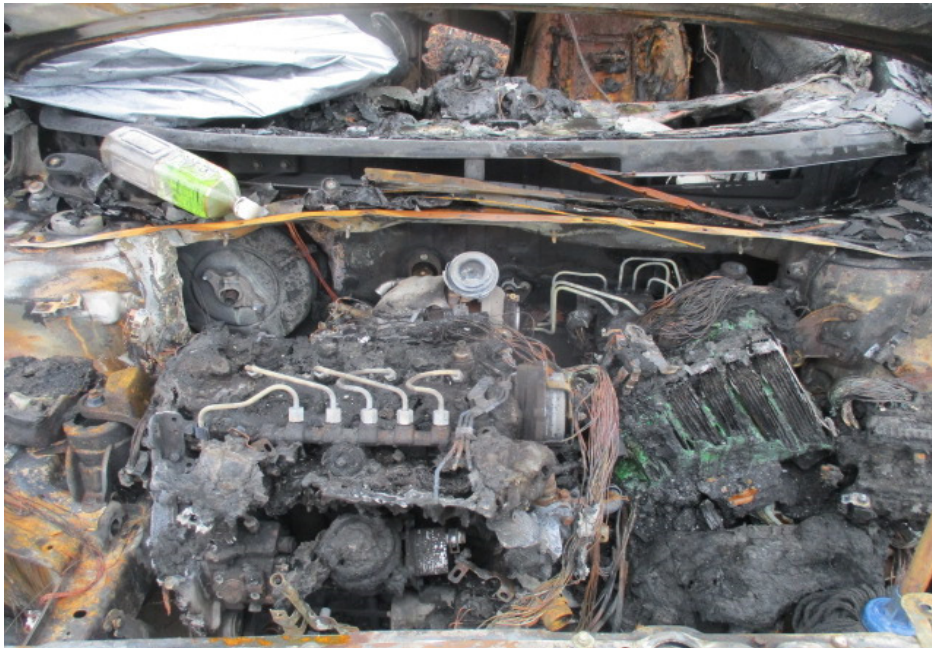
Photo 5 shows the engine compartment of the Insured Vehicle at the time of our inspection. The entire engine compartment of the Insured Vehicle was observed to be severely burnt. Most of the parts inside the engine compartment were found to be burnt and/or melted as a result of the fire.

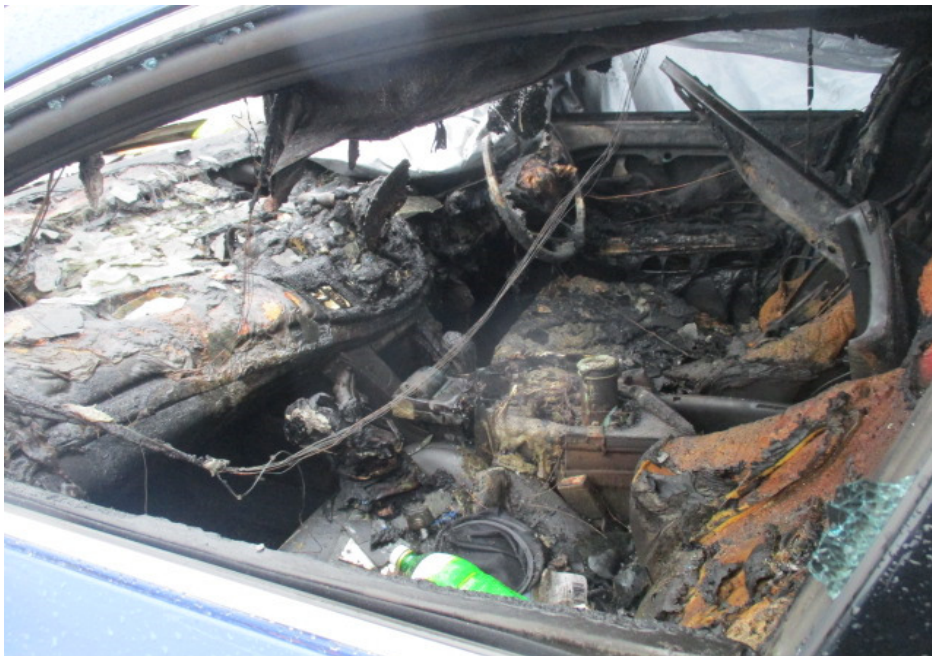
Photo 6 shows the interior compartment of the Insured Vehicle, which was significantly affected by the fire.

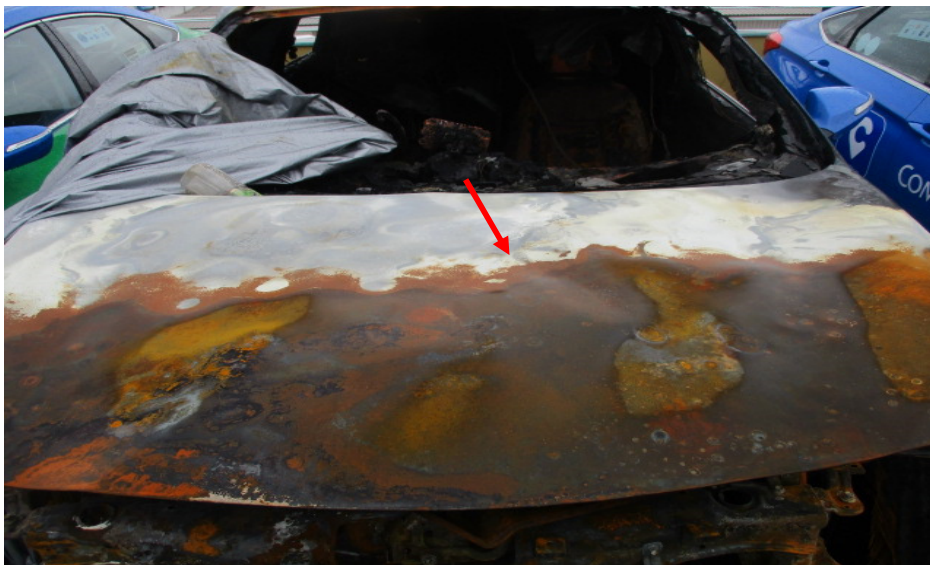
7. For this particular case, the fire appears to have originated within the engine compartment of the Insured Vehicle, somewhere around the centre rear portion of the engine compartment. This can be determined from the burn pattern and the high heat intensity burn marks (whitish burn marks) found on the rear portion of the front bonnet of the Insured Vehicle and also the rust that had developed on the underside of the front bonnet, at the bottom centre portion.

8. The whitish burn marks are a result of exposure to prolonged heat intensity. Rust would normally start to develop around these areas soon after a fire as prolonged exposure to high heat intensity usually causes steel/metal material body parts to be exposed to natural environmental condition. The rust that had developed on the underside of the front bonnet, around the bottom centre portion, is an indication that the centre portion of the engine compartment had sustained exposure to prolonged high heat intensity. See photos 7 & 8 below.

Photo 7 shows the burn pattern and whitish burn marks that were found on the rear portion of the front bonnet of the Insured Vehicle (arrowed). Such whitish burn marks are a result of exposure to prolonged heat intensity, which may indicate where the fire had started. Rust would also begin to develop on these areas soon after the fire.

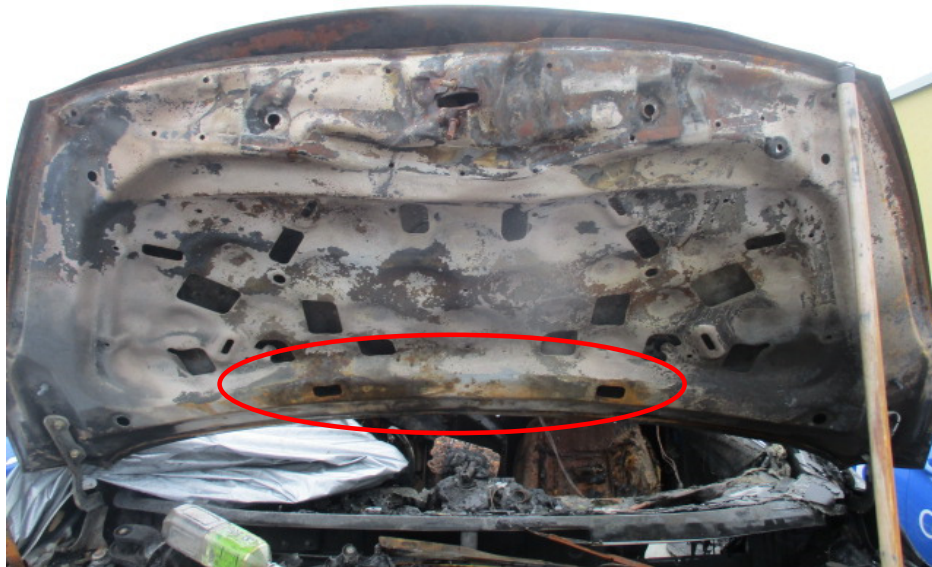
Photo 8 shows the rust that had developed on the underside of the front bonnet, around the bottom centre portion (circled). The development of rust is an indication that this area was subjected to prolonged exposure to high heat intensity, which had caused the steel/metal material of the front bonnet to be exposed to natural environmental condition. Hence the fire to the Insured Vehicle can be determined to have originated towards the centre rear portion of the engine compartment.

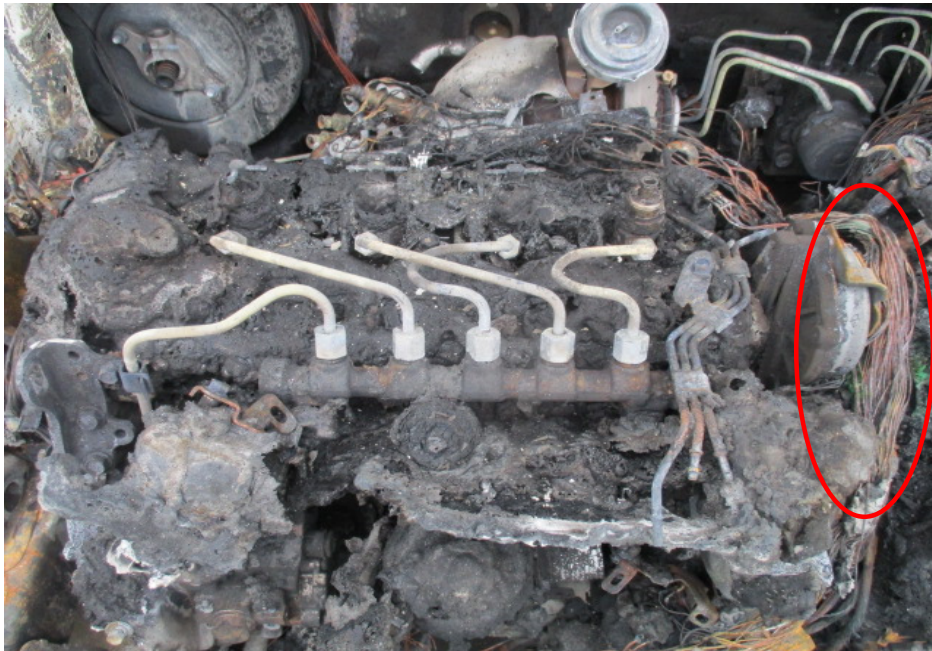
9. Upon closer examination of the centre rear portion of the engine compartment, which was where the fire to the Insured Vehicle had likely started, we had found greenish residue on several burnt stretches of original factory fitted wirings around the centre right portion of the engine compartment. The presence of such greenish residue indicates internal heating of copper wires, a sign of an electrical short circuit occurring. The greenish residue is normally left behind from oxidation as a result of chemical reaction involving the copper wires. This physical evidence would then appear to suggest that the cause of fire to the Insured Vehicle could have possibly been due to electrical in nature. See photos 9 - 12 below.

Photo 9 shows the original factory fitted wirings around the centre right portion of the engine compartment, which is in the immediate vicinity where the fire to the Insured Vehicle had likely started. We had found greenish residue on several burnt stretches of these wirings (circled). The presence of such greenish residue indicates internal heating of copper wires, a sign of an electrical short circuit occurring. The greenish residue is normally left behind from oxidation as a result of chemical reaction involving the copper wires.

24. The possibility of the fire being due to electrical in nature would then seem more likely given that engine overheating and external factors would both seem unlikely. The fire being due to electrical nature is also supported by the condition of the wirings that were found in the engine compartment of the Insured Vehicle, which was earlier discussed in paragraph 9 above.

26. Having investigated and technically analysed the damages of burnt nature to the Insured Vehicle, we are of the view that the cause of fire to the Insured Vehicle was of electrical in nature. For this particular case, the fire had originated along the original factory fitted wirings inside the engine compartment, somewhere around the centre portion of the engine compartment.

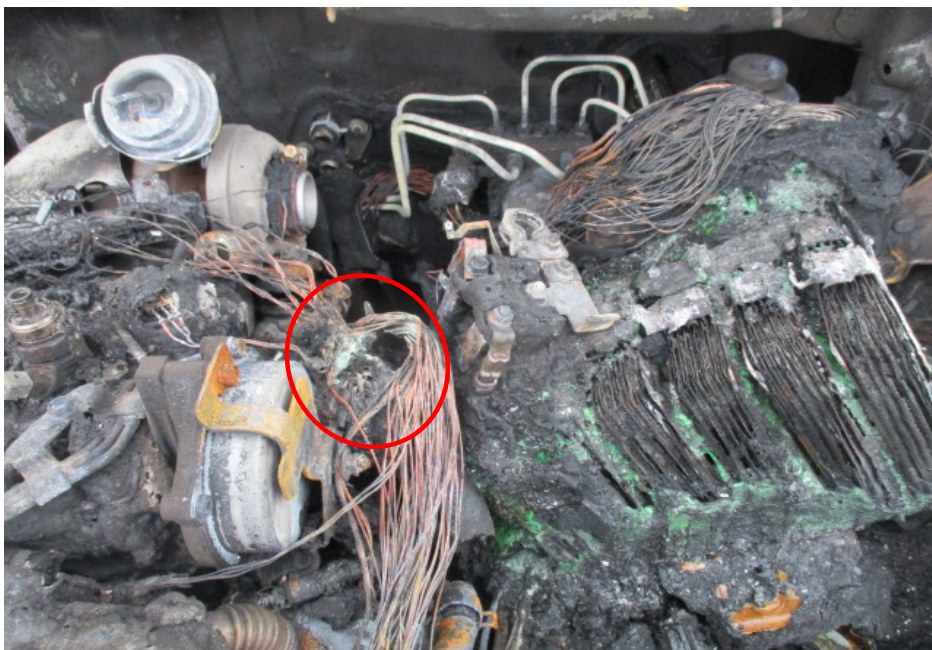
Photo 10 shows a closer view of the greenish residue found on some of the burnt stretches of original factory fitted wirings (arrowed). The presence of such greenish residue suggests occurrence of an electrical short circuit.

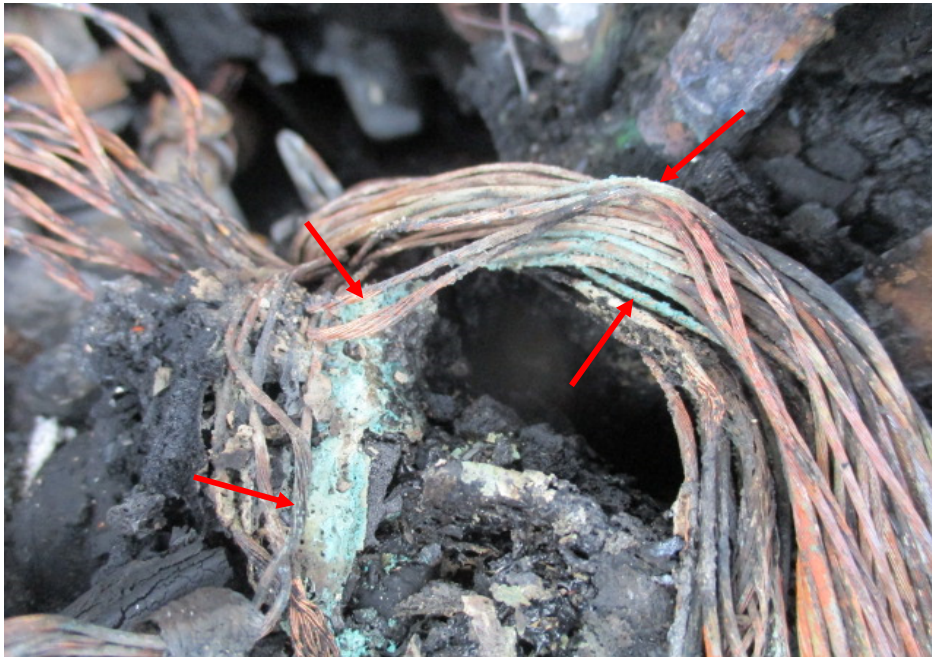
Photo 11 shows a close up view of the greenish residue found on some of the burnt stretches of original factory fitted wirings (arrowed). The presence of such greenish residue suggests occurrence of an electrical short circuit.

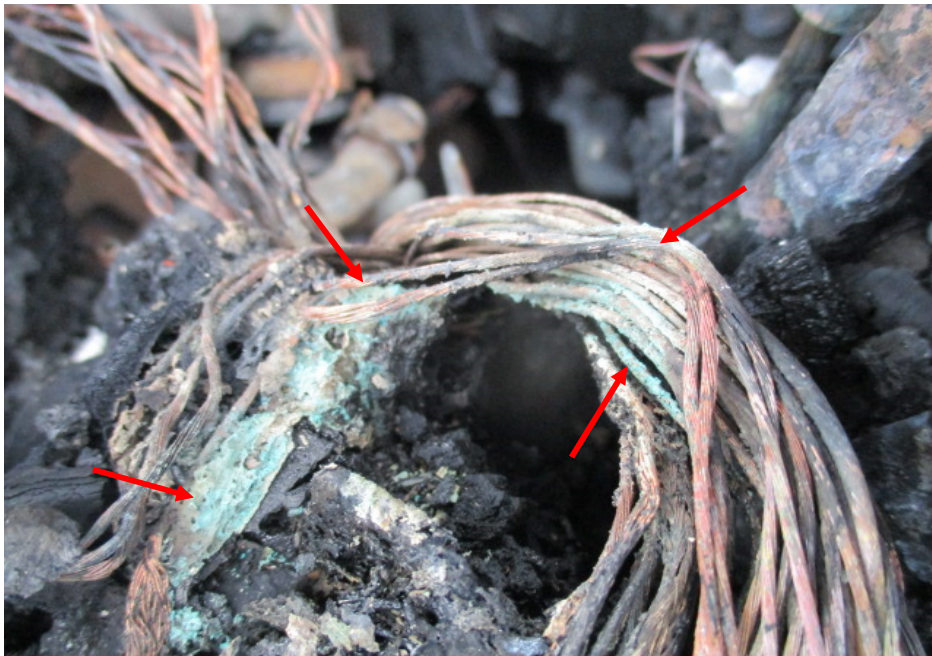
Photo 12 shows a close up view of the greenish residue found on some of the burnt stretches of original factory fitted wirings (arrowed). The presence of such greenish residue suggests occurrence of an electrical short circuit.

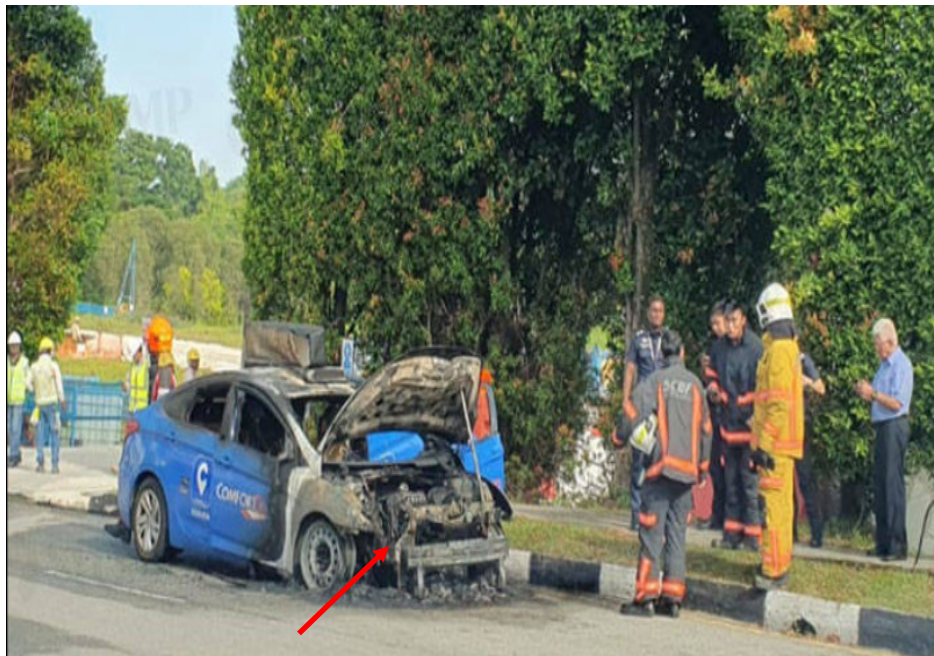
17. We were able to obtain a photograph of the Insured Vehicle which was taken after the fire had been extinguished. In general, the information that could be gathered from this photograph had corresponded to the events that were related to us by Mr Ho. Our close examination of this photograph also showed no unusual foreign material(s) and/or object(s) found on the ground in the immediate area of the road where the Insured Vehicle was positioned. See photo 13 below.

Photo 13 shows the Insured Vehicle after the fire was extinguished by the SCDF. In general, the information that could be gathered from this photograph had corresponded to the events that were related to us by Mr Ho, which is the fire had started from the engine compartment (arrowed).
