ACCIDENT DAMAGED VEHICLE INSPECTION REPORT

: TP/GAS/SKA5577J/8242

: SKA 5577 J

: Corolla Altis 1.6 Auto

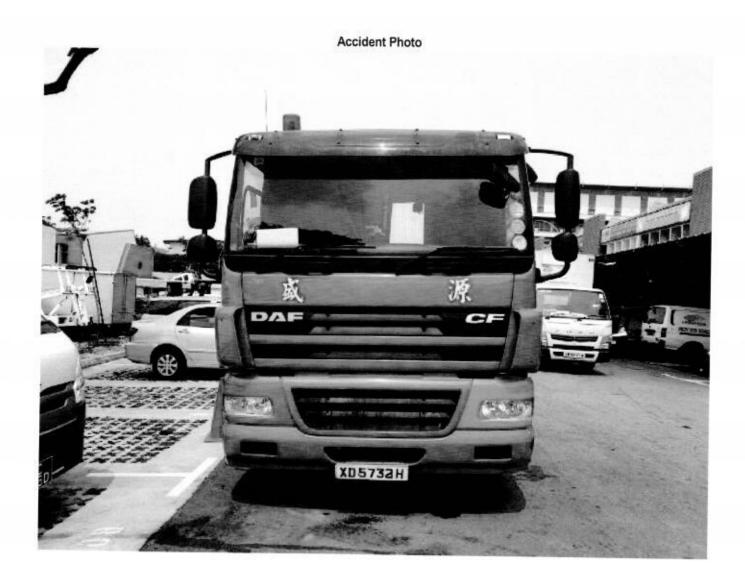
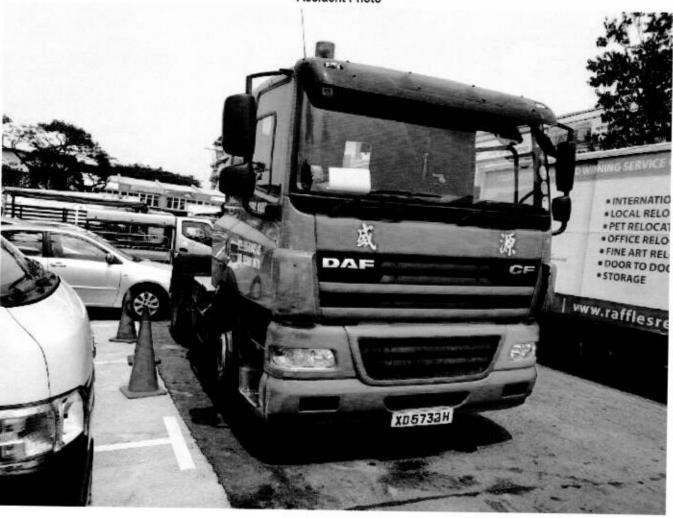
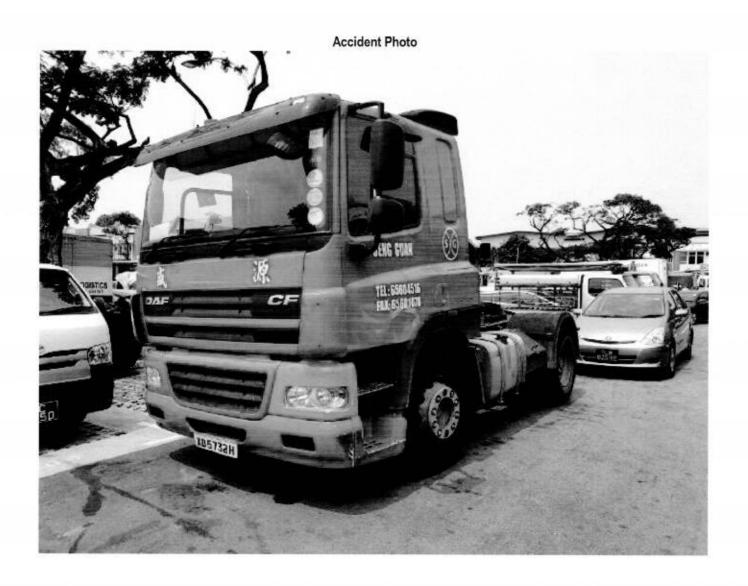
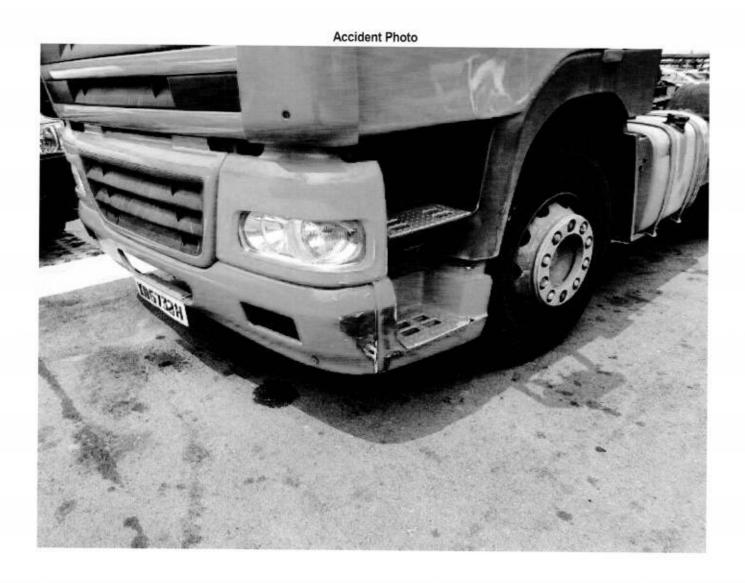
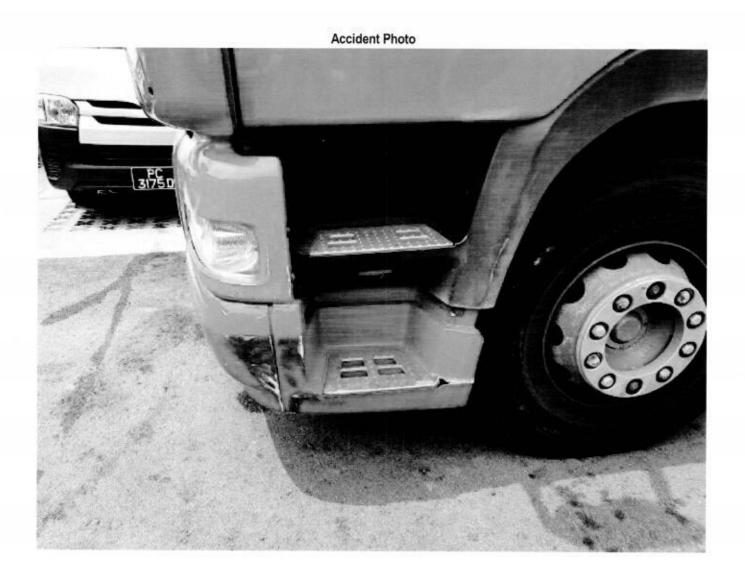
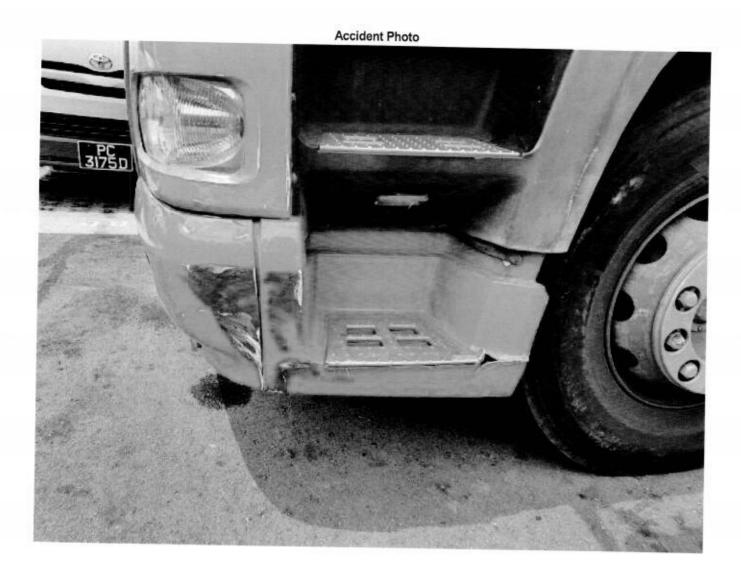
Accident Photo

The impact was confined to the rear off side & front both side portion of the vehicle. The damages appeared to be consistent as per the accident report statement. Please refer the attached schedule and photographs for details.

THE VEHICLE SUSTAINED DAMAGES AT THE FRONT O/S AND N/S PORTION, REAR O/S PORTION, N/S AND O/S BODY.
