Your Ref: TP/IP/75659/2019
Our Ref : CI/TPD19021871/P

Fatal Accident Investigation Team

MECHANICAL INSPECTION REPORT OF MOTOR CAR SDV 8101B

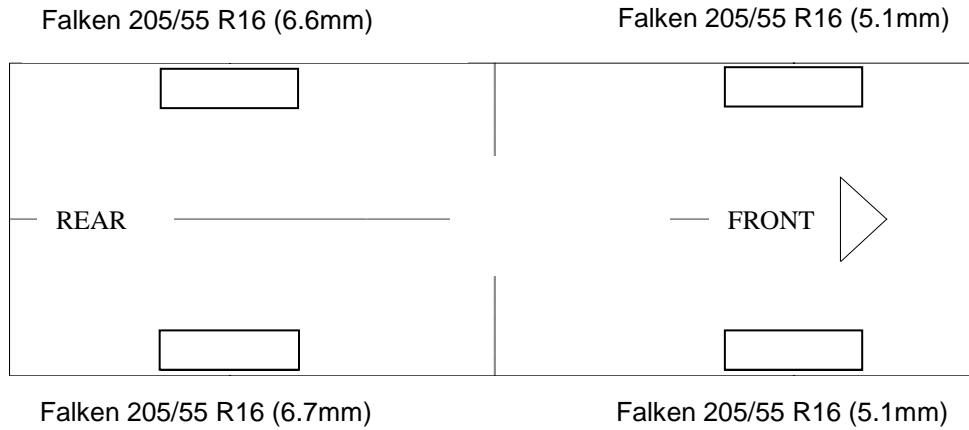
6. The 4 tyres of the Motor Car were observed to be in serviceable condition and sufficiently inflated for vehicular operation. I did not find any tear, cut or burst mark(s) on the outer and the inner sidewalls as well as across the tread of the 4 tyres. The tyre brand, tyre size and remaining tread depth of the 4 tyres of the Motor Car were recorded as follows:-

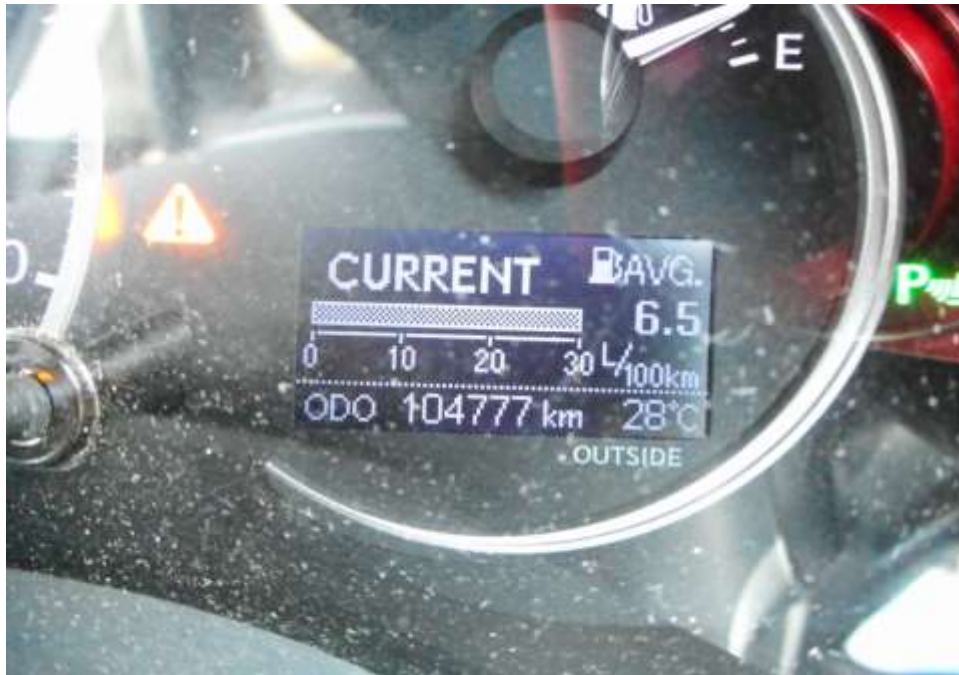
Photo 1 shows a general view of the instrument cluster of the Motor Car at the time of my inspection. The mileage of the Motor Car was 104,777km

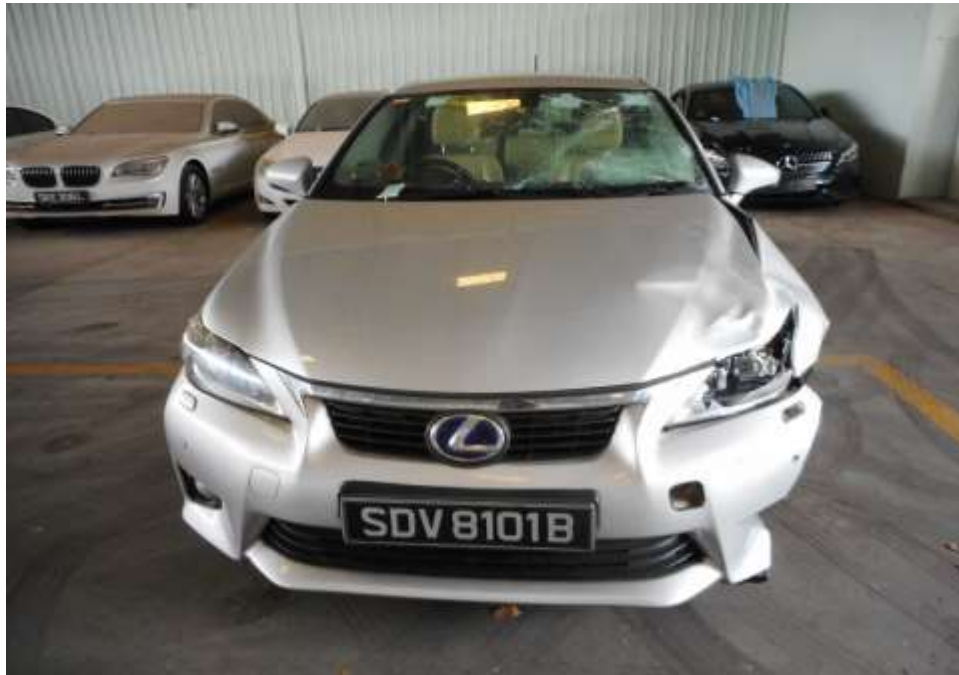
4. The mileage of the Motor Car at the time of my inspection was 104,777km.
5. The Motor Car appeared to have sustained damage at its frontal portion. Its front windscreen, front bonnet, front bumper, left fender, front left headlamp and left rear mirror were damaged at the time of my inspection.

Photo 2 shows a general view of the Motor Car's frontal portion at the time of my inspection. It appeared to have sustained damage at its frontal portion. Its front windscreen, front bonnet, front bumper, left fender, front left headlamp and left rear mirror were damage at the time of my inspection.

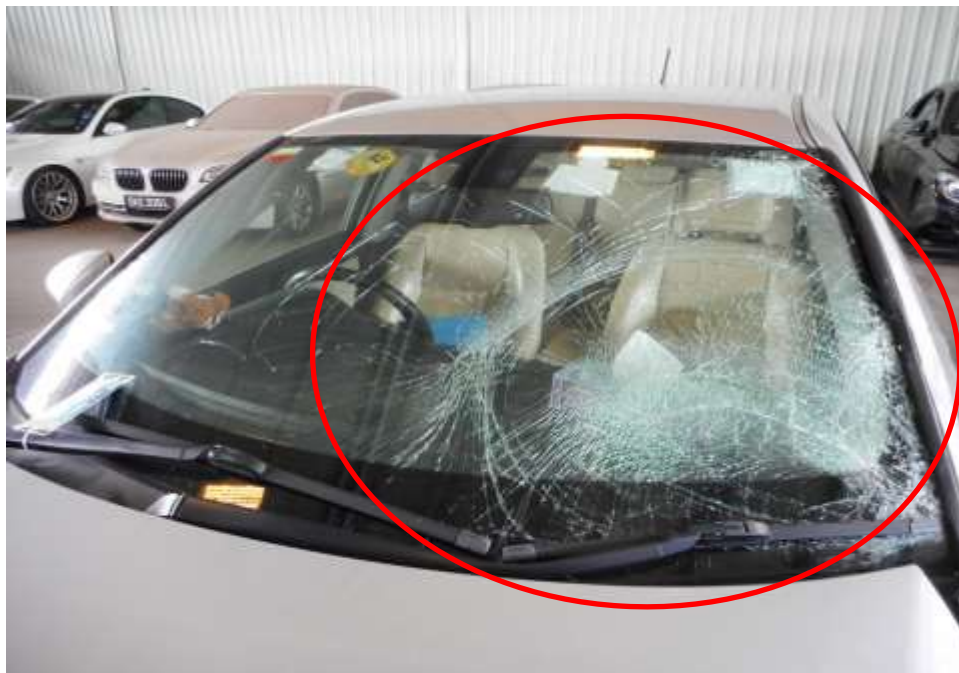
Photo 3 shows a close up view of the Motor Car's frontal portion at the time of my inspection. Its front windscreen (circled) was damage at the time of my inspection.

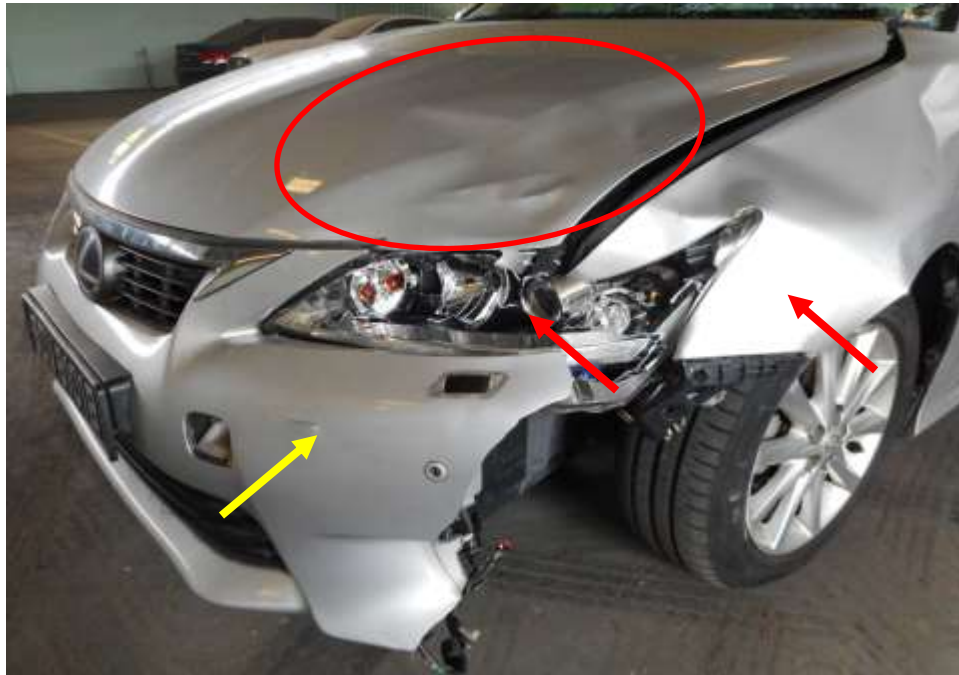
Photo 4 shows a close up view of the Motor Car's frontal portion at the time of my inspection. Its front bonnet (circled), front bumper (yellow arrow), front left fender and front right headlamp (red arrow) were damage at the time of my inspection.

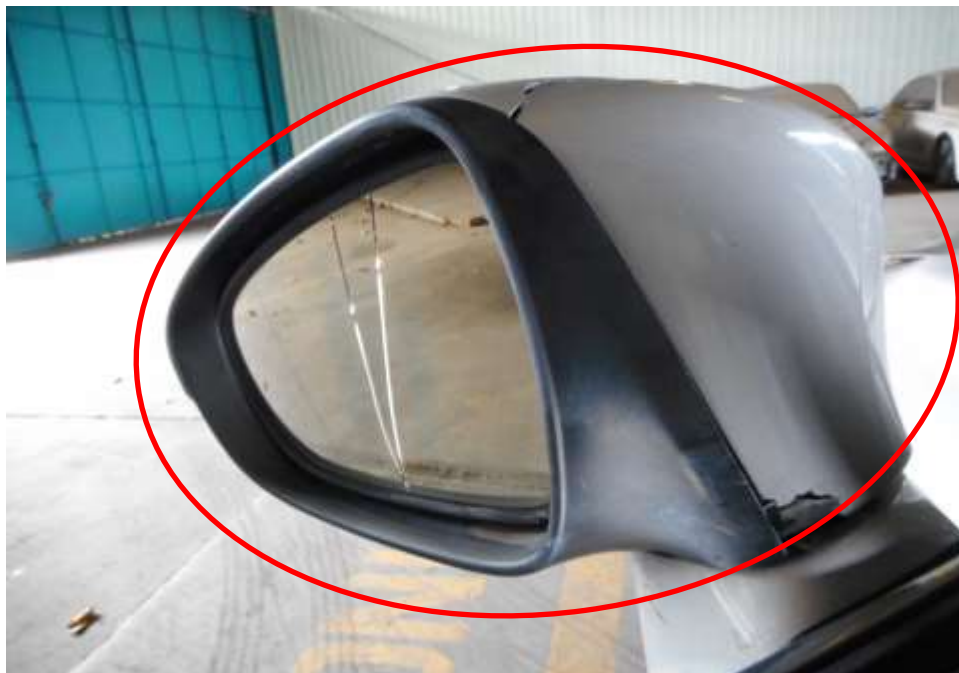
Photo 5 shows a close up view of the Motor Car's left rear mirror at the time of my inspection. Its left rear mirror (circled), were damage at the time of my inspection.

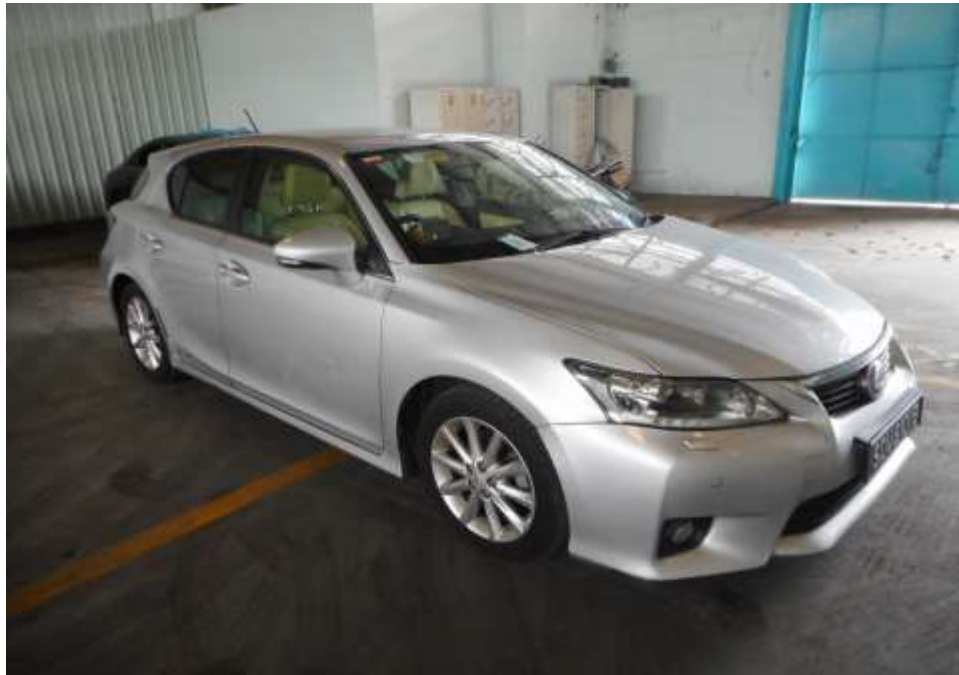
Photo 6 shows a general view of the front right body of the Motor Car at the time of my inspection. The Motor Car was observed to be intact and unaffected by the accident.

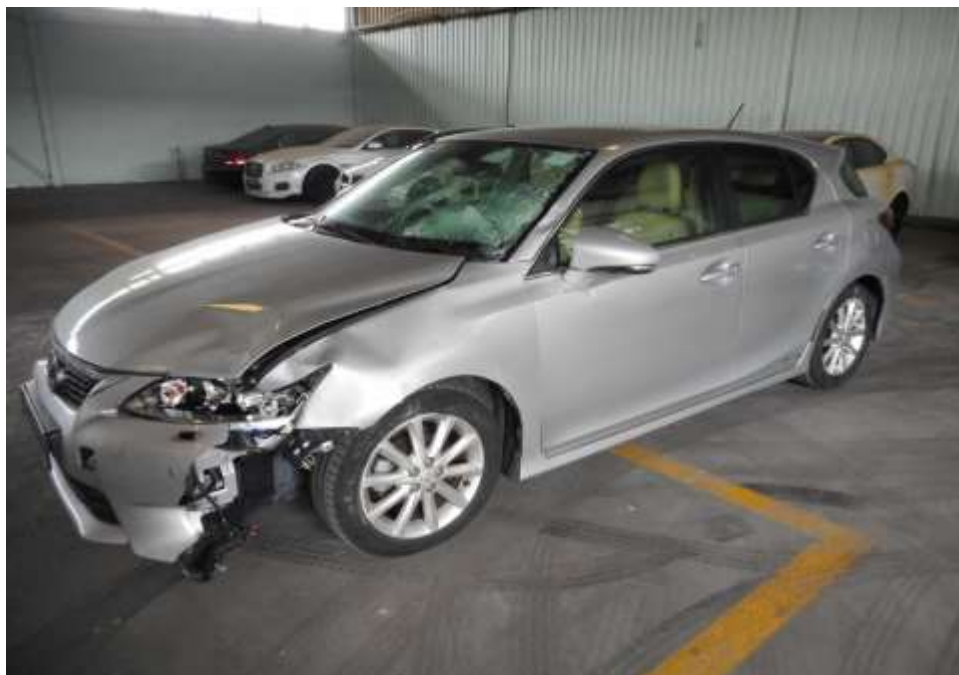
Photo 7 shows a general view of the front left body of the Motor Car at the time of my inspection. The Motor Car was observed to be intact.

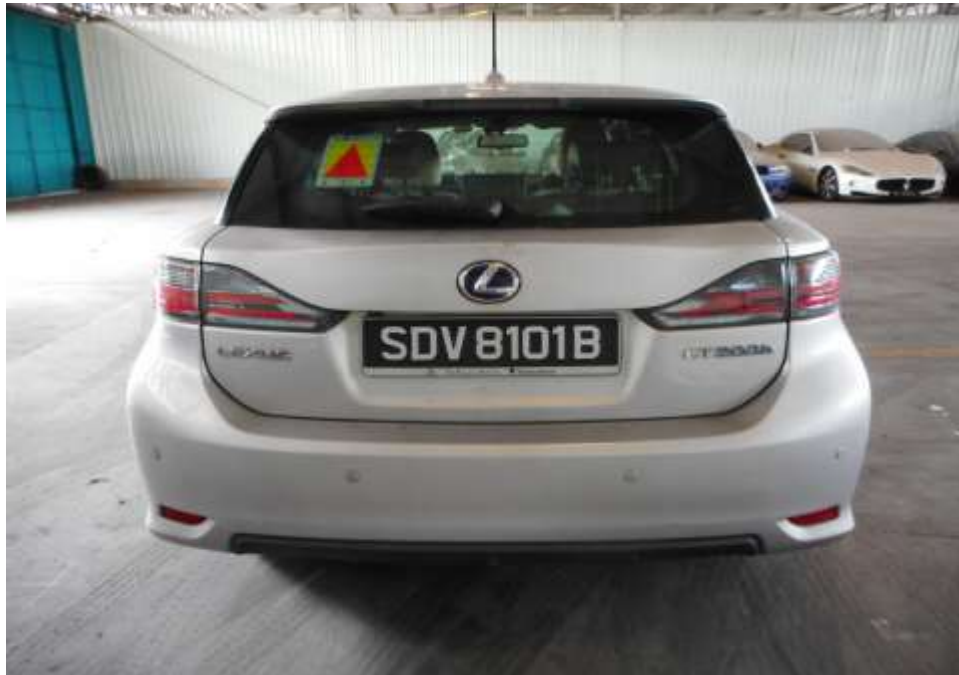
Photo 8 shows a general view of the rear body of the Motor Car at the time of my inspection. The Motor Car was observed to be intact and unaffected by the accident.

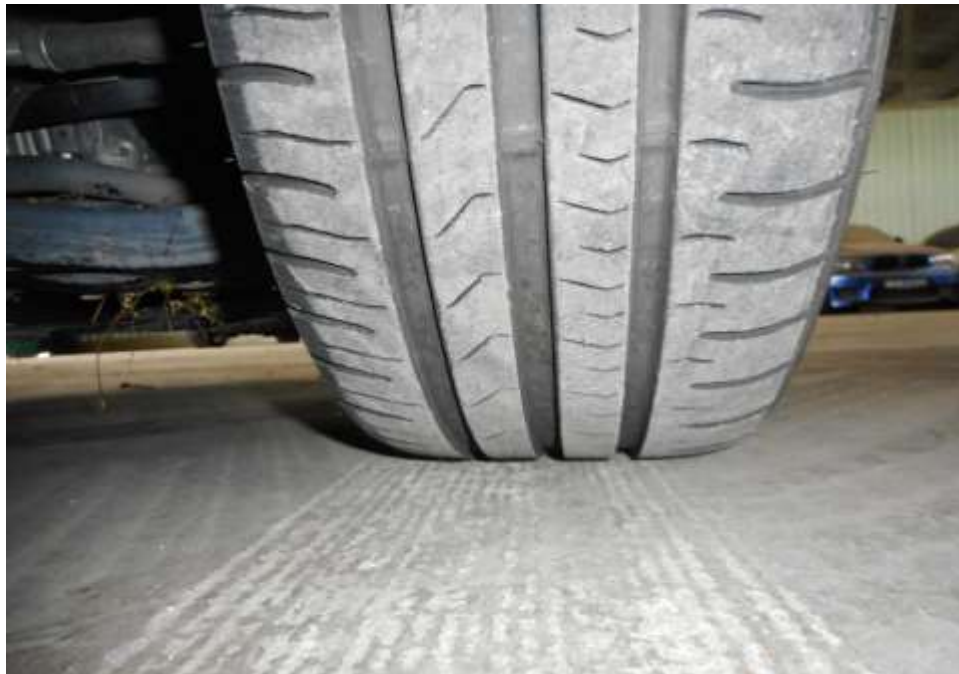
Photo 9 shows the condition of the front right tyre of the Motor Car, which was observed to be in serviceable condition with remaining tread depth of approximately 5.1mm. The tyre, which was wrapped around standard alloy wheel rim, was also observed to be sufficiently inflated for vehicular operation. There was no tear, cut or burst mark(s) on the outer and the inner sidewalls as well as across the tread of the 4 tyres that were fitted on the Motor Car.

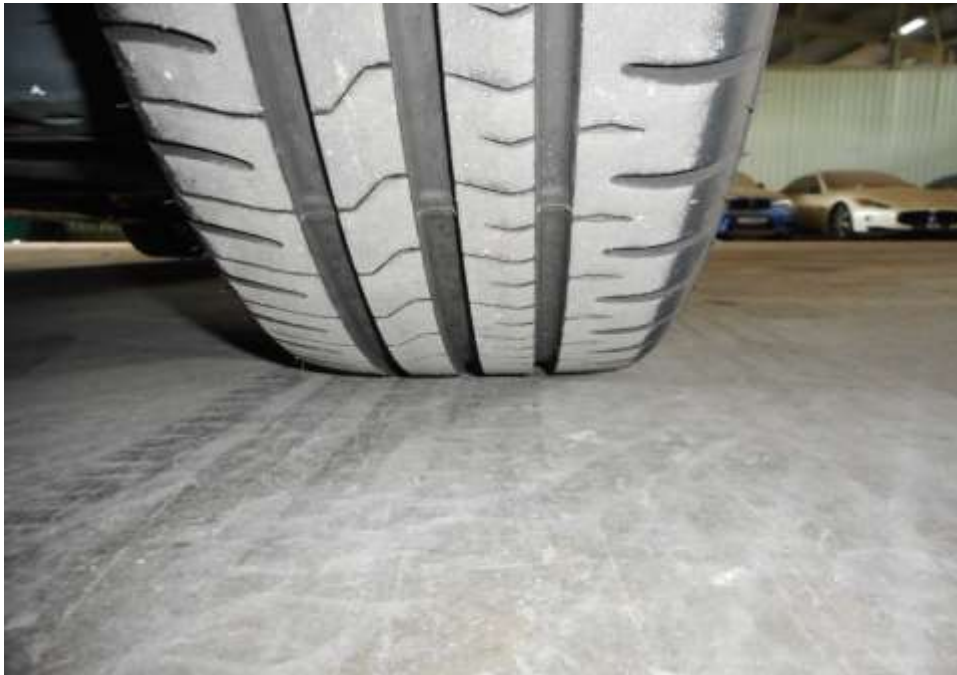
Photo 10 shows the condition of the rear right tyre of the Motor Car, which was observed to be in serviceable condition with remaining tread depth of approximately 6.7mm. The tyre, which was wrapped around standard alloy wheel rim, was also observed to be sufficiently inflated for vehicular operation.

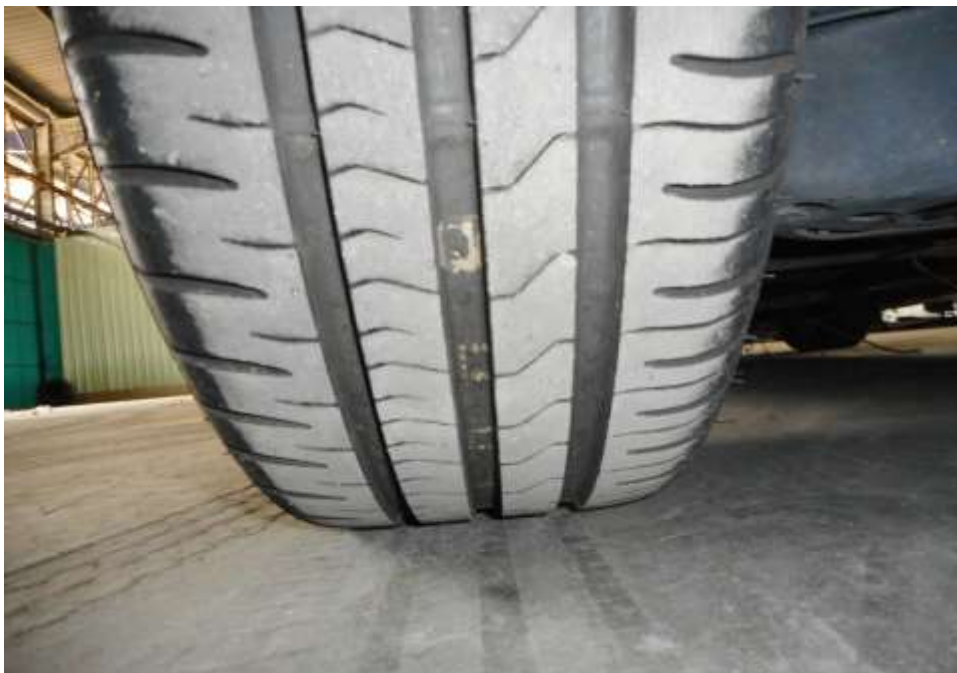
Photo 11 shows the condition of the rear left tyres of the Motor Car, which was observed to be in serviceable condition with remaining tread depth of approximately 6.6mm. The tyres, which were wrapped around standard alloy wheel rim, were also observed to be sufficiently inflated for vehicular operation. There was also no damage found on all 4 alloy wheel rims of the Motor Car.

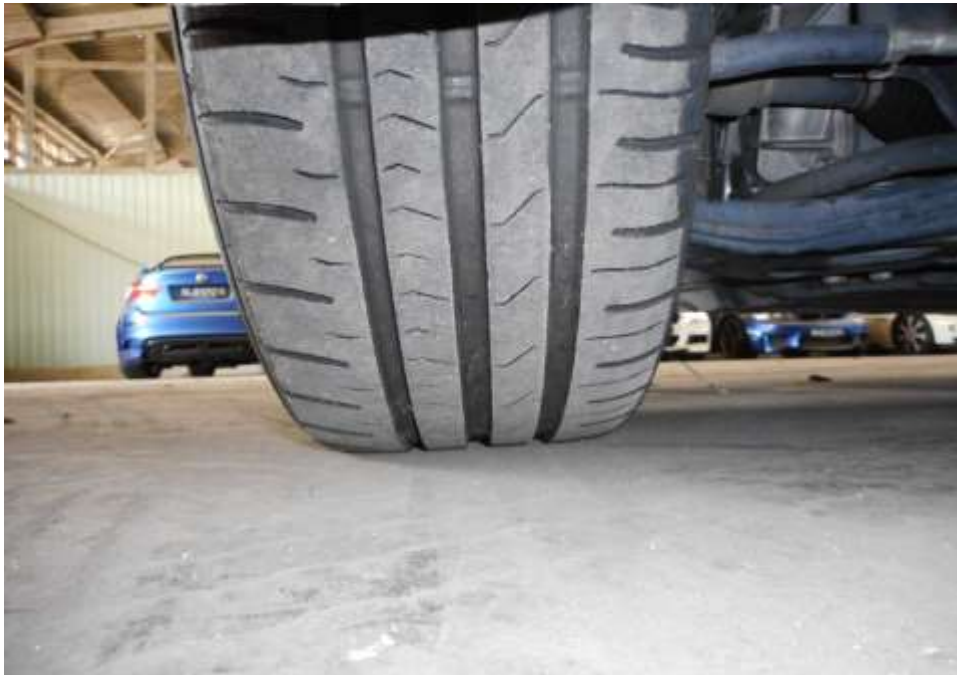
Photo 12 shows the condition of the rear right tyres of the Motor Car, which were observed to be in serviceable condition with remaining, tread depth of approximately 5.1mm. There was also no tear, cut or burst mark(s) on the outer and the inner sidewalls as well as across the tread of the 4 tyres that were fitted on the Motor Car.

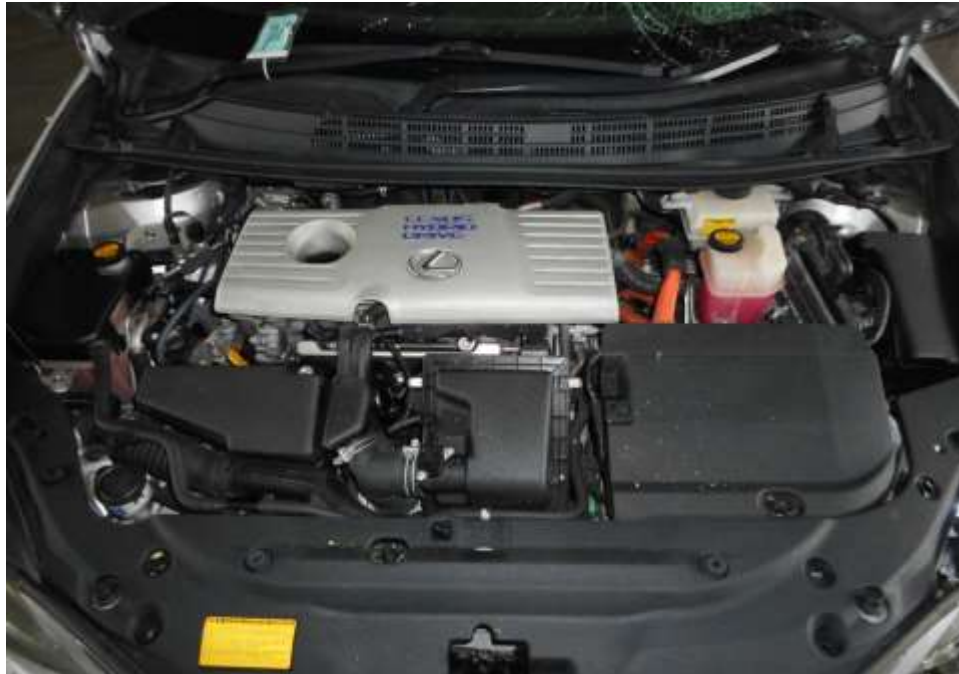
Photo 13 shows a general view of the Motor Car's engine compartment, which was accessed by lifting the front cabin of the Motor Car. The various parts and components inside the engine compartment were unaffected by the accident. There was also no sign(s) or indication(s) of fresh fluid leakage and/or fluid stain within the engine compartment

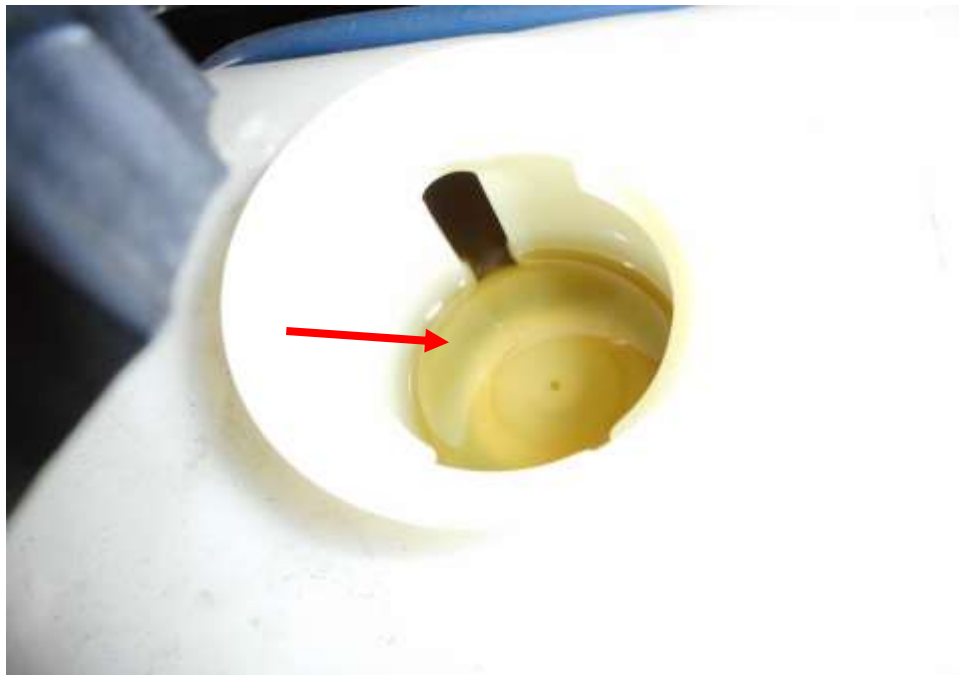
Photo 14 shows the brake fluid reservoir of the Motor Car at the time of my inspection. The brake fluid was observed to be of sufficient level (arrowed) and without any visible contamination.

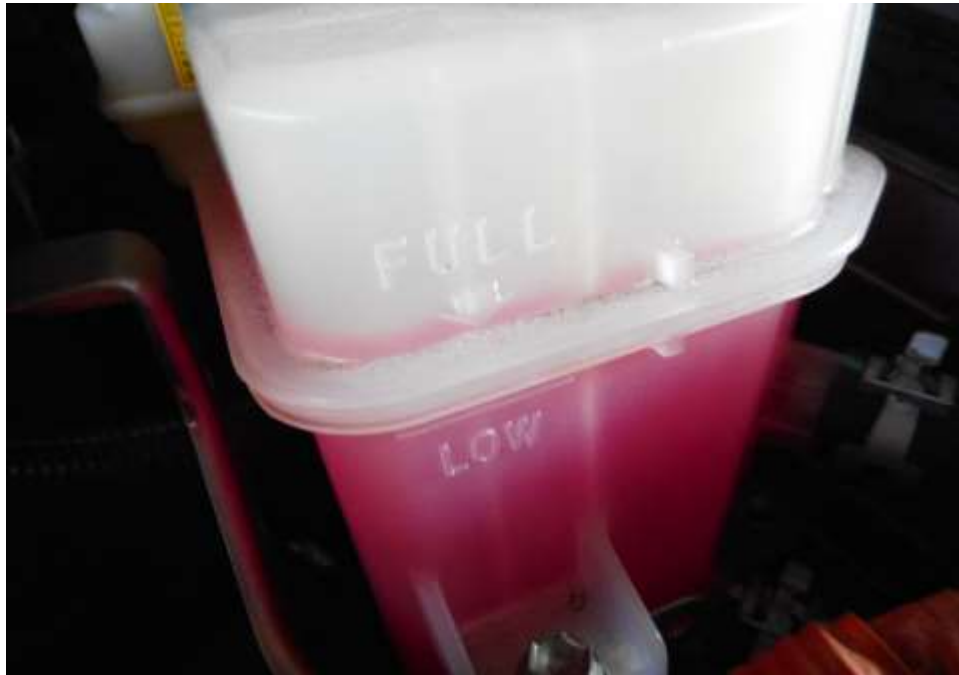
Photo 15 shows the engine coolant reservoir of the Motor Car at the time of my inspection. The engine coolant was observed to be of sufficient level and without any visible contamination.

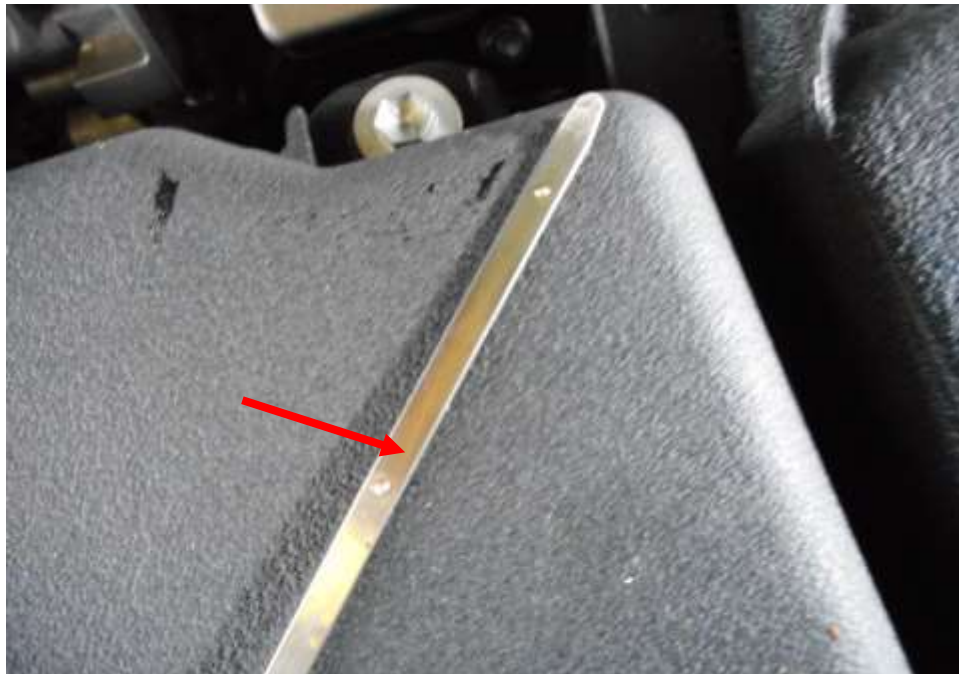
Photo 16 shows the engine oil dip stick of the Motor Car at the time of my inspection. The engine oil was observed to be of sufficient level (arrowed) and without any visible contamination.

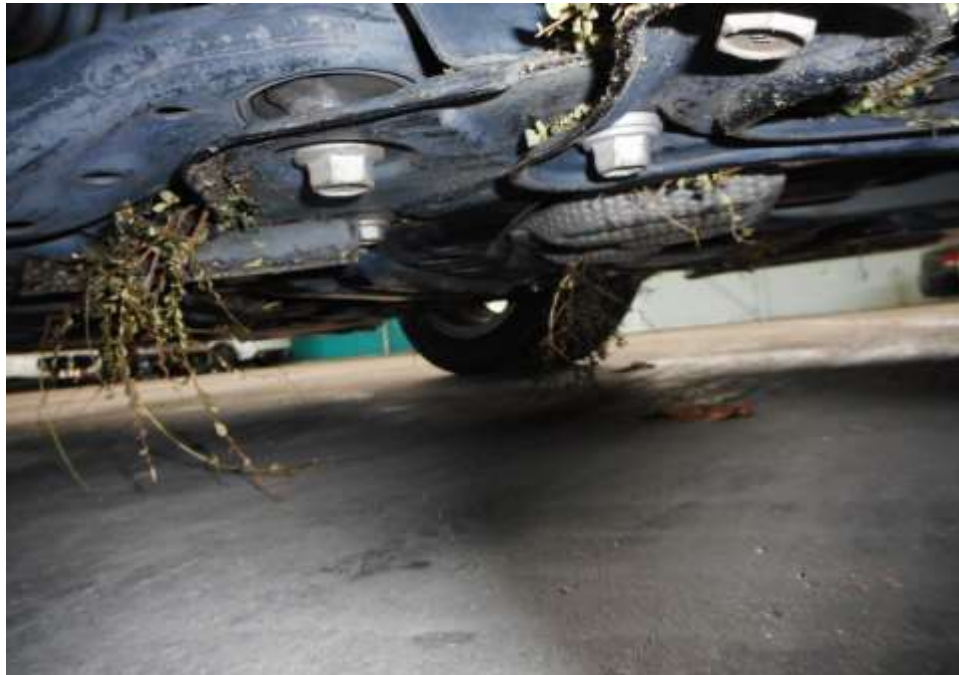
Photo 17 shows the undercarriage of the Motor Car, at the area where the engine housing and transmission housing are located. . I did not find any sign(s) or indication(s) of fluid leak and/or fluid stain(s) on the underside of the Motor Car.

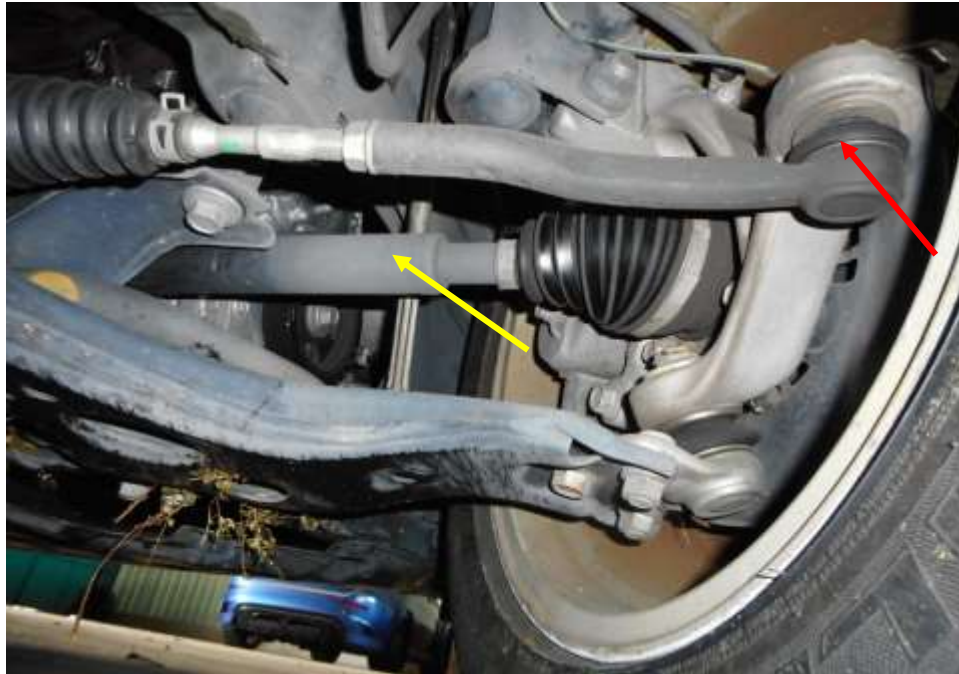
Photo 18 shows the various undercarriage components at the front right wheel of the Motor Car, in particular the steering tie rod end (arrowed) and drive shaft (yellow arrow). The various steering components were all found to be intact, suggesting that the steering system of the Motor Car was likely to be in serviceable condition at the material time of accident. There was also no sign of fluid stain(s) observed on the various undercarriage components.

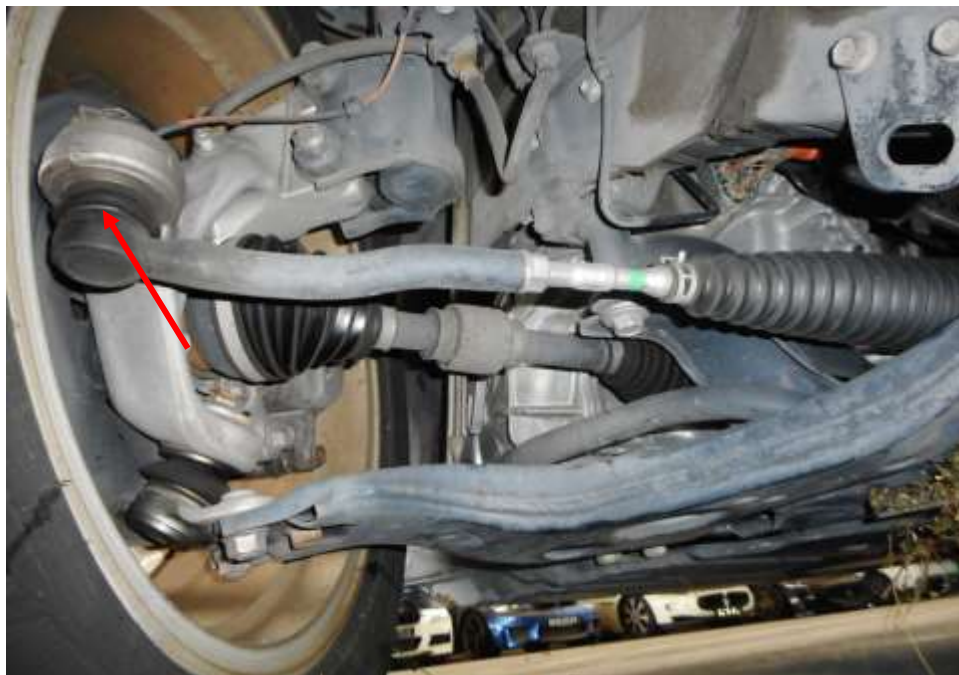
Photo 19 shows the various undercarriage components at the front left wheel of the Motor Car, in particular the steering tie rod end (arrowed). The various undercarriage components of the Motor Car were all found to be intact without any visible damage. There was also no sign of fluid stain(s) observed on the various undercarriage components.

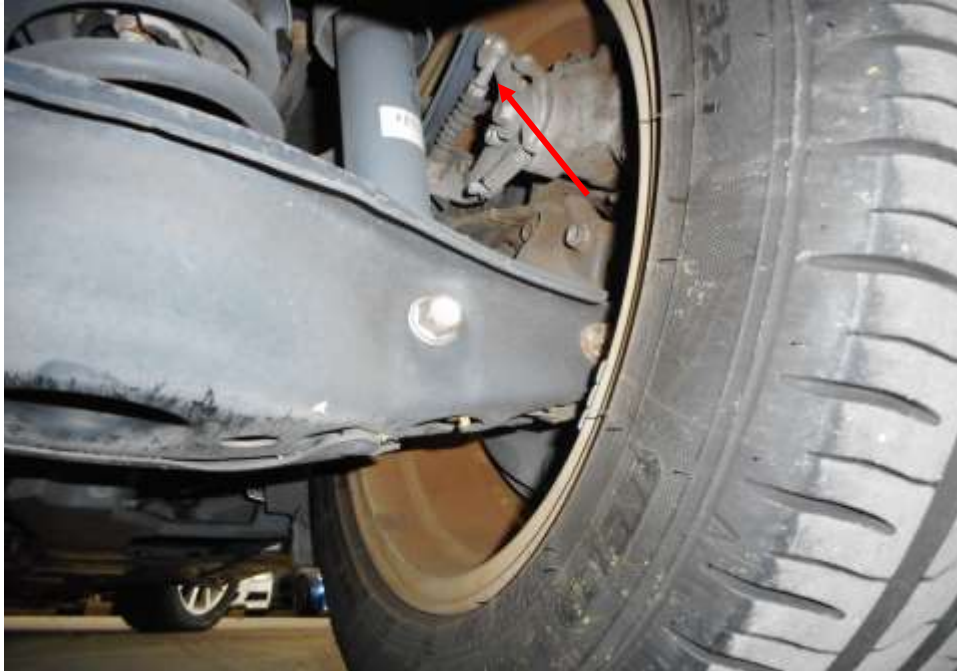
Photo 20 shows the brake pipe (arrowed) at the rear right wheel of the Motor Car. I did not observe any leakage of brake fluid at the time of my inspection of the Motor Car. My static tests of the Motor Car's braking system, along with my visual examination of the various mechanical components in the braking system, had indicated that there was no internal leakage of pressure/vacuum. Hence the braking system of the Motor Car was likely to be in serviceable condition at the material time of accident.

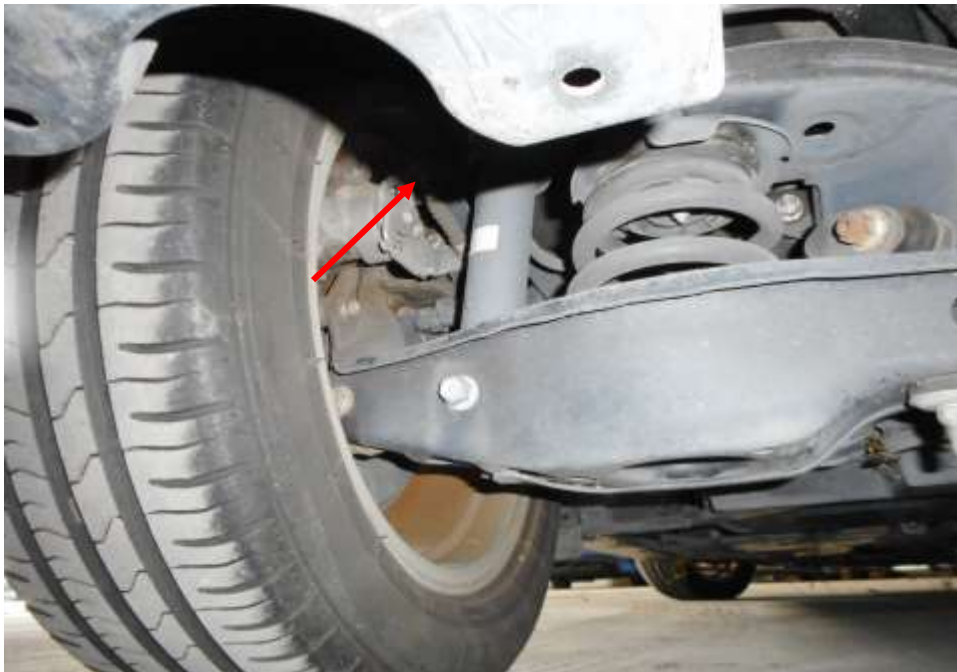
Photo 21 shows the brake pipe (arrowed) at the rear left wheel of the Motor Car. I did not observe any leakage of brake fluid at the time of my inspection of the Motor Car. My static tests of the Motor Car's braking system, along with my visual examination of the various mechanical components in the braking system had indicated that there was no internal leakage of pressure/vacuum. Hence the braking system of the Motor Car was likely to be in serviceable condition at the material time of accident.

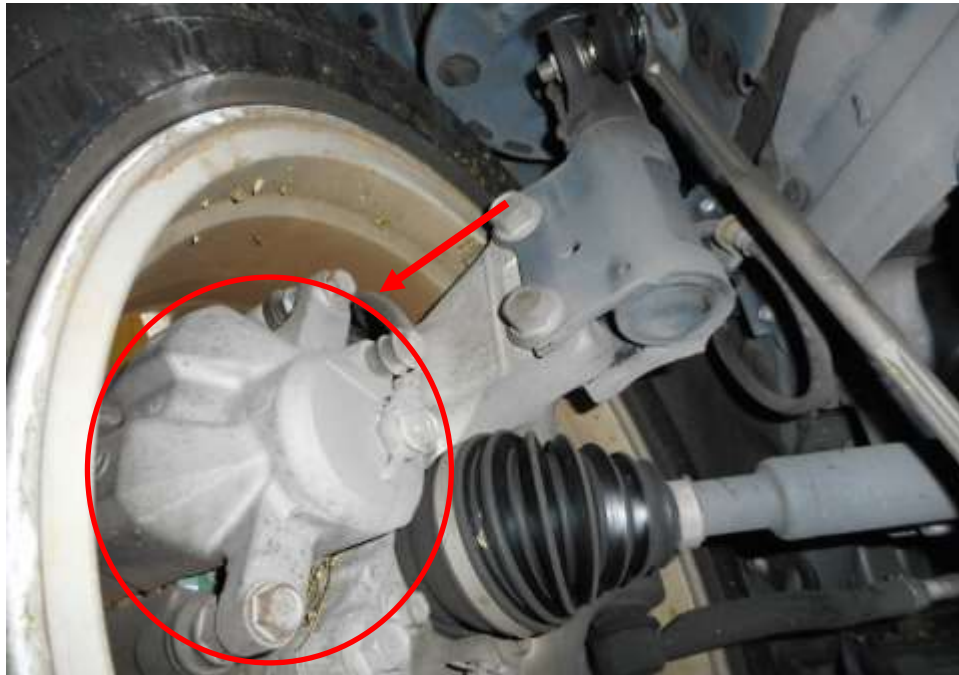
Photo 22 shows the brake hose/pipe (arrowed) at the front right wheel of the Motor Car. No leakage of brake fluid was observed. Visual examination of the various components of the braking system like the brake caliper (circled), brake booster, brake pedal etc had revealed all to be intact and without visible damage at the time of accident. There was also no sign of fluid stain(s) observed on the various undercarriage components.

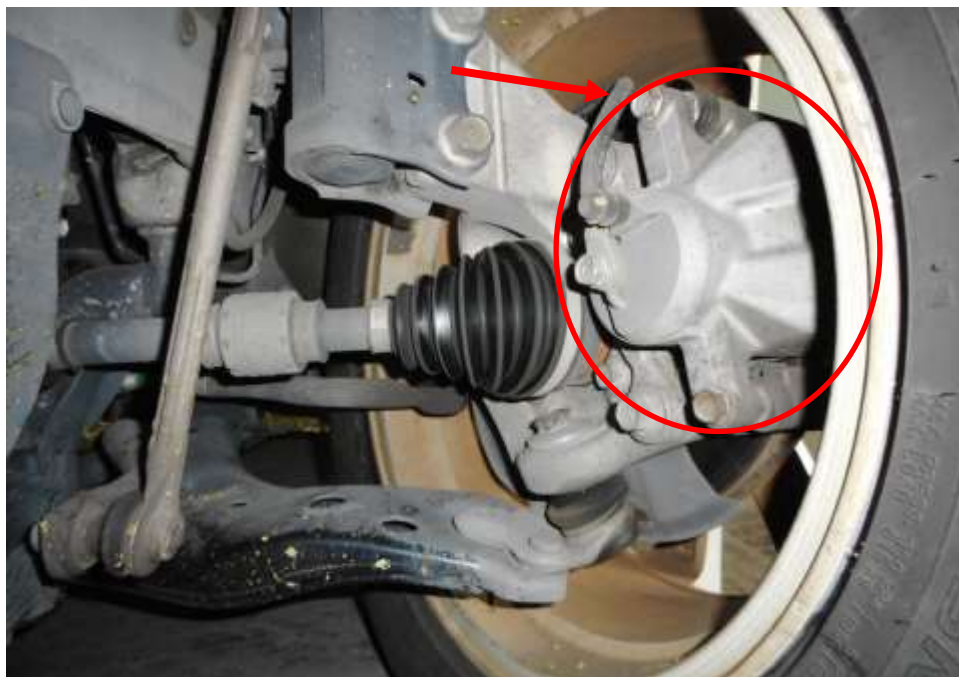
Photo 23 shows the brake hose/pipe (arrowed) at the front left wheel of the Motor Car. No leakage of brake fluid was observed. Visual examination of the various components of the braking system like the brake caliper (circled), brake booster, brake pedal etc had revealed all to be intact and without visible damage at the time of accident. There was also no sign of fluid stain(s) observed on the various undercarriage components.

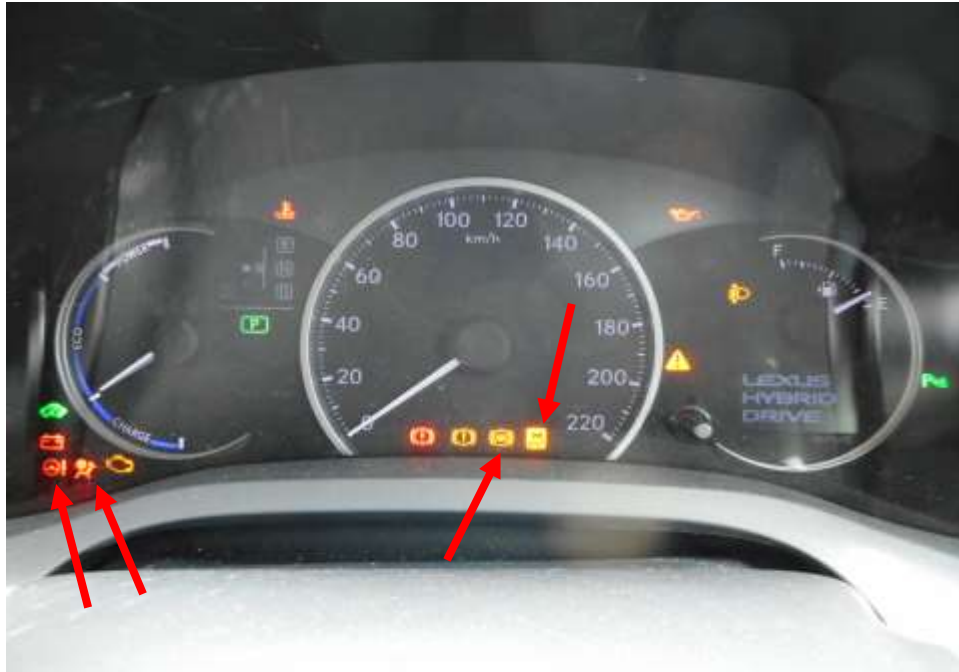
Photo 25 shows the warning light for Anti-Lock Brake System (ABS) and Supplemental Restraint System (SRS) and Electric Power Steering System (EPS) and Traction Control (TC) appearing on the instrument panel of the Motor Car during the self-test of its various electronic operating systems when its engine was cranked.

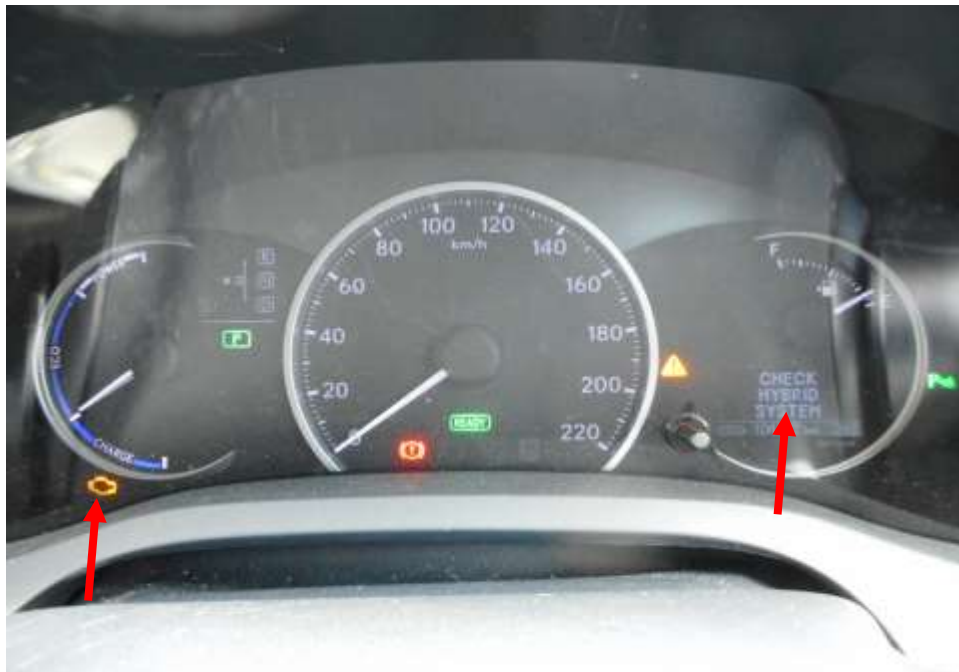
Photo 26 shows only the engine check lights remained on due to a fault in the Motor Car's hybrid system (arrowed) as a result of the accident. No other warning lights illuminated on the instrument panel of the Motor Car after the engine was cranked. This would suggest that there was no abnormality to the various electronic operating systems of the Motor Car, like the ABS, SRS, EPS and TC.
