Your Ref: 6000029265
Our Ref : CI/SPF19022277/N

10 December 2019

MECHANICAL INSPECTION REPORT OF MOTOR LORRY GBC 7848K

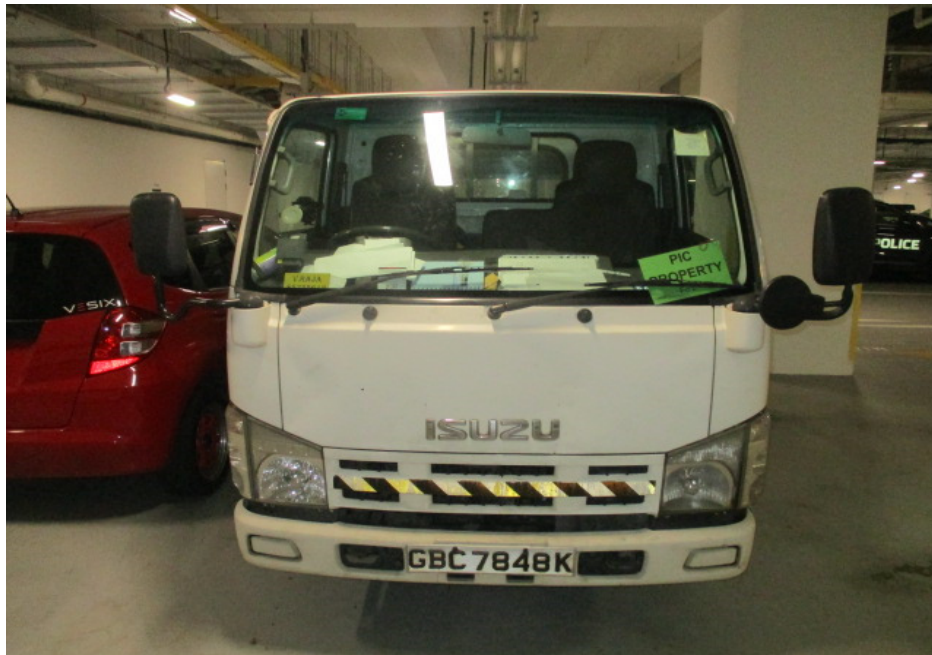
Photo 1 shows a general view of the front body of the Motor Lorry at the time of our inspection. At the time of our inspection, we did not observe any damage on the Motor Lorry (IO in charge was informed that the damaged parts were replaced prior to inspection). The mileage of the Motor Lorry at the time of our inspection was 337, 761km.

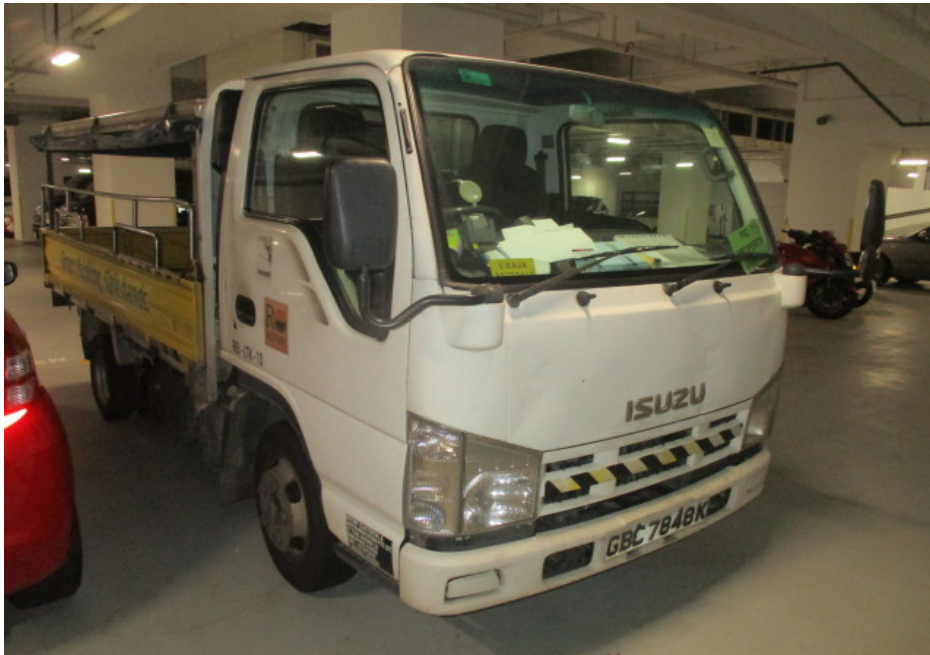
Photo 2 shows a general view of the right front body of the Motor Lorry at the time of our inspection.

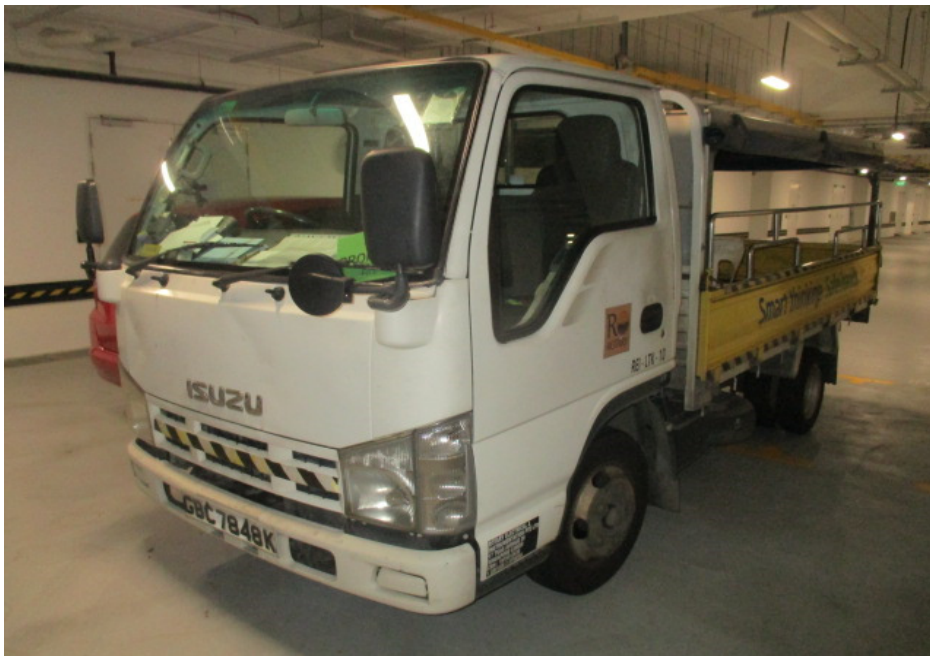
Photo 3 shows a general view of the left front body of the Motor Lorry at the time of our inspection.

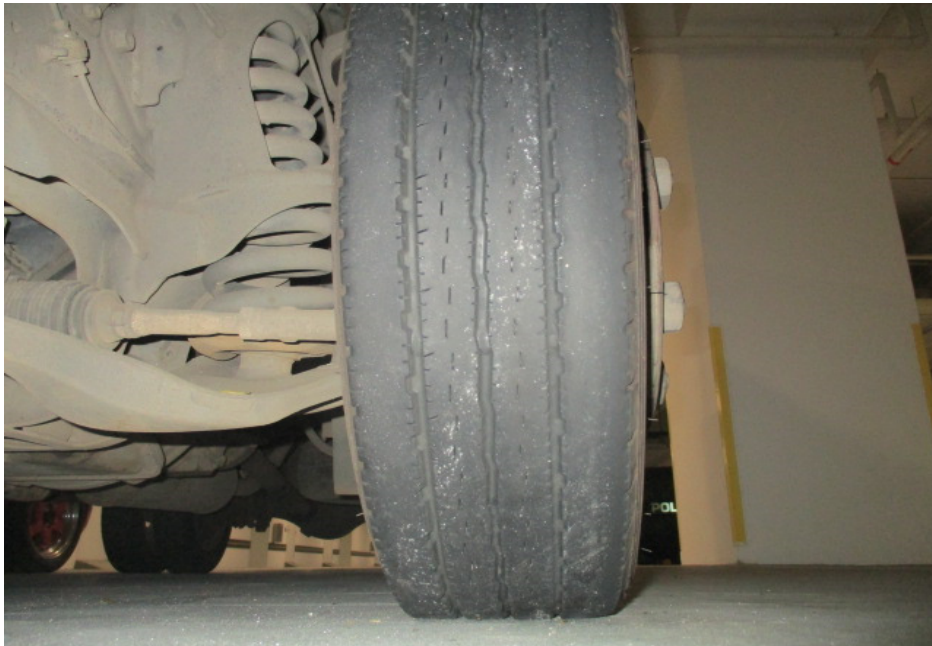
Photo 4 shows the condition of the front left tyre of the Motor Lorry, which was observed to be in serviceable condition with remaining tread depth of approximately 4mm. The tyre, which was wrapped around standard alloy wheel rim, was also observed to be sufficiently inflated for vehicular operation. There was no tear, cut or burst mark(s) on the outer and the inner sidewalls as well as across the tread of the 6 tyres that were fitted on the Motor Lorry.

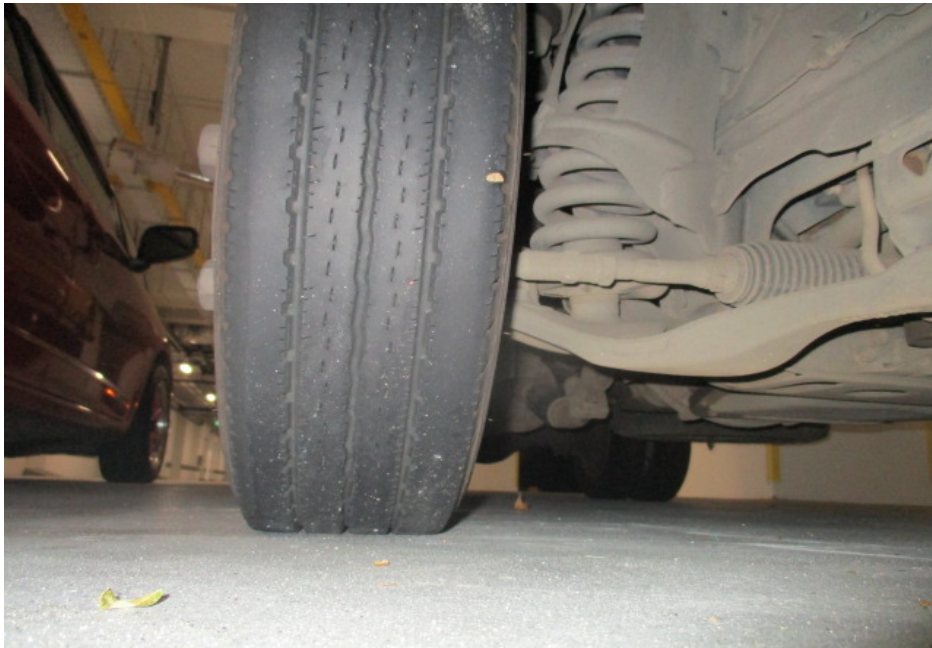
Photo 5 shows the condition of the front right tyre of the Motor Lorry, which was observed to be in serviceable condition with remaining tread depth of approximately 5mm. The tyre, which was wrapped around standard alloy wheel rim, was also observed to be sufficiently inflated for vehicular operation.

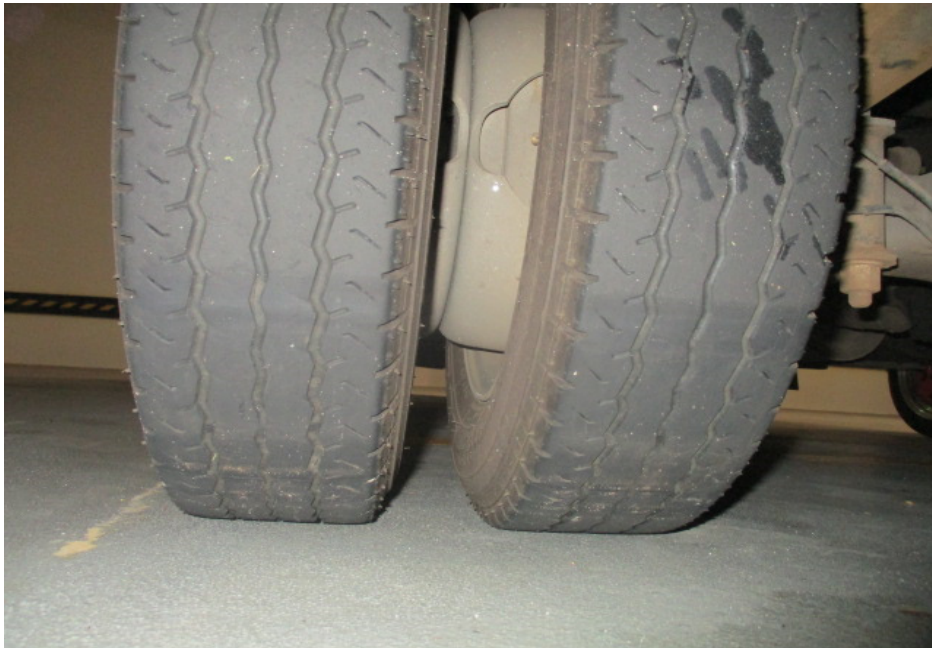
Photo 6 shows the condition of the rear left tyres of the Motor Lorry, which was observed to be in serviceable condition with remaining tread depth of approximately 4mm. The tyres, which were wrapped around standard alloy wheel rim, were also observed to be sufficiently inflated for vehicular operation. There was also no damage found on all 6 alloy wheel rims of the Motor Lorry.

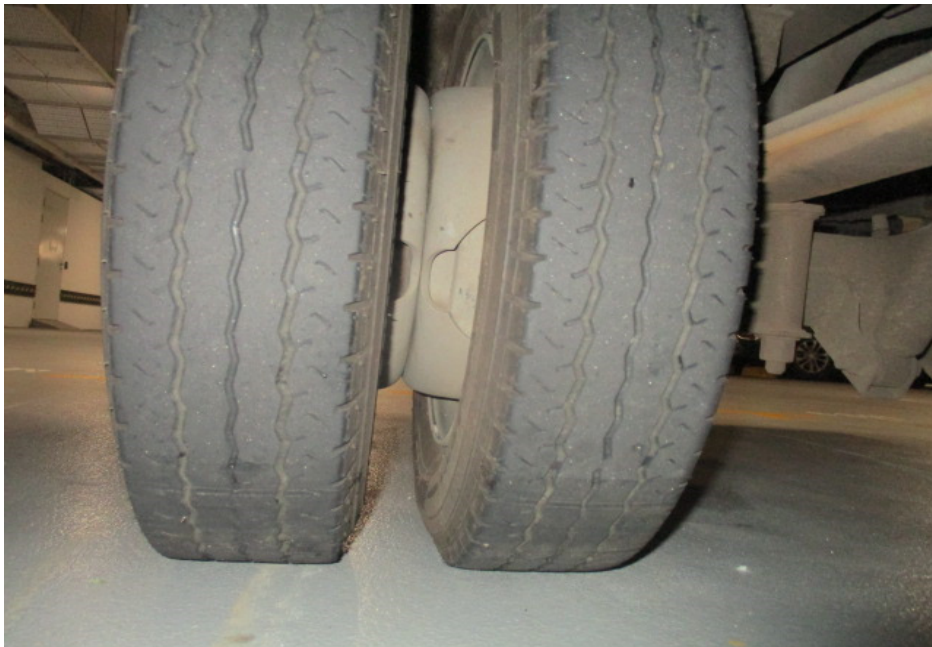
Photo 7 shows the condition of the rear right tyres of the Motor Lorry, which were observed to be in serviceable condition with remaining tread depth of approximately 4mm. There was also no tear, cut or burst mark(s) on the outer and the inner sidewalls as well as across the tread of the 6 tyres that were fitted on the Motor Lorry.

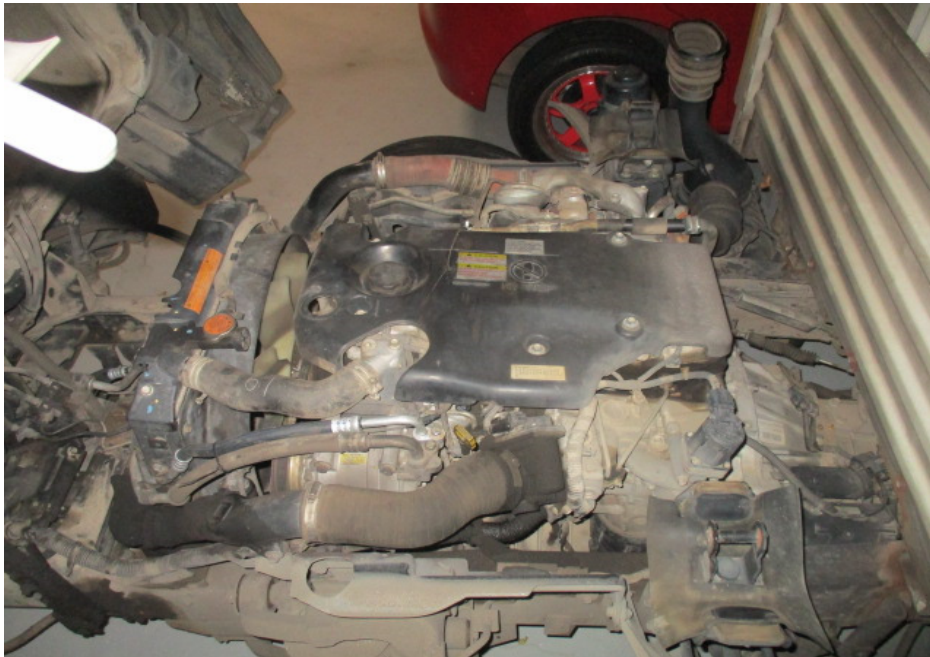
Photo 8 shows a general view of the Motor Lorry's engine compartment, which was accessed by lifting the front cabin of the Motor Lorry. The various parts and components inside the engine compartment were unaffected by the accident. There was also no sign(s) or indication(s) of fresh fluid leakage and/or fluid stain within the engine compartment (photograph shows the engine compartment as viewed from the left front side of the Motor Lorry).

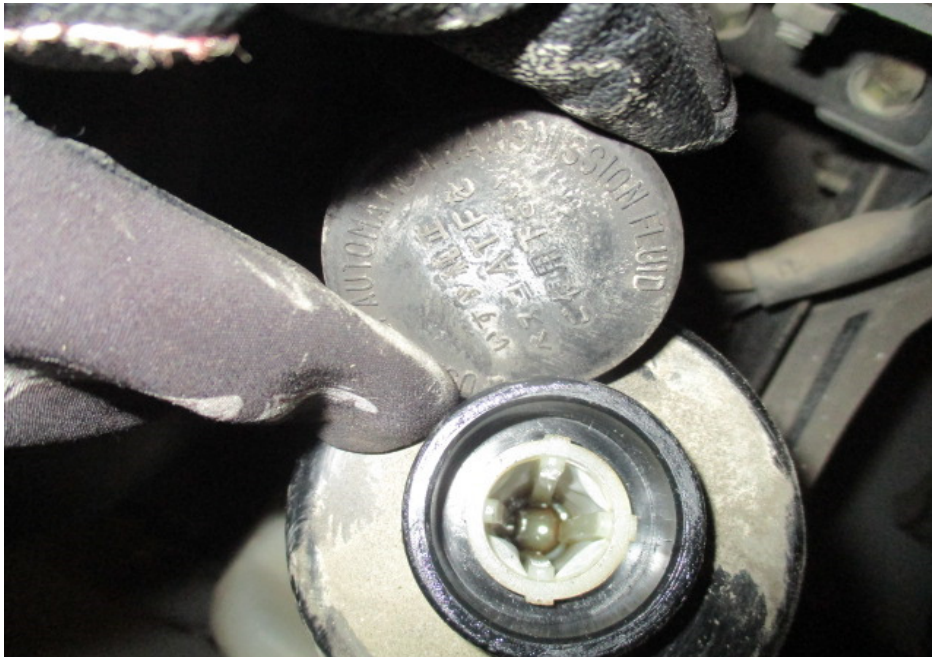
Photo 11 shows the power steering fluid reservoir of the Motor Lorry at the time of our inspection. The power steering fluid was observed to be of sufficient level and without any visible contamination.

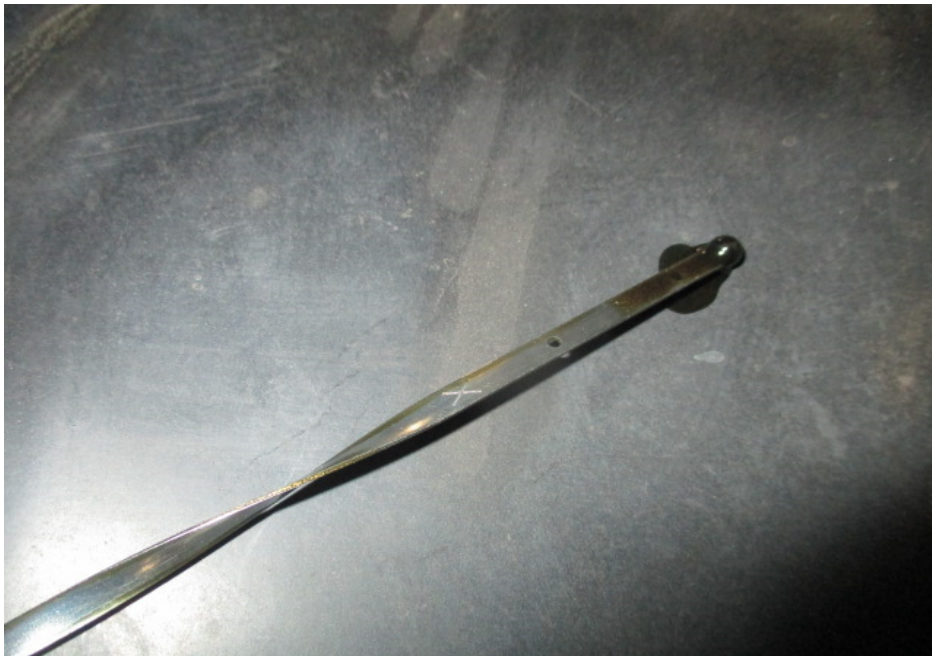
Photo 12 shows the engine dip stick of the Motor Lorry at the time of our inspection. The engine oil was observed to be of sufficient level and without any visible contamination.

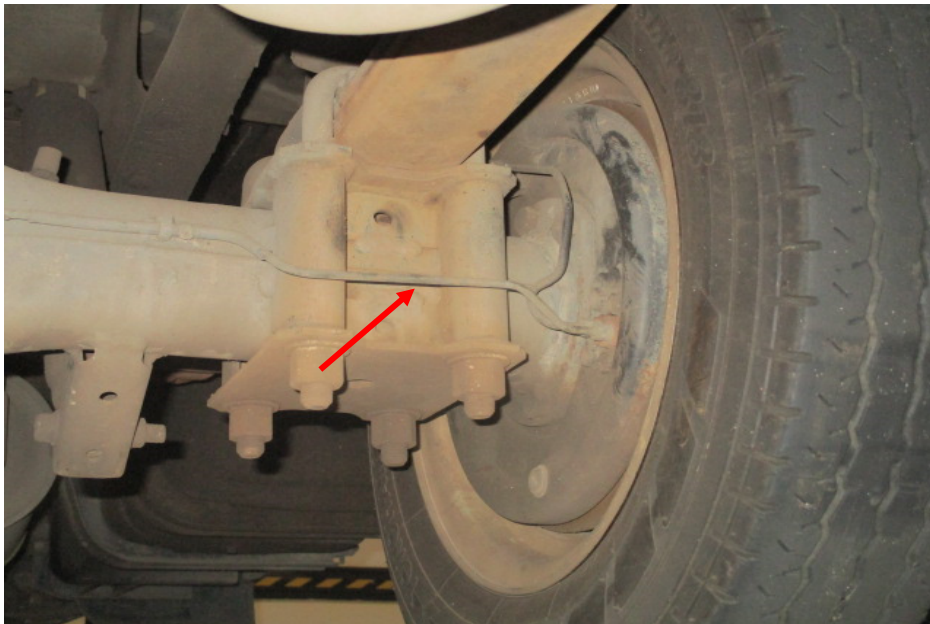
Photo 13 shows the brake pipe (arrowed) at the rear right wheel of the Motor Lorry. We did not observe any leakage of brake fluid at the time of our inspection of the Motor Lorry. Our static tests of the Motor Lorry's braking system, along with our visual examination of the various mechanical components in the braking system, had indicated that there was no internal leakage of pressure/vacuum. Hence the braking system of the Motor Lorry was likely to be in serviceable condition at the material time of accident.

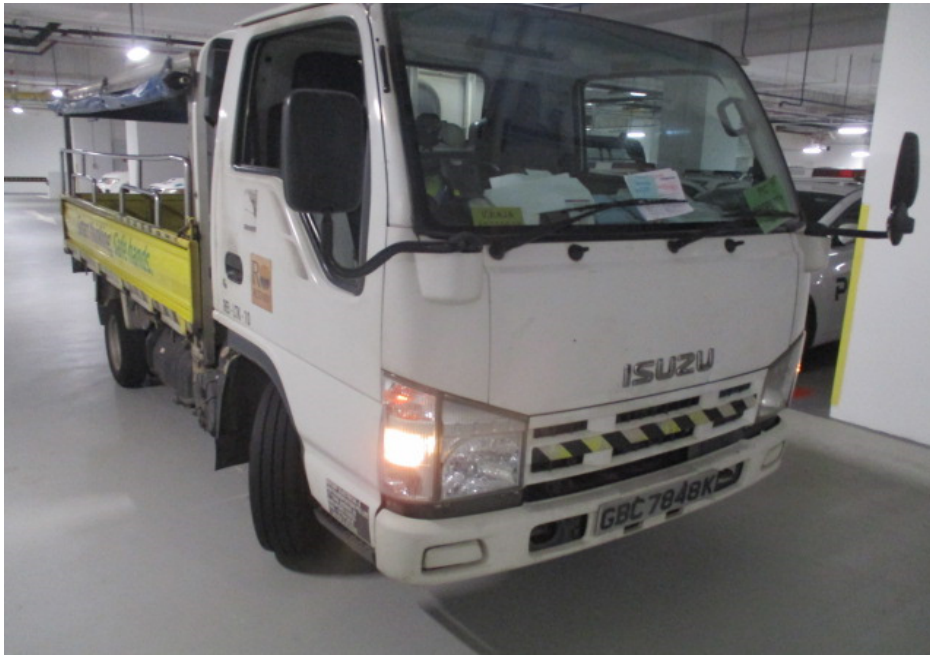
Photo 14 shows the front right wheel of the Motor Lorry turned to its full right. During our steering system test, we did not experience any abnormal free play and/or resistance when we had turned the steering wheel towards full left and full right. This would suggest that the steering system of the Motor Lorry was likely to be in serviceable condition at the material time of accident.

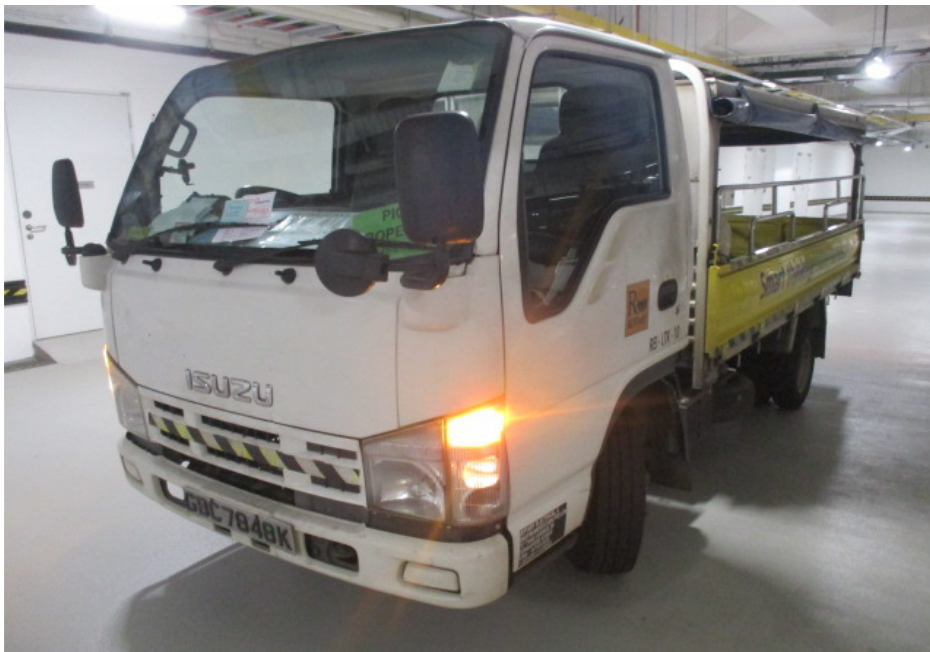
Photo 15 shows the front left wheel of the Motor Lorry turned to its full left. During our steering system test, we did not experience any abnormal free play and/or resistance when we had turned the steering wheel towards full left and full right. This would suggest that the steering system of the Motor Lorry was likely to be in serviceable condition at the material time of accident.

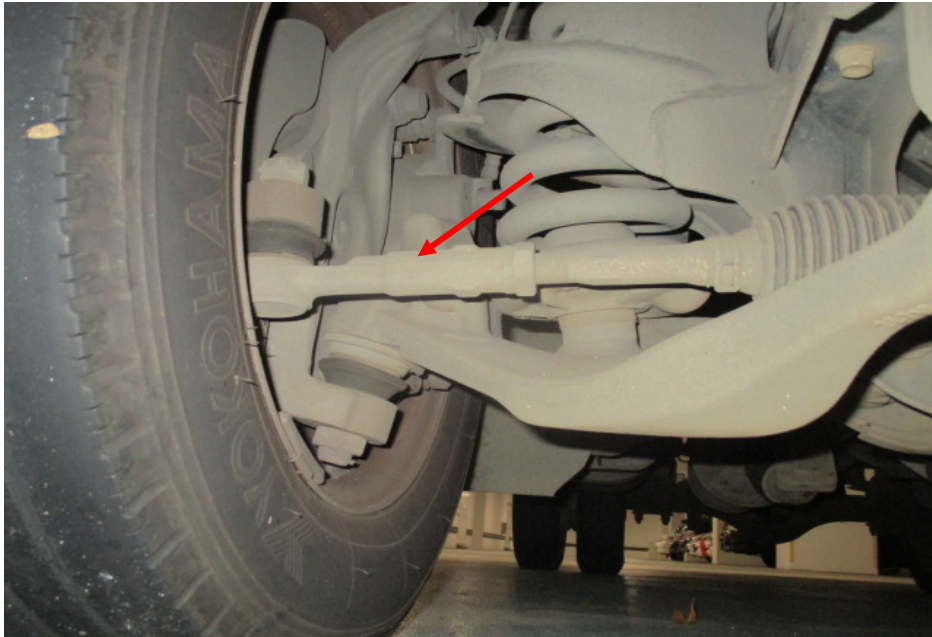
Photo 16 shows the various undercarriage components at the front right wheel of the Motor Lorry, in particular the steering tie rod end (arrowed). The various steering components were all found to be intact, suggesting that the steering system of the Motor Lorry was likely to be in serviceable condition at the material time of accident. There was also no sign of fluid stain(s) observed on the various undercarriage components.

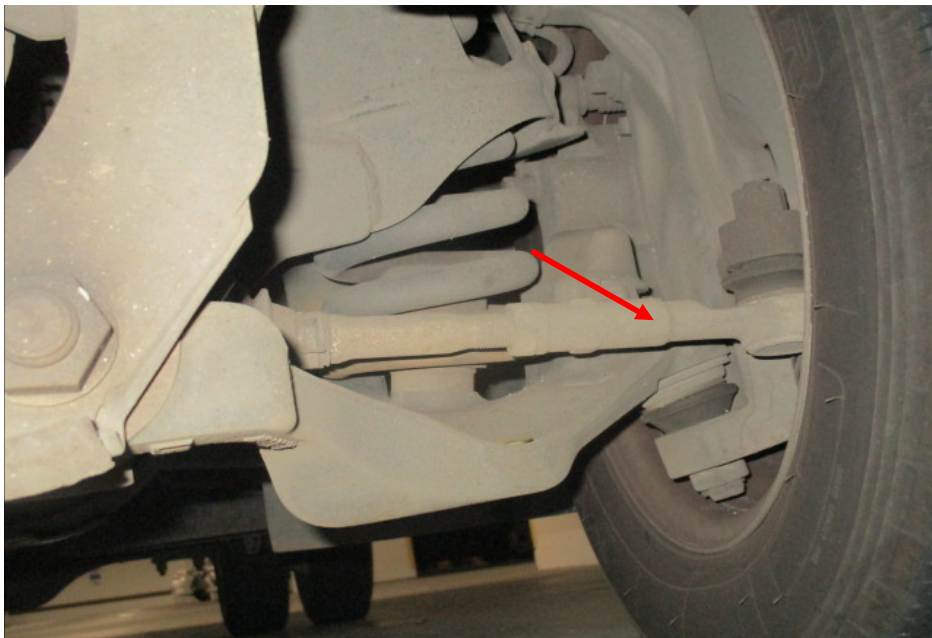
Photo 17 shows the various undercarriage components at the front left wheel of the Motor Lorry, in particular the steering tie rod end (arrowed). The various undercarriage components of the Motor Lorry were all found to be intact without any visible damage. There was also no sign of fluid stain(s) observed on the various undercarriage components.
