Your Ref: TP/IP/74669/2019
Our Ref :CI/TPD19022279/N

Fatal Accident Investigation Team

INSPECTION REPORT OF MOTORCYCLE FBG 9070C

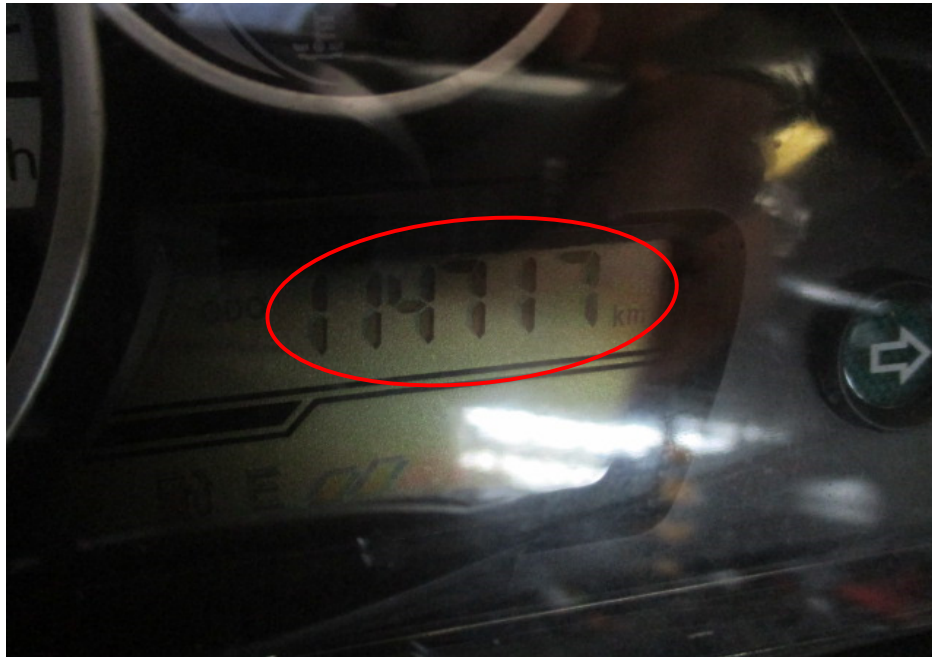
4. The mileage of the Motorcycle recorded at the time of our inspection was 114,717km.
5. The Motorcycle was observed to have sustained minor damages at the frontal and right portion. The body parts that were found to have been damaged include its front mudguard, front brake lever, right side mirror, right cowling, right rear side cover, right pillion foot rest, exhaust muffler, top box rack and top box, amongst others as a result of the accident. See photos 1 – 9 below.

Photo 1 shows the speedometer gauge of the Motorcycle where the mileage recorded at the time of our inspection was 114, 717km (circled).

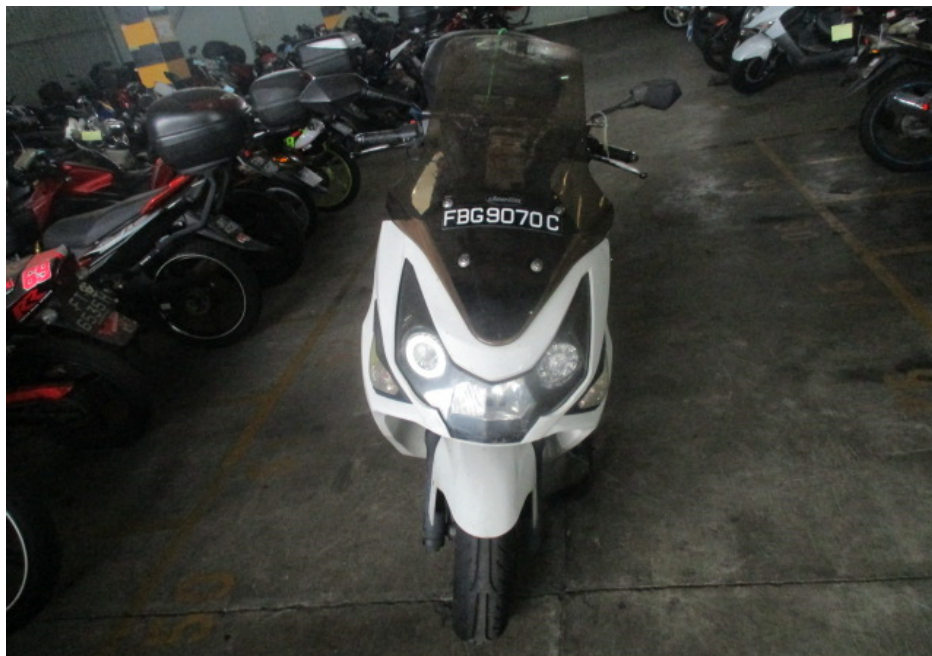
Photo 2 shows a general view of the front body of the Motorcycle at the time of our inspection. The Motorcycle was observed to have sustained minor damages at the frontal portion and left body.

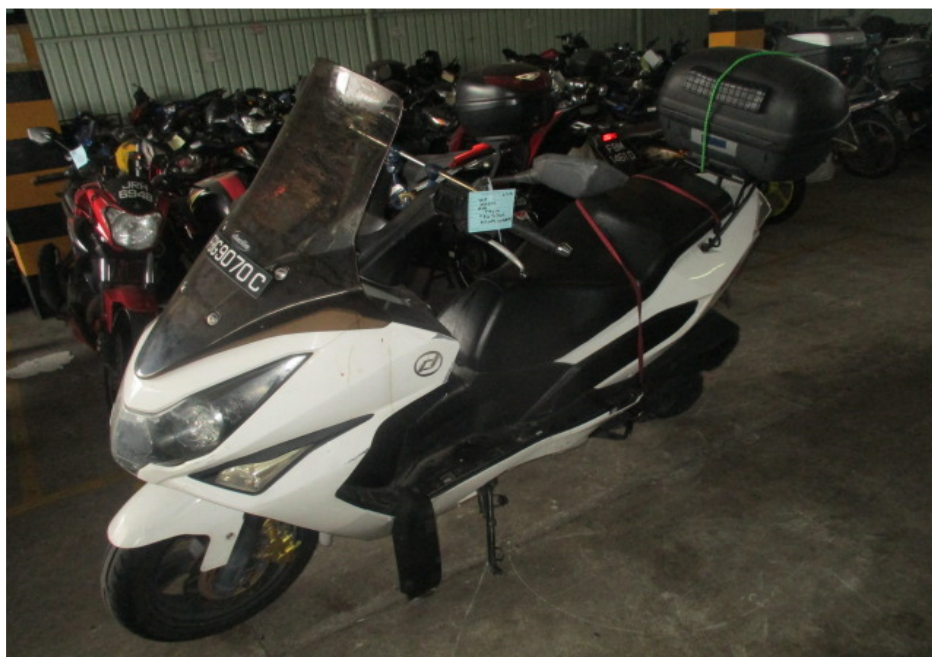
Photo 3 shows a general view of the left front body of the Motorcycle at the time of our inspection. The Motorcycle was observed to have sustained minor damages at the frontal portion and left body. The body parts that were found to have been damaged include its front mudguard, front brake lever, right side mirror, right cowling, right rear side cover, right pillion foot rest, exhaust muffler, top box rack and top box, amongst others as a result of the accident.

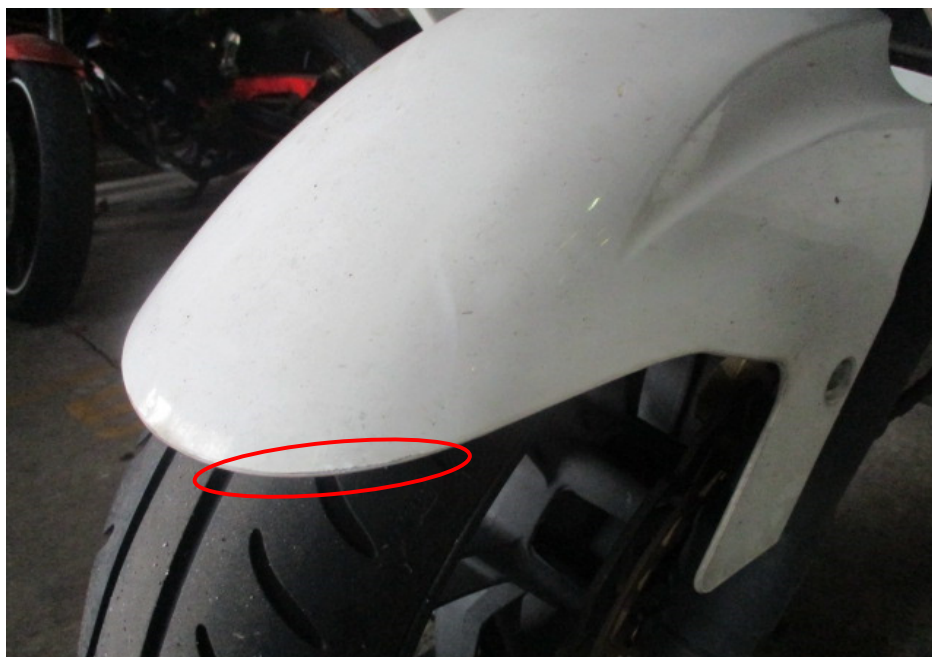
Photo 4 shows a closer view of the front mudguard which was amongst the body parts at the front body of the Motorcycle that had sustained damage as a result of the accident (circled).

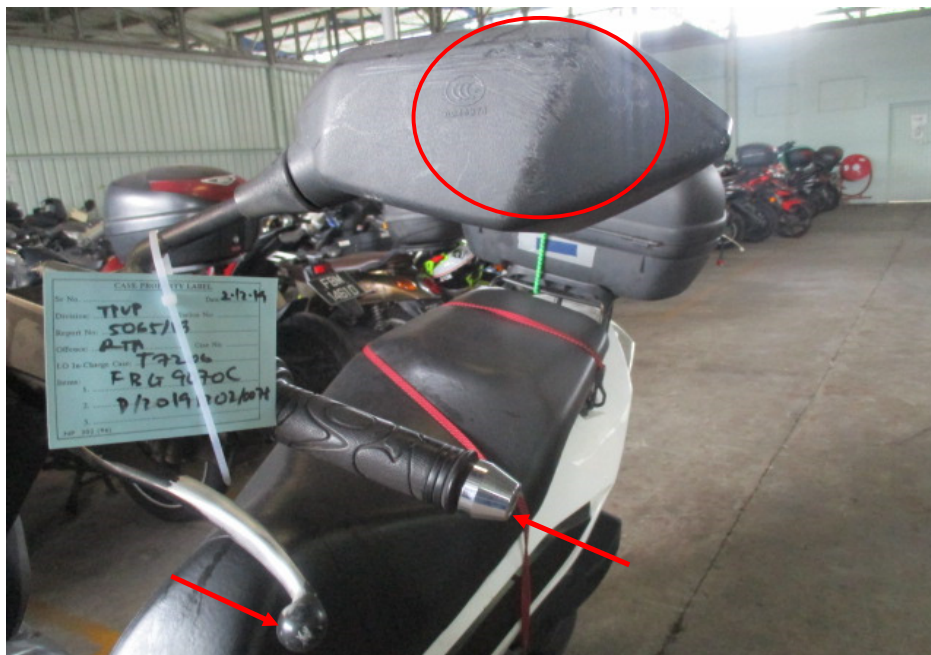
Photo 5 shows a closer view of the rear brake lever and left handlebar end (arrowed) as well as the left side mirror (circled) of the Motorcycle which were observed to be damaged due to the accident

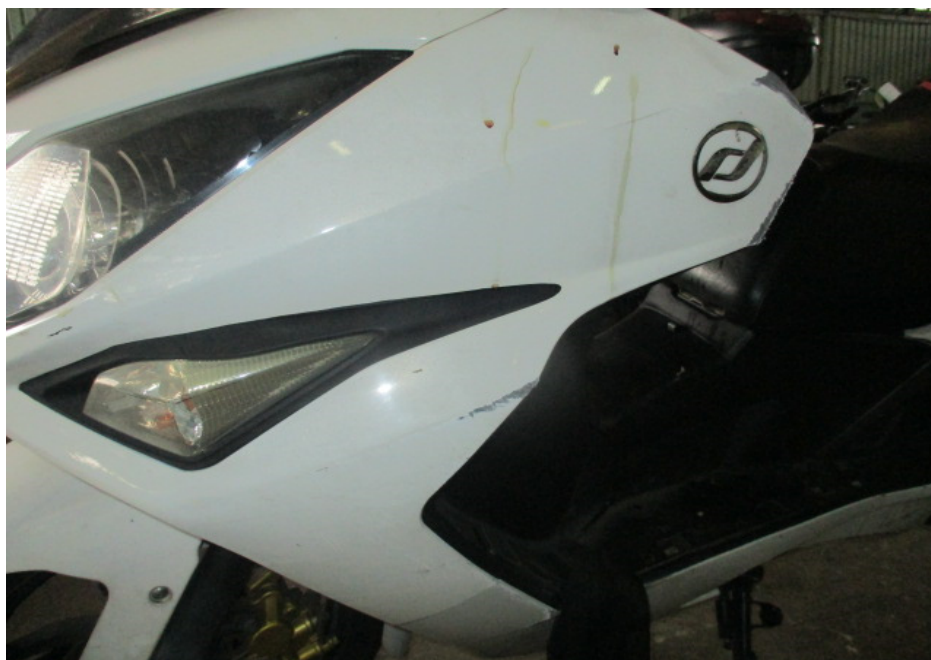
Photo 6 shows a closer view of the left cowling which was amongst the body parts at the front body of the Motorcycle that had sustained damage as a result of the accident.

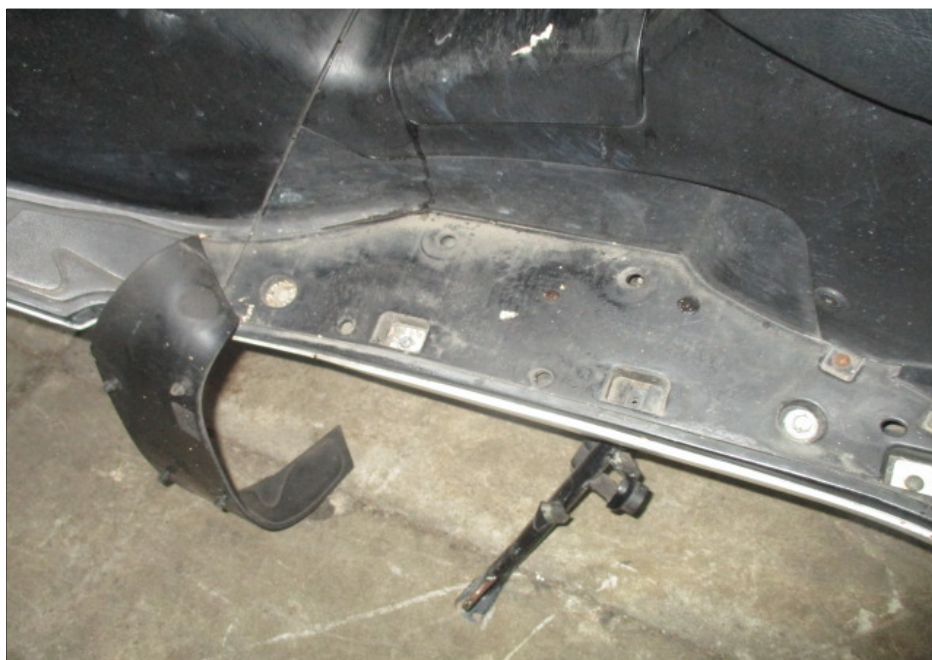
Photo 7 shows a closer view of the left rider step plate of the Motorcycle which was observed to be damaged due to the accident.

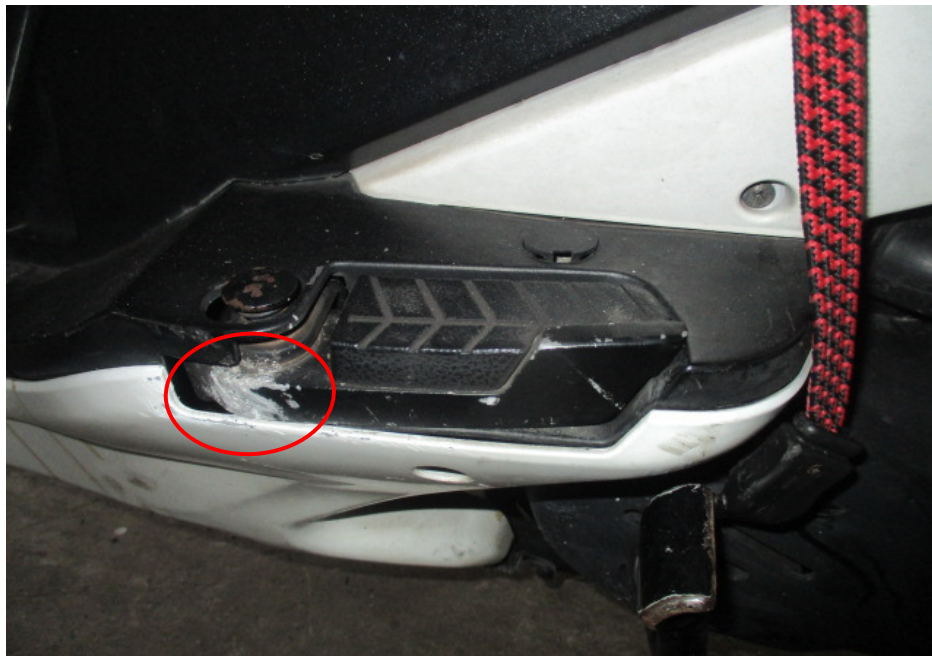
Photo 8 shows a closer view of the damaged left pillion footrest (circled) of the Motorcycle at the time of our inspection.

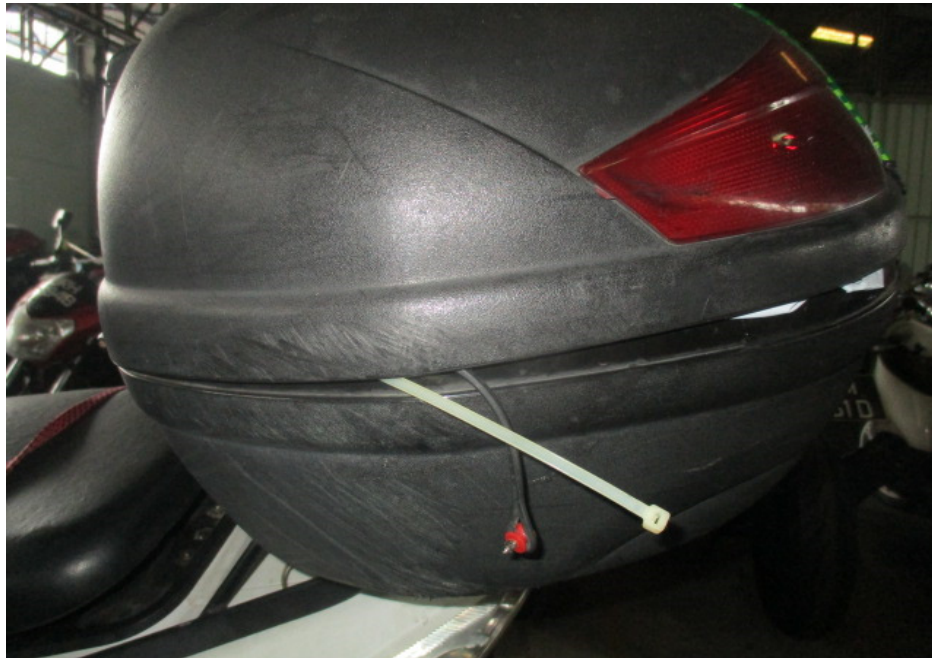
Photo 9 shows a closer view of the top box of the Motorcycle which was observed to have sustained scratches due to the accident.

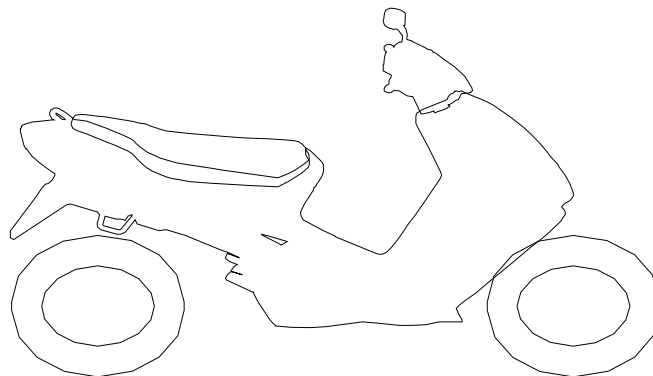
6. The condition of the Motorcycle's 2 tyres was observed to be in serviceable condition. The tread pattern of the 2 tyres was clearly visible. We did not observe any tear, burst mark(s) and/or punctured hole(s) on the sidewalls as well as across the tread of the 2 tyres. The 2 tyres were both observed to be sufficiently inflated for vehicular operation. The tyre brand, tyre size and remaining tread depth of the 2 tyres were recorded as follows:-

Pirelli 140/60 - 13 (5mm)

Michelin 120/70 - 14 (4mm)

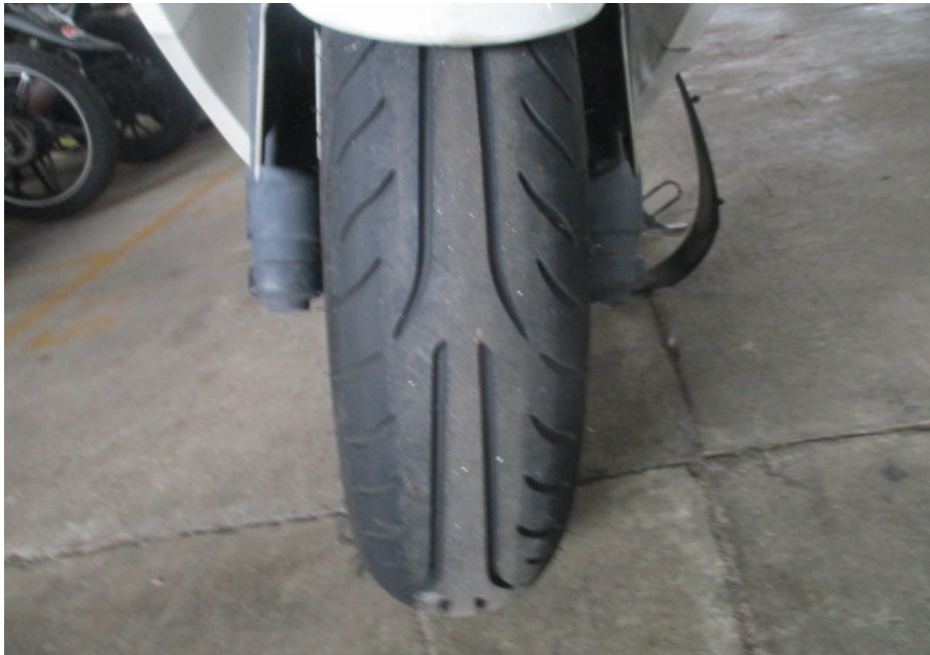
Photo 10 shows the condition of the Motorcycle's front tyre. The front tyre was observed to be in serviceable condition with remaining tread depth of approximately 4mm. There was no tear, burst mark(s) and/or punctured hole(s) on the sidewalls as well as across the tread of the front tyre.

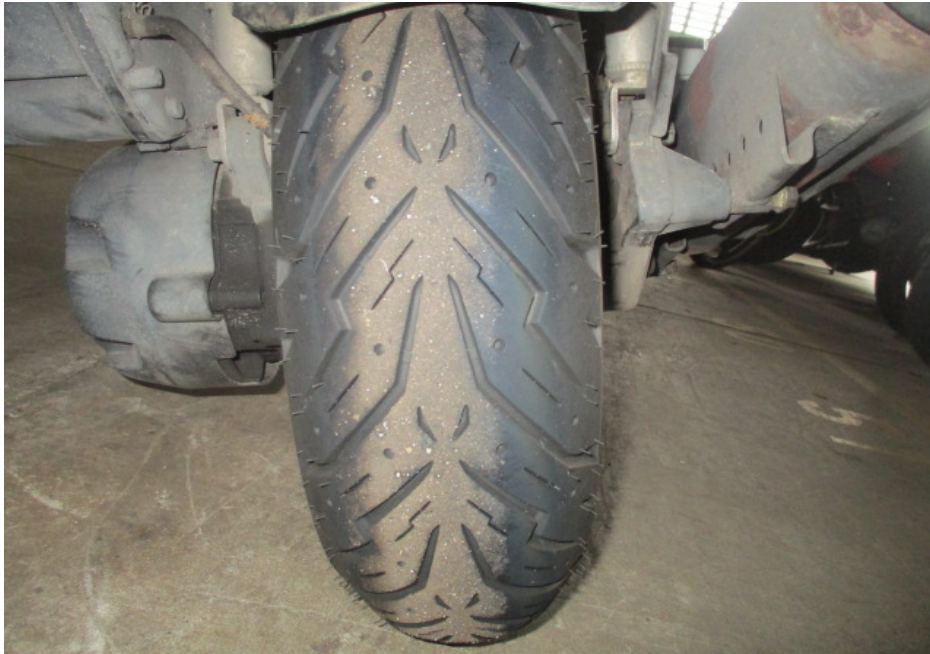
Photo 11 shows the condition of the Motorcycle's rear tyre. The rear tyre was observed to be in serviceable condition with remaining tread depth of approximately 5mm. The tyre was also observed to be sufficiently inflated for vehicular operation. We did not observe any tear, burst mark(s) and/or punctured hole(s) on the sidewalls as well as across the tread of the rear tyre.

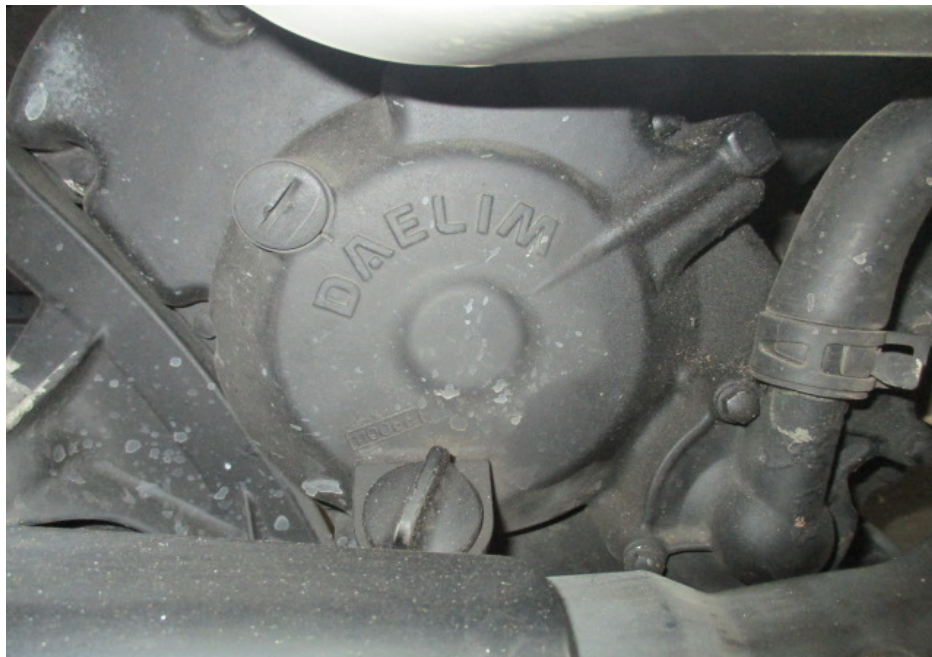
Photo 12 shows the right side of the engine of the Motorcycle at the time of our inspection. The various engine related parts and components were found to be intact with no visible damage. There was also no sign(s) or indication(s) of fluid leak observed around the right engine area of the Motorcycle.

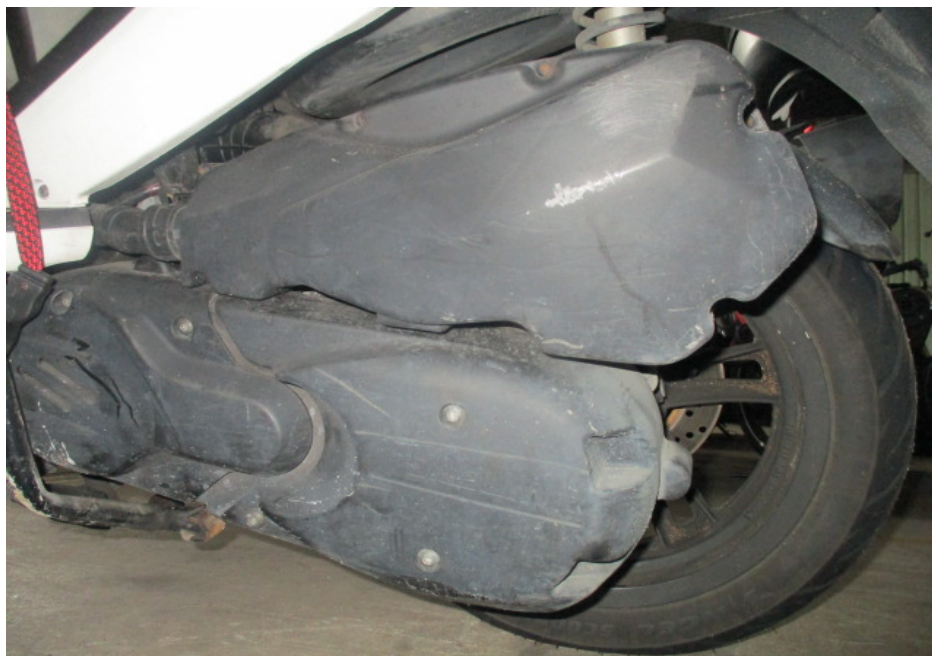
Photo 13 shows the drive train of the Motorcycle which was found to be intact without any misalignment.

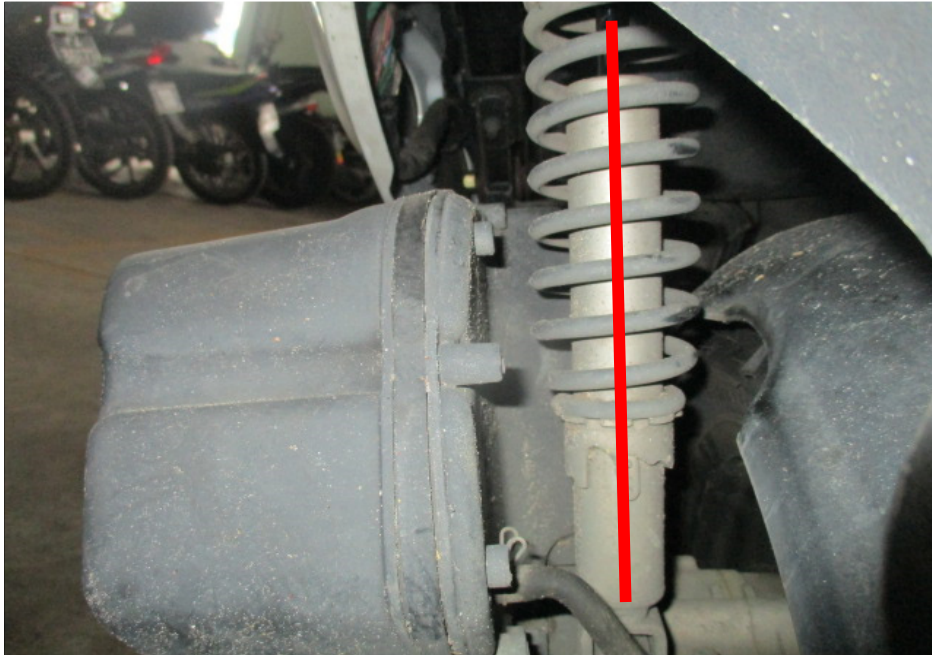
Photo 14 shows the left shock absorber of the motorcycle which was found to be intact without any misalignment.

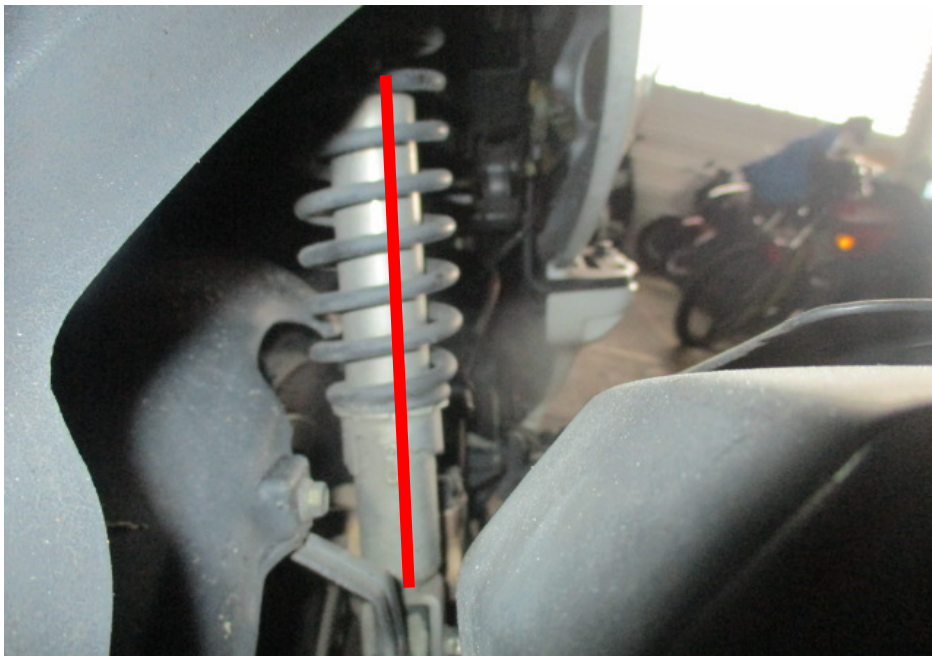
Photo 15 shows the right shock absorber of the motorcycle which was found to be intact without any misalignment.

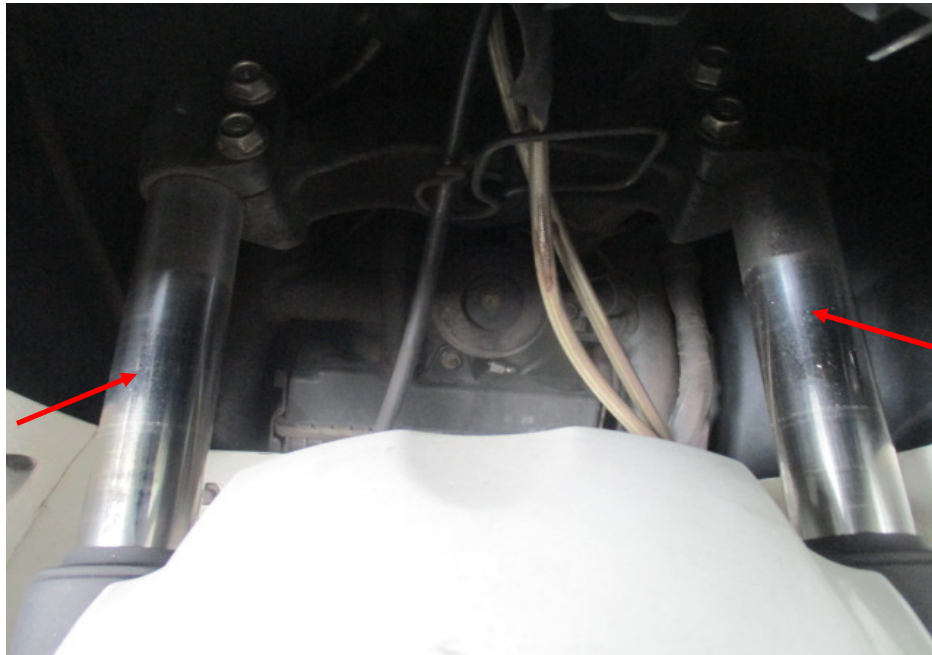
Photo 16 shows the front forks (arrowed) of the Motorcycle. The front forks and fork brackets of the Motorcycle were both found to be intact and undamaged. Turning the Motorcycle's handle bar towards the left and right did not produce any abnormal free play and/or resistance. The steering system of the Motorcycle was in serviceable condition at the time of our inspection.

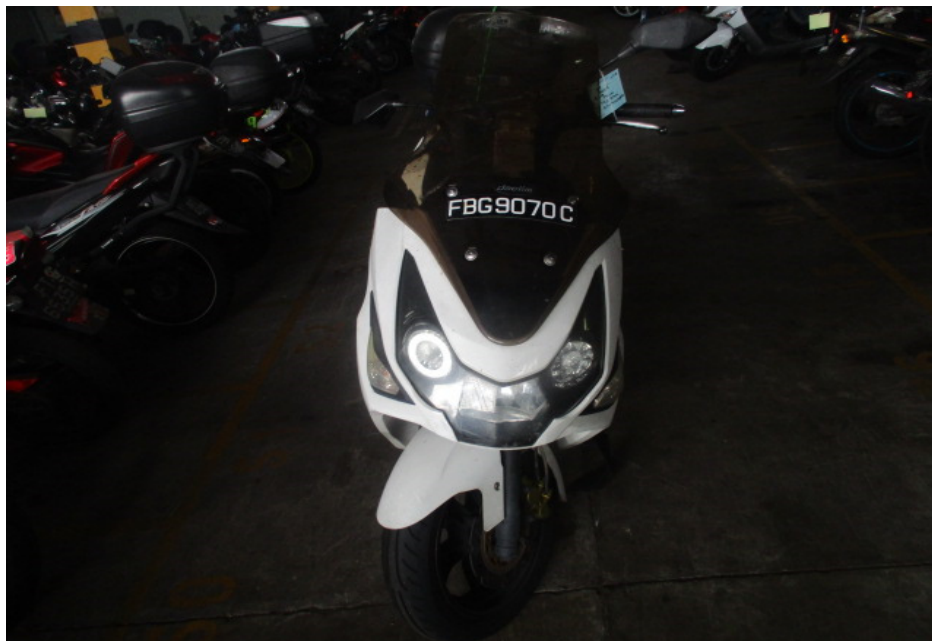
Photo 17 shows the front wheel of the Motorcycle turned towards its full right. Turning the Motorcycle's handle bar towards the left and right did not produce any abnormal free play and/or resistance. This would indicate that the steering system of the Motorcycle was in serviceable condition at the time of our inspection.

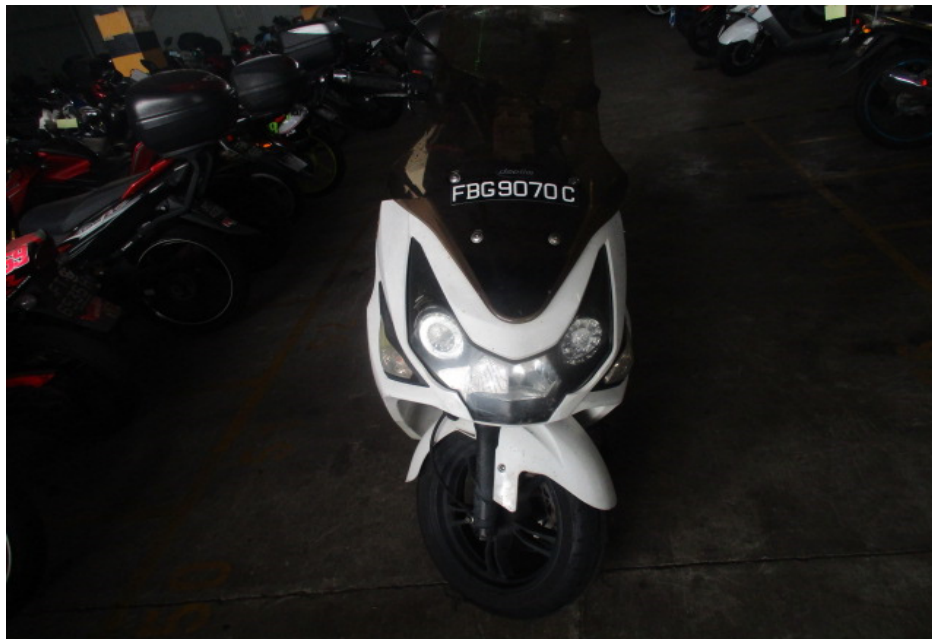
Photo 18 shows the front wheel of the Motorcycle turned towards its full left. Turning the Motorcycle's handle bar towards the left and right did not produce any abnormal free play and/or resistance. This would indicate that the steering system of the Motorcycle was in serviceable condition at the time of our inspection.

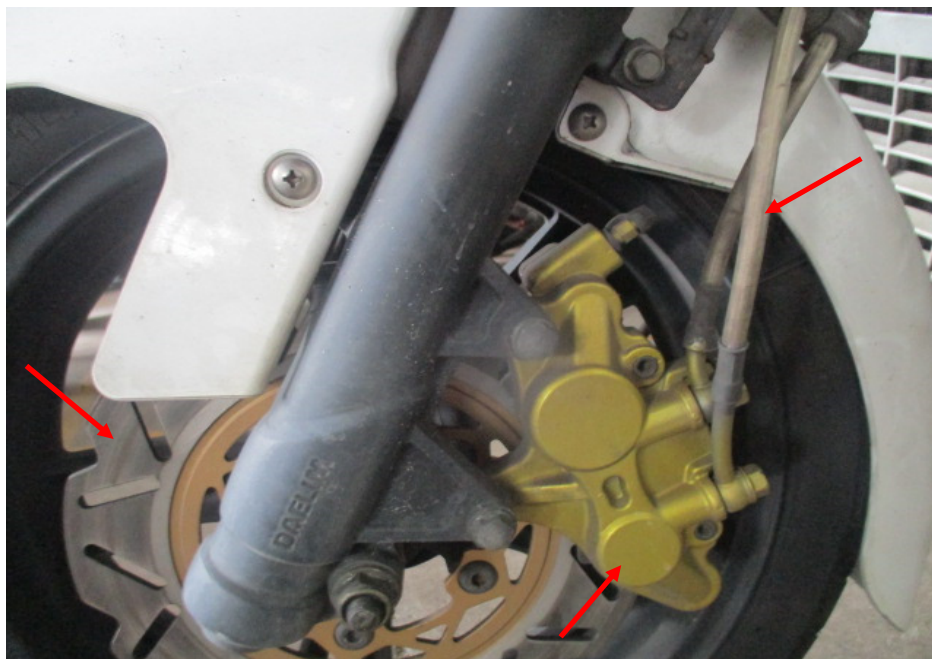
Photo 19 shows a close up view of the front brake caliper, front brake disc and front brake hose (arrowed) of the Motorcycle, which are all part of the components in the hydraulic front brake system of the Motorcycle. Our visual checks of these various components had revealed all to be intact with no visible damage. No leakage of brake fluid was also observed.

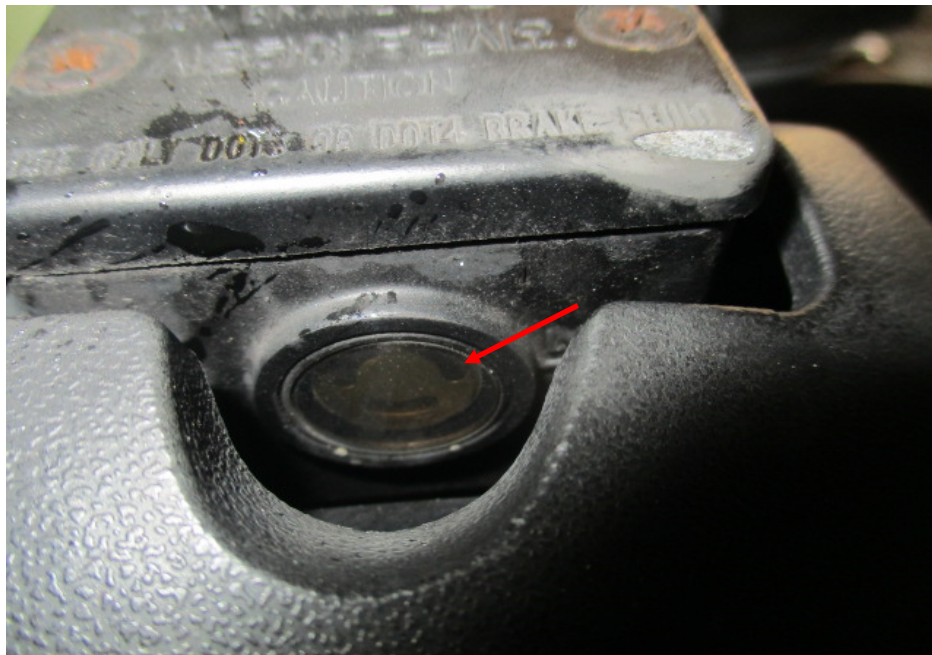
Photo 20 shows the brake fluid reservoir for the rear brake of the Motorcycle. The brake fluid was observed to be of sufficient level and without contamination for operational purposes (arrowed).

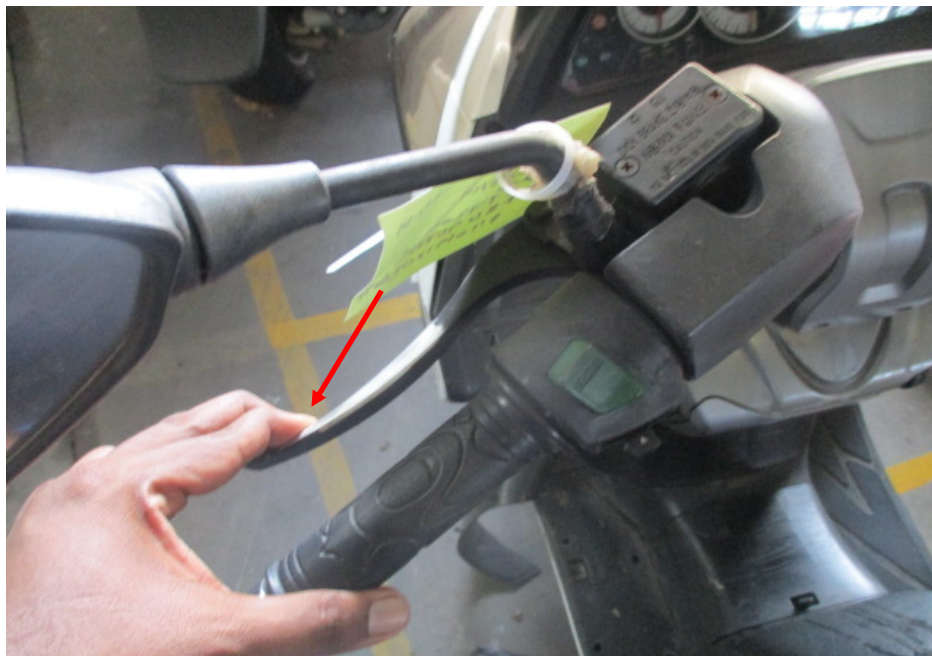
Photo 21 shows the rear brake lever being depressed. There was some resistance felt (spongy like feel) upon pressing the rear brake lever (arrowed). This would indicate that there is no leakage of pressure/vacuum in the brake system.

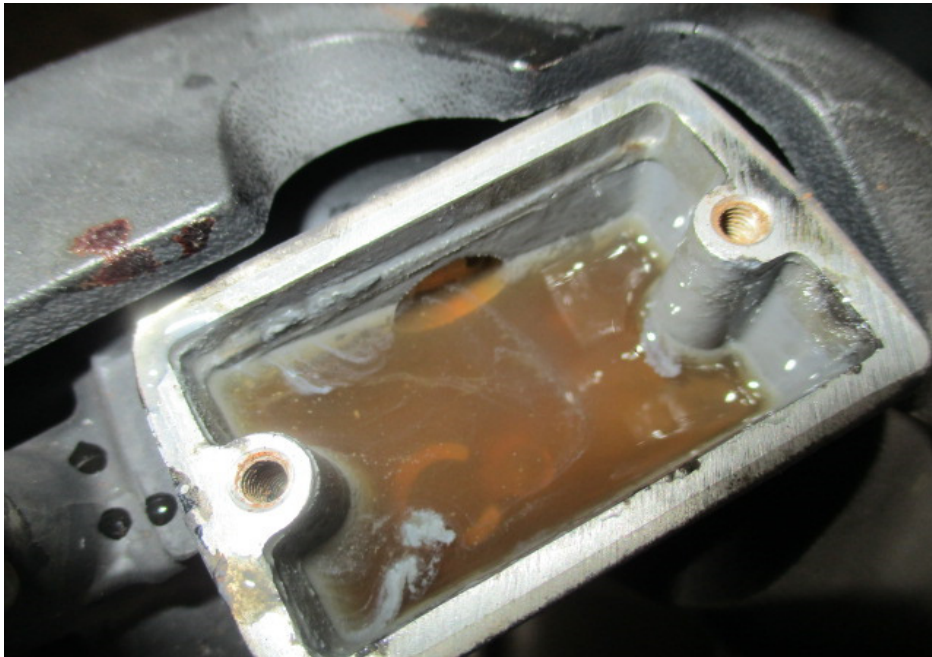
Photo 22 shows the brake fluid reservoir for the front brake of the Motorcycle. The brake fluid was observed to be of sufficient level and without contamination for operational purposes.

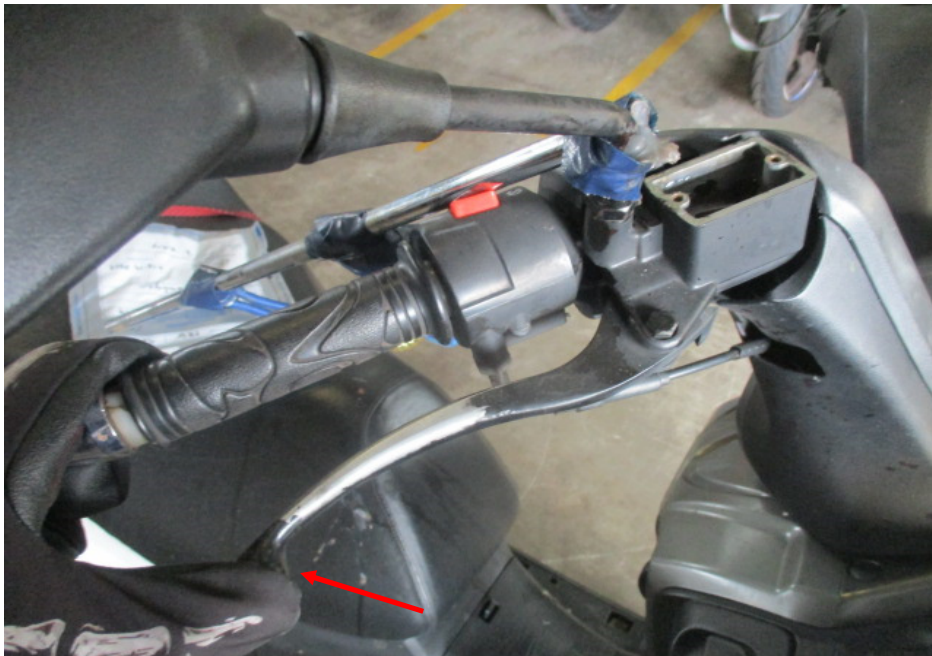
Photo 23 shows the front brake lever being depressed. There was some resistance felt (spongy like feel) upon pressing the front brake lever (arrowed). This would indicate that there is no leakage of pressure/vacuum in the brake system.

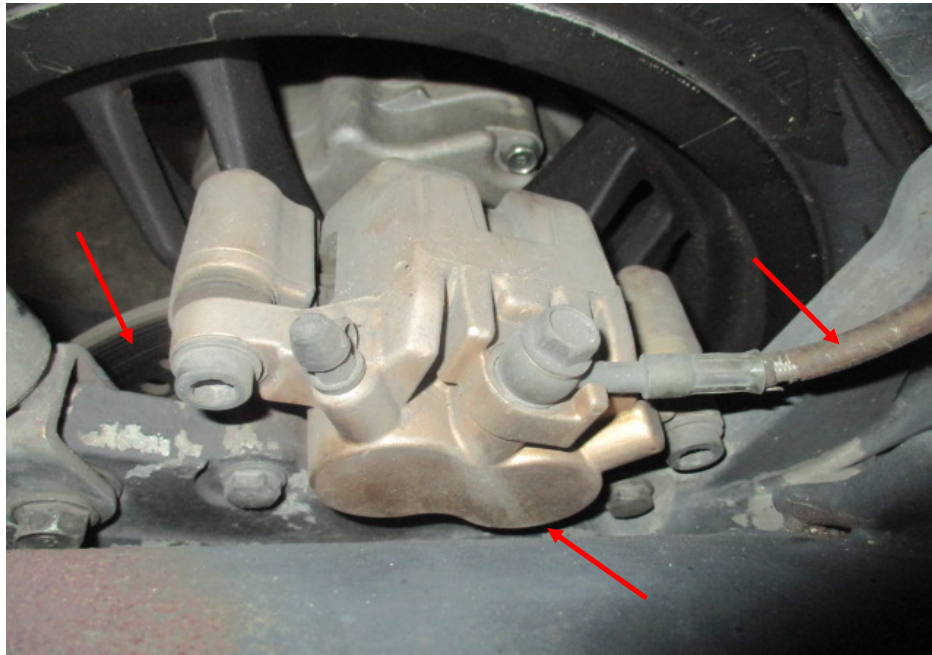
Photo 24 shows a close up view of the rear brake caliper, rear brake disc and rear brake hose (arrowed) of the Motorcycle, which are all part of the components in the hydraulic rear brake system of the Motorcycle. Our visual checks of these various components revealed all to be intact with no visible damage. No leakage of brake fluid was also observed.
