Your Ref: TP/IP/59379/2019
Our Ref : CI/TPD19022286/N

Fatal Accident Investigation Team

INSPECTION REPORT OF MOTORCYCLE FBE 735M

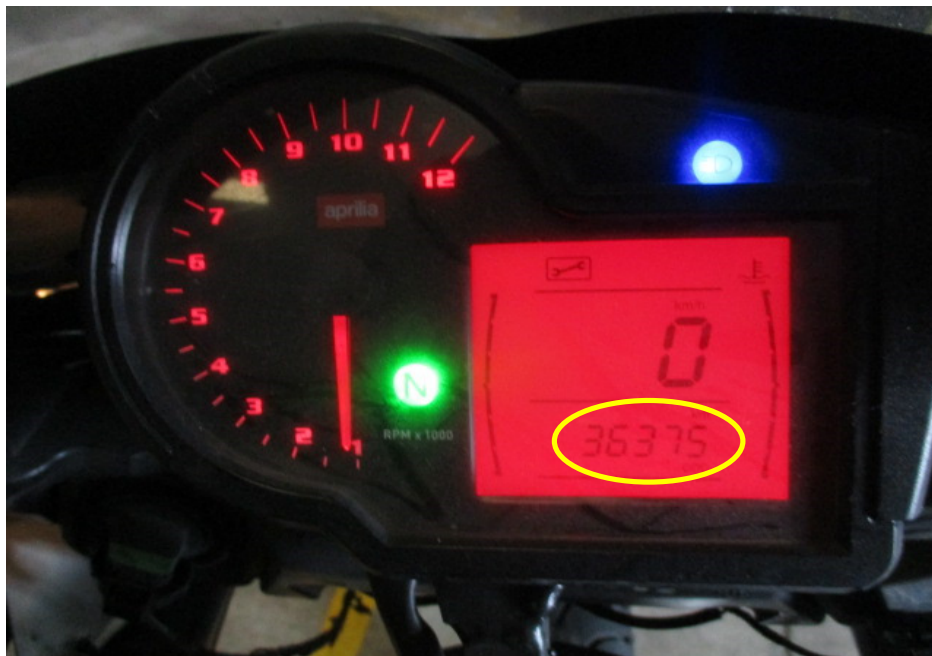
Photo 1 shows the speedometer gauge of the Motorcycle where the mileage recorded at the time of our inspection was 36, 375km (circled).

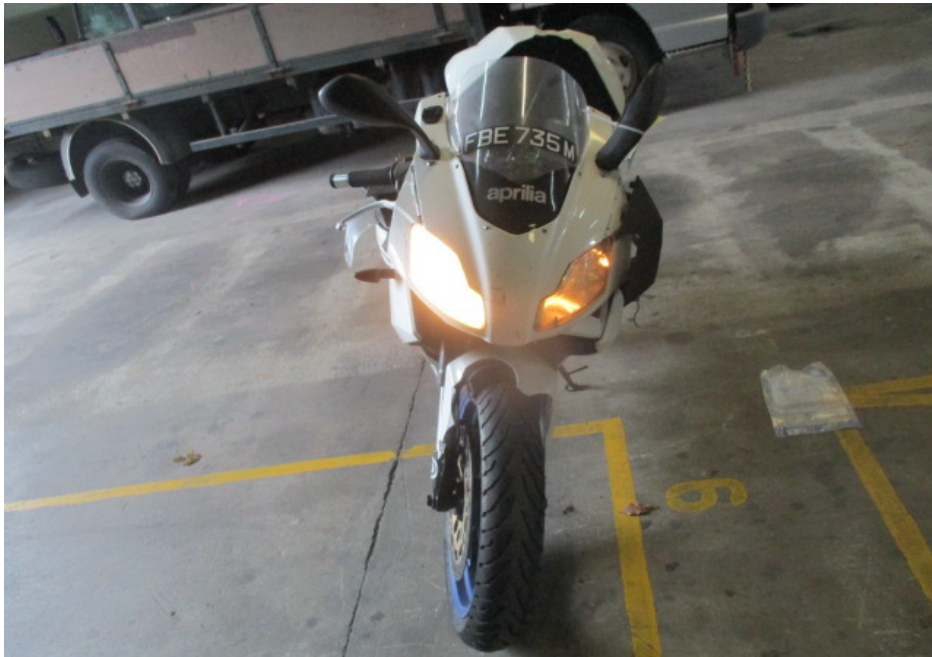
Photo 2 shows a general view of the frontal portion of the Motorcycle at the time of our inspection. The Motorcycle was observed to have sustained damages all around.

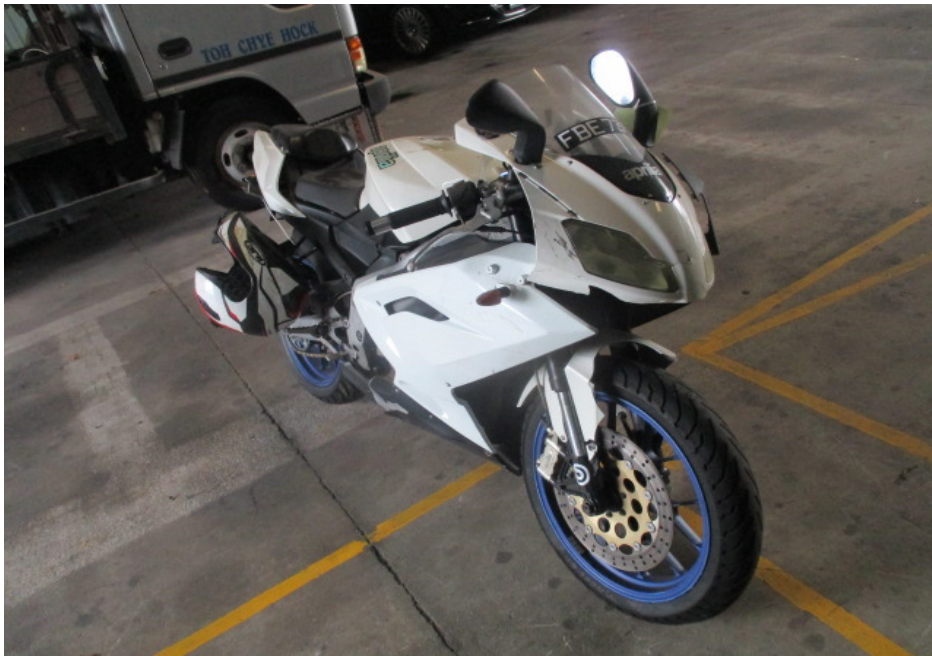
Photo 3 shows a general view of the right front body of the Motorcycle at the time of our inspection. The Motorcycle was observed to have sustained damages all around.

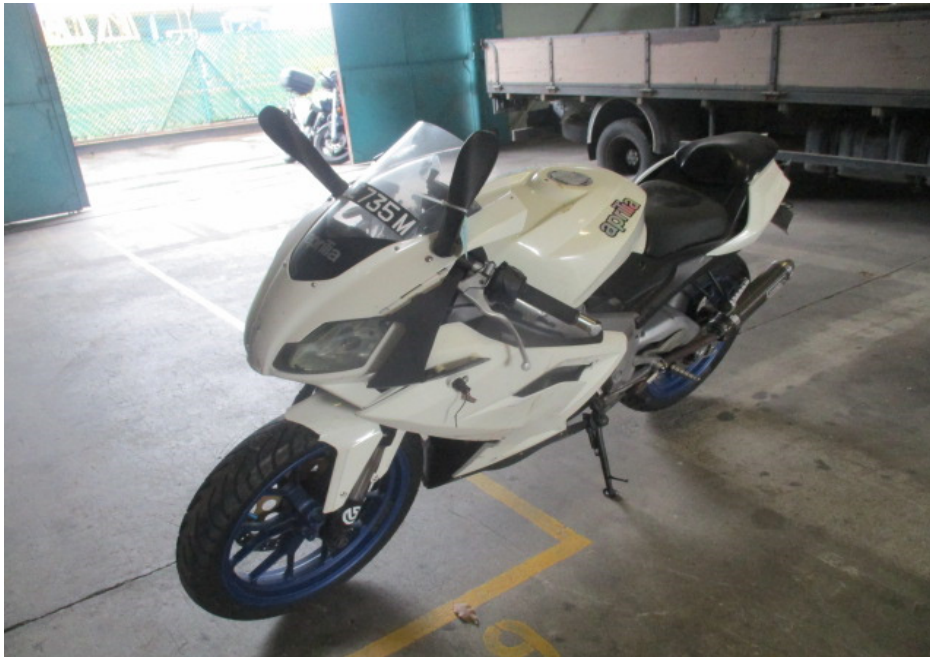
Photo 4 shows a general view of the left front body of the Motorcycle at the time of our inspection. The Motorcycle was observed to have sustained damages all around. Amongst the body parts that were found to have been damaged include its head cowl, front mudguard, side cowlings, left handlebar end, left side mirror, clutch lever, gear shift pedal, rear side covers, rear cover, exhaust muffler, rear number plate and tail light, amongst others.

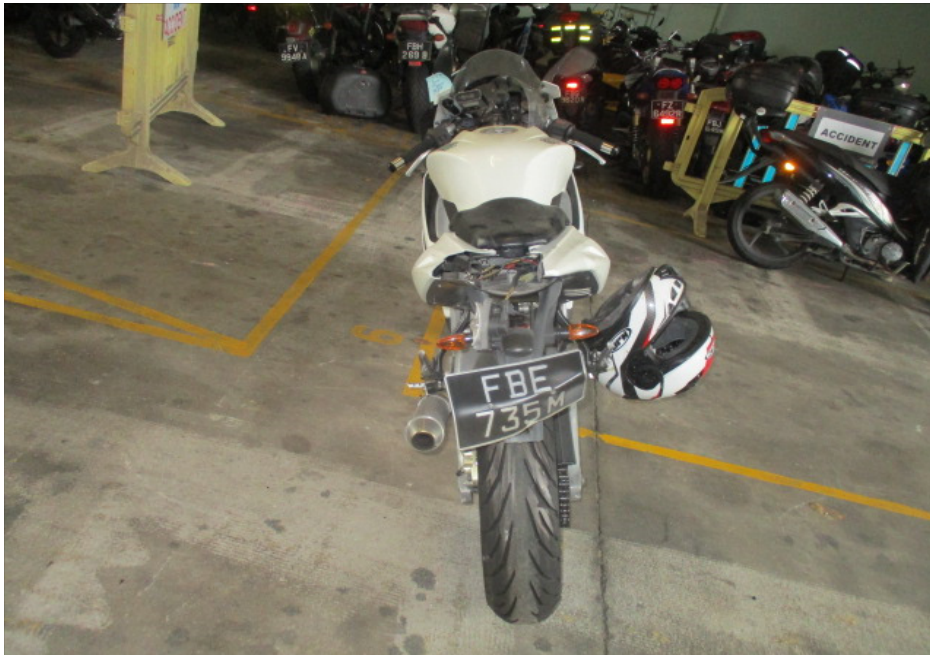
Photo 5 shows a general view of the rear portion of the Motorcycle at the time of our inspection. The Motorcycle was observed to have sustained damages all around.

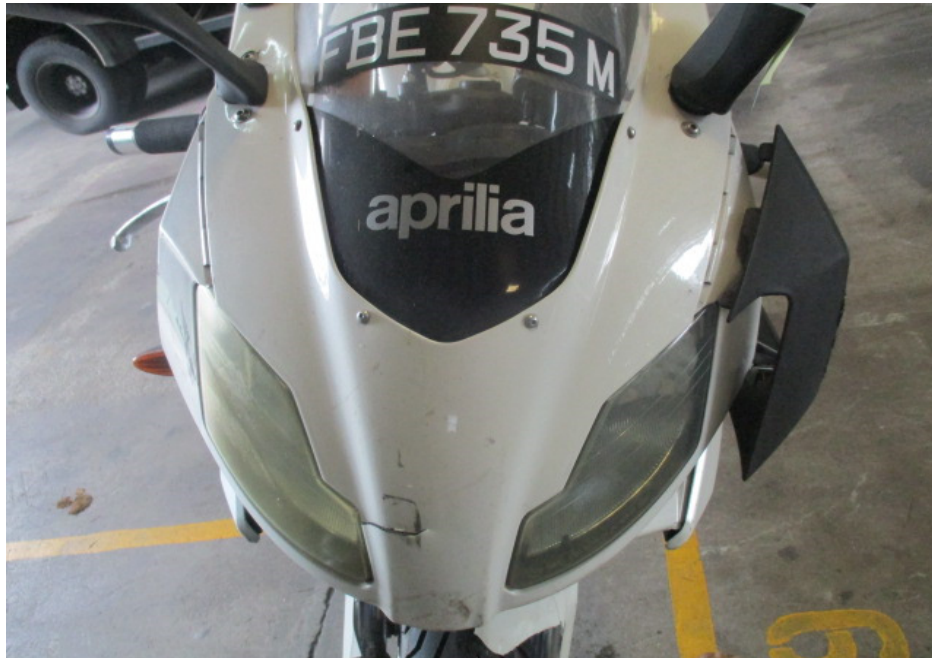
Photo 6 shows a close up view of the head cowling which was amongst the body parts of the Motorcycle that had sustained damage as a result of the accident.

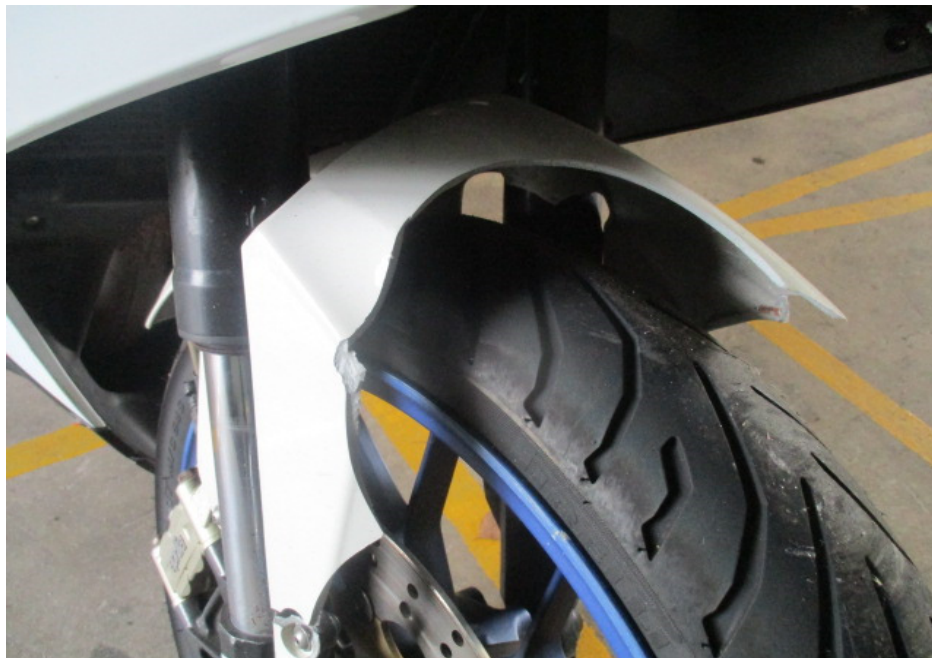
Photo 7 shows a closer view of the cracked front mudguard which was amongst the body parts at the front body of the Motorcycle that had sustained damage as a result of the accident.

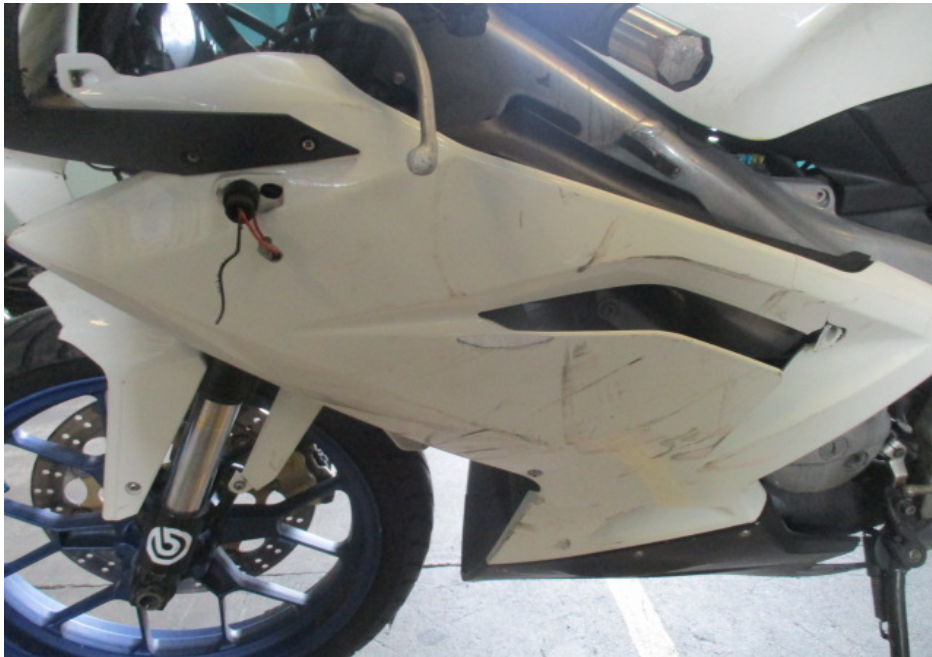
Photo 8 shows a closer view of the left cowling of the Motorcycle that had sustained damages of grazing nature as a result of the accident.

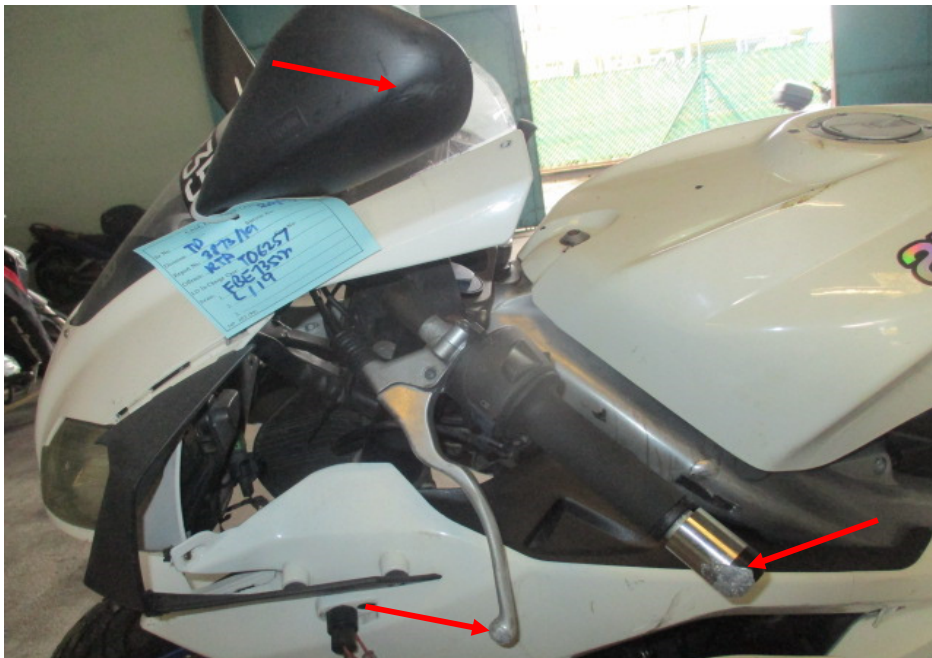
Photo 9 shows a closer view of the left handlebar end, clutch lever as well as left side mirror (arrowed) which were amongst the body parts of the Motorcycle that had sustained damage as a result of the accident.

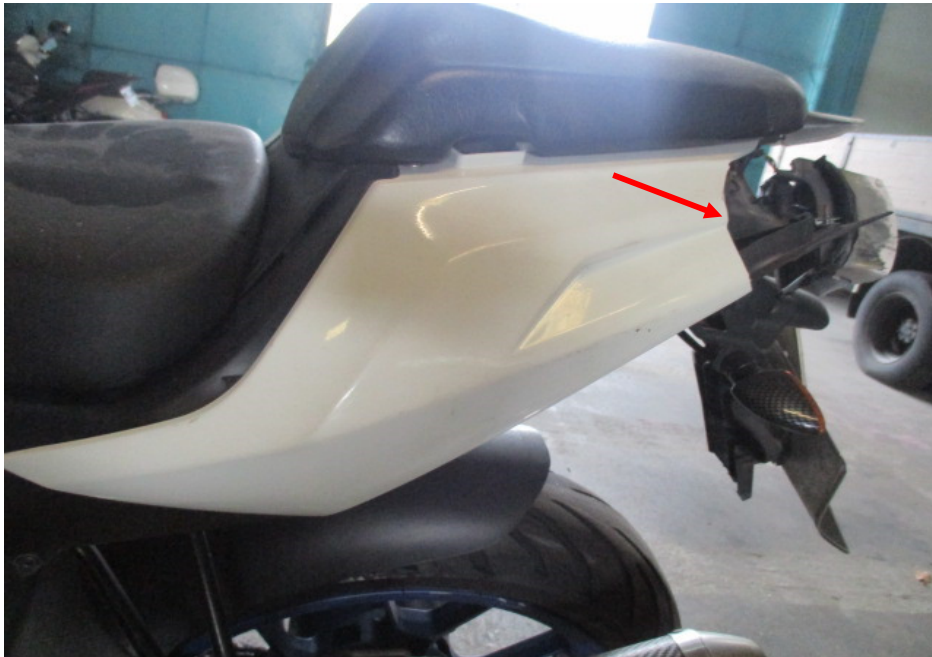
Photo 10 shows a closer view of the cracked left rear side cover (arrowed) of the Motorcycle as a result of the accident.

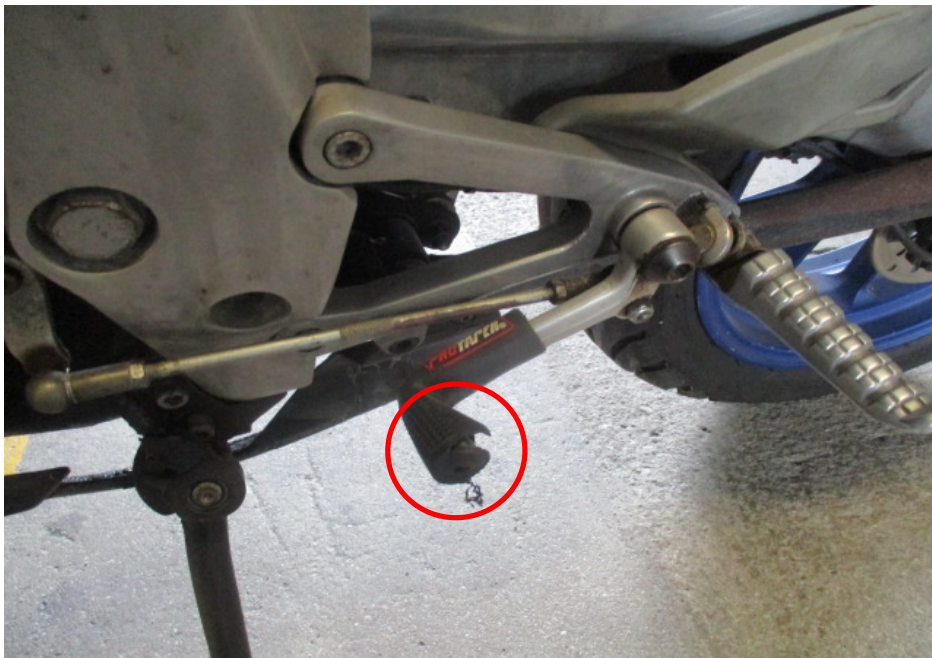
Photo 11 shows a closer view of the gear shift pedal (circled) which was amongst the body parts of the Motorcycle that had sustained damage as a result of the accident.

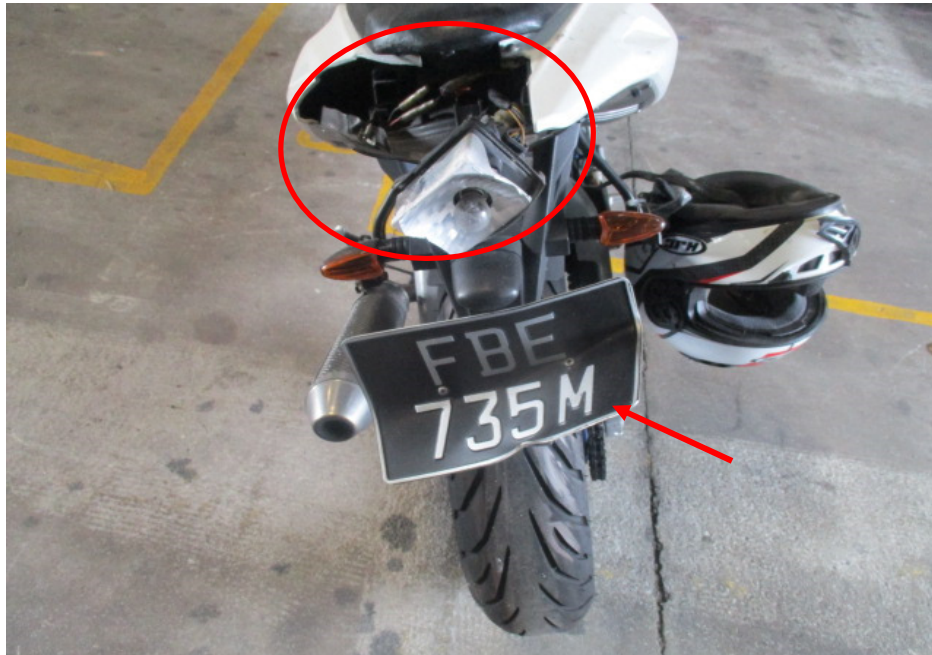
Photo 12 shows the cracked rear cover and tail light (circled) as well as the dented rear number plate (arrowed) of the Motorcycle as a result of the accident.

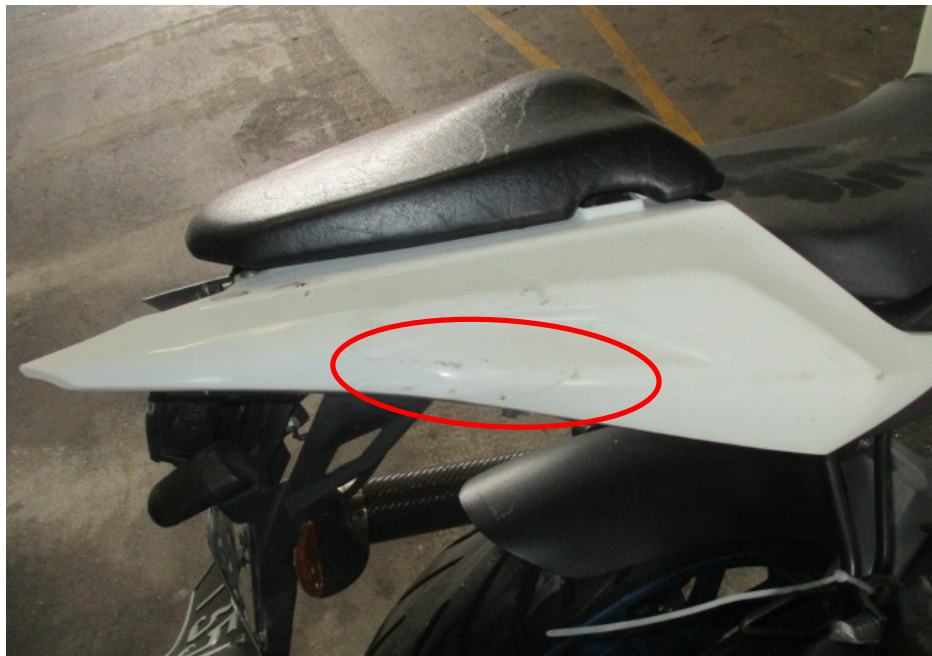
Photo 13 shows a closer view of the right rear side cover of the Motorcycle that had sustained damages of grazing nature as a result of the accident (circled).

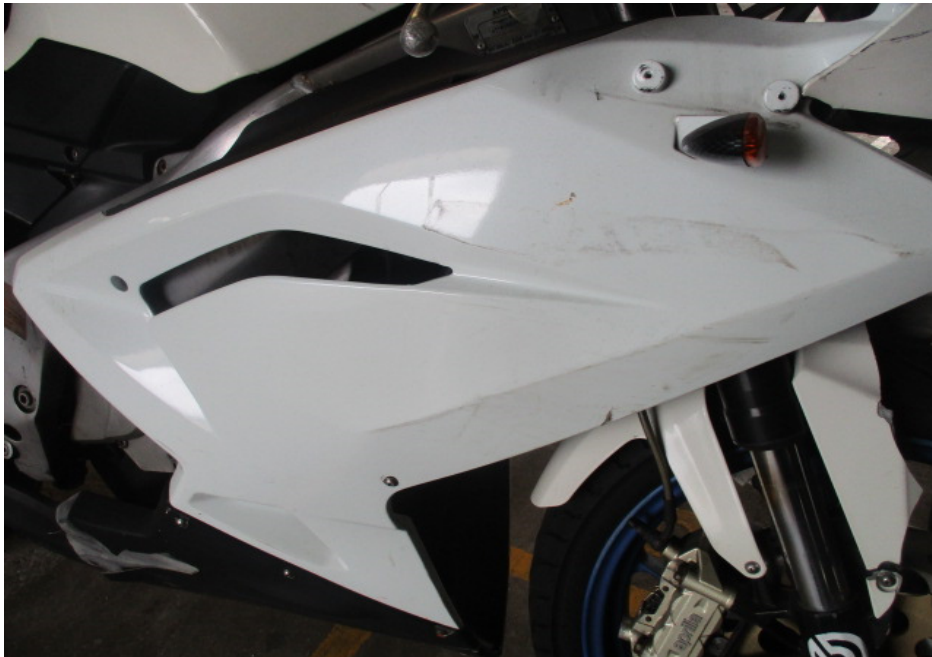
Photo 14 shows a closer view of the right cowling of the Motorcycle that had sustained damages of grazing nature as a result of the accident.

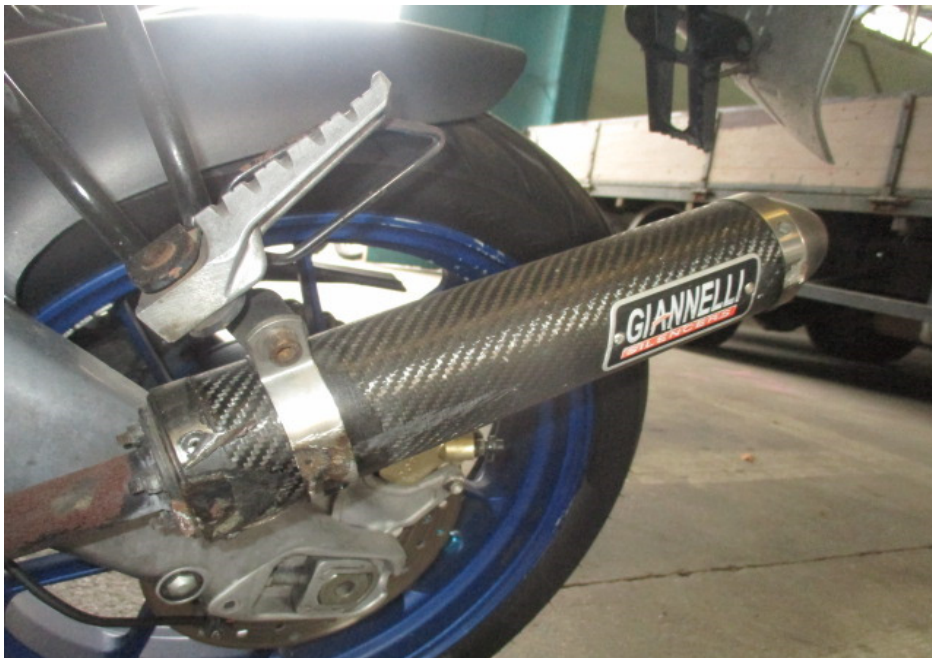
Photo 15 shows a closer view of the exhaust muffler of the Motorcycle that had sustained damages of grazing nature as a result of the accident.

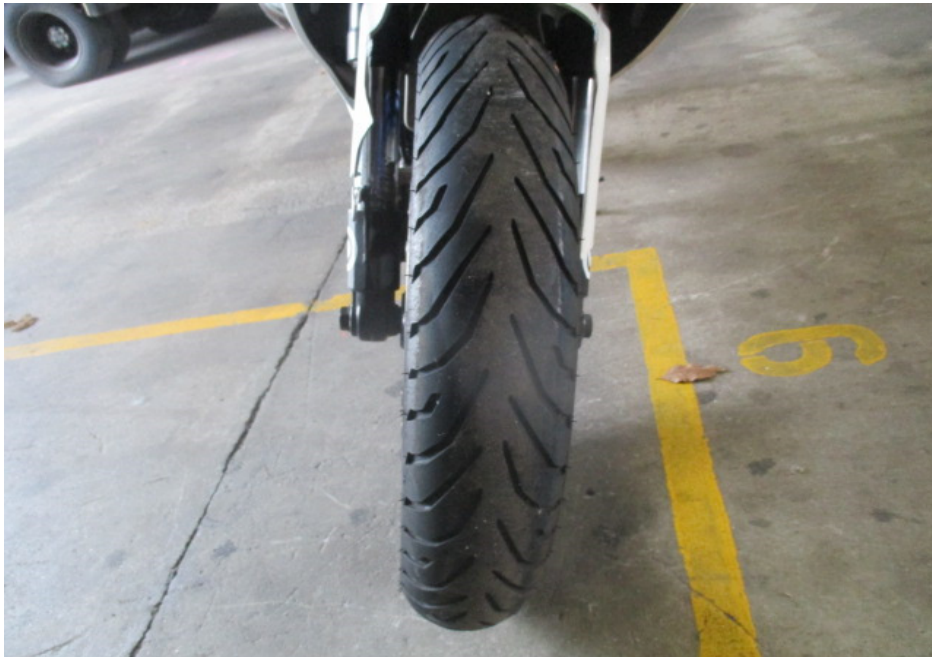
Photo 16 shows the condition of the Motorcycle's front tyre. The front tyre was observed to be in serviceable condition with remaining tread depth of approximately 4mm. There was no tear, burst mark(s) and/or punctured hole(s) on the sidewalls as well as across the tread of the front tyre.

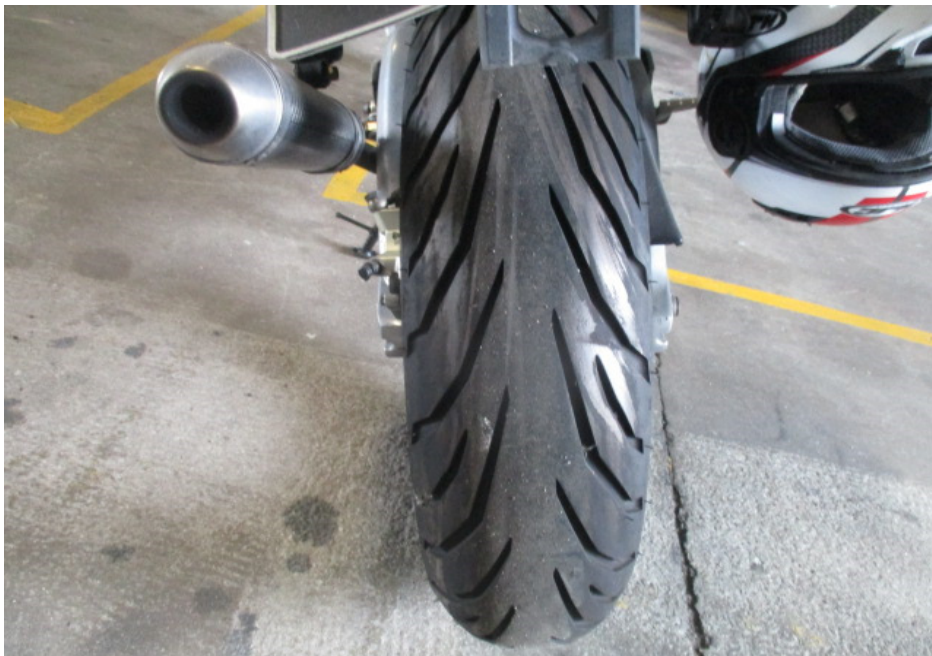
Photo 17 shows the condition of the Motorcycle's rear tyre. The rear tyre was observed to be in serviceable condition with remaining tread depth of approximately 5mm. The tyre was also observed to be sufficiently inflated for vehicular operation. We did not observe any tear, burst mark(s) and/or punctured hole(s) on the sidewalls as well as across the tread of the rear tyre.

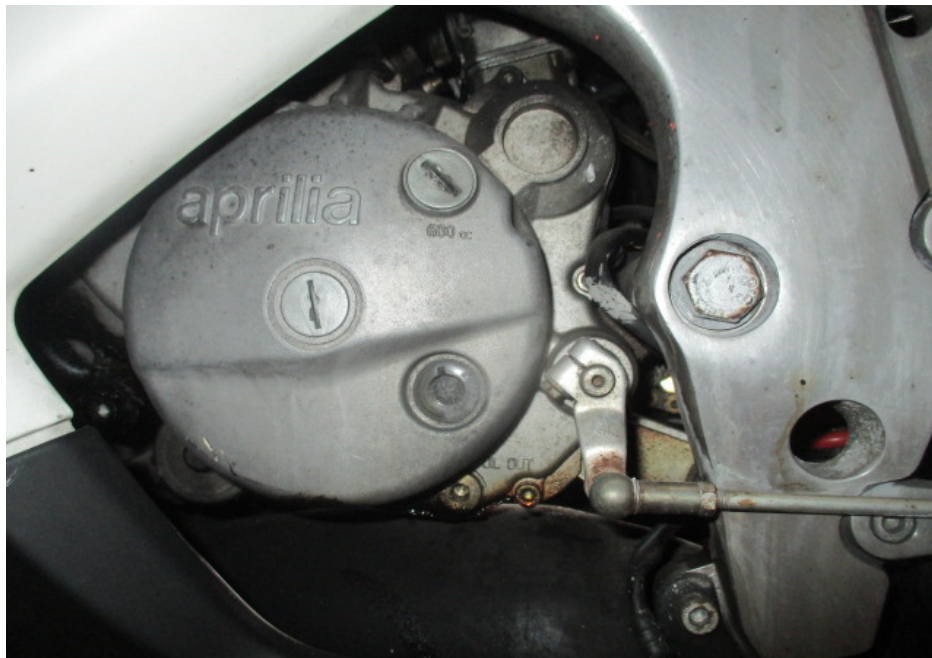
Photo 18 shows the left side of the engine of the Motorcycle at the time of our inspection. The various engine related parts and components were found to be intact with no visible damage. There was also no sign(s) or indication(s) of fluid leak observed around the left engine area of the Motorcycle.

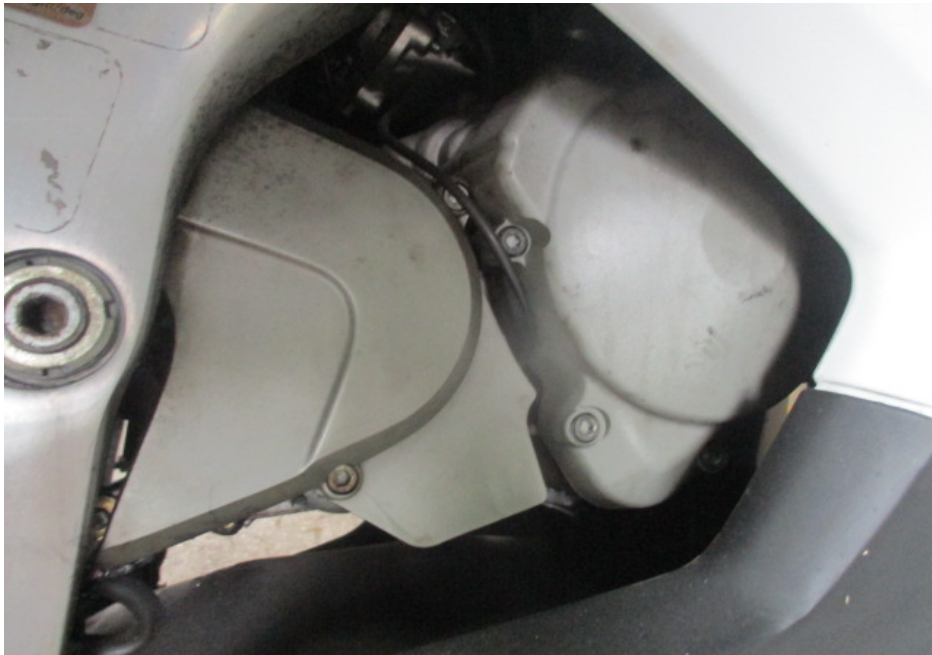
Photo 19 shows the right side of the engine of the Motorcycle at the time of our inspection. The various engine related parts and components were found to be intact with no visible damage. There was also no sign(s) or indication(s) of fluid leak observed around the right engine area of the Motorcycle.

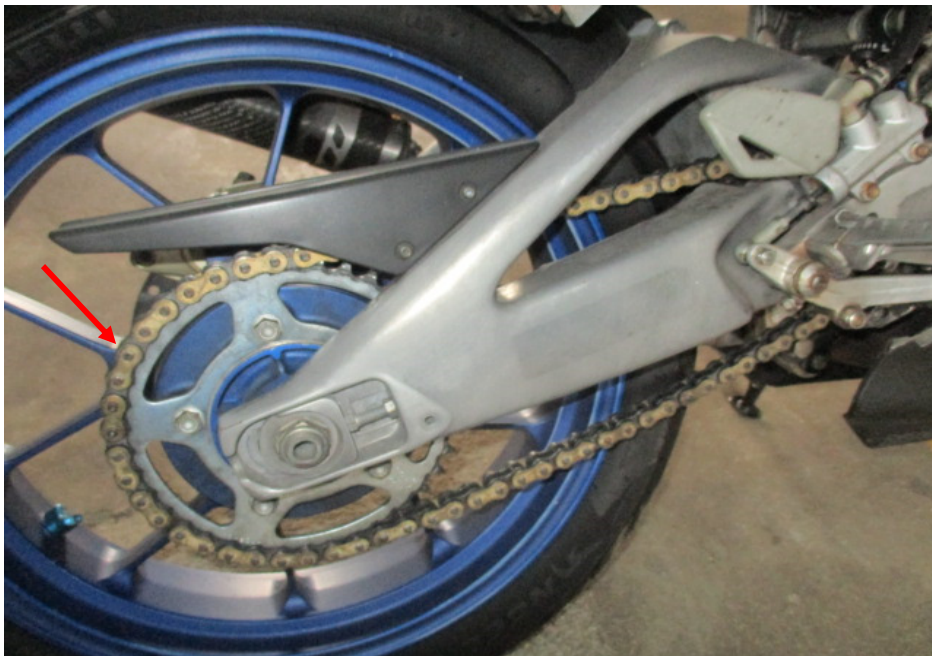
Photo 20 shows the general view of the gear train (arrowed) of the Motorcycle, which was observed to be intact with no misalignment. It was also adequately lubricated for operating purposes.

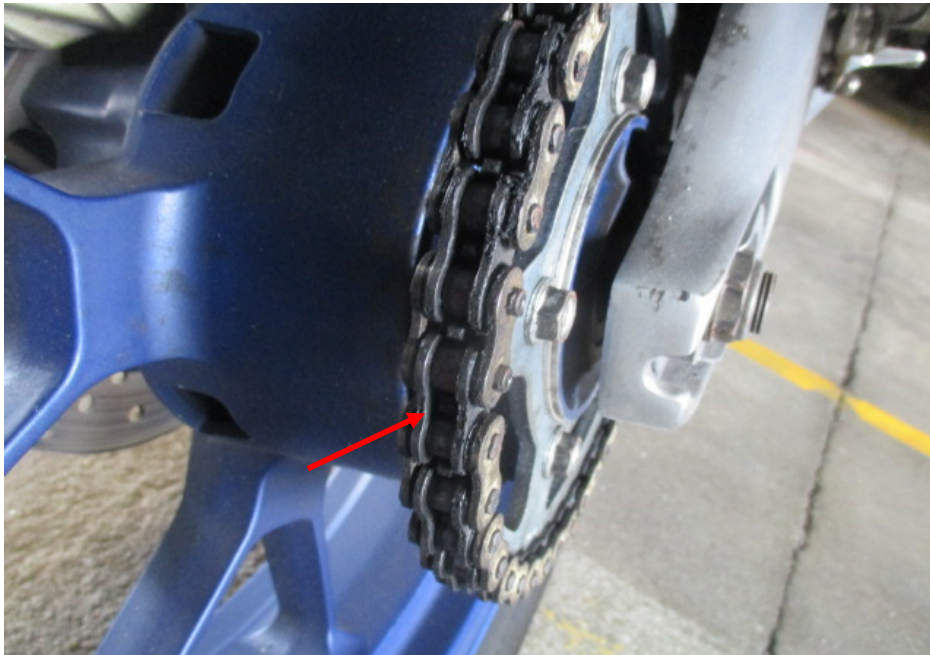
Photo 21 shows a closer view of the gear train (arrowed) of the Motorcycle, which was observed to be intact with no misalignment. It was also adequately lubricated for operating purposes.

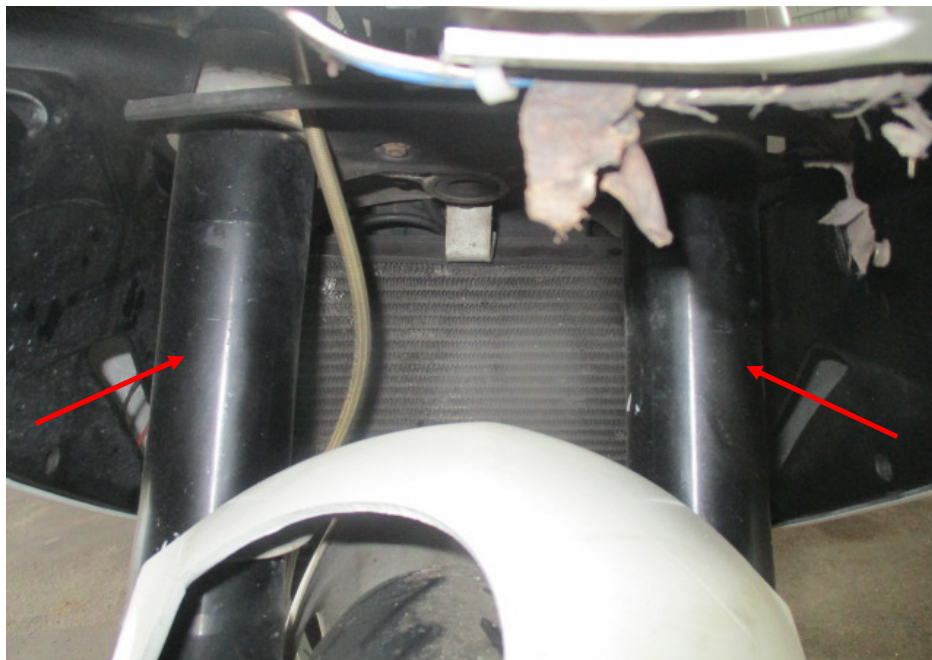
Photo 22 shows the front fork (arrowed) of the Motorcycle. The front fork and fork bracket of the Motorcycle were both found to be intact and undamaged. Turning the Motorcycle's handle bar towards the left and right did not produce any abnormal free play and/or resistance. The steering system of the Motorcycle was in serviceable condition at the time of our inspection.

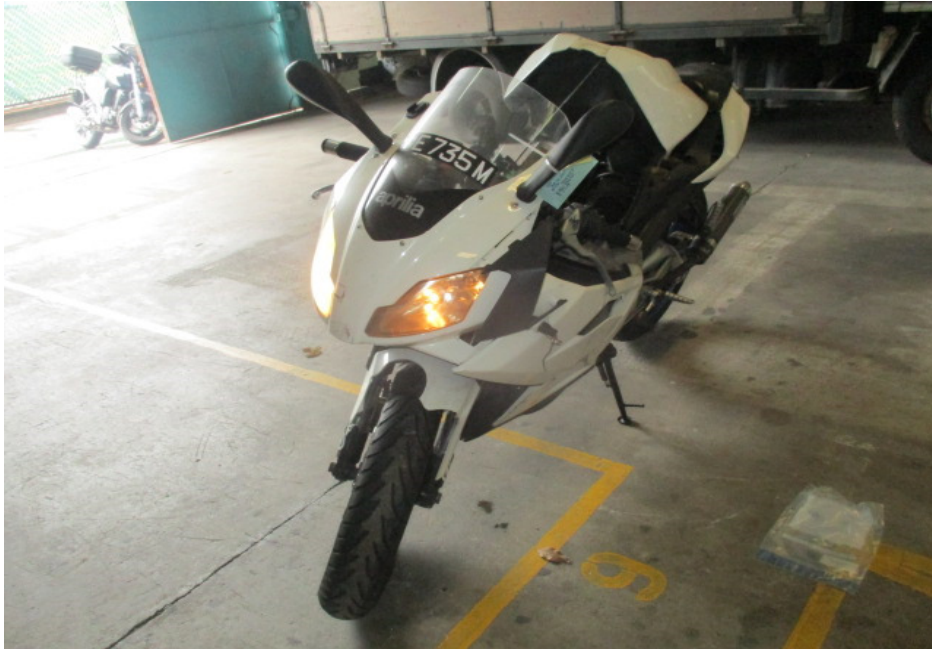
Photo 23 shows the front wheel of the Motorcycle turned towards its full left. Turning the Motorcycle's handle bar towards the left and right did not produce any abnormal free play and/or resistance. This would indicate that the steering system of the Motorcycle was in serviceable condition at the time of our inspection.

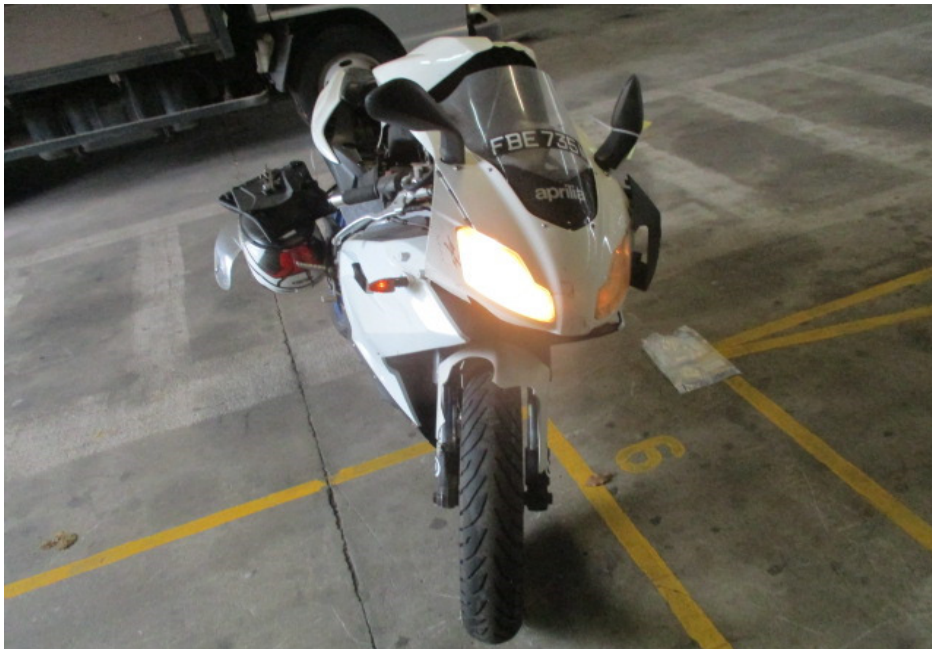
Photo 24 shows the front wheel of the Motorcycle turned towards its full right. Turning the Motorcycle's handle bar towards the left and right did not produce any abnormal free play and/or resistance. This would indicate that the steering system of the Motorcycle was in serviceable condition at the time of our inspection.

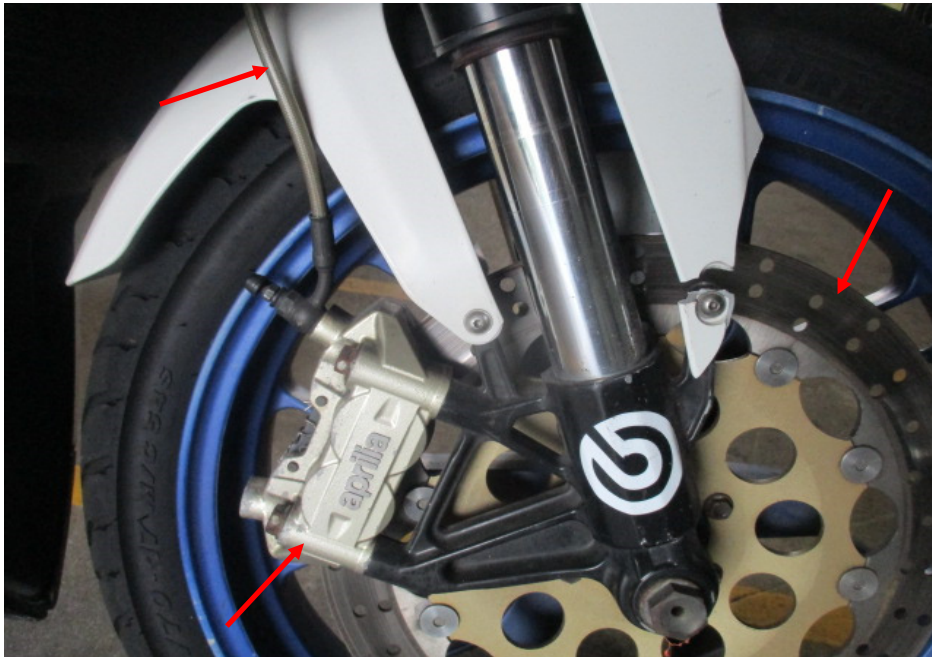
Photo 25 shows a close up view of the front brake caliper, front brake disc and front brake hose (arrowed) of the Motorcycle, which are all part of the components in the hydraulic front brake system of the Motorcycle. Our visual checks of these various components had revealed all to be intact with no visible damage. No leakage of brake fluid was also observed.

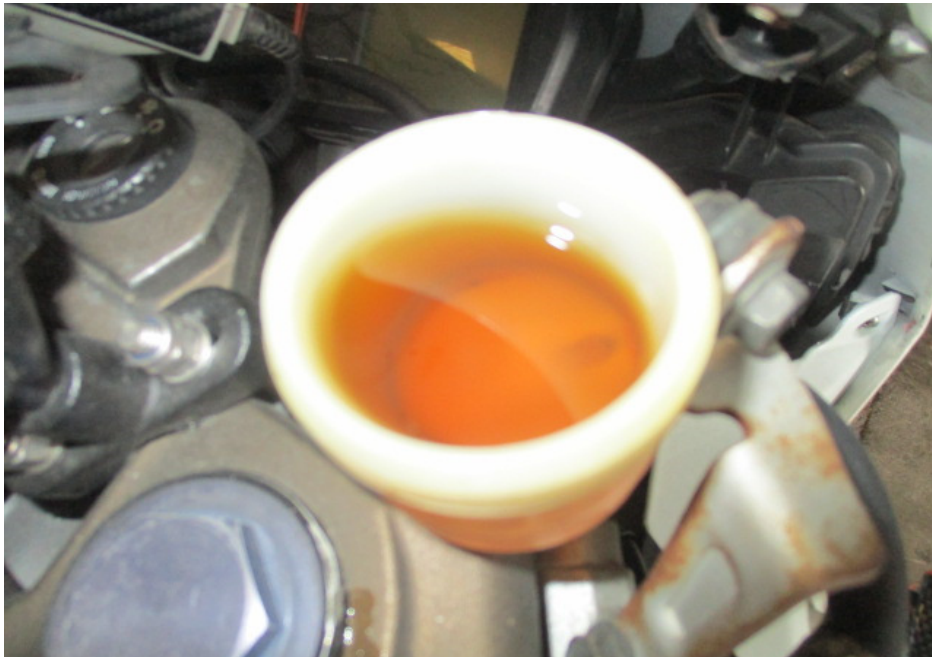
Photo 26 shows the brake fluid reservoir for the front brake of the Motorcycle. The brake fluid was observed to be of sufficient level and without contamination for operational purposes.

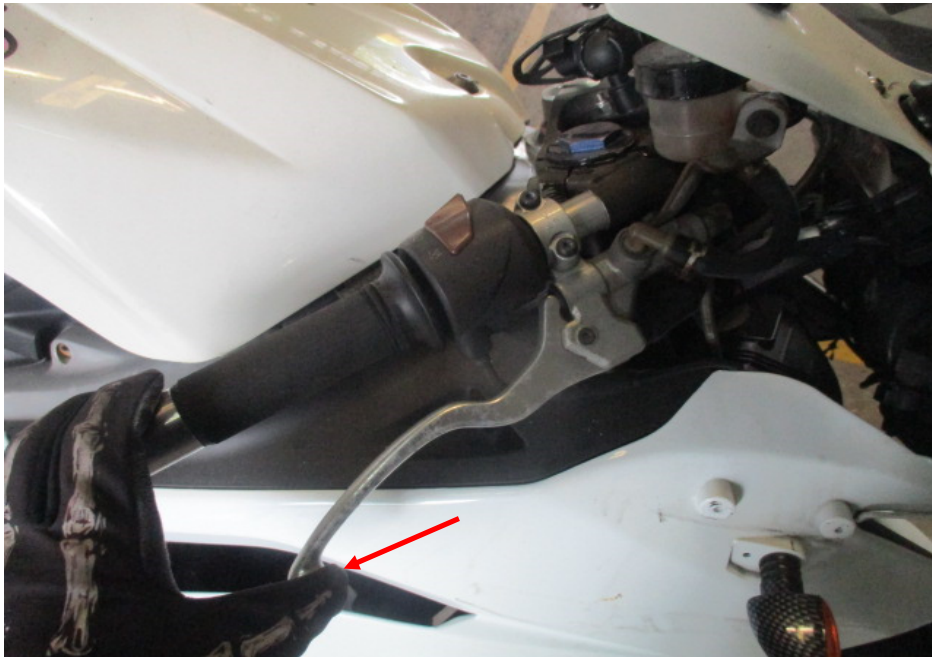
Photo 27 shows the front brake lever being depressed. There was some resistance felt (spongy like feel) upon pressing the front brake lever (arrowed). This would indicate that there is no leakage of pressure/vacuum in the brake system.

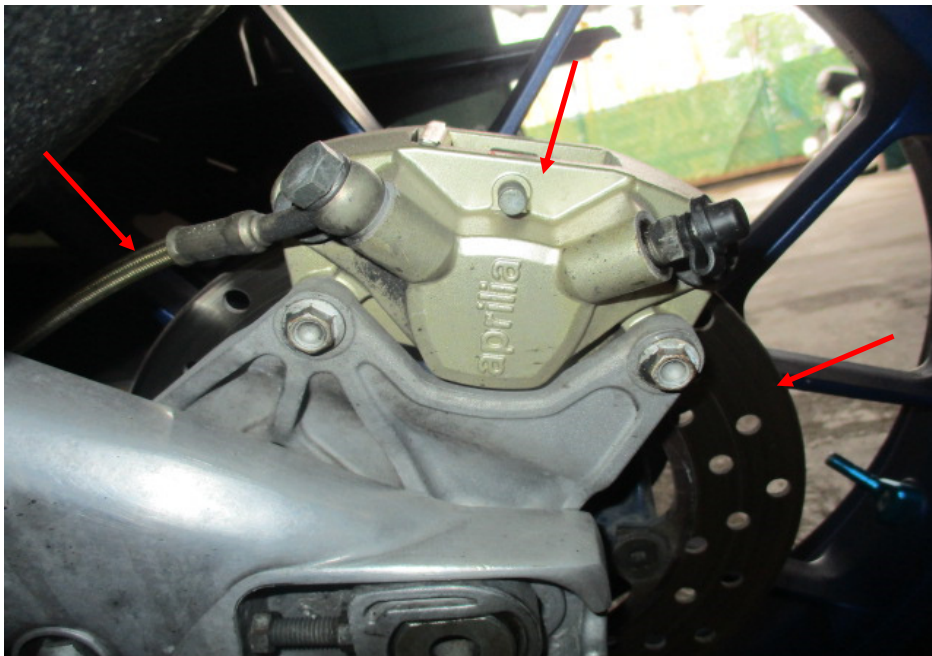
Photo 28 shows a close up view of the rear brake caliper, rear brake disc and rear brake hose (arrowed) of the Motorcycle, which are all part of the components in the hydraulic rear brake system of the Motorcycle. Our visual checks of these various components had revealed all to be intact with no visible damage. No leakage of brake fluid was also observed.
