Your Ref: TP/IP/69597/2019
Our Ref : CI/TPD19022287/N

19 December 2019

INSPECTION REPORT OF MOTORCYCLE JRR 7688

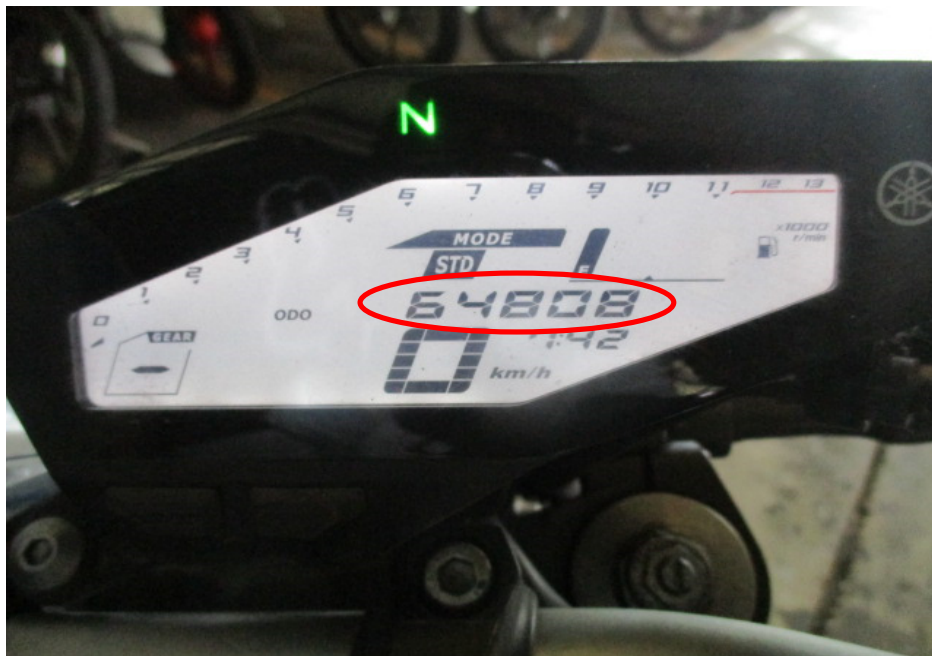
Photo 1 shows the speedometer gauge of the Motorcycle where the mileage recorded at the time of our inspection was 64, 808km (circled).

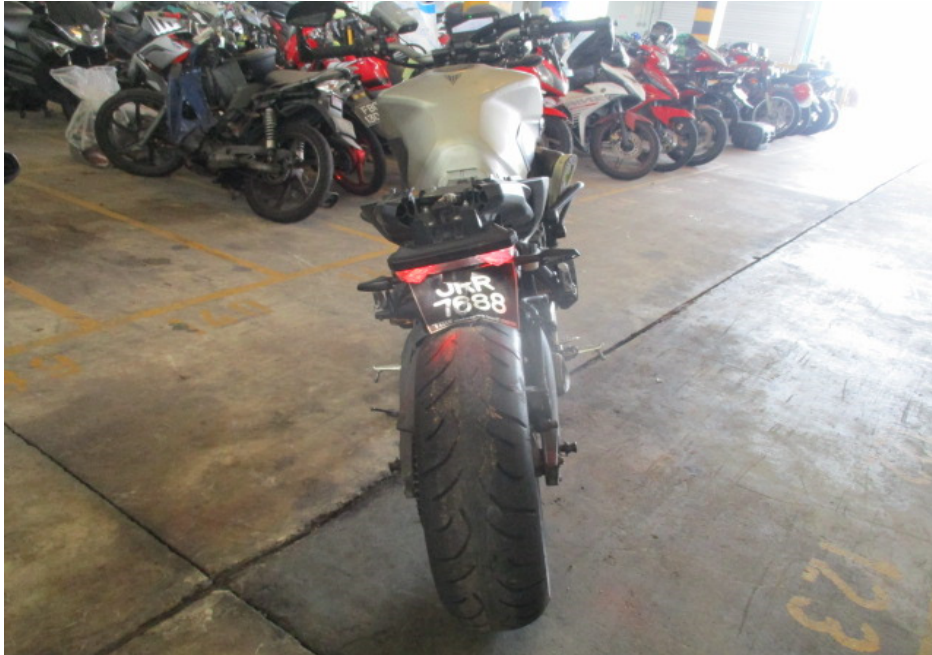
Photo 2 shows a general view of the rear portion of the Motorcycle at the time of our inspection. The Motorcycle was observed to have sustained damages all around.

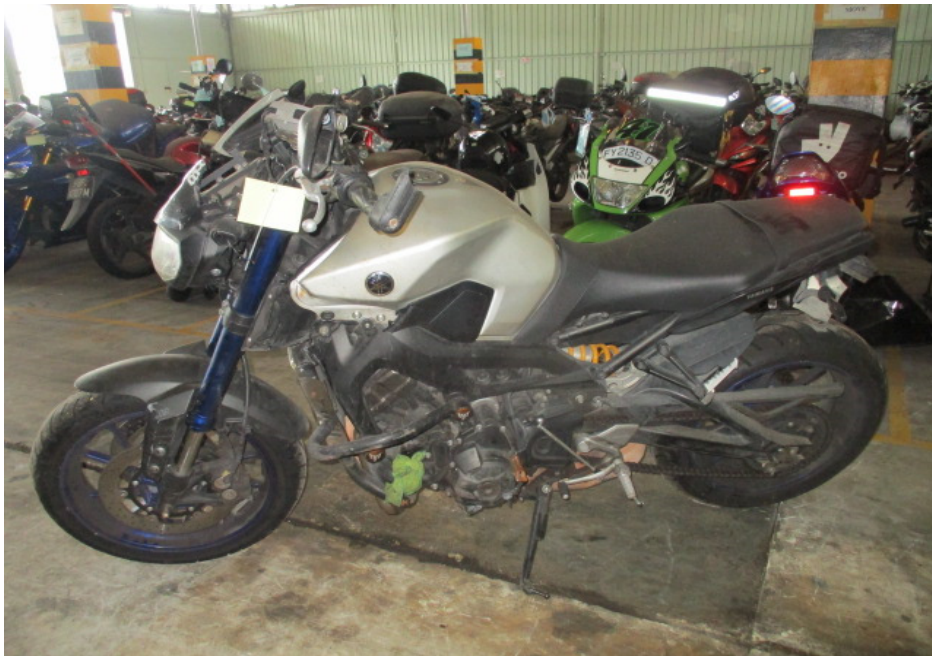
Photo 3 shows a general view of the left body of the Motorcycle at the time of our inspection. The Motorcycle was observed to have sustained damages all around.

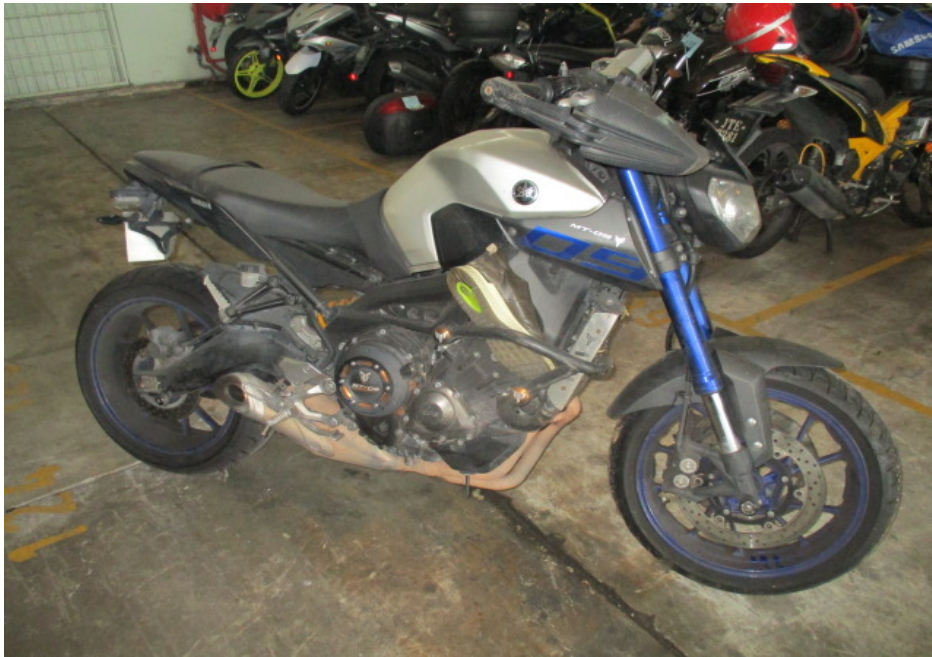
Photo 4 shows a general view of the right body of the Motorcycle at the time of our inspection. The Motorcycle was observed to have sustained damages all around. Amongst the body parts that were found to have been damaged include its windshield, front mudguard, left engine crash bar, left handlebar end, left side mirror, clutch lever, gear shift pedal, left front footrest and right rear side cover, amongst others.

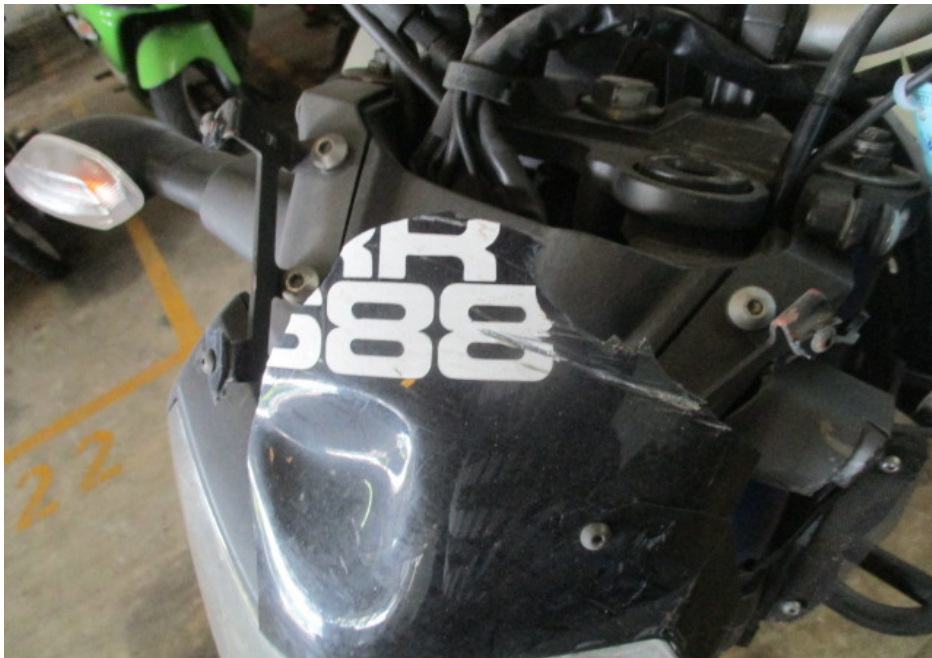
Photo 5 shows a close up view of the cracked windshield which was amongst the body parts of the Motorcycle that had sustained damage as a result of the accident.

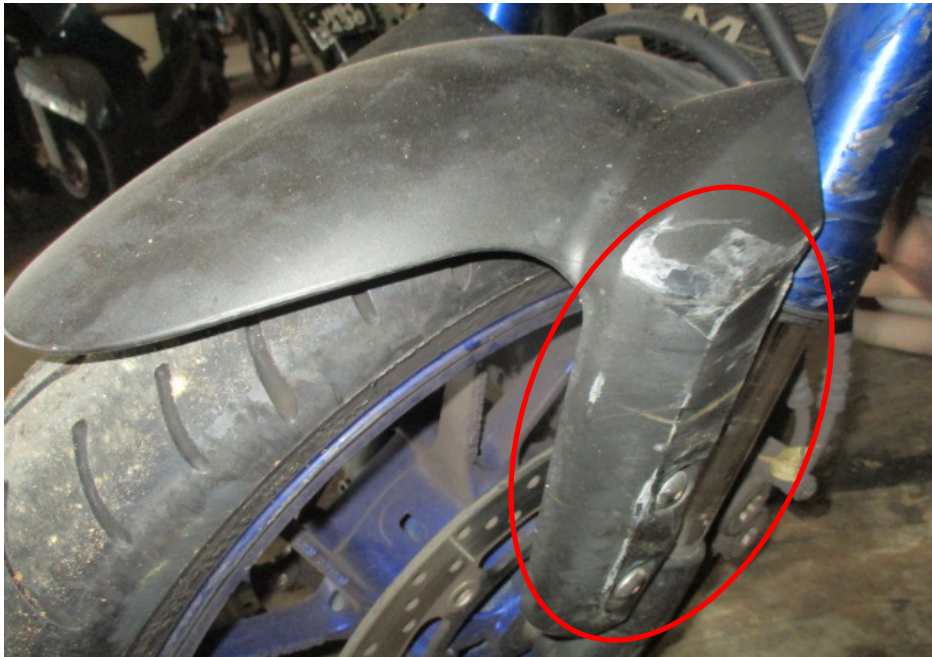
Photo 6 shows a closer view of the front mudguard which was amongst the body parts at the front body of the Motorcycle that had sustained damage as a result of the accident (circled).

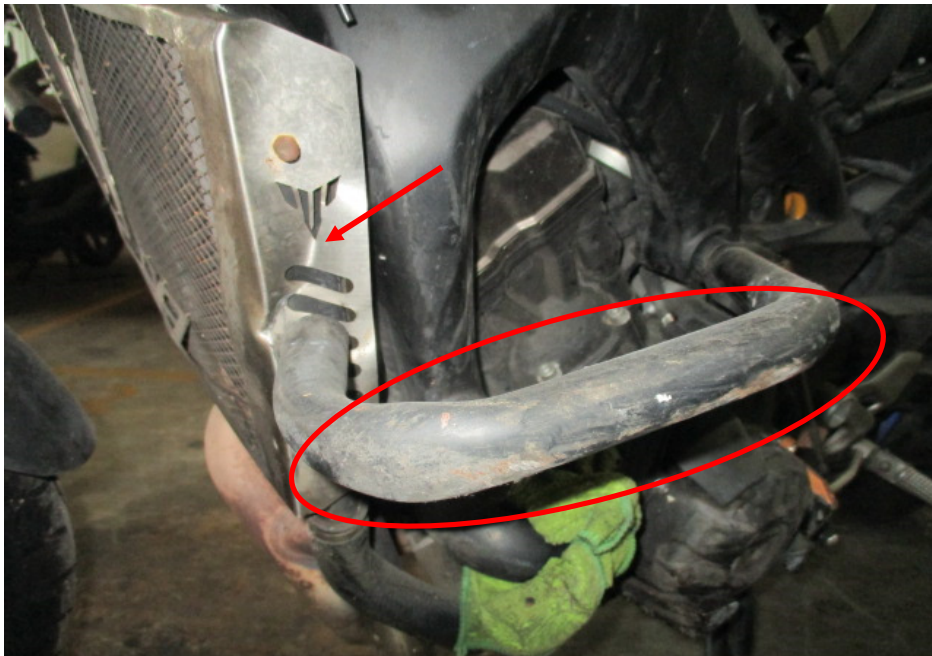
Photo 7 shows a closer view of the left engine crash bar (circled) and radiator guard (arrowed) of the Motorcycle that had sustained damage as a result of the accident.

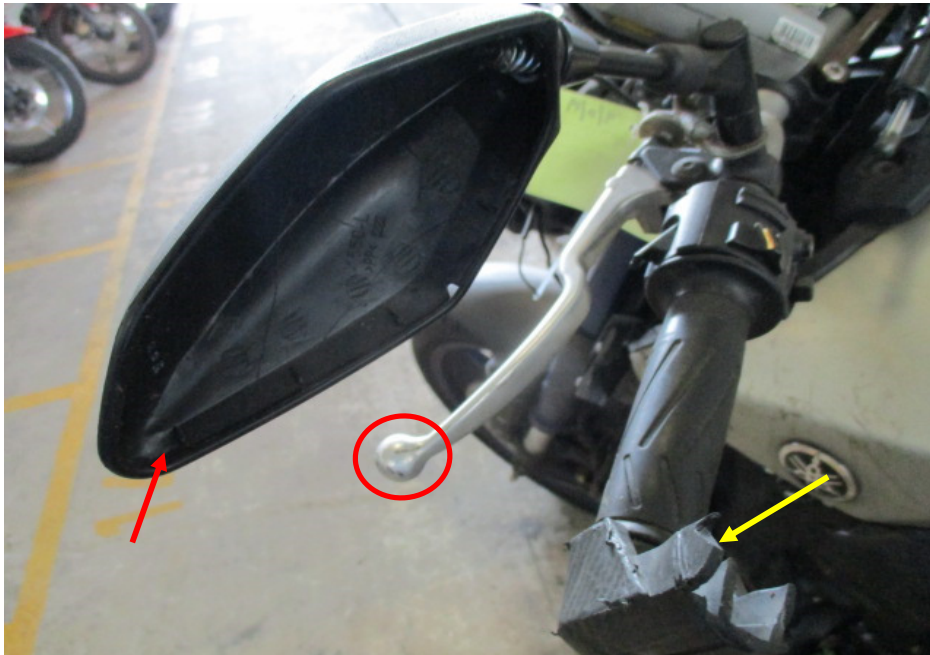
Photo 8 shows a closer view of the left handlebar end (yellow arrow), left side mirror (red arrow) and front brake lever (circled) which were amongst the body parts of the Motorcycle that had sustained damage as a result of the accident.

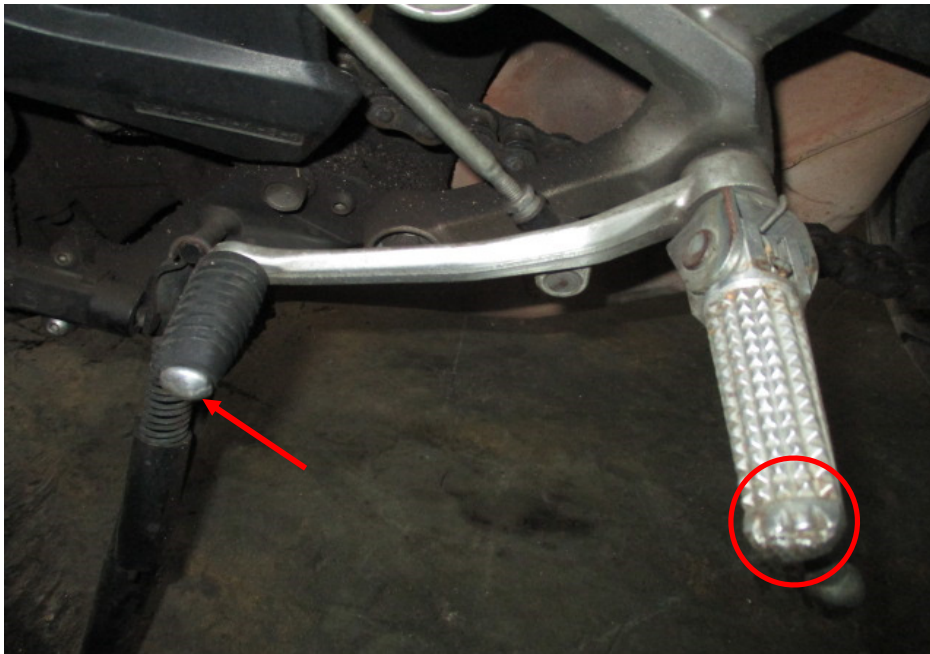
Photo 9 shows a closer view of the gear shift pedal (arrowed) and left front footrest (circled) which were amongst the body parts of the Motorcycle that had sustained damage as a result of the accident.

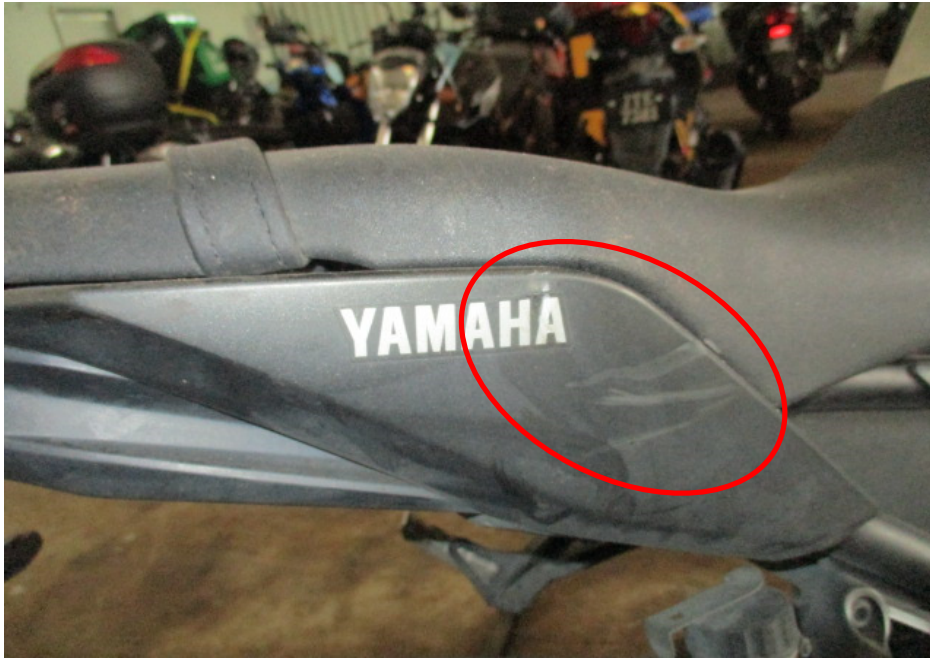
Photo 10 shows a closer view of the right rear side cover which was amongst the body parts of the Motorcycle that had sustained damages of grazing nature as a result of the accident (circled).

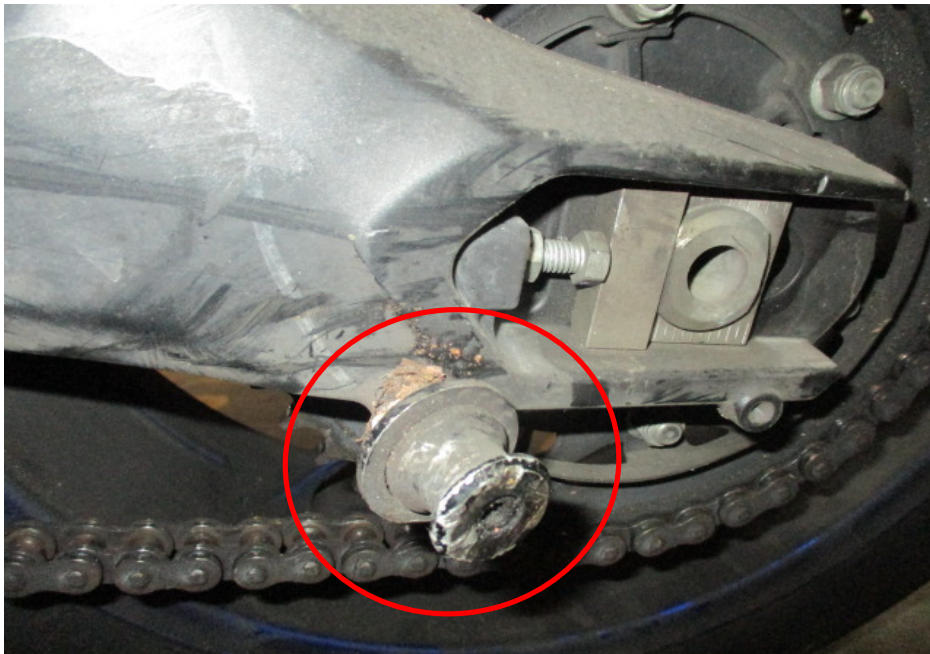
Photo 11 shows a closer view of the swingarm and left swingarm spool which were amongst the body parts of the Motorcycle that had sustained damages of grazing nature as a result of the accident (circled).

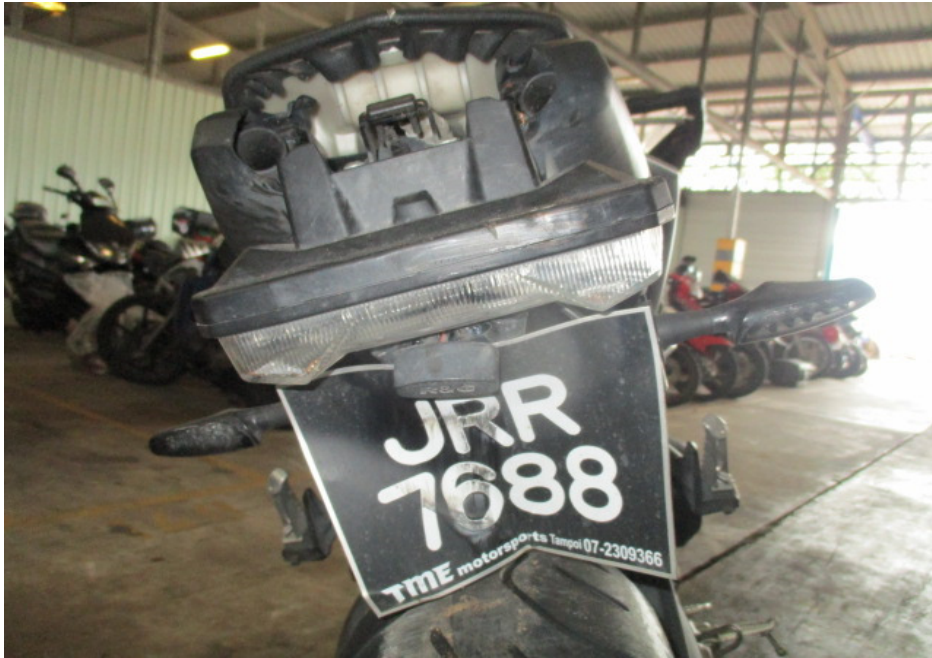
Photo 12 shows a closer view of the tail light and rear number plate of the Motorcycle that had sustained damage as a result of the accident.

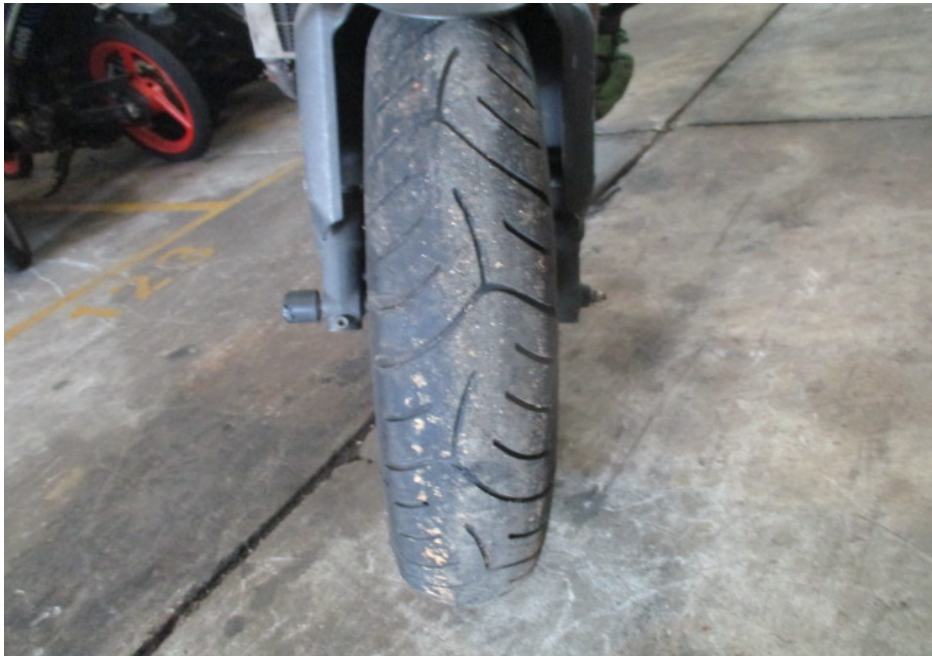
Photo 13 shows the condition of the Motorcycle's front tyre. The front tyre was observed to be in serviceable condition with remaining tread depth of approximately 3mm. There was no tear, burst mark(s) and/or punctured hole(s) on the sidewalls as well as across the tread of the front tyre.

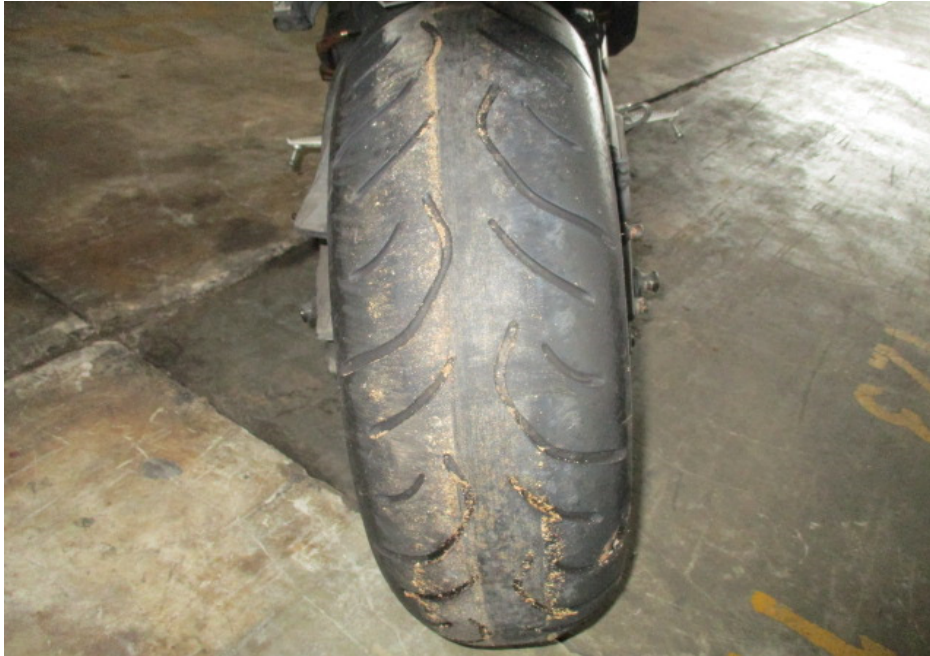
Photo 14 shows the condition of the Motorcycle's rear tyre. The rear tyre was observed to be in serviceable condition with remaining tread depth of approximately 3mm. The tyre was also observed to be sufficiently inflated for vehicular operation. We did not observe any tear, burst mark(s) and/or punctured hole(s) on the sidewalls as well as across the tread of the rear tyre.

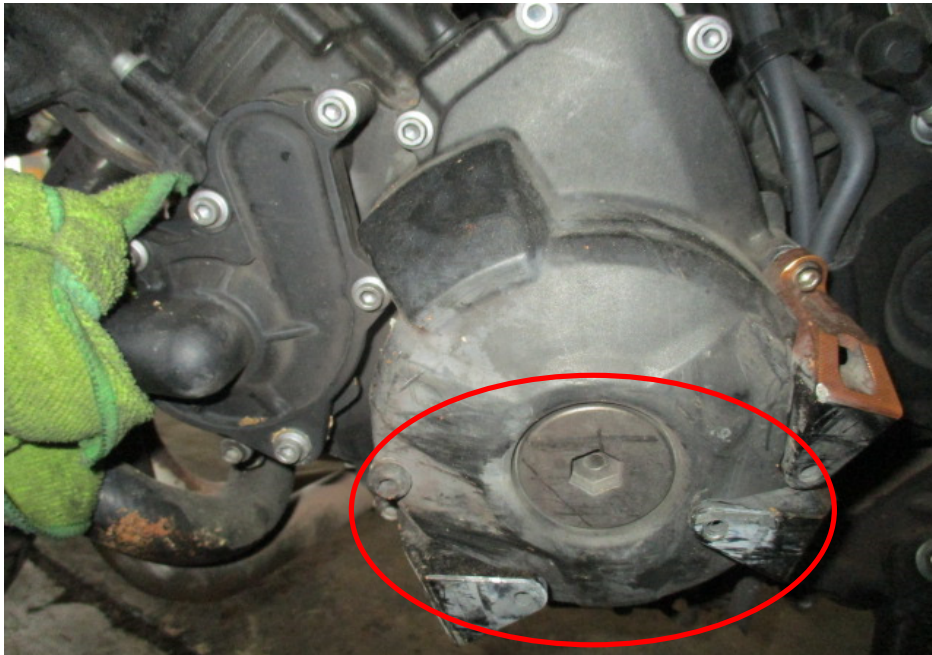
Photo 15 shows the left side of the engine of the Motorcycle at the time of our inspection. The various left engine components had sustained damage of grazing nature as a result of the accident (circled) however the engine components were still intact. There was also no fluid leak and/or fluid stain found around the left engine area of the Motorcycle.

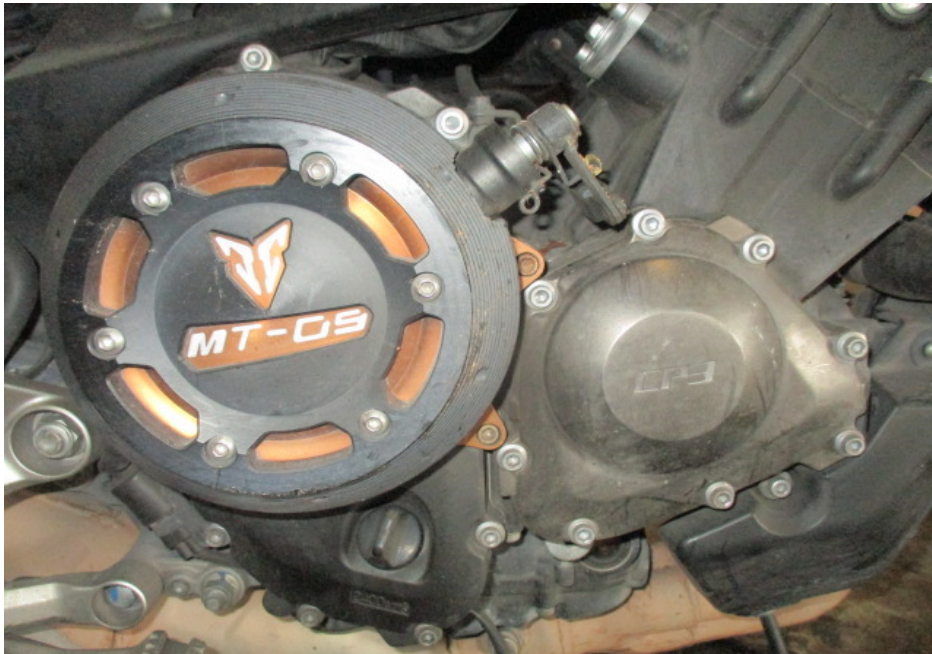
Photo 16 shows the right side of the engine of the Motorcycle at the time of our inspection. The various engine related parts and components were found to be intact with no visible damage. There was also no sign(s) or indication(s) of fluid leak observed around the right engine area of the Motorcycle.

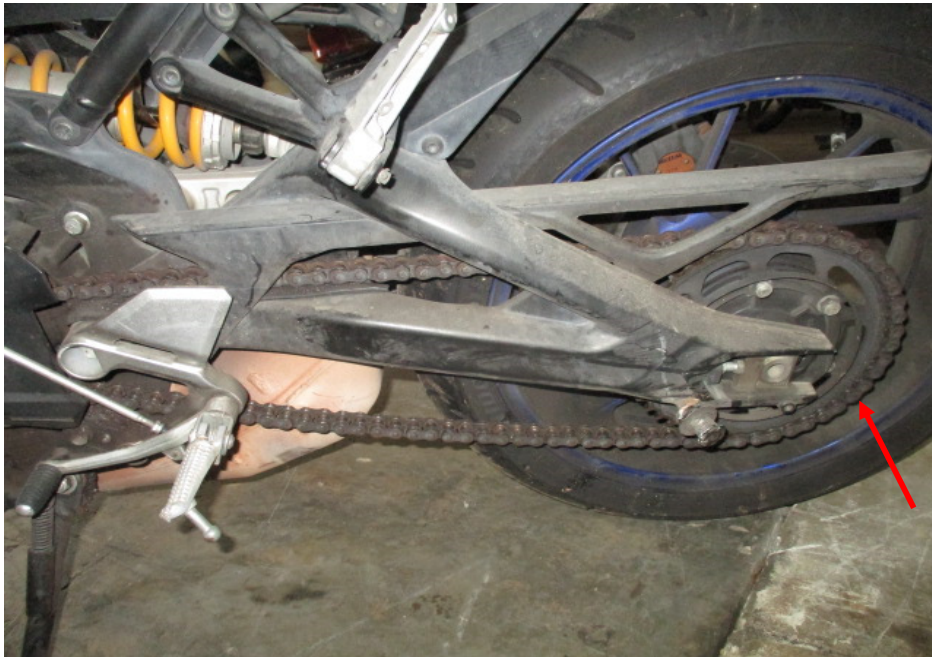
Photo 17 shows the general view of the gear train (arrowed) of the Motorcycle, which was observed to be intact with no misalignment. It was also adequately lubricated for operating purposes.

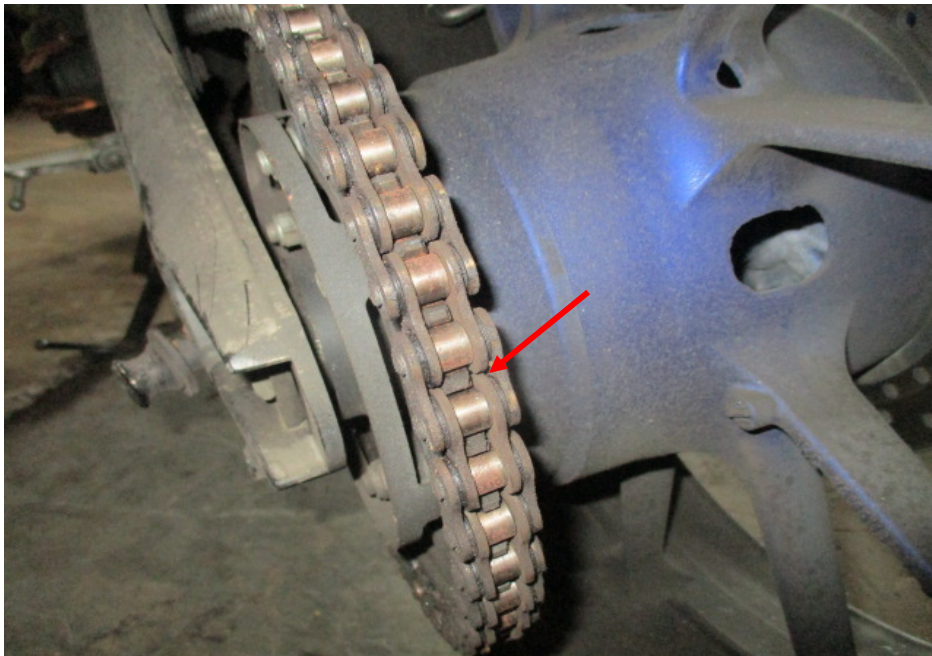
Photo 18 shows a closer view of the gear train (arrowed) of the Motorcycle, which was observed to be intact with no misalignment. It was also adequately lubricated for operating purposes.

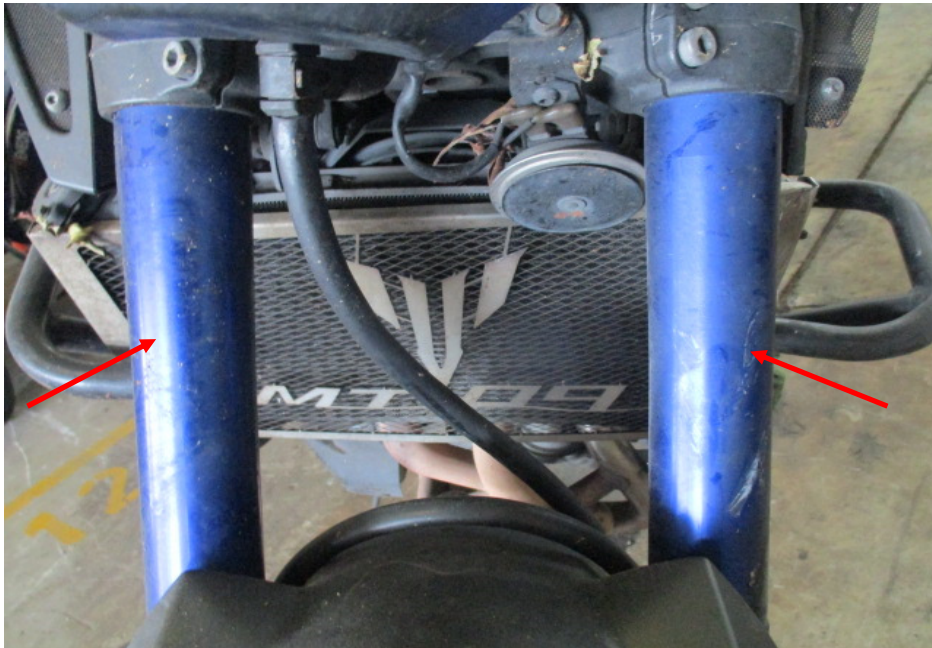
Photo 19 shows the front fork (arrowed) of the Motorcycle. The front fork and fork bracket of the Motorcycle were both found to be intact and undamaged. Turning the Motorcycle's handle bar towards the left and right did not produce any abnormal free play and/or resistance. The steering system of the Motorcycle was in serviceable condition at the time of our inspection.

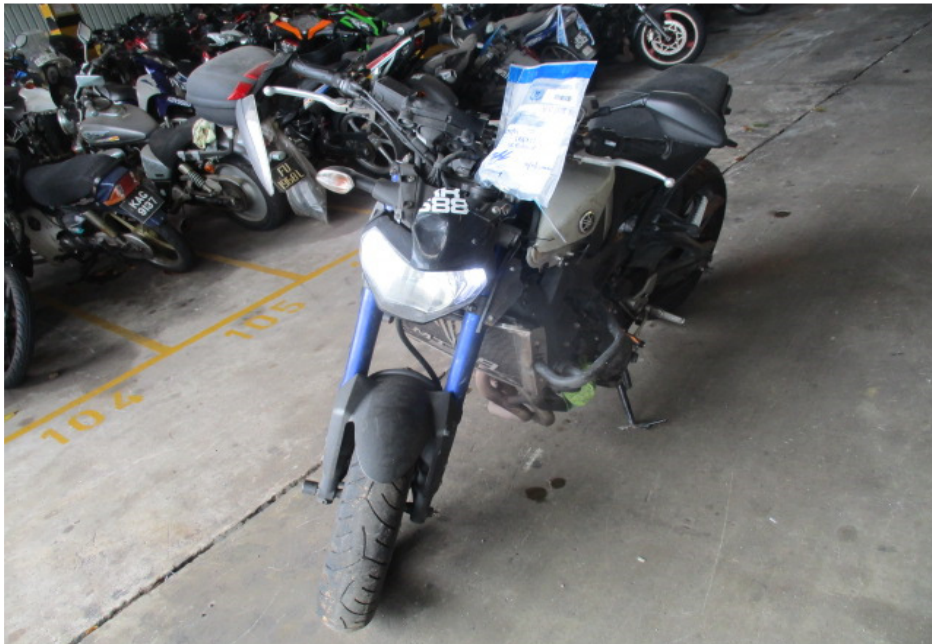
Photo 20 shows the front wheel of the Motorcycle turned towards its full left. Turning the Motorcycle's handle bar towards the left and right did not produce any abnormal free play and/or resistance. This would indicate that the steering system of the Motorcycle was in serviceable condition at the time of our inspection.

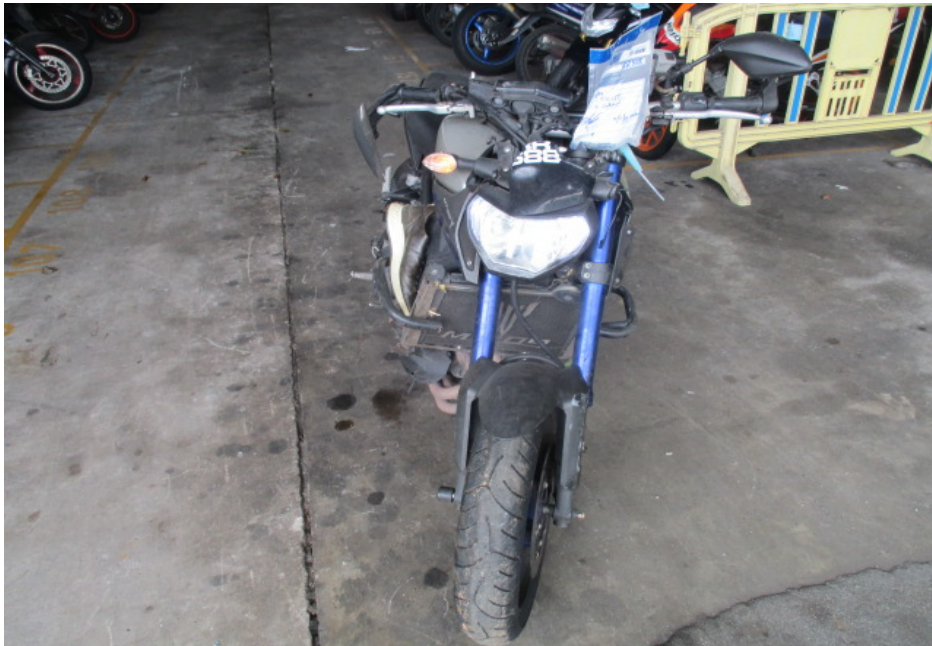
Photo 21 shows the front wheel of the Motorcycle turned towards its full right. Turning the Motorcycle's handle bar towards the left and right did not produce any abnormal free play and/or resistance. This would indicate that the steering system of the Motorcycle was in serviceable condition at the time of our inspection.

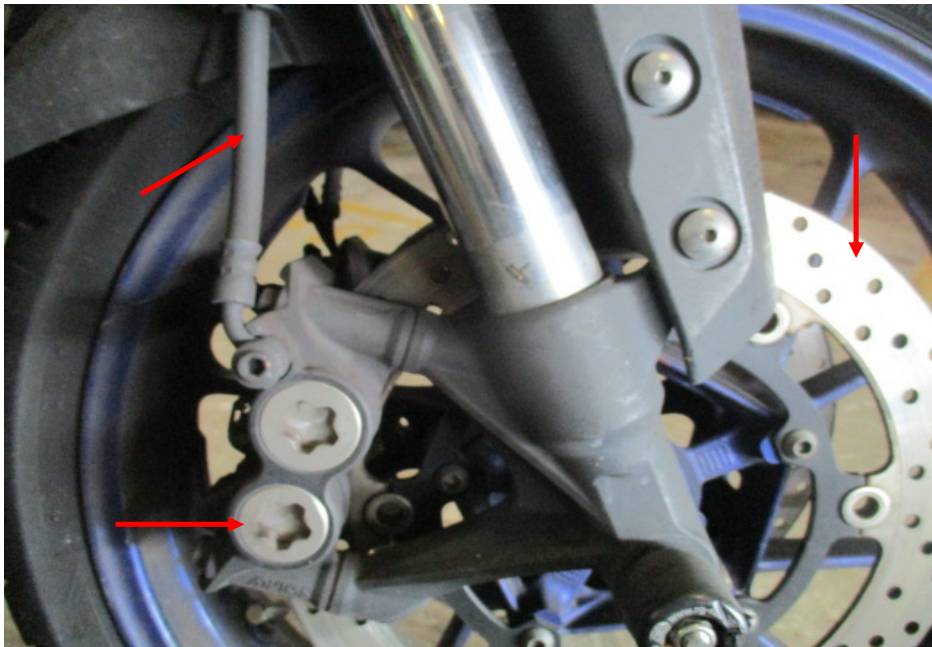
Photo 22 shows a close up view of the front brake caliper, front brake disc and front brake hose (arrowed) at the right side of the Motorcycle's front wheel, which are all part of the components in the hydraulic front brake system of the Motorcycle. Our visual checks of these various components had revealed all to be intact with no visible damage. No leakage of brake fluid was also observed.

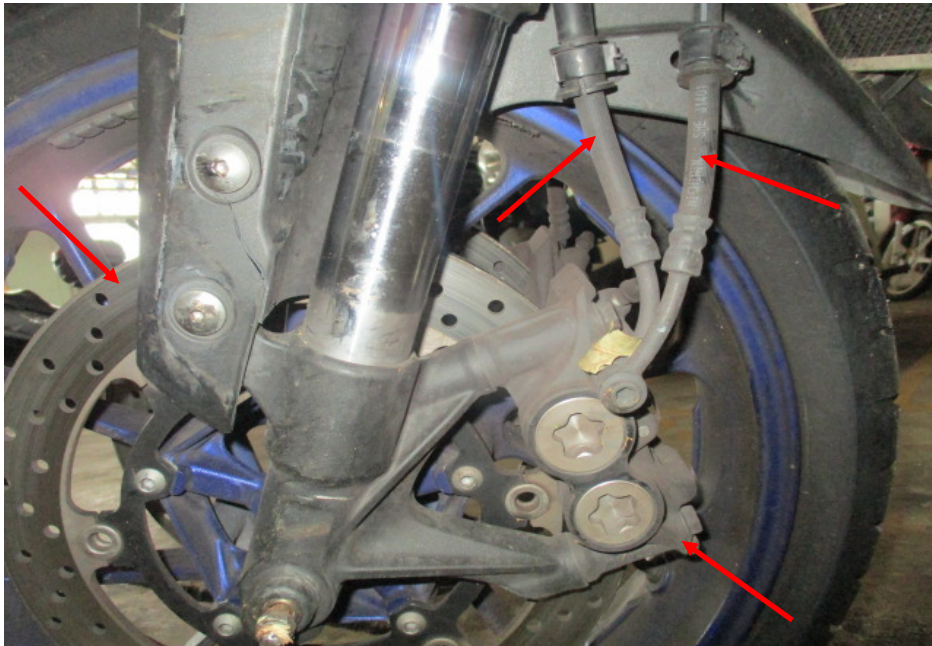
Photo 23 shows a close up view of the front brake caliper, front brake disc and front brake hose (arrowed) at the left side of the Motorcycle's front wheel, which are all part of the components in the hydraulic front brake system of the Motorcycle. Our visual checks of these various components had revealed all to be intact with no visible damage. No leakage of brake fluid was also observed.

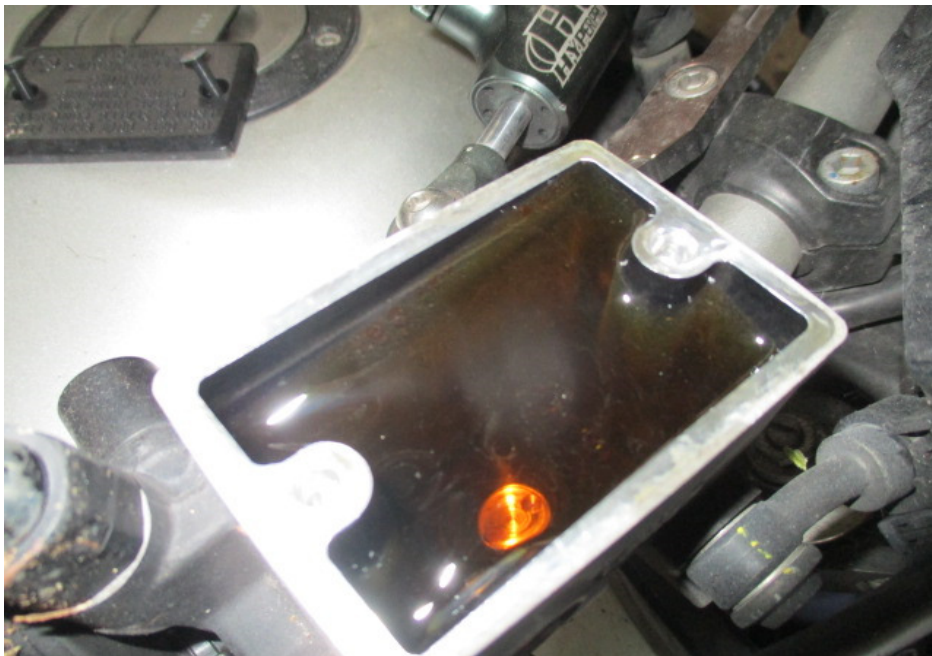
Photo 24 shows the brake fluid reservoir for the front brake of the Motorcycle. The brake fluid was observed to be of sufficient level and without contamination for operational purposes.

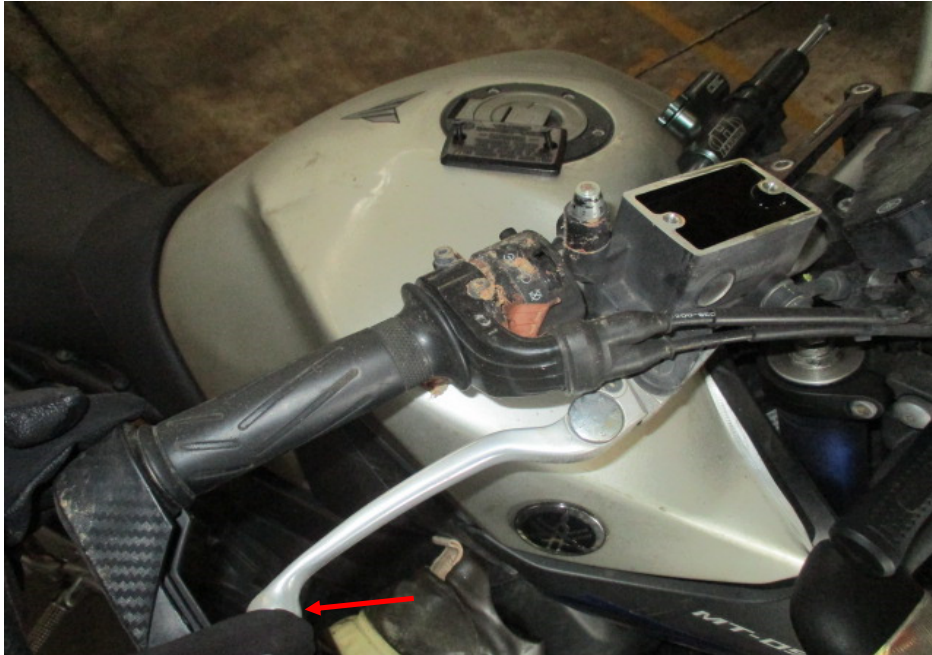
Photo 25 shows the front brake lever being depressed. There was some resistance felt (spongy like feel) upon pressing the front brake lever (arrowed). This would indicate that there is no leakage of pressure/vacuum in the brake system.

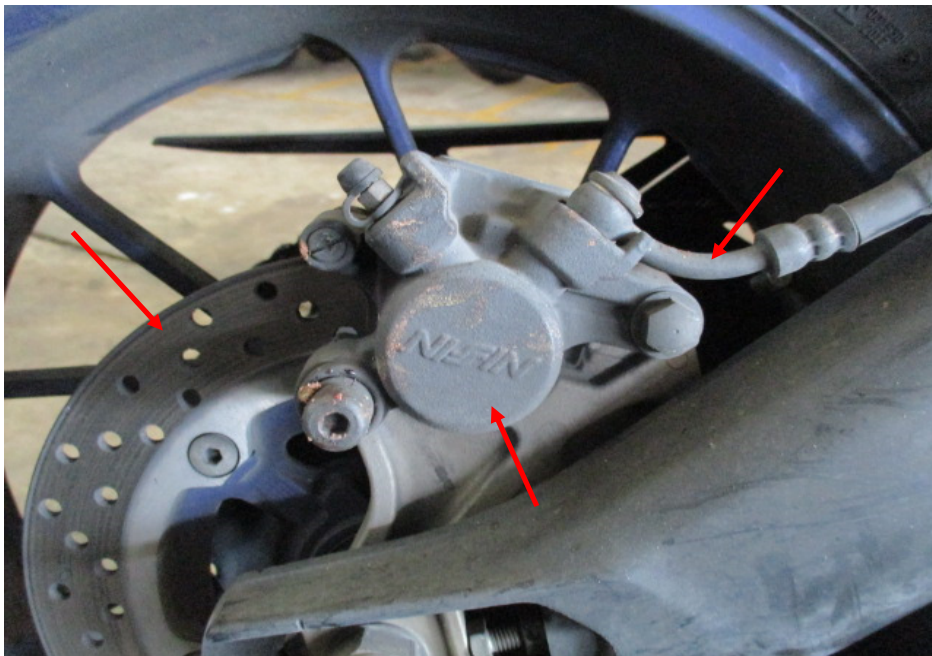
Photo 26 shows a close up view of the rear brake caliper, rear brake disc and rear brake hose (arrowed) of the Motorcycle, which are all part of the components in the hydraulic rear brake system of the Motorcycle. Our visual checks of these various components had revealed all to be intact with no visible damage. No leakage of brake fluid was also observed.
